**ASBESTOS MANAGEMENT PLAN
JUNEAU STATE OFFICE BUILDING
333 WILLOUGHBY AVE
JUNEAU, ALASKA
Program # 25RC013611, 25RC013612
AUGUST 5, 2024**

Alaska Department of Transportation and Public Facilities
333 Willoughby Ave.
Juneau, AK 99801

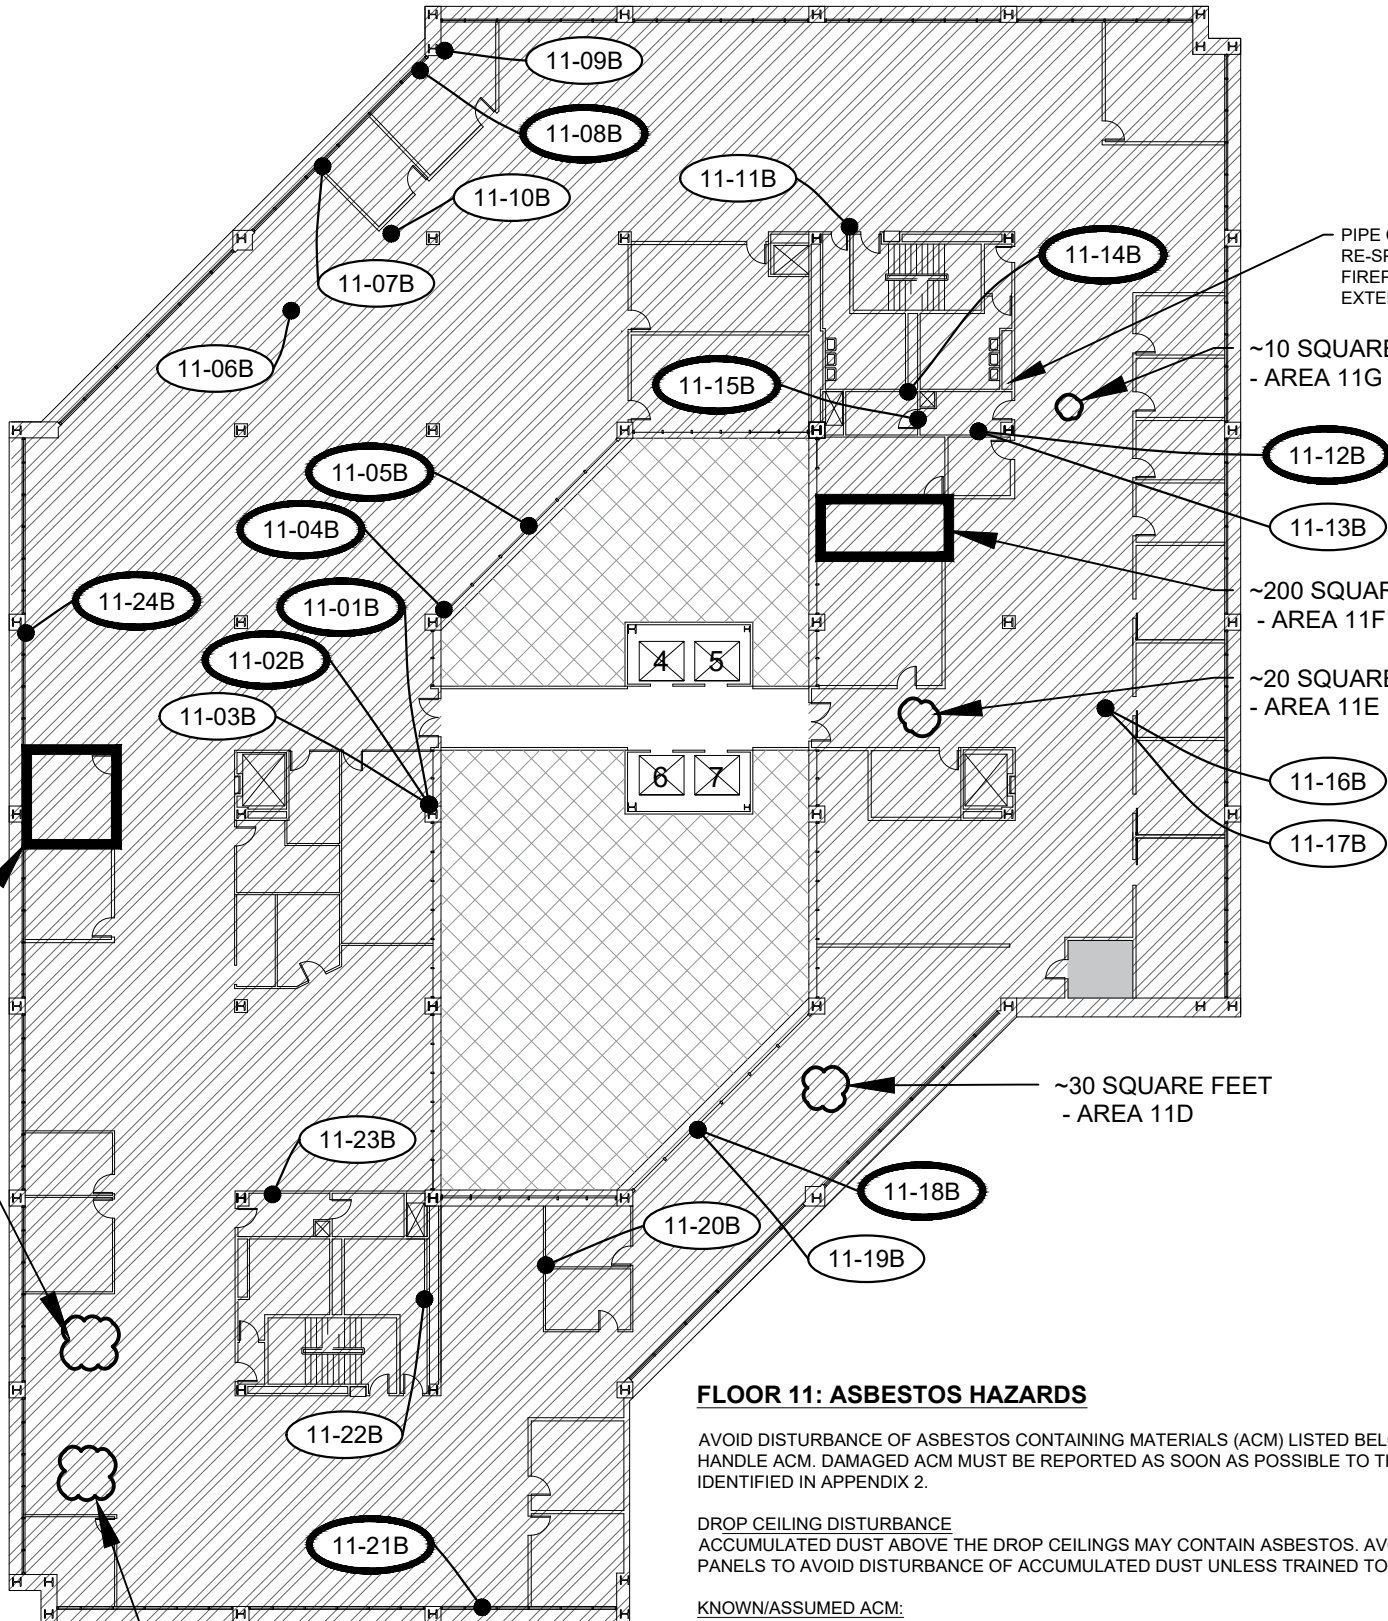
11-19B	Tan Carpet Mastic	ND
11-20B	Brown/Gray GWB	ND
11-21B	Brown/Gray GWB	ND
11-21B	White Joint Compound	3% Chrysotile
11-22B	Tan Ceiling Tile #3	ND
11-23B	Gray Floor Tile	ND
11-24B	Stone Pattern Flooring & Brown/Gray GWB	Both ND
11-24B	White Joint Compound	6% Chrysotile

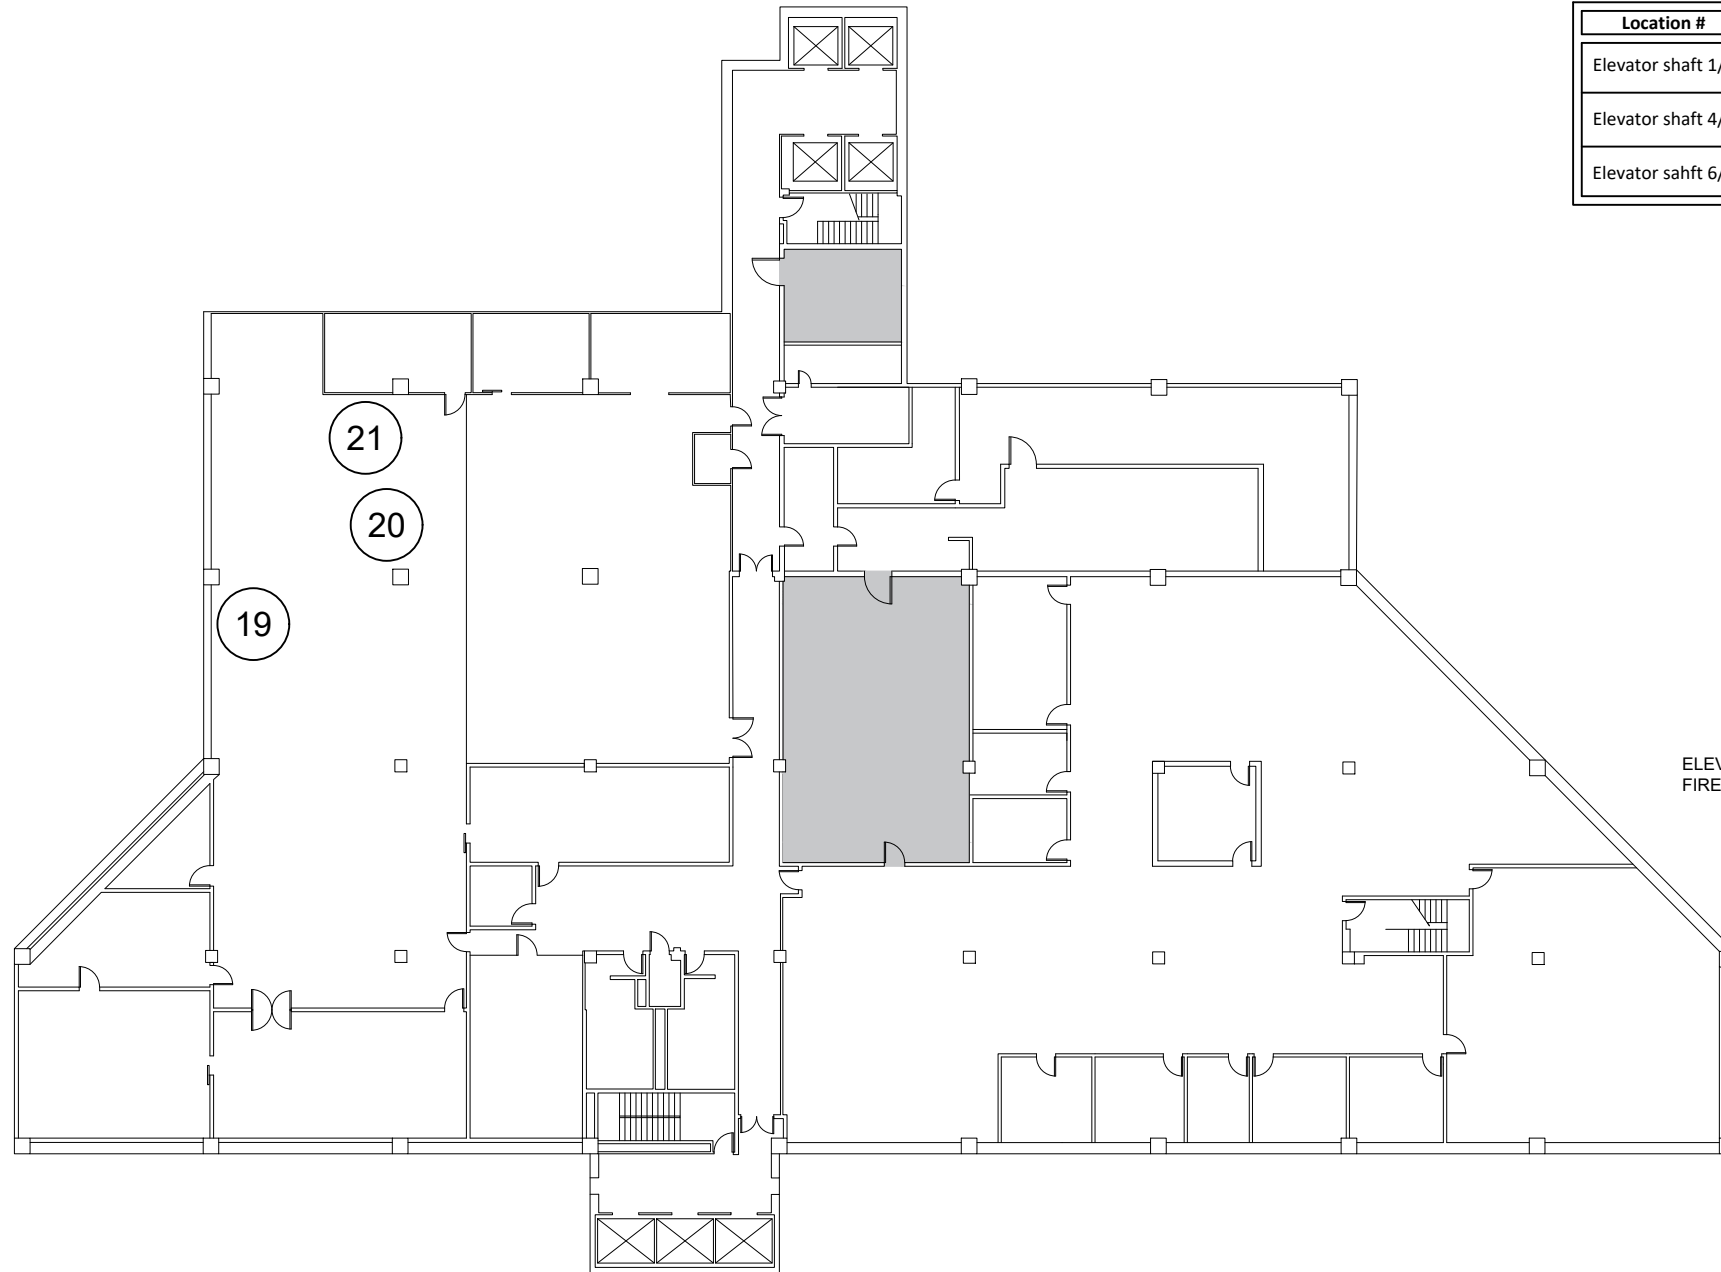
ELEVATOR 1/2: EXTENSIVE CRACKING OF ACM FIREPROOFING THROUGHOUT SHAFT

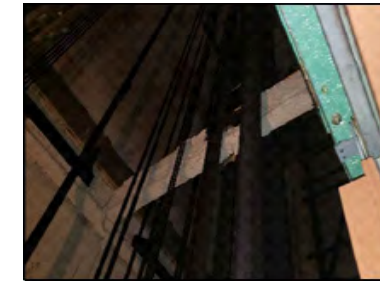
ELEVATOR 7/8: CRACKING AND MISSING PIECES OF ACM FIREPROOFING THROUGHOUT ELEVATOR SHAFT.

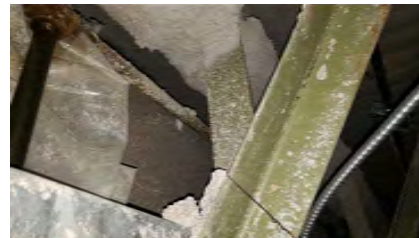
LOCATION 2: OVERSPRAY OF ACM FIREPROOFING IN CHANNEL IRON.

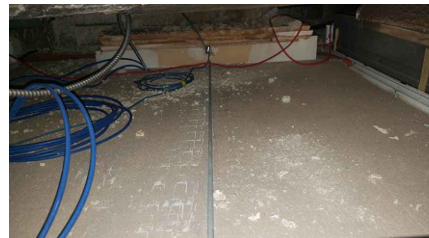
LOCATION 23: OVERSPRAY OF ACM FIREPROOFING IN CHANNEL IRON AND ON TOP OF CEILING TILES. ASSOCIATED ACM FIREPROOFING ON PANDECKING IN GOOD CONDITION.

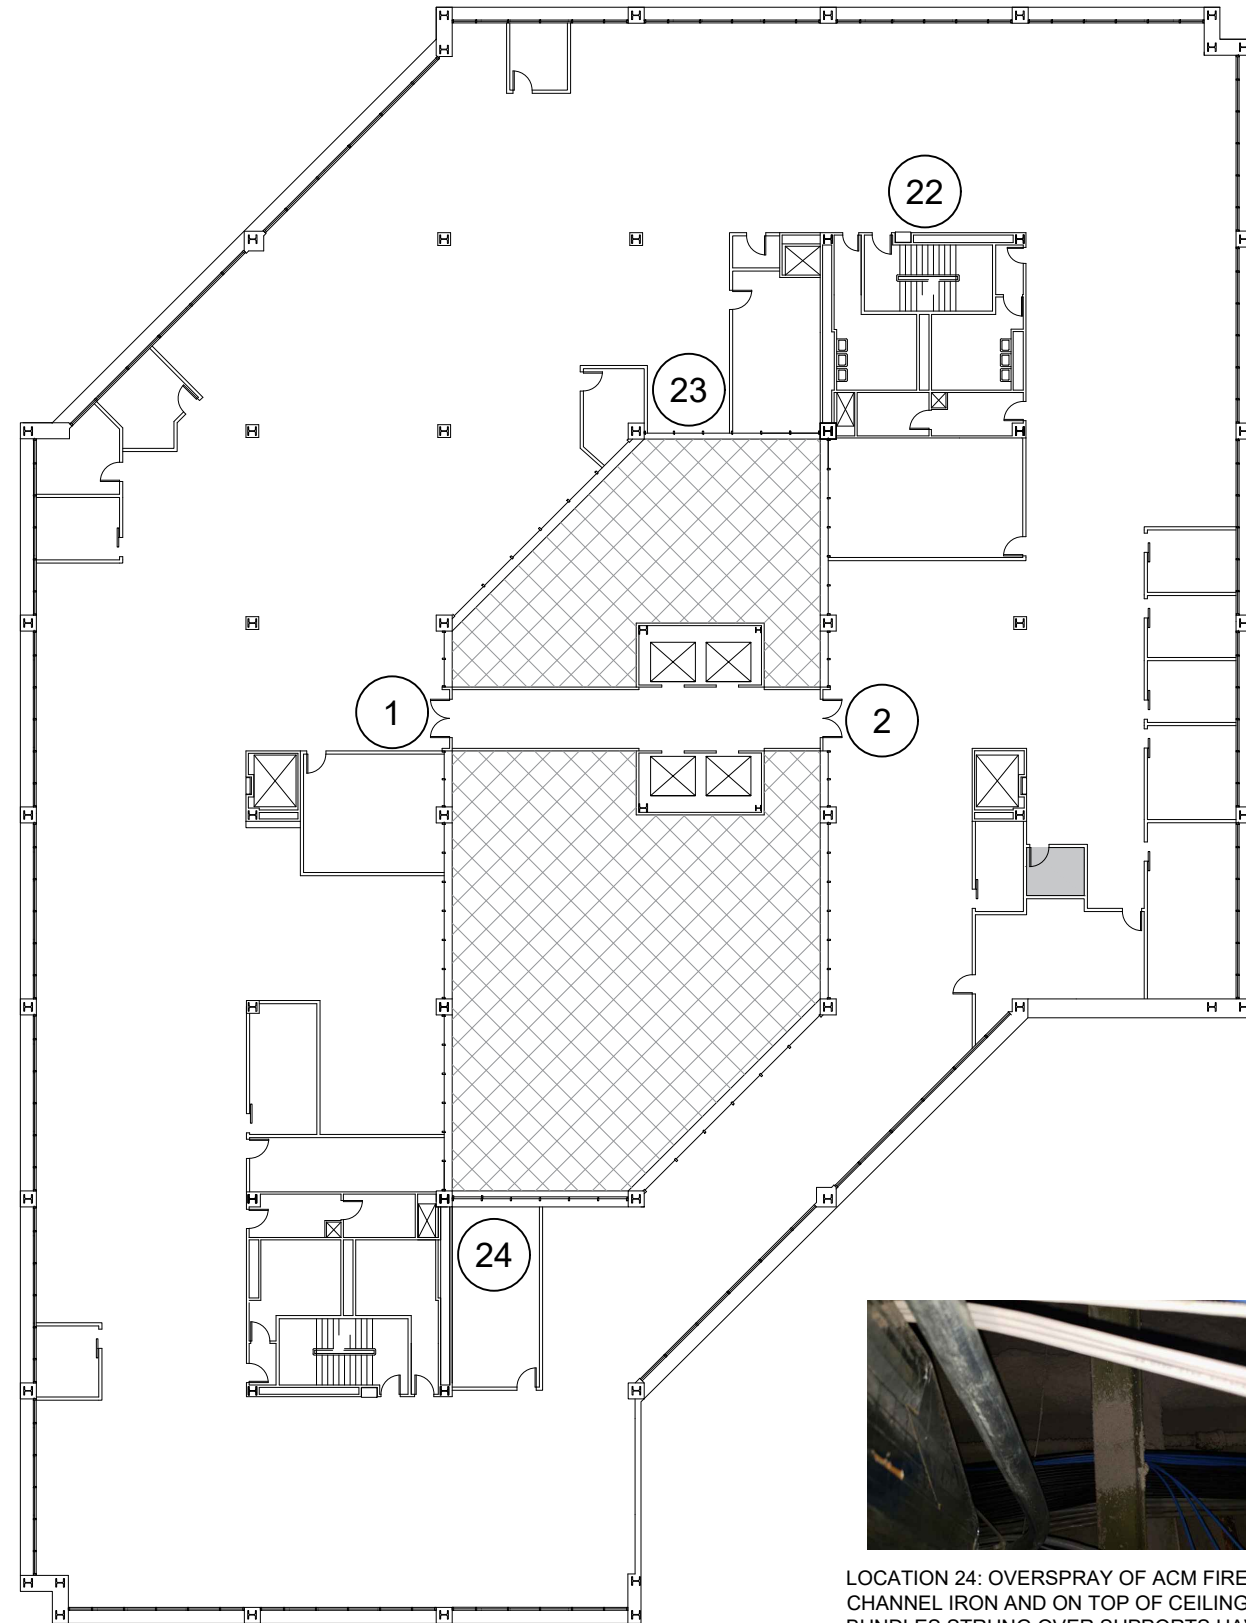
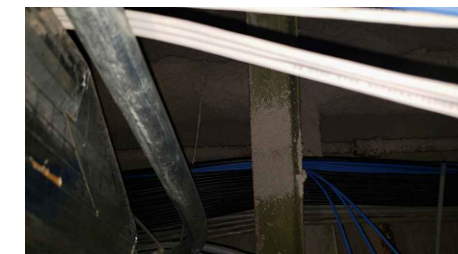
LOCATION 24: OVERSPRAY OF ACM FIREPROOFING IN CHANNEL IRON AND ON TOP OF CEILING TILES. CABLE BUNDLES STRUNG OVER SUPPORTS HAVE ACM FIREPROOFING ON THEM, DAMAGING THE ACM.

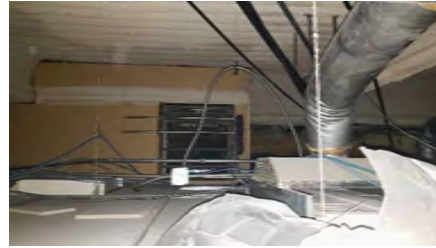
LOCATION 3: OVERSPRAY OF ACM FIREPROOFING ON TOP OF CEILING TILES. ACM FIREPROOFING IN GOOD CONDITION.

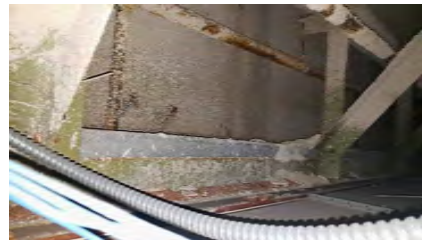
LOCATION 4: OVERSPRAY OF ACM FIREPROOFING ON TOP OF CEILING TILES. ACM FIREPROOFING IN GOOD CONDITION.

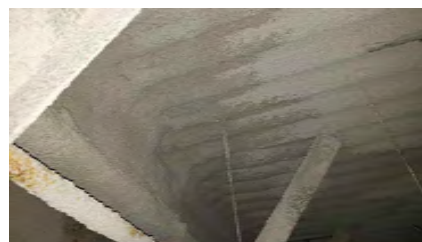
LOCATION 4: ACM FIREPROOFING ON PANDECKING IN GOOD CONDITION.

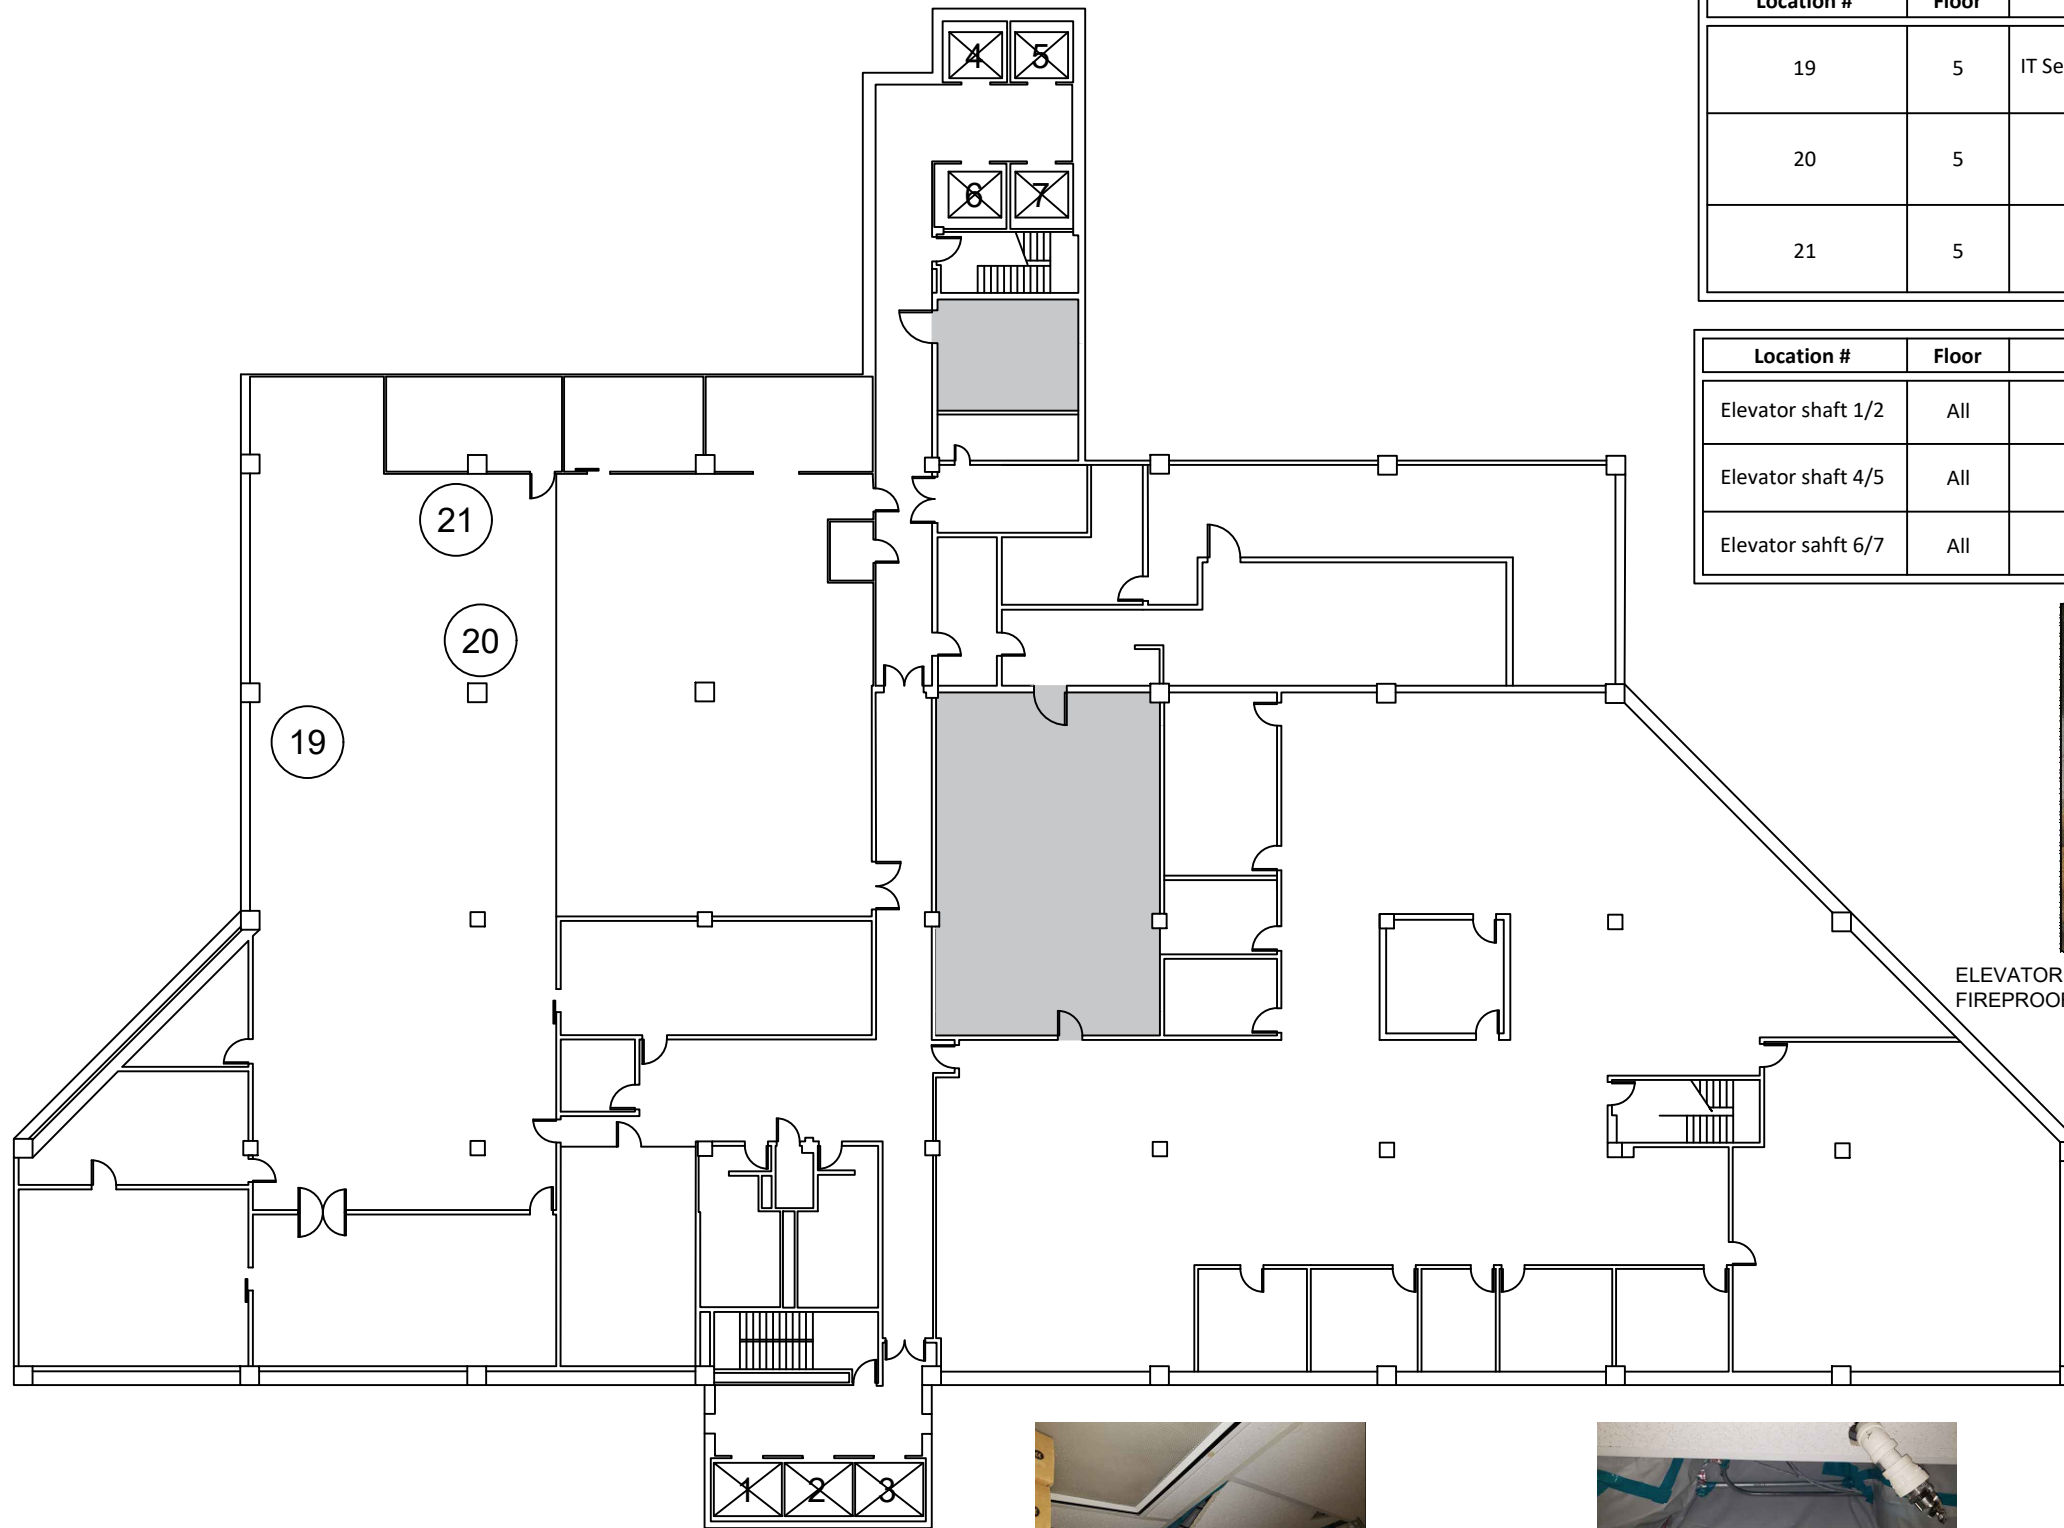
Location #	Floor	Area Description	Damage Description
19	5	IT Server Room, near air sample 5-13	Water damage from pipe leaks? Near a halon fire suppression globe. Tiles screwed in place, could not assess spray on ACM
20	5	IT Server Room	Water damage from pipe leaks? Near a halon fire suppression globe. Tiles screwed in place, could not assess spray on ACM
21	5	IT Server Room	Water damage from pipe leaks? Near a halon fire suppression globe. Tiles screwed in place, could not assess spray on ACM

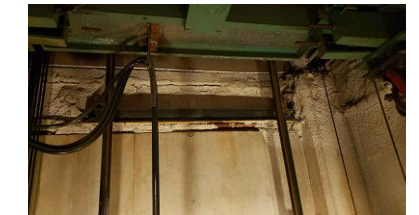
ELEVATOR 4/5: CRACKING AND MISSING PIECES OF ACM FIREPROOFING THROUGHOUT ELEVATOR SHAFT.

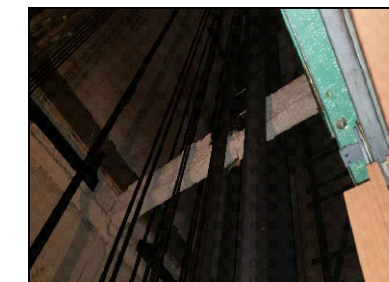
ELEVATOR 7/8: CRACKING AND MISSING PIECES OF ACM FIREPROOFING THROUGHOUT ELEVATOR SHAFT.

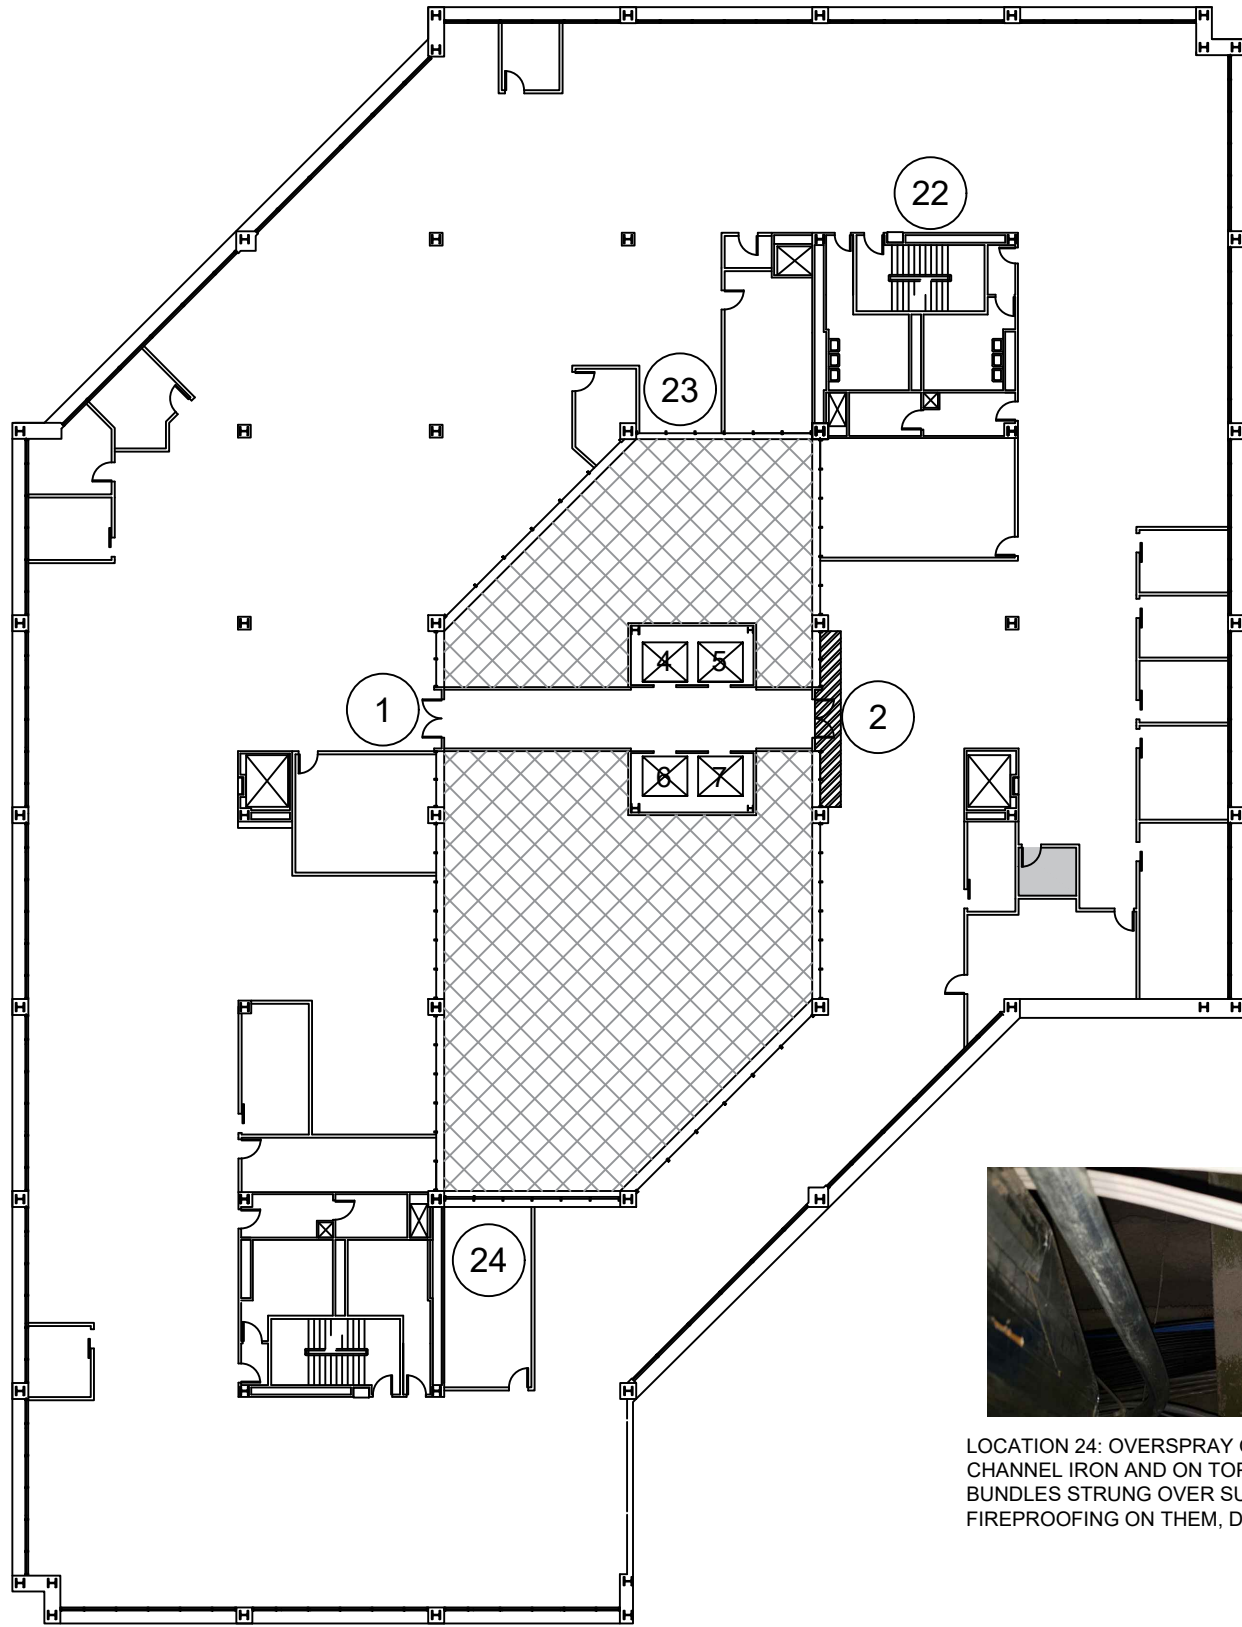
LOCATION 1: OVERSPRAY OF ACM FIREPROOFING IN CHANNEL IRON.

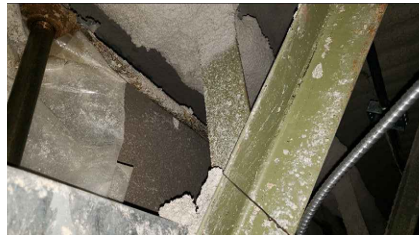
LOCATION 2: OVERSPRAY OF ACM FIREPROOFING IN CHANNEL IRON.

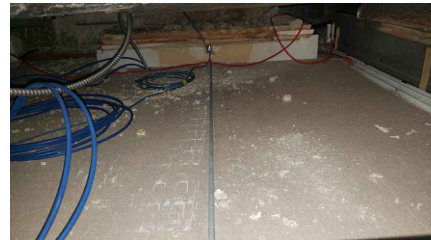
LOCATION 23: OVERSPRAY OF ACM FIREPROOFING IN CHANNEL IRON AND ON TOP OF CEILING TILES. ASSOCIATED ACM FIREPROOFING ON PANDECKING IN GOOD CONDITION.

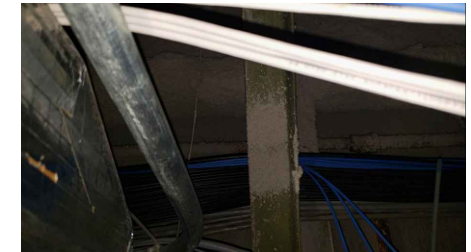
LOCATION 24: OVERSPRAY OF ACM FIREPROOFING IN CHANNEL IRON AND ON TOP OF CEILING TILES. CABLE BUNDLES STRUNG OVER SUPPORTS HAVE ACM FIREPROOFING ON THEM, DAMAGING THE ACM.

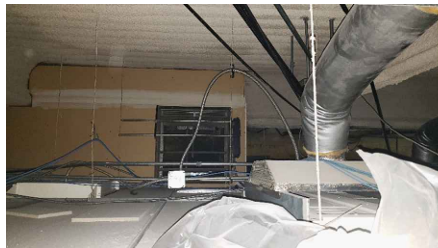
LOCATION 3: OVERSPRAY OF ACM FIREPROOFING ON TOP OF CEILING TILES. ACM FIREPROOFING IN GOOD CONDITION.

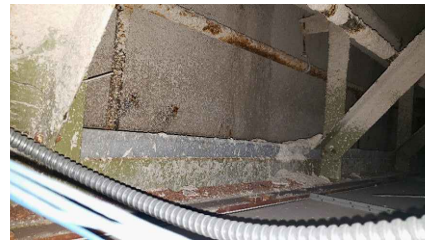
LOCATION 4: OVERSPRAY OF ACM FIREPROOFING ON TOP OF CEILING TILES. ACM FIREPROOFING IN GOOD CONDITION.

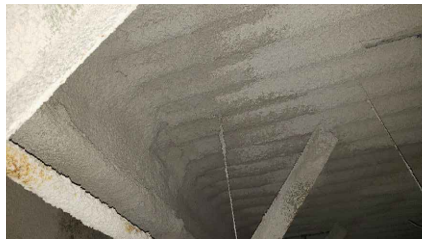
LOCATION 4: ACM FIREPROOFING ON PANDECKING IN GOOD CONDITION.

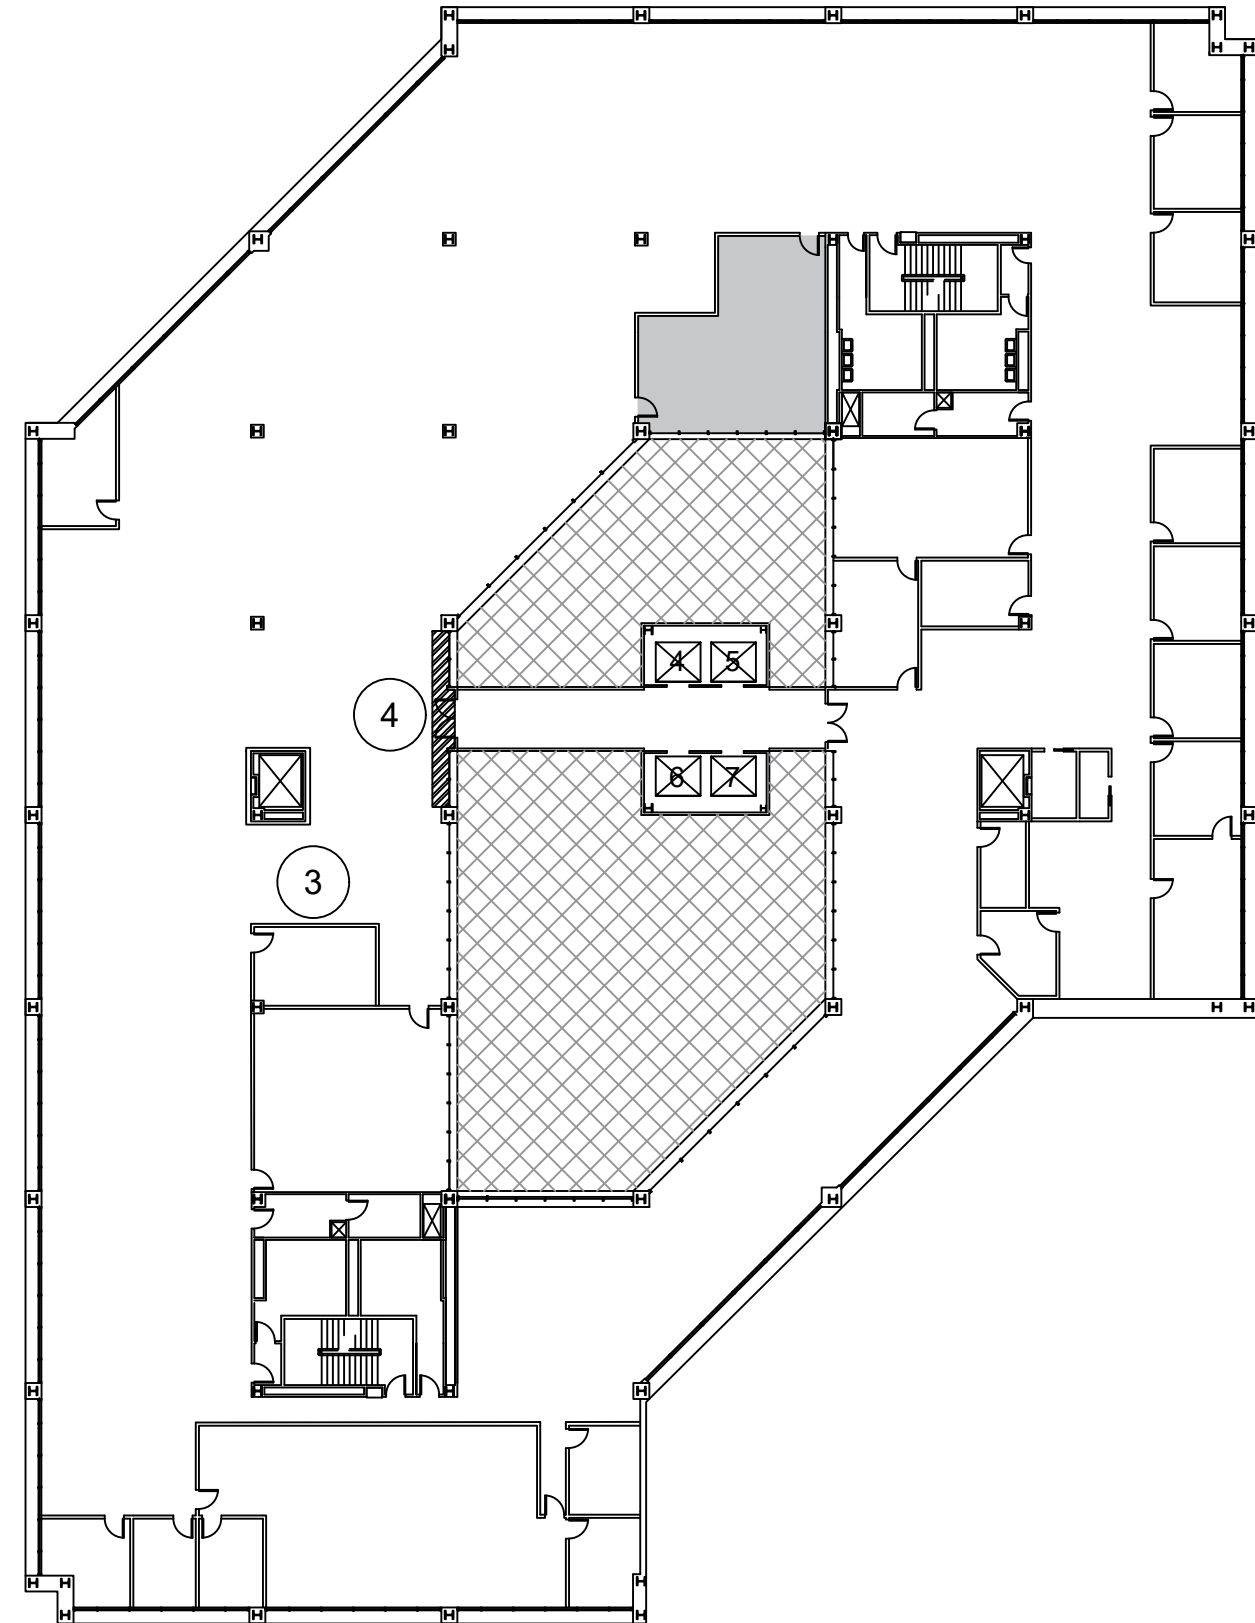
ENVIRONMENT, ENERGY, HEALTH & SAFETY CONSULTANTS
 2400 College Road, Fairbanks, AK. 99709, 907-452-5688
 3105 Lakeshore Dr., Anchorage, AK. 99517 907-222-2445
 5438 Shaune Dr., Juneau, AK. 99801 907-586-6813

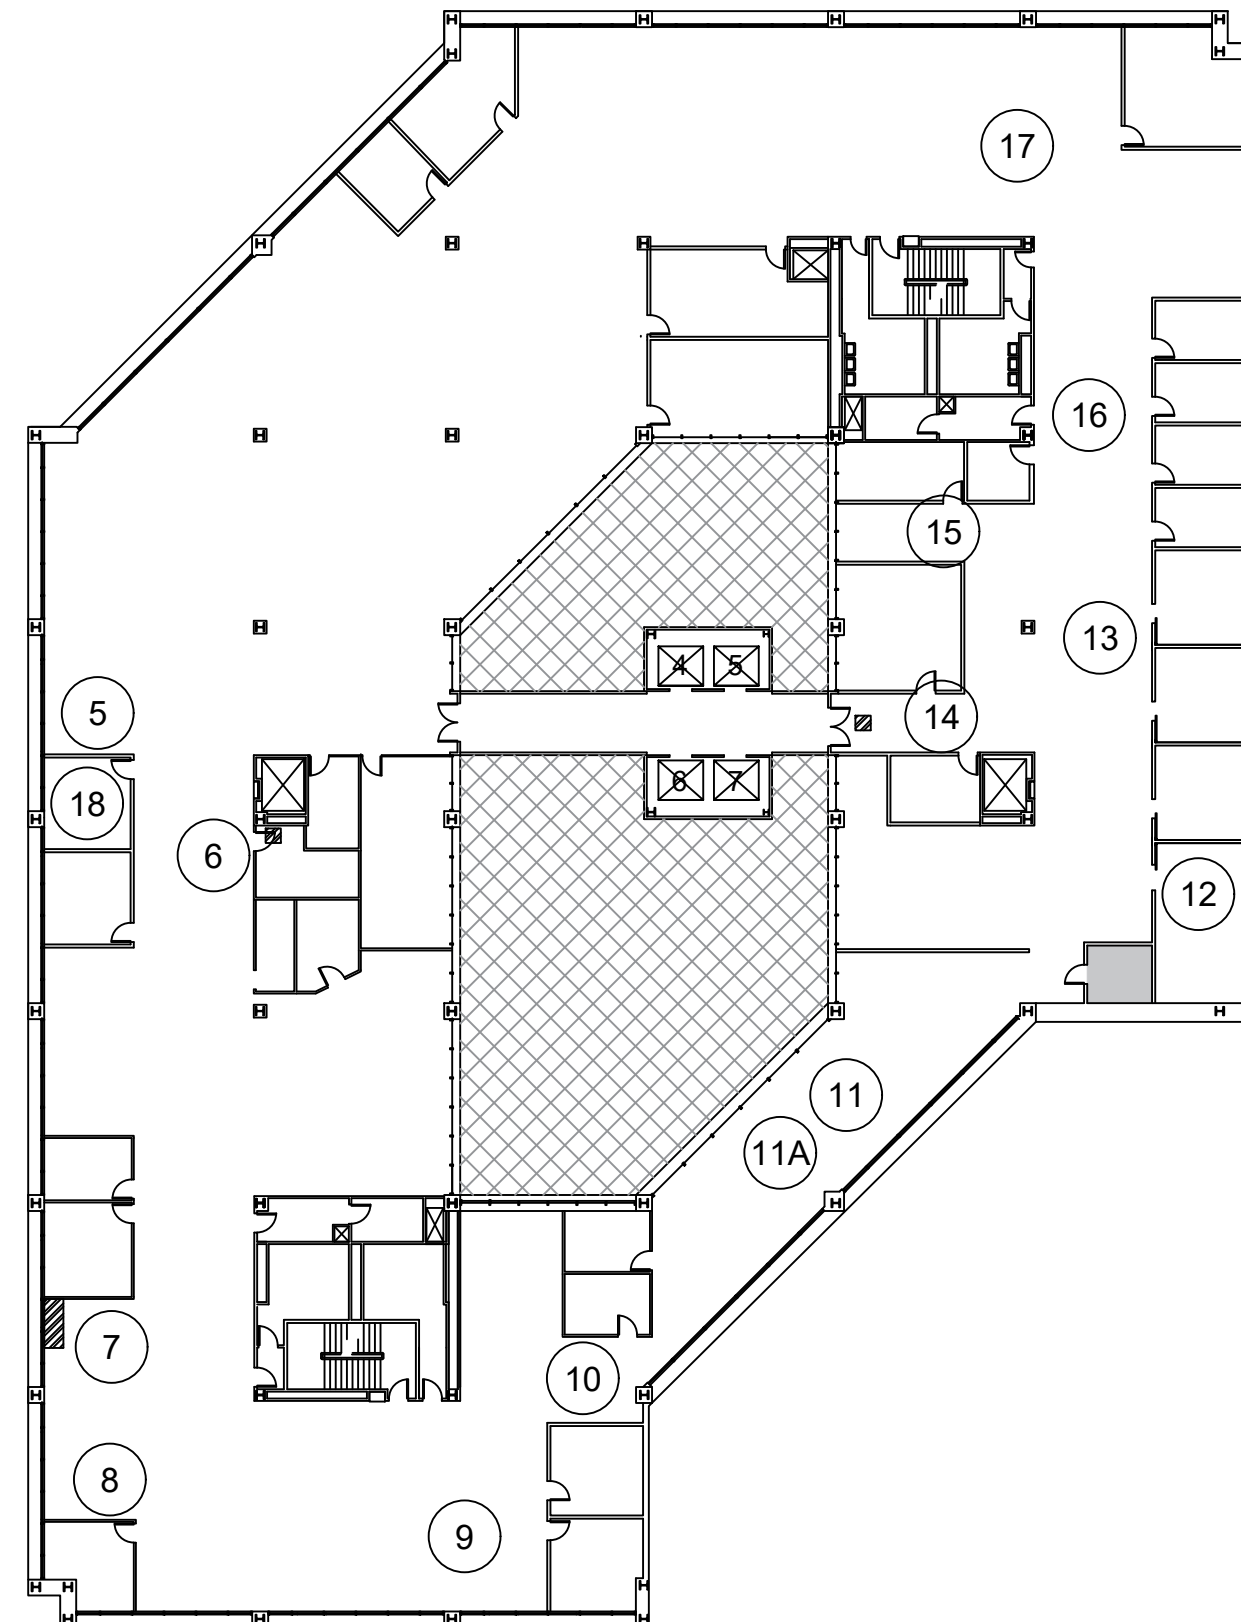
ENVIRONMENT, ENERGY, HEALTH & SAFETY CONSULTANTS
 2400 College Road, Fairbanks, AK. 99709, 907-452-5688
 3105 Lakeshore Dr., Anchorage, AK. 99517 907-222-2445
 5438 Shaune Dr., Juneau, AK. 99801 907-586-6813

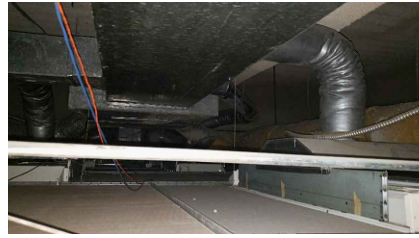
LOCATION 5: OVERSPRAY OF ACM FIREPROOFING ON TOP OF CEILING TILES. ACM FIREPROOFING ON PANDECKING IN GOOD CONDITION.

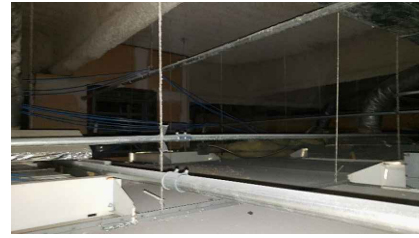
LOCATION 6: OVERSPRAY OF ACM FIREPROOFING ON TOP OF CEILING TILES. ACM FIREPROOFING ON PANDECKING IN GOOD CONDITION.

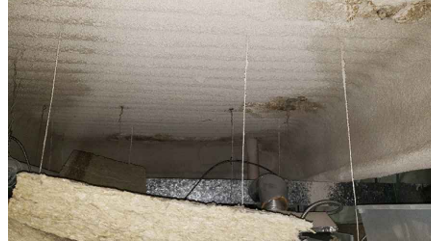
LOCATION 8: WATER STAINED/DAMAGED SPRAY-ON ACM FIREPROOFING.

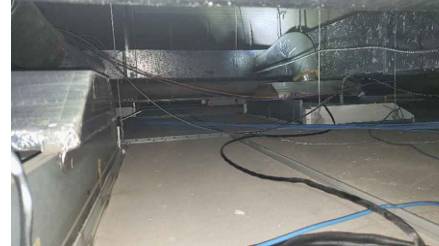
LOCATION 9: OVERSPRAY OF ACM FIREPROOFING ON TOP OF CEILING TILES. ACM FIREPROOFING ON PANDECKING IN GOOD CONDITION.

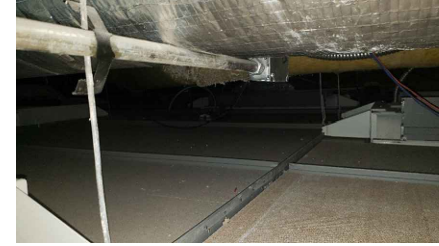
LOCATION 10: OVERSPRAY OF ACM FIREPROOFING ON TOP OF CEILING TILES. ACM FIREPROOFING ON PANDECKING IN GOOD CONDITION.

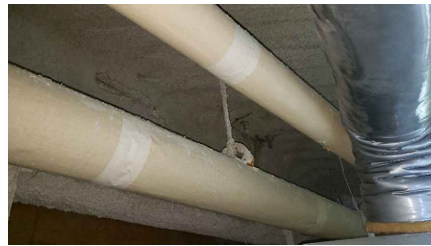
LOCATION 11: CRACKING/STAINING IN DAMAGED ACM FIREPROOFING ON PANDECKING.

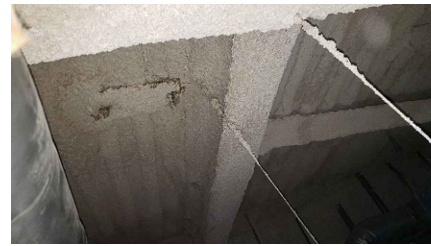
LOCATION 12: RUSTING AROUND BRACKETS. ACM FIREPROOFING NOT STAINED.

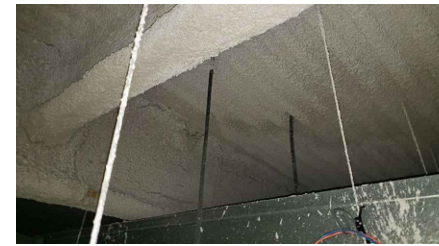
LOCATION 13: RUSTING AROUND BRACKETS. ACM FIREPROOFING NOT STAINED.

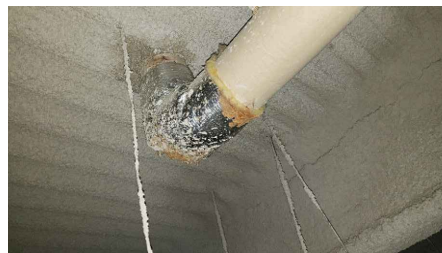
LOCATION 14: WATER STAINING NEAR PIPE PENETRATIONS IN PANDECKING.

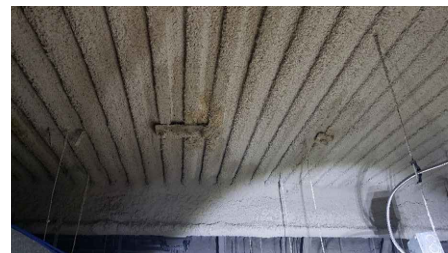
LOCATION 15: WATER STAINING AROUND ROOF PENETRATIONS.

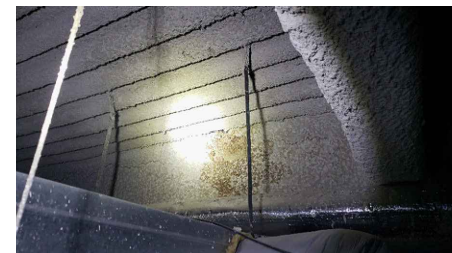
LOCATION 16: WATER STAINING ON I-BEAM WITH SUPERFICIAL CRACKS.

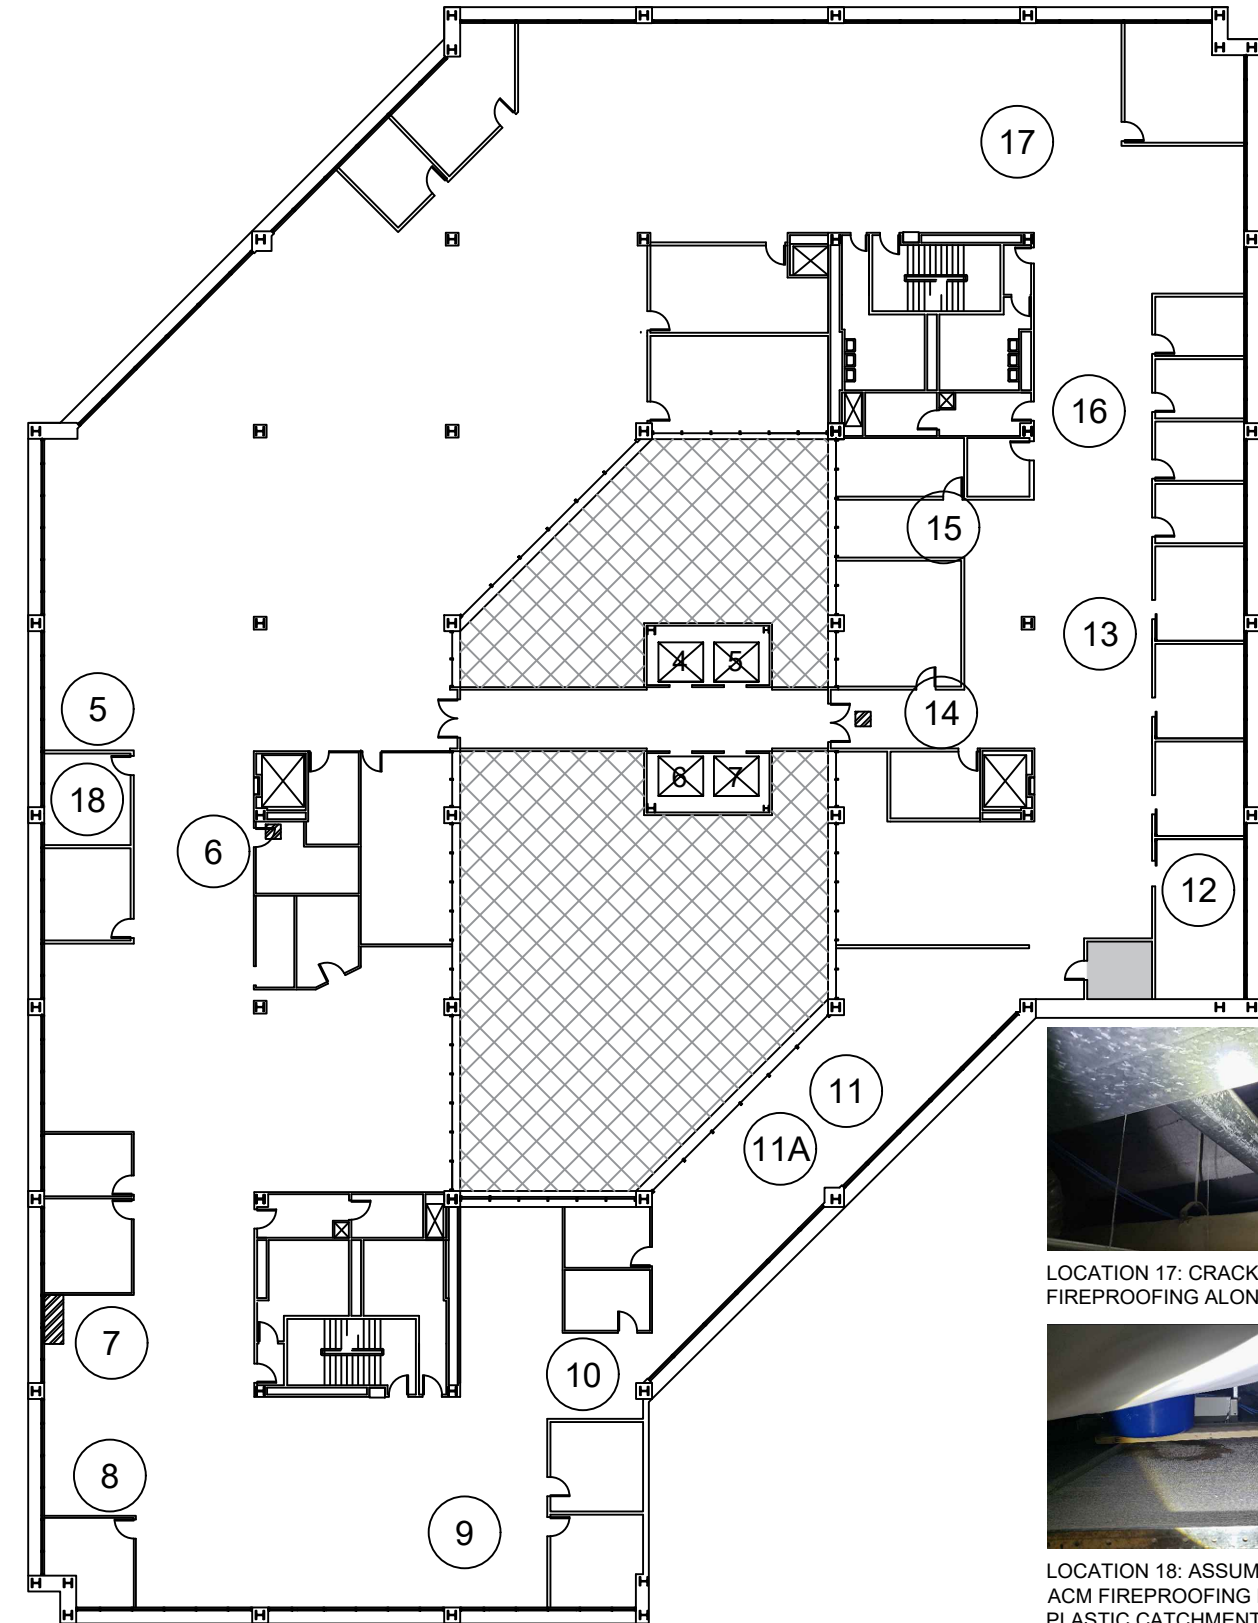
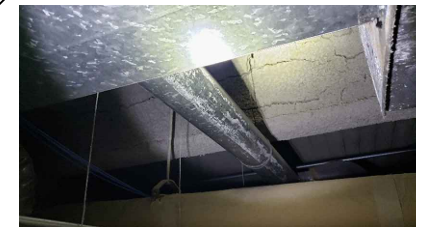
LOCATION 17: CRACKS IN ACM FIREPROOFING ALONG I-BEAM.

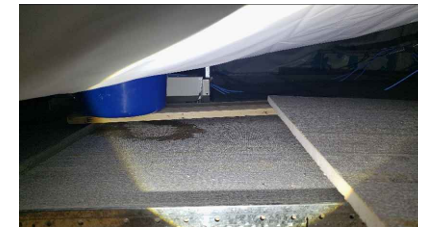
LOCATION 18: ASSUMED WATER DAMAGE. ACM FIREPROOFING NOT VISIBLE DUE TO PLASTIC CATCHMENT.

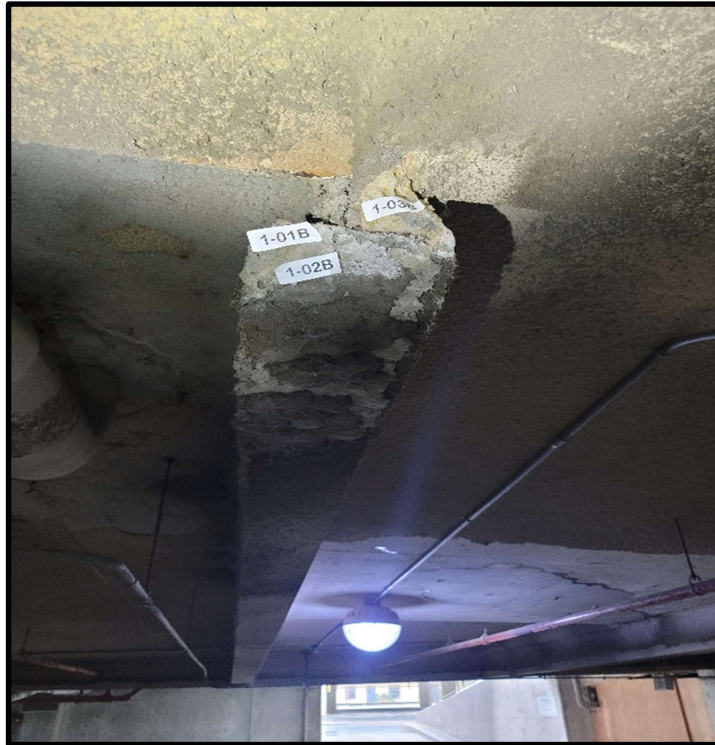
Photo 1: 1st floor garage showing 3 different materials of fireproofing overlapped, non-homogenous, and damaged.

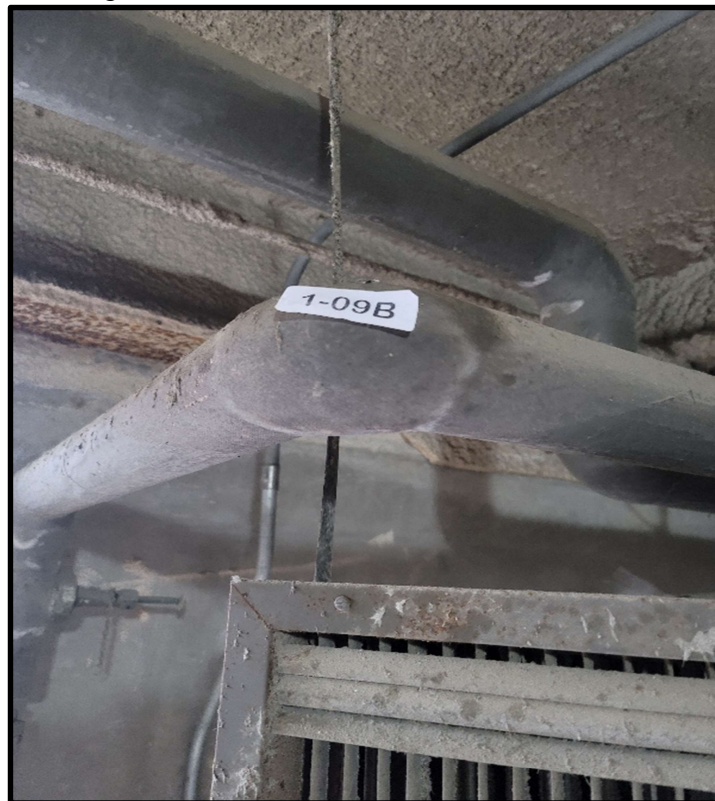
Photo 2: Pipe elbow containing 6% Amosite asbestos. Small diameter insulated piping sporadic throughout parking garages.
