**ASBESTOS MANAGEMENT PLAN
JUNEAU STATE OFFICE BUILDING
333 WILLOUGHBY AVE
JUNEAU, ALASKA
Program # 25RC013611, 25RC013612
AUGUST 5, 2024**

Alaska Department of Transportation and Public Facilities
333 Willoughby Ave.
Juneau, AK 99801

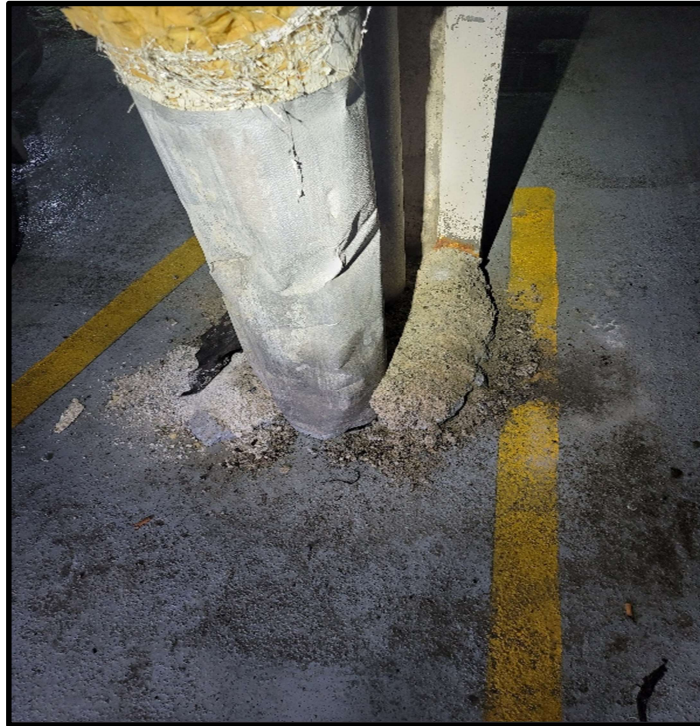
Photo 3: *Deterioration of pipe insulation and ceiling spray-on fireproofing accumulating on ground.*

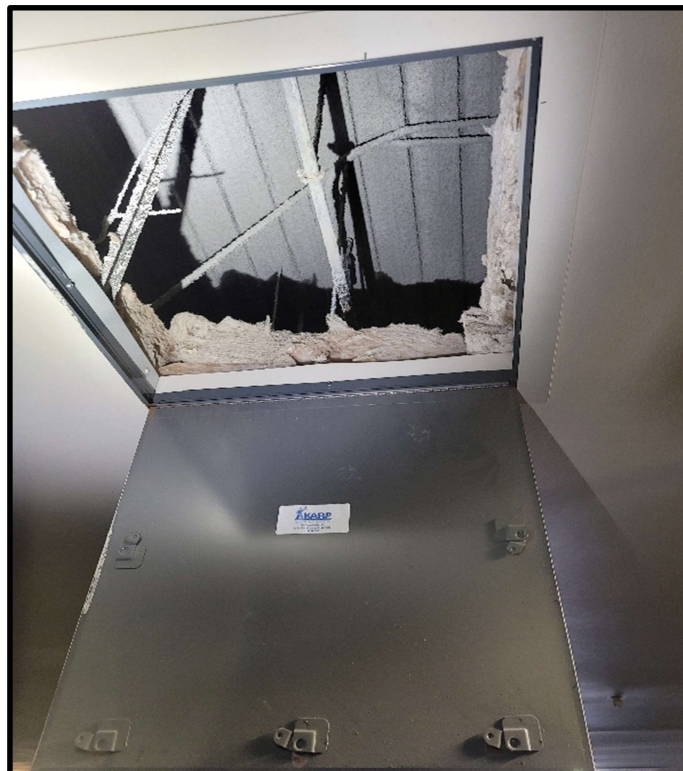
Photo 4: *4th floor parking garage view above hard lid. Gray spray-on fireproofing present on pandecking consistent with rest of building. Assumed to contain chrysotile asbestos.*

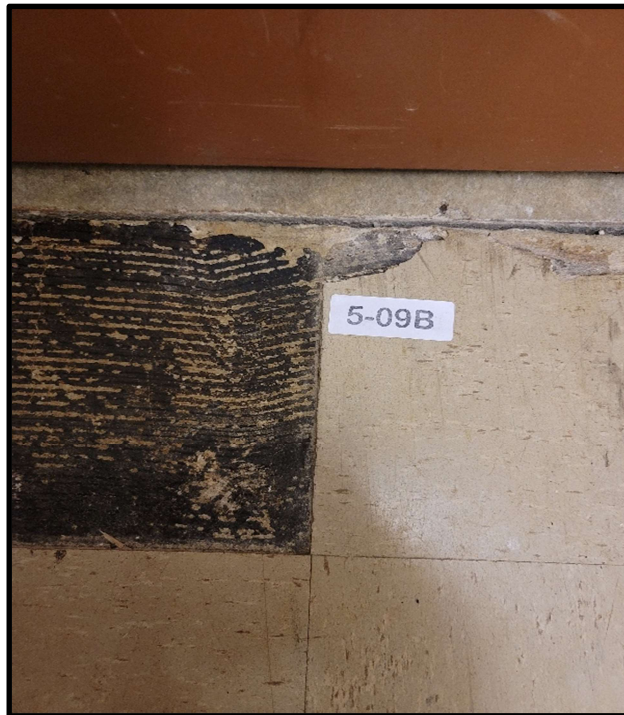
Photo 7: 5th floor office building server room entry floor tiles and black mastic both contain Chrysotile asbestos. Floor tiles brittle and damaged.

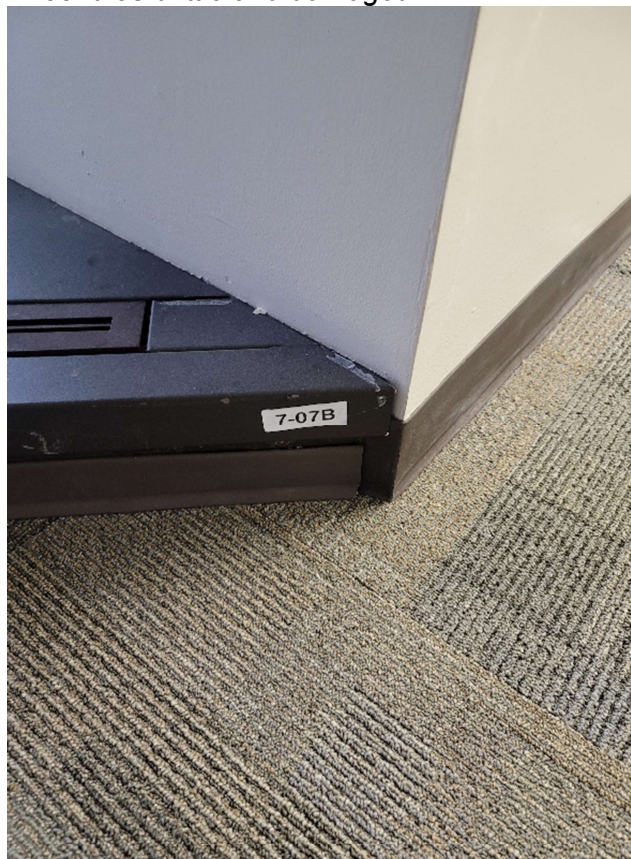
Photo 8: Light tan mastic behind brown cove base contains 2.5% Anthophyllite asbestos.

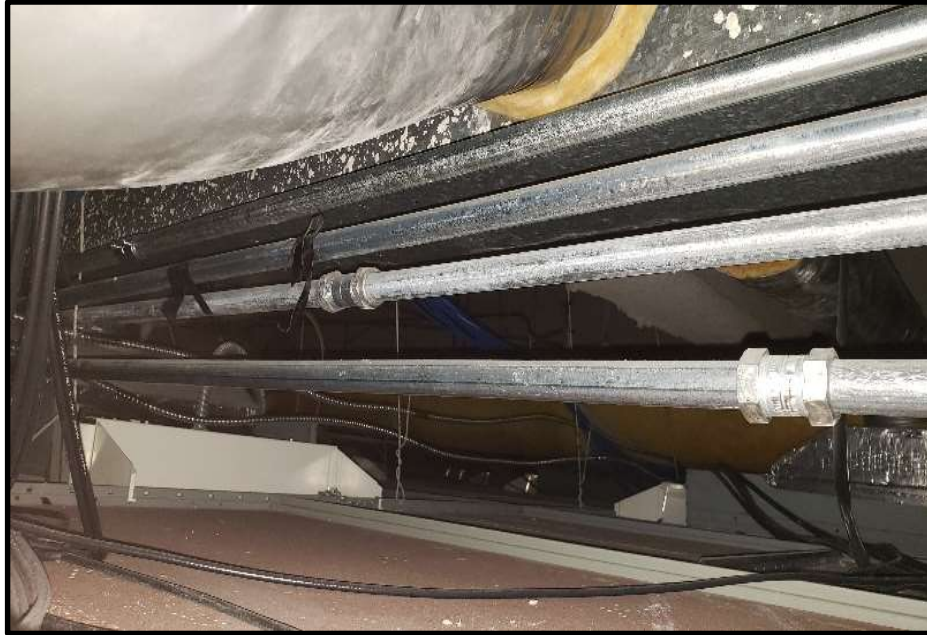
Photo 13: Space between drop ceiling and pan decking on 9th floor. White spots shown are overspray from spray-on fireproofing. White spots on ceiling tile in bottom of photo are fireproofing that has deteriorated and fallen. Fireproofing contains 10-15% Chrysotile asbestos.

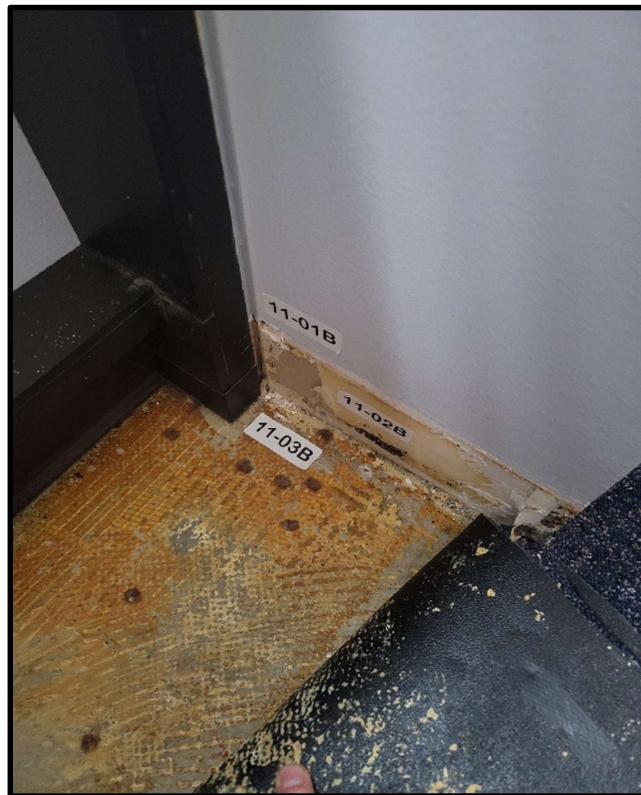
Photo 14: Joint compound (6% Chrysotile) and cove base mastic (1.25% Anthophyllite) contain asbestos. Old carpet mastic and existing carpet adhesive do not contain asbestos.

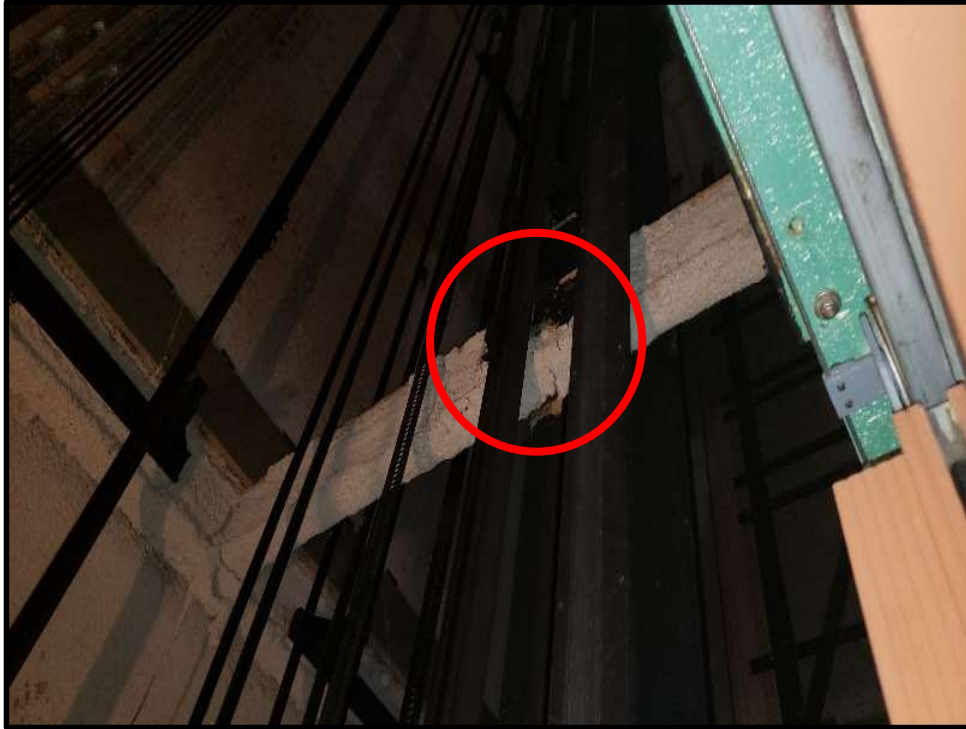
Photo 19: Elevator shaft 6/7, southern 2 elevators in center of building connecting Floors 5-11, showing asbestos containing gray fireproofing. Damage to fireproofing on central beam outlined in red.

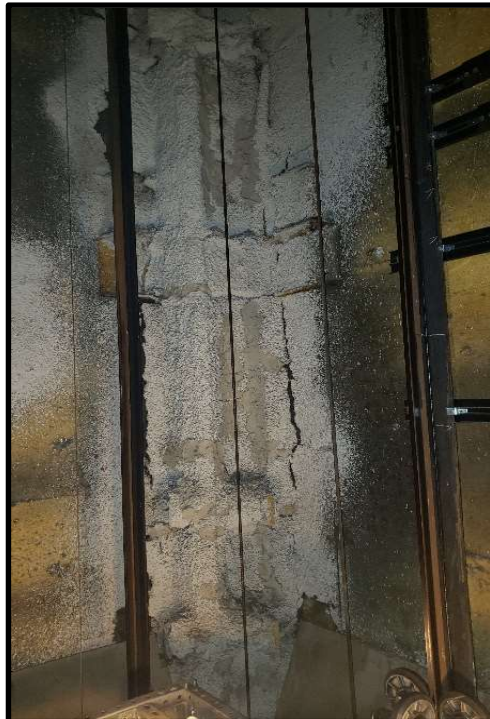
Photo 20: Elevator shaft 1/2, western and central elevators on south edge of building connecting Floors 1-8, showing asbestos containing gray fireproofing. Damage to fireproofing present throughout shared elevator shaft including missing and cracking fireproofing.

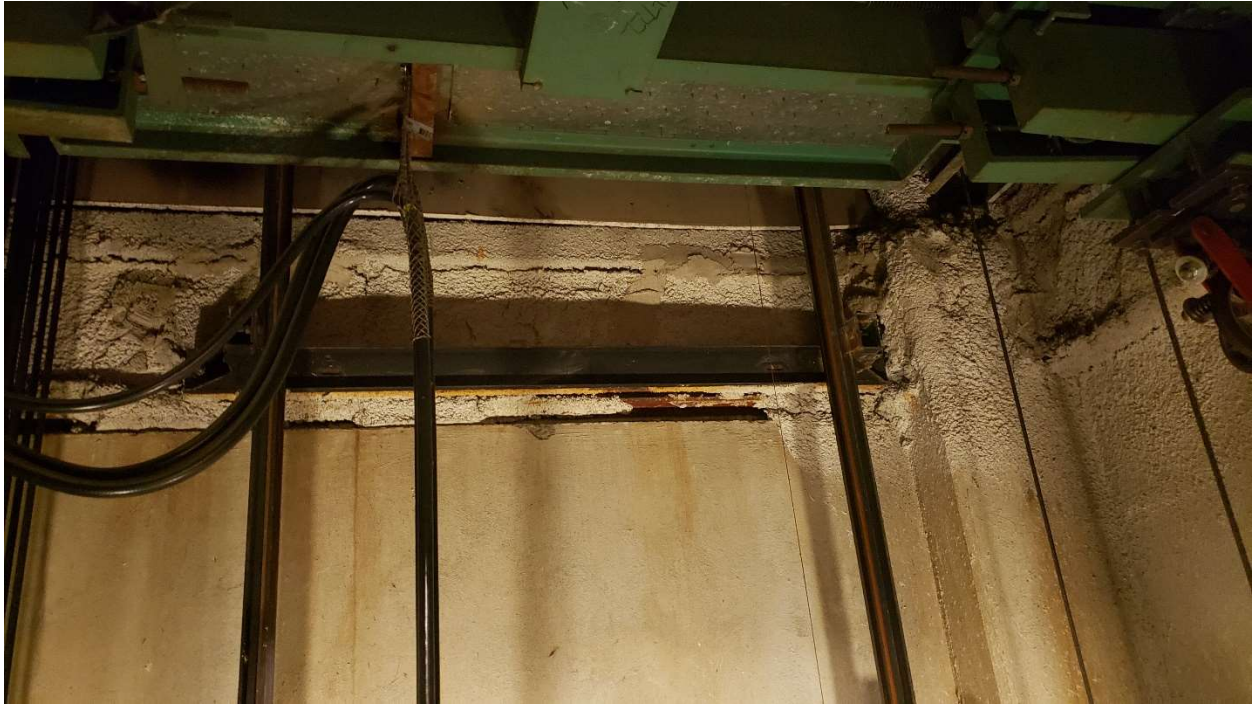
Photo 21: Damaged ACM containing fireproofing within an elevator shaft. Note the cracks and missing pieces.

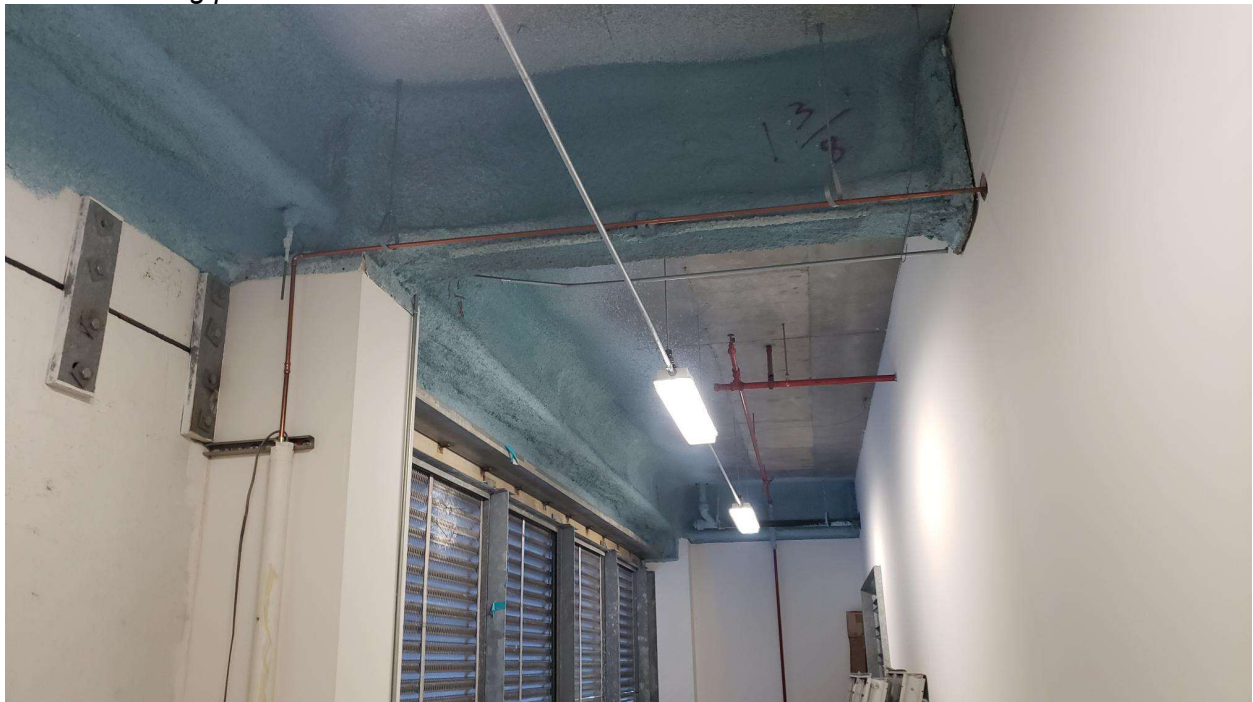
Photo 22: Air plenum and intake area. Note the spray on fireproofing has been abated and non-ACM fireproofing has been sprayed blue.

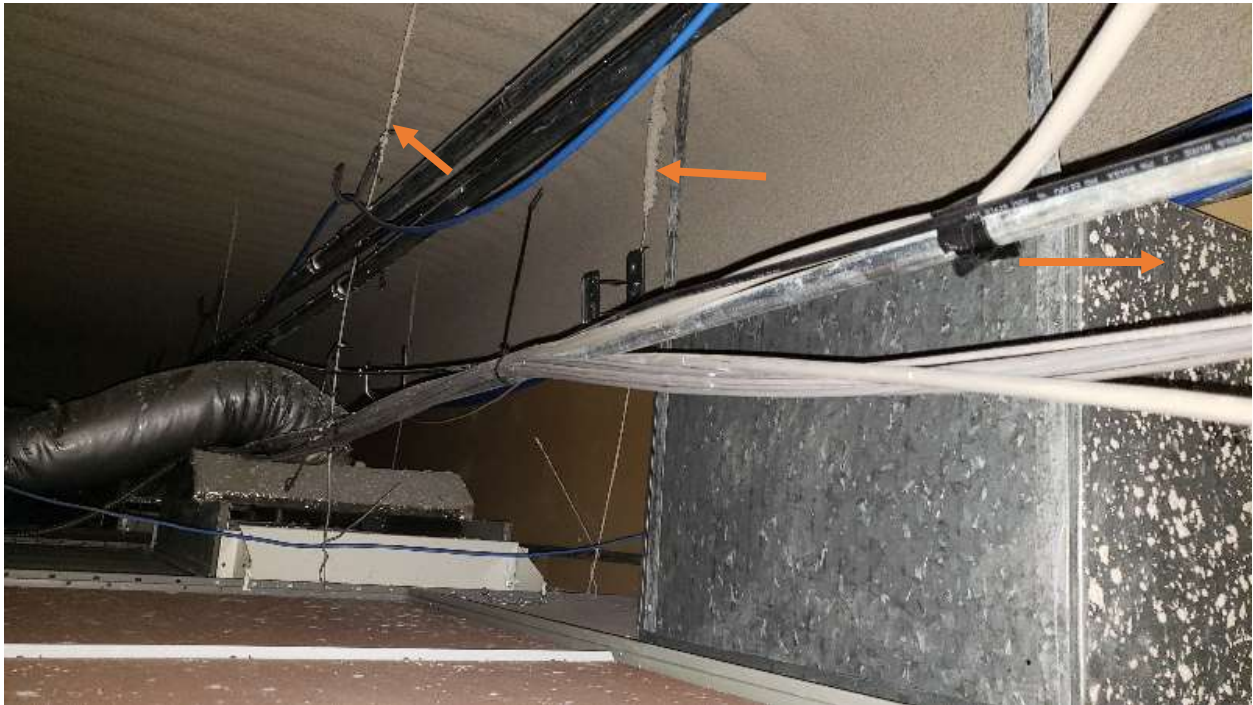
Photo 25: ACM spray on fireproofing on top of ceiling tiles. Note the spray on fireproofing on the pandecking above the tiles is in good condition. Note the overspray on the support wires and ducting (arrows).

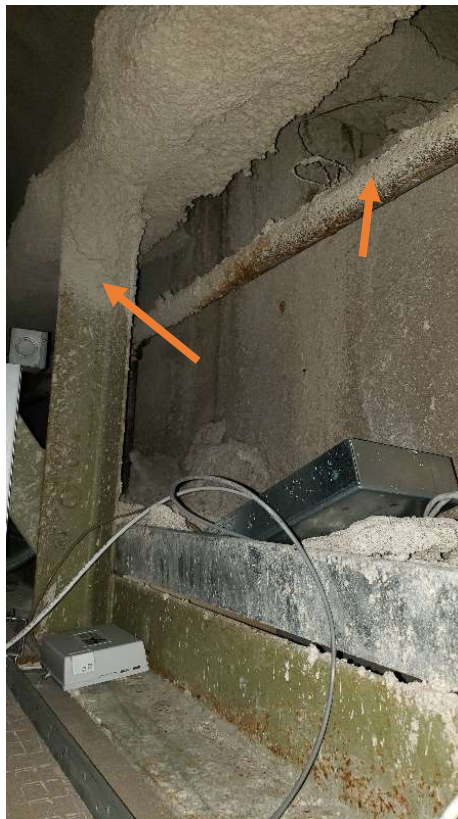
Photo 26: Fireproofing in channel iron on the concrete wall sill. Note the router placed on top of the ACM fireproofing and the overspray (arrows).
