STATE OF ALASKA  
DEPARTMENT OF TRANSPORTATION  
& PUBLIC FACILITIES  
S.E. REGION DESIGN & ENGINEERING  
SERVICES DIVISION  
SITKA  
MILLERVILLE OBSTRUCTION  
REMOVAL  
Vicinity Aerial Photo

| 69122 | |

Hazmat & Demolition  
Details

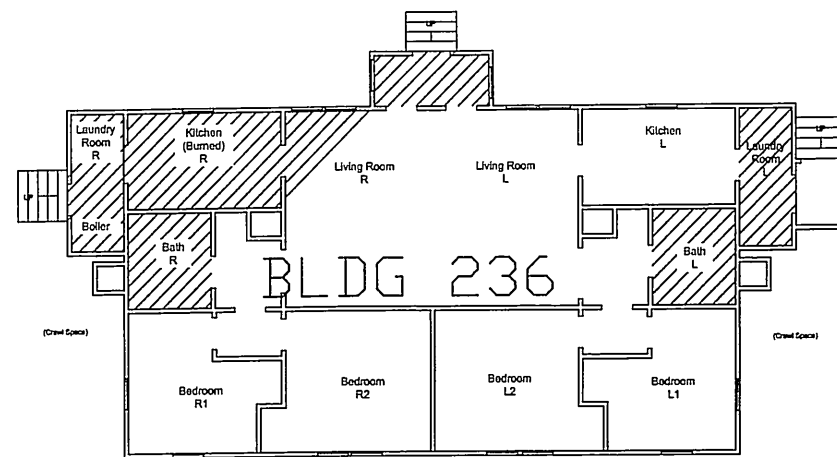
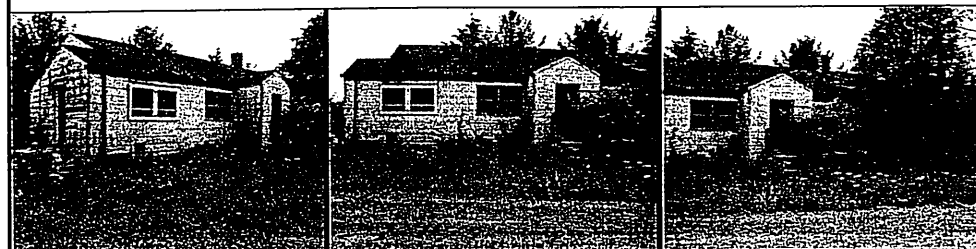
# D4-A: BUILDING 236 HAZMAT & DEMOLITION DETAILS

Front view shows peeling lead-based paint on exterior CAB.

Front view with holes in roof.

View from road with overgrowth.

## BUILDING 236 NOTES

- Crawl space
- Sewer line out NW
- 2-3 tube circular fluorescent light fixtures
- All popcorn ceilings with exception of kitchen, baths, and utility entrance

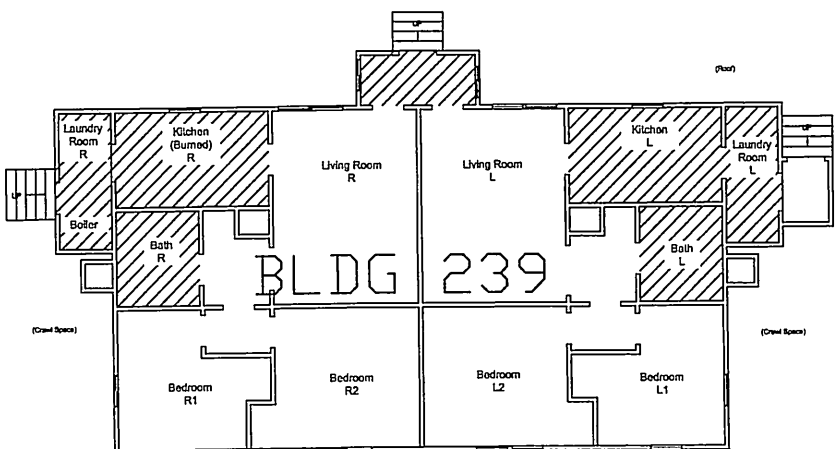
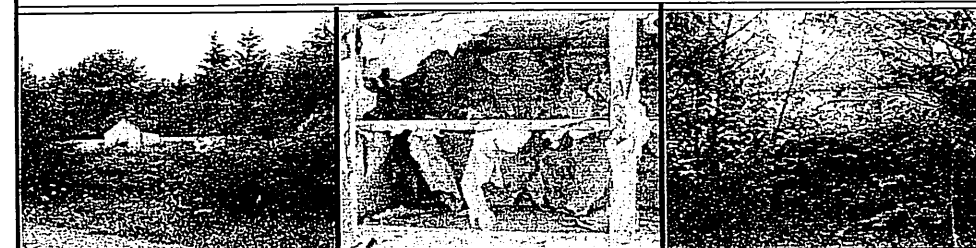
# D4-B: BUILDING 239 HAZMAT & DEMOLITION DETAILS

## BUILDING 239 NOTES

- Boiler in place - some burned out sections around this room
- Crawl space
- Fuel lines going out both ends but no evidence of tanks remaining
- Vent pipe to fuel is still sticking above house and goes into crawl space
- 100 In ft of ACM TSI in crawl space

Front view of building and overgrowth.

Interior Kitchen L, observed lead paint condition.

End of building showing overgrowth.

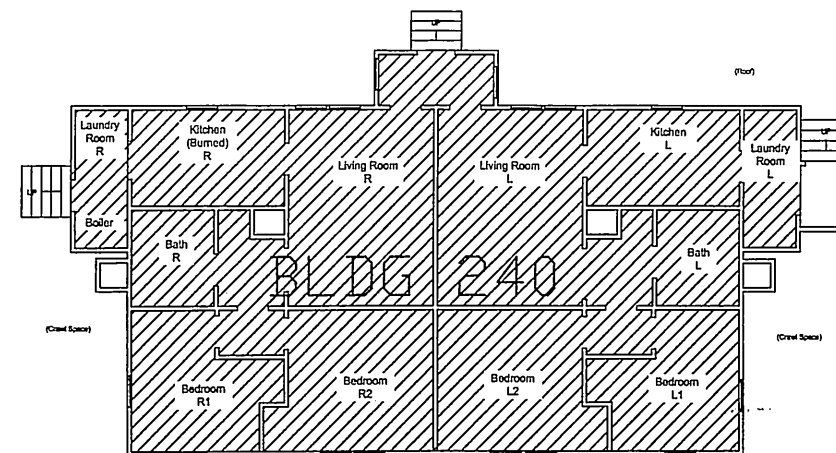
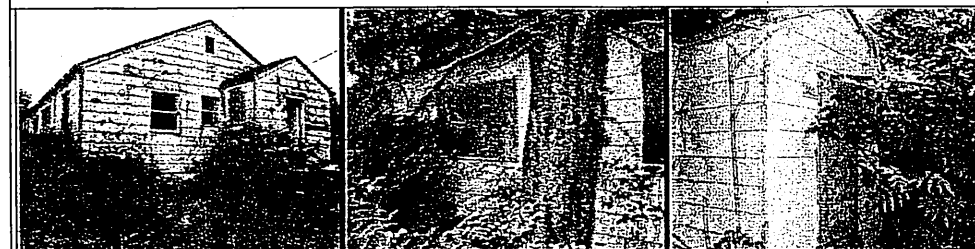
# D4-C: BUILDING 240 HAZMAT & DEMOLITION DETAILS

## BUILDING 240 NOTES

- Doors and window boarded up
- Crawl space
- Aluminum rain gutter and plastic pipe stacked outside building
- Baseboard heating-boiler in SE end
- Smoke guard fire alarm
- All walls & carpet, ceiling all interior space in place
- Round fluorescent light w/ ballast on floor, one in each kitchen
- Standing water under building
- 100 In ft of ACM TSI in crawl space

End view shows peeling lead-based paint and overgrown vegetation.

Front view of overgrown vegetation.

Front up.

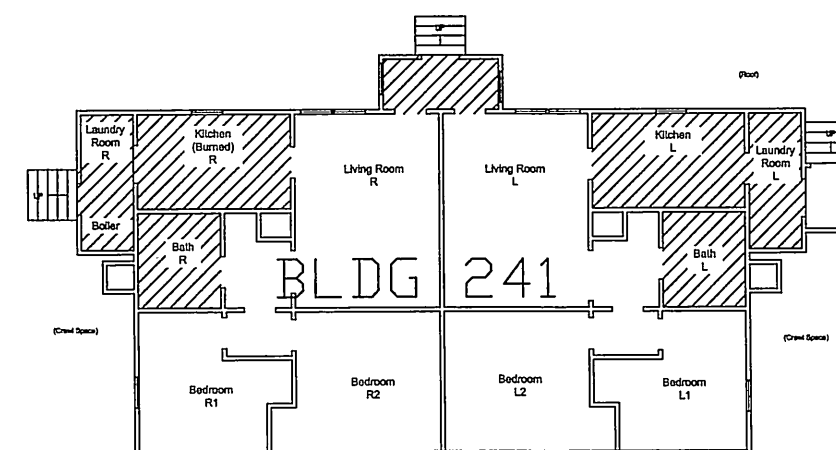
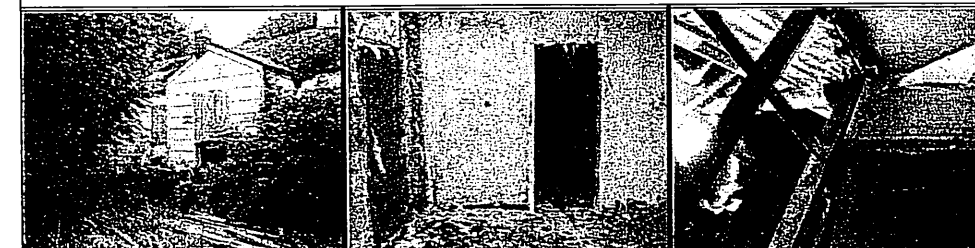
# D4-D: BUILDING 241 HAZMAT & DEMOLITION DETAILS

## BUILDING 241 NOTES

- Crawl space at least 6' deep
- Tile under carpet
- All interior walls w/covering still in place
- No boiler - baseboard heater
- 100 In ft of ACM TSI pipe in crawl space
- 2-3 tube mercury circular fluorescent light fixtures

Front view of building. Notice pile of pipe and rain gutter in foreground.

Interior view of observed lead paint condition.

Interior attic view from hall.

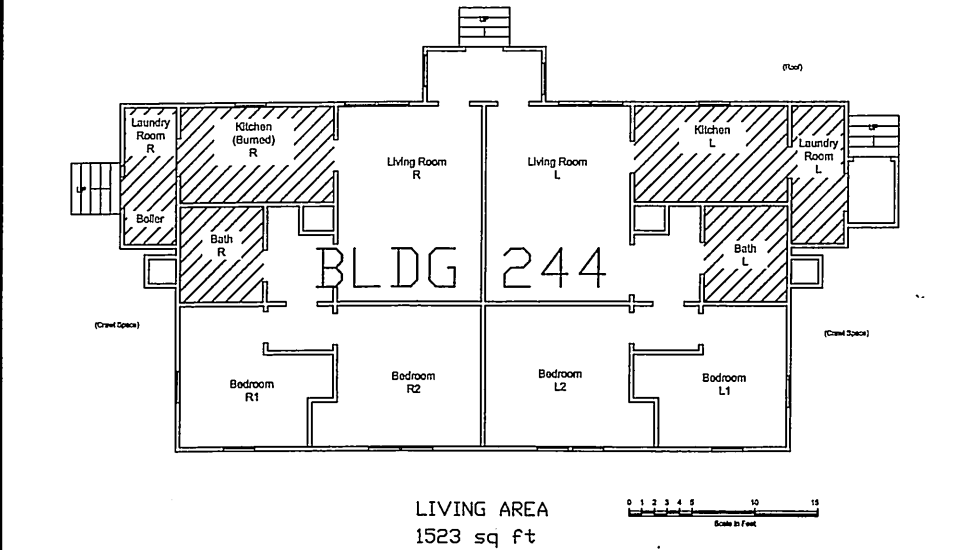
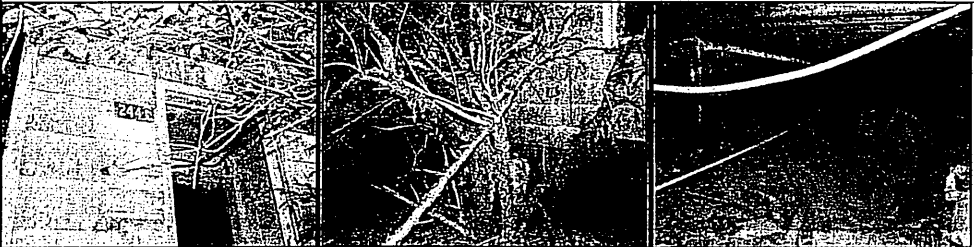
D5-A: BUILDING 244 HAZMAT & DEMOLITION DETAILS

- BUILDING 244 NOTES**
- 29'x60' wood frame 2"x4"
  - Building standing - in fair condition
  - Roof, interior walls, floor, & exterior walls
  - Concrete footing - 8" thick w/ 3' stem all the way around; 24 concrete piling 2'x2' 3' high
  - Crawl space
  - 100 In ft of TSI pipe insulation in crawl space
  - Cement asbestos board (CAB) exterior
  - Lead concentrations of 1089.6 and 1899.2 mg/kg were found in composite soil samples taken from foundation. Remove 6" of soil from within foundation before testing for leads. Continue to remove soil and test until soil clean.

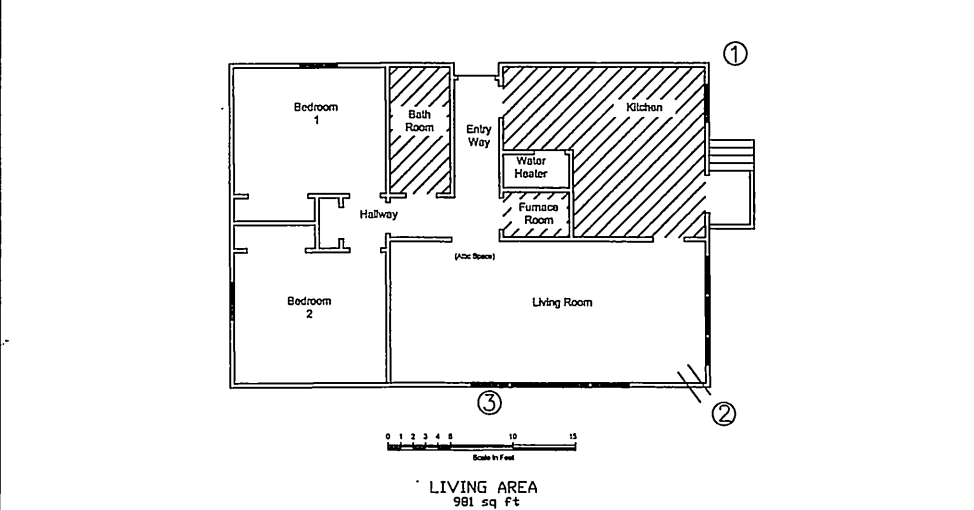
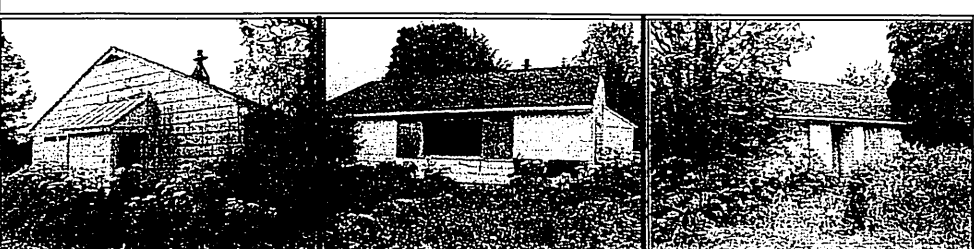
D5-B: BUILDING VS2 HAZMAT & DEMOLITION DETAILS

- BUILDING VS2 NOTES**
- Standing 2"x4" wood frame 41'x24' - fair condition
  - Roof (composite shingle), ceiling, all interior & exterior walls, flooring
  - Concrete foundation 8" thick w/3' stem all the way around
  - Assume concrete spread footing
  - Crawl space
  - Building has interior wall & floors w/carpet
  - Asbestos TSI on heating duct in attic
    - 70' of 8" dia
    - 20' of 12-14" dia
    - 10' of 10"x20" square duct
    - 8' stack 11" dia
  - Sewer lines under house
  - Cement asbestos board (CAB) exterior
  - Pile of garbage 4'x6' out back

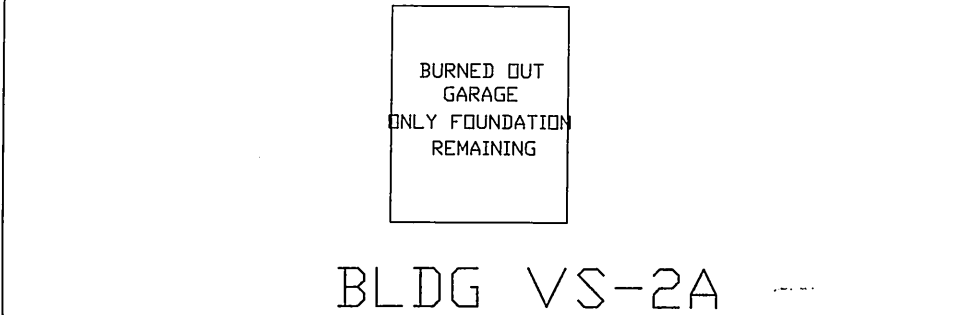
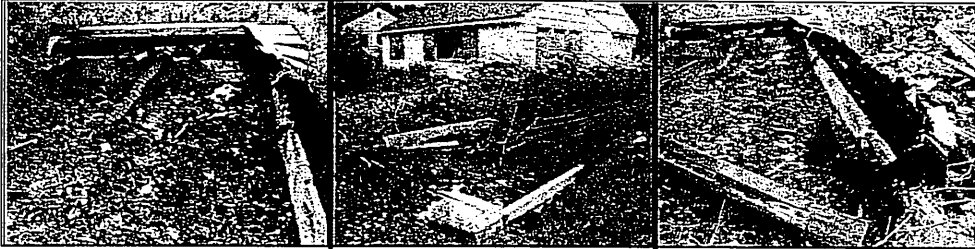
D5-C: BUILDING VS2A HAZMAT & DEMOLITION DETAILS

- BUILDING VS-2A NOTES**
- Structure has burned to the ground, small amount of burned wood remains
  - 14'x17'x2'high concrete foundation remains
  - Concrete floor - assume 6" slab

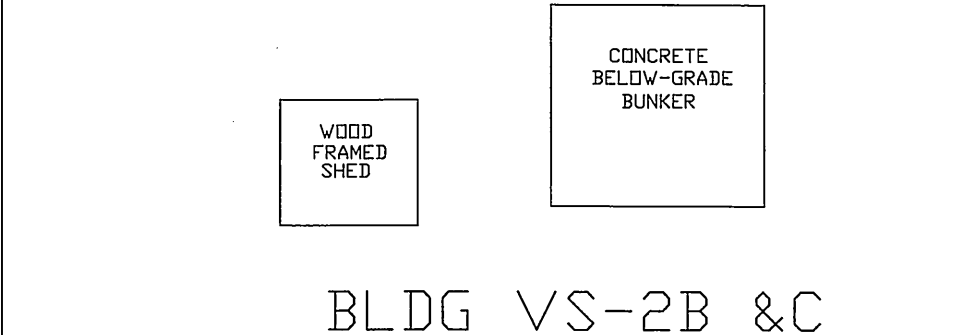
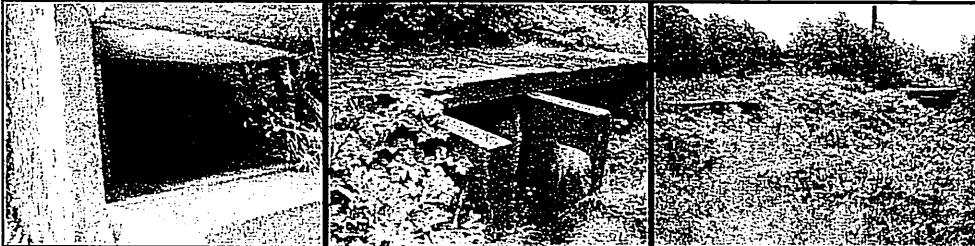
D5-D: BUILDING VS2B & C HAZMAT & DEMOLITION DETAILS

- BUILDING VS2B & 2C NOTES**
- VS-2B SHELTER (BUNKER)**
- Structure is completely concrete
  - 8" thick walls, roof, and floor
  - 17'x16' and is 8' deep
  - Stairs leading down with 2 wing walls 3'x8'x8"
- VS-2C STORAGE SHED**
- 2"x4" wood frame building 11'x10'-standing
  - Metal roof
  - Wooden floor
  - No foundation visible - assume 8"x12" footing
  - Four 25# propane canisters next to building

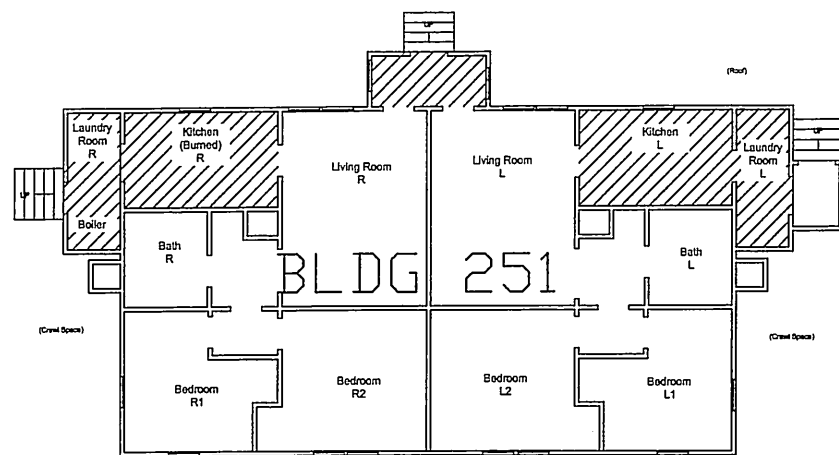
# D6-A: BUILDING 251 HAZMAT & DEMOLITION DETAILS

Interior looking to side.

Interior fiber wallboard in piles on floor.

Interior looking to front. Fiber wallboard piled on floor.

## BUILDING 251 NOTES

- Building standing – in poor condition
- No interior walls, ceiling, or flooring
- Basement at least 6' deep ACM shingles outside over timber sheeting 1"x8"
- Interior wall board in pile in middle of floor
- Cook stove inside
- 100 In ft of TSI pipe in crawl space
- Lead concentrations of 2000 and 6907.2 mg/kg in composite soil samples taken along drip lines
- Lead concentrations of 1440 mg/kg in a composite soil sample taken from foundation. Remove 6" of soil from within foundation before testing for leads. Continue to remove soil and test until soil clean.

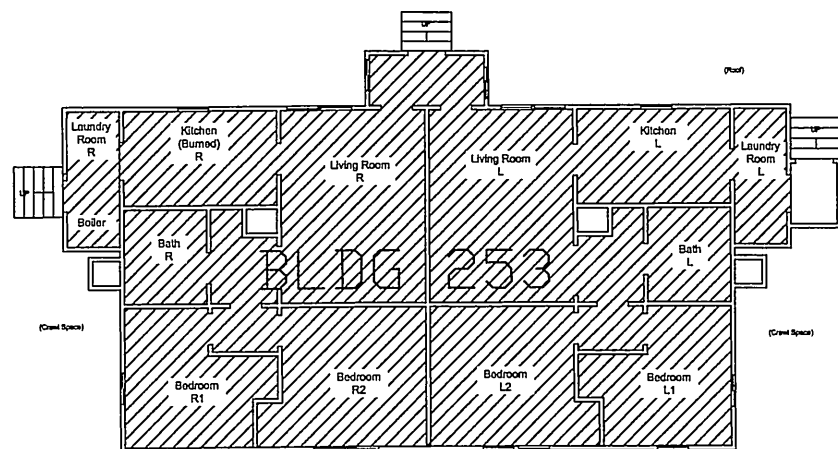
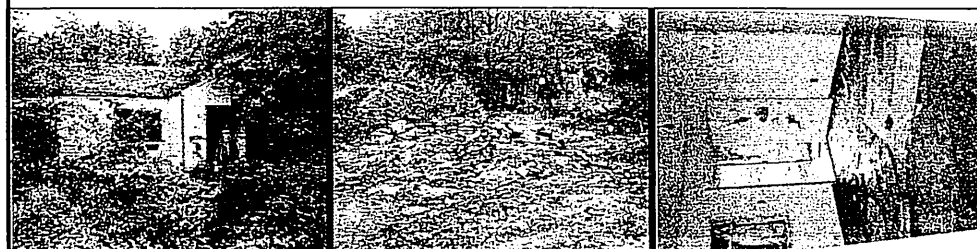
# D6-B: BUILDING 253 HAZMAT & DEMOLITION DETAILS

Front view very overgrown.

Building 253 in background with burn pile in foreground.

Interior lead-based paint condition.

## BUILDING 253 NOTES

- Building standing – in fair to poor condition
- Roof, interior walls, floor, & exterior walls
- Crawl space
- Duplex & all walls are standing
- Floor tiles throughout
- No boiler
- 1/2" buried fuel line coming p and out of ground at the back w/valve
- 2-3 tube mercury circular fluorescent light fixture (kitchen)
- Lead concentrations of 1440 mg/kg in a composite soil sample taken from foundation
- Cement asbestos pipe (CAB) waste pieces

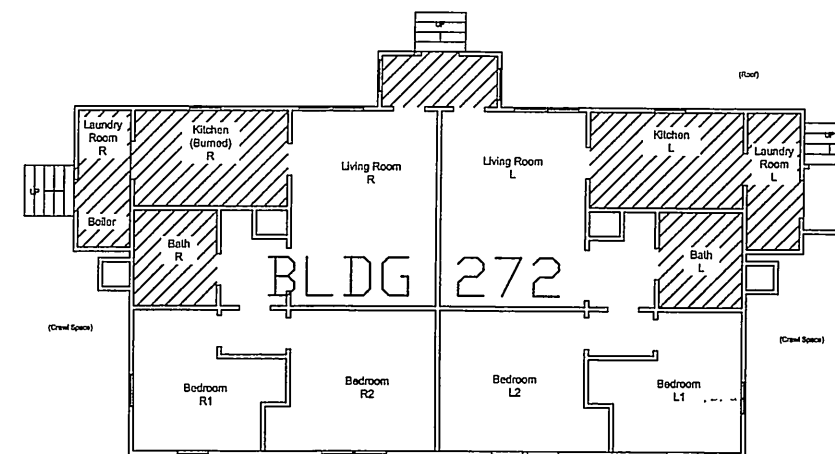
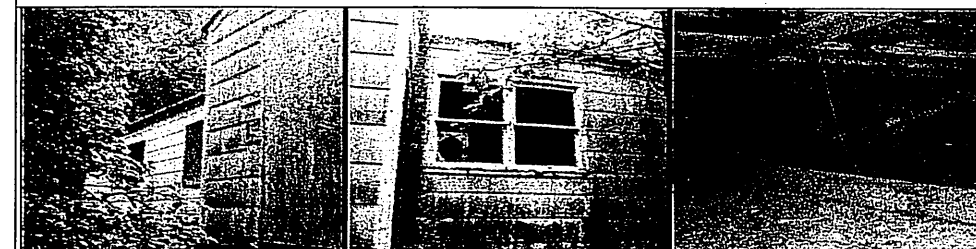
# D6-C: BUILDING 272 HAZMAT & DEMOLITION DETAILS

## BUILDING 272 NOTES

- Building standing – in fair condition
- Roof, interior walls, hardwood floor & exterior walls
- 24 concrete piling 2'x2' 3' high, 8" thick w/ 3' stem all the way around
- Crawl space
- All hardwood floors with linoleum in kitchen, utility, and bath
- 3 tube mercury fluorescent light fixture
- Fiberboard walls and ceiling
- 100 In ft of TSI pipe in crawl space

NW end of building.

SE end showing peeling lead-based paint and CAB.

Beneath building showing foundation erosion.

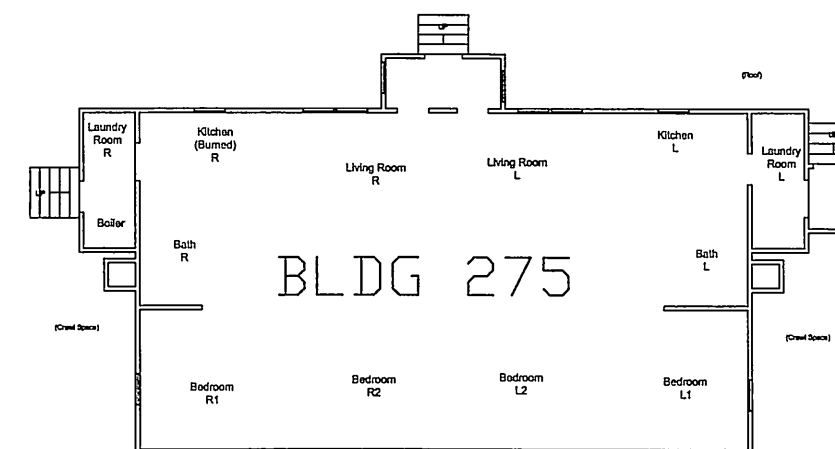
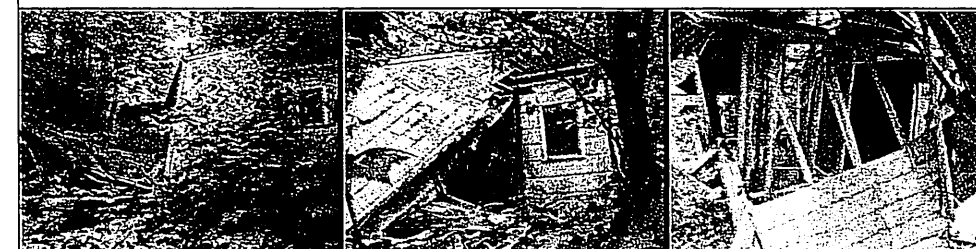
# D6-D: BUILDING 275 HAZMAT & DEMOLITION DETAILS

## BUILDING 275 NOTES

- Building has fallen down – in very poor condition
- Split cedar shakes covered by composite shingles
- 100 In ft of ACM TSI in crawl space
- Lead concentrations of 1000, 1029.6, and 1729.6 mg/kg in composite soil samples taken along drip lines. Remove 6" of soil from within foundation before testing for leads. Continue to remove soil and test until soil clean.

Front view from road collapsed.

End view debris, some exterior CAB siding.

View looking into interior debris.
