Rapid Seismic Repair of Column to Footing Connections – Phase 2

Prepared By: Taylor J. Brodbeck, Ph.D. Student Zachary A. Shurow, MS Mervyn J. Kowalsky, Professor, Ph.D. Rudolf Seracino, Professor, Ph.D.

1. AGENCY USE ONLY (LEAVE BLANK)	2. REPORT DATE	3. REPORT TYPE AND DA	TES COVER	ED
	May 31, 2022	FINAL REPORT, Jan.	2019 thro	ugh May 2022
4. TITLE AND SUBTITLE Rapid Seismic Repair of Column to F	Footing Connections – Phase 2		5. FUNDING	NUMBERS

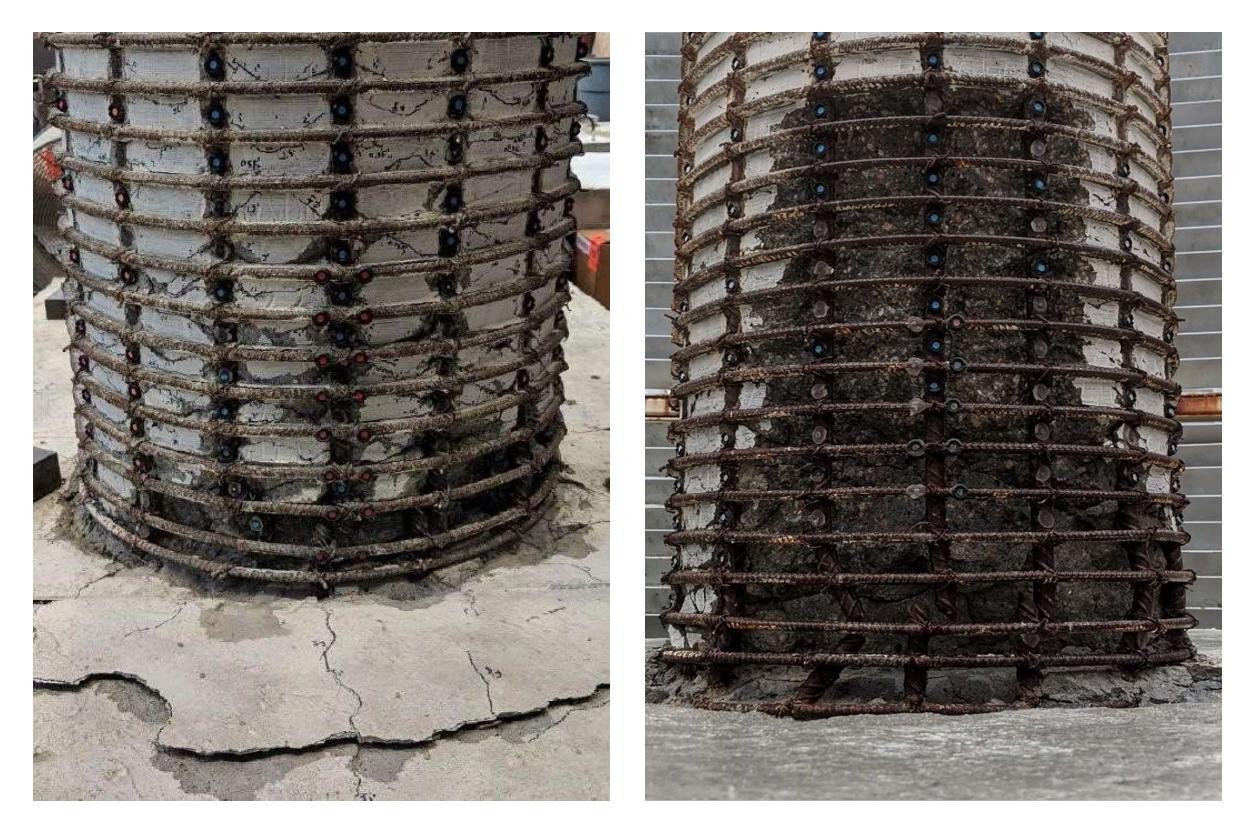
Figure 3.4: Before and After Removal of Damaged Concrete.

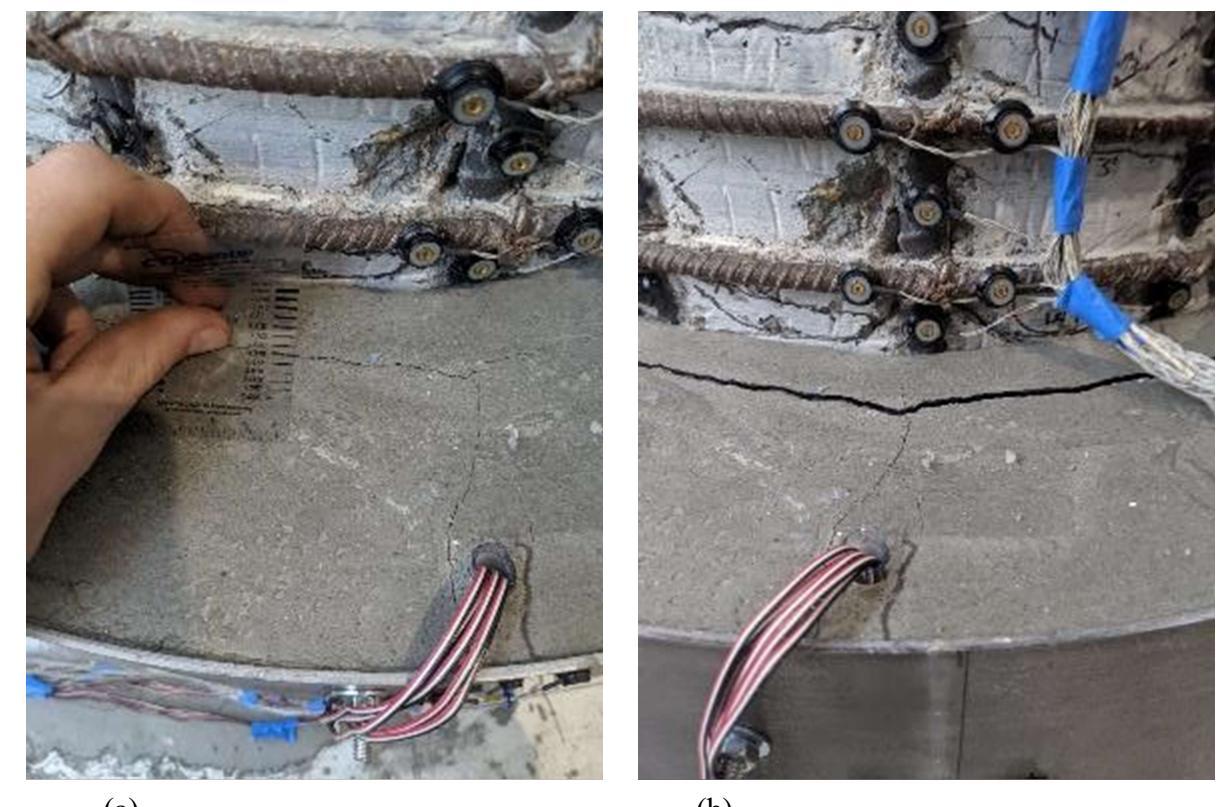
(a) (b) Figure 4.3: Cracking of the Top of Repair Grout at (a) ¹/₄ F_y' and (b) F_y'.

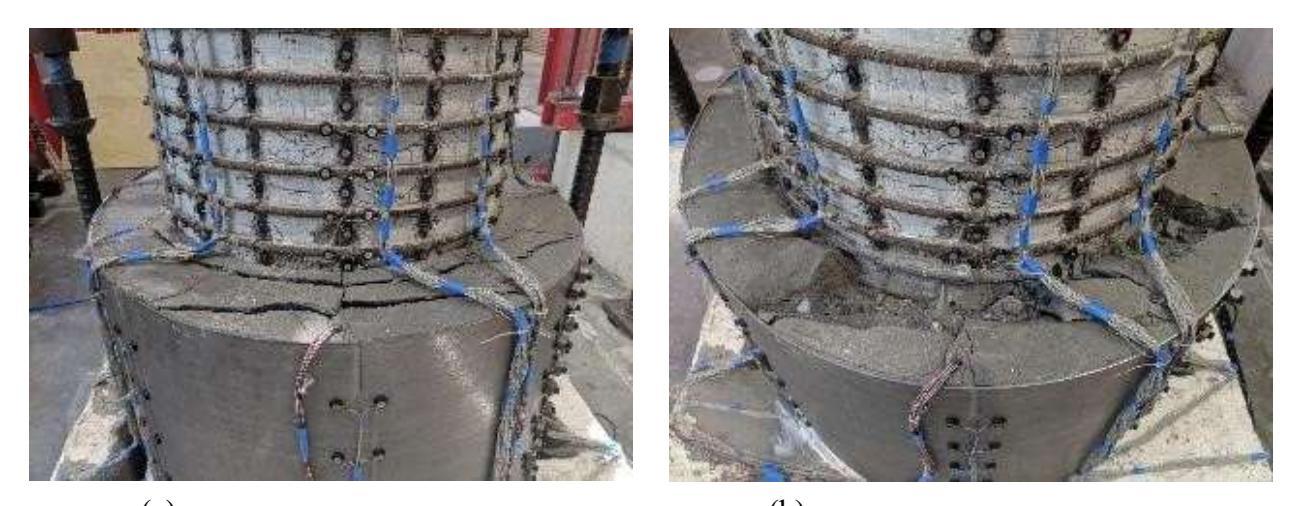
(a) (b) Figure 4.4: Cracking of the Top of Repair Grout (a) Before Removal of Loose Grout and (b) After.

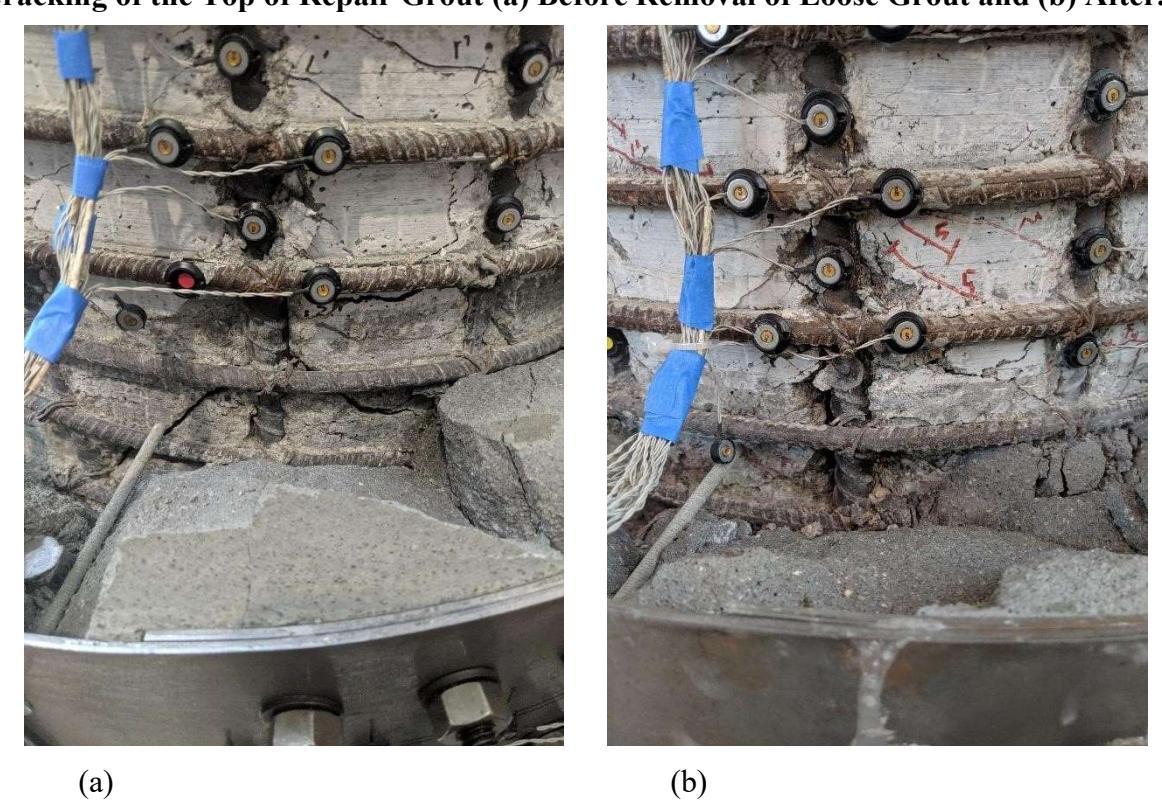
Figure 4.5: Concrete (a) cracking and (b) crushing visible during the 1st cycle at ductility 4.

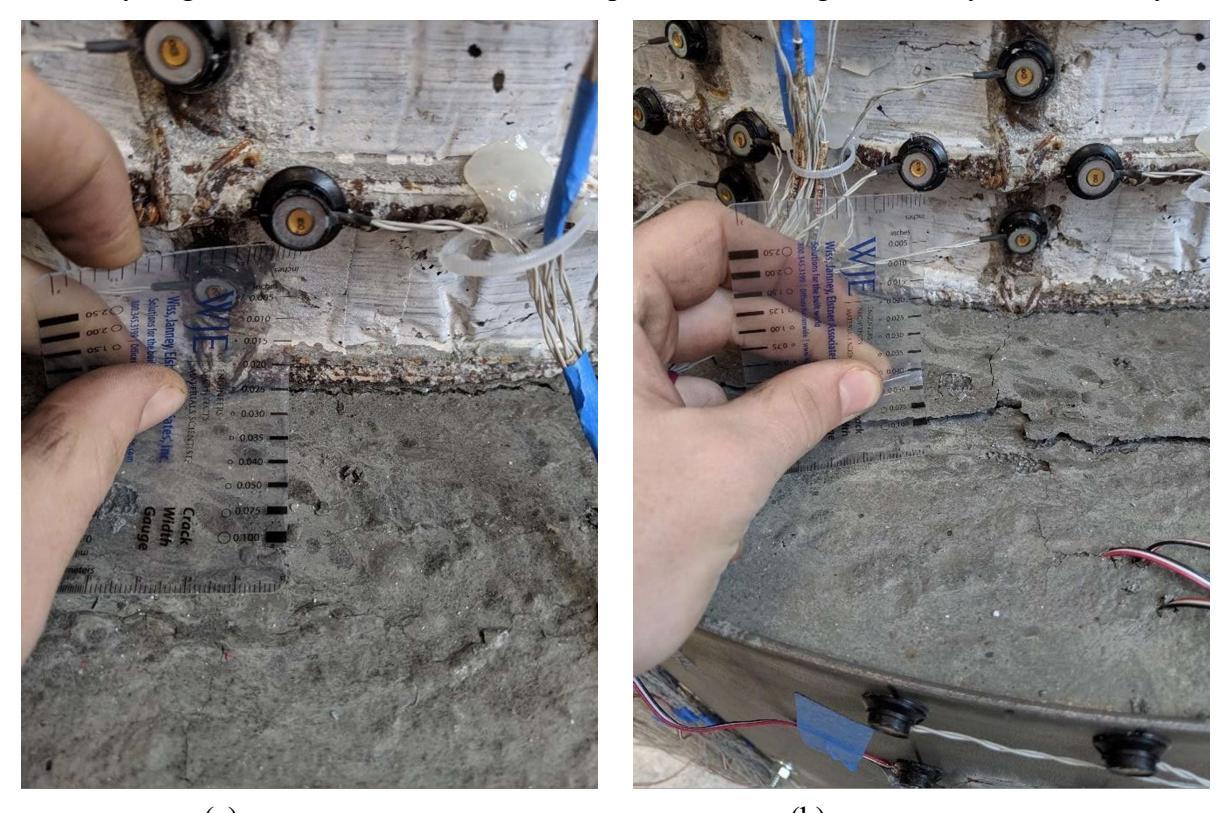
(a) (b) Figure 4.14: Cracking of the top of repair grout at (a) ½ Fy' and (b) ductility 1.

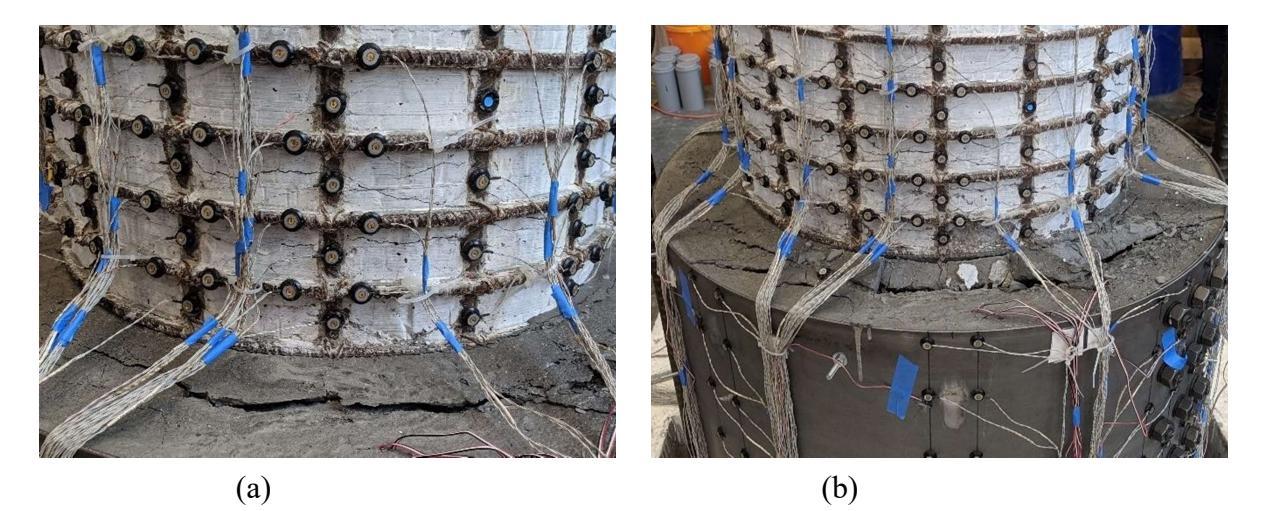
Figure 4.15: (a) cracking on column and (b) removal of loose grout.

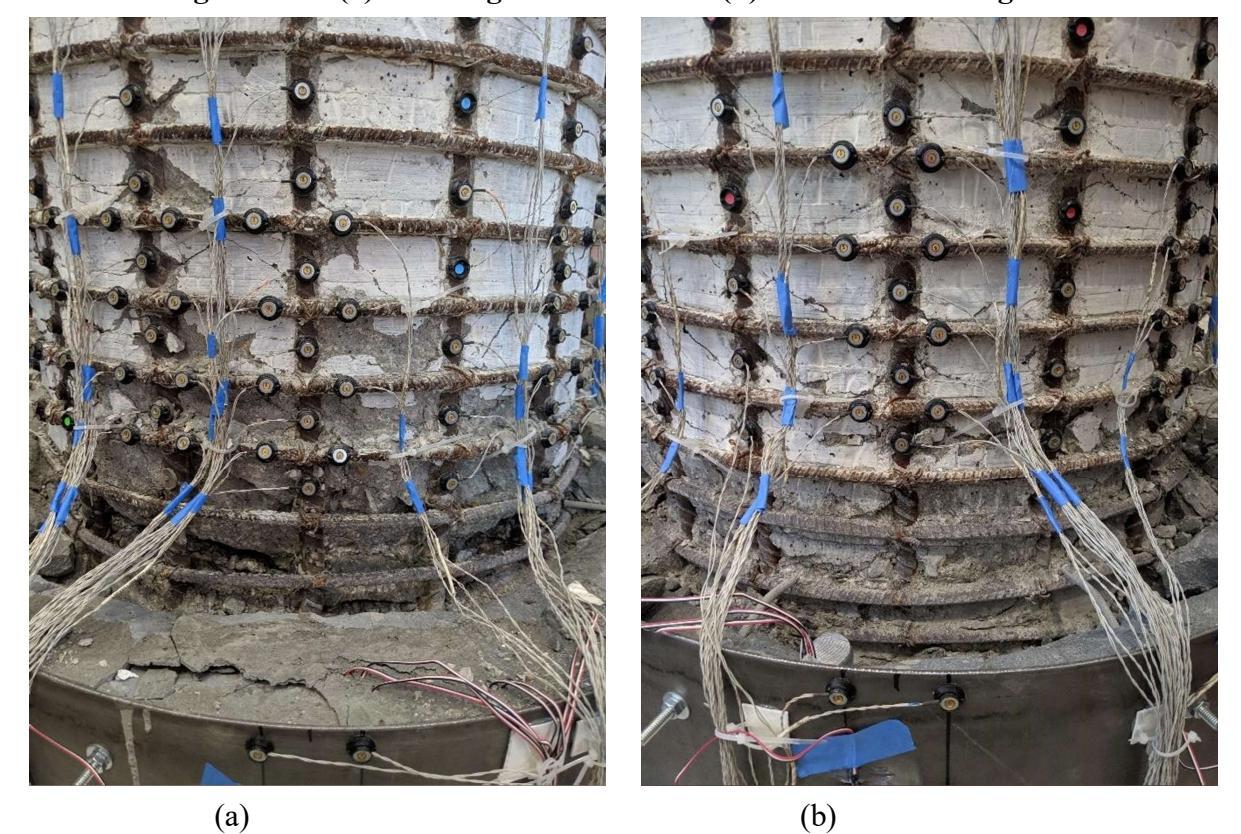
This is likely due to the north side having less initial damage than the south (2 fractured bars vs 3). Buckling was first observed in N3 during the final cycle at ductility 4. On the first push cycle of ductility 5, N2 and N6 also buckled. When pulling back in the opposite direction N3 fractured and S2 and S6 buckled. In the second cycle at ductility 5 each of the buckled bars were further buckled but did not fracture. For the third cycle S2, N2, and N6 fractured. Though the column had completed all three cycles at ductility 5, the column was pushed one more time to fracture S6. At a displacement of 7.45 inches, S6 fractured and the test was concluded. A progression of buckling to fracture is shown in Figure 4.17 for N6, with other bars showing similar damage progression. Lastly, Figure 4.18 shows the column's displacement during the final cycle of ductility 5.

Figure 4.16: Damage comparison during ductility 5 on the North (left) and South (right) sides.

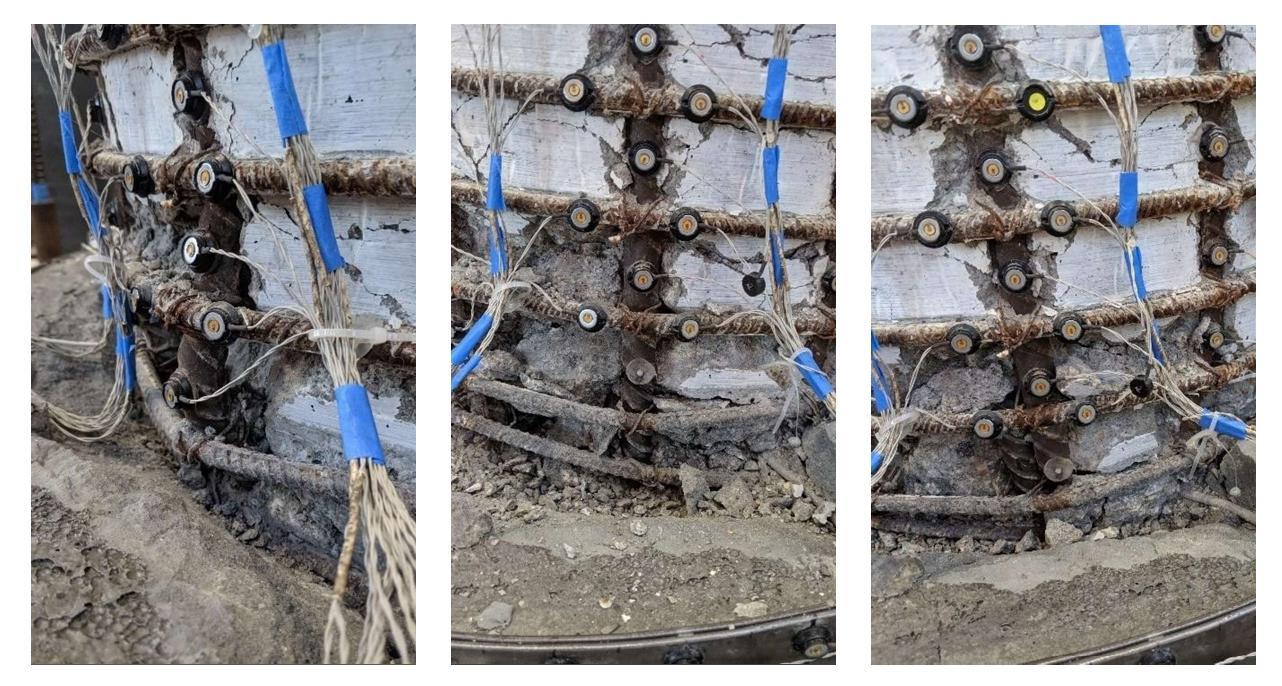
Figure 4.17: Final cycles of N6 showing (left) buckling, (middle) fracture, and (right) next compression cycle.

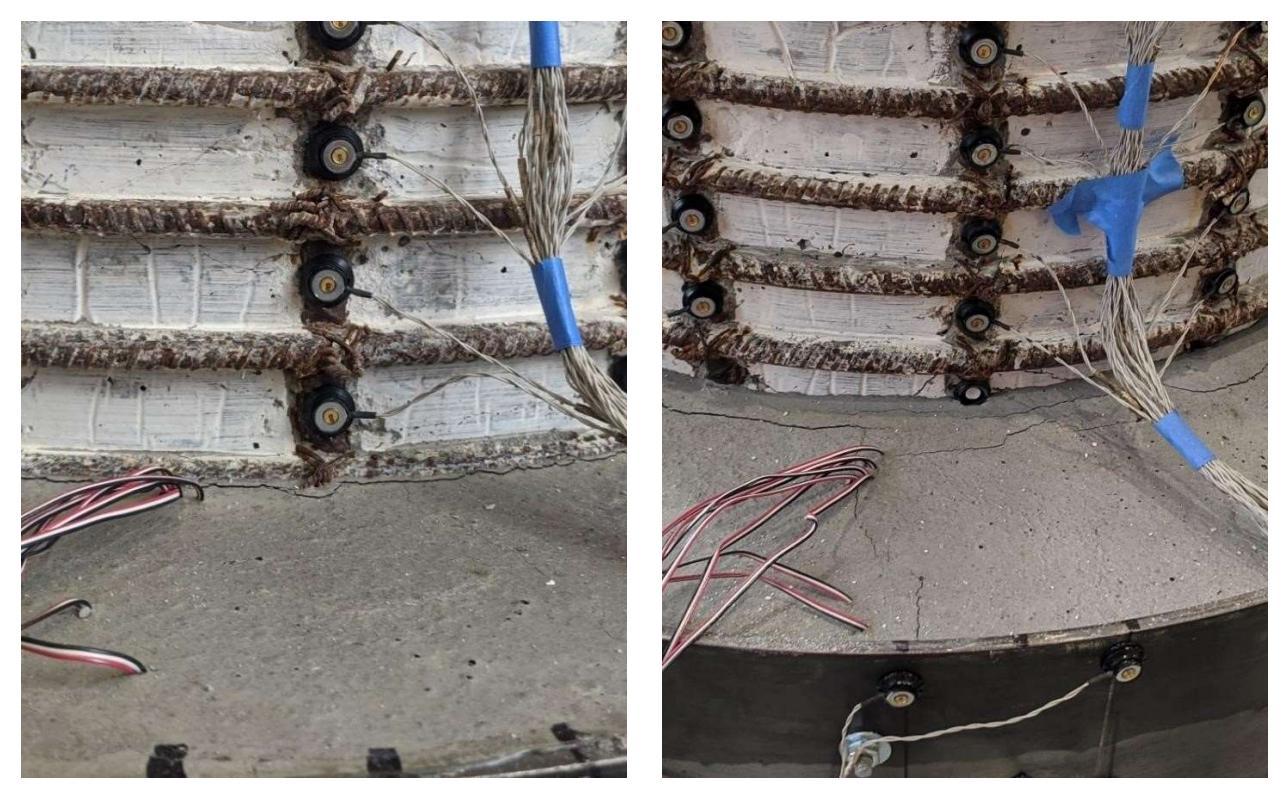
Figure 4.27: Circumferential cracks in grout at ½ Fy' for the North (left) and South (right).

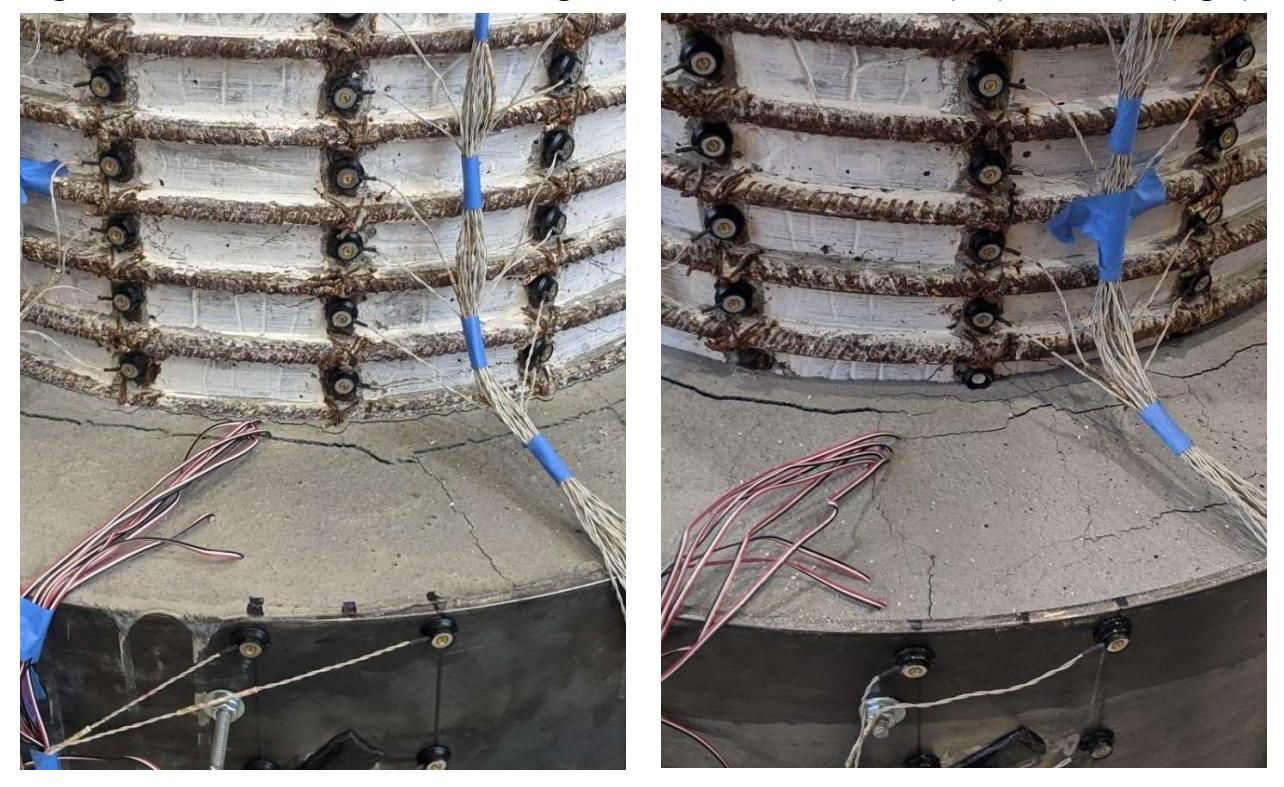
Figure 4.28: Comparison of cracking during ductility 1 for the North (left) and South (right).

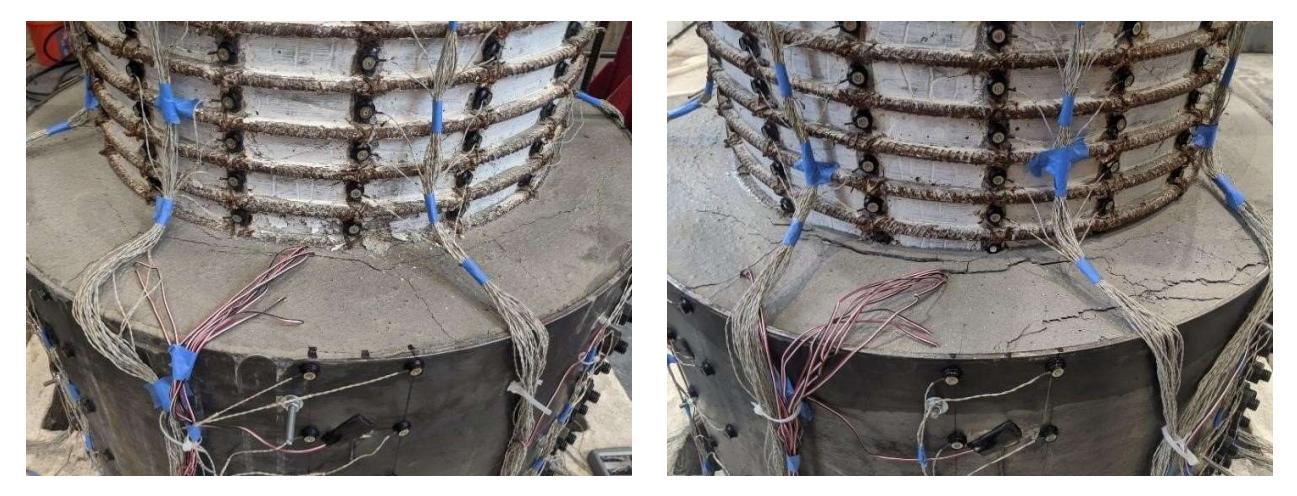
Figure 4.29: Damage Comparison after ductility 1.5 of the North (left) and South (right) sides.

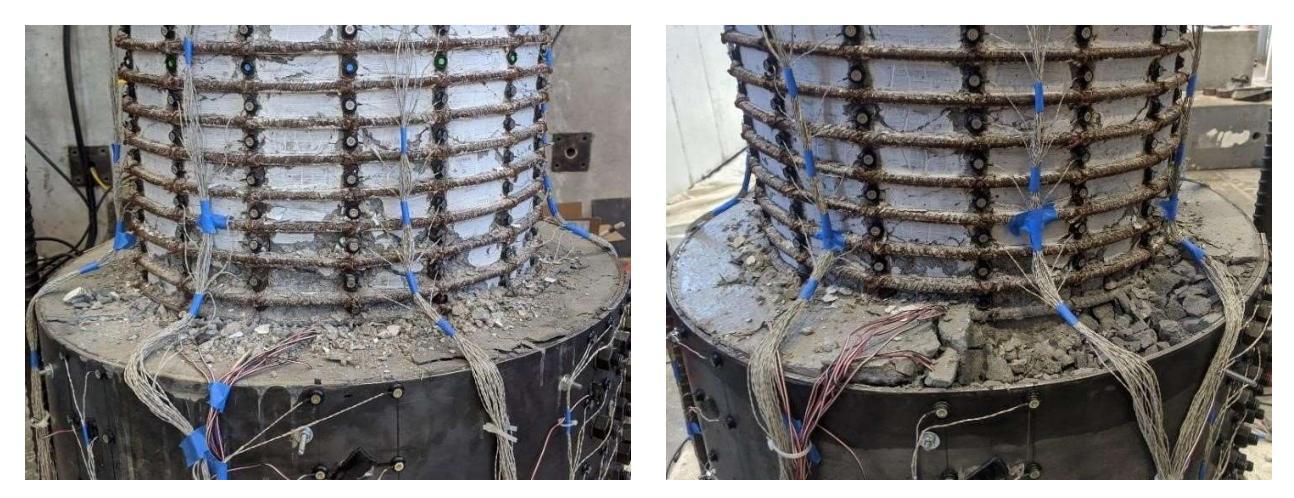
Figure 4.32: Damage Comparison after Ductility 4.

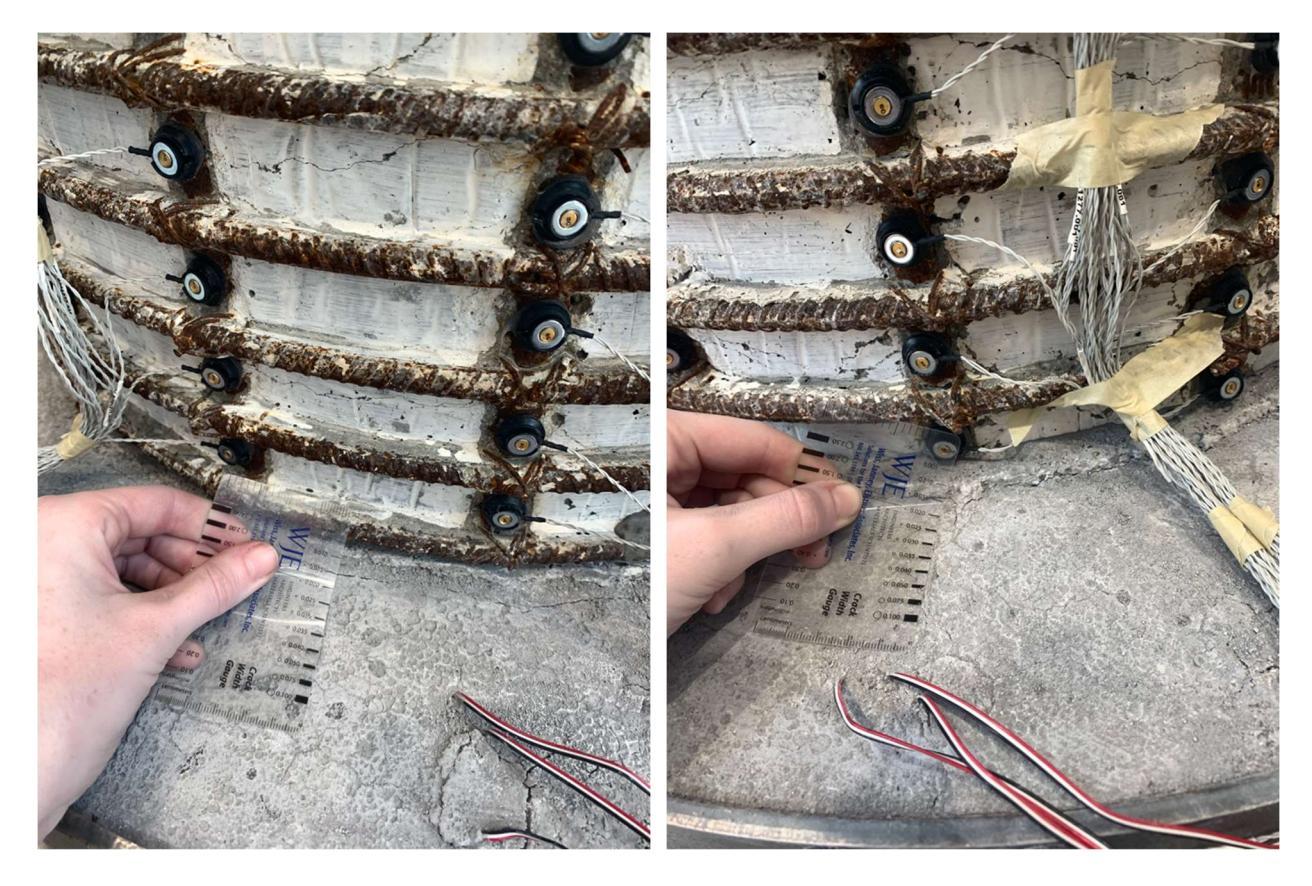
Figure 4.42: Circumferential cracks in the top of repair grout at ½ Fy' for the North (left) and South (right) sides.

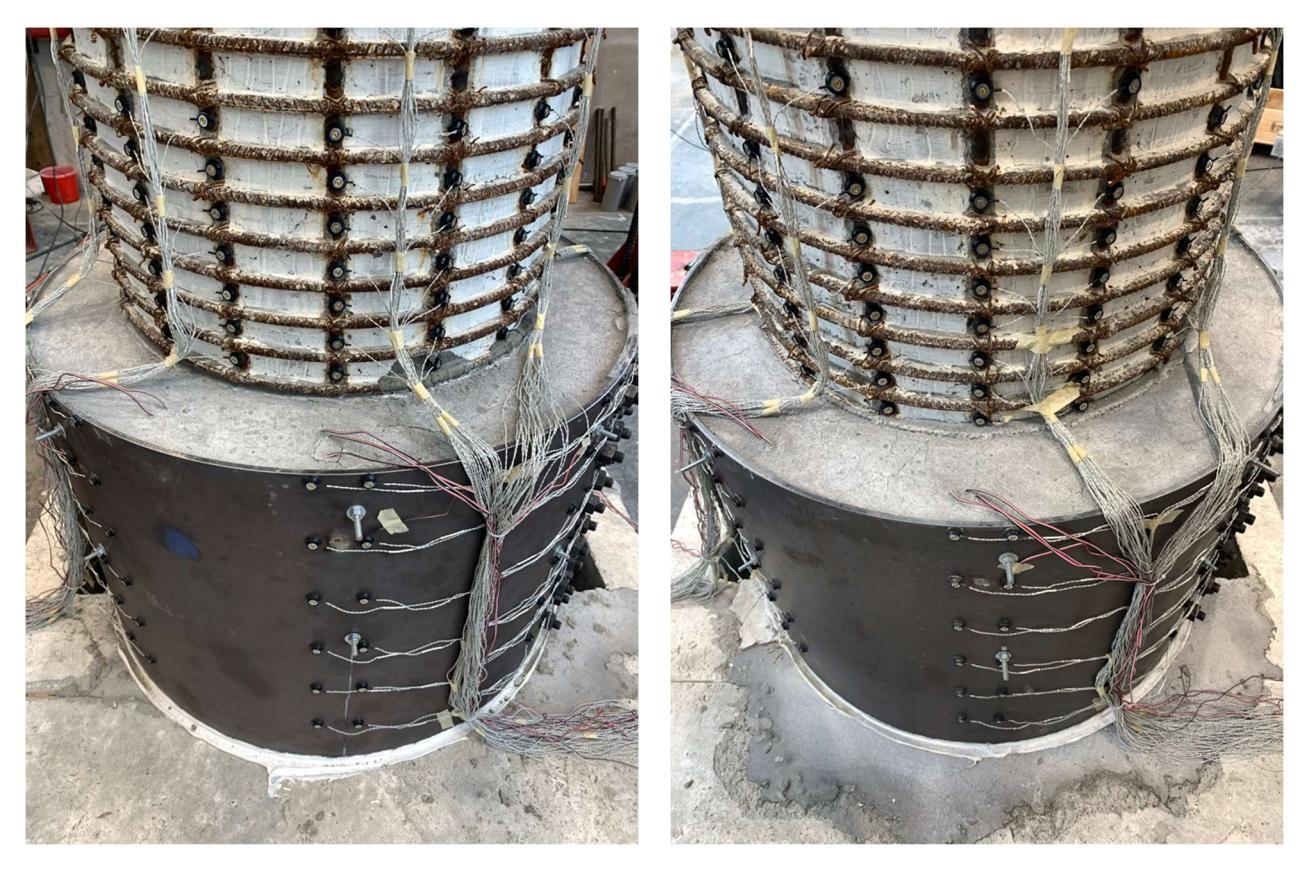
Figure 4.43: Comparison of grout cracking during ductility 1 for the North (left) and South (right) sides.

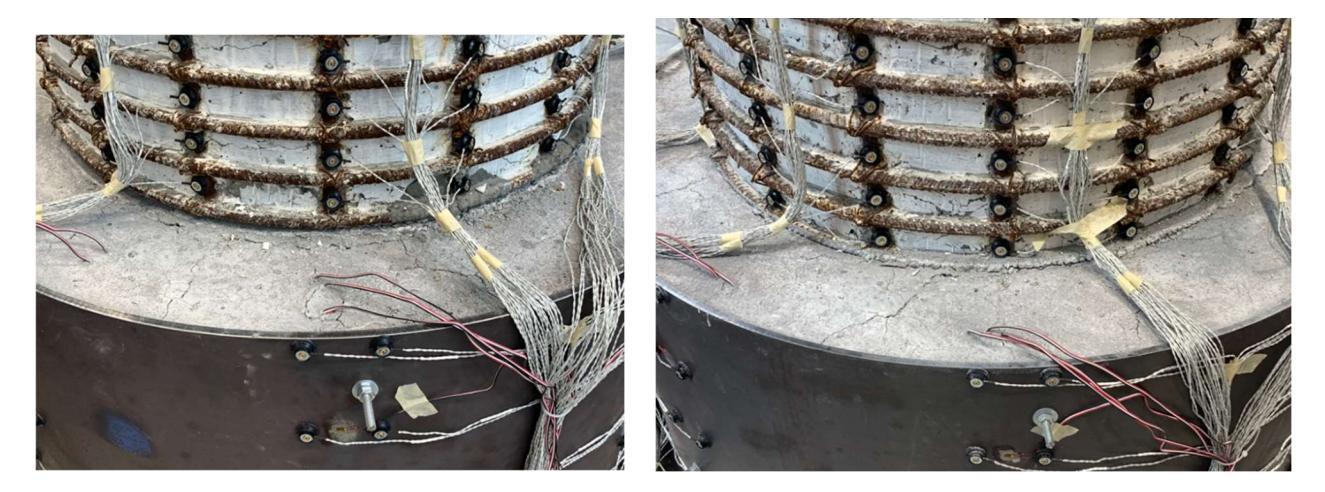
Figure 4.45: Damage Comparison after Ductility 2 of the North (left) and South (right) sides.

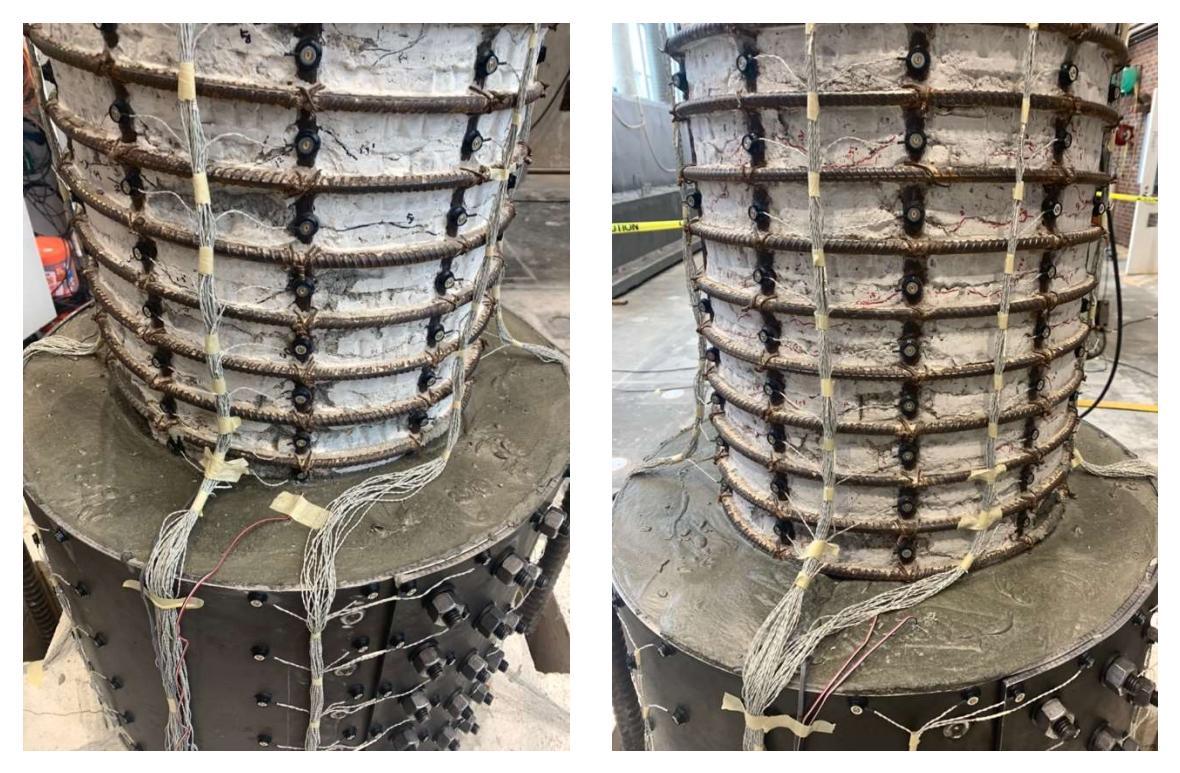
Figure 4.67: Damage During Ductility 1 of the North (left) and South (right) Sides.

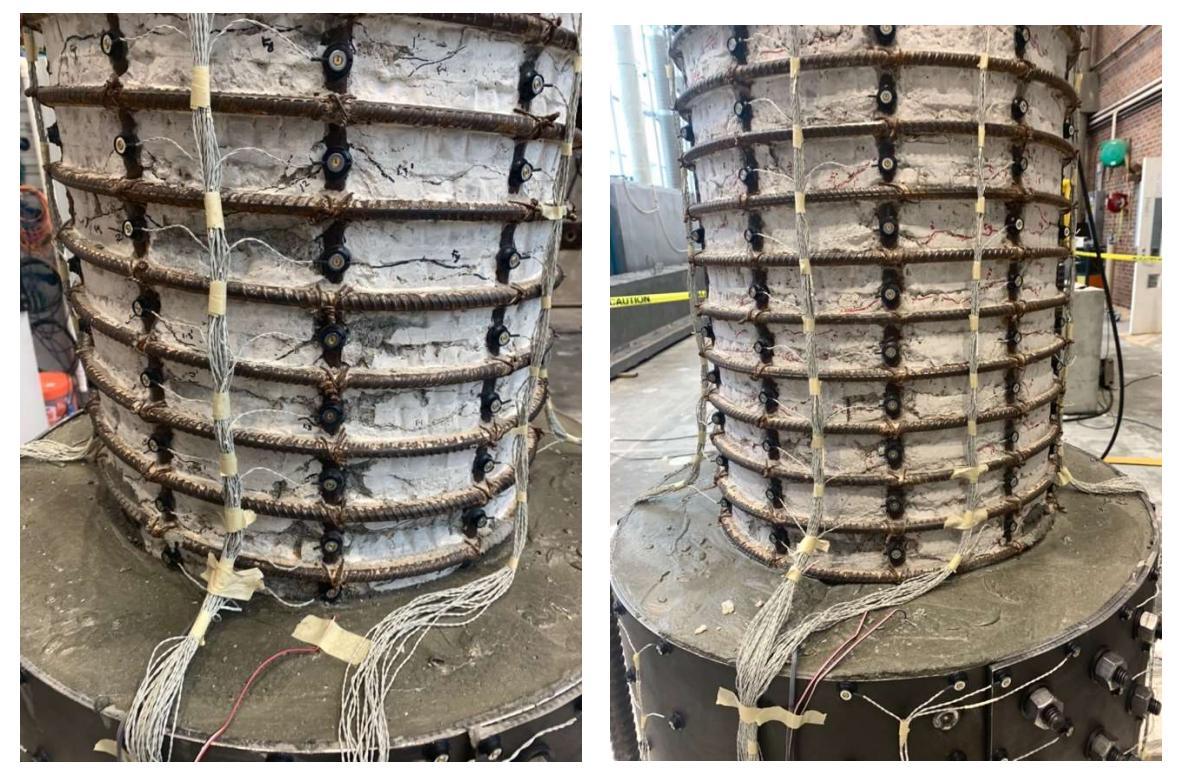
Figure 4.68: Damage During Ductility 1.5 of the North (left) and South (right) Sides. 100

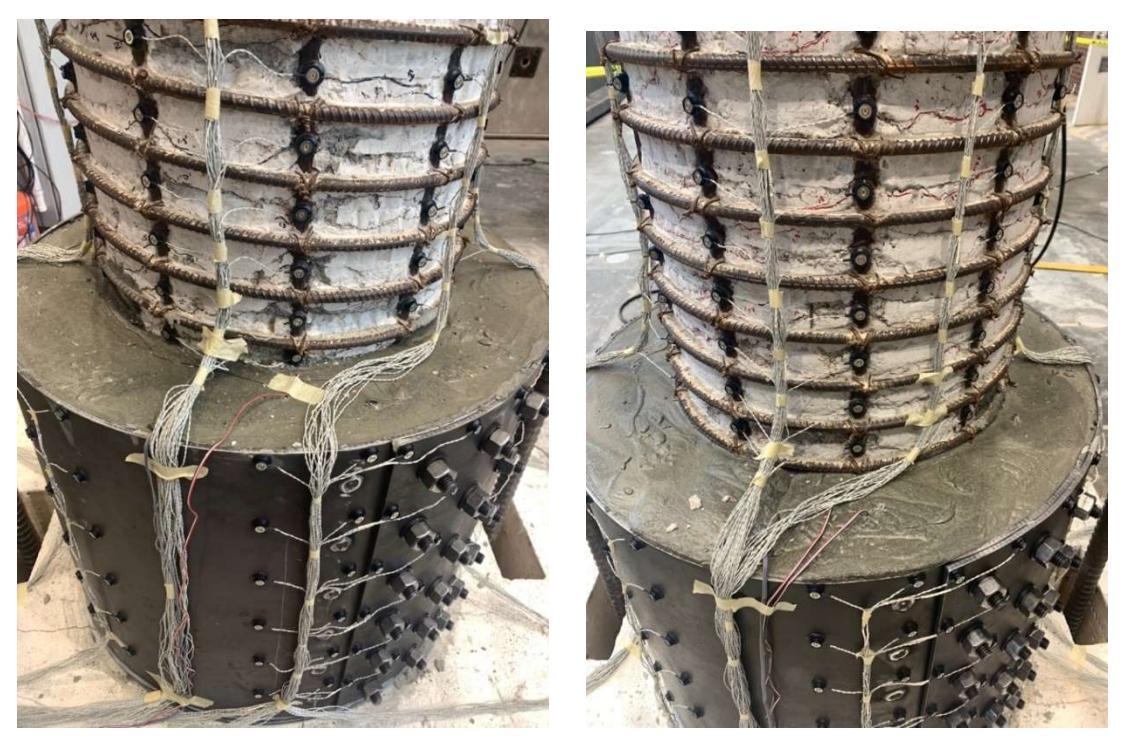
Figure 4.69: Damage During Ductility 2 of the North (left) and South (right) Sides.

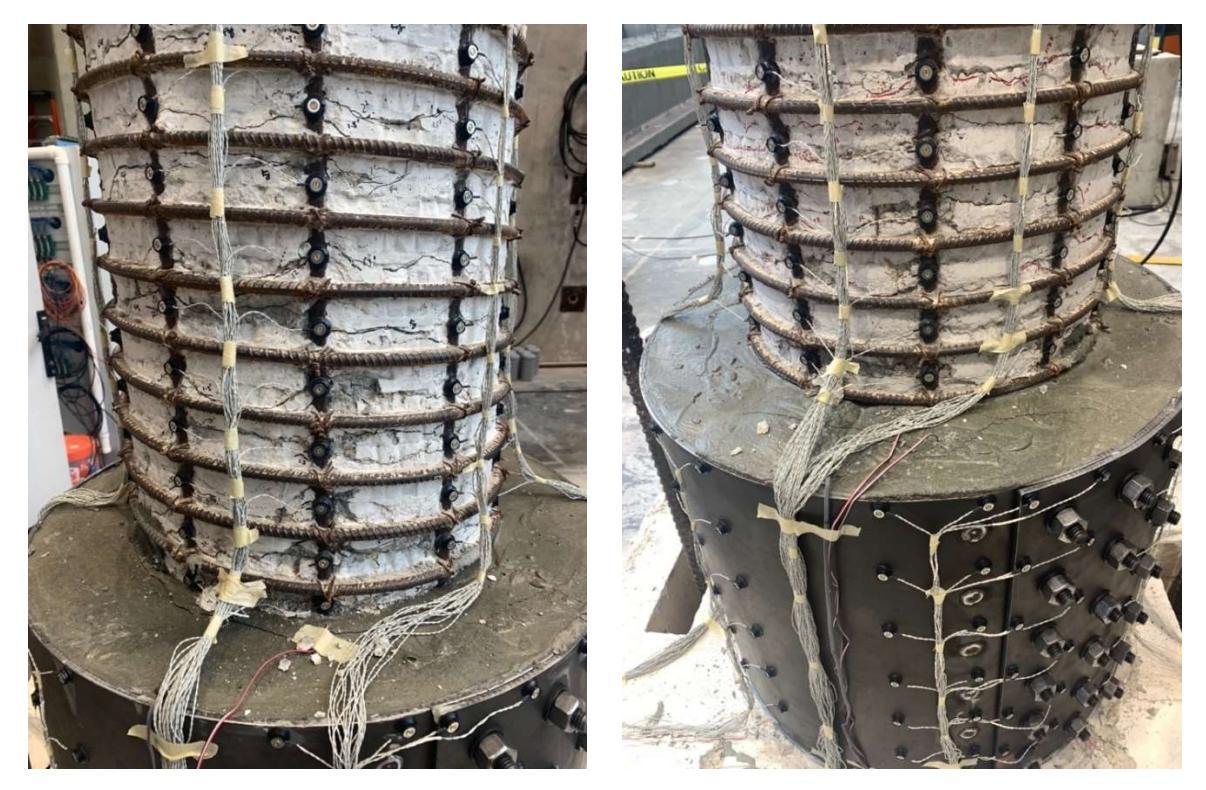
Figure 4.70: Damage During Ductility 3 of the North (left) and South (right) Sides.

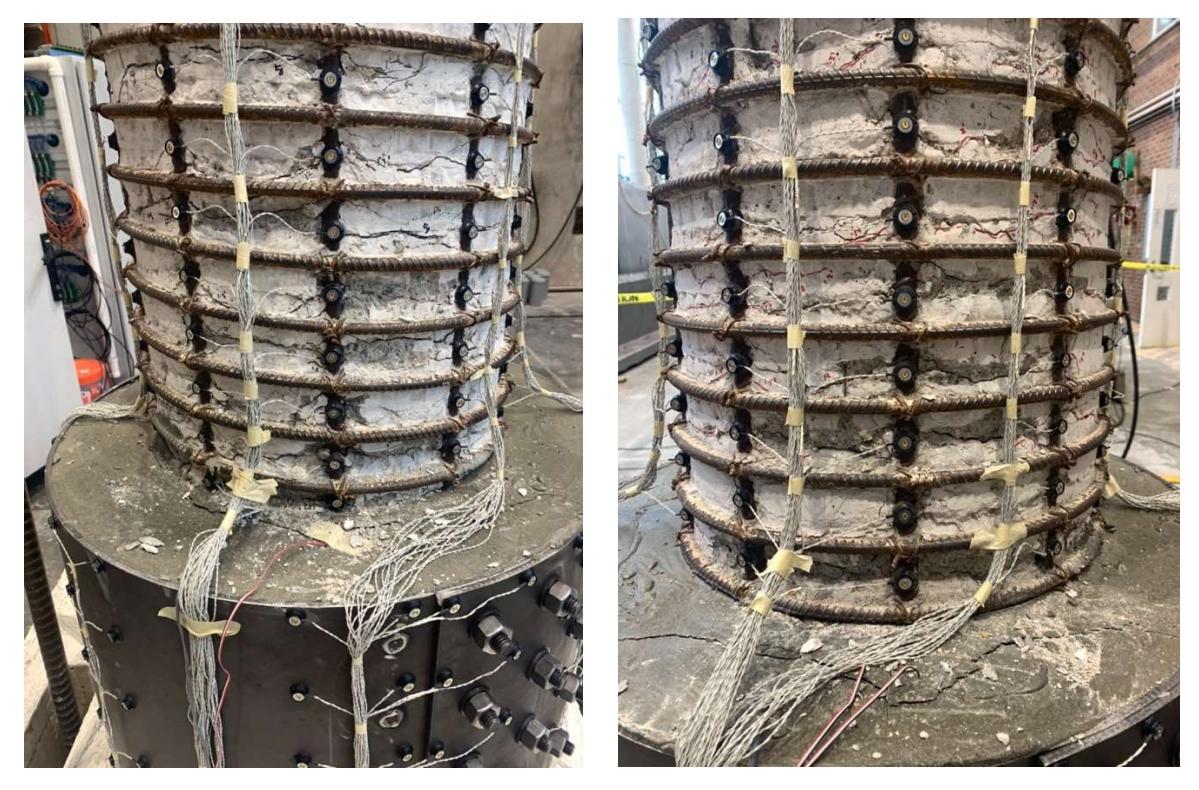
Figure 4.71: Damage During Ductility 4 of the North (left) and South (right) Sides.

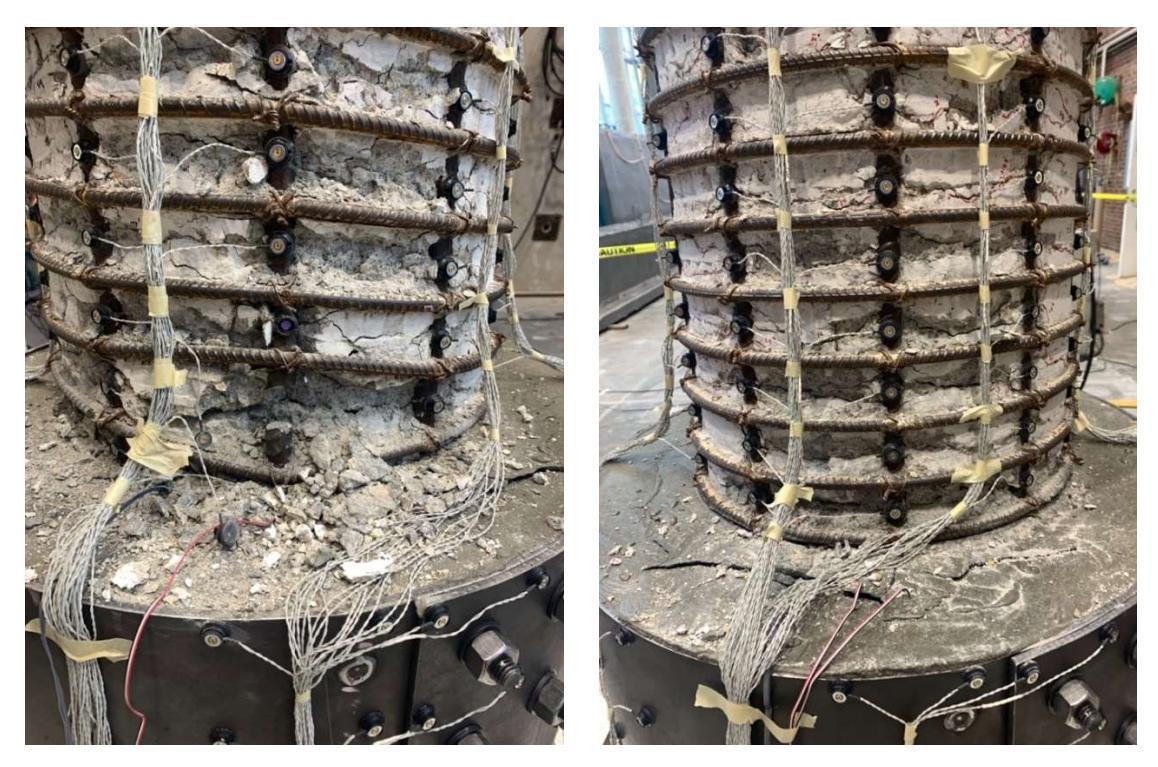
Figure 4.72: Damage During Ductility 5 of the North (left) and South (right) Sides.

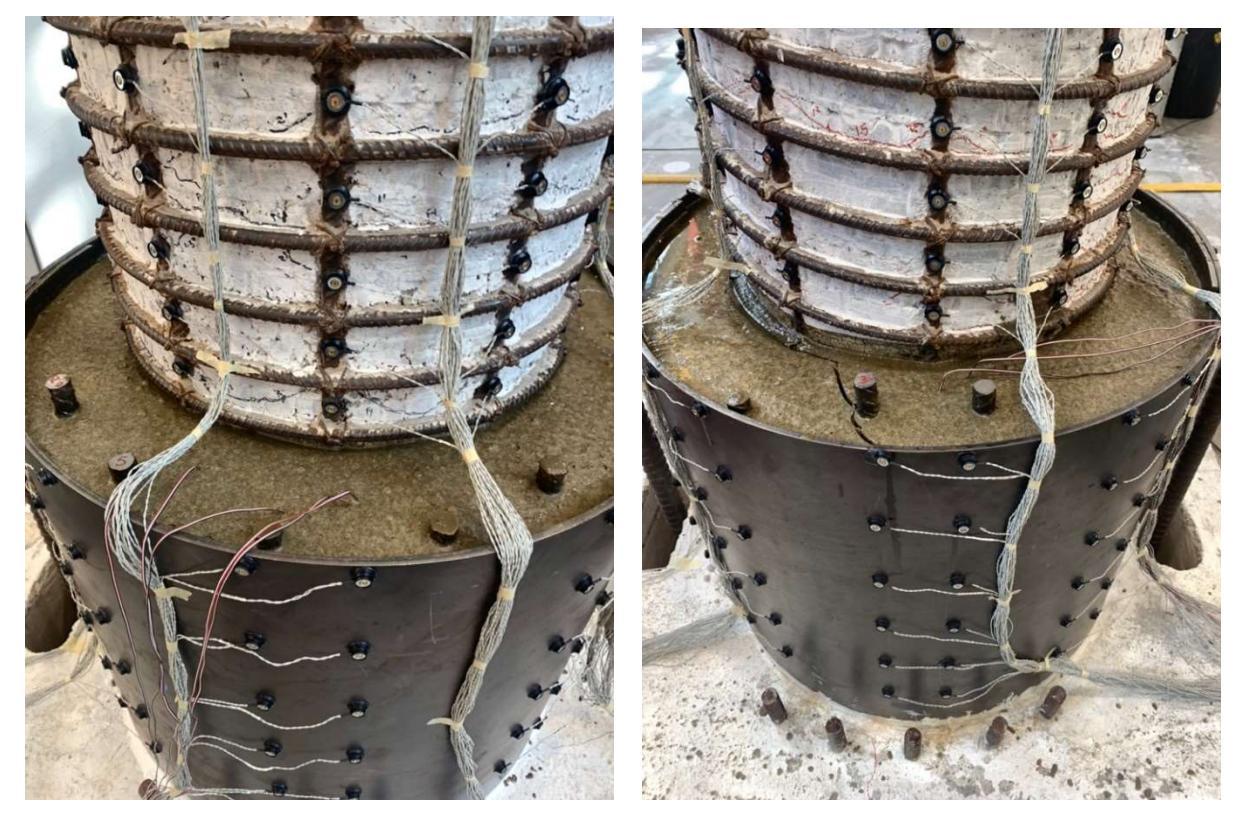
Figure 4.80: Damage During Ductility 1 of the North (left) and South (right) Sides.

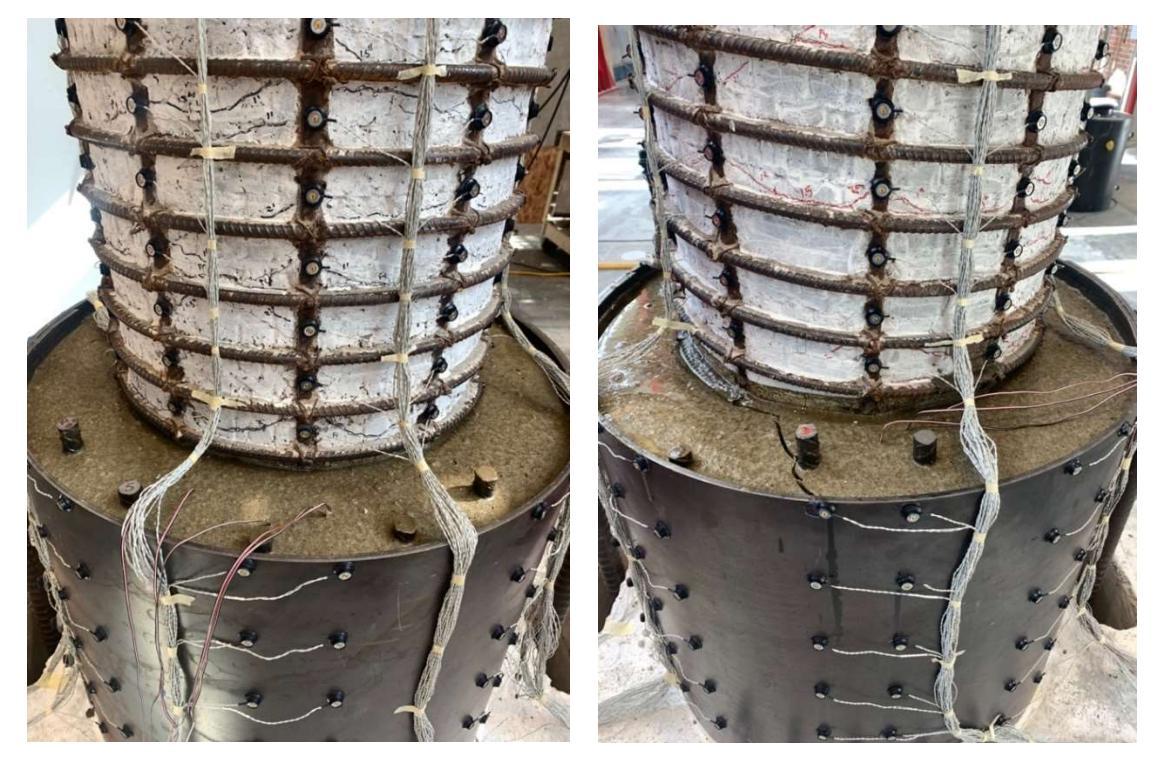
Figure 4.81: Damage During Ductility 1.5 of the North (left) and South (right) Sides.

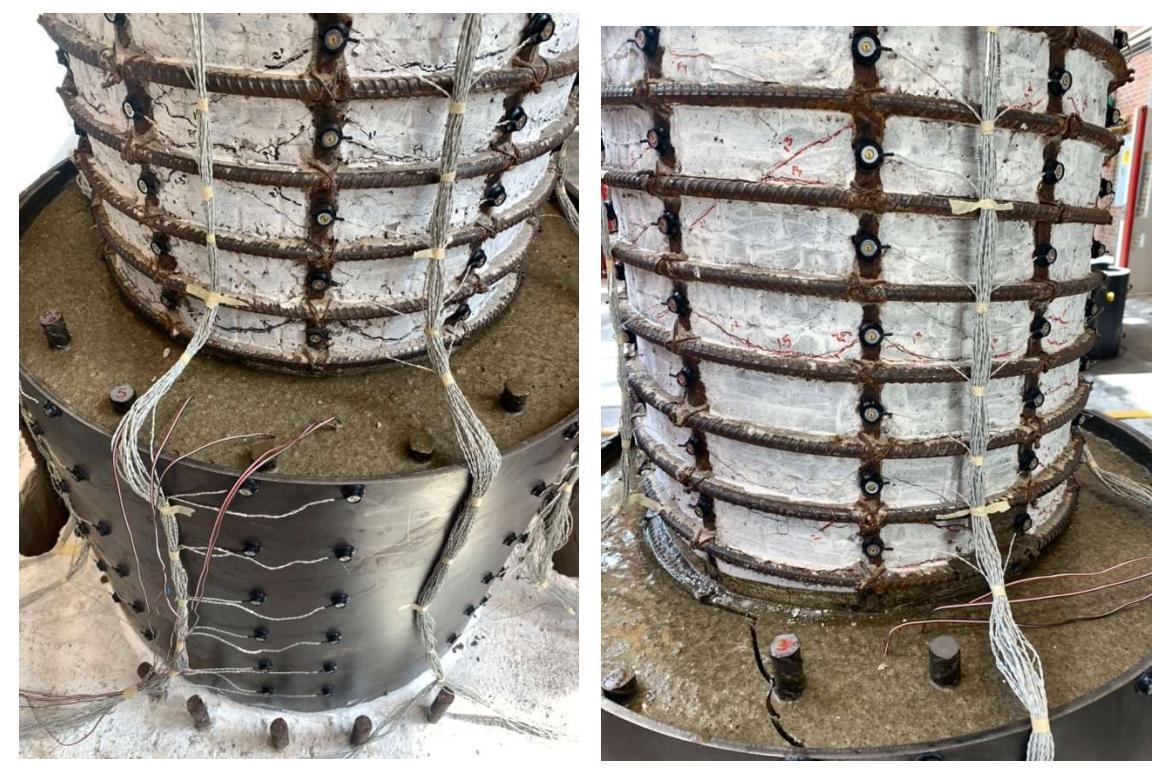
Figure 4.82: Damage During Ductility 2 of the North (left) and South (right) Sides.
