Rapid Seismic Repair of Column to Footing Connections – Phase 2

Prepared By: Taylor J. Brodbeck, Ph.D. Student Zachary A. Shurow, MS Mervyn J. Kowalsky, Professor, Ph.D. Rudolf Seracino, Professor, Ph.D.

1. AGENCY USE ONLY (LEAVE BLANK)	2. REPORT DATE	3. REPORT TYPE AND DA	TES COVER	ED
	May 31, 2022	FINAL REPORT, Jan.	2019 thro	ugh May 2022
4. TITLE AND SUBTITLE Rapid Seismic Repair of Column to F	Footing Connections – Phase 2		5. FUNDING	NUMBERS

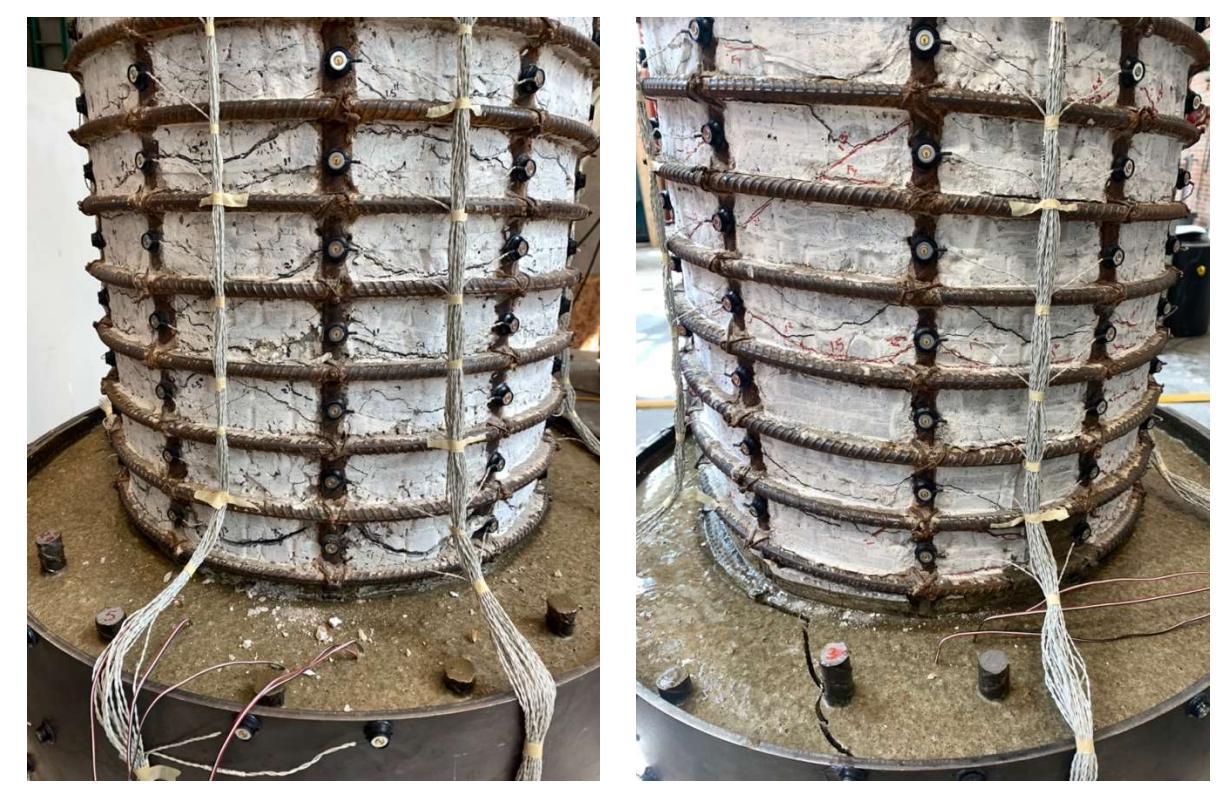
Figure 4.83: Damage During Ductility 3 of the North (left) and South (right) Sides.

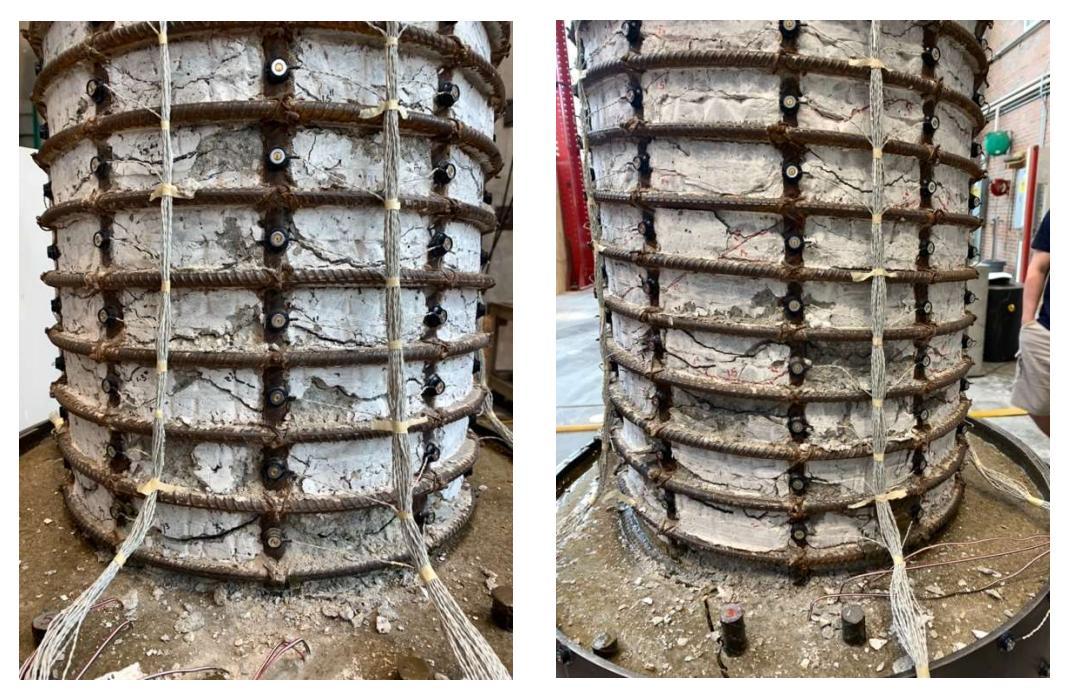
Figure 4.84: Damage During Ductility 4 of the North (left) and South (right) Sides.

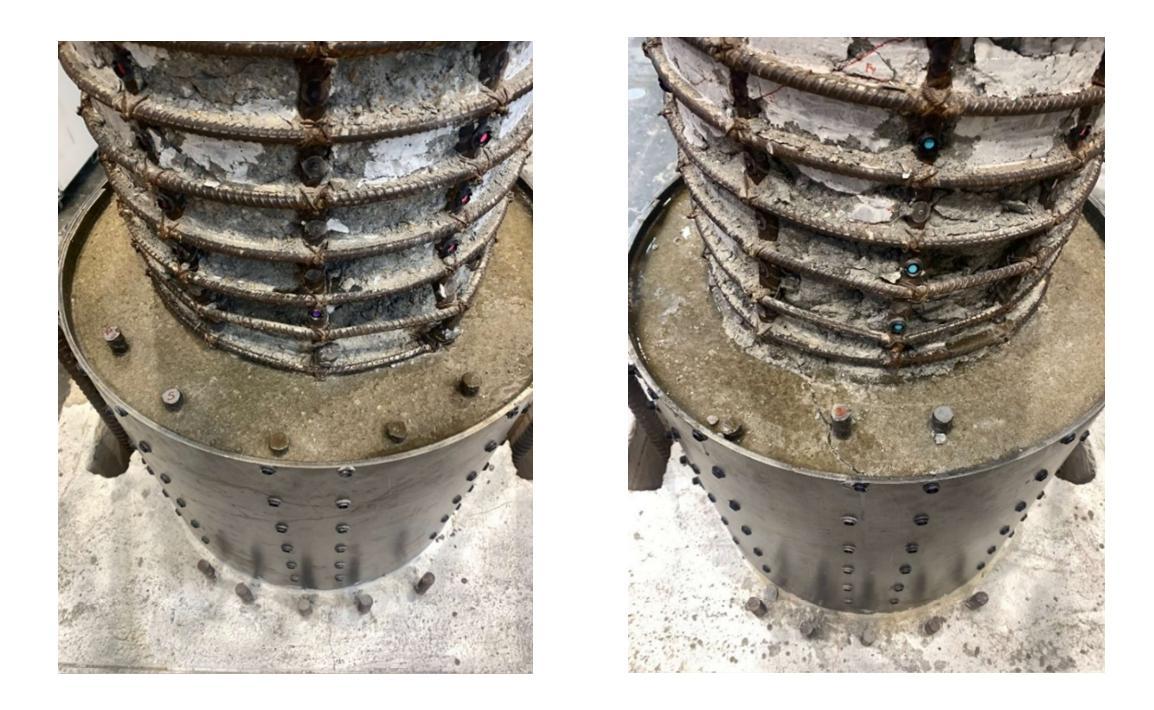
Figure 4.85: Damage after the test when all loose concrete was removed of the North (left) and South (right) sides.

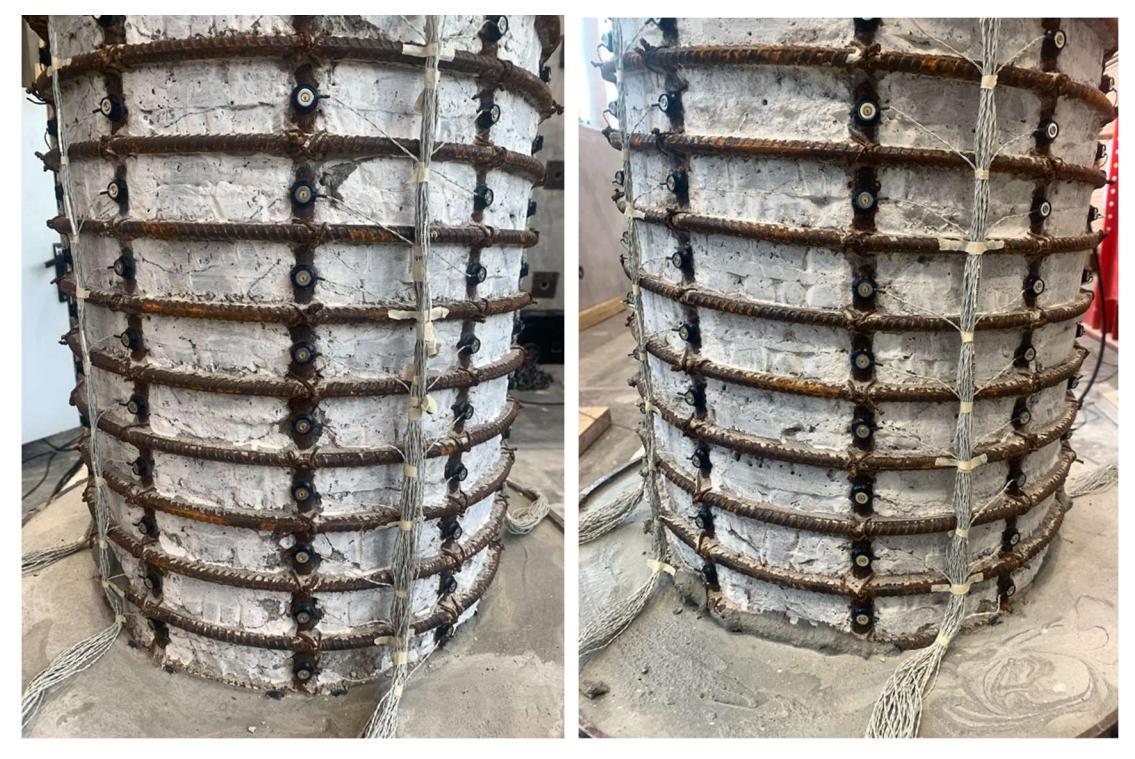
Figure 4.92: Initial Damage of the North (left) and South (right) Sides.

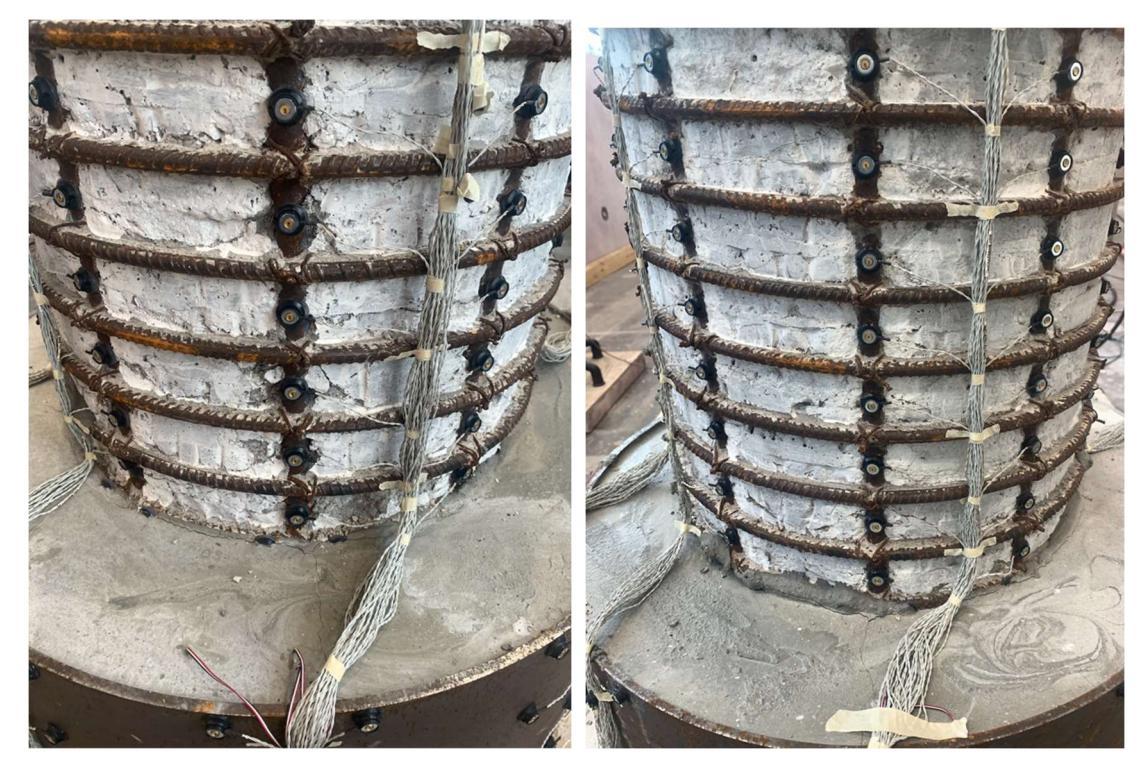
Figure 4.93: Damage During Ductility 1 of the North (left) and South (right) Sides.

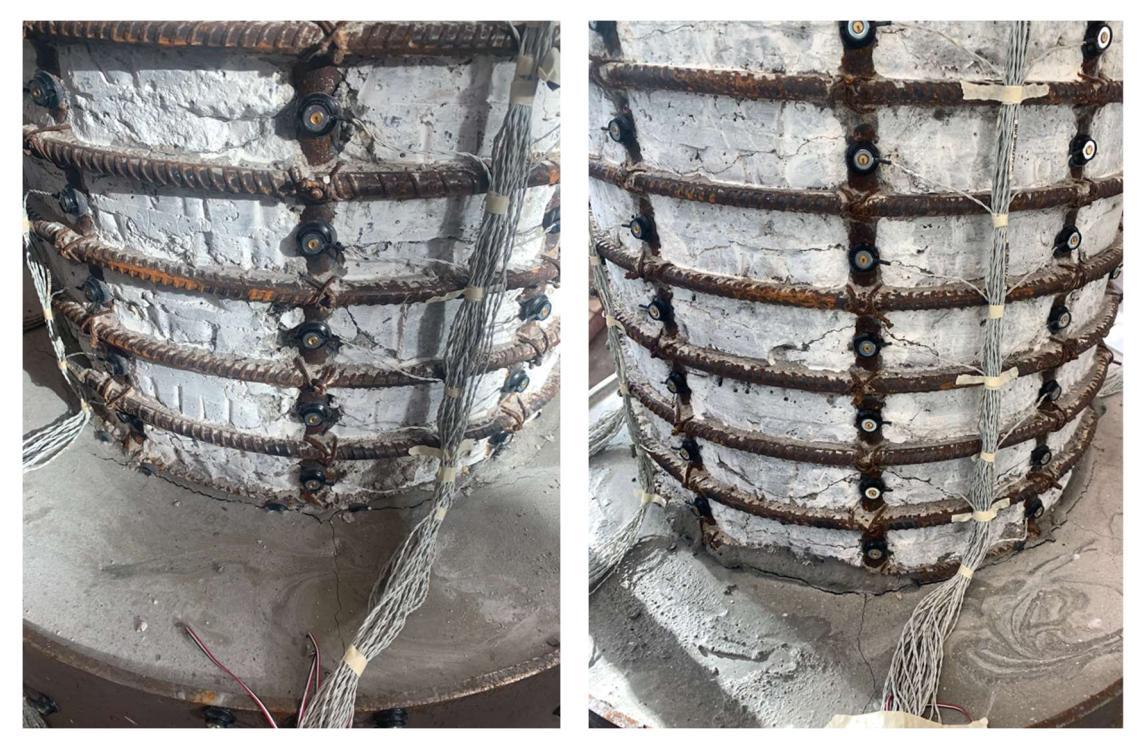
Figure 4.94: Damage During Ductility 2 of the North (left) and South (right) Sides.

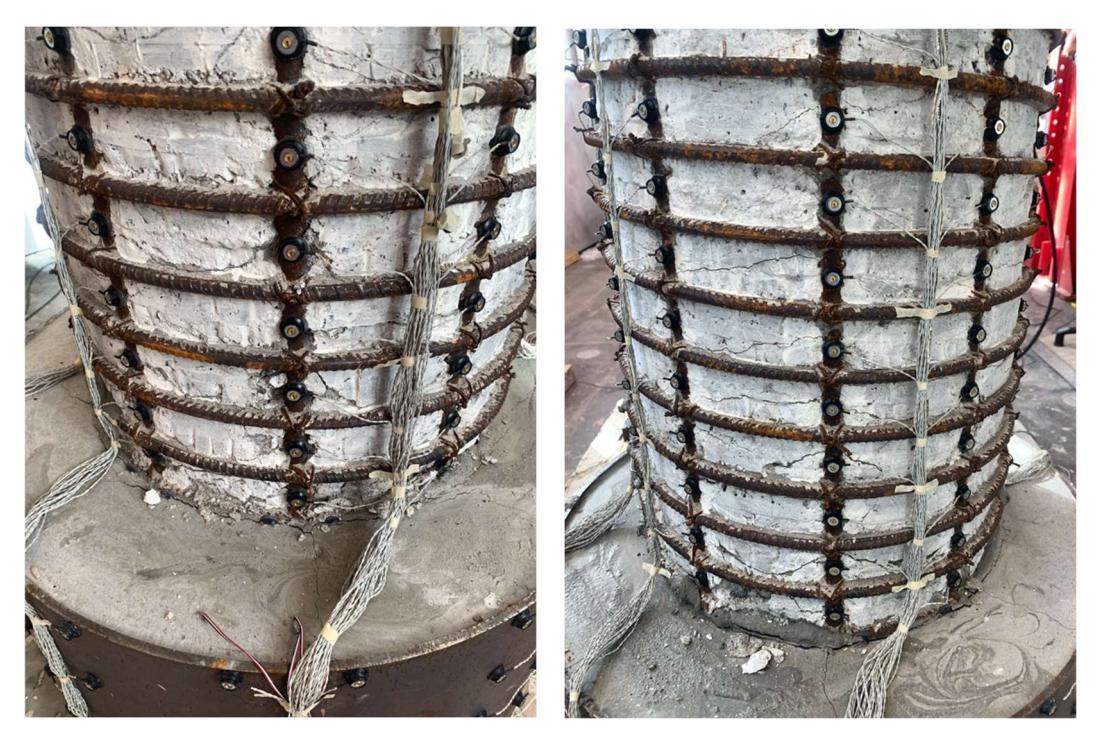
Figure 4.95: Damage During Ductility 3 of the North (left) and South (right) Sides.

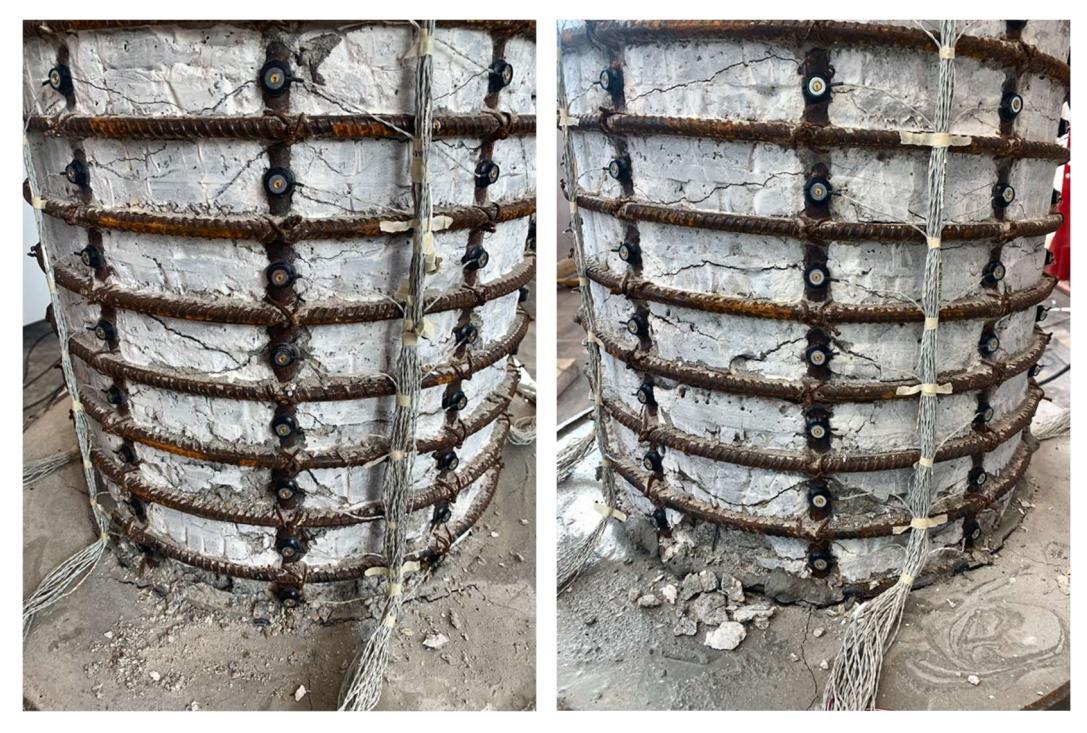
Figure 4.96: Damage During Ductility 4 of the North (left) and South (right) Sides.

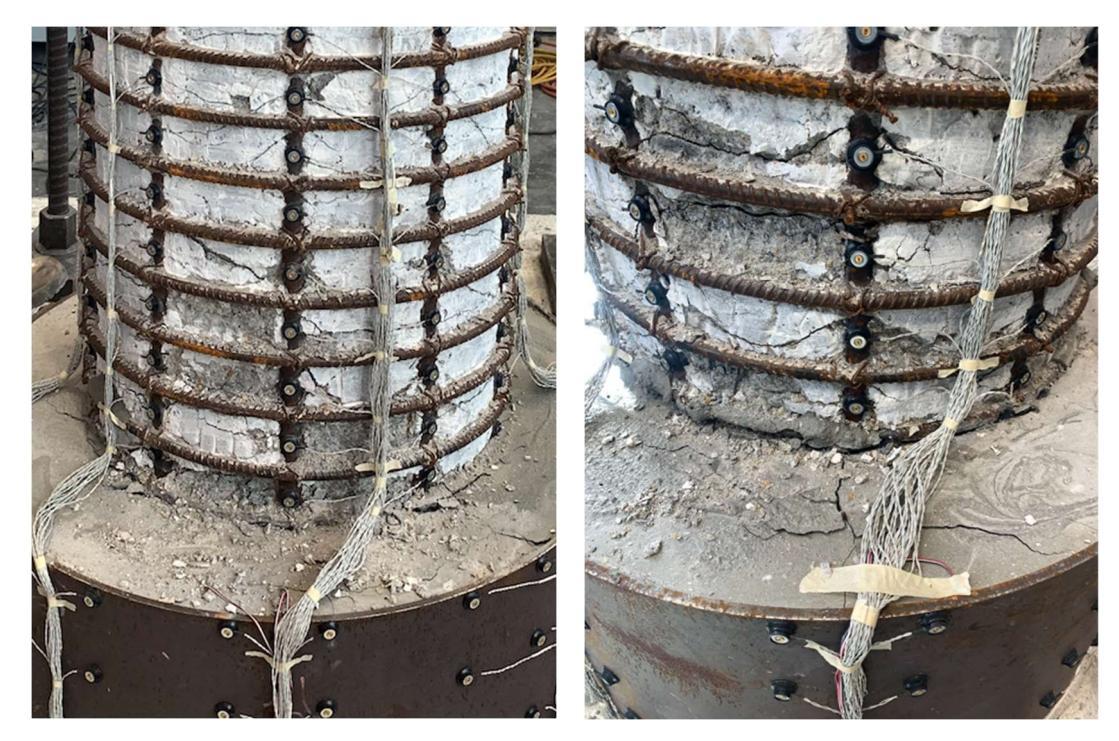
Figure 4.97: Damage During Ductility 5 of the North (left) and South (right) Sides.

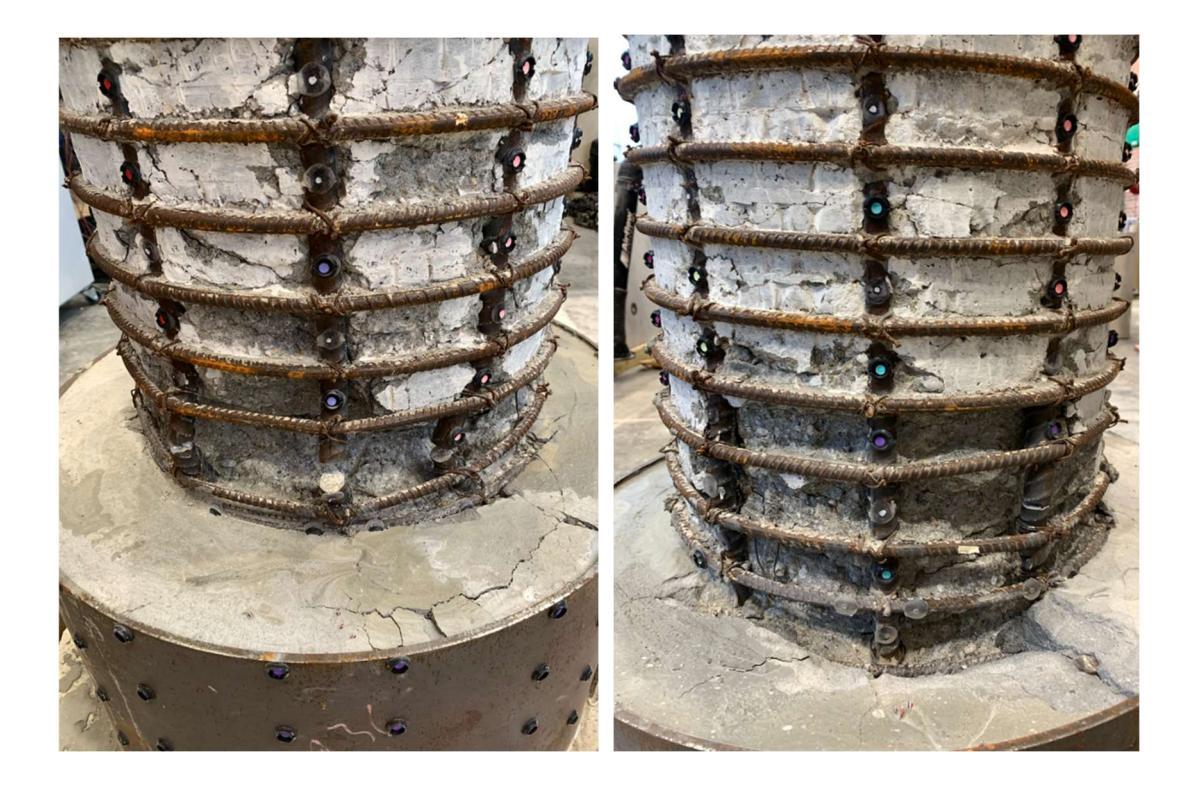
Figure 4.98: Final Damage of the North (left) and South (right) Sides.

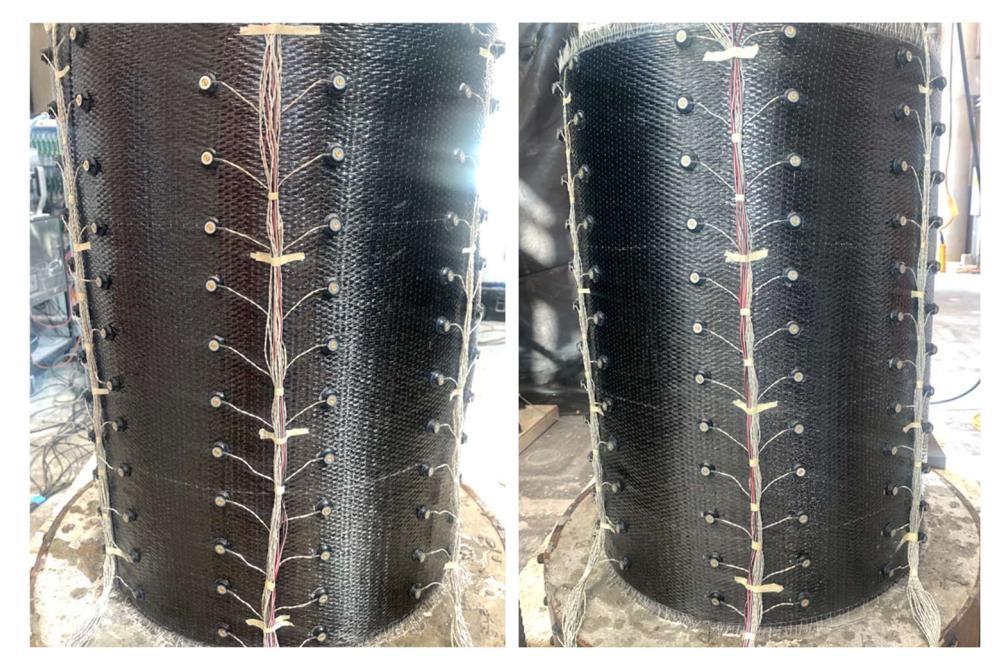
Figure 4.103: Damage During Ductility 1.5 of the North (left) and South (right) Sides.

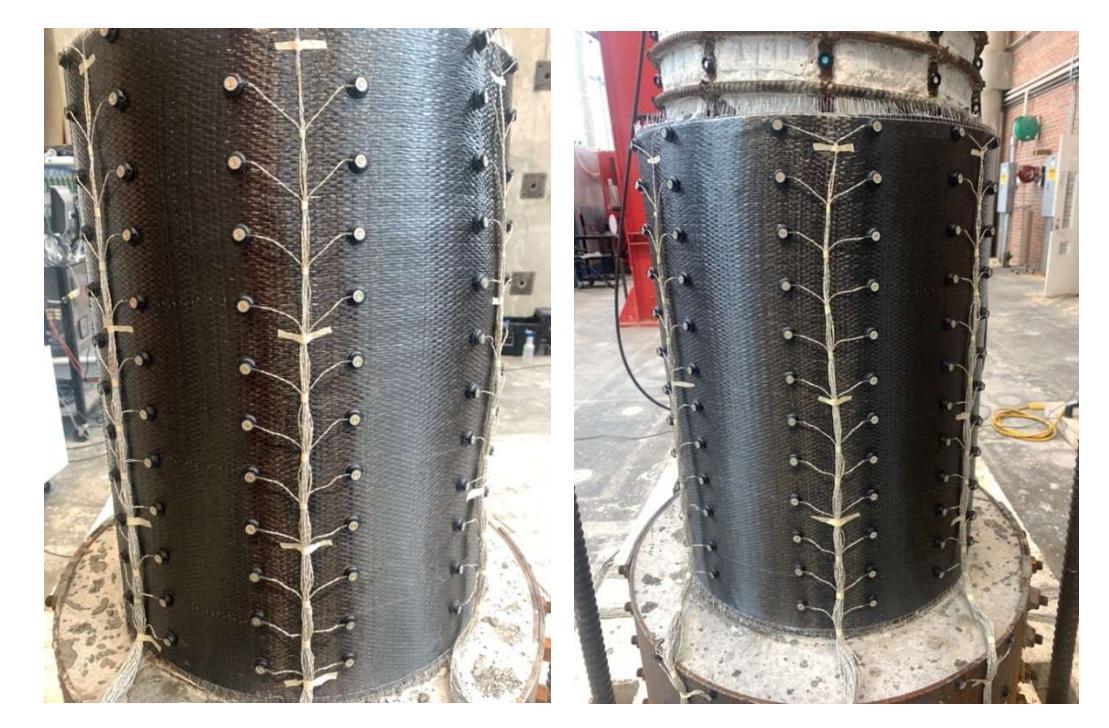
Figure 4.115: Damage During Ductility 2 of the North (left) and South (right) Sides.

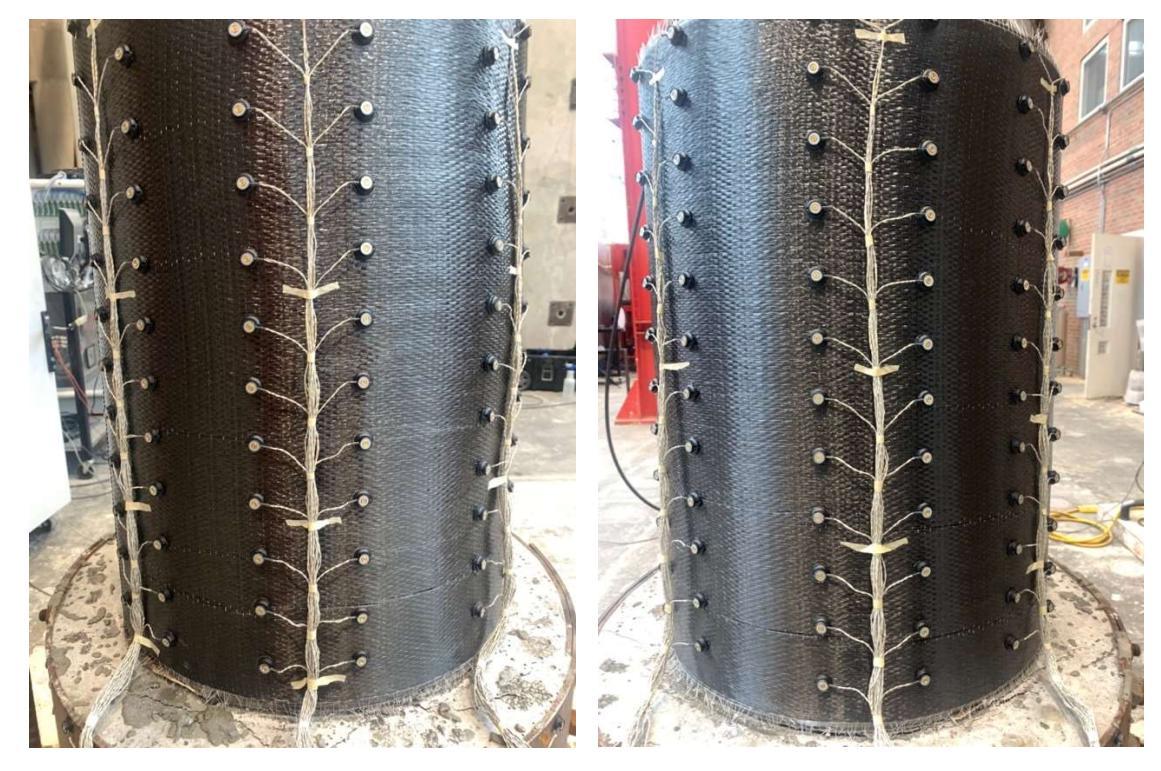
Figure 4.117: Damage During Ductility 3 of the North (left) and South (right) Sides.

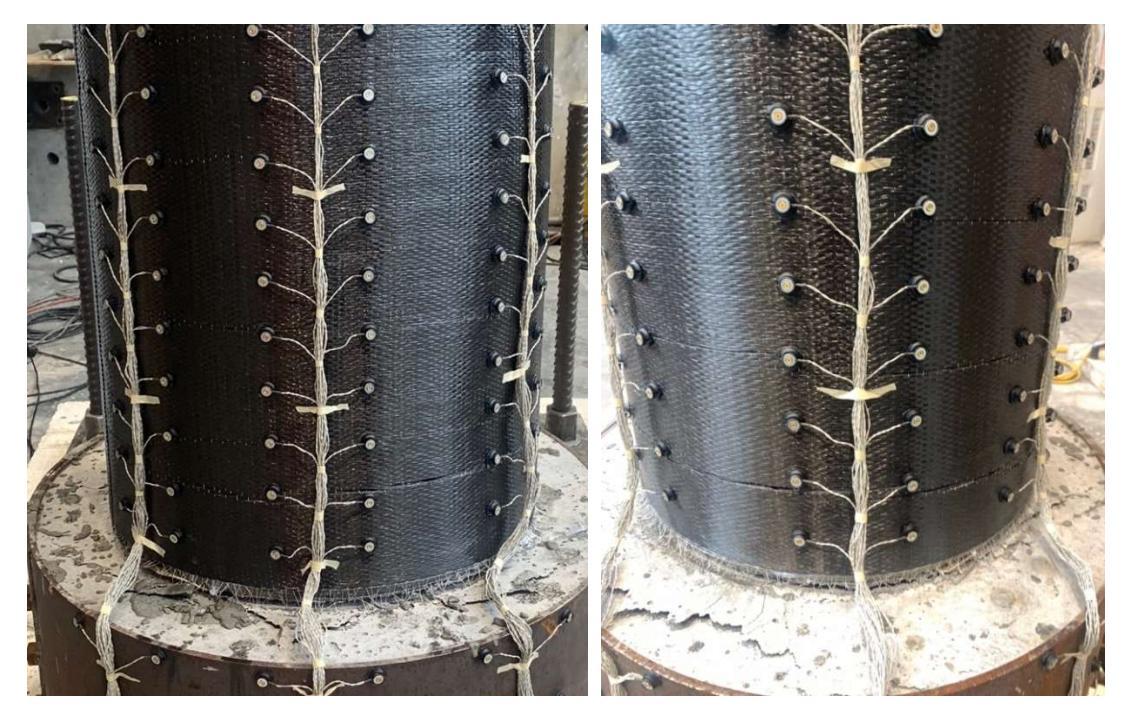
Figure 4.119: Damage During Ductility 4 of the North (left) and South (right) Sides.

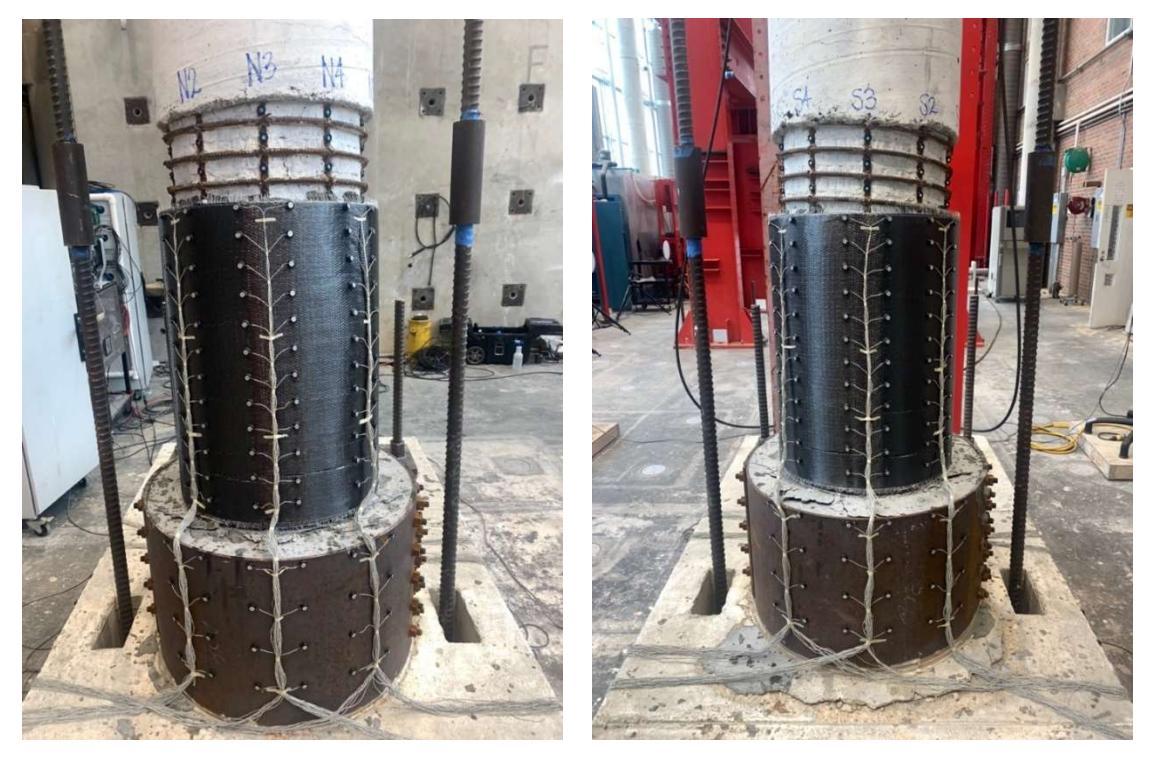
Figure 4.120: Damage During Ductility 5 of the North (left) and South (right) Sides.

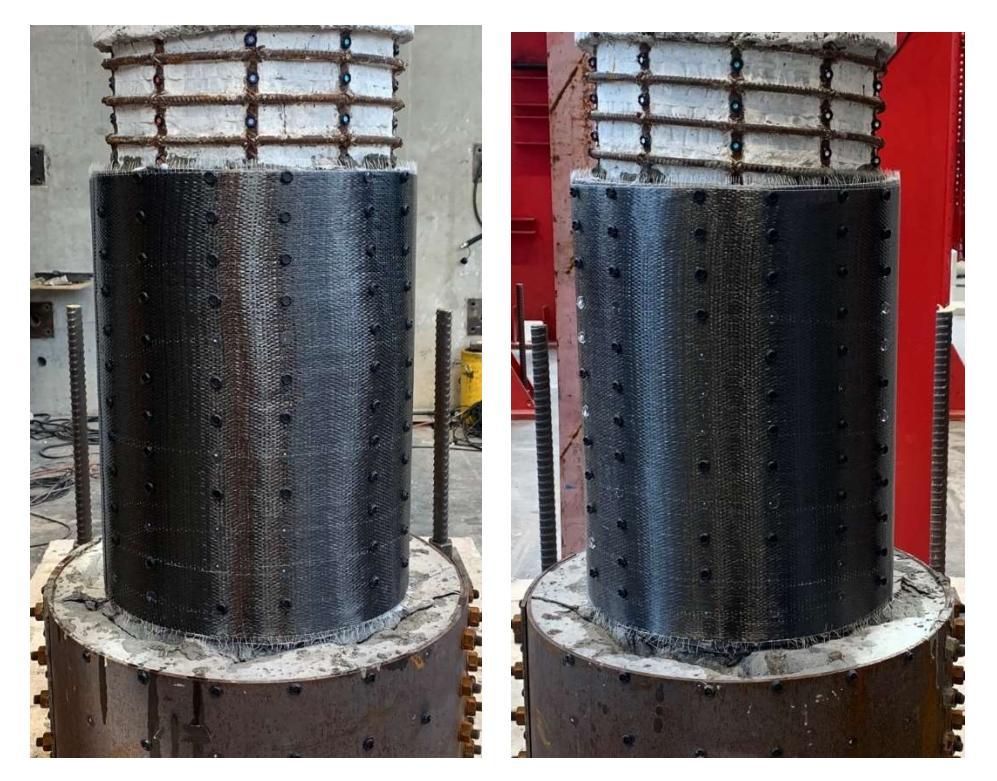
Figure 4.121: Final Damage of the North (left) and South (right) Sides.
