# Airport Field Maintenance Storage Yard Expansion

Project No. CFAPT00131

## Environmental Assessment

#### Permits & Section 404 Permit Application

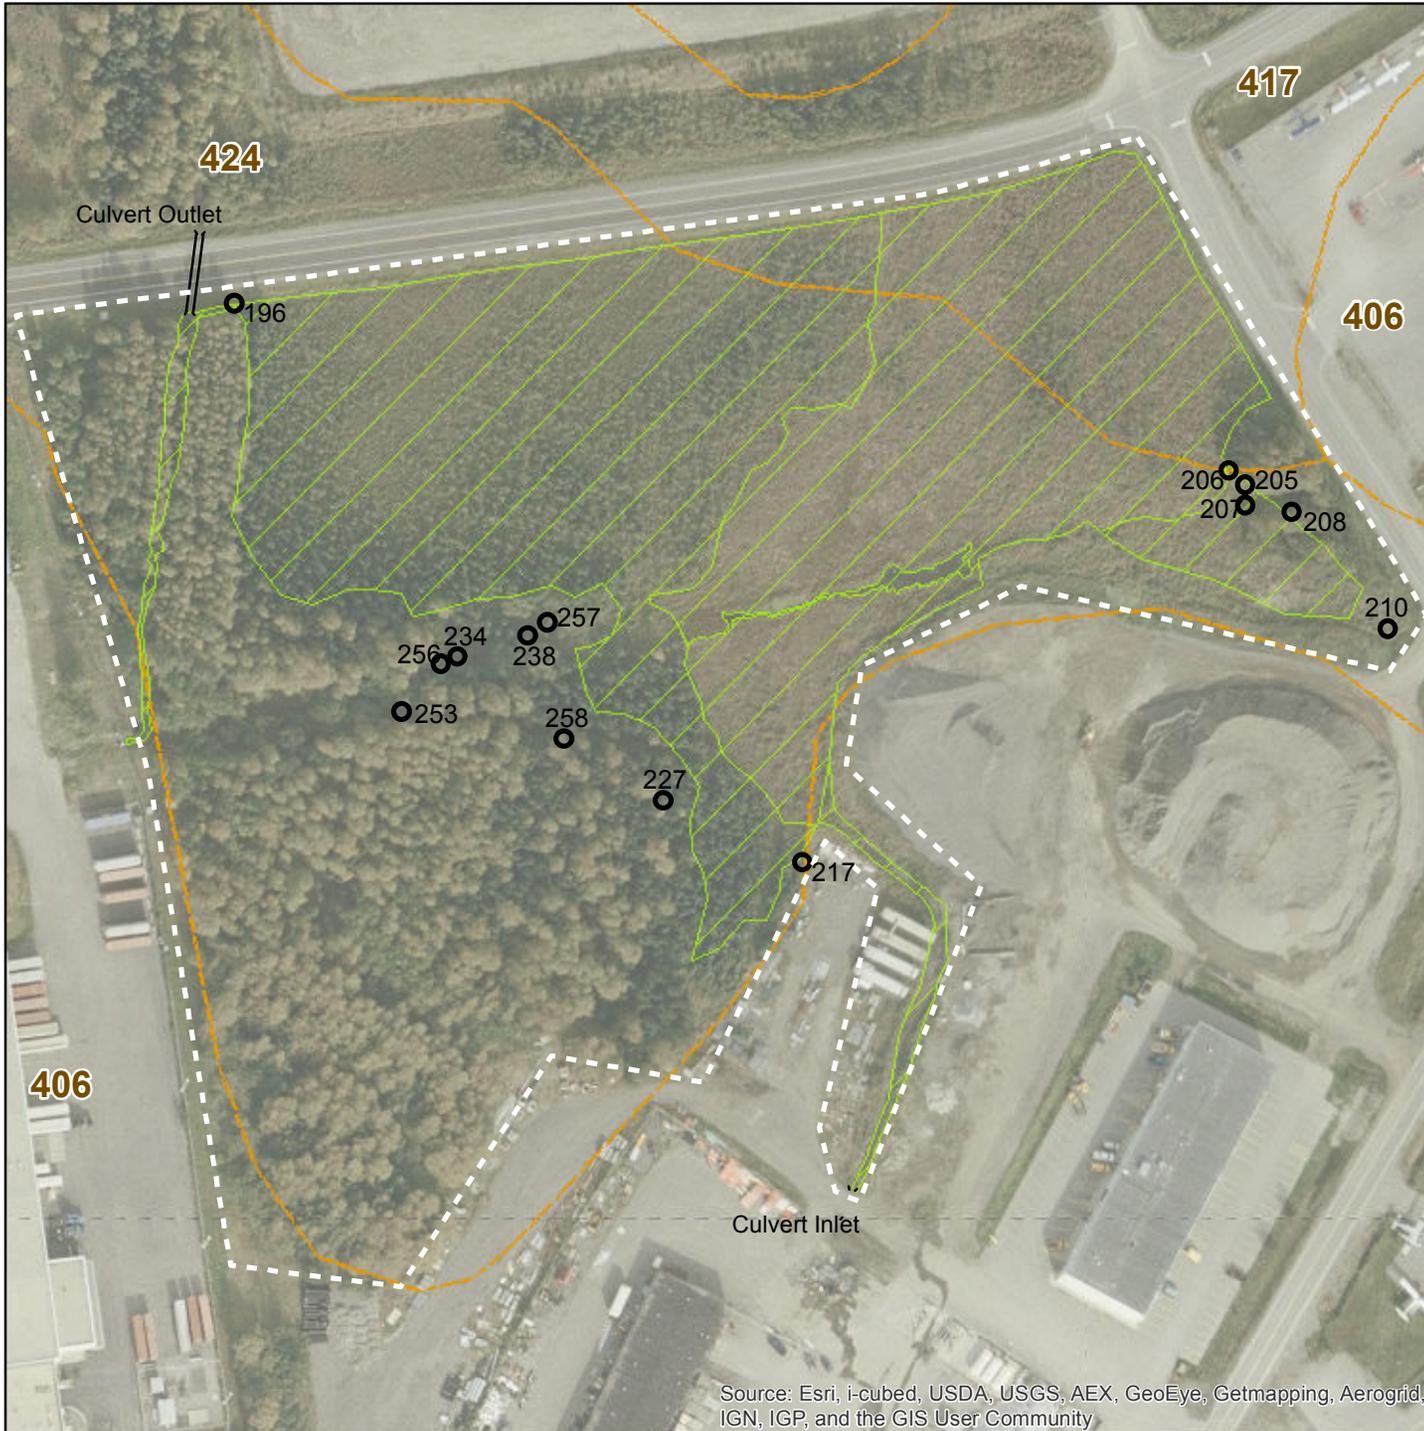
**Map 3**  
**2012 RSE Mapped**  
**Wetlands and Waters**  
 AFM Storage Yard Expansion  
 Wetland Field Verification  
 Ted Steven Anchorage Intl' Airport  
 Section 27, T 13N, R 04 W, SM;  
 South of Lake Hood Drive

The boundary along the west side was re-delineated and adjusted based on the additional information to include an approximate 0.29 acre area that was not included in the wetland boundary in 2012. The area is consistent with the surrounding wetlands. The area is dominated by a mixture of needle-leaved and broad-leaved trees and shrubs such as paper black spruce (*Picea mariana*), alders (*Alnus rubra*), and birch shrubs (*Betula papyrifera*). The area is also dominated graminoid species such as bluejoint reed grass (*Calamagrostis Canadensis*) and sedges (*Carex* spp.) Saturated organic soils were encountered through all depths of the soil profile with gley and redox features. The wetland determination points (DPs) indicated saturation in the upper 12 inches of the soil. The hydrology and soil observations are consistent with the NRCS classification of the area. See Map 3 with the updated wetland boundary.

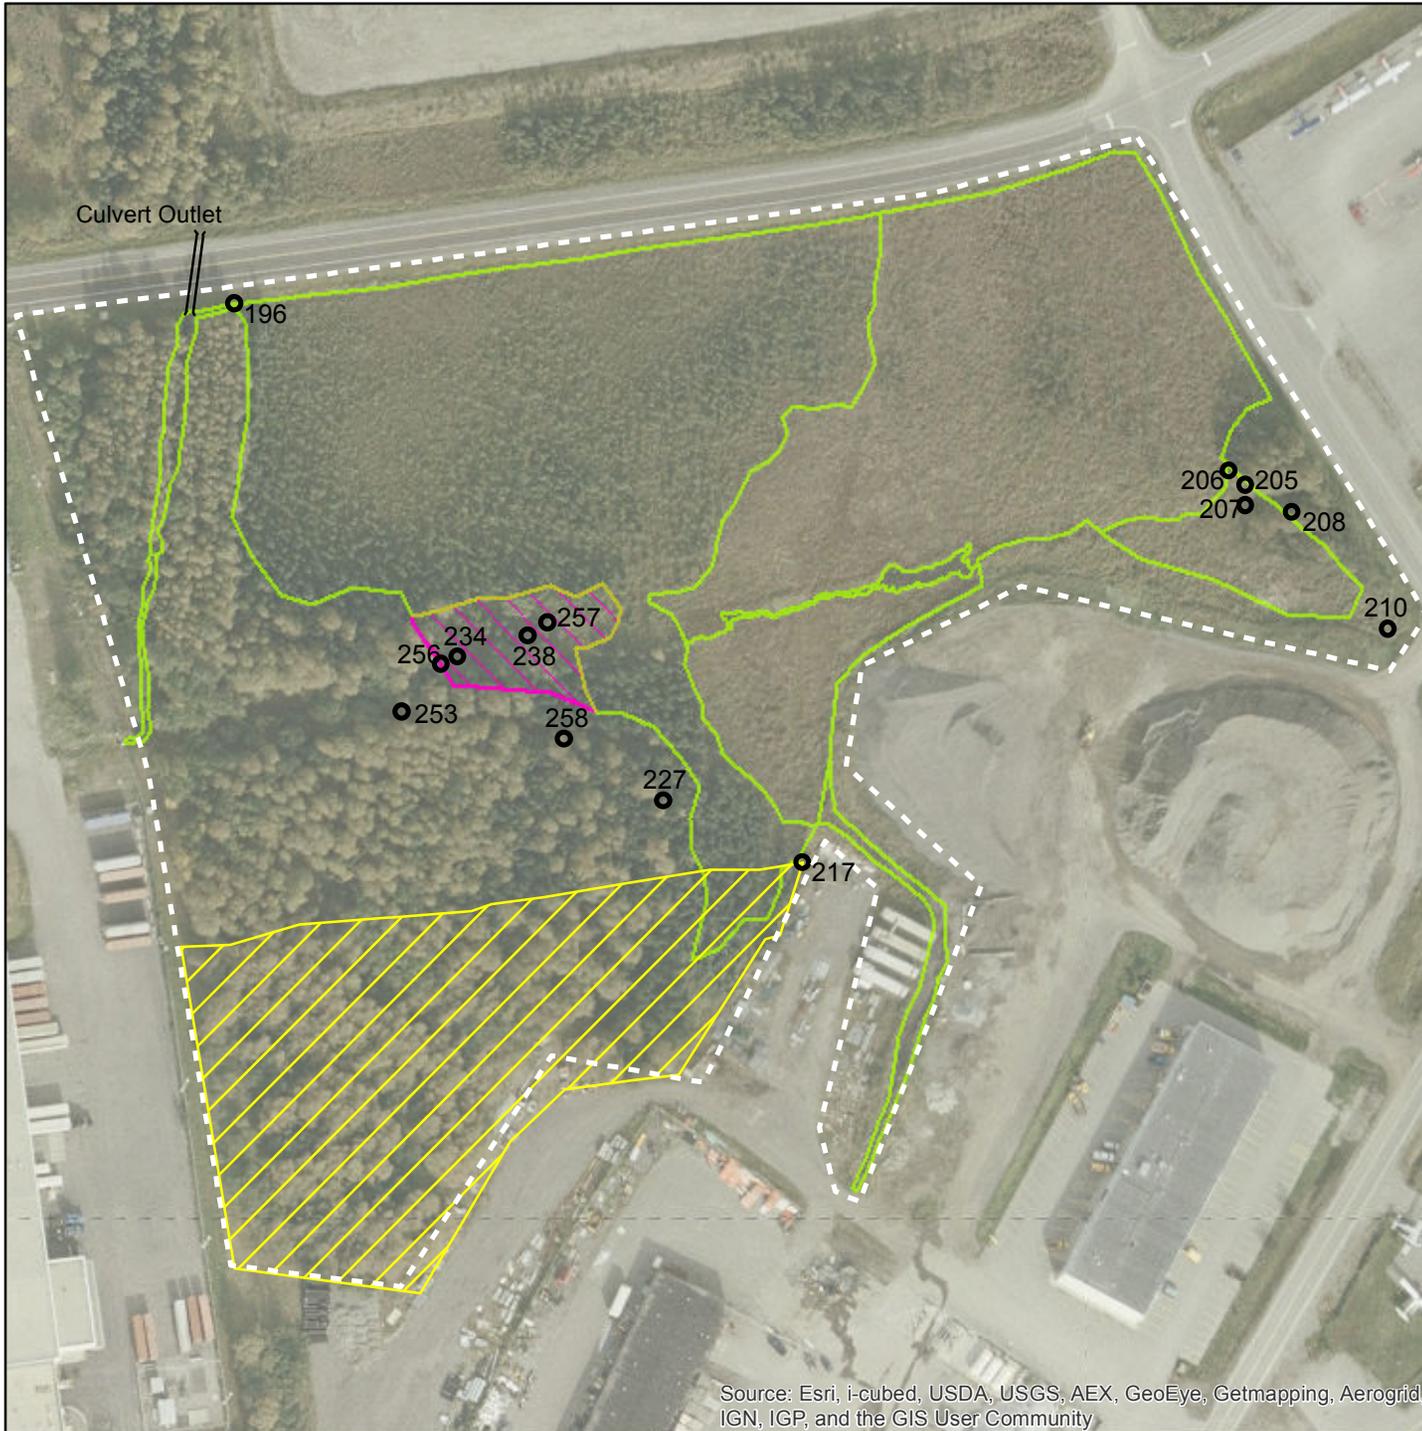
- 2016 Field Verification Determination Points (DPs)
- - - Subject Property Boundary
- 2012 RSE Field Mapped Wetlands
- 2016 RSE Field Mapped Wetland Boundary Update/Inclusion
- RSE Mapped Cleared Area

The identified upland community in the 2012 delineation report located on the southwest side of the subject site was observed to have been recently cleared. The cleared area included approximately 3,568 square feet (0.08 acres) of the southern portion of the field mapped wetland area (See Map 4).

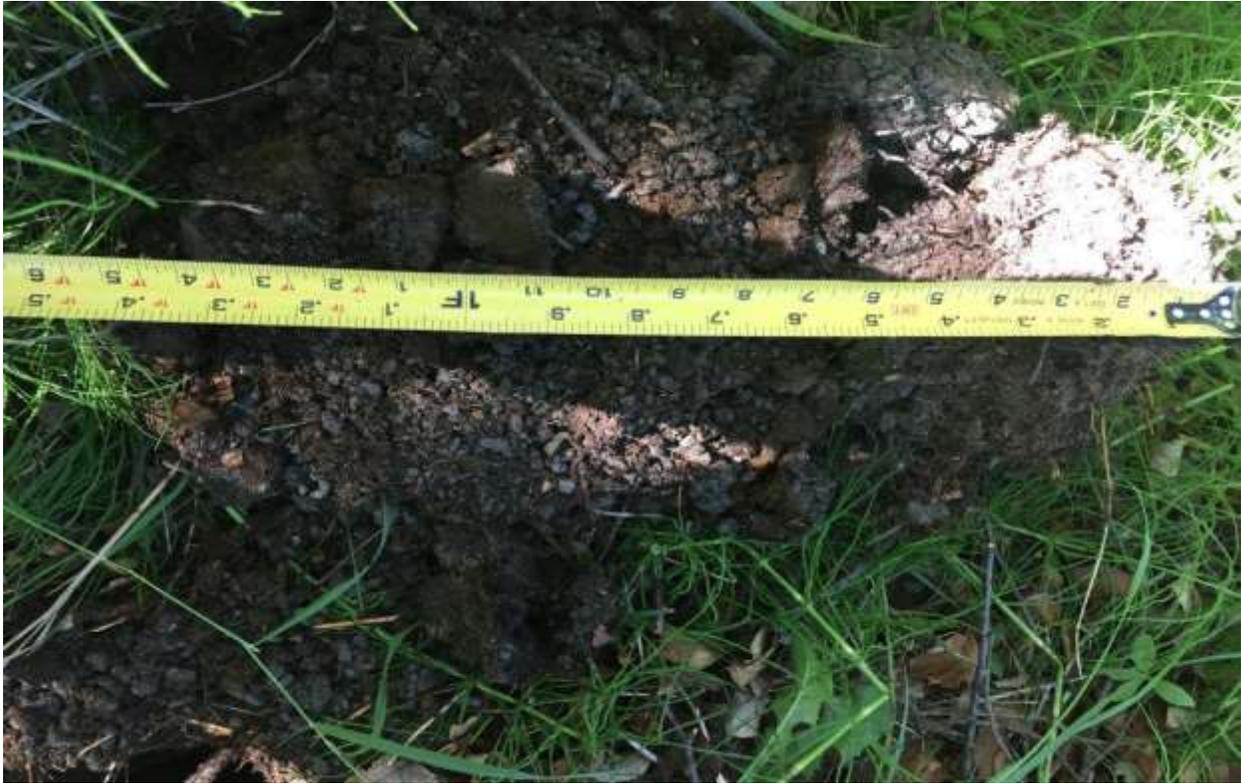
Remarks:  
 Potential dry season & below average rainfall → would consider transition area based on 2012 delineation

Wetland Boundary Verification – WP205 Soils (07-08-2016)

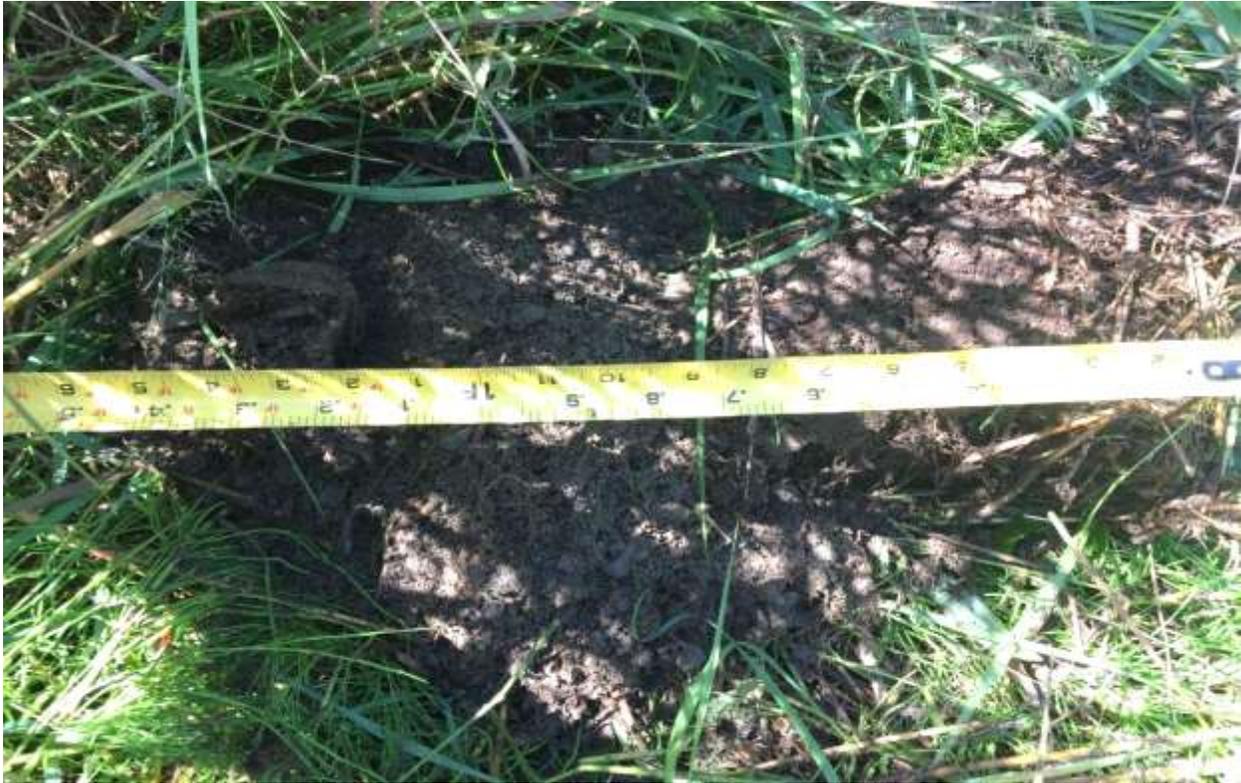
Remarks:  
Below average rainfall & dry season. 2012 delineation is also consistent. Although culvert & drainage - soils appear to be well drained.

Wetland Boundary Verification – WP210 Soils (07-08-2016)

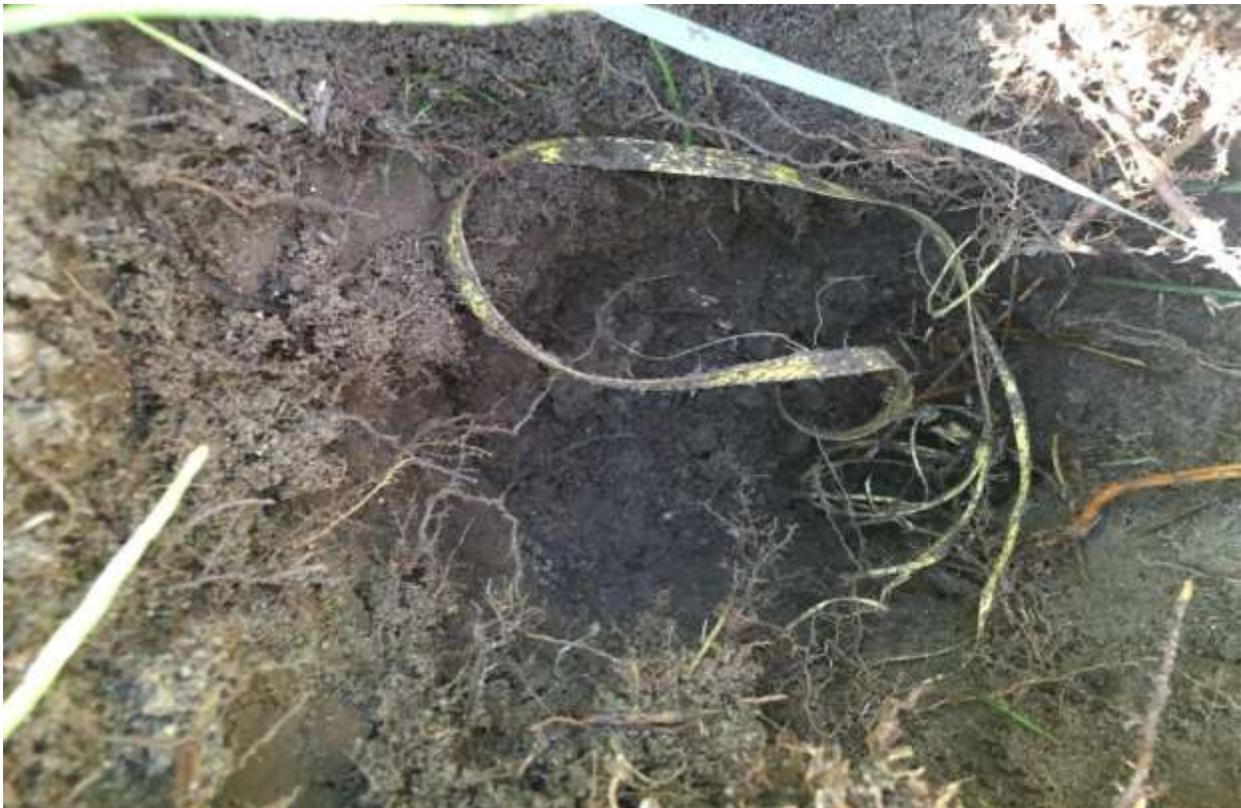
Wetland Boundary Verification – WP210 Soil Test Pit – debris barried, dry (07-08-2016)

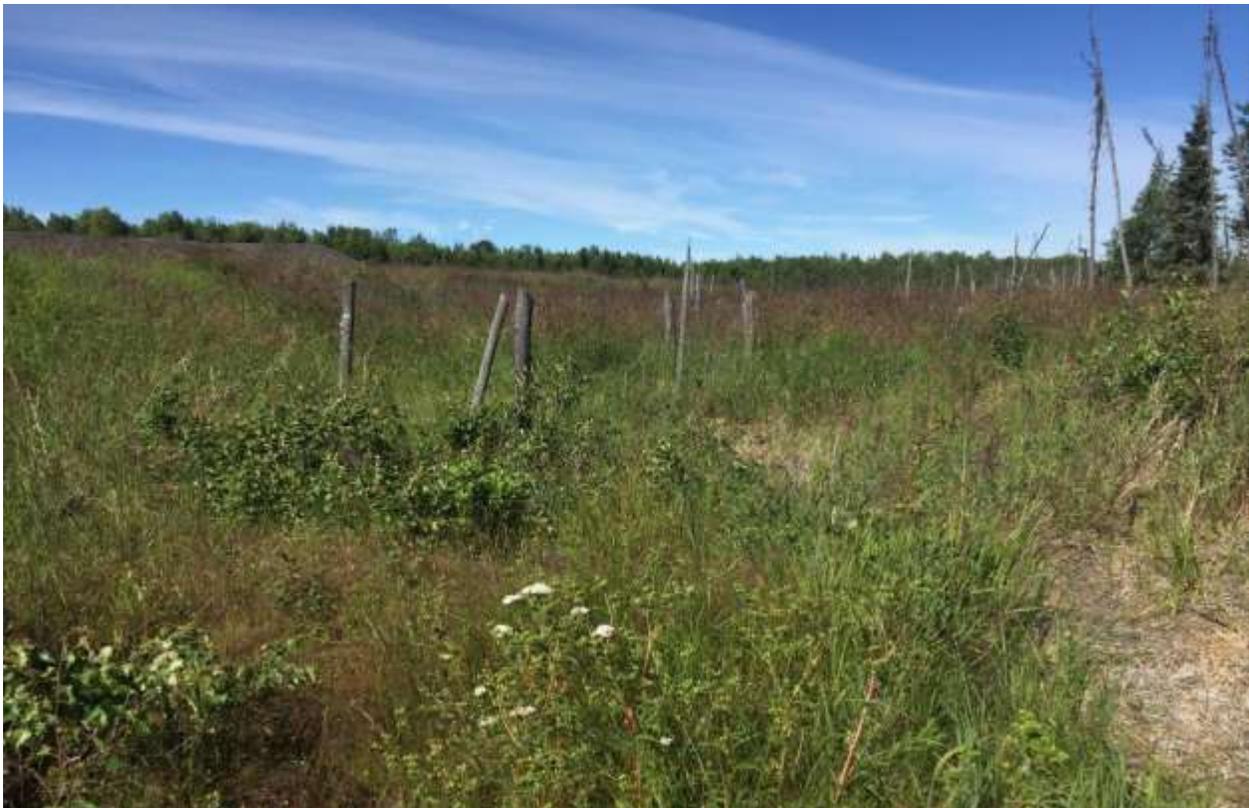
Southeast end of the project area, dry season conditions, water stained (07-08-2016)

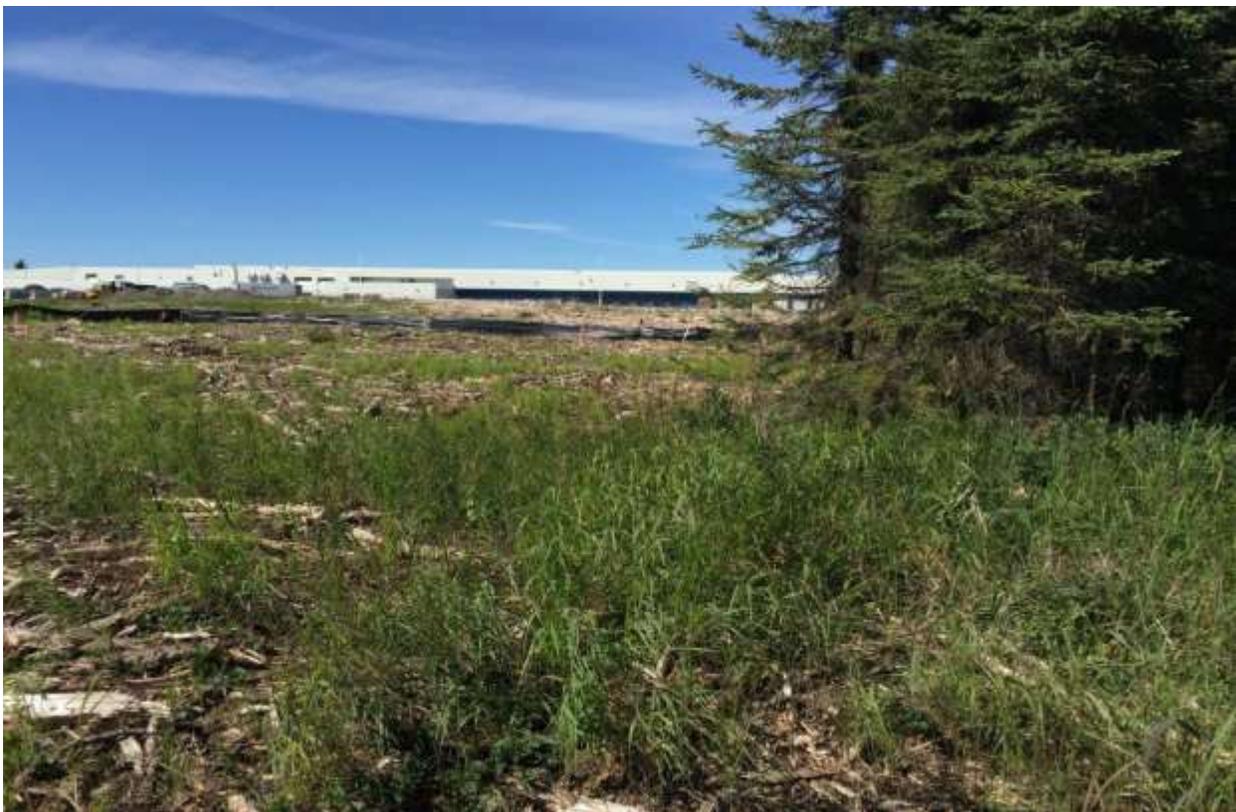
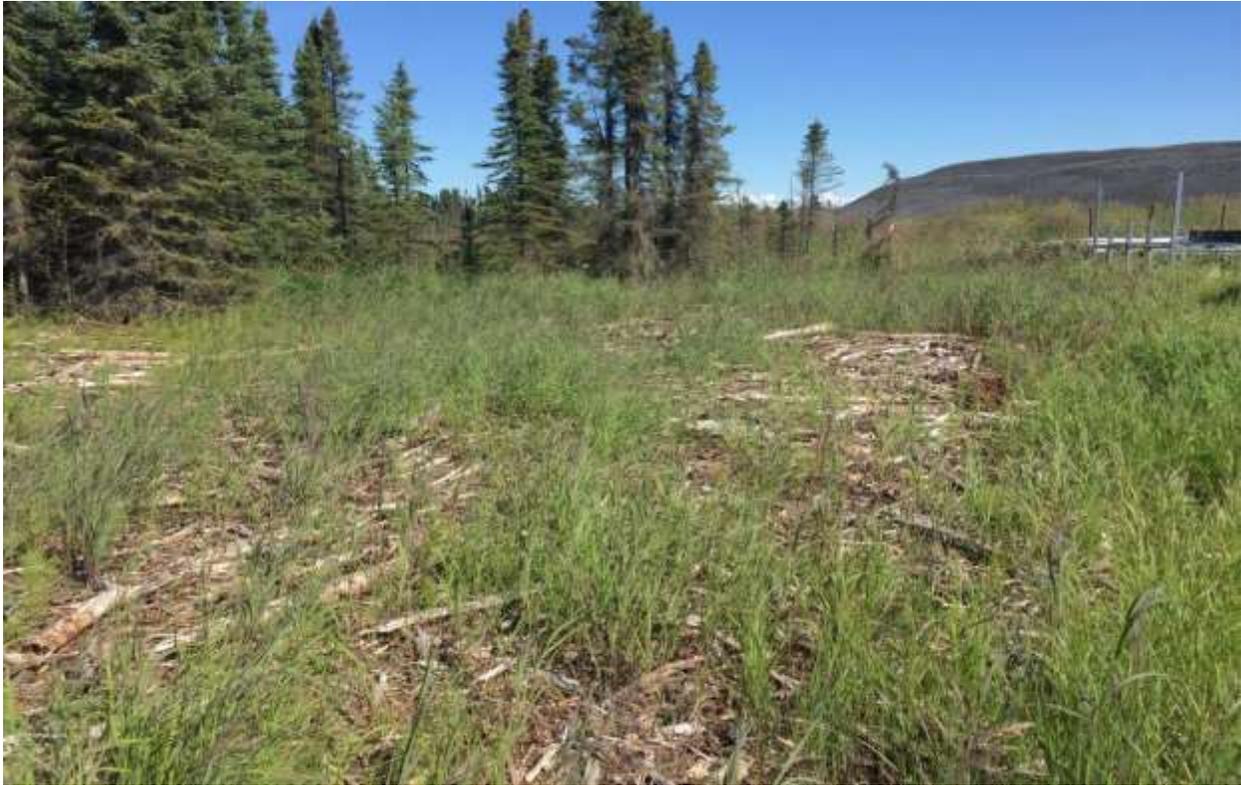
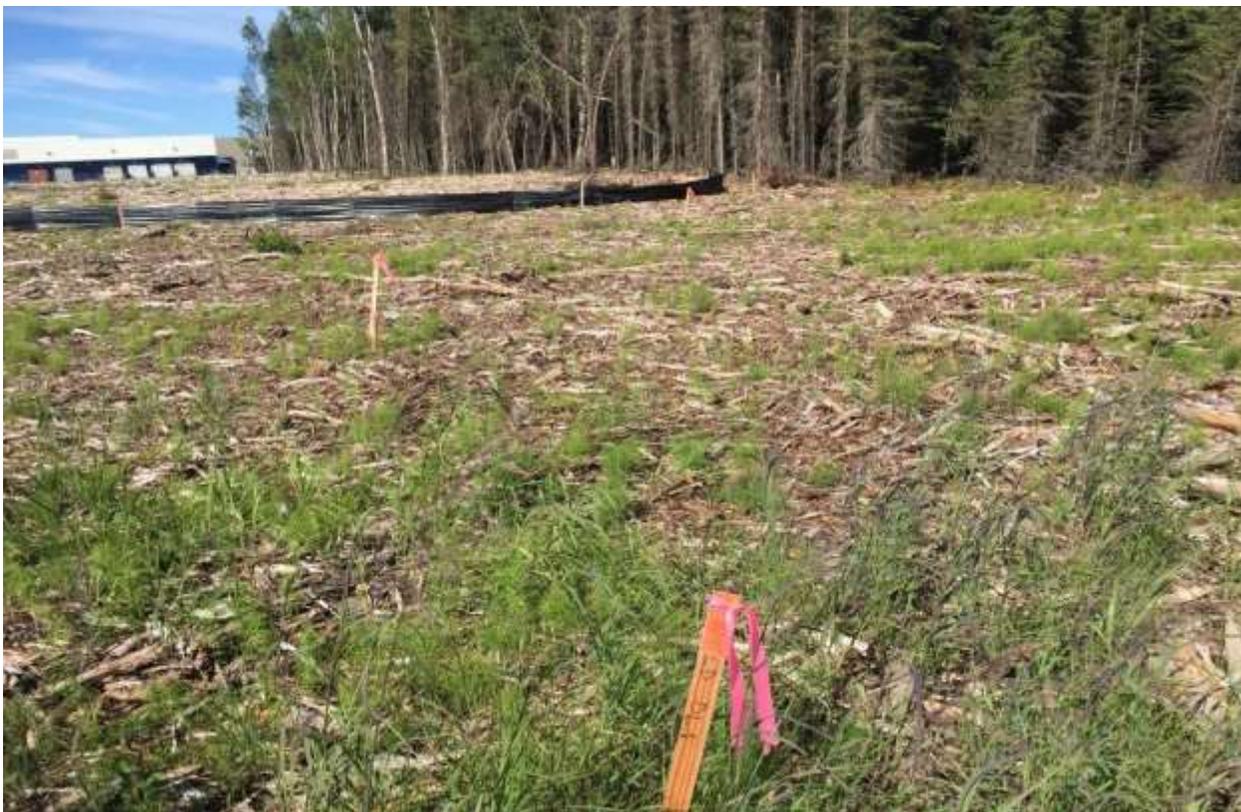
Cleared area located on the southwest corner of the project area – view west (07-08-2016)

Cleared area located on the southwest corner of the project area – view east (07-08-2016)

Cleared area located on the southwest corner of the project area – view northwest (07-08-2016)

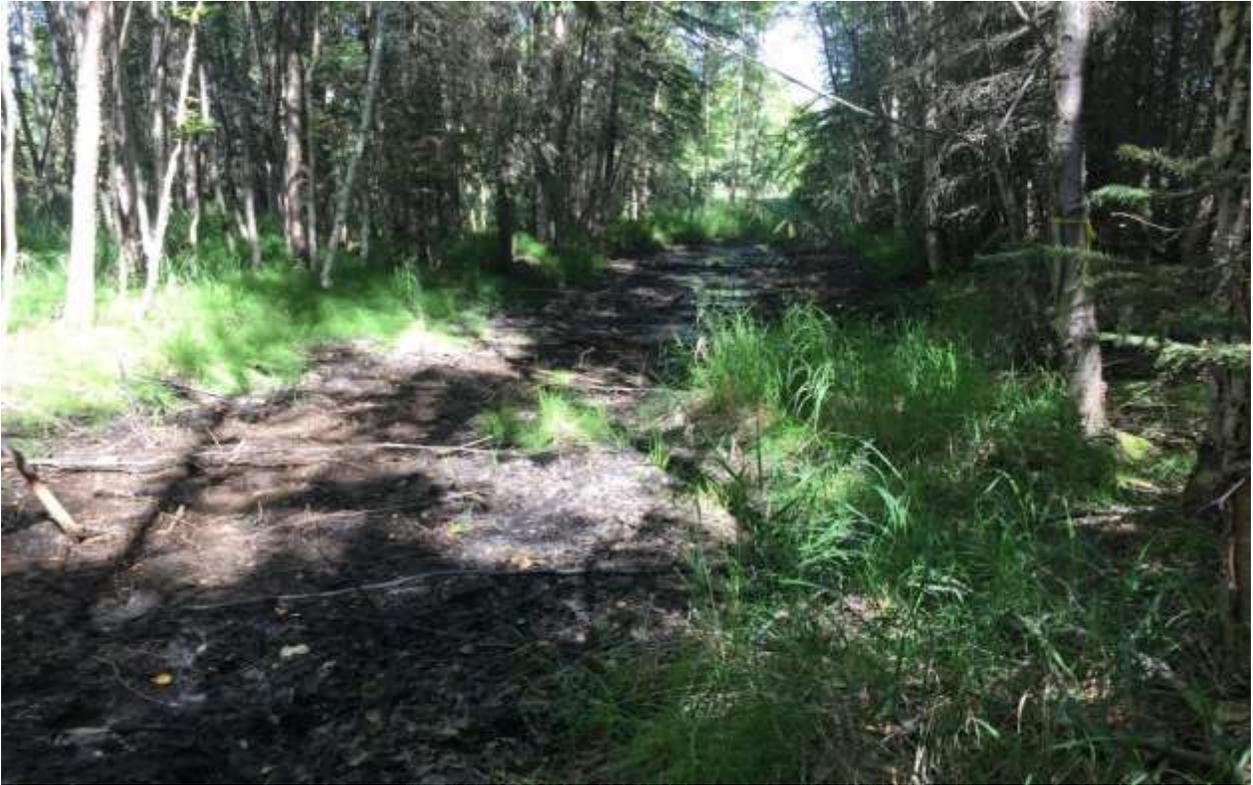
Drainage on the west side of the project area – view north (07-08-2016)
