**APPENDIX A**

Nightmute Airport Improvements  
51809

**USACE STANDARD WETLAND DELINEATION DATA  
FORMS**

## Wetland Avoidance and Minimization Checklist

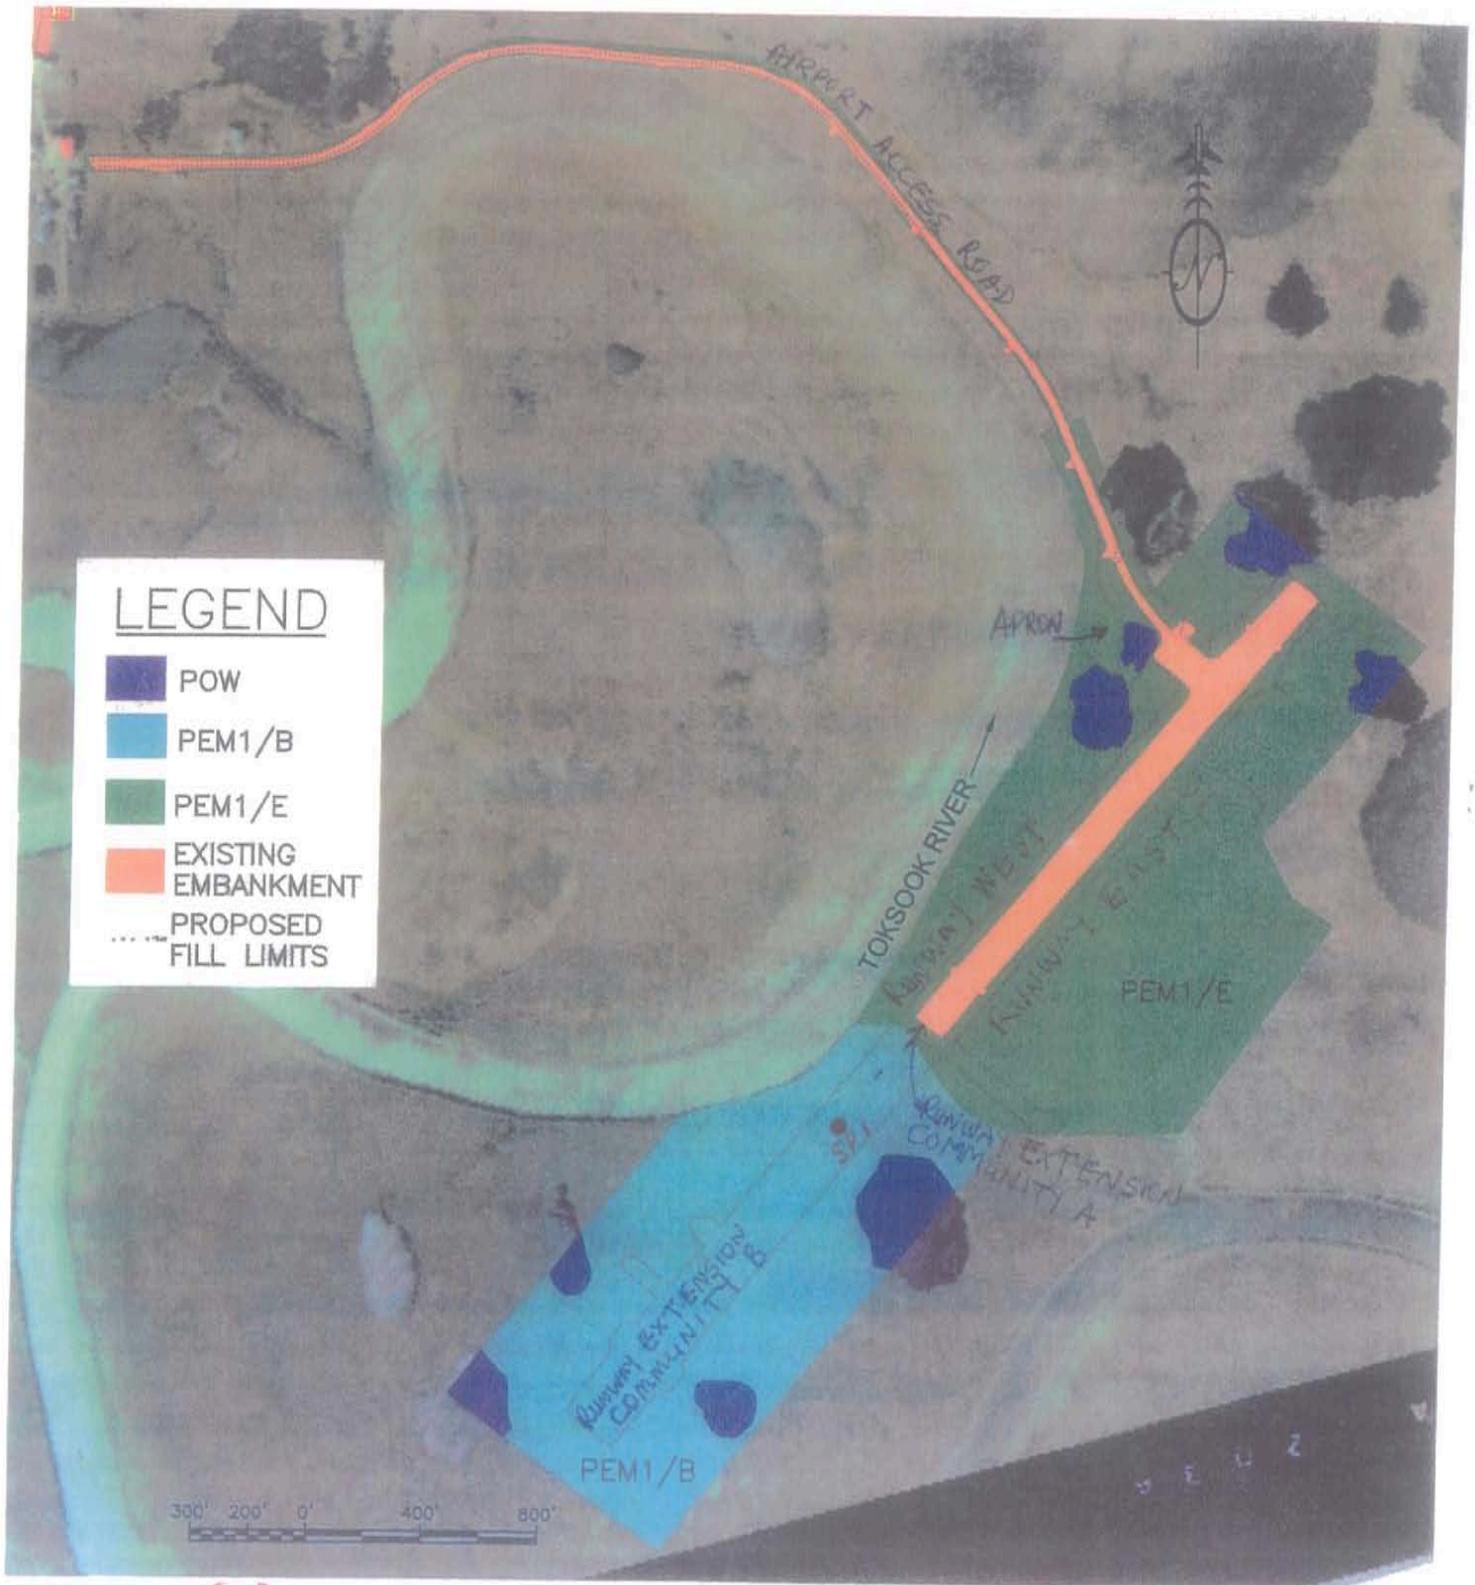
Wetlands Mapping **WITH SP**  
 FIGURE 3A-2

• Soil Pit (SP)

Project/Site: <u>Runway extension Community B</u> Applicant/Owner: _____ Investigator: <u>Abigail Egbe</u>	Date: <u>8/8/05</u> County: _____ State: <u>AK</u>
Do Normal Circumstances exist on the site? <span style="float: right;"><input checked="" type="radio"/> Yes <input type="radio"/> No</span> Is the site significantly disturbed (Atypical Situation)? <span style="float: right;"><input type="radio"/> Yes <input checked="" type="radio"/> No</span> Is the area a potential Problem Area? <span style="float: right;"><input type="radio"/> Yes <input checked="" type="radio"/> No</span> (If needed, explain on reverse.)	Community ID: _____ Transect ID: _____ Plot ID: <u>SP1 (see figure 3A-2)</u>

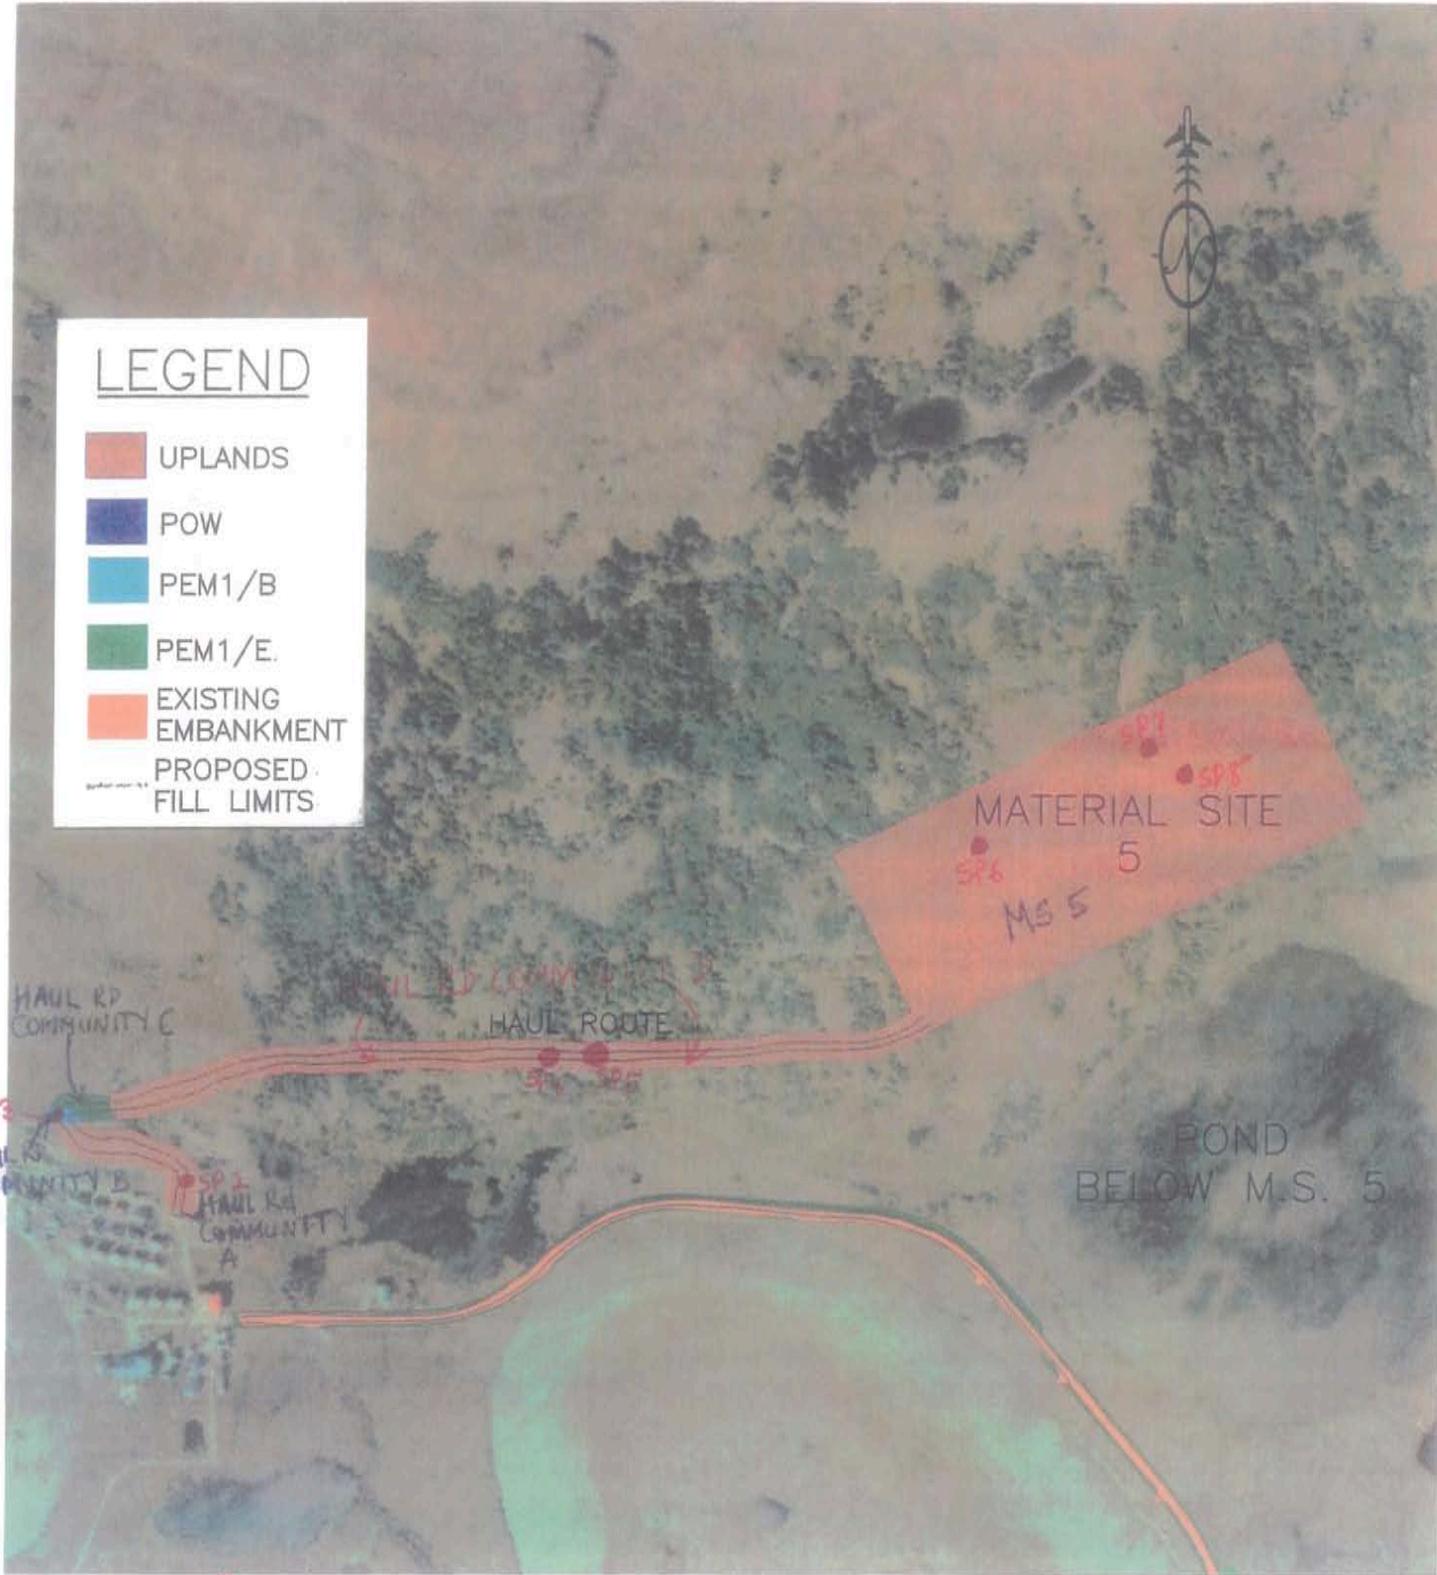
FIGURE 3B-2

• Soil Pit (SP)

Project/Site: <u>Nightmute Haul Rd Community A</u> Applicant/Owner: <u>0</u> Investigator: <u>Abigail Ogbe</u>	Date: <u>8/8/05</u> County: _____ State: <u>AK</u>
Do Normal Circumstances exist on the site? Yes <input type="checkbox"/> No <input checked="" type="checkbox"/> Is the site significantly disturbed (Atypical Situation)? <del>Yes</del> No <input type="checkbox"/> Is the area a potential Problem Area? Yes <input type="checkbox"/> No <input type="checkbox"/> (If needed, explain on reverse.)	Community ID: _____ Transect ID: _____ Plot ID: <u>SP2 (see figure 3B-2)</u>

Project/Site: <u>Hawl Rd Community B</u> Applicant/Owner: _____ Investigator: <u>Abigail Ogbe</u>	Date: <u>8/8/05</u> County: _____ State: <u>AK</u>
Do Normal Circumstances exist on the site? <input checked="" type="radio"/> Yes <input type="radio"/> No Is the site significantly disturbed (Atypical Situation)? Yes <input type="radio"/> No <input checked="" type="radio"/> Is the area a potential Problem Area? Yes <input type="radio"/> No <input checked="" type="radio"/> (If needed, explain on reverse.)	Community ID: _____ Transect ID: _____ Plot ID: <u>SP 2 (see Figure 3B-2)</u>

Project/Site: <u>Haul Rd Community D</u> Applicant/Owner: _____ Investigator: <u>Abigail Ogbe</u>	Date: <u>8/8/05</u> County: _____ State: <u>AK</u>
Do Normal Circumstances exist on the site? <input checked="" type="radio"/> Yes <input type="radio"/> No Is the site significantly disturbed (Atypical Situation)? Yes <input type="radio"/> No <input checked="" type="radio"/> Is the area a potential Problem Area? Yes <input type="radio"/> No <input checked="" type="radio"/> (If needed, explain on reverse.)	Community ID: _____ Transect ID: _____ Plot ID: <u>SP 4 &amp; SP 5 (see Figure 3B-2)</u>
