Kotzebue to Cape Blossom Road Draft Environmental Assessment

Appendix D **Kotzebue to Cape Blossom Road Project, 2012 Spring Breakup
Study: Sadie Creek**

KOTZEBUE TO CAPE BLOSSOM ROAD 2012 SPRING BREAKUP STUDY: SADIE CREEK

Alaska Department of Transportation & Public Facilities
2301 Peger Road
Fairbanks, Alaska 99709
AKSAS Project No: 76884 / Federal Project No: NCPD-0002(204)
PSA No: 025-2-1-009

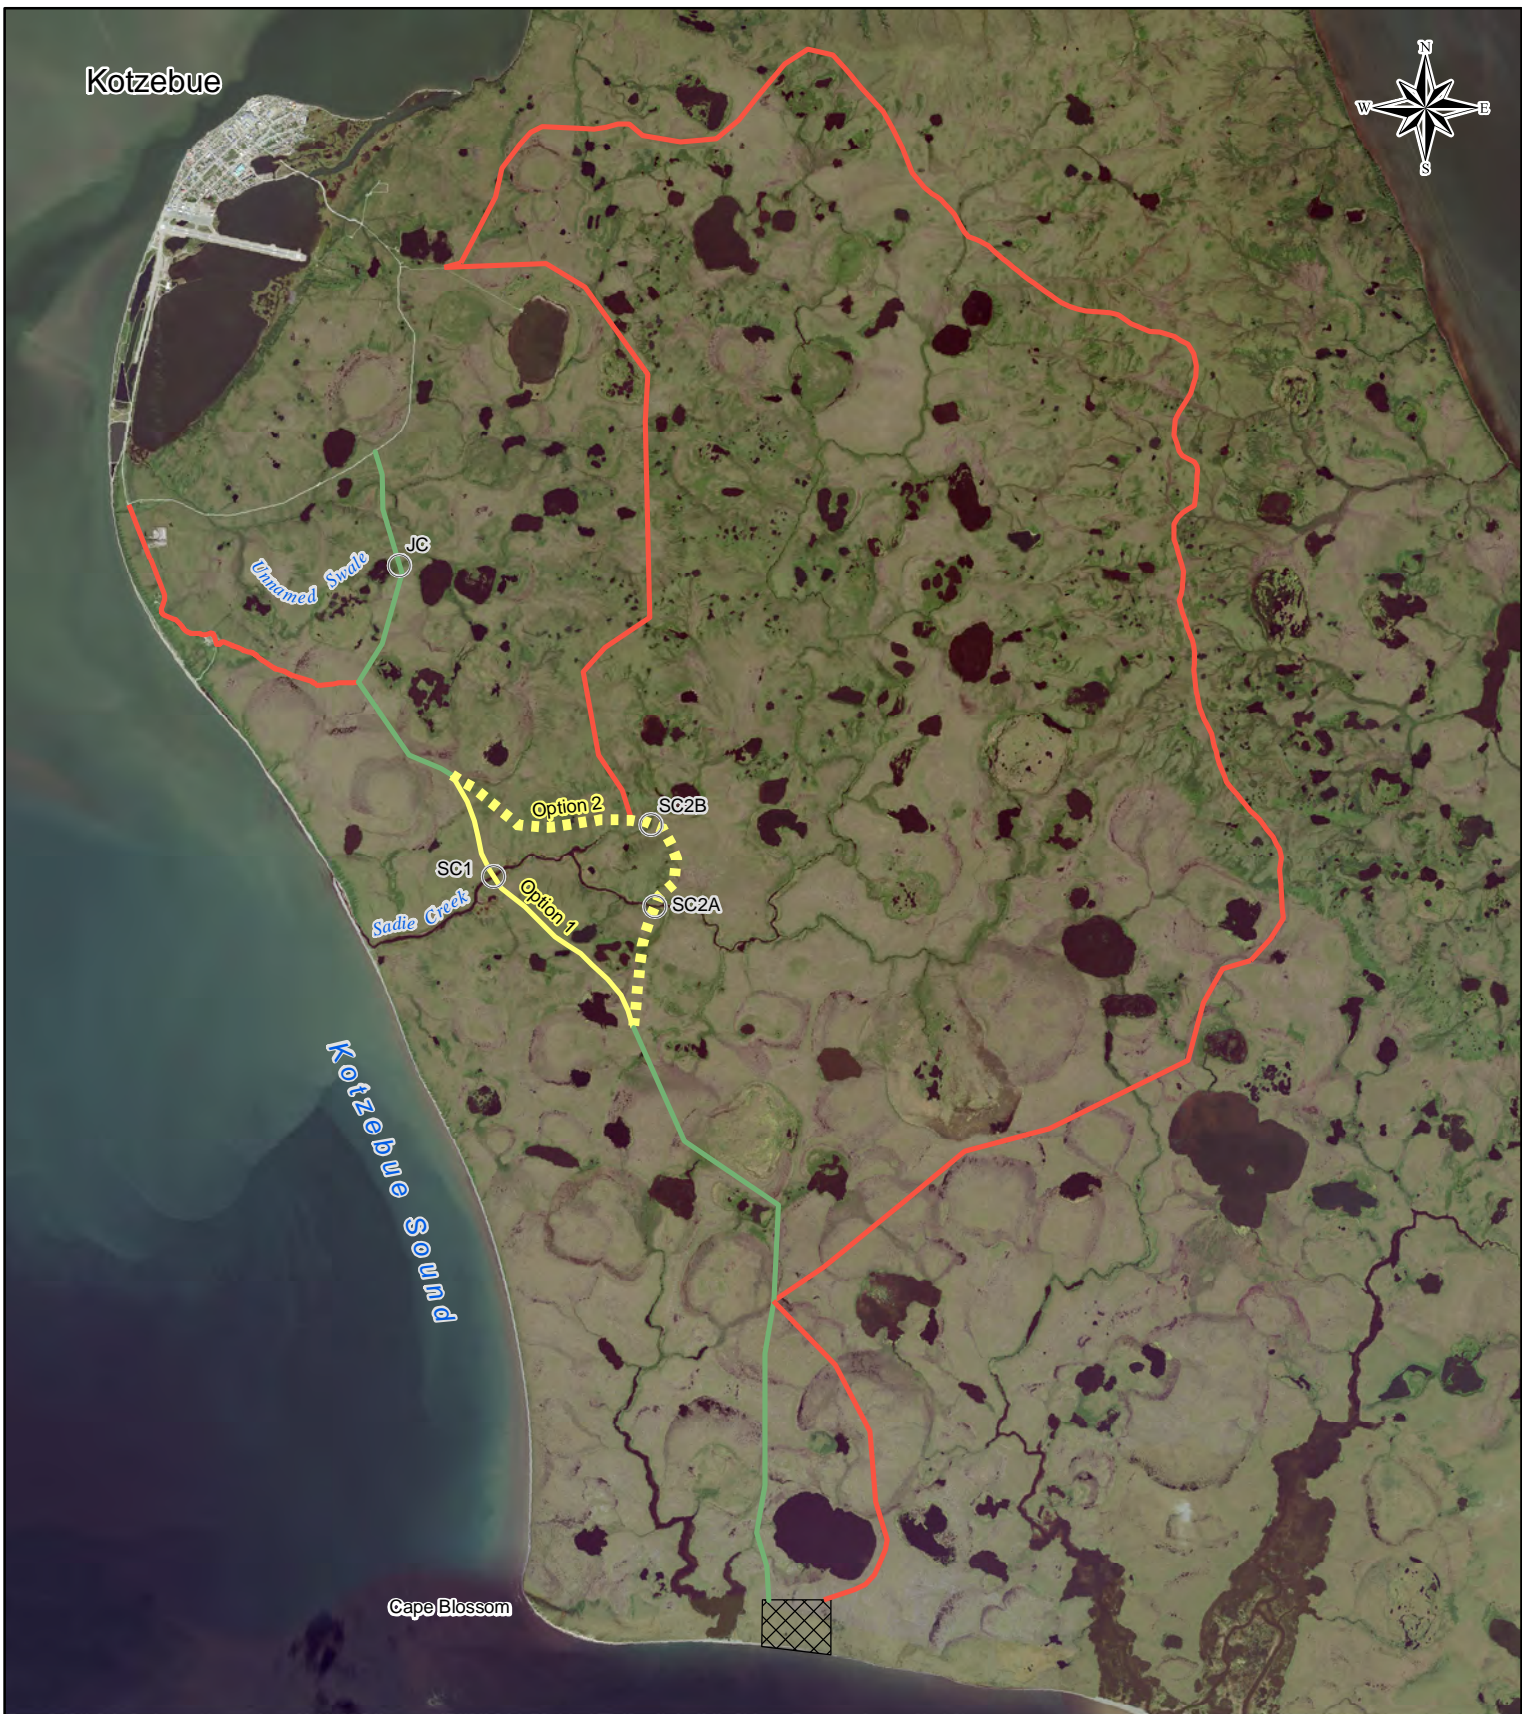
Kotzebue to Cape Blossom Road
Overview Map
Figure 1.1

Observations and measurements were recorded at four water crossings along the proposed routes (shown in Figure 1.1):

- One crossing at Sadie Creek (SC1) along Option 1
- Two crossings at Sadie Creek (SC2A and SC2B) along Option 2
- One crossing at an unnamed swale (JC)

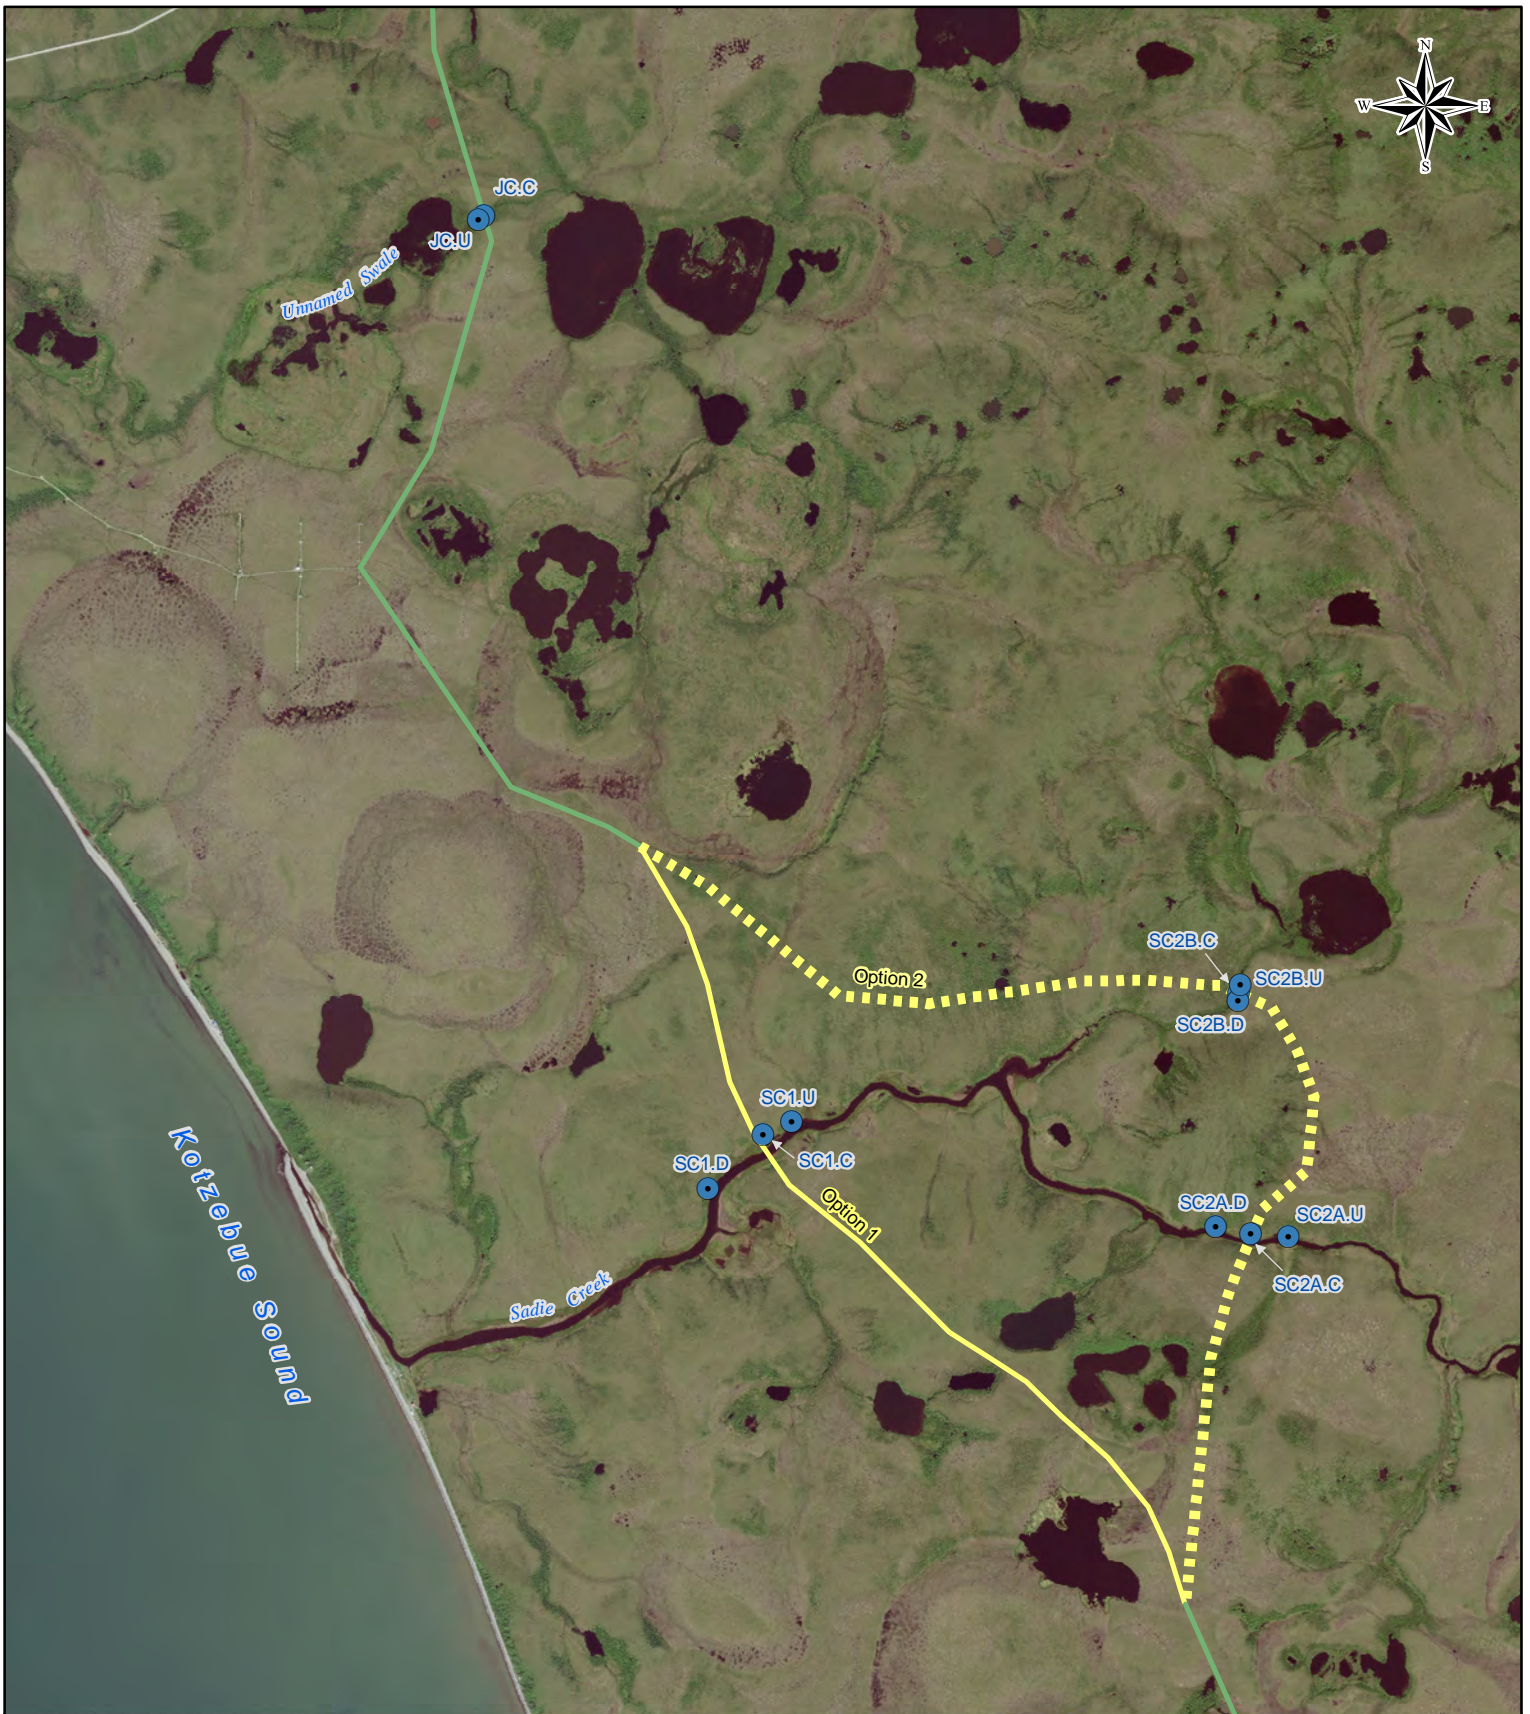
Kotzebue to Cape Blossom Road
Monitoring Locations
Figure 2.1

Monitoring was conducted at four channel crossings associated with the proposed alignment, presented in Figure 2.1. Two alternative alignments cross Sadie Creek; the Upgrade Route (Option 1) crosses Sadie Creek (SC1) where all flow is confined to a single channel, while the dismissed upper option (Option 2) crosses two smaller branches of Sadie Creek (SC2A and SC2B) approximately 1.5 river miles (RM) upstream of the western alignment. The confluence of the SC2A and SC2B channels lies approximately 0.75 RM upstream of the SC1 crossing. The fourth crossing is an unnamed swale (JC) which drains a ponded wetland area into June Creek.

Three gage sites (upstream [U/S], centerline, and downstream [D/S]) at each potential crossing on Sadie Creek and two gage sites (upstream and centerline) at the unnamed swale were monitored during the 2012 Spring Breakup Study. At each site, gages are installed in sets to capture the anticipated vertical change in WSE. The quantity of gages per set was dependent on local topography. Table 2.1 lists the hydrologic staff gages installed at each monitoring location and provides a summary of the naming convention. Hydrologic staff gages are discussed in more detail in Section 3.2.1.

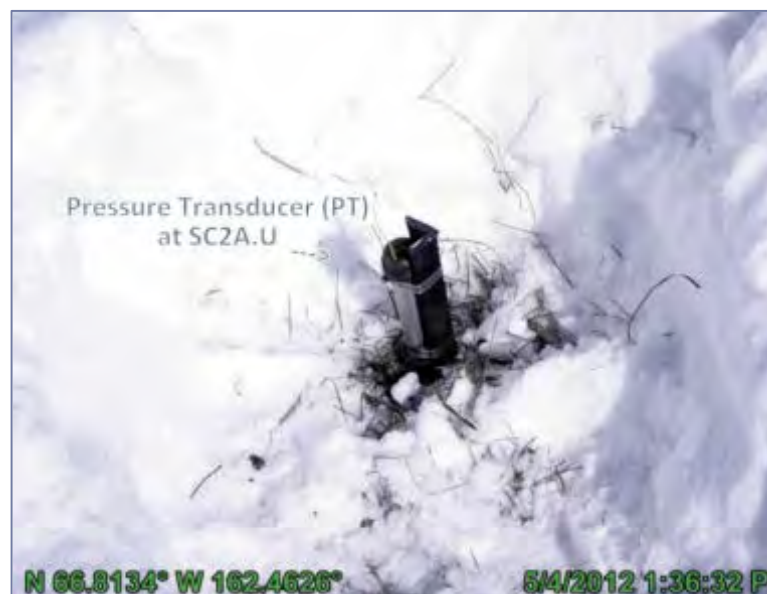
Solinst 3001 Levelogger® Gold sensors were used. The instrument is a non-vented pressure sensor designed to collect and store pressure and temperature data at discrete intervals. The factory-calibrated transducers were set to collect absolute pressure and water temperature at 15-minute intervals. The measured pressure datum is the sum of the forces imparted by both the water column and atmospheric conditions. A correction of local barometric pressure was required and obtained from a Solinst 3001 Barologger® Gold located at SC1.C. This Barologger® location is considered to be representative of conditions at each monitoring site. See Appendix A for PT and Barologger® basis of elevation and horizontal positions.

PHOTO 3.2: PT ASSEMBLY INSTALLED AT SC2A.U; MAY 4, 2012

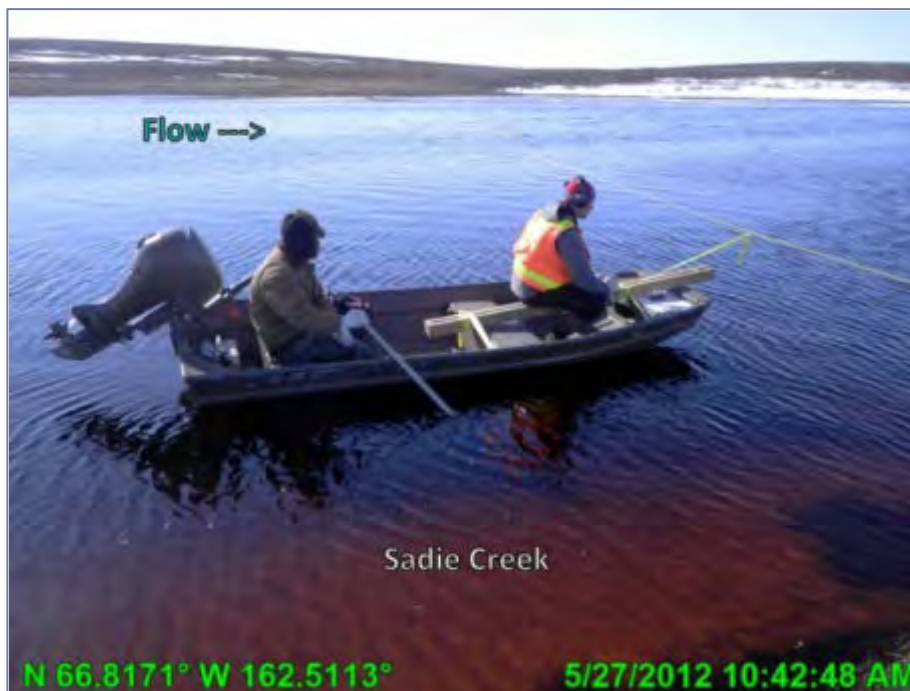
Depth and velocity measurements were taken from a jon boat at SC1 and SC2A with a sounding reel mounted on a wooden boom (Photo 3.3). A Price AA velocity meter was attached to the sounding reel and stabilized with a 30-pound Columbus-type lead sounding weight. A tag line was placed across the channel to define the cross section and to delineate measurement subsections within the channel. To ensure accurate performance of meters, procedures outlined in the Office of Surface Water Technical Memorandum No. 99.06 (OSW 1999) were followed.

PHOTO 3.3: DIRECT-DISCHARGE MEASUREMENT AT SC1, LOOKING SOUTHEAST; MAY 27, 2012

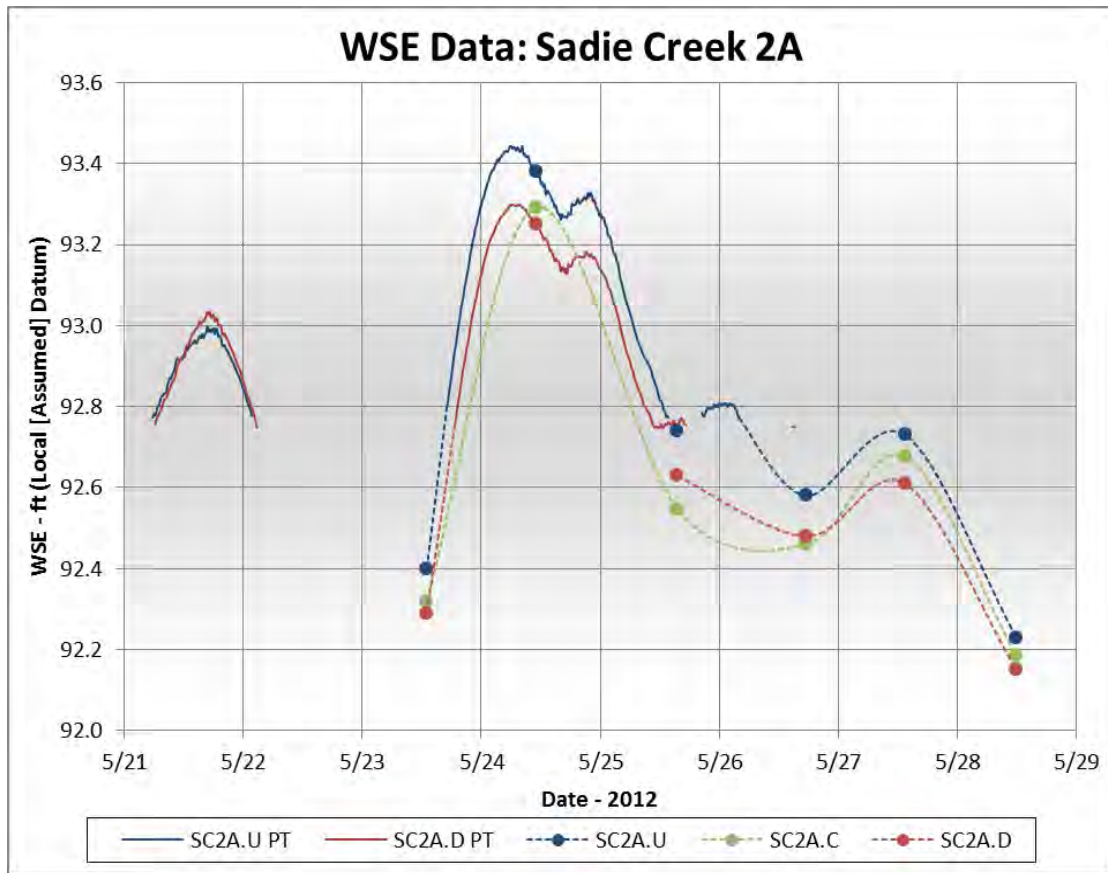
Stage data for the SC2A gages during breakup monitoring are presented in Table 4.2 and Graph 4.2.

GRAPH 4.2: STAGE DATA, SC2A GAGES

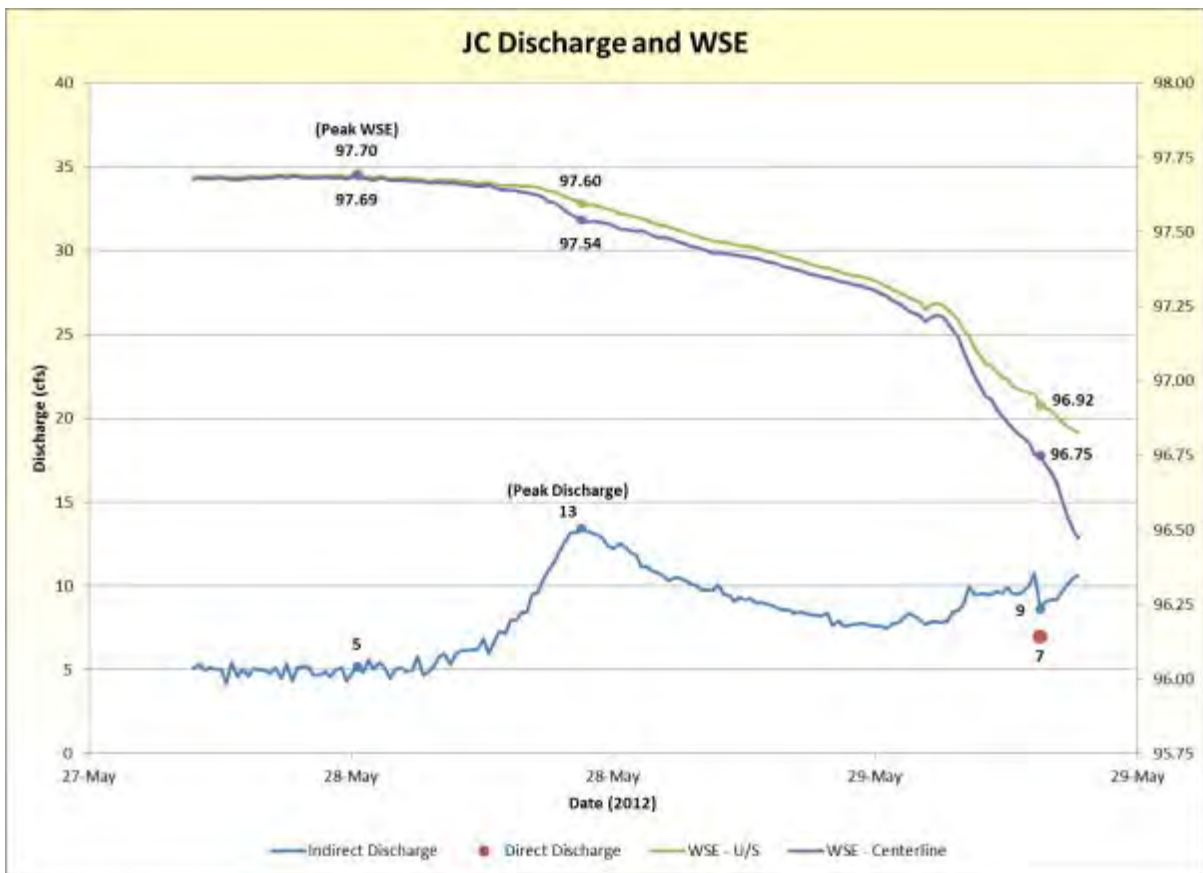
A comparison of direct and indirect discharge values and WSE at JC is shown in Graph 5.4. Peak discharge at JC was calculated as 13 cfs, occurring on May 28.

GRAPH 5.4: JC DISCHARGE AND WSE
