# KOTZEBUE TO CAPE BLOSSOM ROAD 2012 SPRING BREAKUP STUDY: SADIE CREEK

Prepared for

Alaska Department of Transportation & Public Facilities  
2301 Peger Road  
Fairbanks, Alaska 99709  
AKSAS Project No: 76884 / Federal Project No: NCPD-0002(204)  
PSA No: 025-2-1-009

Michael Baker Jr., Inc.  
1400 W. Benson Blvd., Suite 200  
Anchorage, AK 99503  
Project No. 128262

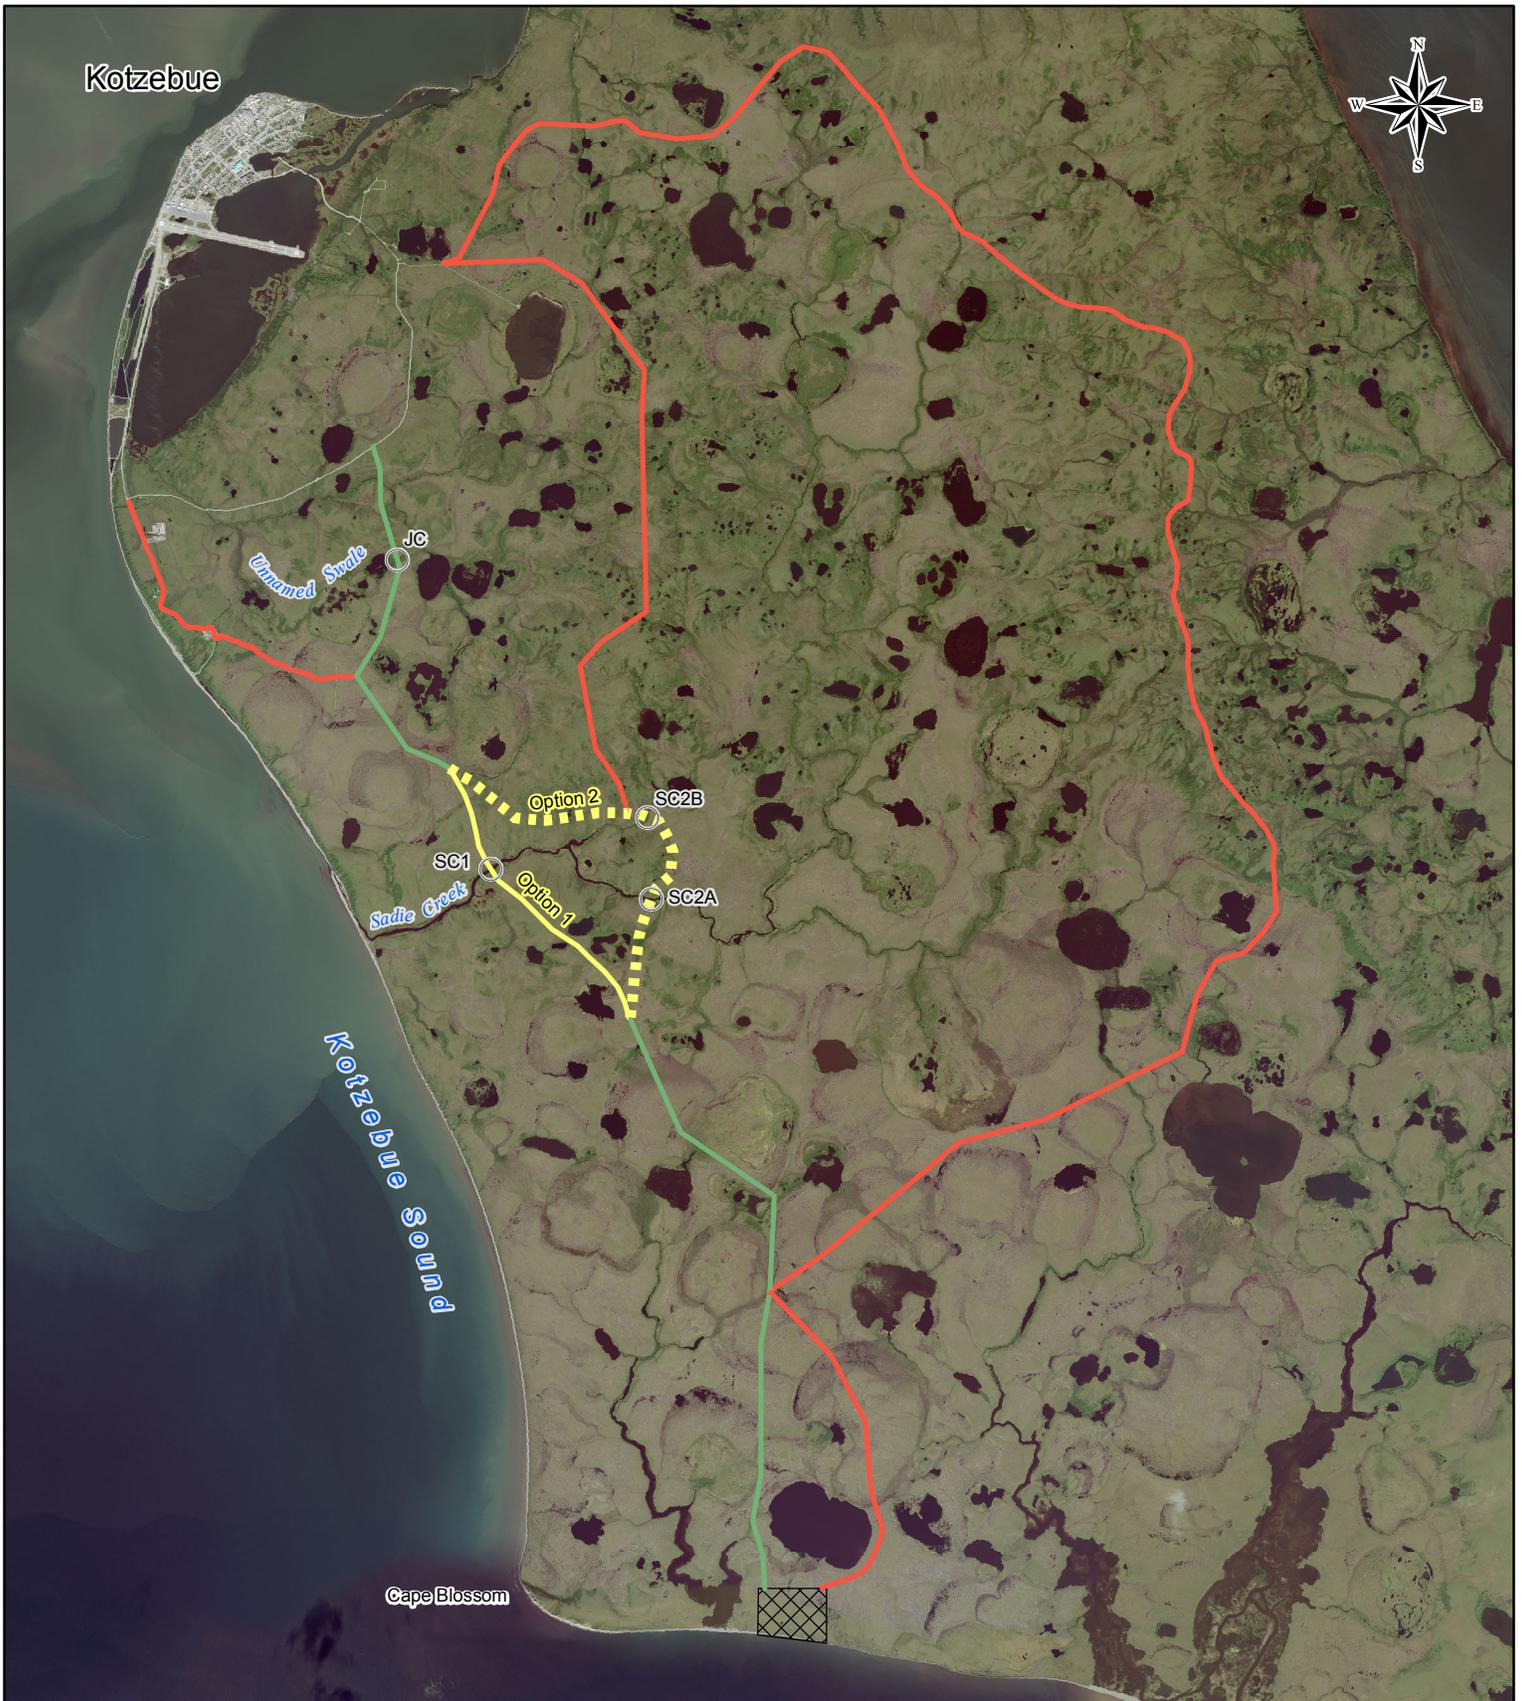
Kotzebue to Cape Blossom  
Overview Map  
Figure 1.1

Observations and measurements were recorded at four water crossings along the proposed routes (shown in Figure 1.1):

- One crossing at Sadie Creek (SC1) along Option 1
- Two crossings at Sadie Creek (SC2A and SC2B) along Option 2
- One crossing at an unnamed swale (JC)

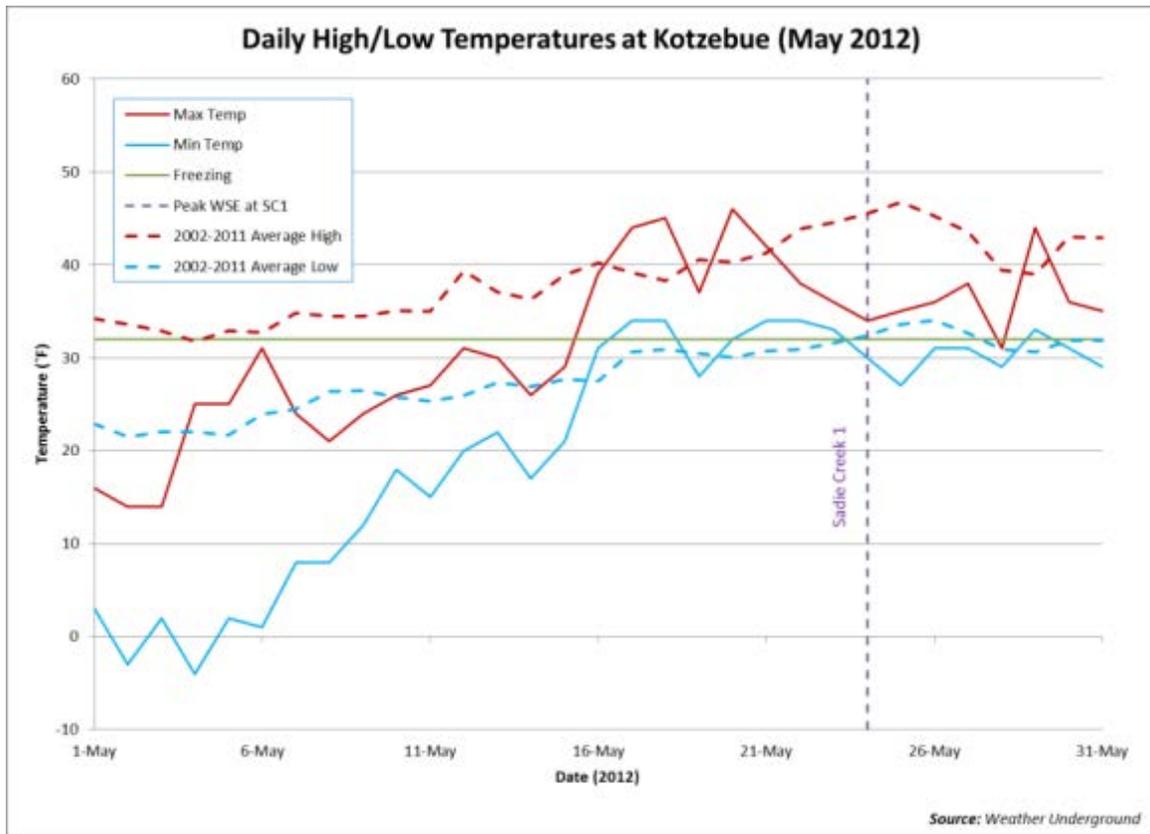
Review of daily high and low temperatures can be helpful when considering breakup timing. Breakup processes initiate as daily temperatures rise toward freezing. As nightly lows begin to approach and exceed freezing temperatures, breakup processes tend to accelerate. Climatic records for 2012 are available from a monitoring station at Ralph Wien Memorial Airport in Kotzebue, approximately 4 air miles north of the monitored locations. Graph 1.1 provides high and low temperatures at Kotzebue for May 2012.

GRAPH 1.1: DAILY HIGH AND LOW TEMPERATURES AT KOTZEBUE (MAY 2012)

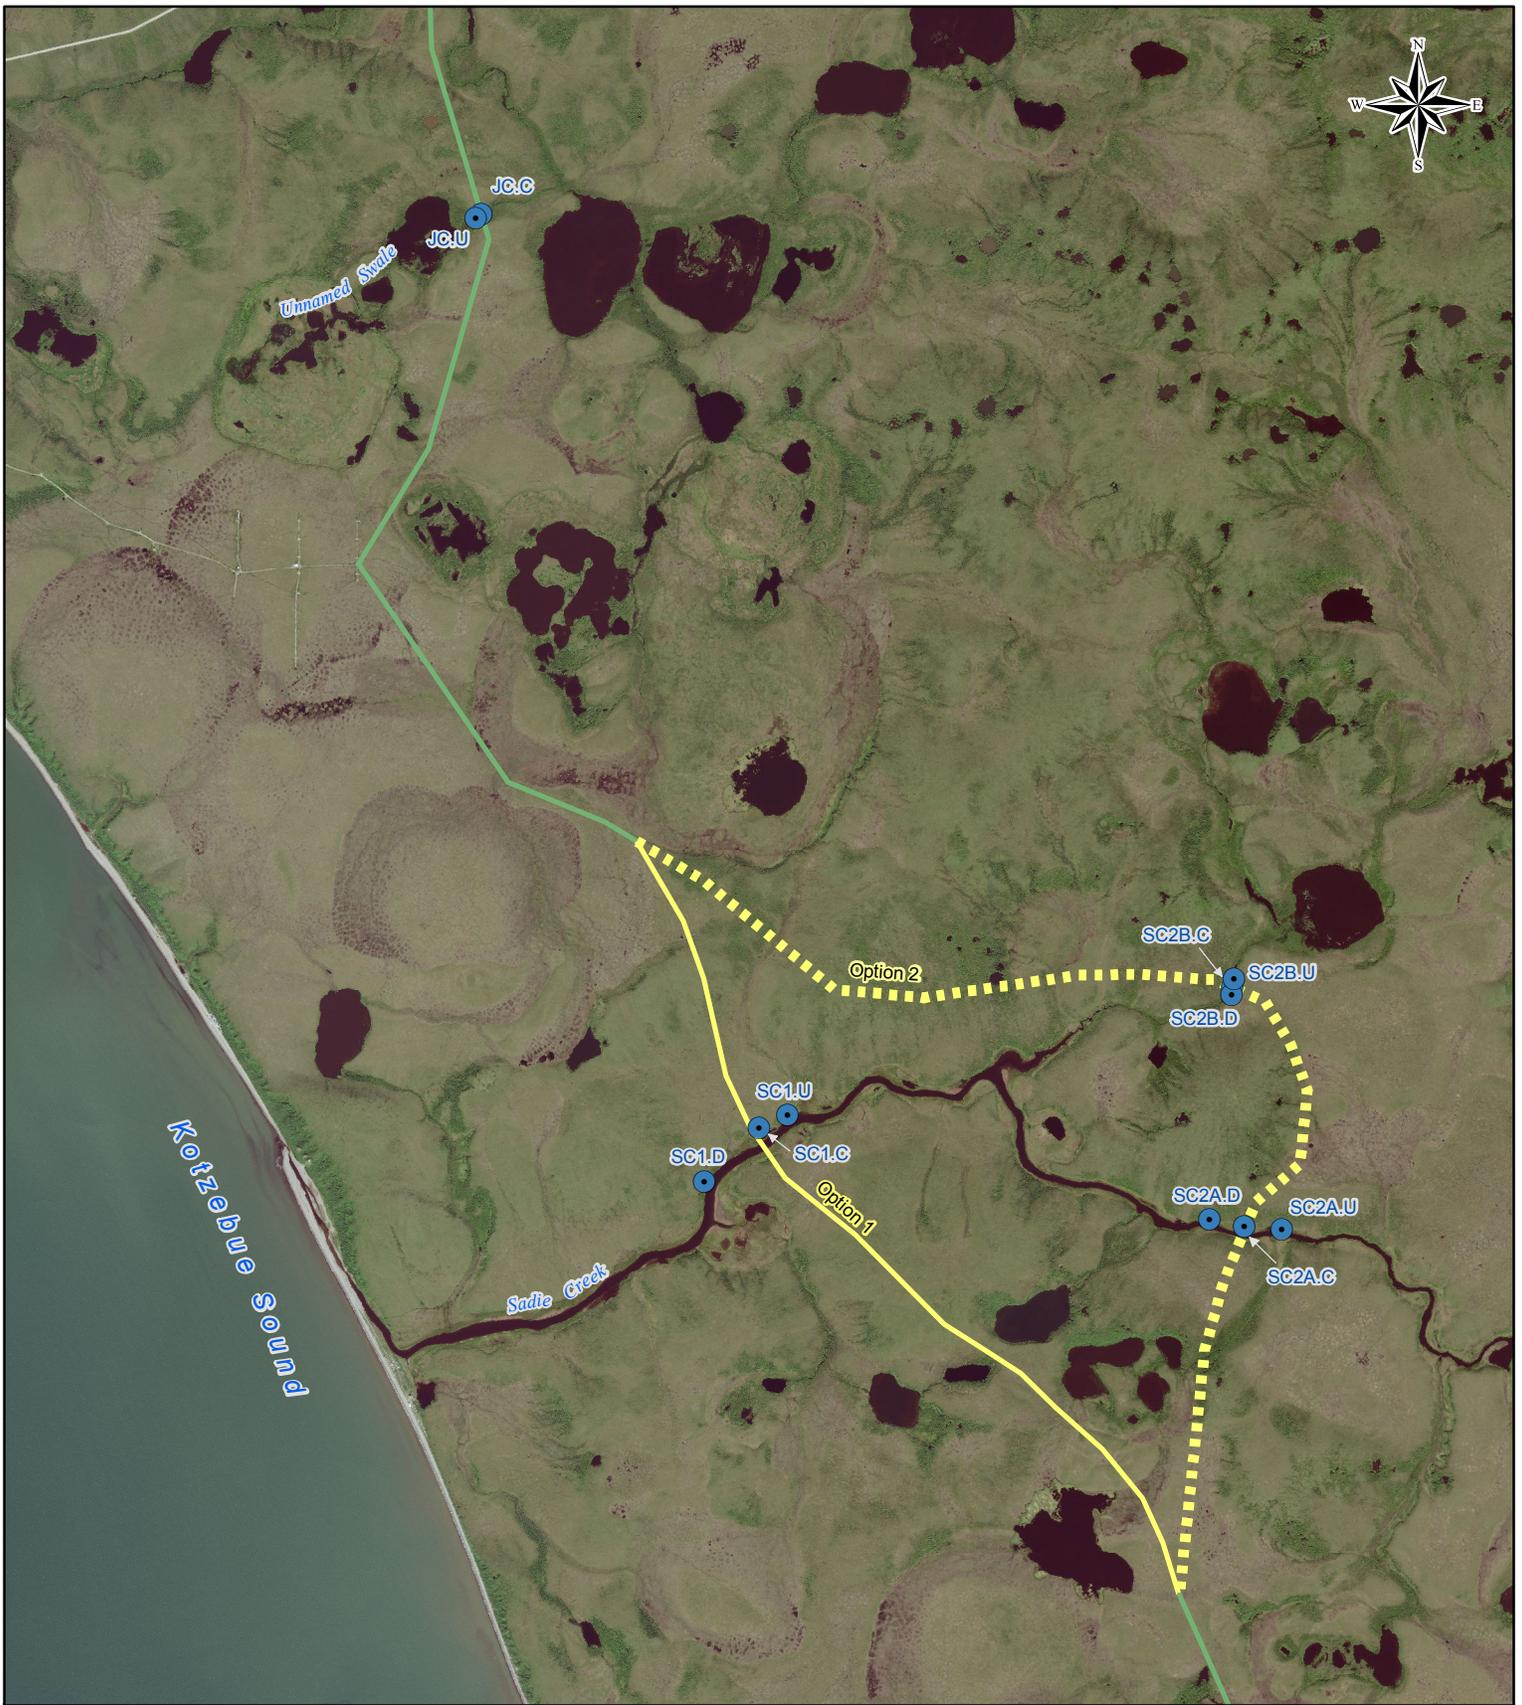
Kotzebue to Cape Blossom Road  
Monitoring Locations  
Figure 2.1

Three gage sites (upstream [U/S], centerline, and downstream [D/S]) at each potential crossing on Sadie Creek and two gage sites (upstream and centerline) at the unnamed swale were monitored during the 2012 Spring Breakup Study. At each site, gages are installed in sets to capture the anticipated vertical change in WSE. The quantity of gages per set was dependent on local topography. Table 2.1 lists the hydrologic staff gages installed at each monitoring location and provides a summary of the naming convention. Hydrologic staff gages are discussed in more detail in Section 3.2.1.

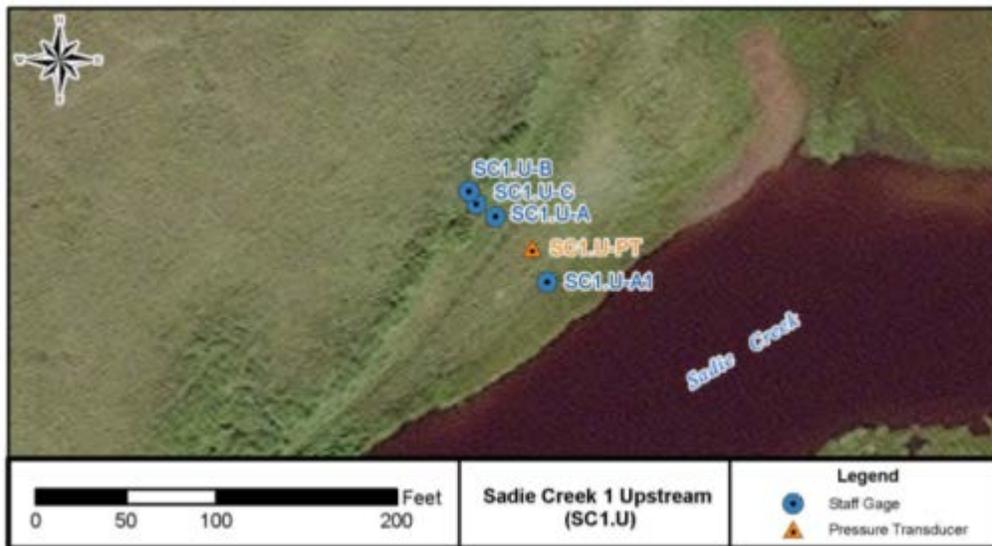
SC1 is located roughly 5 miles south of Kotzebue along the Option 1 road alignment. Gages located at SC1 were installed along a well-defined, fairly straight reach on May 3 and surveyed for elevation on May 5, 2012. They were located at the proposed crossing centerline, 500 feet upstream, and 1,000 feet downstream. PTs were installed at SC1.U and SC1.D. Hydrologic staff gage locations at SC1 are presented in Figure 2.2 through Figure 2.4. Photo 2.1 shows pre-breakup conditions at SC1 on May 2.

FIGURE 2.2: HYDROLOGIC STAFF GAGES INSTALLED AT SC1.U

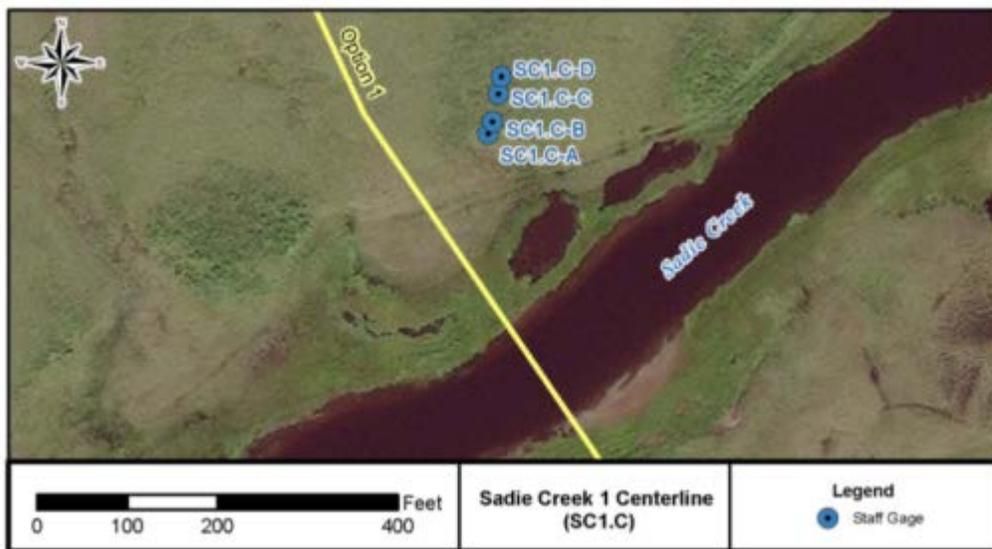
FIGURE 2.3: HYDROLOGIC STAFF GAGES INSTALLED AT SC1.C

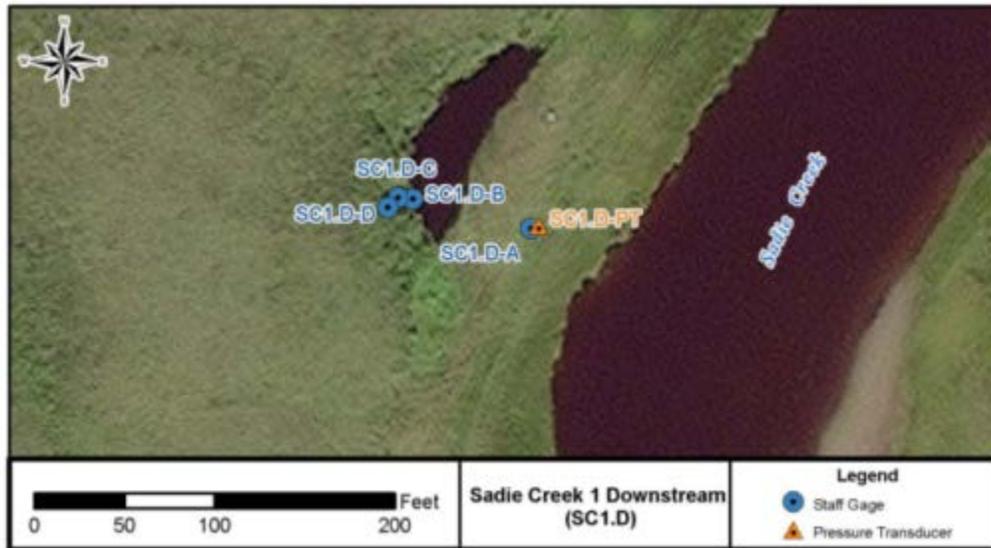
FIGURE 2.4: HYDROLOGIC STAFF GAGES INSTALLED AT SC1.D

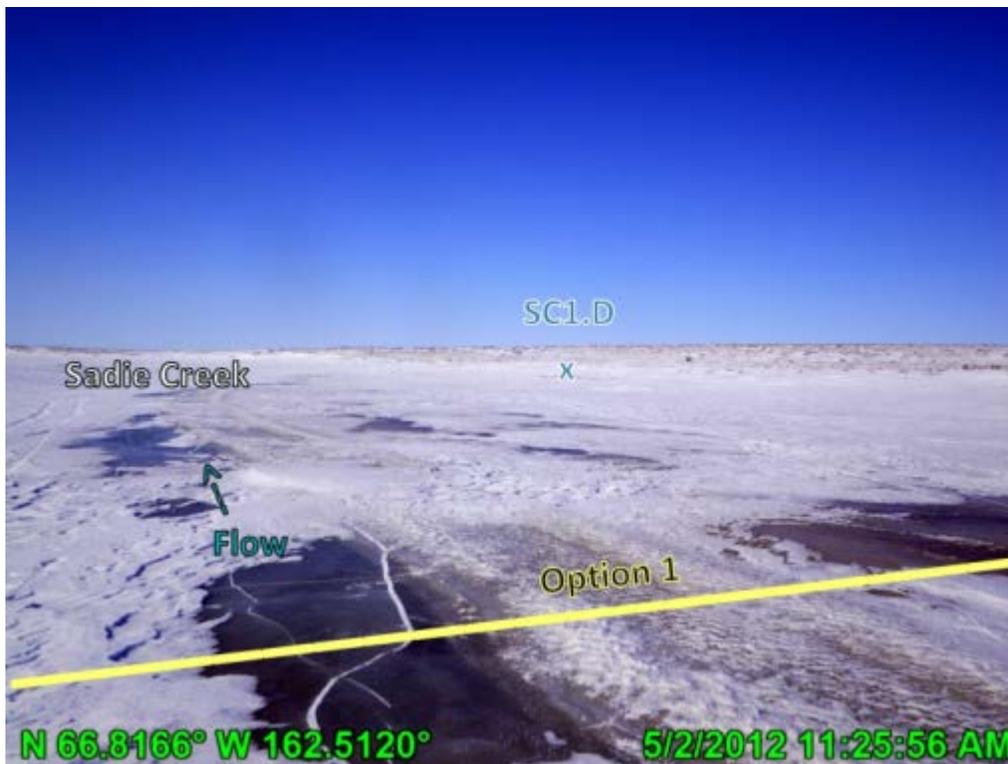
PHOTO 2.1: PROPOSED SC1 CROSSING PRIOR TO BREAKUP, LOOKING WEST; MAY 2, 2012

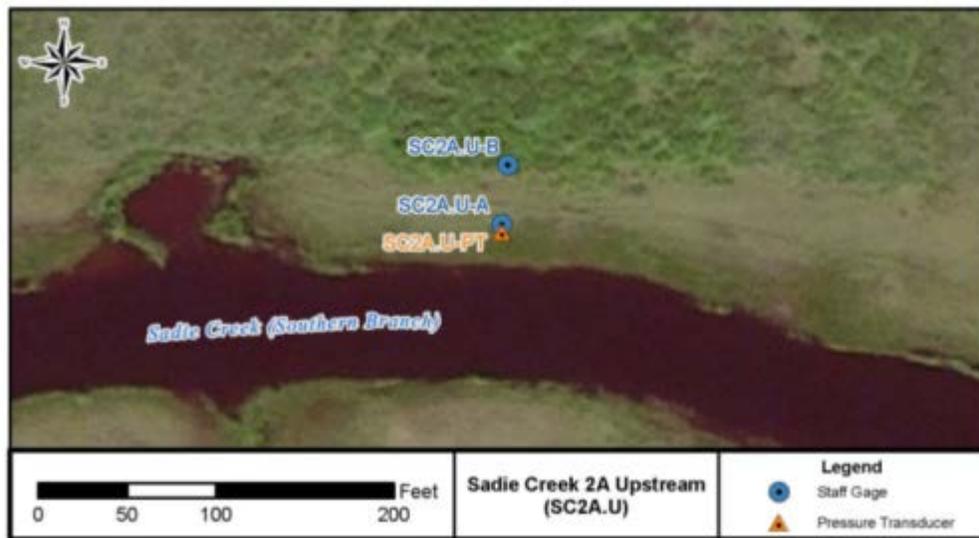
Gages located at SC2A were installed along a nearly straight reach and surveyed for elevation on May 4. Gages were established at the proposed road crossing centerline and approximately 500 feet upstream and downstream. PTs were installed at SC2A.U and SC2A.D. Hydrologic staff gage locations at SC2A are presented in Figure 2.5 through Figure 2.7. Photo 2.2 shows pre-breakup conditions at SC2A on May 2.

FIGURE 2.5: HYDROLOGIC STAFF GAGES INSTALLED AT SC2A.U

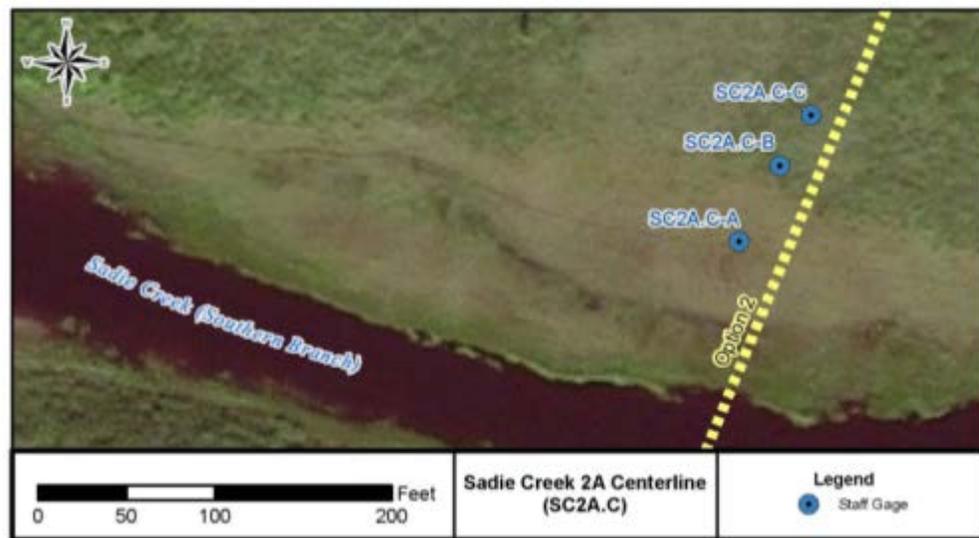
FIGURE 2.6: HYDROLOGIC STAFF GAGES INSTALLED AT SC2A.C

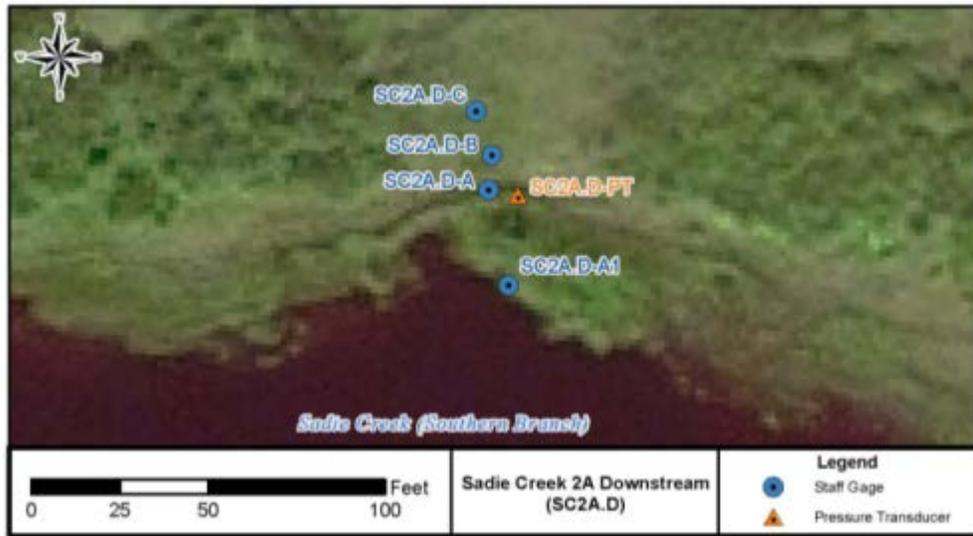
FIGURE 2.7: HYDROLOGIC STAFF GAGES INSTALLED AT SC2A.D

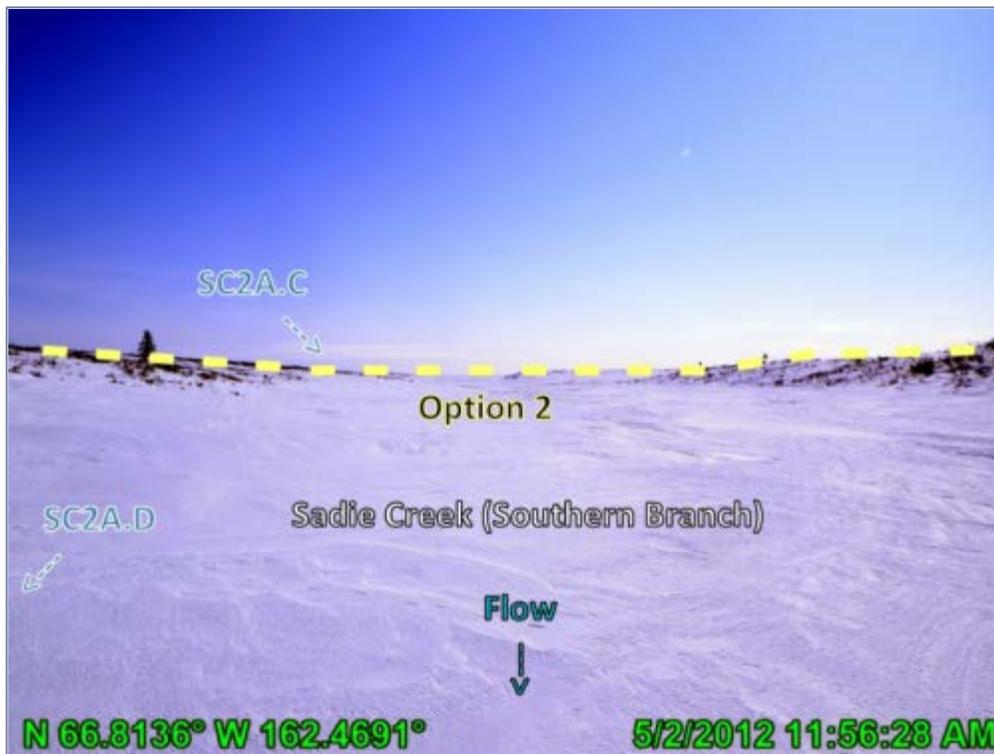
PHOTO 2.2: PROPOSED SC2A CROSSING PRIOR TO BREAKUP, LOOKING EAST; MAY 2, 2012

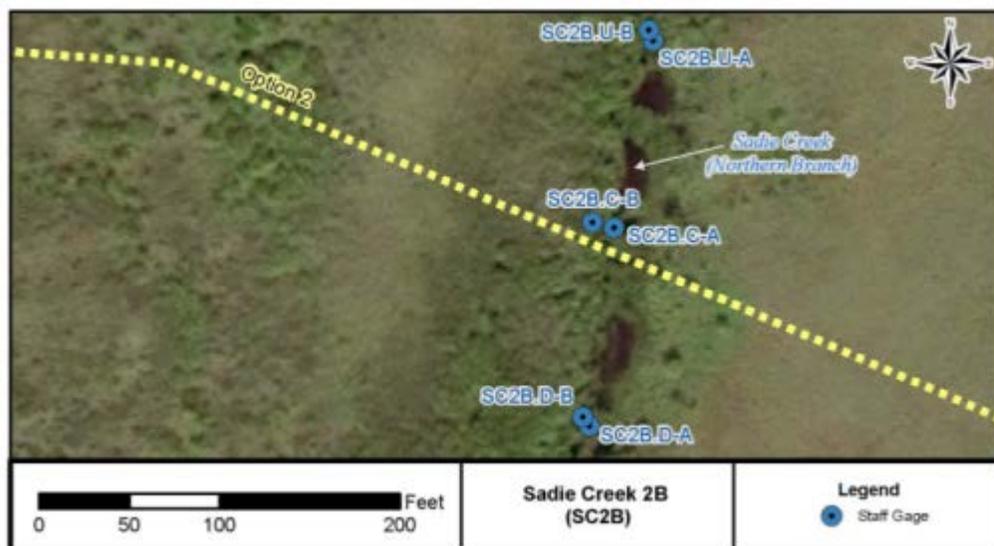
Gages were established at the proposed road crossing centerline along a nearly straight reach, approximately 100 feet upstream and downstream, and surveyed for elevation on May 5. PTs were installed at SC2B.U and SC2B.D at the base of the "A" gages. Hydrologic staff gage locations at SC2B are presented in Figure 2.8. Photo 2.3 shows pre-breakup conditions at SC2B on May 2 ("←x→" indicates location and alignment of channel).

FIGURE 2.8: HYDROLOGIC STAFF GAGES INSTALLED AT SC2B

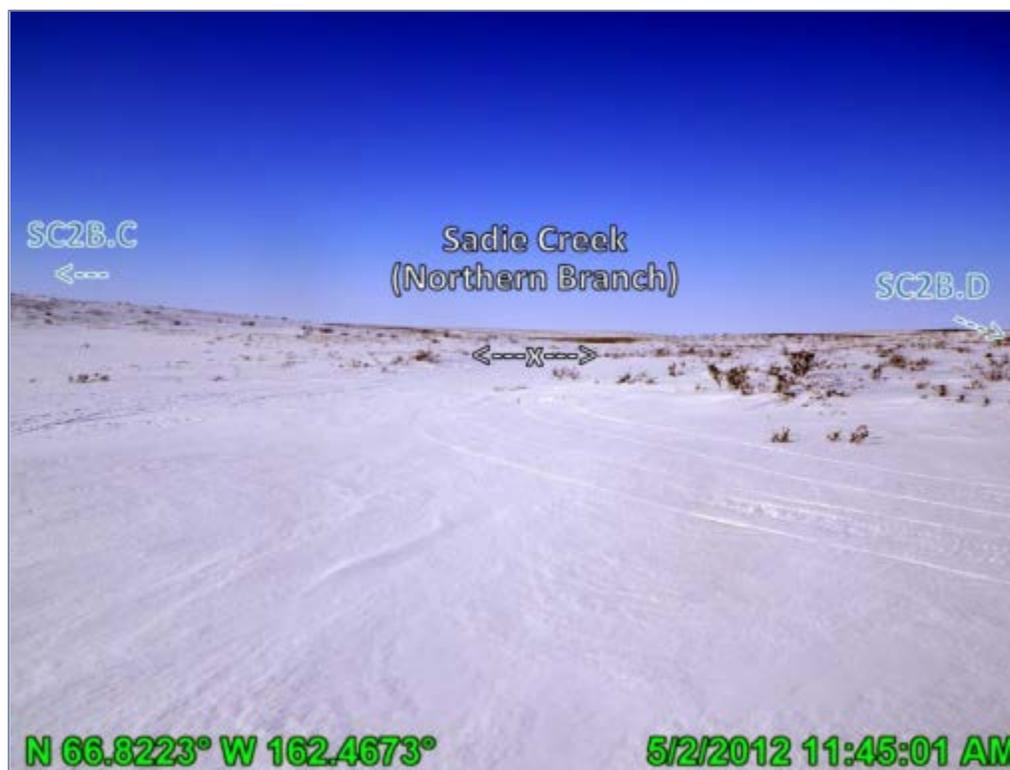
PHOTO 2.3: SC2B PRIOR TO BREAKUP, LOOKING EAST; MAY 2, 2012

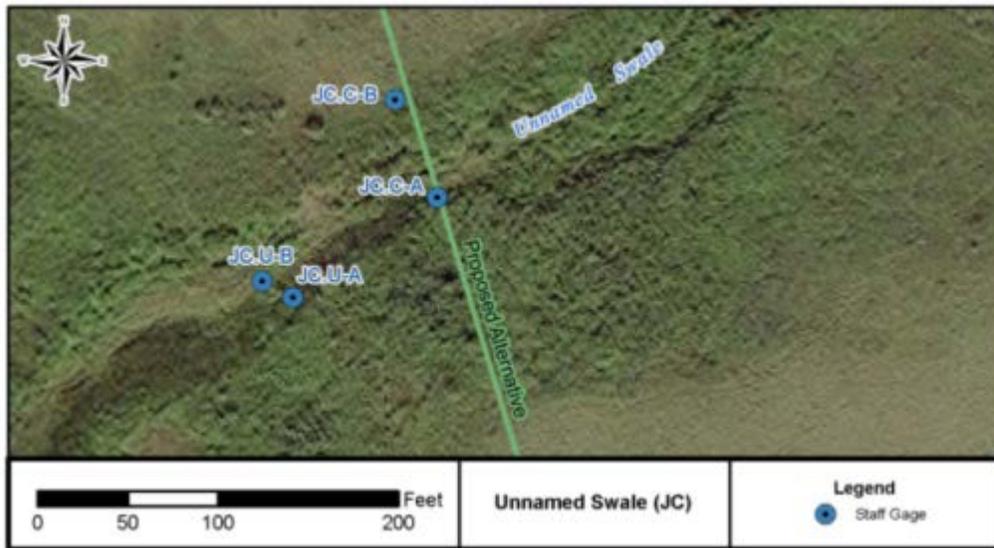
The proposed crossing of the unnamed swale is located 3 miles southeast of Kotzebue. Upstream of the site is a pond connected to a small network of wetlands or smaller ponds. This crossing was characterized by small brush and grasses with a fairly well defined drainage once the snowpack opened to floodwaters. On May 5, gages were installed and surveyed for elevation at the proposed road crossing centerline and 100 feet upstream. PTs were installed at JC.U and JC.C at the base of the "A" staff gages. Hydrologic staff gage locations at JC are presented in Figure 2.9. Photo 2.4 shows pre-breakup conditions at the proposed crossing on May 2.

FIGURE 2.9: HYDROLOGIC STAFF GAGES INSTALLED AT JC

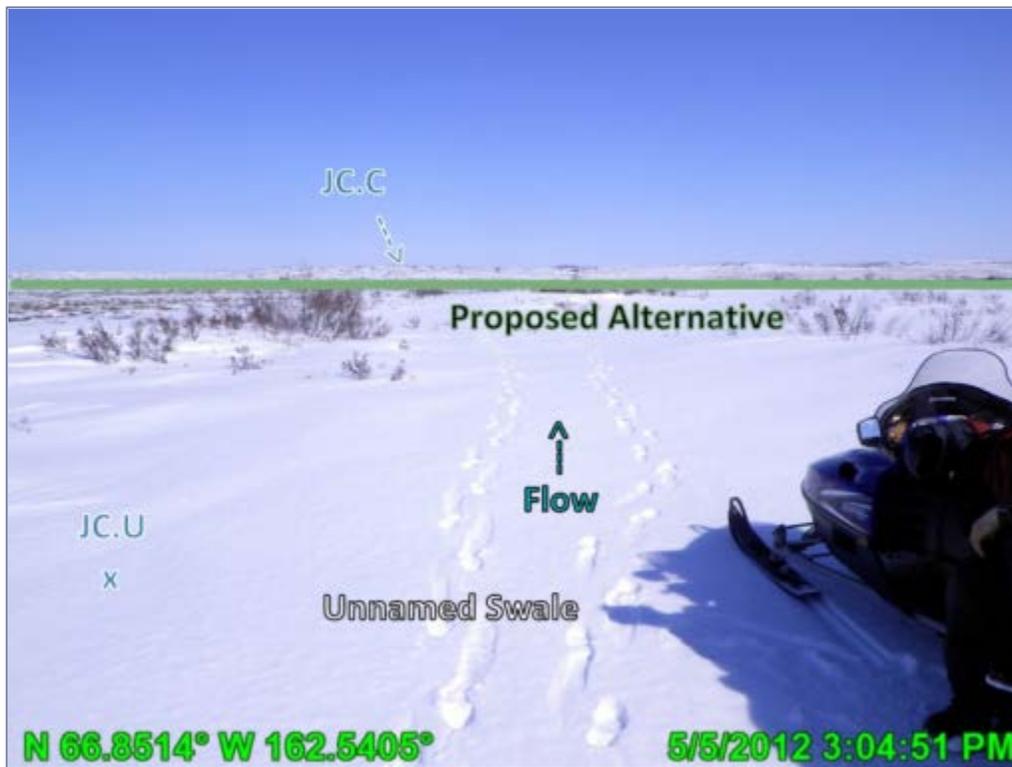
PHOTO 2.4: PROPOSED CROSSING OF THE UNNAMED SWALE PRIOR TO BREAKUP, LOOKING EAST; MAY 5, 2012

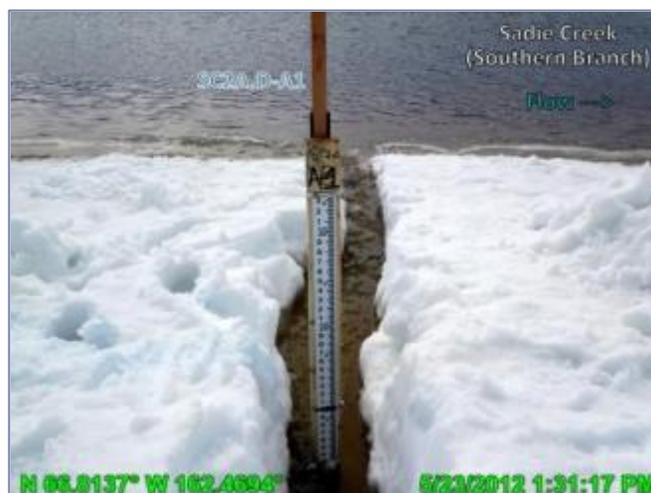
Temporary benchmarks, consisting of a 2-foot long piece of rebar and a 5-inch square cap, were placed on the upper banks at each monitoring site. Each benchmark was assigned an assumed elevation prior to breakup. They were not tied together or to a known datum. The elevation of each gage was established from its local benchmark using standard level loop techniques. Elevations at each gage location are relative only to that site.

**PHOTO 3.1: GAGE ASSEMBLY AT SC2A.D, LOOKING SOUTH;  
MAY 23, 2012**

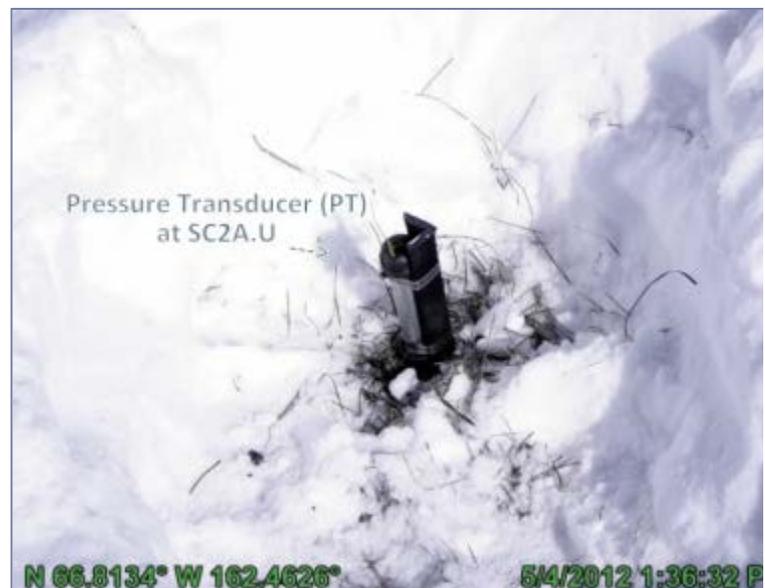
Solinst 3001 Levelogger® Gold sensors were used. The instrument is a non-vented pressure sensor designed to collect and store pressure and temperature data at discrete intervals. The factory-calibrated transducers were set to collect absolute pressure and water temperature at 15-minute intervals. The measured pressure datum is the sum of the forces imparted by both the water column and atmospheric conditions. A correction of local barometric pressure was required and obtained from a Solinst 3001 Barologger® Gold located at SC1.C. This Barologger® location is considered to be representative of conditions at each monitoring site. See Appendix A for PT and Barologger® basis of elevation and horizontal positions.

PHOTO 3.2: PT ASSEMBLY INSTALLED AT SC2A.U; MAY 4, 2012

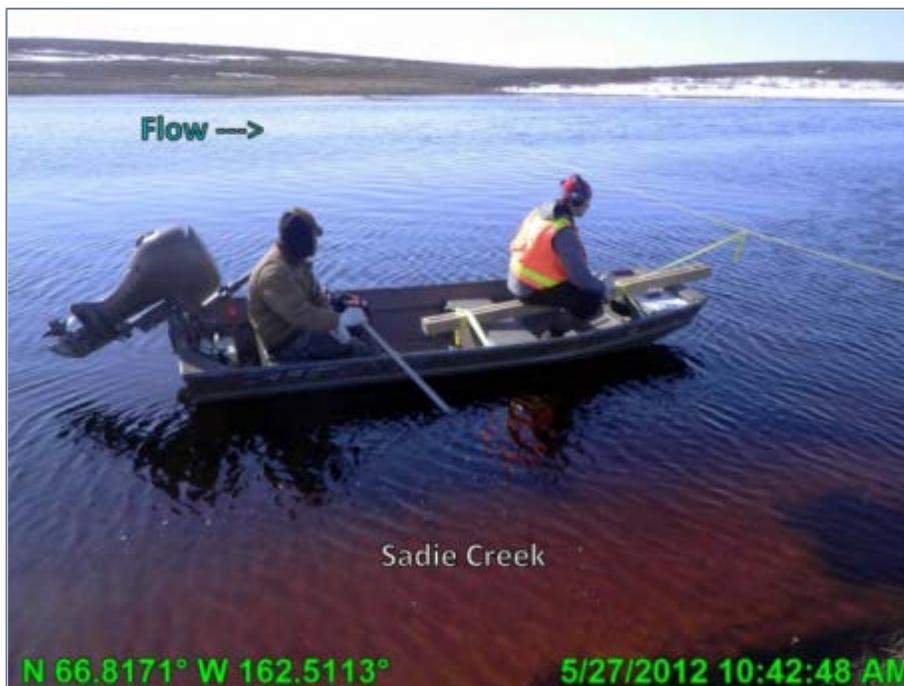
Depth and velocity measurements were taken from a jon boat at SC1 and SC2A with a sounding reel mounted on a wooden boom (Photo 3.3). A Price AA velocity meter was attached to the sounding reel and stabilized with a 30-pound Columbus-type lead sounding weight. A tag line was placed across the channel to define the cross section and to delineate measurement subsections within the channel. To ensure accurate performance of meters, procedures outlined in the Office of Surface Water Technical Memorandum No. 99.06 (OSW 1999) were followed.

PHOTO 3.3: DIRECT-DISCHARGE MEASUREMENT AT SC1, LOOKING SOUTHEAST; MAY 27, 2012

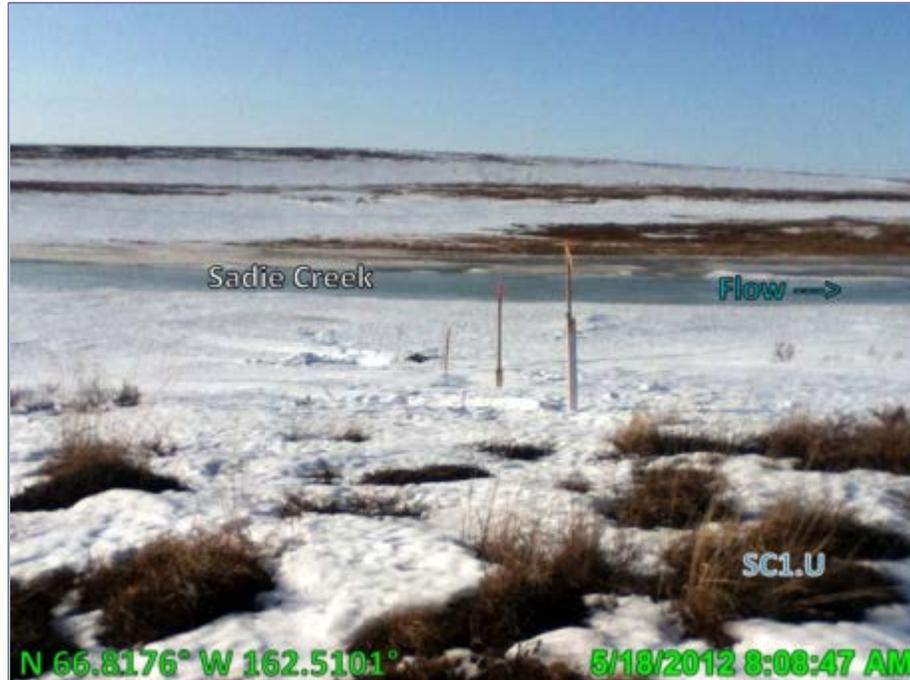
Victor Jones, a local subcontractor with the Native Village of Kotzebue, provided photographic evidence of breakup processes at the monitoring areas beginning on May 18 (Photo 4.1), prior to Baker field crew mobilization to Kotzebue on May 22.

PHOTO 4.1: BREAKUP INITIATION AT SC1.U, LOOKING SOUTH; MAY 18, 2012

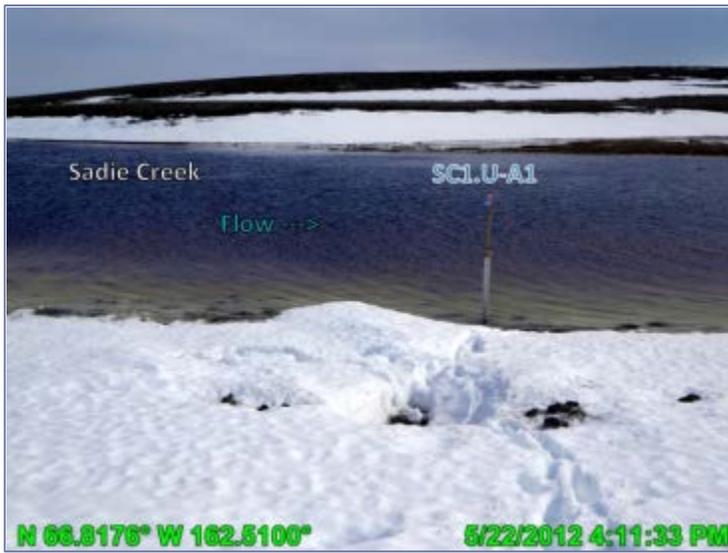
PHOTO 4.2: BOTTOM-FAST ICE AT SC1.U, LOOKING SOUTHEAST; MAY 22, 2012

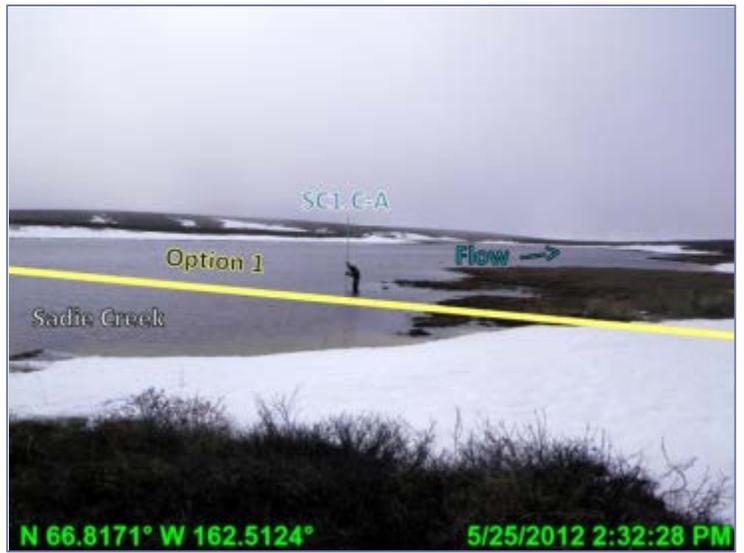
PHOTO 4.3: BOTTOM-FAST ICE ALONG TOE OF BANK AT SC1.C, LOOKING DOWNSTREAM; MAY 25, 2012

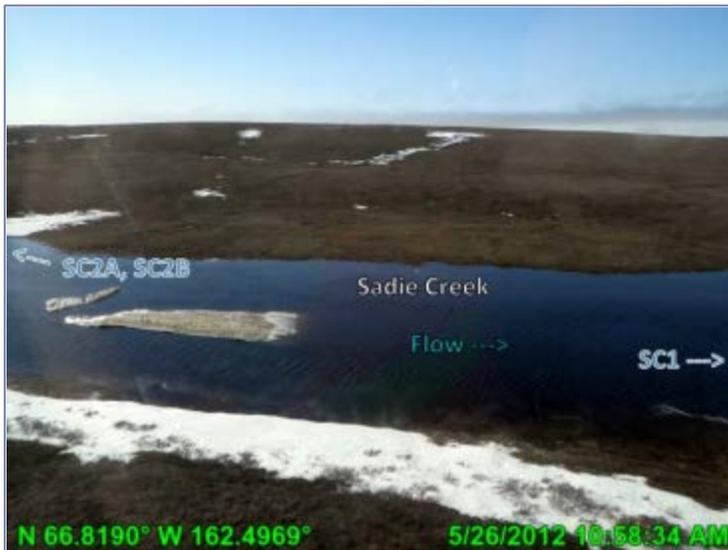
By May 26, ice had lifted off the channel bed both upstream and downstream of the SC1 reach (Photo 4.4) and stage at all locations rose slightly. The following day, ice floes were observed approximately 0.5 RM upstream of SC1 (Photo 4.5). No significant effects to flow were seen at the crossing location as a result of this ice. Floes remained in the channel upstream of SC1 on May 29 as stage continued to drop..

PHOTO 4.4: ICE LIFTING OFF THE CHANNEL BED 0.5 MILES UPSTREAM OF SC1 GAGES, LOOKING SOUTH; MAY 26, 2012

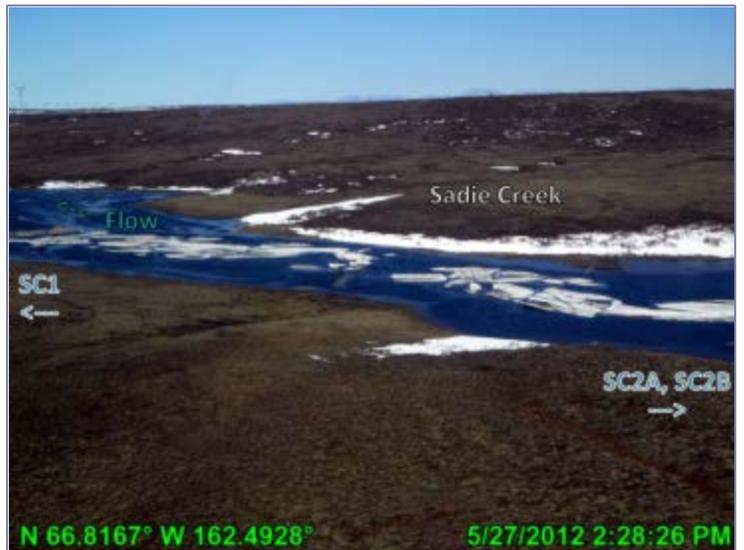
PHOTO 4.5: ICE FLOES UPSTREAM OF SC1 GAGES, LOOKING NORTHWEST; MAY 27, 2012

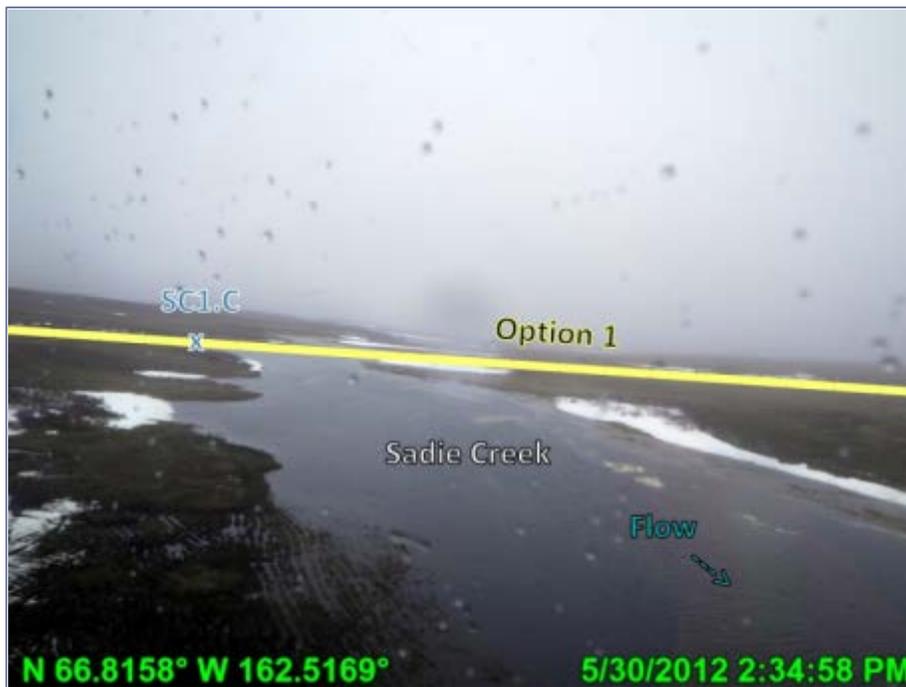
PHOTO 4.6: OPEN CHANNEL CONDITIONS DOWNSTREAM OF SC1 GAGES,  
LOOKING UPSTREAM TO CROSSING LOCATION; MAY 30, 2012

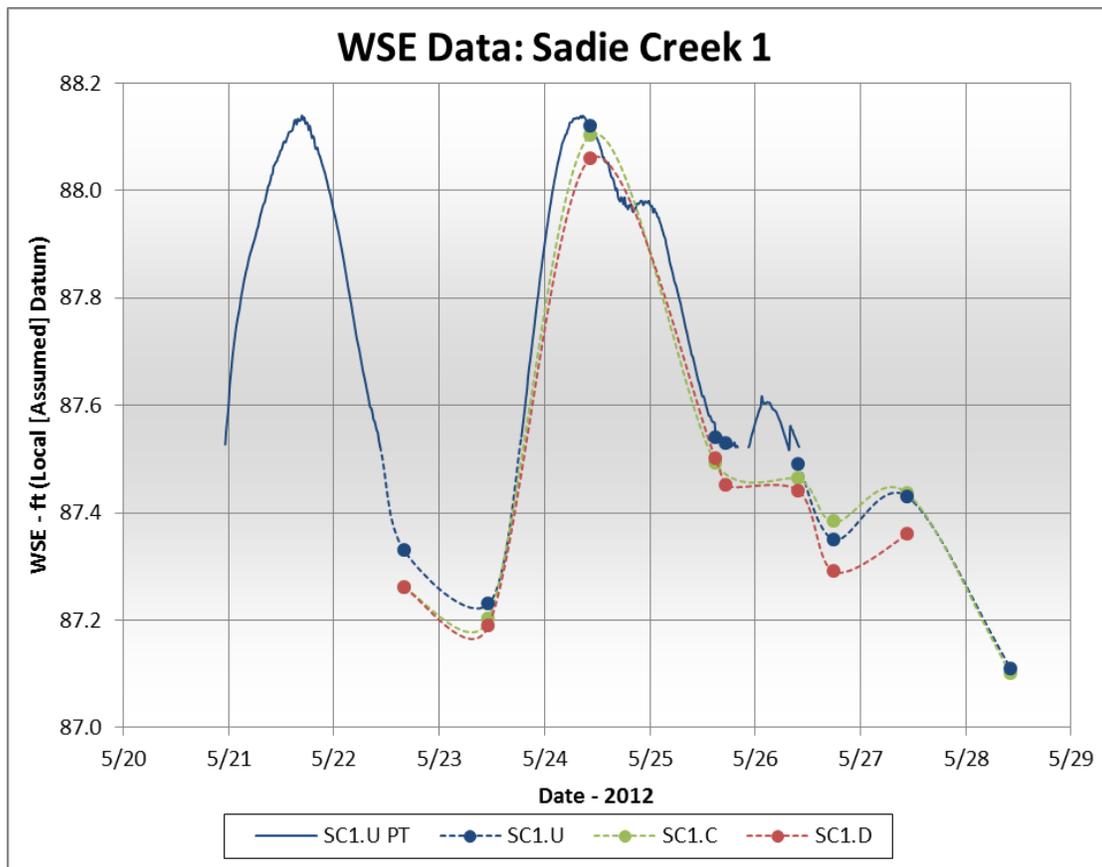
Stage data for the SC1 gages during breakup monitoring are contained in Table 4.1 and Graph 4.1. The PT at the SC1.D location malfunctioned and data was not recoverable.

GRAPH 4.1: STAGE DATA, SC1 GAGES

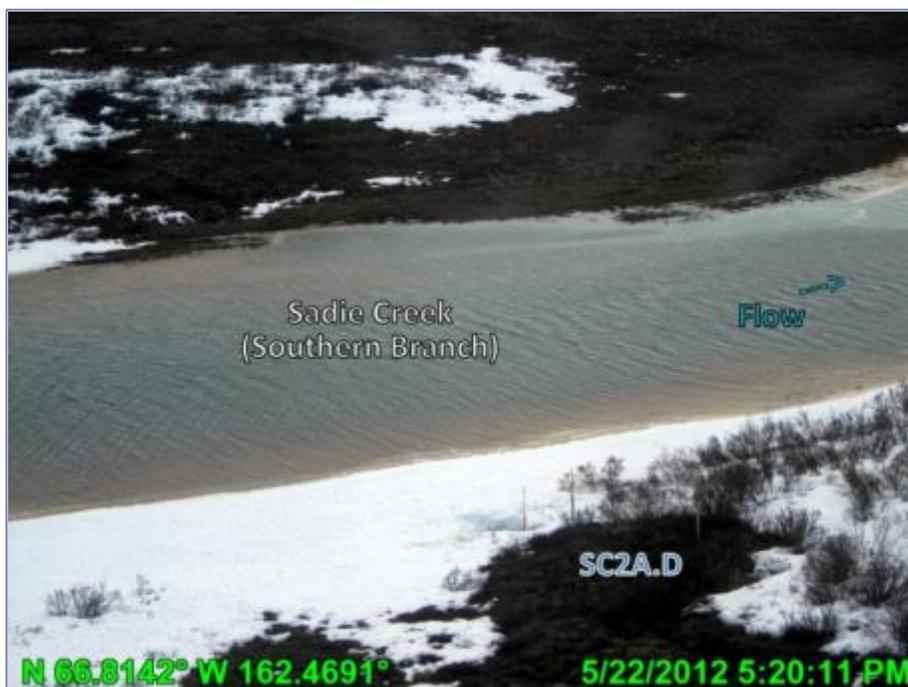
PHOTO 4.7: BOTTOM-FAST ICE ALONG BANKS AT SC2A.D, LOOKING SOUTHWEST; MAY 22, 2012

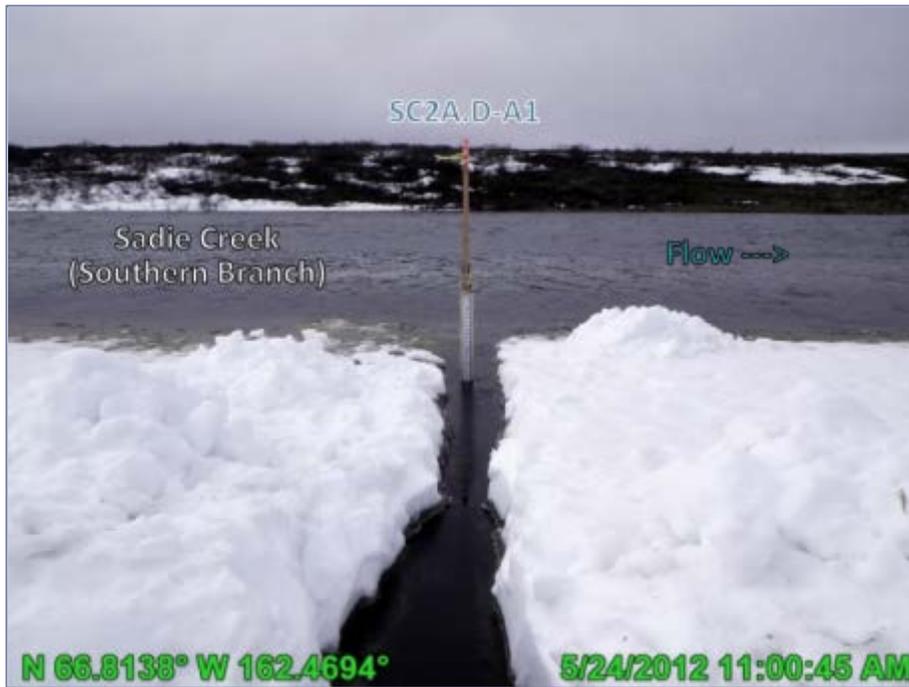
PHOTO 4.8: CONDITIONS DURING PEAK STAGE AT SC2A.D, LOOKING SOUTHWEST; MAY 24, 2012

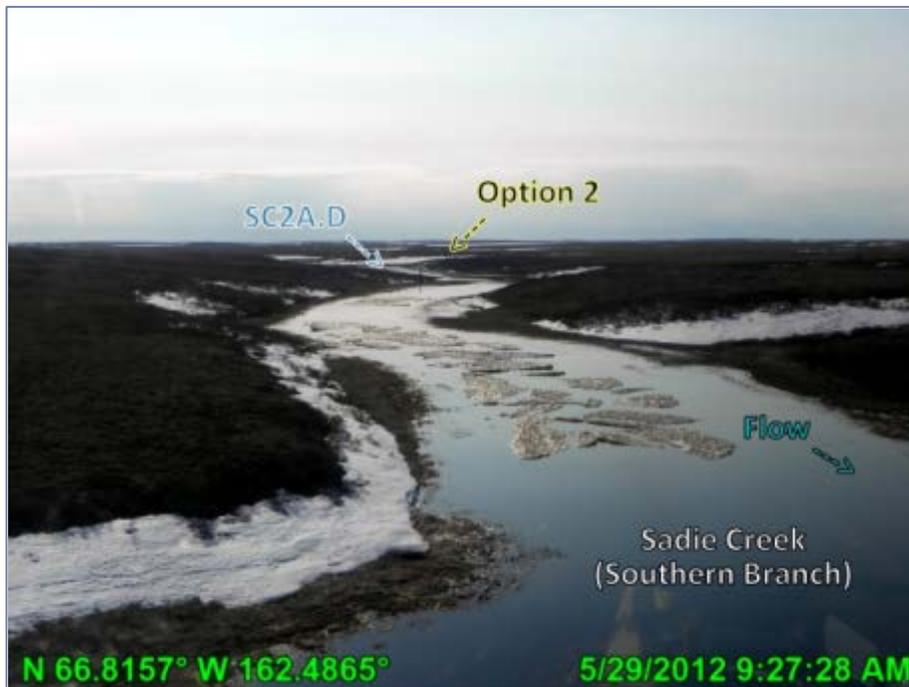
On May 25, the channel remained free of snow and ice floes as stage continued to drop. Conditions were similar until May 28 when bottom-fast ice lifted to the surface. Stage dropped below gages by May 29. Ice floes were grounding out approximately 0.5 RM downstream of SC2A and flow within the reach was confined almost entirely within the channel banks (Photo 4.9). No backwater effects were observed at the crossing location as a result of the rafted floes downstream. The majority of the snow in the area had melted and monitoring was discontinued.

PHOTO 4.9: ICE FLOES 0.5 RM DOWNSTREAM OF SC2A, LOOKING WEST; MAY 29, 2012
