# KOTZEBUE TO CAPE BLOSSOM ROAD 2012 SPRING BREAKUP STUDY: SADIE CREEK

Prepared for

Alaska Department of Transportation & Public Facilities  
2301 Peger Road  
Fairbanks, Alaska 99709  
AKSAS Project No: 76884 / Federal Project No: NCPD-0002(204)  
PSA No: 025-2-1-009

Michael Baker Jr., Inc.  
1400 W. Benson Blvd., Suite 200  
Anchorage, AK 99503  
Project No. 128262

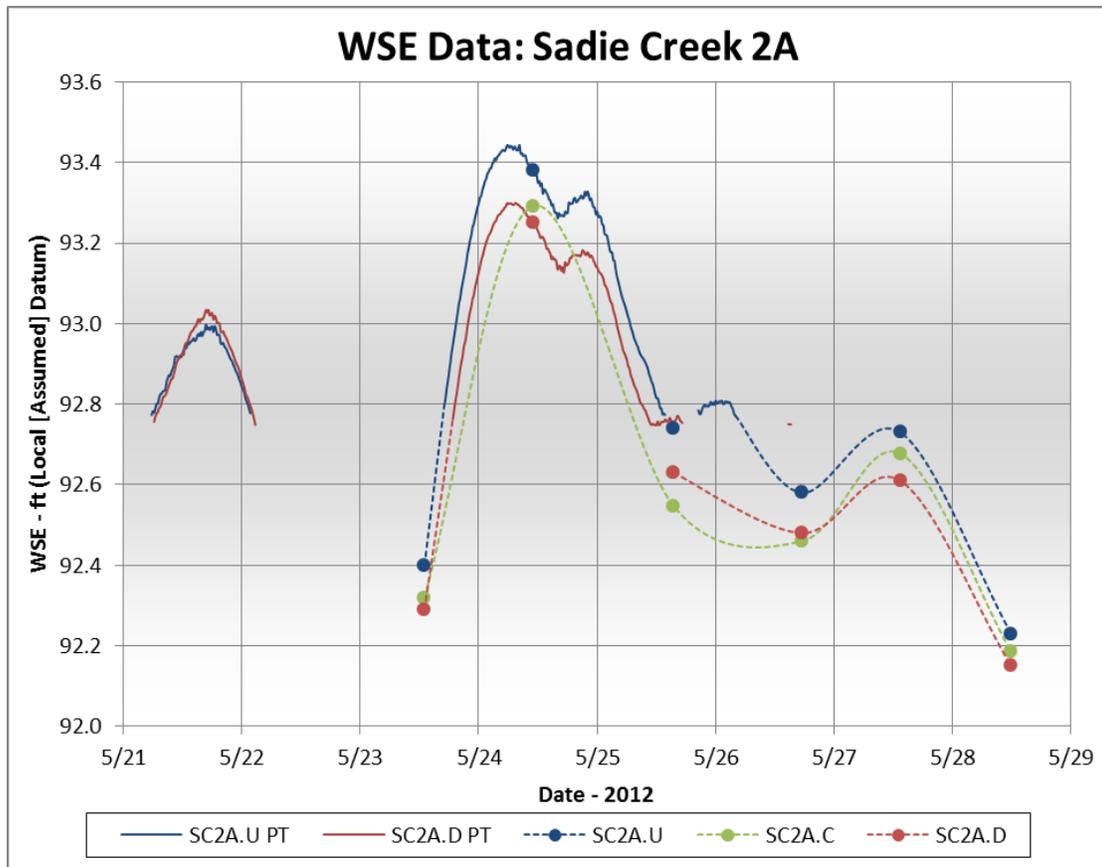
Stage data for the SC2A gages during breakup monitoring are presented in Table 4.2 and Graph 4.2.

GRAPH 4.2: STAGE DATA, SC2A GAGES

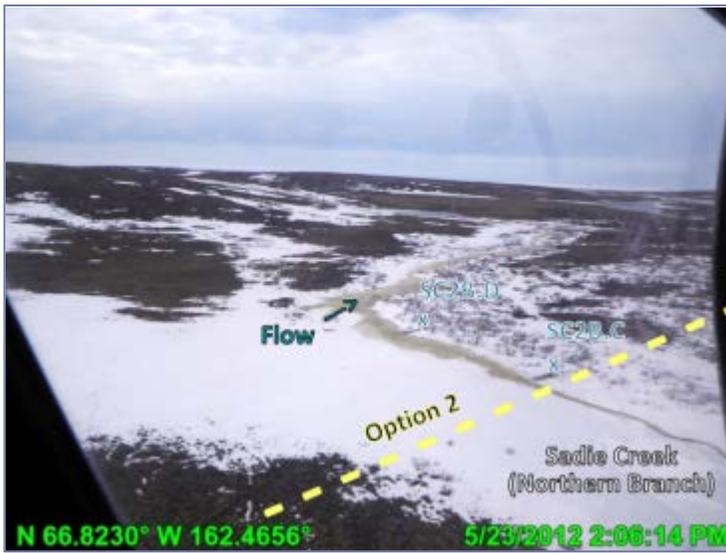
This channel is a small tributary of Sadie Creek which drains a network of ponds. Conditions through this reach during spring breakup were very dynamic as flood flow was conveyed on top of and through the snowpack, adjacent to the natural channel, for the majority of the monitoring period. The gradient and geometry of the incised channel changed, becoming deeper and wider as breakup melt progressed. Eventually, flow cut through the snow near the end of the monitoring period, migrating to the natural channel on the ground. Stage was affected by this process and should not be considered representative of the natural channel.

PHOTO 4.10: STEEPER TO SHALLOWER GRADIENT FLOW OVER SNOW AT SC2B, LOOKING DOWNSTREAM; MAY 23, 2012

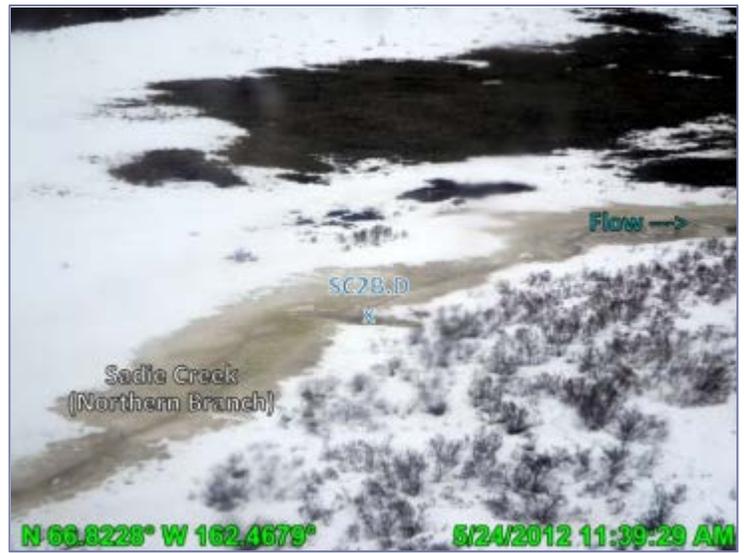
PHOTO 4.11: FLOW LESS CONFINED AS A RESULT OF SHALLOWER DOWNSTREAM GRADIENT AT SC2B, LOOKING DOWNSTREAM; MAY 24, 2012

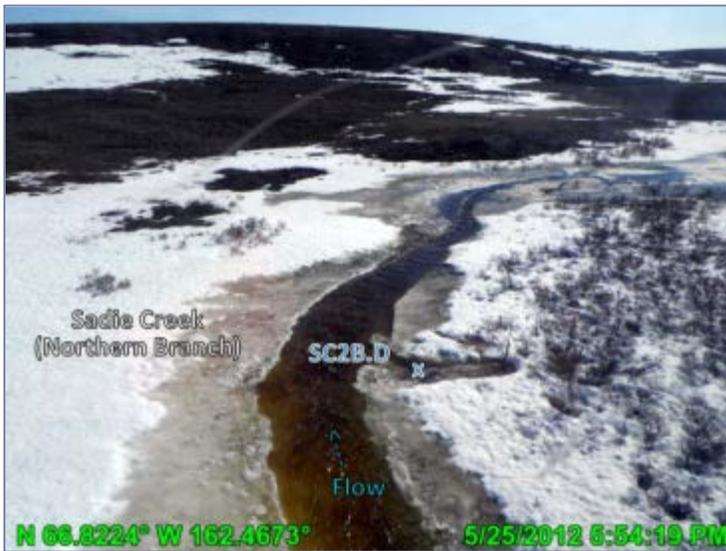
PHOTO 4.12: BREAKUP PROGRESSION AT SC2B AND DOWNSTREAM PONDING, LOOKING DOWNSTREAM; MAY 25, 2012

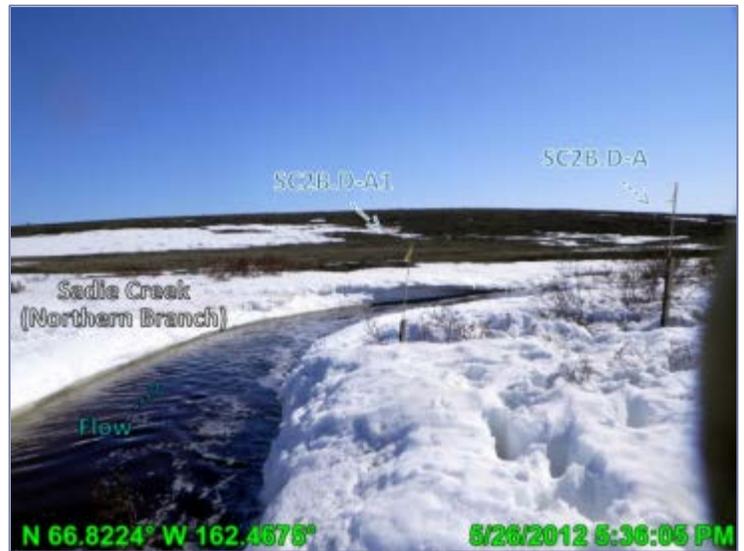
PHOTO 4.13: SC2B CHANNEL CUTTING INTO THE SNOWPACK, LOOKING DOWNSTREAM; MAY 26, 2012

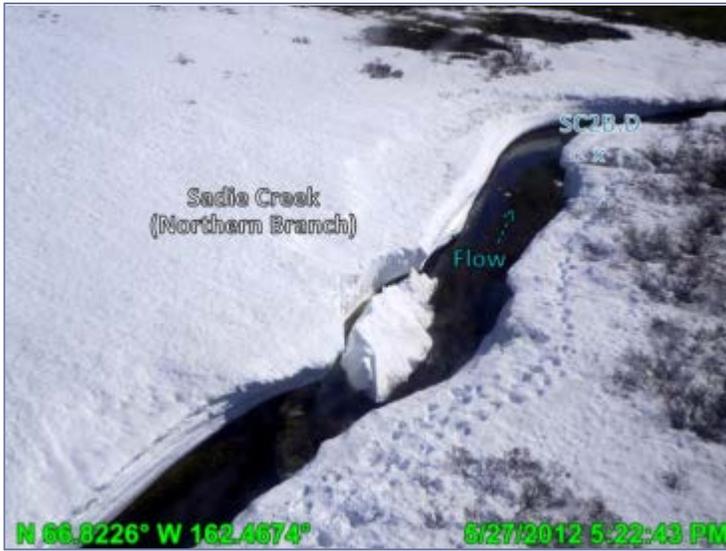
PHOTO 4.14: SC2B CHANNEL CUT TO THE BOTTOM OF THE SNOWPACK, LOOKING DOWNSTREAM; MAY 27, 2012

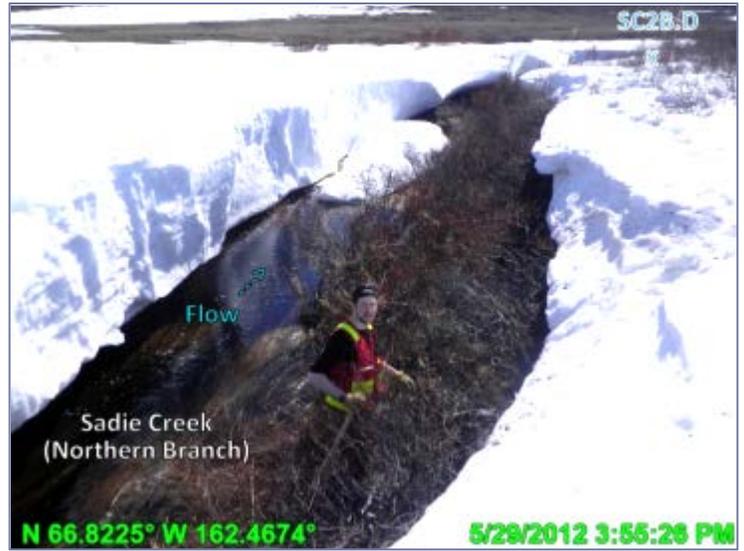
PHOTO 4.15: CUT IN SNOWPACK LEFT BY SC2B AND MIGRATION OF FLOW TOWARD NATURAL CHANNEL, LOOKING DOWNSTREAM; MAY 29, 2012

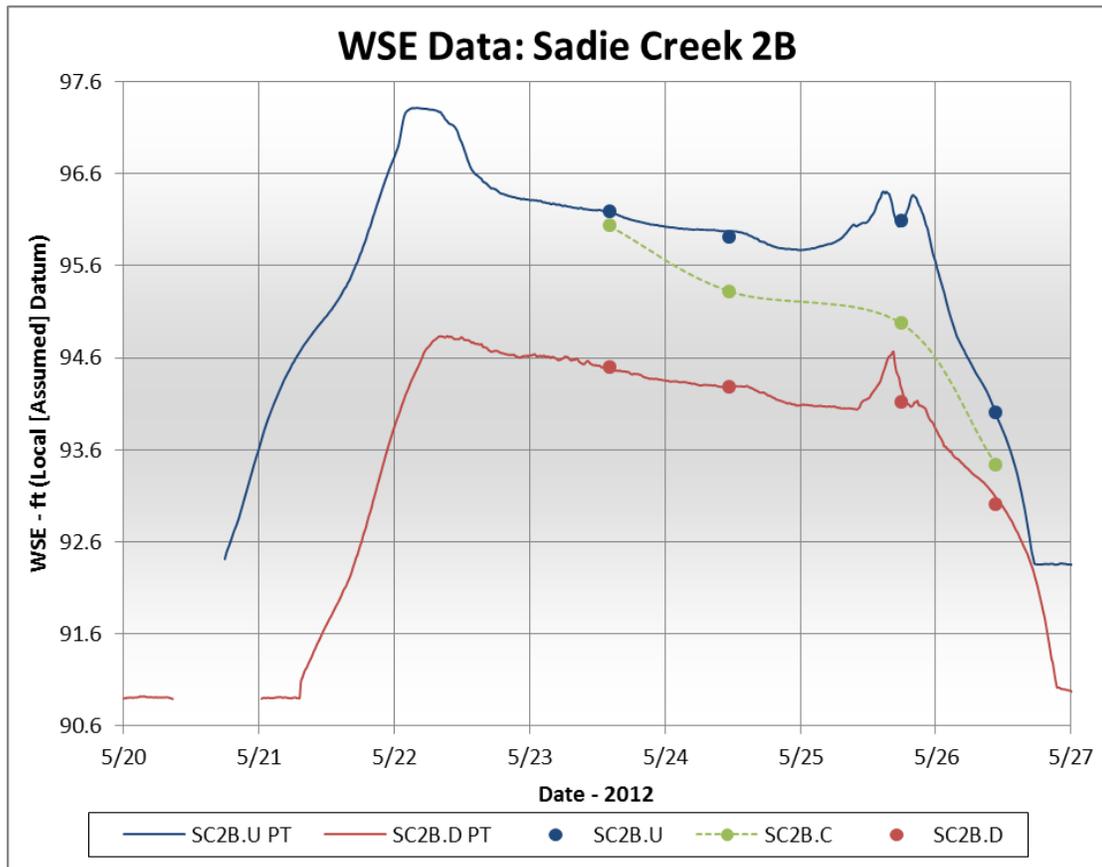
Stage data for the SC2B gages during breakup monitoring are presented in Table 4.3 and Graph 4.3.

1. Elevations are based on SC2B at 100.00 feet (local datum - assumed elevation) surveyed by Baker in 2012.
2. Flow through this reach was conveyed via a channel incised into the snowpack. Channel geometry and gradient changed with the progression of breakup melt. Stage data was affected by these processes and should not be considered representative of the natural channel.

GRAPH 4.3: STAGE DATA, SC2B GAGES

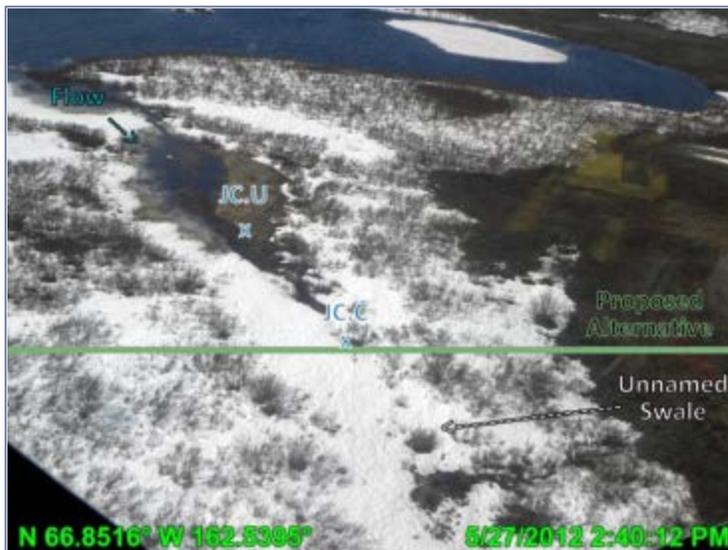
The swale drains a network of small ponds and wetlands into June Creek. Local melt was observed at JC gages during the reconnaissance flight on May 22. By May 27, melt in the pond upstream had progressed sufficiently so water had reached the crossing location but stage was low (Photo 4.16). Snow was still present downstream of the gages and there was no flow. This swale was conveying flow at a maximum top-width of 30 feet by May 29 (Photo 4.17). The maximum depth was 1.3 feet and the surface of the water was discontinuous with ice, snow, and vegetation. Stage and flow had decreased by May 30, after which monitoring was discontinued.

PHOTO 4.16: PROPOSED UNNAMED SWALE CROSSING,  
LOOKING WEST; MAY 27, 2012

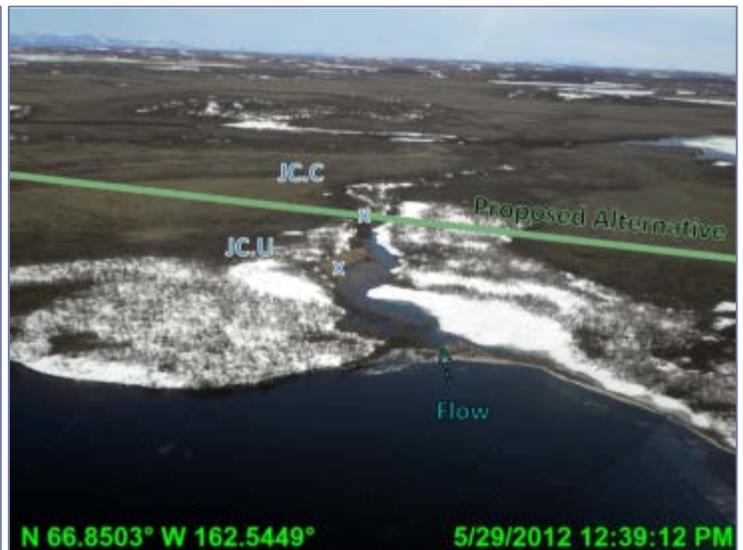
PHOTO 4.17: PROPOSED UNNAMED SWALE CROSSING,  
LOOKING NORTHEAST; MAY 29, 2012

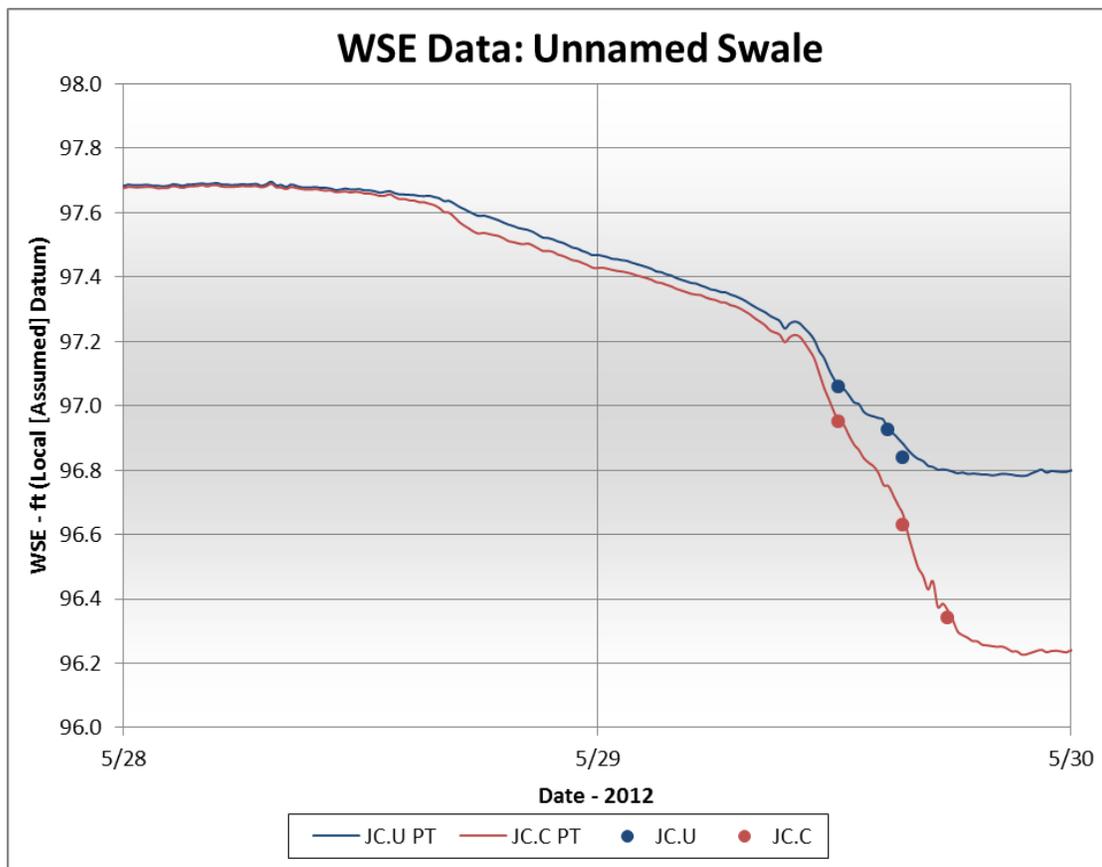
Stage data for the JC gages during breakup monitoring are contained in Table 4.4 and Graph 4.4.

1. Elevations are based on JC at 100.00 feet (local datum - assumed elevation) surveyed by Baker in 2012.
2. Local melt only through morning of May 28.
3. Only limited outflow was observed through the swale.

GRAPH 4.4: STAGE DATA, JC GAGES

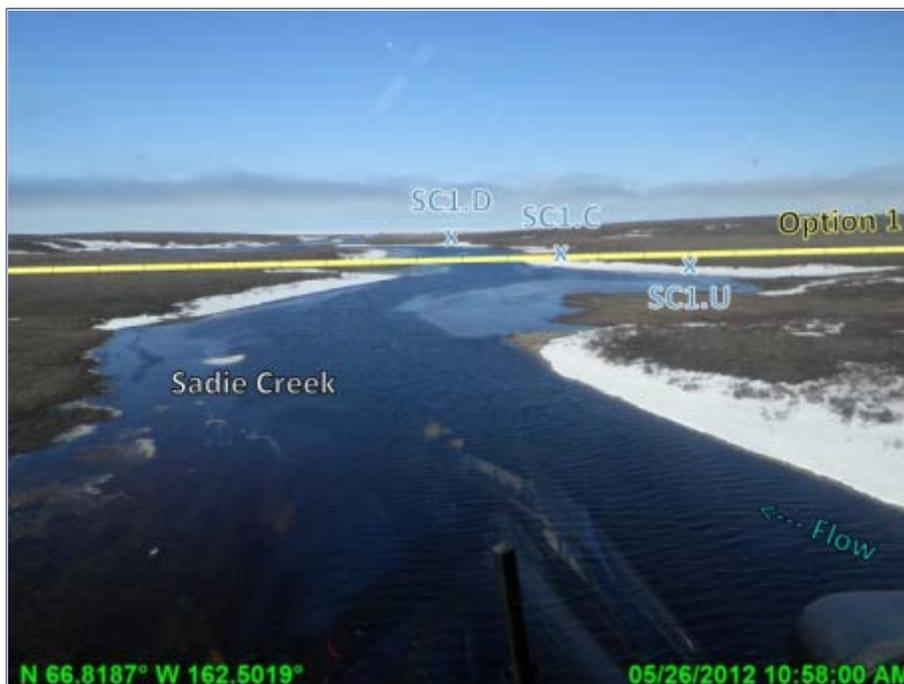
Conditions affecting discharge measurements were fairly consistent each day (Photo 5.1). A strong west wind persisted throughout the monitoring period and was strong enough to push the boat upstream of the tagline during each measurement. Direct discharge measurements were most likely impacted by the flow resistance induced by the wind, which varied in strength, and was weakest on May 26. The reach banks were free of snow prior to the first discharge measurement on May 24. Bottom-fast ice lined approximately half the channel cross section and remained in place during all discharge measurements. Bottom-fast ice began lifting upstream and downstream of the SC1.C on May 26. These floes gathered 0.5 RM upstream of SC1 and remained in place. No floes were in the vicinity of the crossing location during discharge measurements. No significant backwater effects were evident at SC1 as a result of downstream ice conditions.

PHOTO 5.1: SC1 REACH UPSTREAM OF GAGES, LOOKING DOWNSTREAM; MAY 26, 2012

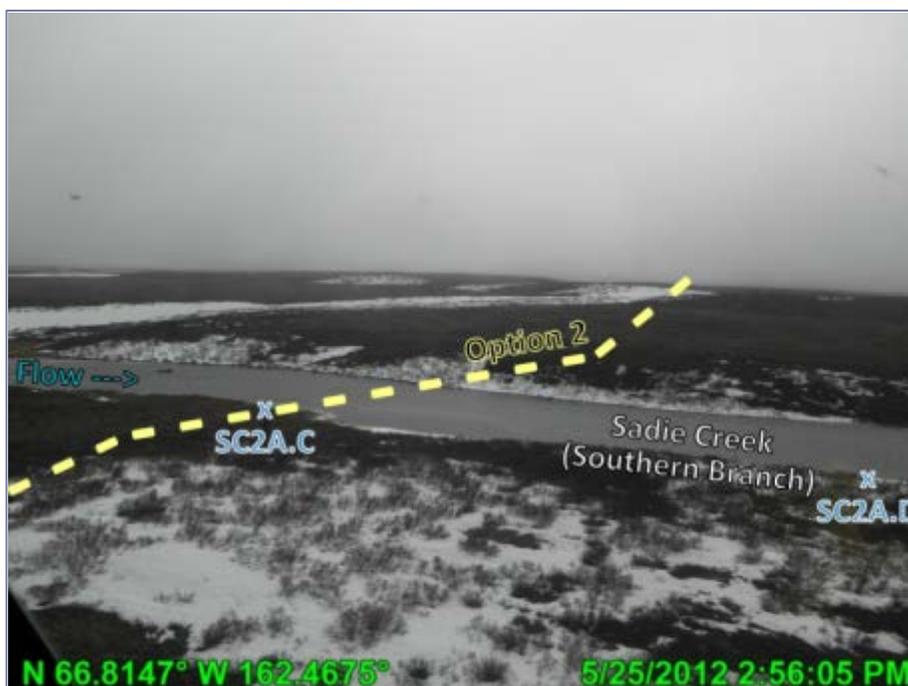
Conditions at SC2A were similar to SC1 and remained fairly consistent each day (Photo 5.2). Similar to SC1, wind resistance most likely had an impact on direct discharge measurements. The reach overbanks were free of snow for all direct discharge measurements. Bottom-fast ice was present along the profile, but was not continuous across the entire width. Ice was observed lifting off the channel bottom both upstream and downstream of SC2A on May 26, but bottom-fast ice was not observed lifting at SC2A.C. No floes were in the vicinity of the crossing location during measurements and no significant backwater effects were observed.

PHOTO 5.2: SC2A REACH, LOOKING SOUTH; MAY 25, 2012

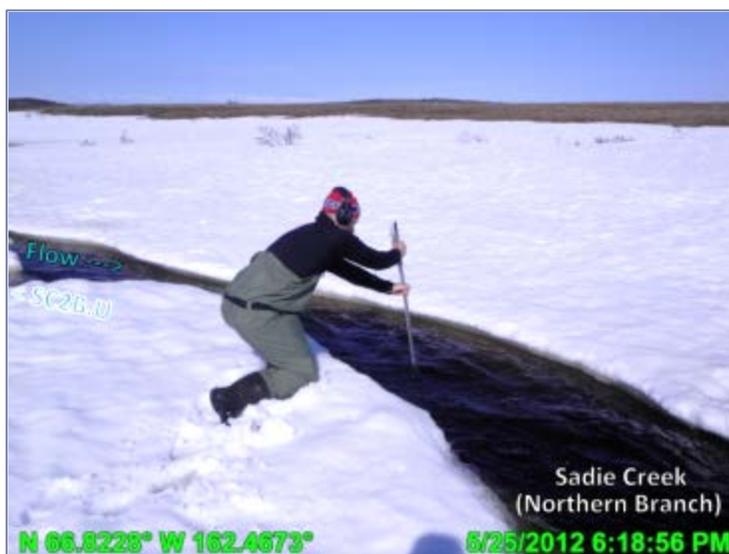
Direct discharge measurements were conducted at SC2B on May 25 and 26 near the centerline gaging location (SC2B.C). As discussed, flow at this location moved on top of and through the snowpack (Photo 5.3 and Photo 5.4) for the duration of the monitoring period, gradually cutting a rectangular channel toward the natural bed. The geometry of the incised channel consistently changed, as did the gradient. Data was collected as conditions allowed and with regard to safety. Mean velocity was estimated from a single measurement from the center of the channel at 60% water depth from the surface. Cross-sectional area was determined using rough measurements of the width and depth of the channel, which was soft and saturated snow. Discharge was computed using the continuity equation (Equation 1) where  $Q$  is discharge,  $A$  is cross-sectional area, and  $V$  is velocity.

PHOTO 5.3: SC2B CONDITIONS DURING DISCHARGE MEASUREMENT, LOOKING NORTHEAST; MAY 25, 2012

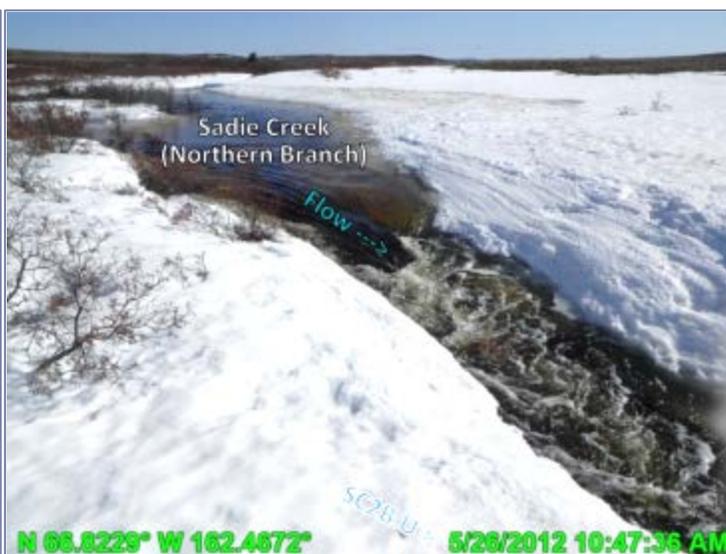
PHOTO 5.4: CONDITIONS UPSTREAM OF SC2B.U, LOOKING NORTH; MAY 26, 2012

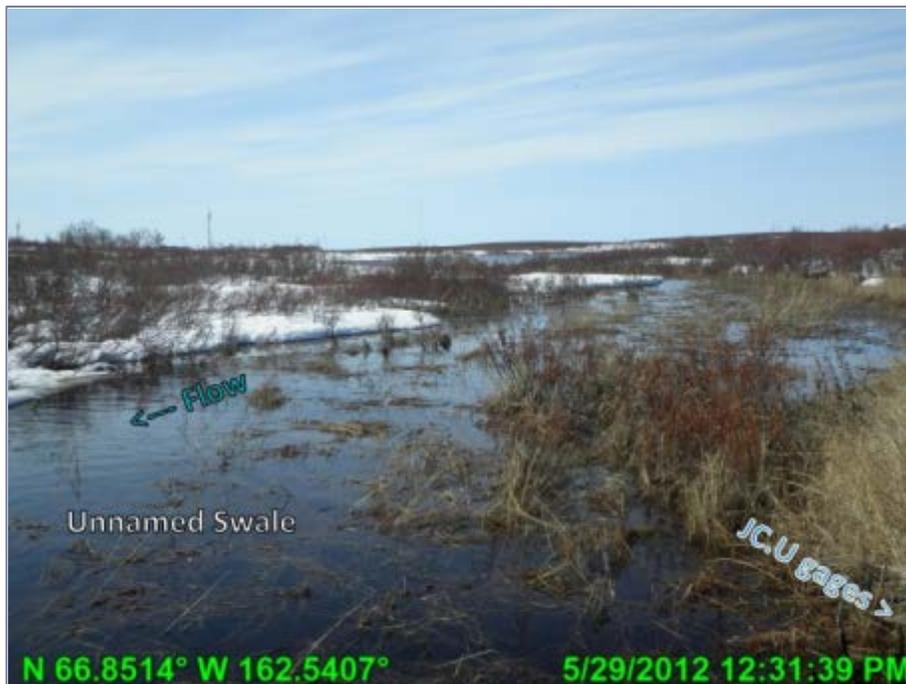
Local melt was present under the snow at JC until flow was observed in the unnamed swale on May 29 (Photo 5.5). One discharge measurement was performed at the centerline gage location (JC.C).

Velocity was slow and the depth of water was low. Discharge was impacted by vegetation and snow in the channel.

PHOTO 5.5: JC CONDITIONS BEFORE DISCHARGE MEASUREMENT, LOOKING DOWNSTREAM; MAY 29, 2012

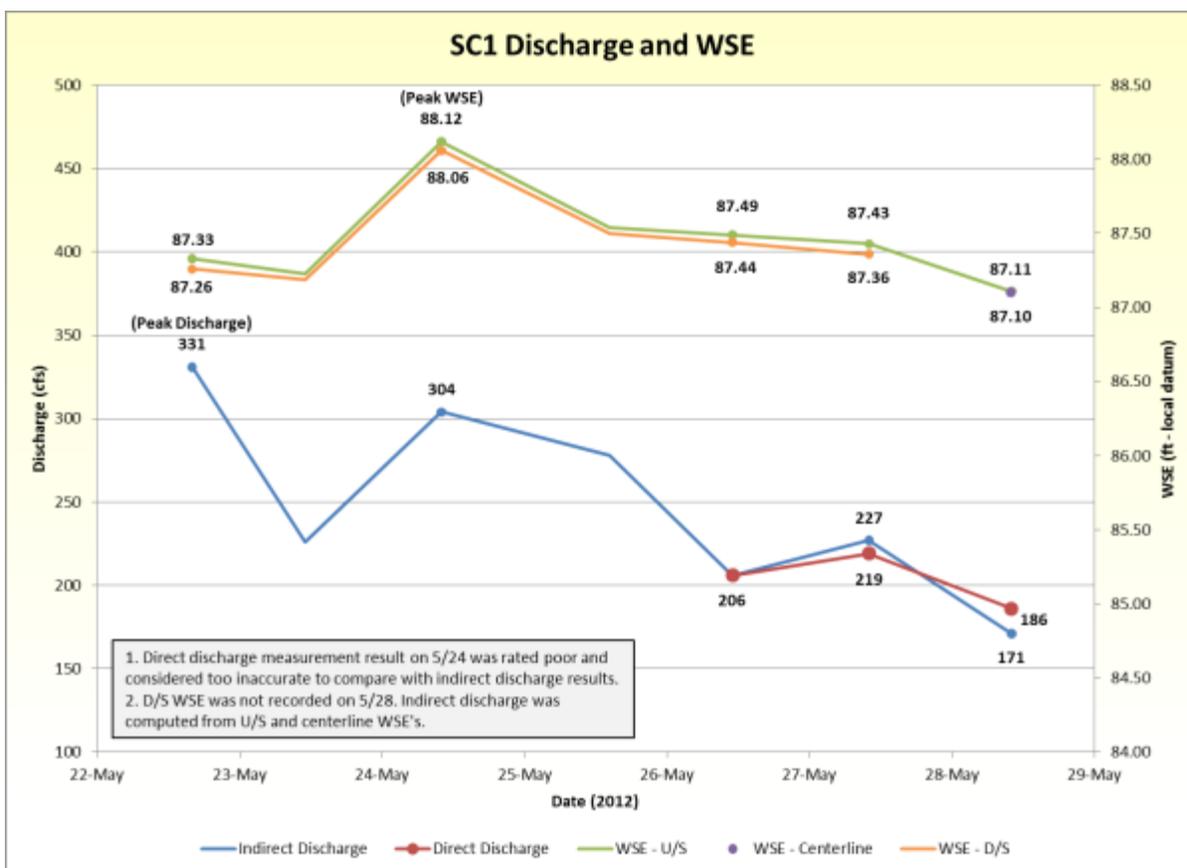
Channel geometry and roughness from direct discharge measurements on May 26 were used to calibrate the indirect discharge calculations. The May 26 direct discharge measurement was considered the most accurate based on flow conditions, including wind impacts. Close agreement between the other direct discharge values and the indirect discharge values, with the exception of the May 24 direct discharge measurement, justifies using the May 26 calibration. The May 24 direct discharge measurement was heavily impacted by opposing winds and was considered too inaccurate to be included for comparison with indirect discharge results. Channel geometry, the presence of bottom-fast ice, and snow conditions along the banks remained relatively consistent through the monitoring period; therefore, the calibration was deemed applicable for all indirect discharge measurements. A comparison of direct and indirect discharge values and WSE at SC1 is shown in Graph 5.1.

Peak discharge at SC1 was calculated as 331 cfs, occurring on May 22.

GRAPH 5.1: SC1 DISCHARGE AND WSE

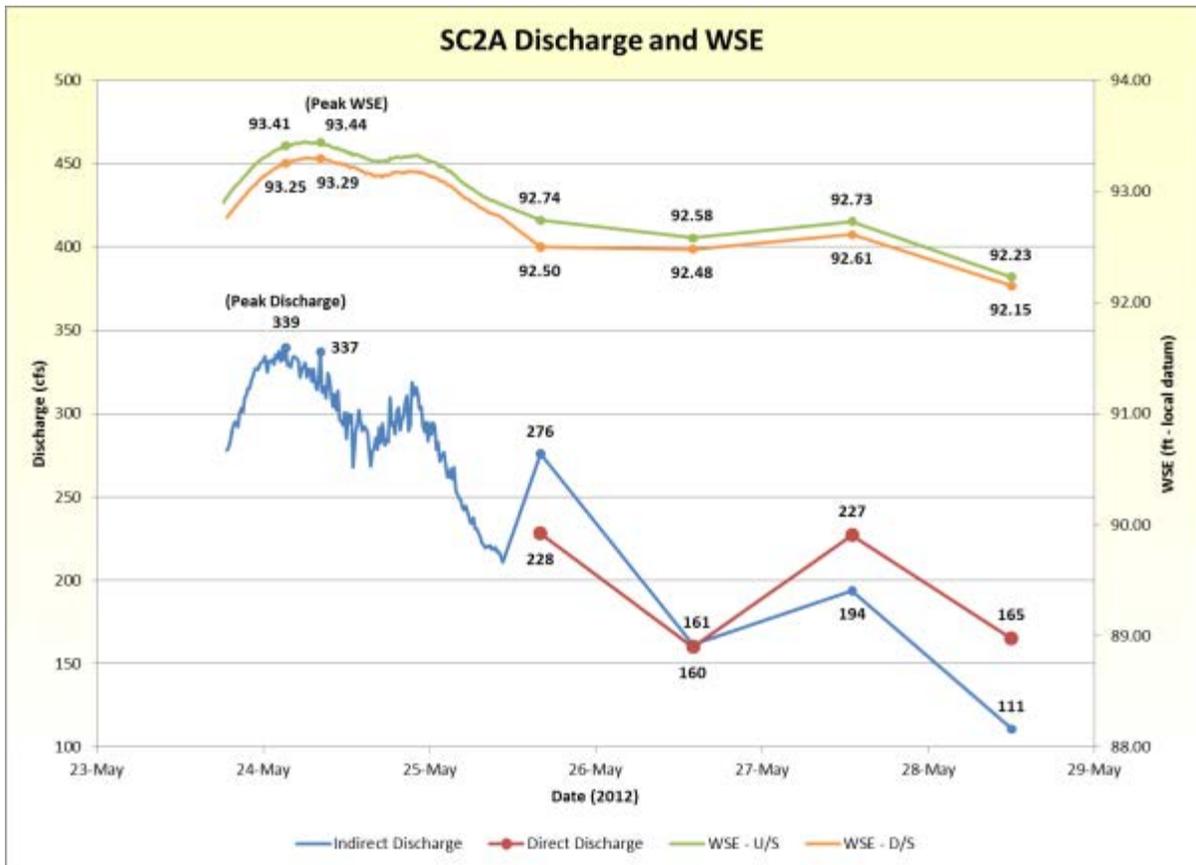
Channel geometry and roughness from direct discharge measurements on May 26 were used to calibrate the indirect discharge calculations. The May 26 direct discharge measurement was considered the most accurate based on flow conditions, including wind impacts. General agreement between the other direct discharge values and the indirect discharge values justifies using the May 26 calibration. Channel geometry, the presence of bottom-fast ice, and snow conditions along the banks remained relatively consistent through the monitoring period; therefore, the calibration was deemed applicable for all indirect discharge measurements. A comparison of direct and indirect discharge values and WSE at SC2A is shown in Graph 5.2.

Peak discharge at SC2A was calculated as 339 cfs, occurring on May 24.

GRAPH 5.2: SC2A DISCHARGE AND WSE

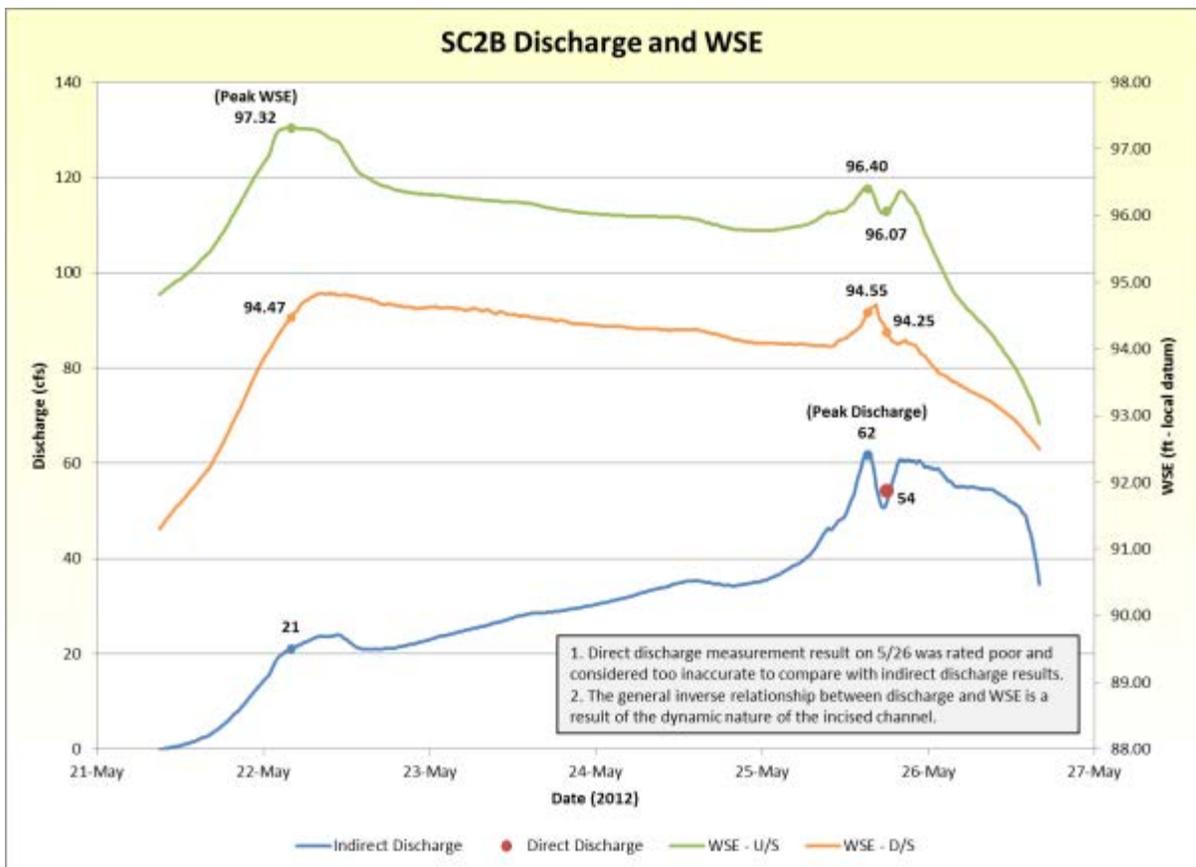
A comparison of direct and indirect discharge values at SC2B is shown in Graph 5.3. The dynamic nature of the incised channel at SC2B resulted in an inverse relationship between the discharge and the WSE. As snow melt progressed and discharge increased, the widening and deepening of the channel caused the WSE to decrease. The May 26 direct discharge measurement was considered too inaccurate to be included for comparison with indirect discharge results. The single velocity measurement in the widening channel resulted in an overestimate of discharge.

Peak discharge at SC2B was determined to be 62 cfs, occurring on May 25. This value was the result of indirect discharge computations based on coarse direct discharge measurements. It is presented as a first order approximation and should be evaluated in terms of conditions at the time of measurement.

GRAPH 5.3: SC2B DISCHARGE AND WSE

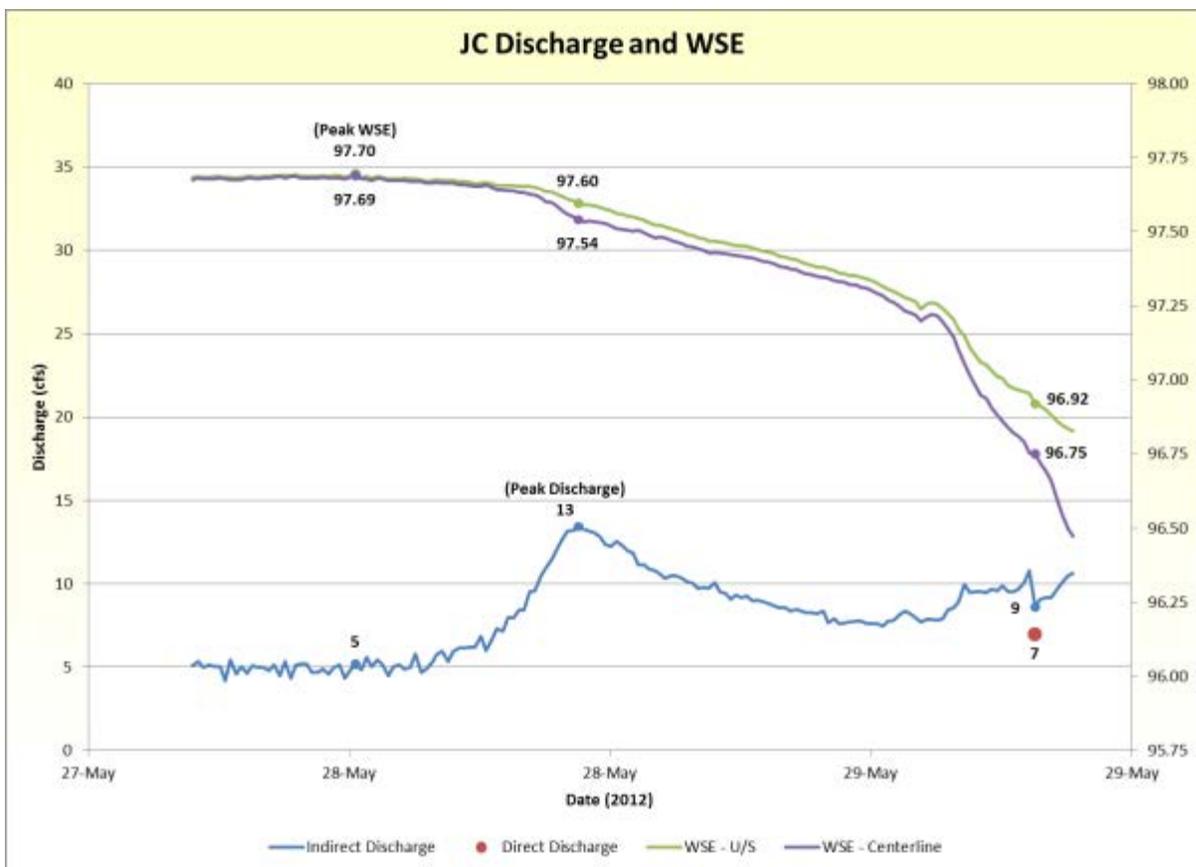
A comparison of direct and indirect discharge values and WSE at JC is shown in Graph 5.4. Peak discharge at JC was calculated as 13 cfs, occurring on May 28.

GRAPH 5.4: JC DISCHARGE AND WSE
