Noatak River Erosion Update

Site Visit: March 25th, 2015

6/10/2015

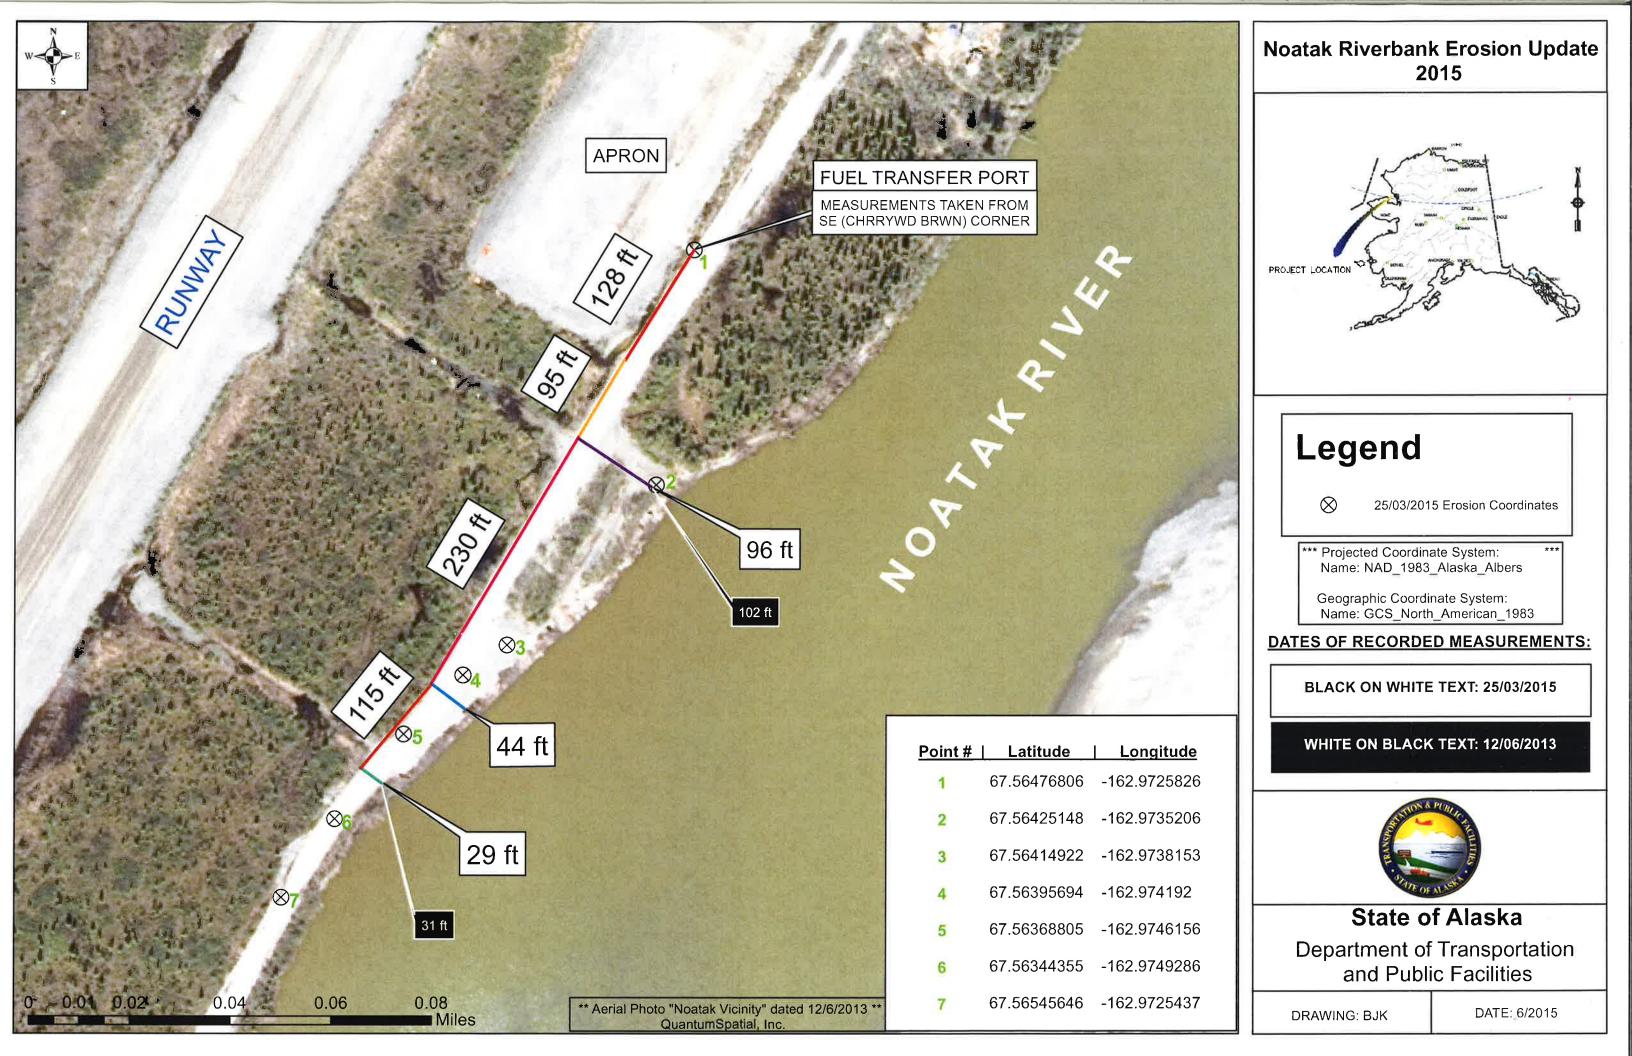
As shown in the graphic attached, there are two significant locations labeled in negatives (black and white) which display the total perpendicular distances of the far edge of haul road to the gravel pit to the edge of the eroding riverbank.

Distance (1) which was recorded in 2013 was taken at 102 feet. Distance (2) which was recorded in 2015 was taken at 96 feet. This two year interval indicates there is a loss of **6 feet** at this particular section of the haul road.

Distance (3) was also recorded in 2013 was taken at 31 feet. Distance (4) was recorded in 2015 was taken at 29 ft. This displays a loss of **2 feet** at this particular section of the haul road.

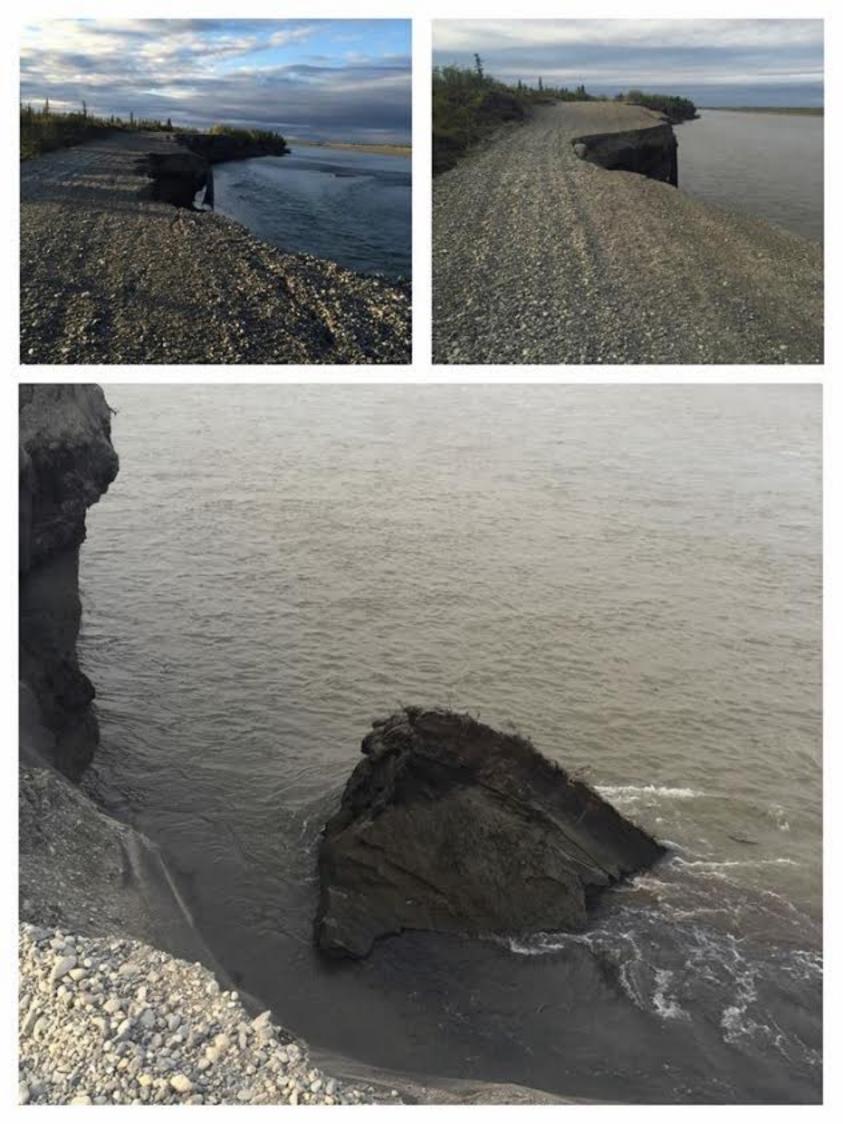
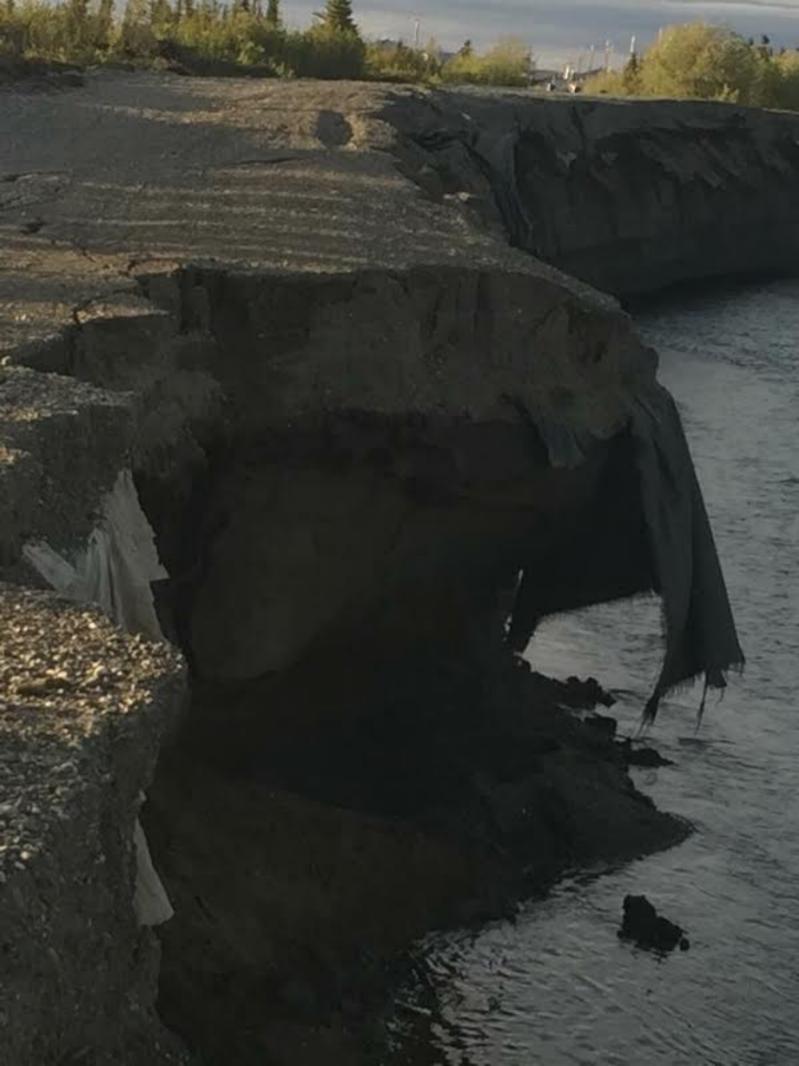
** The DOT&PF recently received notices as well as the provision of photos of the gravel cliff from residents of Noatak, displaying the aftermath of ice-breakup and the effects of the continually thawing and exposed active layer of permafrost.

Following the graphic of the erosion occurring is a few recent photos of the erosion from a community member, for the DOT&PF.
