FOUNDATION GEOLOGY REPORT

Parks Highway Milepost 237

Riley Creek Bridge Replacement No. 0695

June 2014

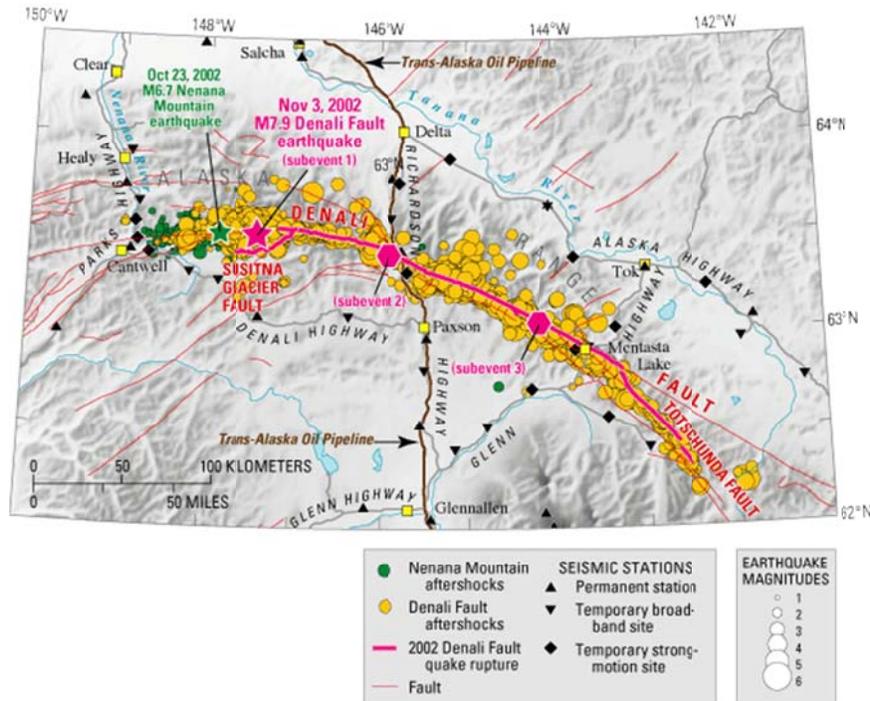
Figure 3: Denali Fault Earthquakes (Source - USGS)

The tectonically active Denali Fault lies approximately 19 miles south of the project site. The Denali Fault (right lateral strike-slip) is the fastest moving and most active fault in interior Alaska, slipping at a rate of 1/4" to 1/3" per year. A magnitude 7.9 earthquake ruptured the fault in November of 2002, representing interior Alaska's largest recorded event. This seismic event involved a complex series of sub-events summarized in the figure below.

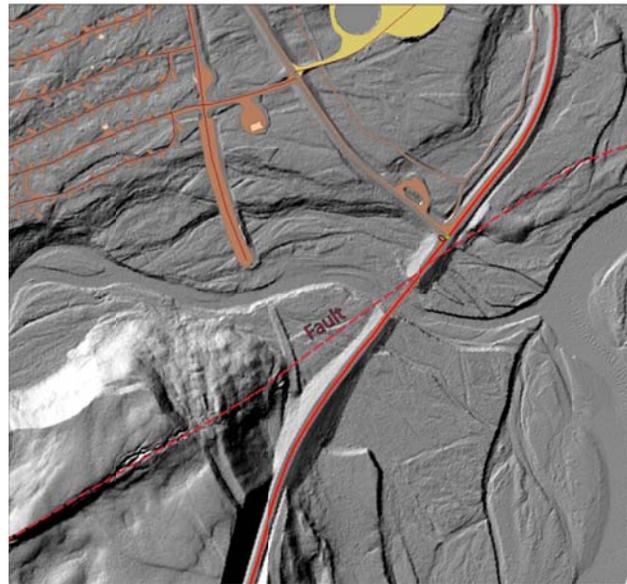
Figure 4 (fault location approximate)

Disparate sub-surface conditions observed in closely spaced test holes advanced through the proposed north abutment provide corroborating evidence that the Hines Creek Fault passes through the proposed bridge alignment (Figure 4). The reverse fault dips 84-87 degrees to the northwest and has recently been identified as active. This fault has been characterized by pure dip/slip displacement and does not exhibit any measureable lateral component. Based on this investigation and historical boring logs, the fault obliquely intersects the proposed bridge alignment between TH12-11 and TH12-12 extending to the west beneath the existing pier 2. For further information on the characteristics of the Hines Creek fault, refer to the attached reports.

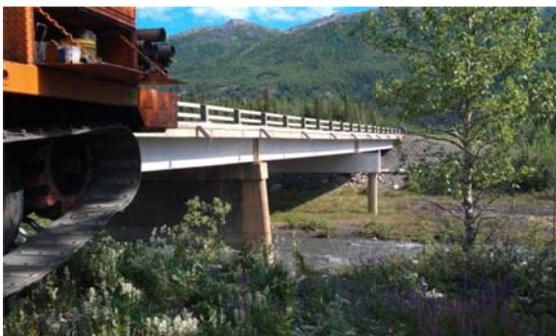
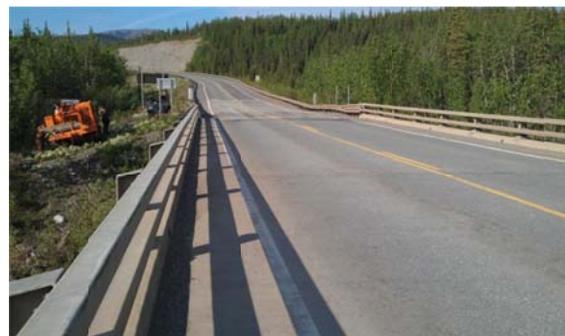
P12-02 Location

The presence of coarse sands and gravels containing cobbles and boulders in the upper 31 feet of test hole TH12-01 prevented the collection of valid SPT data and drilling proved very difficult. A dense gravel layer was encountered at 64 feet bgs, beneath 33 feet of cohesive and fine granular soils which damaged the casing shoe to the degree that we could not continue beyond 68 feet of depth. Penetrometer P12-02 met refusal at 60 feet bgs.

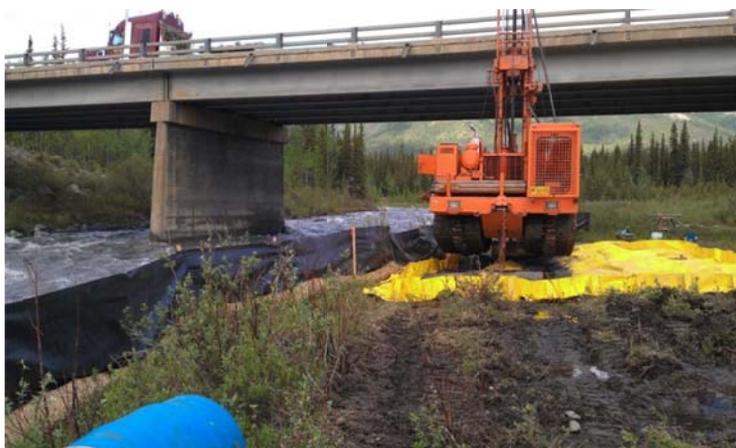
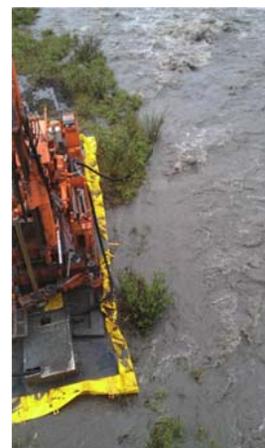
TH12-06 Site

Soils just ahead station from the proposed center pier are primarily stiff to hard cohesive soils overlain by 5 to 7.5 feet of course alluvial material. Penetrometer P12-07 met refusal at 72 feet bgs.

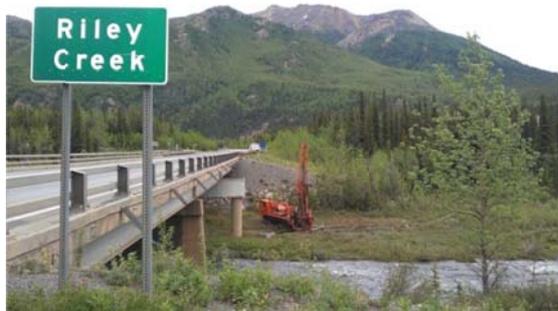
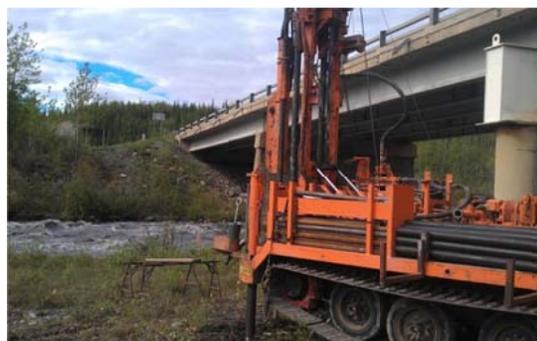
*P12-08 Site*

Soils at this site are primarily stiff to very stiff cohesive soils overlain by 5 to 6.5 coarse alluvial material containing organics. Note that the soils observed during this investigation portrays a significantly different soil profile than is indicated by historical data collected at the existing pier location (see Appendix D). These test holes are located within the fault zone and soil conditions may vary significantly over short horizontal distances. Penetrometer P12-08 met refusal at 78 feet bgs.

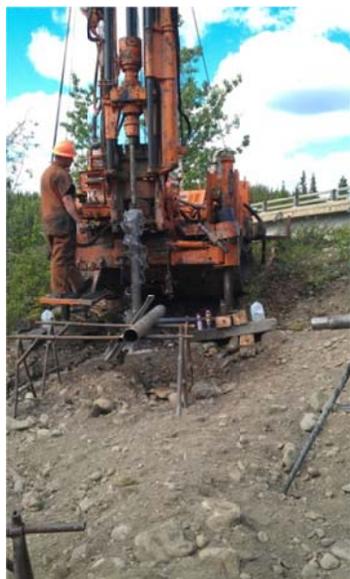
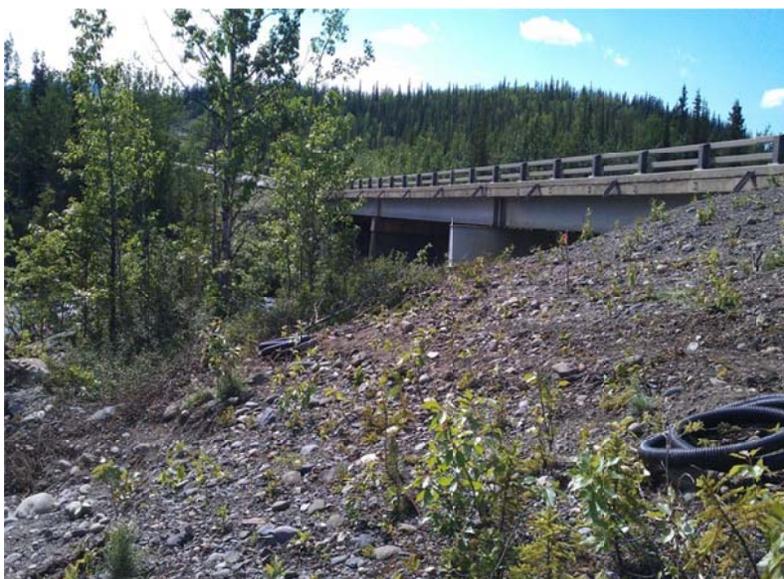
TH12-11 Site

The Hines Creek Fault intersects this proposed abutment structure. This is evident when comparing test hole TH12-11 with test hole TH12-12 (50 feet ahead station) and historical borings 3 and 9 beneath the existing north abutment (Appendix D). Very fine grained and cohesive soils extending to 103 feet bgs (bottom of test hole) were observed beneath the embankment material at TH12-11. In contrast, historical borings advanced beneath the existing abutment indicate coarse granular material beneath approximately 21 feet of clayey silt. The refusal depths of the two penetrometers advanced adjacent to TH12-11 may indicate that conditions at these locations correspond with soil profiles seen in TH12-12 and the historical borings 3 and 9. Penetrometer P12-10 and P12-13 met refusal at 45 and 53 feet, respectively, which roughly corresponds with denser, granular soils observed in test holes on the north side of the fault (project left).

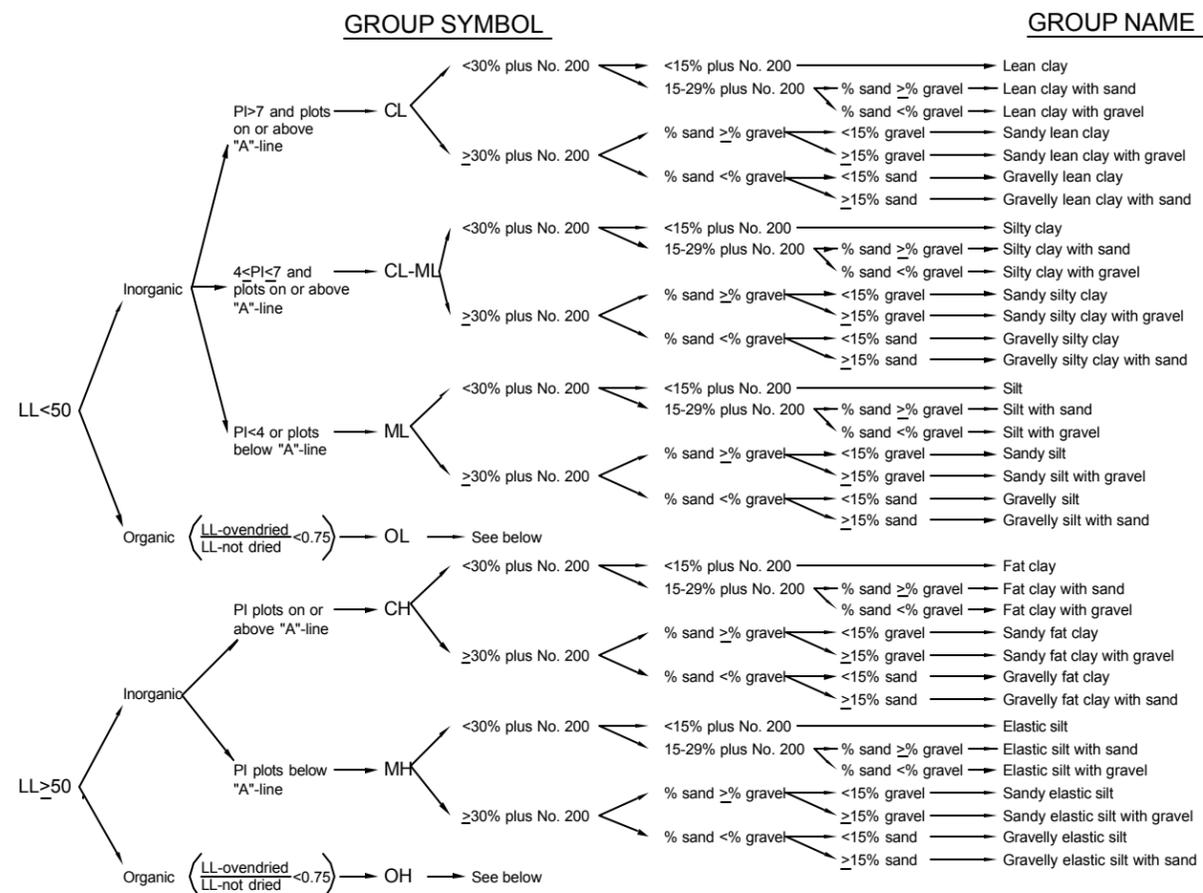
Figure 1: Flow Chart for Classifying Fine-Grained Soil (50% or More Passes No. 200 Sieve)

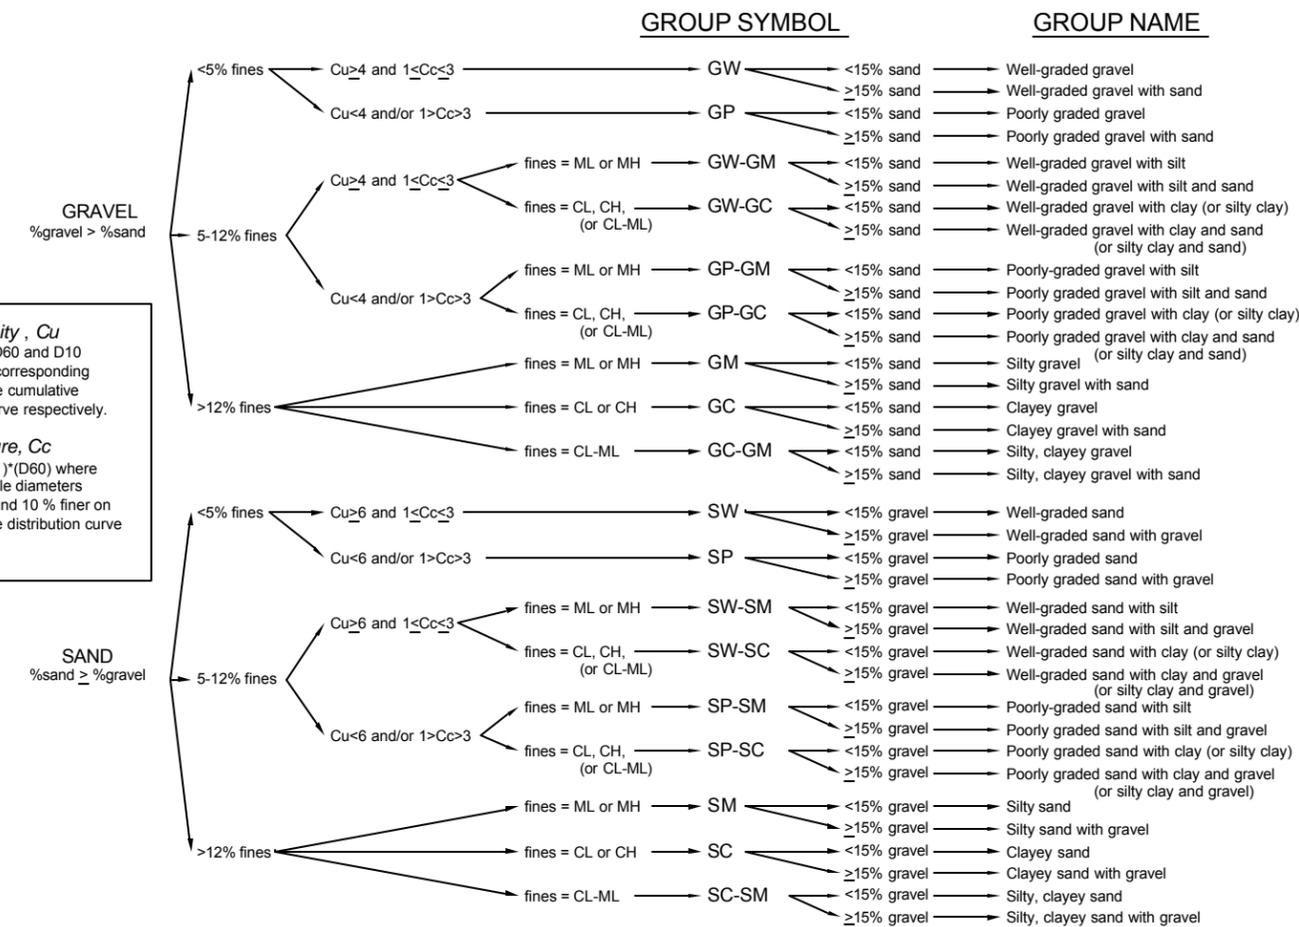
Figure 3: Flow Chart for Classifying Coarse-Grained Soil (More Than 50% Retained on No. 200 Sieve)

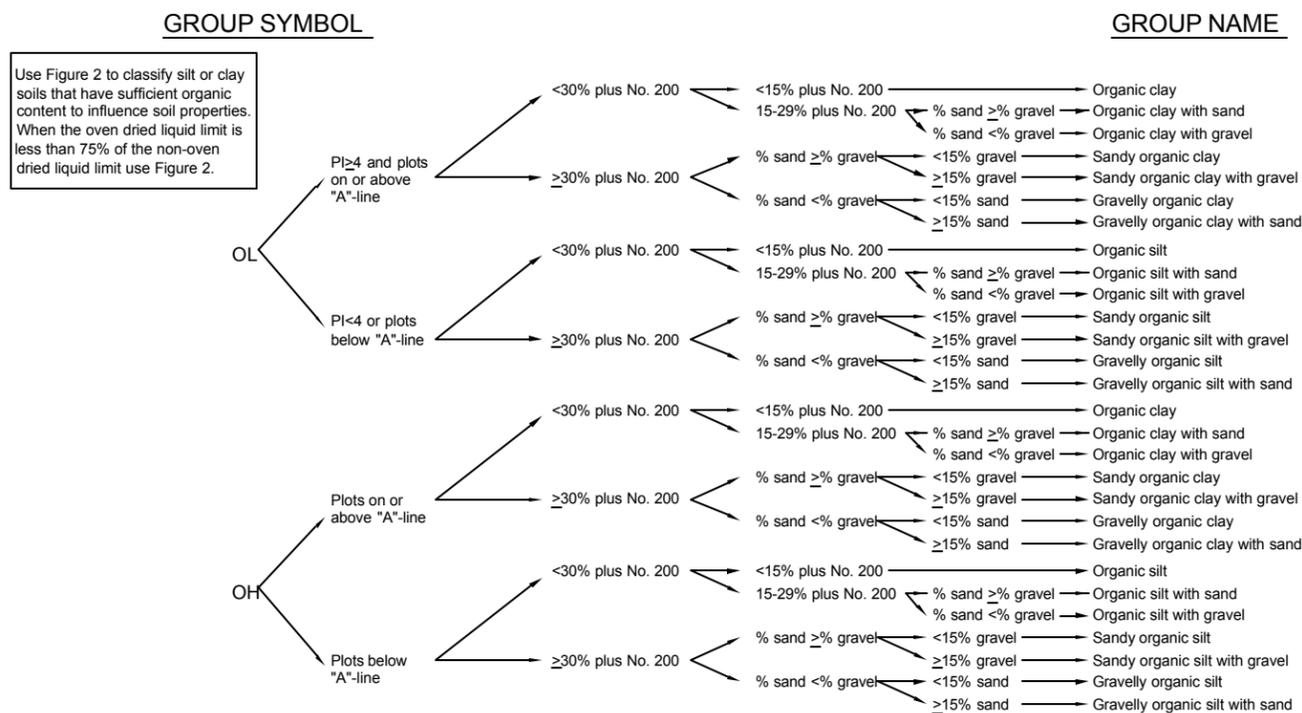
Figure 2: Flow Chart for Classifying Organic Fine-Grained Soil (50% or More Passes No. 200 Sieve)

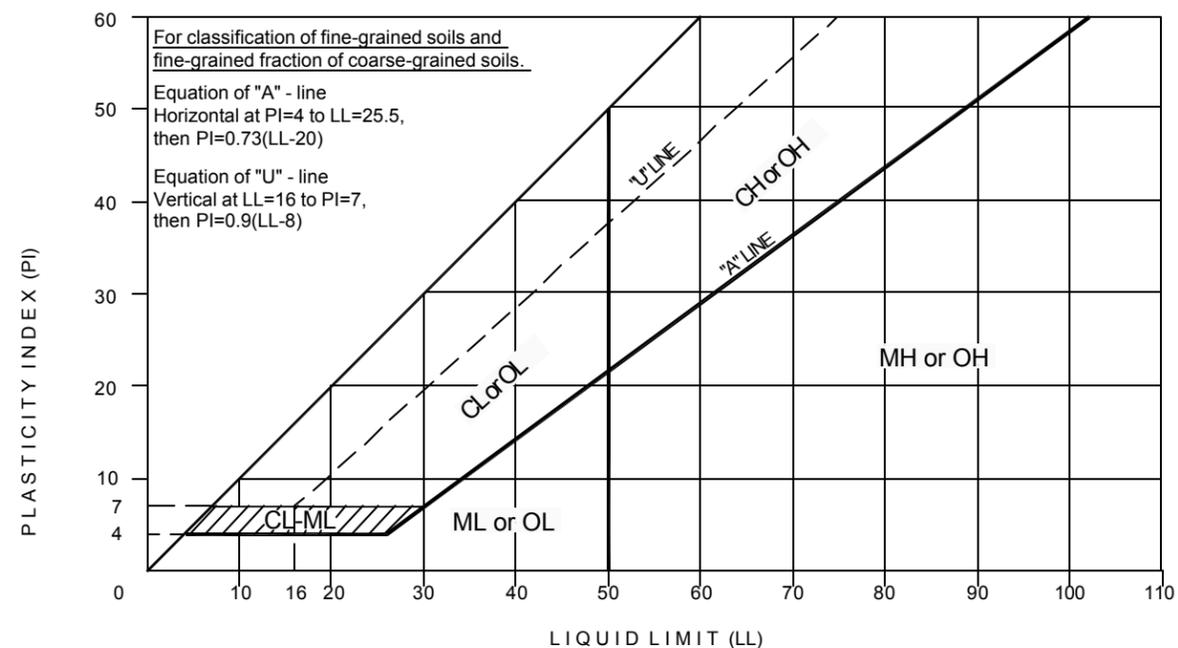
Figure 4: Plasticity Chart

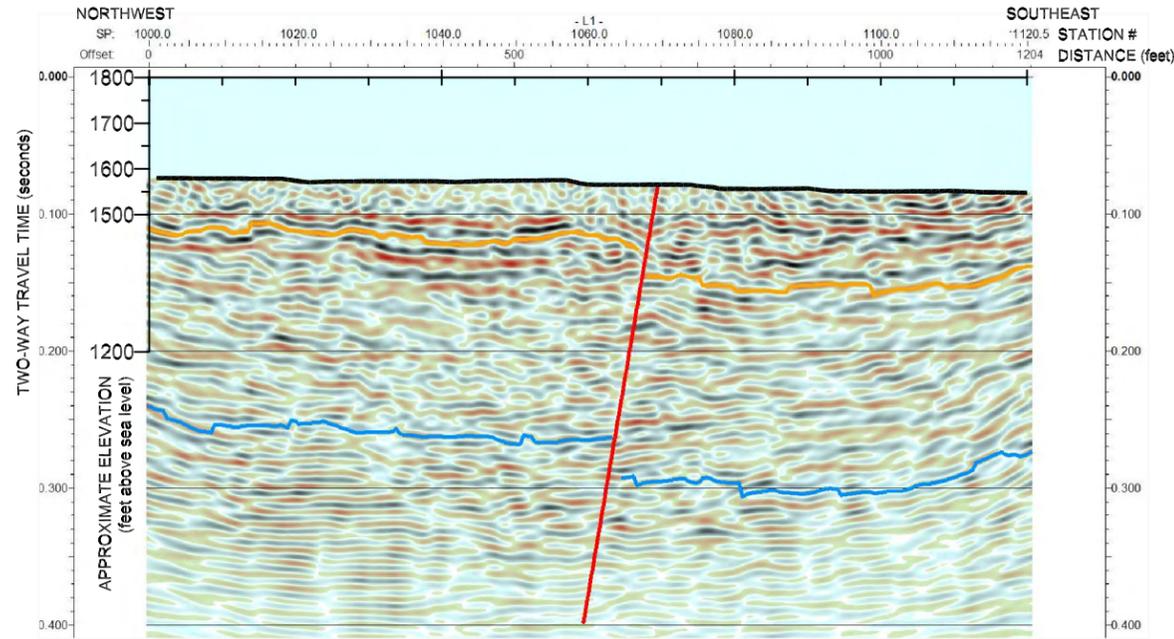
LINE SL1: INTERPRETED MIGRATED SECTION

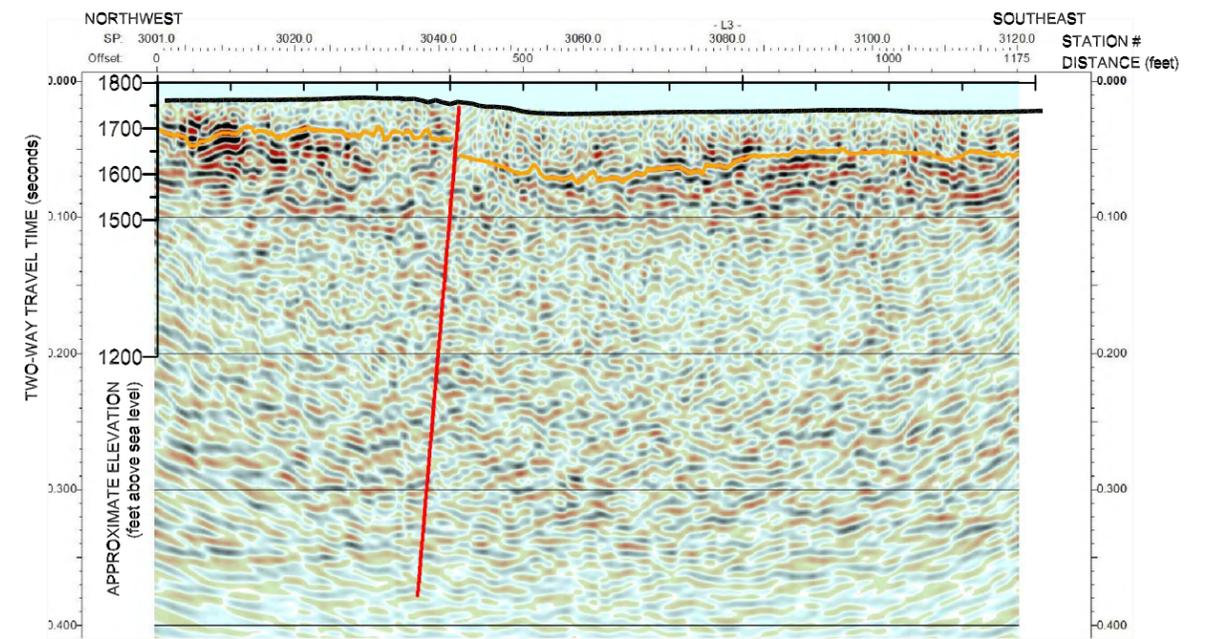
LINE SL3: INTERPRETED SEISMIC SECTION

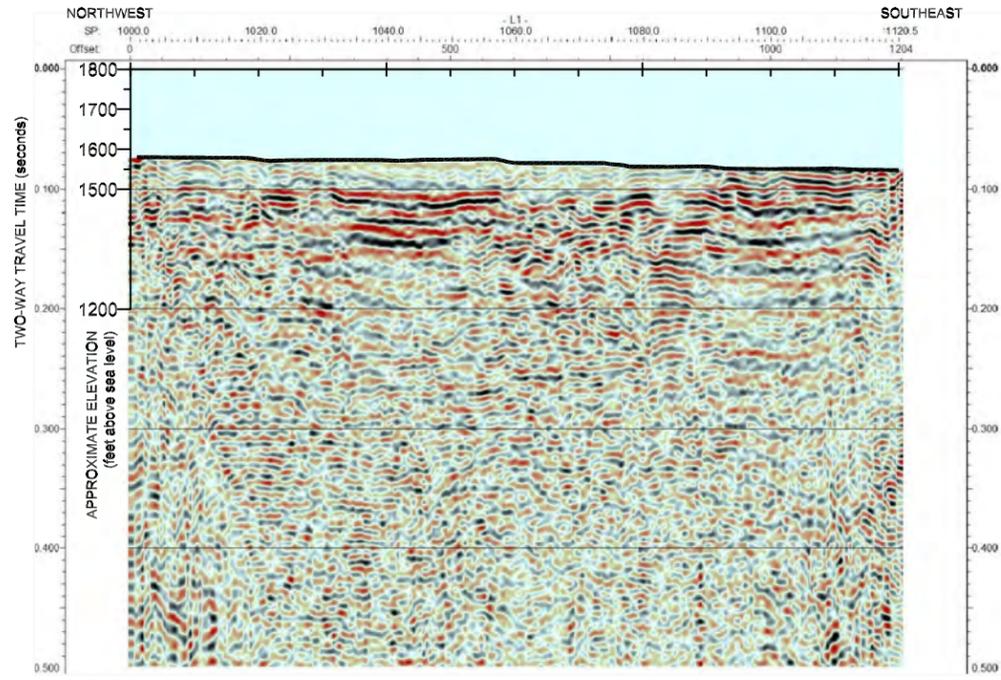
LINE SL1: FINAL STACKED SECTION

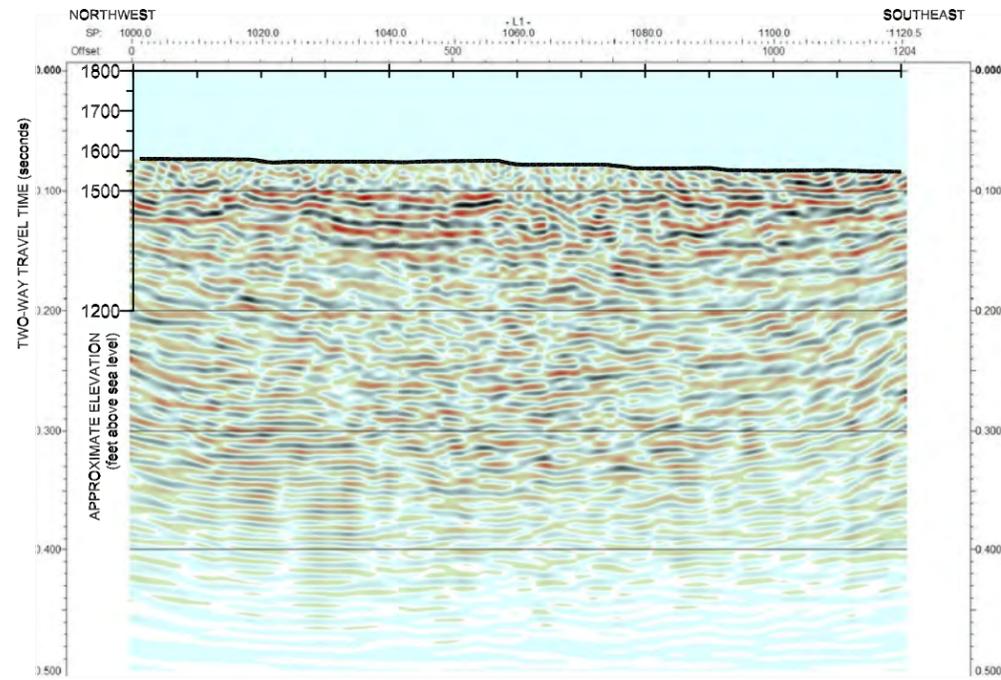
LINE SL1: MIGRATED SECTION

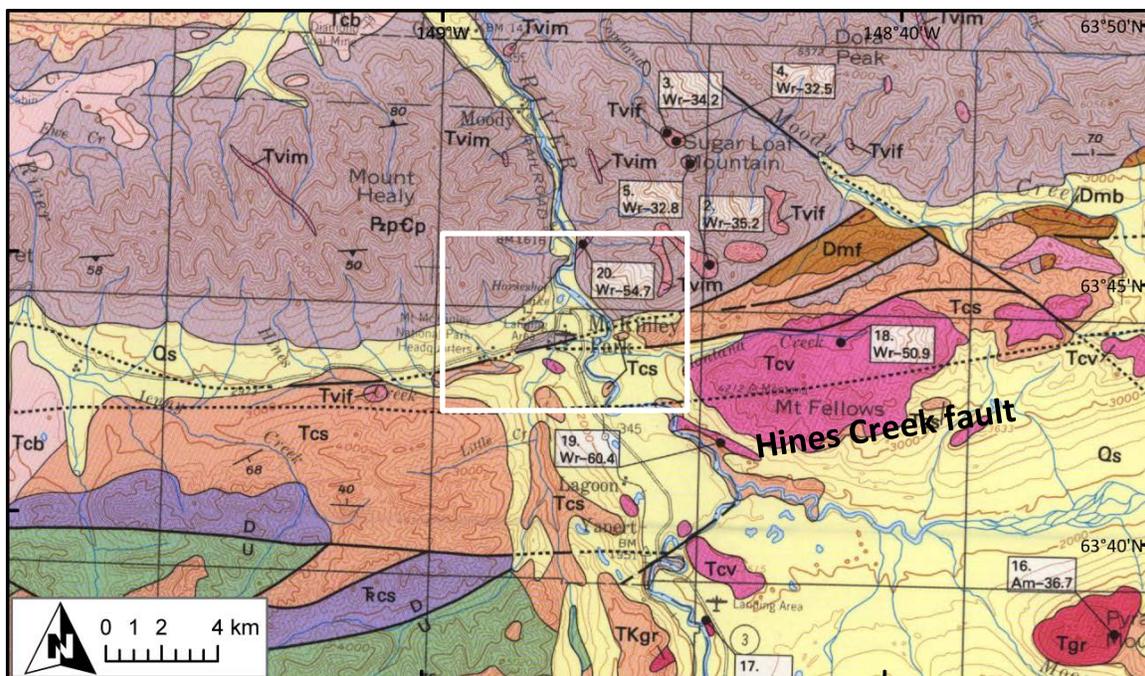
Figure 1. Geologic map of the Hines Creek fault/Riley Creek area excerpted from Csejtey et al. (1992). The white box illustrates the map areas of Figure 2. Note that this map depicts the Hines Creek fault as concealed across the entire region and as a separate fault from those identified as the Hines Creek fault by previous studies.

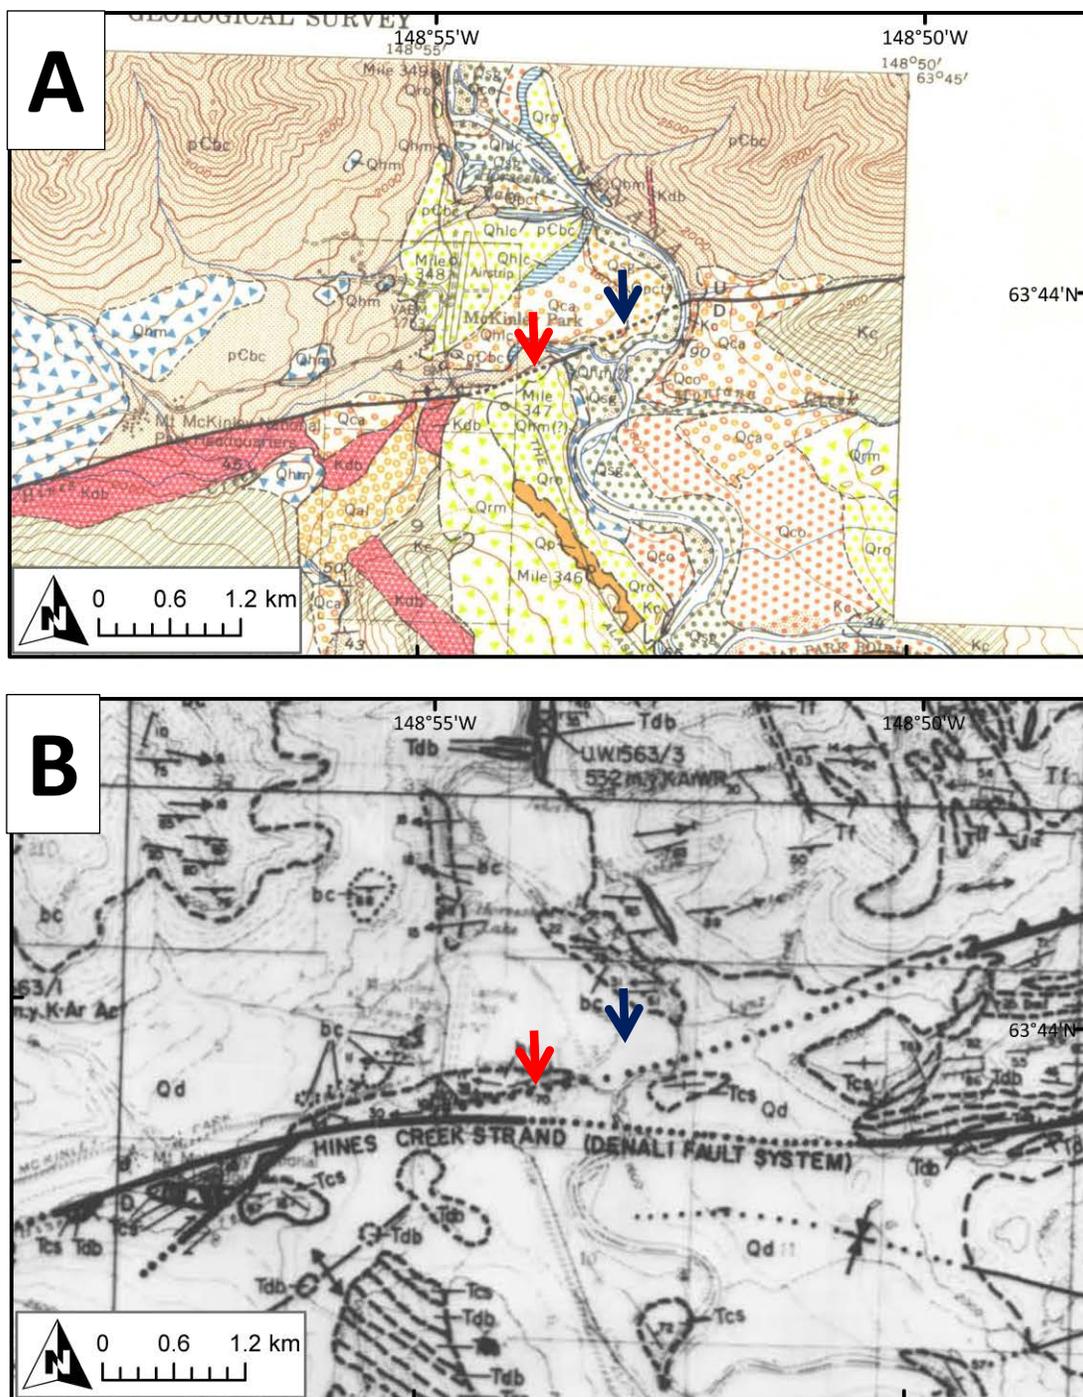
Figure 2. Excerpts of geologic maps from A) Wahrhaftig (1958) and B) Sherwood and Craddock (1979). The white box on Figure 1 illustrates the location of these two maps where the Hines Creek fault crosses the Nenana River. The solitary fault on (A) is the Hines Creek fault, and is depicted as locally offsetting late Quaternary geologic units as well as juxtaposing Cretaceous against Precambrian metamorphic rocks. The Hines Creek "Strand" shown on (B) follows an identical trace to the west, but to the east they connect the Hines Creek fault to a different fault with a more southerly trace. The blue and red arrows denote Sites A and B from this study, respectively.

The published geologic mapping of the Hines Creek fault in the vicinity of the Nenana River presents a complicated range of interpretations for the trace of the fault. As the most recent published geologic map of this region, the 1:250,000 Healy quadrangle geologic map (Csejtey et al., 1992) includes the previously mapped fault traces and introduces a new interpretation of the trace of the Hines Creek fault (Figure 1). Previous geologic maps by Wahrhaftig (1958) and Sherwood and Craddock (1979) depict similar traces for the Hines Creek fault to the west of the Nenana River, but these fault traces diverge significantly to the east (Figure 2). Both Wahrhaftig (1958) and Sherwood and Craddock (1979) map the Hines Creek fault as offsetting the late Cretaceous to Paleogene Cantwell Formation, but only Wahrhaftig (1958) clearly indicates that this fault is visible within late Quaternary deposits (Figure 2).

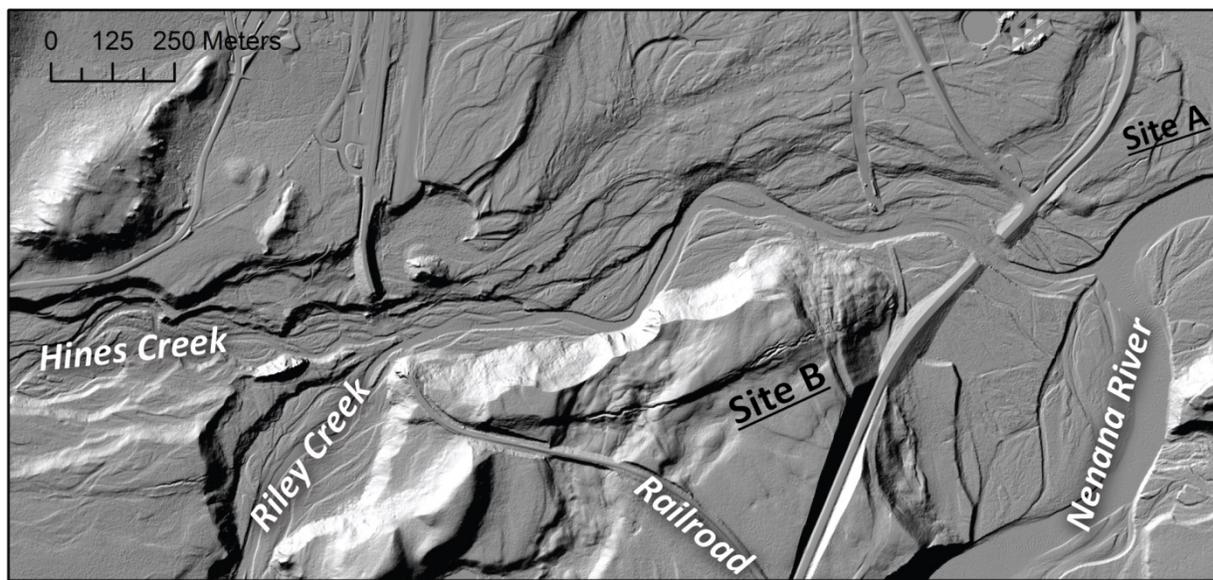
Figure 3. Shaded-relief LiDAR-derived topography of the Hines Creek fault near the Nenana River. Site A and B are the locations of our focused paleoseismic studies.

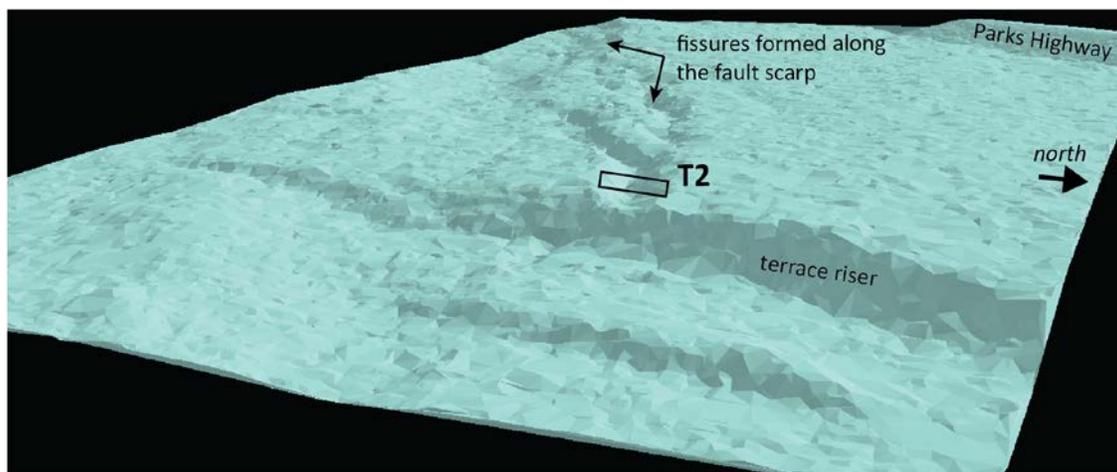
Figure 4. Oblique, southwest-looking view along the Hines Creek fault and paleoseismic Site A. The location of trench 2 is illustrated by the black rectangle, at a site chosen because the deformation of the scarp surface appears to be concentrated along a single fissure. Photomosaics and interpreted trench logs are presented in Appendix B. Base data is a full resolution shaded-relief of a TIN surface constructed from the ground-classified LiDAR point cloud.

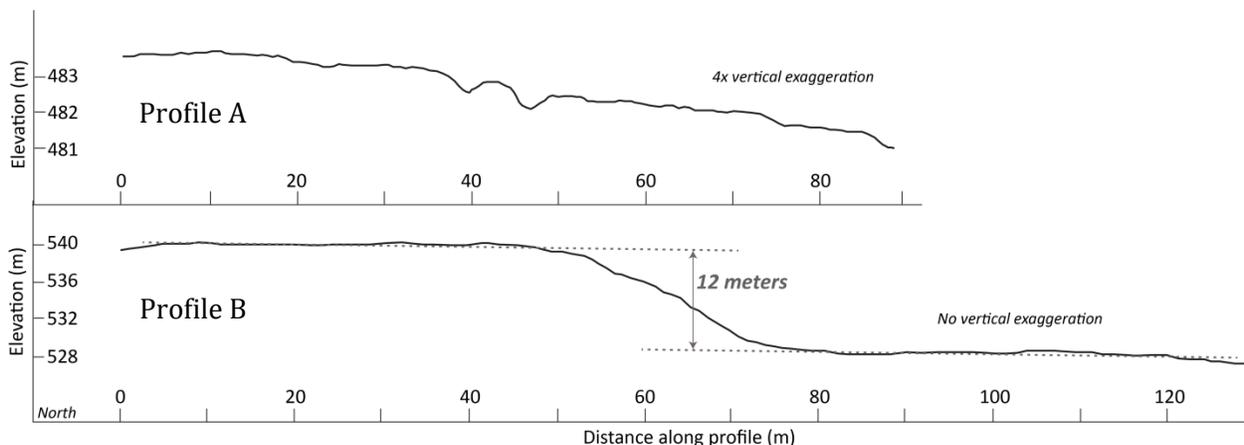
Figure 5. Topographic profiles across the Hines Creek fault scarp. Profile A, from the lower terrace east of the Parks Highway (Figure 7), crosses a potentially complex surface that may have experienced some deposition and erosion during the formation of the fault scarp, and thus direct measurement of vertical offset is uncertain. Profile B, from the high terrace west of the Parks Highway (Figure 7), has a clear 12 m offset of the terrace surface, and the parallel surface on either side supports our interpretation that surface offset during earthquakes is concentrated across the narrow fault scarp zone.

The long-term rate of movement across the Hines Creek fault in the study area is determined from the cumulative offset of the latest Pleistocene outwash surface (Figures 5 and 6) across the fault. This long-term slip rate averages the near-instantaneous relative motion during earthquakes with the long interseismic periods and serves as a proxy for the far-field tectonic loading rate for this fault. We did not determine any new age constraints for this surface, but based upon the close proximity to glacial moraine deposits associated with the Riley Creek glacial advance (Marine Isotope Stage 2), we can establish reasonable limits on the surface age. Surface exposure ages of the next younger glacial advance along the Nenana River valley indicate that the absolute minimum age for this surface is ~16 ka (Dortch et al., 2010), whereas the maximum age is provided by the correlation with the initiation of the global cooling trend. However, we suggest that the global maximum ice volume at ~20-22 ka is a more likely maximum age, because this upper terrace surface represents a proximal outwash surface that formed as the glaciers began to retreat from their maximum extent. With a cumulative offset of this terrace surface across the Hines Creek fault of ~12 m (Figure 5), the late Quaternary slip rate for this fault is ~0.6 mm/yr.

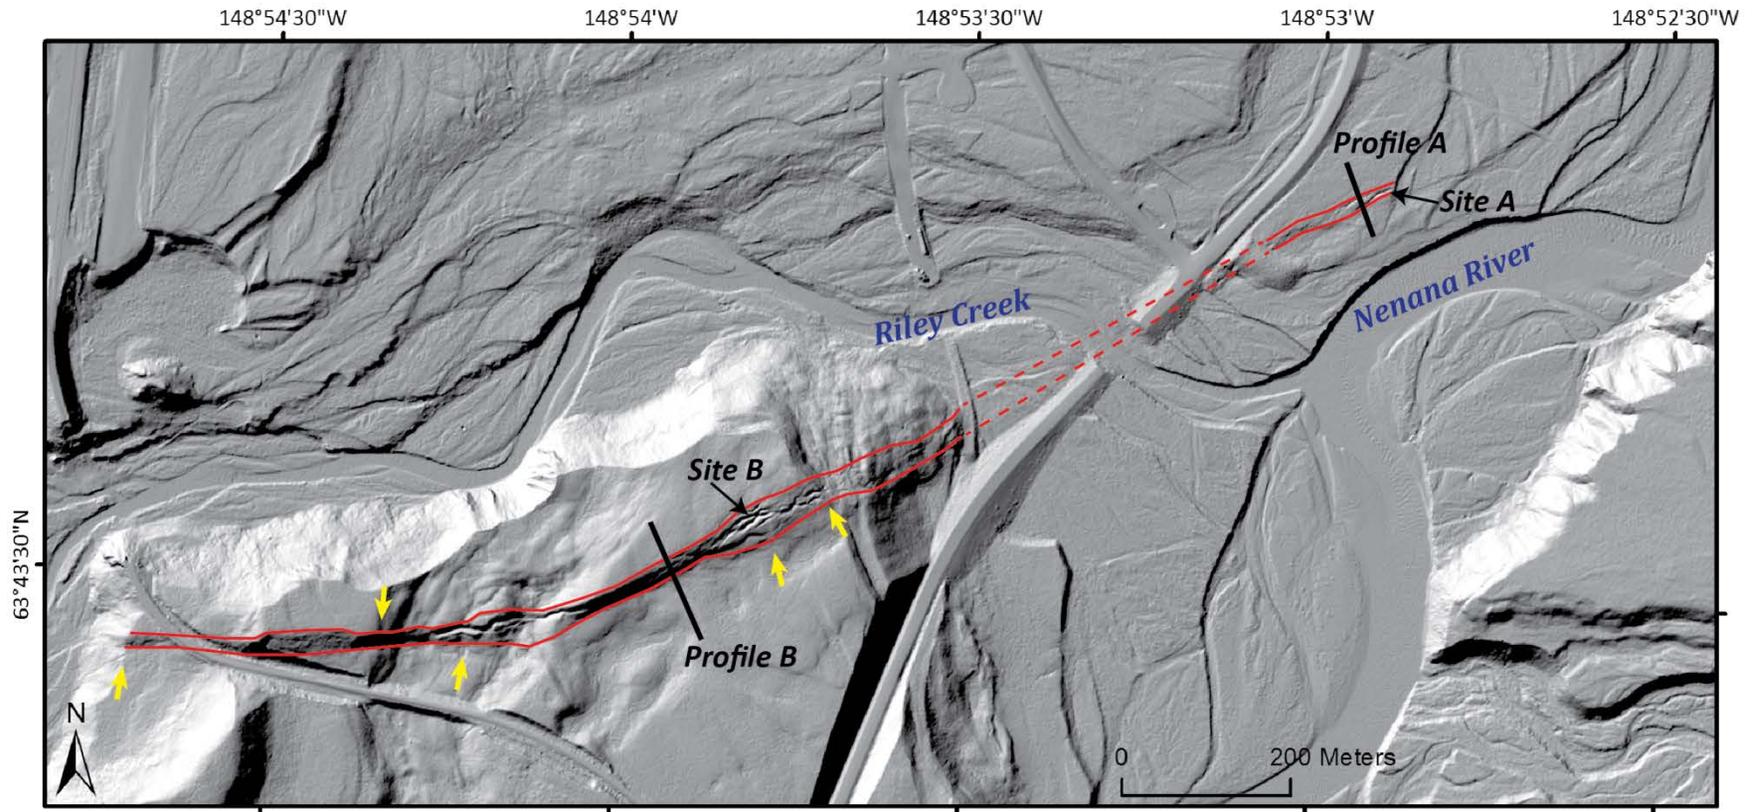
Figure 7. High-resolution shaded-relief topography of the Hines Creek fault scarp across the upper terrace surface west of the Parks Highway and low terraces to the east. Yellow arrows highlight some of the linear geomorphic features that project across the fault scarp without displaying lateral offset, demonstrating this fault is purely dip-slip since the late Pleistocene. The solid red lines depict the width of the primary deformed zone along the fault scarp- essentially where discrete offset is concentrated during earthquakes. Topographic profiles in Figure 5 are shown as Profile A and B, with nearby paleoseismic sites A and B shown for reference.

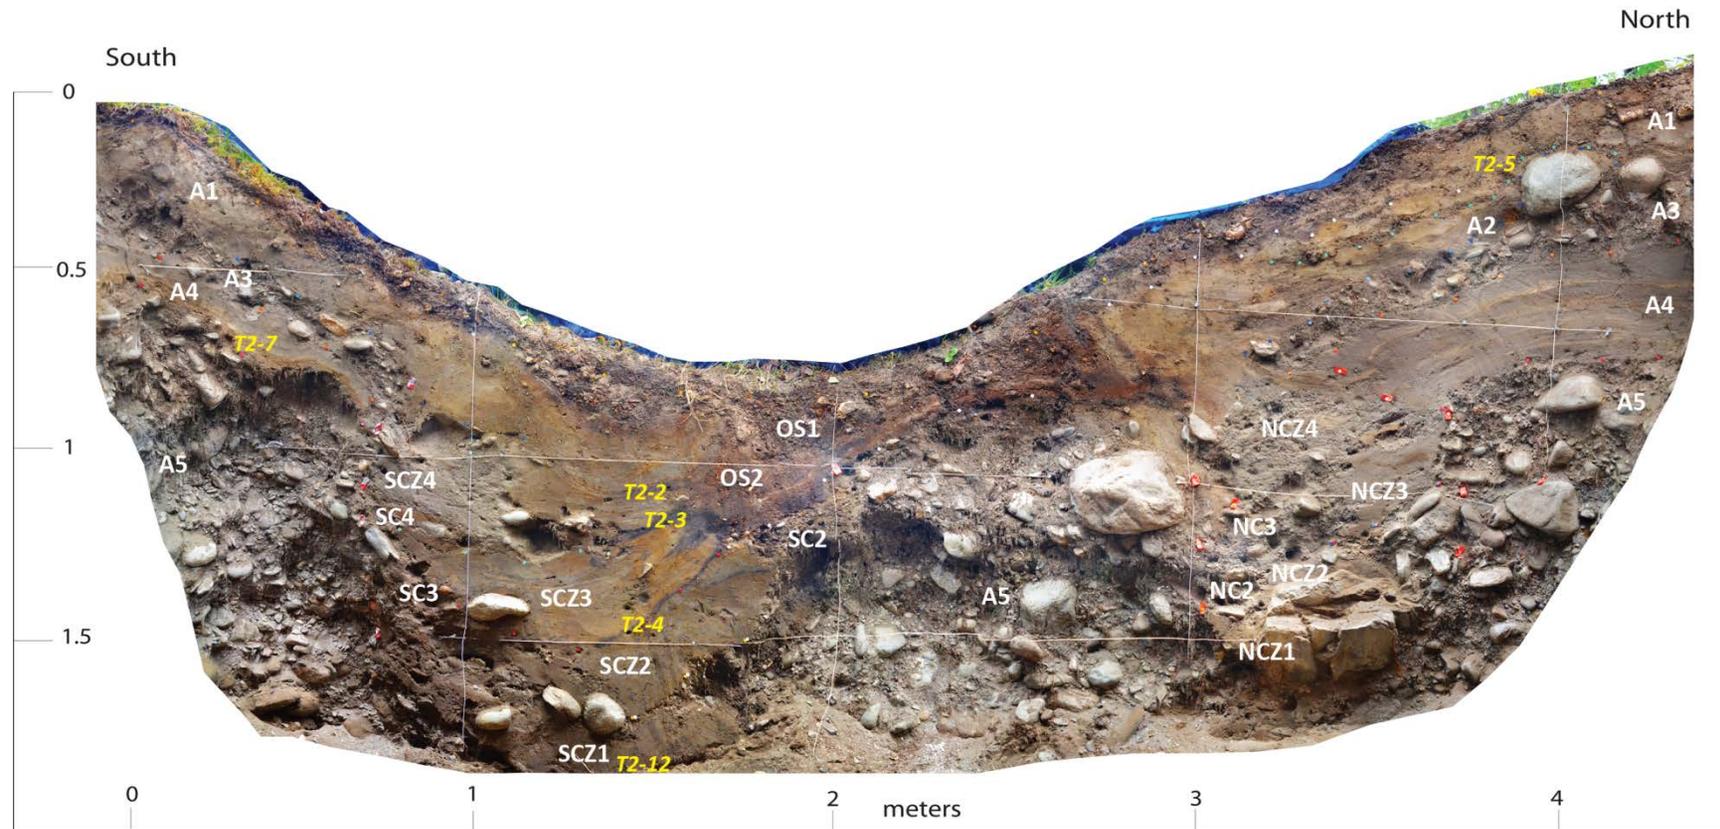
Figure B1. Photomosaic of the east wall of trench 2 (Site A) across the Hines Creek fault, reversed to imitate the same orientation of the west wall (Figures B3 and B4). White labels define lithostratigraphic units (unit descriptions in Table B1) and yellow labels identify locations of dated radiocarbon samples (age data in Table A1).

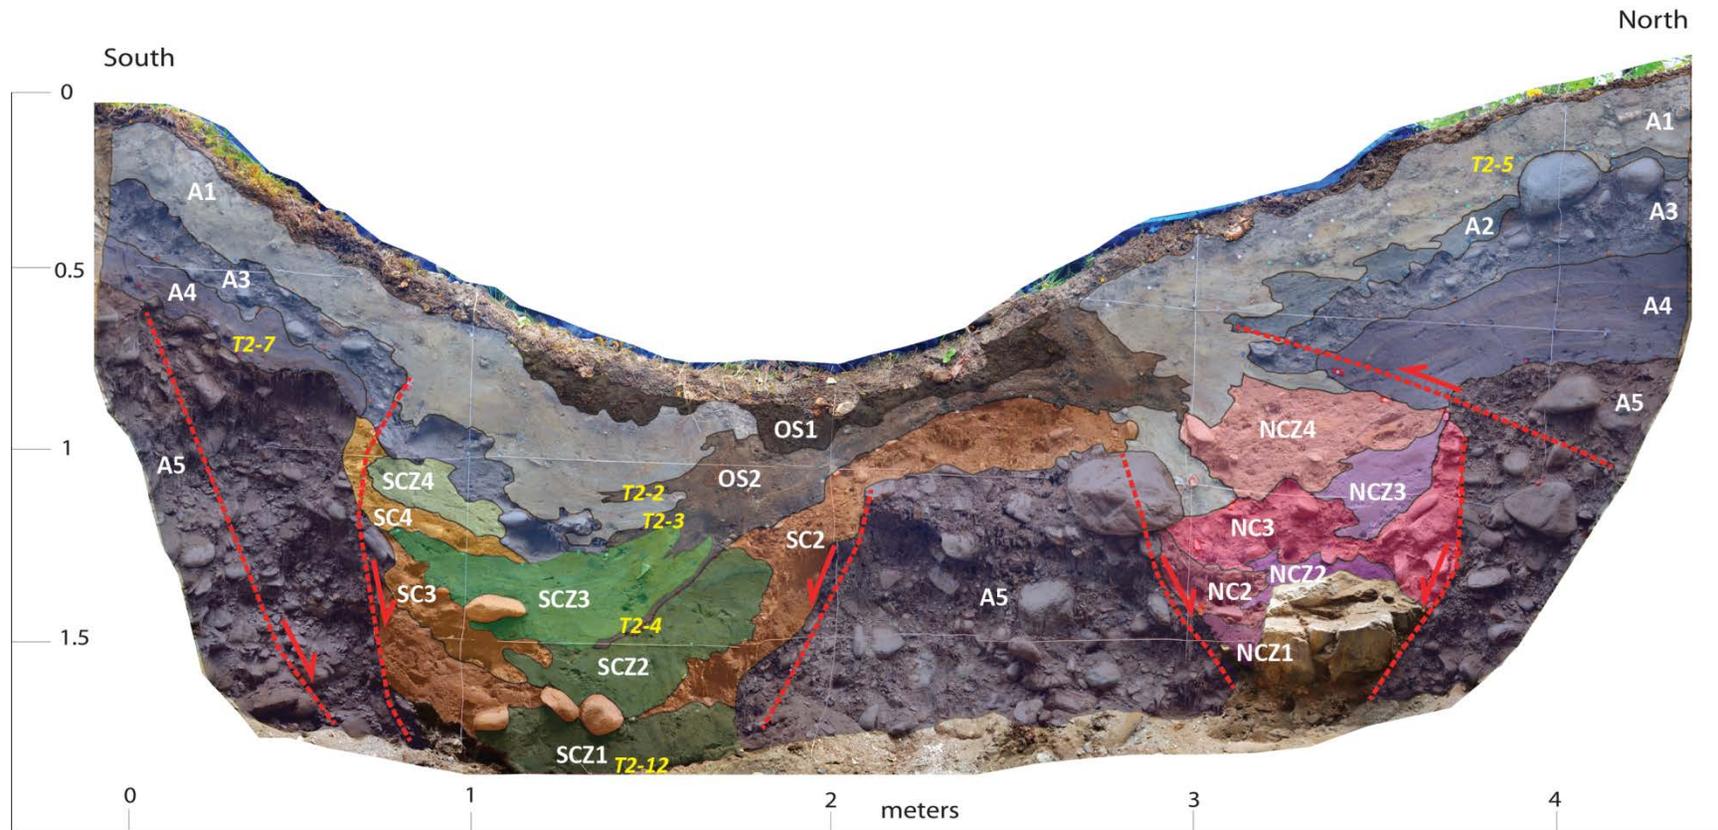
Figure B2. Photomosaic and trench log of the east wall of trench 2 (Site A) across the Hines Creek fault, reversed to imitate the same orientation of the west wall (Figures B3 and B4). Transparent overlay illustrates the interpretation of geologic units and deformation preserved within the trench stratigraphy. All labels in the same position at Figure B1. Red lines indicate locations of faults and shear zones, and arrows depict relative displacement. Much of the discrete displacement in the stratigraphy appears to have occurred as distributed zones of sheared and rotated gravel.

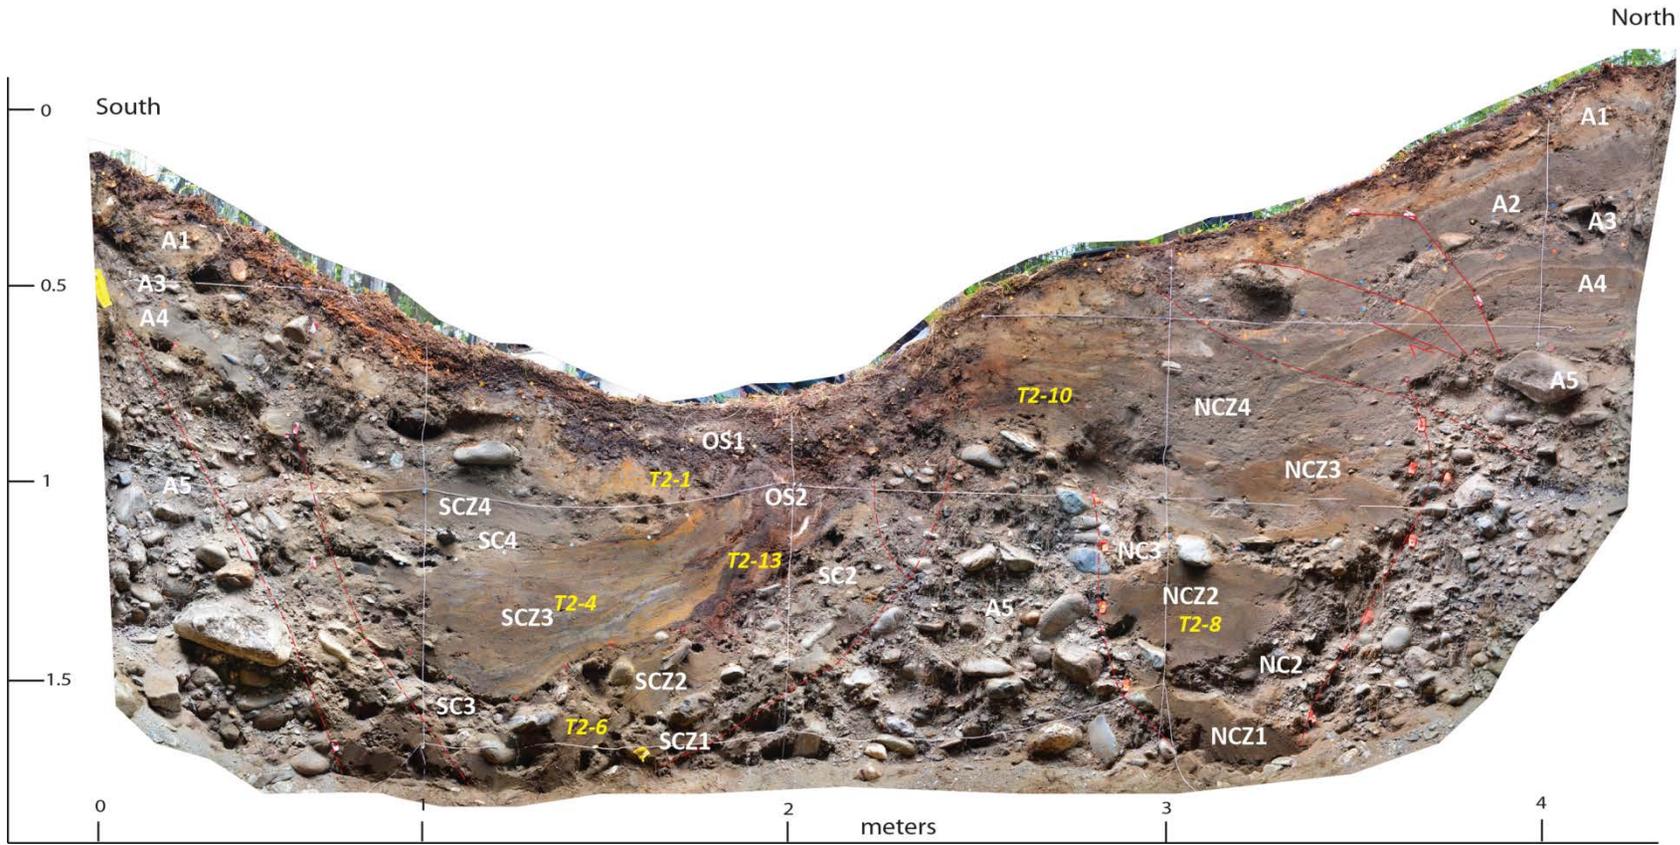
Figure B3. Photomosaic of the west wall of trench 2 (Site A) across the Hines Creek fault. White labels define lithostratigraphic units (unit descriptions in Table B1) and yellow labels identify locations of dated radiocarbon samples (age data in Table A1).
