FOUNDATION GEOLOGY REPORT

Parks Highway Milepost 237

Riley Creek Bridge Replacement No. 0695

June 2014

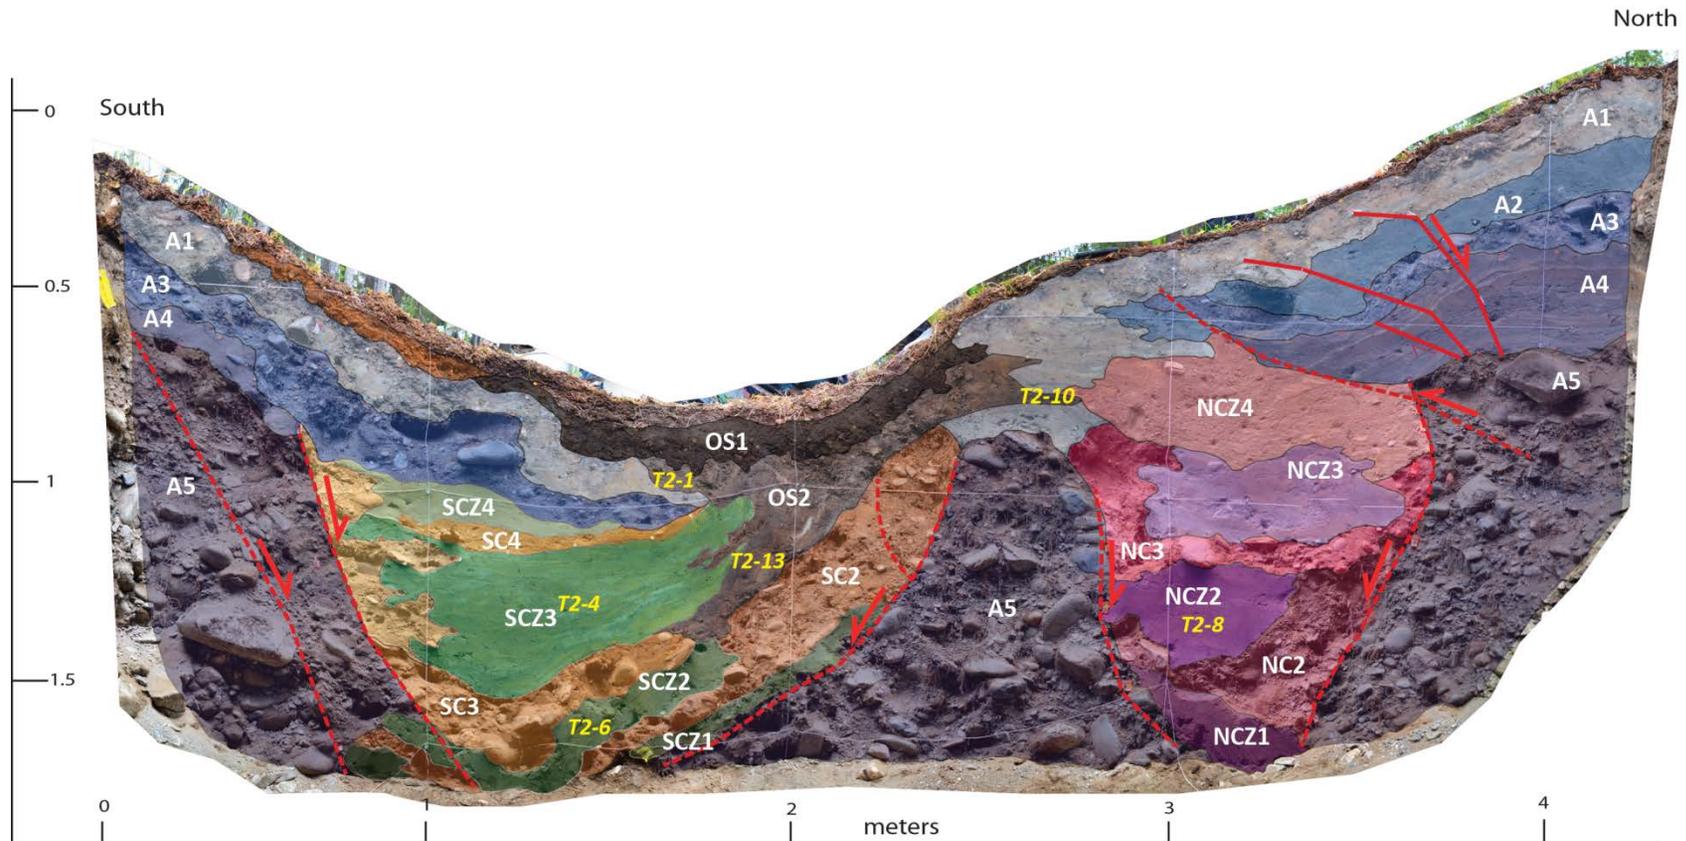
Figure B4. Photomosaic and trench log of the west wall of trench 2 (Site A) across the Hines Creek fault. Transparent overlay illustrates the interpretation of geologic units and deformation preserved within the trench stratigraphy. All labels in the same position at Figure B3. Red lines indicate locations of faults and shear zones, and arrows depict relative displacement. Much of the discrete displacement in the stratigraphy appears to have occurred as distributed zones of sheared and rotated gravel.

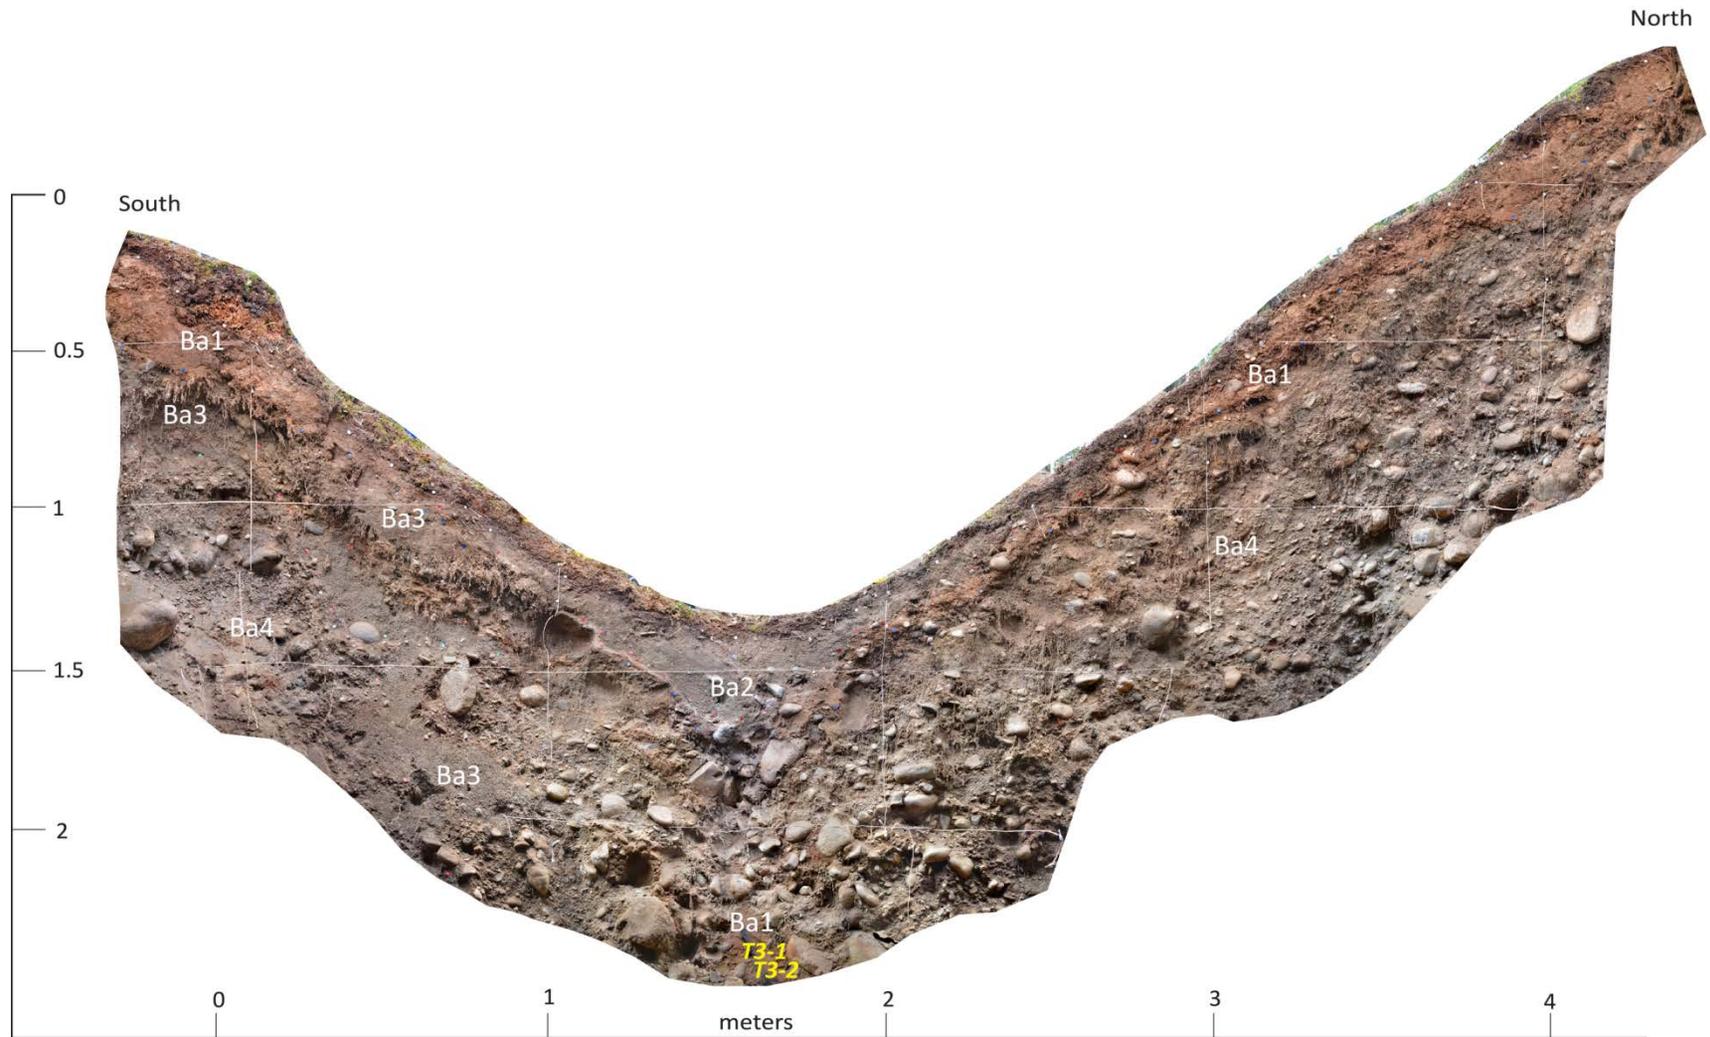
Figure B5. Photomosaic of the west wall of trench 3 (Site B) across a portion of the Hines Creek fault scarp. White labels define lithostratigraphic units (unit descriptions in Table B1) and yellow labels identify locations of dated radiocarbon samples (age data in Table A1). The significantly lower proportion of fine-grained deposits in this trench relative to trench 2 provides fewer stratigraphic markers for use in the interpretation of the structure and deformation.

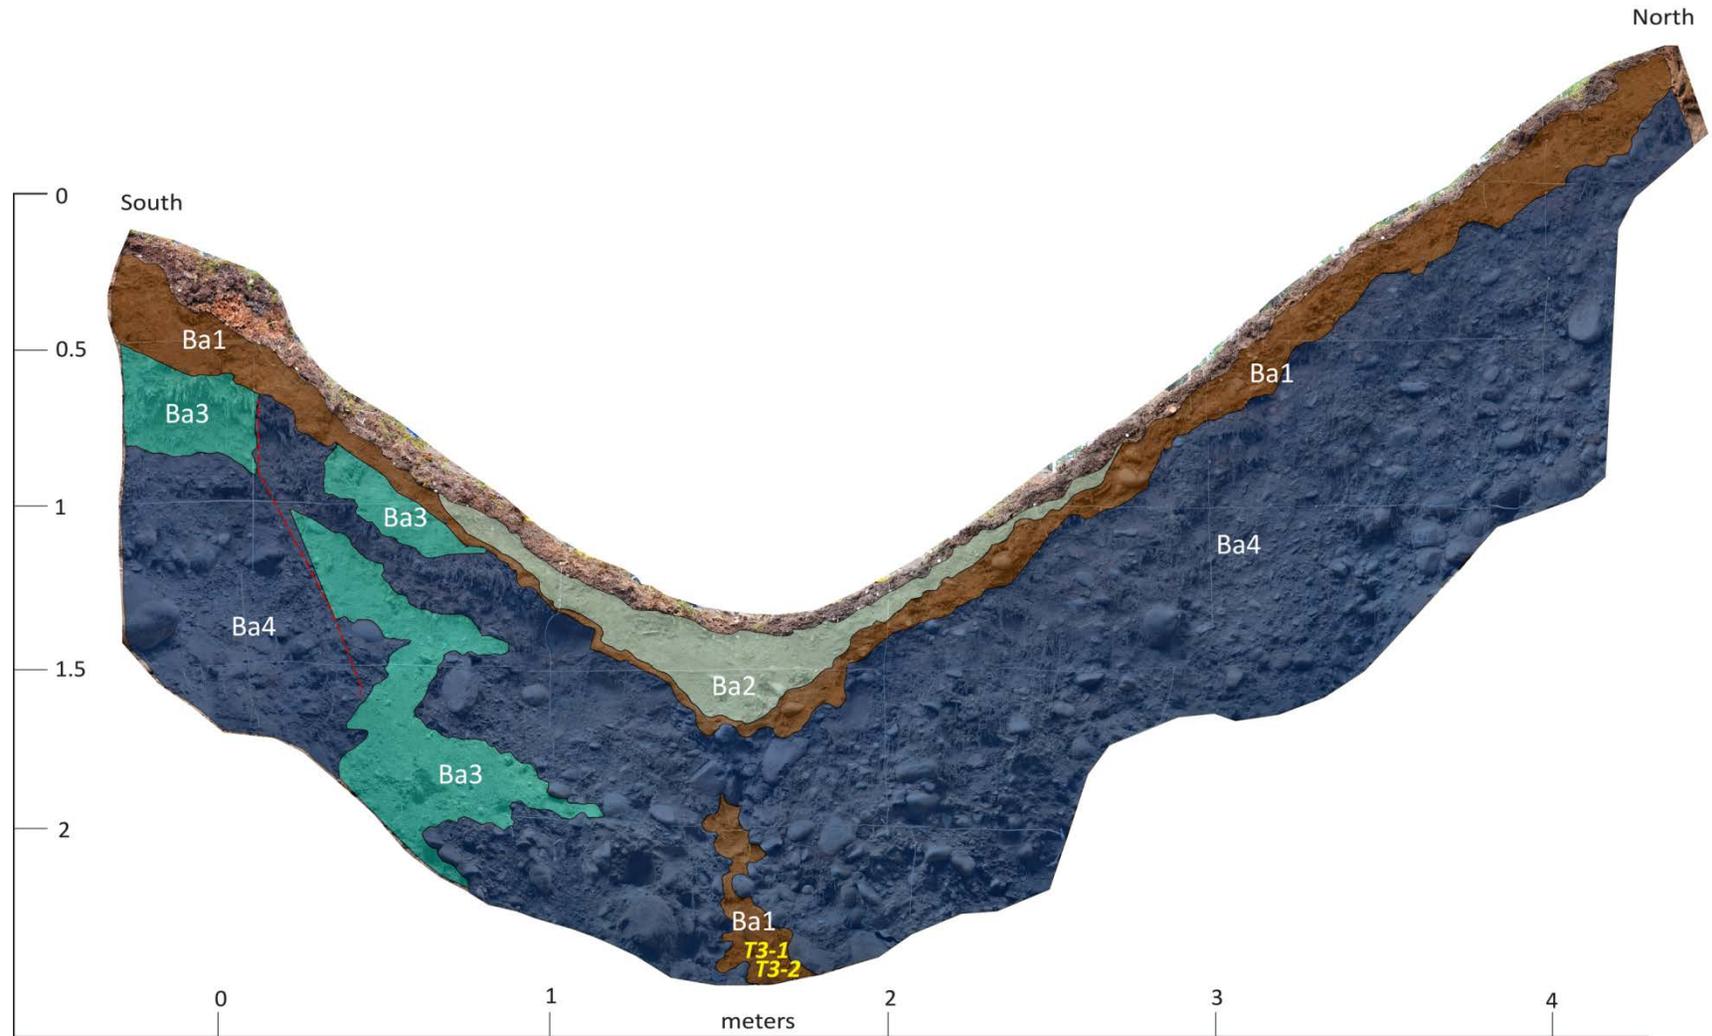
Figure B6. Photomosaic and trench log of the west wall of trench 3 (Site B) across a portion of the Hines Creek fault scarp. White labels and transparent polygons define lithostratigraphic units (unit descriptions in Table B1) and yellow labels identify locations of dated radiocarbon samples (age data in Table A1). Red lines indicate locations of faults and shear zones, and arrows depict relative displacement. The significantly lower proportion of fine-grained deposits in this trench relative to trench 2 provides fewer stratigraphic markers for use in the interpretation of the structure and deformation.

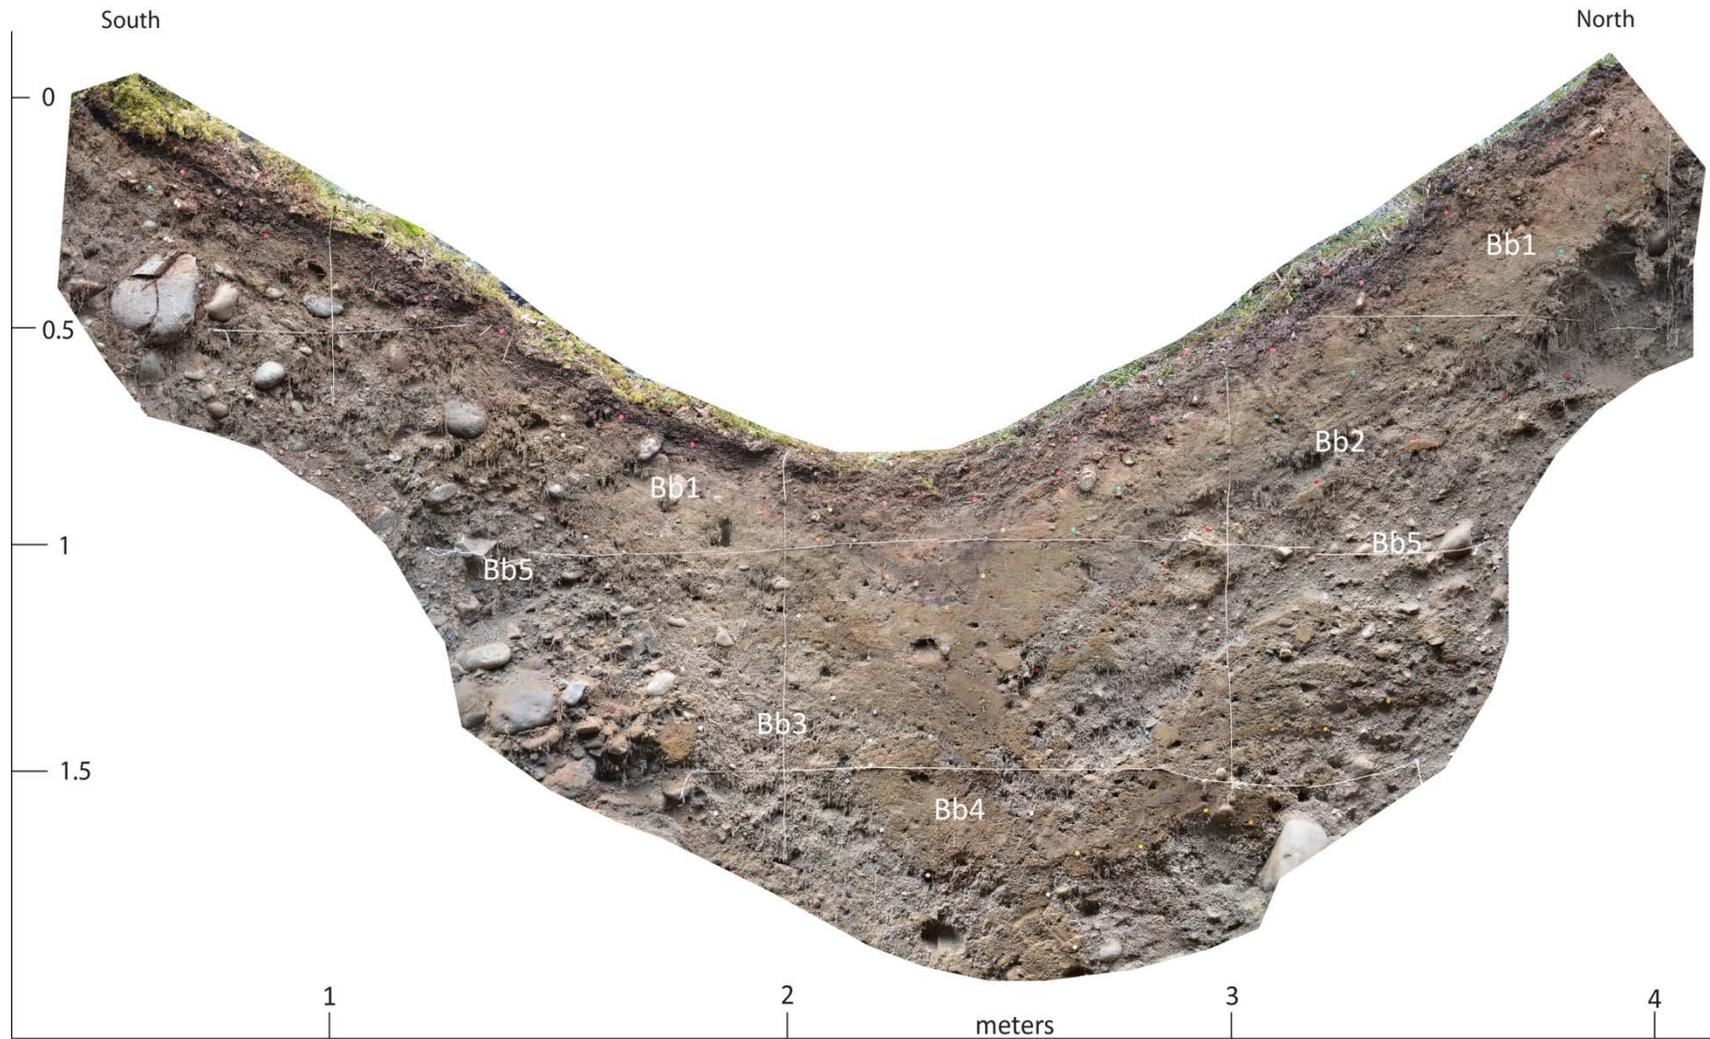
Figure B7. Photomosaic of the west wall of trench 3 (Site B) across a portion of the Hines Creek fault scarp. White labels define lithostratigraphic units (unit descriptions in Table B1). The significantly lower proportion of fine-grained deposits in this trench relative to trench 2 provides fewer stratigraphic markers for use in the interpretation of the structure and deformation.

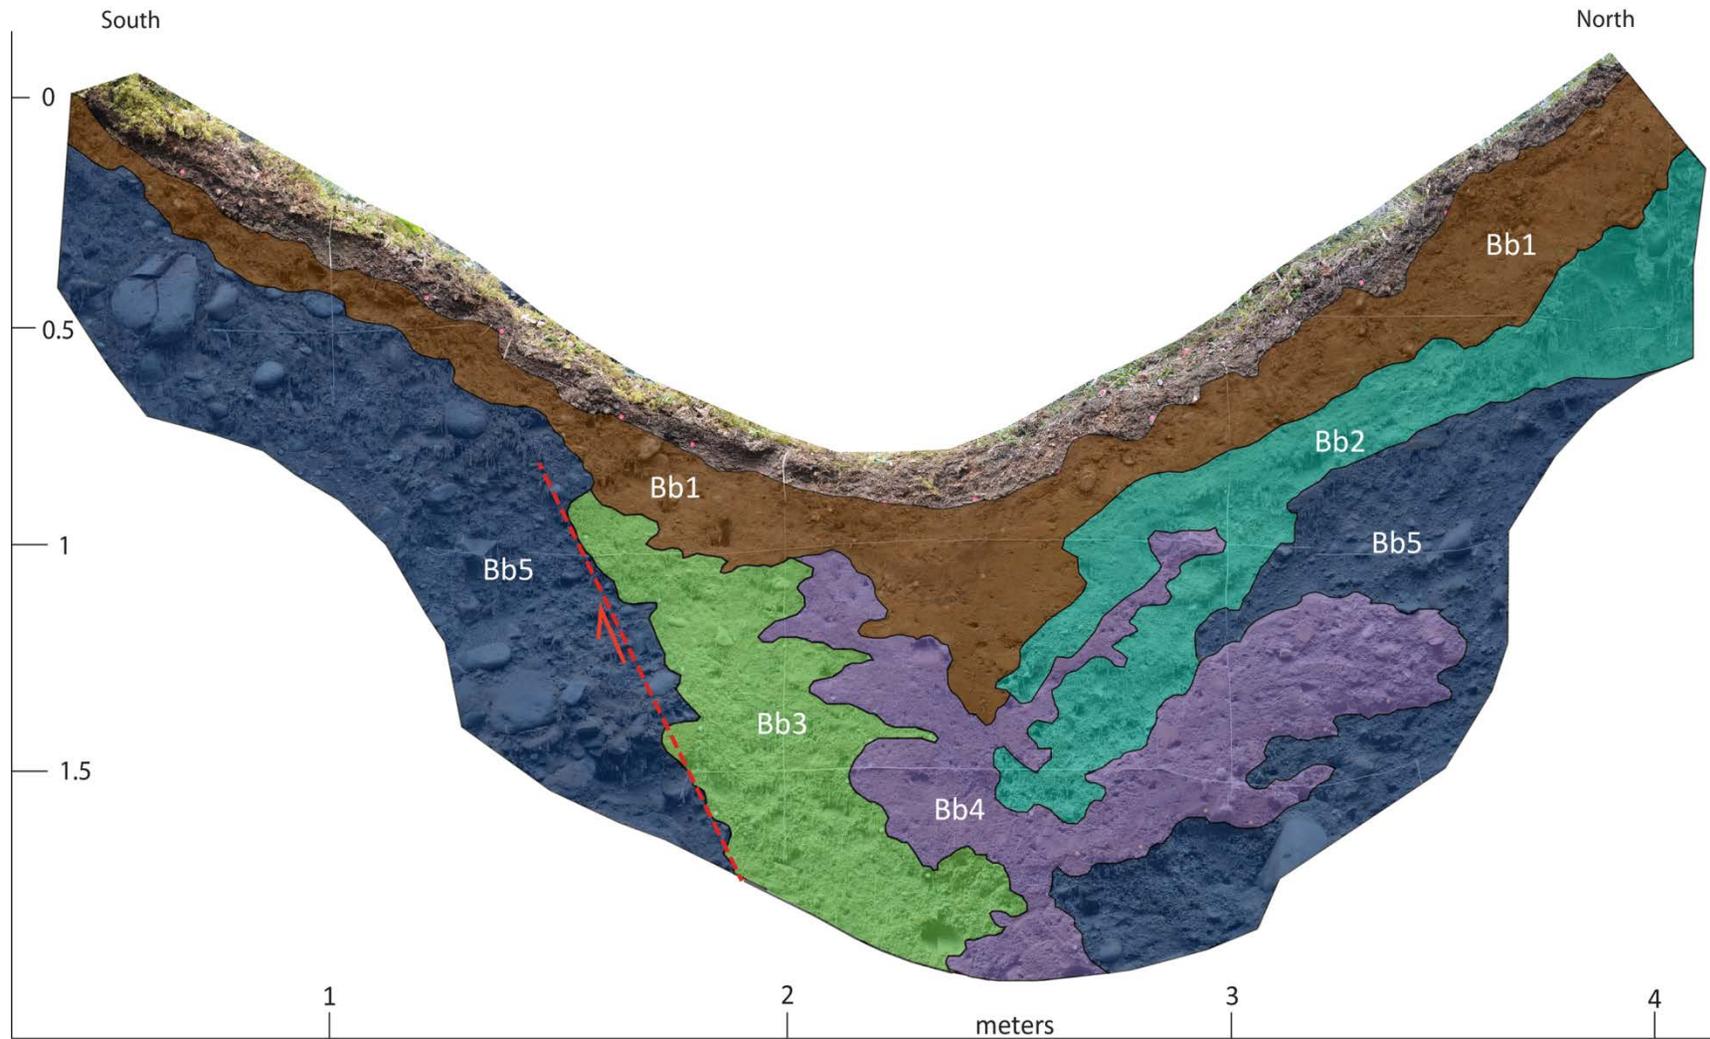
Figure B8. Photomosaic and trench log of the west wall of trench 4 (Site B) across a portion of the Hines Creek fault scarp. White labels and transparent polygons define lithostratigraphic units (unit descriptions in Table B1). Red lines indicate locations of faults and shear zones, and arrows depict relative displacement. The significantly lower proportion of fine-grained deposits in this trench relative to trench 2 provides fewer stratigraphic markers for use in the interpretation of the structure and deformation.

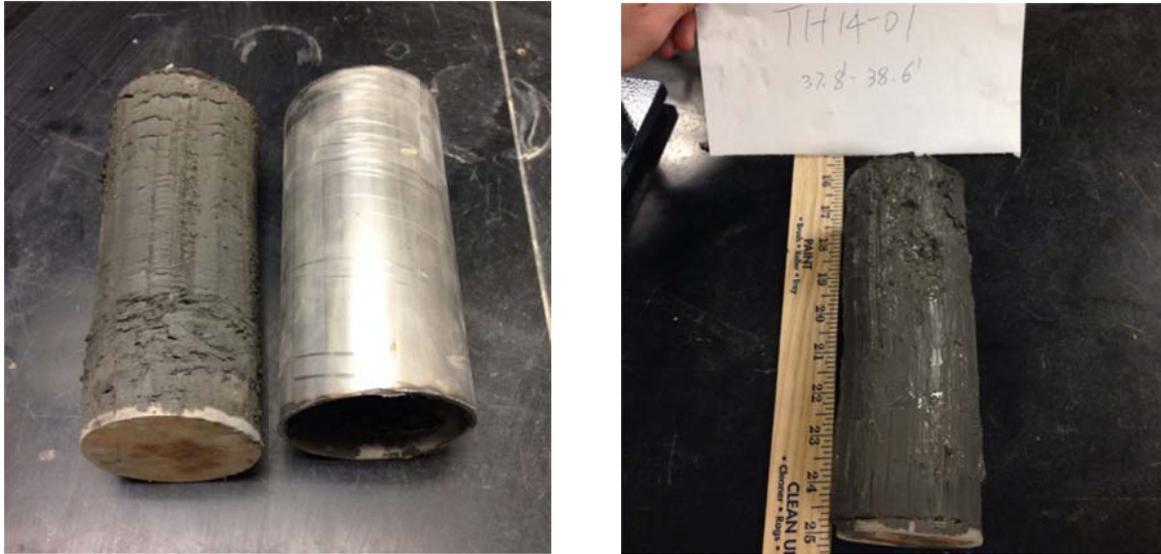
Figure 2.1 Soil Sample Extraction with Cutting Disc

Two methods were used to extract the in-situ soil sample. The first method was to use the cutting disc to disintegrate the sample into small sections (7-8 inches) as shown in Figure 2.1. Then the sample was extracted by a hydraulic extruder. However, some disturbance on sample surface was observed after extraction as shown in Figure 2.1. To minimize the disturbance during cutting and extraction, as shown in Figure 2.2, hydraulic extruder in Shannon & Wilson Inc. was utilized to extract the soil samples. As shown in Figure 2.2, no obvious disturbance on sample surface was observed after extraction.

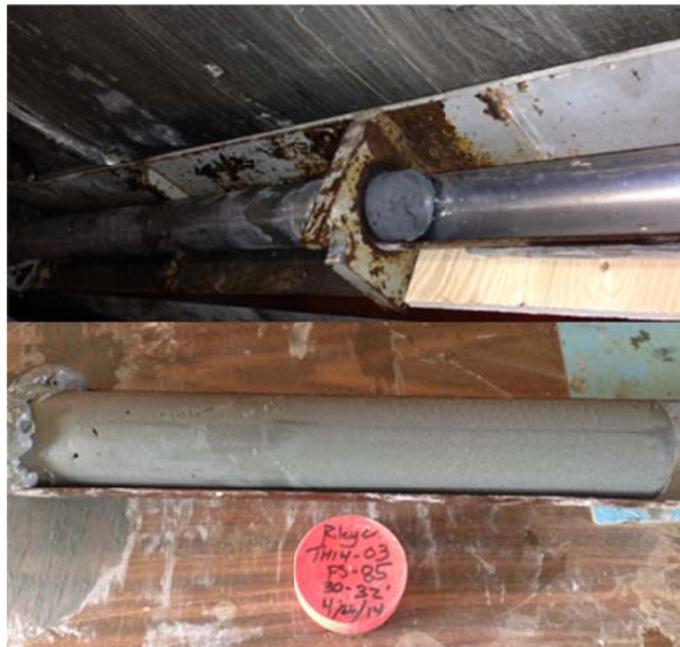
Figure 2.2 Soil Sample Extraction with Hydraulic Extruder

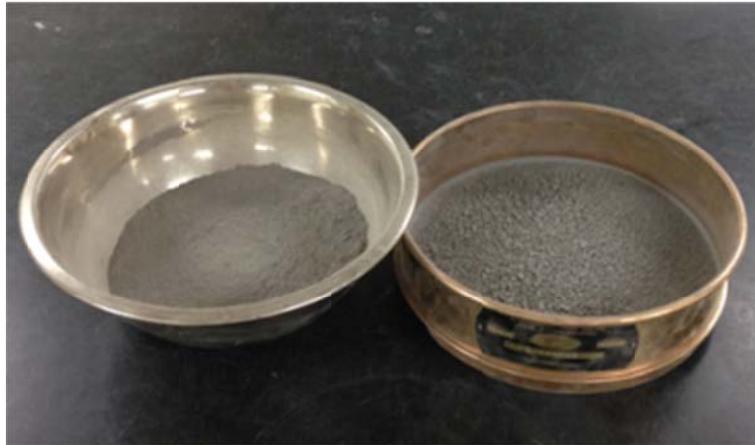
Figure 2.3 Soil sieving

After extraction, some fundamental tests were performed first to determine soil water content, unit weight, Atterberg limits, specific gravity, and gradation curve. Before testing, soil sample was oven-dried to a constant mass. Then, soil passed a No.40 sieve, as shown in Figure 2.3, before being used for testing. A rubber hammer was used to powdering soil clods.

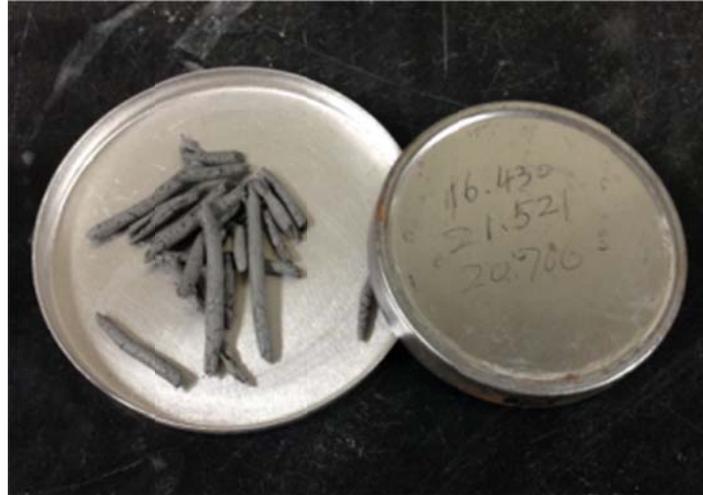
Figure 2.6 Plastic Limit

Water content was first determined based on ASTM D 4643-00 (Determination of Water Content of Soil by the Microwave Oven Heating), as shown in Figure 1.4. The sample was first divided into 9 pieces and the middle piece was used to determine the water content. Then, Atterberg limits were determined according to ASTM D 4318-00 (Standard Test Methods for Liquid Limit, Plastic Limit, and Plasticity Index of Soils) as shown in Figure 2.5 for liquid limit and Figure 2.6 for plastic limit, respectively. Calibrate the liquid limit device before performing the test, the height of the drop of the cup was adjusted so that the cup was raised to a height of 10 mm. Then, several trials with different water content were conducted to adjust the samples water content until the constancy required about 25 to 35 blows of the liquid limit device to close the groove. A minimum of 3 trials were conducted and based on the regression analysis of the water content of each trial, the liquid limit of the soil sample is the water content corresponding to 25 blow counts.

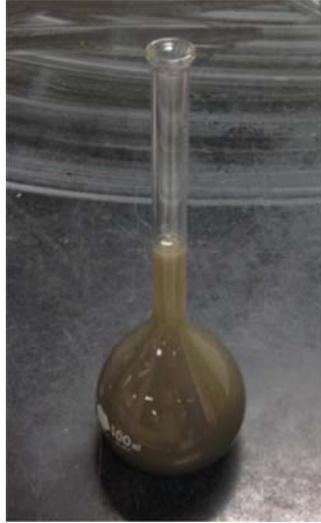
Figure 2.8 Specific Gravity

Soil specific gravity of the in-situ soil sample was determined according to ASTM D 854-00 (Standard Test Methods for Specific Gravity of Soil Solids by Water Pycnometer) as shown in Figure 2.8. Before conducting the test, the pycnometer was calibrated. Then determine the mass of the pycnometer, verify that the mass of pycnometer is within 0.06 g of the average calibrated mass. Measure 50 g soil sample and add water until the water level is between 1/3 and 1/2 of the depth of the main body of the pycnometer. And add water to the pycnometer to the 500 ml mark then measure the mass of the water and pycnometer. Measure 50 g of the oven dried soil sample and add distilled water. Agitate the water until slurry is formed. Rinse any soil adhering to the pycnometer into the slurry. After that, deair the water with a vacuum and the pycnometer was continually agitated under vacuum for at least 2 hours. Continually agitated means the soil solid will remain in suspension and the slurry is in constant motion. The vacuum must remain relative constant and be sufficient to cause bubbling at the beginning of the deairing process. Finally, fill the pycnometer with deaired water to the 500 ml mark. Measure and record the mass of the pycnometer, soil and water to the nearest 0.01 g using the same balance used for pycnometer calibration. Measure and record the temperature of the soil slurry to the nearest 0.1°C.

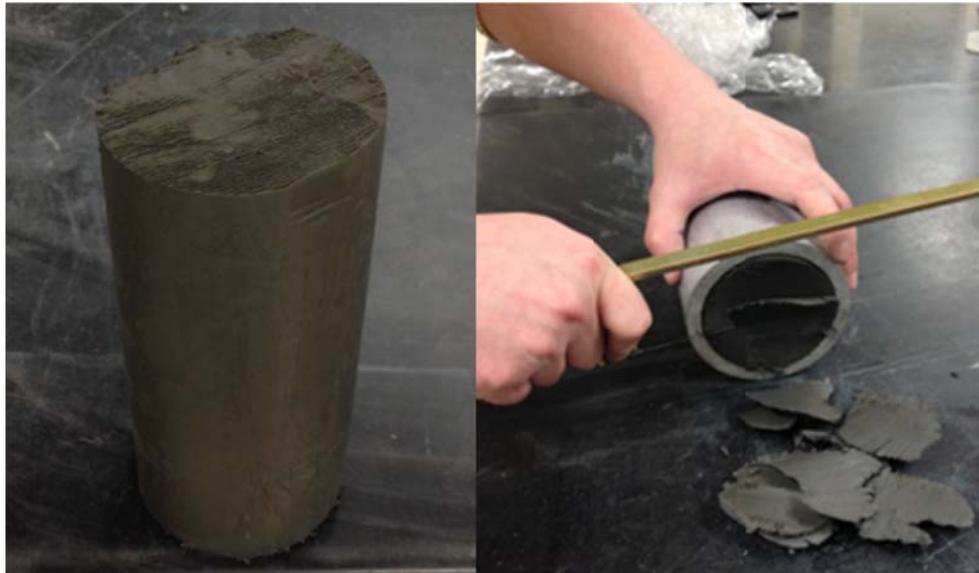
(a) Sample after extraction

(b) Sampling

Figure 2.9 Sampling for Unconsolidated Undrained Test

The unconsolidated undrained triaxial test was performed according to ASTM D2166 (Standard Test Method for Unconfined Compressive Strength of Cohesive Soil). To perform the unconsolidated undrained triaxial test, in-situ soil sample as shown in Figure 2.9a was cut into 142 mm in height and 71 mm in diameter cylinder using a wire saw as shown in Figure 2.9b. The mass of the wet sample was determined right after the sampling to accurately determine its water content before testing.

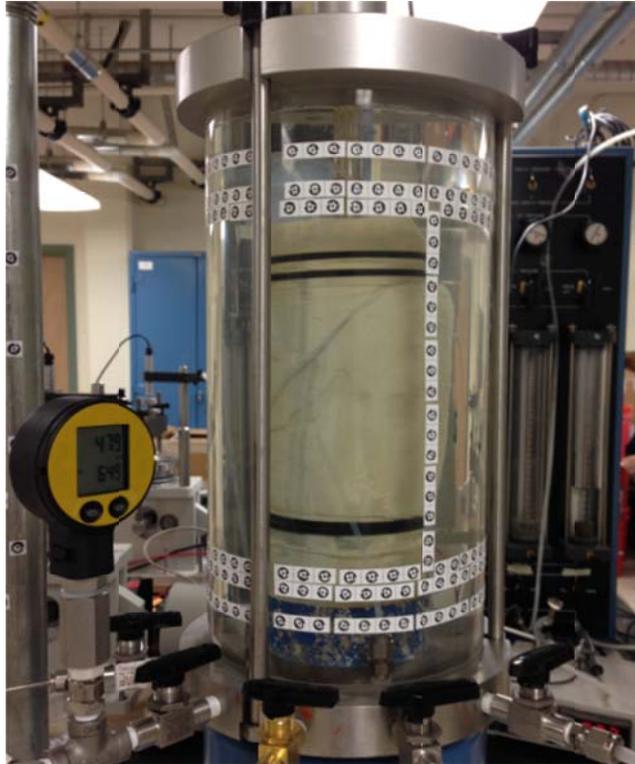
Figure 2.11 Unconsolidated Undrained Test

After saturation, which could be checked by B-value ($B > 0.95$ indicated saturation), the saturated soil sample was sheared with a loading rate of 1 mm/min as shown in Figure 2.11. During this process, the pore water pressure inside the soil sample was recorded by the pressure meter as shown in Figure 2.11. Also, the applied axial load was recorded to determine soil strength properties. Shearing was stopped when reached the 15% axial strain.

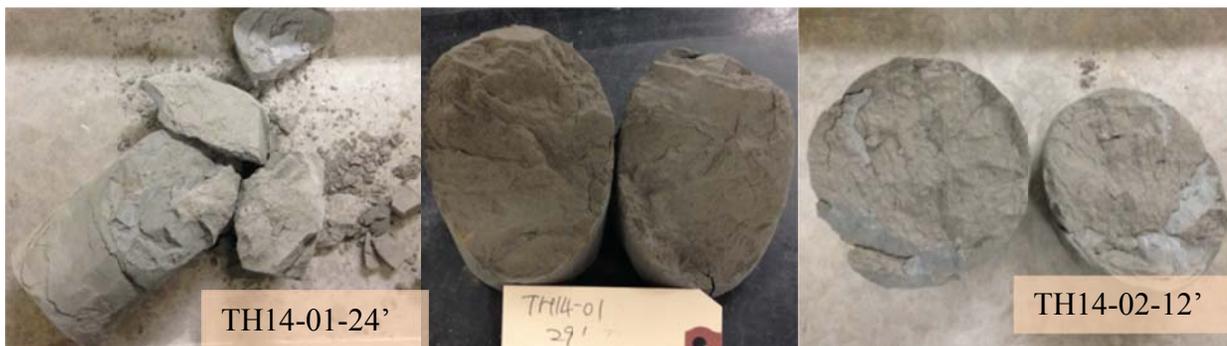
Figure 2.12 Samples after Unconsolidated Undrained Test

After shearing, triaxial cell was disassembled and soil sample was extracted for water content determination. In order to prevent water absorption, the disassembling process was performed under undrained condition. Figure 2.12 shows pictures of three soil samples after oven-dried. After oven drying, data analysis was performed to determine the corresponding shear strength of the tested soil sample. Also, comparisons were made on soil water content, void ratio, and unit weight variations before and after the unconsolidated undrained triaxial test.

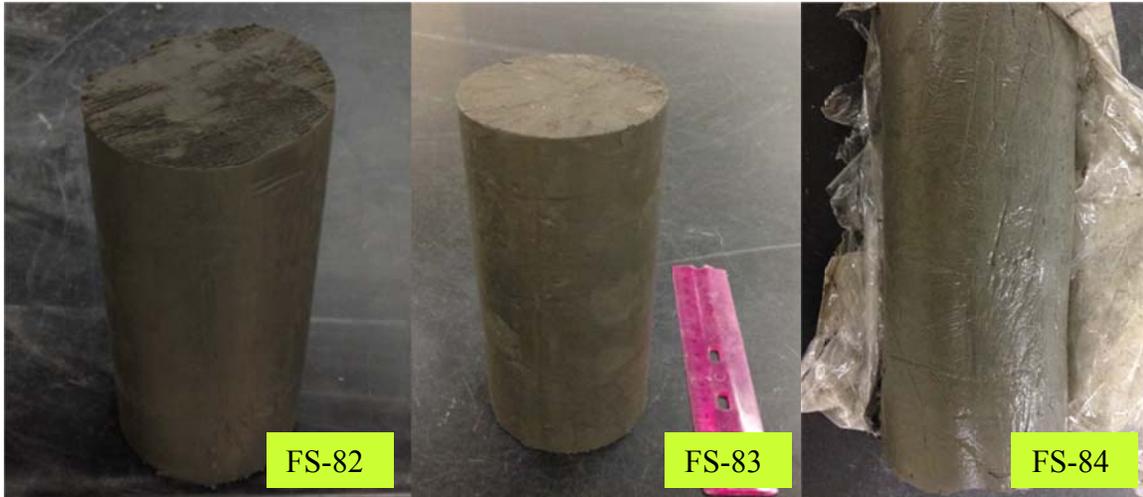
Figure 2.14 Soil Samples before Isotropically Consolidated Undrained Test

For the specimen from tube FS-84 as shown in Figure 2.14, water was observed at the surface of the specimen. Specimen became very weak due to liquefaction during handling process. So, it's required to pay attention on this silt layer, which has great potential to liquefy under vibration, during foundation design.

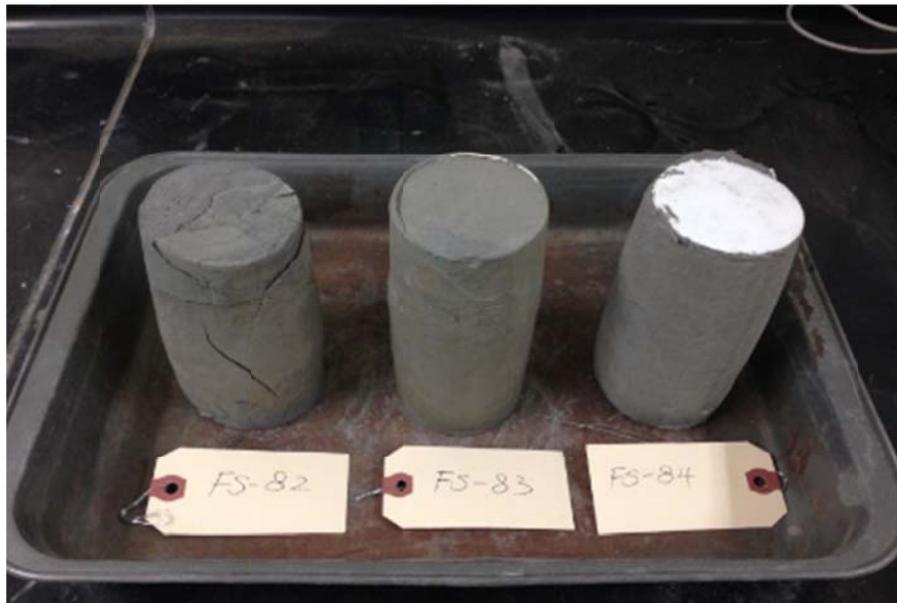
Figure 2.15 Samples after Isotropically Consolidated Undrained Test

The isotropically consolidated undrained triaxial tests were performed according to ASTM D4767 (Standard Test Method for Consolidated Undrained Triaxial Compression Test for Cohesive Soils). A total number of five isotropically consolidated undrained triaxial tests for samples from three tubes (FS-82, FS-83, and FS-84) were performed to evaluate the saturated soil behavior under undrained condition. The test setup for the isotropically consolidated undrained triaxial test is consistent with the unconsolidated undrained triaxial test. However, after saturation, the test specimen suffered an isotropically consolidation process. In this test, for samples from different tubes, the applied consolidation stress is the corresponding preconsolidation stress obtained from the one-dimensional consolidation test. Two more isotropically consolidated undrained triaxial tests were performed on samples from tube FS-83 to evaluate saturated soil behavior under different confining pressure levels. After consolidation, specimens were sheared to 15% axial strain under undrained condition. During this process, pore water pressure change in the specimen was recorded by a pressure meter. Specimens from different tubes before and after the triaxial tests are shown in Figure 2.14 and 2.15, respectively.

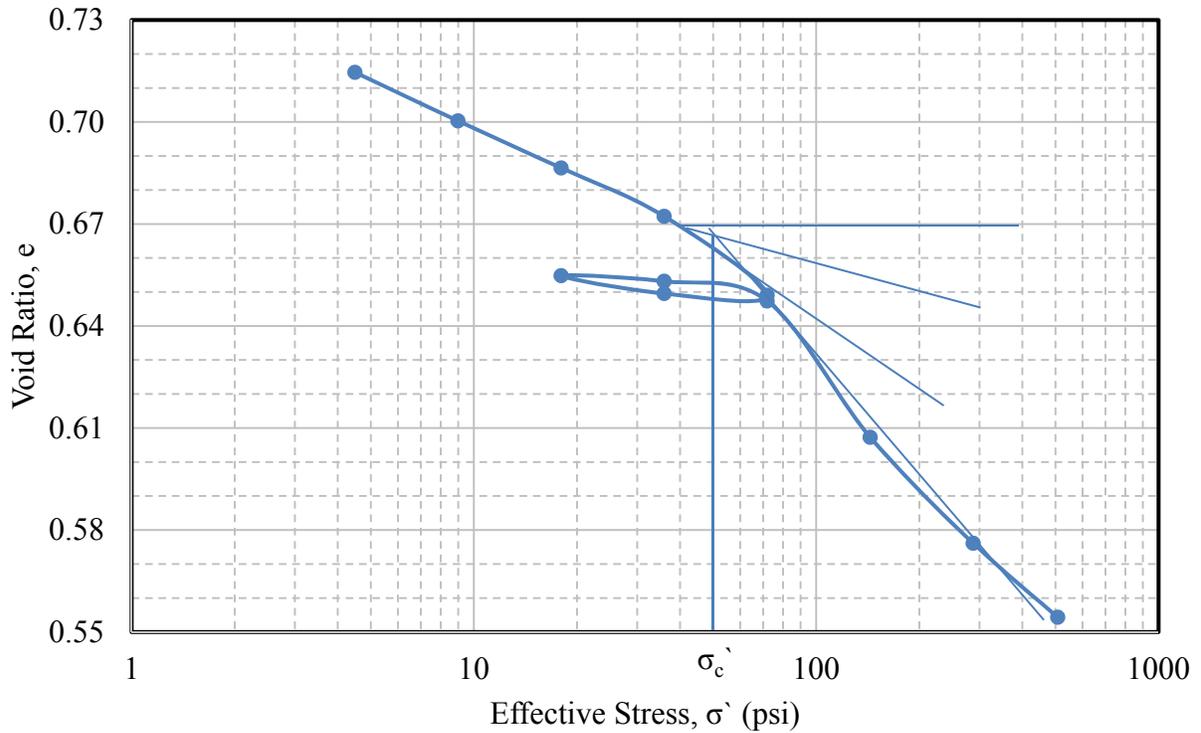
Figure 3.2 Void Ratio vs. Effective Stress (TH14-03 FS-83 at 22 ft)

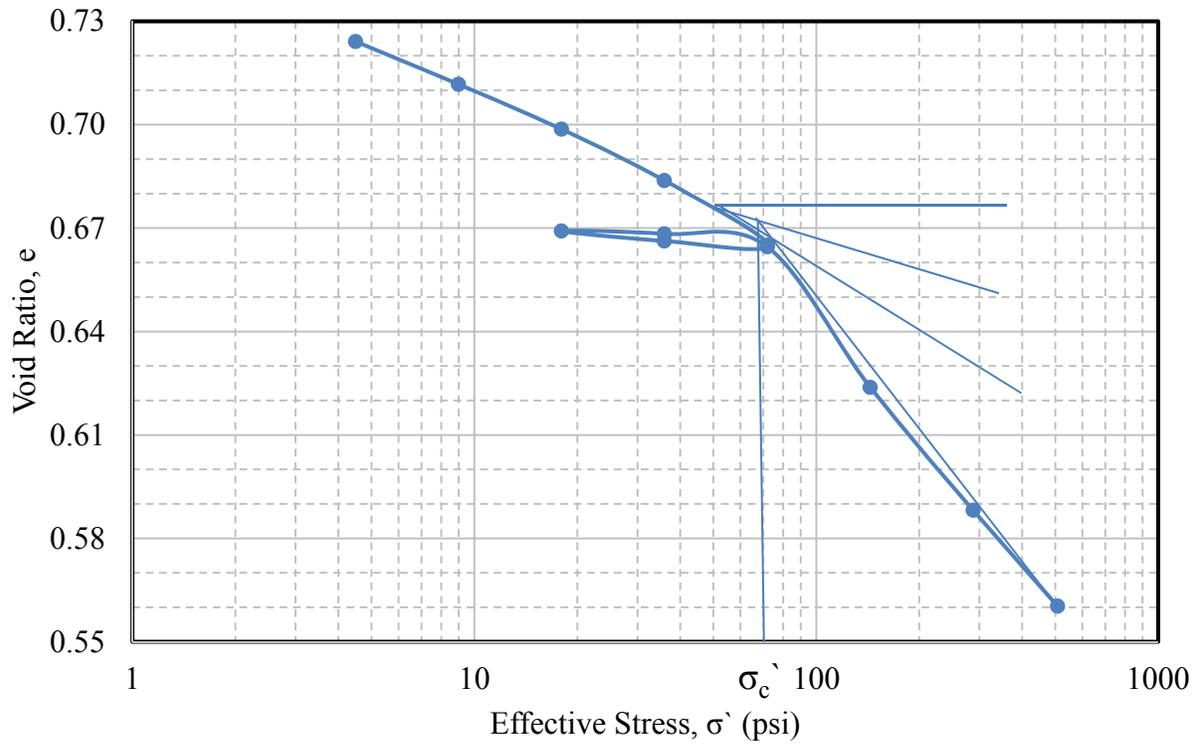
Figure 3.3 Void Ratio vs. Effective Stress (TH14-03 FS-83 at 21 ft)

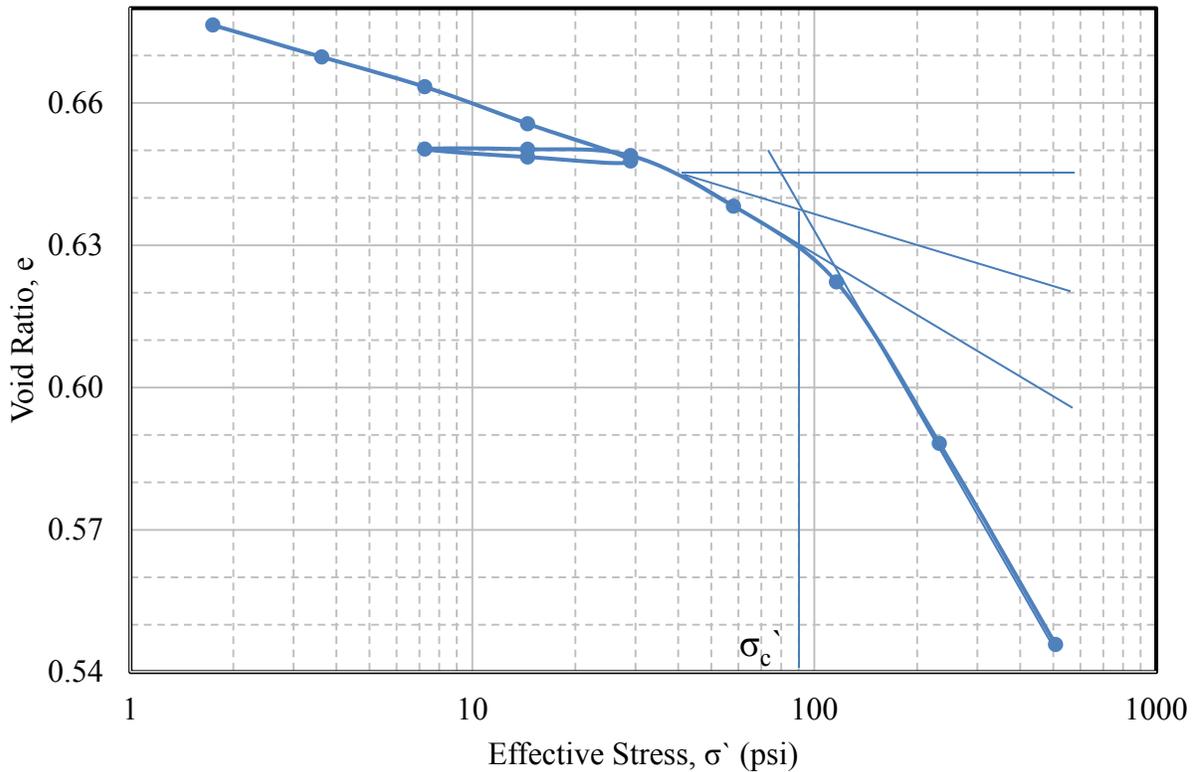
Figure 3.4 Void Ratio vs. Effective Stress (TH14-03 FS-82 at 16 ft)

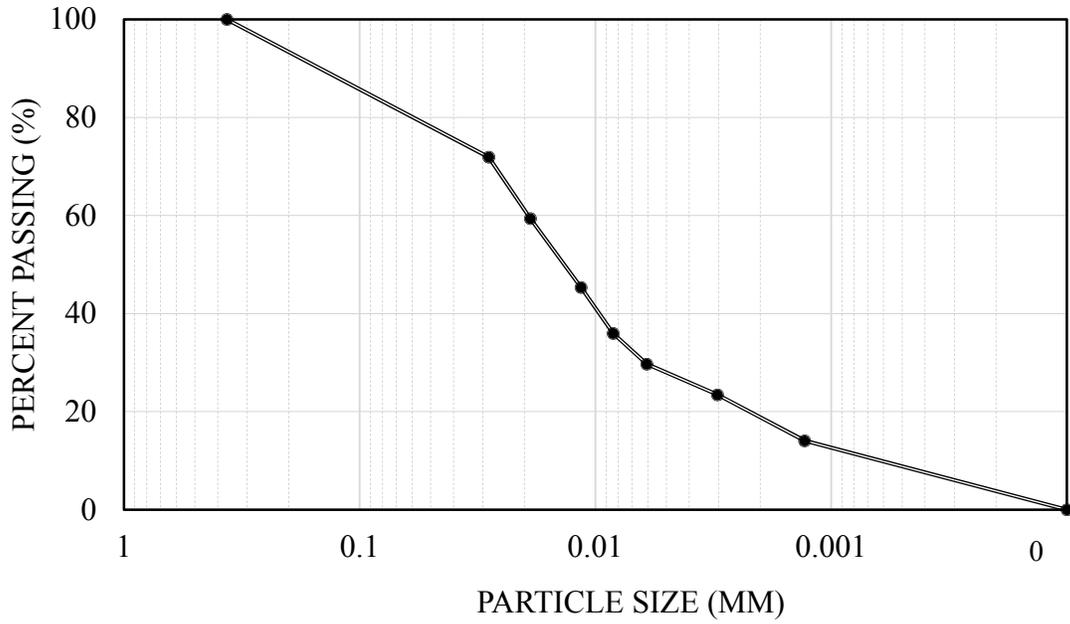
Figure A.1 Gradation Curve (TH14-01 FS-91 at 13 ft)

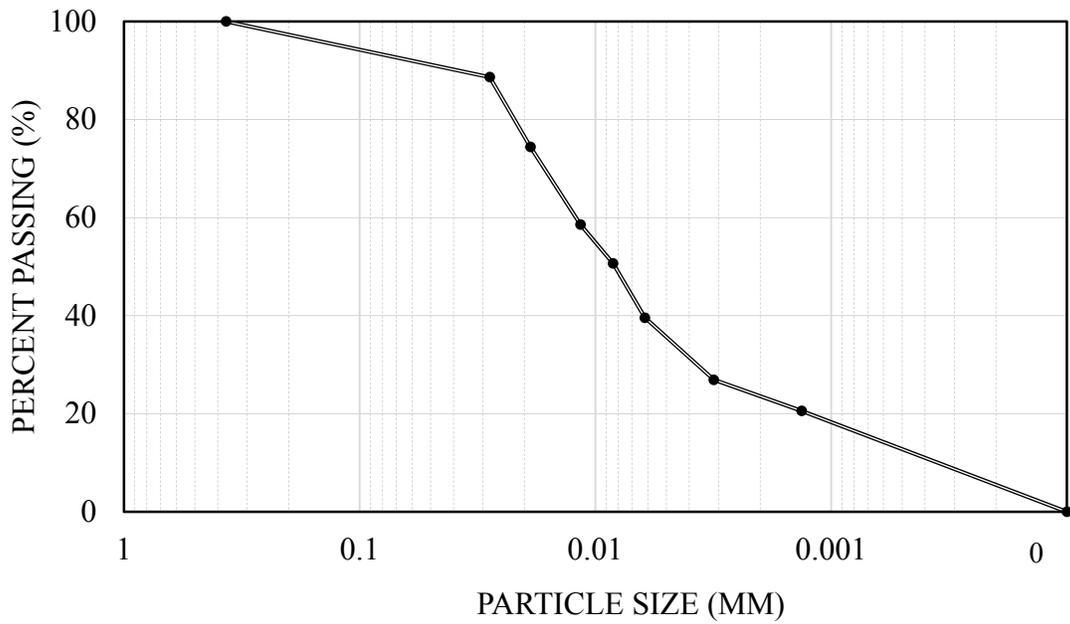
Figure A.2 Gradation Curve (TH14-01 FS-92 at 19.5 ft)
