Geotechnical Report

PARKS HIGHWAY MP 237 RILEY CREEK BRIDGE REPLACEMENT

AKSAS: 63763

FEBRUARY 2014

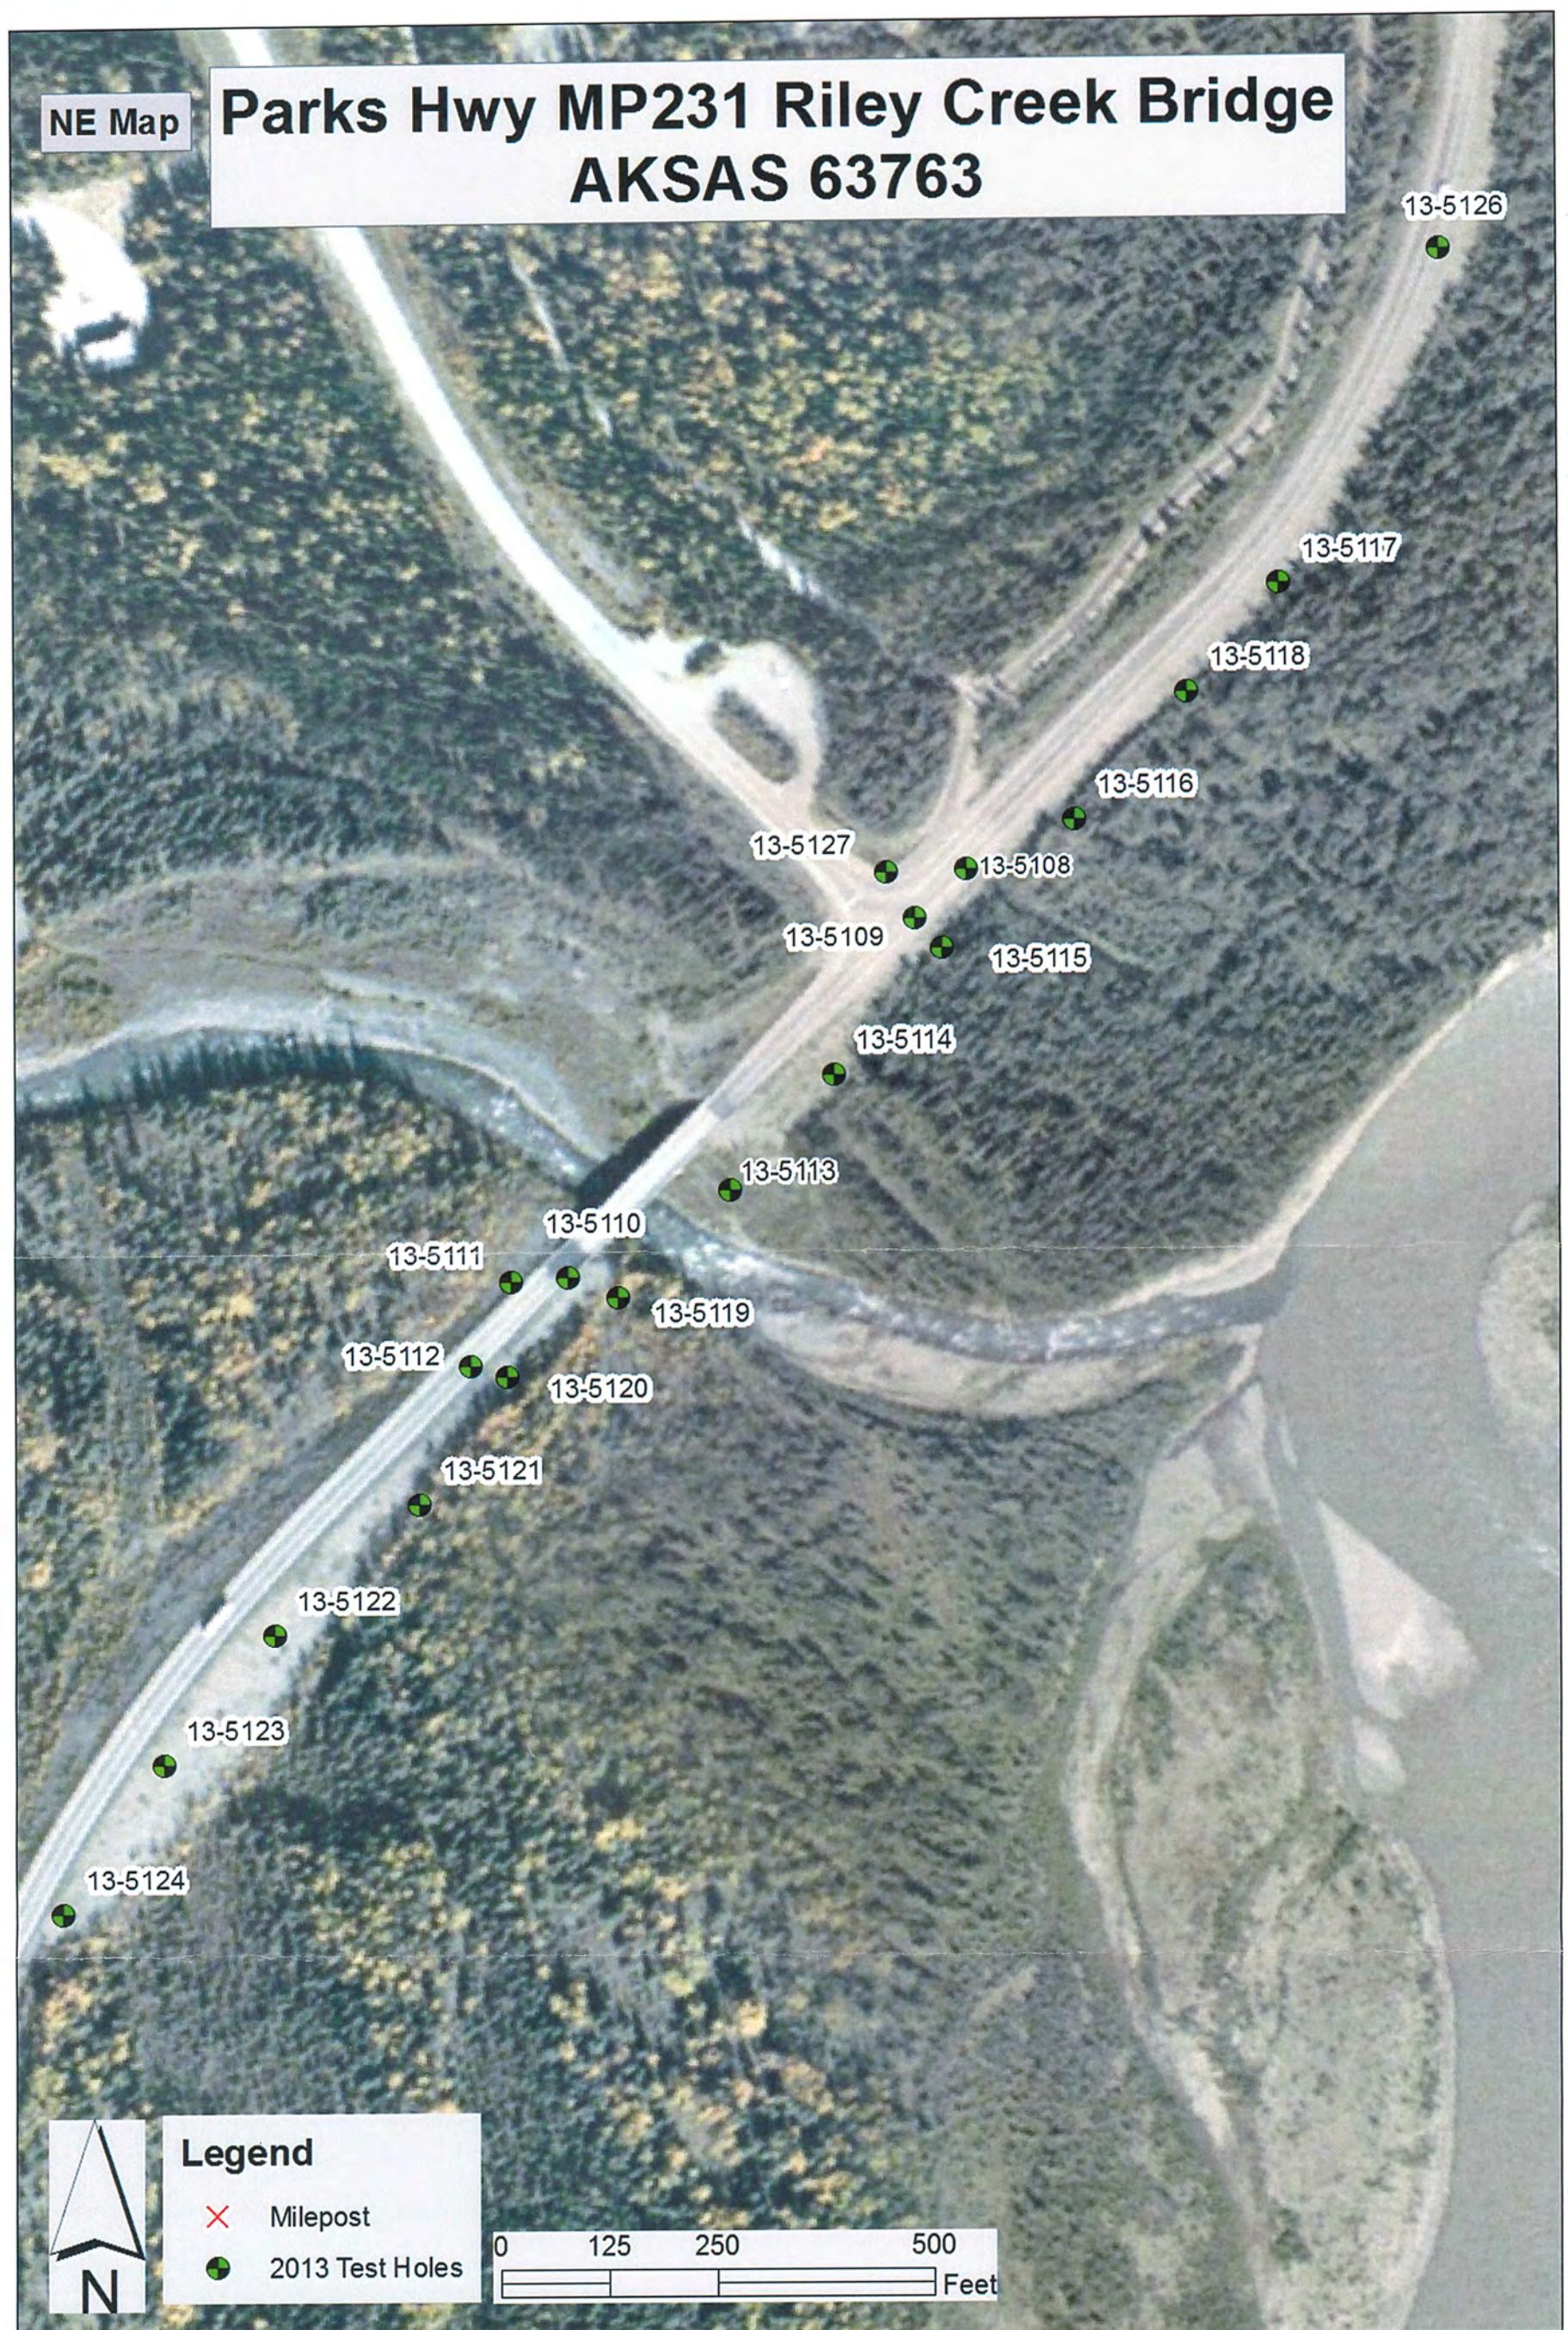
Figure 3. Detailed map of NE drill pattern.

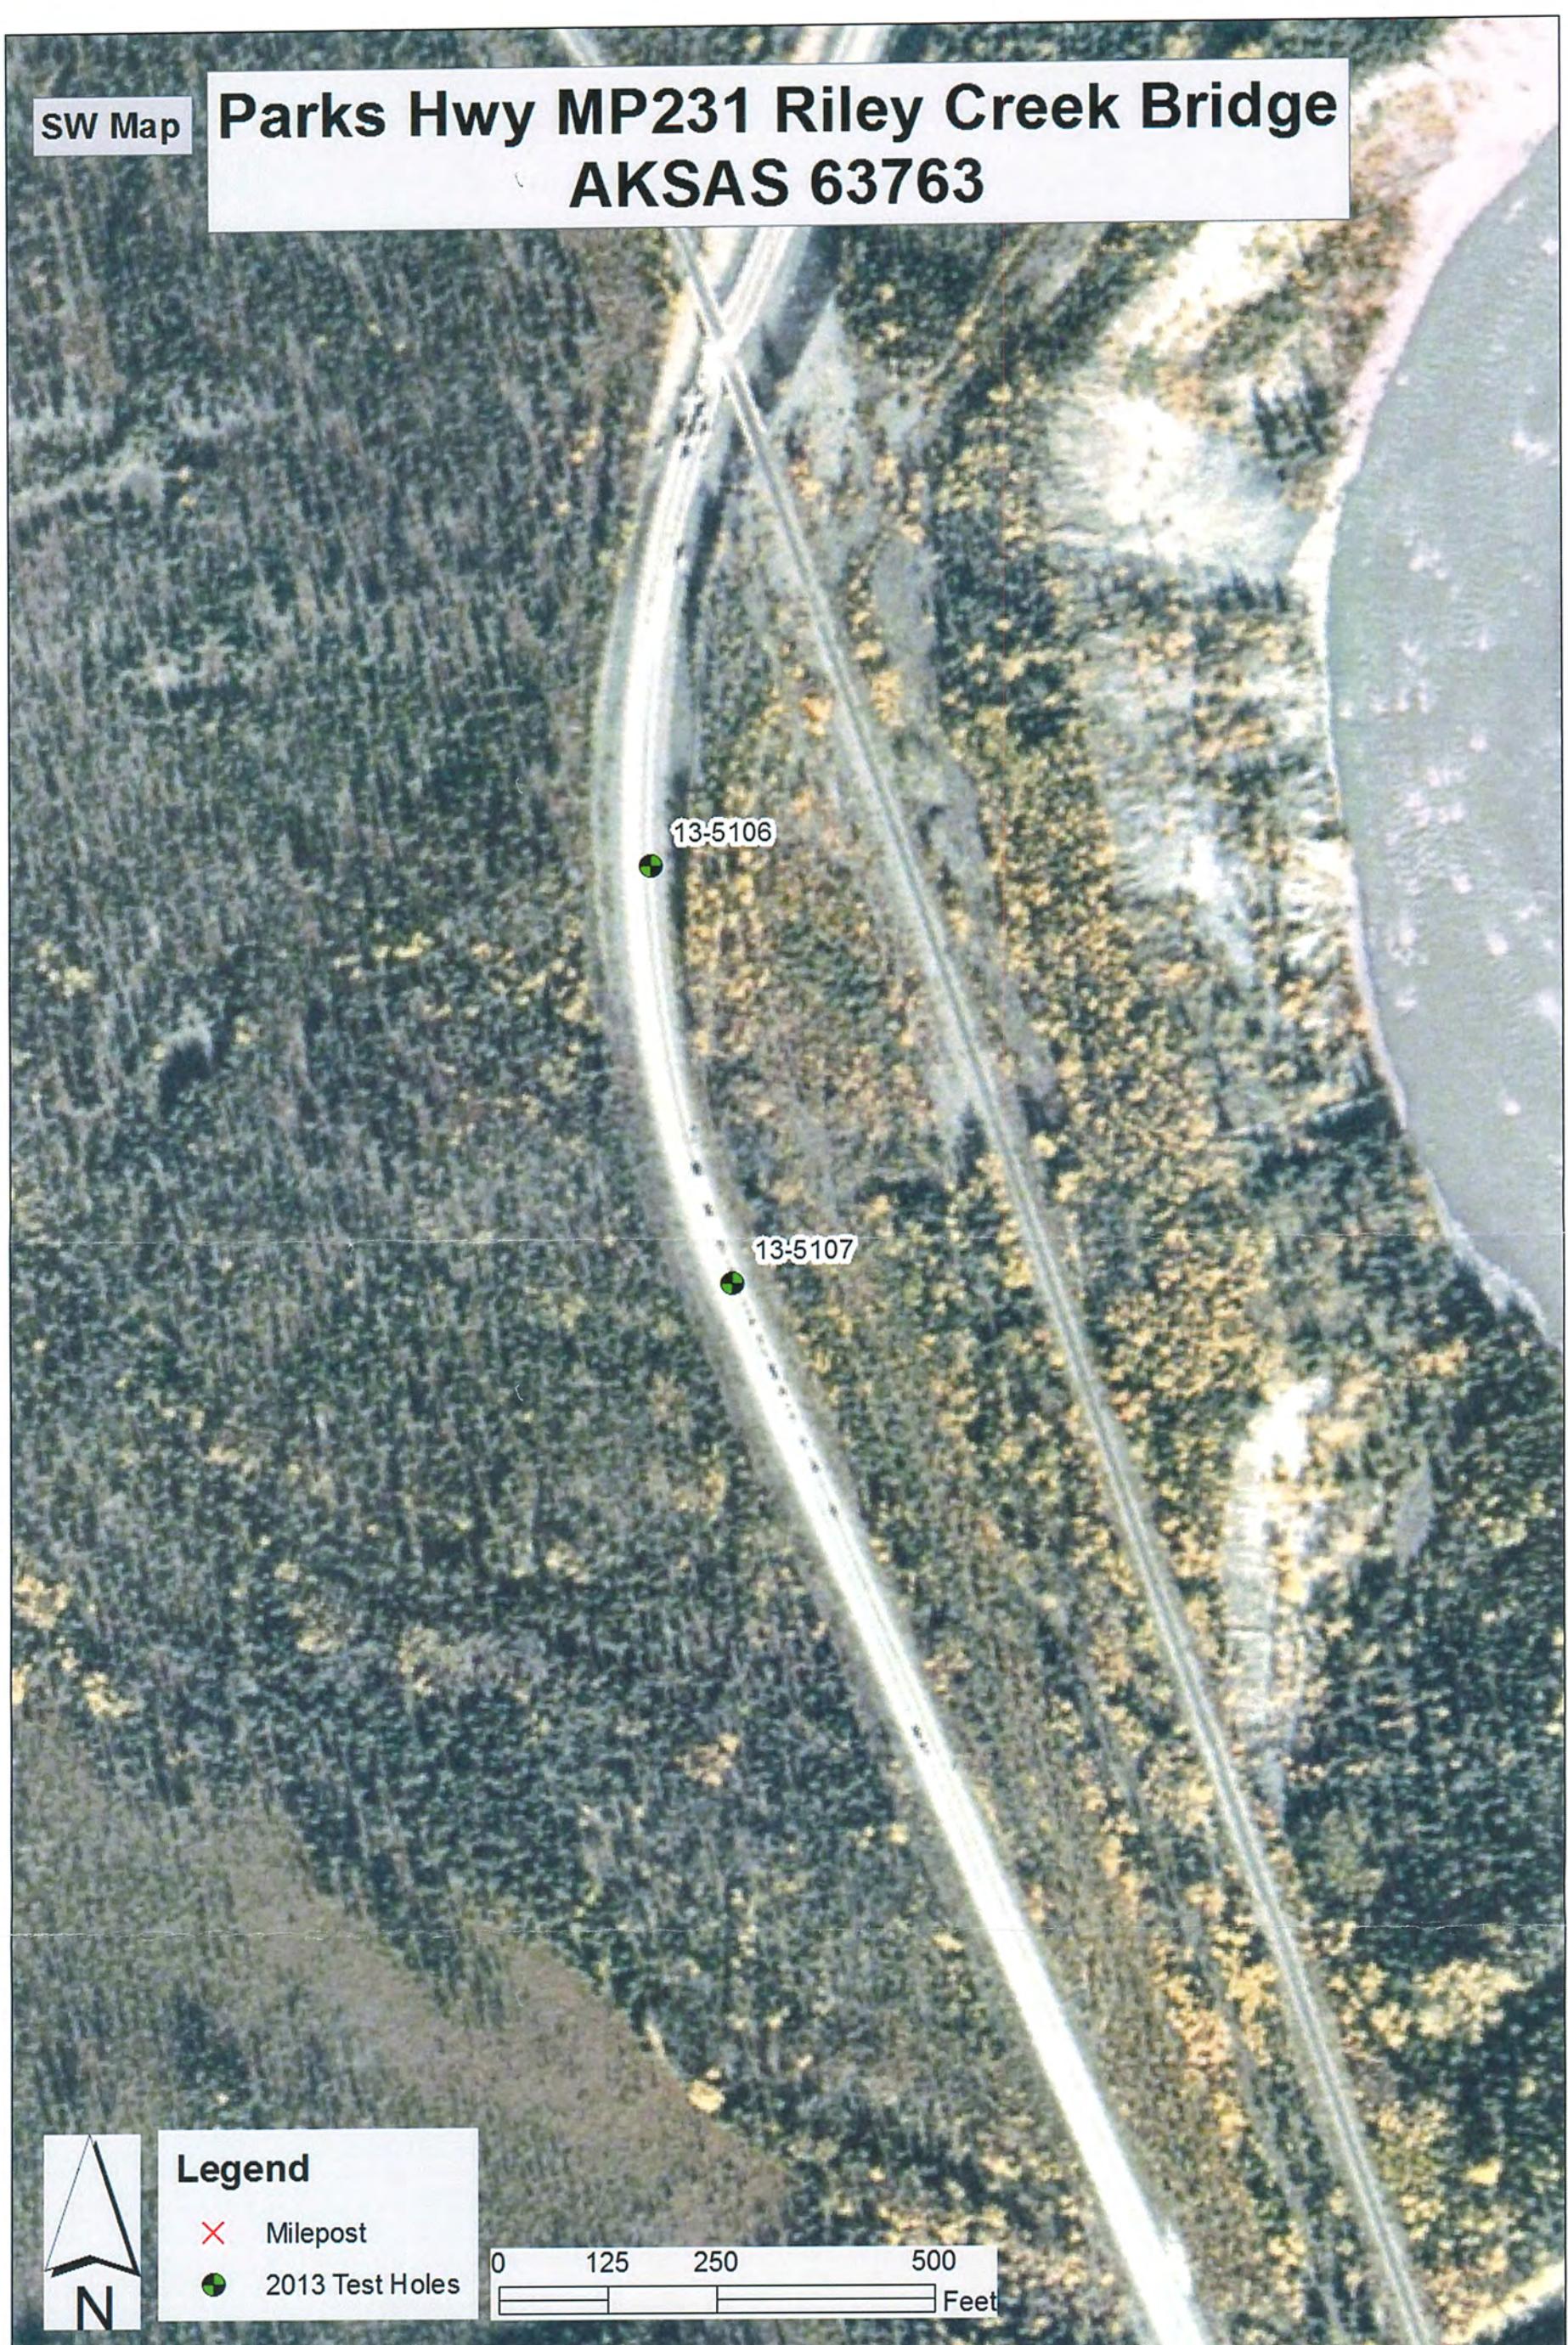
SW Map

Figure 4. Map of SW drill pattern.
