CADD	ALF/ECC	SOIL UNITS LYNN CANAL HIGHWAY PHASE I ZONE 4 GEOTECHNICAL INVESTIGATION		
	DATE	10/18/06			
	CHECK	RGD			
FILE No.	SOIL_UNITS.PPT	DATE	10/19/06	ADOT / LYNN CANAL HWY ZONE 4 / AK	A-1
PROJECT No.	063-5782	REV	0

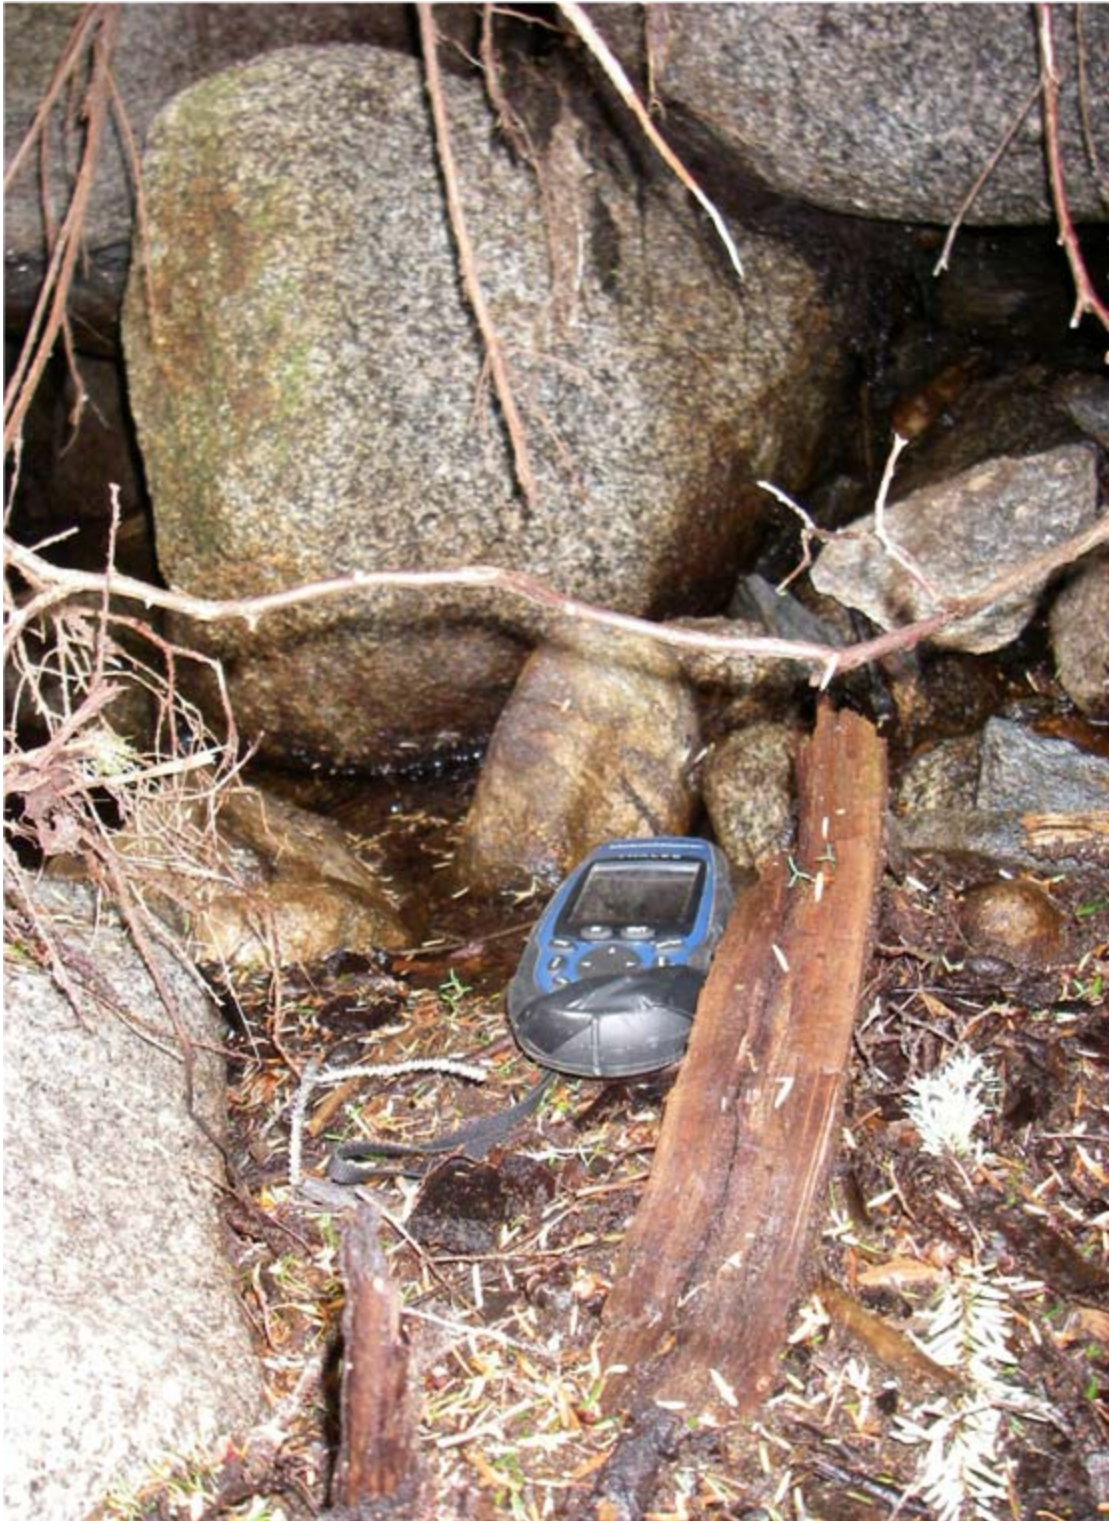
Colluvium (Qc) - View of typical colluvial material. Material is angular to subrounded and multi-lithic. Handheld MobileMapper™ is 3 inches wide for scale. Photo taken 75 ft right of IRP 2006 2008+50.

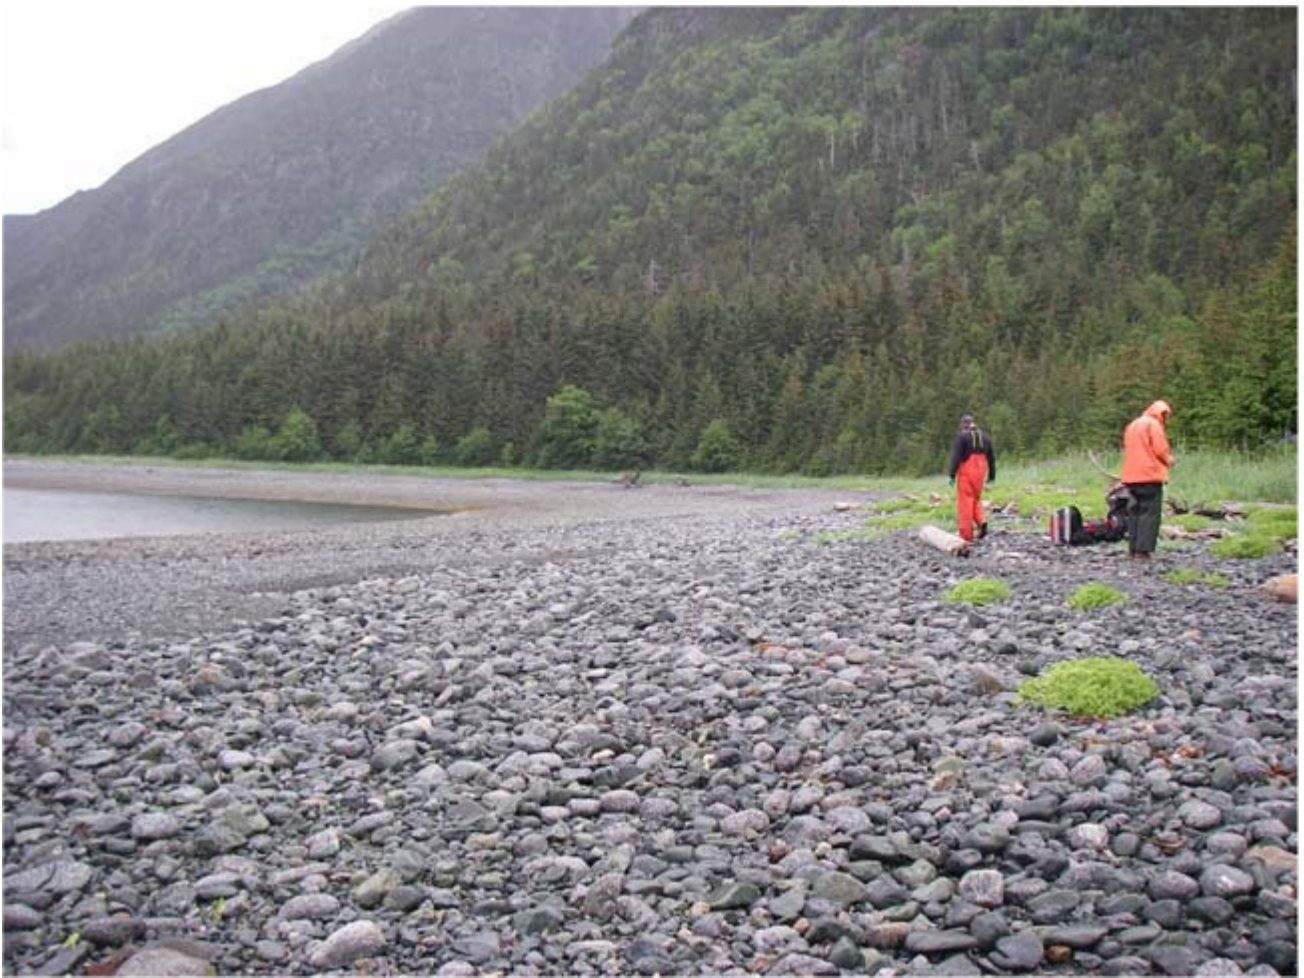
Modern beach deposits (Qb) - View north across typical modern beach deposits. Notice lack of fines and subrounded to rounded cobbles. Photo taken 100 ft left of IRP 2006 1455+00.

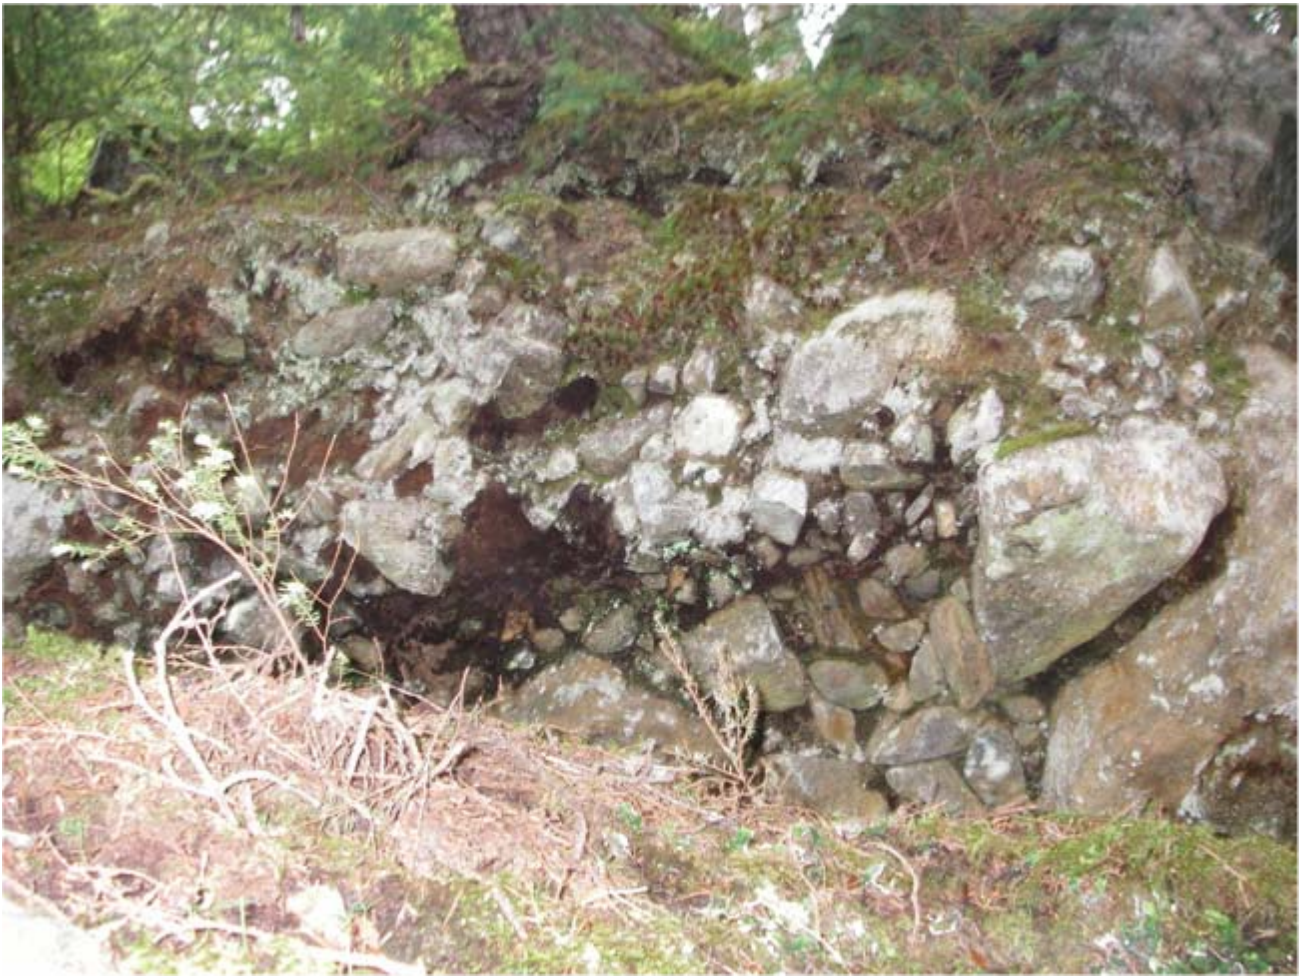
Elevated beach deposits (Qeb) - View upslope at weakly cemented elevated beach deposits. Photo taken at centerline at IRP 2006 2158+00.

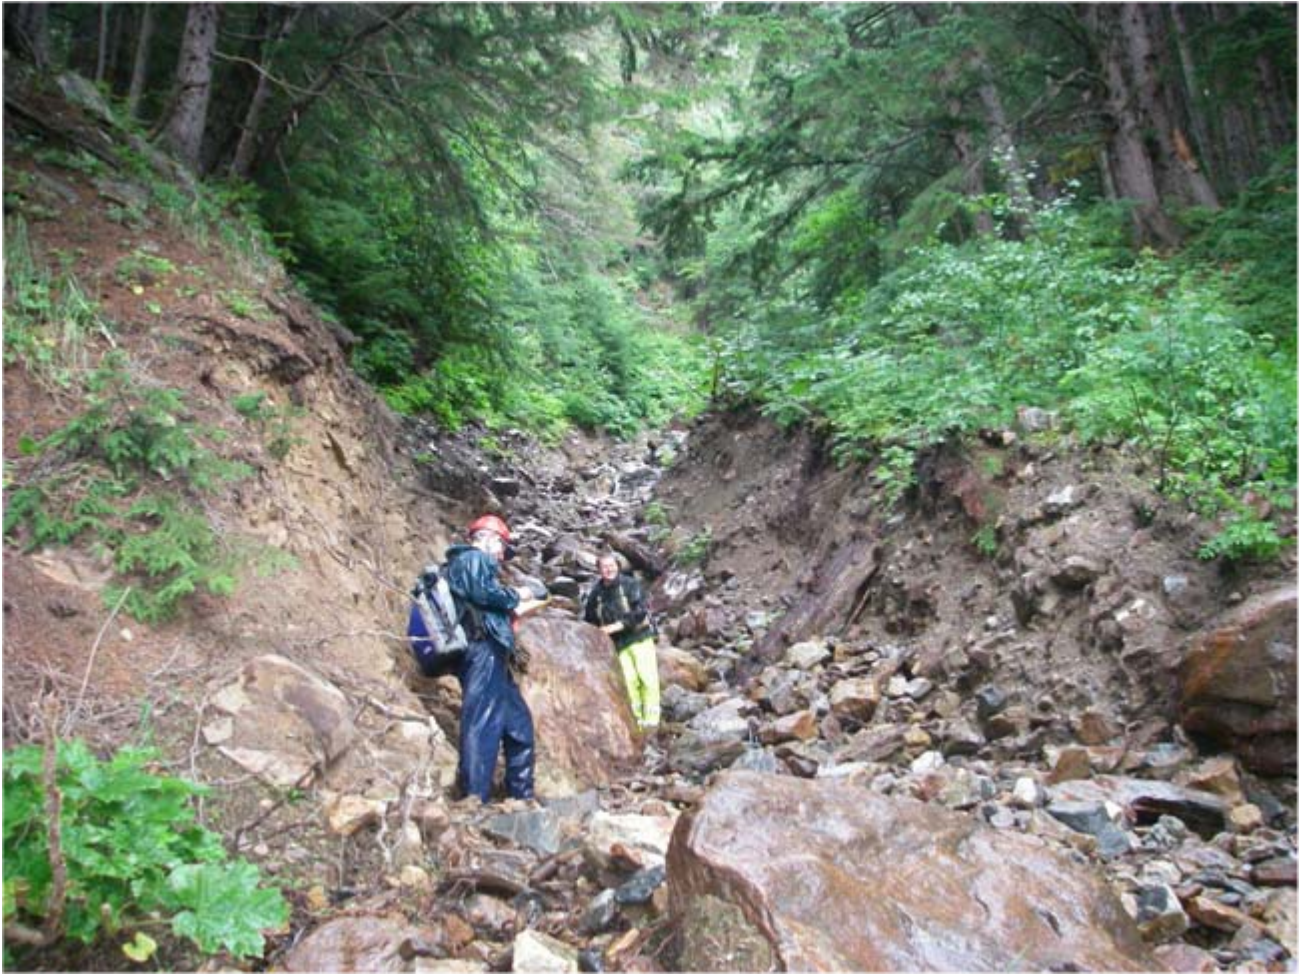
Debris flow deposits (Qdf) - View upslope at typical debris flow deposits. Photo taken at centerline at IRP 2006 1747+00.

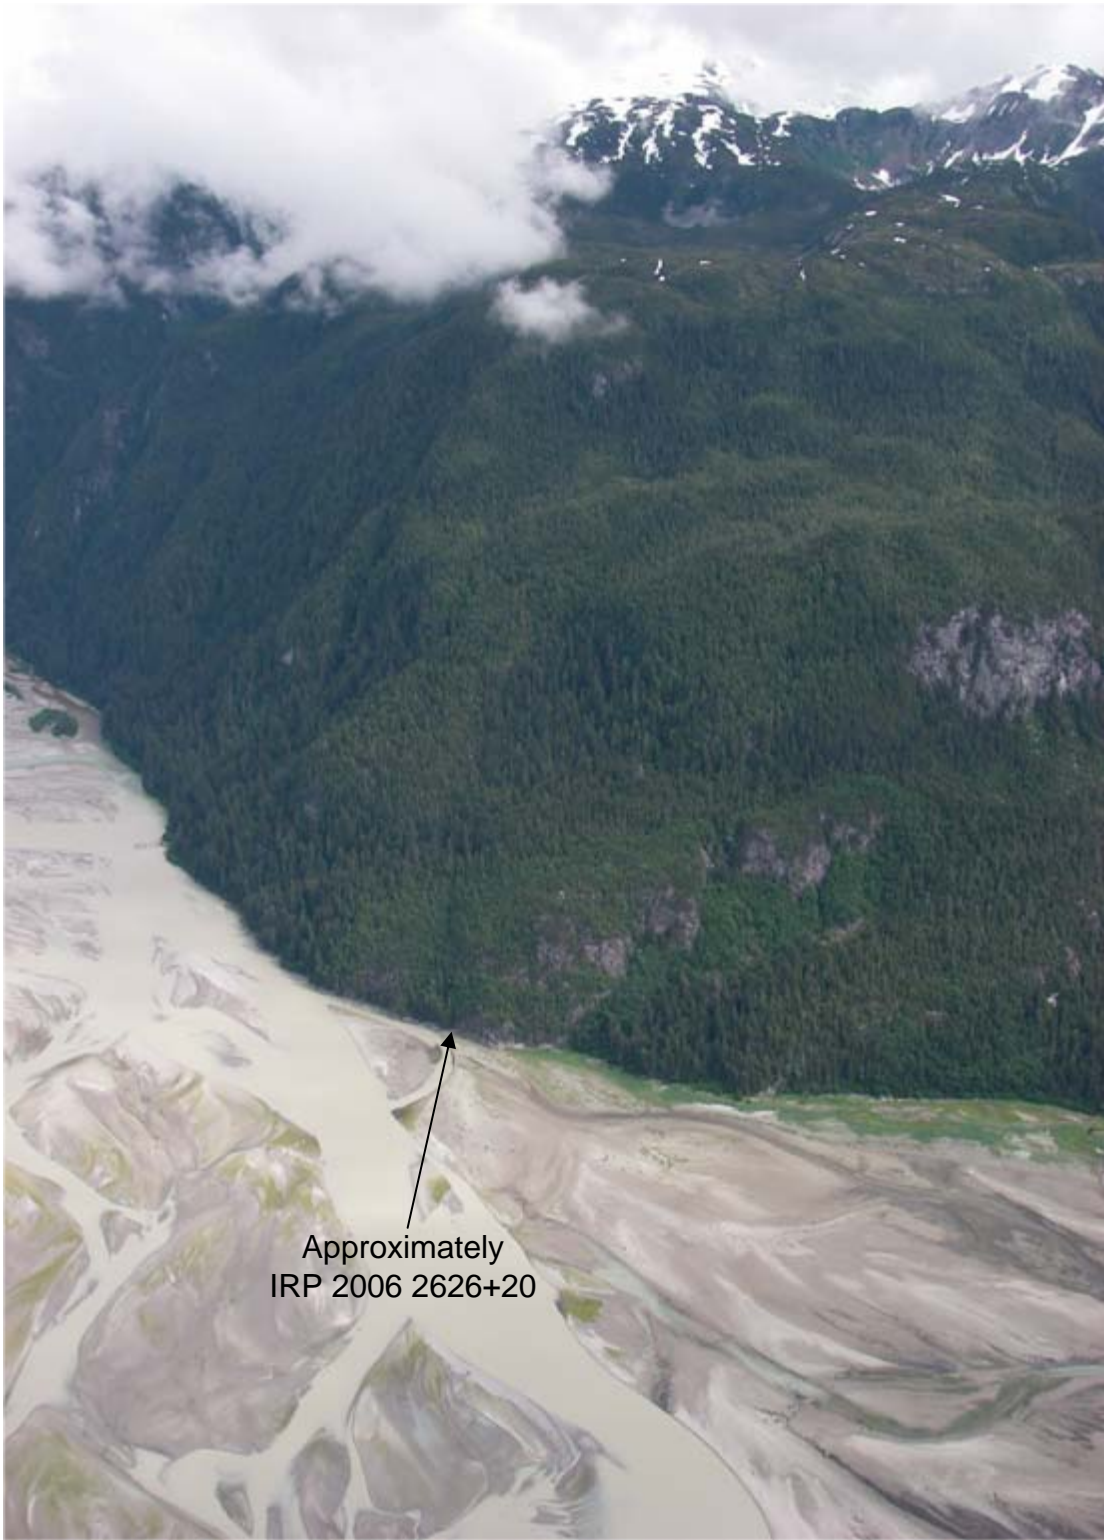
Approximately
IRP 2006 2626+20

River deposits (Qr) - View east at the mouth of the Katzehin River and typical river deposits.

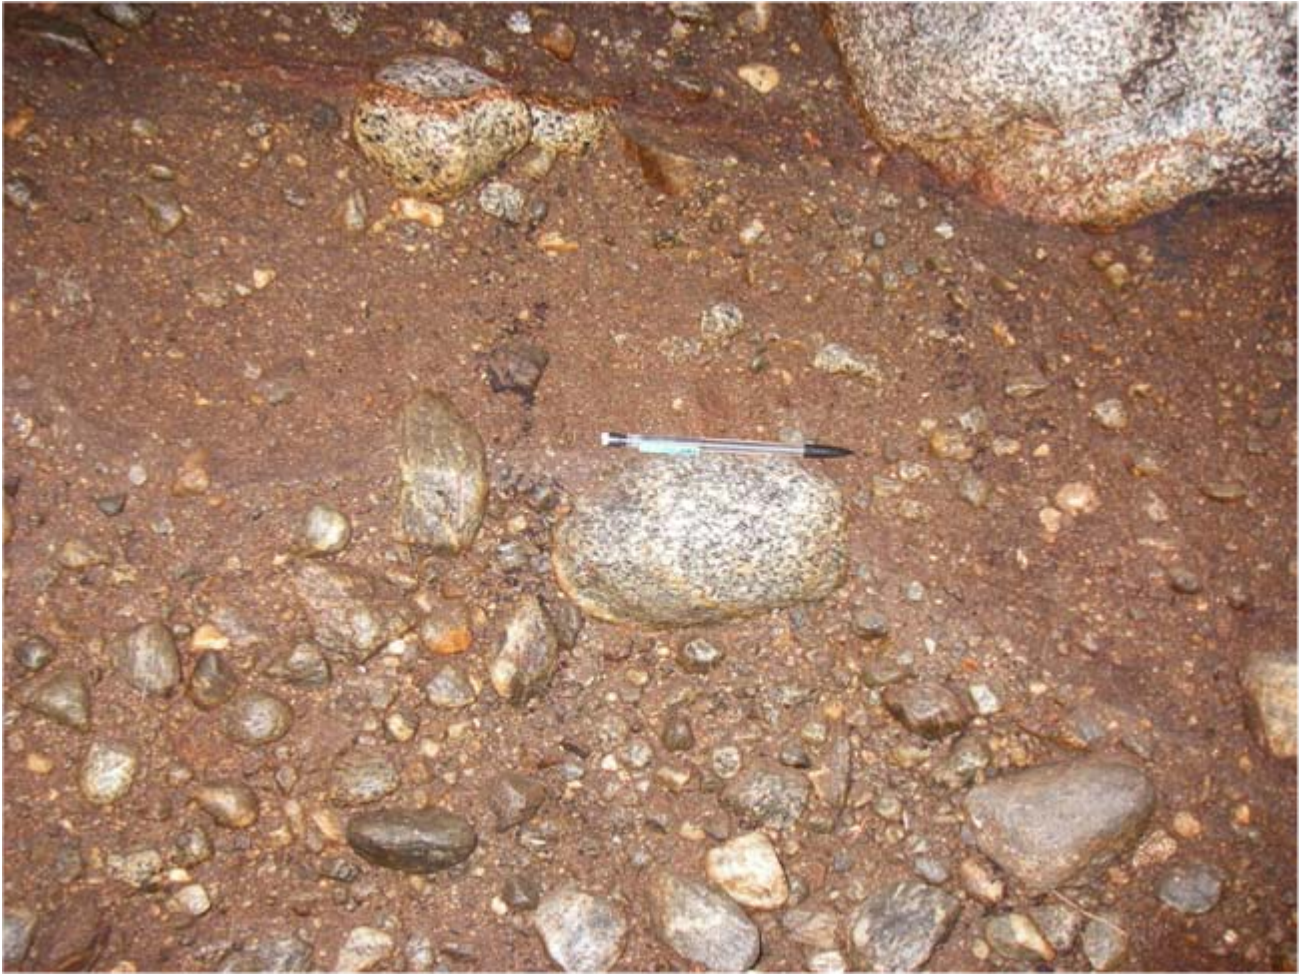
Glacial outwash deposits (Qgo) - View of typical glacial outwash deposit. Pencil approximately 6 inches long for scale. Photo taken 120 ft right of IRP 2006 2427+00.

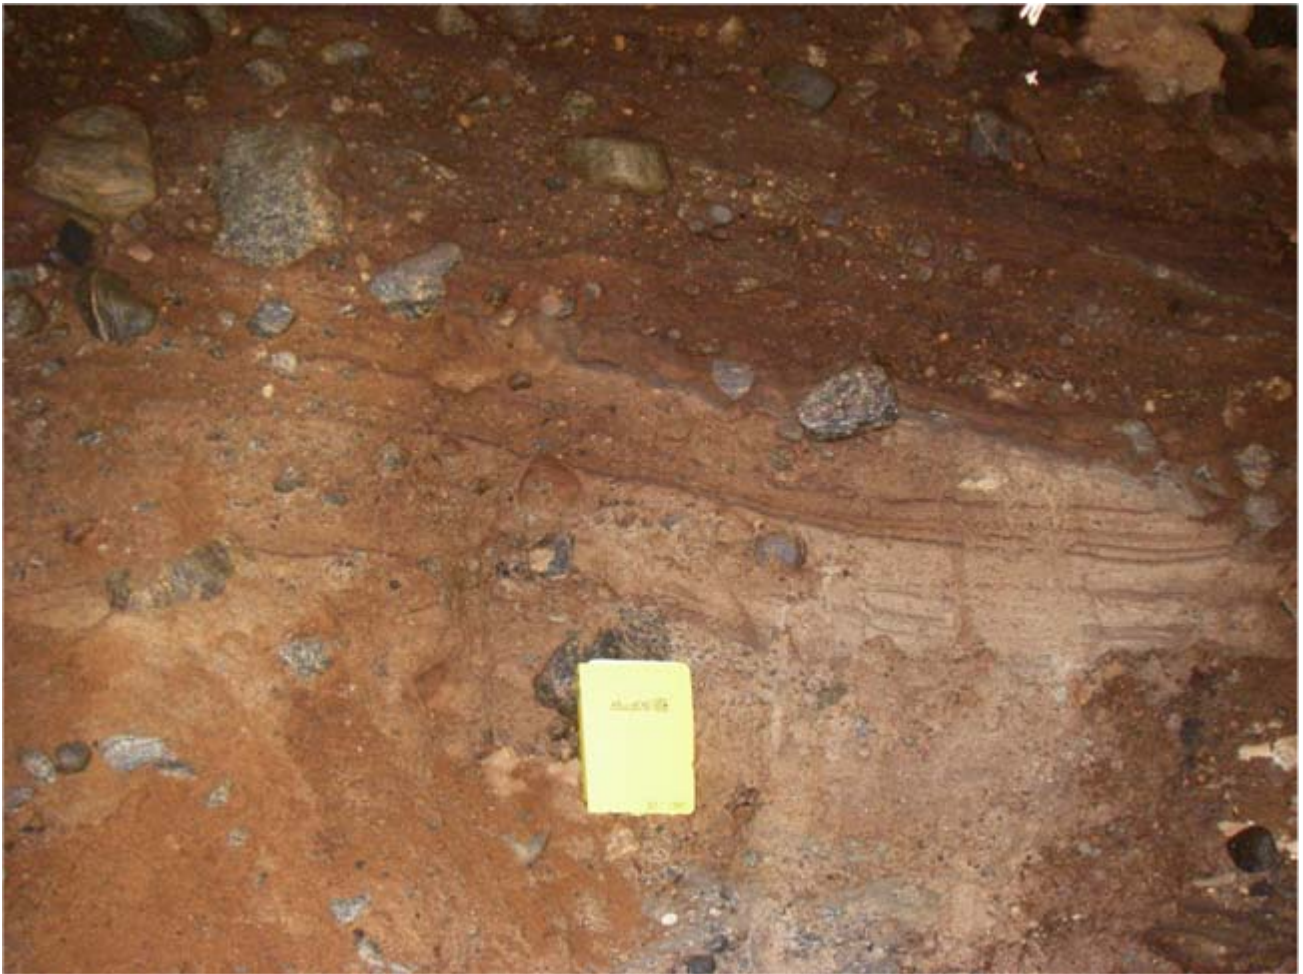
Glacial outwash deposits (Qgo) - View of typical glacial outwash deposit. Note stratification of sands. Field book approximately 5.5 inches wide for scale. Photo taken 120 ft right of IRP 2006 2427+00.

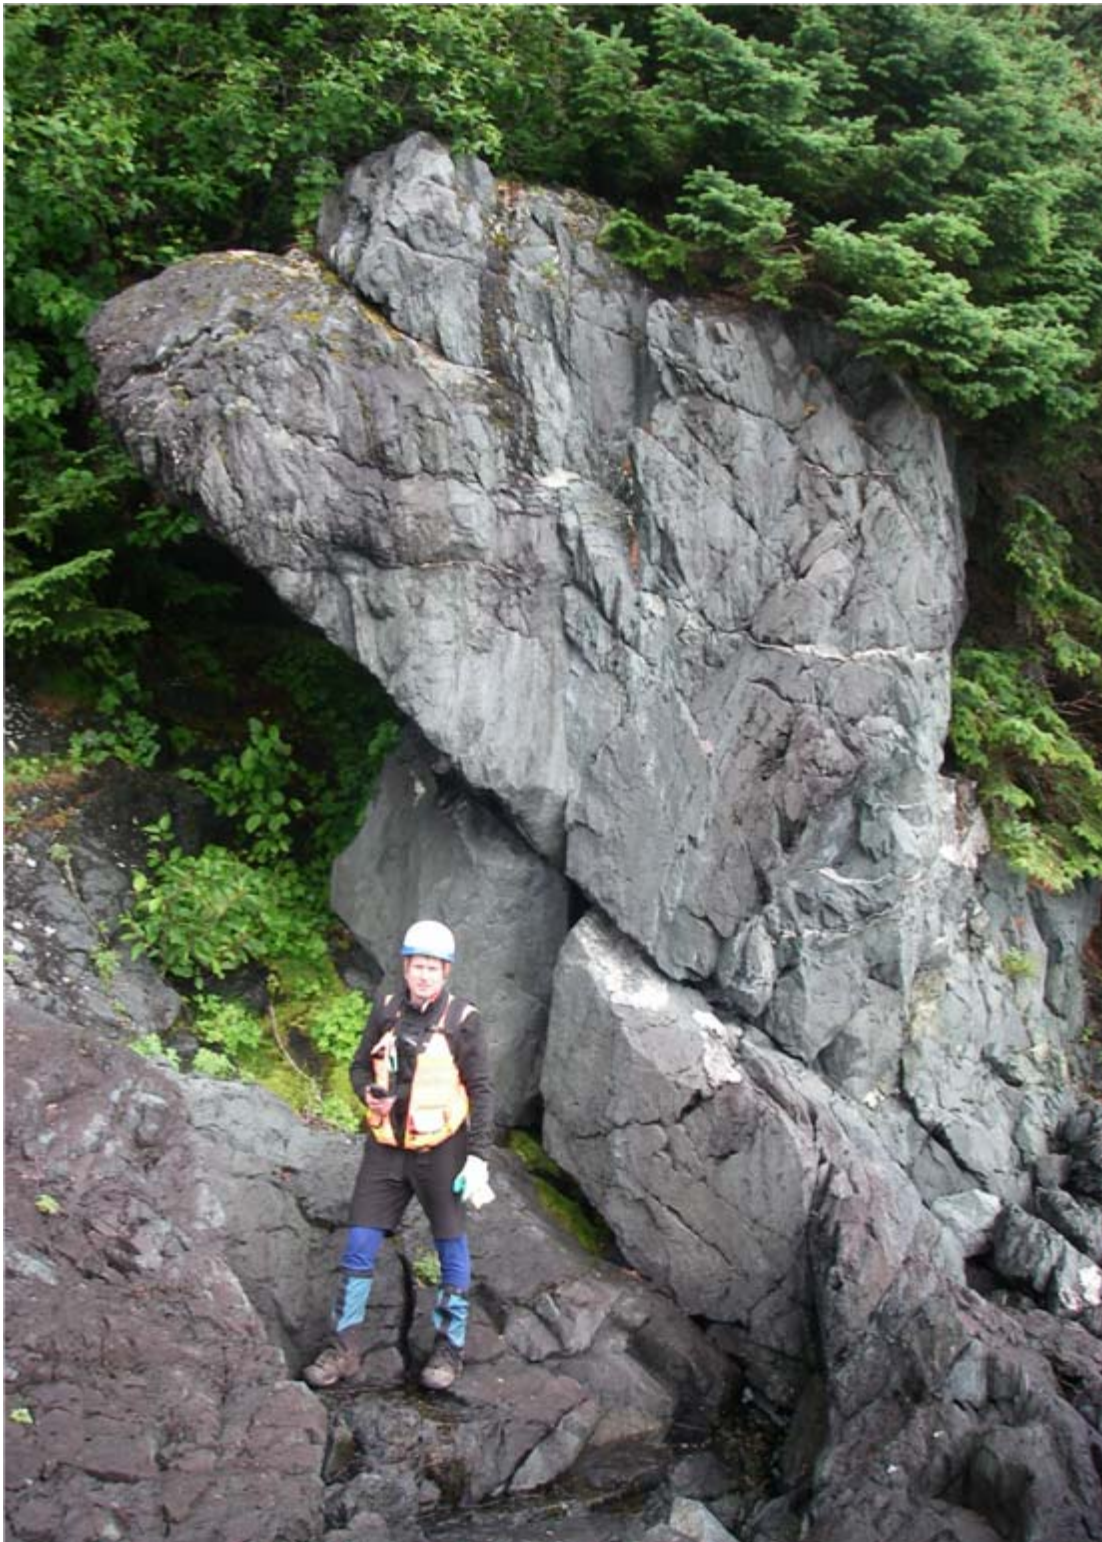
Basalt bedrock (Bxv) - view of typical basalt bedrock outcrop. Note massive appearance and multiple joint sets. Photo taken 15 ft left of IRP 2006 1716+00.

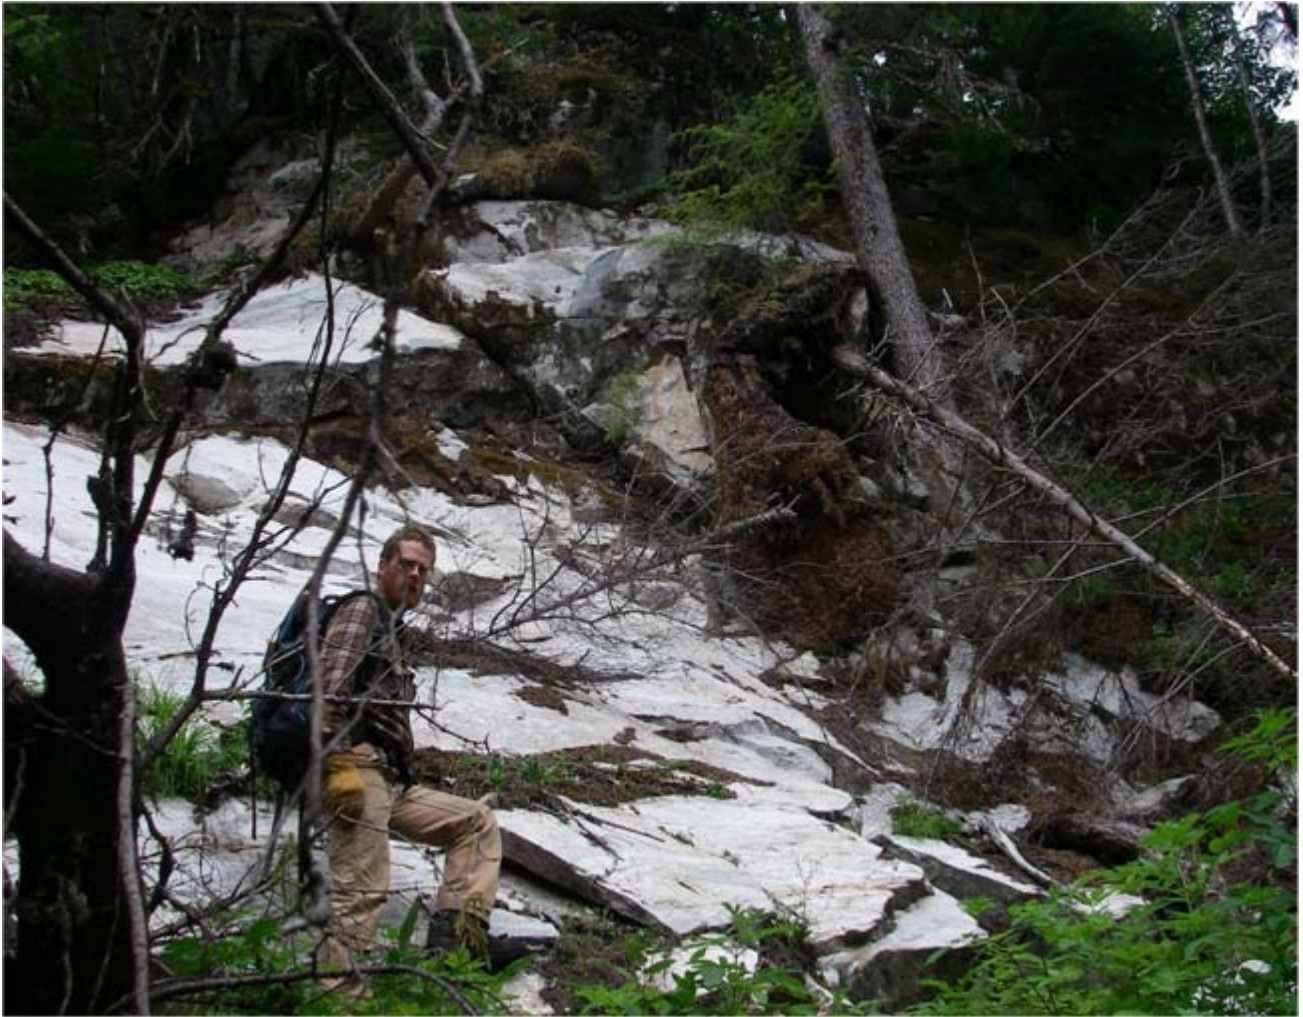
Gneiss bedrock (Bxmg) - View upslope of freshly exposed gneiss outcrop. Photo taken 140 ft right of IRP 2006 2605+00.

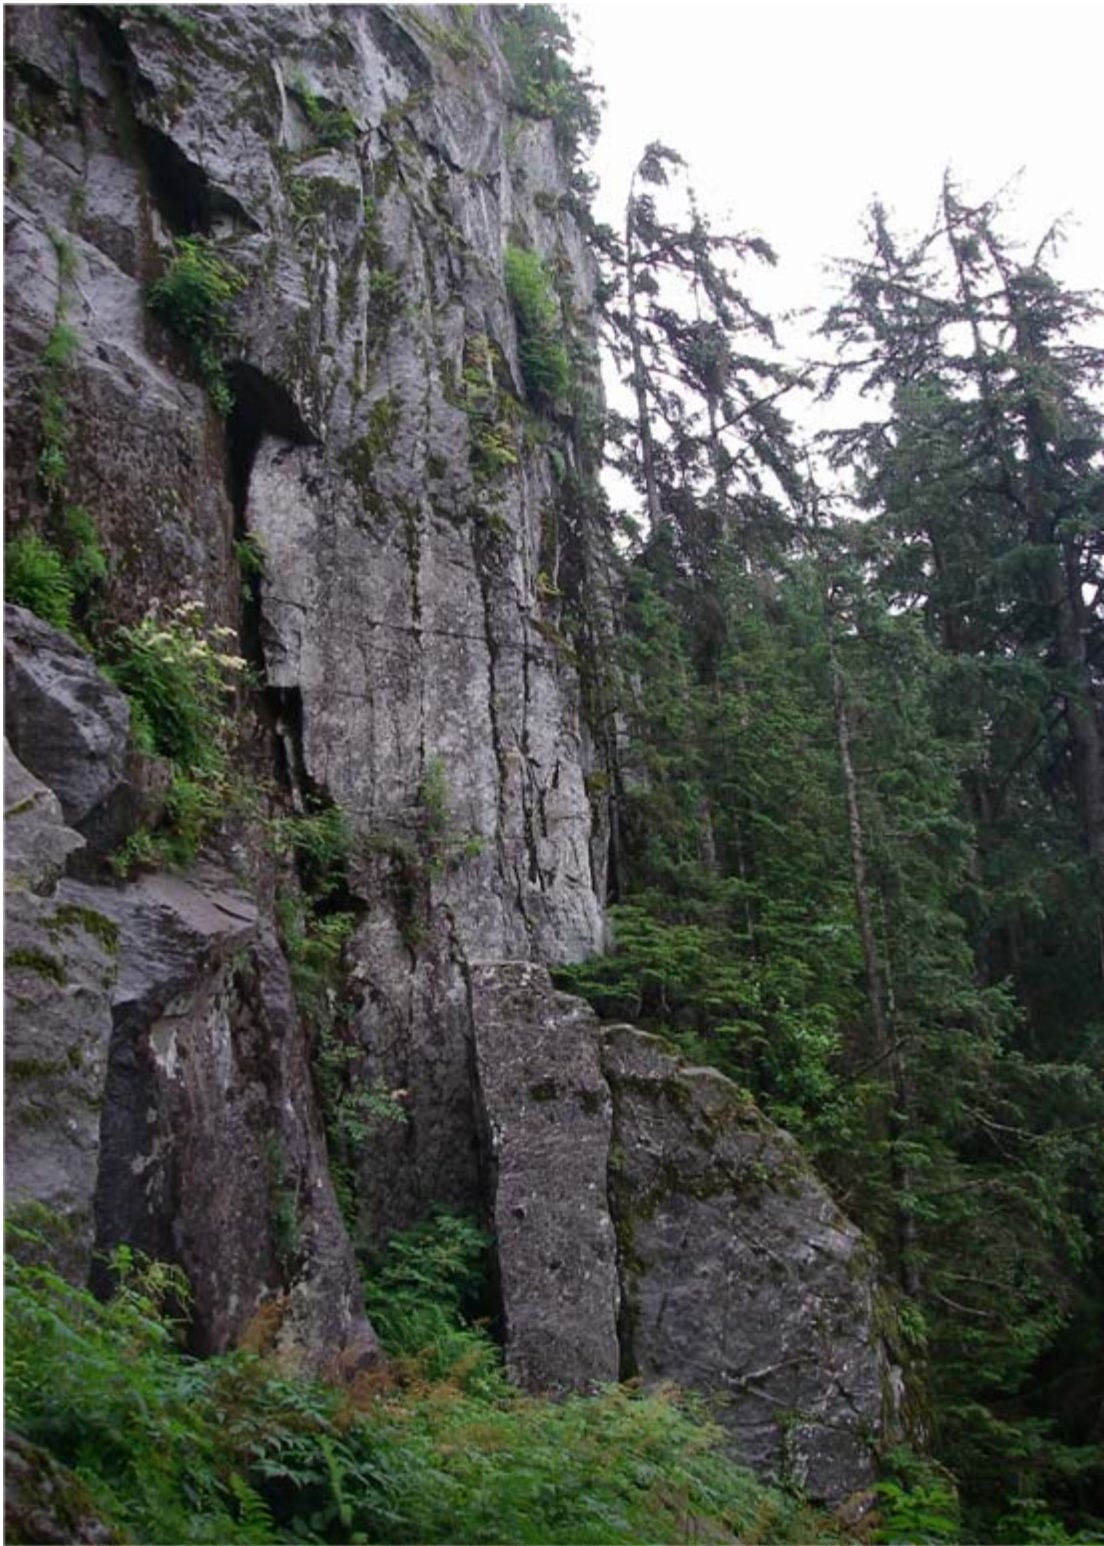
Gneiss bedrock (Bxmg) - View of typical gneiss cliff. Note prominent joint set. Visible cliff is approximately 150 ft tall. Photo taken 100 ft right of IRP 2006 2365+00.

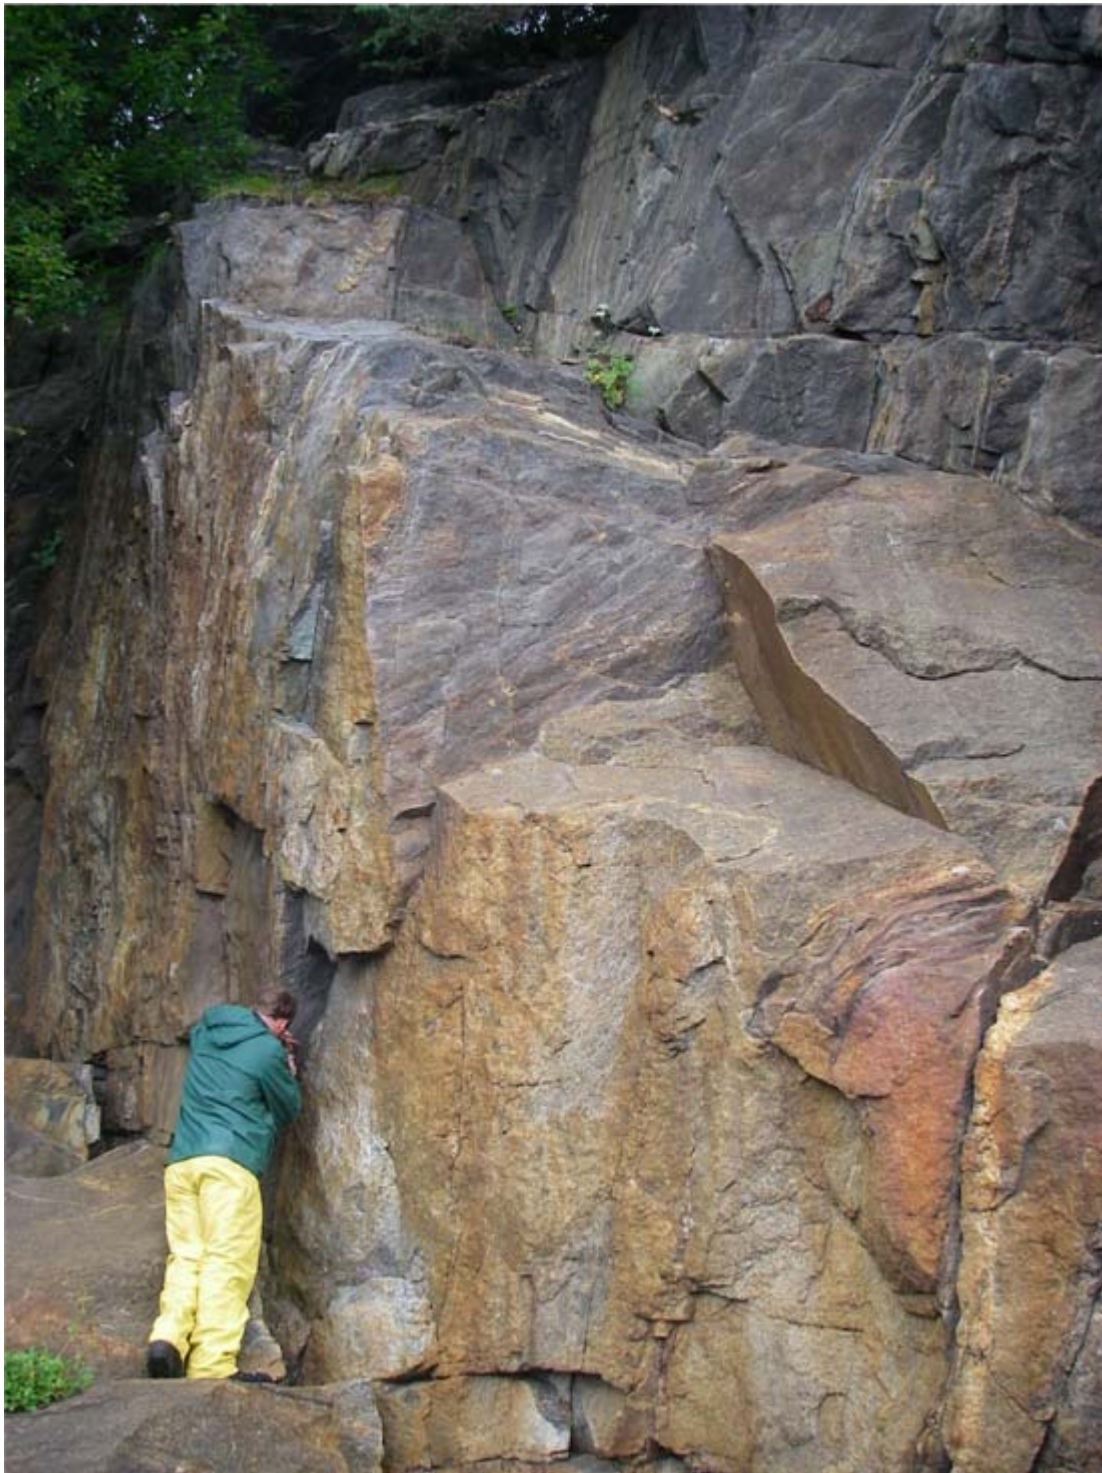
Undifferentiated metamorphic bedrock (Bxm) – View east at a shoreline cliffs greater than 40 ft high, with banded gneiss and metasedimentary bedrock (quartzite and metamorphosed carbonate observed.) Photo taken on centerline at IRP 2006 2106+75.
