WETLANDS TECHNICAL REPORT

JUNEAU ACCESS IMPROVEMENTS SUPPLEMENTAL DRAFT ENVIRONMENTAL IMPACT STATEMENT

**STATE PROJECT NUMBER: 71100
FEDERAL PROJECT NUMBER: STP-000S (131)**

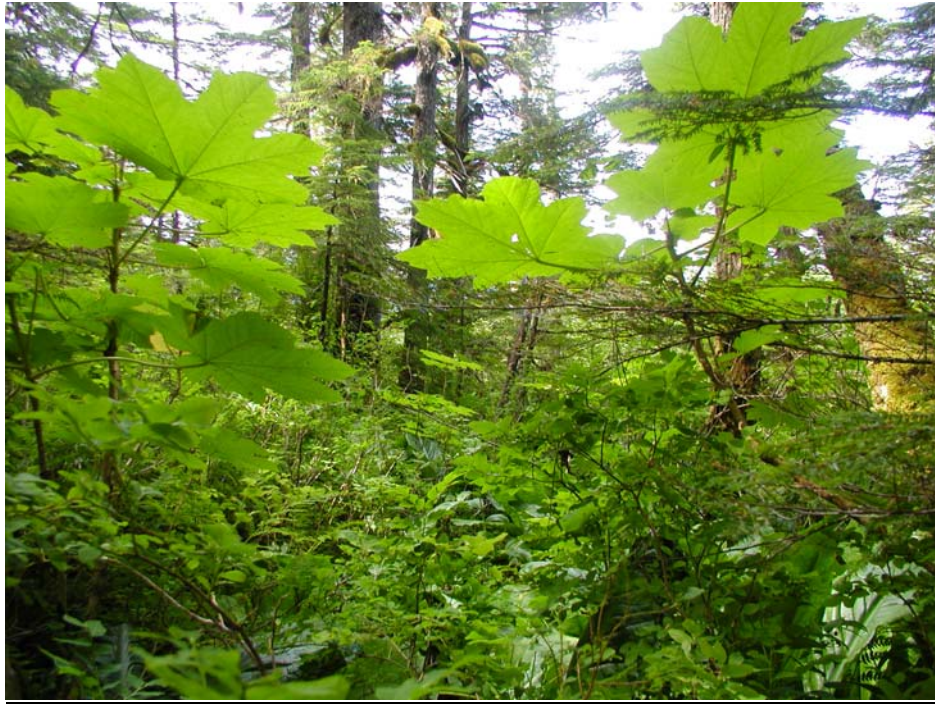
Needleleaf forested wetland vegetation at site 415-1

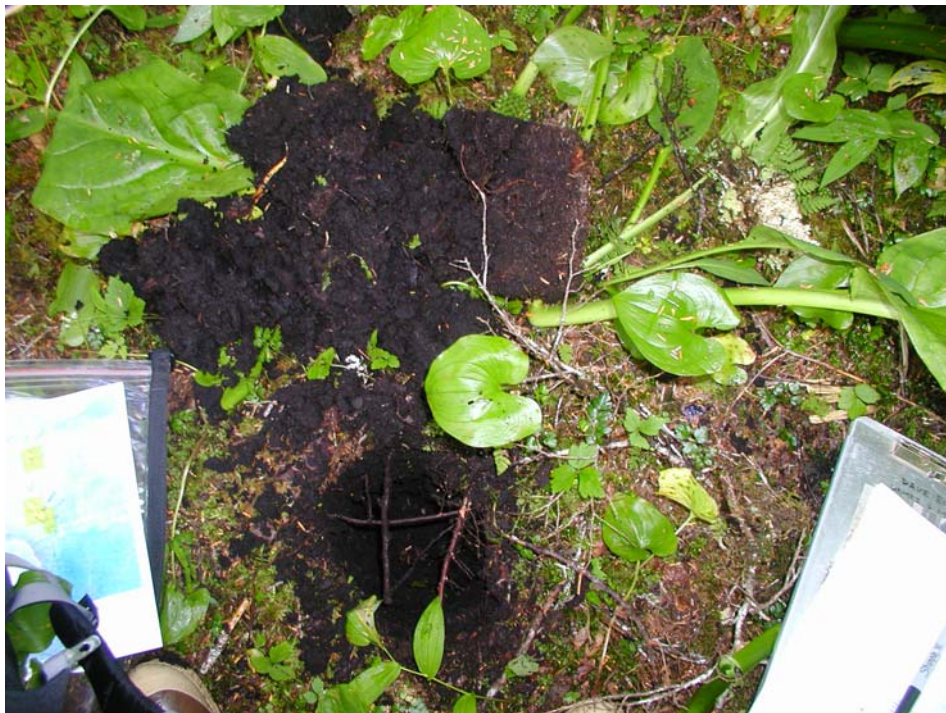
Hydric soil at site 415-1

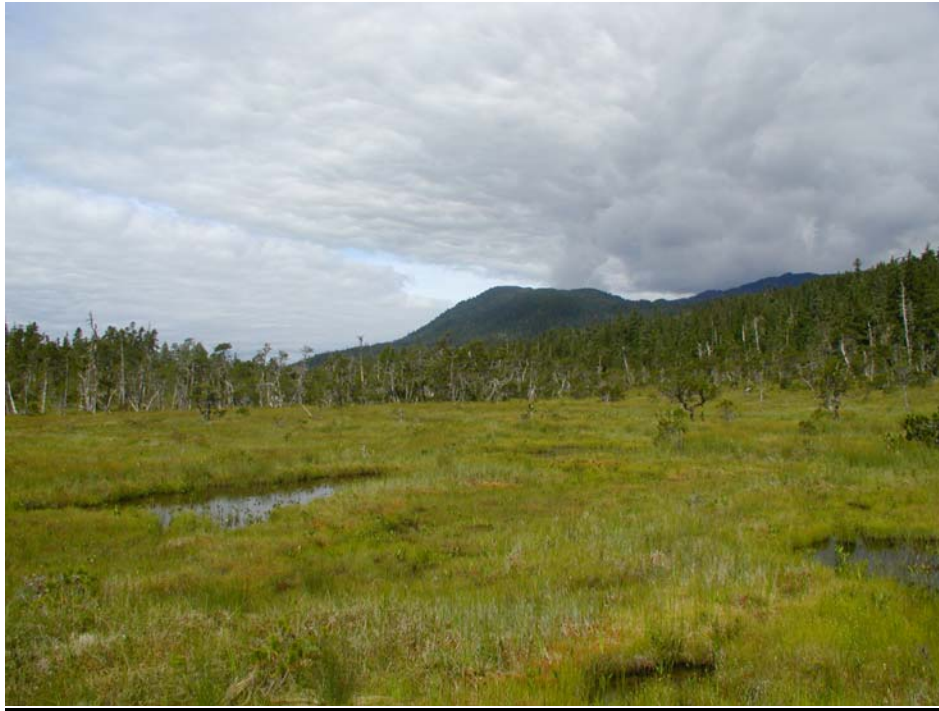
Emergent and scrub-shrub wetland vegetation at site 955-1

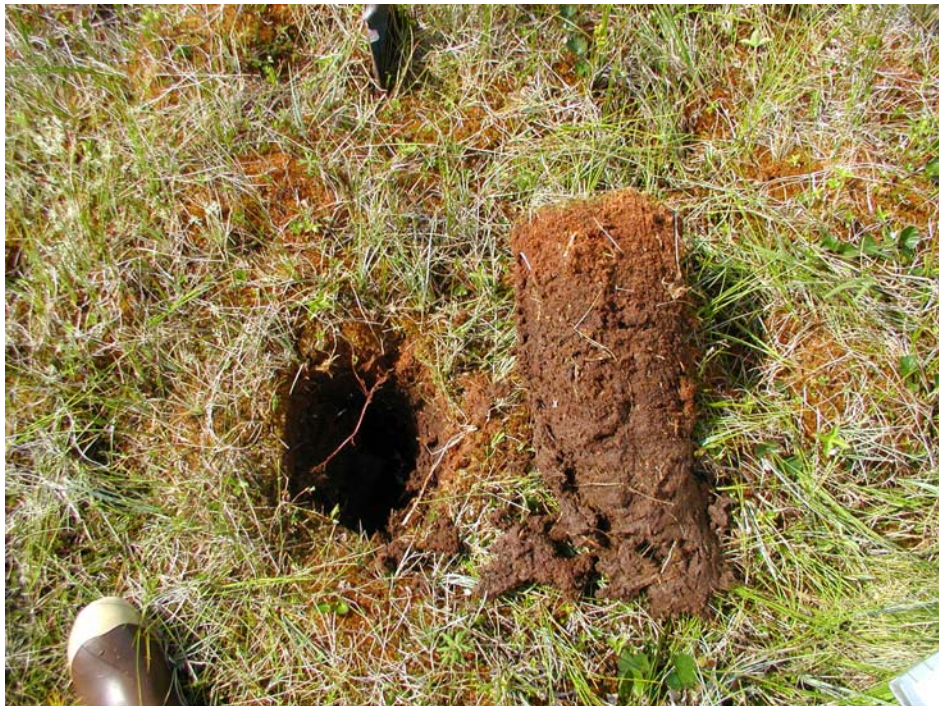
Hydric peat soils at site 955-1

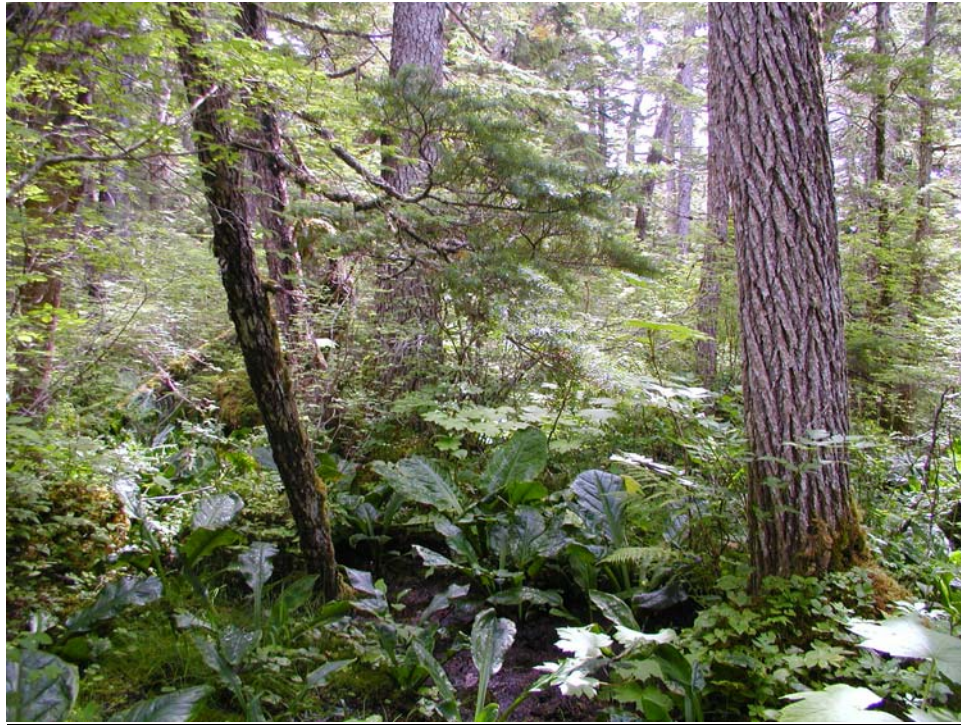
Needleleaf forested wetland vegetation at site 955-2

Wetland functions for the large continuous band of forested wetlands (955-2; Figures 8 and 9) are rated high for sediment retention; high to moderate for groundwater recharge, groundwater discharge, and lateral flow; and high for ecological replacement cost. Emergent/scrub-shrub wetlands (e.g., 955-1) are generally rated high to moderate for groundwater recharge and high for sediment retention.

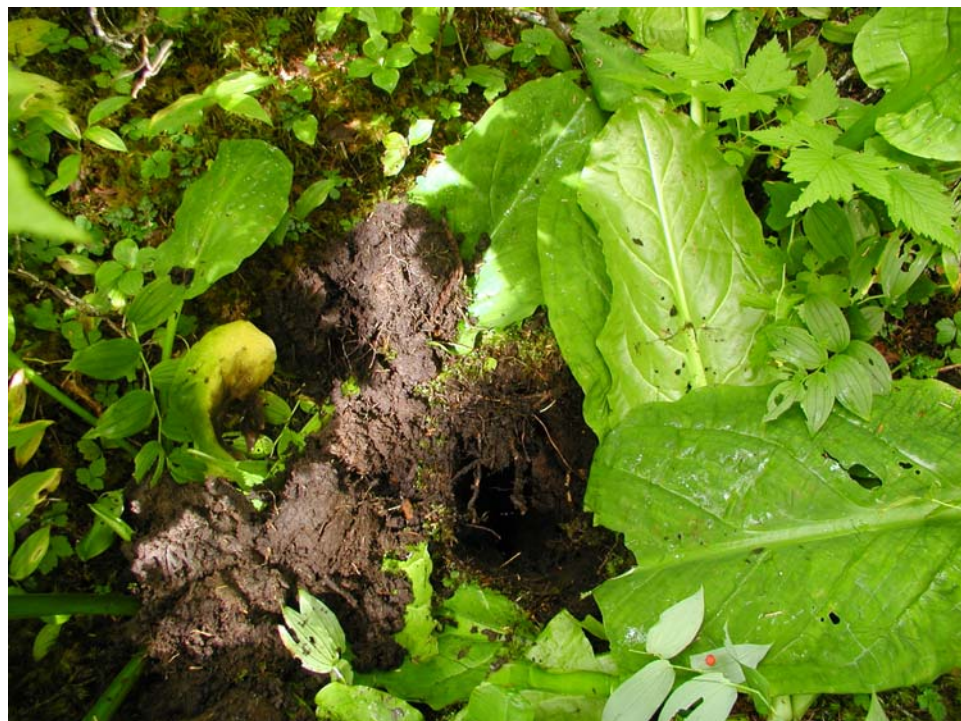
Hydric soil at 955-2

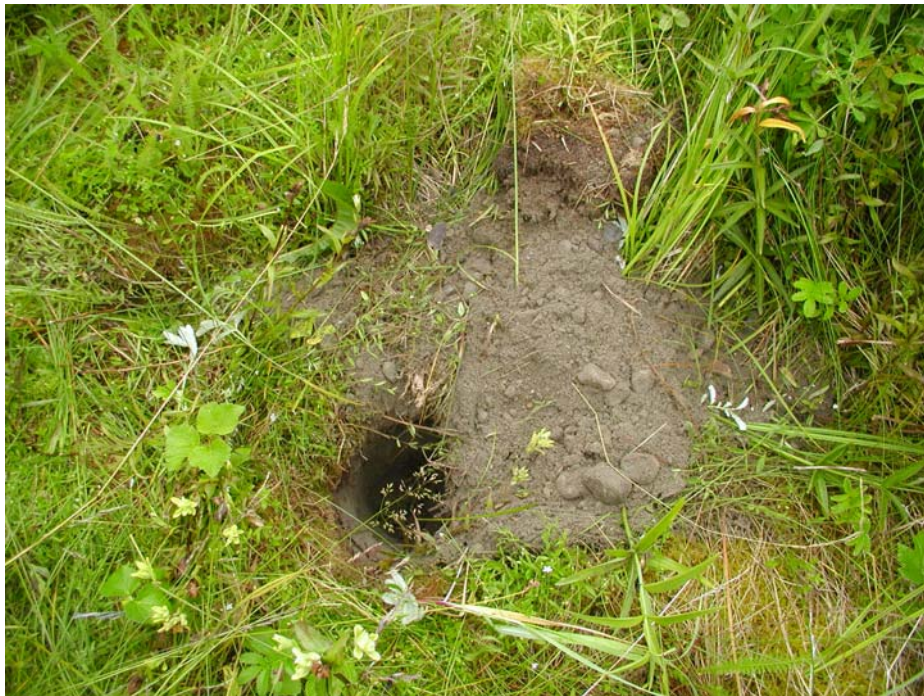
Upland soil at site 2630-3

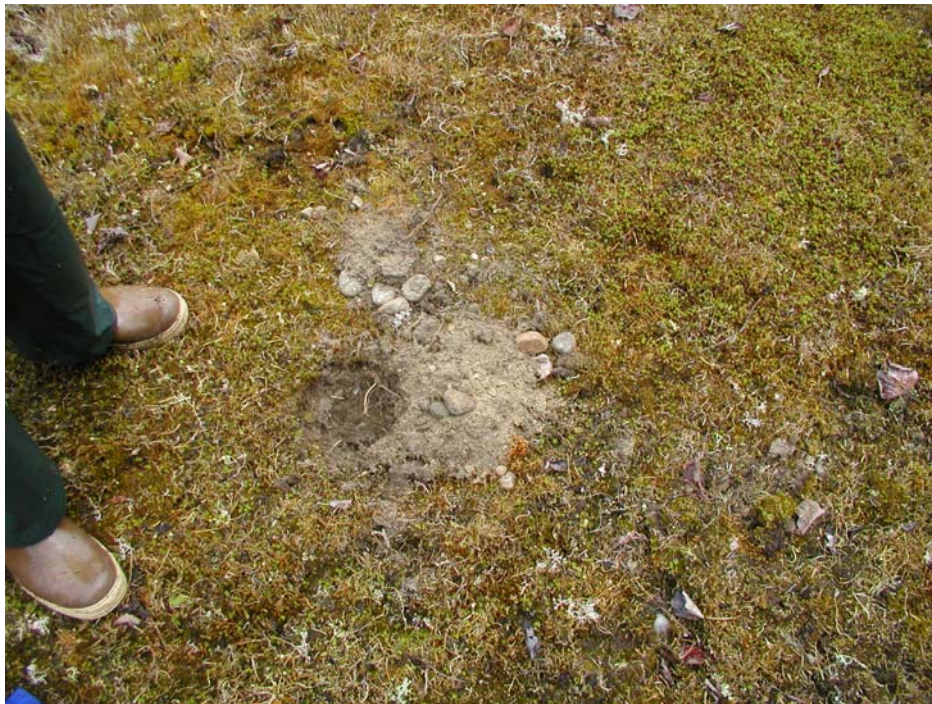
Gravel and sand upland soil at site 2665-1

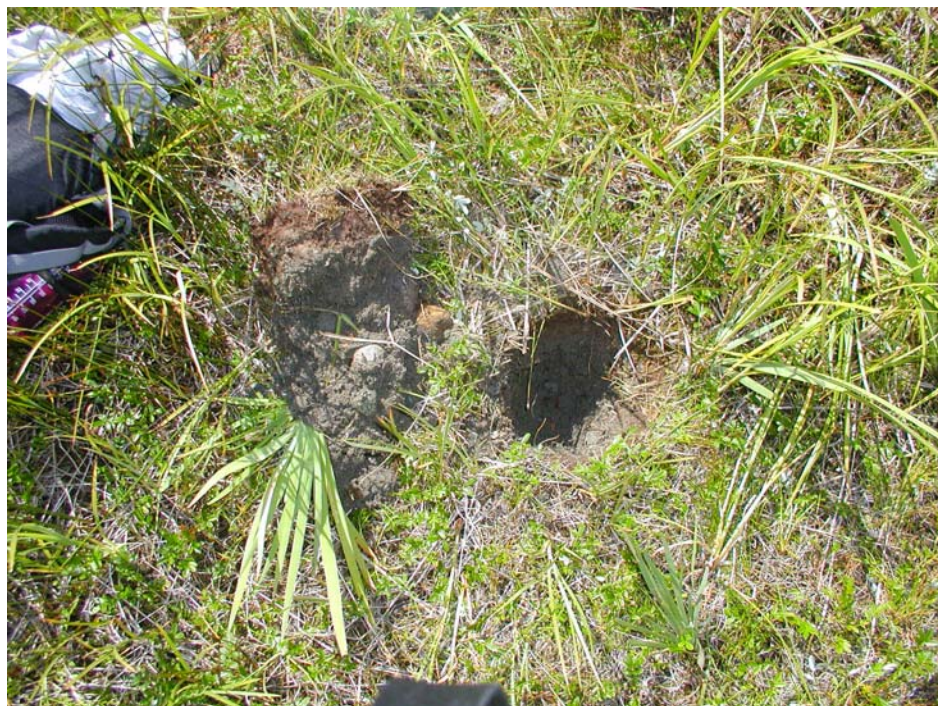
Upland soil at site 2735-1

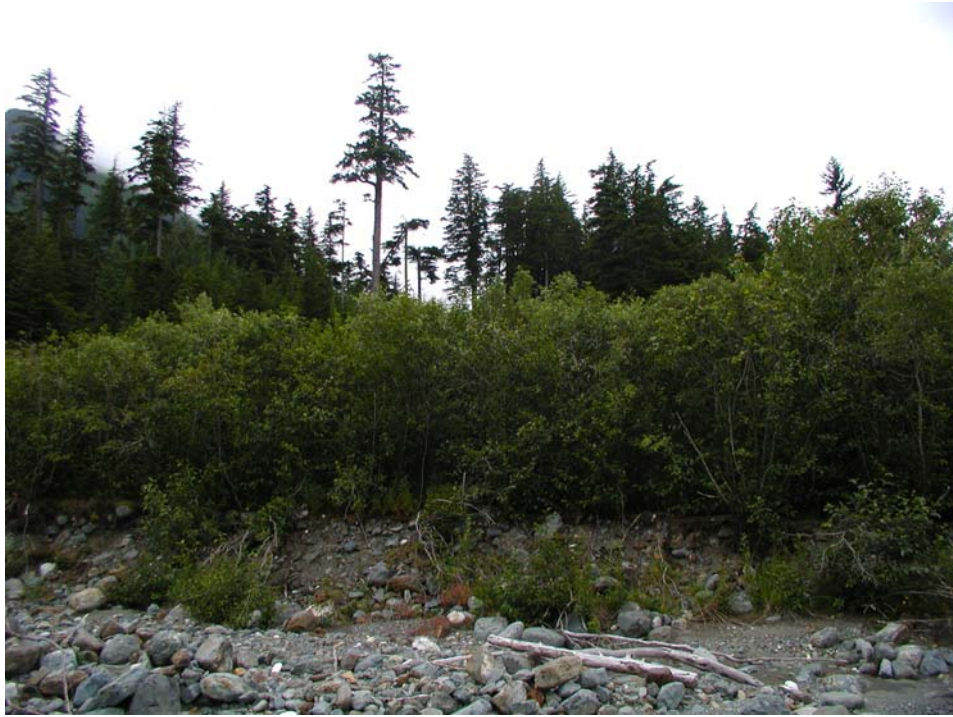
Eroding slopes near stream at site 5150-1, looking north from center of alignment

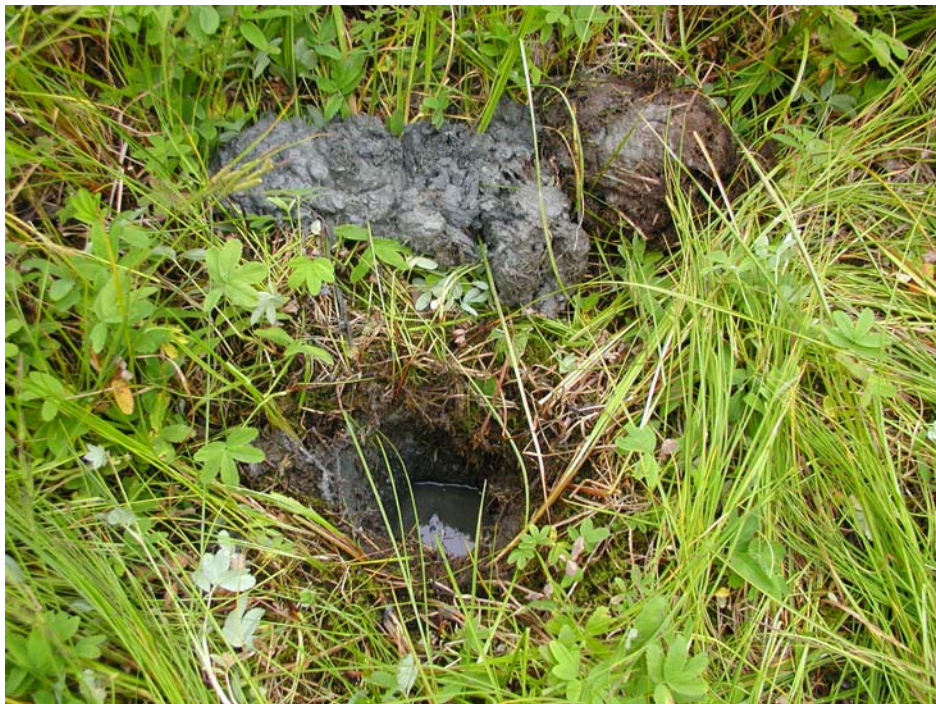
Gleyed hydric soil at site 5595-1

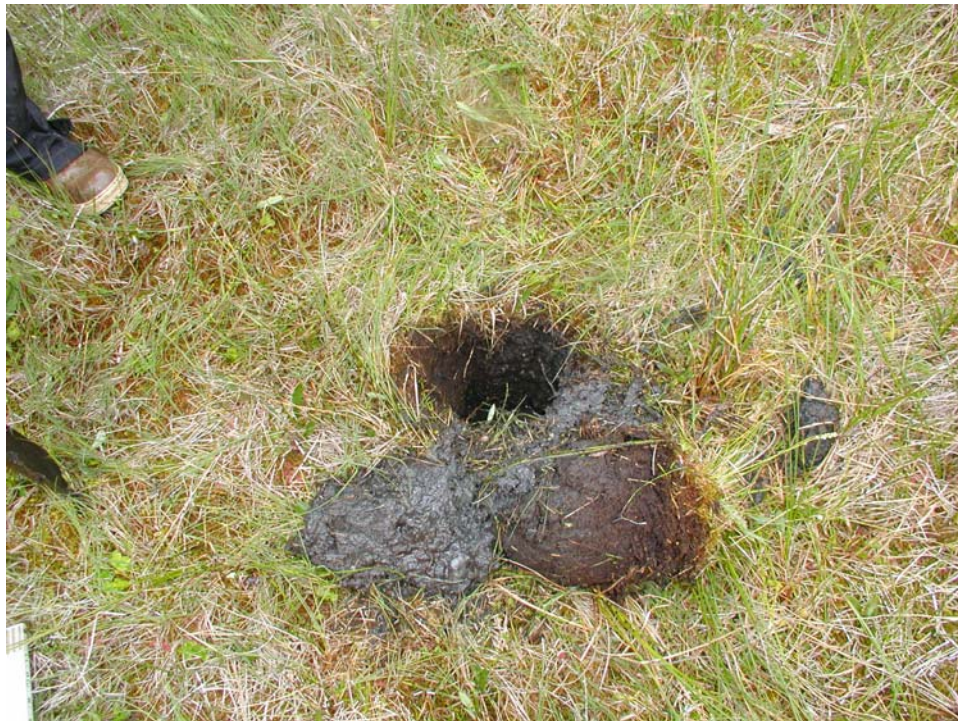
Gleyed hydric soil at site 5660-3

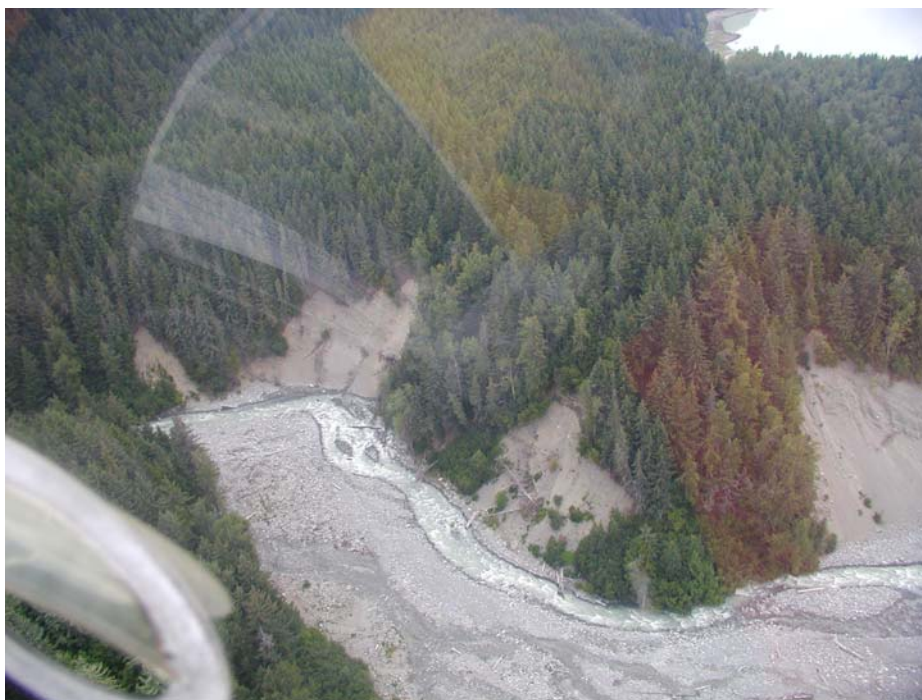
Stream and eroding banks at site 5910-1
