# **ANADROMOUS AND RESIDENT FISH STREAMS TECHNICAL REPORT**

## **JUNEAU ACCESS IMPROVEMENTS SUPPLEMENTAL DRAFT ENVIRONMENTAL IMPACT STATEMENT**

**STATE PROJECT NUMBER: 71100  
FEDERAL PROJECT NUMBER: STP-000S (131)**

**OCTOBER 2004**

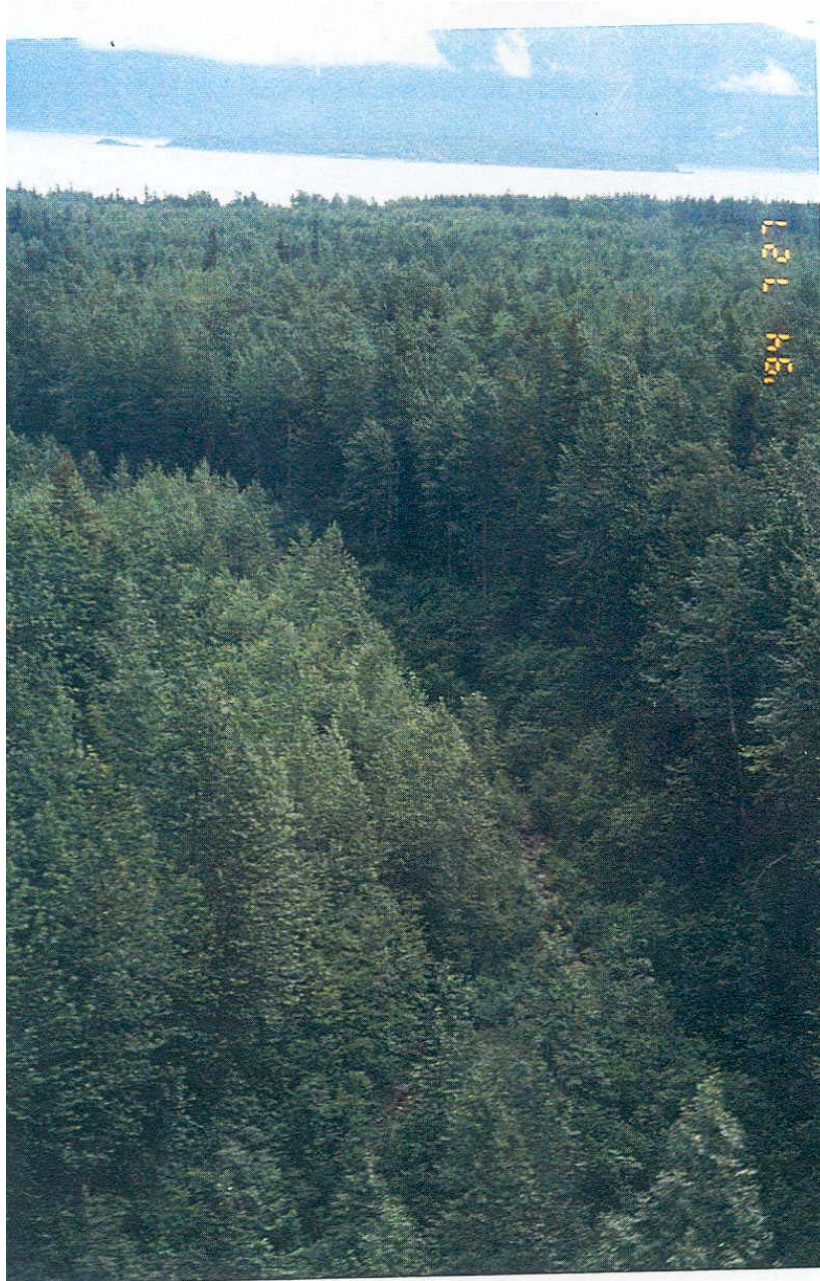
**Davidson River as shown on the 1954 quad map was dry in 1994. The river flowing from Davidson Lake changed course to Stream 17BW.**
