Appendix C: Fish

KATLIAN BAY ROAD CONSTRUCTION

SUBJECT: Katlian Bay Road

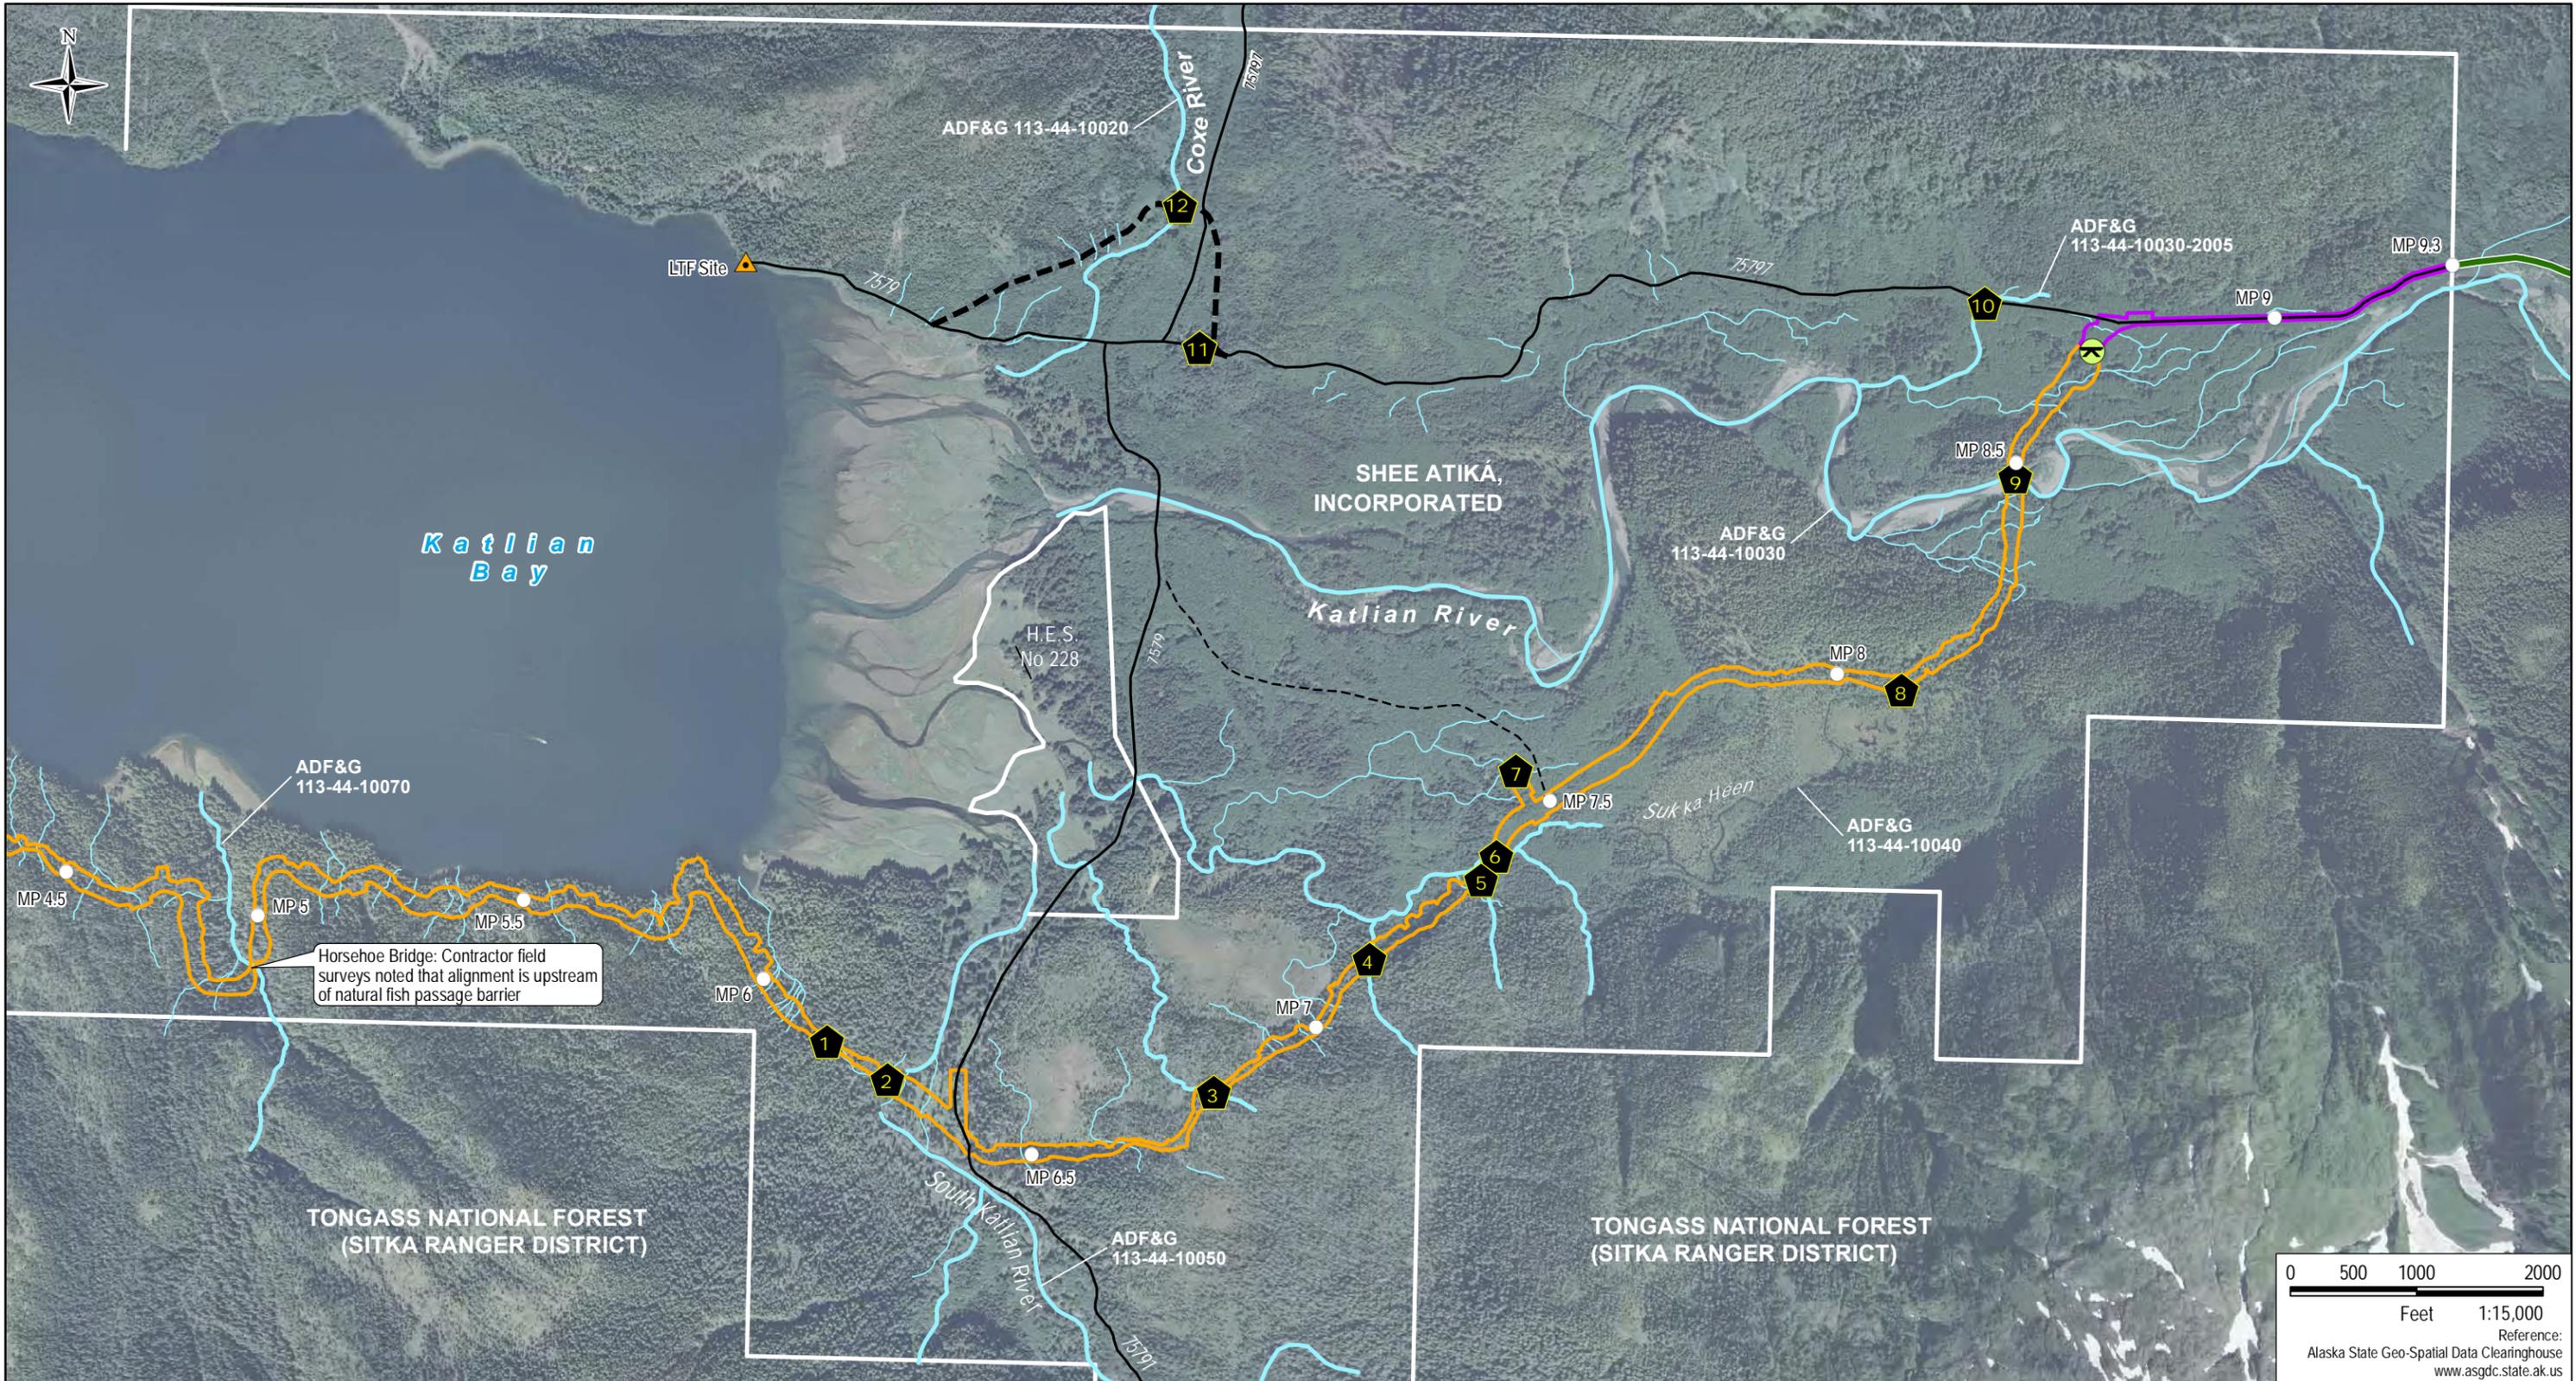
FIGURE C-1 Proposed Action and Fish Stream Crossings

1	2	3	4	5	6	7	8	9	10	11	12
STREAM NAME	Unnamed Tributary to South Katlian River	South Katlian River and overflow channels	Unnamed Tributary to Katlian Bay	Unnamed Tributary to Sukka Héen	Unnamed Tributary to Sukka Héen	Sukka Héen	Unnamed Tributary to Sukka Héen	Unnamed Tributary to Sukka Héen	Katlian River and overflow channels	Unnamed Tributary to Katlian River	Unnamed Tributary to Katlian River	Coxe River
ADF&G	Uncatalogued	113-44-10050	Uncatalogued	Uncatalogued	Uncatalogued	113-44-10040	Uncatalogued	Uncatalogued	113-44-10030	113-44-10030-2005	Uncatalogued	113-44-10020
MILEPOST (approx.)	MP 6.20	MP 6.24	MP 6.80	MP 7.15	MP 7.30	MP 7.39	MP 7.50	MP 8.10	MP 8.49	FR 75797	FR 75797	FR 75797
PROPOSED ACTION	Culvert upstream of fish habitat Road bed within riparian buffer	Bridge across river Culverts for 2 overflow channels	Culvert	Structural plate pipe arch	Structural plate pipe arch	Structural plate pipe arch	Replace culvert for existing road for construction access to log deck area	Road bed within riparian buffer	Bridge across river Culverts for 5 overflow channels	Replace existing log culvert for construction access	Replace existing log culvert for construction access	Permanent bridge for construction access

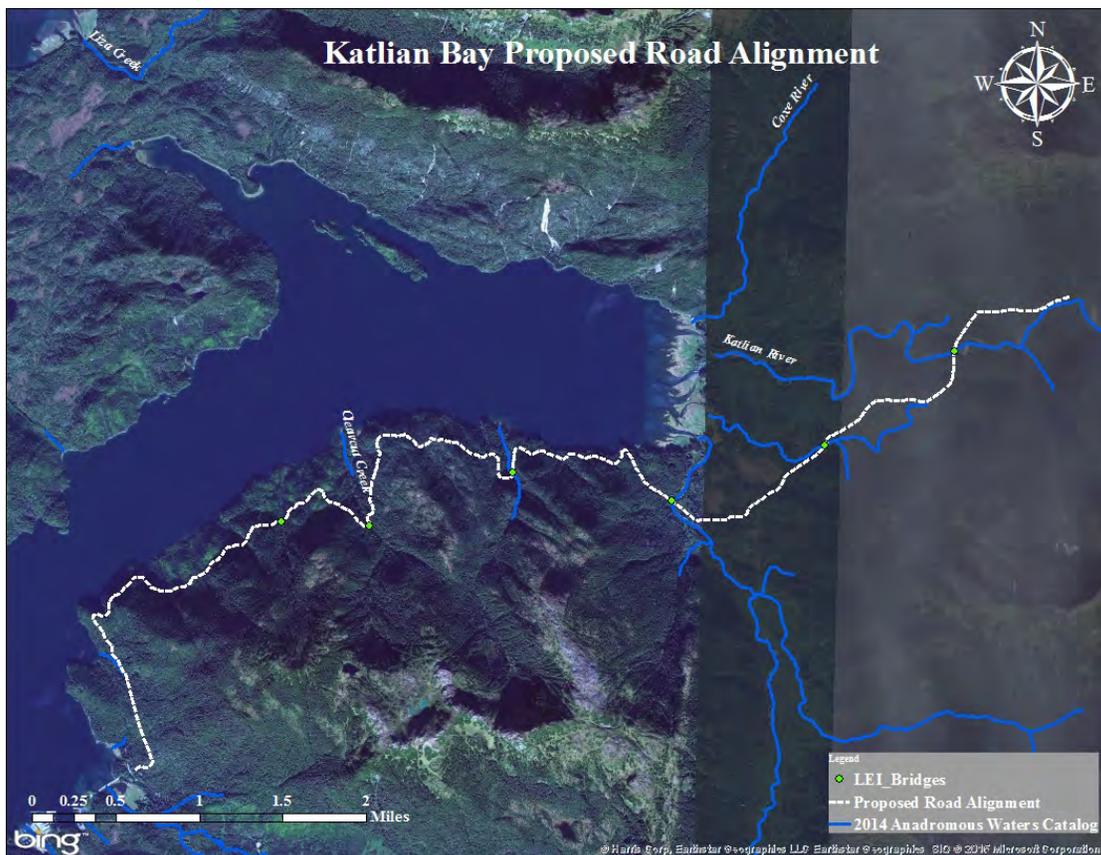
Figure 1.-Katlian Bay Road Alignment map.

The Alaska Department of Transportation and Public Facilities (ADOT&PF) proposes to build a one-lane, unpaved road between Starrigavan Bay and Katlian Bay, connecting Halibut Point Road in Sitka with U.S. Forest Service roads (Figure 1). The new road would be approximately 9 miles long and provide access to recreation and subsistence areas, and material sources located on private, state, and federal lands. ADOT&PF's chosen alignment includes 66 locations for culverts or bridges.

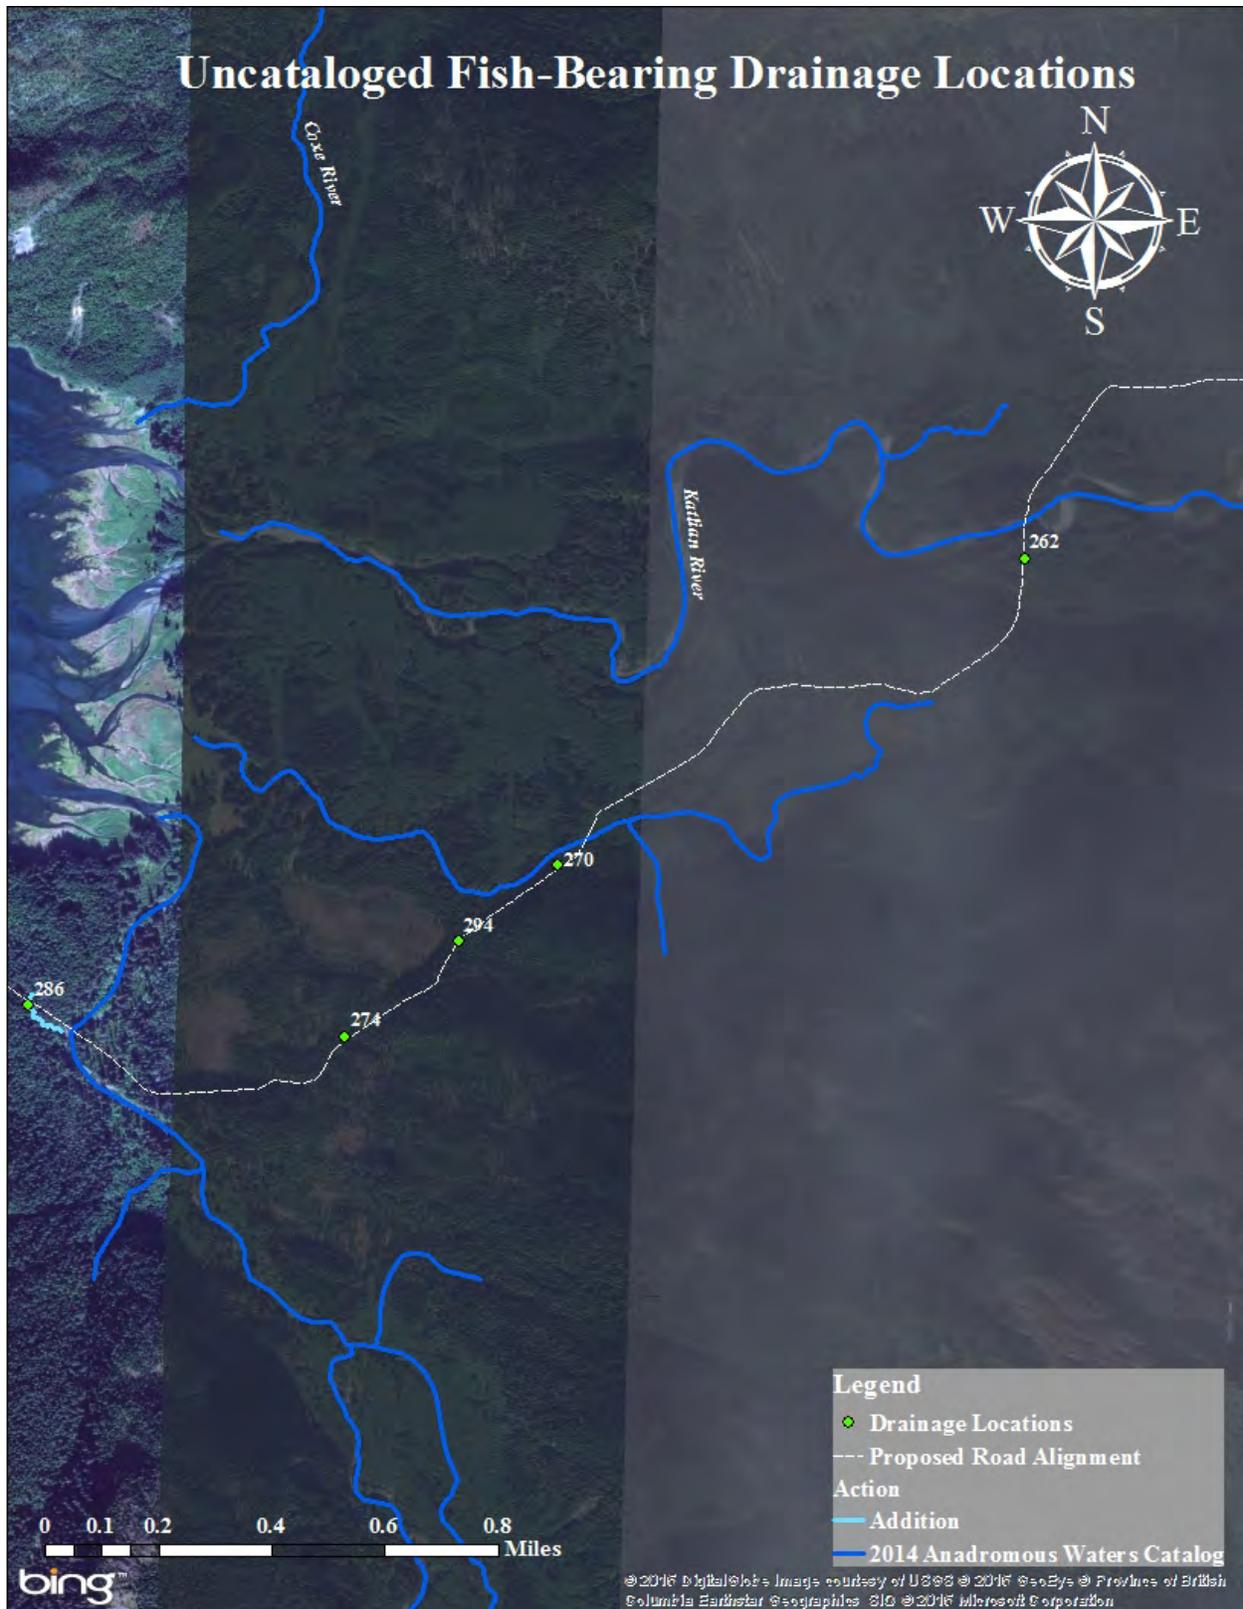
Figure 2.—Uncataloged fish-bearing drainages map.

During the week of May 10, 2015, Habitat biologist Gordon Willson-Naranjo and I surveyed streams along the proposed road corridor to document fish presence at stream crossings. The first 6 miles of the proposed route is in steep terrain, so we focused our efforts on the last 3 miles of the alignment where we would most likely encounter fish. We identified five uncataloged fish-bearing drainages (Table 1, Figures 2–8).

Waypoint	Latitude	Longitude	Notes	Sample Effort	Sample Results
262	57.1702	-135.237	Intermittent dry channel. 1 DV captured at the crossing. Five above the crossing.	EF	6 DV
270	57.1621	-135.2586	Small trib just before elevation gain.	EF	2 CO, 2 DV
294	57.1601	-135.2632	Very dry stream. Large cobble substrate. Water just seeping through rock. 3 DV.	EF	3 DV
274	57.1576	-135.2684	2 CO captured 20 yrds down from the crossing. Mid gradient, bedrock and cobbles. No spawning gravel. No fish at crossing, but no barrier. Visual on fish above the alignment.	EF	2 CO, 1 VI of salmonid
286	57.1582	-135.2833	Proposed road crossing anadromous stream, very low flows. We captured coho throughout this stream.	EF	Multi CO

I recommend we further investigate fish use and extent in the uncataloged and ephemeral drainages during ordinary stream flows, information necessary to determine Fish Habitat Permits required for the project.

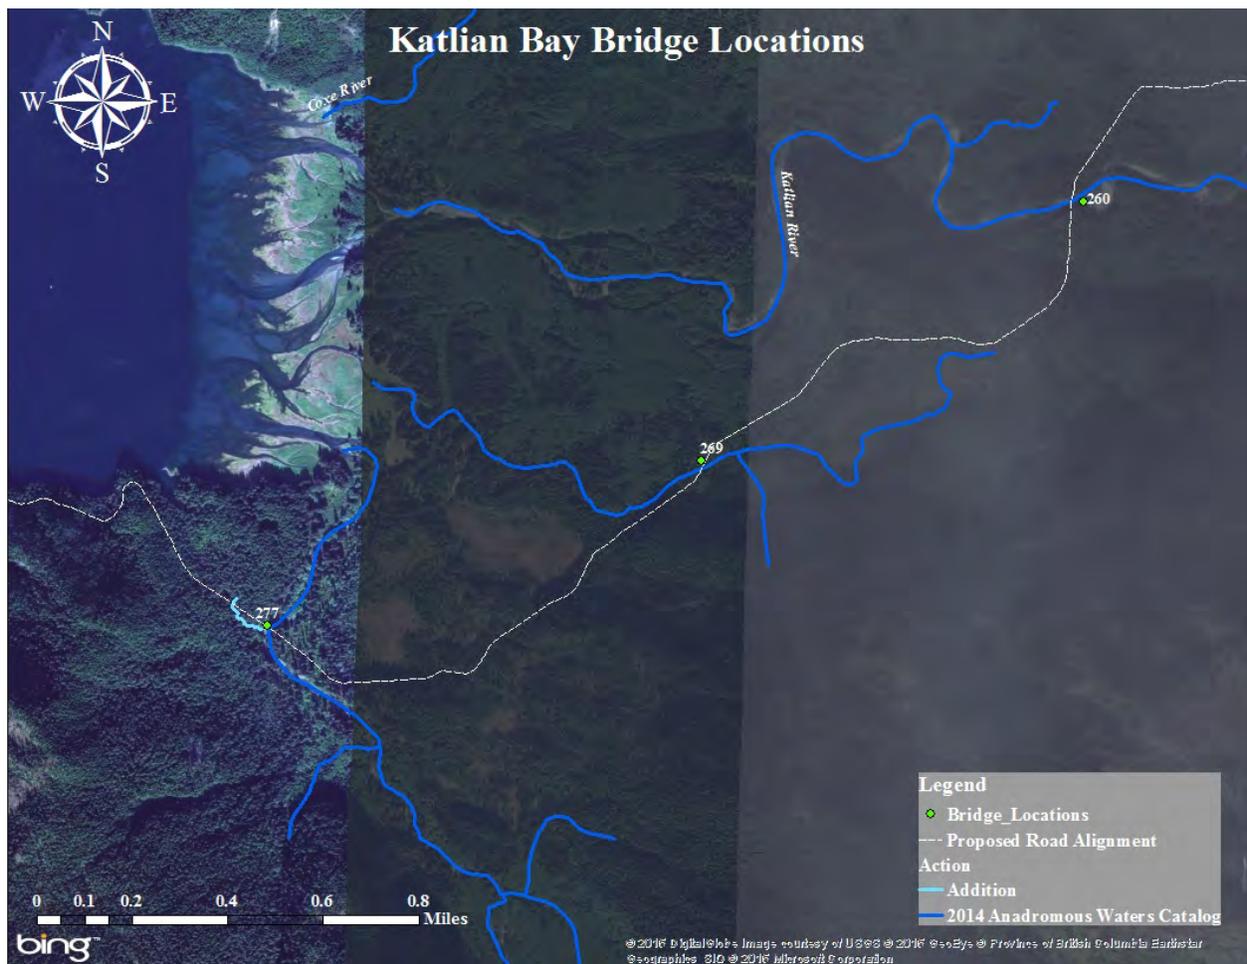
Figure 9.–Bridge site map.

We surveyed three of the six bridge crossings (Table 2, Figures 9–12). At the South Katlian bridge location we found an uncataloged drainage crossing the proposed road alignment. We captured juvenile coho salmon downstream of the proposed crossing, and provide details in the Anadromous Waters Catalog nomination report (Appendix A).

Waypoint	Latitude	Longitude	Notes	Sample Effort	Sample Results
260	57.1711	-135.2364	Multiple coho captured at the Katlian bridge crossing site.	EF	Multiple CO
269	57.163	-135.2574	Middle fork bridge crossing. 13 CO, 2 DV, 3 SC. Visual on many more coho.	EF	13 CO, 2 DV, 2 SC
277	57.1577	-135.2814	Bridge crossing. Large lovely stream. Supposedly a forest service road somewhere... 1 CO, 1 DV.	EF	1 CO, 1 DV

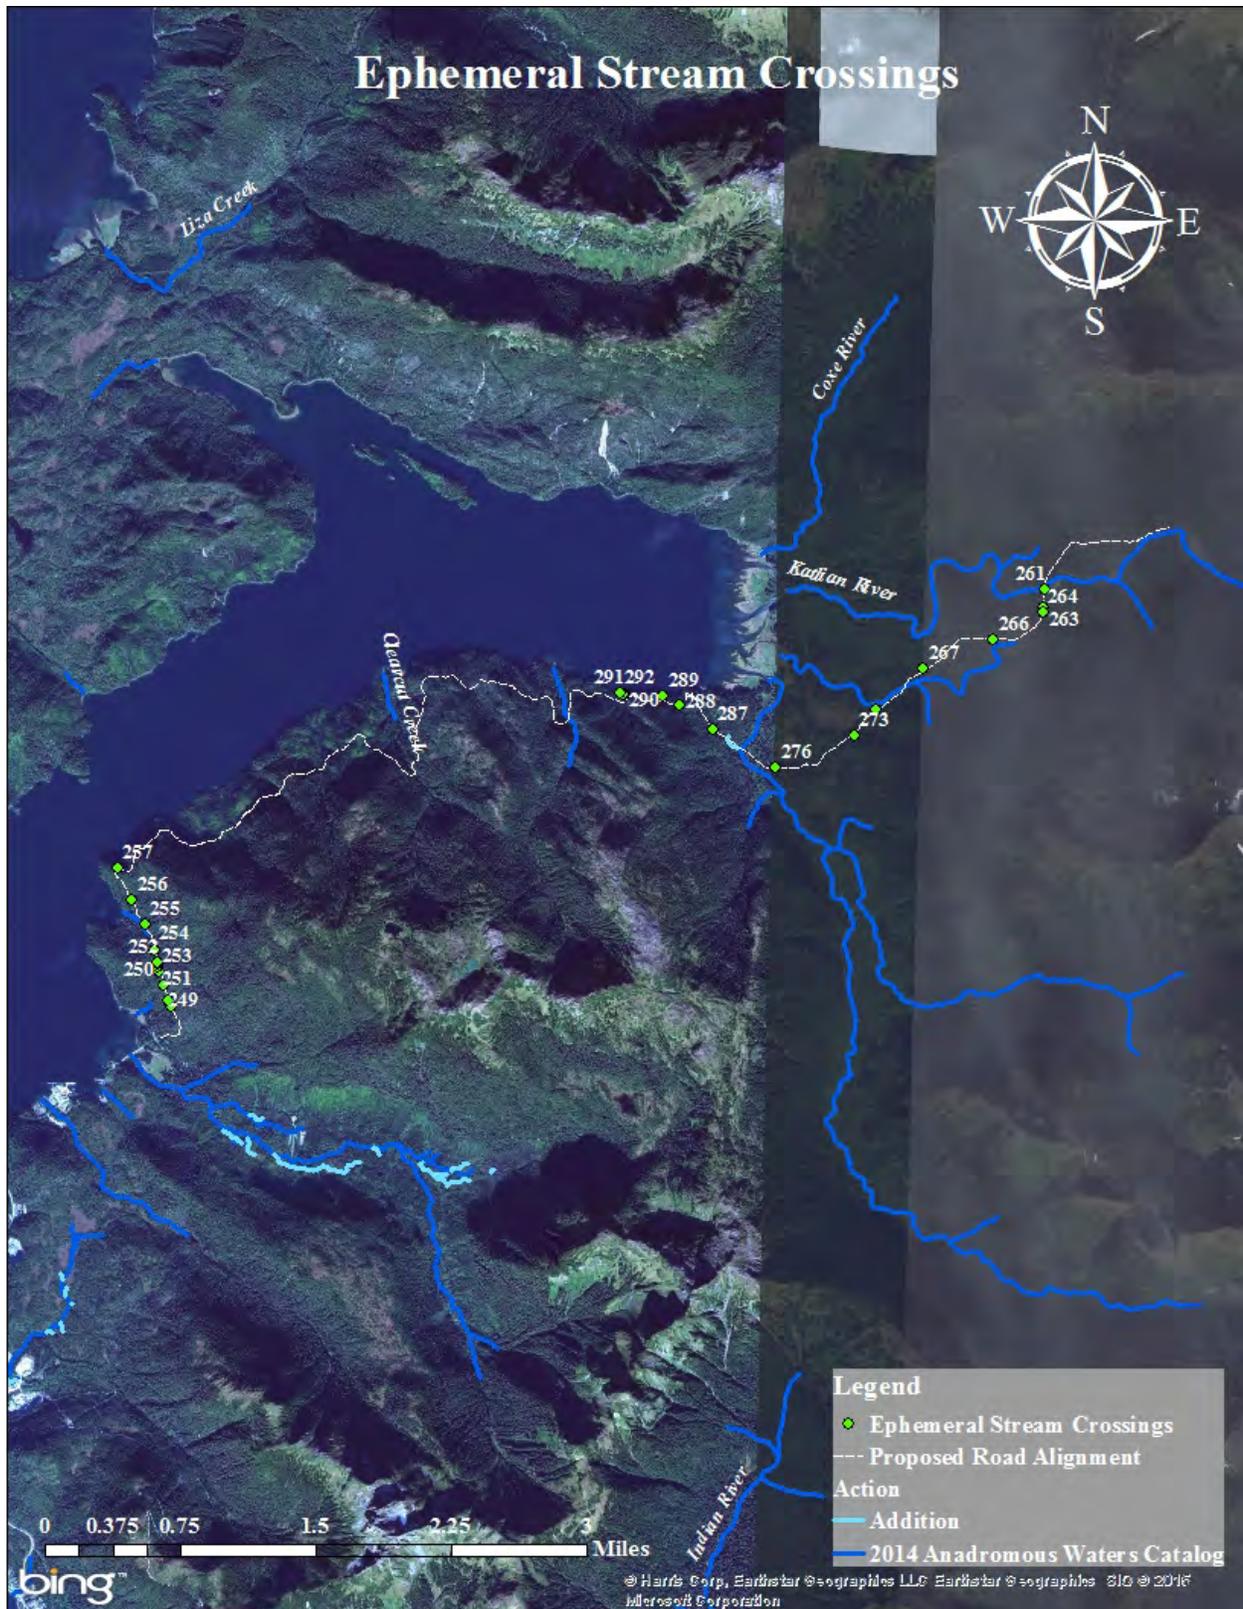
Figure 13.—Ephemeral stream crossing map.

Due to dry spring weather, we encountered 14 dry uncataloged drainages that may support fish when flowing (Table 3, Figures 13–18).

Waypoint	Latitude	Longitude	Notes	Sample Effort	Sample Results
247	57.1358	-135.3642	Stream marked as potential fish. High gradient, low flows. 40% over 40ft. No fish.	EF	0
248	57.1362	-135.3647	High gradient bedrock cascades with pockets of angular cobbles.No fish.	EF	0
249	57.1374	-135.3655	Medium gradient, cobble, gravel substrate.		0
250	57.1386	-135.3662	Low gradient small incised stream flows into muskeg. Gravels, organics, good overhanging veg and banks. No fish.	EF	0
251	57.1389	-135.3664	Intermittent flows, cobble substrate. This are is a braided forested wetland. Originates from a mainstem on the hillside.		0
252	57.1392	-135.3665	Small stream originating from a seep in the moss.		0
253	57.1393	-135.3665	Larger moderate gradient stream, cobbles, gravels, lots of large wood and small pools.		0
254	57.1403	-135.367	High gradient , no place to fish. Very low flows. Unlikely habitat.		0
255	57.1423	-135.3684	Very high gradient. Bedrock and cobble. No fish.	EF	0

Waypoint	Latitude	Longitude	Notes	Sample Effort	Sample Results
261	57.1708	-135.2369	Potential distributary marked as fish, but totally dry.		0
263	57.1694	-135.2371	Isolated pool in dry channel. No fish captured. Water is very stagnant and likely has low DO.	EF	0
264	57.169	-135.2371	Intermittent dry channel. No fish. Gravel substrate. Flanks hillside. Water clear.	EF	0
266	57.1667	-135.2444	Very tiny mucky seep. Deep organic substrate. No fish.	EF	0
267	57.1643	-135.2546	Wet lowlying area. Coming up on the middle fork bridge site. No water.		0
272	57.1609	-135.2615	Channel dries up in elevated ground. No place to fish.		0
273	57.1588	-135.2646	Steep ephemeral stream. No fish.	EF	0
276	57.1561	-135.276	Steep dry channel. No water. No fish. Cobbles.		0
287	57.159	-135.2855	Just a wet spot. Might flow sometimes. No place to fish.		0
288	57.1609	-135.2904	Steep bedrock chute. Very low flows. No fish.	EF	0

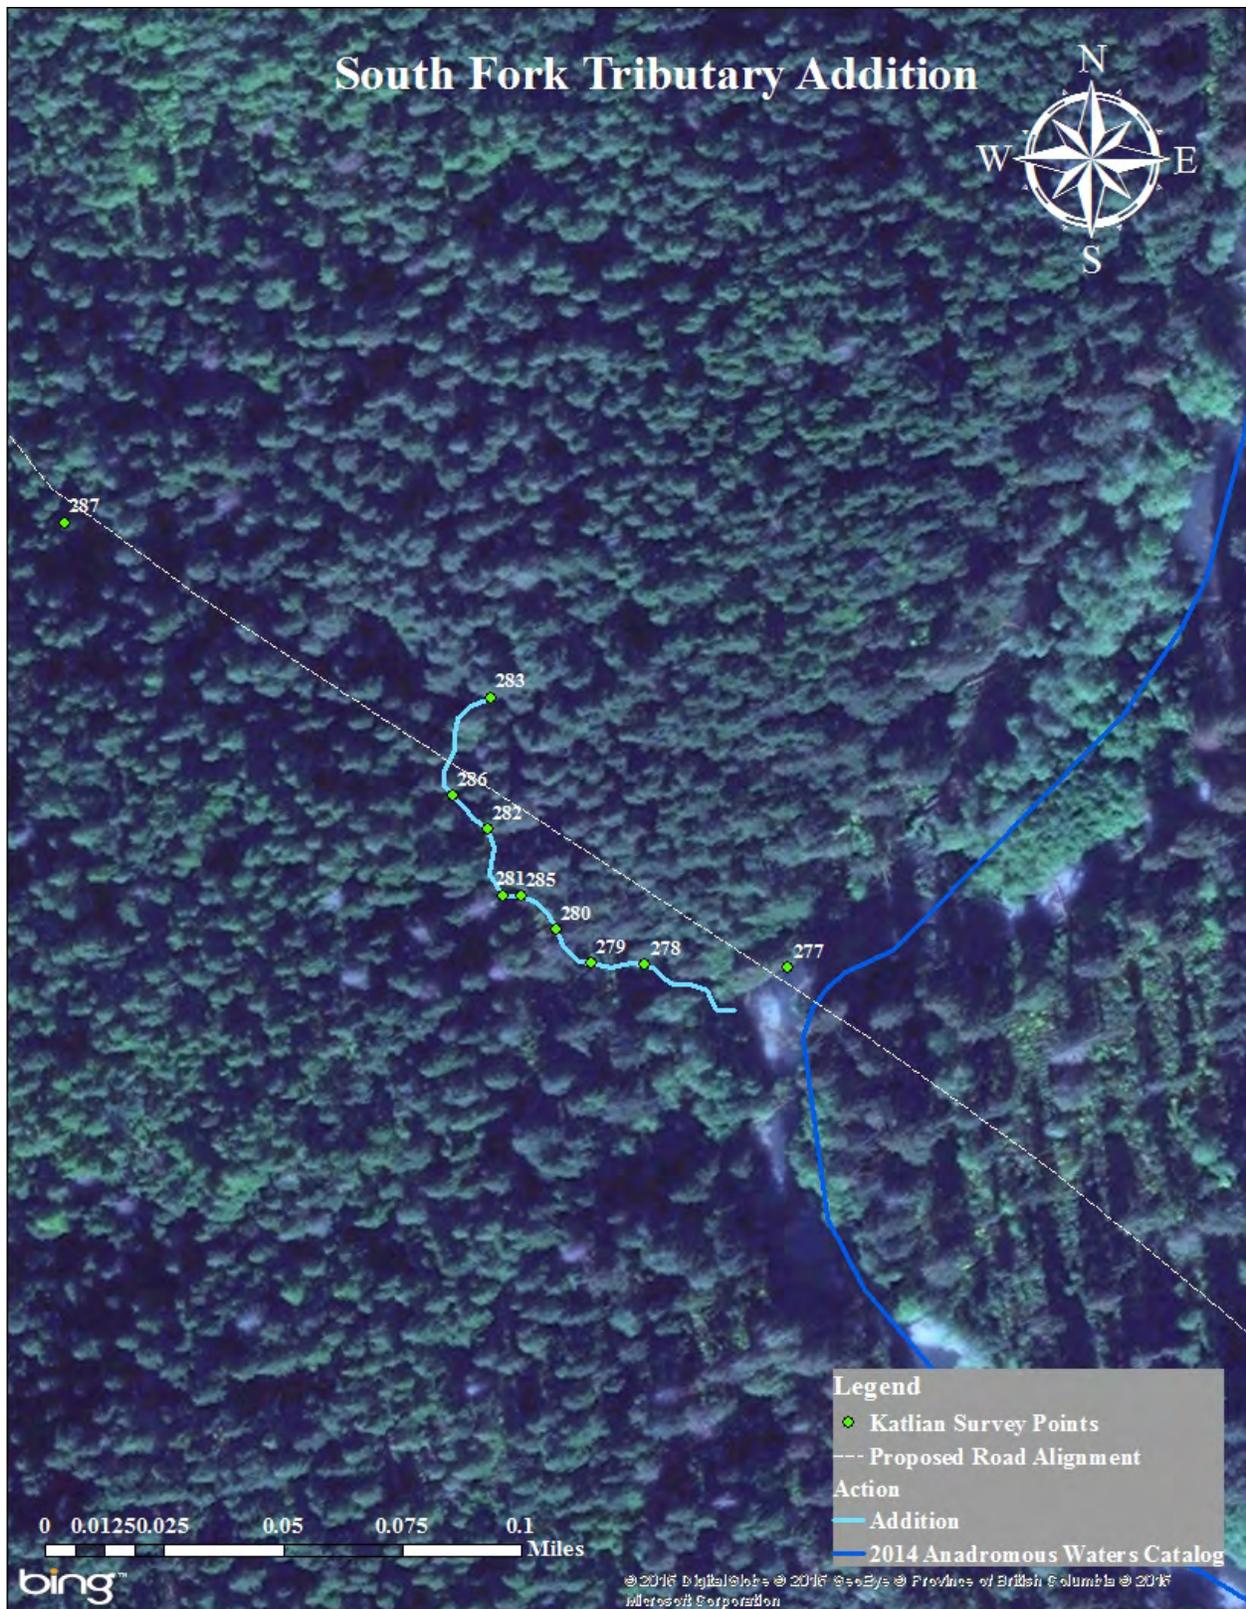
Figure 3.—South Fork Tributary Addition map.

SOUTH FORK TRIBUTARY**ADDITION****Water body name:** [Click here to enter text.](#)**Survey date:** 5/13/2015**Water body number:** 113-44-10050 tributary**Species & Lifestage:** COr**Watershed:** Sitka Sound**MTR:** C054S064E **Quad:** Sitka A-4**Findings:** This stream provides excellent rearing habitat for juvenile coho salmon.**Recommendations:** Please include this stream in the Anadromous Waters Catalog.

Waypoint	Latitude	Longitude	Notes	Sample Effort	Sample Results
277	57.1577	-135.2814	Bridge crossing. Large lovely stream. Supposedly a forest service road somewhere... 1 Co, 1 DV.	EF	1 CO, 1 DV
278	57.1577	-135.2822	4 Co in trib on RL. YOTY.	EF	4 CO
279	57.1577	-135.2825	Multiple coho.	EF	Multiple CO
280	57.1578	-135.2827	2 co just underneath road alignment.	EF	2 CO
281	57.1579	-135.283	1 CO	EF	1 CO
282	57.1581	-135.2831	2 CO	EF	2 CO
283	57.1585	-135.2831	end trib. Road crossing just below.		0
284	57.1624	-135.2736	On FS road. LSB. Intermittent dry channel filled with coho and chum salmon. Stranded.		CO, CH
285	57.1579	-135.2829	Pocket dial.		0
286	57.1582	-135.2833	Proposed road crossing anadromous stream, very low flows. We captured coho throughout this stream.	EF	Multi CO
