High Performance Hot Mix Asphalt Intersections

MD Intersection Competition

Maryland Asphalt Association Strategy

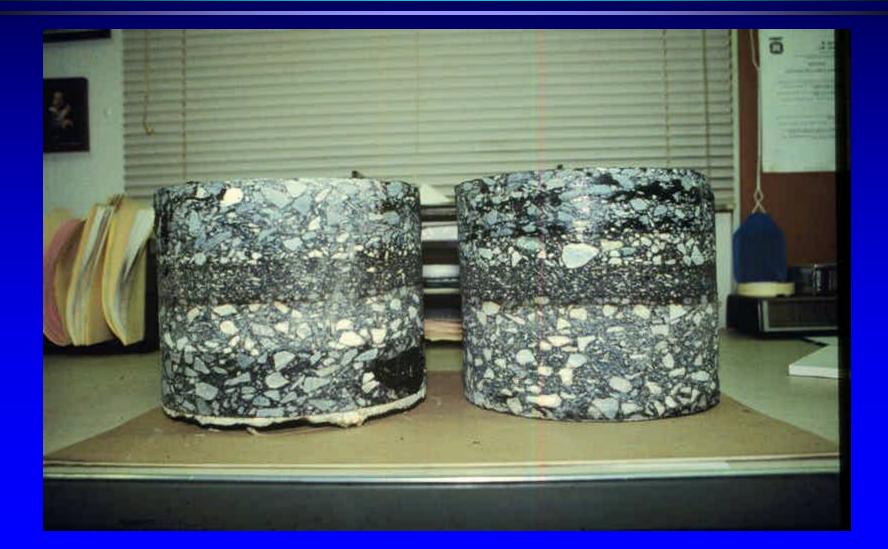
Forensics - 10" Roadway Cores

- Rutting was evident almost to bottom of existing 8" HMA in trench
- Remove and replace all 8" of existing HMA
- Use SUPERPAVE mixes rather than MD SHA mixes
 - **↗** Coarser aggregate structure
 - Specify asphalt binder to meet both climatic and traffic conditions

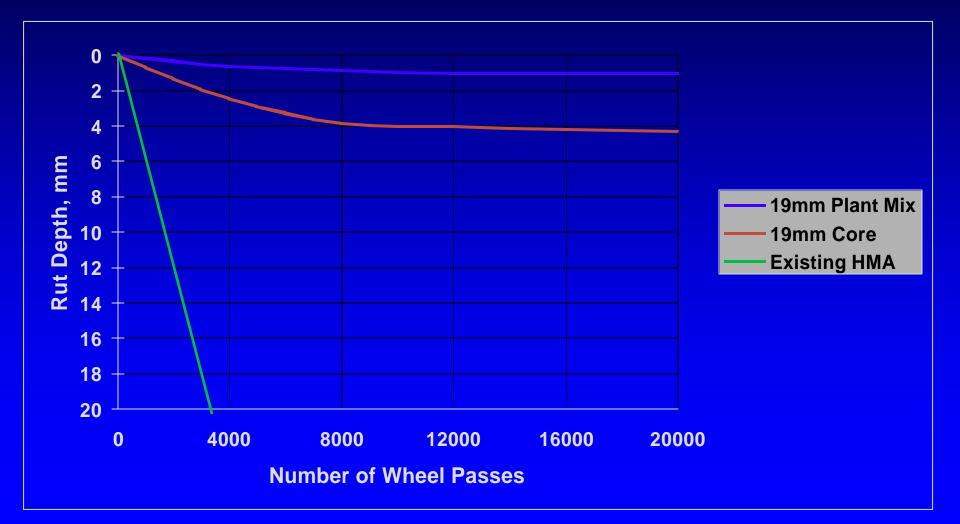
Forensics - Hamburg Wheel Tracking Device Testing

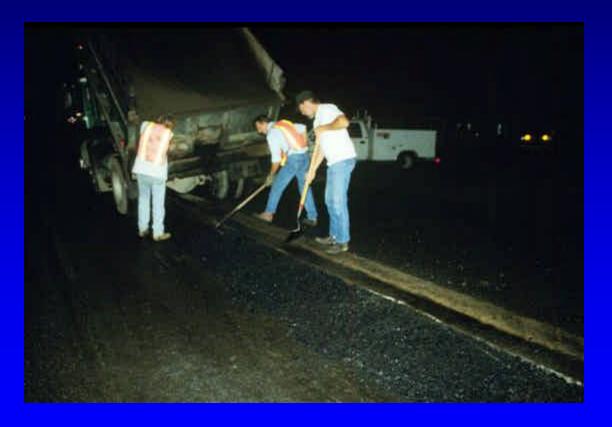
Placed
 temporary HMA
 ramps at all
 entrances after
 milling
 operation

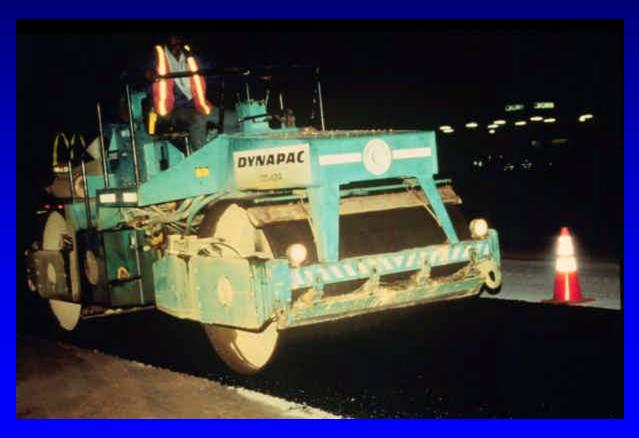
→ Used 2 double drum vibratory rollers **7** High frequency, low amplitude **NO TENDER** ZONE **7** Achieved density

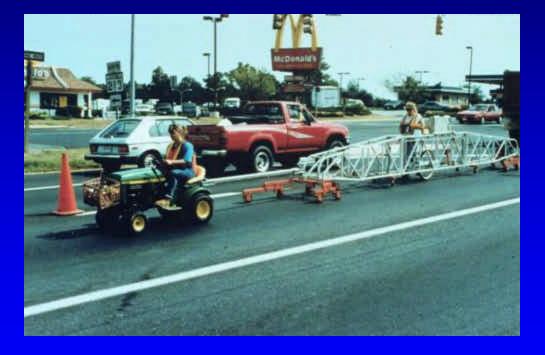
Performance Testing - Ride

- Used California Type Profilograph
- Measured both HMA intersection and PCC intersection one year after paving

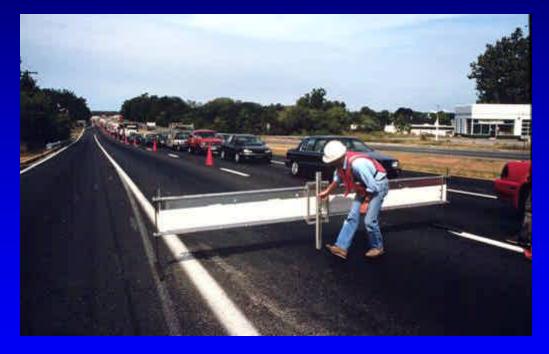
Performance Testing - Rutting

- Transverse Profilograph
- Pen holding device
 follows roadway
 surface
- Pen draws profile on chart paper
- After 5 years 1/16" rutting

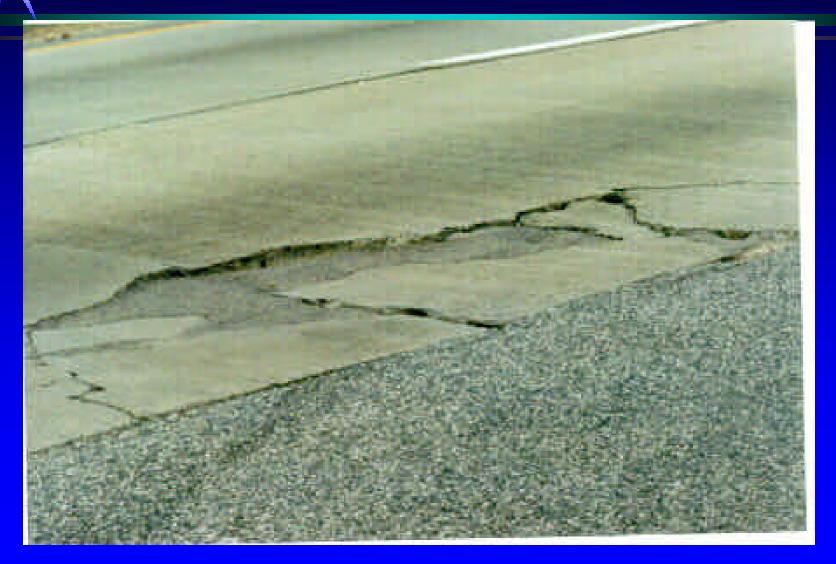
PCC Performance - March 2000

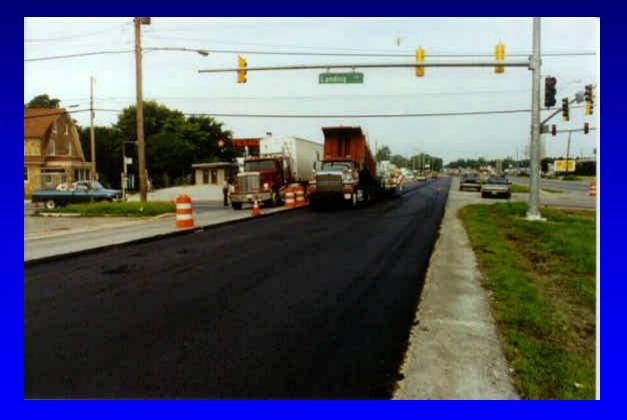
PCC Performance - July 2000

PCC required <u>288 hours to</u> install

PCC removed and replaced with HMA in <u>22 hours</u>

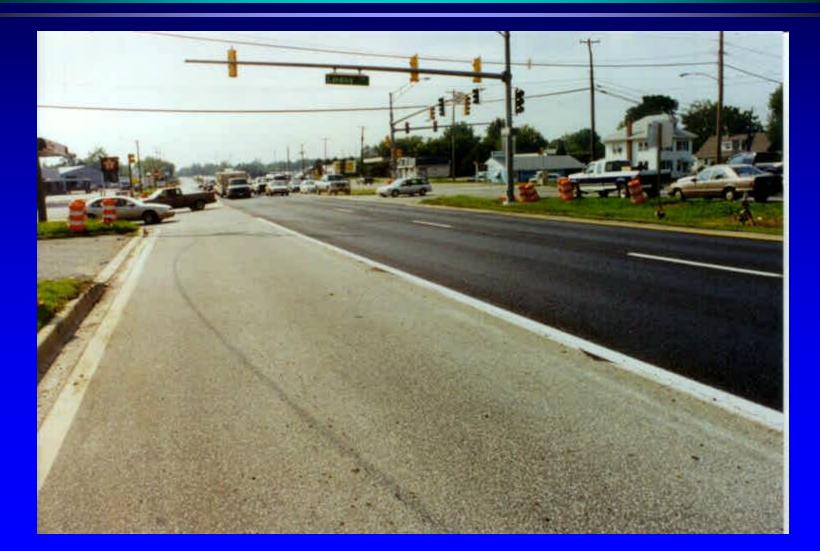
PCC Performance - July 2000

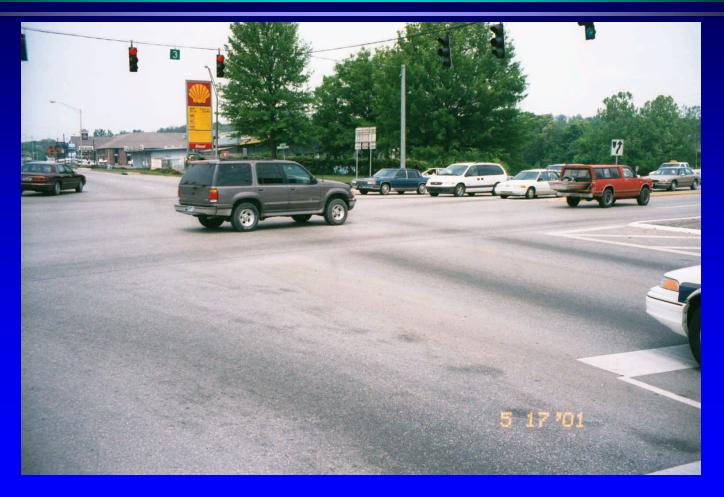
Asphalt Pavement Sections

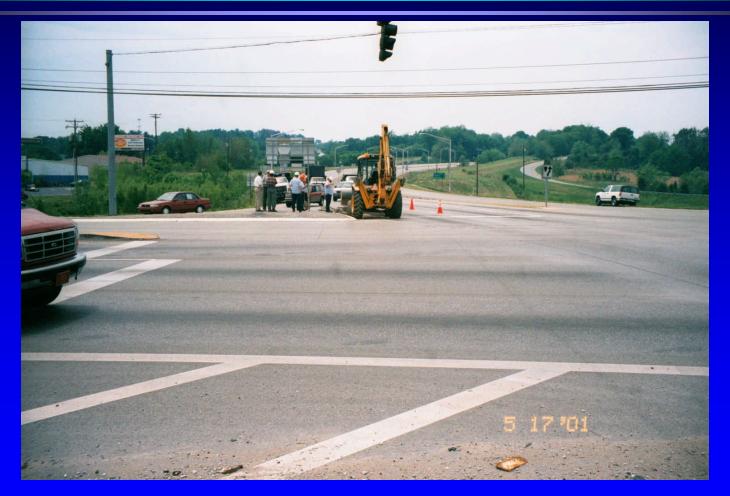
Asphalt Pavement Sections
