ALASKA ASPHALT SUMMIT
November 2009

THERMAL SEREGREGATION
(unseen enemy)

Jim Hedderich
ROADTEC
423-593-7587
jhedderich@roadtec.com

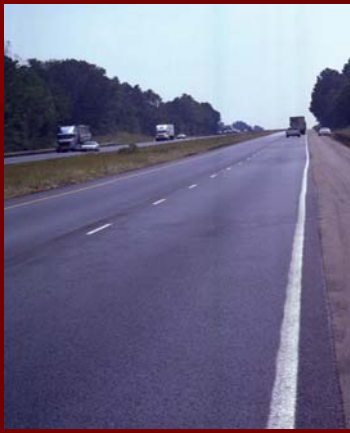
THERMAL SEGREGATION Temperature Differentials

- WDOT & University of Washington-1996
Stephen Read/Dr. Joe Maloney
- Lead states of Washington, Texas, Minnesota
- Specs in Washington, Arkansas, Texas,
Massachusetts, Missouri, South Dakota, South
Carolina, Ontario, Illinois, etc. (26 states)
- Increased Interest (Auburn, Clemson, & TTI)
- ROADTEC Research-Technical Assistance

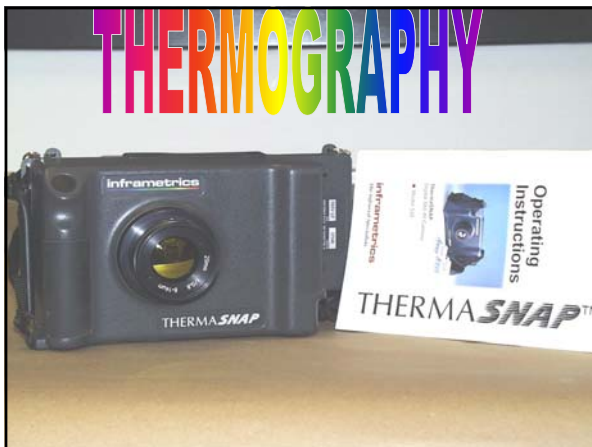
Washington Conclusions 2009

- Survey results of DOT & Contractors-Use of MTV greatest improvement in quality.
- Temperature testing and MTV use increased life of HMA by 50%
- All 2010 projects require use of MTV

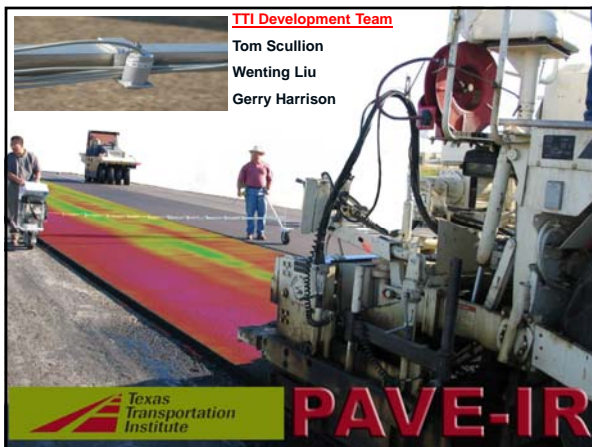
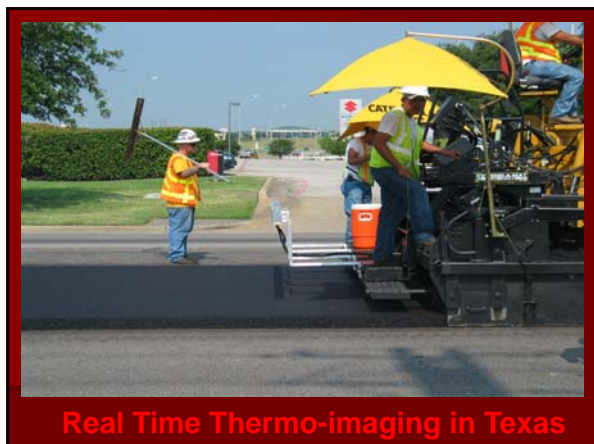
Real Time Thermo-imaging in Texas
