# Repair of Reinforced Concrete Bridge Columns via Plastic Hinge Relocation

## *Volume 1: Repair Using Conventional Materials*

Alaska Department of Transportation & Public Facilities

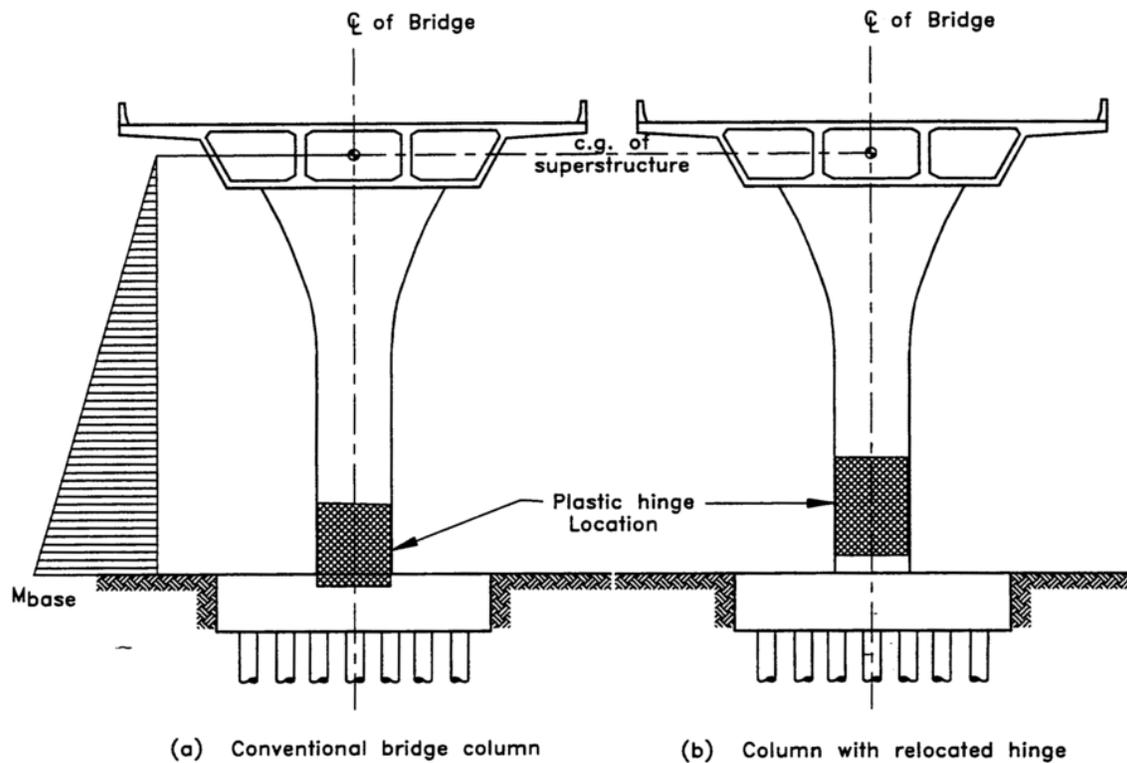
Figure 1.4: Plastic hinge formation in a typical single column bent (Hose et al., 1997).

Plastic hinges are typically the preferred mechanism through which RC members deform under earthquakes. Relocation of plastic hinges is essentially exactly how it sounds: the properties of the system are modified such that plastic rotation occurs in a different location within the member. Typically, in fixed moment reaction members the greatest demands are located at the joint interface, whether that is a beam-column joint or column-footing connection. These regions is notoriously difficult to repair, as damage spreads into the joint due to strain penetration from the plastic hinge. A group of researchers noted this and conducted a study to investigate whether columns could be designed such that plastic hinges were located away from the joint region in RC bridge columns (Hose, Priestley, & Seible, 1997). This is illustrated schematically in Figure 1.4 with experimental confirmation in Figure 1.5. The authors demonstrate that relocation of the plastic hinge is possible for new construction by terminating a portion of the longitudinal reinforcement a specified distance from the joint. While not considered as a repair, the research presented by the authors does provide the first known instance of this technique for RC structures.

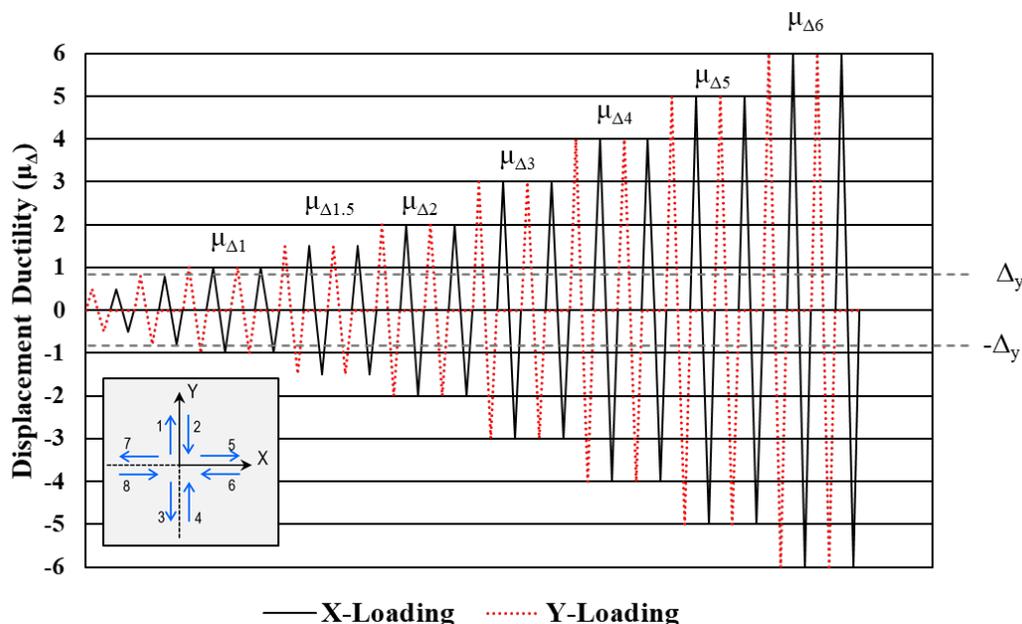
Figure 3.8: Definition of two-cycle set load history.

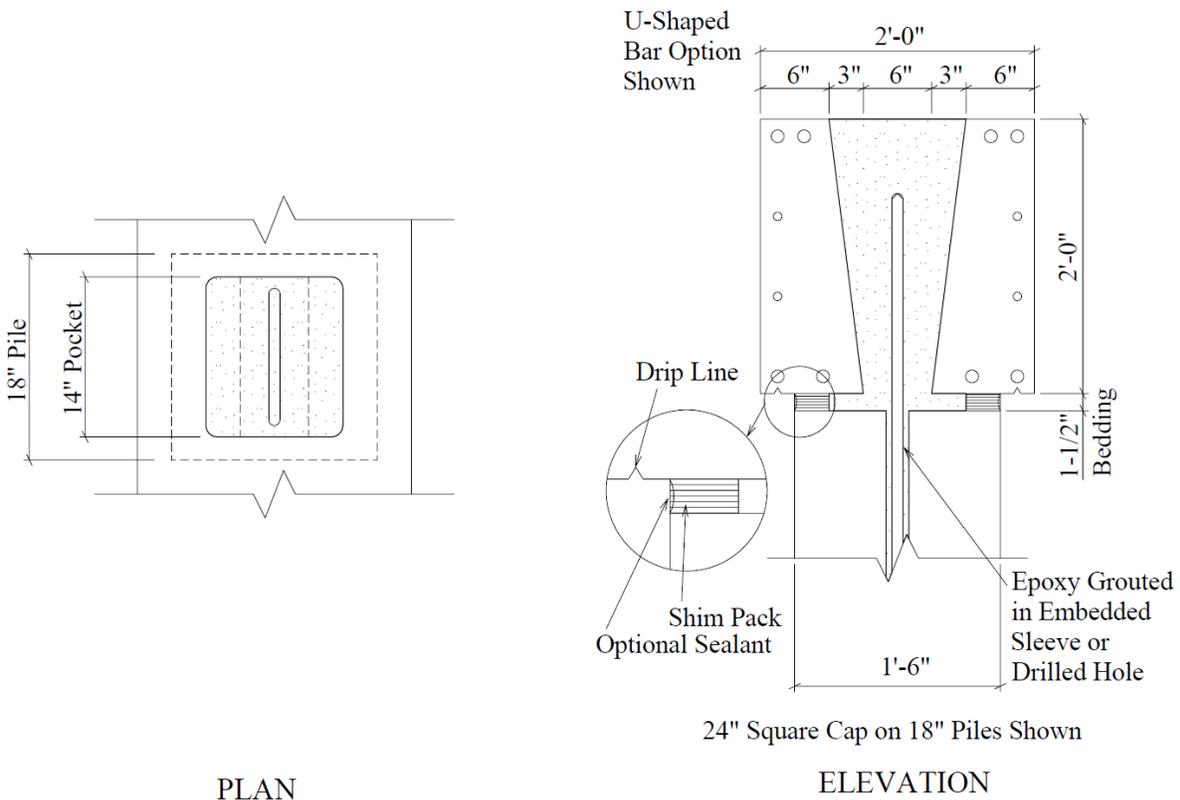
**Figure 3.12: Grouted Pocket Connection in a precast bridge system (Matsumoto 2001).**

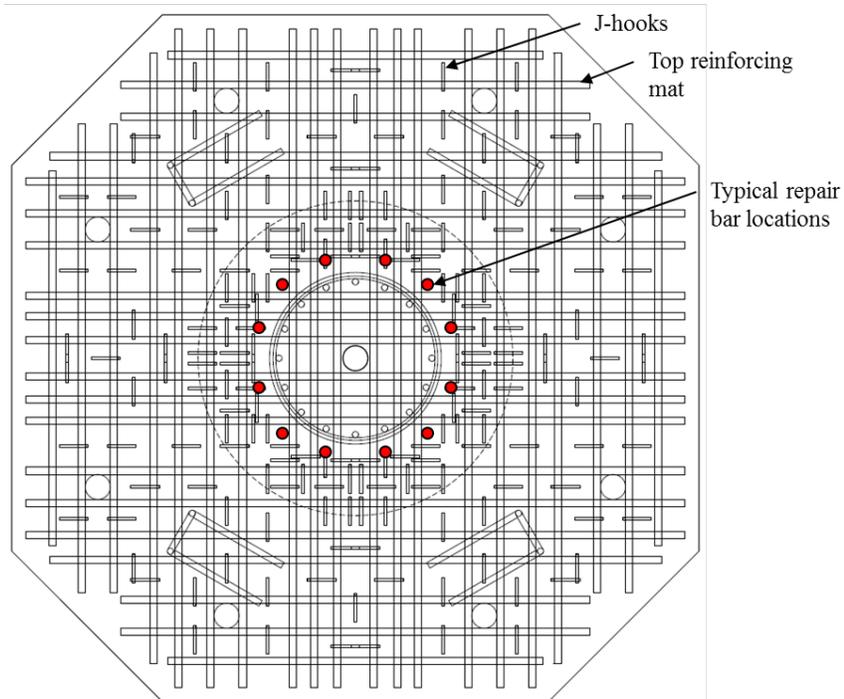
Figure 3.15: Typical footing reinforcement plan layout.

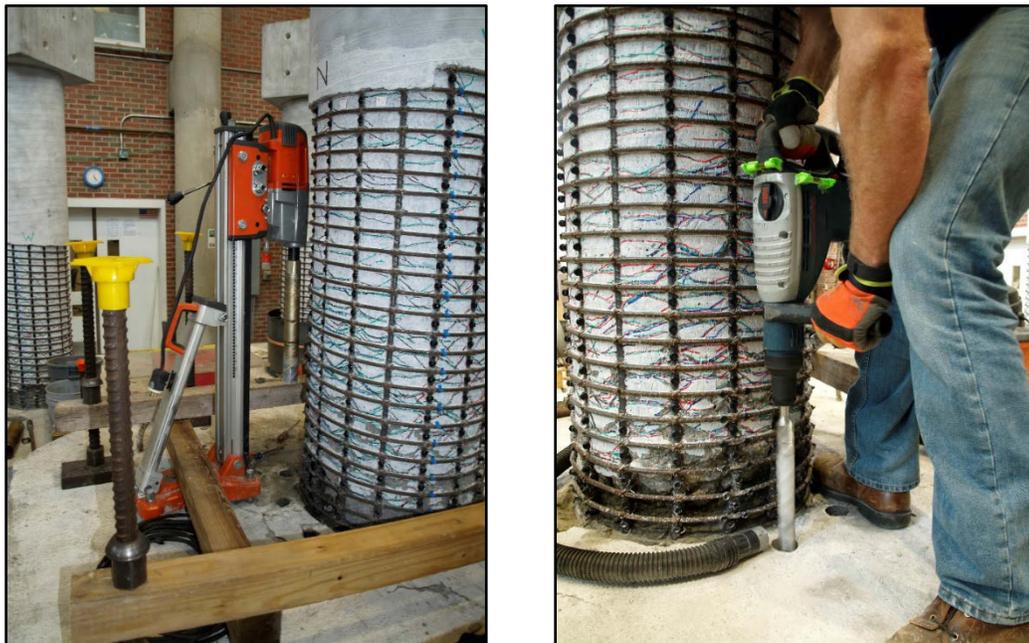
(a) (b)  
Figure 3.16: Setup for (a) core drilling and; (b) hammer drilling.

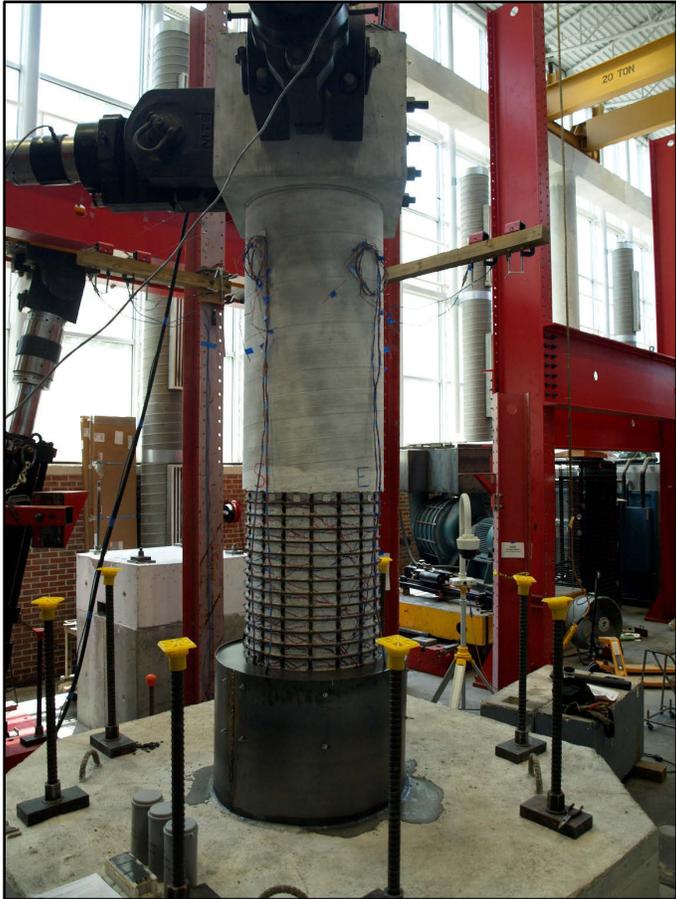
Figure 3.28: Completed repair installation on lab specimen.

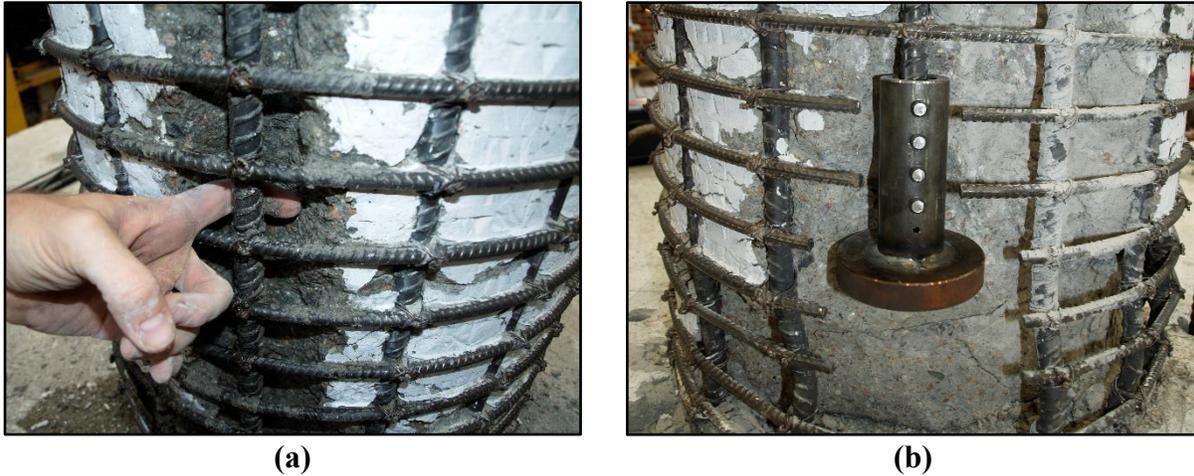
**Figure 3.32: Installation of fractured bar anchorage mechanisms.**

Repair #5 follows the typical installation procedure, with the exception of special considerations made to the fractured bars in an attempt to improve their bond development. Two were fully exposed by chipping away the existing concrete, as per the ACI Guide to Concrete Repair (ACI Committee 546, 2014), and one was outfitted with a mechanical headed stud. An example of the first method is shown in Figure 3.32 (a) while the mechanical headed stud installation is shown in Figure 3.32 (b). Installation of each requires clear access to the existing column and should be done prior to installation of the repair bars.

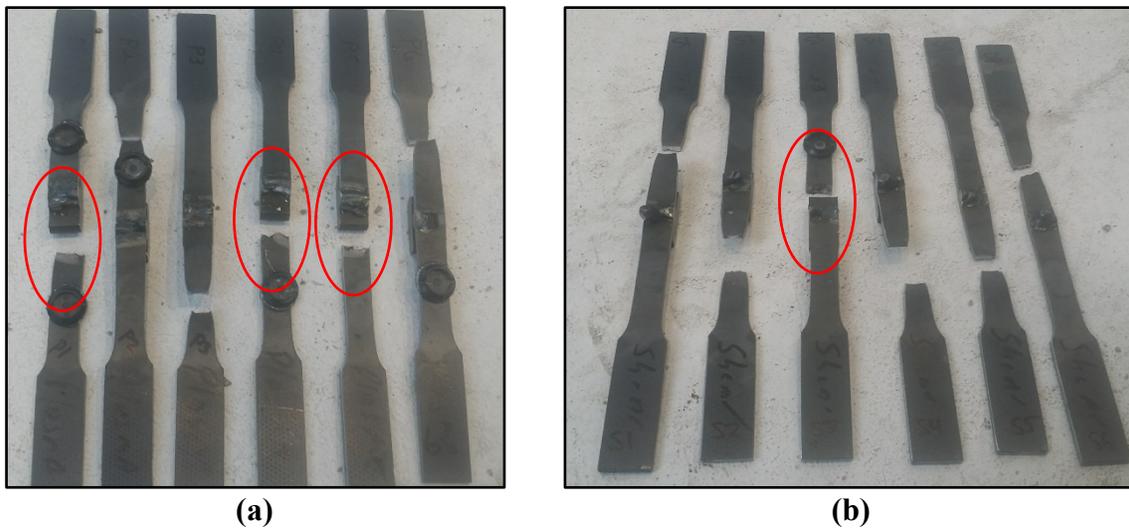
Figure 3.39: Tested samples constructed using a welded edge cut by (a) plasma torch; and (b) shear cut.

The test resulted in 3 of the 6 samples with plasma cut edges fracturing at the weld interface at about half of the strain of those that failed through the base metal alone. The shear cut samples only resulted in 1 of the 6 coupons failing at the weld, and the one that did fail was noted to have a significant dip in the weld metal resulting in a reduced cross section at that location. Figure 3.39 (a) and (b) show the tested coupons of the plasma cut and shear cut samples respectively, with weld failures circled in red. While it was clear that more of the plasma cut specimens failed through the weld, it is also noted that the quality of the weld on these specimens were much lower than on the shear cut samples. This could be a result of the weld metal not penetrating the base metal due to HAZ effects, but it is also noted that the edges of the plasma cut sections were much more jagged. This could have also contributed to the reduced capacity in the weld as well. From these results, it is concluded that extreme care should be taken in the edge preparation and weld quality when welding plasma cut thin gauge sheet metal for this repair. Should this process be used, the installer should ensure a clean cut and a properly prepared edge surface, and welding should be overseen by a certified weld inspector and performed by a certified welder.

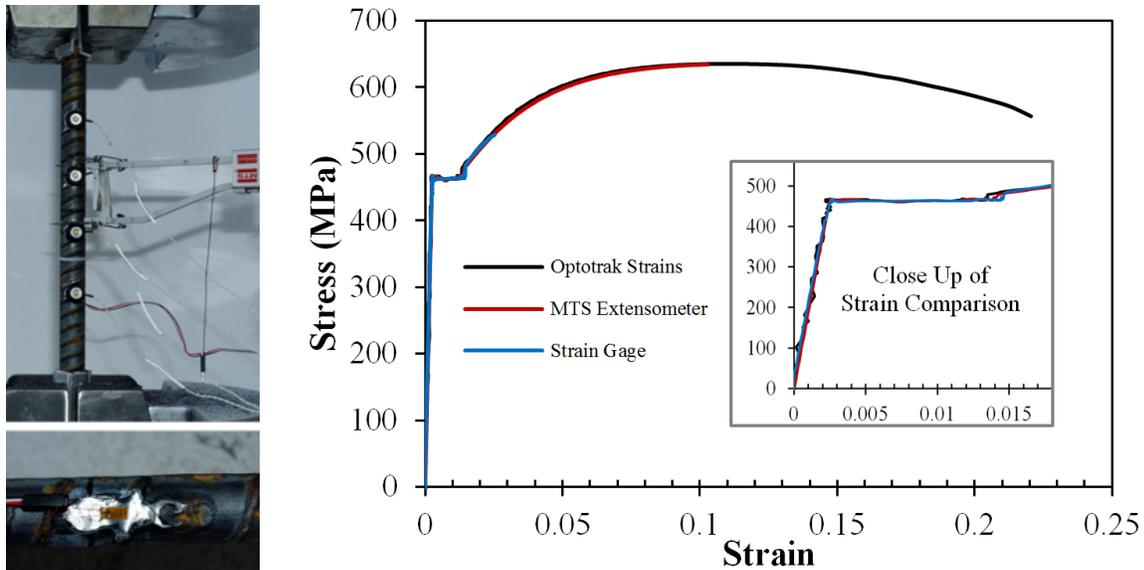
**Figure 3.44: Comparison of Optotrak strain measurements to strain gauge and MTS extensometer (Goodnight et al., 2015).**

An extensive discussion of the instrumentation process and relative accuracy is provided by (Goodnight, Kowalsky, & Nau, 2015). Figure 3.44 illustrates a comparison between the strain measurement readings of the Optotrak Certus HD system to those of a traditional strain gauge and extensometer. Each method produces accurate results, but the Optotrak system is obviously capable of measuring significantly larger deformations.

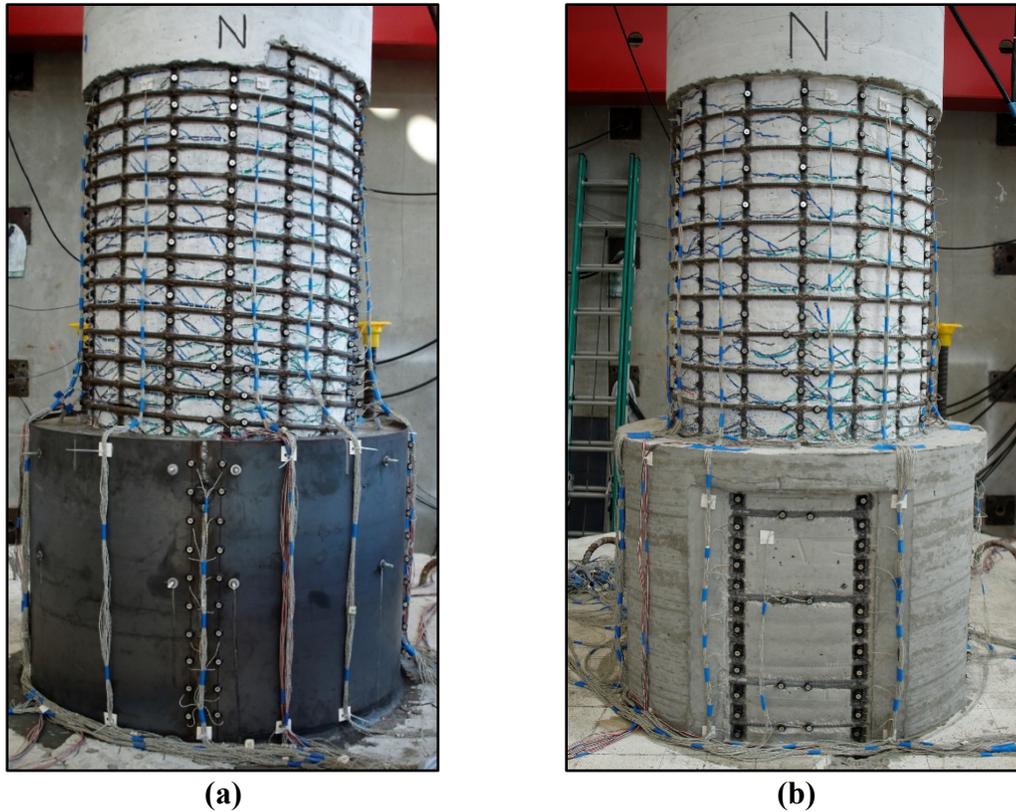
Figure 3.45: Optotrak sensor installation on (a) typical steel sleeve and; (b) directly to repair bars.

The study conducted by Goodnight, et. al. (2017) used the same instrumentation system and constructed the specimens to allow for the LEDs to be installed directly to the reinforcing steel. The columns were cast with complete cover blockouts to a depth of the outside face of the longitudinal reinforcement over the bottom 4' of the column. The repaired specimens were able to utilize the exposed steel construction to measure the strains in the bars above the repair, but those within the repaired region were no longer visible. The repair sleeve was also instrumented to measure its total deformation, and Repair #4 was actually constructed using similar techniques to the original columns allowing for Optotrak sensors to be placed directly on the longitudinal repair bars. Figure 3.45 (a) shows an example of a repaired column with the new hinge and repair sleeve instrumented, while Figure 3.45 (b) shows Repair #4 with LED targets installed directly on the repair bars. Figure 3.46 shows the real-time computer tracking of the Optotrak data along with a 3D visualization of each target's location.

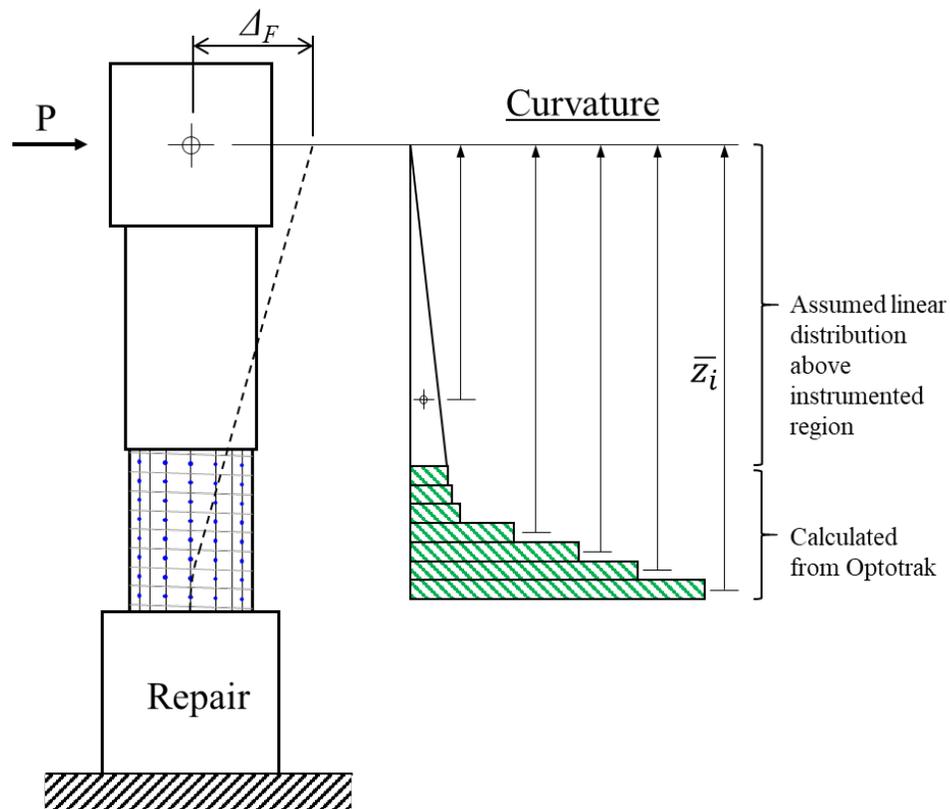
Figure 3.55: Curvature distribution over column height.

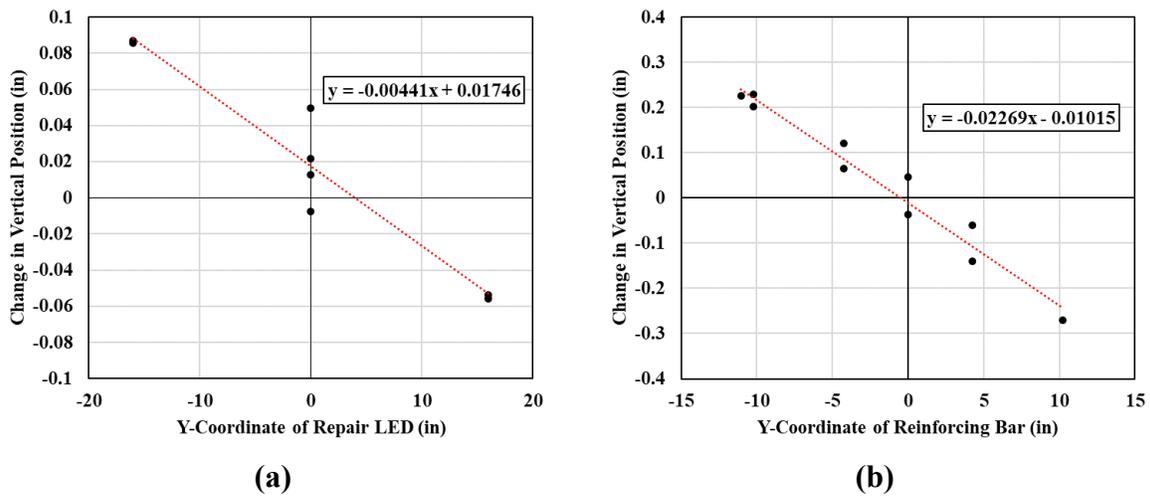
Figure 3.56: Example of linear fit through Optotrak data to calculate (a) Repair rotation and; (b) Column strain penetration rotation.

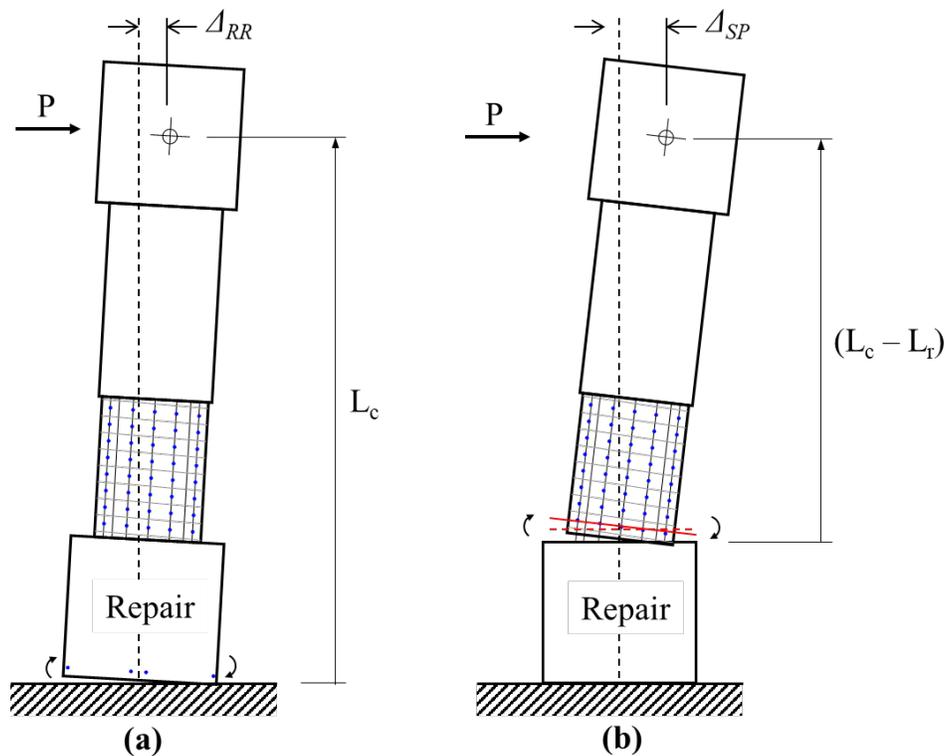
Figure 3.57: Isolated components of column displacement from (a) Rigid repair rotation and; (b) Rotation from strain penetration of column bars into repair.

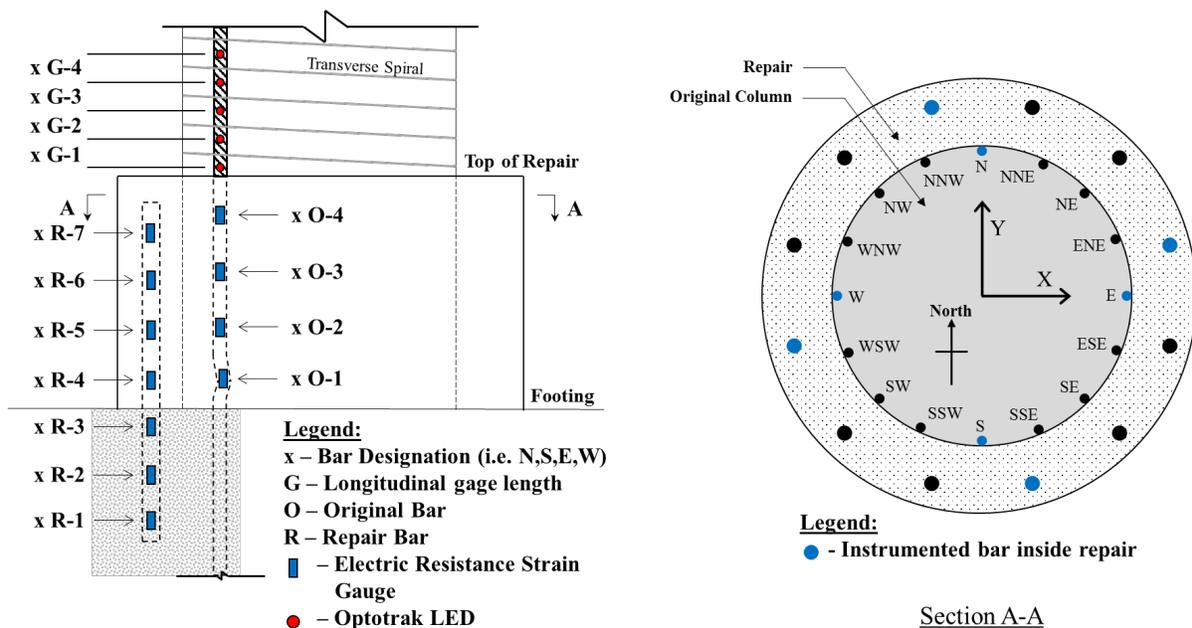
Figure 4.2: Repair #1 Instrumentation labels and repair cross section layout.

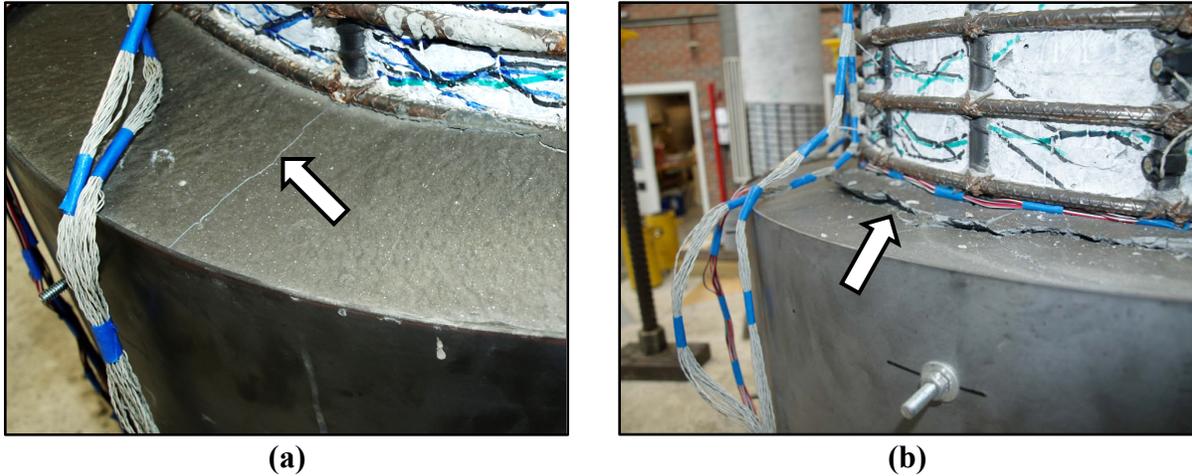
Figure 4.3: Repair #1 (a) Slight cracking on top of repair during  $F_y$  cycle; (b) progression of top surface cracking during cycle  $\mu_{A2}^{-2x}$ .

Overall, the repair performed as expected with the plastic hinge developing just above the annular ring and the strength and displacement capacities restored. Visible cracks began to appear on top of the repair during the  $F'_y$  cycle as shown in Figure 4.3 (a). These cracks grew progressively larger through later cycles with the top portion of repair grout spalling away, as seen in Figure 4.3 (b). The first cycles of  $\mu_{\Delta 3} = 4.2$  in. showed signs of core concrete crushing with further deterioration through ductility cycles 4 and 5, shown in Figure 4.4. Finally, visible buckling was observed during  $\mu_{\Delta 6} = 8.22$  in. along with complete crushing of the concrete core and spalling of the top surface of the repair concrete shown in Figure 4.5. The test was terminated after visible buckling was observed in 13 of the 16 longitudinal bars in the relocated plastic hinge above the repair.

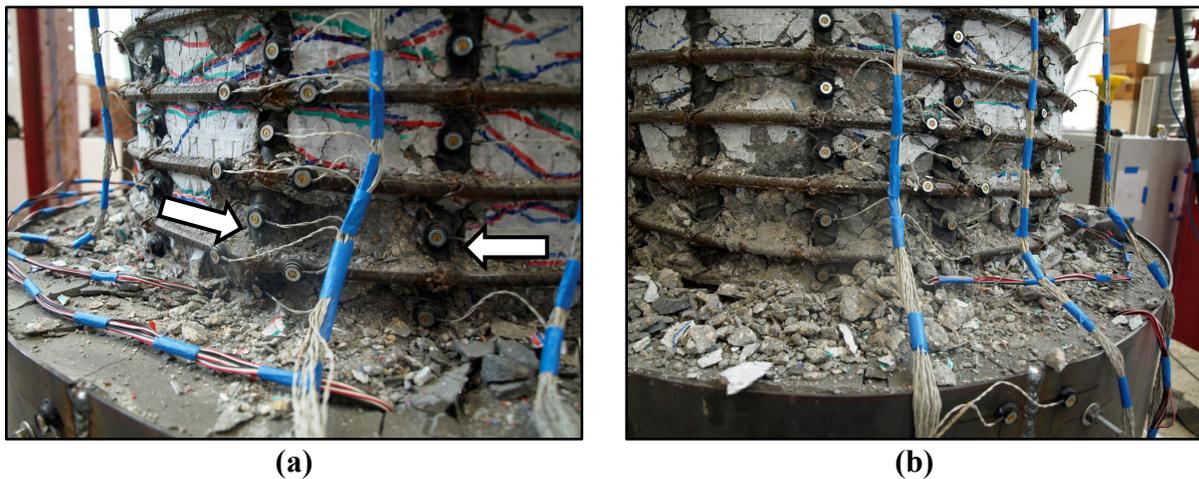
Figure 4.5: Repair #1 (a) Buckled longitudinal bars during  $\mu_{A6}^{-2y}$ ; (b) Final state of relocated plastic hinge.

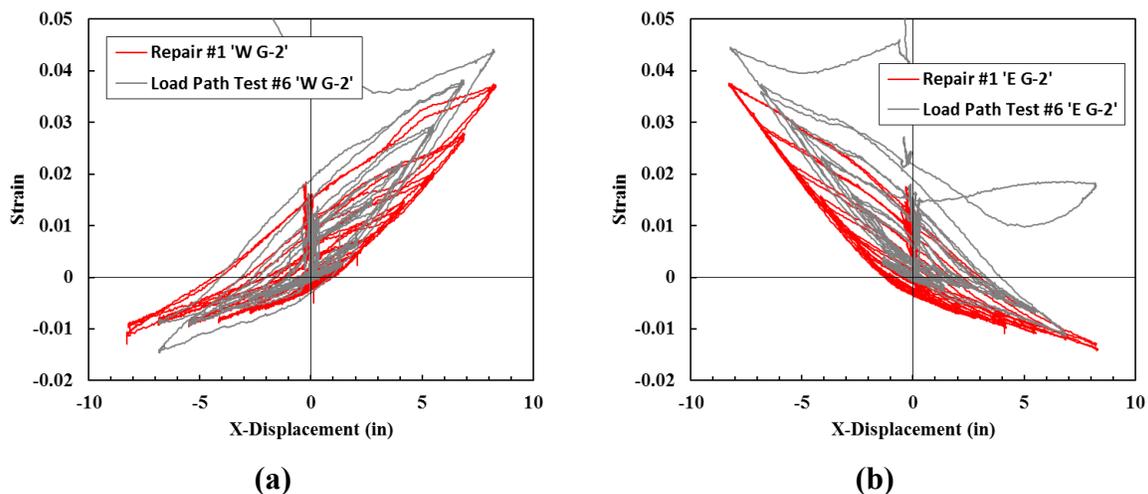
Figure 4.11: Repair #1 Strain vs. X-Displacement above the repaired region on the (a) West and (b) East faces of the column.

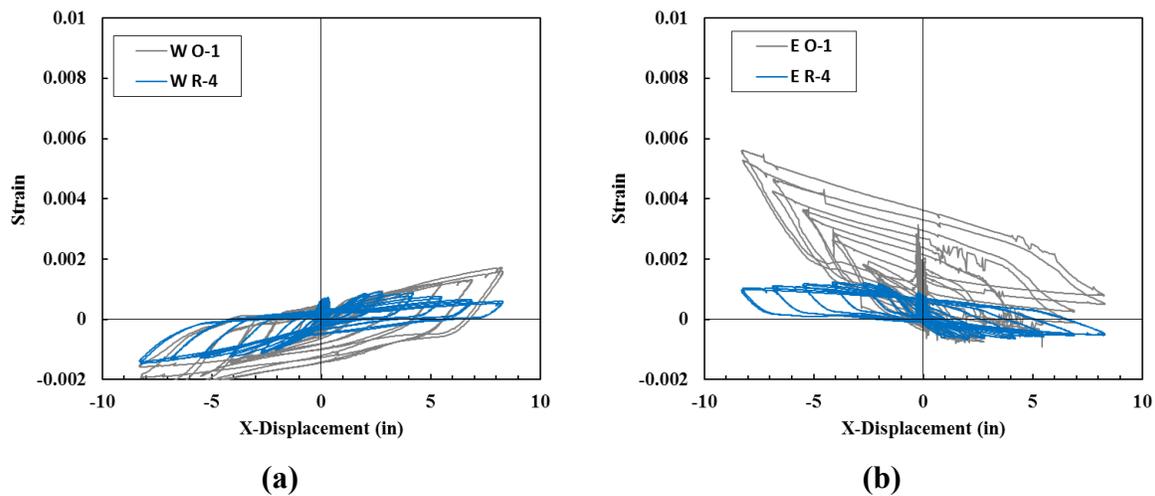
Figure 4.13: Repair #1 Strain vs. X-Displacement inside the repaired region on the (a) West and (b) East faces of the column.

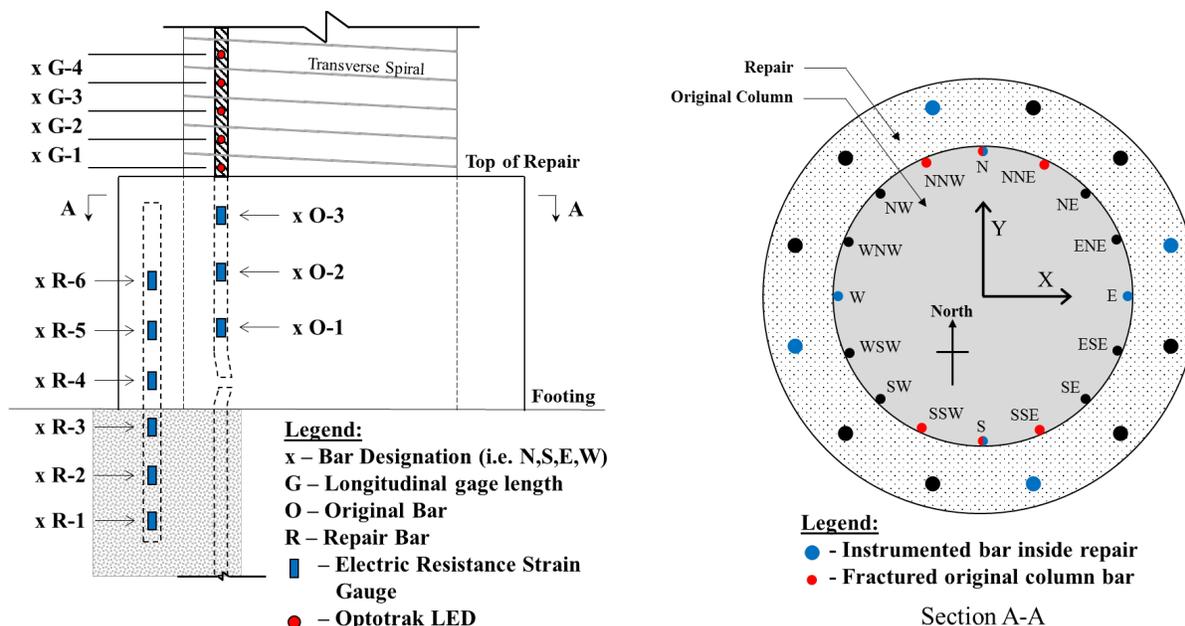
Figure 4.15: Repair #2 Instrumentation labels and repair cross section layout.

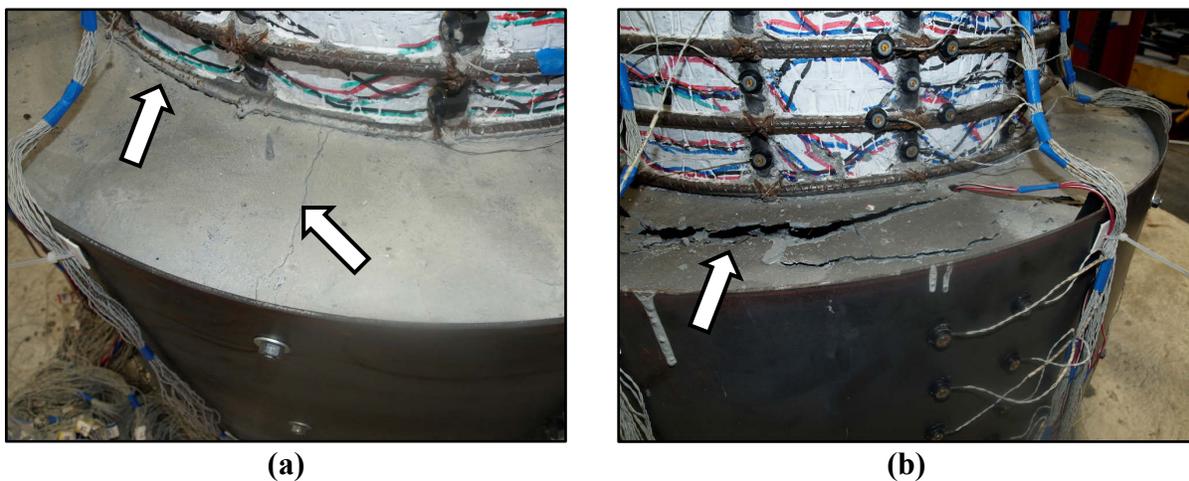
Figure 4.16: Repair #2 (a) Slight cracking on top of repair during  $F'_y$  cycle; (b) progression of top surface deterioration during cycle  $\mu_{\Delta 2}$ .

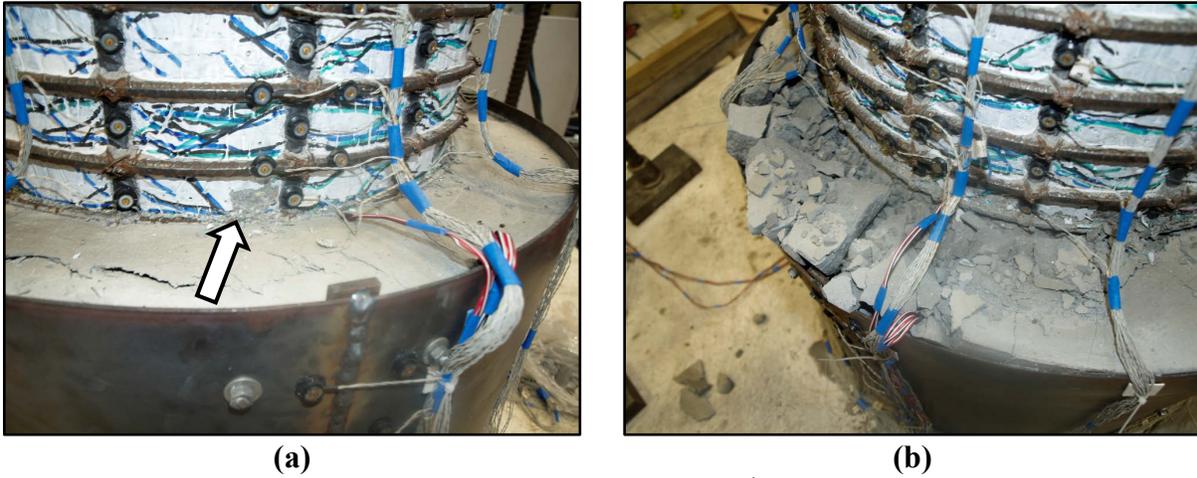
Figure 4.17: Repair #2 (a) Onset of core crushing during cycle  $\mu_{\Delta 3}^{+1y}$ ; (b) Further deterioration of hinge core and top of repair region during  $\mu_{\Delta 5}^{-1y}$ .

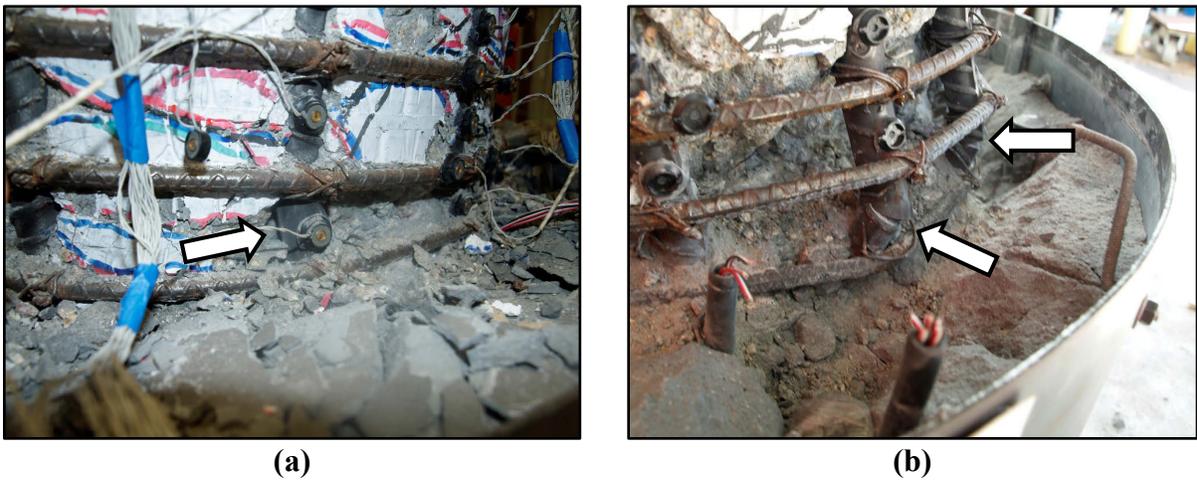
Figure 4.18: Repair #2 (a) Visible bar buckling during  $\mu_{\Delta 6}^{+1x}$ ; (b) Final damage state after multiple bar fractures during  $\mu_{\Delta 6}^{-1x}$ .

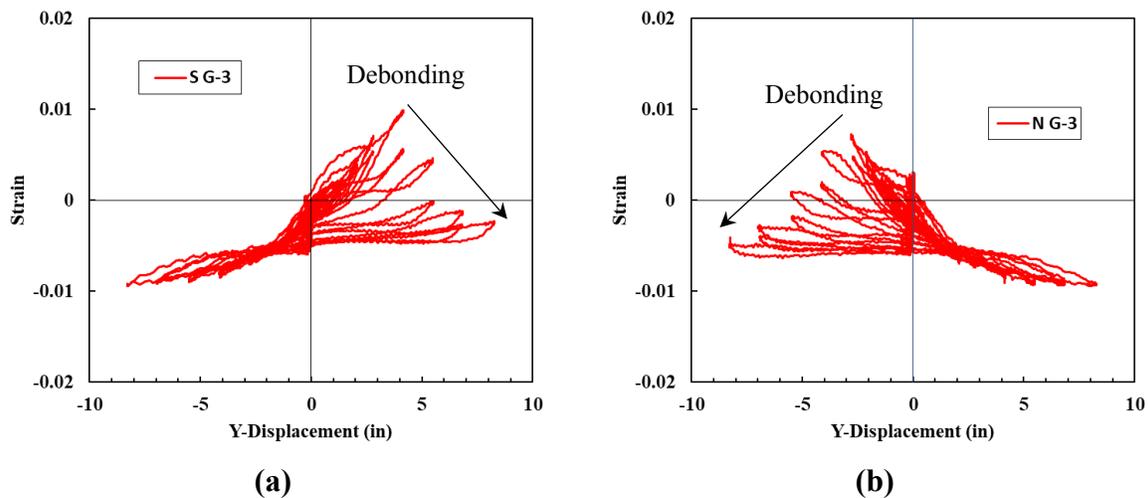
Figure 4.22: Repair #2 Strain in longitudinal bars vs Y- Displacement on (a) South face; (b) North face.

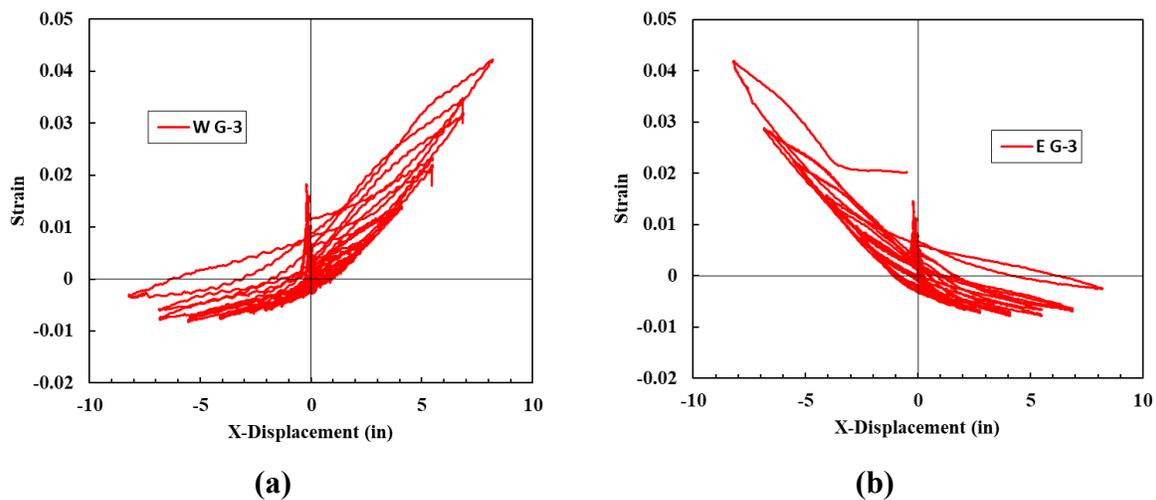
Figure 4.23: Repair #2 Strain in longitudinal bars vs X- Displacement on (a) West face; (b) East face.

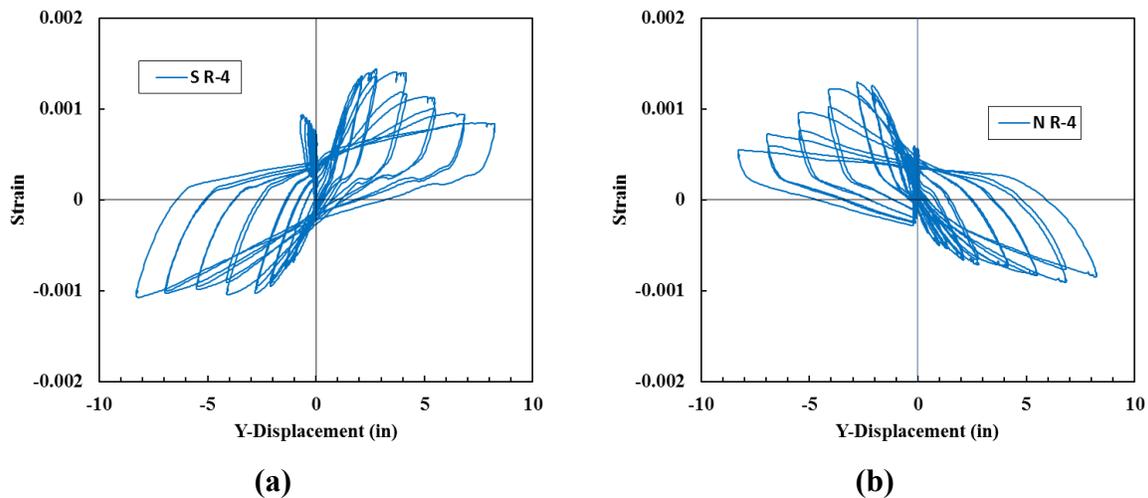
Figure 4.24: Repair #2 Strain in repair bars vs. Y-Displacement on the (a) South and (b) North faces of the column.

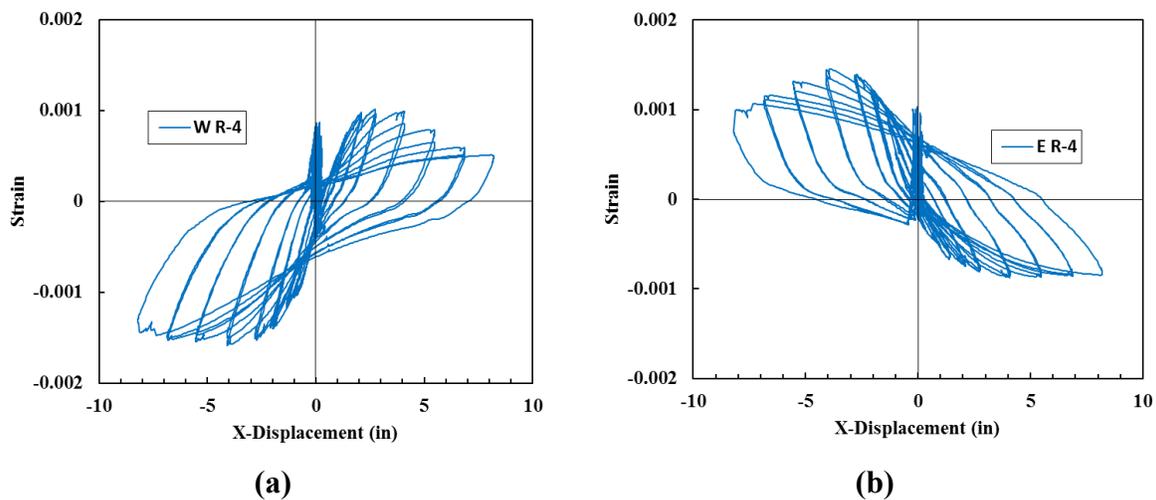
Figure 4.25: Repair #2 Strain in repair bars vs. X-Displacement on the (a) West and (b) East faces of the column.

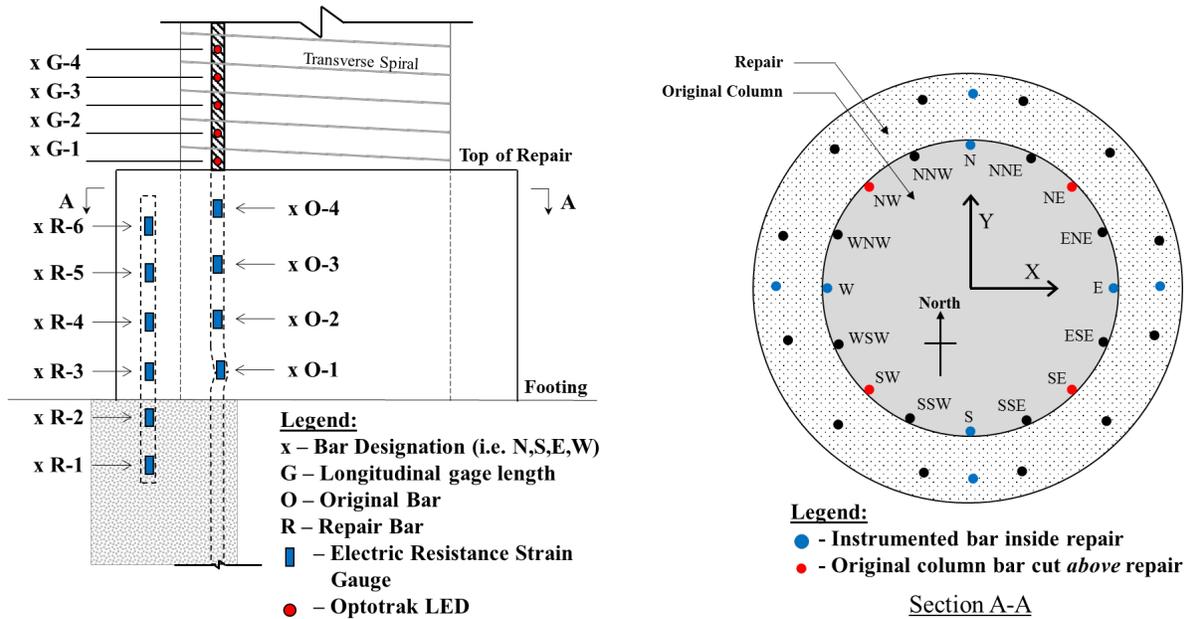
Figure 4.27: Repair #3 Instrumentation labels and repair cross section layout.

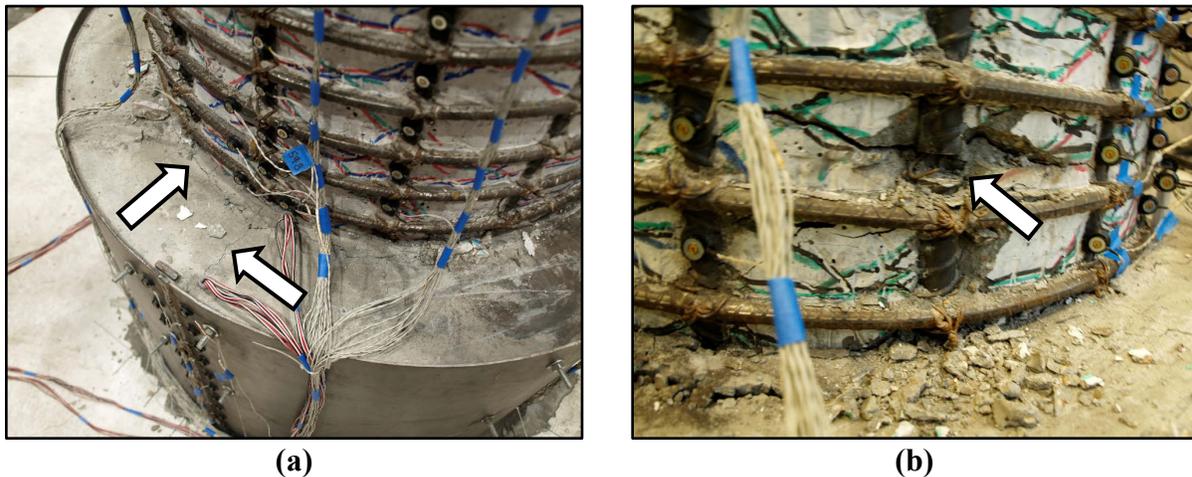
**Figure 4.28: Repair #3 (a) Slight cracking on top of repair during  $\mu_{\Delta 1.5}$  cycle; (b) accumulation of damage and large crack width opening during  $\mu_{\Delta 3}^{-1y}$ .**

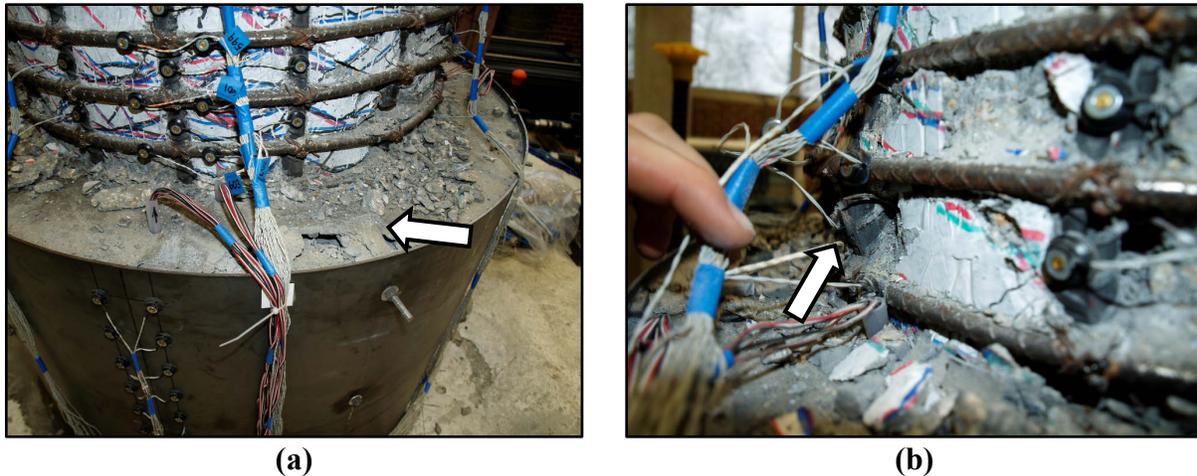
Figure 4.29: Repair #3 (a) beginning of top of repair deterioration during  $\mu_{A4}^{-1y}$ ; (b) Onset of bar buckling during  $\mu_{A5}^{-1y}$ .

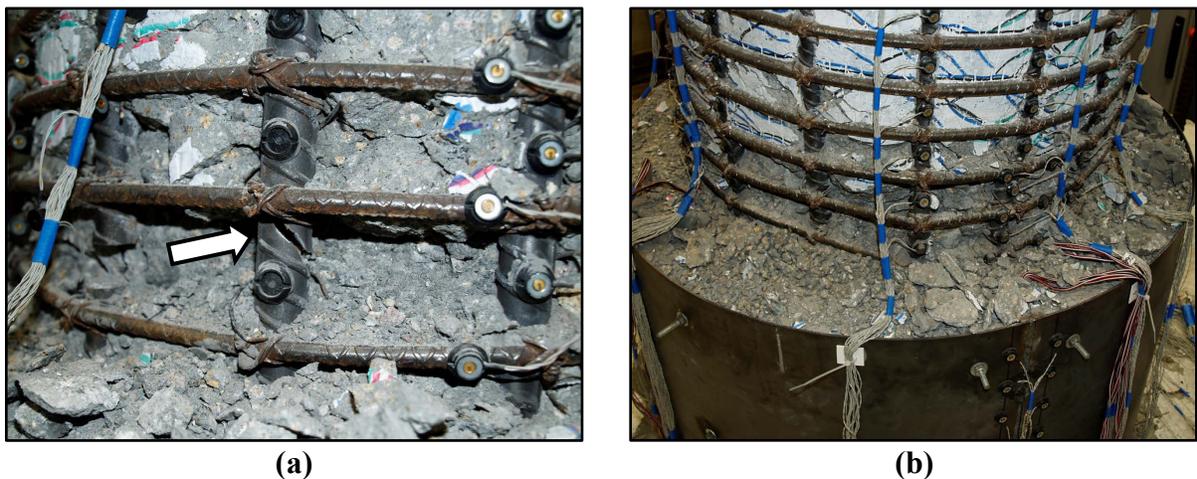
Figure 4.30: Repair #3 (a) Fracture of SSW bar during  $\mu_{A5}^{+2y}$ ; (b) Final damage state.

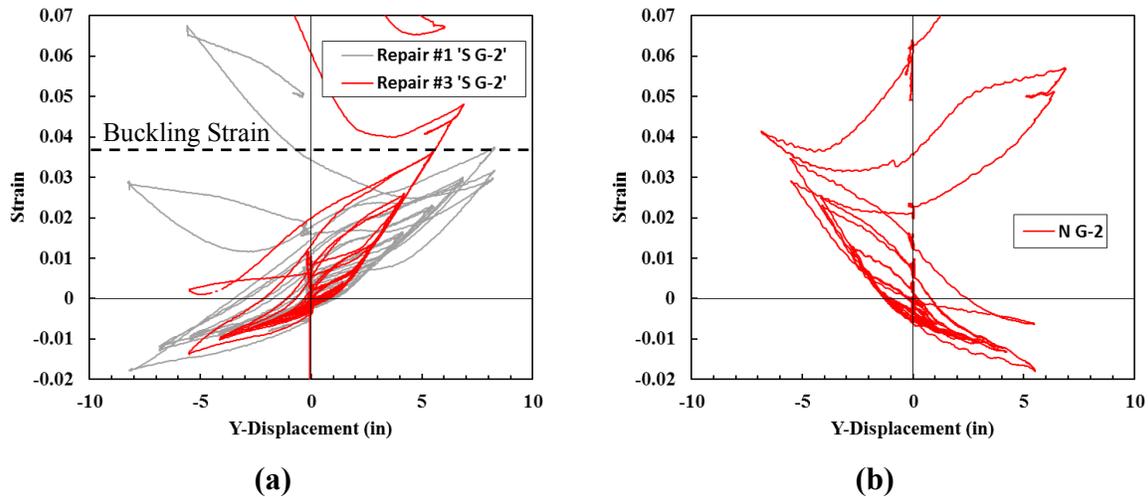
Figure 4.33: Repair #3 Strain in longitudinal bars vs Y- Displacement on (a) South face; (b) North face.

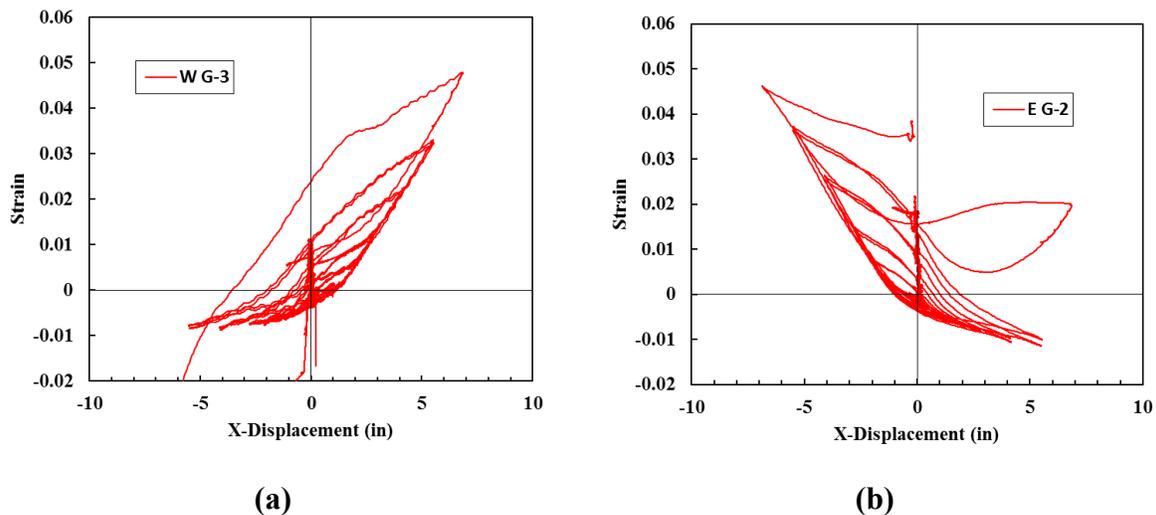
Figure 4.34: Repair #3 Strain in longitudinal bars vs X- Displacement on (a) West face; (b) East face.
