# Repair of Reinforced Concrete Bridge Columns via Plastic Hinge Relocation

## *Volume 1: Repair Using Conventional Materials*

Alaska Department of Transportation & Public Facilities

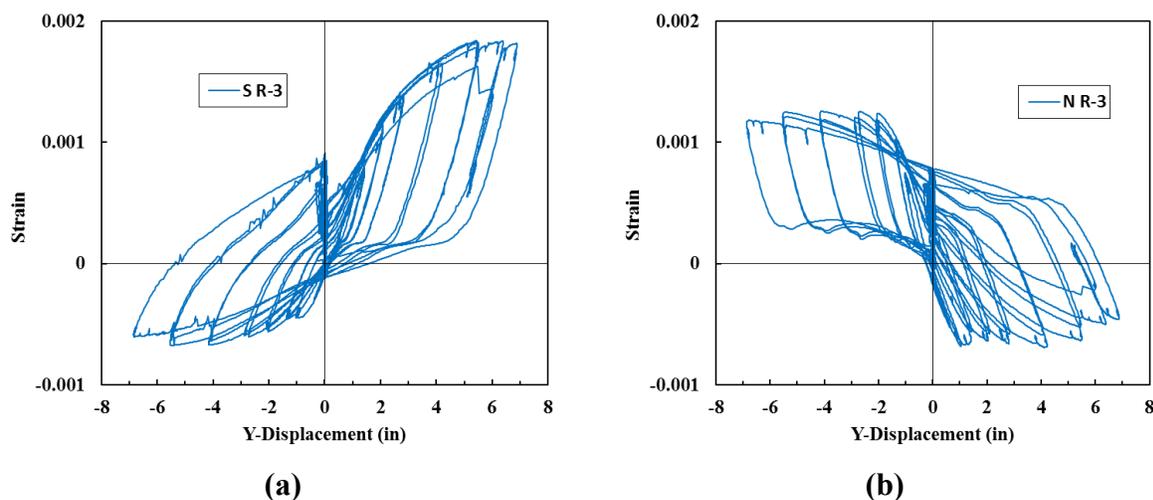
Figure 4.36: Repair #3 Strain in repair bars vs. Y-Displacement on the (a) South and (b) North faces of the column.

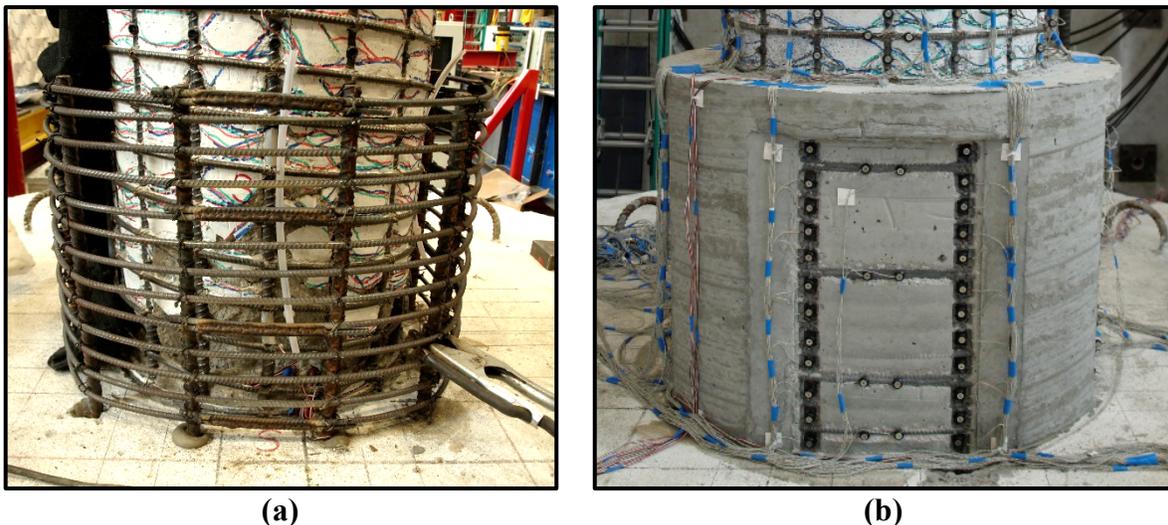
Figure 4.38: Repair #4 (a) welded rebar hoop construction; (b) blocked out repair section.

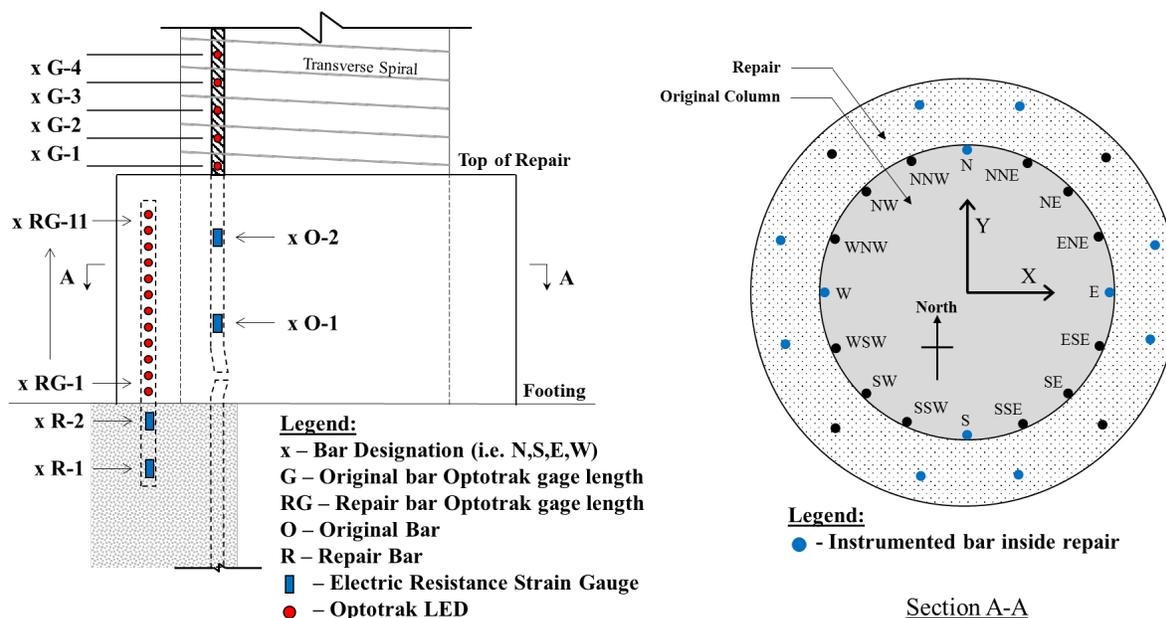
Figure 4.40: Repair #4 Instrumentation labels and repair cross section layout.

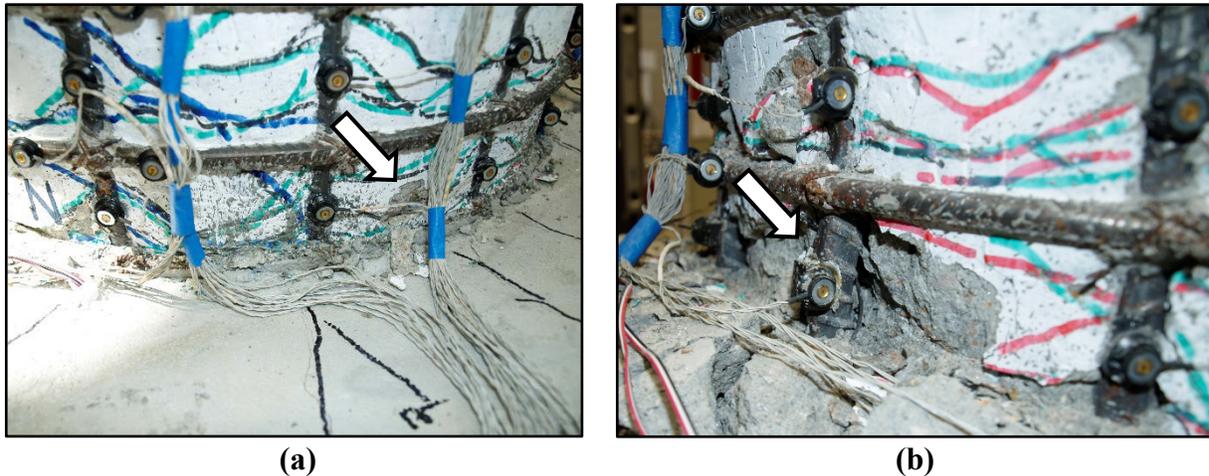
Figure 4.42: Repair #4 (a) Onset of core crushing during cycle  $\mu\Delta_3^{+\gamma}$ ; (b) Onset of bar buckling during  $\mu\Delta_5^{-2x}$ .

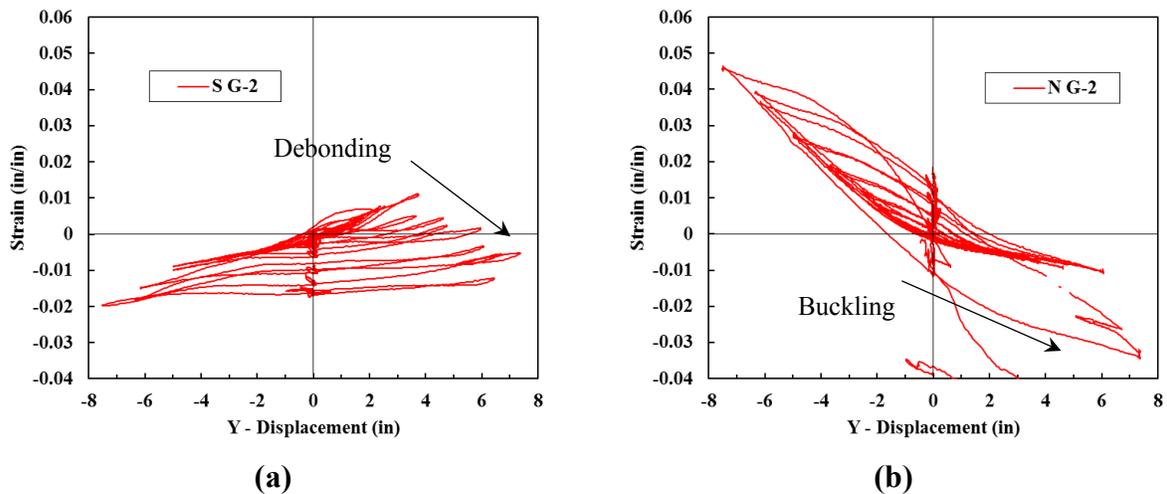
Figure 4.48: Repair #4 Strain in longitudinal bars vs Y- Displacement on (a) South face; (b) North face.

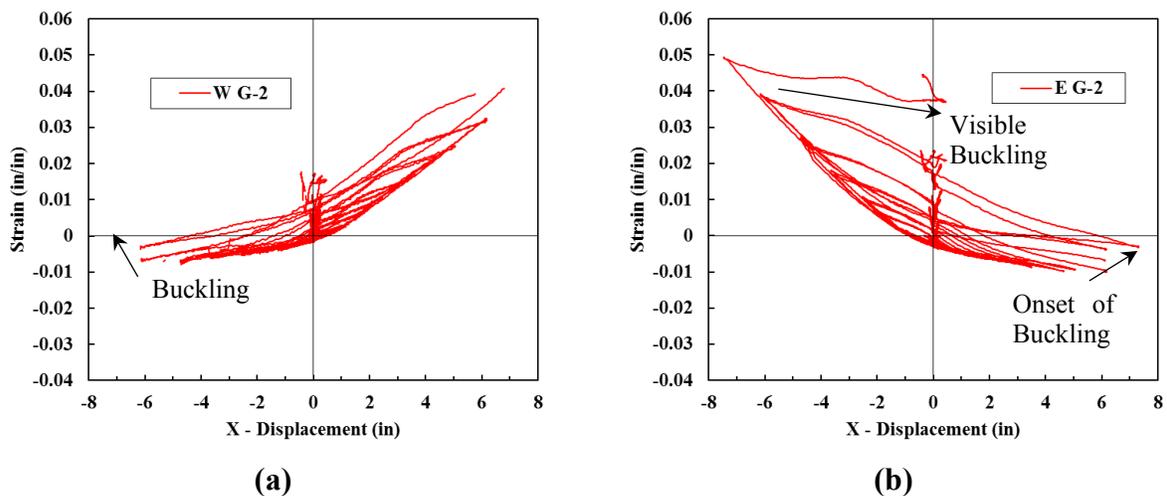
Figure 4.49: Repair #4 Strain in longitudinal bars vs X- Displacement on (a) West face; (b) East face.

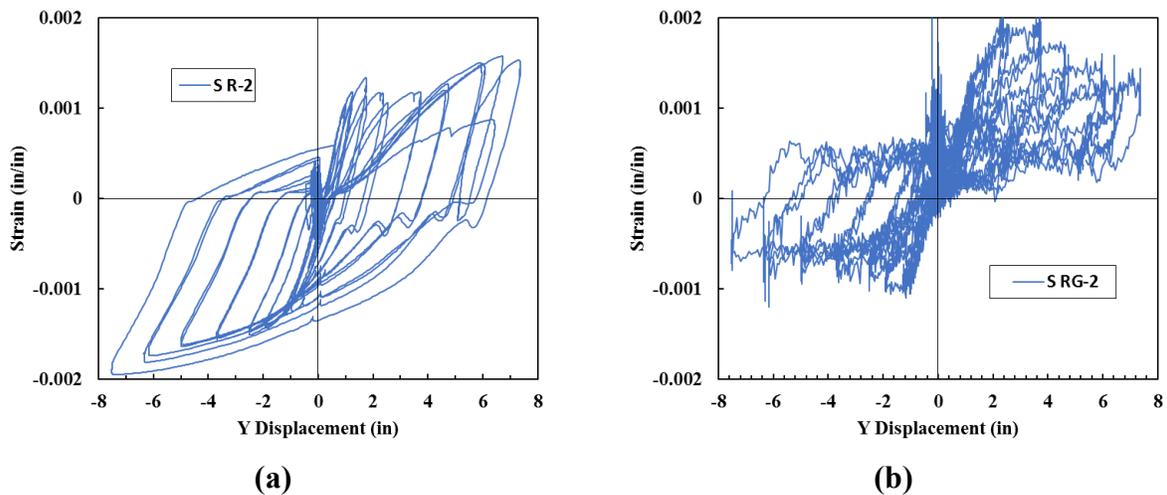
Figure 4.50: Repair #4 Strain in South repair bars vs Y- Displacement from (a) SG2-RS; (b) Optotrak gage 2.

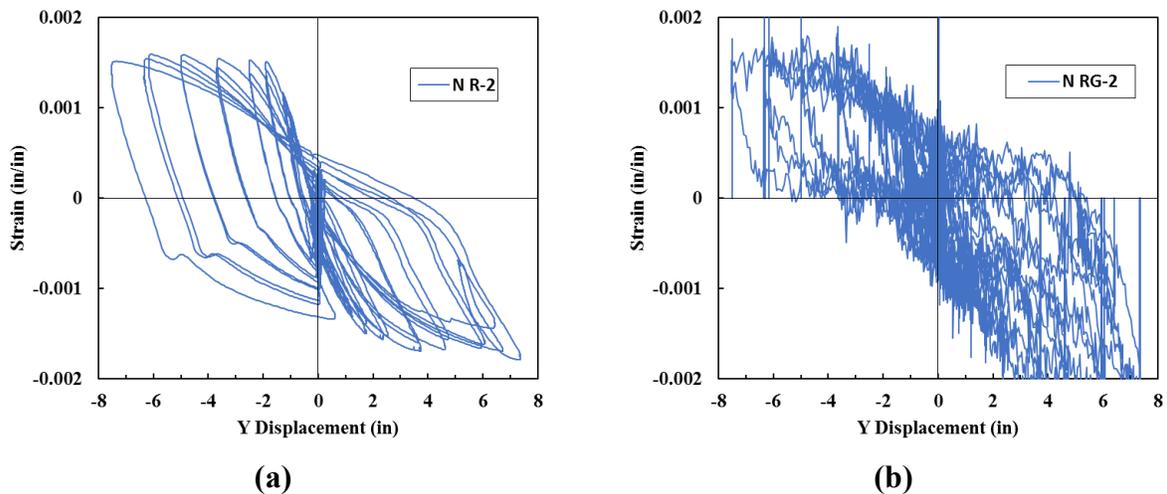
Figure 4.51: Repair #4 Strain in North repair bars vs Y- Displacement from (a) SG2-RN; (b) Optotrak gage 2.

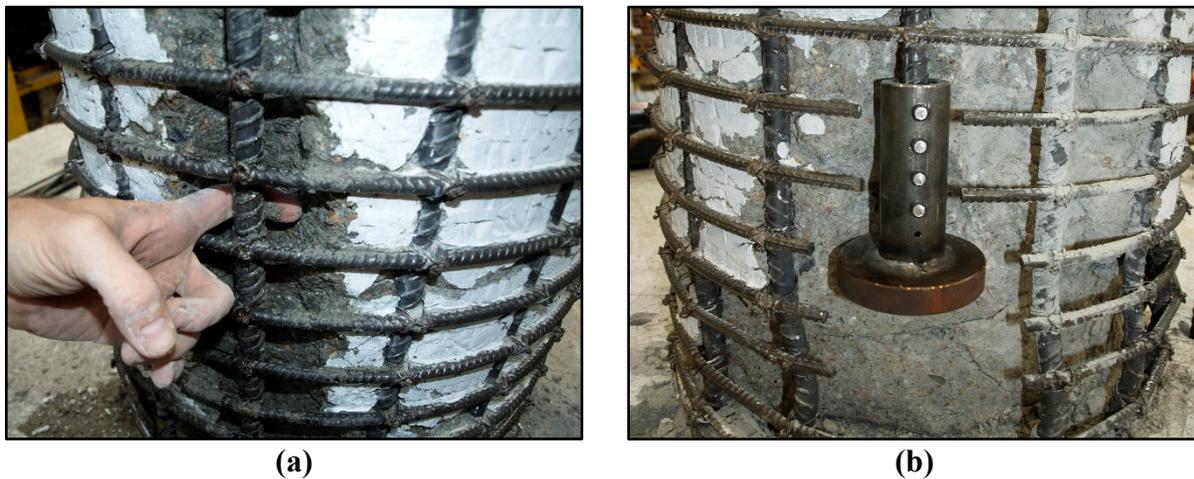
Figure 4.54: Repair #5 fractured bar anchorage mechanisms considered.

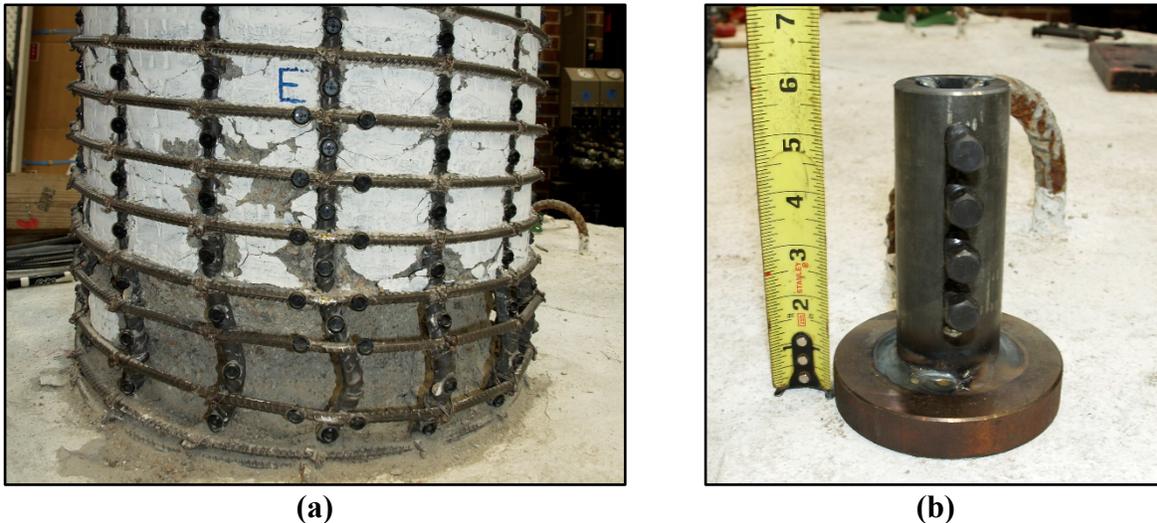
**Figure 4.55: Repair #5 (a) Initial state of damage prior to headed anchor installation; (b) Dayton Superior D252L Bar Lock ® End Anchor.**

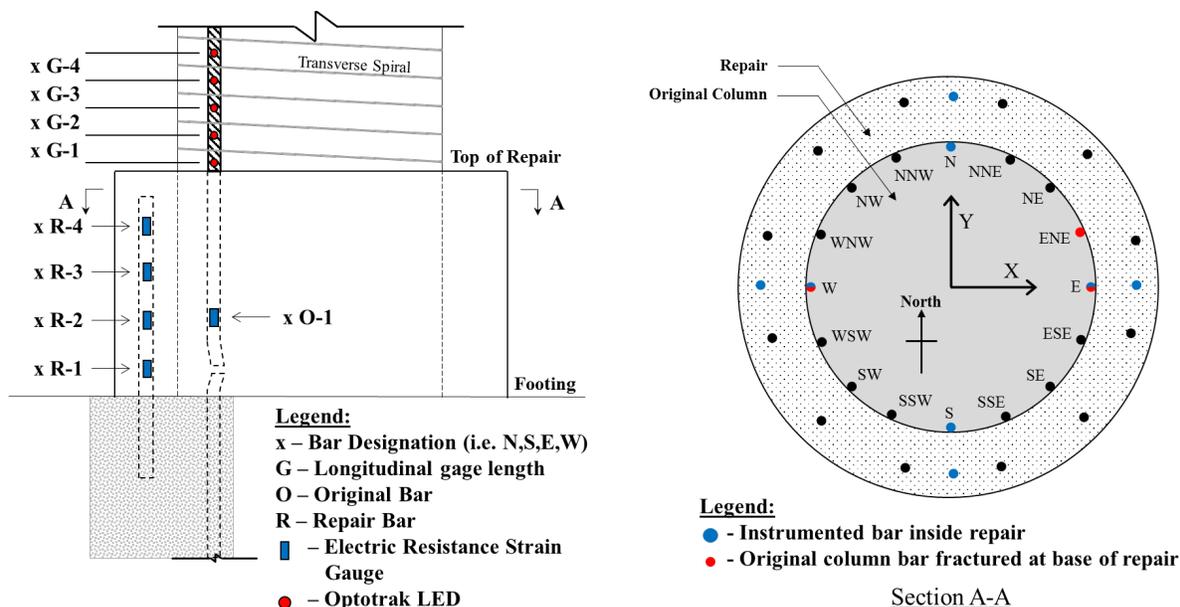
Figure 4.58: Repair #5 Instrumentation labels and repair cross section layout.

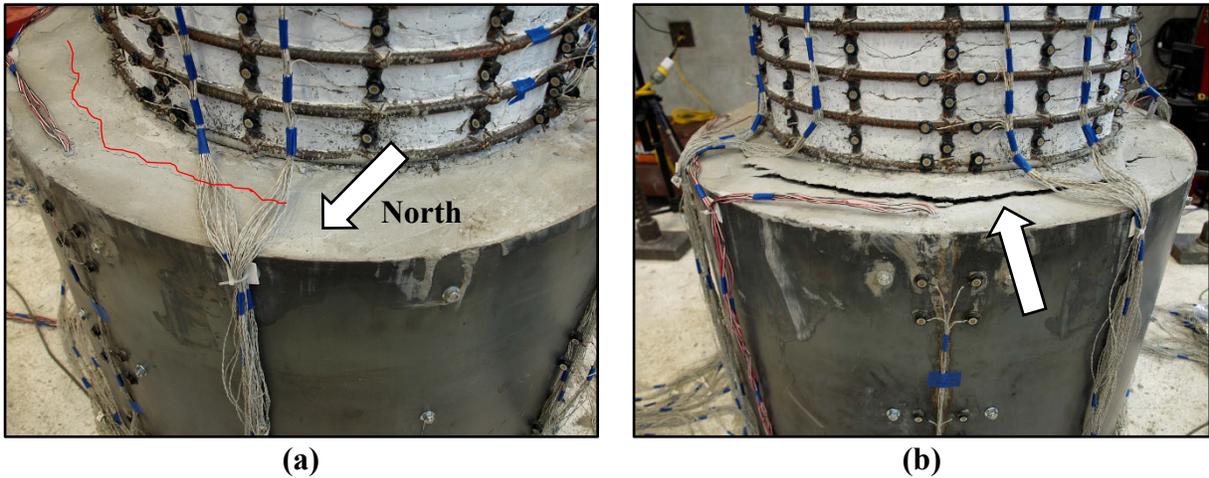
Figure 4.59: Repair #5 (a) Cracking at the top of the repair during cycle  $\mu_{\Delta 1}^{-y}$ ; (b) Progression of crack opening on North Face during cycle  $\mu_{\Delta 2}^{-y}$ .

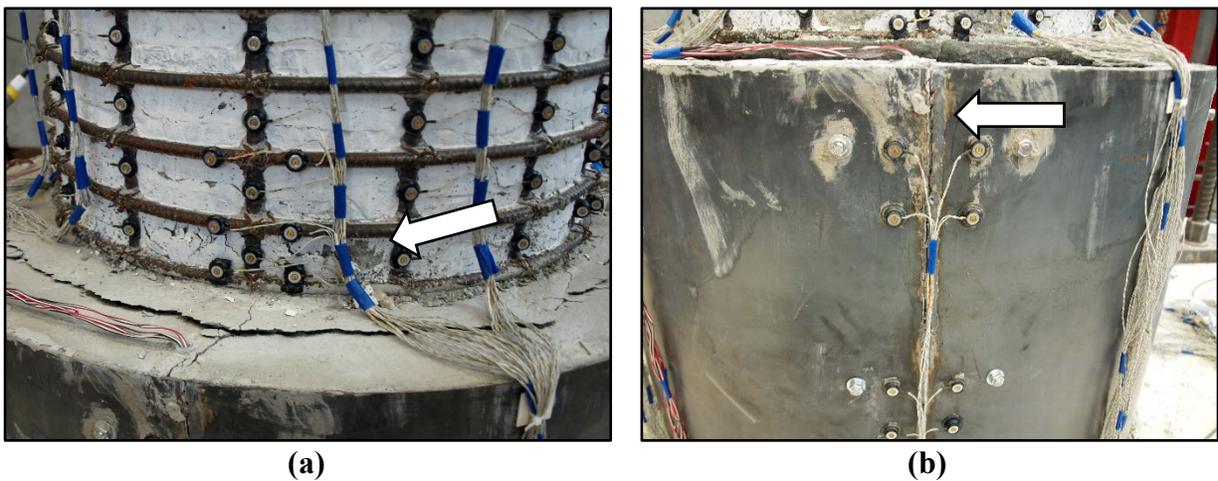
Figure 4.60: Repair #5 (a) Onset of core crushing during cycle  $\mu_{\Delta 3}^{+y}$ ; (b) Initiation of weld failure on North Face during cycle  $\mu_{\Delta 3}^{-2y}$ .

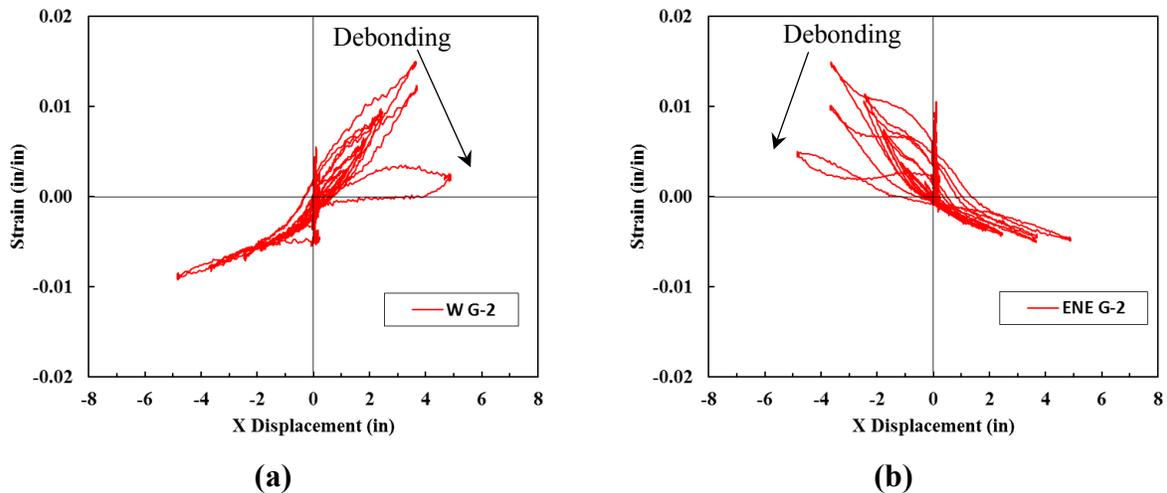
Figure 4.64: Repair #5 strain in longitudinal bars vs X- Displacement on (a) W Bar; (b) ENE Bar.

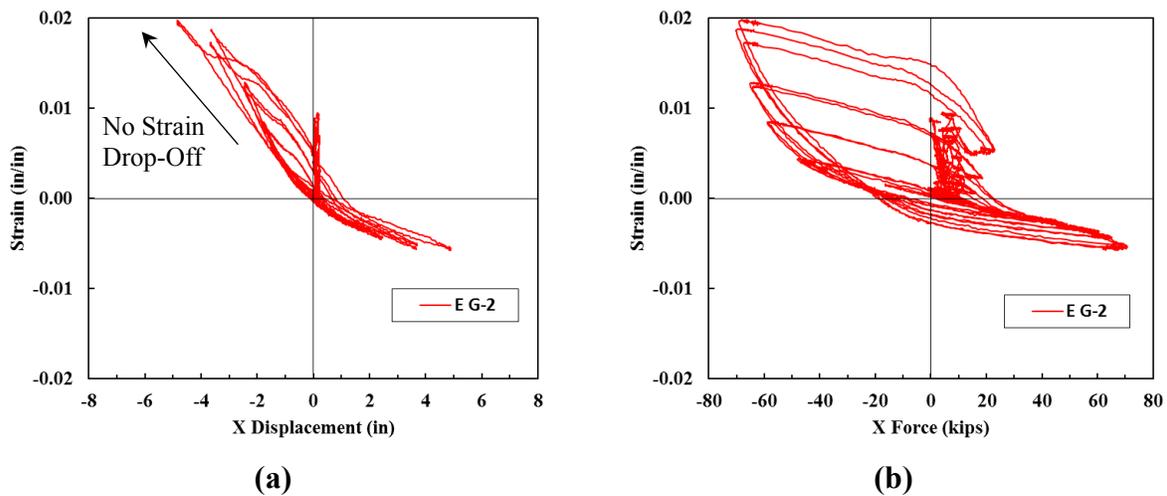
Figure 4.65: Repair #5 (a) Strain in longitudinal bars vs X- Displacement on East bar with Mechanical Headed Stud; (b) Strain vs. X-Force on East bar.

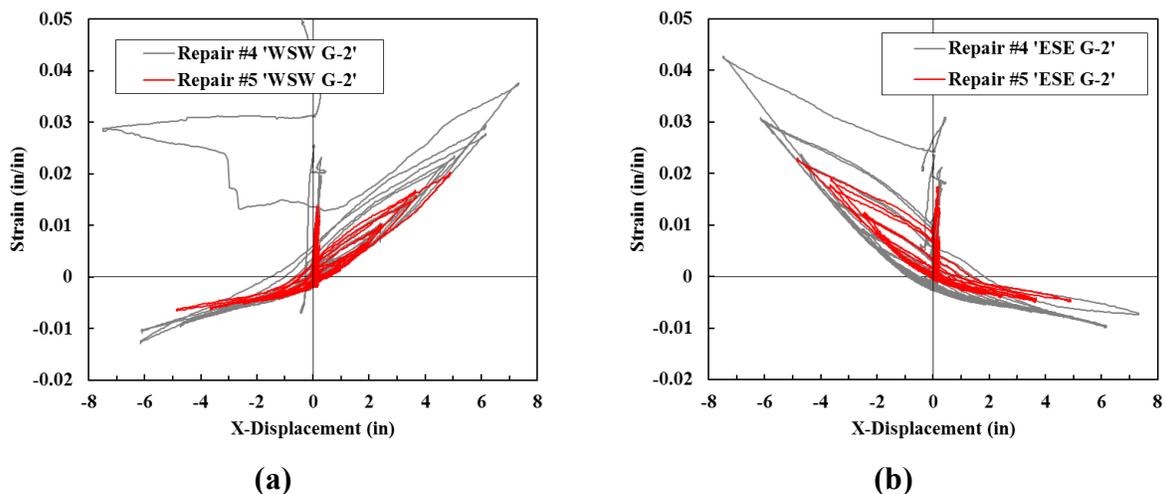
Figure 4.66: Comparison of strain history between Repair #4 and Repair #5 in the (a) WSW bars and; (b) ESE bars.

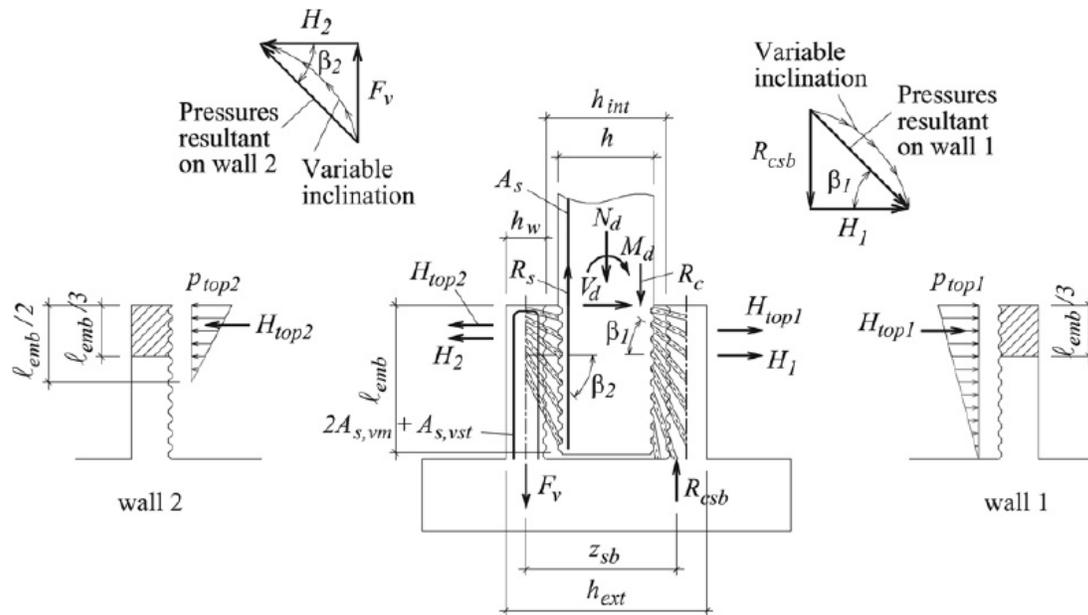
**Figure 4.68: Transfer of force resultants from precast column to socket base with roughened interface (Canha, de Borja Jaguaribe, de Cresce El Debs, & El Debs, 2009).**

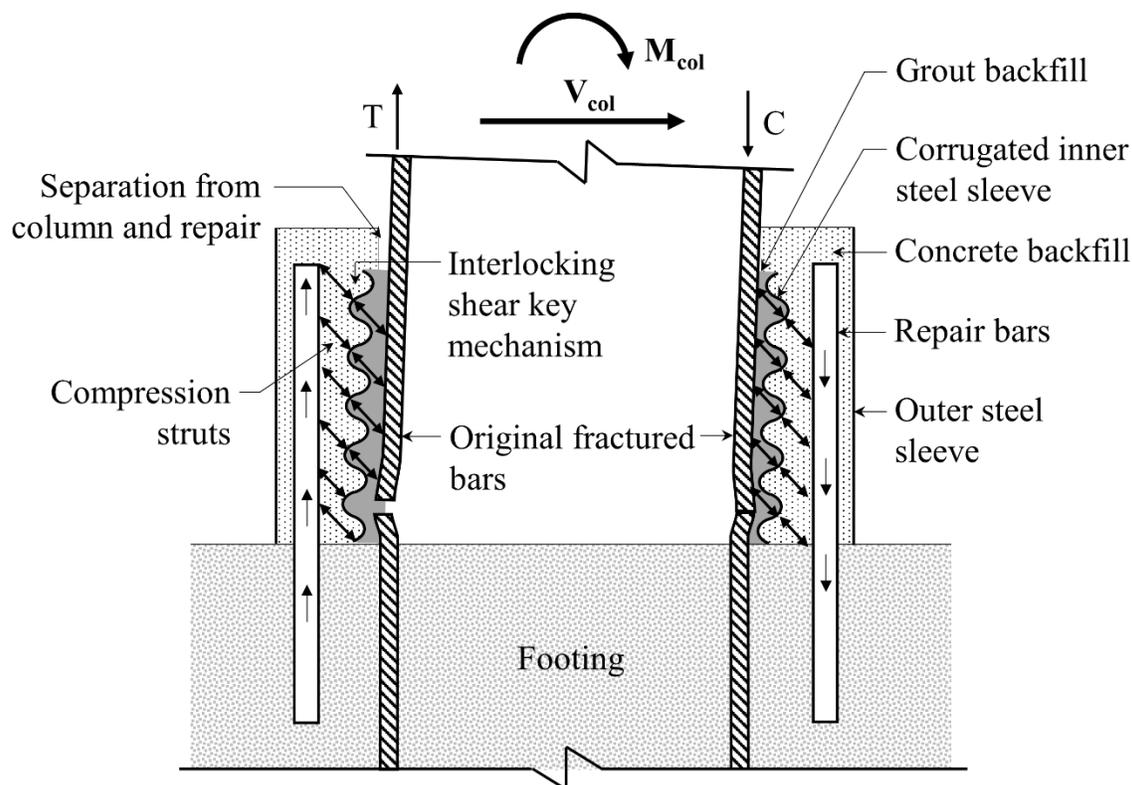
Figure 4.69: Illustration of corrugated steel sleeve shear key mechanism.

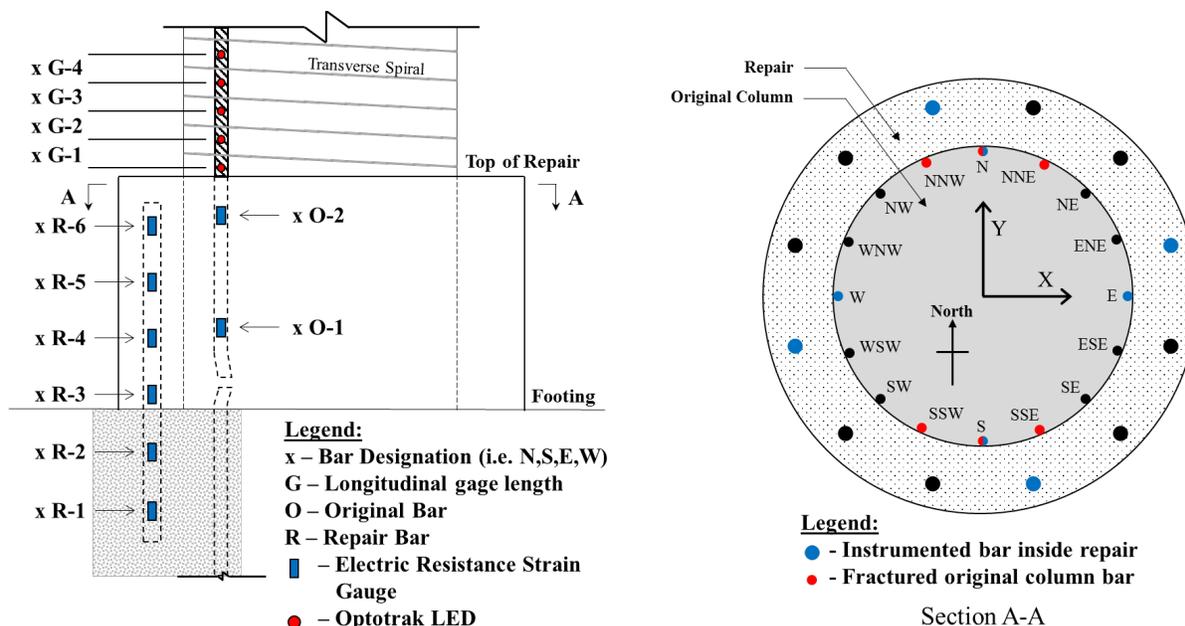
Figure 4.72: Repair #6 Instrumentation labels and repair cross section layout.

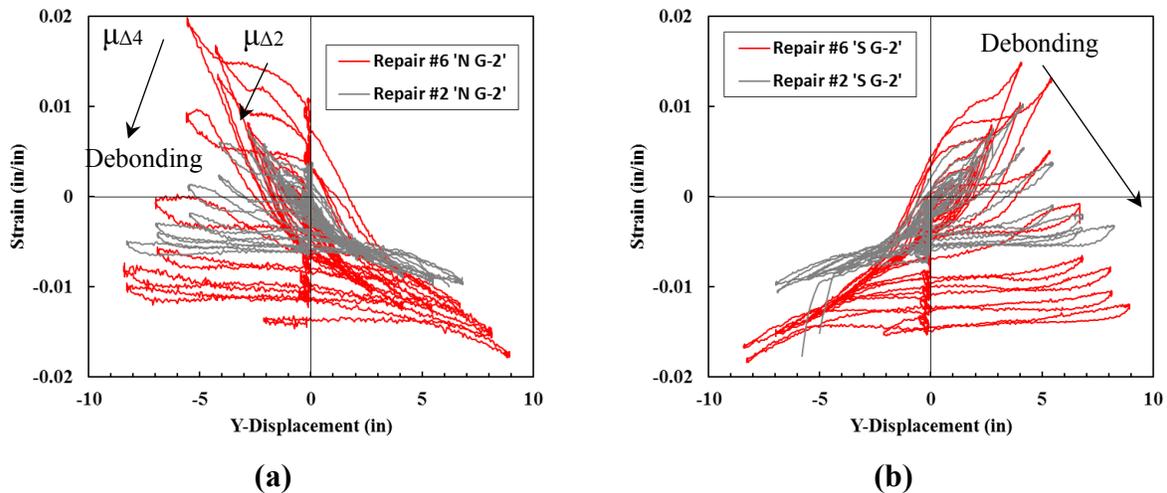
Figure 4.80: Strain in longitudinal bars vs Y- Displacement on (a) North Bar; (b) South Bar.

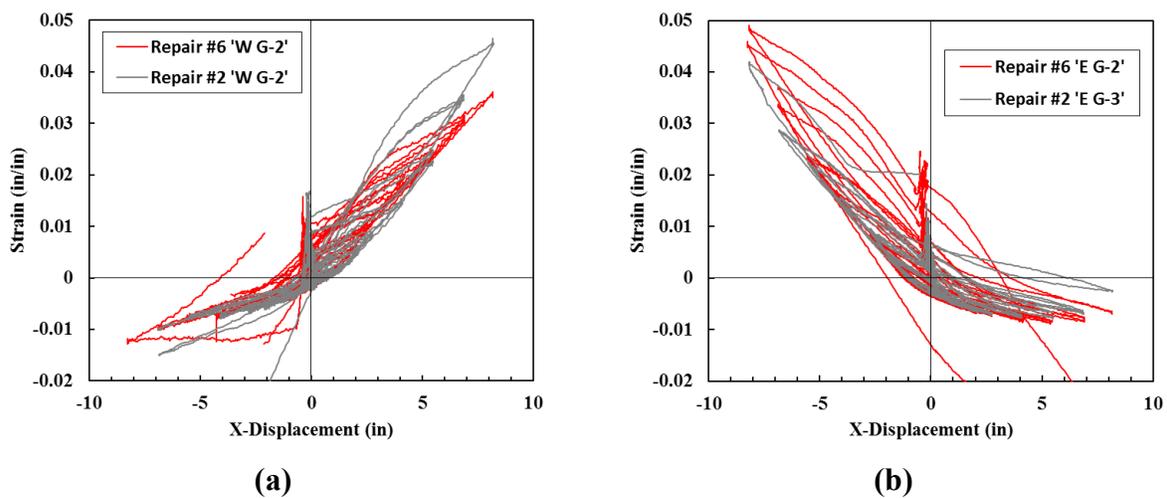
Figure 4.81: Strain in longitudinal bars vs X- Displacement on (a) West Bar; (b) East Bar.

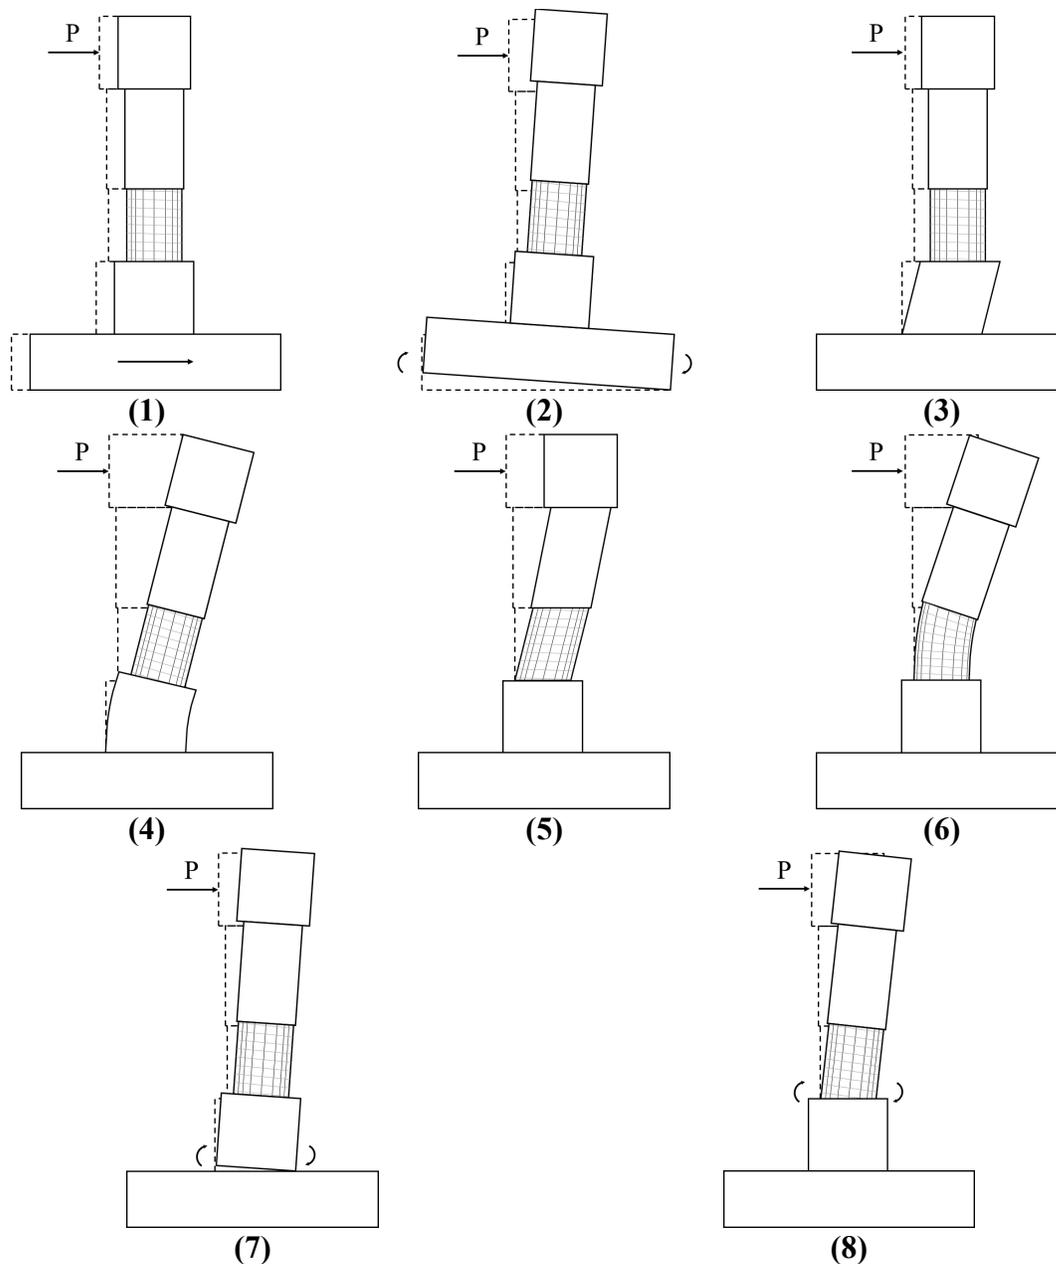
**Figure 5.1: Visualization of the components of lateral column displacements.**

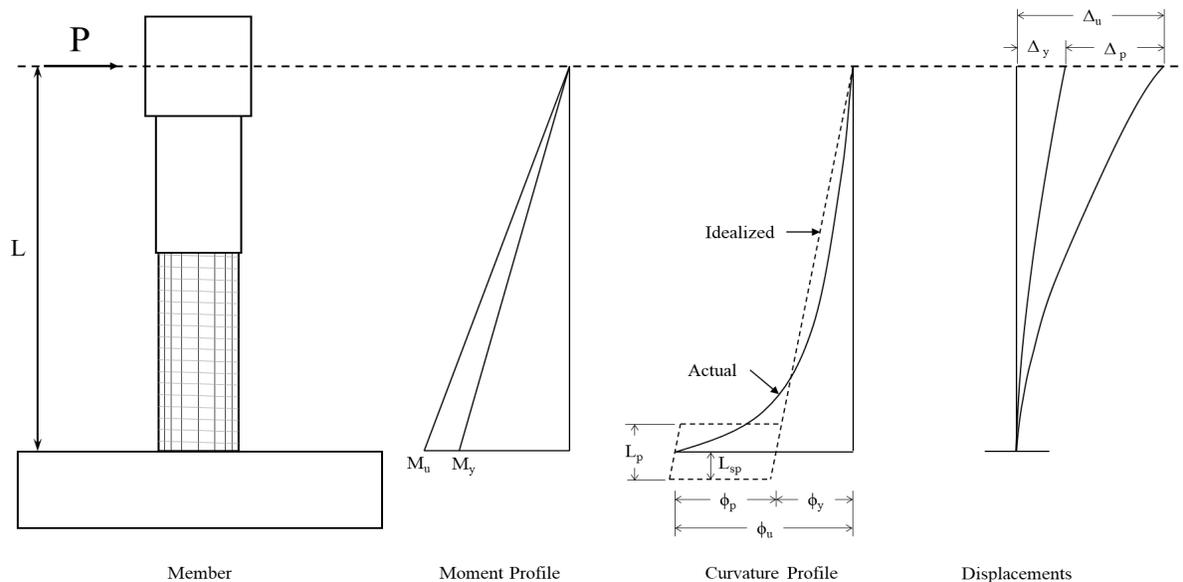
**Figure 5.8: Force and deformation profile for typical single bending column, adapted from (Priestley et al., 2007).**

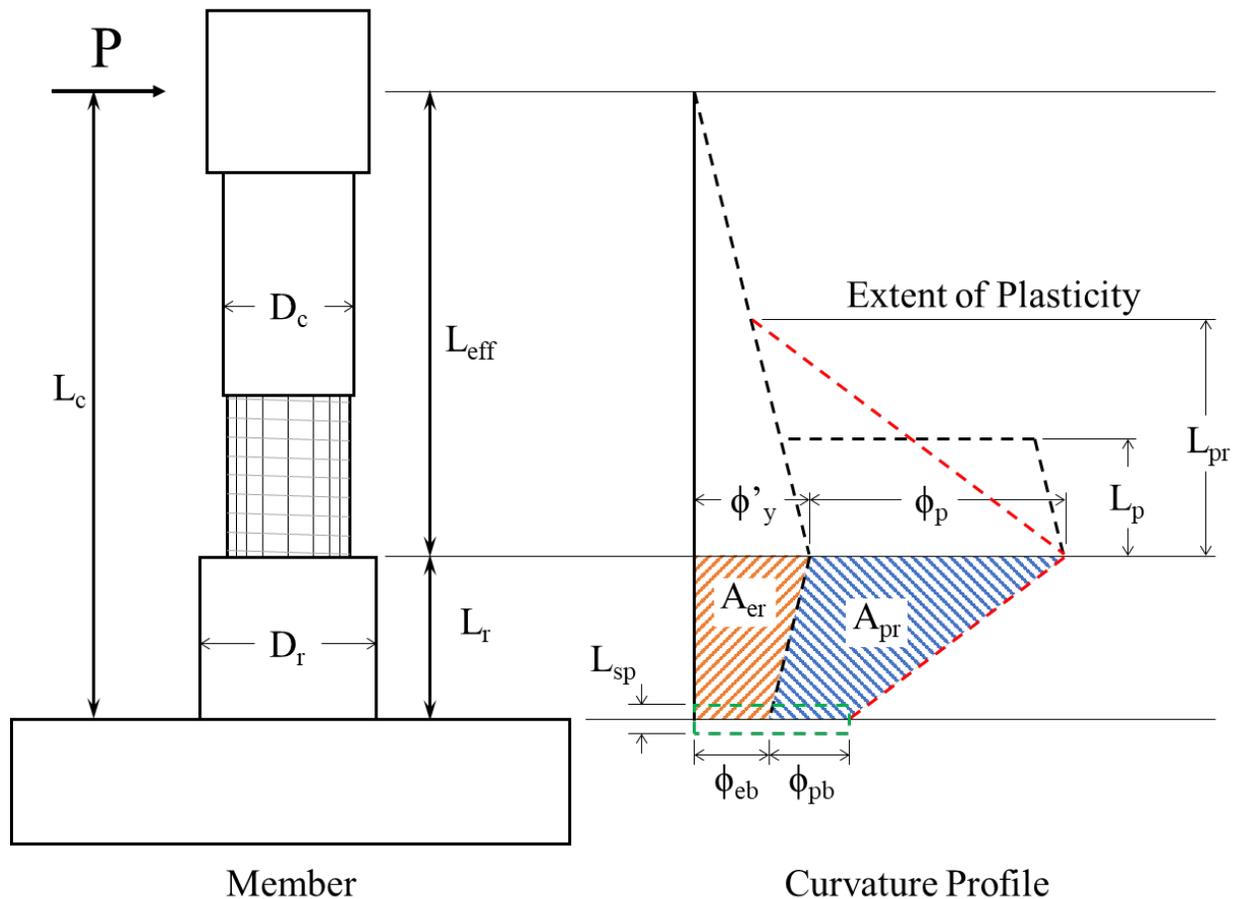
**Figure 5.11: Idealization of repaired column curvature distribution with mirrored plasticity.**

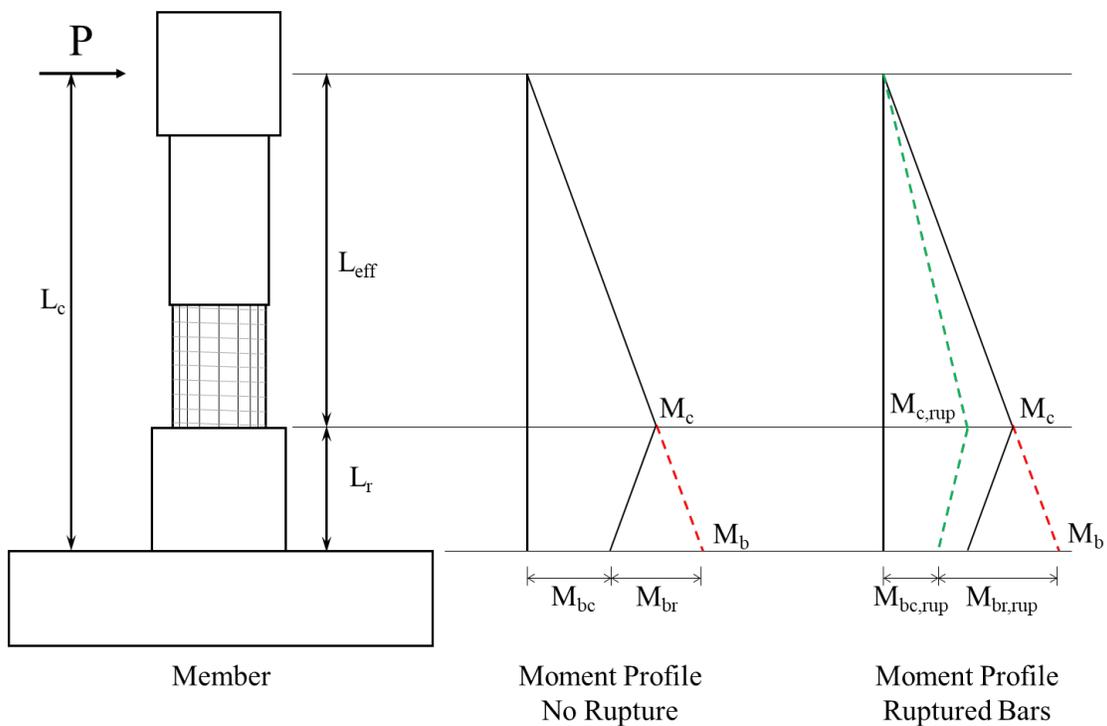
Figure 5.13: Repaired column assumed moment distribution

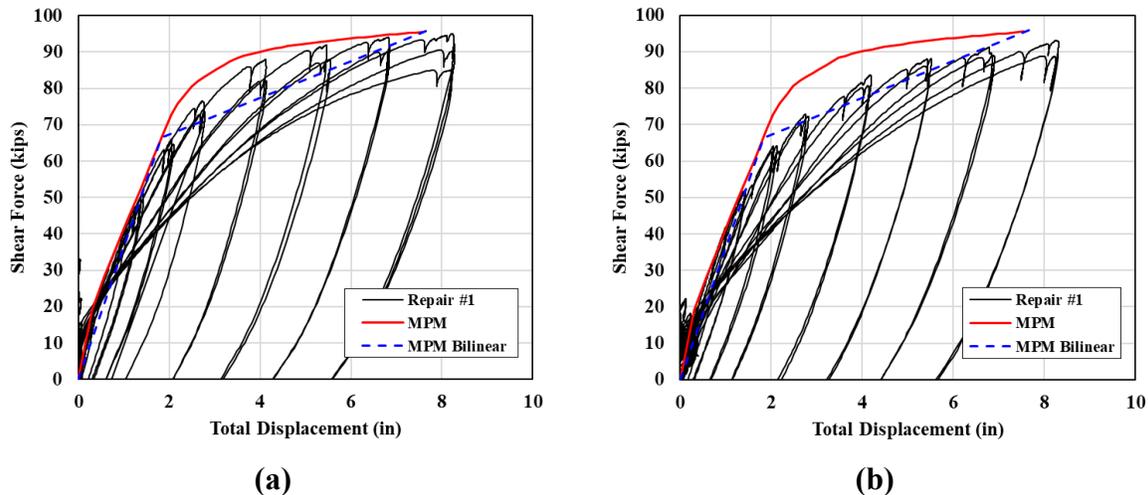
Figure 5.15: Repair #1 Force vs. Displacement response with comparison to MPM prediction in the (a) Y-direction; and (b) X-direction.

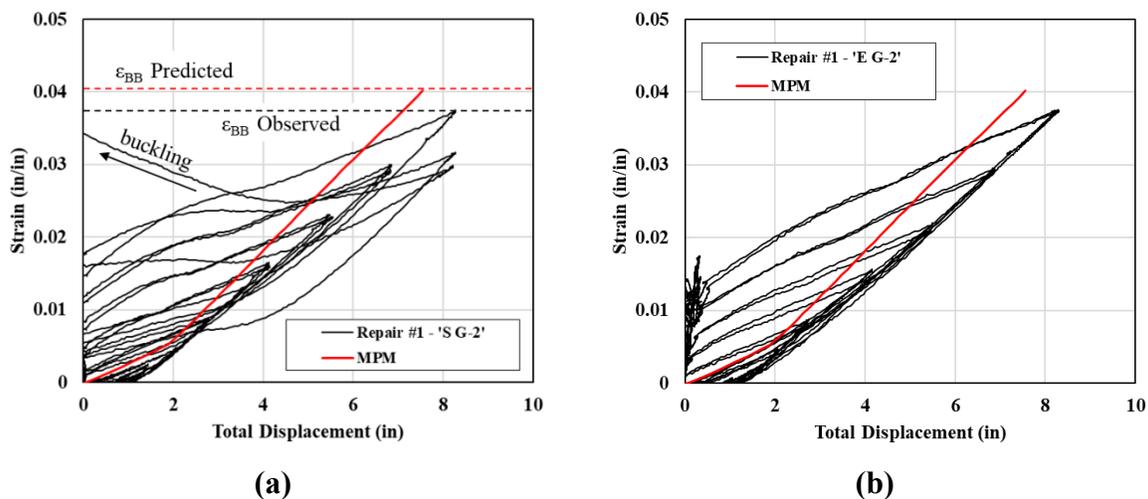
Figure 5.17: Repair #1 relocated hinge strain vs. displacement response with comparison to MPM prediction in the (a) Y-direction; and (b) X-direction.

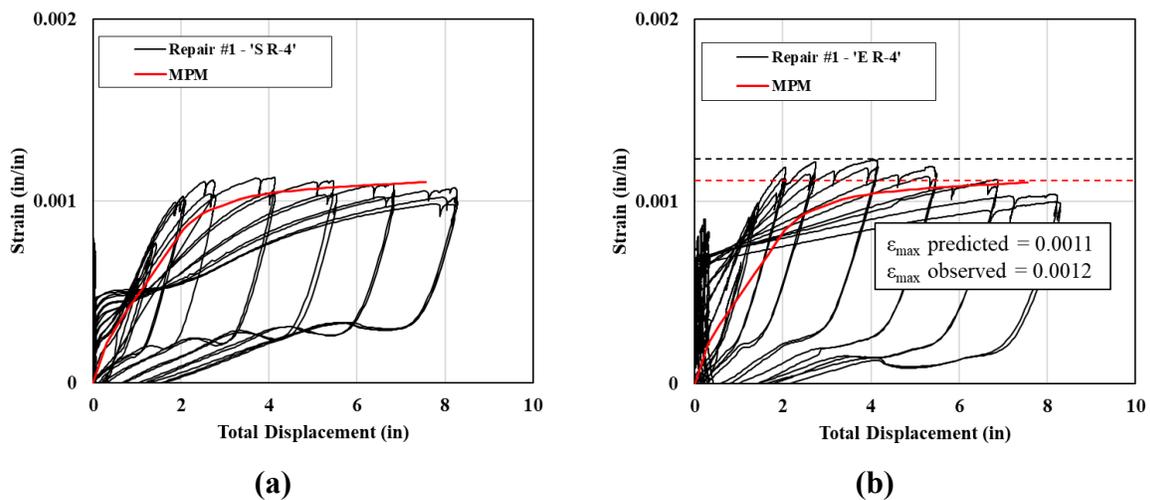
Figure 5.20: Repair #1 repair bar strain vs. displacement response with comparison to MPM prediction in the (a) Y-direction; and (b) X-direction.

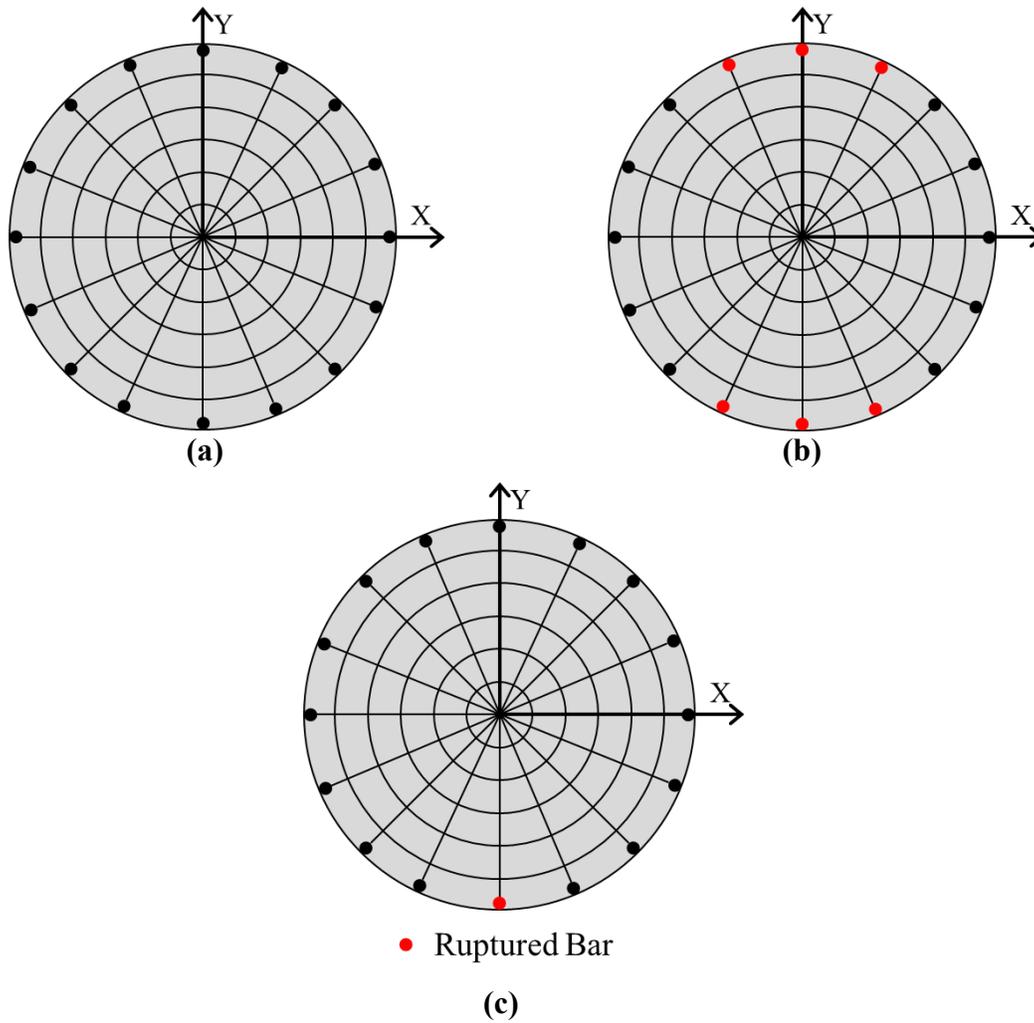
Figure 5.22: Discretization of column cross section used in moment-curvature analysis for (a) full cross section; (b) fractured base of Repair #2 and #6; and (c) fractured base of Repair #4.

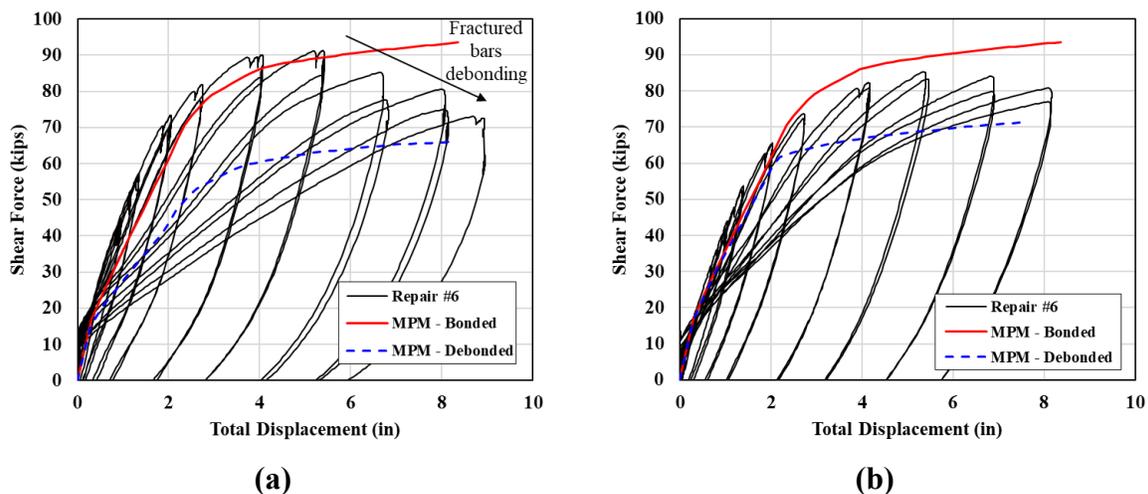
Figure 5.25: Repair #6 Force vs. Displacement response with comparison to MPM prediction in the (a) Y-direction; and (b) X-direction.

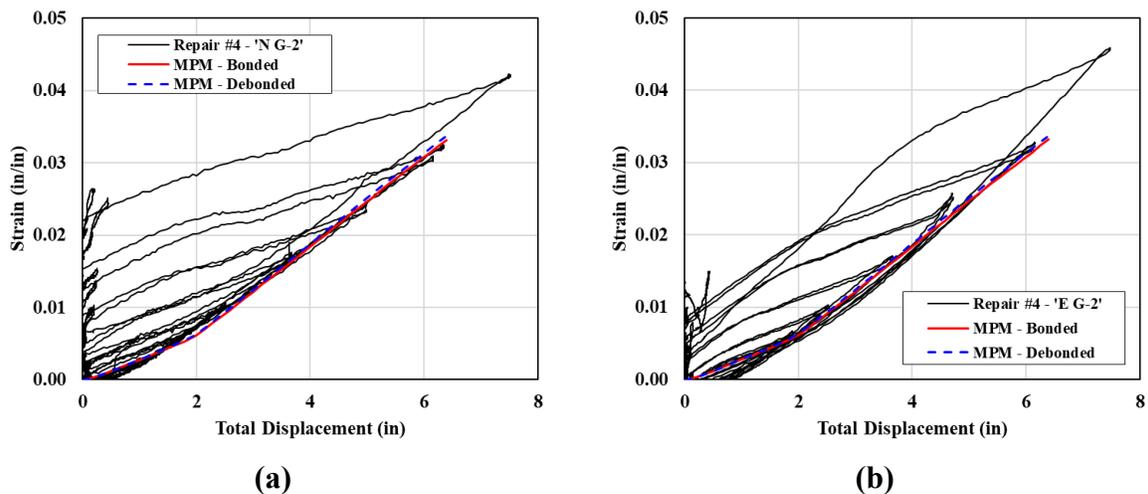
Figure 5.27: Repair #4 relocated hinge strain vs. displacement response with comparison to MPM prediction in the (a) Y-direction; and (b) X-direction.

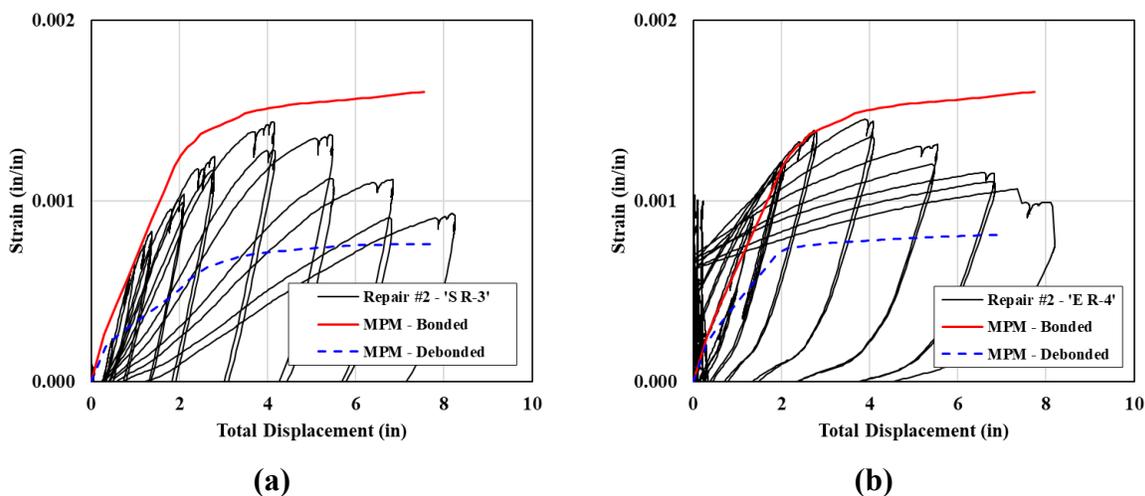
Figure 5.30: Repair #2 repair bar strain vs. displacement response with comparison to MPM prediction in the (a) Y-direction; and (b) X-direction.
