# Repair of Reinforced Concrete Bridge Columns via Plastic Hinge Relocation

## *Volume 1: Repair Using Conventional Materials*

Alaska Department of Transportation & Public Facilities

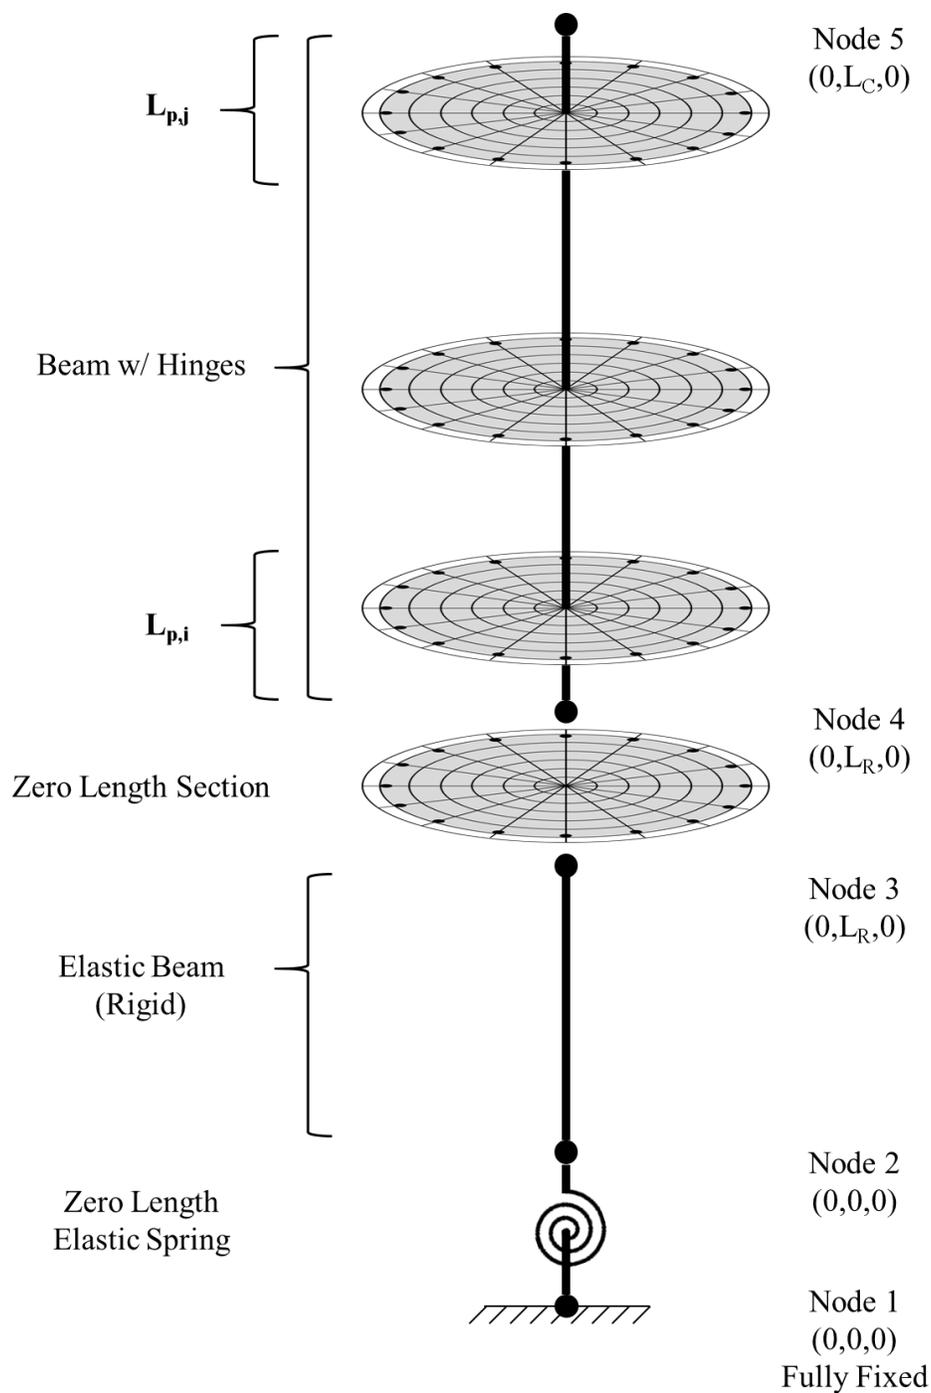
Figure 6.1: Computational model schematic diagram.

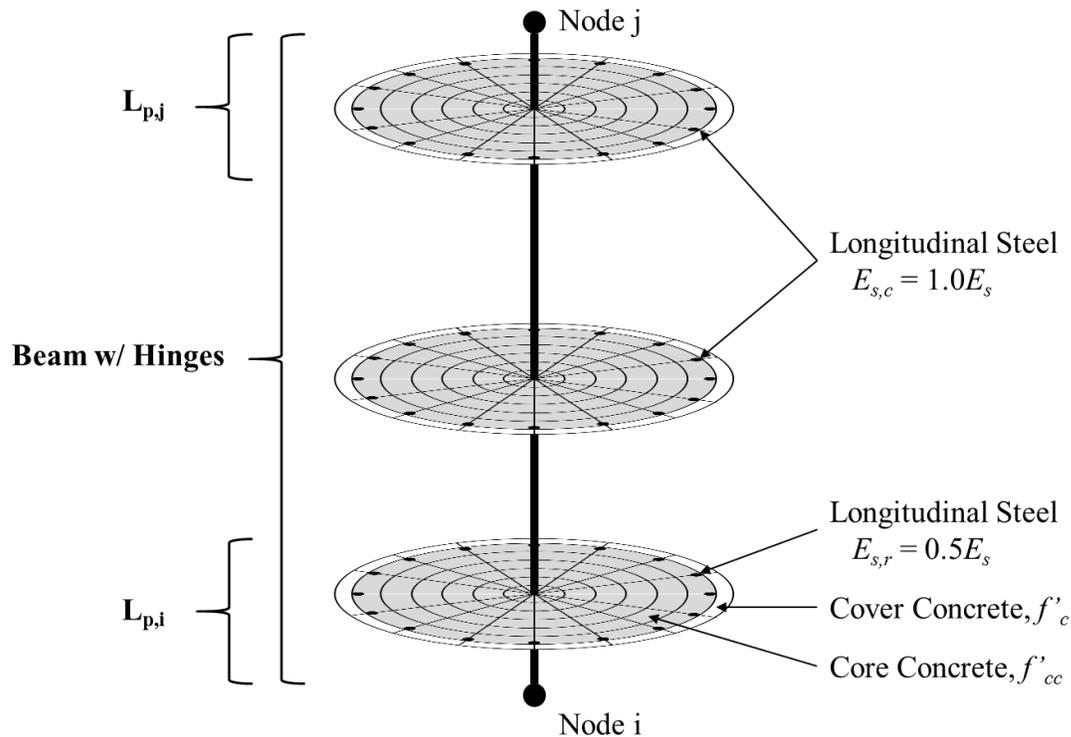
Figure 6.3: Definition of column section material properties within repaired member.

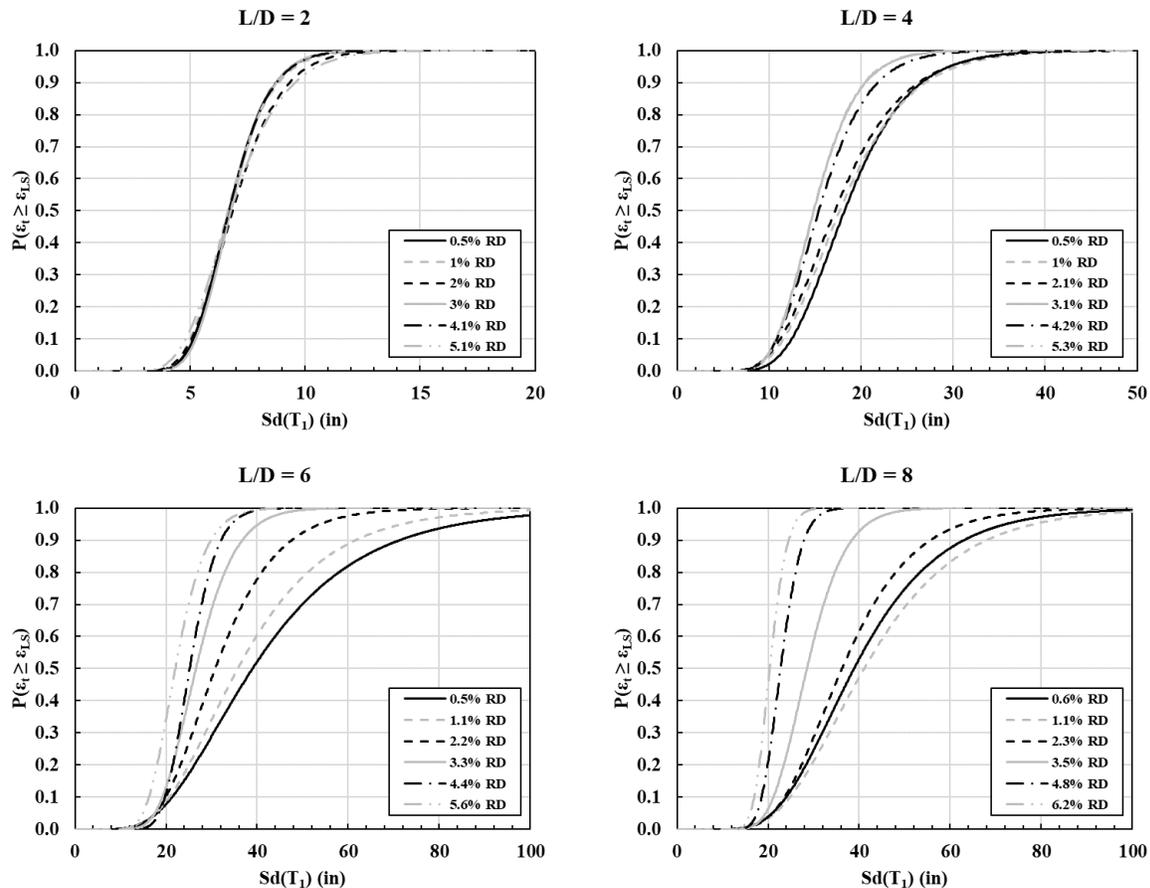
Figure 7.14: Influence of L/D on residual drift sensitivity for  $\varepsilon_{LS} = 0.03$ , ALR = 10%,  $\rho_1 = 2.5\%$ .

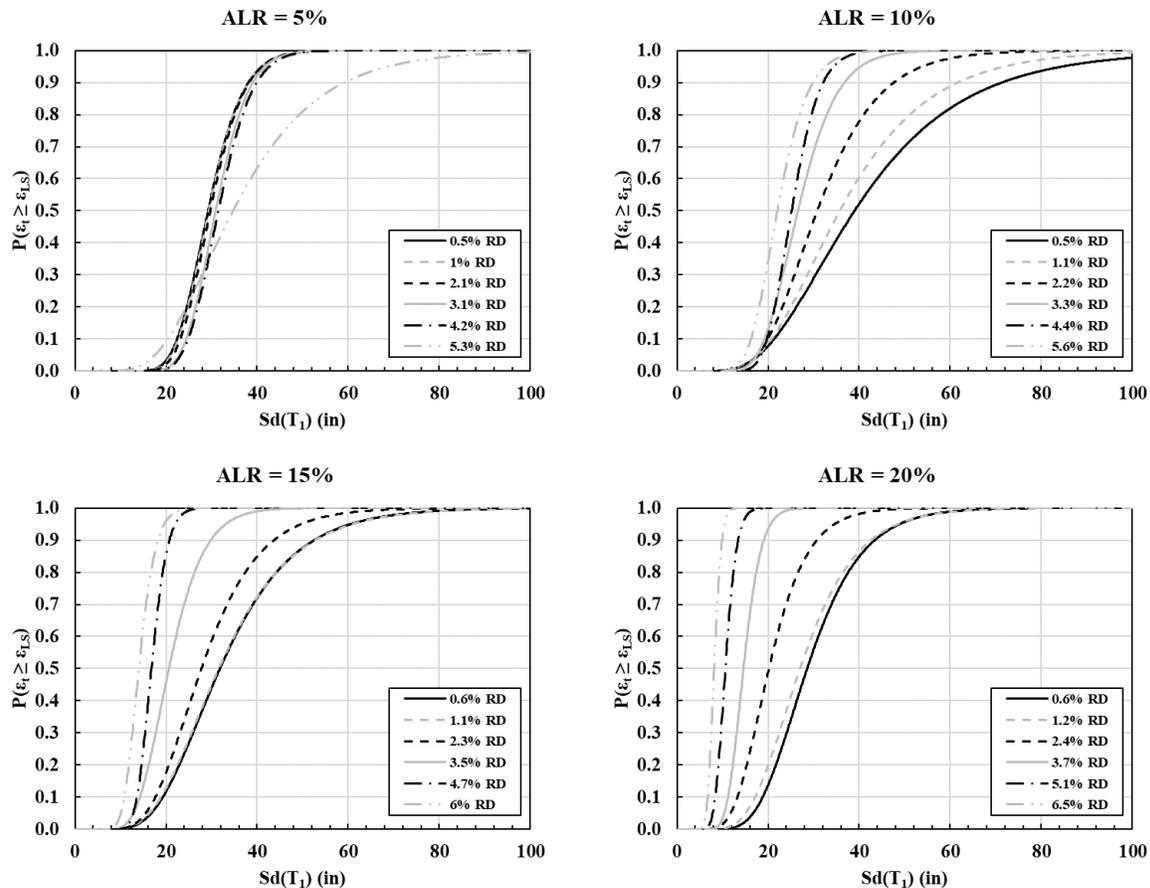
Figure 7.15: Influence of ALR on residual drift sensitivity for  $\epsilon_{LS} = 0.03$ ,  $L/D = 6$ ,  $\rho_l = 2.5\%$ .

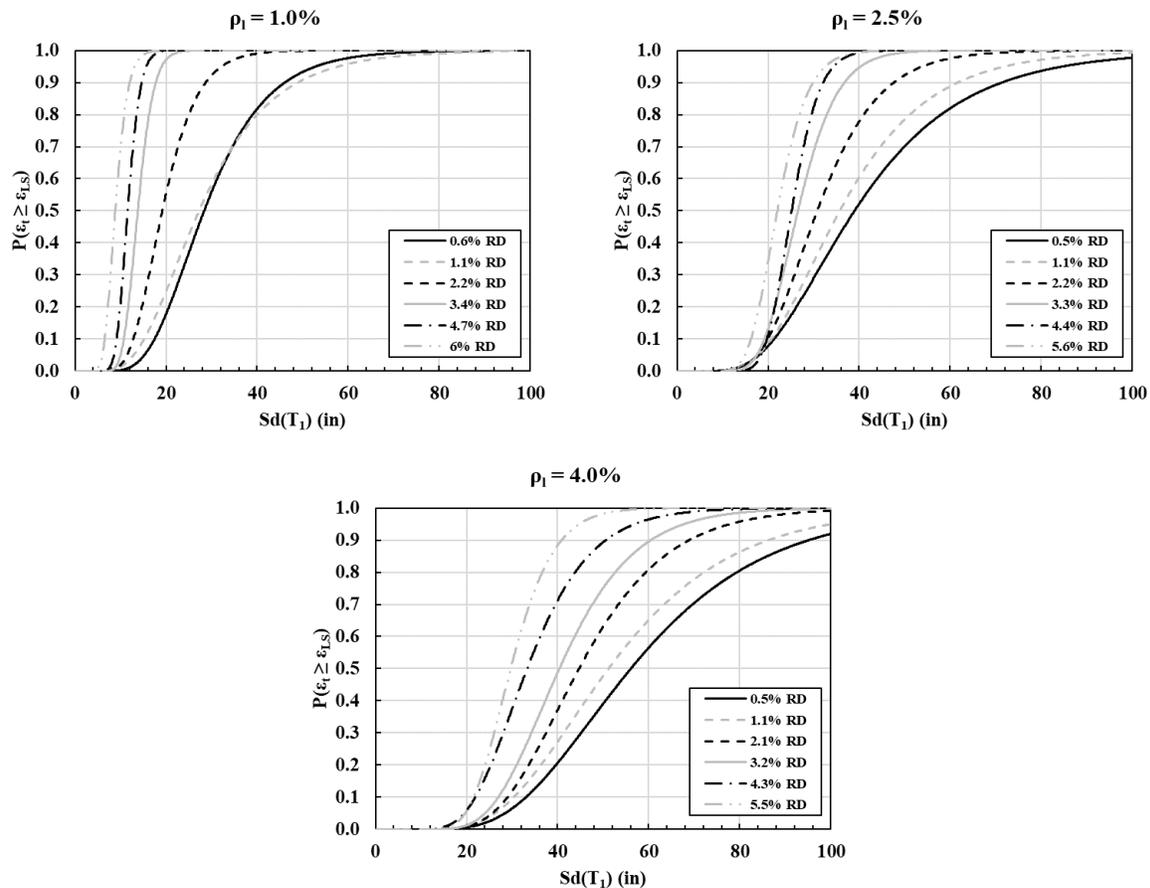
Figure 7.16: Influence of  $\rho_1$  on residual drift sensitivity for  $\epsilon_{LS} = 0.03$ ,  $L/D = 6$ ,  $ALR = 10\%$ .

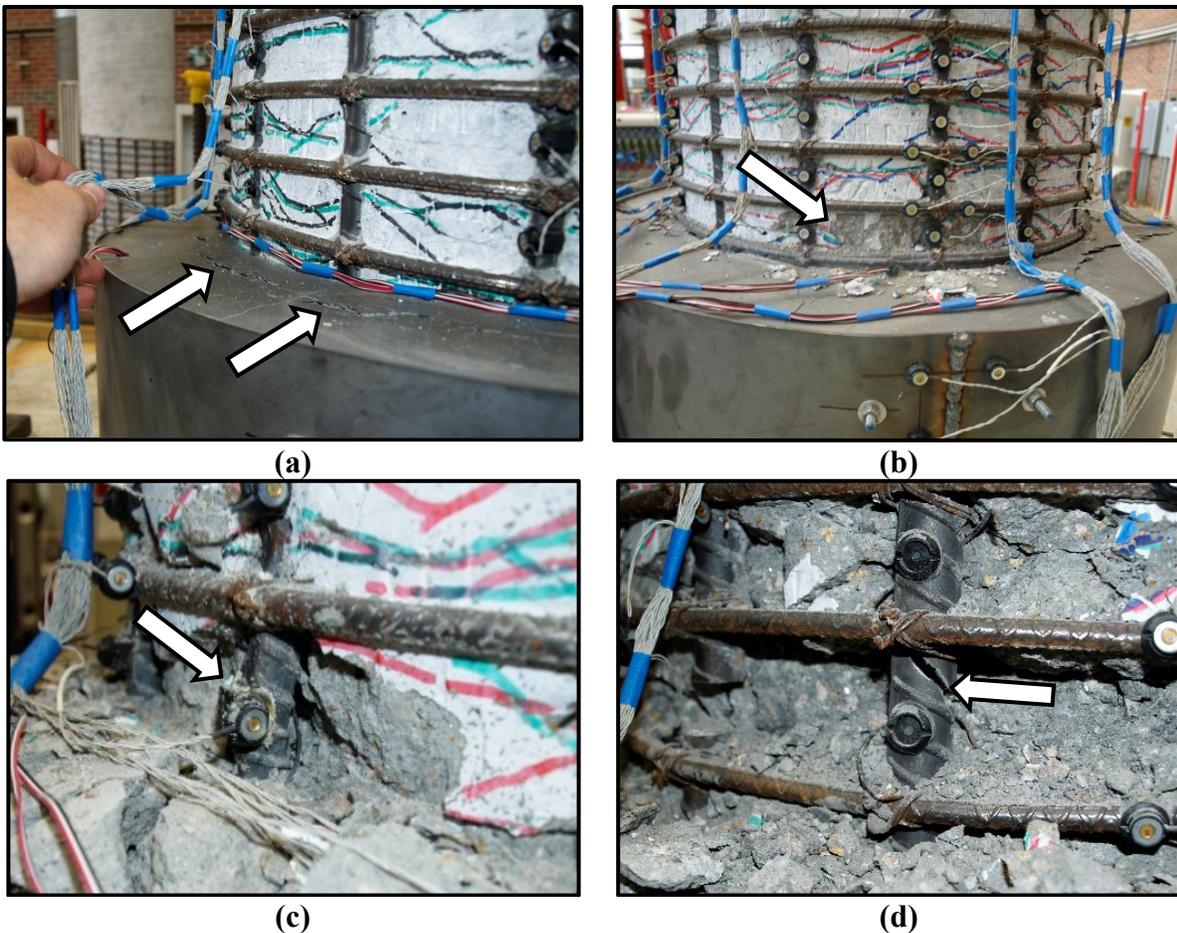
**Figure 8.1:** Typical damage progression of column with relocated plastic hinge: (a) Initial cracking, (b) core crushing, (c) bar buckling, and (d) bar fracture.
