Repair of Reinforced Concrete Bridge Columns via Plastic Hinge Relocation

Volume 2: Repair Using CFRP Materials

1. AGENCY USE ONLY (LEAVE BLANK) 4000(142)		2. REPORT DATE September 30, 2018		3. REPORT TYPE AND DATES COVERED Final Report, May 2015 through September 2018

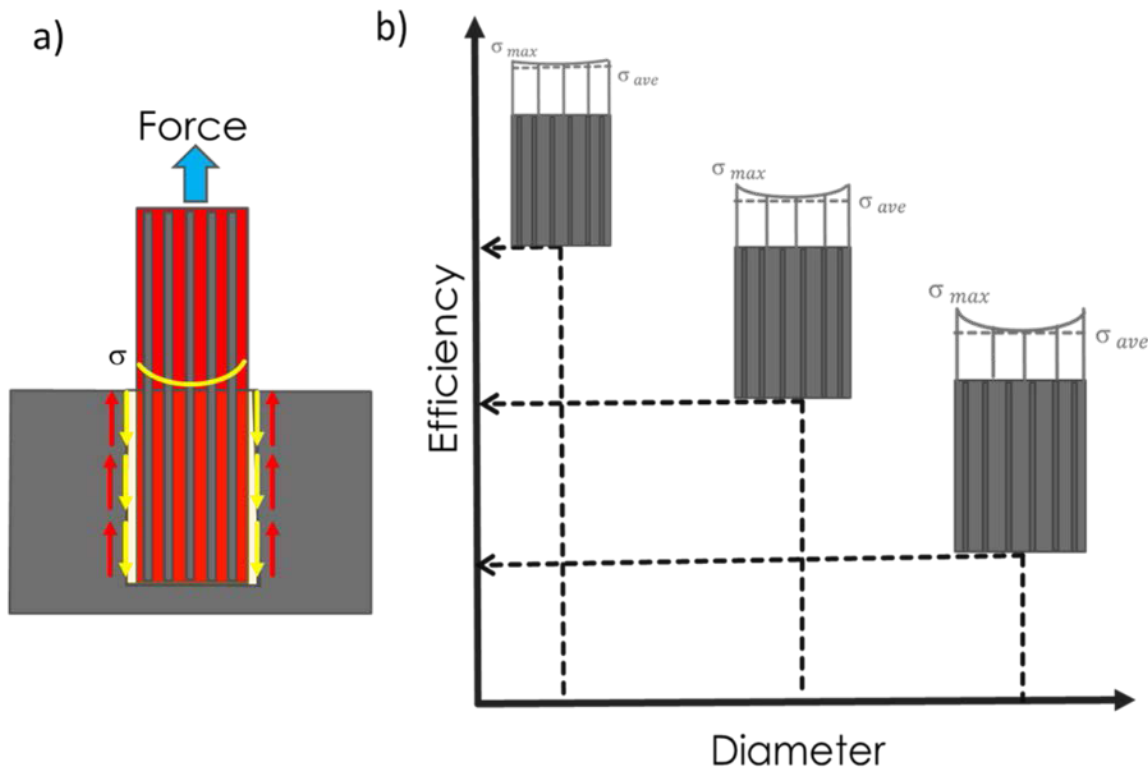
Figure 1.7: Efficiency Distribution of FRP Bar/Anchor

It is observed that the theoretical tensile rupture capacity of CF anchors is related to the anchor diameter [9]–[11]. This theoretical rupture capacity is often referred to as an efficiency ratio, defined by del Re Castillo et al.[11]. Efficiency is defined as the ratio of average stress developed in the bar/anchor to the manufacturer provided rupture stress of the anchor. Average stress is defined as the force developed in the bar divided by the nominal area of the anchor. The reason for the reduced efficiency with increasing diameter is attributed to the shear lag effect that plays a role in the force transfer mechanism of FRP composites bars [13]. When an FRP bar/anchor is installed in a drilled hole of concrete element, the applied tensile force is transferred to the bar/anchor by the epoxy bond developed between the concrete and the outermost fibers, as shown in Figure 1.7a. The fibers at the perimeter of the bar/anchor reach the maximum stress before the fibers towards the middle of the section. The fibers transfer force to the adjacent fibers through the softer resin matrix. Due to the shear lag effect, the stress across the section is non-uniform. The variation of stress is greater as the size of the anchor increases. That is, as the size of the anchor increases, efficiency decreases as shown in Figure 1.7b.

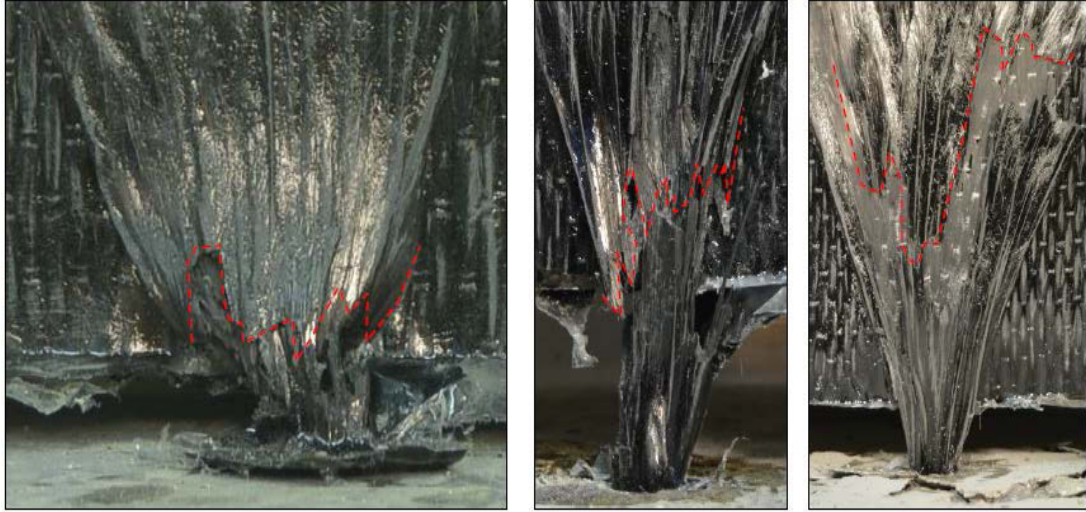
Figure 2.16: Ruptured Anchors[11]

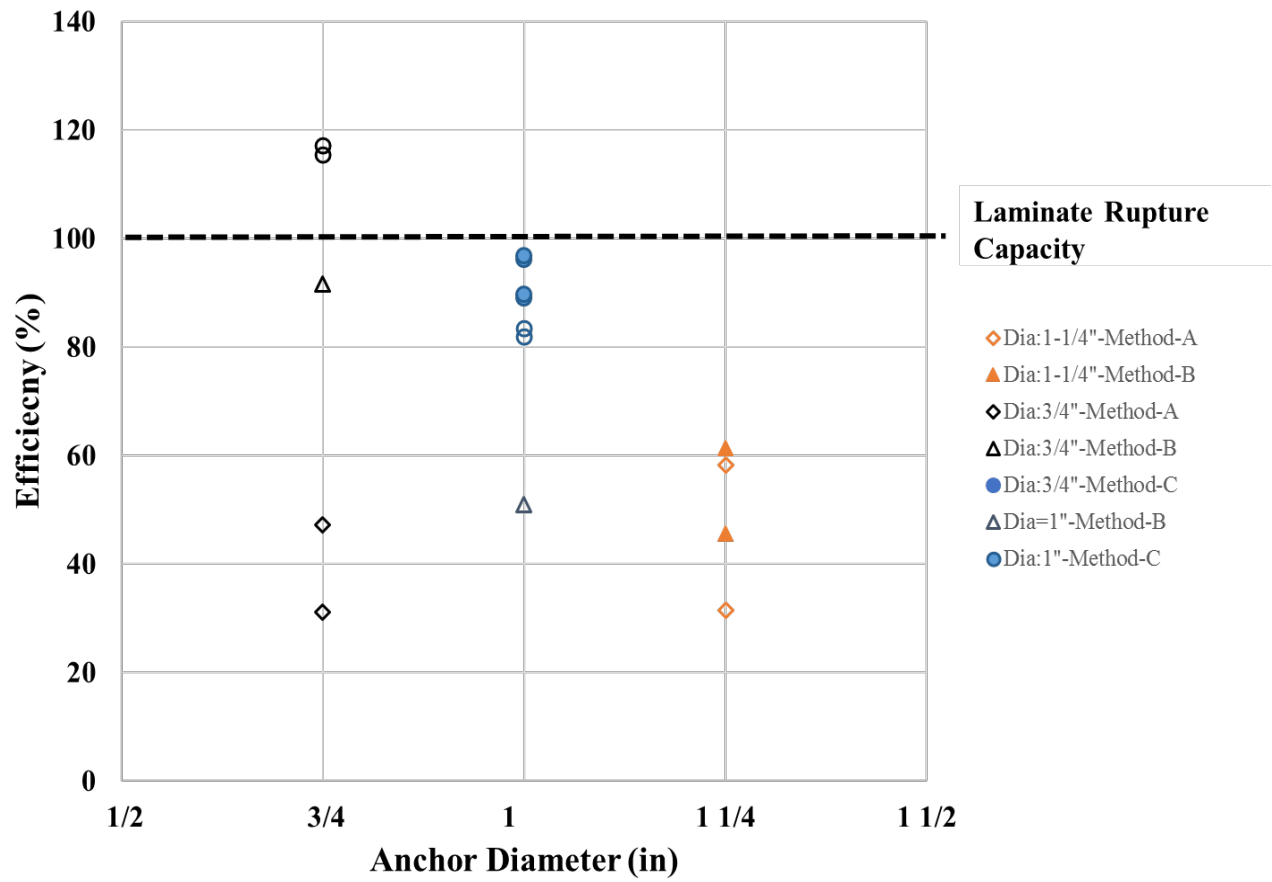
Figure 3.16: Efficiency Distribution of Tested Anchors

For the 1-1/4 in. diameter anchors, only preparation Method-A and Method-B was used. It can be seen in Figure 3-15, an improvement was observed as the method improved but there is a need for more testing to confirm the improvement in the anchor quality. For anchors prepared by Method-A, rupture failure was observed, but a huge stress variation was observed due to flaw caused by the preparation method. As the preparation Method-B used, embedment depth increased to resist the increased capacity and the failure mode changed from rupture to pull-out. But it was concluded that the provided embedment depth ($13d_{\text{hole}}$) was inadequate to rupture the anchors. Using 1-1/2 in. diameter hole was assumed to be enough, as the intention was to have least amount of epoxy around the embedded anchor.

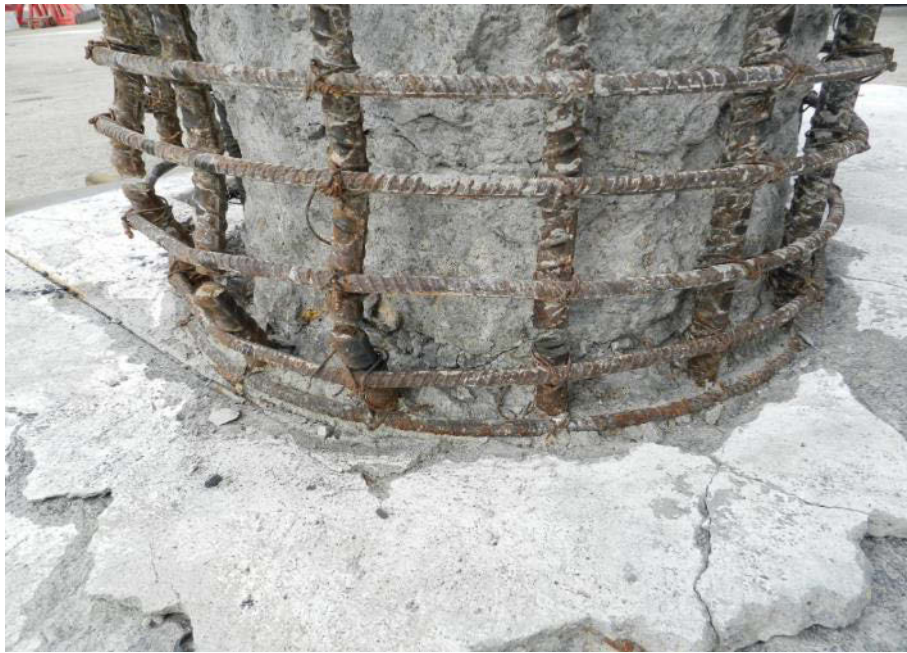
Figure 4.2: Removal and Cleaning of Loose Core Concrete

system, and the damage was in form of bar buckling, bar fracture and core concrete crushing in the plastic hinge region. High strength non-shrink grout was used to restore the circular concrete section. Any loose and damaged core concrete was removed but nothing was done to the steel reinforcement. To create a good bond between the non-shrink grout and the reinforcing bars, concrete from behind the bars was also removed as shown in Figure 4.2. Later, to clean dust and debris from the core concrete, pressurized water was applied to the concrete surface.

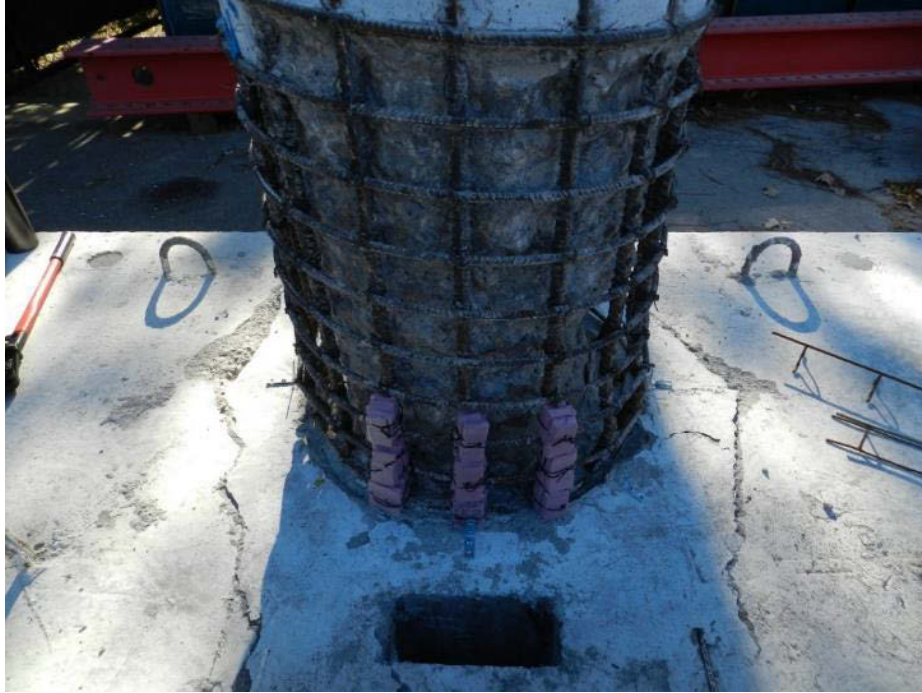
Figure 4.3: Foam Board to Bloc-out Grout on Straight Bars

As shown in Figure 4.3, foam blocks were placed on the straight bars near the mid-height to block out the high-strength grout so that strain gauges could be attached to the bars. The damaged columns were 24 in. in diameter, but a 26 in. circular cross-section was created using the grout. The reason for using a larger diameter cross-section was to make sure that all the longitudinal steel reinforcing bars had enough concrete cover. Due to the buckled bars at the plastic hinge region, a larger cross-section was needed. A flexible board, shown in Figure 4.4, was placed around the column to serve as the form for the high-strength grout repair. After removing the form, a smooth surface was obtained as shown in Figure 4.5.

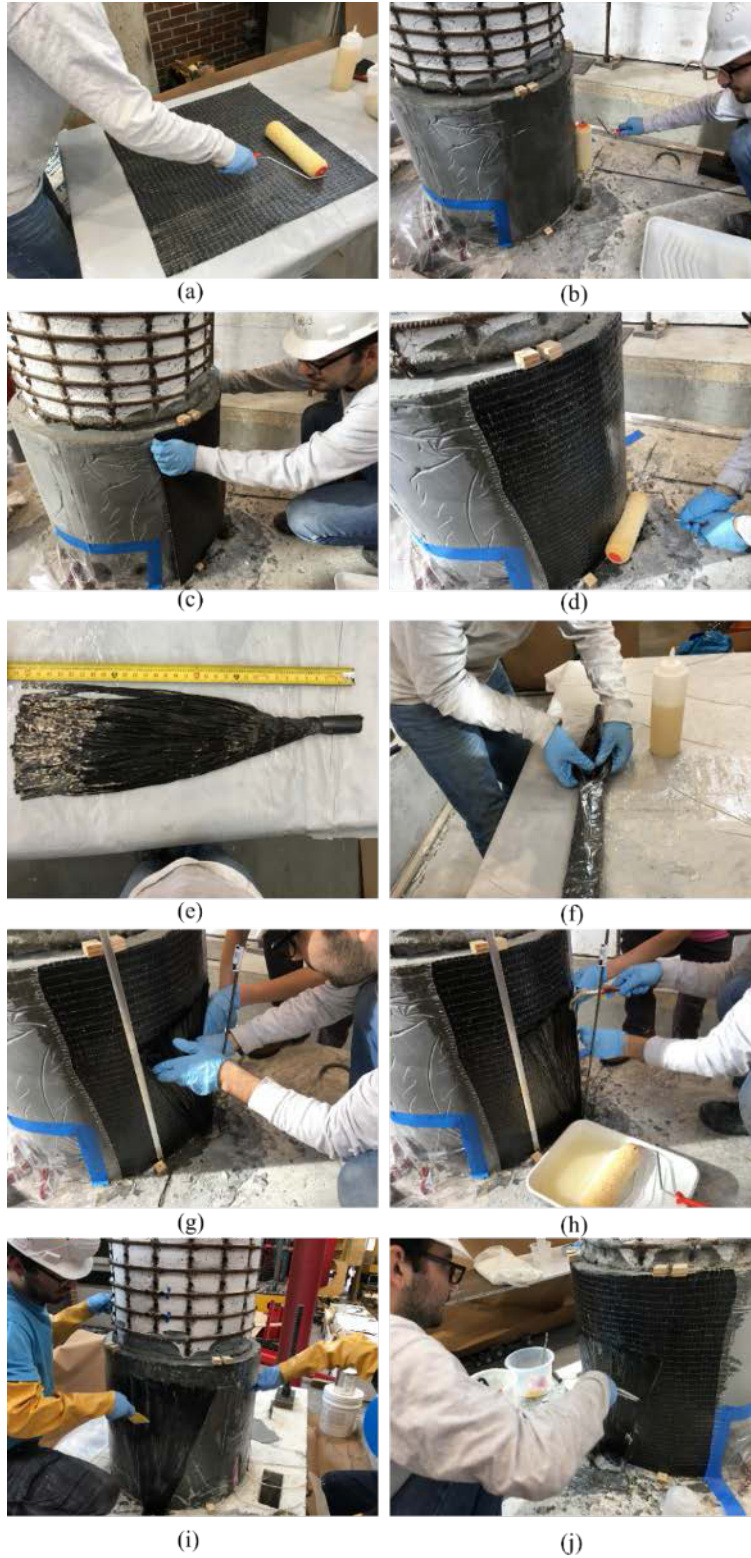
Figure 4.7: Anchor Preparation Process

- In addition to putty knife, a roller handle was used to remove air bubbles as shown Figure 4.7j.

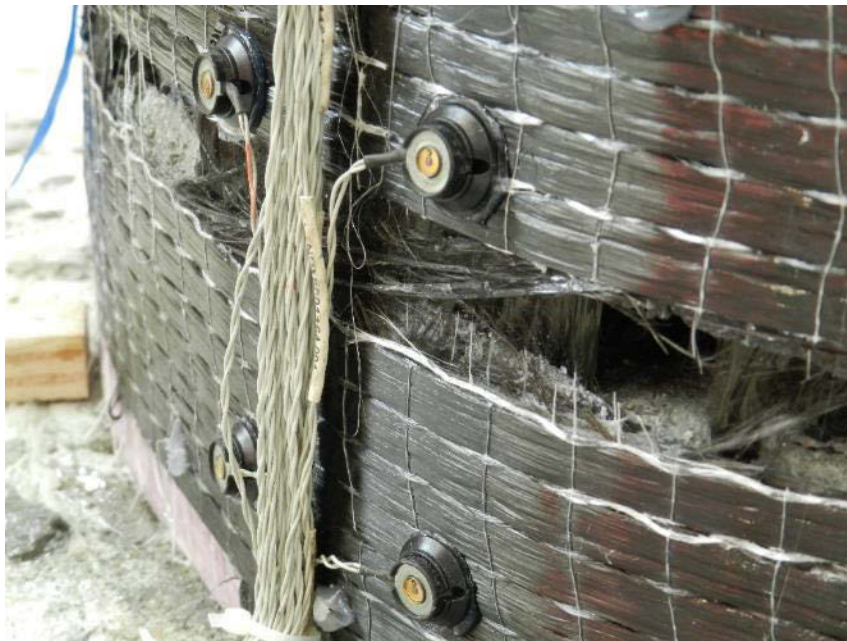
Figure 4.19: Splitting Failure in the Anchor on the Compression Side

Similarly, Column 2 was tested under monotonic push and pull cycle. A displacement-controlled loading protocol that was used for Column 1 was adopted for this test. A quarter inch displacement applied to the top of the column until a failure mode occurred. The column was pulled in the direction of the strong wall to fail anchor on the opposite side. The lateral force reached 38 kips and displacement was 1.45 in, as shown in Figure 4.16. Figure 4.16 also shows the force-displacement curve of Column 1. Provided wrapping enable the CF anchor to resist more force that the anchor installed on the first column. A sudden drop was observed when a strong rupture noise heard from the anchor. Once rupture of the anchor took place, the restored concrete section lifted. Figure 4.17 shows the failure in the anchor. Moreover, due to ruptured bars at the bottom of the column, a crack occurred in the concrete section. This crack caused splitting of CFRP wrap as shown in Figure 4.18. The propagation of splitting stopped at a location where the CF anchor was attached to concrete substrate. Due to improper saturation of the anchor on the compression side of the column, full capacity of the CF anchor was not reached, and a splitting was observed in CFRP wrap as shown in Figure 4.19.

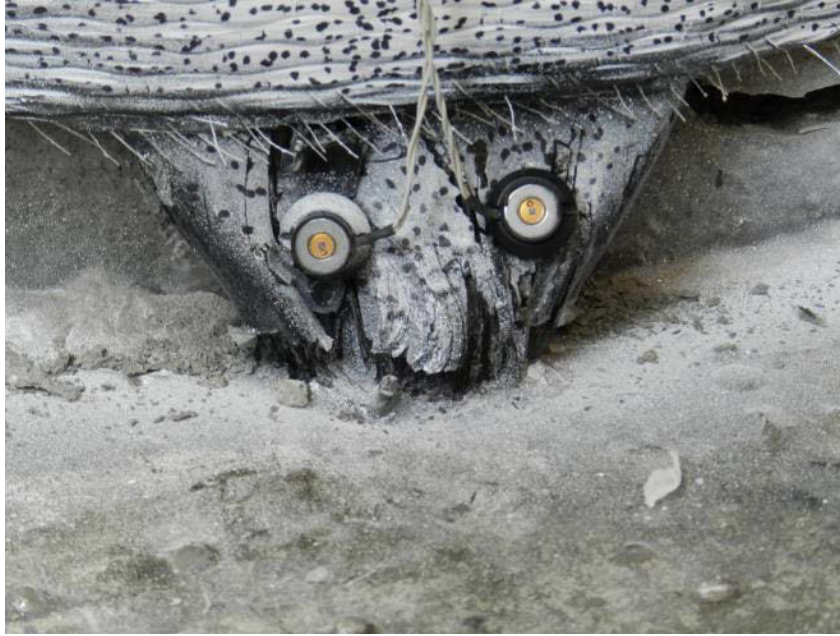
Figure 4.23: Fiber Rupture in the CF Anchor

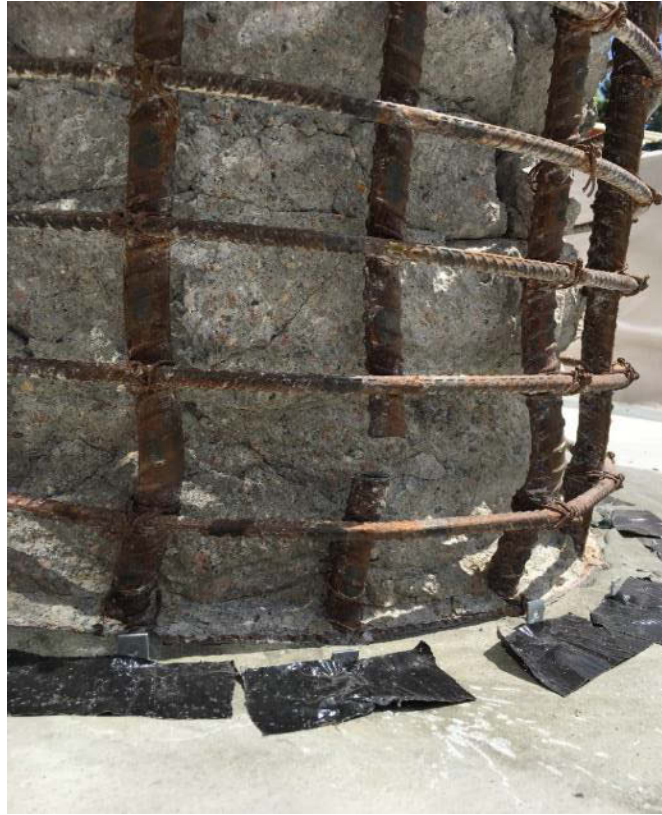
Figure 5.13: A Column after Removal of Loose Concrete

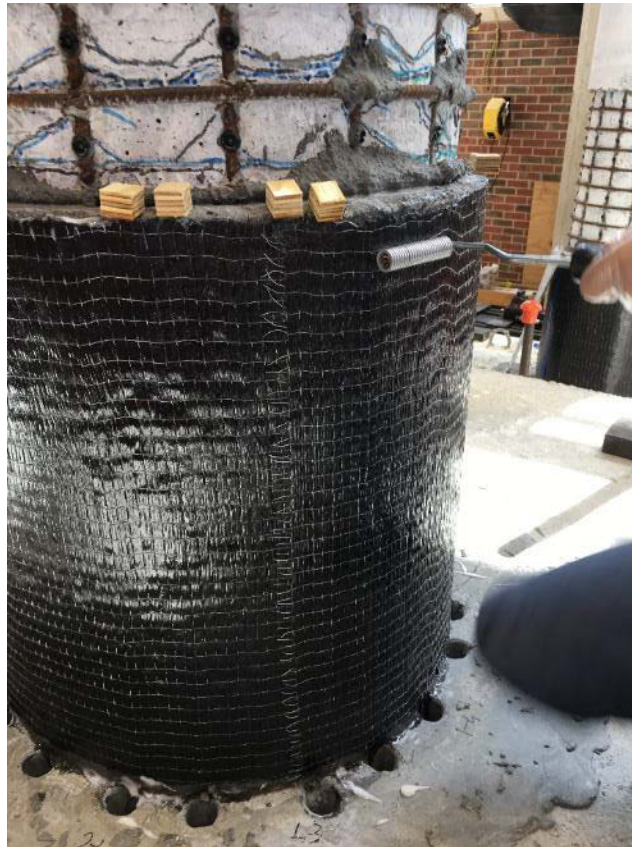
Figure 5.20: Air Removal with a Rib Roller

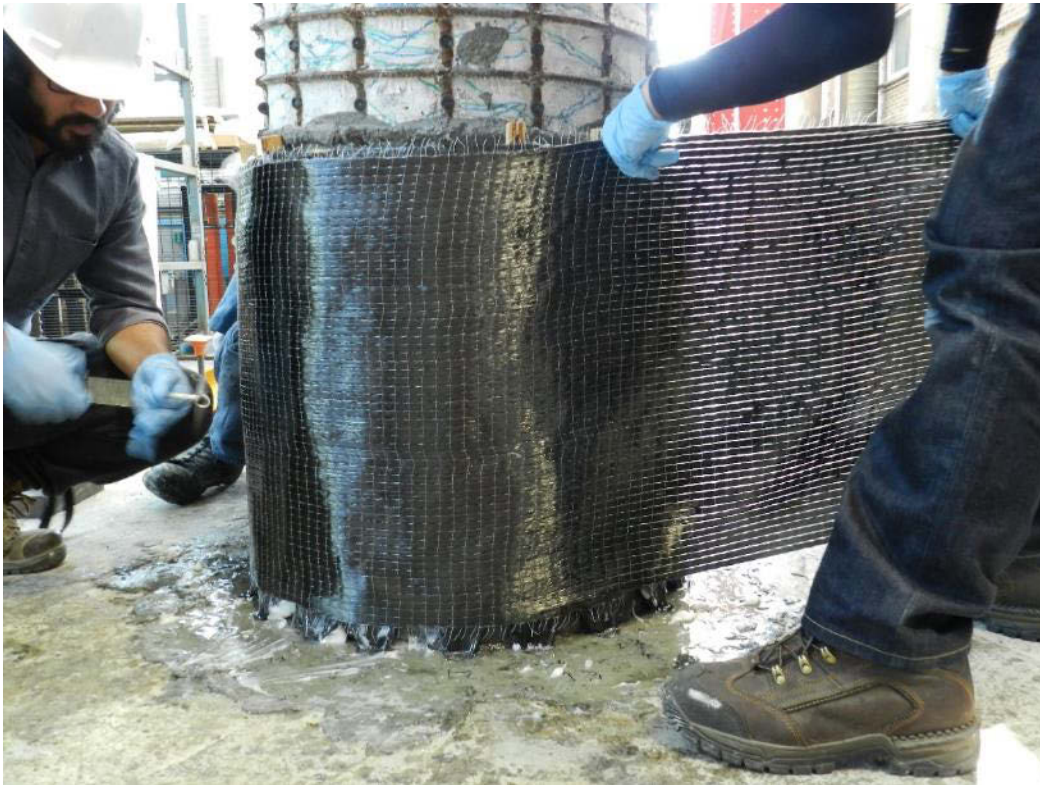
Figure 5.24: Application of Hoop Fiber for C1 Column Specimen

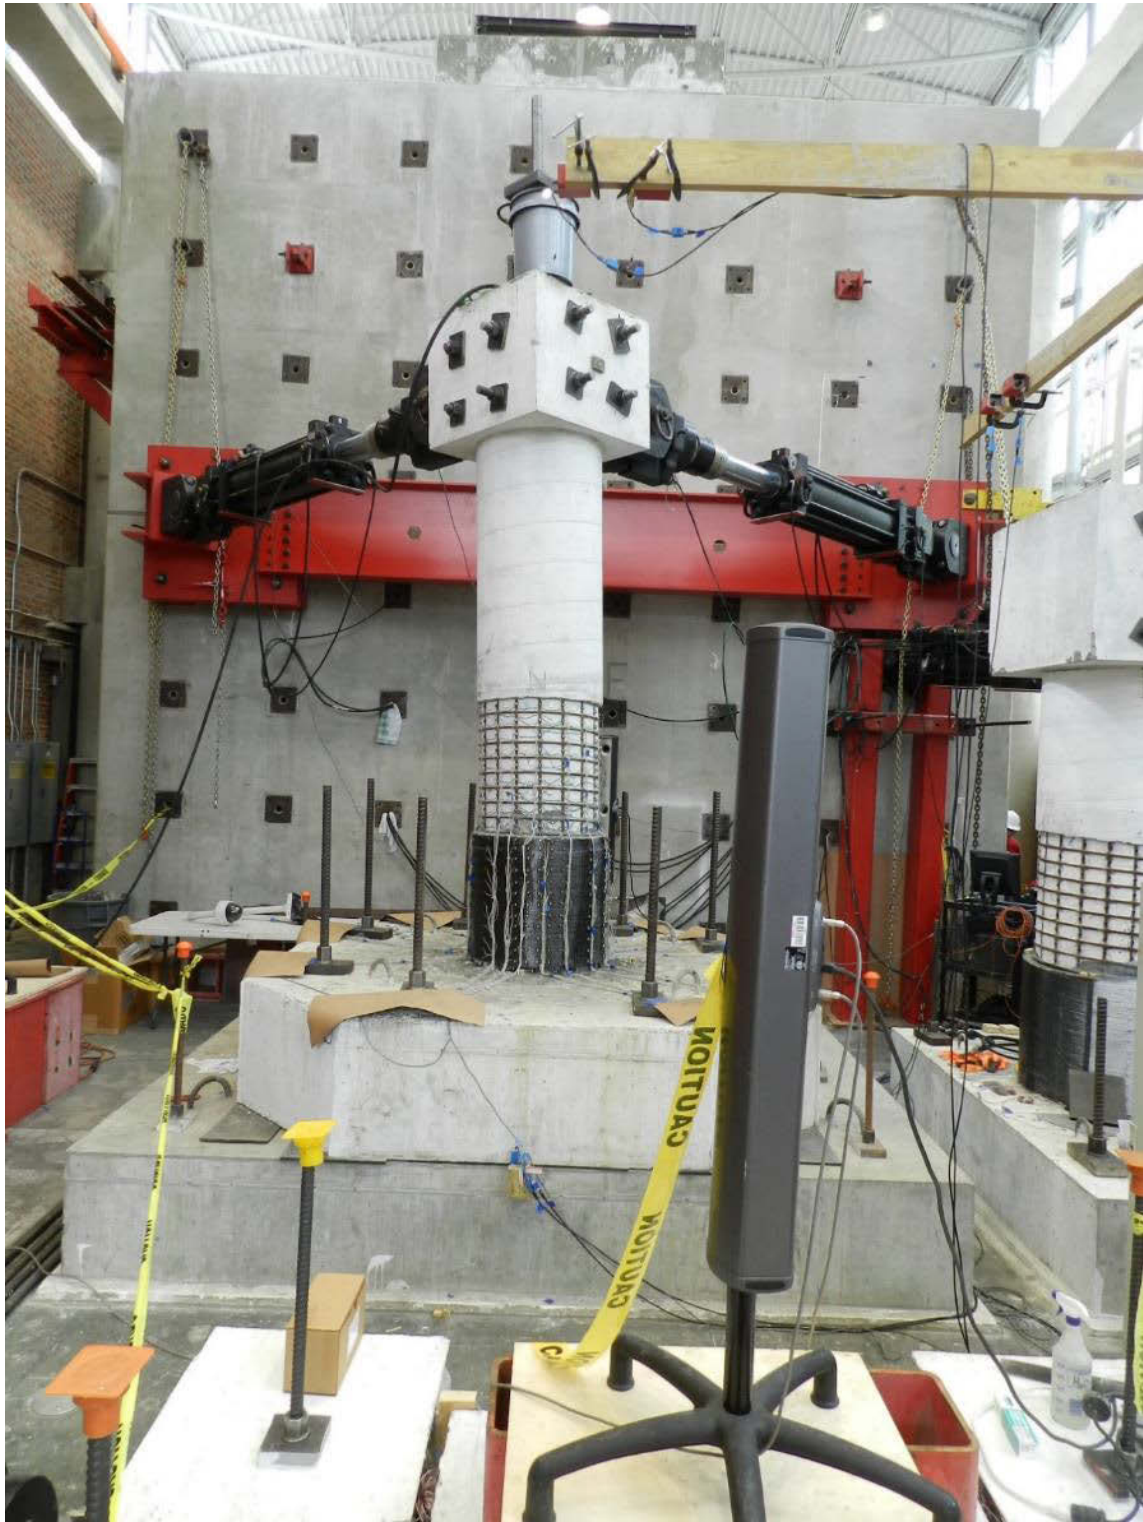
Figure 5.37 : Plastic Hinge Formation above Repair

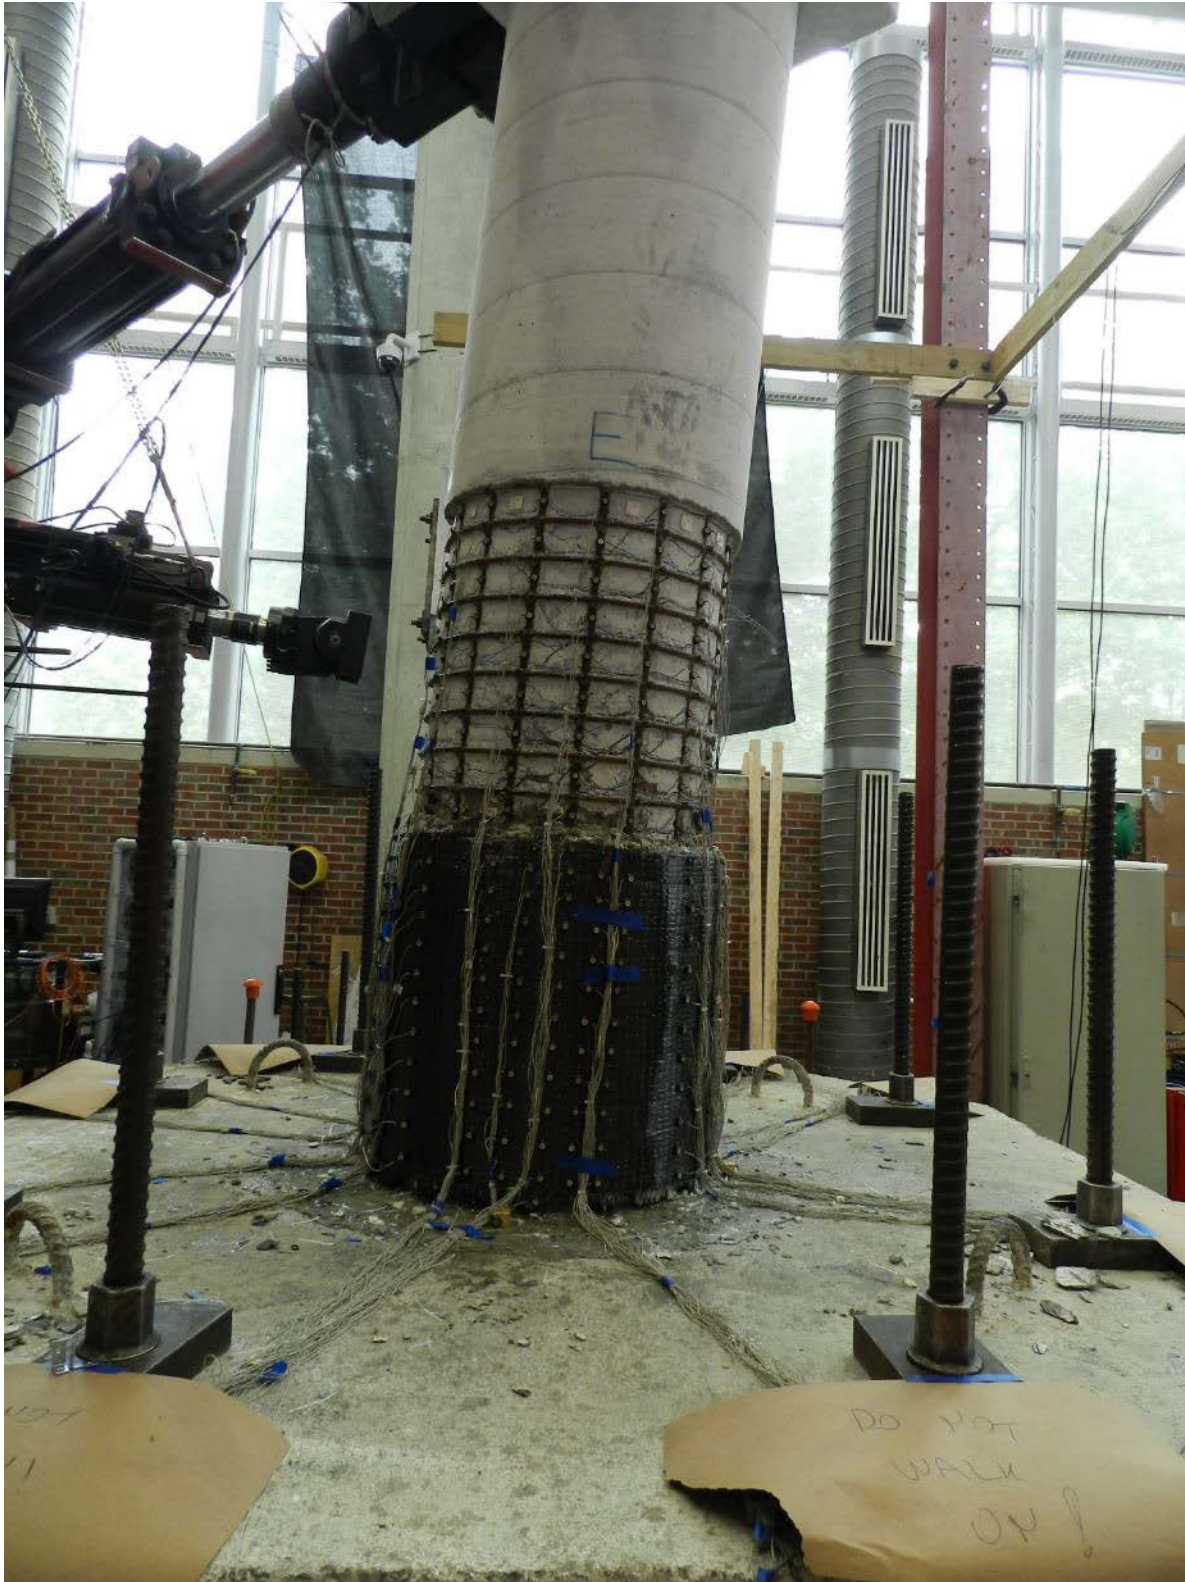
Figure 5.38 : Column Rotation about its Bottom End
