Transverse Seismic Design of Bridges with Longitudinal Keyway Joints

Prepared by:
Christopher W. Price, Ph.D. Candidate
Mervyn J. Kowalsky, Professor, Ph.D.
James M. Nau, Professor, Ph.D.
Rudolf Seracino, Professor, Ph.D.

24 May 2019

Prepared for:
Alaska Department of Transportation & Public Facilities
Statewide Research Office
3132 Channel Drive
Juneau, AK 99801-7898

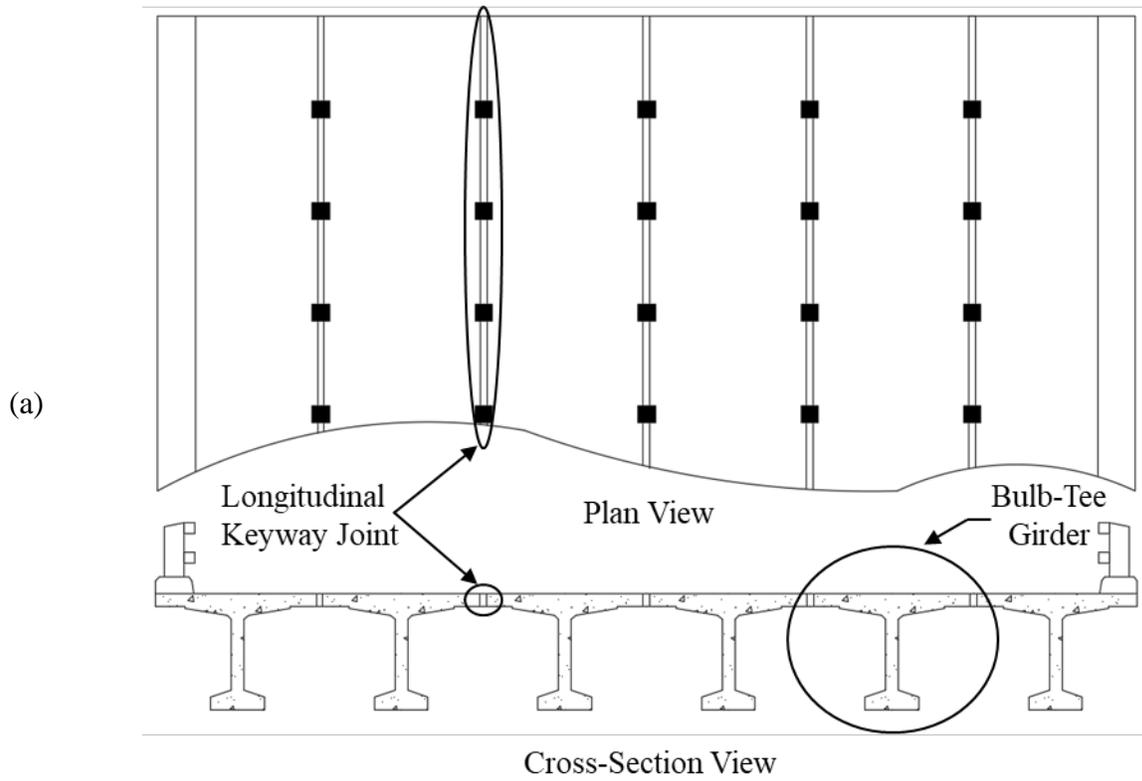
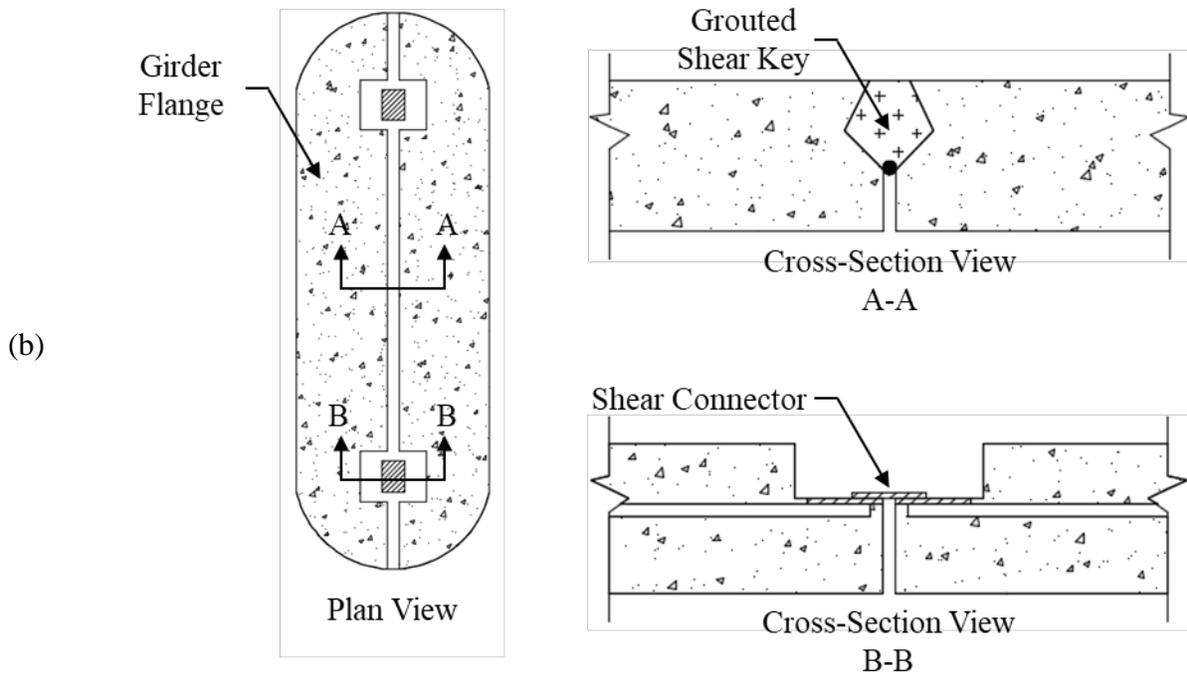
Figure 1.1: Typical Longitudinal Keyway Joint (a) Global View (b) Local View.

Bulb-tee girder bridges with longitudinal joints date back to the 1960's. Adjustments to their design over the last 50 years have been based upon field observations of existing joints,. Past research on bridges with longitudinal keyway joints have focused on longitudinal vertical load distributions including the effects of diaphragms, the development of new joints, and constructability. No known research has focused on the transverse response, which can be initiated from earthquake induced excitation, impact loading, ice drifts, wind gusts, and tsunamis. Some similar connections in precast diaphragms have been studied, such as parking decks, but none that match the popular connection seen in Figure 1.1.

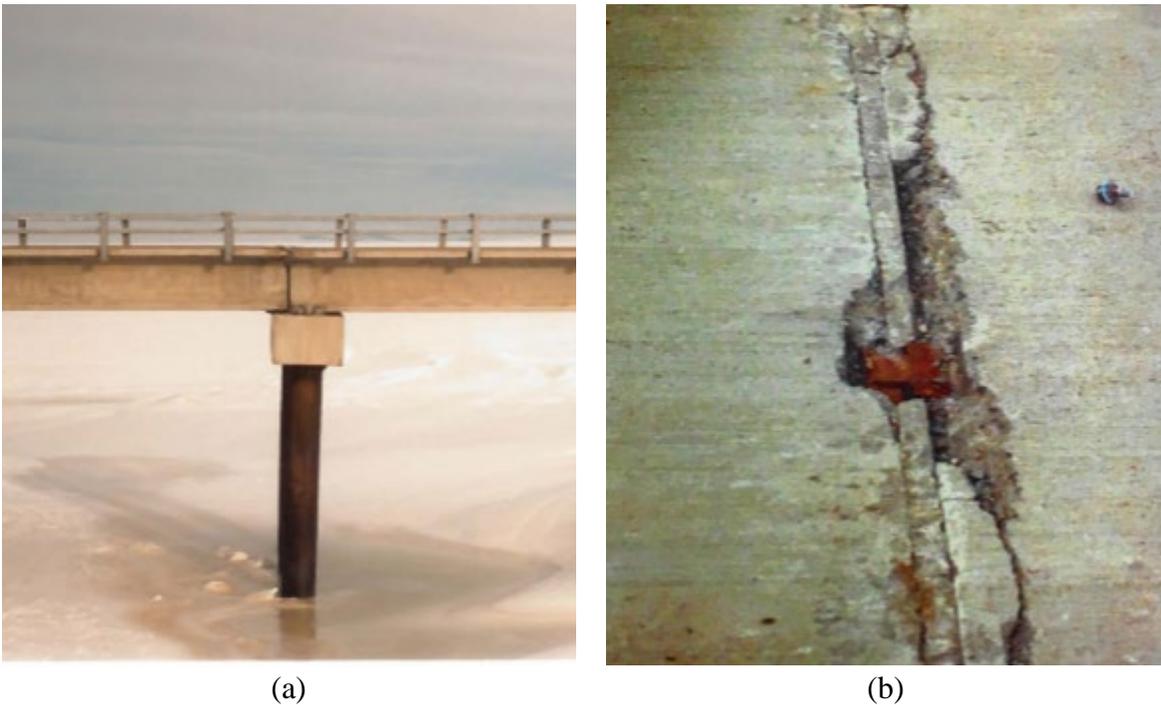
Figure 1.2: Safety Sound Estuary Bridge (a) Damaged Pier (b) Damaged Longitudinal Keyway Joint.

Alaska is a good representation of the Northwest United States because a majority of their bridge inventory is composed of bulb-tee girder bridges with longitudinal joints, starting with the Carlanna Creek Bridge in 1973, and extending to the Klehini River Bridge in 2017. Alaska is also located near to the Pacific Plate and North American Plate boundary and is considered a highly hazardous seismic region. Therefore, bridges with longitudinal keyway joints have a high probability of experiencing earthquake induced excitation. Despite Alaskan bulb-tee girder bridges dating back to the 1970s, the last major earthquake was The Great Alaska Earthquake, occurring on March 27, 1964. One case study exists where an ice drift imposed a transverse load on the Safety Sound Estuary Bridge. The ice drift caused one of the piers to displace and damaged the longitudinal keyway joint as shown in Figure 1.2.

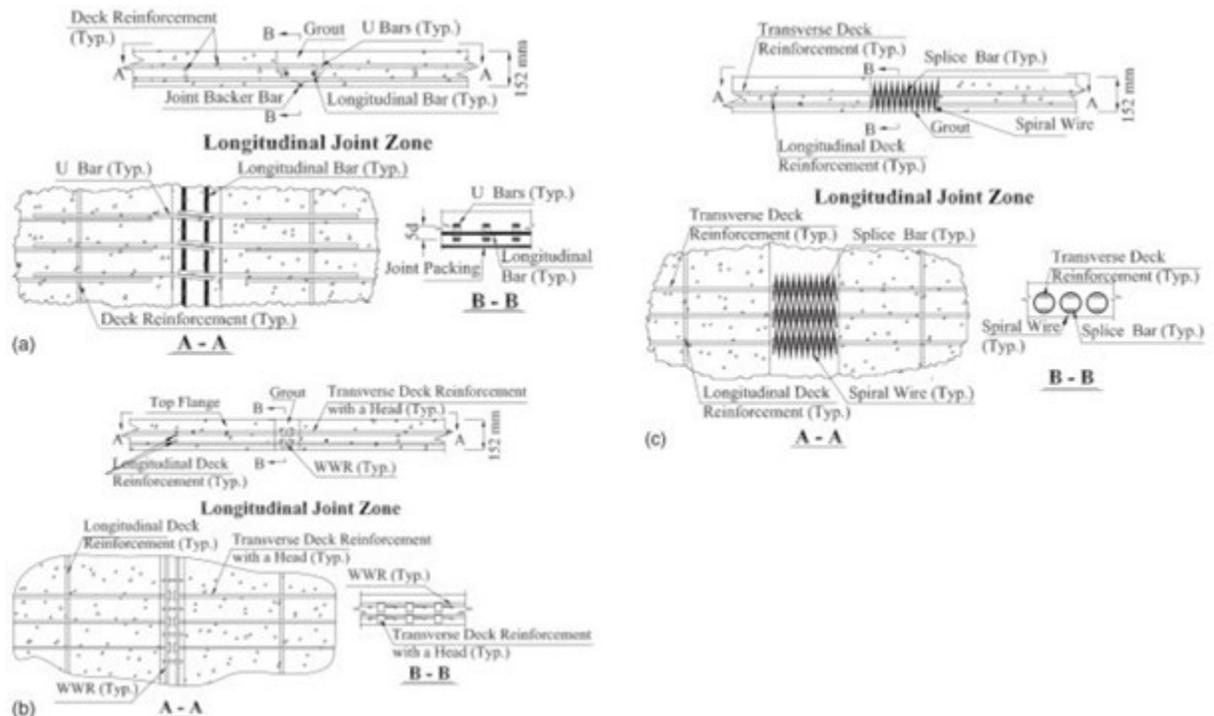
Figure 2.6: Proposed New Joint Details (Li, Ma, Griffey, et al., 2010)

Since the first tests on keyway joints, it has been perceived that current joints are not durable due to their limitation in transferring moment and the formation of cracks along the joint. Thus further research was performed looking at different possible joints that would eliminate the concerns of durability (Li, Ma, Griffey, & Oesterle, 2010). Some of the first research looked at three unique longitudinal joint details that considered constructability and cost. The three details explored were a U-bar detail, a headed bar detail, and a spiral bar detail which can be seen in Figure 2.6. A survey was given to practicing professionals about the three details. Results from the survey showed concern with the spiral and U-bar detailing, and suggested a welded wire

reinforcement detailing. Thus only the studded head method and welded wire reinforcement method were adopted.

Specimens were created for the studded head, the welded wire reinforcement, and a control specimen with dimensions of two feet wide, ten feet long and six inches deep and cast monolithically to remove the interaction of the grout. The experiments studied the lap length and reinforcement spacing. Specimens were tested using four-point bending to impose maximum moment across the joint. It was found that the welded wire reinforcement was not an adequate design due to sudden failure during testing. The optimal detailing was a studded head design with six inches of lap space to develop the bars and provide substantial ductility.

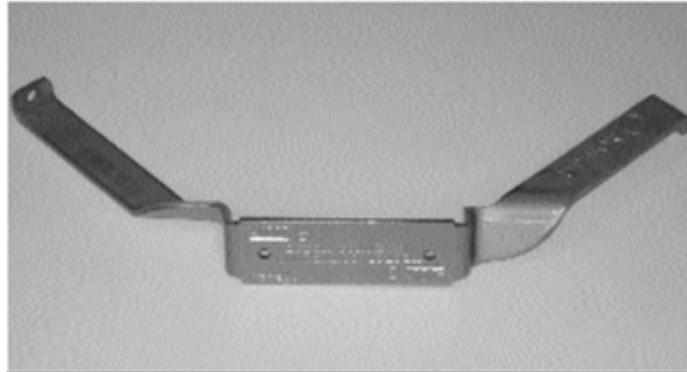
Figure 2.11: Vector Connector (Fattah Shaikh & Feile, 2004)

Two new shear vector connectors were tested under shear, tension and multiaxial loading (Fattah Shaikh & Feile, 2004). The vector connectors were made from a single plate of either A36 steel or stainless steel (see Figure 2.11). The plate was bent to provide a vertical face at the connection and two forty-five degree embedded legs. Twenty-nine, four-foot by four-foot by four-inch specimens were cast with the specified detail and used for testing under monotonic and cyclic loading for each load case. It was found that the stainless steel showed a more ductile response, with almost four times the yield displacement as the A36 steel, but overall failure modes and loads achieved were similar between the two steels. Under monotonic horizontal shear and biaxial loading, which included both horizontal shear and tension forces, failure was due to pull out of the tension leg of the connector. In the multiaxial load case, tension was applied to the joint until a one inch gap was measured and then shear loading was applied. Under cyclic horizontal shear and biaxial loading, rupture of the plate was observed. Under monolithic vertical shear loading, failure occurred from failure of the concrete. Under monolithic tensile

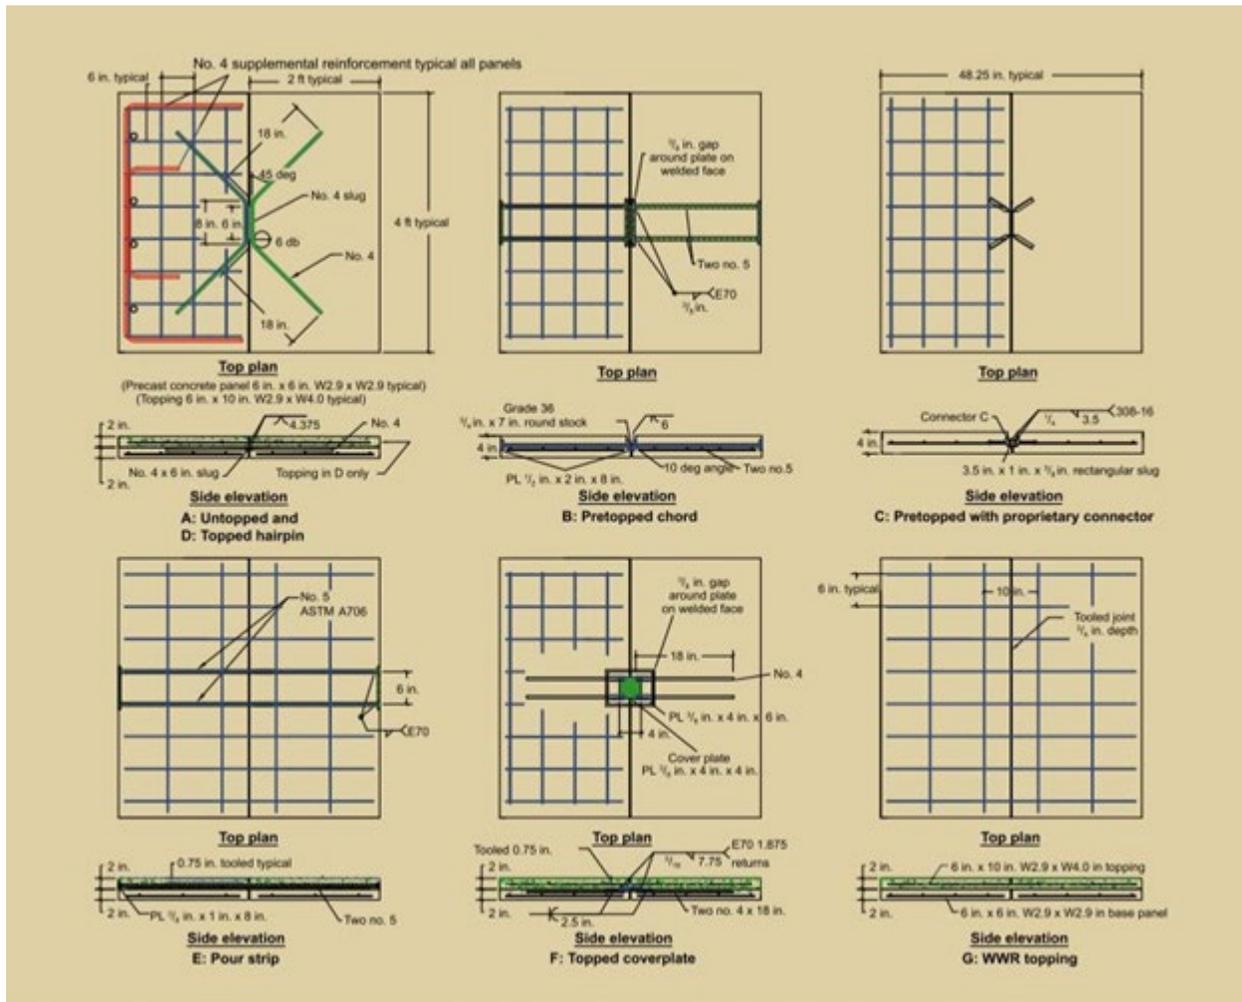
Figure 2.13: Shear Connectors (Cao & Naito, 2009; Naito et al., 2009)

load. These characteristics were then used in a Phase II, which consisted of full-scale testing of shear connector groups and connections between precast members. Scaled panel joints monotonically tested were used to inform 3-D finite element models of parking deck structures, which in turn were used for parametric studies.

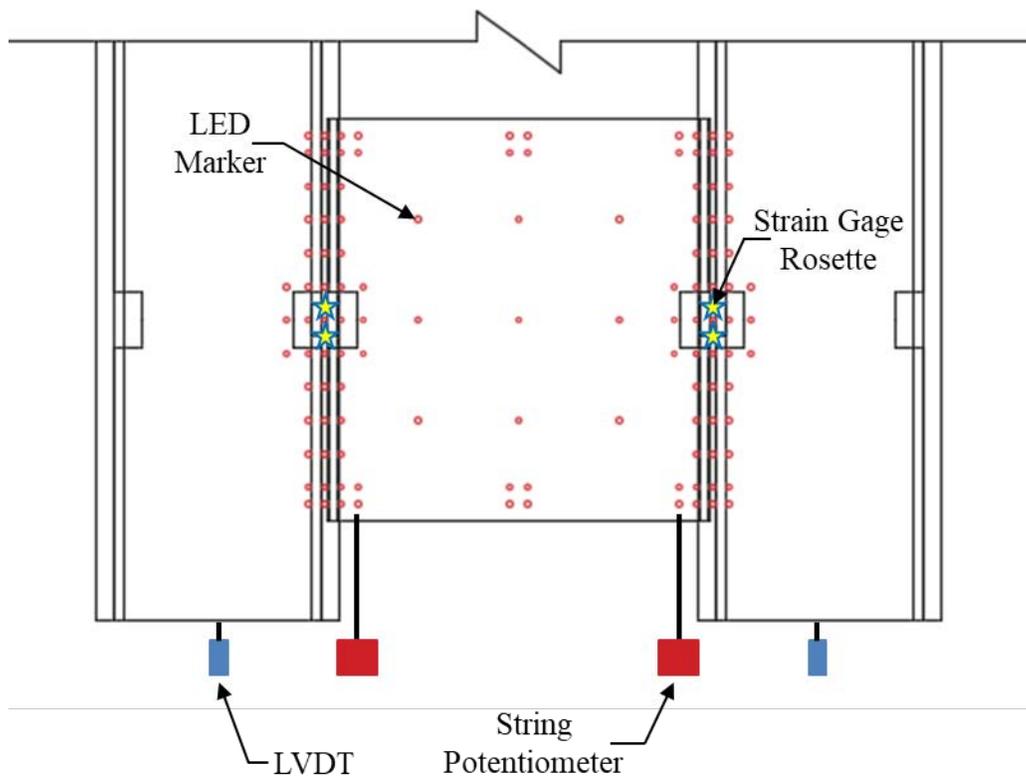
Figure 4.5: Instrumentation of Test Specimen

The specimen was instrumented with: (1) infrared LED markers, (2) string potentiometers, (3) electrical resistant strain gage rosettes and (4) Linear Variable Differential Transformers (LVDTs). Figure 4.5 shows the schematic of the instrumentation. It should be noted that load for the system was obtained from an internally integrated load cell inside the actuator ram.

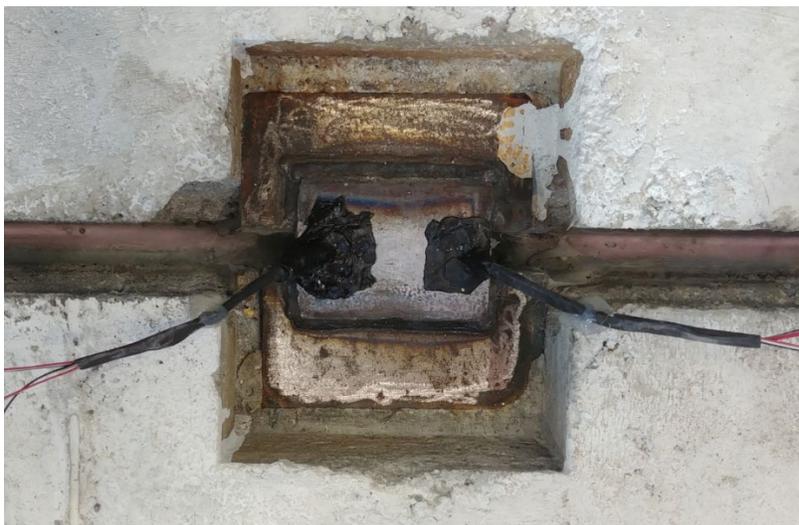
Figure 4.6: Electrical Resistant Strain Gage Rosettes Applied to Connector Plate

For all but one test, the grout poured into the shear key would conceal the shear connector below. Simple hand calculations showed shear failure of the connector plate, connecting the embedded shear connector inserts, to be the critical component. Due to this, the connector plates were instrumented with electrical resistant strain gage rosettes. Two rosettes placed on the longitudinal center line of the joint, half an inch from either free face as shown in Figure 4.6. The rosettes would allow the measurement of principal strains in the plate.

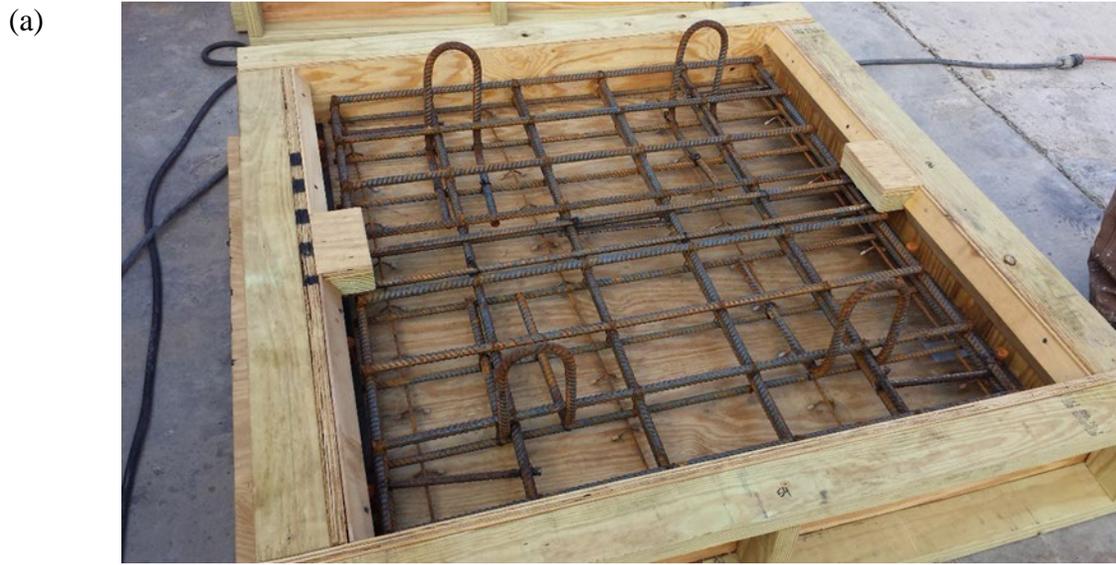
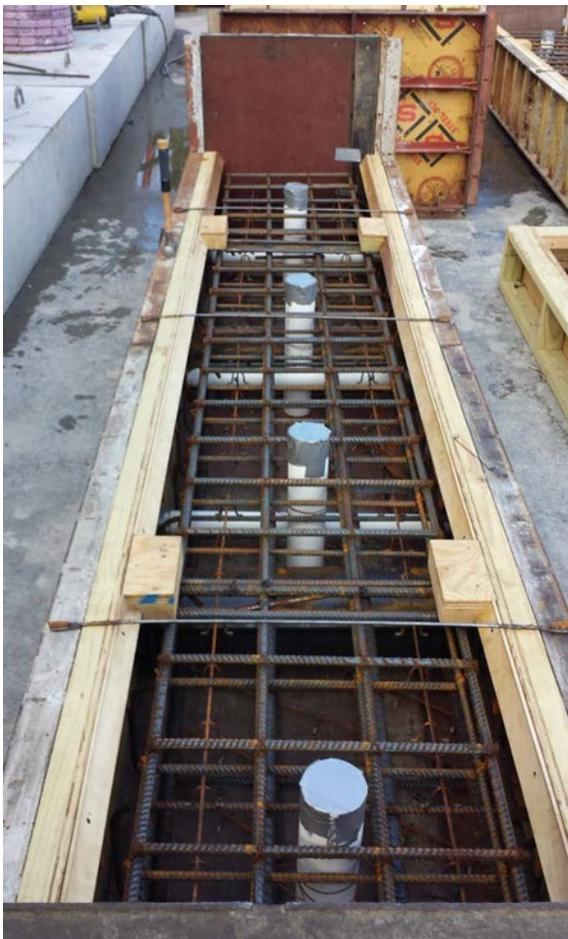
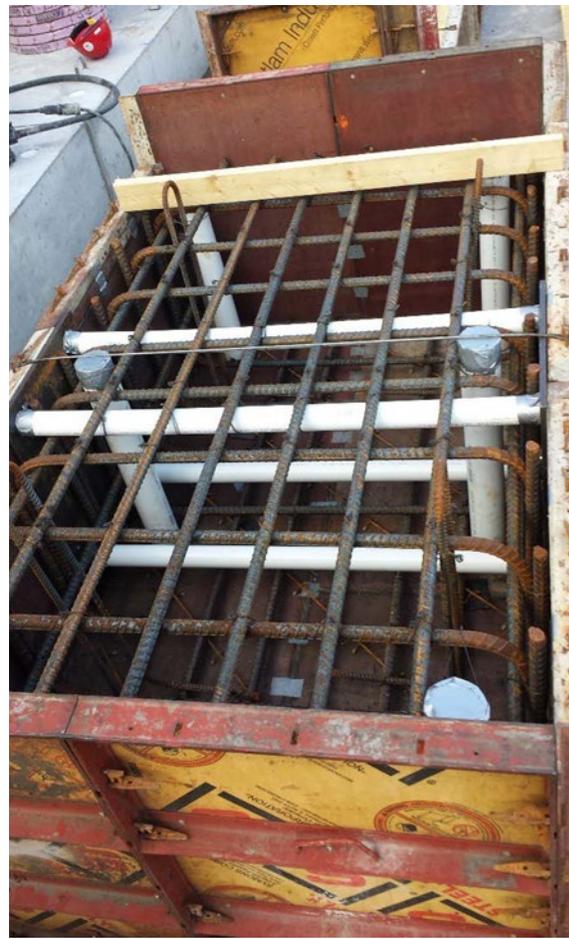
Figure 4.10: Specimen Construction (a) Specimen (b) Side Block (c) Reaction Block

The side block formwork was first sprayed with form release and allowed to dry. Then the steel cages that make up the bottom section of the side block element were placed. The horizontal duct work were then inserted which comprised of HSS ducts and 2 in. PVC ducts. The steel angles were bolted to the side of the forms to make up the side block lip. The key block out was assembled, sprayed and inserted on top of the steel angles, which included adding two inches of additional block out. Next the steel mats were placed in the forms with the steel connector imbeds on the top of the mats. Rectangular wood blocks covered the steel connector insert plates and blocked out the shear pocket. Lastly the horizontal duct work was placed.

The reaction block formwork was first sprayed with form release and allowed to dry. The steel plates were then fastened to the forms. The steel U bars pairs were assembled prior to placing them in the formwork. Once placed the steel cage was tied inside the forms. The horizontal and vertical ductwork were installed.

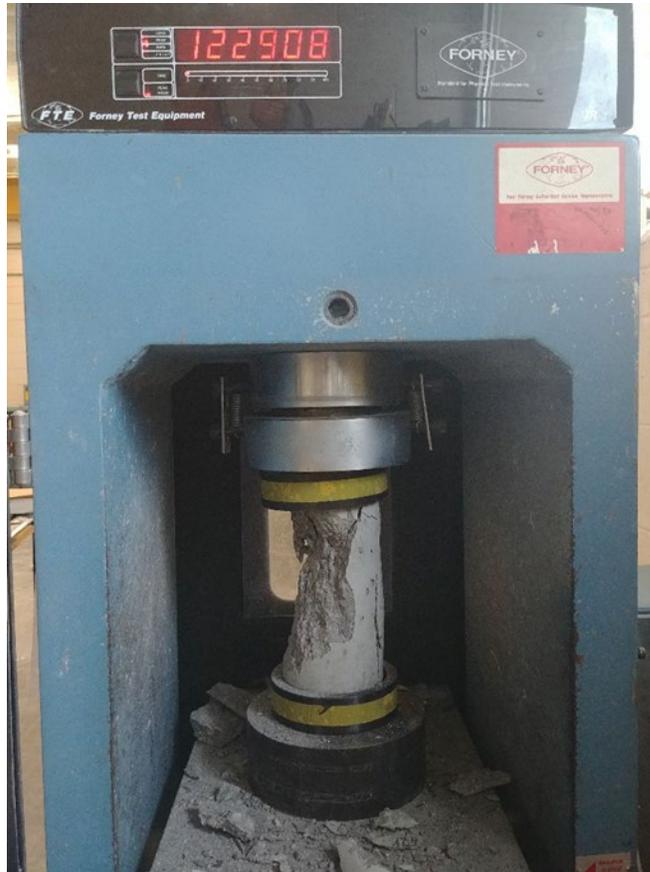
Figure 4.16 ASTM C39 Cylinder Test

Concrete compressive strength was specified as 6,750 psi at 28 days which matched strength specifications for bulb-tee girders in recent Alaska bridge 663 drawings. The mix was designed and produced locally. All concrete elements were poured from the same batch. After casting, a water-based concrete curing and sealing compound was applied on the surface. The elements were left to cure in their formwork for the next seven consecutive days. Cylinders were cast to verify the required compressive strength and to determine compressive stress on specimen testing day. Compressive strength was determined in accordance with ASTM C39, (2016). A sample of a tested cylinder is presented in Figure 4.16. The average concrete compressive strength for each specimen is detailed in Table 4.2.

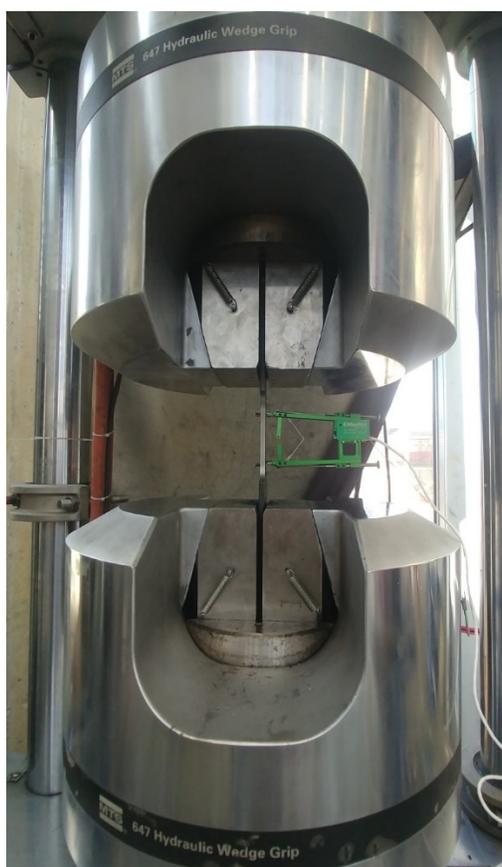
Figure 4.17: ASTM 370 Tension Test

Coupon Tensile Test ID	Properties at Yield Stress		Properties at Maximum Stress	
	Stress [ksi]	Strain [in/in]	Stress [ksi]	Strain [in/in]
1	59.04	0.0022	75.05	0.1229
2	59.10	0.0023	74.93	0.1376
3	56.88	0.0032	74.28	0.1399
Average	58.34	0.0026	74.75	0.1335

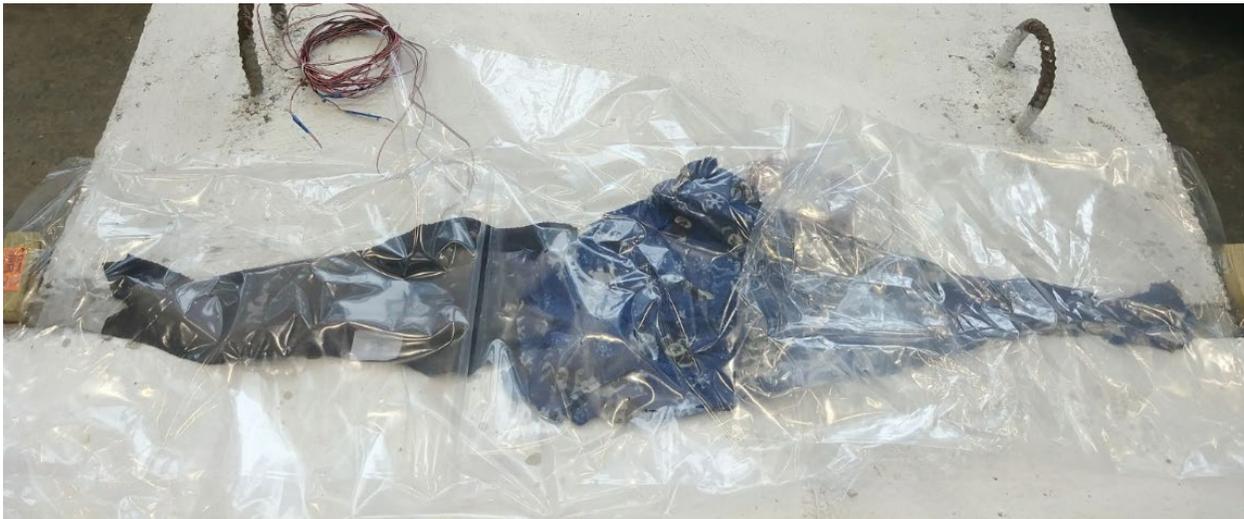
Figure 4.18: Moist Curing of Grouted Specimen

Test specimens were prepared as per manufacturer recommendations, with the surface saturated four hours prior to pouring the grout into the keyway and shear connector pocket. The water content used in the mix for all the tests was 6.6 pounds of water per 50 pounds of mix. After the grout was poured, it was moist cured for three days using a layer of plastic followed by a layer of moist cloth followed by one more layer of plastic (Figure 4.18). To acquire material properties for test day prediction, ASTM C109,(2010). Tests were performed on 2x2x2 inch cubes on the day of the test, with results shown in Table 4.8.

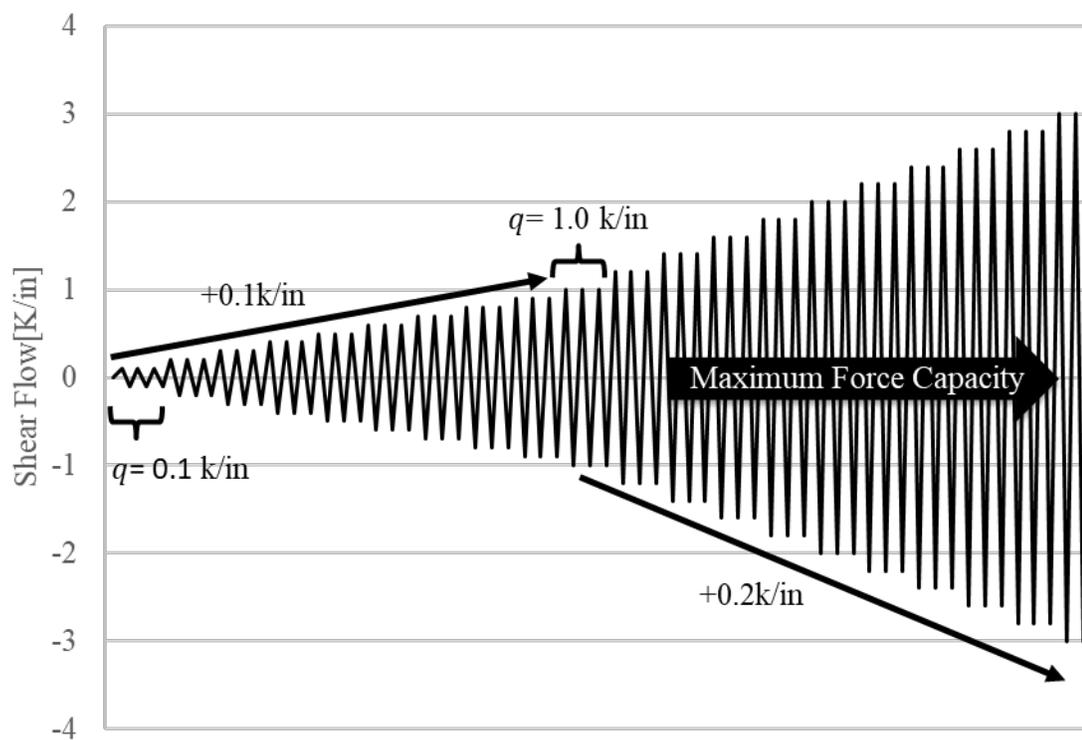
Figure 4.22: Cyclic Force Loading Protocol

Test 3, the first cyclic test, showed that no significant damage accumulation occurred prior to the maximum force capacity due to cyclic loading. Therefore, the force portion of the loading protocol was switched to single cycle sets at quarter increments of the maximum anticipated strength, calculated as mentioned above, until strength loss occurred.

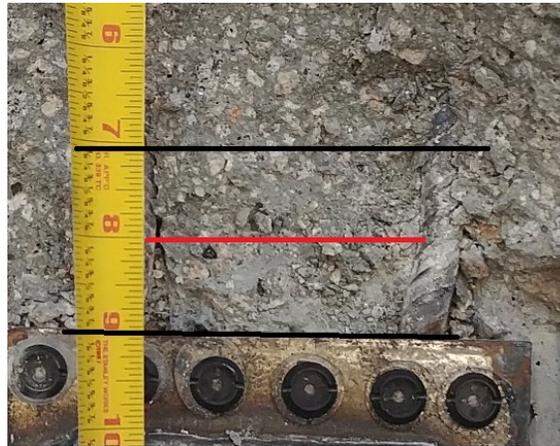
Figure 5.11: Plastic Moment of Embedded Rebar

$$Z_{circle} = \frac{d_{bar}^3}{6} = \frac{(0.5 \text{ in})^3}{6} = 0.0208 \text{ in}^3 \quad \text{Equation 5.1}$$

$$M_P = f_y Z_{circle} = 60 \text{ ksi} (0.0208 \text{ in}^3) \\ = 1.25 \text{ kin} \quad \text{Equation 5.2}$$

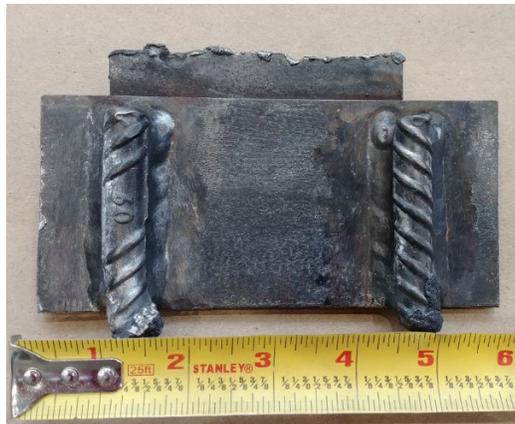
Figure 5.12: Test 1a Welds of Embedded Plates

No rupture was observed in the 3/16th field fillet welds around the connector plate. In order to check the welds of the embedded plates, the plates were cut out with a torch. Inspection of the welds showed no damage occurred. This can be seen in Figure 5.12.

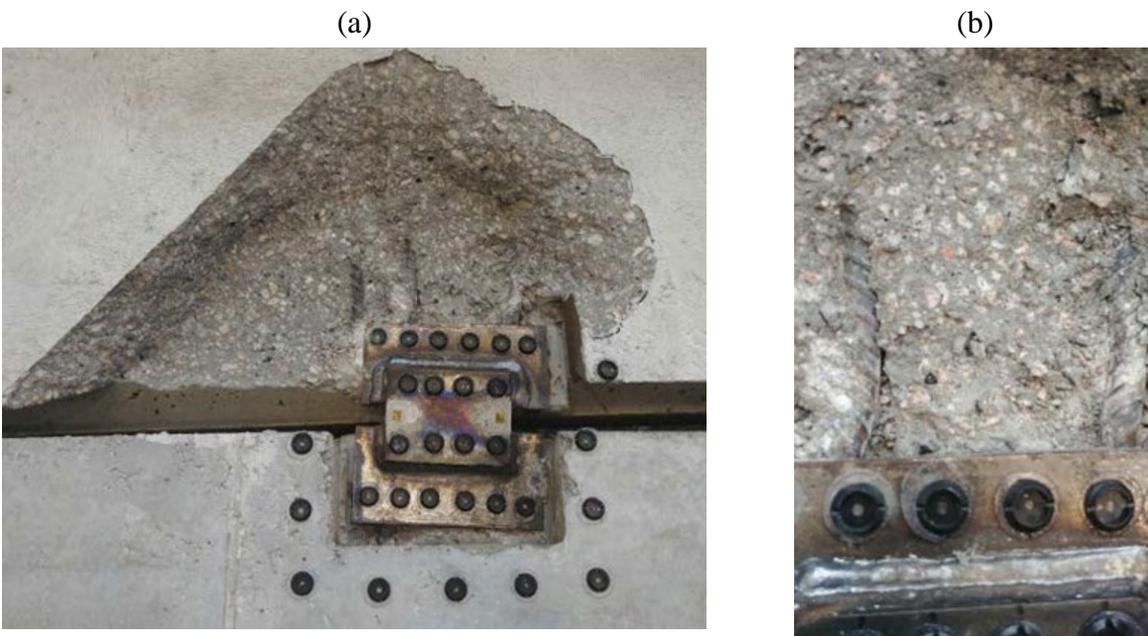
Figure 5.13: Test 1a. Damage to the Shear Connector Pocket (a) Concrete Pocket (b) Embedded Rebar

rotations of the specimen. Most of the damage occurred in one of the shear pockets of the joint. It is most likely that the specimen first failed due to embedded rebar crushing the concrete that it was bearing against. This led to unsupported rebar, which in turn led to large demands and deformation of the plate until it was able bear against the pocket. Once the concrete stress was sufficiently high from the plate bearing, the concrete cracked causing a large area of concrete to spall off as visible in Figure 5.13. Since the presence of grout would prevent additional rotation, it was decided that a cyclic test of just the steel connector plate would not likely yield useful results.

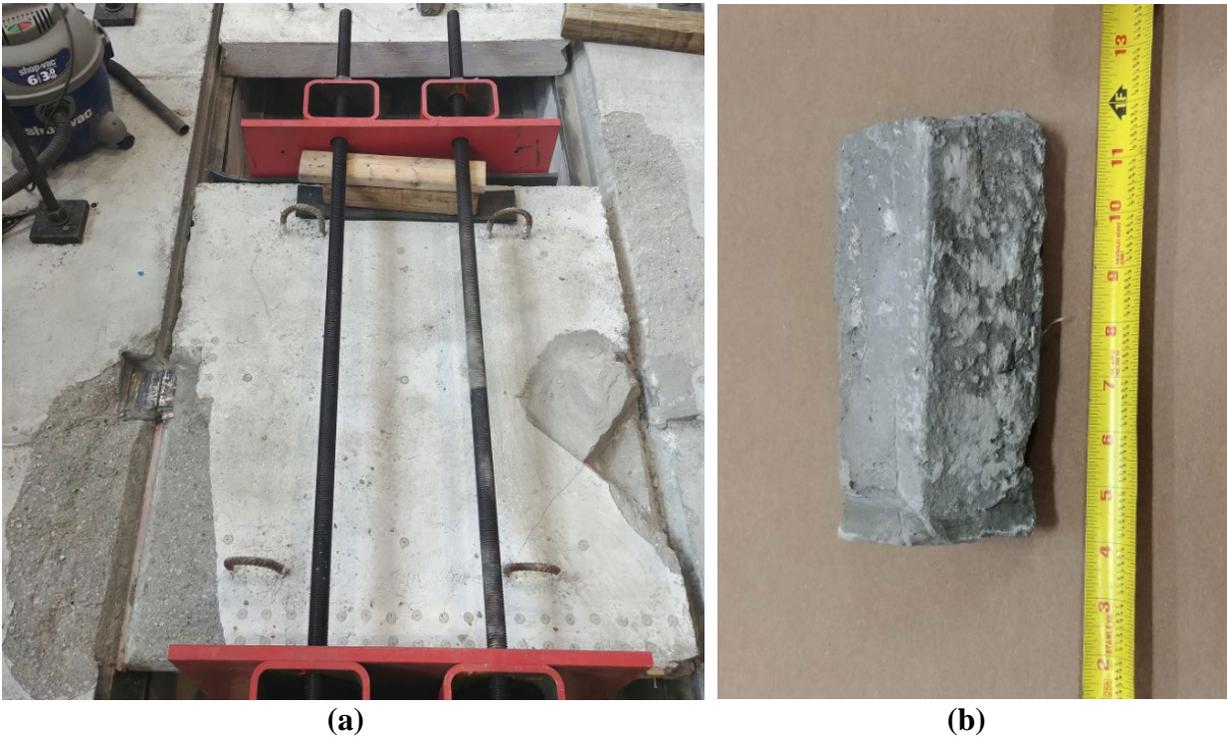
Figure 5.29: Post Test 1b. Damage (a) Test Specimen and Side Blocks (b) Shear Key Grout

5.29 (b). A notable observation of the grout was that some concrete was still bonded to the sides where the needle scalar could clean the joint prior to the pour but not present on the unscaled sections. On the prepared section, grinding between the interface of the shear key and grout was also noted. It was also observed that most of the spalling grout on top of the joint seen during the test did not penetrate into the grout section but rather was localized to the top of the grout.

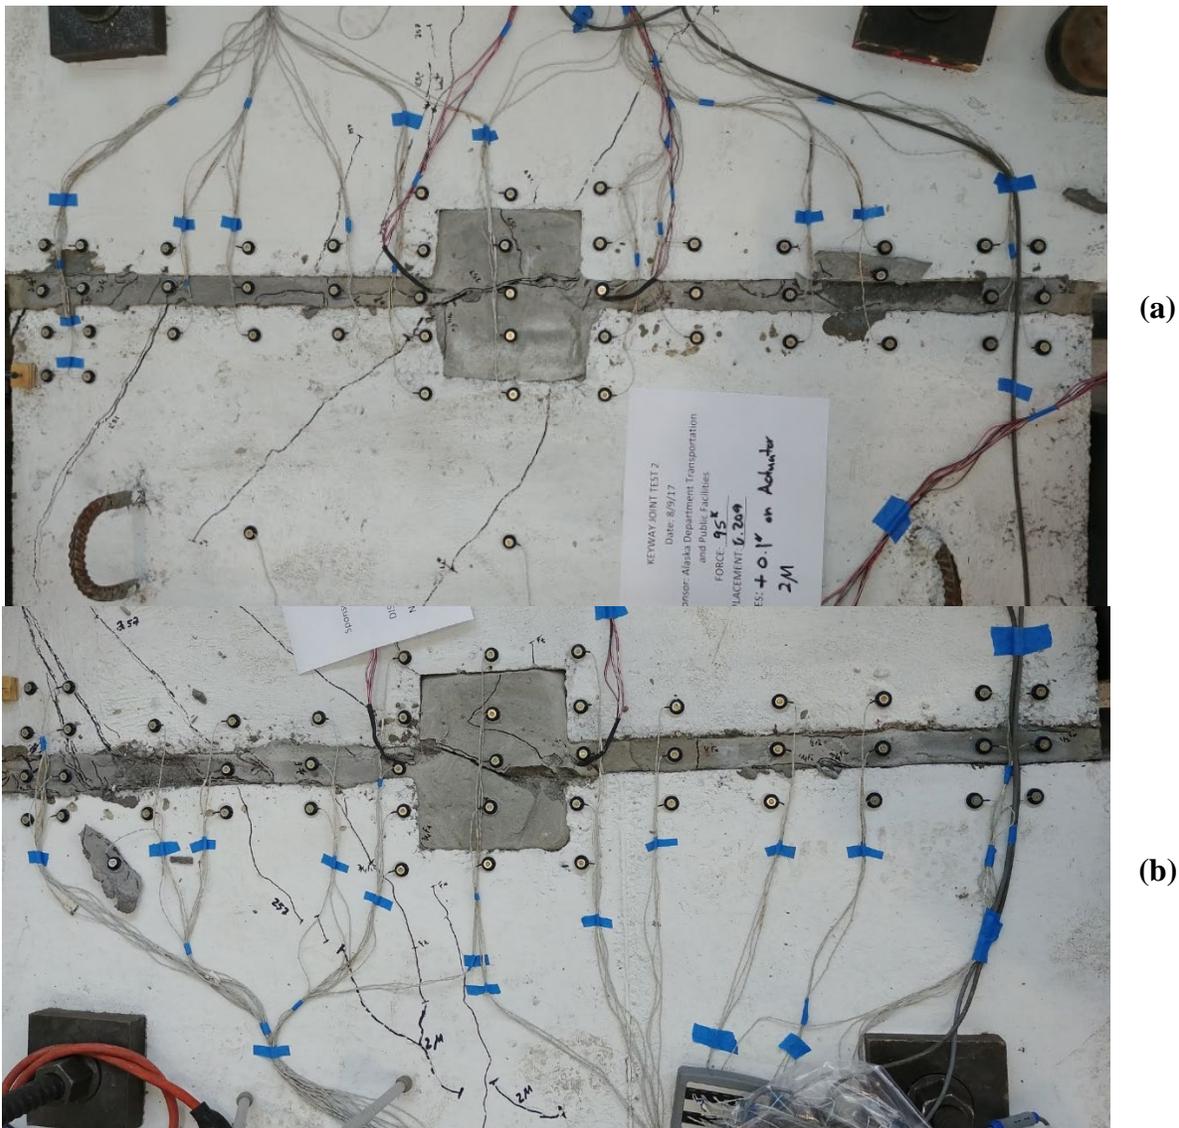
Figure 5.37: Test 2 Grouted Shear Key at 0.44 in. RAM Δ (a) Left Side (b) Right Side

A new displacement limit was set for 0.50 inches and the loading protocol was switched from force control to displacement control at increments of 0.10 inches of actuator ram displacement. At the first increment the total actuator displacement was equal to 0.44 inches corresponding to a load of 92.3 kips. The displacement at the center of the specimen reached 0.315 inches with a rigid body rotation of 0.048° . Figure 5.37 (a) and Figure 5.37 (b) depicts the damage of the left and right joint respectively, which mainly consisted of widening cracks with two cracks lengthening on the right side specimen that are associated with cover concrete spalling.

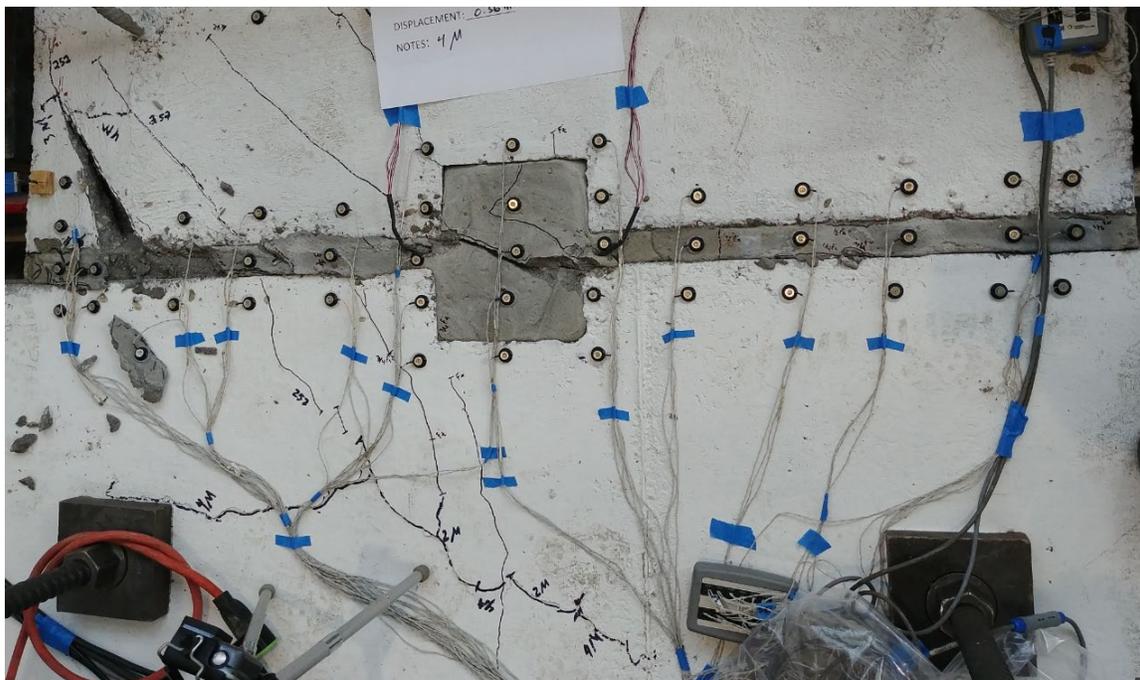
Figure 5.39: Test 2 Right Side Grouted Shear Key at 0.58 in. RAM Δ

ones in the side block resembling damage associated with large spalling of cover concrete. Additionally, loose concrete was removed from the specimen close to the loading plate. Damage can be seen in Figure 5.39.

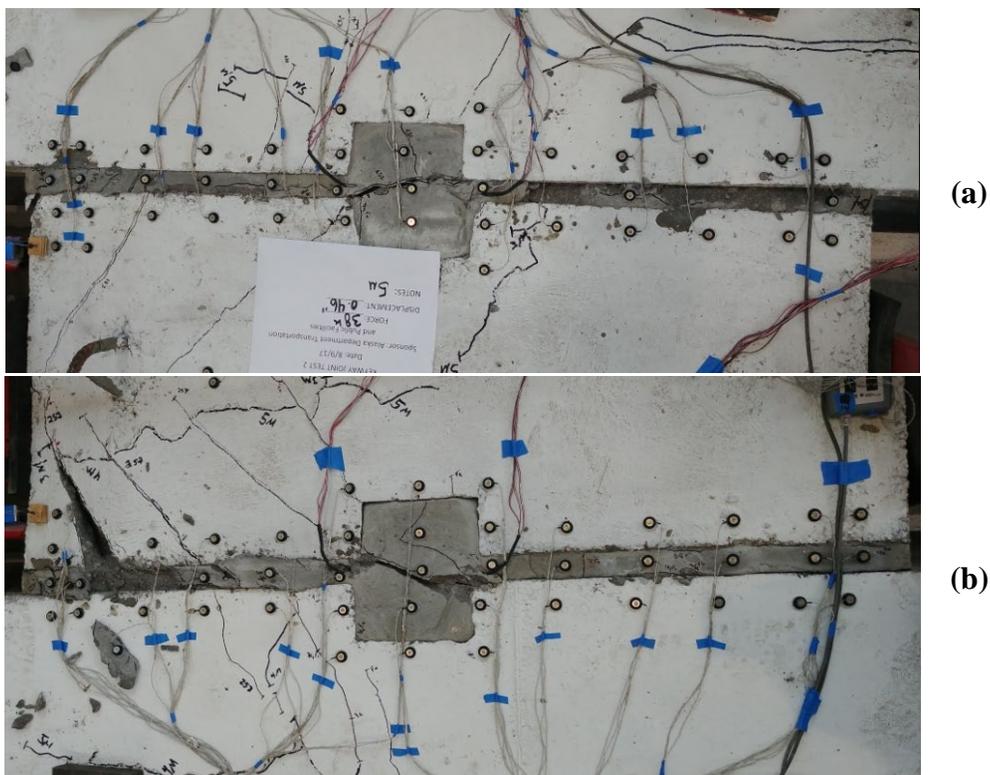
Figure 5.40: Test 2 Grouted Shear Key at 0.74 in. RAM Δ (a) Left Side (b) Right Side

An additional 0.1 increment of displacement was applied for a total of 0.74 inch actuator displacement and a load of 34.4 kips. The displacement at the center of the specimen was 0.641 inches. The displacement of the left keyway joint was 0.580 inches and the right joint was 0.702 inches. The damage can be seen in Figure 5.40. Notable damage occurred on the side block of the left joint. A large single piece of cover concrete on the end of the side block farthest from the actuator displaced upwards creating large cracks in the side block and a gap between the grouted joint and the concrete lip of the shear key. Additionally, on the right side, large connected cracks appeared on the specimen resembling damage associated with spalling cover concrete.

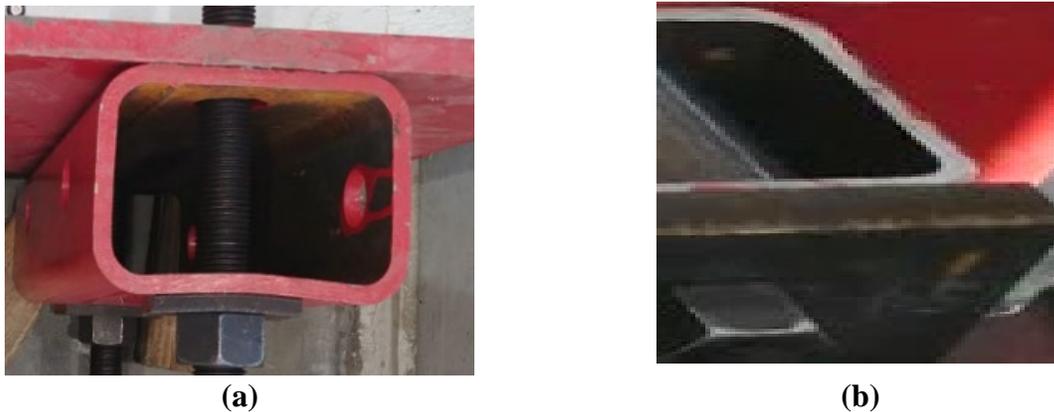
Figure 5.56: Test 3 HSS Load Spreader (a) Pre-Altered Test Setup (b) Post-Altered Test Setup

The increments of loading applied to the specimen increased to 19.2 kips or $q_{\text{average}} = 0.2\text{k/in}$. No new cracks were observed until a crack perpendicular to the pocket occurred on the left side block at $q_{\text{average}} = 1.6\text{k/in}$. The crack continued to propagate at $q_{\text{average}} = 1.8\text{k/in}$ and can be seen in Figure 5.55. When the load reached -189 kips ($q_{\text{average}} = -2.0\text{k/in}$), unexpected localized yielding was observed in the HSS's that make up the load spreader. After one more push cycle, the test was terminated. The maximum positive and negative displacement of the center of the specimen at $q_{\text{average}} = 2.0\text{k/in}$ was 0.011 in. and -0.022 in. with an associated rigid body rotation of -0.002° and -0.004° respectively. Upon termination it was found that the data acquisition system was not recording and only optical tracking system data and hand written data was available. The localized yielding in the HSS's was resolved using $1\frac{1}{4}$ in. plates to transfer rod forces to the HSS walls and inserting 4 in. x 4 in. x $\frac{3}{8}$ in. HSS tubes to change boundary conditions of the original HSS faces. The pre-altered and post-altered test setup can be seen in Figure 5.56.

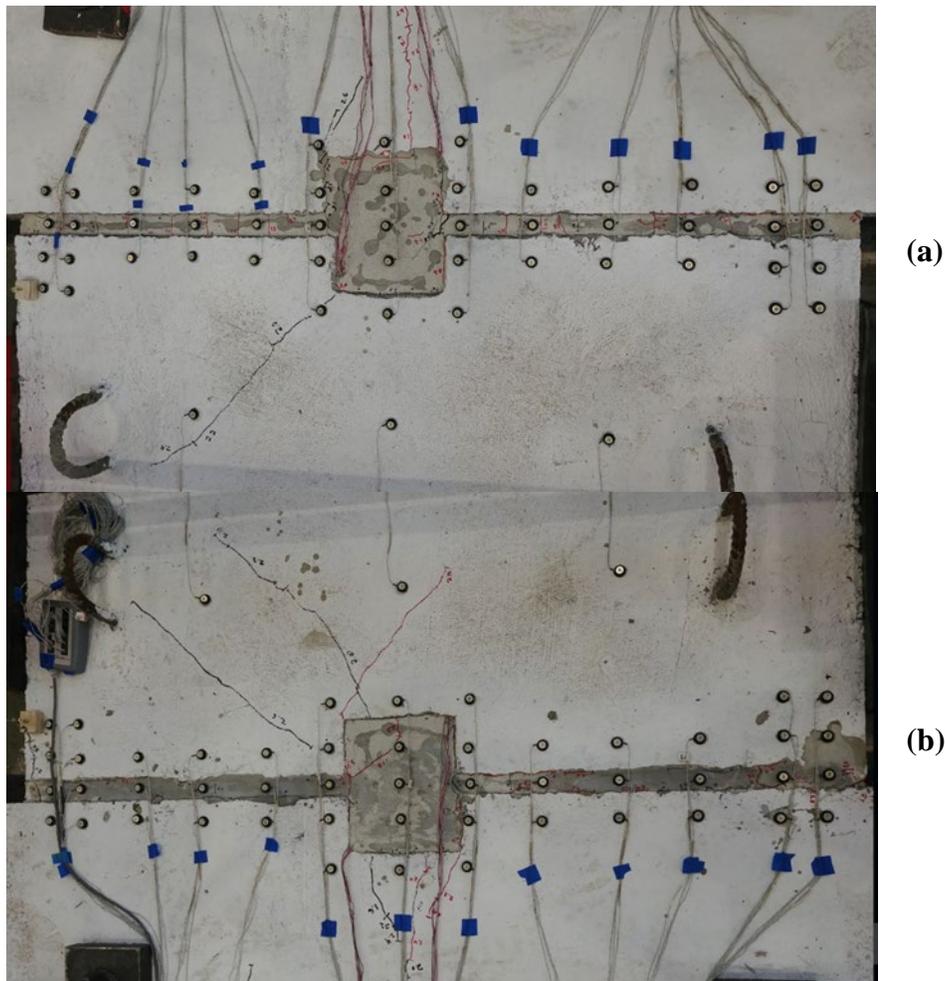
Figure 5.57: Test 3 Grouted Shear Key Pocket $q_{\text{average}} = 2.6\text{k/in}$ (a) Left Side (b) Right Side– Third Cycle

After the test setup was altered, the test was resumed on November 15, 2017. One cycle of $q_{\text{average}} = 1.0\text{k/in}$ and $q_{\text{average}} = 1.6\text{k/in}$ was repeated to compare with the available data from the previous segment of Test 3. This led to a minor crack propagating in the right joint pocket and some cracking in the patched section of the right side block. The original loading protocol was then continued at $q_{\text{average}} = 2.0\text{k/in}$ to $q_{\text{average}} = 2.6\text{k/in}$ (246 kips) at which point, large cracks began to form diagonally in the specimen, starting around the pockets and propagating towards the applied load as seen in Figure 5.57. Prior to completion of the first cycle of $q_{\text{average}} = 2.8\text{k/in}$, the reaction block bond failed and the reaction block slipped at 214 kips, triggering a displacement limit. Since the predicted strength of the specimen was 264 kips, we continued pushing the specimen in an attempt to reach maximum strength capacity. With the specimen experiencing significant strength loss the test could continue using three cycle sets based on the displacement of significant strength loss. The reaction block slipped six more times and the test was terminated. During the last push, the specimen reached a load of 310 kips with a center of specimen displacement of 0.057 in. and a rotation of -0.001° . No new visible damage was observed.

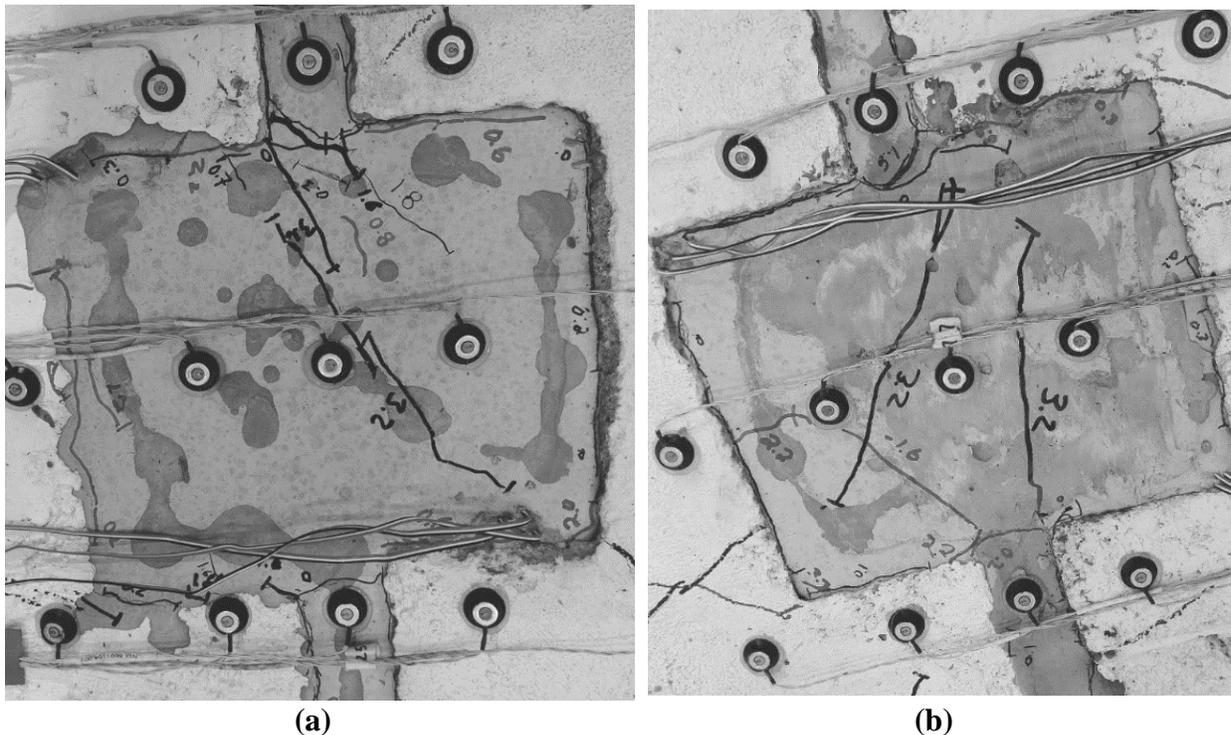
Figure 5.58: Test 3 Grouted Shear Key Pocket $q_{average} = 3.2\text{k/in}$ (a) Left Side (b) Right Side– Third Cycle

The test was resumed on November 29, 2017 after the reaction block was restored. The loading protocol was switched from three cycle to single cycle sets until significant strength loss occurred to ensure that the reaction block would not slip again. The test continued from $q_{\text{average}} = 2.8\text{k/in}$, the load cycle that the reaction block originally slipped at. During $q_{\text{average}} = 3.0\text{k/in}$, new diagonal cracks appeared in the specimen. At $q_{\text{average}} = 3.2\text{k/in}$ (303 kips), diagonal cracks could be seen in both joint pockets (Figure 5.58). The displacement at the center of the specimen was 0.065 in with no measurable rotation. On the reversal, the load reached -286 kips when the grout in the longitudinal joint cracked. The center of the specimen displacement became -0.085 in. with a rigid body rotation of -0.003° .
