Transverse Seismic Design of Bridges with Longitudinal Keyway Joints

Prepared by:
Christopher W. Price, Ph.D. Candidate
Mervyn J. Kowalsky, Professor, Ph.D.
James M. Nau, Professor, Ph.D.
Rudolf Seracino, Professor, Ph.D.

24 May 2019

Prepared for:
Alaska Department of Transportation & Public Facilities
Statewide Research Office
3132 Channel Drive
Juneau, AK 99801-7898

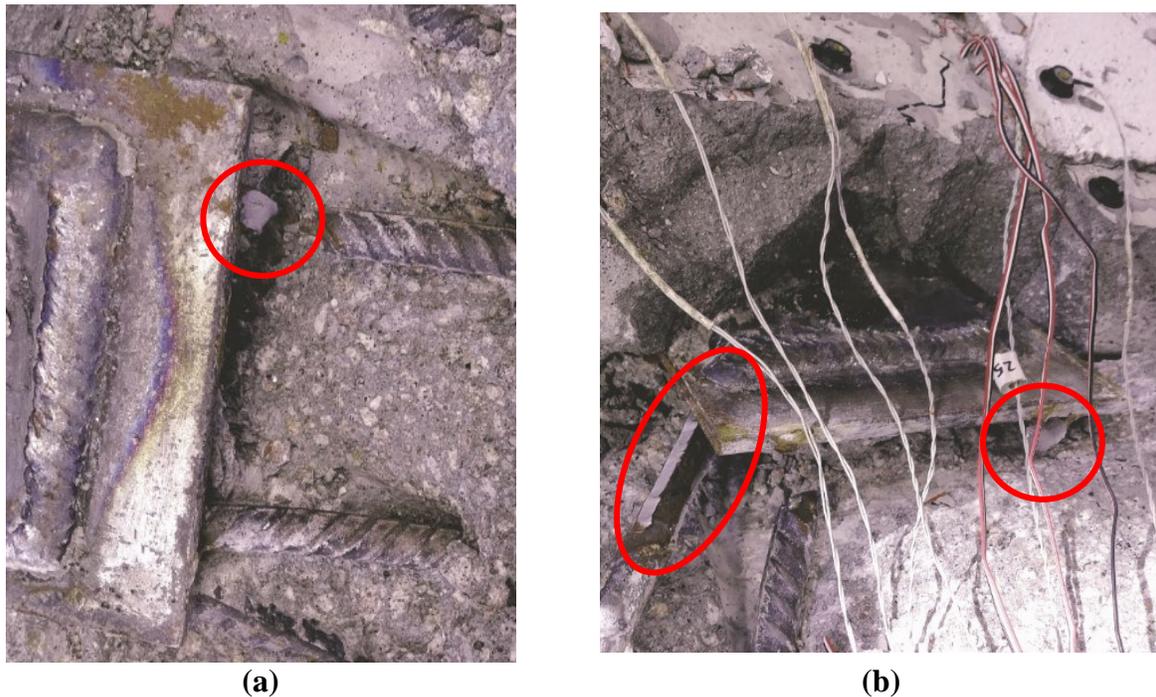
Figure 5.62: Test 3 Damage to Shear Connector Inserts at $\Delta = -4.093$ in. (a) Left Side
(b) Right Side

block immediately followed by failure of weld in the other rebar in the same shear connector insert. The damage can be seen in Figure 5.62. The recorded displacement was -3.234 inches with a force of 29.09 kips.

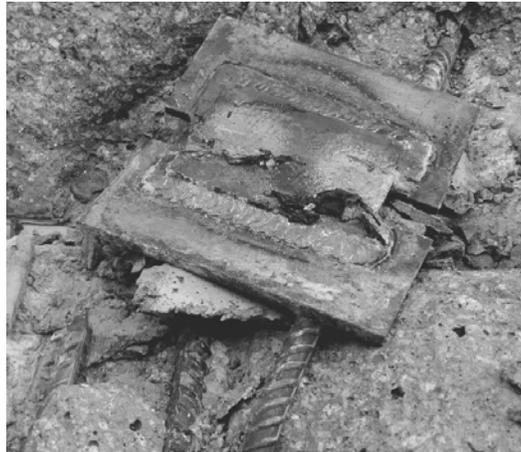
Figure 5.63: Test 3 Damage to Right Side Shear Connector Inserts at $\Delta = 4.423$ in.

It was decided to apply an equal positive displacement in case there was remaining strength in the positive direction. Little strength was observed up until a center of specimen displacement of 0.069 in. The strength then began to steadily increase from 3 kips to 20 kips. At this point the rebar welded to the shear connector insert embedded in the right side specimen fractured at a displacement of 0.997 in. The fracture can be seen in Figure 5.63. The strength then decreased to 0 kips and steadily increased to 21 kips at a center of specimen displacement of 4.423 in and a rotation of -0.314° . No more damage was observed. The specimen was then brought back to a zero displacement with center of specimen displacement of 0.082 in. During that duration no more observable damage occurred as seen in Figure 5.64 and the strength did not increase beyond -4 kips. The test was then terminated. The welds of the shear connectors can be examined in Figure 5.65. While unintended, the loading history resembled multiple low level cycles, followed by a large monotonic push (similar to a velocity pulse).

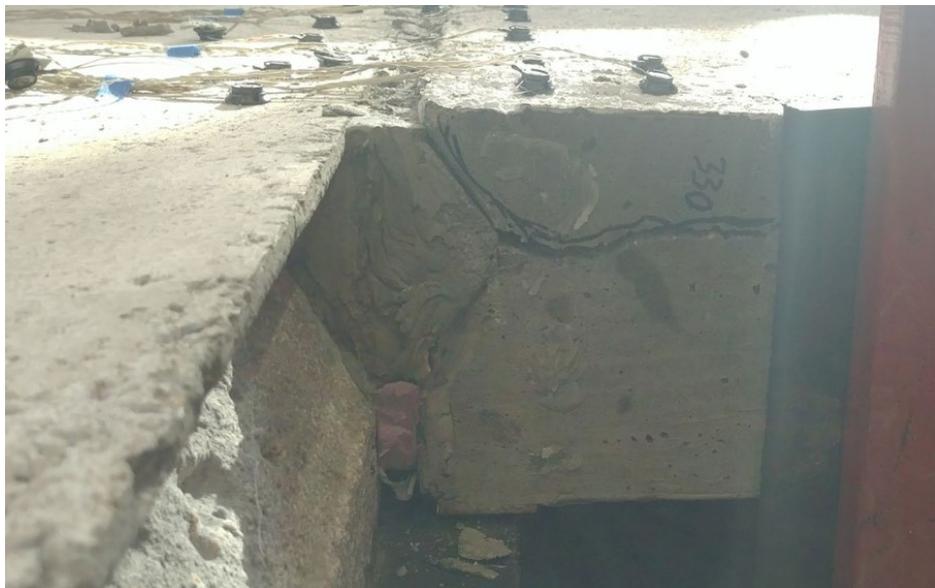
Figure 5.74: Test 4 Left Side of Grouted Shear Key Cracking Δ_{c1} –First Cycle

Since loss of strength was not achieved in the last increment of loading, another 78 kip increment was applied, however, the specimen did not reach that level before the load rapidly degraded. The maximum load sustained was 317 kips (the maximum expected load based on Test 3 was 310 kips). At this point, the displacement of the center of the specimen was 0.134 inches with a rigid body rotation of -0.102° . As the displacement limit was reached, the forces on the specimen relaxed and the displacement reduced to 0.110 inches. This was thought to be the displacement of significant strength loss of the joint used to define the increments of displacement, Δ_{c1} . Significant observable damage occurred as seen in Figure 5.73 and Figure 5.74. The grout in the left joint cracked down the length of the joint. A large crack also formed at the vertex of the keyway faces at the specimen face in which load was being applied. The diagonal cracks propagating from the pockets increased in size, with one pair of cracks connecting from one pocket to another.

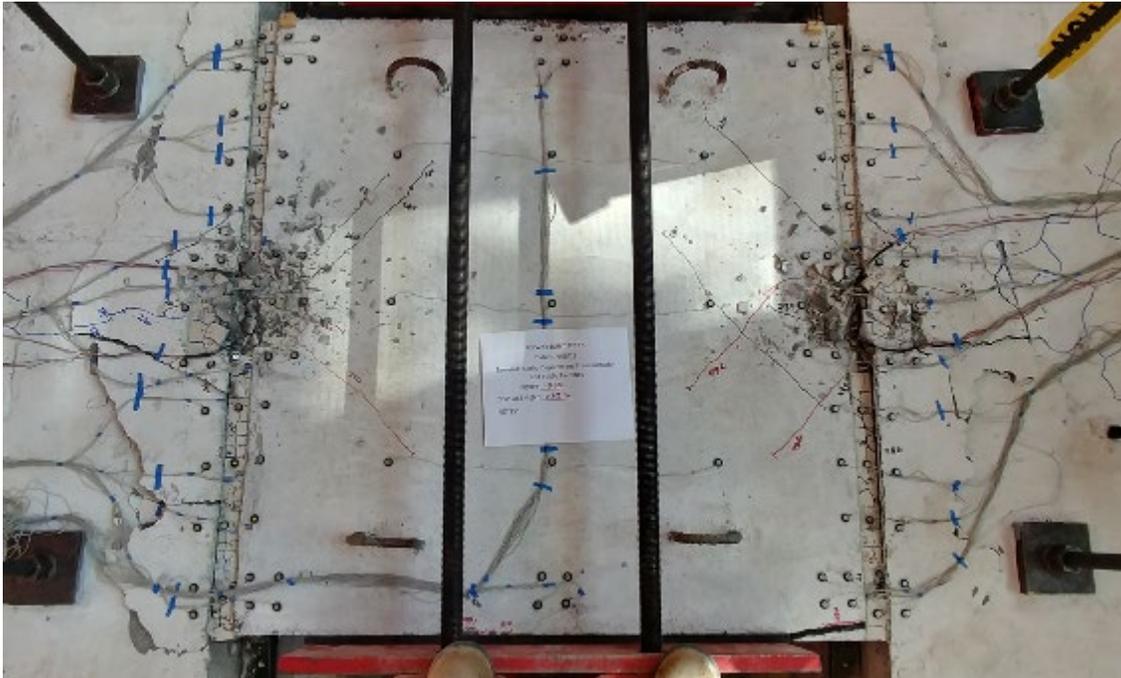
Figure 5.94: Test 5 Grouted Shear Key – Significant Strength loss

At this point in the test, the displacement of the center of the specimen was 0.665 inches with a rigid body rotation of 0.047° with significant damage to the longitudinal joint as seen in Figure 5.94. Damage was focused in the side blocks. Cracks formed in both side blocks along the vertex of the keyway faces leading to the removal of large pieces of cover concrete. Removing the unbonded cover concrete by hand revealed the shear connector plates and embedded rebar depicted in Figure 5.95.

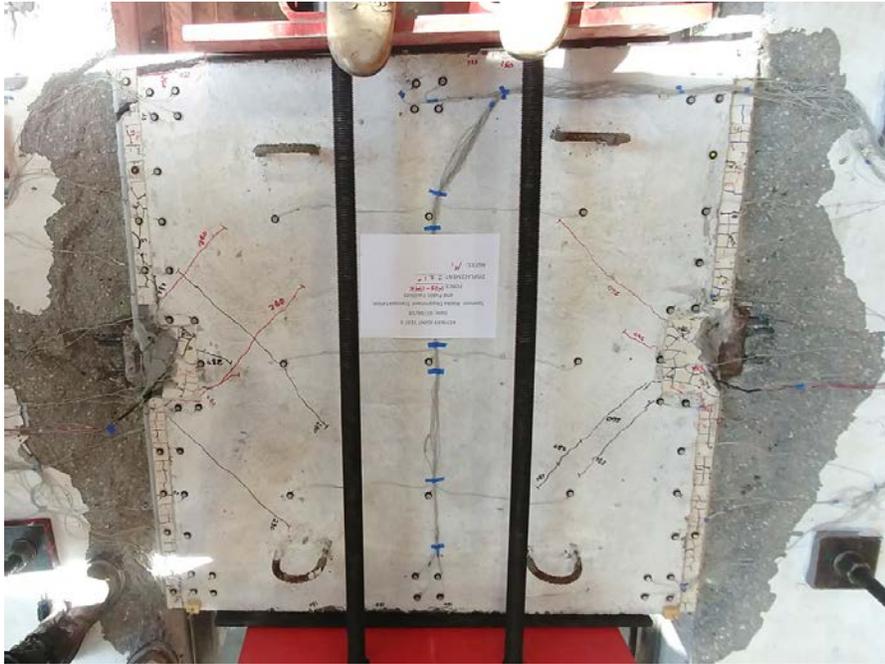
Figure 5.96: Test 5 Grouted Shear Key - Δ_{c1} –Third Cycle

The actuator was then switched to displacement control. The displacement at significant strength loss was estimated at 0.100 inches, which was used to define the displacement of significant strength loss of the joint, Δ_{c1} . Demand was applied in three cycle sets at increments proportional to Δ_{c1} . Due to the unpredictability of using the actuator displacement, the rate of loading was reduced and the displacement of the center of the specimen was monitored manually to conclude the loading for each cycle. Little damage was accumulated through cycles Δ_{c1} to Δ_{c4} . The deformation and therefore the associated damage occur only at the exposed embedded rebar. As the rebar deformed only minor spalling of concrete surrounding the rebar occurred. Figure 5.96 and Figure 5.97 show the accumulated damage from Δ_{c1} to Δ_{c4} . During the first push cycle of Δ_{c6} (0.594 in.), bar fracture was observed in the right shear connector insert shown in Figure 5.98. Successively, the first Δ_{c6} pull cycle (-0.588 in.) led to damage to the right and left embedded shear connectors. Instead of bar fracture, the embedded rebar appeared to be failing at the weld as seen in Figure 5.99 and Figure 5.100 for the right and left side respectively. No significant observable damage occurred for the remainder of the Δ_{c6} cycles. Upon the first push cycle of Δ_{c8} instead of weld failure, the remainder of the exposed rebar fractured leaving no connectivity between the side blocks and the specimen through the shear connectors. The fractured rebar can be seen in Figure 5.101. With only the grout providing the response, no notable additional damage occurred with little residual strength (+/- 8kips). Only the first full cycle was completed before the test was concluded and the specimen was returned to zero displacement.

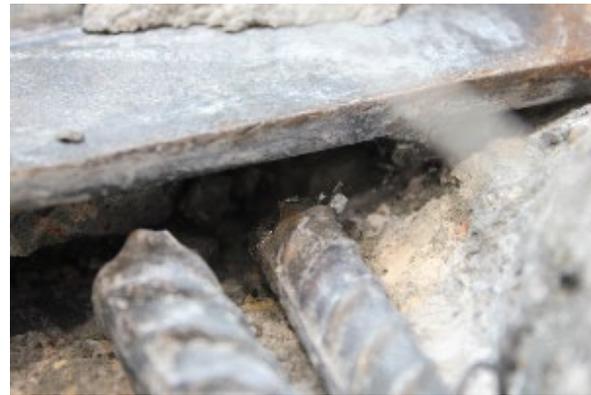
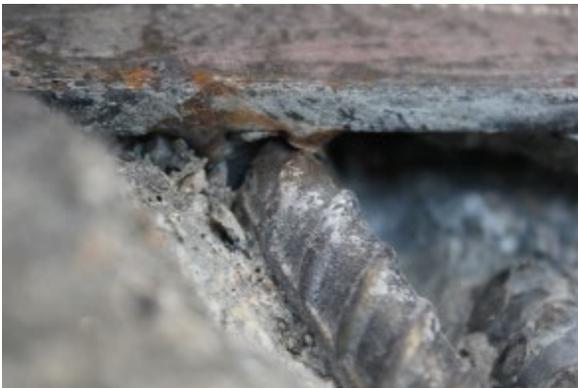
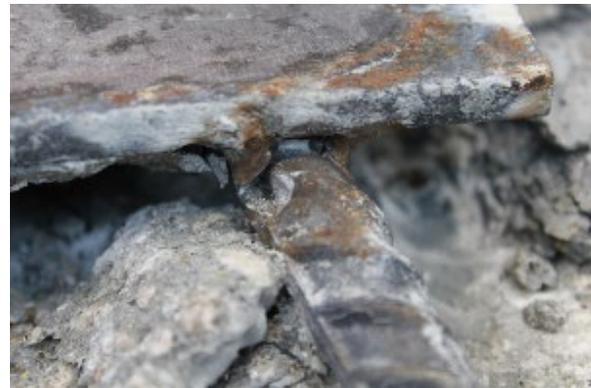
Figure 5.101: Test 5 Damage to Shear Connector Insert at Δ_8 –First Cycle

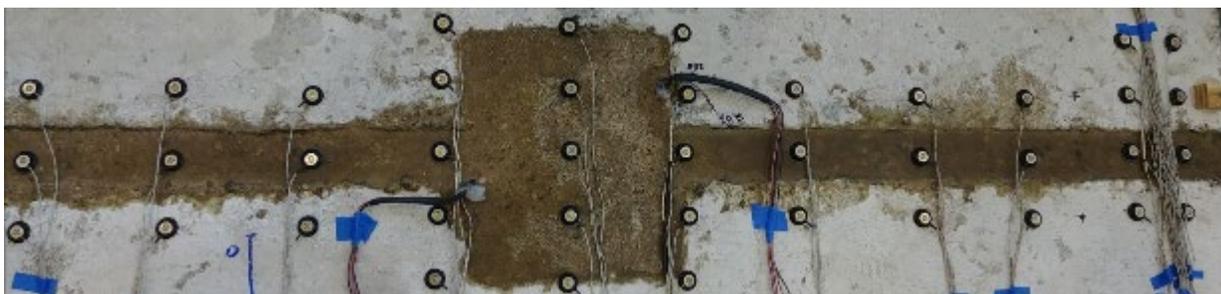
Figure 5.109: Test 6 Right Side Grouted Shear Key with Applied Load = 260 kips

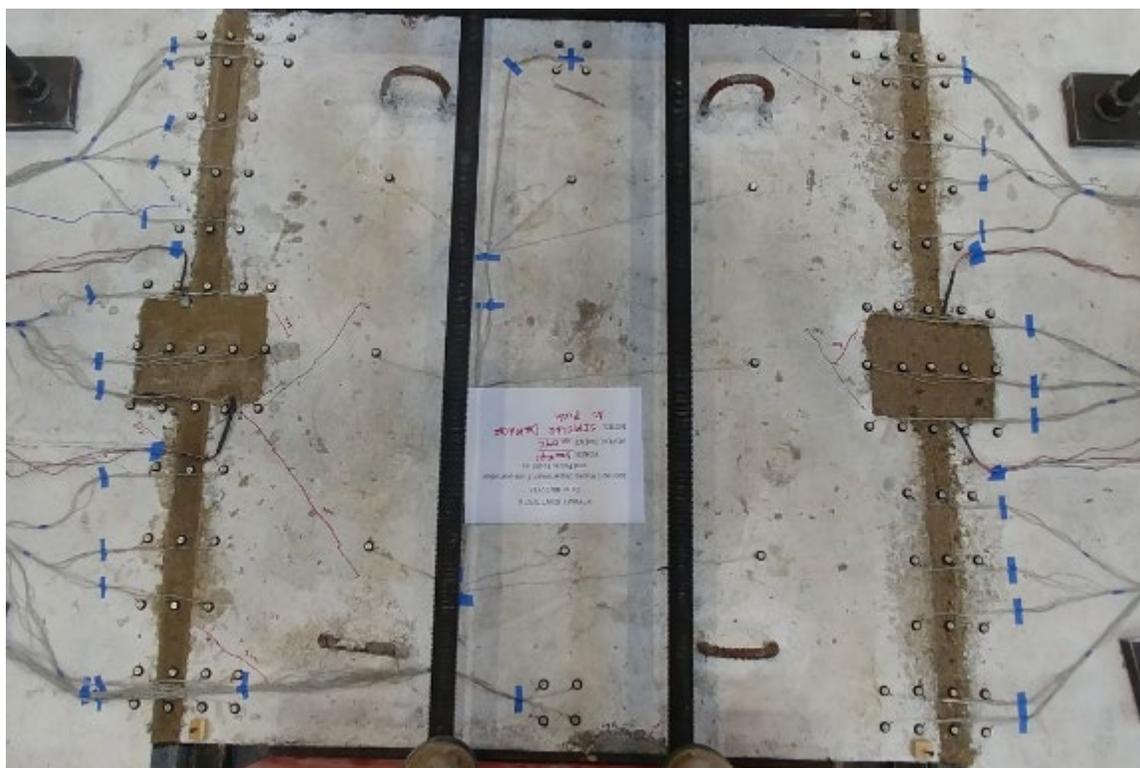
Figure 5.110: Test 6 Grouted Shear Key with Applied Load = -300 kips

cracking which propagated toward the applied load in both directions. Cracks formed in both the specimen and the side blocks as seen in Figure 5.110. The max positive and negative displacement of the center of the specimen was 0.062 inches and -0.047 inches with an associated rigid body rotation of -0.001° and -0.003° respectively. The push load was then increased to 320 kips ($q_{\text{average}} = 3.3\text{k/in}$). The specimen reached a center specimen displacement of 0.093 inches with a rigid body rotation of 0.008° . Upon holding the load, the specimen drifted to 0.156 inches with a rigid body rotation of 0.056° before the sustained load began to drop. Damage was evident with significant diagonal cracking appearing in the specimen and the left side block. Additionally longitudinal cracks appeared on the joint interface between the concrete and the PPC parallel to the joint. Damage can be seen in Figure 5.111. The actuator was then switched to displacement control. The displacement at significant strength loss was estimated at 0.120 inches, which was used to define the displacement of significant strength loss of the joint, Δ_{c1} . Demand was applied in three cycle sets at increments proportional to Δ_{c1} . Due to the unpredictability of using the actuator displacement, the rate of loading was reduced and the displacement of the center of the specimen was monitored manually to conclude the loading for each cycle.

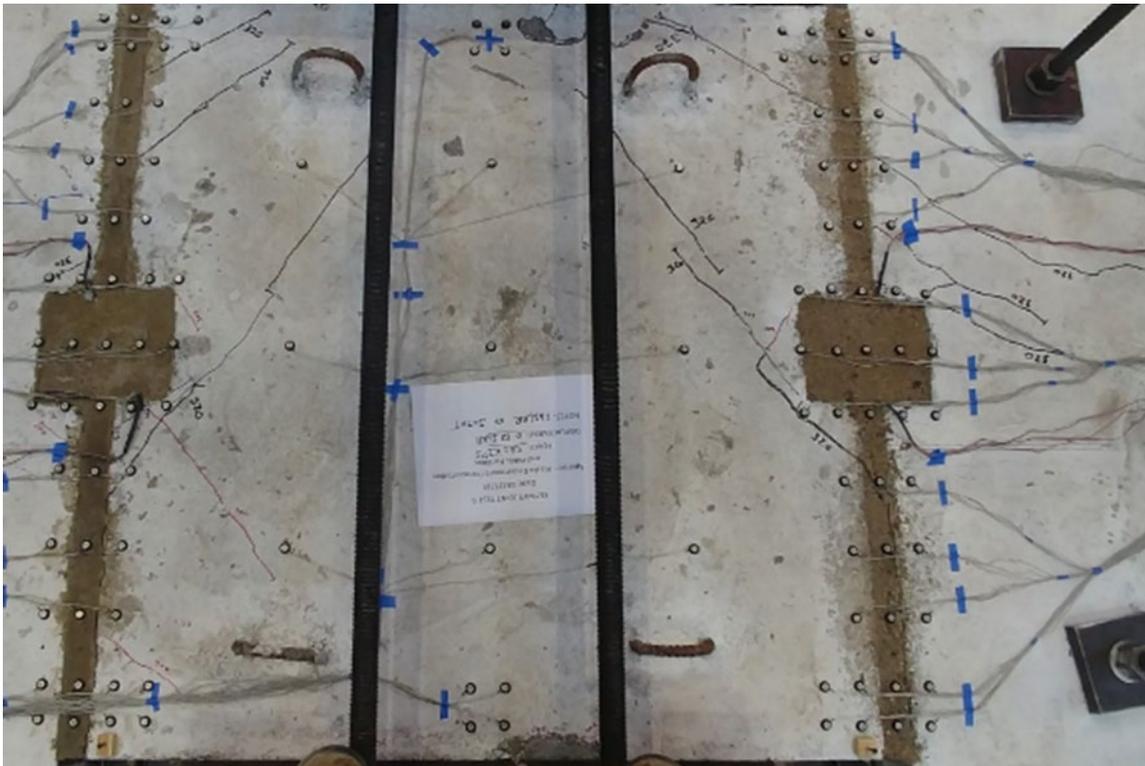
Figure 5.111: Test 6 Grouted Shear Key with Applied Load = 320 kips

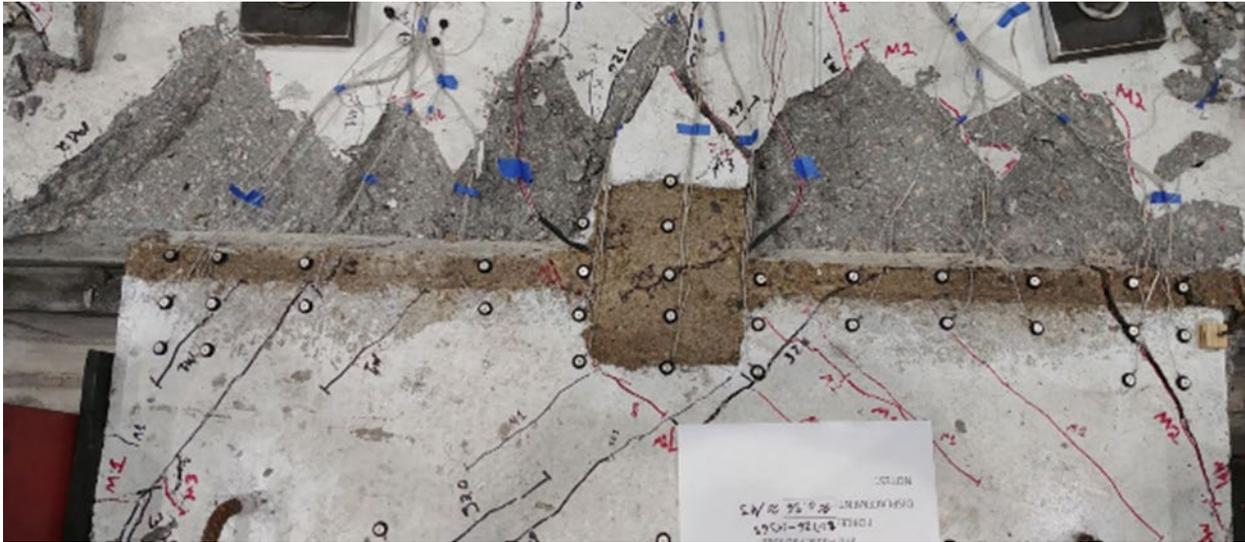
Figure 5.115: Grouted Shear Key - Δ_{c3} –Third Cycle

Spalling of the left side block continued into the Δ_{c3} (Figure 5.115). The capacity of the joint began to reduce with more capacity in the push direction as opposed to the pull direction. At the end of the third cycle, the force was 48 kips and -27 kips with an associated rigid body rotation of -0.356° and 0.100° . Little damage was accumulated in the Δ_{c4} cycles, though the larger displacements exposed the left joint shear connector. No damage to the embedded rebar was observed. The first embedded rebar to fracture occurred during the first pull cycle of Δ_{c6} cycle. The second rebar fracture occurred during the second pull cycle. Both fractured rebar were embedded into the left side block leaving the specimen attached only through the grout. The damage can be seen in Figure 5.116. It should be noted that the longitudinal gap in the right joint was observed rotating as the longitudinal gap closed and opened in the push and pull cycles respectively (Figure 5.117).

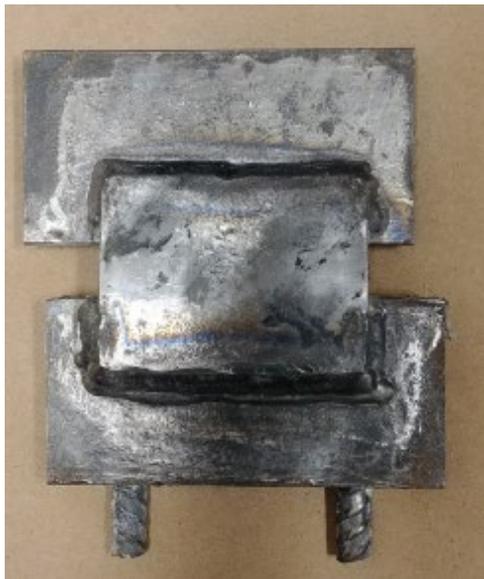
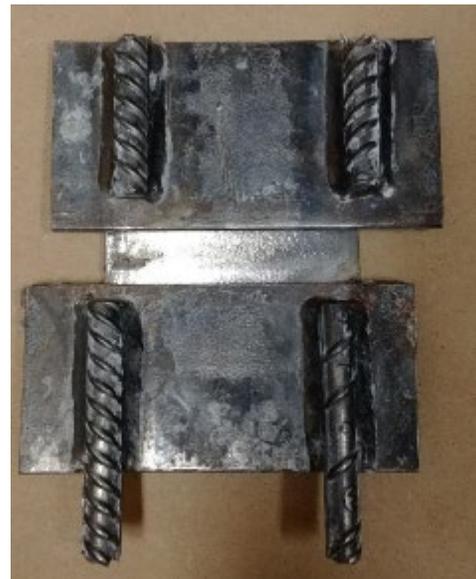
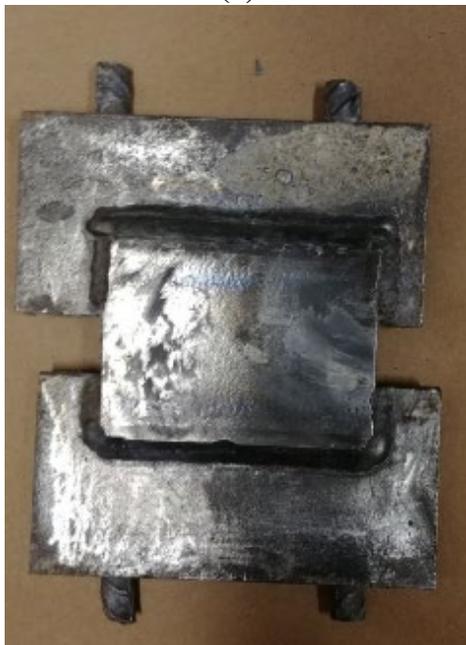
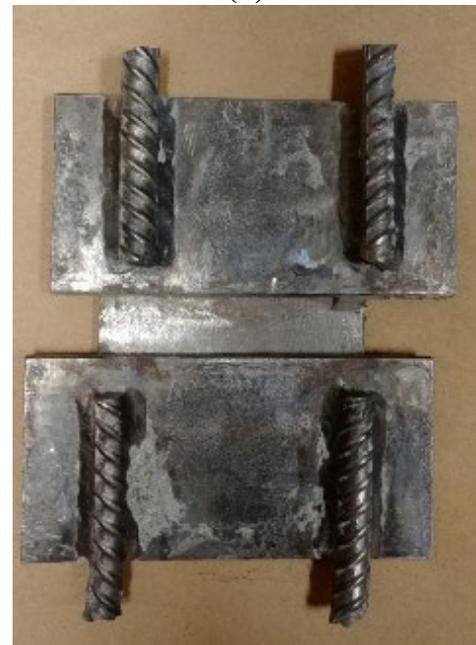
Figure 5.118: Test 6 Removed Shear Connector Plate (a) Top View Left Connector (b) Bottom View Left Connector (c) Top View Right Connector (d) Bottom View Right Connector

The test continued to Δ_{c8} with little associated additional damage. Rotation of the specimen became more prevalent and after completing the final cycle, the test was concluded and the specimen was returned to zero displacement. It should be noted that there was still 52 kips of residual strength at the first push cycle. The shear connector plates were removed from the specimen to examine the welds as seen in Figure 5.118. All of the welds remained undamaged.

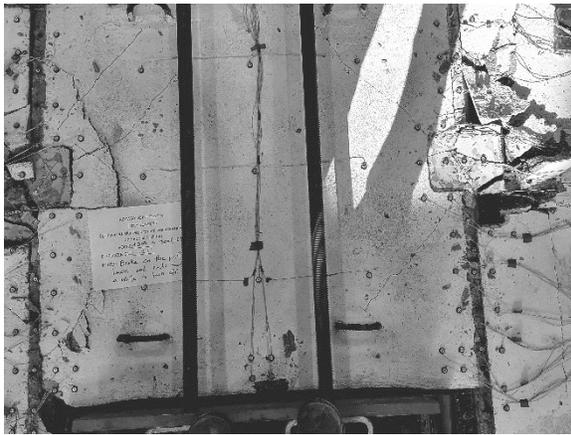
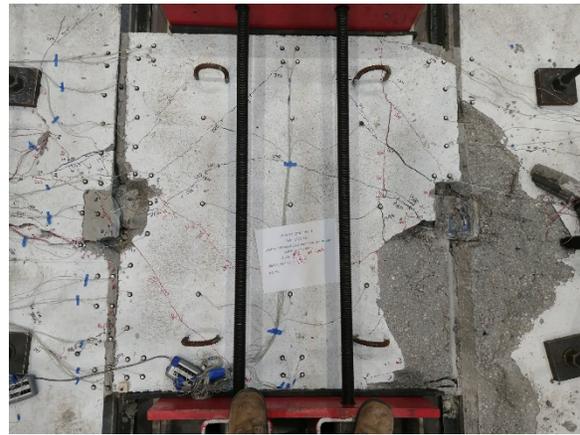
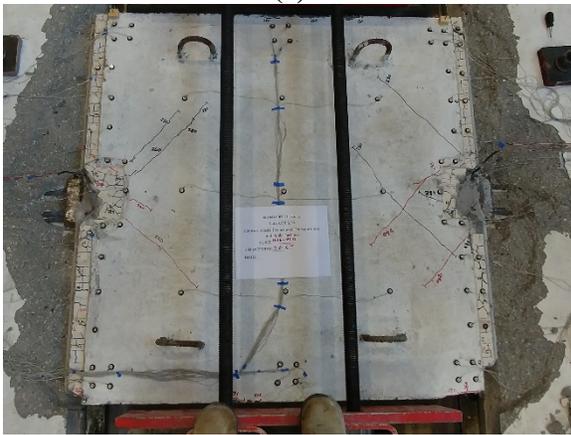
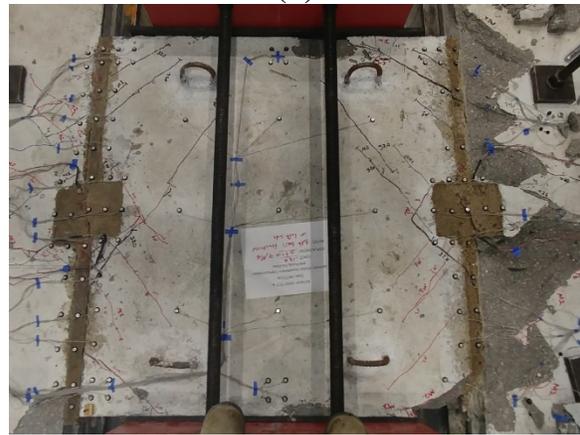
Figure 5.127 Rebar Fracture (c) Test 3 (d) Test 4 (e) Test 5 (f) Test 6

The progression of damage for each grouted test can be seen in Figure 5.123 through Figure 5.127. While the loading protocol attempted to remain constant for all tests, due to the nature of the test setup and damage progression, some tests were pushed beyond certain damage states and photos were not available. For example, Test 3 underwent a large displacement once the capacity of the grout was exceeded. This led to grout failure of the grouted joint, spalling of cover concrete, and rebar fracture at the end of the loading step. Therefore, no photo is available for cover concrete spalling and only photos just prior to grout failure are available for failure of the grouted joint. The force and displacement at which each damage state occurred for the tests in Phase I can be found in Table 5.1. Damage states that did not occur in the test as well as values that are not known are left blank.

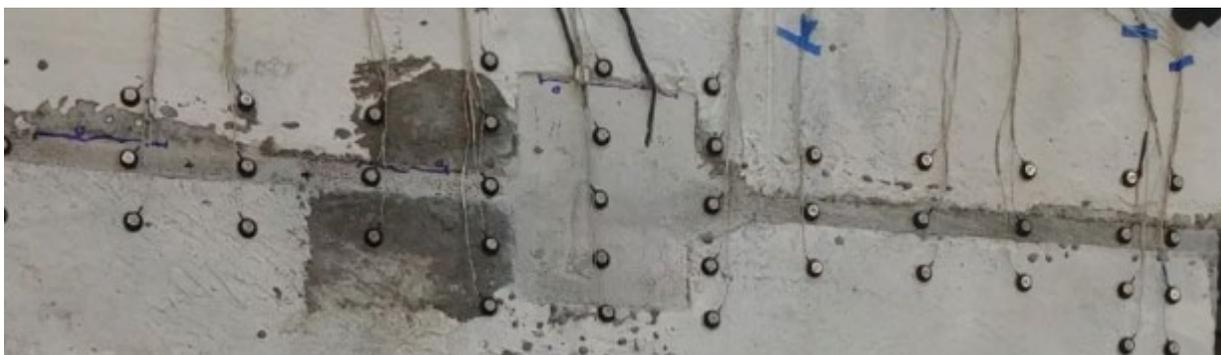
Figure 6.5: Test 7 Left Side Grouted Shear Key with Applied Load = 0 kips

Force was applied cyclically in single cycle sets, at increments of 58 kips ($q_{\text{average}} = 0.6\text{k/in}$). Prior to loading, minor shrinkage cracking was visible along the left joint and slab surface interface (Figure 6.5). During the first two increments of loading, additional cracking formed in the left joint, where cracks traced the interface of the grouted joint and slab, including the perimeter of the shear pocket. Upon the next load increment, 174 kips ($q_{\text{average}} = 1.8\text{k/in}$), the first visible cracks appeared in the specimen. The displacement at the center of the specimen was 0.021 inches with a rigid body rotation of 0.001° . The cracking started at both the left and right joint shear pockets and ran diagonally towards the direction of loading as seen in Figure 6.6. In addition to the damage in the specimen, a crack perpendicular to the right joint formed in the right side block. For the same cycle in the opposite direction, diagonal cracking appeared near the shear pocket and along the joint between the shear pocket and the applied load (Figure 6.7). At the anticipated capacity of the joint, 232 kips ($q_{\text{average}} = 2.4\text{k/in}$), the maximum positive displacement at the center of the specimen was 0.048 inches with an associated rigid body rotation of 0.013° . At this force, existing diagonal cracks continued to increase in length while a new diagonal crack formed through the left shear pocket as seen in Figure 6.8. Upon the reversal cycle, the specimen reached -216 kips with a displacement of -0.059 inches at the center of the specimen before the load began to decrease. The specimen reached -212 kips with an associated displacement and rotation of 0.098 inches and -0.039° before significant strength loss of the specimen occurred. The resulting damage can be seen in Figure 6.9. The damage included additional diagonal cracking through the specimen, cover concrete spalling of the specimen around the shear pocket, and cracking along the joint at the keyway interface that continued through the shear pockets.

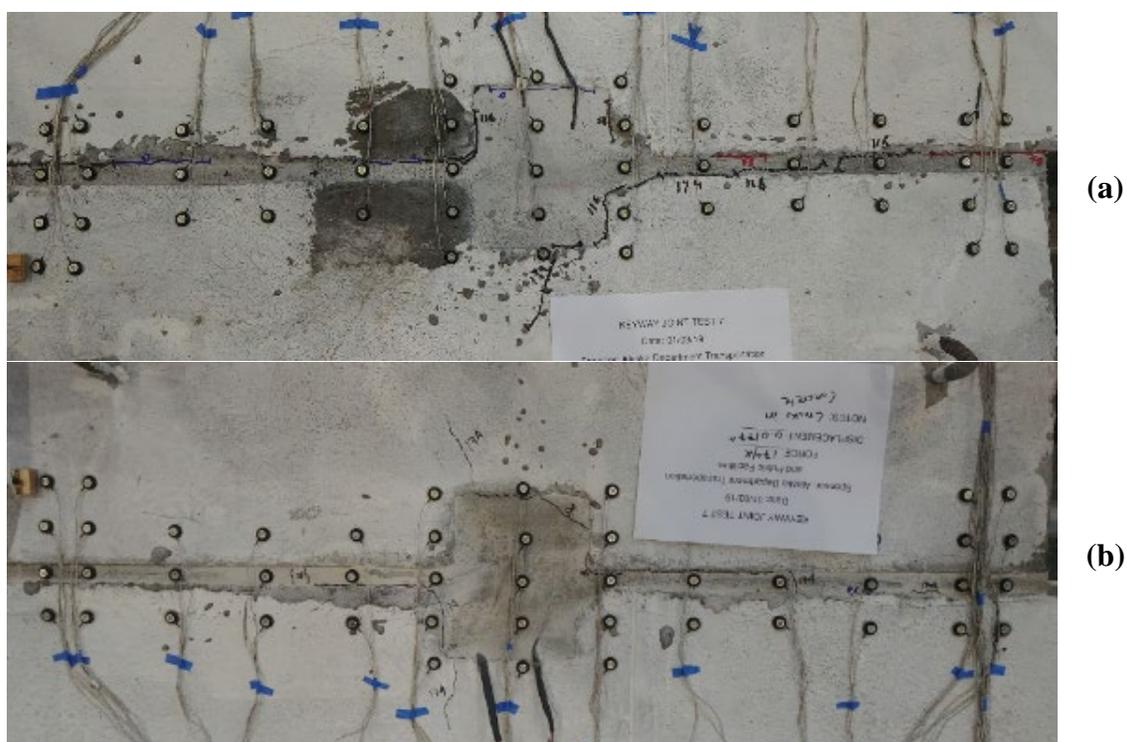
Figure 6.6: Grouted Shear Key with Applied Load = 174 kips (a) Left Side (b) Right Side

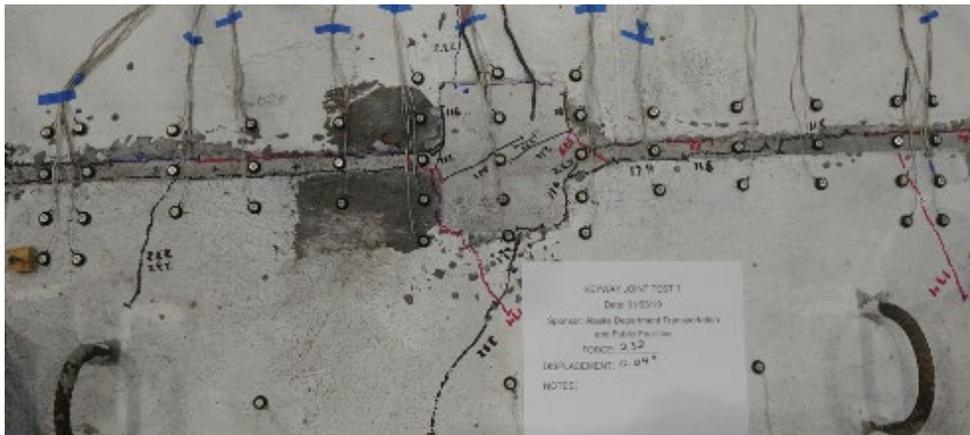
Figure 6.8: Test 7 Left side of Grouted Shear Key with Applied Load = 232 kips

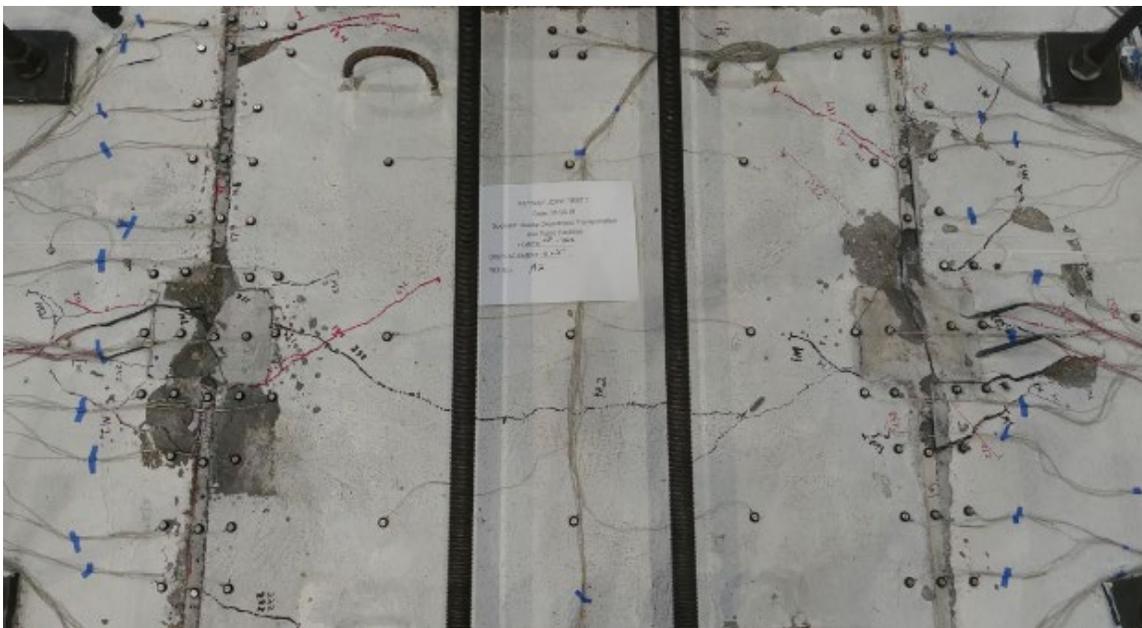
Figure 6.11: Test 7 Grouted Shear Key $-\Delta_{c2}$ -Third Cycle

Δ_{c2} , minor cracking continued to form in the left side block while cover concrete in the right side block began to lift up. Additionally a crack formed completely across the specimen to connect two existing diagonal cracks (Figure 6.11).

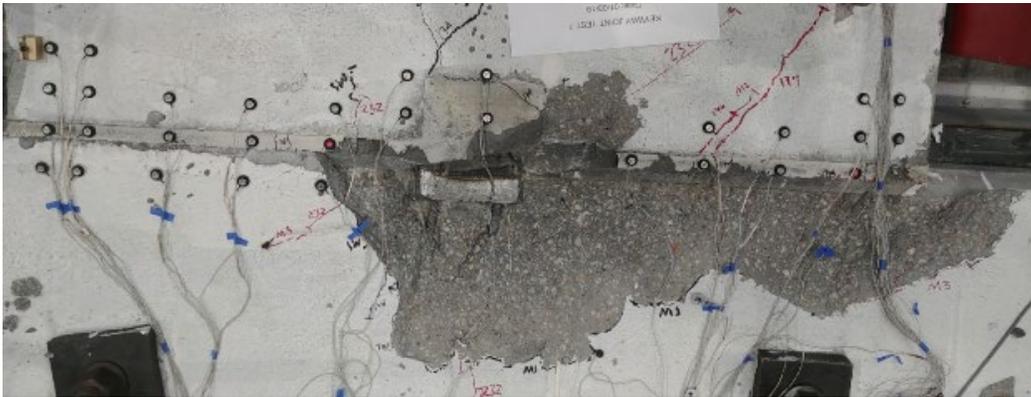
Figure 6.12: Test 7 Right Side of Grouted Shear Key $-\Delta_{c3}$ -First Cycle

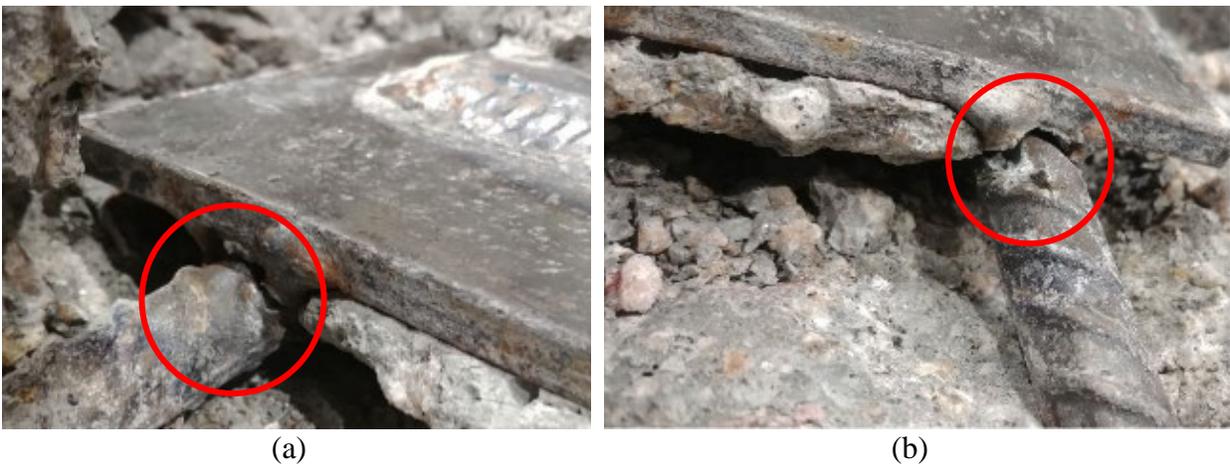
Figure 6.16: Test 7 Damage to Left Side Shear Connector Insert at Δ_{c6} -Third Cycle

Upon the third cycle of Δ_{c6} , the two newly exposed embedded rebar in the left side block fractured (Figure 6.16). The displacement at the center of the specimen was 0.607 inches with a force of 9 kips and rigid body rotation of -0.052° . The test continued to Δ_{c8} , where minimal strength was seen and no additional damage noted. The shear connector plates were removed from the specimen to examine the welds as seen in Figure 6.17. All of the welds remained undamaged.

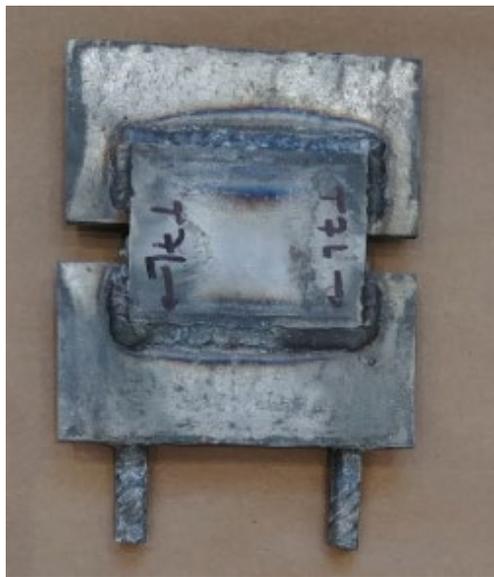
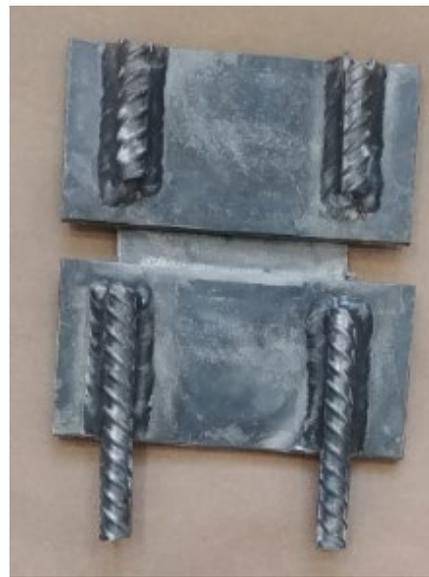
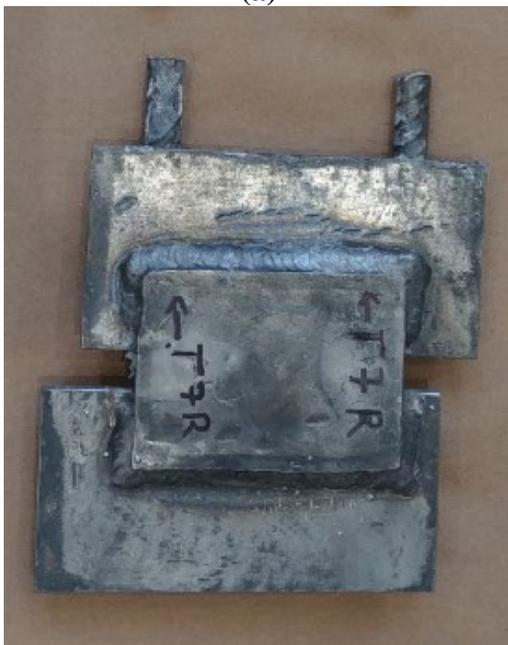
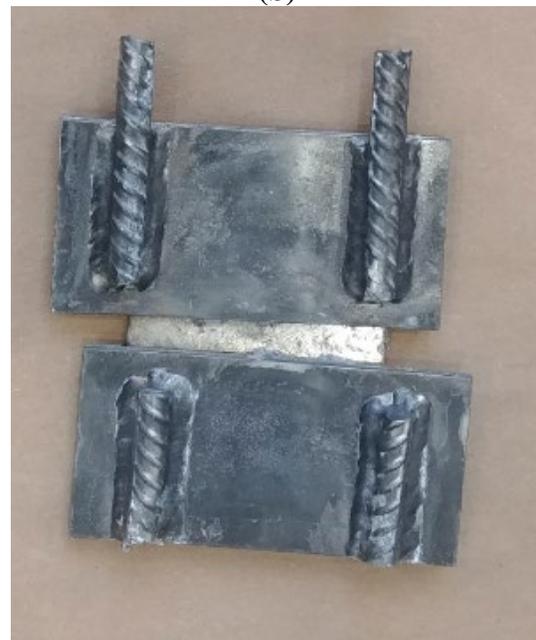
Figure 6.17: Test 7 Test 6 Removed Shear Connector Plate (a) Top View Left Connector (b) Bottom View Left Connector (c) Top View Right Connector (d) Bottom View Right Connector

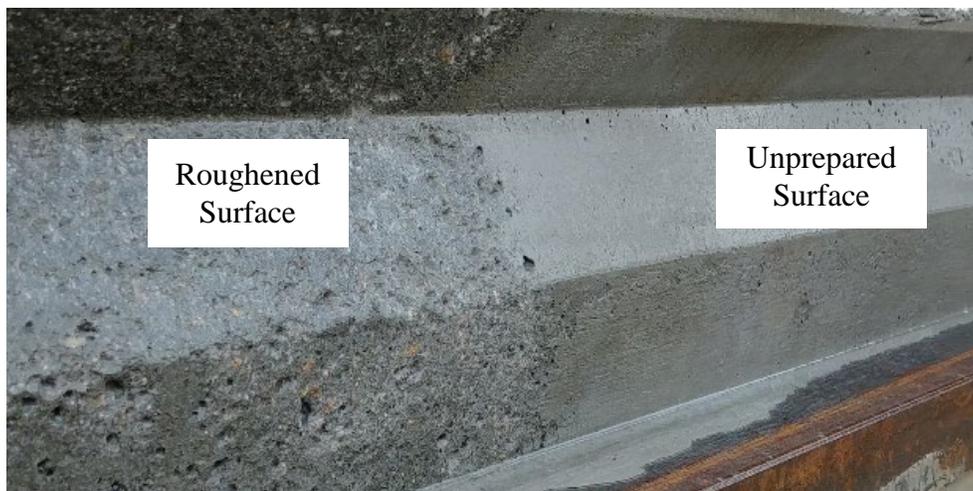
Figure 6.18: Variance in Surface Preparation of the Shear Key

The focus of the test was to examine the effects of grout bond strength through surface preparation of the grouted shear key. AKDOT requires grout to be applied as directed by the manufacturer, which typically states that the grout is applied to sound and roughened concrete. In the case of this test, bond strength between the grout and the shear key was reduced by skipping preparation to the shear key as seen in Figure 6.18. Damage development throughout the test was similar to Test 5, where damage was concentrated in the side blocks. This led to an earlier onset of rebar fracture, which occurred at Δc_6 , approximately +/- 0.6 inches. The expected capacity was 232 Kips, which was achieved just prior to significant strength loss making the ratio of the maximum recorded load over the expected maximum load equal to 1.0. When the ratio of the maximum recorded load over the expected maximum load is compared to previous tests, the tests with a prepared surface had at least a 20% greater capacity. If that ratio was applied to the maximum load of Test 7, the capacity of the joint would be anticipated to be 46 kips larger which translates to the ability to reach an additional 0.5k/in $q_{average}$. Test 7 can also be compared with Test 1b and Test 2 to provide more insight. Due to these tests being welded into place prior to surface preparation, only the bottom faces of the shear key were accessible. So opposed to the full diamond shape being roughened, a V-shaped was roughened. Test 1b achieved a load ratio of 1.12 kips, while Test 2 achieved a ratio of 1.06. While one test may not be enough to determine the exact impact of a reduction in bond strength, there does appear to be an effect.

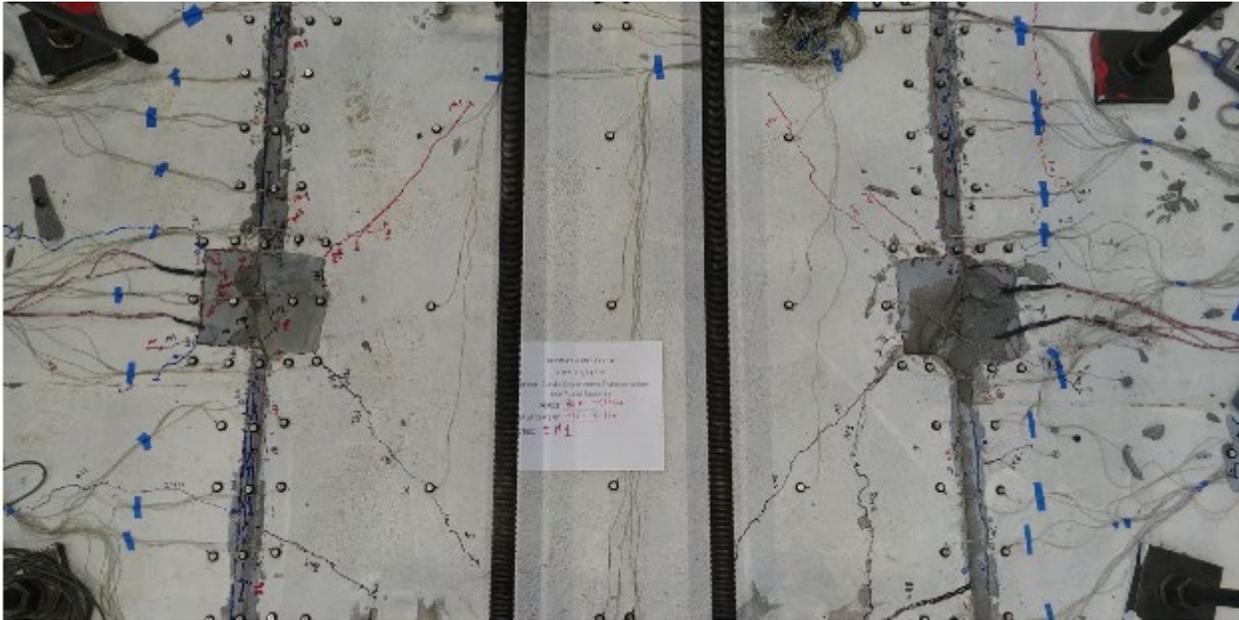
Figure 6.31: Test 8 Grouted Shear Key - Δ_{c1} –Third Cycle

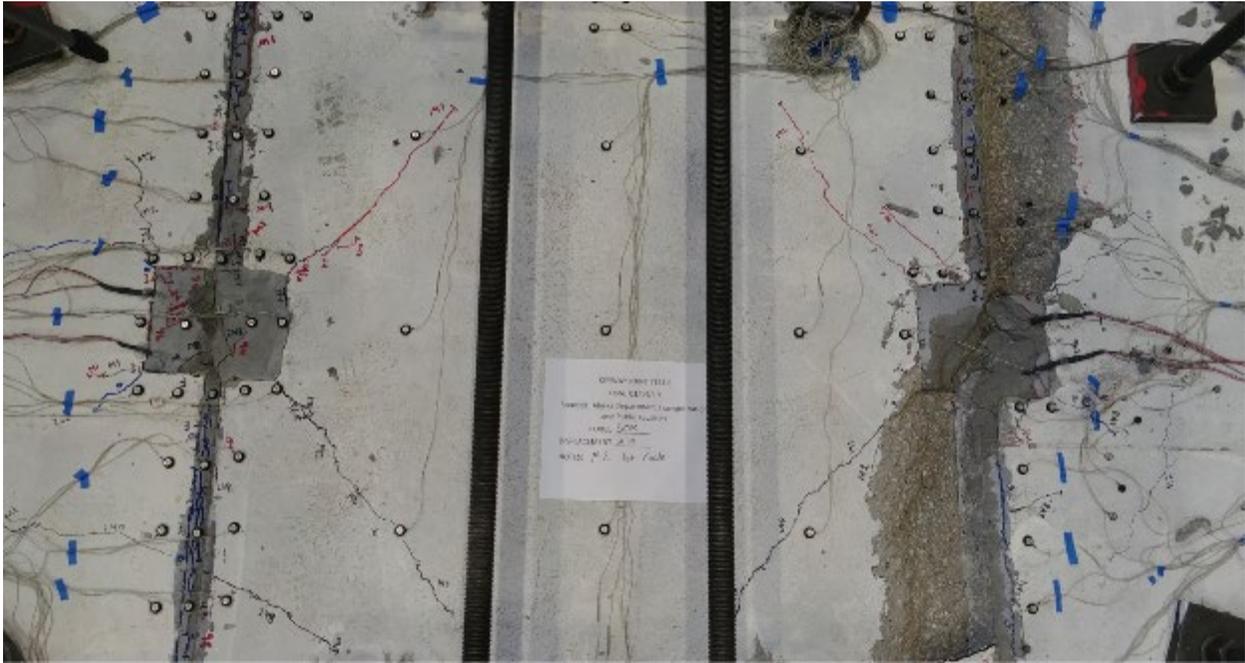
Figure 6.32: Test 8 Grouted Shear Key Δ_{c2} –First Cycle

During the first push cycle of Δ_{c2} , the cover concrete surrounding the right joint spalled off from the previously mentioned cracks as seen in Figure 6.32. New cracks associated with cover concrete spalling formed around the right pocket in the side block. The displacement at the center of the specimen was 0.203 inches with a rigid body rotation of -0.018° and a force of -63 kips. The following pull cycle exposed the right pocket shear connector. The displacement at the center of the specimen was -0.197 inches with a rigid body rotation of -0.138° and a force of -73 kips. During the second push cycle, the embedded rebar became visible (Figure 6.33). No rebar bending was visible. The displacement at the center of the specimen was 0.220 inches with a rigid body rotation of -0.059° and a force of 43 kips. During the subsequent pull cycle, one of the embedded rebar welded to the right shear connector embedded in the side block fractured. The fracture is visible in Figure 6.34. Also visible is the damage to the $\frac{1}{4}$ in. x 3 in. x 4 in. welded shear tab, which shows a shear fracture in the plate. The displacement at the center of the specimen was -0.191 inches with a rigid body rotation of -0.151° and a force of -49 kips. Upon the next push cycle, the other exposed rebar in the right side block fractured (Figure 6.35). The displacement at the center of the specimen was 0.246 inches with a rigid body rotation of 0.115° and a force of 28 kips. On the last pull cycle of Δ_{c2} , cover concrete began to spall from the left joint as seen in Figure 6.36.

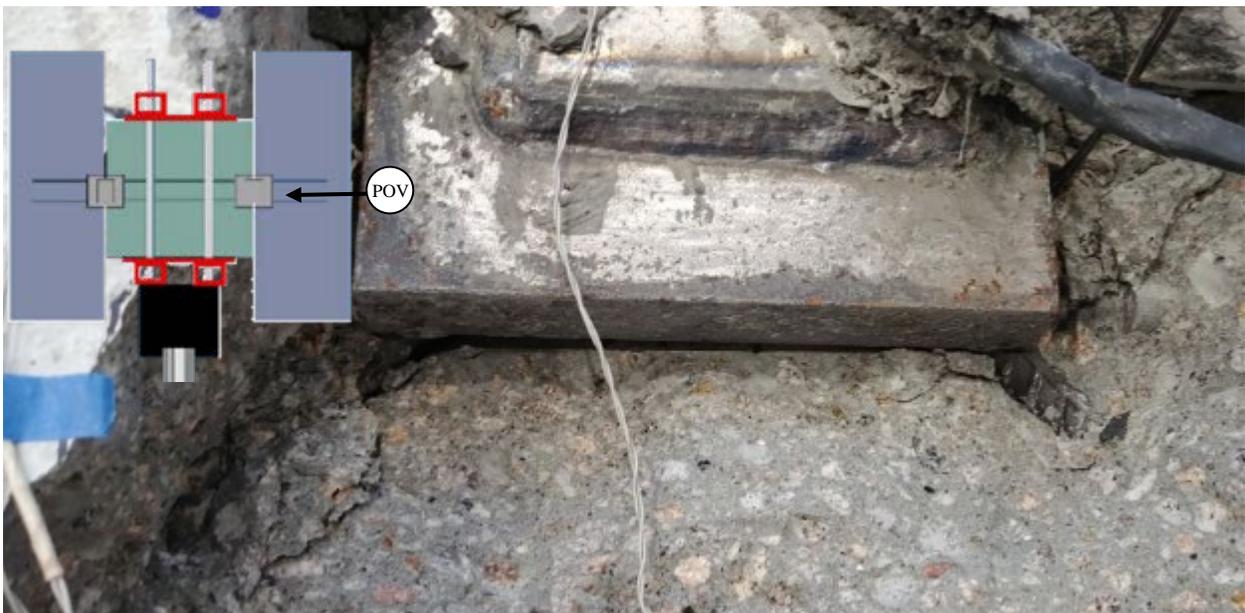
Figure 6.33: Test 8 Right Shear Connector Δ_{c2} –Second Cycle

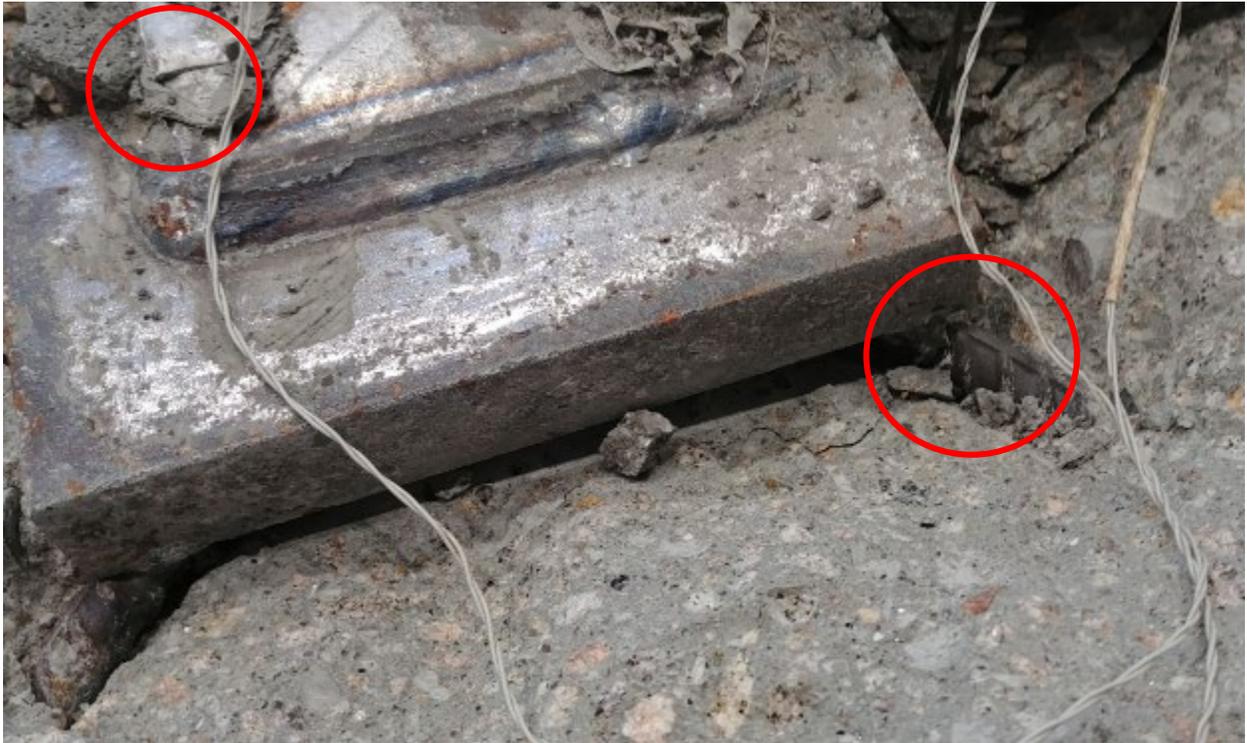
Figure 6.34: Test 8 Damage to the Right Shear Connector $-\Delta_{c2}$ –Second Cycle

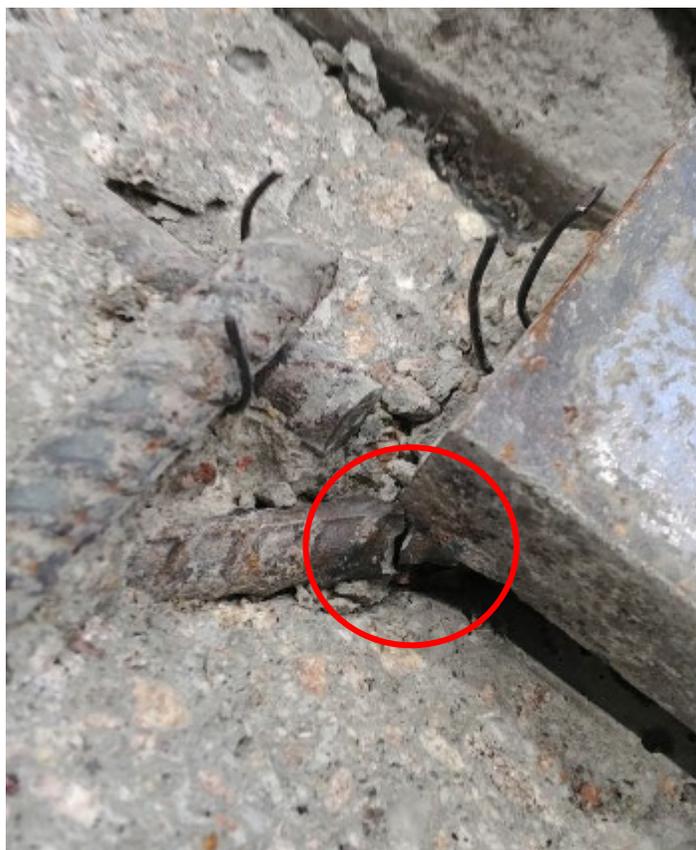
Figure 6.35: Test 8 Damage to Right Shear Connector Δ_{c3} –Third Cycle

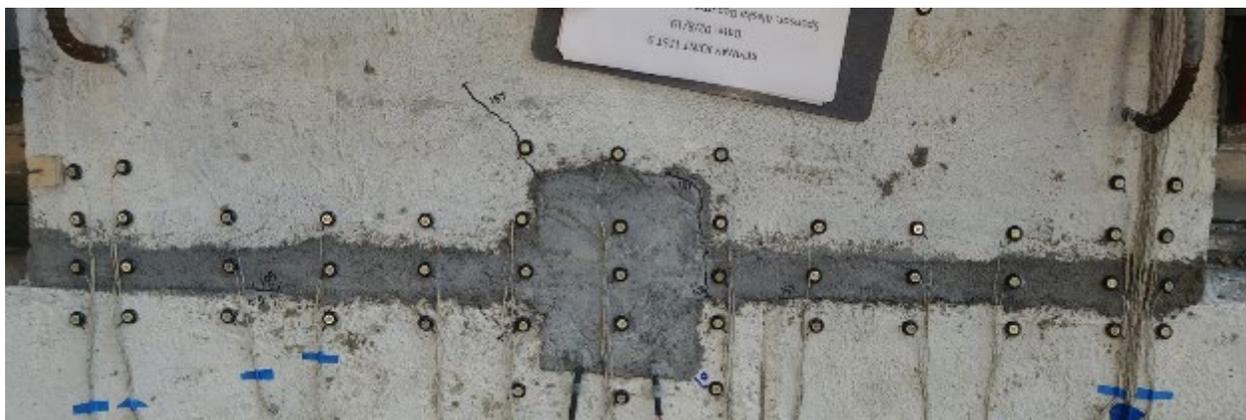
Figure 6.47: Test 9 Right Side of Grouted Shear Key with Applied Load = 156 kips
