Transverse Seismic Design of Bridges with Longitudinal Keyway Joints

Prepared by:
Christopher W. Price, Ph.D. Candidate
Mervyn J. Kowalsky, Professor, Ph.D.
James M. Nau, Professor, Ph.D.
Rudolf Seracino, Professor, Ph.D.

24 May 2019

Prepared for:
Alaska Department of Transportation & Public Facilities
Statewide Research Office
3132 Channel Drive
Juneau, AK 99801-7898

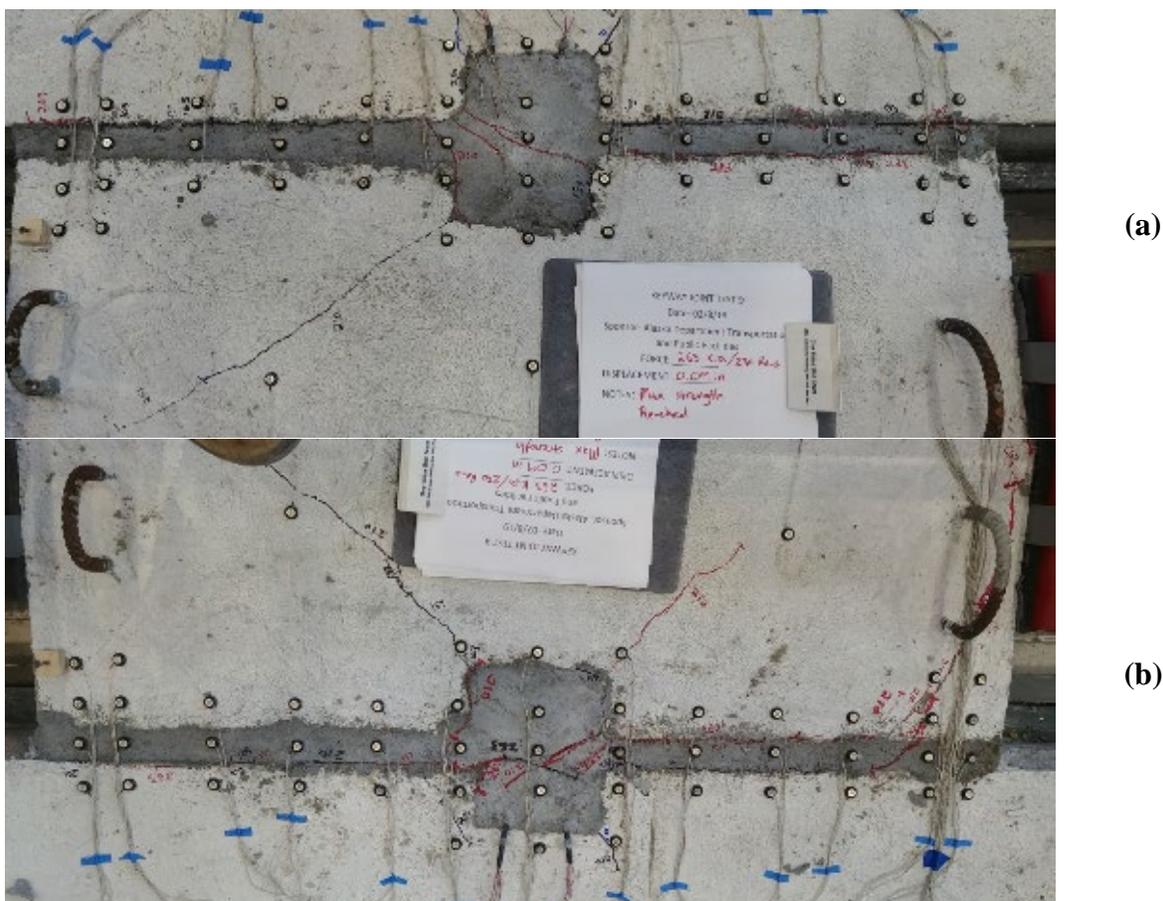
Figure 6.50: Grouted Shear Key – Significant Strength Loss (a) Left Side (b) Right Side

Force was applied cyclically in single cycle sets, at increments of 53 kips ($q_{\text{average}} = 0.5 \text{ k/in}$). Prior to loading, cracking was present in the corner of both side blocks as seen in Figure 6.46. Minor damage occurred during the first two increments of loading, which comprised of minor cracks along the joint at the grout concrete interface. The first crack in the specimen occurred at a load of 156 kips ($q_{\text{average}} = 1.6 \text{ k/in}$), displacement at the center of the specimen was 0.018 inches with a rigid body rotation of 0.001° . The crack propagated from the right shear pocket corner towards the direction of loading (Figure 6.47). A crack also formed around the perimeter of the right pocket. No damage was observed in the subsequent pull cycle. Upon the next increment of loading, diagonal cracking became more prevalent. The right pocket's existing diagonal crack grew in length, while the left pocket acquired a similar diagonal crack. The right pocket also attained two new diagonal cracks inside the side block. The load was 208 kips ($q_{\text{average}} = 2.2 \text{ k/in}$) with a displacement at the center of the specimen of 0.028 inches and a rigid body rotation of 0.003° . The succeeding pull had a force of -206 kips ($q_{\text{average}} = 2.2 \text{ k/in}$) with a displacement of -0.040 inches at the center of the specimen and a rigid body rotation of 0.022° . This created the first diagonal cracks associated with the pull direction, which formed in the specimen at the corner of the right shear pocket and right joint near the loading plate. More significantly was the formation of diagonal crack through the right shear pocket. Additional cracking occurred in both shear pockets, cutting across the joint and going around the perimeter of the pocket interface. Damage is visible in Figure 6.48. Another diagonal crack appeared in grout of the right shear pocket under the load of 260 kips (Figure 6.49). The displacement was 0.049 inches at the center of the specimen and a rigid body rotation of 0.005° . During the following reversal, the specimen achieved -238 kips before the strength began to reduce. The maximum recorded load over the expected maximum load ratio was equal to 1.2. The center of the specimen reached a displacement of -0.110 inches with a rigid body rotation of -0.044° . Cracking ran down the entire length of both joints, starting on the specimen side closet to the load and crossing the joint through diagonal cracks in the pockets to reach the side block. Damage can be seen in Figure 6.50.

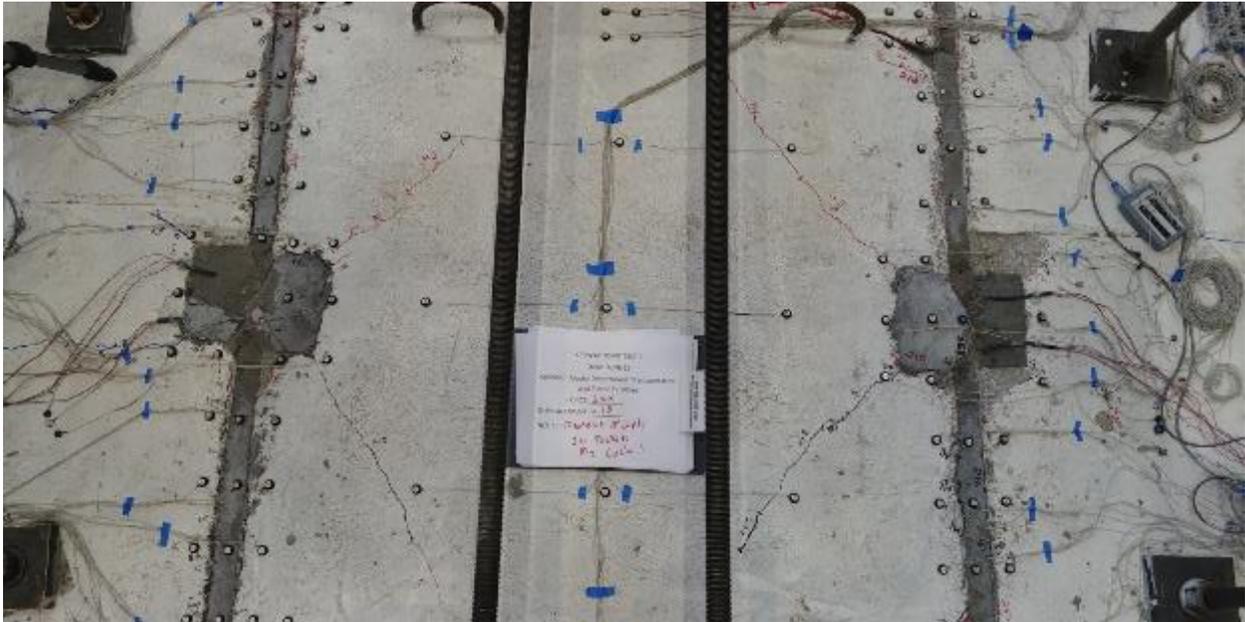
Figure 6.52: Grouted Shear Key at $-\Delta c_2$ – First Cycle

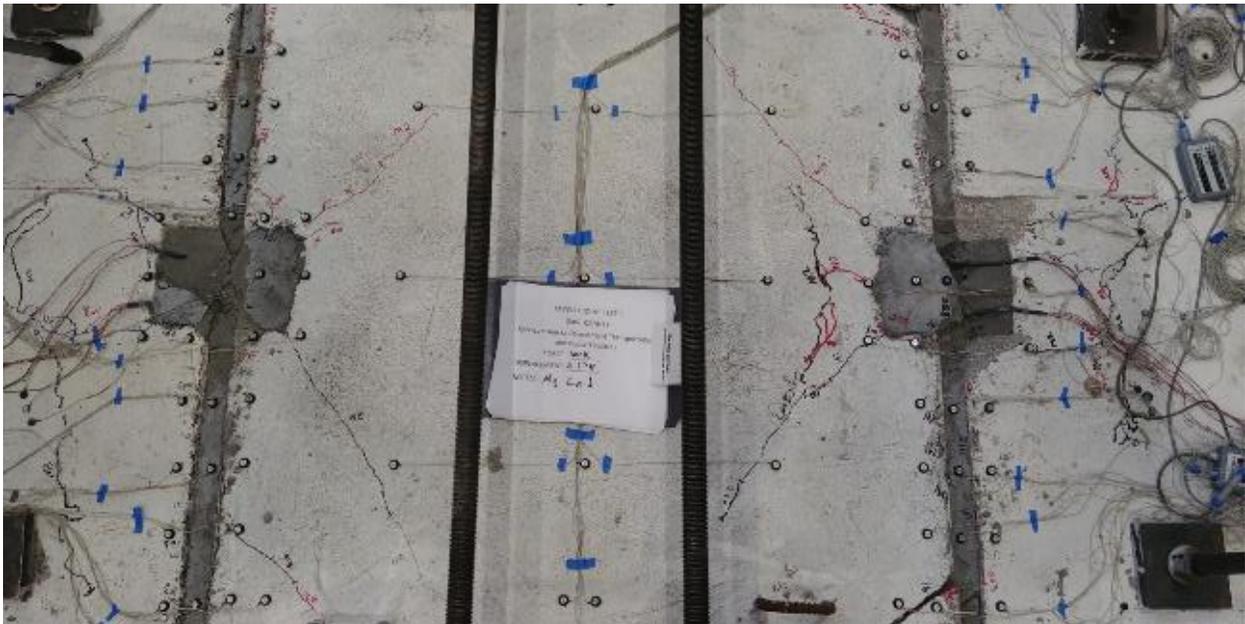
Figure 6.54: Grouted Shear Key at Δ_{c3} –First Cycle

Upon the first push cycle of Δ_{c3} , significant cracking associated with cover concrete uplift began to occur in the left side block (Figure 6.54). The displacement was 0.274 inches at the center of the specimen with a rigid body rotation of -0.048° and a force of 99 kips. More cracking associated with cover concrete uplift occurred during the second push cycle of Δ_{c3} . Cracking ensued in the specimen along the left side as seen in Figure 6.55. Upon the following pull cycle, rebar fracture occurred causing the cover concrete on the right side block to debond and be removed (Figure 6.56). This exposed the right shear connector insert as seen in Figure 6.57. The embedded shear connector shows little sign of movement or damage. It was not clear which rebar fractured but was later confirmed as the embedded bar in the right side block farthest from the actuator ram. Additionally, minor shear fracture of the welded shear tab connecting the embedded shear connectors was noted. The displacement of the center of the specimen was -0.284 inches at the center of the specimen with a rigid body rotation of -0.137° and a force of -43 kips.

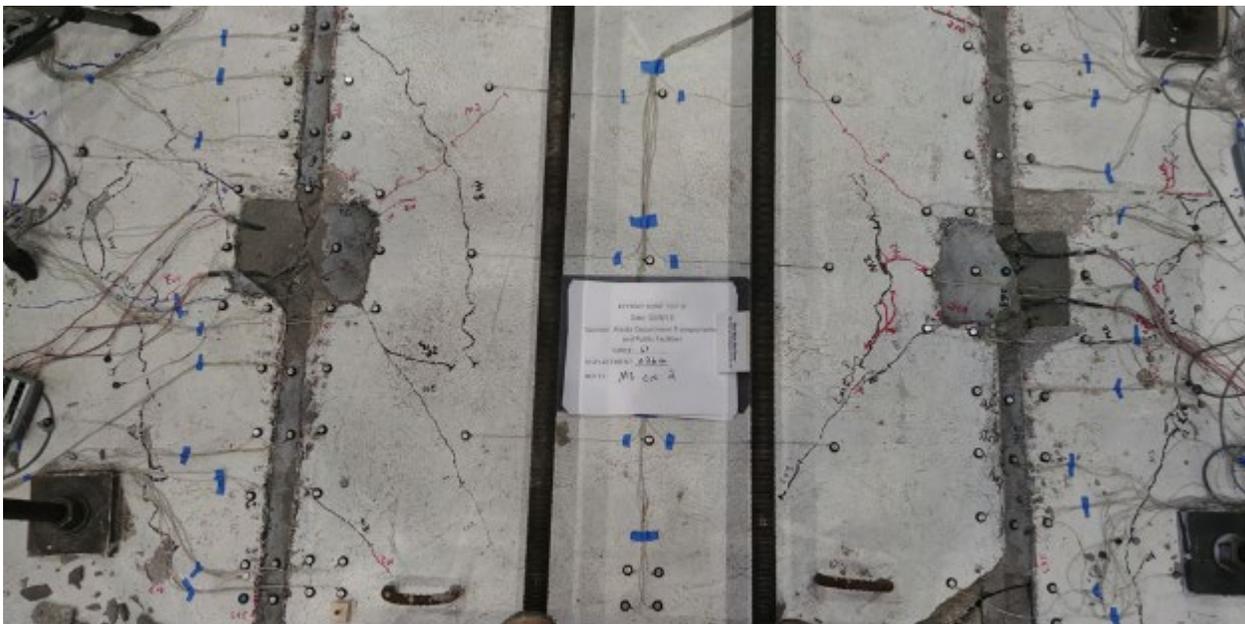
Figure 6.55: Grouted Shear Key at Δ_{c3} –Second Cycle

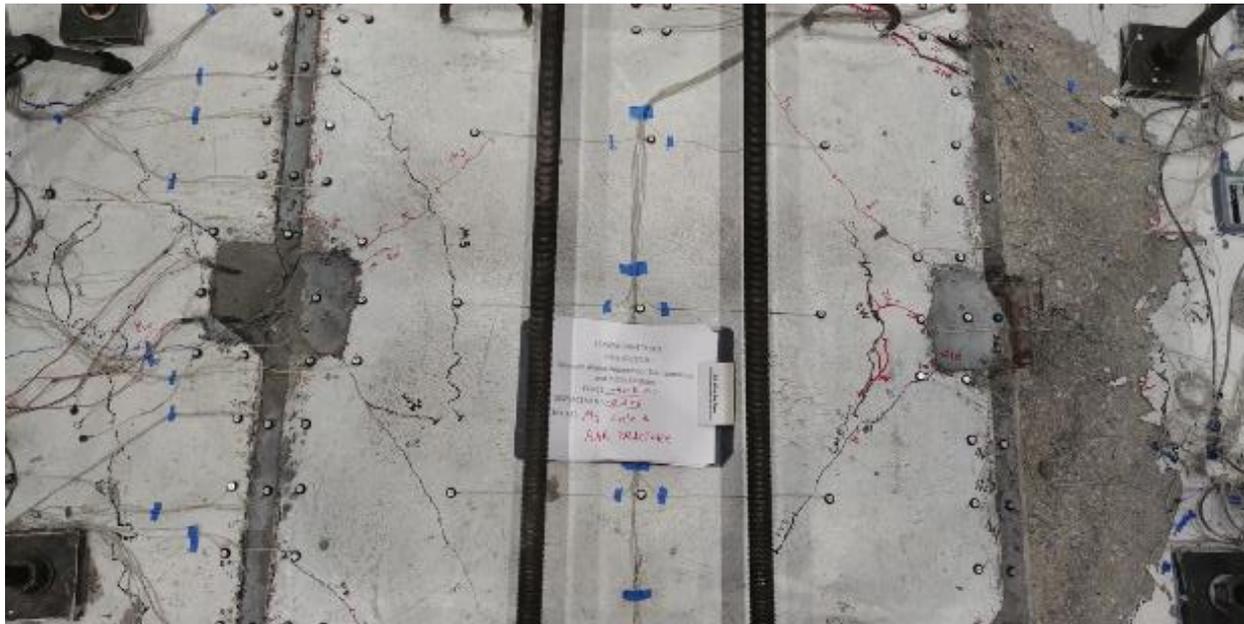
Figure 6.56: Grouted Shear Key at $-\Delta_{c3}$ –Second Cycle

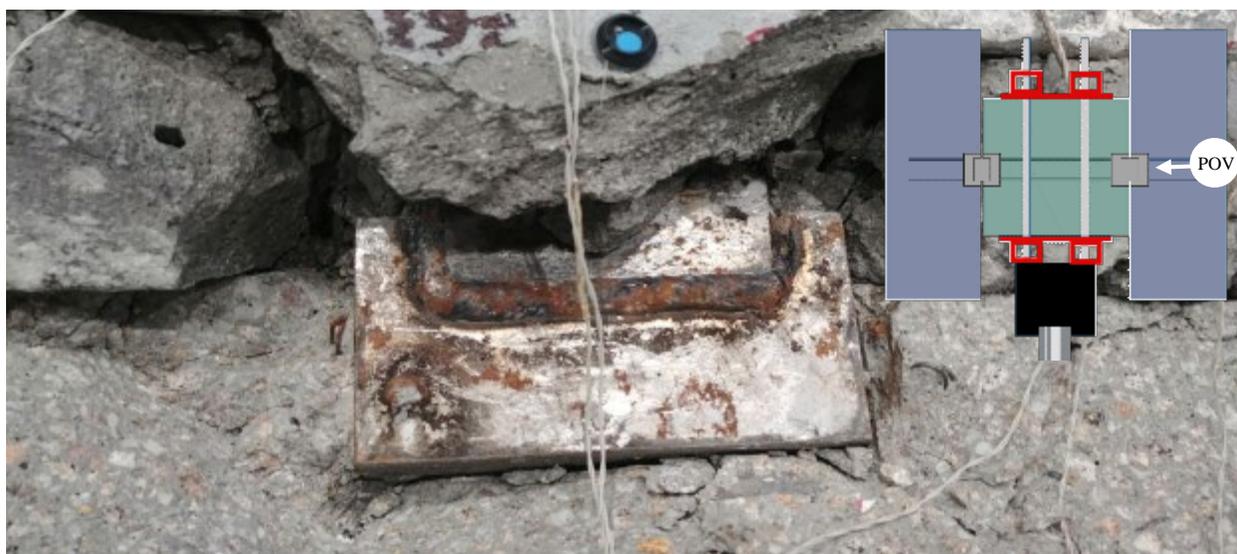
Figure 6.57: Right Side Shear Connector Insert at $-\Delta_{c3}$ - Third Cycle

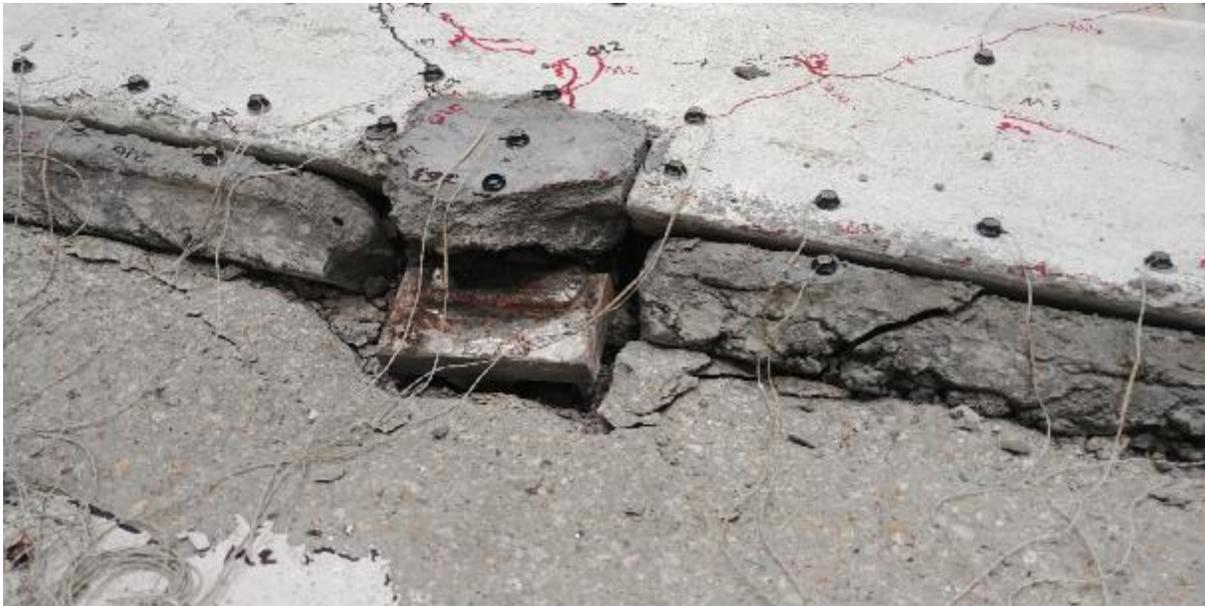
Figure 6.59: Right Side of Grouted Shear Key at $-\Delta_{c4}$ - First Cycle

During the subsequent push cycle, a second shear connector rebar fractured. It was not clear which bar fractured but was later confirmed as the shear connector rebar farthest from the actuator ram embedded in the right side of the specimen. The displacement of the center of the specimen was 0.271 inches with a rigid body rotation of -0.010° and a force of 50 kips. Little additional damage accumulated during the final cycle of Δ_{c3} as seen in Figure 6.58. During Δ_{c4} the right shear connector began to rotate and pry up the cover concrete on the right side of the specimen as seen in Figure 6.59. The displacement of the center of the specimen was -0.359 inches with a rigid body rotation of -0.613° and a force of -26 kips. Upon the third cycle, the specimen's right joint cover concrete could be removed, exposing the entire shear connector (Figure 6.60). The displacement of the center of the specimen was 0.362 inches with a rigid body rotation of 0.529° and a force of 24 kips. The test was terminated after the third cycle of Δ_{c4} due to large rotations. The final state of the specimen can be seen in Figure 6.61. The shear connector plates were removed from the specimen to reveal the welds as seen in Figure 6.62. All of the welds remained undamaged. A slight tear was visible in the left shear tab.

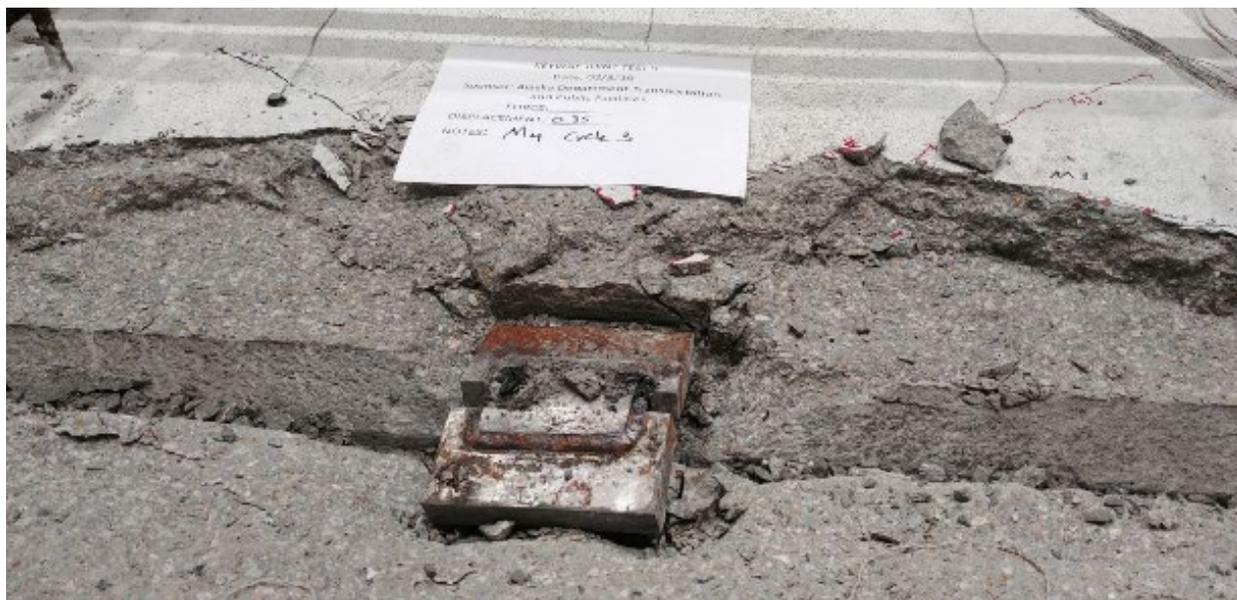
Figure 6.60: Right Side of Grouted Shear Key at $-\Delta_{c4}$ - Third Cycle

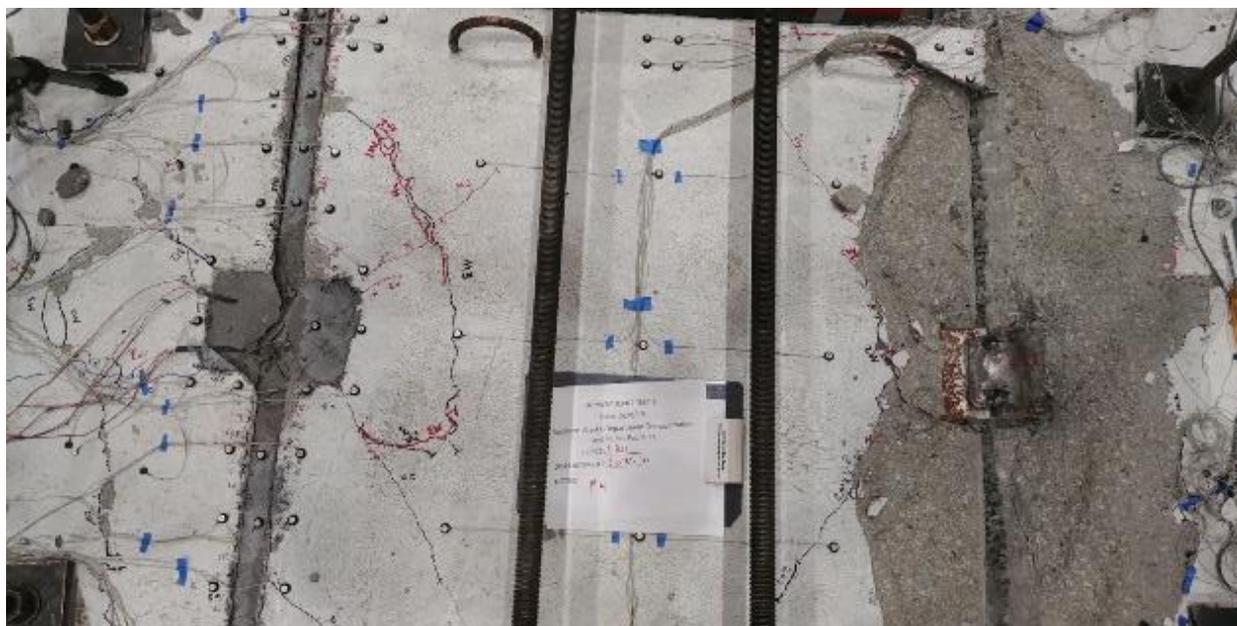
Figure 6.61: Grouted Shear Key at $-\Delta_{c4}$ - Third Cycle

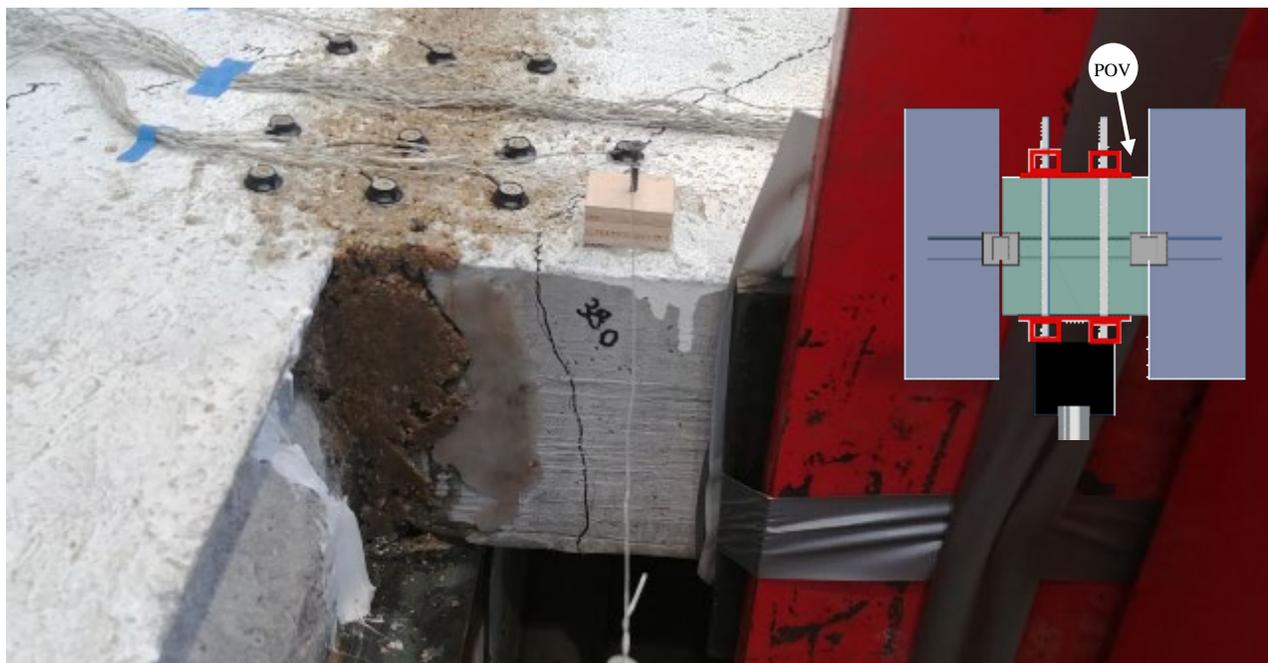
Figure 6.74: Test 10 Damage to the Right Grouted Shear Key with Applied Load = 391 kips

Upon the next increment of loading, the maximum force capacity of 417 kips was reached. The specimen displacement was increasing, yet the force remained constant. A diagonal crack formed on the left side of the specimen but most of the damage was focused on the right joint between the shear pocket and the loading plate farthest from the actuator. A crack ran down that portion of the joint at the grout-concrete interface. The damage can be seen in Figure 6.75. When the specimen reached maximum strength, the center displacement was 0.073 inches with a rigid body rotation of 0.041° , but ended at 0.107 inches of displacement and 0.080° of rigid body rotation. It should be noted that during this cycle, the side blocks began to slip significantly with 0.033 inches in the right side block and 0.035 inches in the left side block. During the test, the slip was not noted and thus the displacement at maximum strength was estimated at 0.100 inches and was used to define the displacement of significant strength loss of the joint, Δ_{c1} . The actuator was then switched to displacement control. Demand was applied in three cycle sets at increments proportional to Δ_{c1} . Due to the unpredictability of controlling the actuator displacement, the rate of loading was reduced and the displacement of the center of the specimen was monitored manually to conclude the loading for each cycle, which did not account for slip of the side blocks.

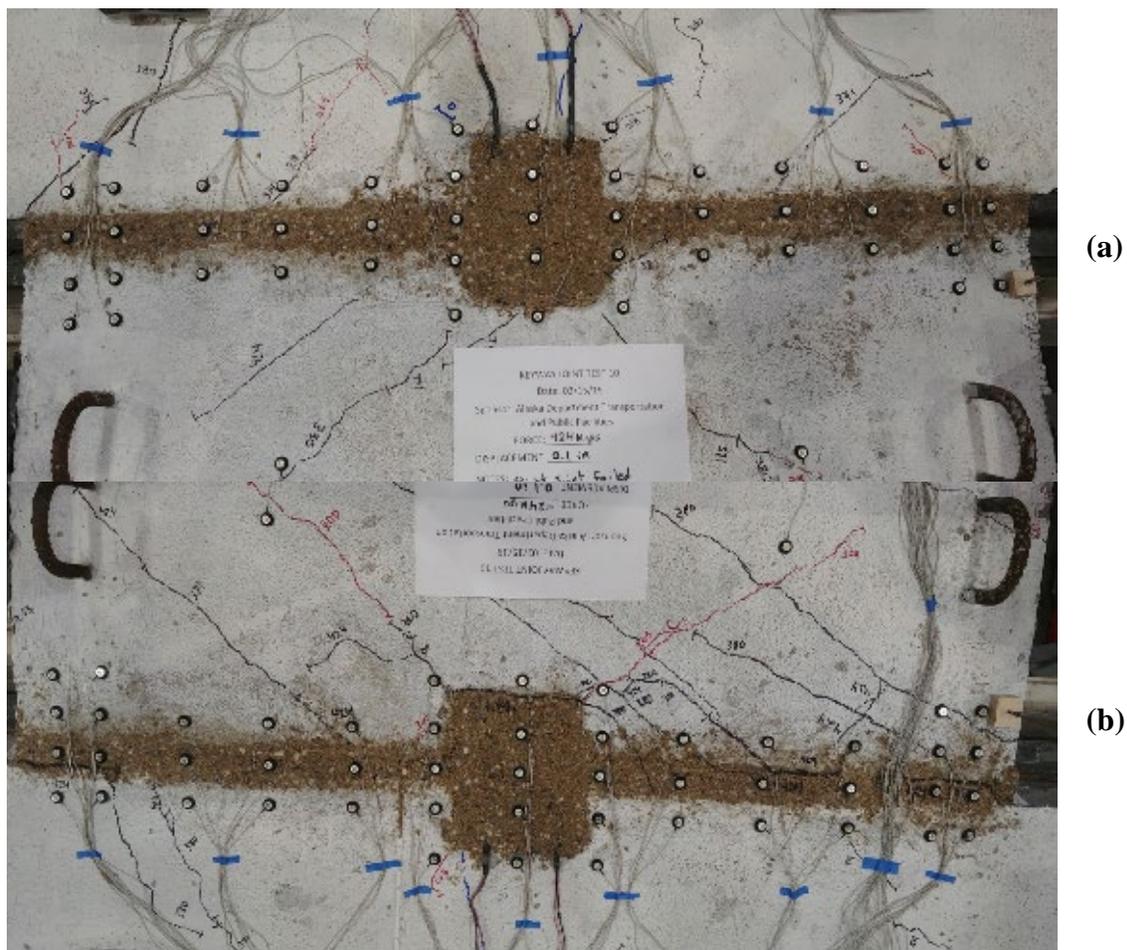
Figure 6.75: Test 10 Grouted Shear Key – Significant Strength Loss (a) Left Side (b) Right Side

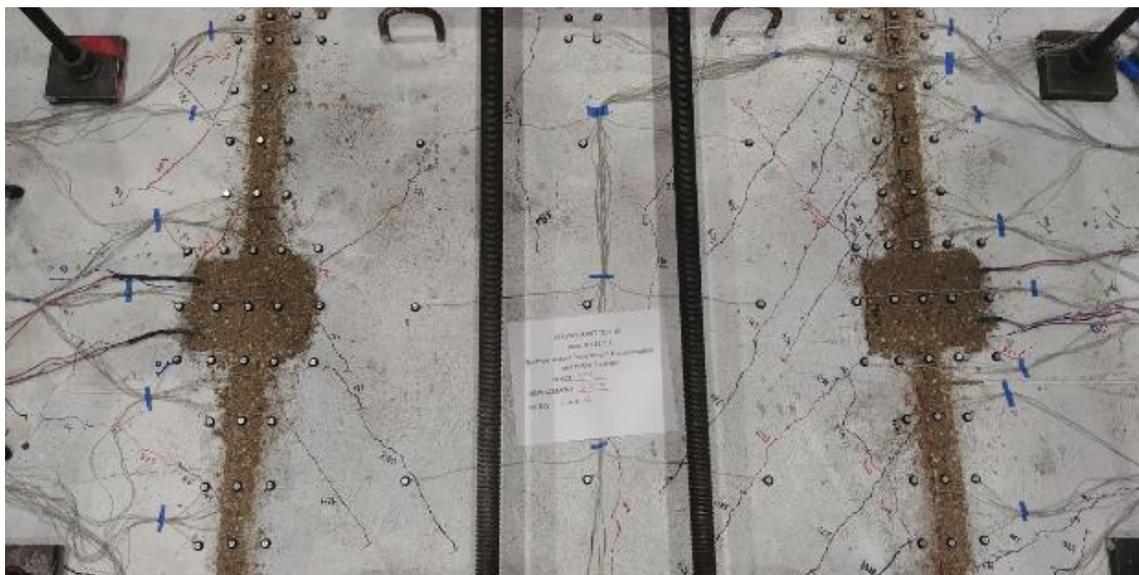
Figure 6.77: Test 10 Right Side of Grouted Shear Key at $-\Delta_{c1}$ – Second Cycle

Since the strength of the pull cycles still exceeded the capacity of the actuator, the specimen was loaded to a force of 299 kips in the pull direction. During the first cycle, the remainder of the right joint cracked down the interface between the grout and the concrete with some slight diagonal cracking joining existing cracks (Figure 6.76). The specimen displacement was -0.026 inches with a rigid body rotation of -0.014° . The load dropped in the second push cycle of Δ_{c1} (+0.100 inches) to 307 kips at a displacement of 0.077 inches with little damage accumulation. During the second pull cycle of Δ_{c1} (-299 kips), cracking accumulated in the left side block typical of cover concrete pry up as seen in Figure 6.77. The specimen had a displacement of -0.032 inches and a rigid body rotation of 0.025° . The remaining Δ_{c1} cycle had similar loads and displacement as the previous cycle with no major damage. Minor damage accumulated Δ_{c2} (+0.200 inches/-299 kip), though it should be noted that slip in the side blocks became more predominate on the left side. During the first push cycle, slip in the left side block was 0.063 inches, while the slip in the right side block was 0.035 inches. At this point the displacement at the center of the specimen, after adjusting for slip, was 0.156 inches with a recorded load of 392 kips and a rigid body rotation of 0.094° . Damage from the three cycle set is shown in Figure 6.78 and Figure 6.79. Where Figure 6.79 shows another crack along the right joint develop through the entire depth of the specimen panel.

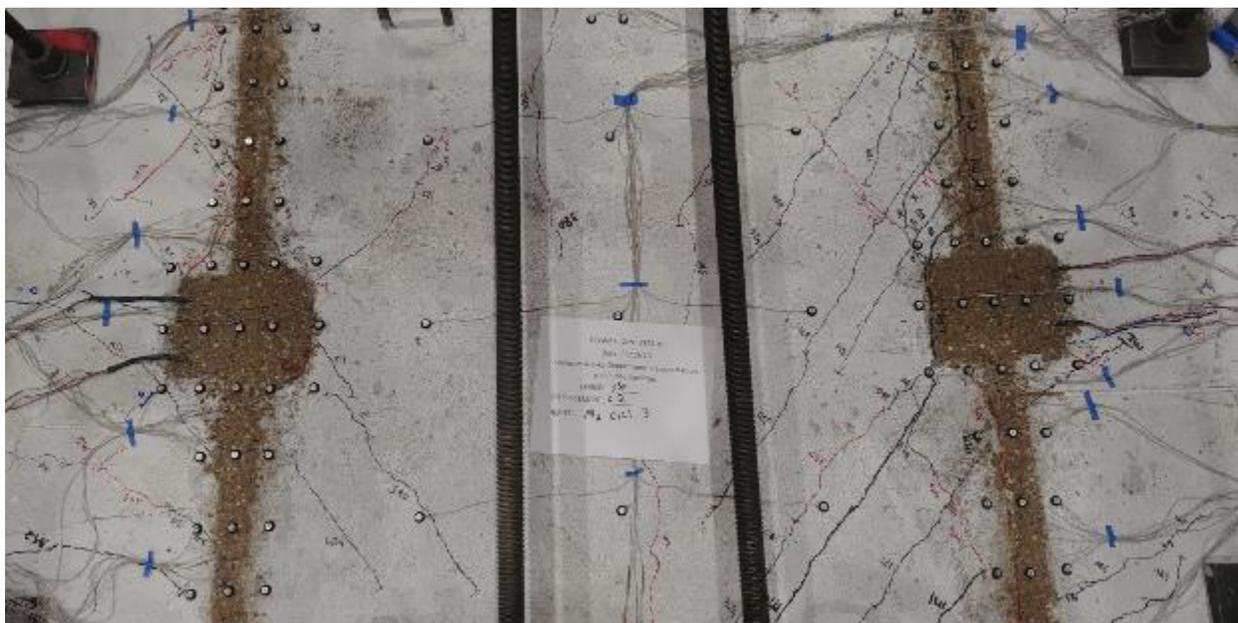
Figure 6.78: Test 10 Grouted Shear Key at Δ_{c2} – Third Cycle

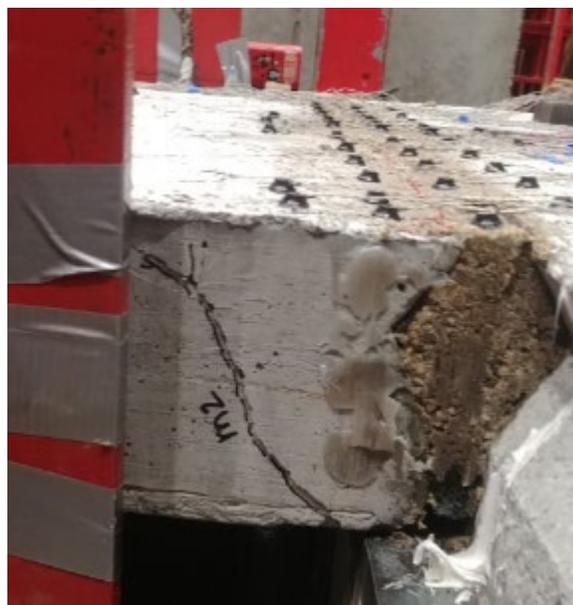
Figure 6.79: Test 10 Damage to the Right Grouted Shear Key at Δ_{c2} – Third Cycle

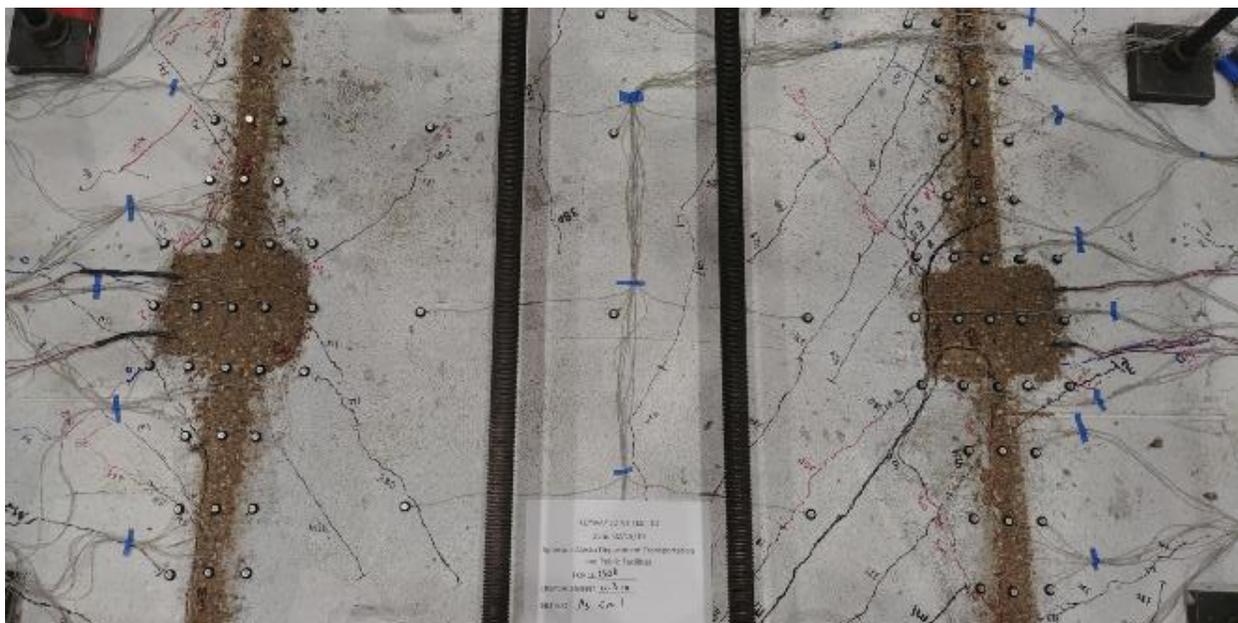
Figure 6.80: Test 10 Grouted Shear Key at Δ_{c3} – First Cycle

No new damage occurred during the first push cycle of Δ_{c3} (Figure 6.80). The displacement of the specimen was 0.258 inches with a rigid body rotation of 0.110° and a force of 300 kips. The next pull cycle led to significant damage and a significant decrease in strength. The specimen reached 288 kips before the force started to decrease. The center of specimen displacement was -0.142 inches with a rigid body rotation of -0.114° . At the end of the cycle, the force had decreased to -67 kips at a displacement of -0.690 inches with a rigid body rotation of 0.058° . Damage was focused predominantly around the left joint with cover concrete spalling off of the left side block around the shear pocket and exposing an embedded rebar. The right joint had a crack going through the shear pocket, connecting the cracks between the concrete grout interfaces on either side. Additionally there was minor cover concrete spalling in the specimen near the pocket. The damage is visible in Figure 6.81. With the pull cycle no longer exceeding the actuator capacity, the pull cycles were controlled in displacements at increments of Δ_c . The following pull cycle led to more cover concrete spalling in the left side block as seen in Figure 6.82. The center of the specimen reached a displacement of 0.341 inches with a rigid body rotation of 0.001° and a force of -27 kips. The final pull cycle of Δ_{c3} initiated spalling cover concrete along the right joint of the specimen (Figure 6.83). The center of the specimen reached a displacement of -0.341 inches with a rigid body rotation of -0.023° and a force of -27 kips.

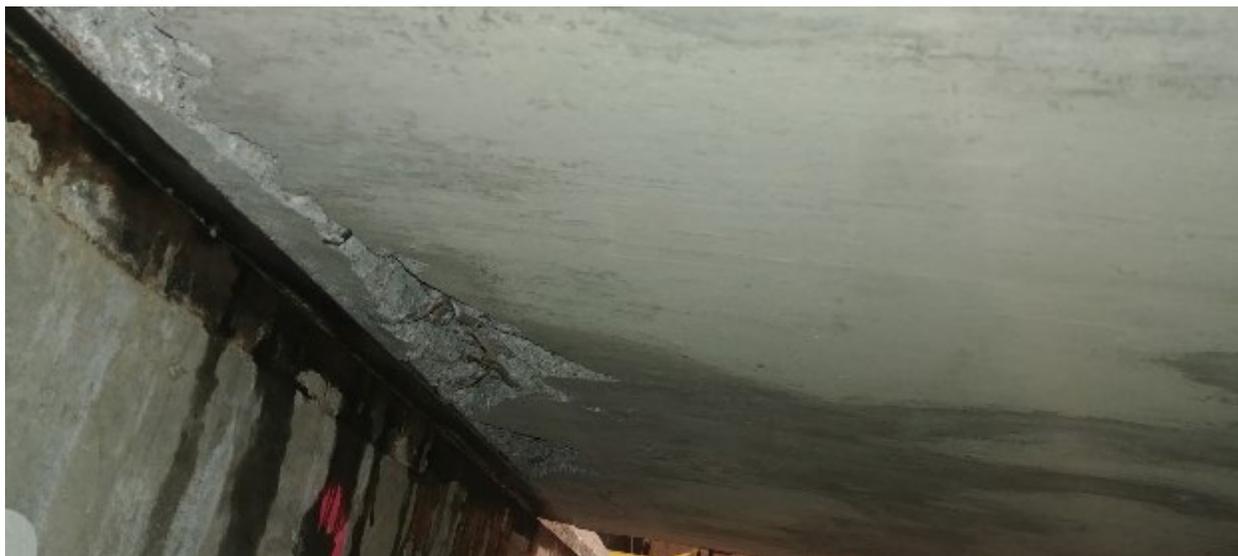
Figure 6.85: Test 10 Damage to Right Side of Grouted Keyway from Underneath

The increment was then increased to Δc_4 (± 0.400 inches), but no additional damage accumulated (Figure 6.84) during the three cycle set and little residual strength remained in the specimen, thus the test was terminated. The final push cycle had displacement at the center of the specimen of 0.373 inches with a rigid body rotation of -0.262° and a force of 26 kips. The final pull cycle had displacement at the center of the specimen of -0.444 inches with a rigid body rotation of -0.195° and a force of -17 kips. During the disassembling process, after the loading plates were removed, cracking and spalling of concrete was observed under the specimen (Figure 6.85). Therefore the specimen concrete failed rather than the grout concrete interface.

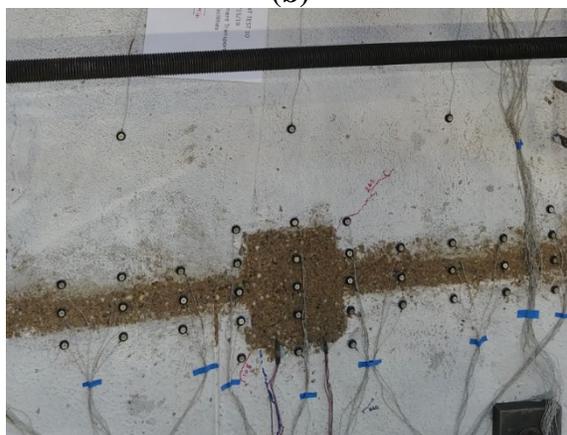
Figure 6.91 Diagonal Cracking (a) Test 7 (b) Test 8 (c) Test 9 (d) Test 10

The progression of damage for each test in Phase II can be seen in Figure 6.90 through Figure 6.94. The force and displacement at which each damage state occurred for the tests in Phase II can be found in Table 6.1. Damage states that did not occur in the test as well as values that are not known are left blank.
