Durability of the Grouted Shear Stud Connection at Low Temperatures

FINAL REPORT

Alaska Department of Transportation & Public Facilities

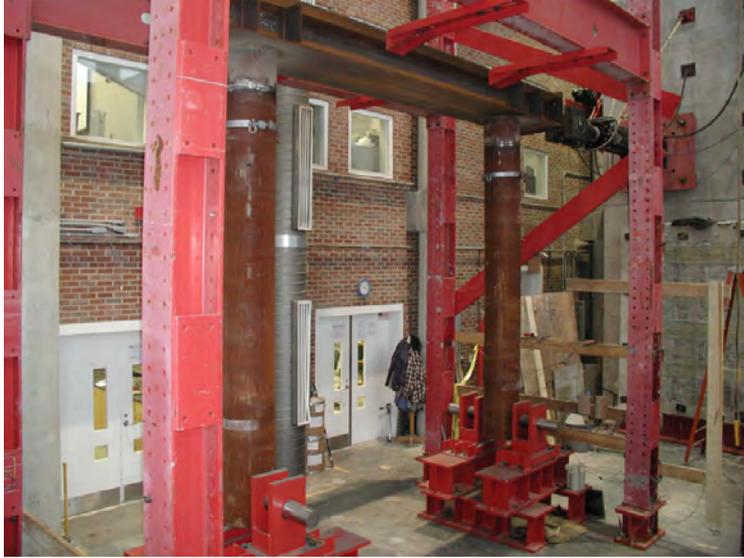
Figure 1.1: Test set up from Fulmer et al. [17, 18] to test directly welded connections.

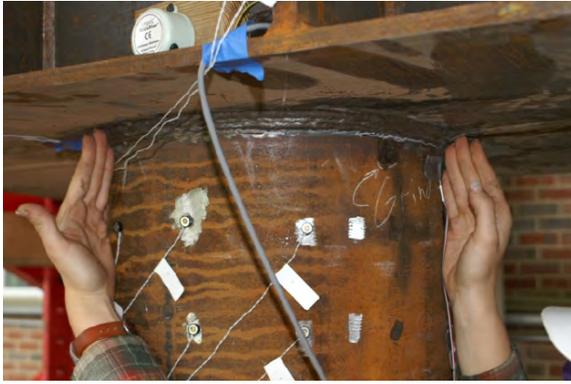
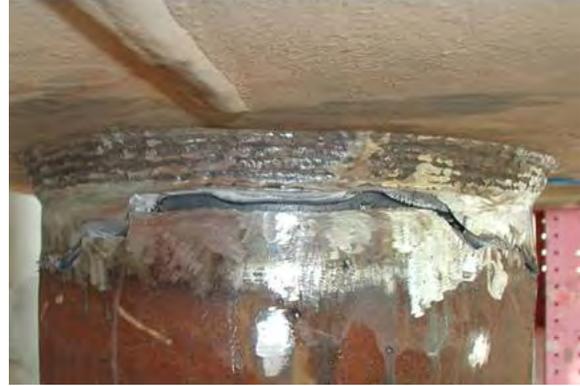
Figure 1.2: Brittle failure observed in [17, 18] on directly welded connections (a) Fillet weld (b) Complete Joint Penetration weld.

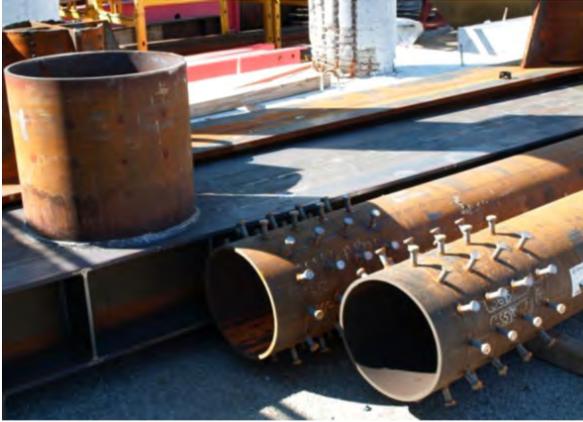
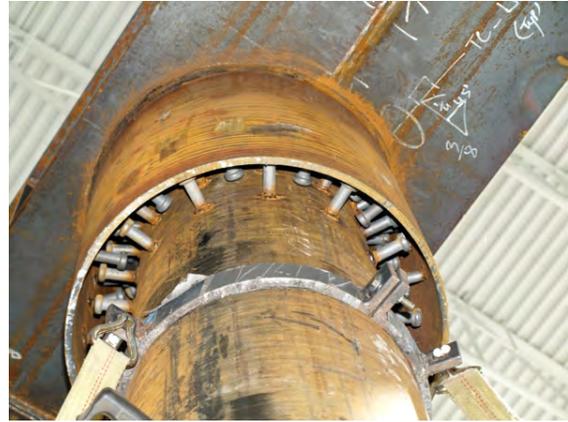
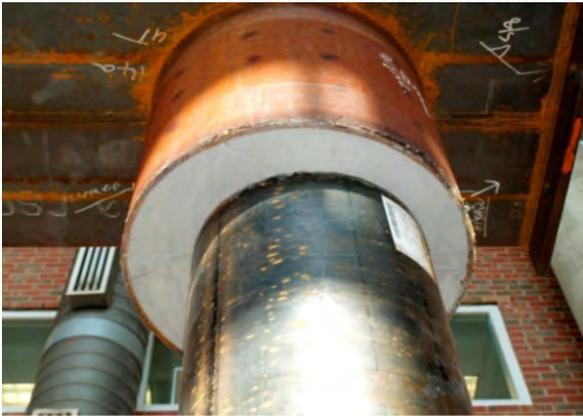
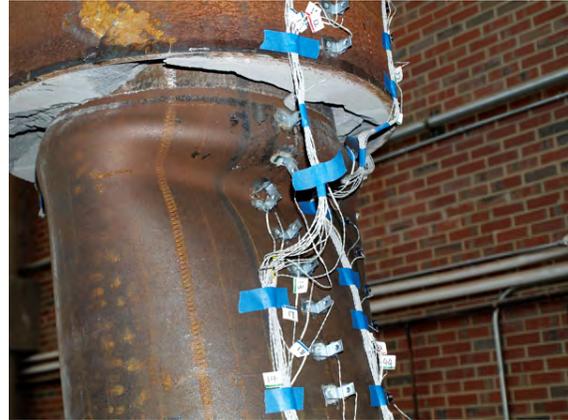
Figure 1.3: Stages of the GSS connection: (a) Constituent components, (b) Connection before grouting, (c) Connection after grouting, (d) Failure by plastic hinge relocation.

The GSS connection is an external socket type connection and consists of a prefabricated cap beam (double wide HP was used by Fulmer et al. [16]) to which a stub pipe section is welded, as shown in Figure 1.3a. The stub pipe, larger in diameter than the column, acts as a socket into which the column can be inserted. In Figure 1.3a, the cap beam is shown on the left, resting on its top surface. The inner wall of the stub pipe contained 12 vertical lines of $\frac{3}{4}$ inch diameter shear studs. Similarly, the top of each pile section had 12 lines of studs, as shown in Figure 1.3a.

In the field, shear studs are welded to the pile after driving and cutting it at the proper elevation. No field welding (other than installation of the shear studs) is required in the construction of the GSS connection. After inserting the pile in the stub (Figure 1.3b), the moment resisting connection is completed by pumping a high-strength, non-shrink flowable grout into the annular region (Figure 1.3c). Fulmer et al. [16] tested two-column steel bents that use the GSS connection detail by subjecting them to cyclic quasi-static lateral loading. These tests showed the proof of concept that the GSS connection can successfully protect

the welded region by relocating the plastic hinge formation to the steel column (Figure 1.3d) below the larger diameter pipe stub. The GSS connection also provided increased system displacement capacity when compared to the directly welded connections.

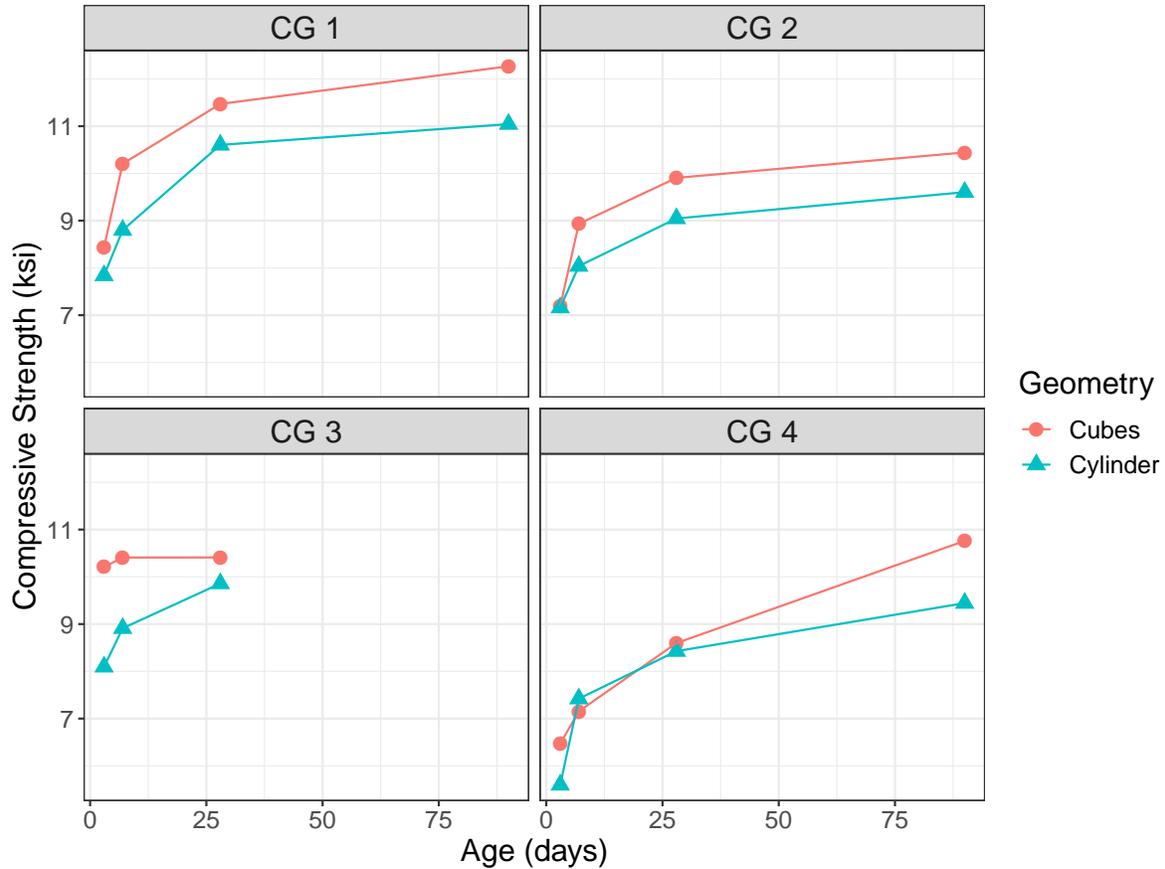
Figure 2.1: Comparison of cube strength and cylinder strength for all the tested grouts.

improper curing. Cubes of CG3 grout were not sealed after demolding due to misplacement. Drying ensued preventing further hydration. This halted strength gain. The authors would like to emphasize the importance of curing for strength test samples, especially for cubic specimens since they can lose significant amount of moisture rapidly. Data from other grouts, which were cured without moisture loss, show an increase in strength with age. The error bars indicate one standard deviation above and below the mean of the sample data. Compressive strengths of cubes are higher than those of cylinders, on average. This conforms to expectations as specimens with higher aspect ratios show lower strengths due to localization [27]. Cube and cylinder samples had an aspect ratio of 1 and 2 respectively. Both classifications of strength show the same pattern of increase with age, which indicates that measuring strength of grout cubes can be a valid alternative to measuring strength of grout cylinders, if all steps of testing are performed properly. CG1 and CG3 showed high strengths very early and kept increasing up to 90 and 28 days respectively. CG2 and CG4 had comparatively lower early age strength and a lower 90-day strength compared to

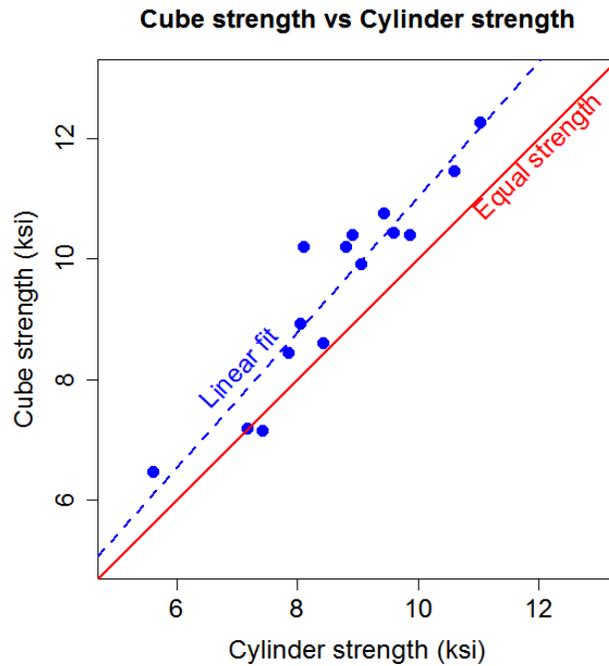
Figure 2.2: All average cube strengths versus average cylinder strengths.

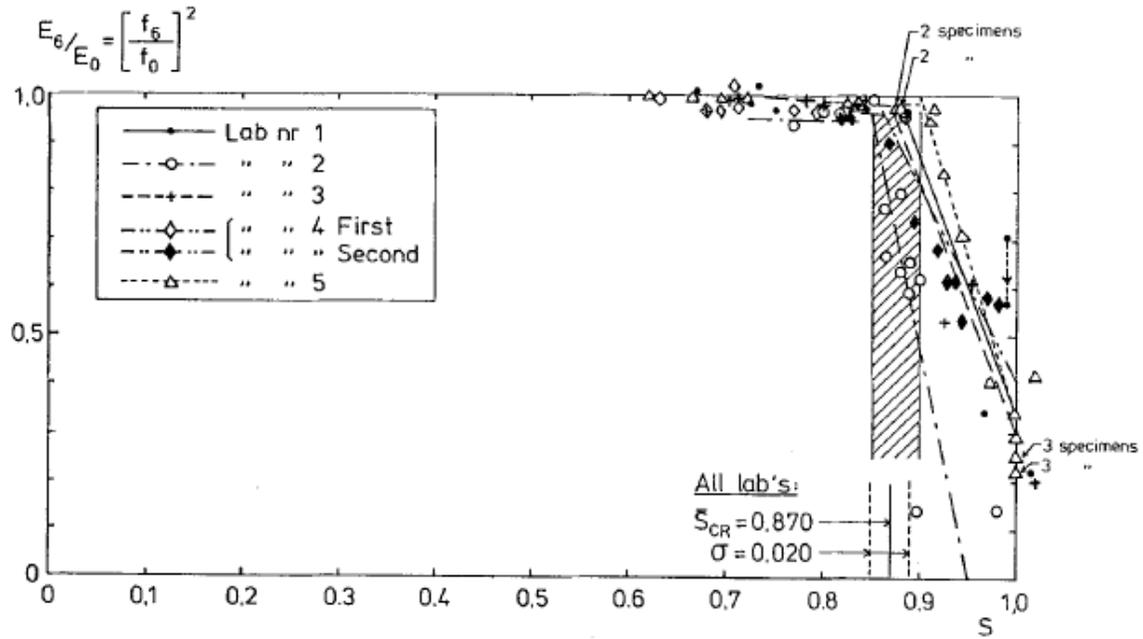
Figure 2.3: A sample plot showing dynamic elastic modulus vs degree of saturation for concrete specimens tested in five different laboratories [15].

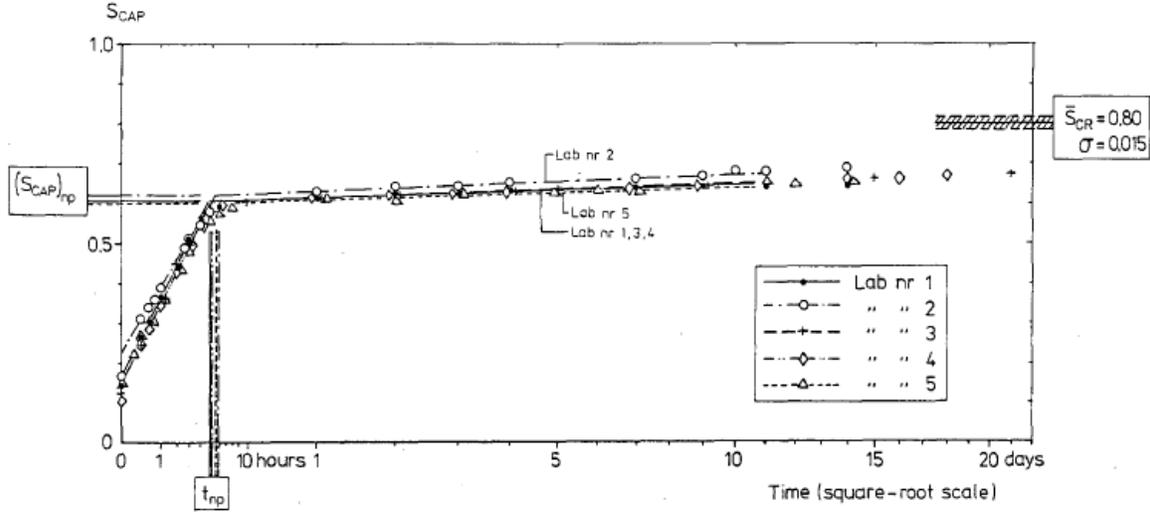
Figure 2.4: A sample plot showing mean values of capillary degree of saturation vs time of water uptake [15].

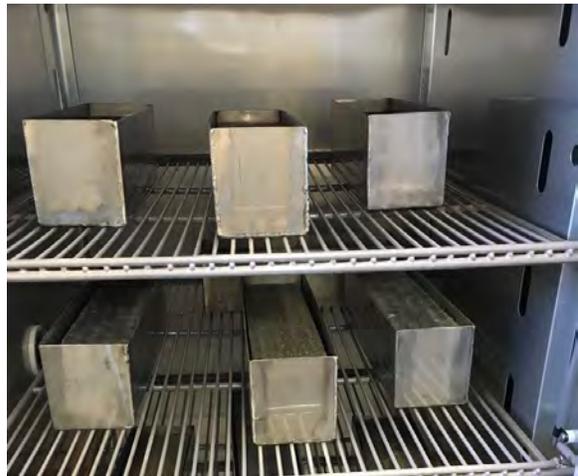
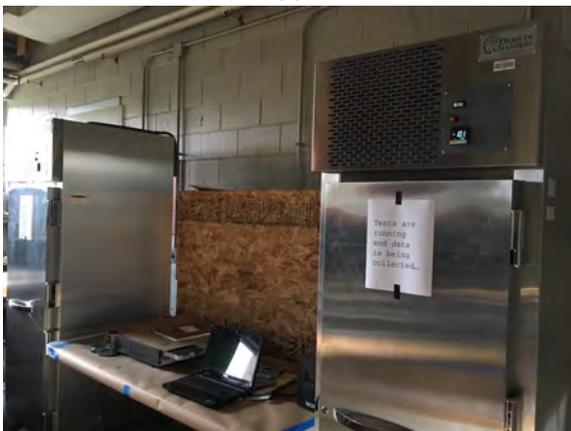
Figure 2.5: Photographs of various steps during the FT resistance testing procedure.

Four commonly available commercial grouts were tested according to ASTM C666. The specimens were 3" × 3" × 12" prismatic beams prepared in steel molds, as shown in Figures 2.5a and 2.5b. The specimens were cured under saturated lime water for 14 days after demolding. Identical specimens were required as controls to monitor the temperature inside the material during the testing because ASTM C666 specifies the control of the core temperature of the samples rather than the ambient temperature. Thermocouples were embedded within the control specimens (Figure 2.5c) for continuous acquisition of temperature data. A cycle period of 6 hours was used which enabled 4 cycles per day. The specimens were submerged in water throughout the testing and were kept in steel trays that were fabricated in-house meeting ASTM requirements. The specimens were subjected to FT cycles between 40 ± 3 °F (4 ± 2 °C) and 0 ± 3 °F (-18 ± 2 °C) in an environmental chamber (Figure 2.5d and Figure 2.5e) that was capable of being programmed with a pre-defined temperature cycle. A typical temperature cycle for the control specimens and the chamber air is shown in Fig 2.6.

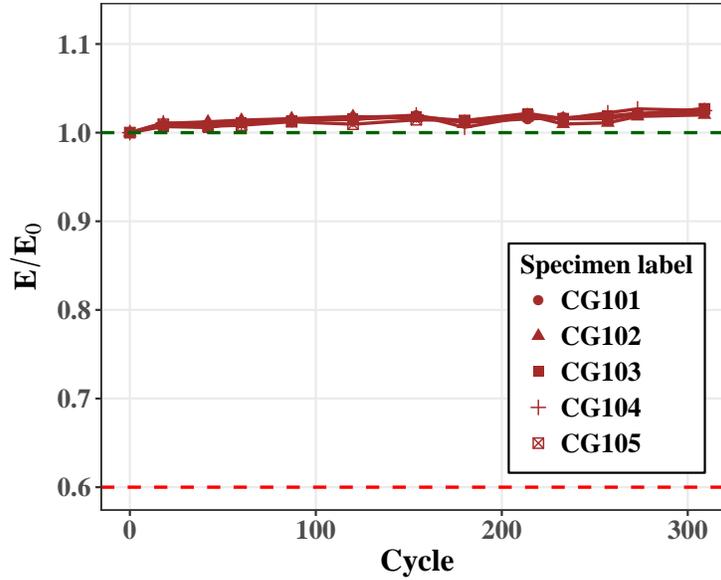
Figure 2.9: Results from ASTM C666 FT tests on multiple commercial grout (Good performance). Grout: CG1, Water per bag: 8.5 lbs.

CG2 and CG3 also showed similar resistance to freeze and thaw as that of CG1. Figures

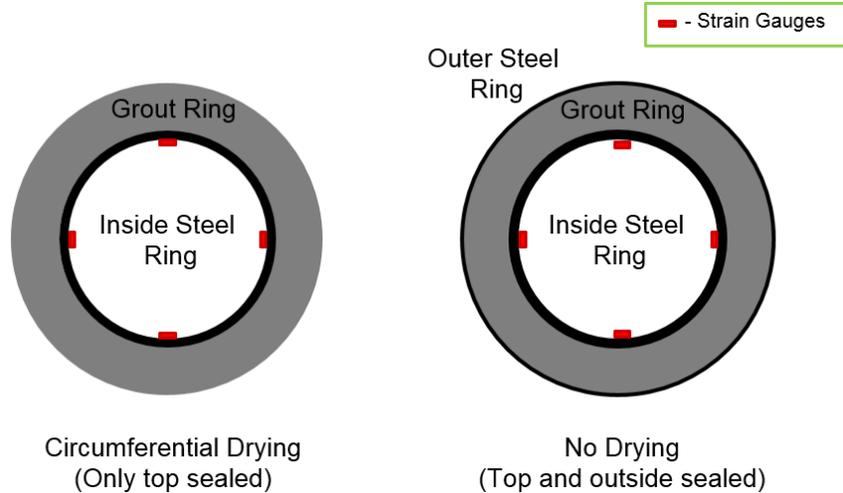
Figure 2.15: Restrained ring test specimen cross section schematic: Circumferential drying specimen (Left) and sealed specimen (Right).

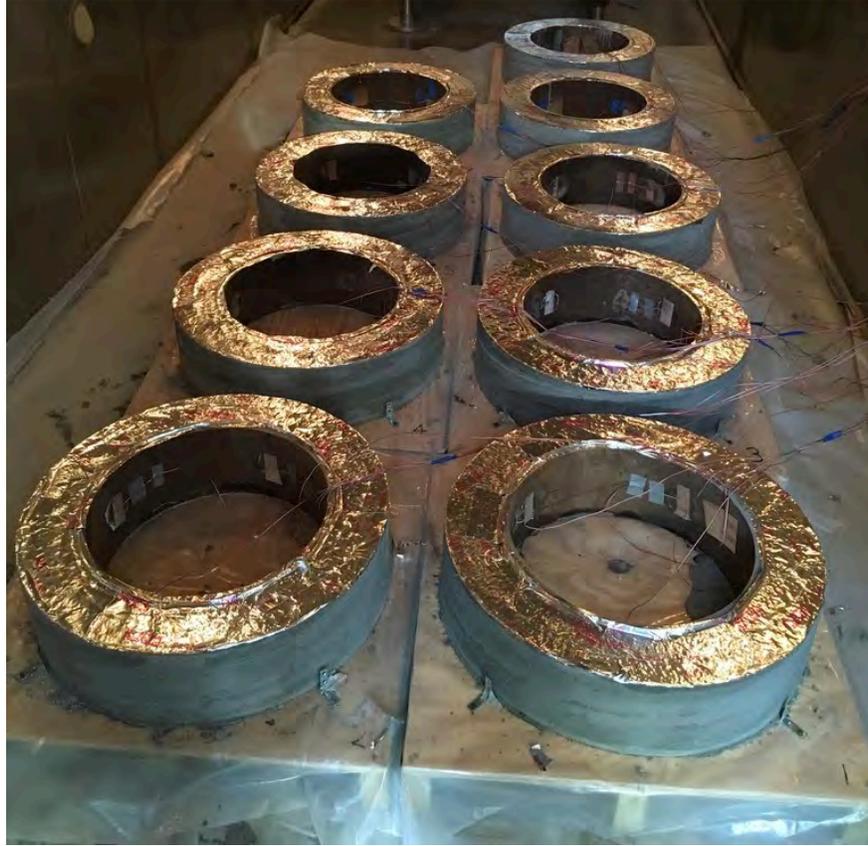
Figure 2.16: Restrained ring test specimens under circumferential drying conditions in the environmental chamber.

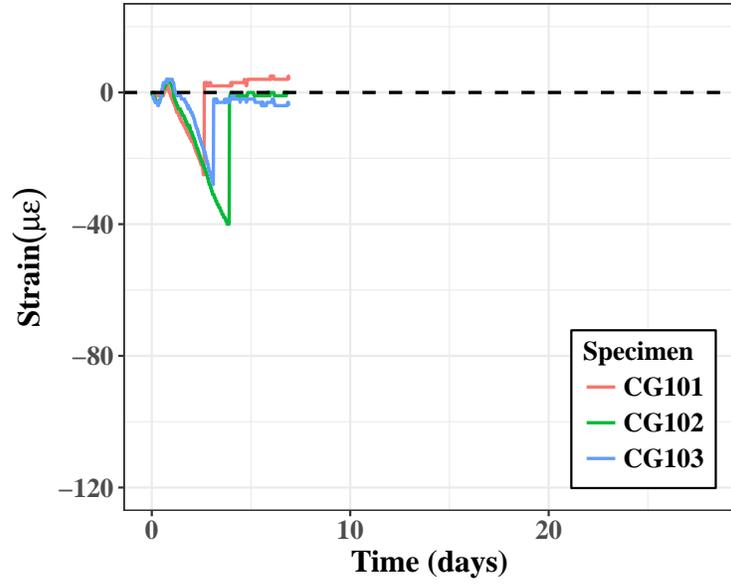
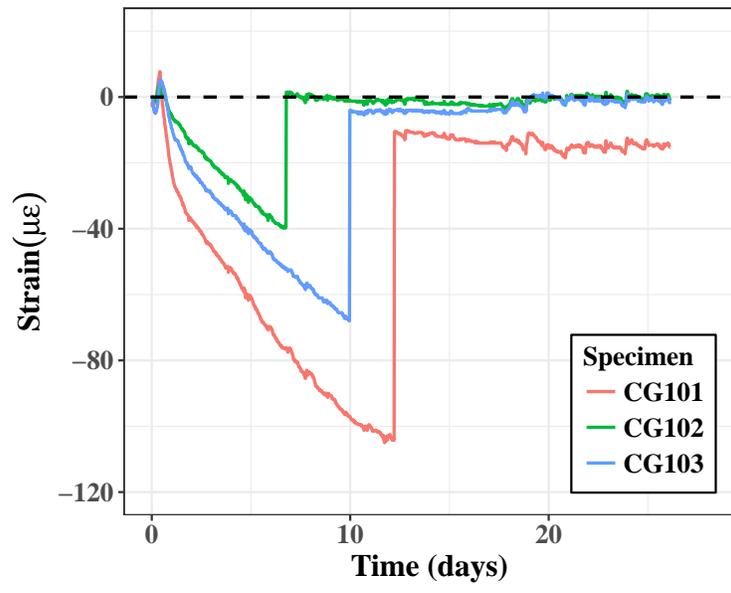
Figure 2.17: Results from restrained ring tests tests on CG1 under two different drying conditions: Circumferential drying (Left) and Sealed (Right) conditions.

Figures 2.17, 2.18, and 2.19 show the results for the first six ring tests. It is divided into two columns and three rows based on the two drying conditions and three grout materials. The sub-figures have time in days on the x-axis. This is the elapsed time from the moment of casting the material. Strain readings averaged over all of the strain gages on one specimen are given on the y-axis. The readings are in micro-strain ($\mu\epsilon$) units. The negative values of strain indicate compression on the inside ring. As time progresses from casting, the strains

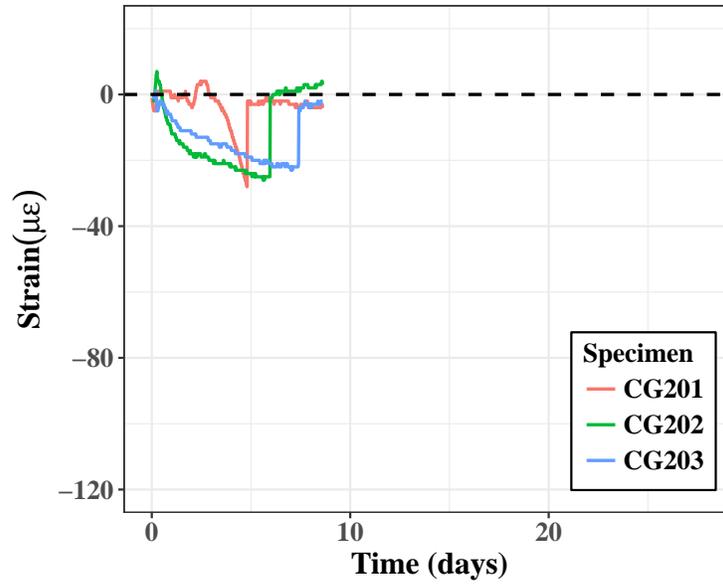
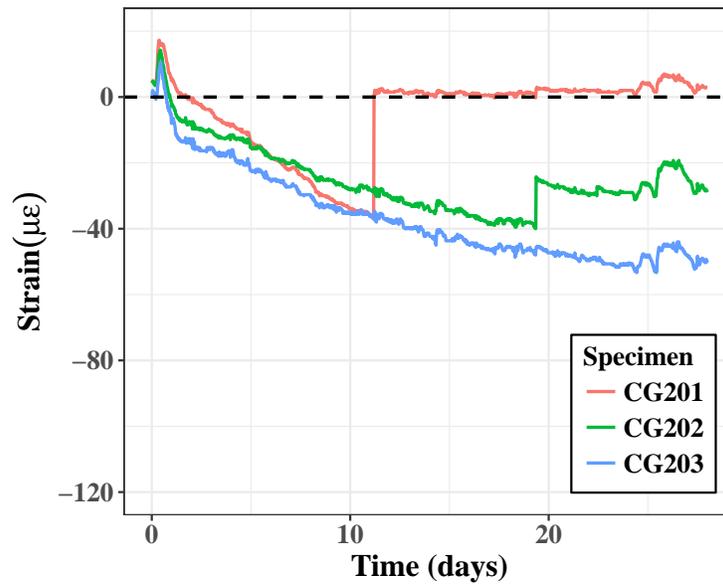
Figure 2.18: Results from restrained ring tests tests on CG2 under two different drying conditions: Circumferential drying (Left) and Sealed (Right) conditions.

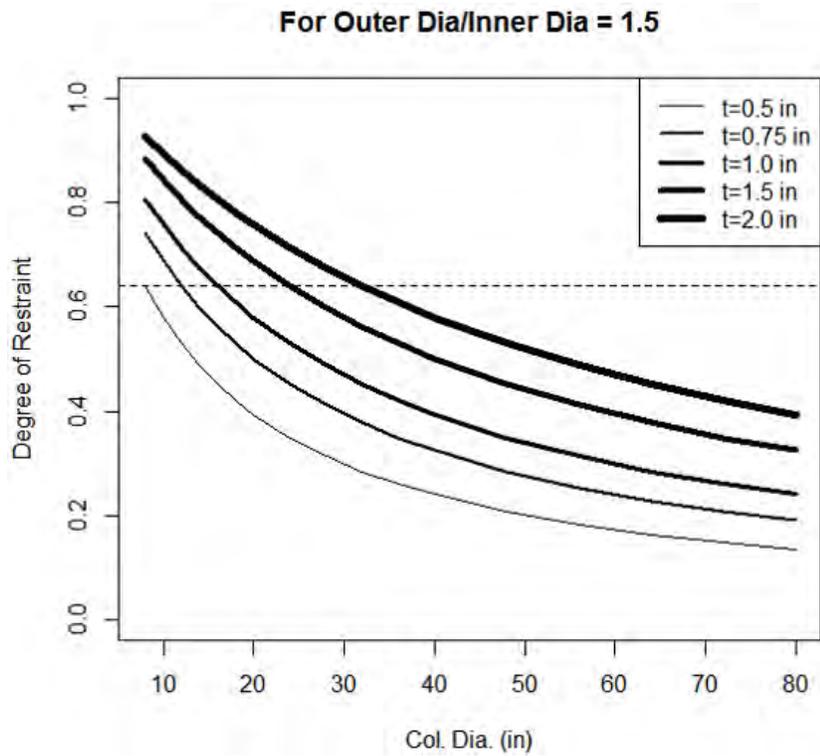
Figure 2.20: Degrees of restraint plotted against column diameter for a GSS connection outer-to-inner diameter ratio of 1.5.

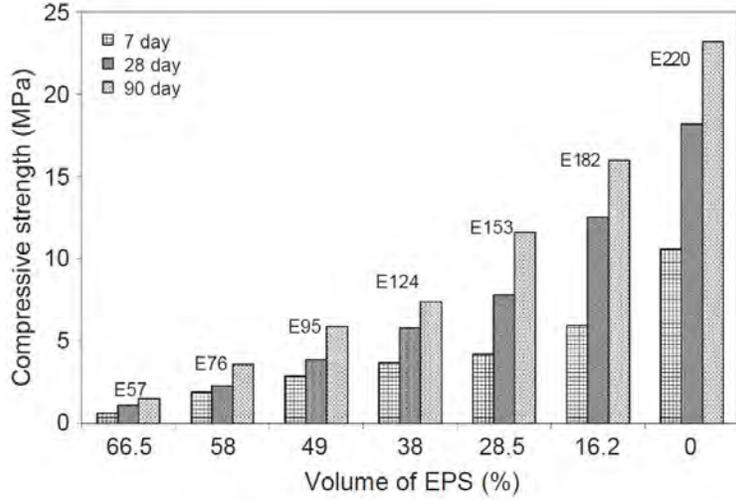
Figure 3.1: Variation of compressive strength with age and EPS volume for concrete added with fly ash [9].

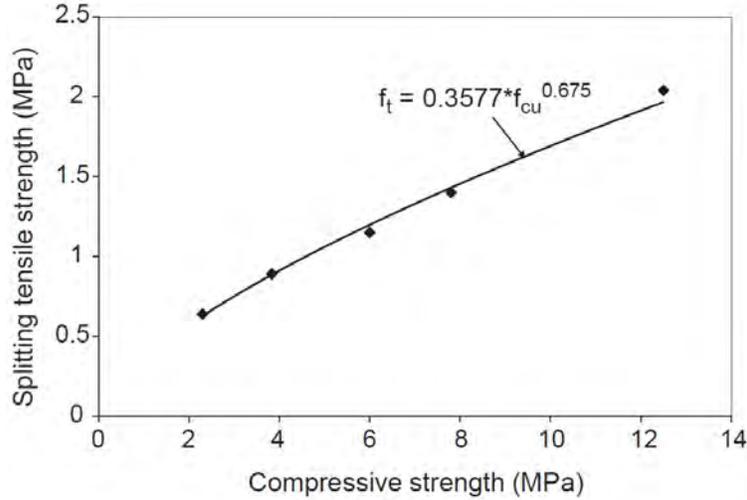
Figure 3.2: Variation of split tensile strength with compressive strength for EPS concrete added with fly ash [9].

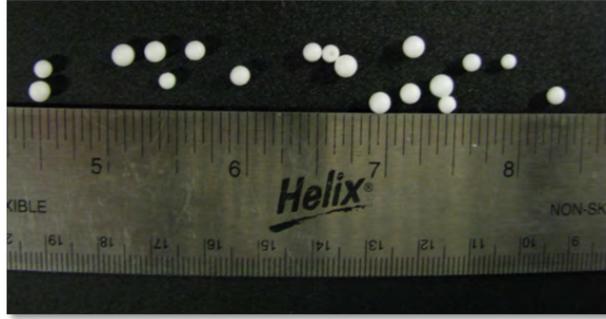
Figure 3.3: Expanded Polystyrene (EPS) beads [13].

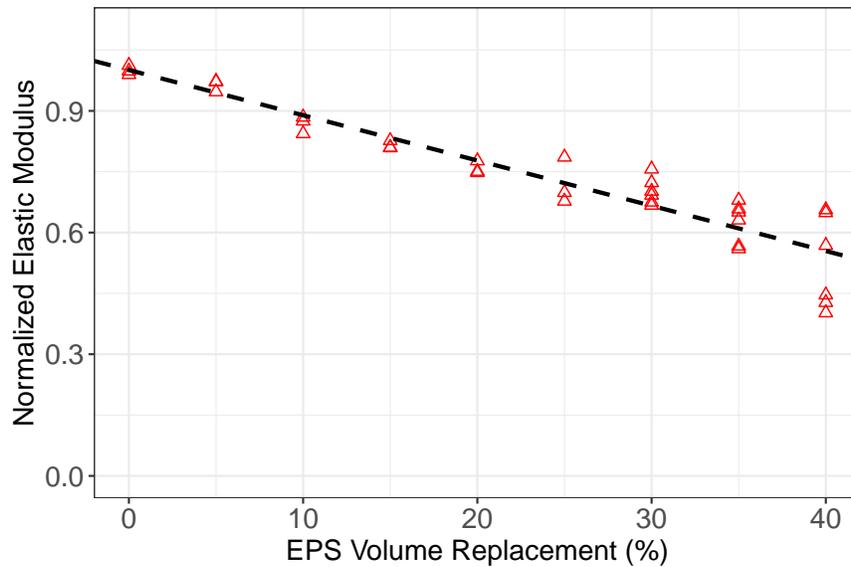
Figure 3.4: Elastic modulus normalized to value at 0% EPS plotted against EPS volume replacements for trial and error mixtures.

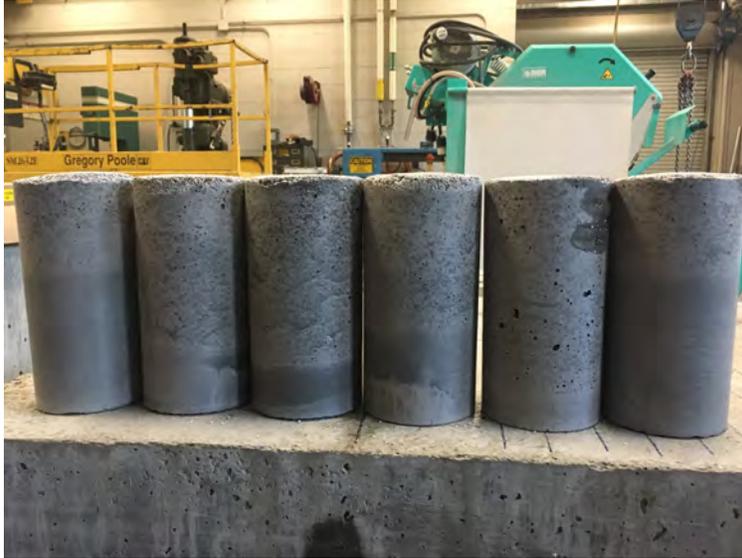
Figure 3.5: Migration of EPS aggregates observed in cylindrical grout samples.

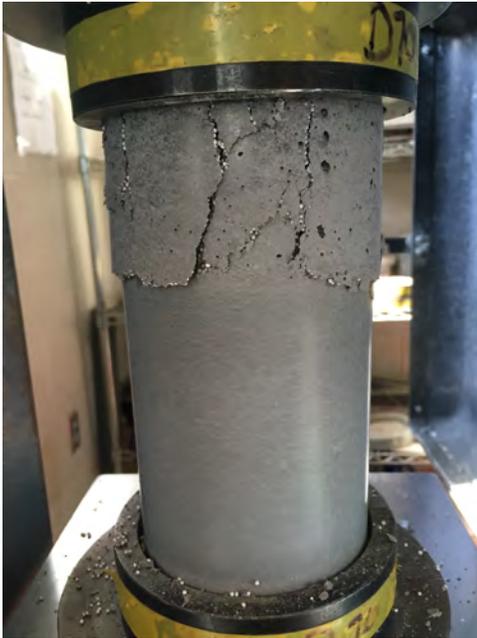
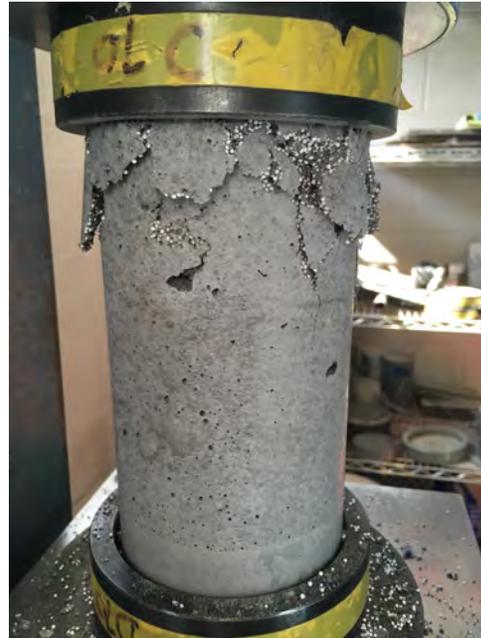
Figure 3.6: Premature failure observed in two different samples of grout mixed with 18% EPS. This corresponds to a 20% reduction of elastic modulus compared to standard grout.

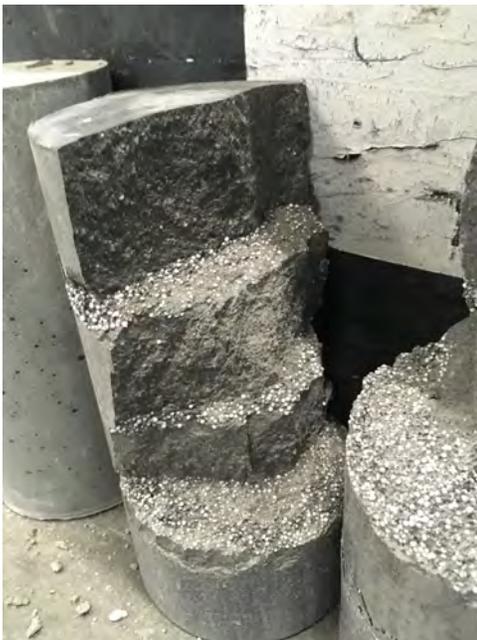
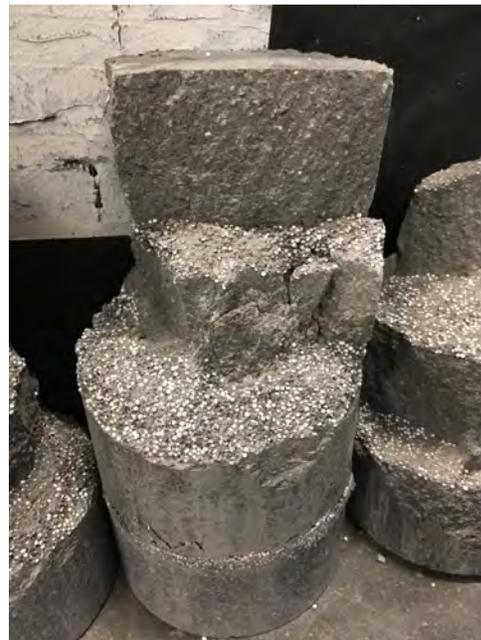
Figure 3.7: Compressive strength cylindrical specimens cast in 2" layers with 18% EPS.

were cast in 2" thick layers. A 4"×8" cylindrical sample contained 4 layers of 2" thick pours. After each layer was cast, 30 minutes elapsed before casting the next layer. The assumption was that this strategy would provide enough time for each layer to achieve sufficient viscosity to prevent the beads from migrating upward. Figure 3.7 shows the samples after compressive strength testing. Although migration to the top of the samples were prevented, there was still migration of the aggregates within each layer. This migration created weak planes along the height of the samples resulting once again in premature failure. This result was also deemed as a failure to effectively simulate grout deterioration.

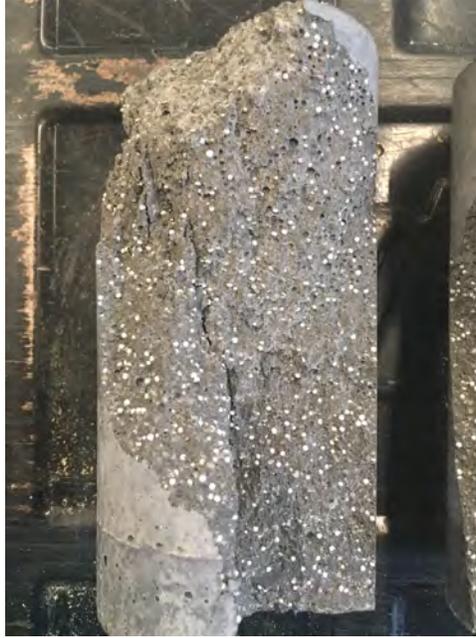
Figure 3.9: Uniform distribution of EPS aggregates observed in cylindrical grout samples under the 1”-layered casting scheme.

Subsequently, the layer thickness in the cylindrical samples was reduced from 2" to 1". This resulted in eight 1" layers in a 4"×8" cylinder. Figure 3.8 shows the 1" layered samples after compression testing. The cylinders failed by cracking through the entire height, which was typical of normal concrete cylinders. No premature failure was observed, and the sample strengths were consistent. One half of a failed sample is shown in Figure 3.9. The EPS aggregates have a uniform distribution along the height of the sample. The layered casting scheme with 1" layers was therefore chosen as the method to physically simulate

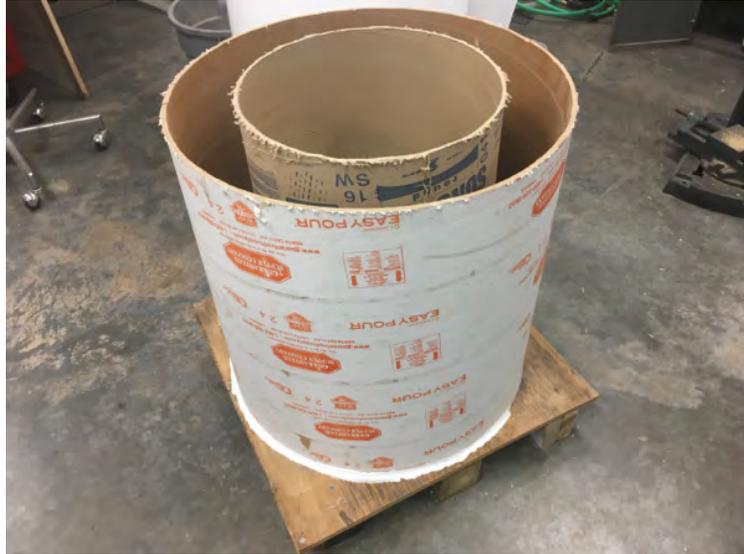
Figure 3.10: Formwork for the mock GSS connection.

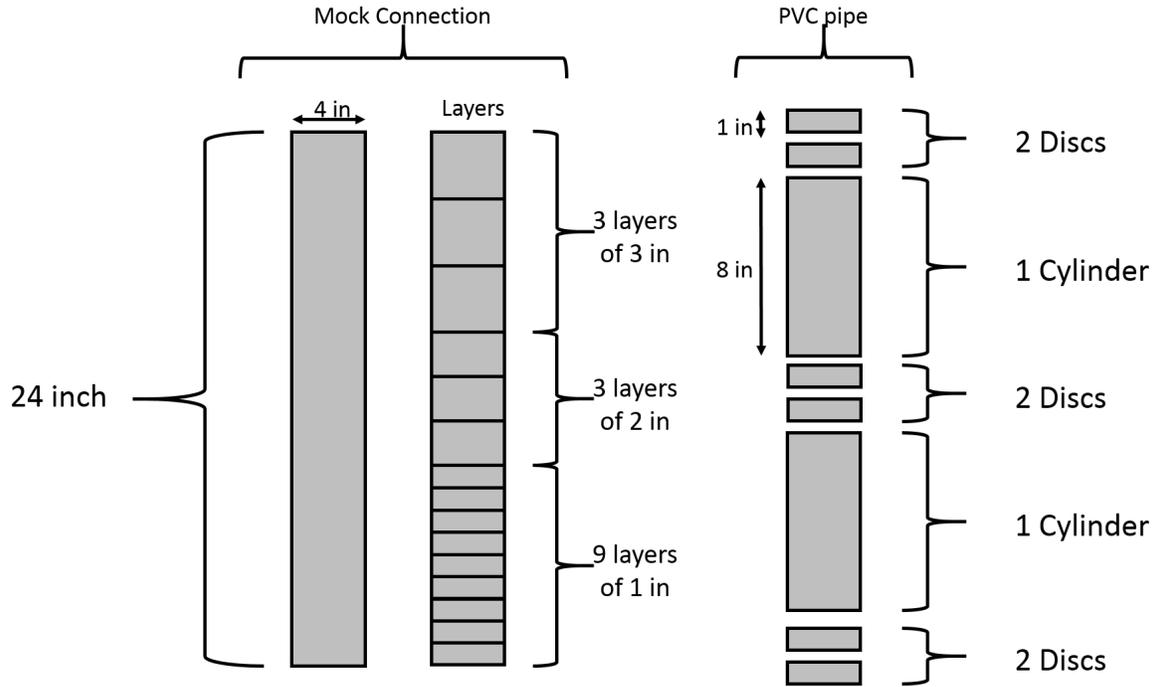
Figure 3.11: The layered scheme used to cast the mock connection and the corresponding 4" × 24" PVC pipes.

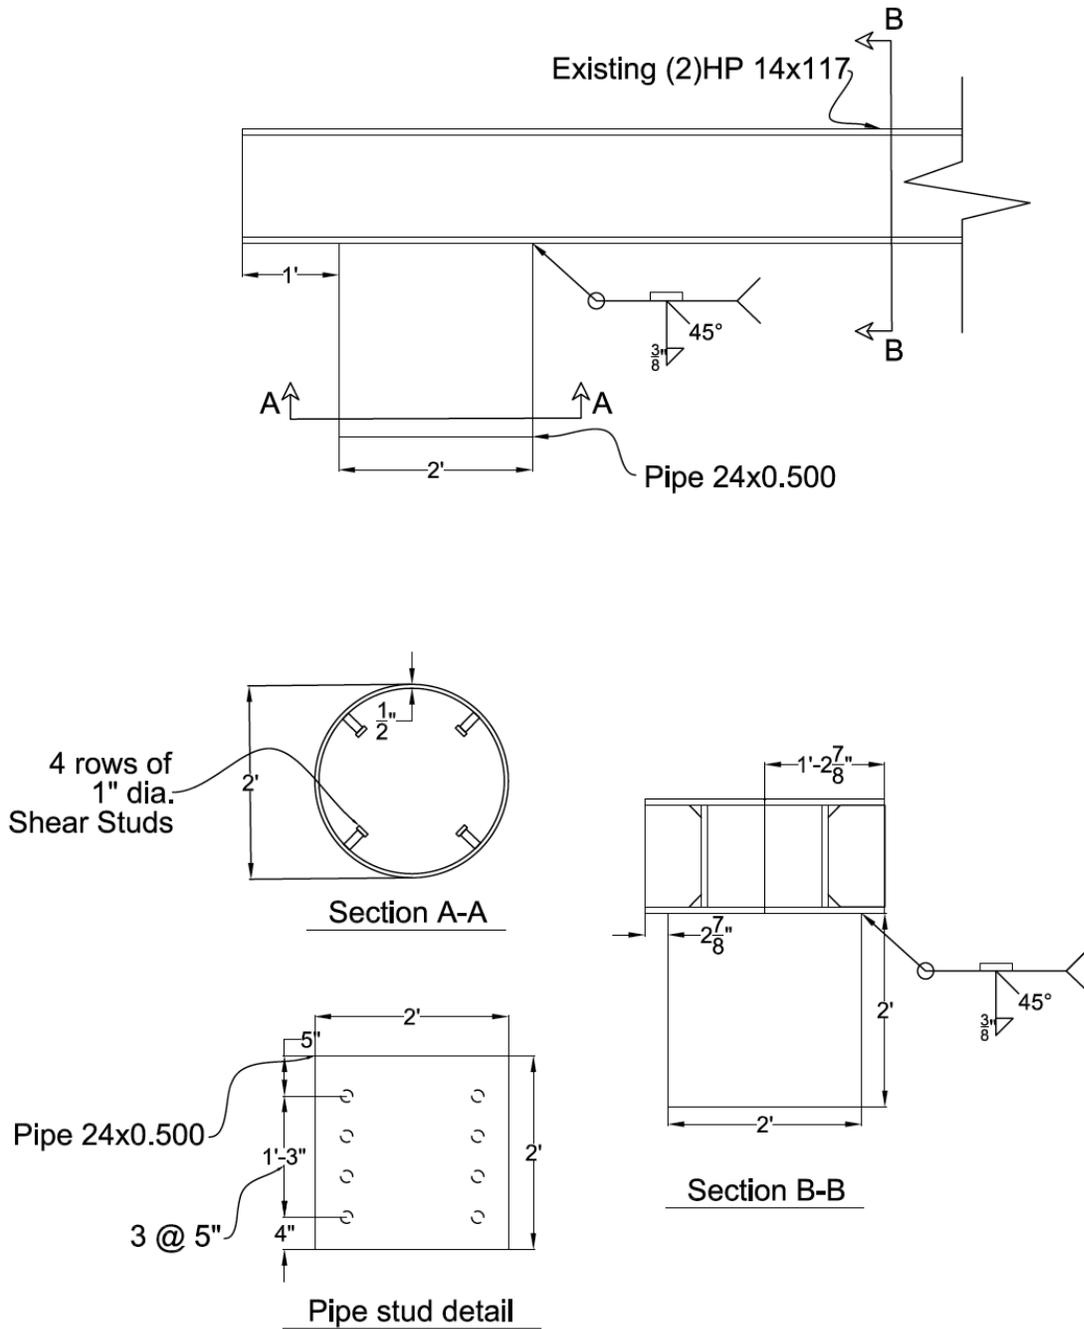
Figure 4.3: Fabrication details for the cap-beam stub assembly of Tests 1 through 4.

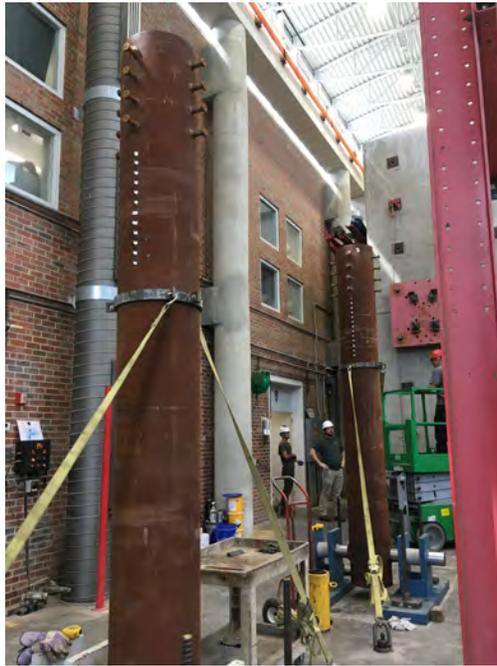
Figure 4.5: Columns erected and ready for cap-beam assembly.

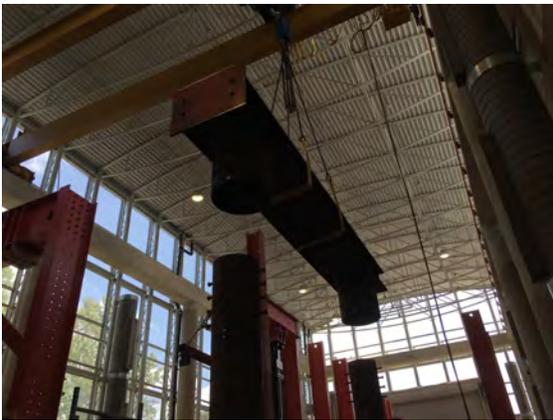
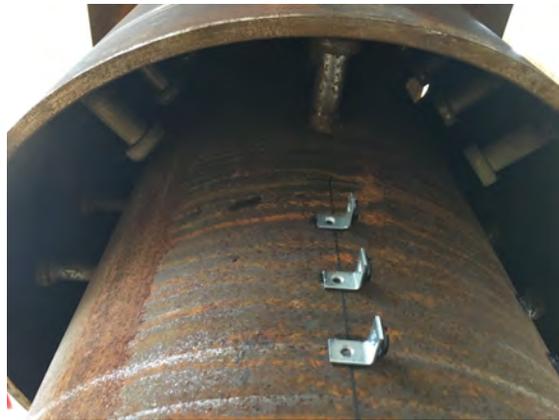
Figure 4.6: Photographs showing (a) the cap-beam stub assembly being lowered onto the columns and (b) one of the columns afterwards.

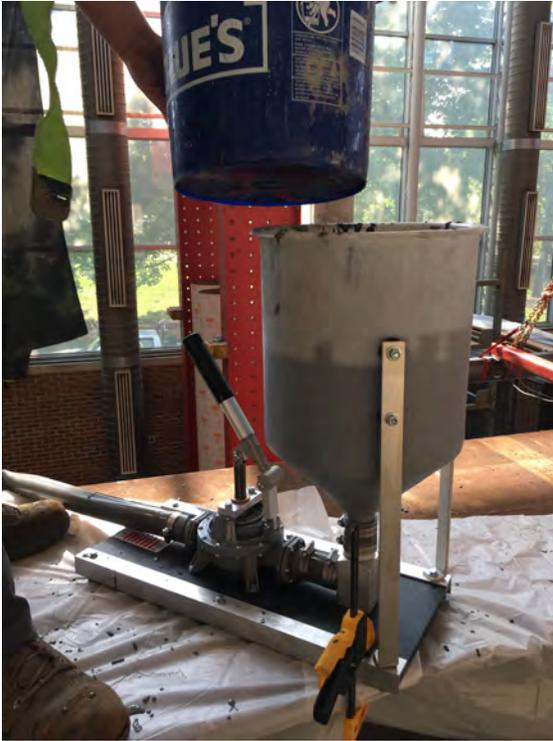
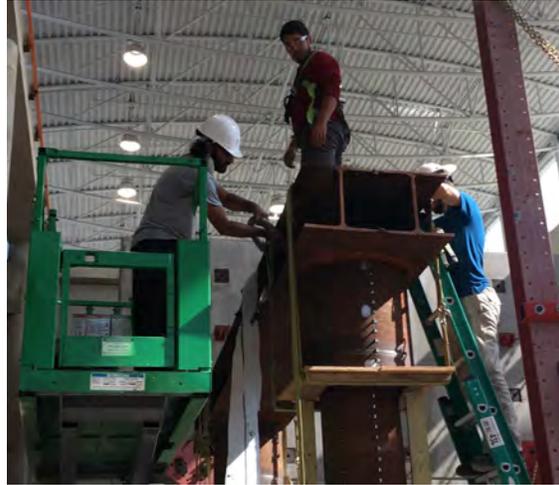
Figure 4.7: Photographs showing (a) the grout pump and (b) the pumping process.

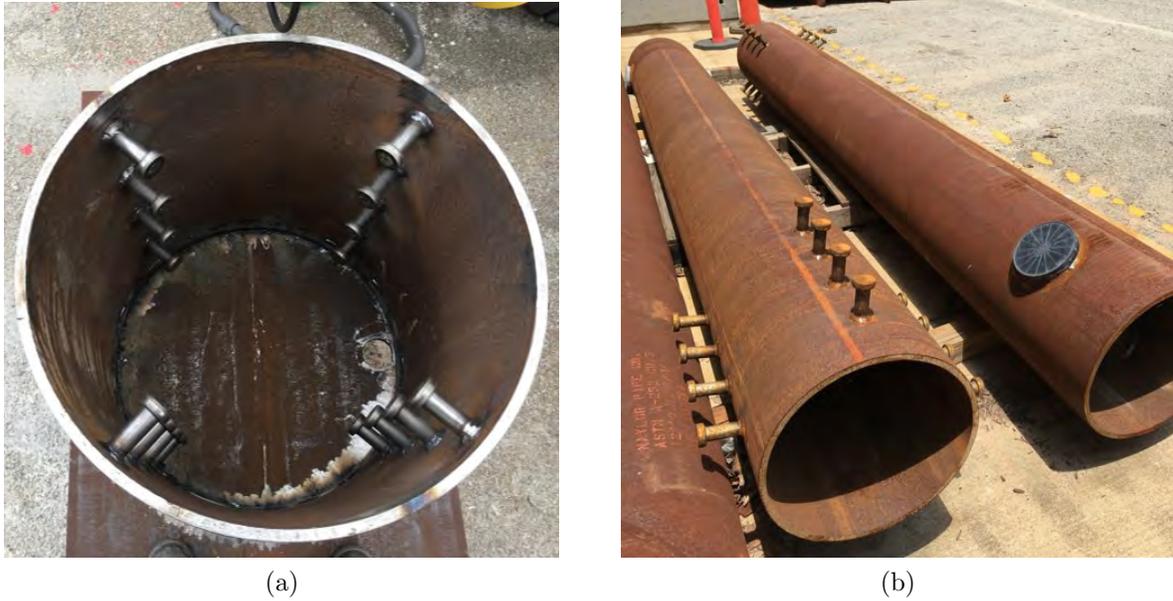
Figure 4.8: Photographs showing the arrangement of shear studs in (a) the stub pipe on the cap-beam, and (b) the pile columns.

Yet another difference from test 0 is that while it had a total of 96 shear studs of 3/4" diameter, per GSS connection, the specimens in tests 1 and 2 consisted of connections with a total of 32 shear studs of 1" diameter (16 on each column and 16 in each stub). Furthermore, Tests 3 and 4 consisted of a total of 16 shear studs of 1" diameter, per GSS connection. A detailed discussion of the reasons for this change is presented in Chapter 5. A shorter version is as follows. The design of the number of shear studs in test 0 was accomplished using an excessively high axial force demand versus what realistically develops. In addition, the capacity of shear studs embedded in confined grout may have been underestimated. AKDOT wanted to explore the possibility of using a smaller number of larger diameter shear studs for economy and ease of construction. In test 1, a total of 32 (16 each on the column and stub pipe) 1" dia. shear studs were welded inside each GSS connection. A symmetrical condition was generated by 4 lines of 4 shear studs at 90 degrees center to center as shown in Figure 4.8.

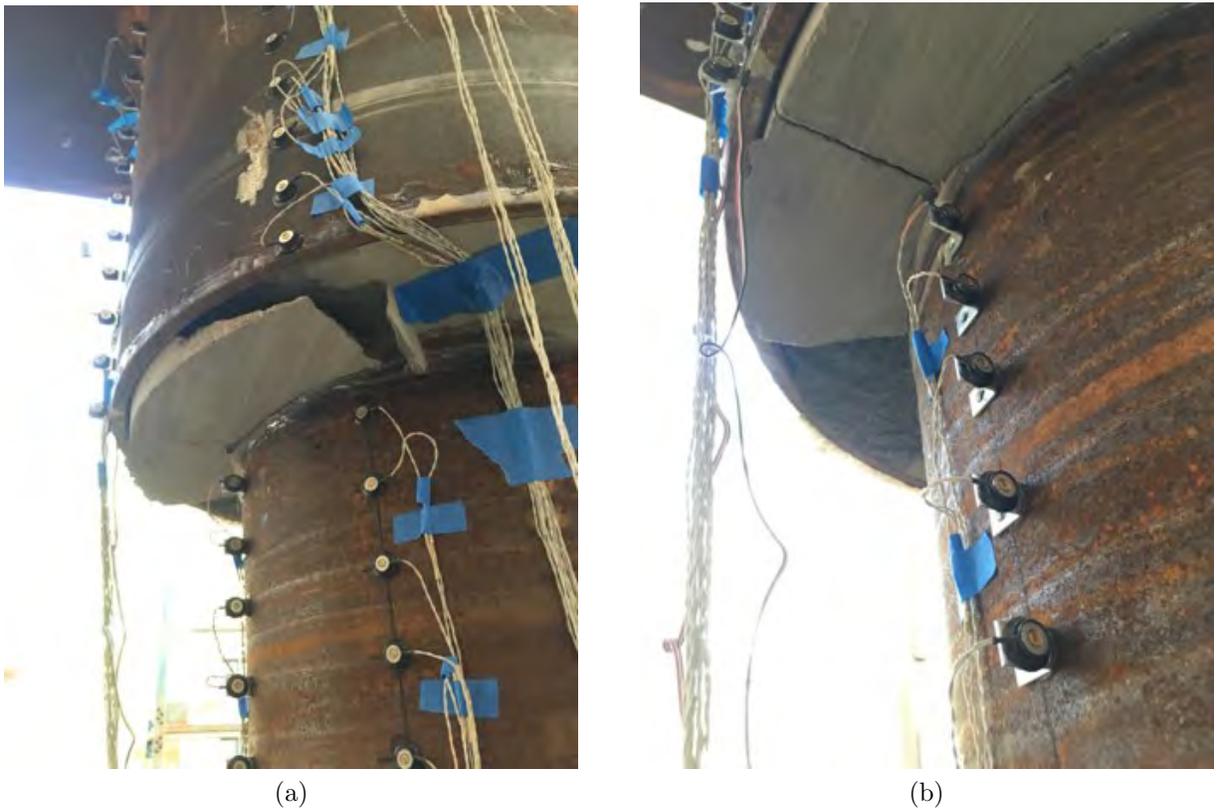
Figure 4.10: Grout spalling observed at (a) North column, South side, and (b) South column, South side (Ductility: 1.5, Cycle: -3, Force: 143.7 kips, Displacement: -4.1 in.).

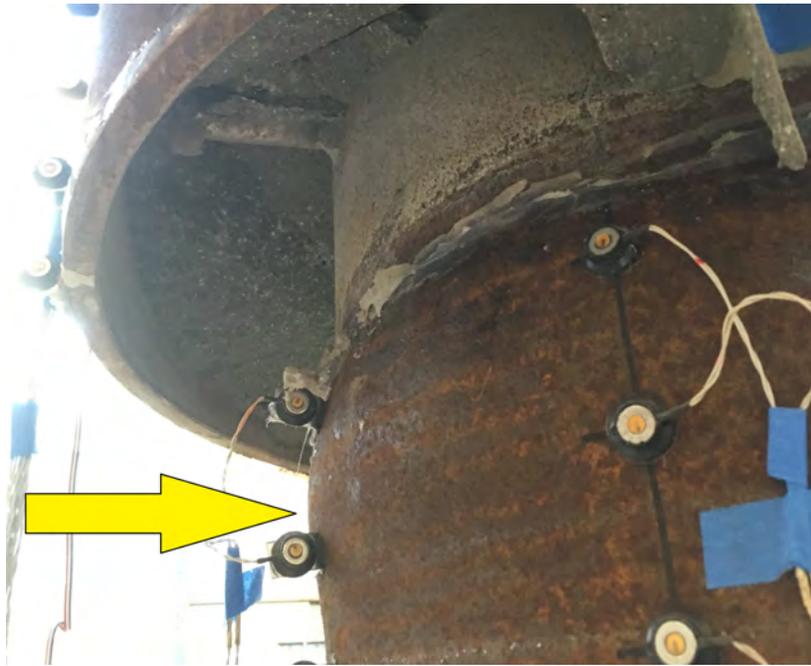
Figure 4.11: Pile wall outward local buckling on the (a) south face of north pile (Ductility: 3, Cycle: +1, Force: 136.3 kips, Displacement: 8.62 in.) and, (b) north face of south pile during the first negative cycle of ductility 3 (Ductility: 3, Cycle: -1, Force: -132.2 kips, Displacement: -8.65 in.).

The first positive cycle of ductility 3 induced outward pile wall local buckling in the south face of the north pile, as shown in Figure 4.11a. On the subsequent negative cycle, similar local buckling was observed on the north face of the south pile (Figure 4.11b). Initially, the outward curvature of buckled pipe walls reduced and “straightened up” upon load reversals. The curvatures increased with each successive cycle and showed permanent buckling. The strength of the specimen continued to drop on each successive cycle. The maximum force

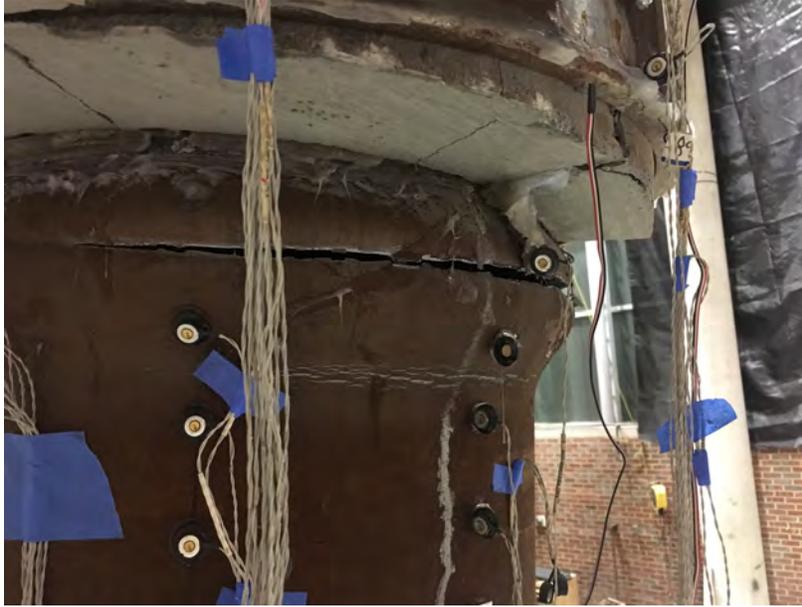
Figure 4.12: Pile wall rupture in the plastic hinge region on the north face of south pile during the first positive cycle of ductility 5 (Ductility: 5, Cycle: +1, Force: 51.0 kips, Displacement: 9.32 in.).
