Durability of the Grouted Shear Stud Connection at Low Temperatures

FINAL REPORT

Alaska Department of Transportation & Public Facilities

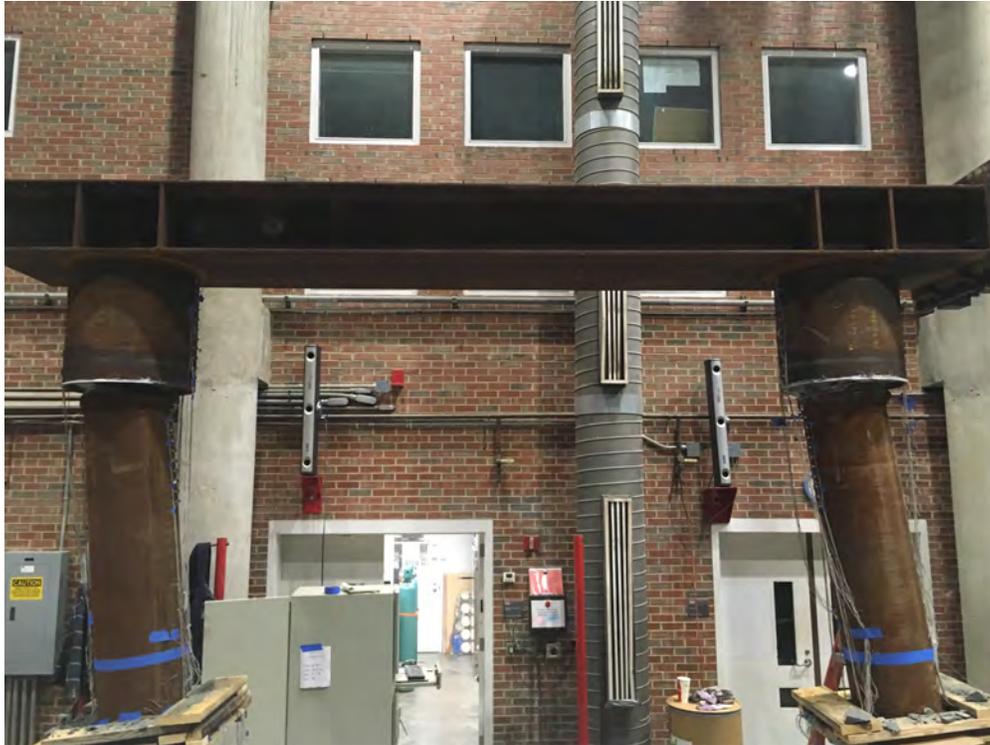
Figure 4.13: The test specimen experienced a maximum drift of 9% (Ductility: 4, Cycle: +3, Force: 82.2 kips, Displacement: 11.60 in.).

During the first positive cycle of ductility 5, the north face of the south pile experienced rupture in the plastic hinge region. This is shown in Figure 4.12. The specimen was deemed to have failed and the test was terminated. The specimen experienced a maximum displacement of 11.7 in before failure which corresponds to 9% drift (Figure 4.13).

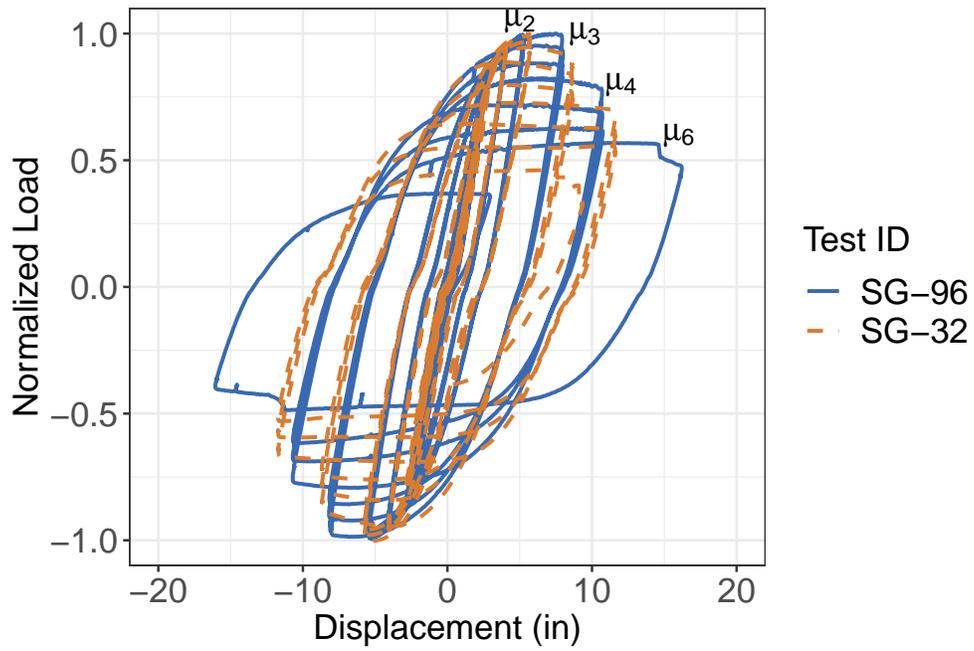
Figure 4.14: Comparison of the force-displacement response of Test 0 (SG-96) and Test 1 (SG-32).

Close to zero load at all ductility levels, a slip was observed in test 1, indicated by a small kink in the force-displacement response. This slip is absent in test 0. This slip also seems to increase in magnitude at higher ductilities. From results of later tests, it was possible to conclude that this was caused by the opening of a gap between the pipe and the grout ring on the tension side of the connection, as shown in Figure 5.31a. When the column bears on the grout ring on the compression side, the round section deforms, and is no longer round. This behavior reduces the diameter of the column orthogonal to the neutral axis, pulling the tension side off of the grout ring. In test 0, however, the number of shear studs was larger compared to test 1. This large number of shear studs prevented the column from detaching from the grout ring, resulting in an insignificant gap. Therefore, the force-displacement

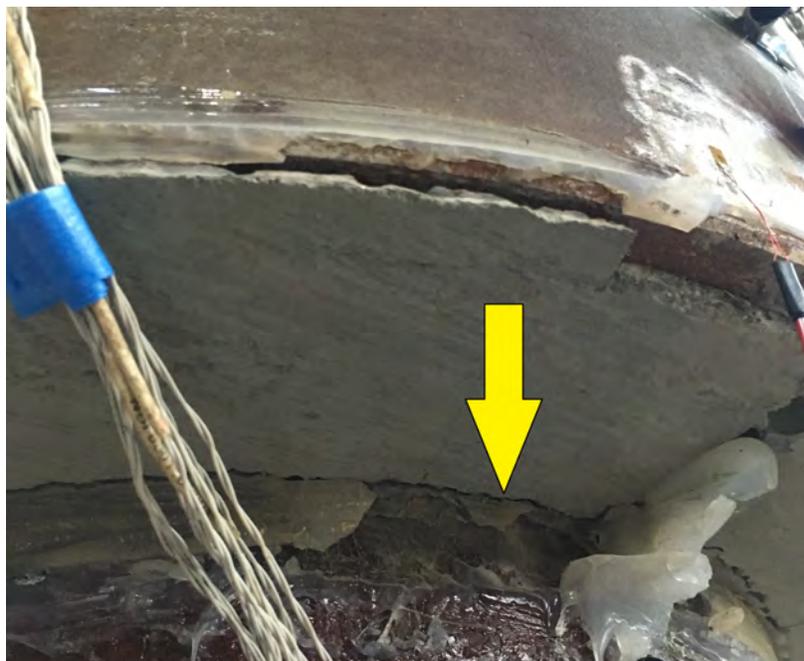
Figure 4.15: Detachment of the column from the surrounding grout ring on the tension side of the connection.

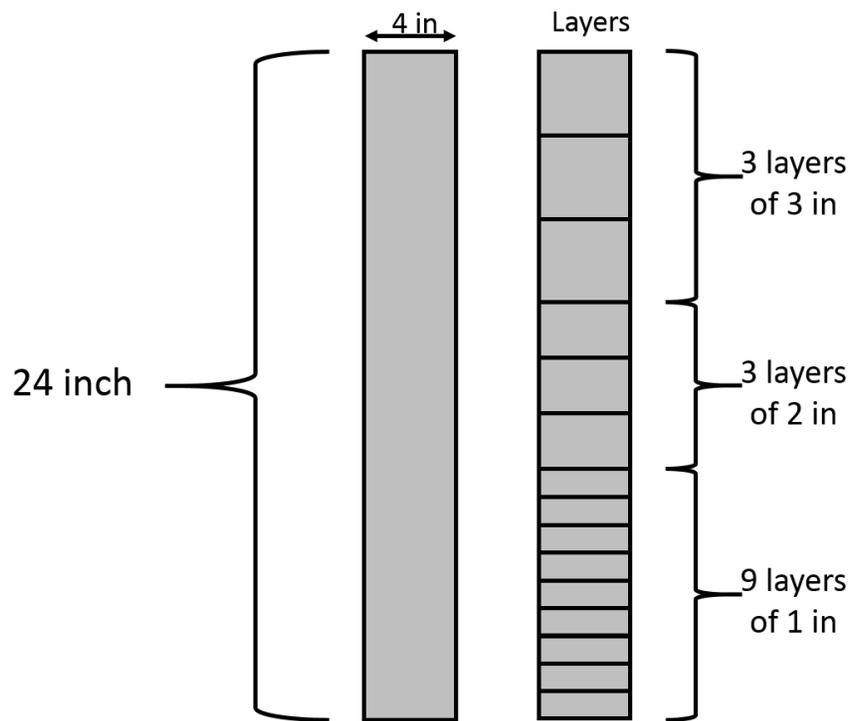
Figure 4.17: Layering scheme used to obtain uniform EPS distribution in GSS connections for physical damage simulation.

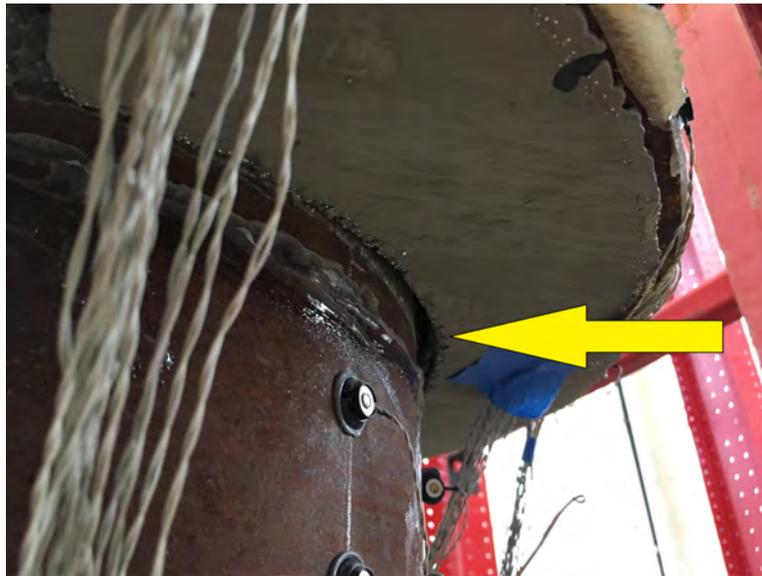
Figure 4.18: (a) Transverse cracking observed at the neutral axis of the GSS connection (Ductility: F_y , Cycle: +1, Force: 97.8 kips, Displacement: 2.53 in.), and (b) the observed gap between the column and surrounding grout ring (Ductility: 3, Cycle: +1, Force: 142.1 kips, Displacement: 8.64 in.).

The structural test was performed 15 days after casting the grout in the GSS connections. Cyclic quasi-static loading was applied to the two-column steel bent in the displacement control mode. The initial load rate was 1.5 in/min which was later changed to 4 in/min in the inelastic cycles. Two cycles at each force level ($0.25F_y$, $0.50F_y$, $0.75F_y$, and F_y) were applied first. Within the first two cycles, there were sounds of grout cracking. These sounds continued to occur until the force level of F_y was reached. Visible separation of the grout ring from the pile wall was observed at about $0.75F_y$. Radial cracks near the neutral axis of the connection started to develop in both connections, as shown in Figure 4.18a. The cracks multiplied during the second cycle of F_y .

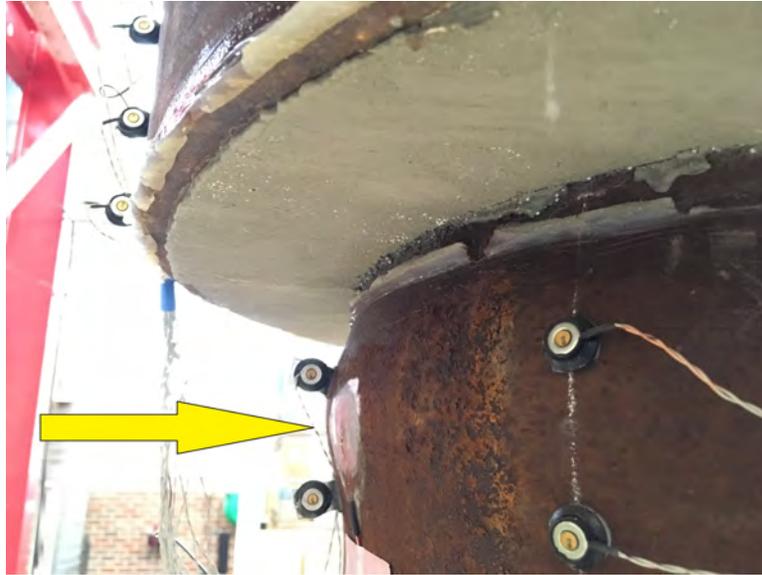
Figure 4.19: Pile wall local buckling (Ductility: 3, Cycle: +1, Force: 142.1 kips, Displacement: 8.64 in.)

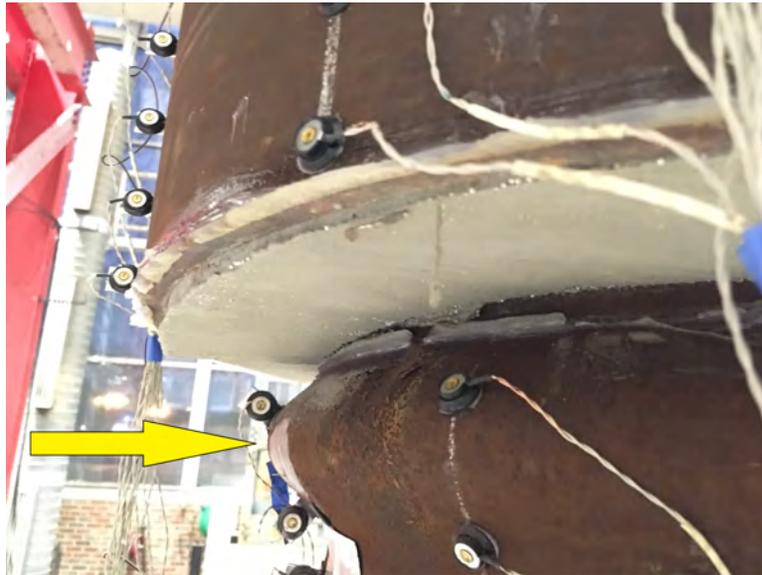
Figure 4.20: Pile wall local buckling (Ductility: 4, Cycle: +1, Force: 112.2 kips, Displacement: 11.50 in.)

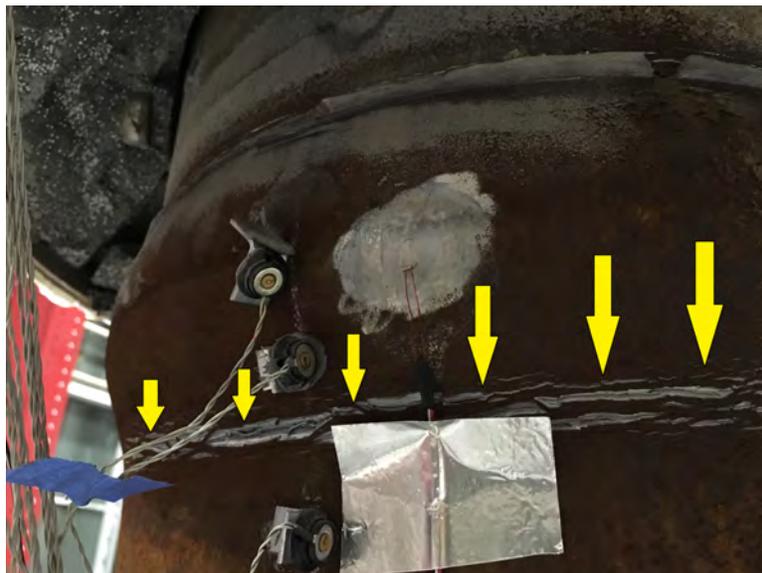
Figure 4.21: Pile wall local buckling (Ductility: 5, Cycle: +1, Force: 84.1 kips, Displacement: 14.21 in.)

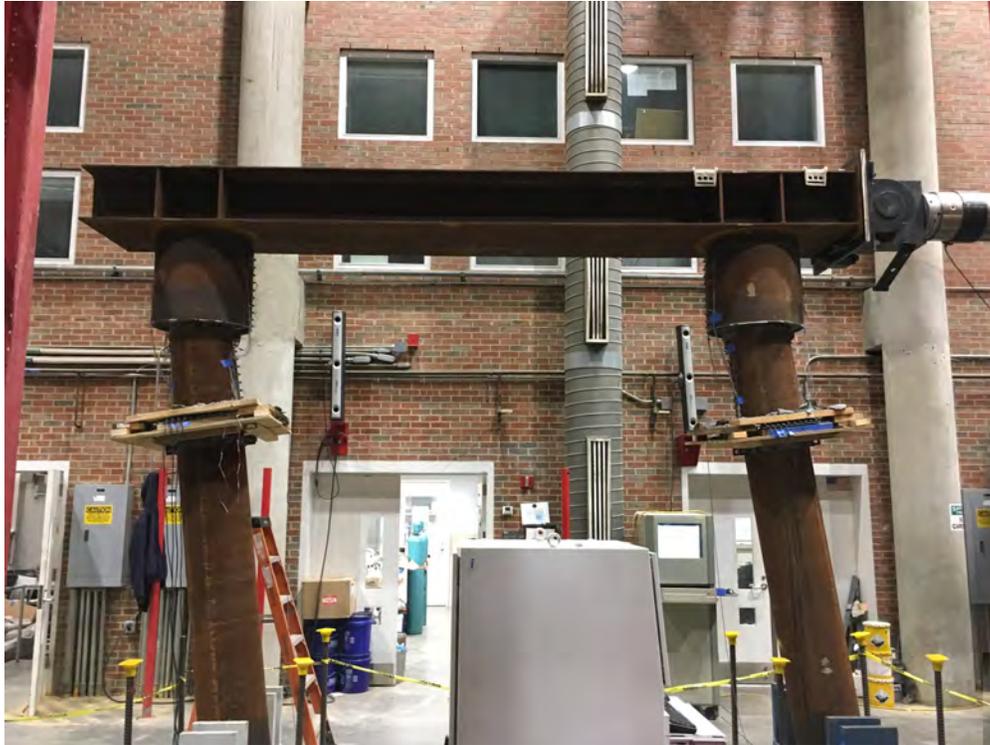
Figure 4.22: Structure drift of 11% (Ductility: 5, Cycle: +1, Force: 84.1 kips, Displacement: 14.21 in.)

load had dropped by 60% and the specimen had attained a drift of 11% as shown in Figure 4.22. The test was terminated at this point because of stability concerns.

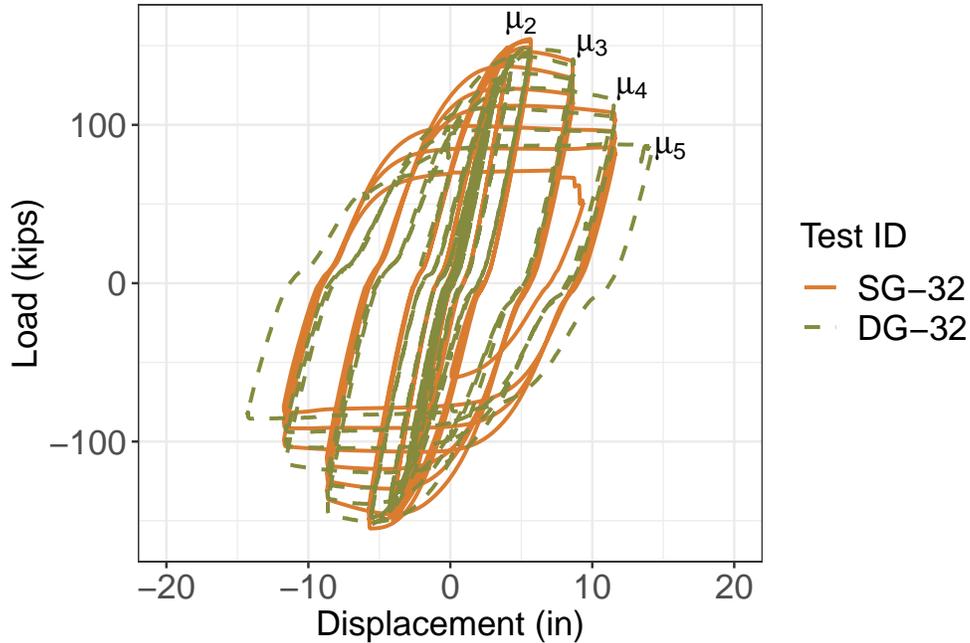
Figure 4.23: A comparison of the force-displacement hysteretic responses: Test 1 (SG-32) v Test 2 (DG-32)

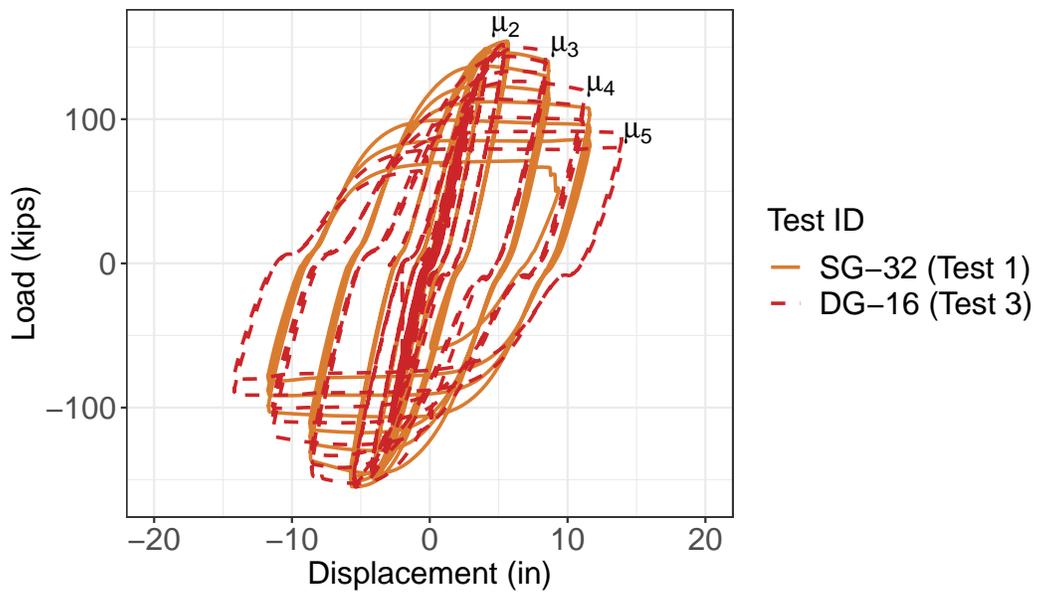
Figure 4.26: A comparison of the force-displacement hysteretic responses: Test 1 (SG-32) v Test 3 (DG-16)

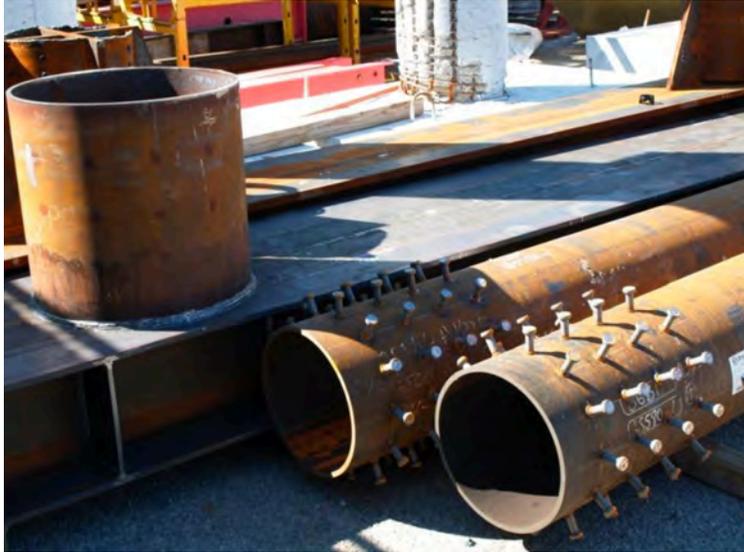
Figure 5.1: Shear stud detail and constituent elements of the specimen in Test 0.

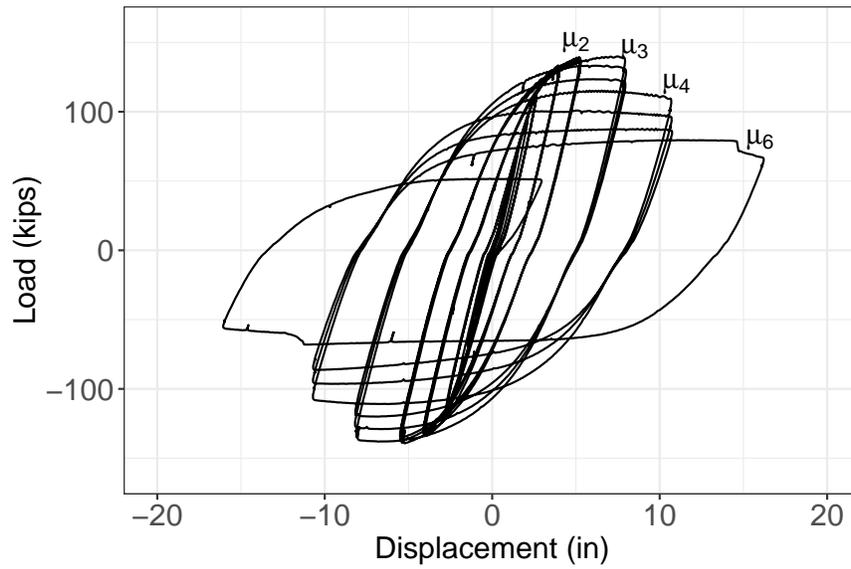
Figure 5.2: Force-displacement hysteresis of the two-column bridge bent specimen tested by Fulmer et al. [18], referred to as Test 0 in this report

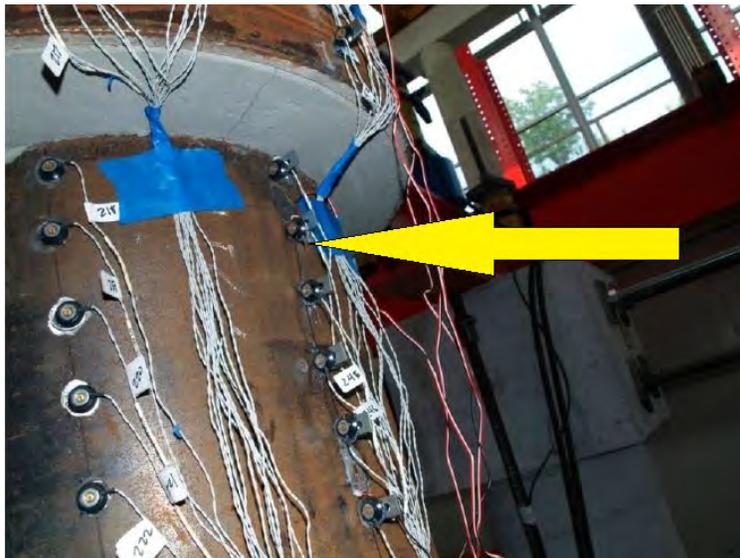
Figure 5.3: Observed local buckling initiation pile wall (Ductility: 2, Cycle: -3, Force: -132 kips, Displacement: -5.62").

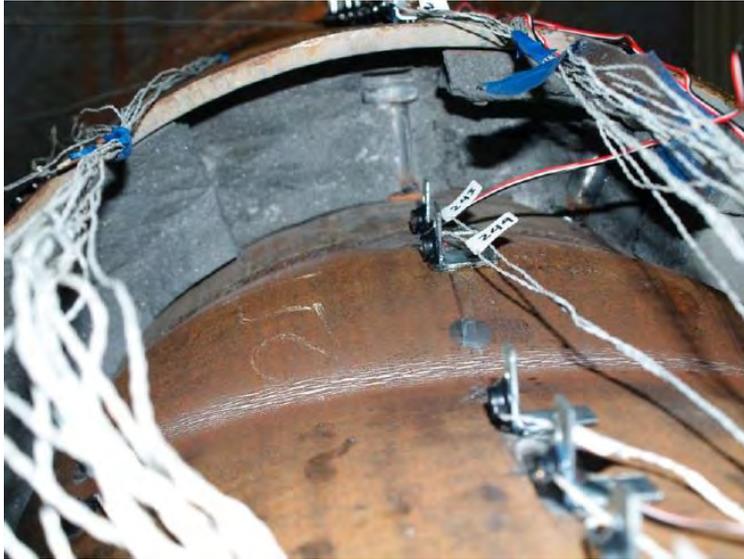
Figure 5.4: Observed grout spalling and tear marks on the pile wall (Ductility: 4, Cycle: 3, Force: 85 kips, Displacement: 11.25").

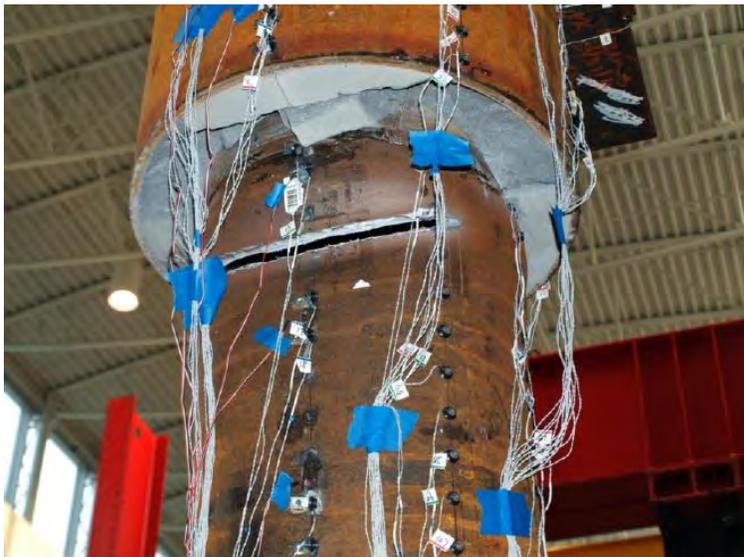
Figure 5.5: Specimen failure mode of pile wall rupture (Ductility: 6, Cycle: -1, Force: -54 kips, Displacement: -16.88").

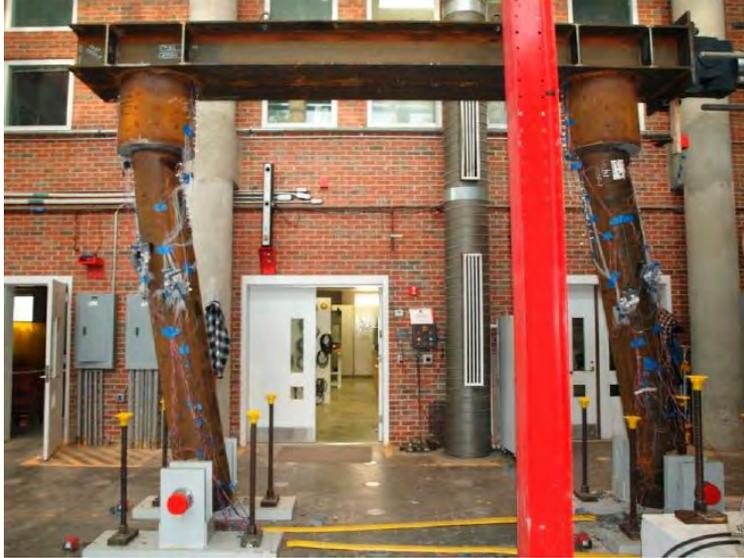
Figure 5.6: Drift of 12% was observed at termination of Test 0 [18] (Ductility: 6, Cycle: 1, Force: 75 kips, Displacement: 16.88")

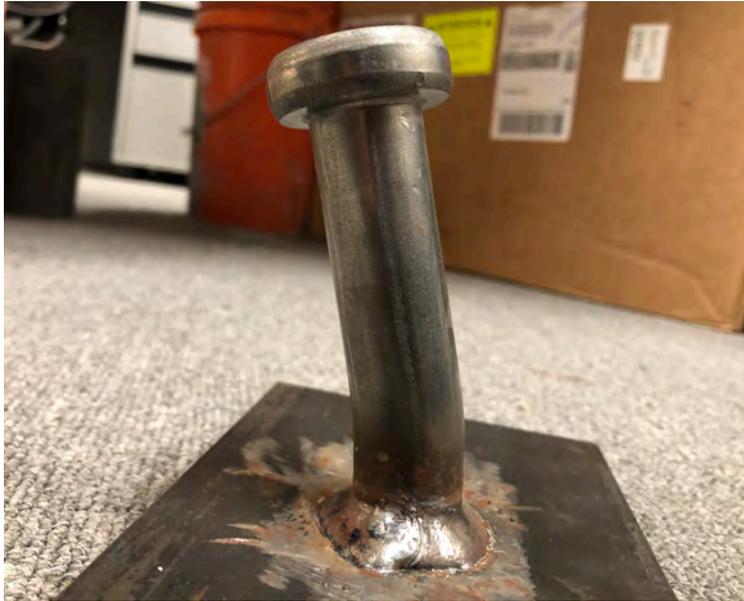
Figure 5.7: Result of the bend test on a sample 1" diameter shear stud.

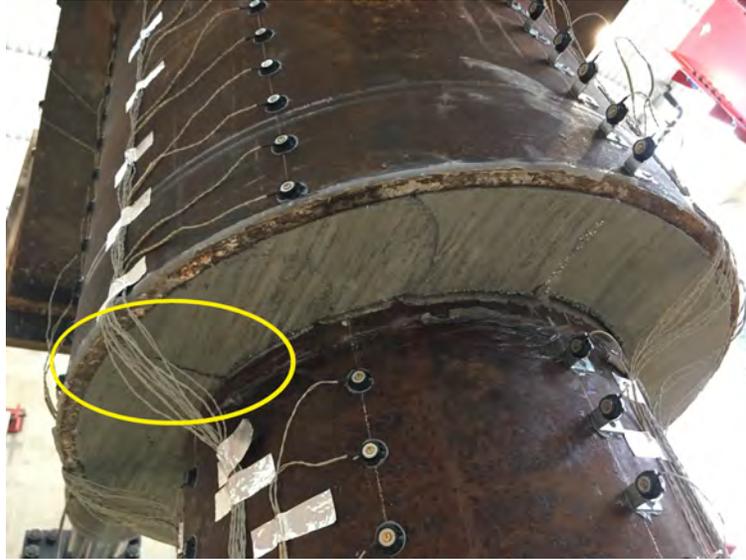
Figure 5.9: Cracks observed at the neutral axis of the GSS connection (Ductility: 1, Cycle: 1, Force: 111 kips, Displacement: 2.79")

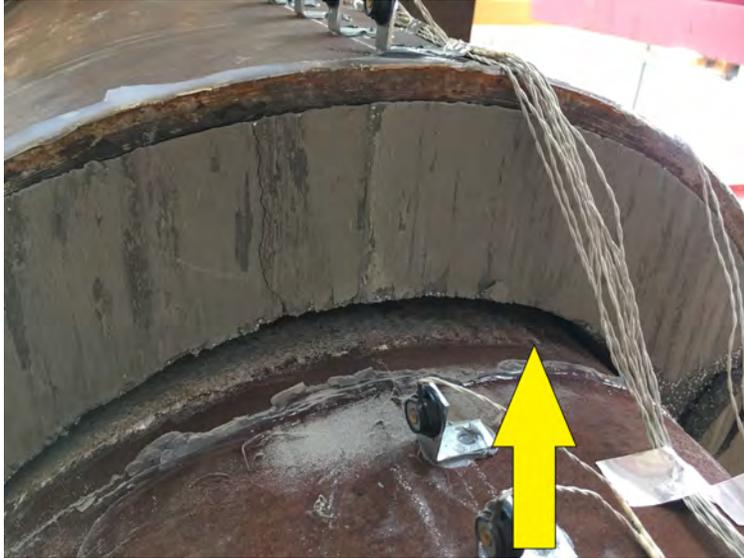
Figure 5.10: The gap between the column wall and the grout ring. (Ductility: 4, Cycle: 1, Force: 119.1 kips, Displacement: 11.19")

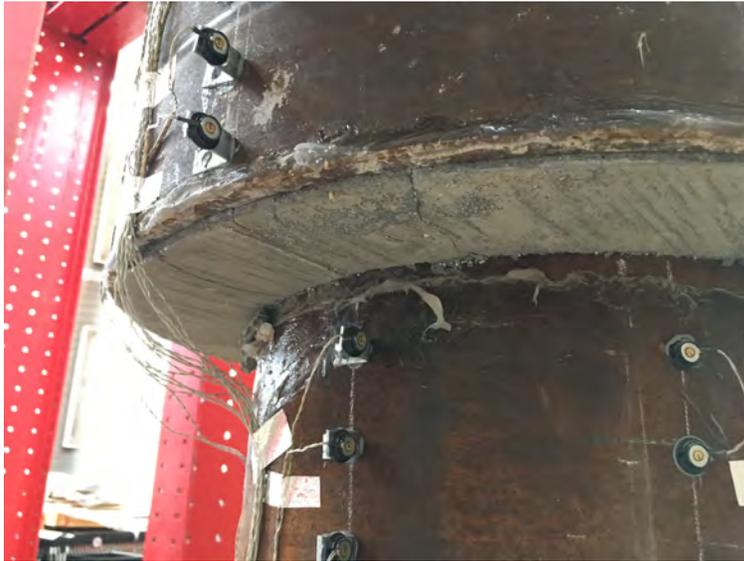
Figure 5.11: GSS connection at ductility 3; No grout spalling was observed in Test 3. (Ductility: 3, Cycle: 1, Force: 145.1 kips, Displacement: 8.39")

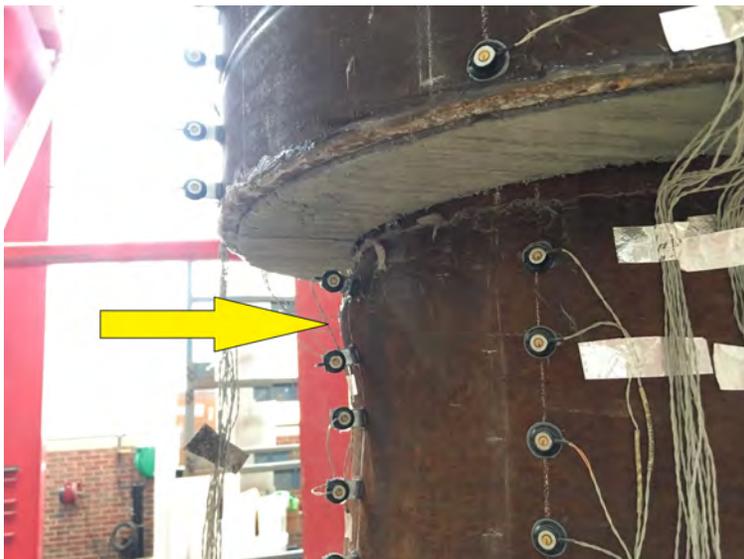
Figure 5.12: Minor buckling observed on the north column. (Ductility: 3, Cycle: 1, Force: 145.1 kips, Displacement: 8.39")

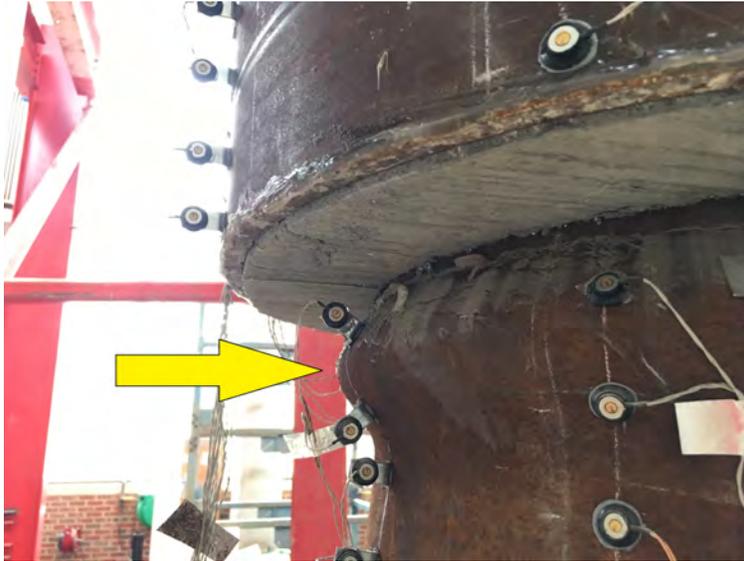
Figure 5.13: Minor buckling observed on the north column. (Ductility: 4, Cycle: 1, Force: 119.1 kips, Displacement: 11.19")

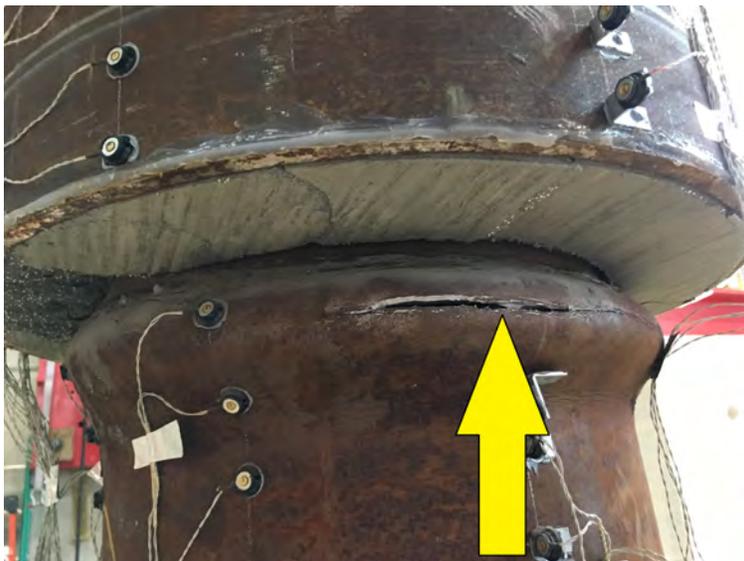
Figure 5.14: Minor buckling observed on the north column. (Ductility: 5, Cycle: 3, Force: -77.5, Displacement: -14.18")

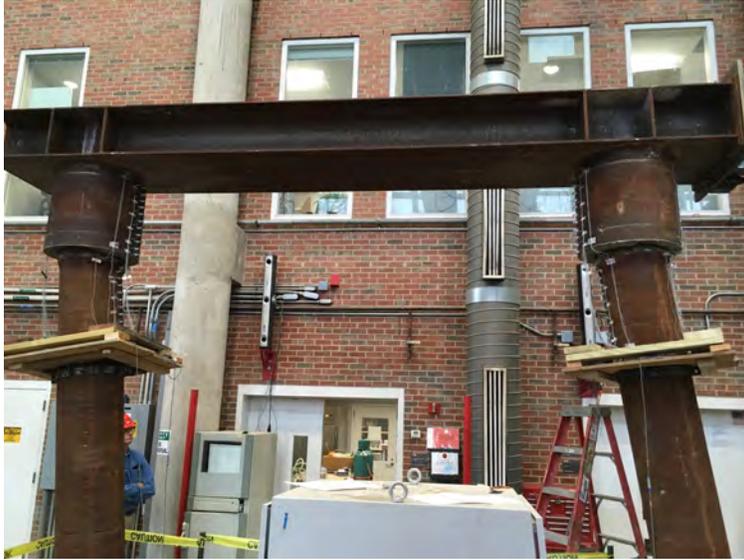
Figure 5.15: Minor buckling observed on the north column. (Ductility: 5, Cycle: 2, Force: 80.3, Displacement: 13.92")

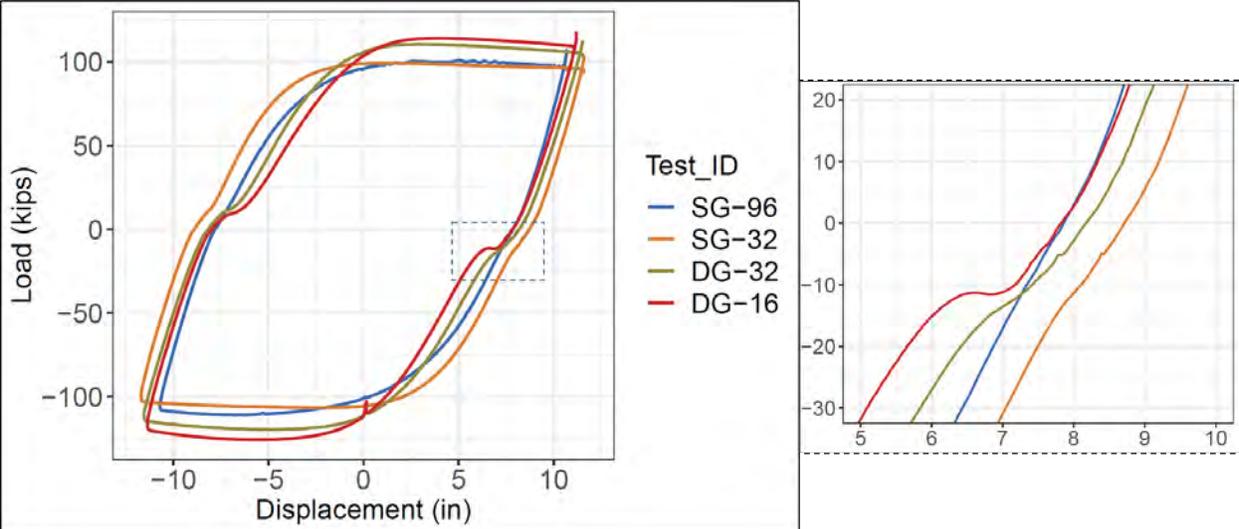
Figure 5.21: Comparison of the slip in the force-displacement response in ductility 4 cycle.

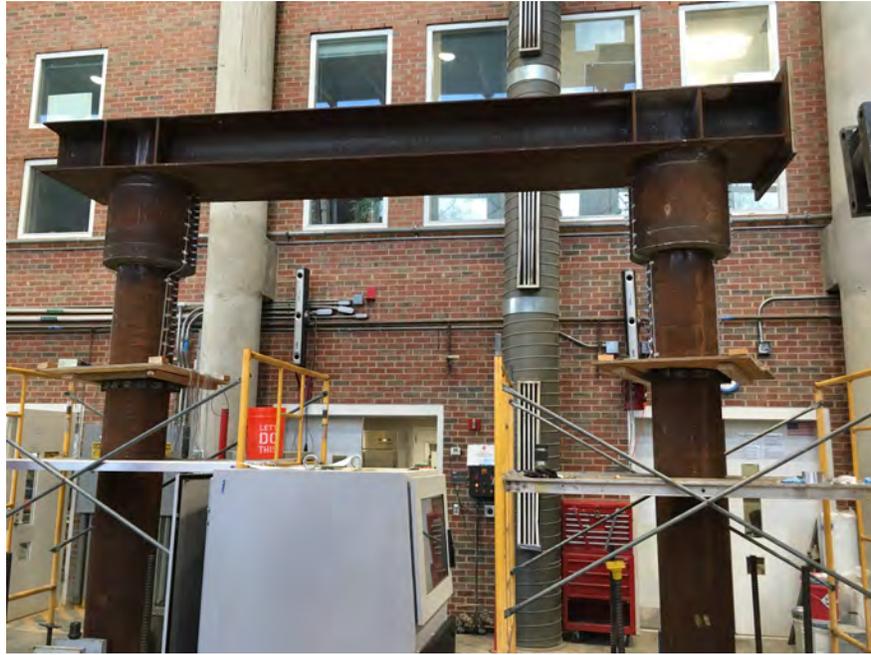
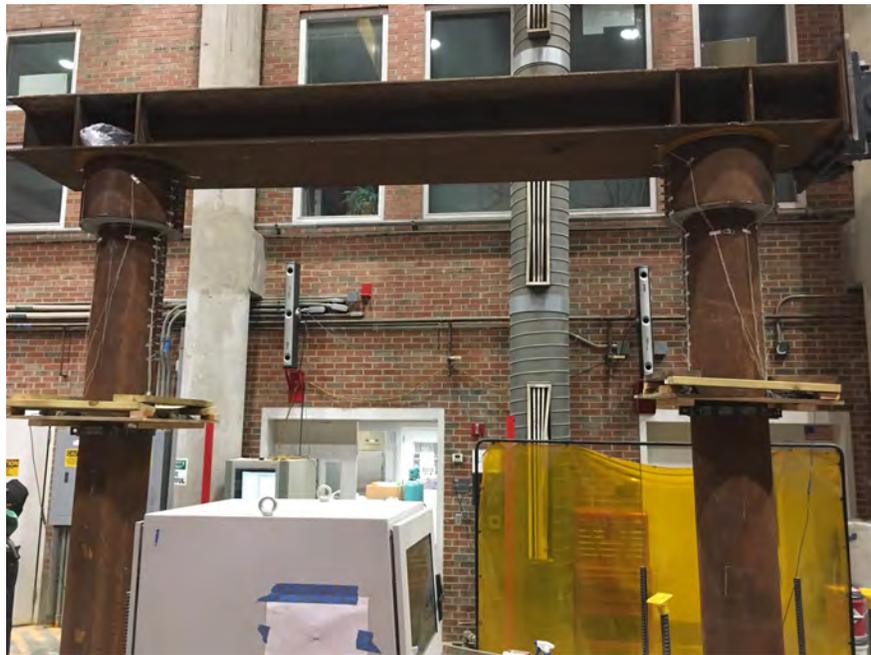
Figure 5.23: Specimens for large scale tests: (a) Test 3 (b) Test 4.

a 16” deep socket. Figure 5.23 shows a visual comparison of the test specimens with 24” and 16” deep sockets.

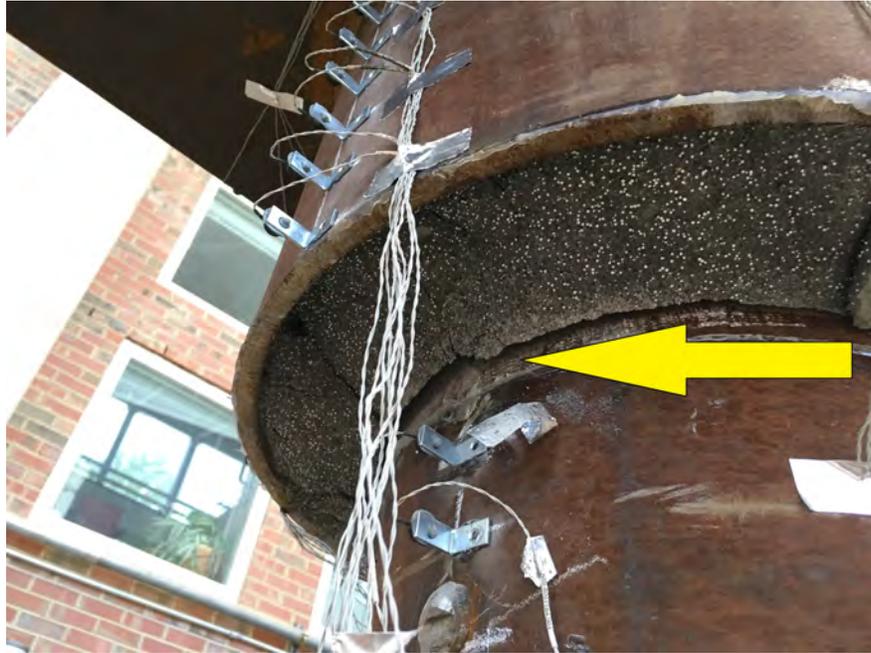
Figure 5.25: Gap opening up between the pile and grout ring (Ductility: 2, Cycle: 1, Force: 107.9 kips, Displacement: 5.46”).

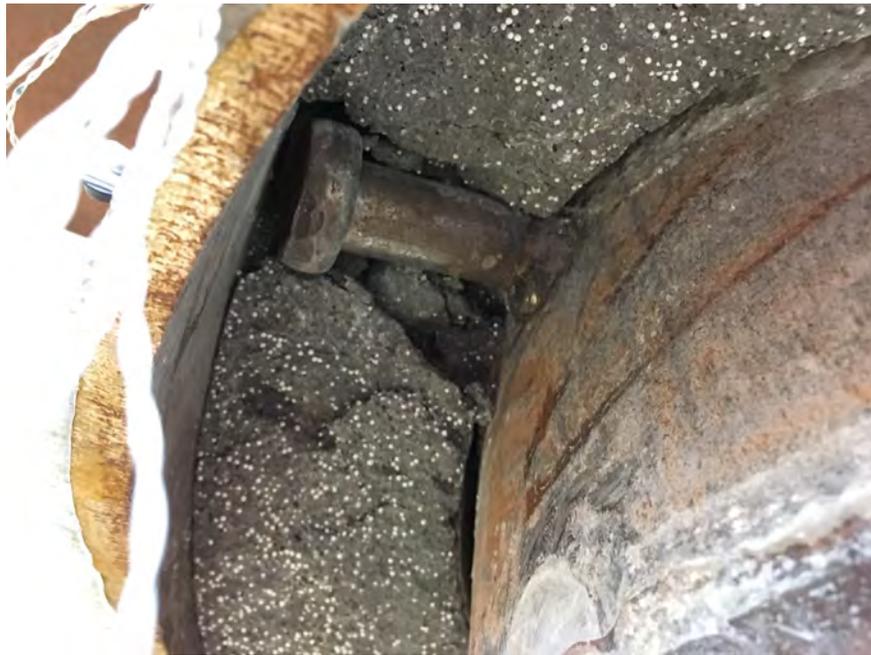
Figure 5.26: Bent shear stud (Ductility: 2, Cycle: 3, Force: 85.5 kips, Displacement: 5.49”).

During the test, grout cracking and spalling initiated early in the initial cycles at ductility 1, as shown in 5.24. The force in the system was also observed to drop in each successive cycle at ductility 1. A peak load of 108 kips was observed during the first cycle of ductility 2. Grout spalling continued to excessive levels throughout the cycles at ductilities 1.5, and 2. During the first cycle of ductility 2, the gap between the column and the grout ring became visible, as shown in Figure 5.25. The grout above the first row of shear studs started pushing the stud down resulting in permanent bending of the stud on the north side of the north column (Figure 5.26).

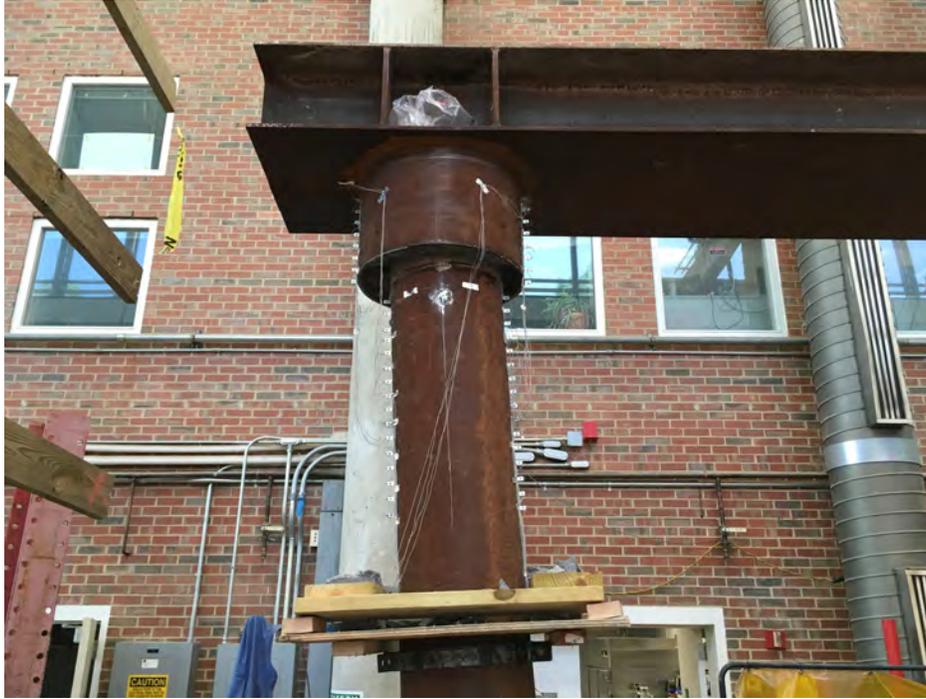
Figure 5.27: Column remaining straight under lateral loading (Ductility: 3, Cycle: 1, Force: 96.1 kips, Displacement: 8.48").

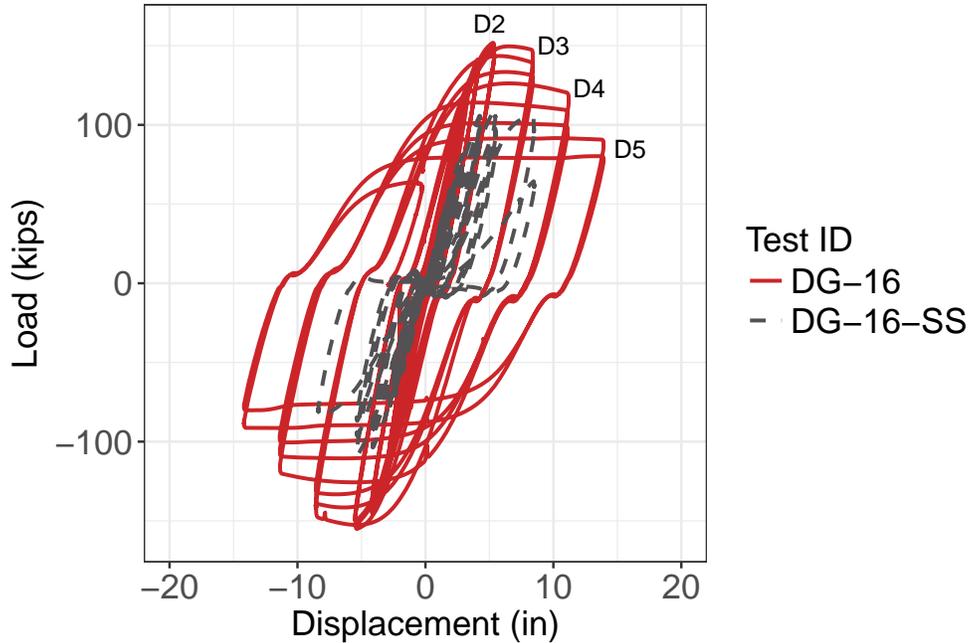
Figure 5.28: A comparison of the force-displacement hysteretic responses: Test 3 (DG-16) v Test 4 (DG-16-SS)

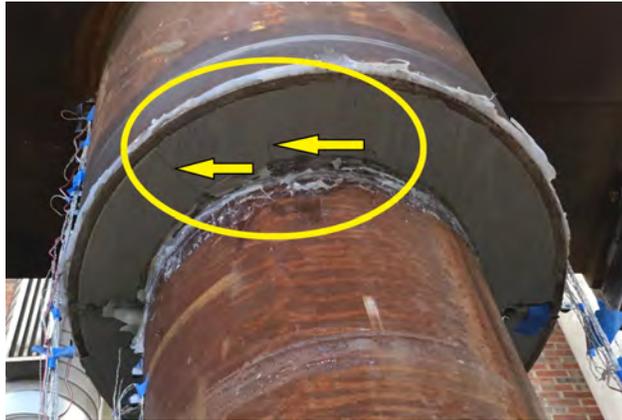
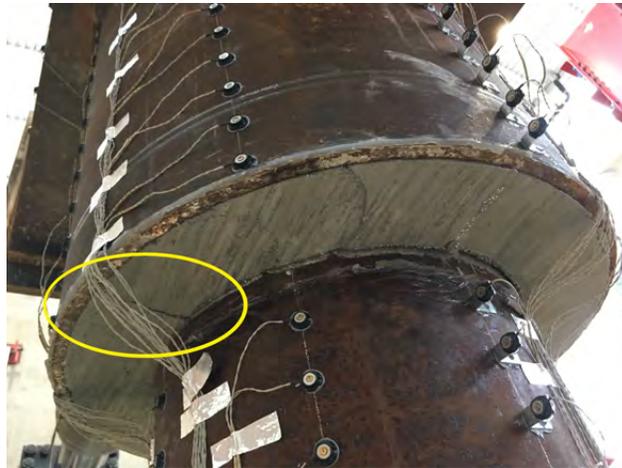
Figure 5.29: Grout cracking observed in the GSS connection transverse to the direction of loading in (a) Test 1 at $\mu_{1.5}$, (b) Test 2 at μ_1 , and (c) Test 3 at μ_1

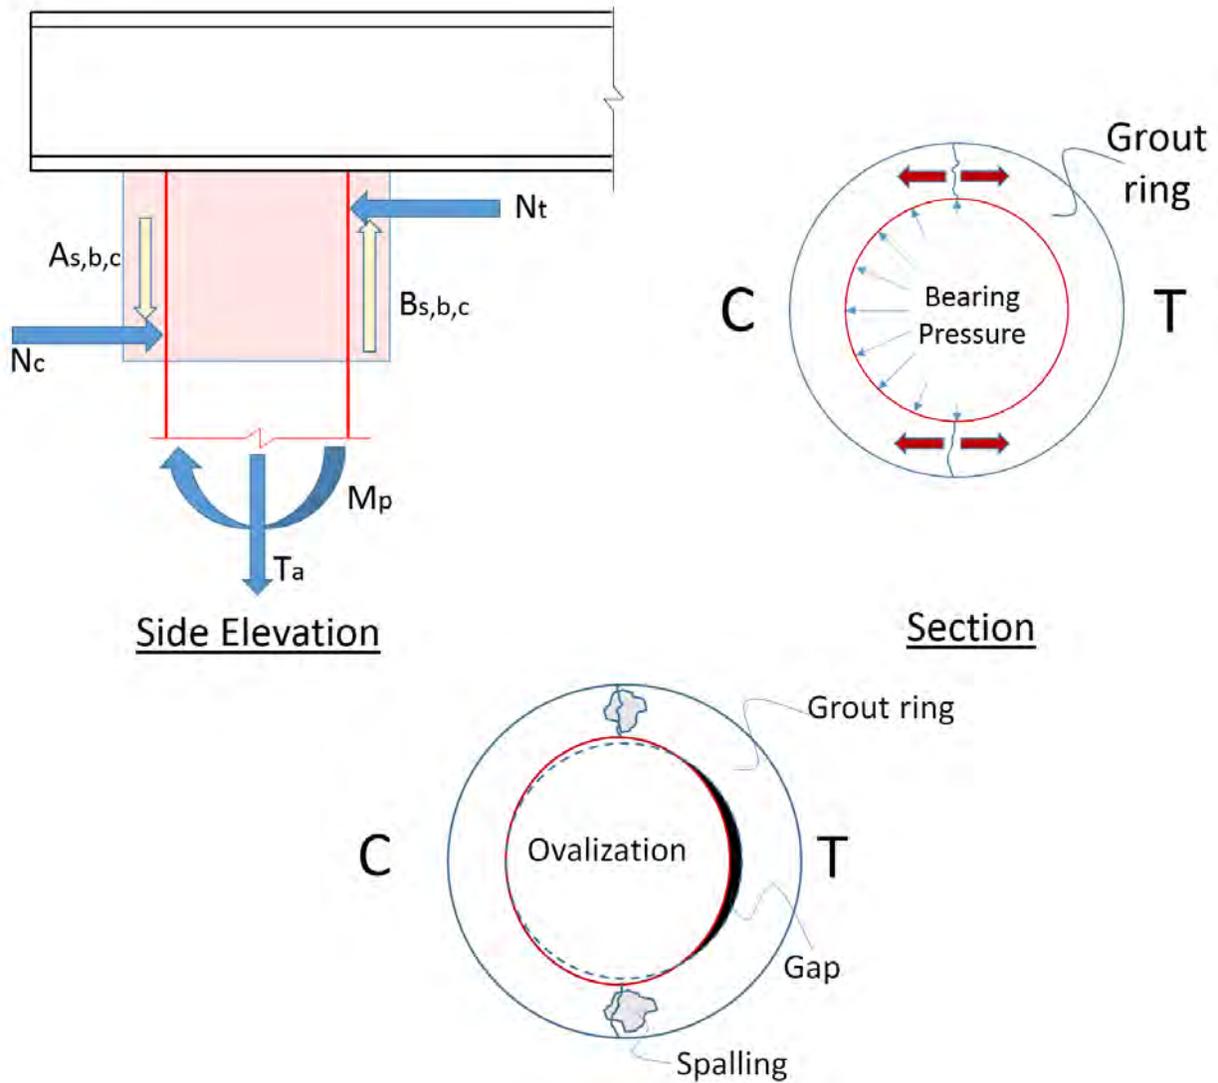
Figure 5.30: A schematic to explain cracking observed at the neutral axis, and the socket detachment limit state of the GSS connection.

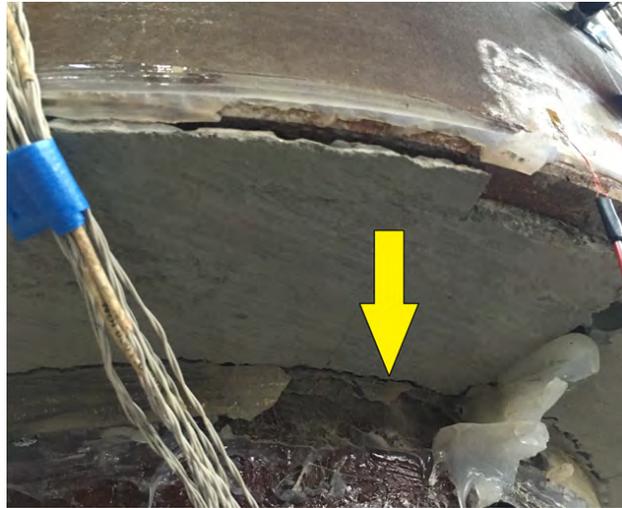
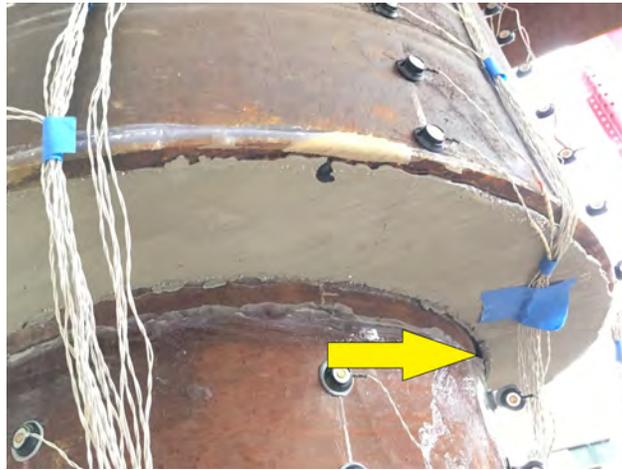
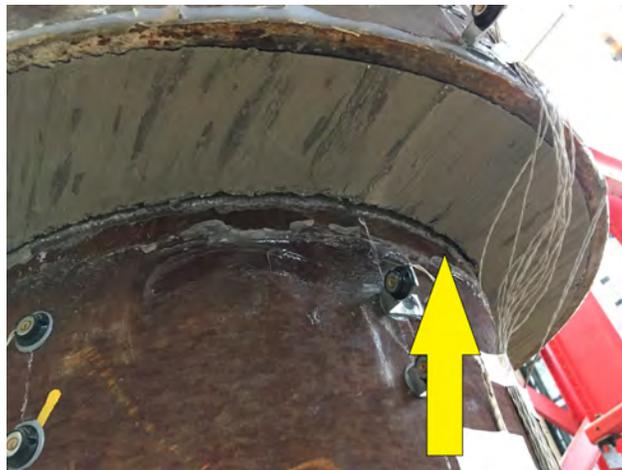
Figure 5.31: Socket detachment observed in the GSS connection on the tension side of the column under bending (a) Test 1 at $\mu_{1.5}$, (b) Test 2 at $\mu_{1.5}$, and (c) Test 3 at $\mu_{1.5}$.

As the tests progressed past ductility 1, a gap between the outside surface of the column and the inside surface of the grout ring opened. This is termed socket detachment. Due to the ovalization of the column section under lateral loading, the extreme ends get pushed inwards. This causes the tension side of the section to detach from the grout ring resulting in a gap.

The gap became visible at ductility 1.5 in all the three tests, as shown in Figure 5.31. A larger gap was observed in test 3 compared to tests 1 and 2. Test 1 had the smallest gap. Figure 5.32 shows the state of this gap at ductility 3. The gaps at ductility 3 were wider than the corresponding ones at ductility 1. Similar to ductility 1, a comparatively smaller gap was observed for test 1, still larger in Test 2, and the largest in test 3. In short, fewer studs led to larger gaps.

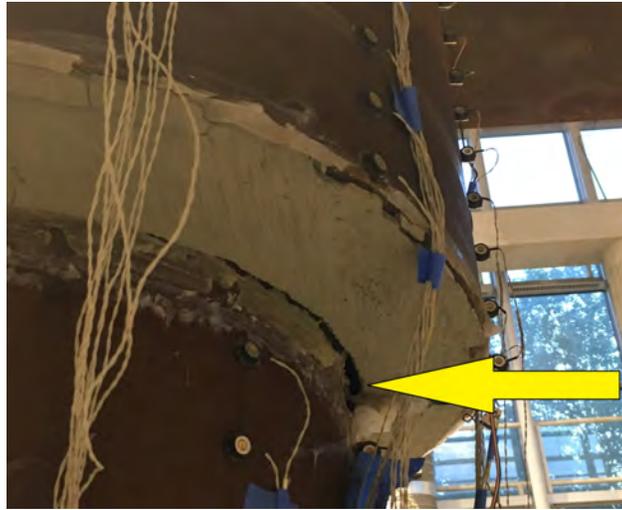
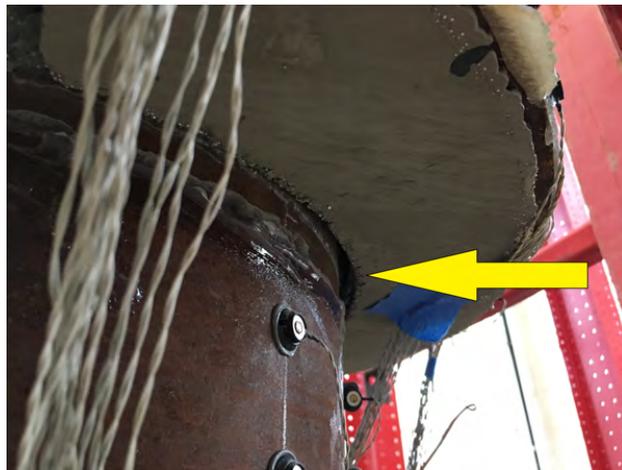
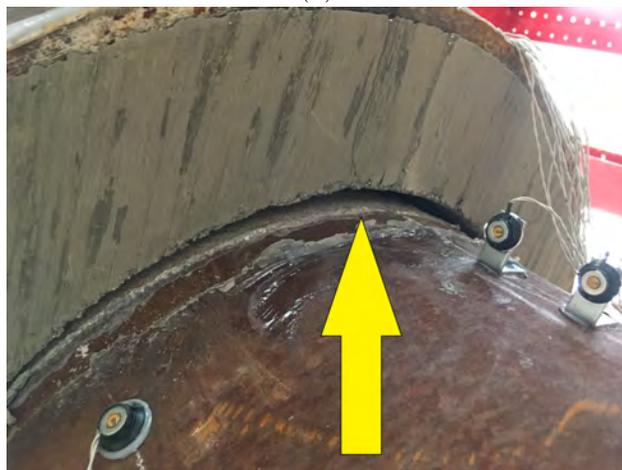
Figure 5.32: Socket detachment observed in the GSS connection on the tension side of the column under bending (a) Test 1 at μ_3 , (b) Test 2 at μ_3 , and (c) Test 3 at μ_3 .

3. The separation between the grout and the column increased to about 0.5" on the north column, as shown in Figure 5.32b. Pile wall local buckling was observed on the south side of the north column on the same cycle (Figure 5.34b). On the subsequent pull cycle, the north side of the south column also experienced pile wall local buckling. On the second push cycle of ductility 3, there was further grout spalling on the north side of the south column and the first row of shear studs was visible. The separation between the pile and the grout ring on the south side during the same cycle increased to 0.7".
