Durability of the Grouted Shear Stud Connection at Low Temperatures

FINAL REPORT

Alaska Department of Transportation & Public Facilities

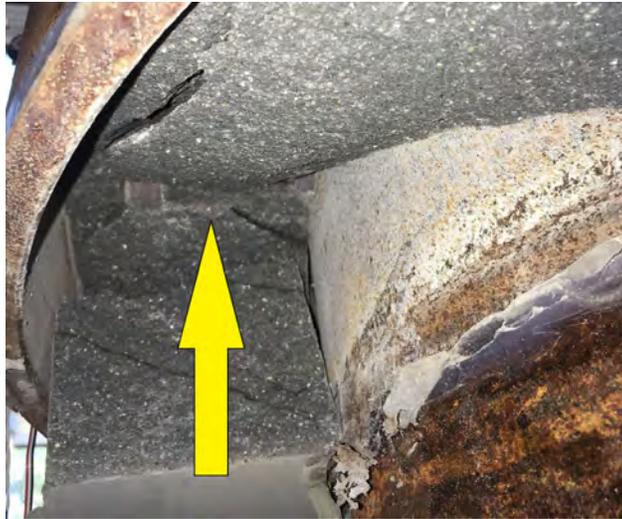
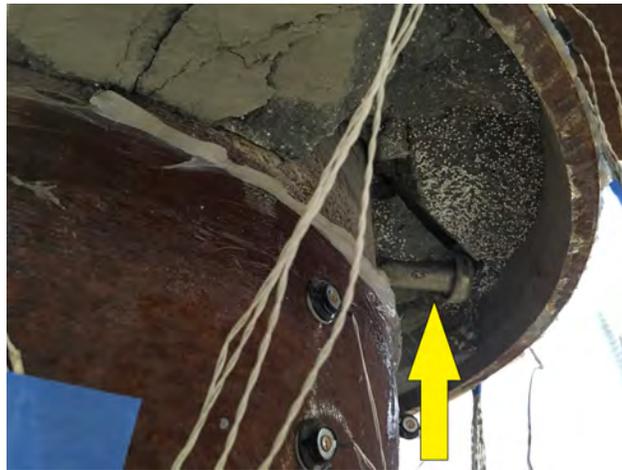
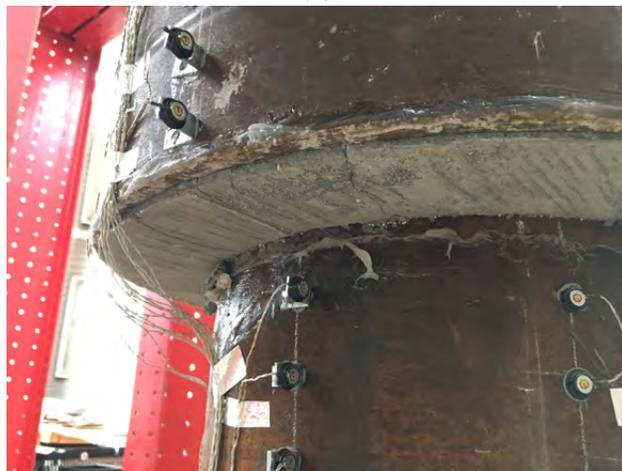
Figure 5.33: Grout spalling observed in a GSS connection in (a) Test 1 at μ_2 , and (b) Test 2 at μ_3 (c) No spalling was observed in Test 3.

The grout on the extreme ends (regions farthest from the neutral axis under bending) of the GSS connection spalled off after ductility 2 cycles. However, in test 3, no spalling was observed even past ductility 4. This may be attributed to the absence of a row shear studs close to the bottom of the connection. Figure 5.33 shows the occurrence of this limit state in the first two tests. As has been discussed earlier, the presence of shear studs closer to the bottom of the connection help resisting the widening of the gap between the column and the grout ring. The shear studs are engaged in tension to achieve this resistance. As the shear studs are loaded axially in tension, the grout immediately around them is also subjected to tensile stresses. When this stress exceeds the tensile capacity of the surrounding grout, the grout cracks and spalls out of the connection.

In test 3, there was a large enough grout cover of 8" from the bottom, that the gap at the level of first row of shear studs was smaller compared to the other two tests. This increased cover resulted in a reduced tensile stress demand on the grout surrounding these shear studs. This may explain the observation of no spalling in test 3.

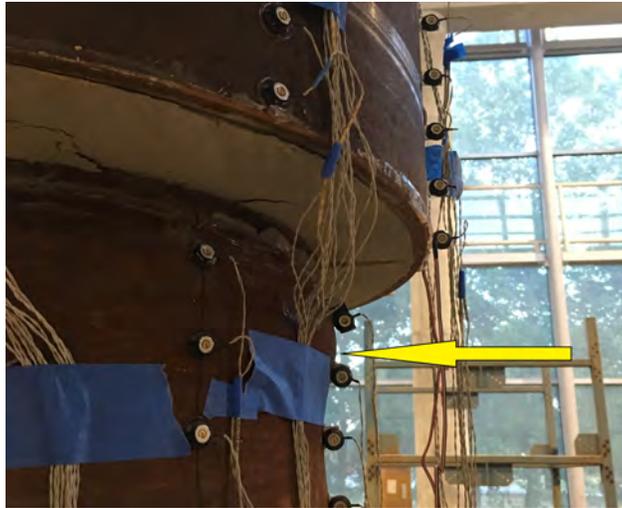
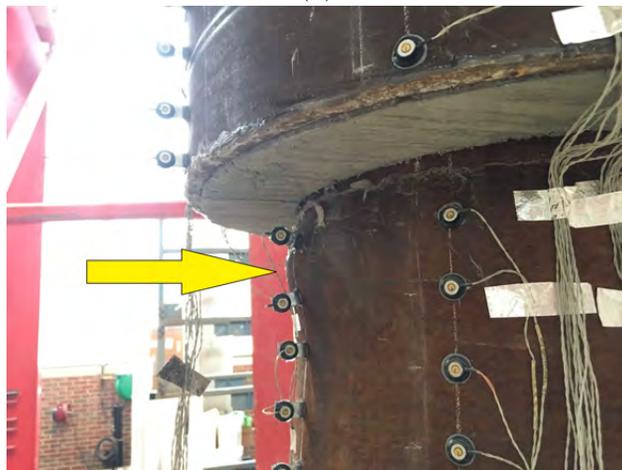
Figure 5.34: Visible pile wall buckling in (a) Test 1 at μ_2 , and (b) Test 2 at μ_3 (c) Test 3 at μ_3 .

Under cyclic loading, the column section reverses its compression and tension sides. Beyond a certain critical inelastic tensile strain, the pile wall has a propensity to buckle on the subsequent compression cycle. Pile wall buckling followed by plastic hinge formation just beneath the GSS connection is the desirable mode of failure for the bridge bent systems discussed in this report.

Figure 5.34 shows the first instance of visible pile wall buckling in tests 1, 2, and 3. Buckling initiated earlier in test 1 compared to the other two tests. This level of buckling typically straightens itself during the subsequent opposite cycle. Figure 5.35 shows buckling which was permanent. Similar to buckling initiation, this level of buckling also occurs earlier in test 1. And finally, Figure 5.36 shows excessive levels of buckling in the columns before rupture. Once again, test 1 attained the same level of buckling earlier at ductility 4 compared to the other two tests, that attained this at ductility 5.

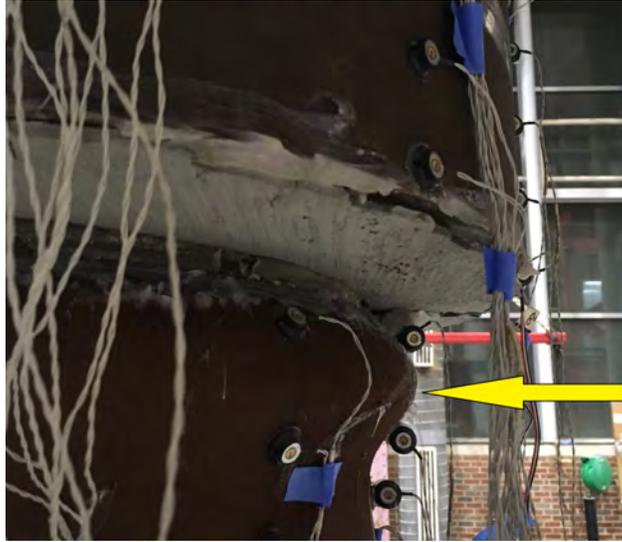
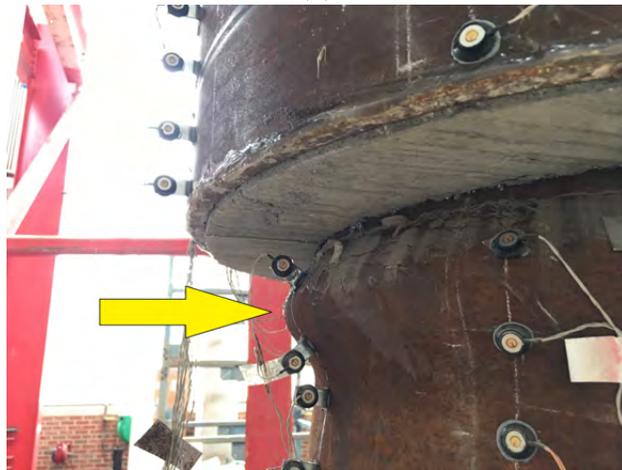
Figure 5.35: Permanent pile wall buckling in (a) Test 1 at μ_3 , and (b) Test 2 at μ_4 (c) Test 3 at μ_4 .

On every subsequent cycle, the load in the system dropped. During the first push of ductility 4, significant local buckling was observed in both columns, as shown in Figure 5.35b. All three cycles at ductility 4 were then completed without any sign of tear or rupture. After the first push cycle of ductility 5, some tear marks developed on the north column (Figure 5.37b). The specimen was then subjected to the first pull cycle at ductility 5. During this cycle, a loud popping sound was heard. Upon investigation, no pipe rupture had occurred yet. It is thought that the shear studs on the columns were bearing against the stub wall and consequently slipped with a sudden release of stored strain energy causing the popping sound. The specimen was then brought back to zero force. By this point, the

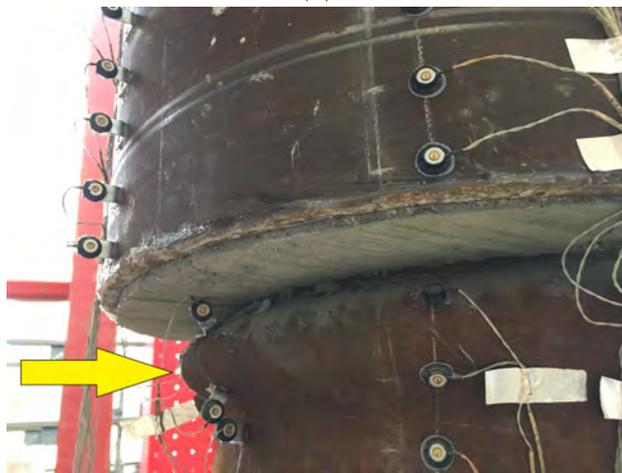
Figure 5.36: Excessive pile wall buckling in (a) Test 1 at μ_4 , and (b) Test 2 at μ_5 (c) Test 3 at μ_5 .

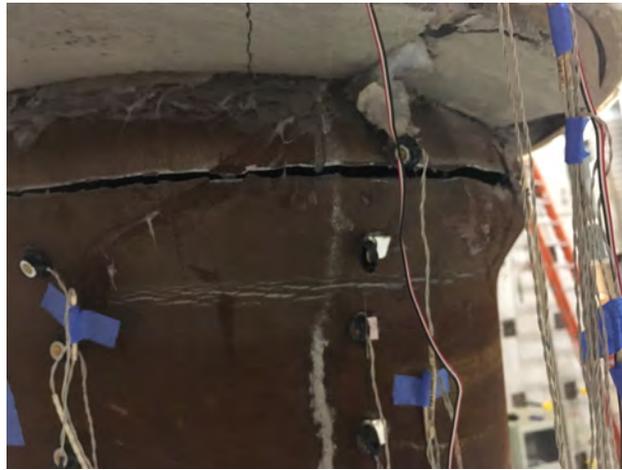
Figure 5.37: Excessive pile wall buckling in (a) Test 1 at μ_4 , and (b) Test 2 at μ_5 (c) Test 3 at μ_5 .

The ultimate limit state in the columns in a bridge bent incorporating the GSS connection is pile wall rupture. Figure 5.37 shows pile wall rupture in tests 1 and 3. Although not ruptured, the pile wall in test 2 showed tear marks. Tear marks were also observed in tests 1 and 3 before rupture during subsequent cycles. This limit state occurs after a large number

of inelastic cycles. In test 1, the pile ruptured during the first push to ductility 5. In tests 2 and 3, this occurred during the final cycle at ductility 5.
