Test Report No. 608331-01-1A-2-3
Test Report Date: April 2019

MASH TL-4 EVALUATION OF 2019 MASH 2-TUBE BRIDGE RAIL

Sponsored by
State of Alaska Department of Transportation and Public
Facilities and North Dakota Department of Transportation

TEXAS A&M TRANSPORTATION INSTITUTE PROVING GROUND

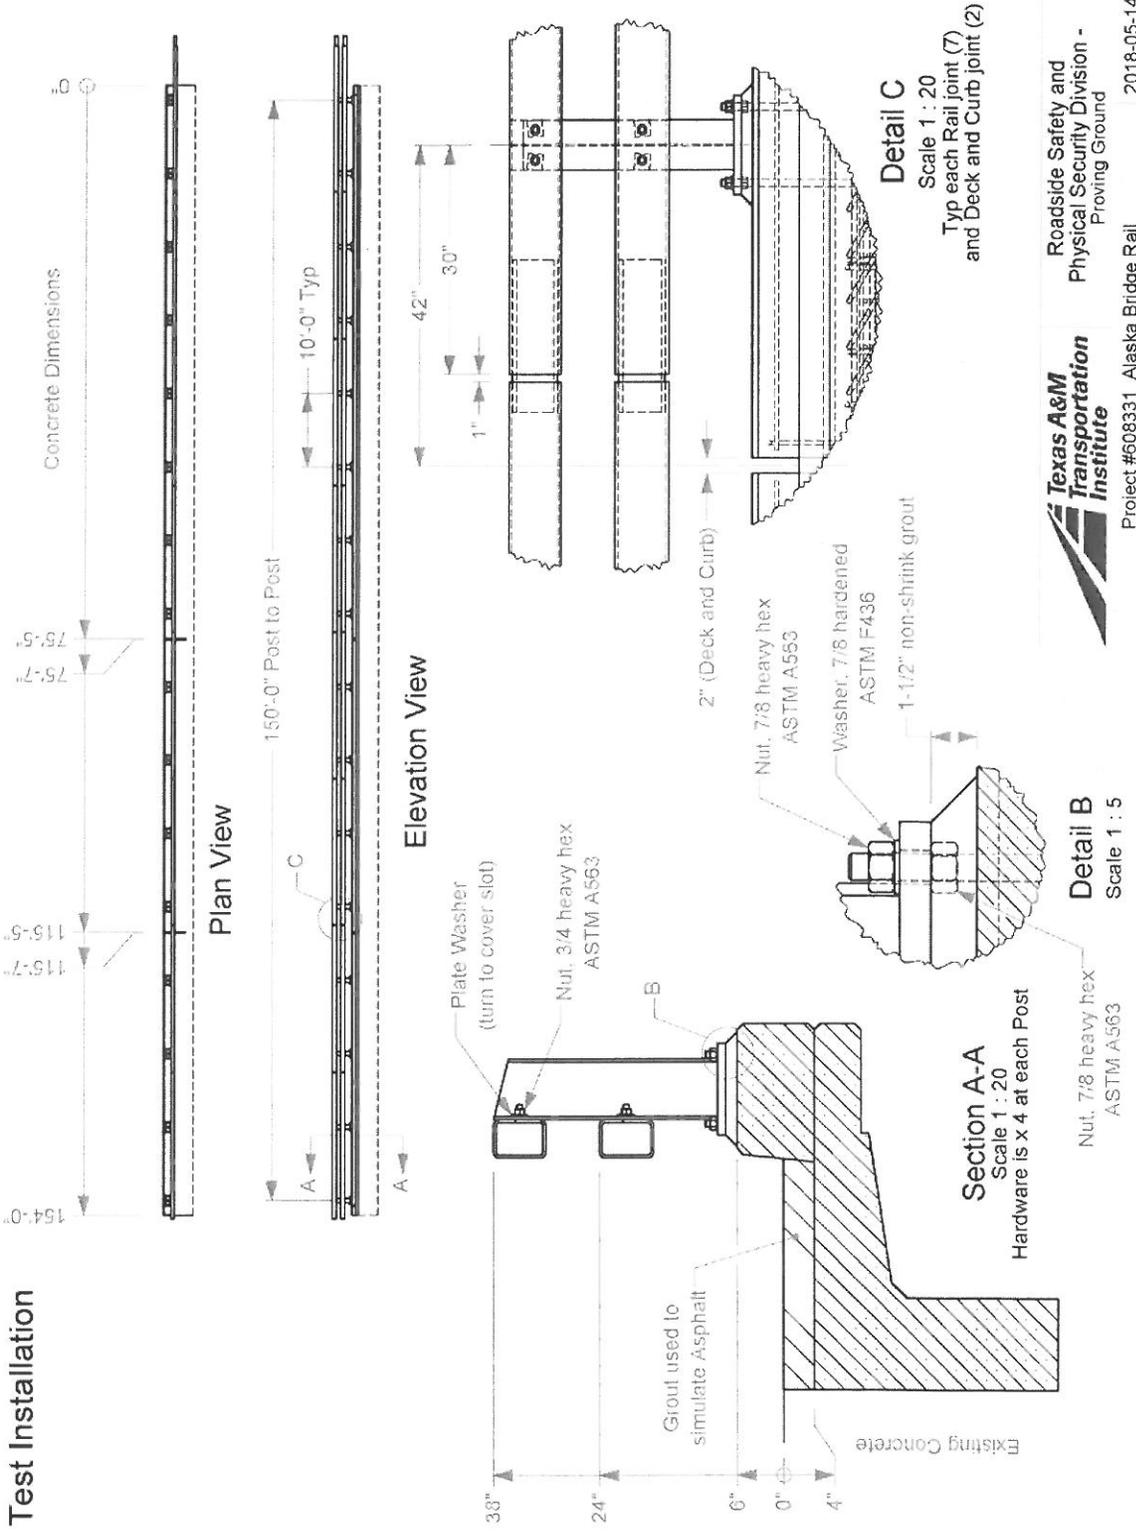
Figure 2.1. Details of the 2019 MASH 2-Tube Bridge Rail.

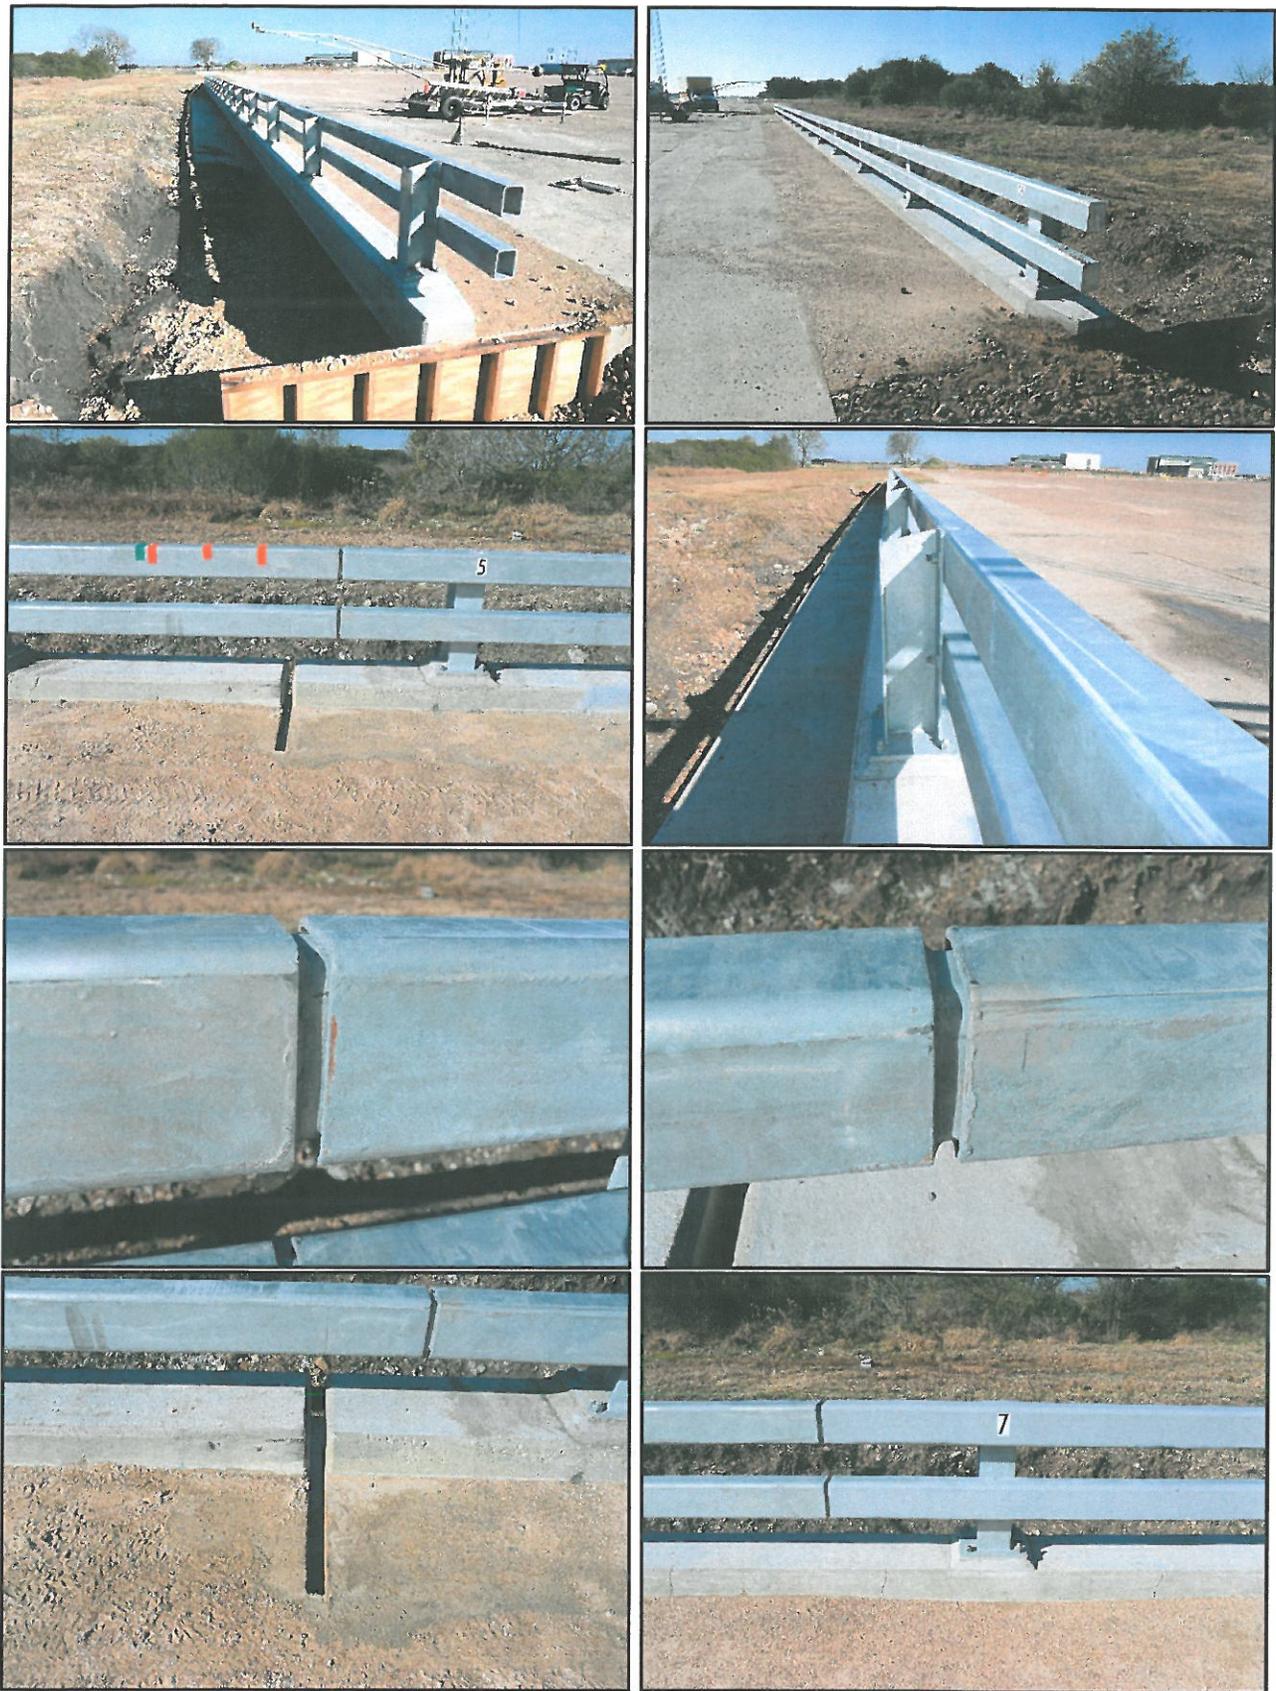
Figure 2.2. 2019 MASH 2-Tube Bridge Rail prior to Testing.

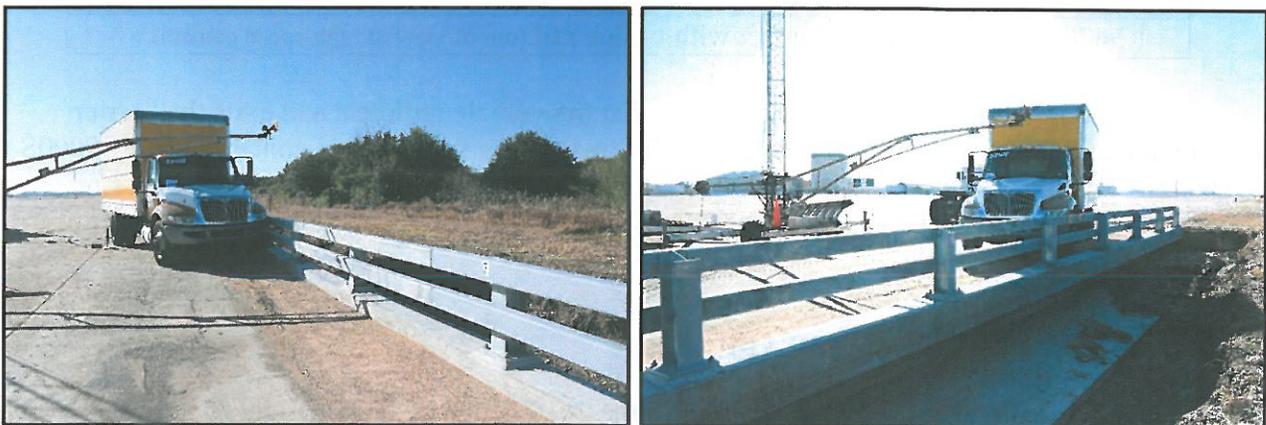
Figure 5.1. 2019 MASH 2-Tube Bridge Rail/Test Vehicle Geometrics for Test No. 608331-01-1A.

Figures 5.1 and 5.2 show the 2011 International 4300 single-unit truck used for the crash test. The vehicle's test inertia weight was 22,050 lb, and its gross static weight was 22,050 lb. The height to the lower edge of the vehicle bumper was 19.0 inches, and height to the upper edge of the bumper was 34.0 inches. The height to the center of gravity of the vehicle's ballast was 61.25 inches. Tables C.1 in Appendix C1 give additional dimensions and information on the vehicle. The vehicle was directed into the installation using the cable reverse tow and guidance system, and was released to be freewheeling and unrestrained just prior to impact.

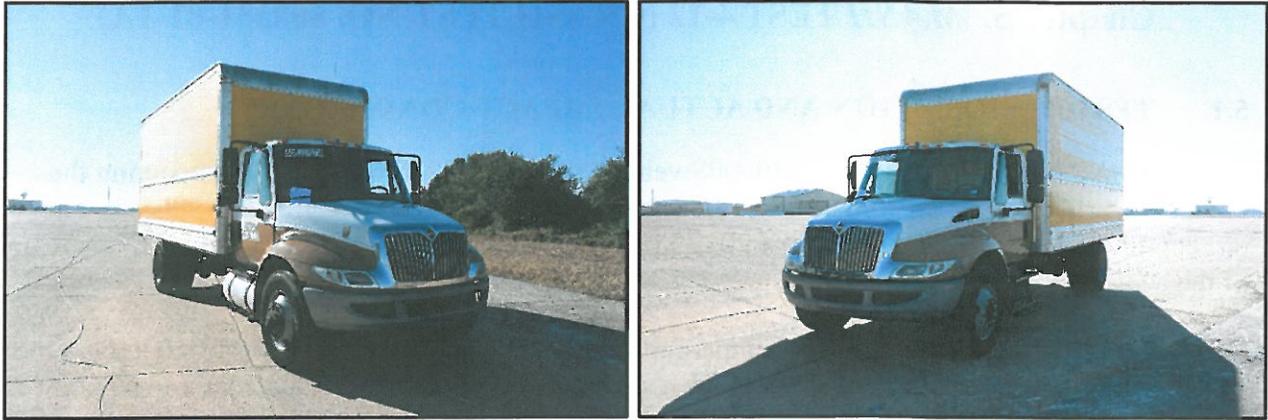
Figure 5.2. Test Vehicle before Test No. 608331-01-1A.

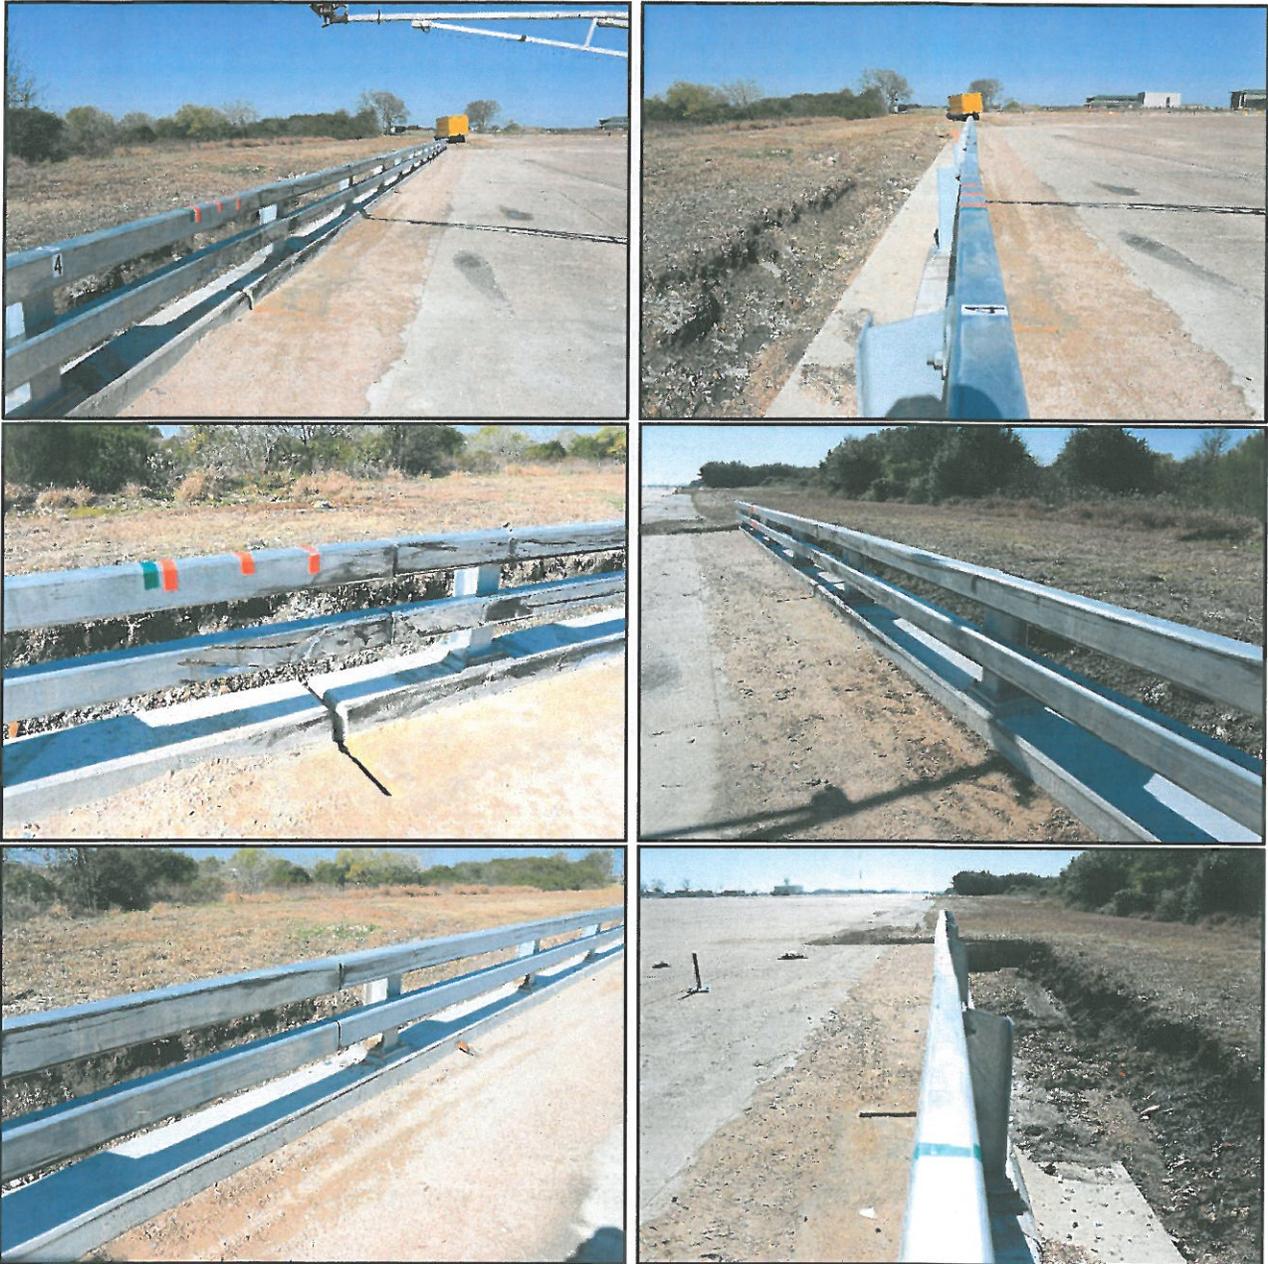
Figures 5.3 and 5.4 show the damage to the 2019 MASH 2-Tube Bridge Rail. The traffic face of the bridge rail was scuffed with tire marks, and the lower rail element was gouged in the impact area. The curb was cracked on the downstream side of post 5 and just upstream of post 5 (see Figure 5.4). Working width was 56.7 inches at a height of 136.8 inches. Maximum

dynamic deflection during the test was 3.0 inches, and maximum permanent deformation was 2.0 inches.

Figure 5.3. Overall Damage to Alaska Bridge Rail after Test No. 608331-01-1A.

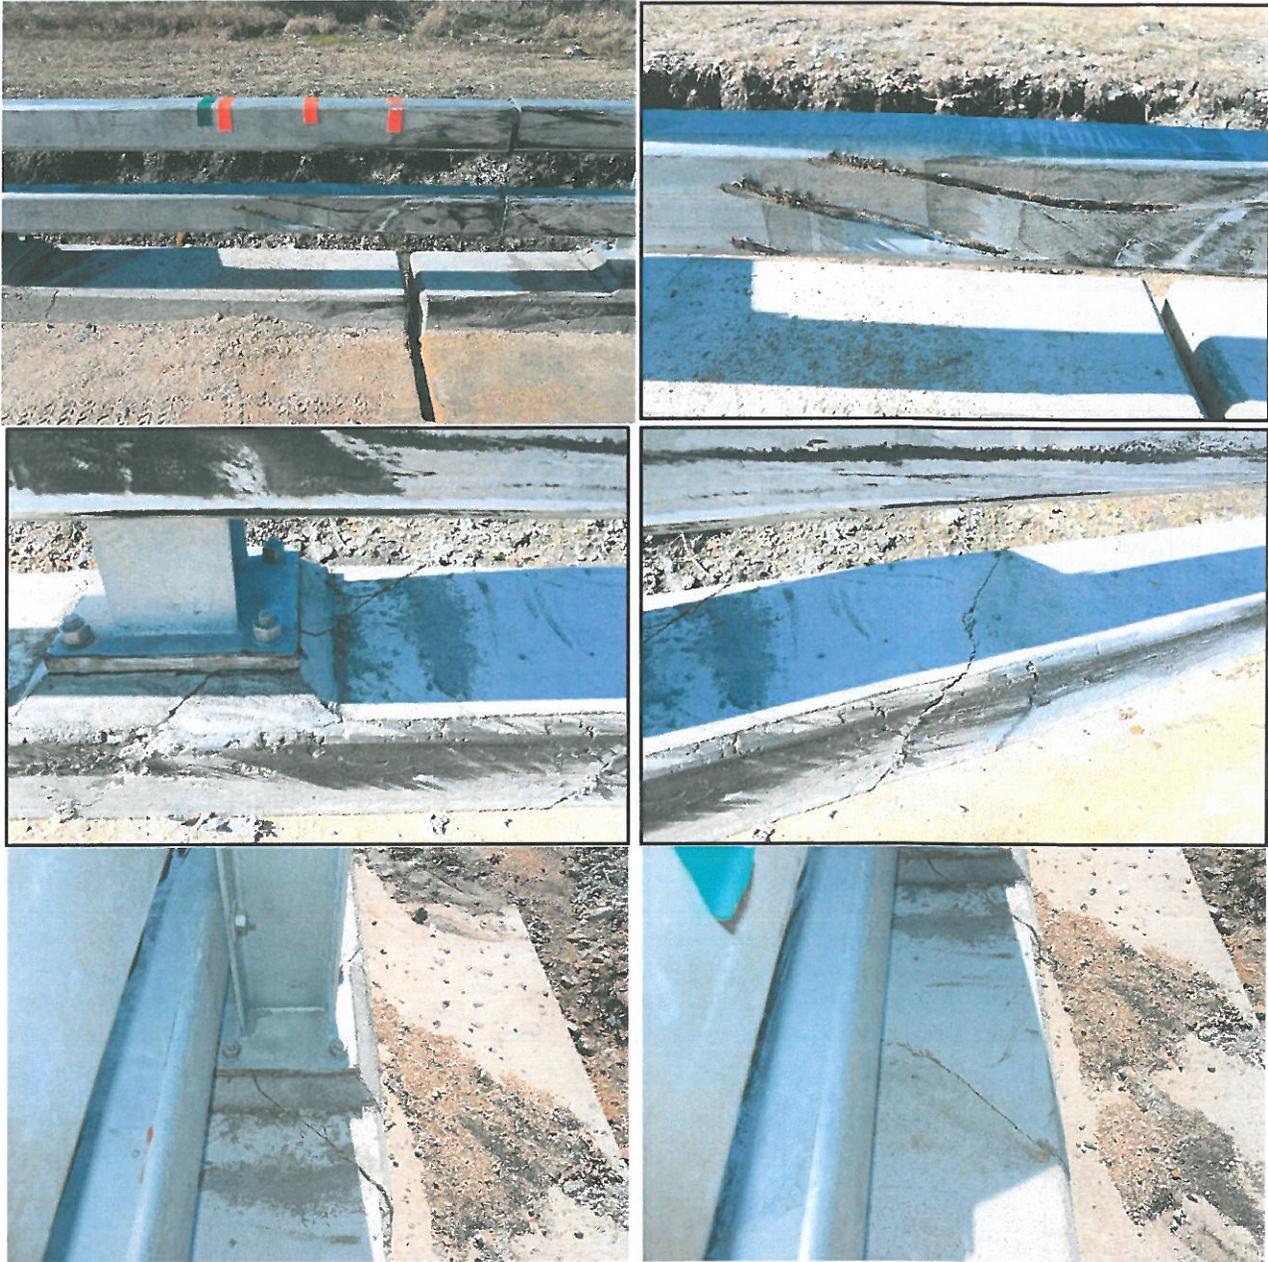
Figure 5.4. Impact Area after Test No. 608331-01-1A.

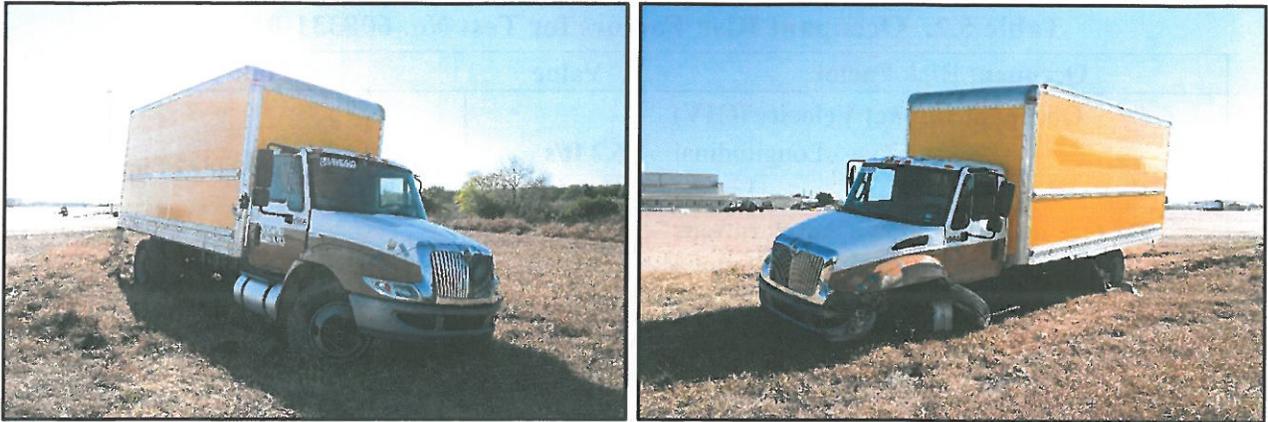
Figure 5.5 shows the damage sustained by the vehicle. The front bumper, hood, left front tire and rim, left front U-bolts, left battery box, left side steps, left door, left rear cab corner, lower edge of box, and left rear outer tire and rim were damaged. Maximum exterior crush to the vehicle was 12.0 inches in the front plane at the left front corner at bumper height. Maximum occupant compartment deformation was 5.5 inches in the left front corner of the floor pan. Figure 5.6 shows the interior of the vehicle.

Figure 5.5. Test Vehicle after Test No. 608331-01-1A.

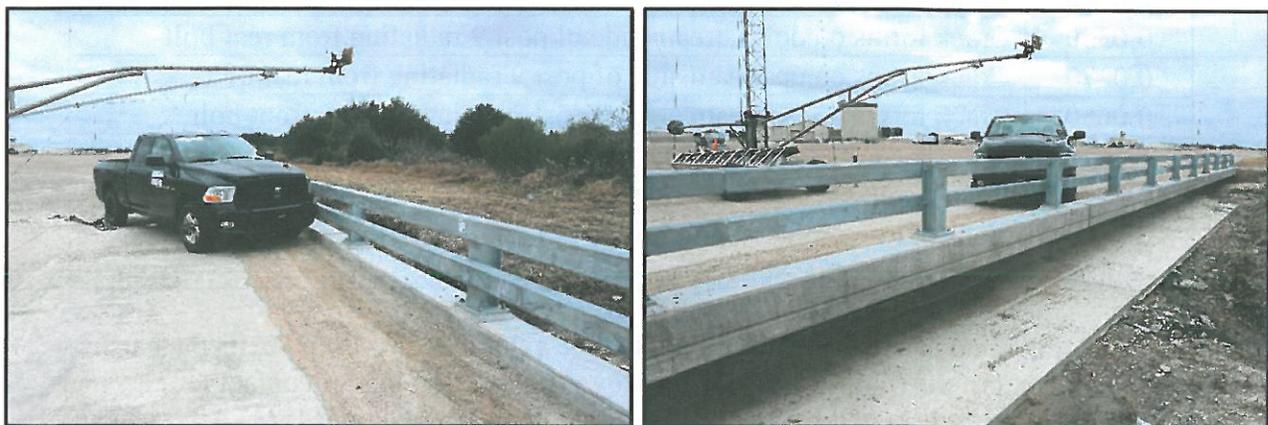
Figure 6.1. 2019 MASH 2-Tube Bridge Rail/Test Vehicle Geometrics for Test No. 608331-01-2.

Figures 6.1 and 6.2 show the 2012 RAM 1500 pickup truck used for the crash test. The vehicle's test inertia weight was 5019 lb, and its gross static weight was 5184 lb. The height to the lower edge of the vehicle bumper was 11.75 inches, and height to the upper edge of the bumper was 27.0 inches. The height to the vehicle's center of gravity was 29.0 inches. Tables D.1 and D.2 in Appendix D1 give additional dimensions and information on the vehicle. The vehicle was directed into the installation using the cable reverse tow and guidance system, and was released to be freewheeling and unrestrained just prior to impact.

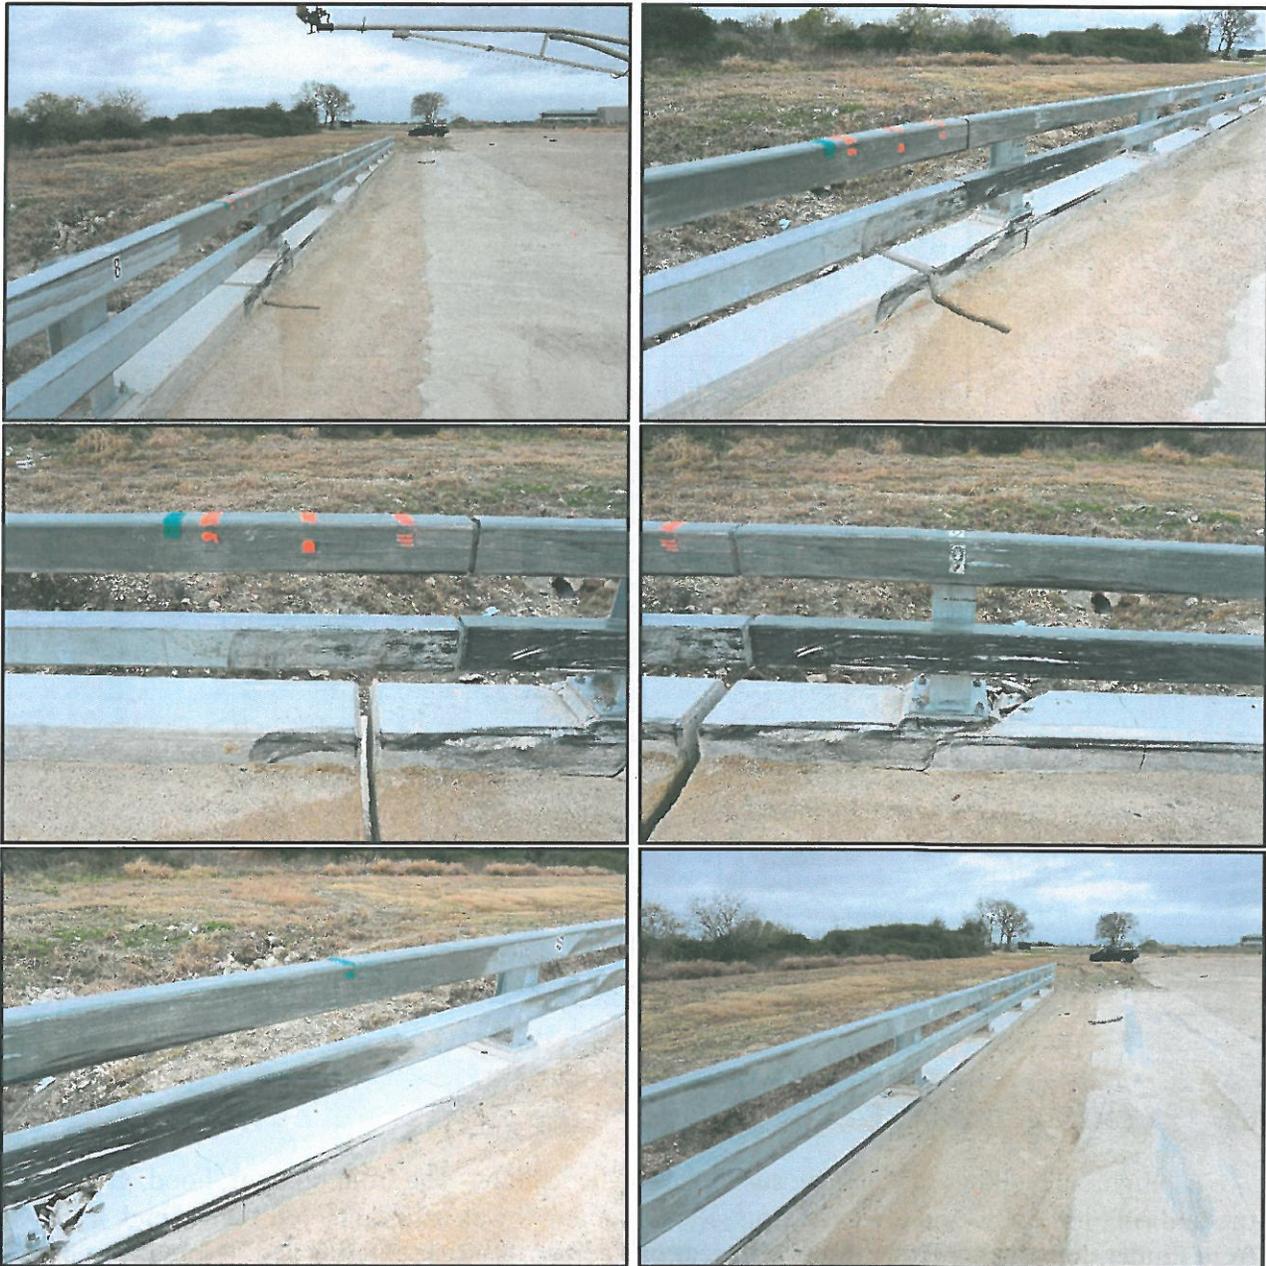
Figures 6.3 and 6.4 show the damage to the 2019 MASH 2-Tube Bridge Rail. The metal rail elements were scuffed with tire marks and cosmetic damage. The concrete around the curb at post 8 was cracked. The concrete around post 9 was cracked and spalled off, revealing the rebar on the field side of the curb and on the underside of the deck. Working width was 20.2 inches at the top of post 9. Maximum dynamic deflection during the test was 7.1 inches, and maximum permanent deformation was 2.0 inches.

Figure 6.3. 2019 MASH 2-Tube Bridge Rail after Test No. 608331-01-2.

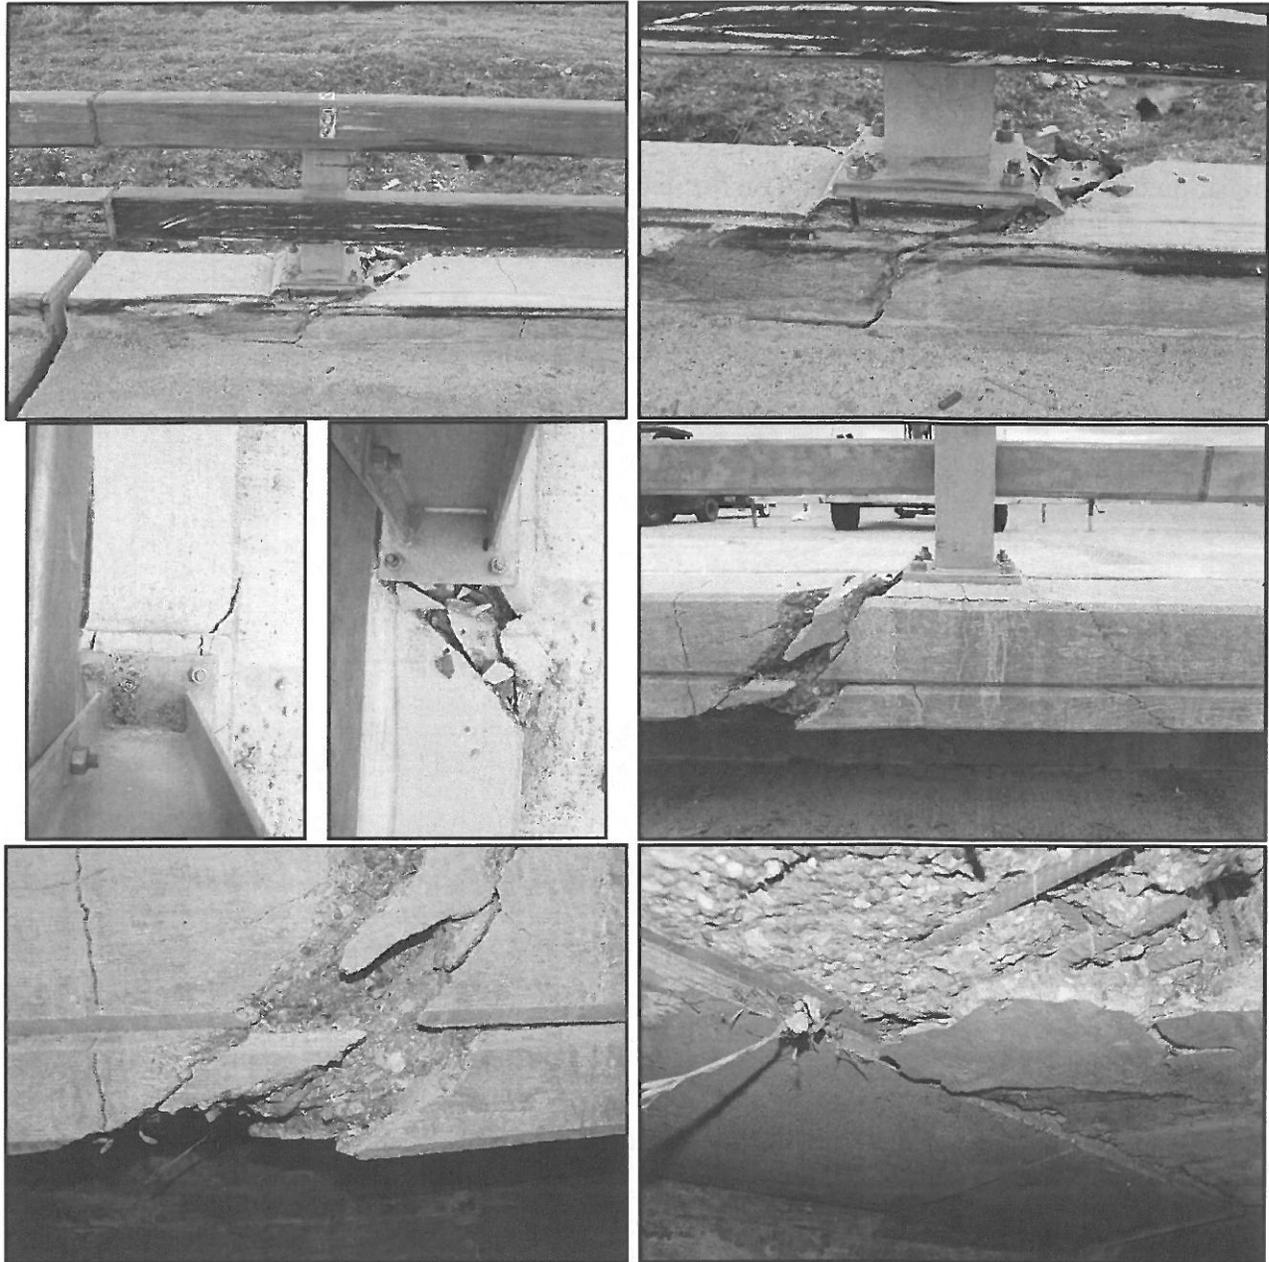
Figure 6.4. Damage at Post 9 after Test No. 608331-01-2.

TIME (s)	EVENTS
0.0000	Vehicle contacts barrier
0.0180	Lower metal rail element begins to deflect
0.0210	Upper metal rail element begins to deflect
0.0220	Vehicle begins to redirect
0.0290	Crack forms on downstream side of post 9 radiating from front bolt
0.0340	Bumper reaches post 9
0.0350	Crack forms on downstream side of post 9 radiating from rear bolt
0.0370	Crack forms on upstream side of post 9 radiating from rear bolt
0.0650	Crack forms on upstream side of post 8 radiating from front bolt
0.1670	Vehicle parallel with bridge rail
0.1720	Rear of vehicle contacts bridge rail
0.2800	Vehicle loses contact with bridge rail while traveling at 52.9 mi/h and exit trajectory/heading of 8.7°/6.5°

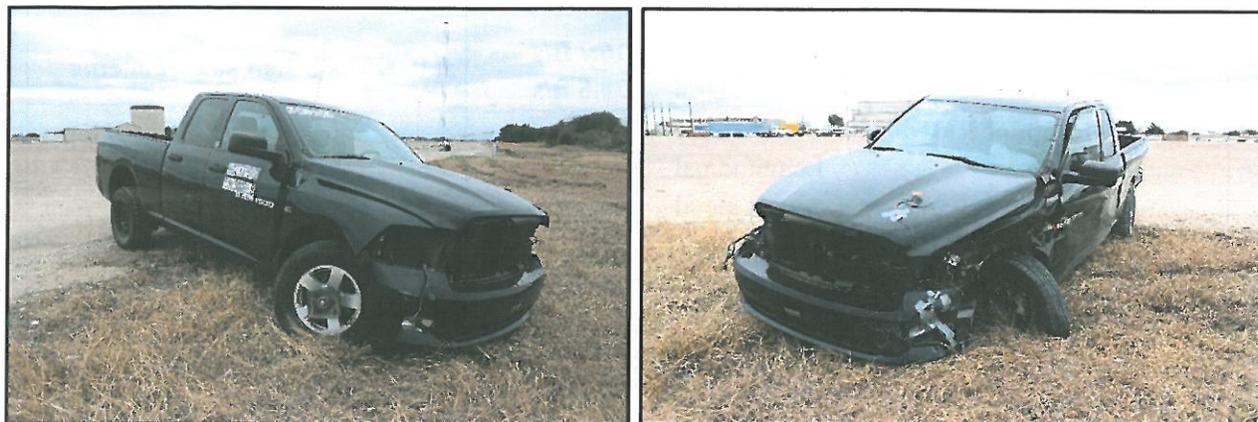
Figure 6.5 shows the damage sustained by the vehicle. The front bumper, hood, grill, left tire and rim, left upper and lower A-arms, left upper and lower ball joints, left tie rod end, left front fender, left front and rear doors, left rear cab corner, left rear exterior bed, left rear rim, rear bumper, and tailgate were damaged. The windshield sustained stress cracks radiating up and out from the left lower corner. Maximum exterior crush to the vehicle was 11.0 inches in the side plane at the left front corner at bumper height. Maximum occupant compartment deformation

was 0.5 inch in the left front firewall area. Figure 6.6 shows the interior of the vehicle. Tables D.3 and D.4 in Appendix D1 provide exterior crush and occupant compartment measurements.

Figure 6.5. Test Vehicle after Test No. 608331-01-2.

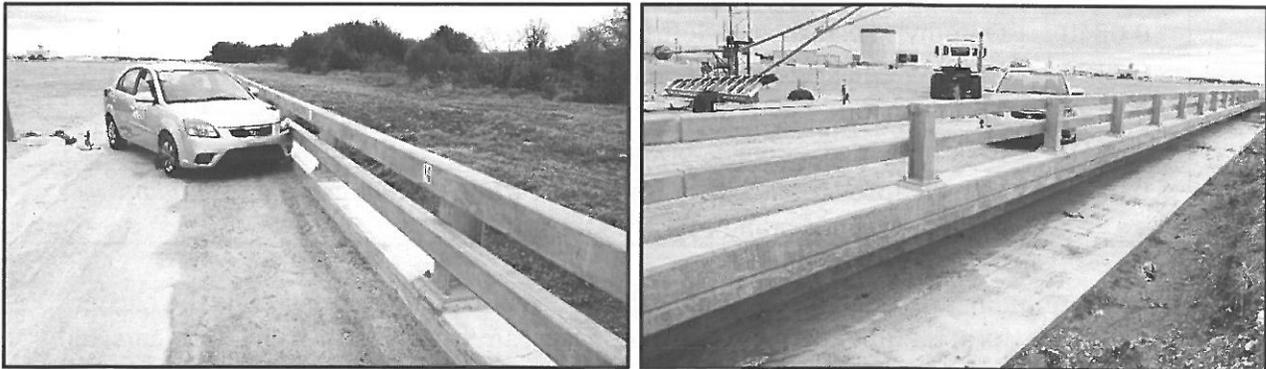
Figure 7.1. 2019 MASH 2-Tube Bridge Rail/Test Vehicle Geometrics for Test No. 608331-01-3.

Figures 7.1 and 7.2 show the 2010 Kia Rio used for the crash test. The vehicle's test inertia weight was 2454 lb, and its gross static weight was 2619 lb. The height to the lower edge of the vehicle bumper was 7.75 inches, and height to the upper edge of the bumper was 21.5 inches. Table E.1 in Appendix E1 gives additional dimensions and information on the vehicle. The vehicle was directed into the installation using the cable reverse tow and guidance system, and was released to be freewheeling and unrestrained just prior to impact.

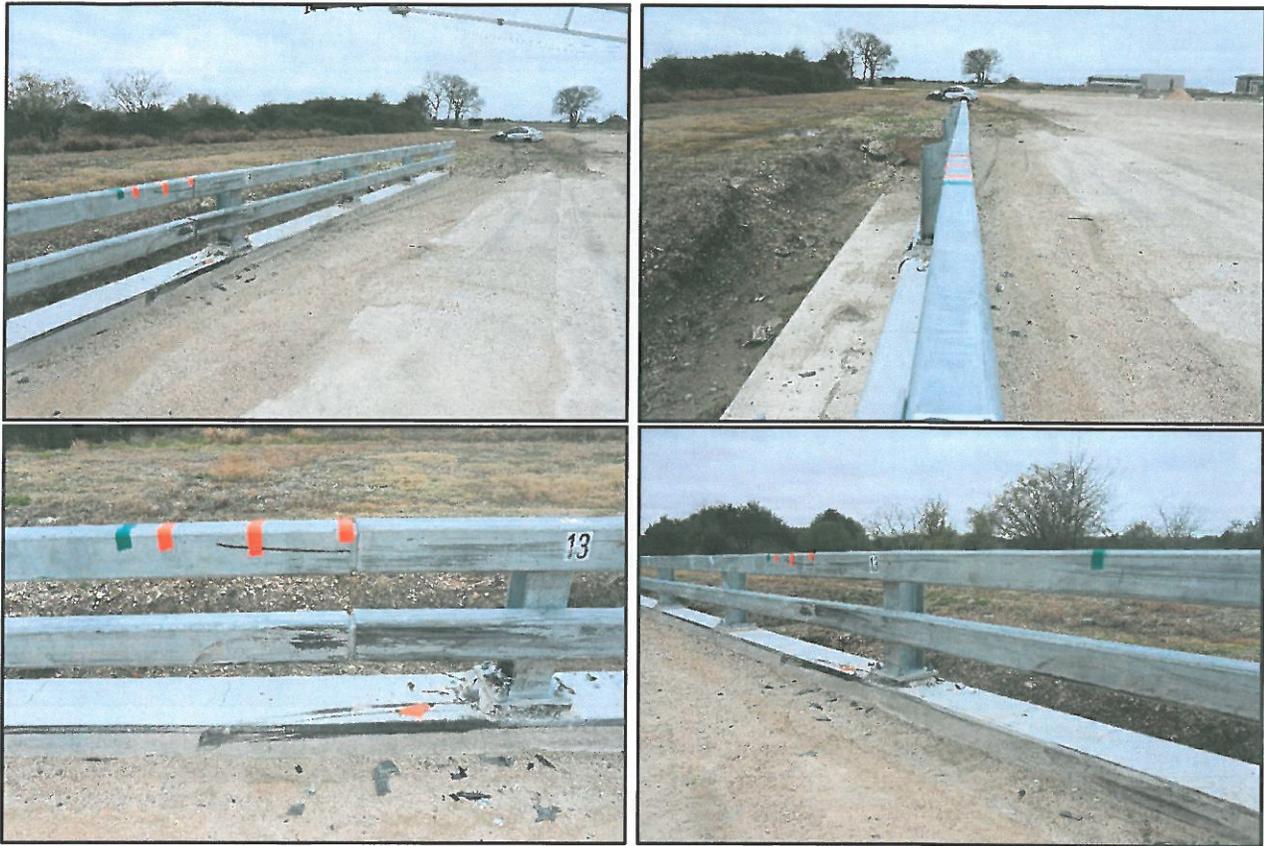
Figure 7.3 and 7.4 show the damage to the 2019 MASH 2-Tube Bridge Rail. The metal rail elements were scuffed with tire marks and cosmetic damage. The concrete around the base

of post 13 was broken through the curb on both sides of the post and extended to the bottom of the deck. Working width was 8.5 inches at a height of 44.3 inches. Maximum dynamic deflection during the test was 2.8 inches, and maximum permanent deformation was 1.0 inch.

Figure 7.3. 2019 MASH 2-Tube Bridge Rail after Test No. 608331-01-3.

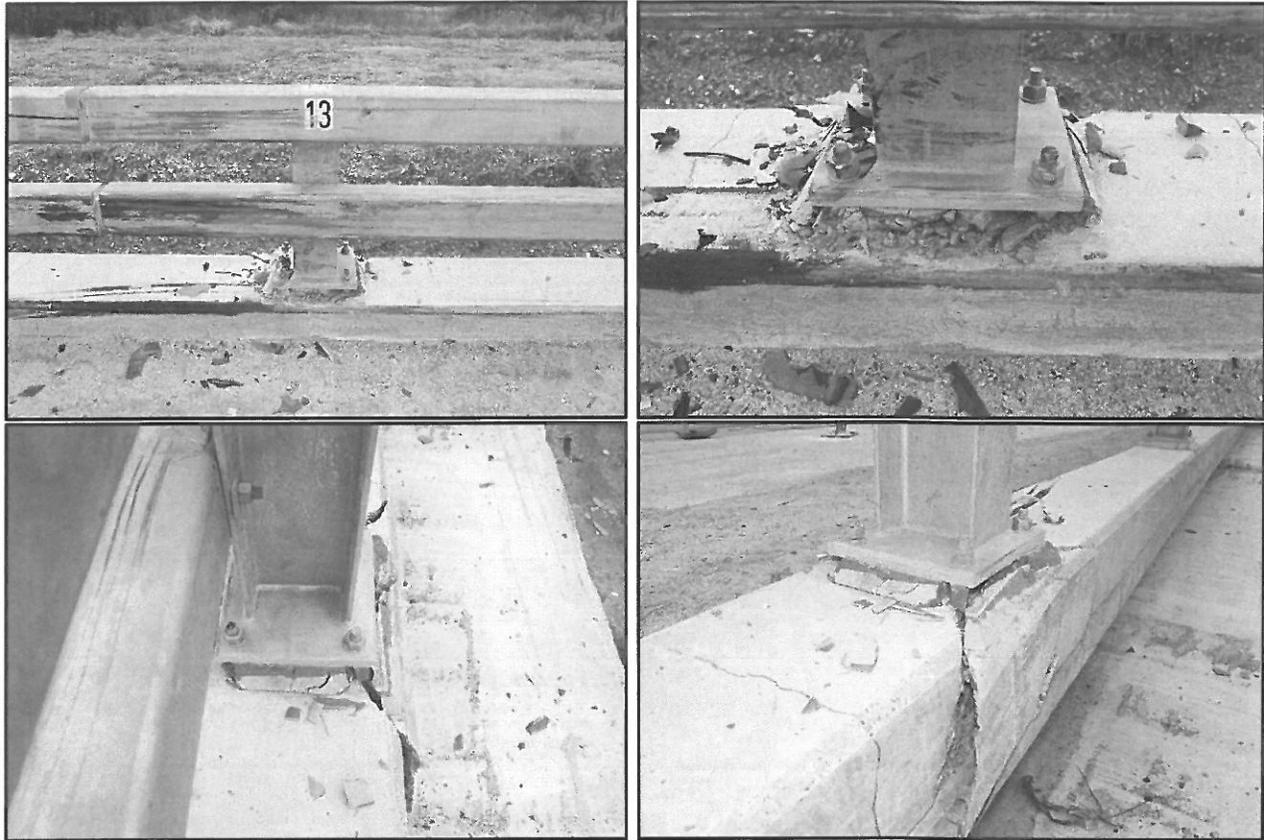
Figure 7.4. Damage at Post 13 after Test No. 608331-01-3.

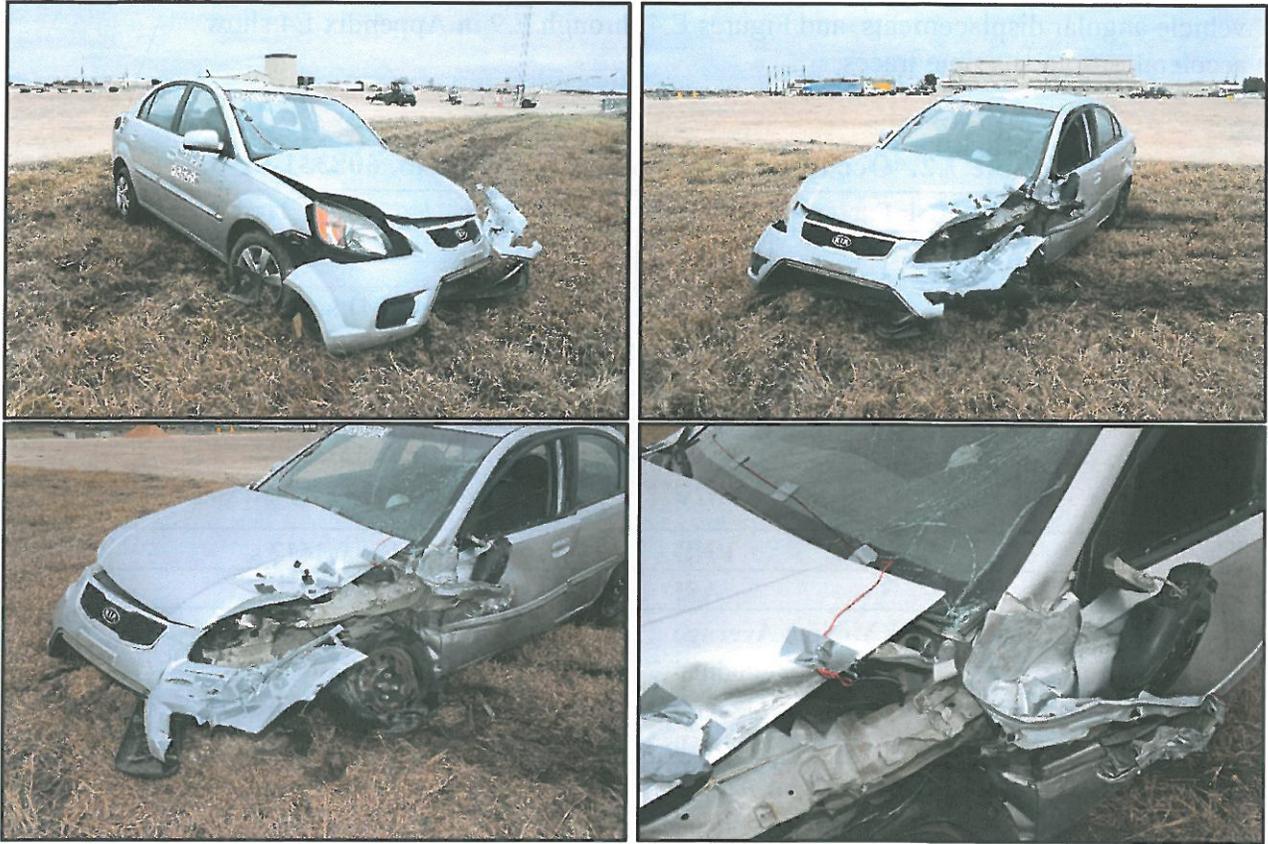
Figure 7.5 shows the damage sustained by the vehicle. The front bumper, hood, radiator and support, left front fender, left front tire and rim, left front strut and tower, left A-post, roof, left front door and window glass, left rear door, left rear quarter panel, and rear bumper were damaged. The windshield sustained stress cracks radiating upward and outward from the left lower corner. Maximum exterior crush to the vehicle was 11.0 inches in the side plane at the left front corner at bumper height. Maximum occupant compartment deformation was 4.0 inches in the left front firewall area. Figure 7.6 shows the interior of the vehicle. Tables E.2 and E.3 in Appendix E1 provide exterior crush and occupant compartment measurements.

Figure 7.5. Test Vehicle after Test No. 608331-01-3.

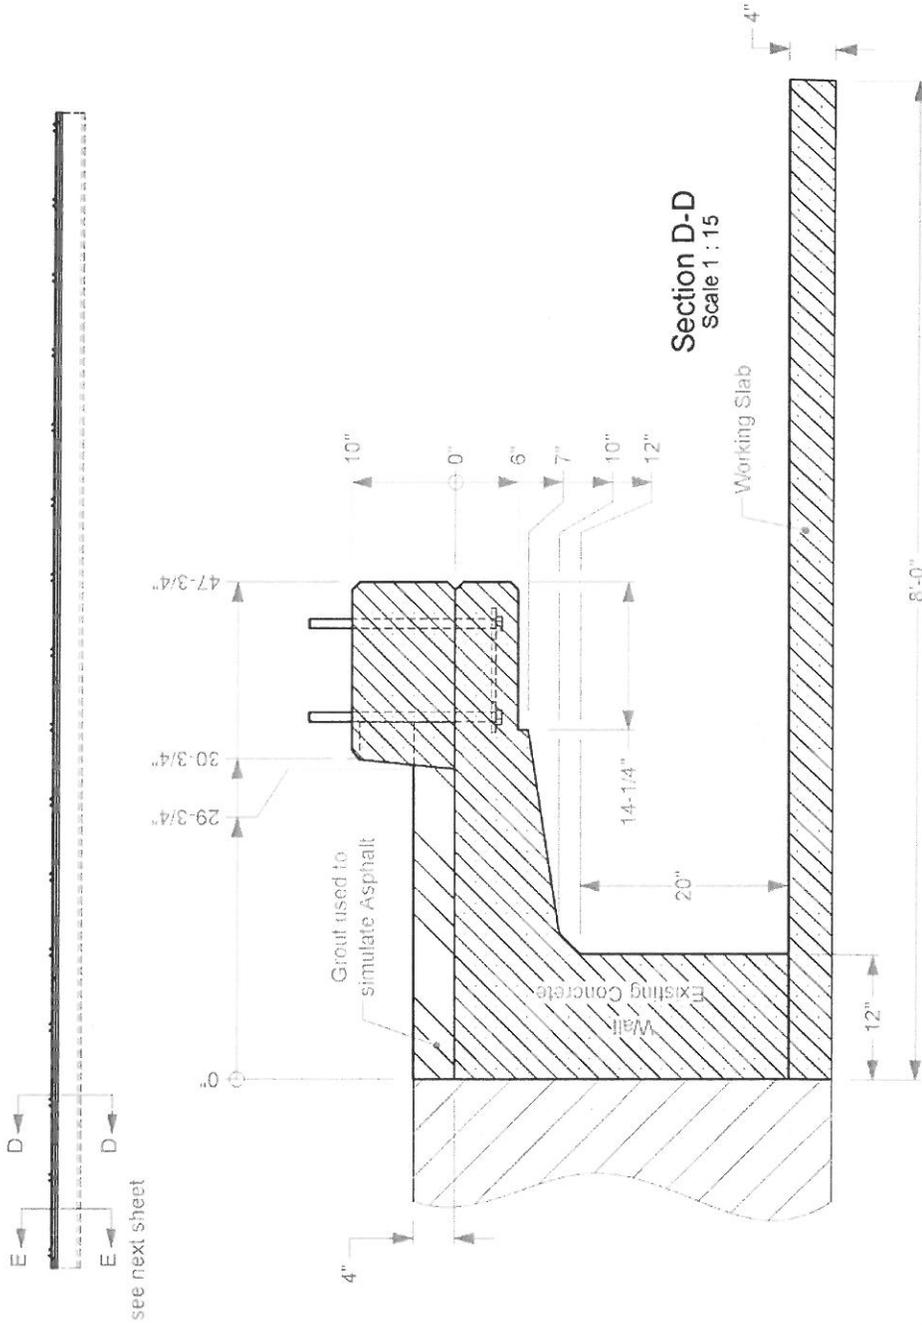
Details, Elevation

2a. Concrete Strength is 5000psi for the Wall and Deck, 3000 psi for the Working Slab, and 4000 psi for the Curb.
 2b. Chamfer Field Side edges of Deck, and field side and top edges of end of Curb 3/4" each way as shown.

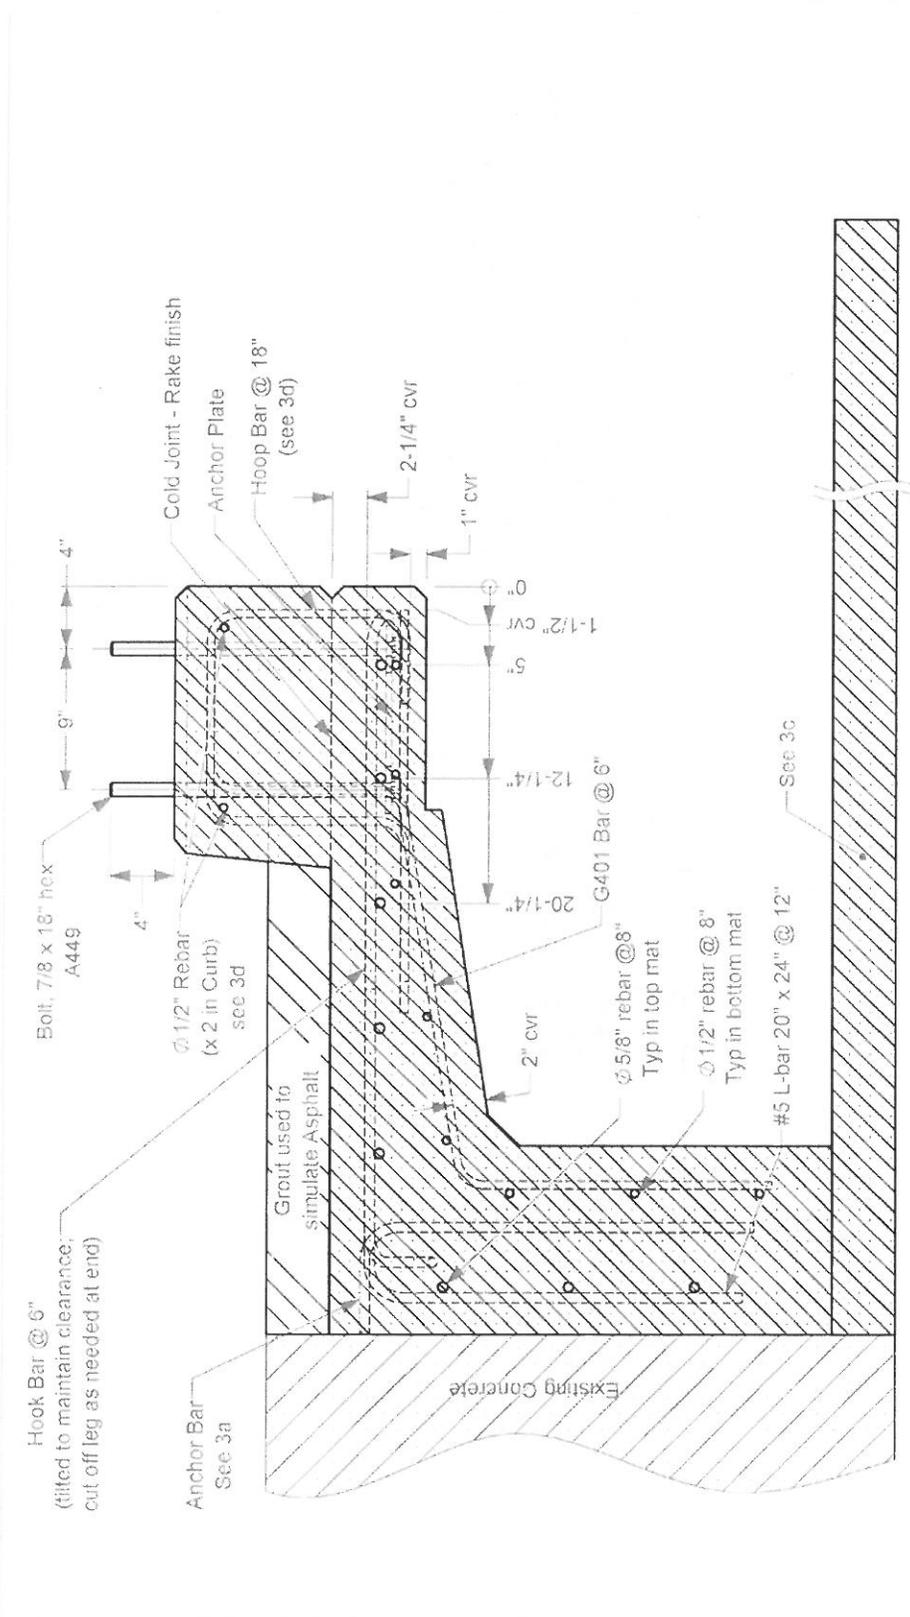
Section E-E

Scale 1 : 10

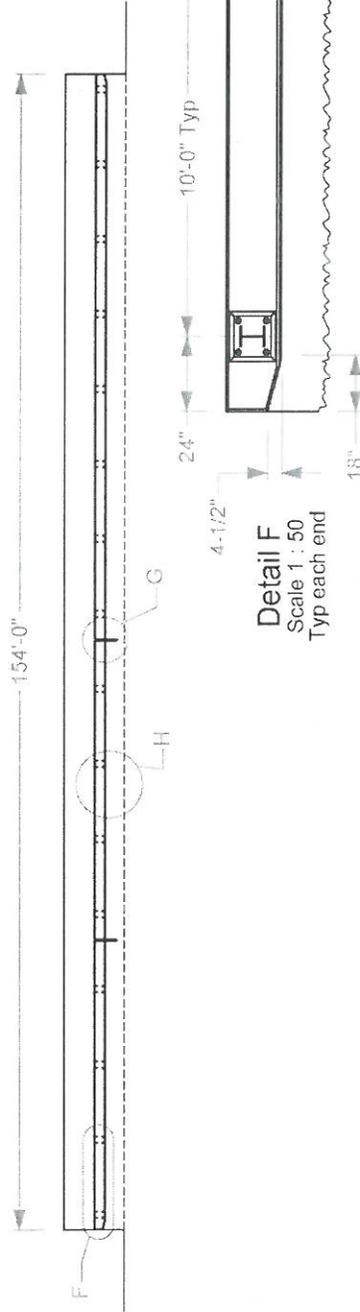
Detail F
Scale 1 : 50
Typ each end

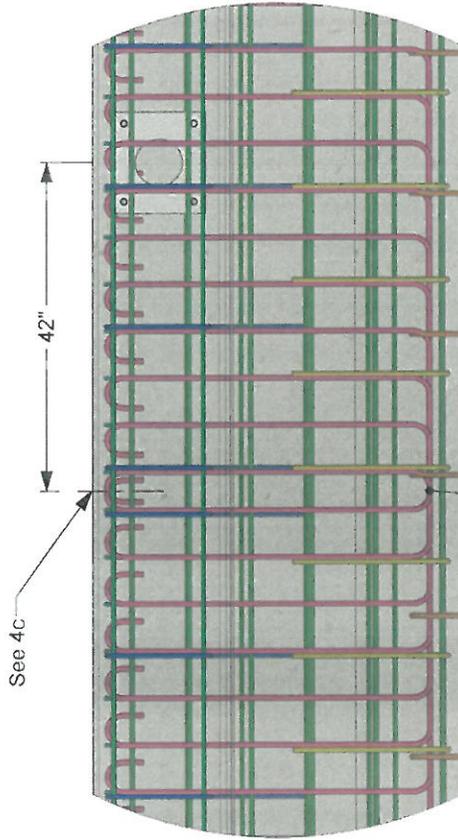
Detail H
Scale 1 : 20

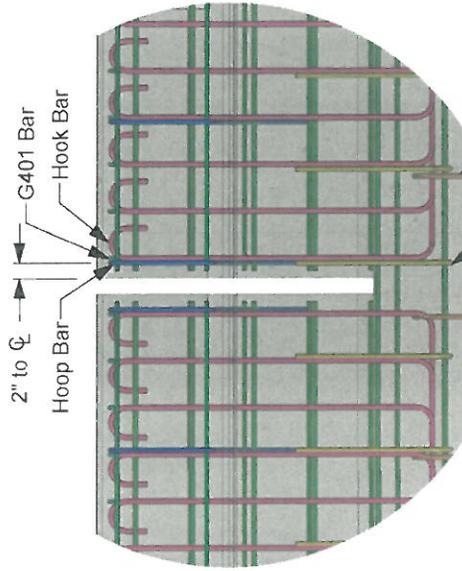
Detail G
Scale 1 : 20
Typ each joint
