Test Report No. 608331-01-1A-2-3
Test Report Date: April 2019

MASH TL-4 EVALUATION OF 2019 MASH 2-TUBE BRIDGE RAIL

Sponsored by
State of Alaska Department of Transportation and Public
Facilities and North Dakota Department of Transportation

TEXAS A&M TRANSPORTATION INSTITUTE PROVING GROUND

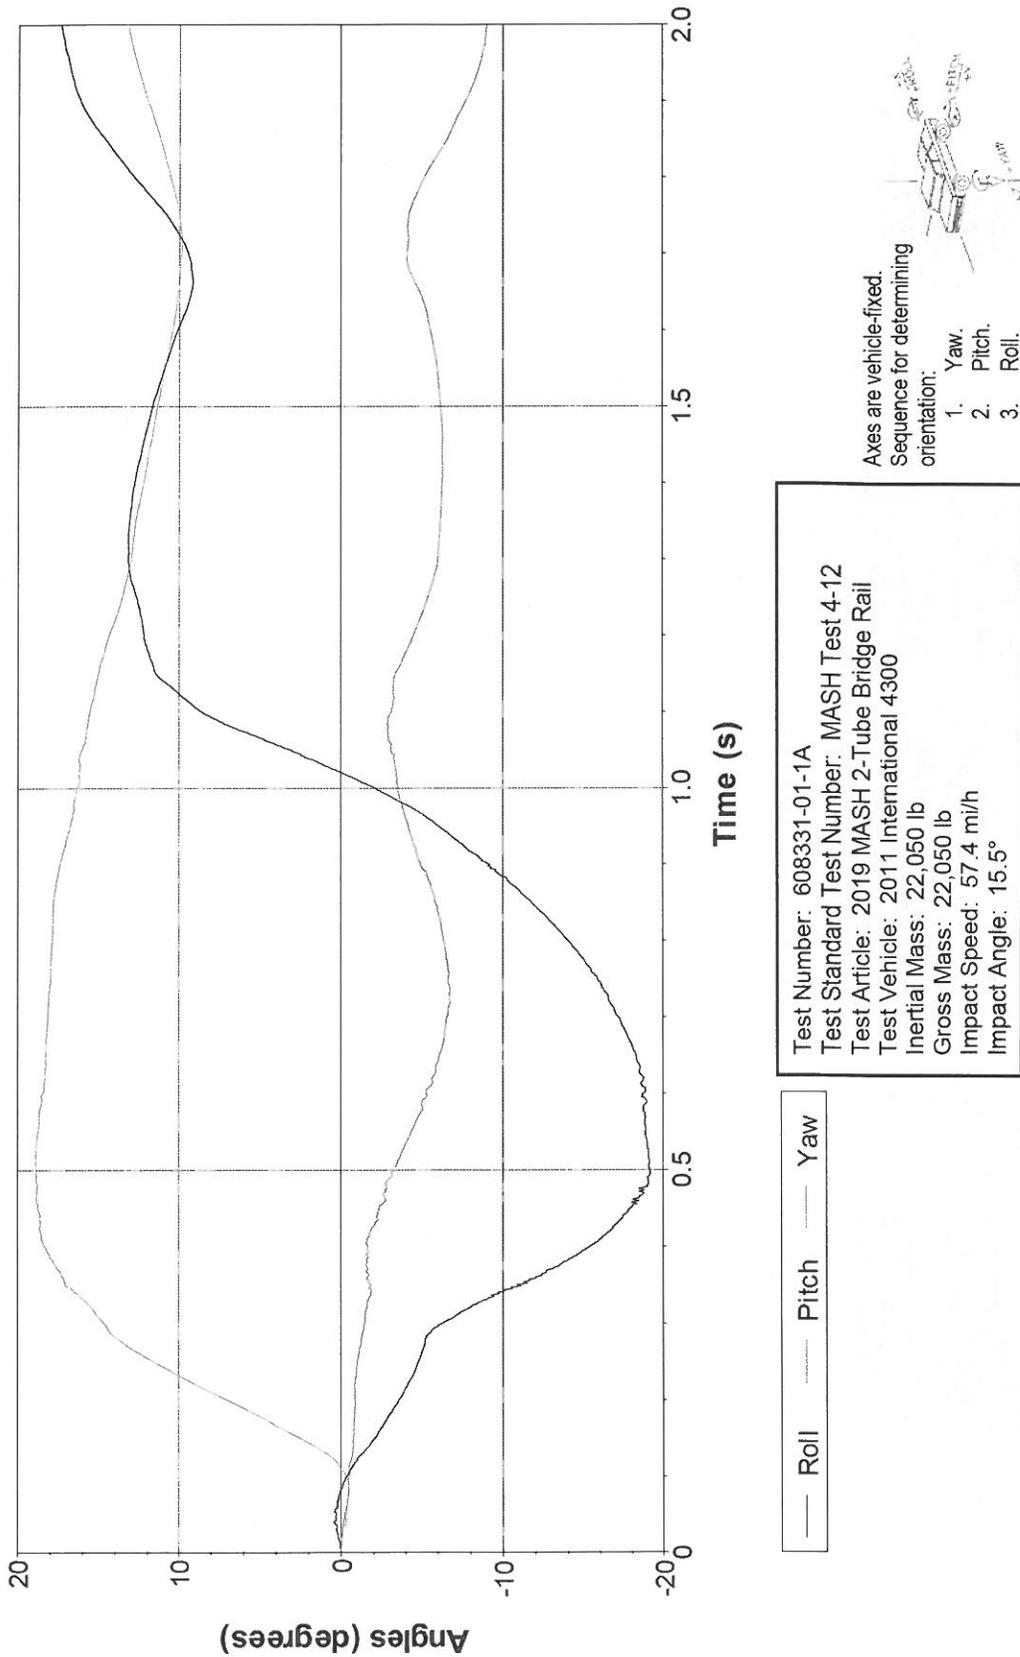
Figure C.3. Vehicle Angular Displacements for Test No. 608331-01-1A.

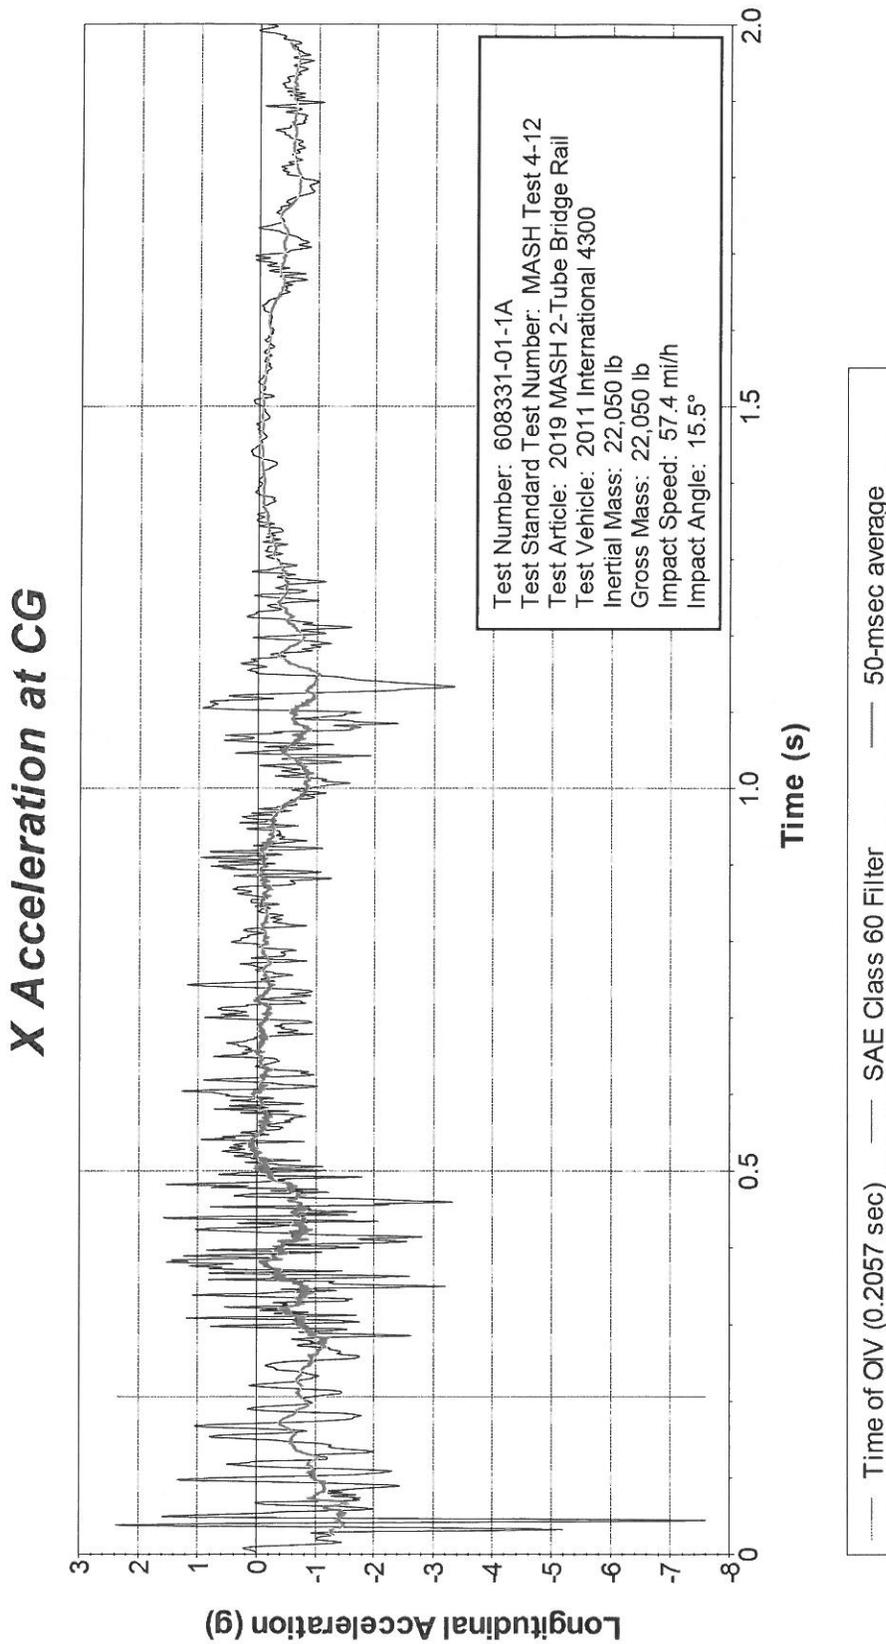
Figure C.4. Vehicle Longitudinal Accelerometer Trace for Test No. 608331-01-1A (Accelerometer Located at Center of Gravity).

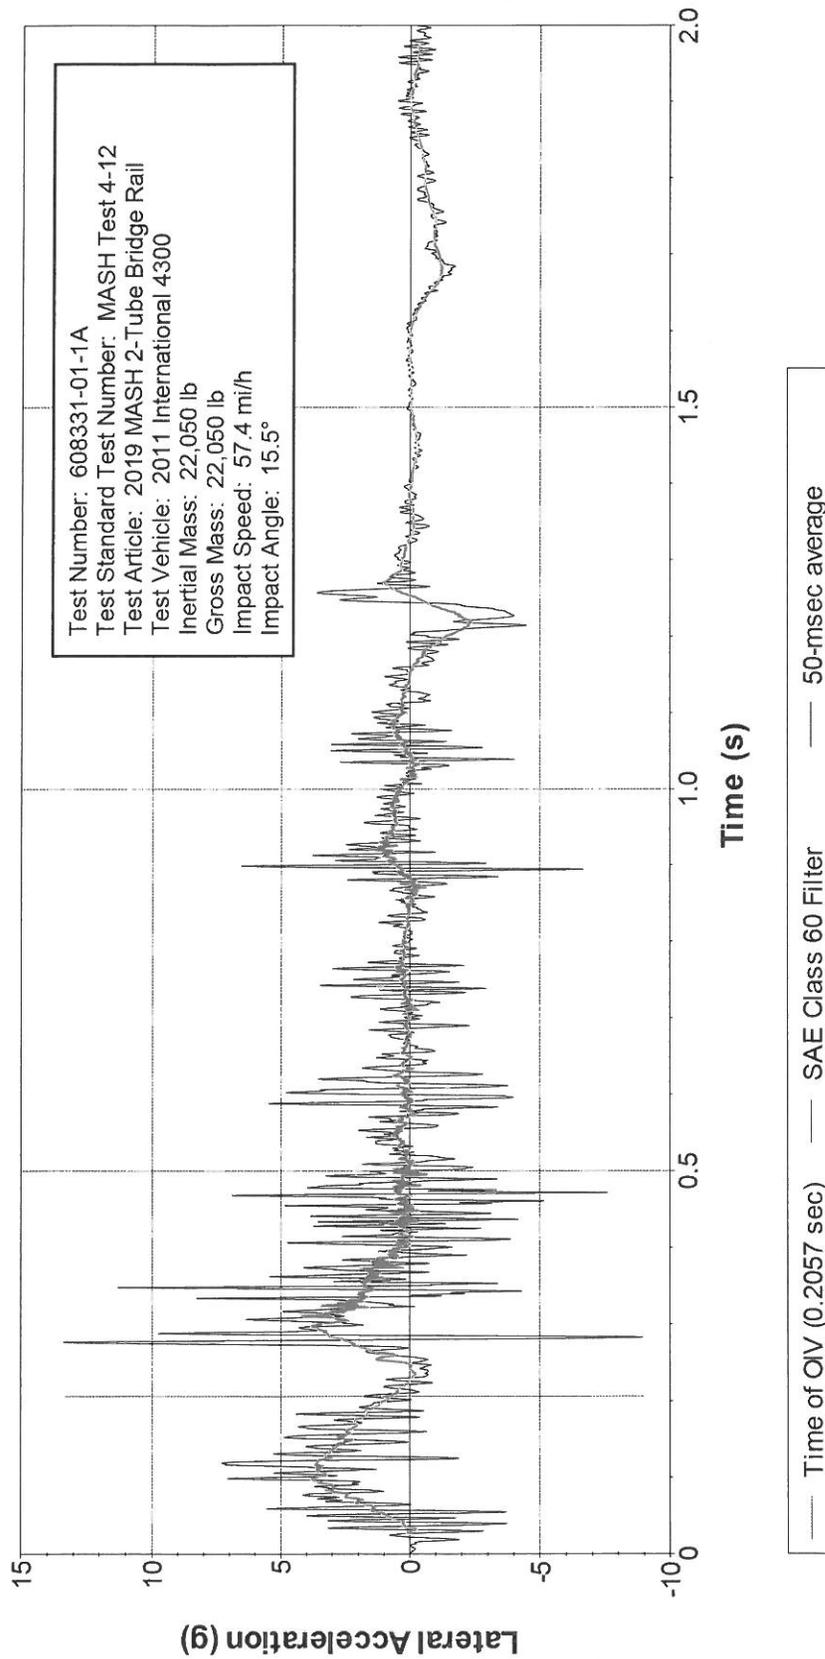
Figure C.5. Vehicle Lateral Accelerometer Trace for Test No. 608331-01-1A (Accelerometer Located at Center of Gravity).

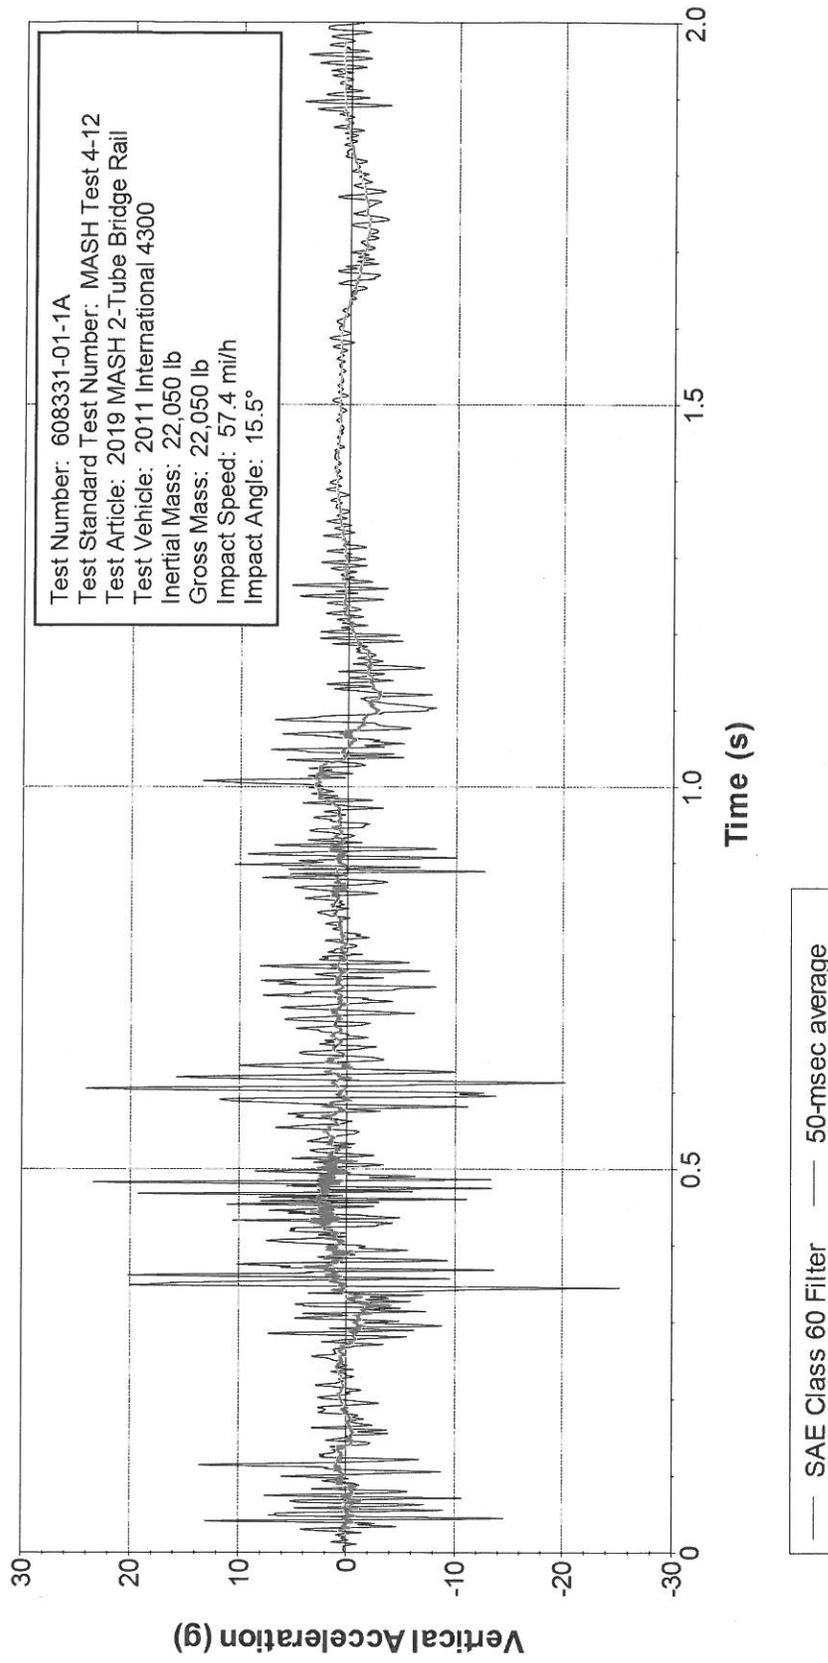
Figure C.6. Vehicle Vertical Accelerometer Trace for Test No. 608331-01-1A (Accelerometer Located at Center of Gravity).

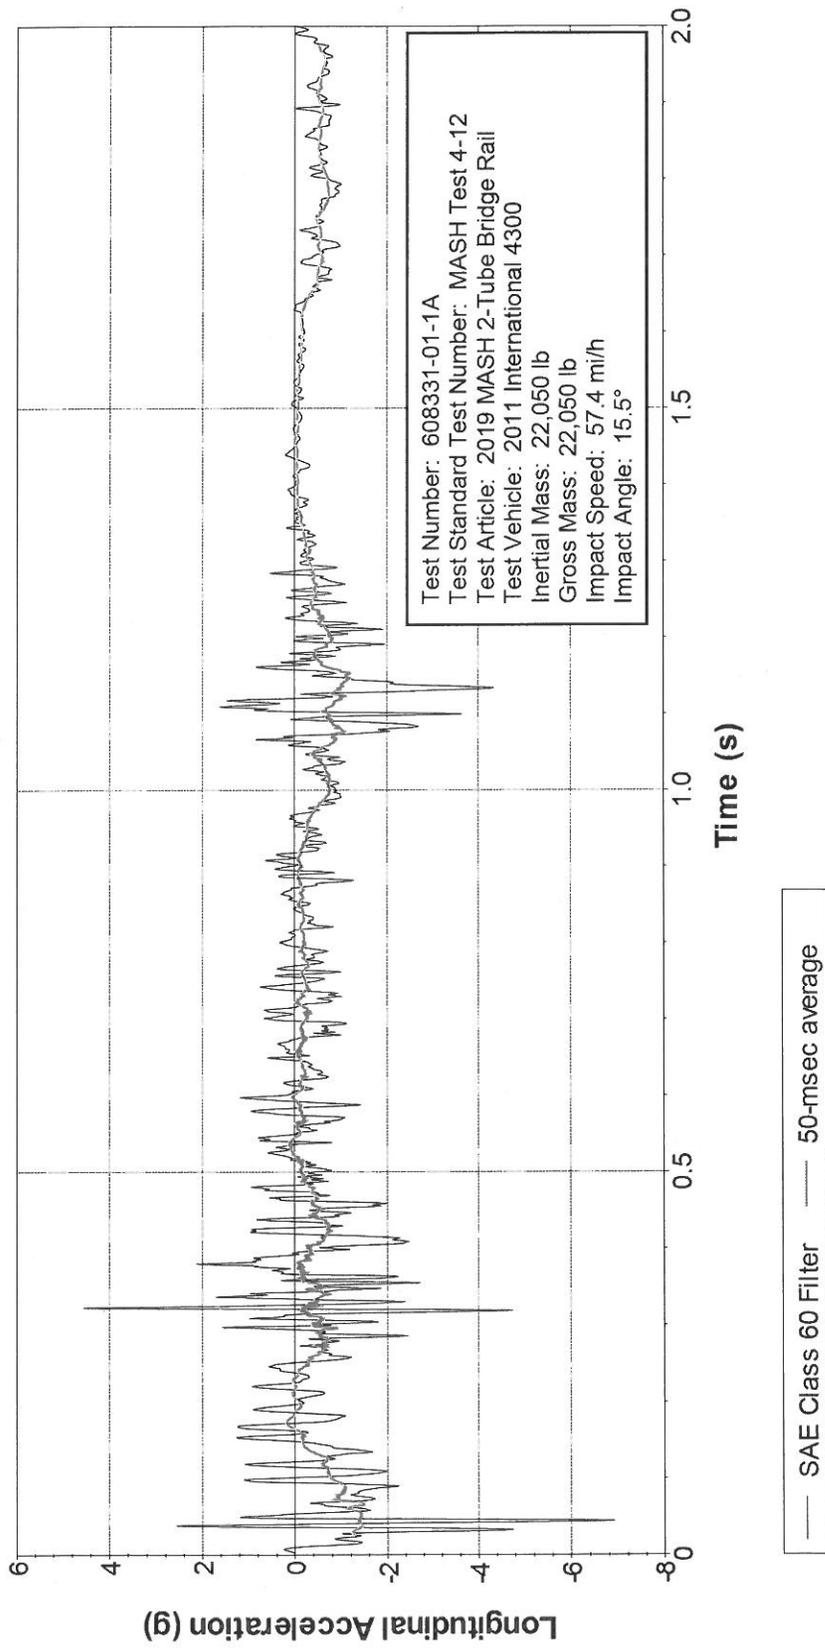
Figure C.7. Vehicle Longitudinal Accelerometer Trace for Test No. 608331-01-1A (Accelerometer Located Rear of Center of Gravity).

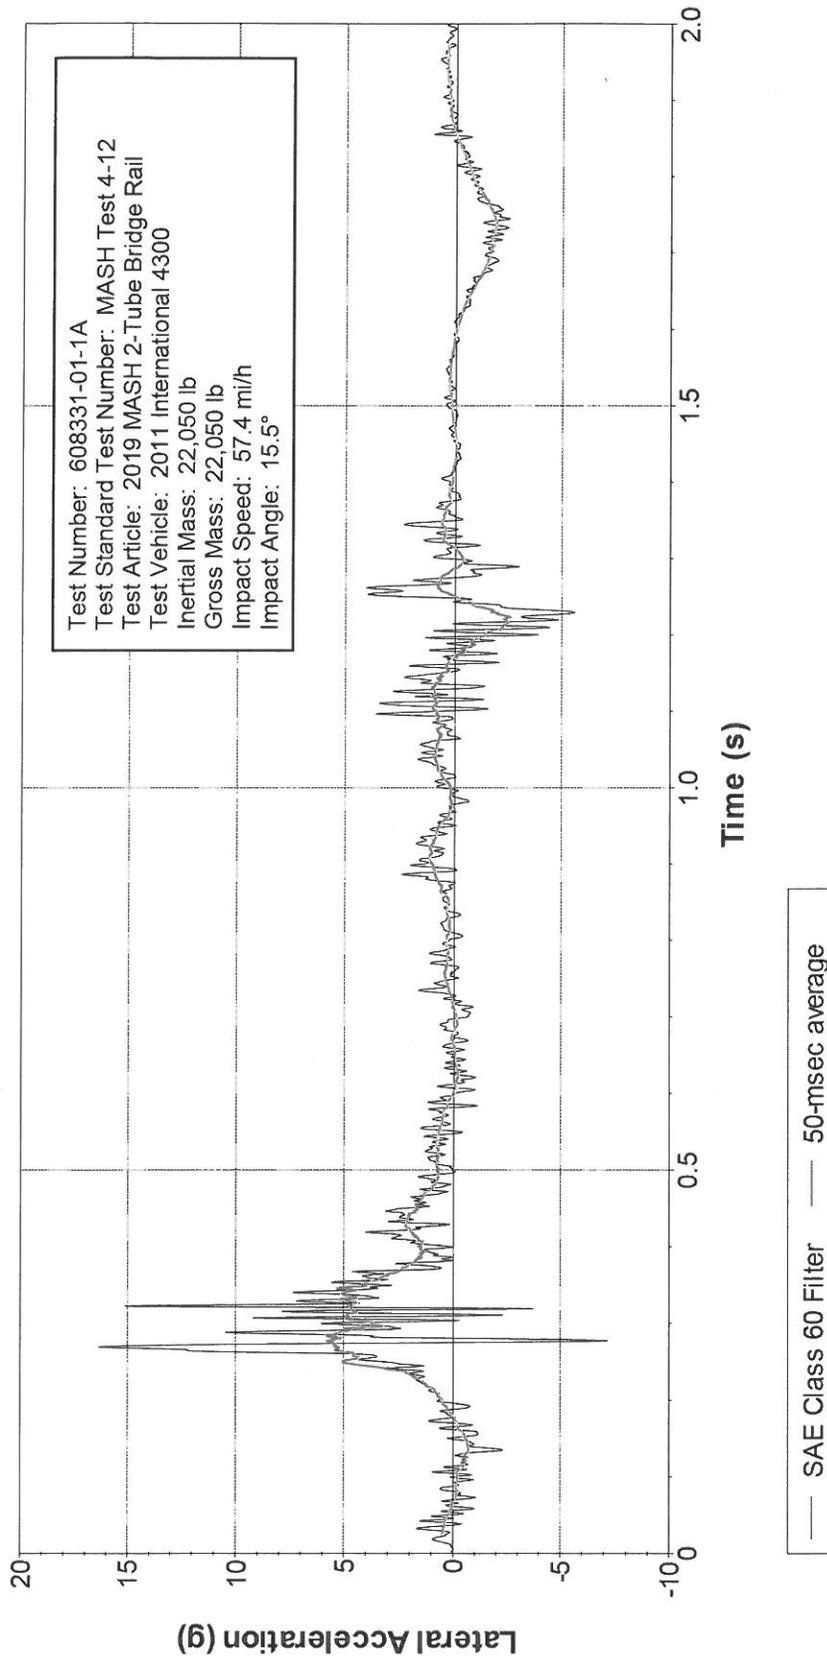
Figure C.8. Vehicle Lateral Accelerometer Trace for Test No. 608331-01-1A (Accelerometer Located Rear of Center of Gravity).

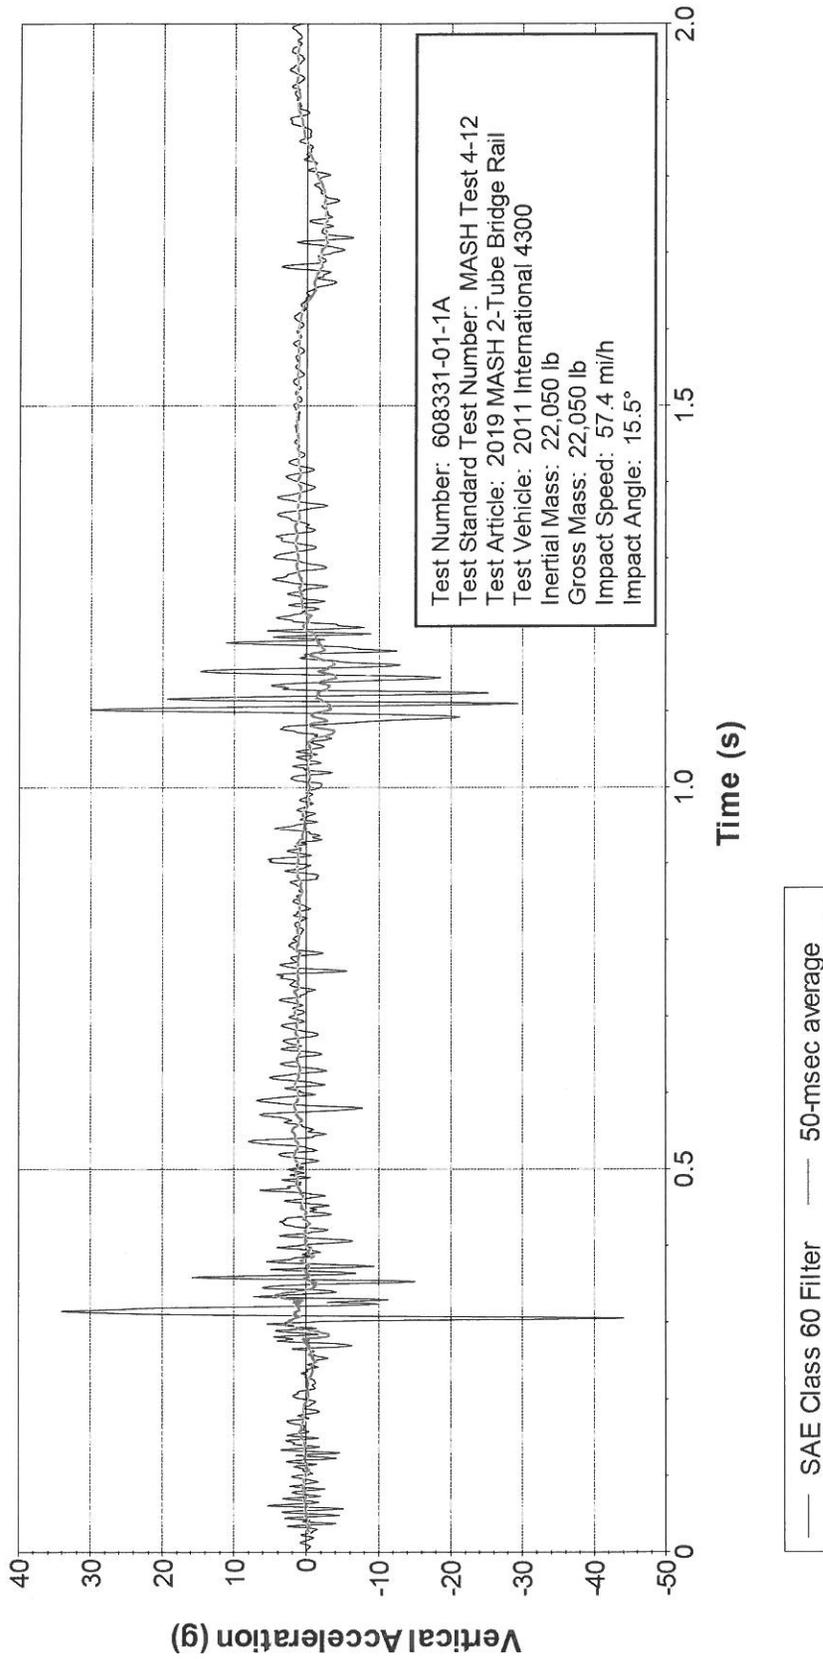
Figure C.9. Vehicle Vertical Accelerometer Trace for Test No. 608331-01-1A (Accelerometer Located Rear of Center of Gravity).

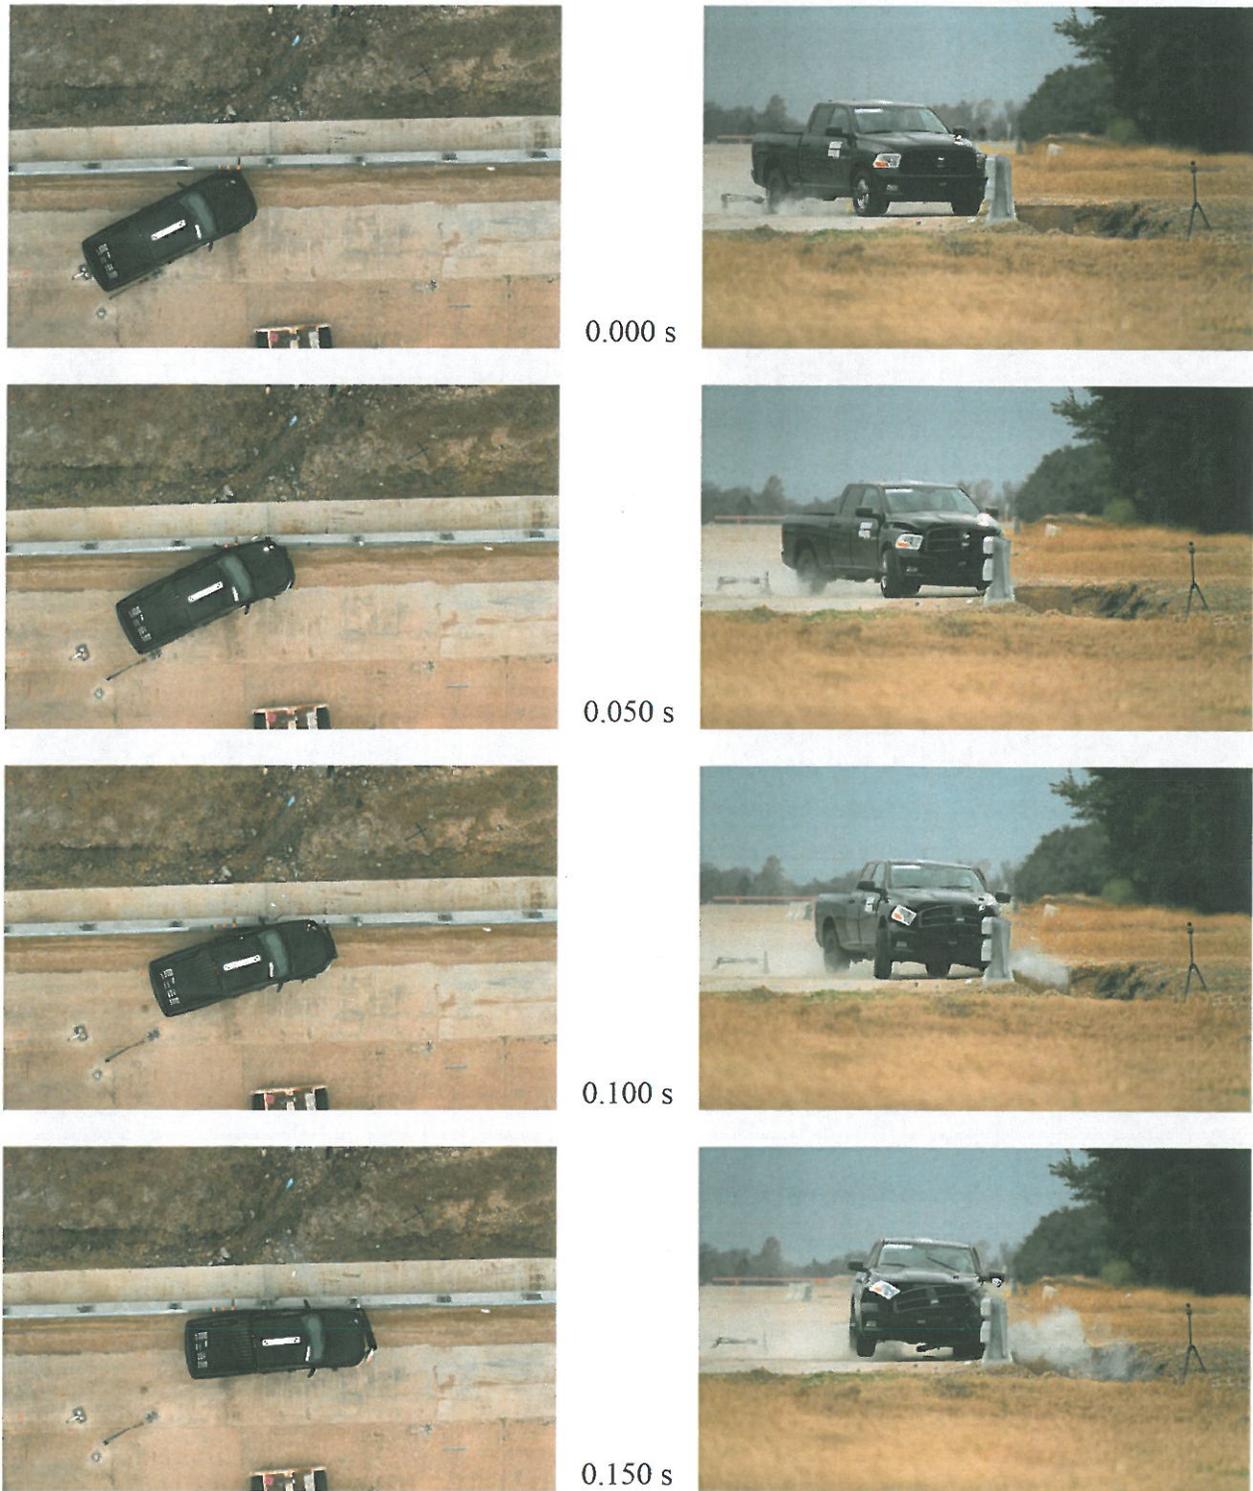
Figure D.1. Sequential Photographs for Test No. 608331-01-2 (Overhead and Frontal Views).

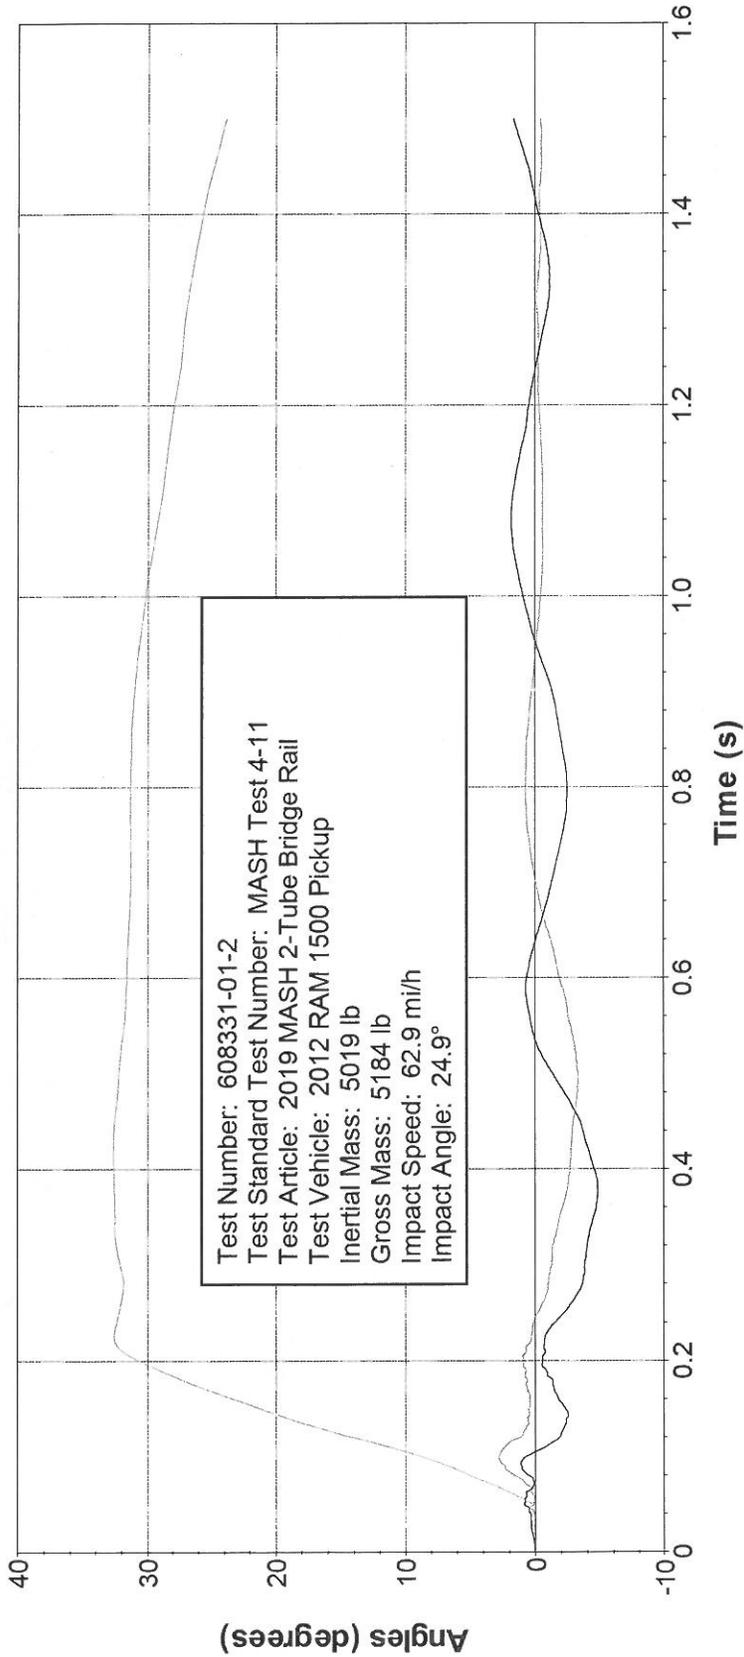
Figure D.3. Vehicle Angular Displacements for Test No. 608331-01-2.

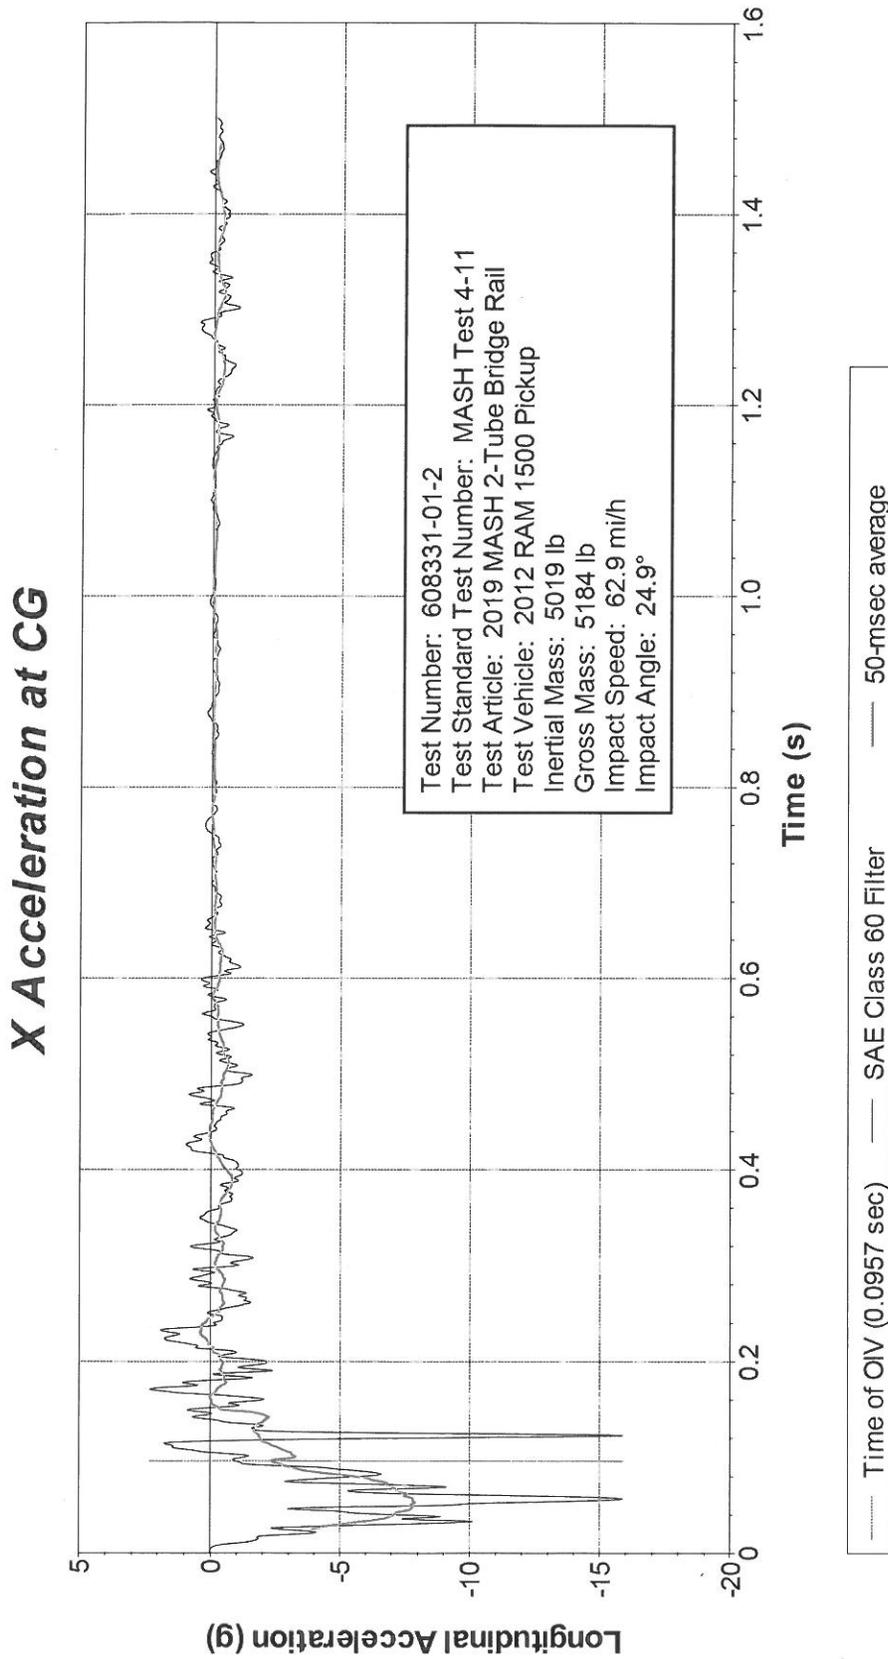
Figure D.4. Vehicle Longitudinal Accelerometer Trace for Test No. 608331-01-2 (Accelerometer Located at Center of Gravity).

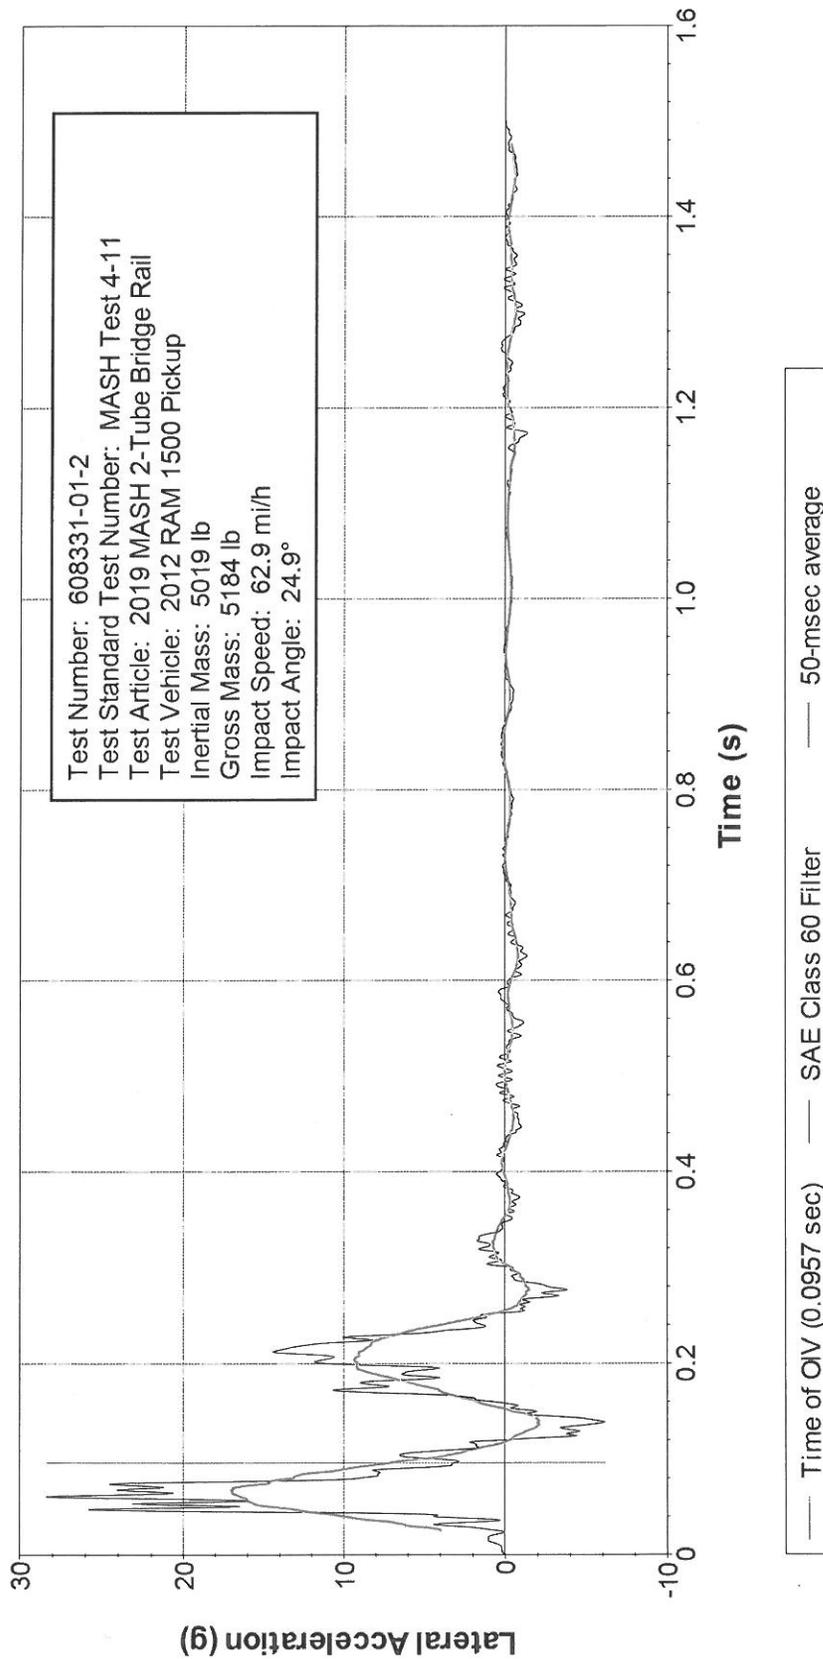
Figure D.5. Vehicle Lateral Accelerometer Trace for Test No. 608331-01-2 (Accelerometer Located at Center of Gravity).

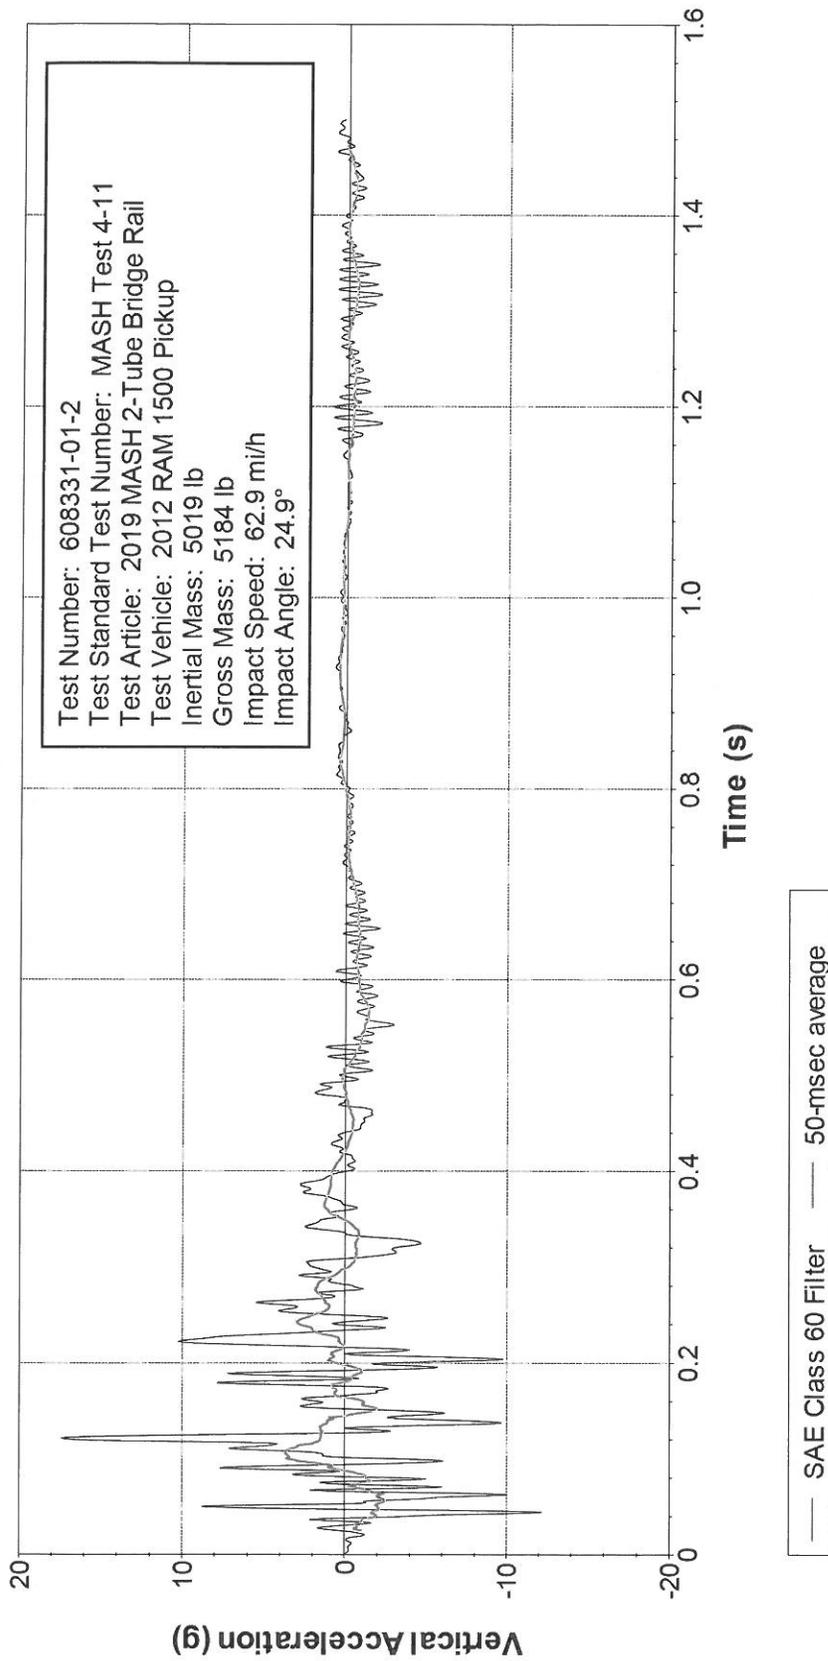
Figure D.6. Vehicle Vertical Accelerometer Trace for Test No. 608331-01-2 (Accelerometer Located at Center of Gravity).

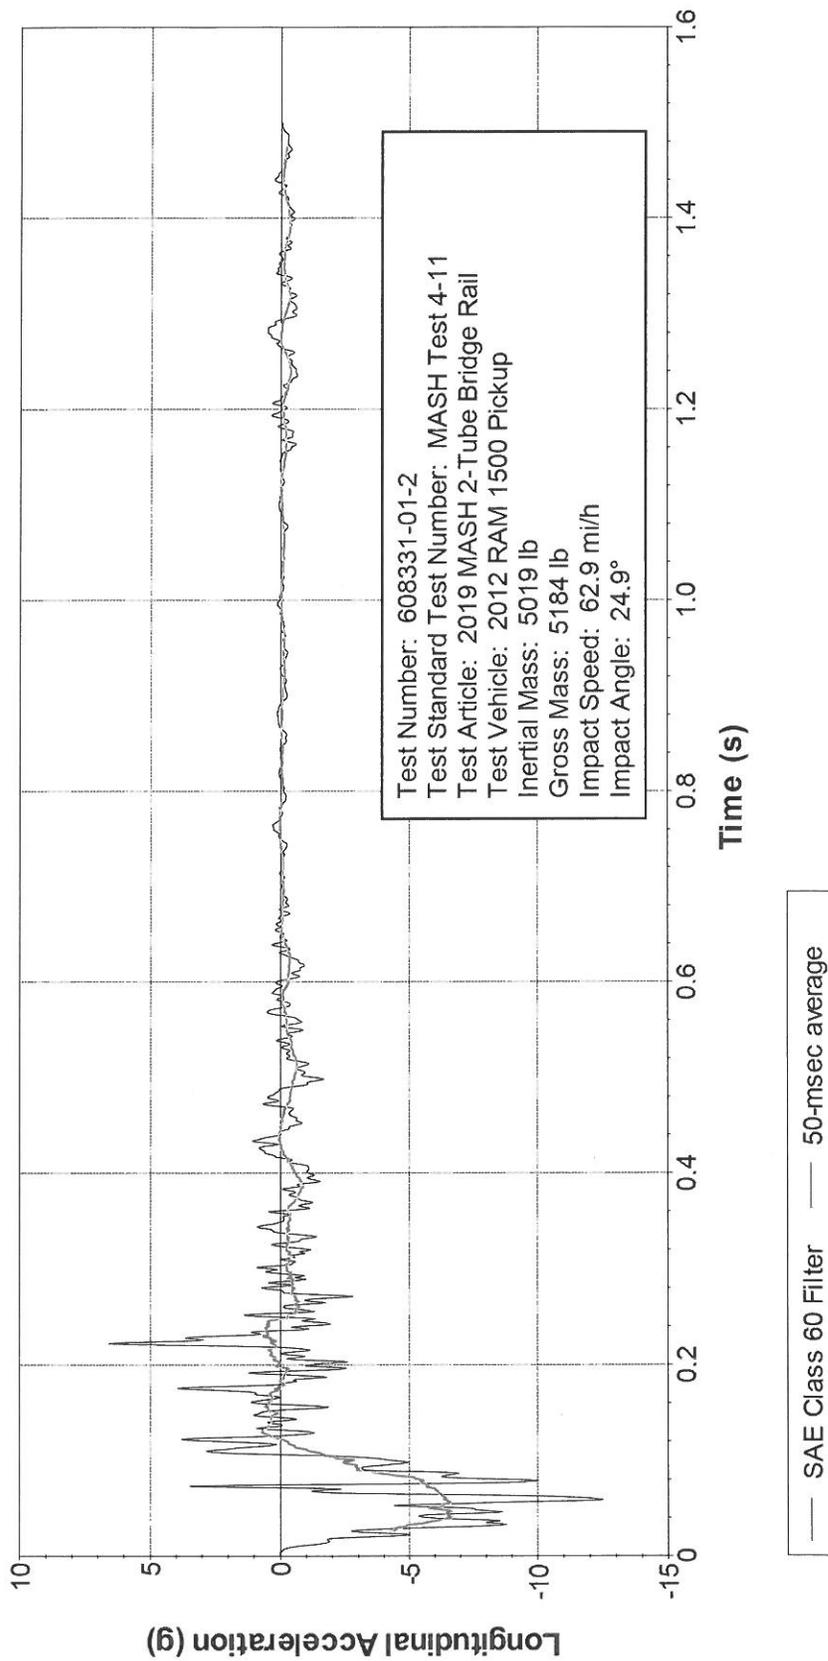
Figure D.7. Vehicle Longitudinal Accelerometer Trace for Test No. 608331-01-2 (Accelerometer Located Rear of Center of Gravity).

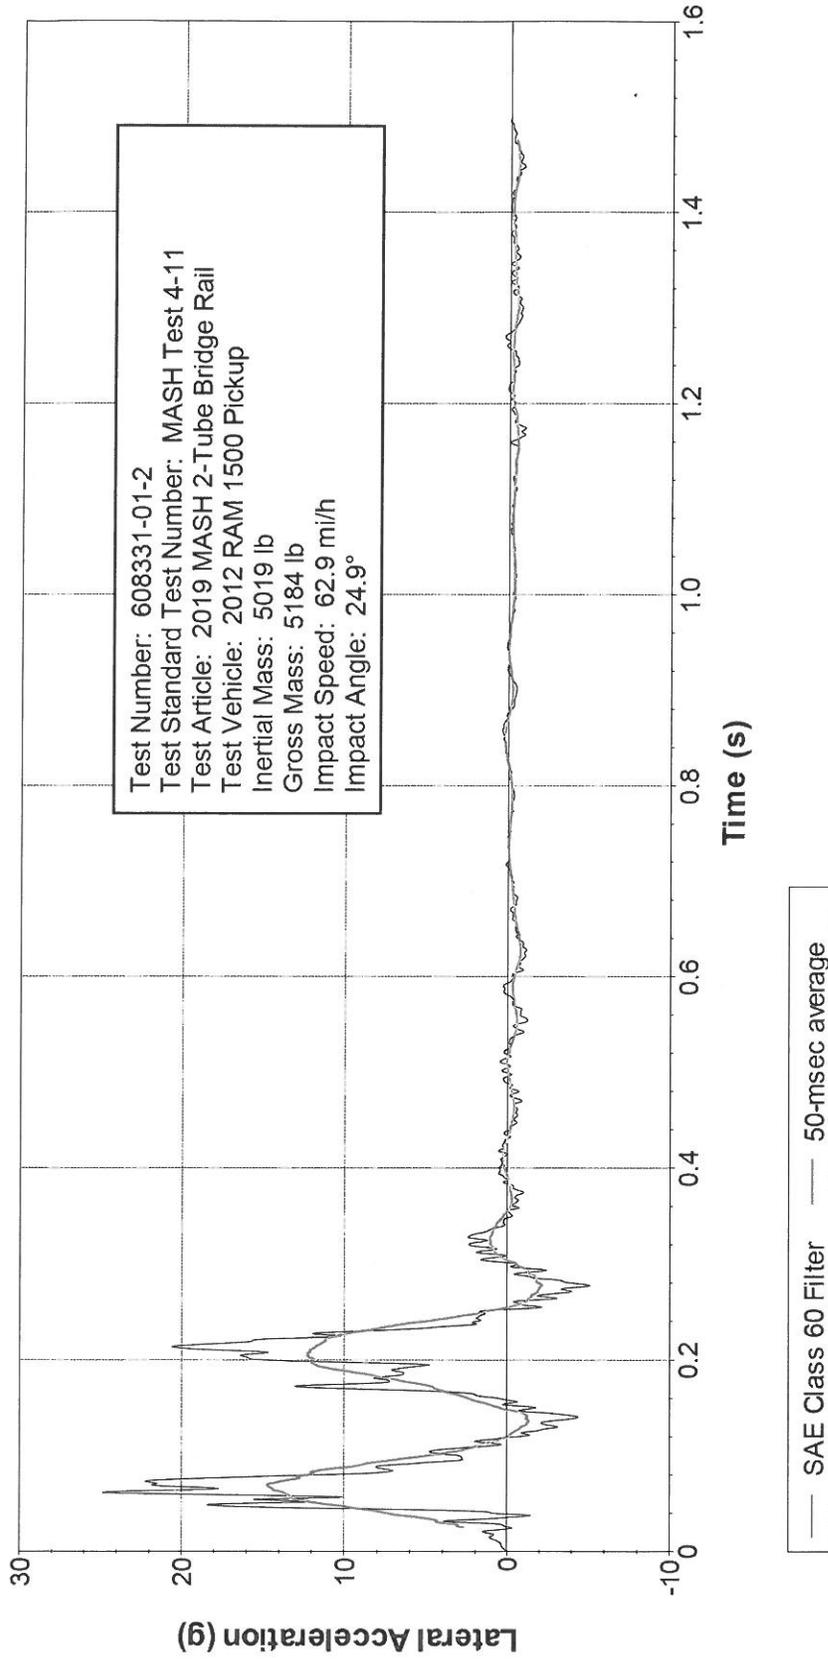
Figure D.8. Vehicle Lateral Accelerometer Trace for Test No. 608331-01-2 (Accelerometer Located Rear of Center of Gravity).

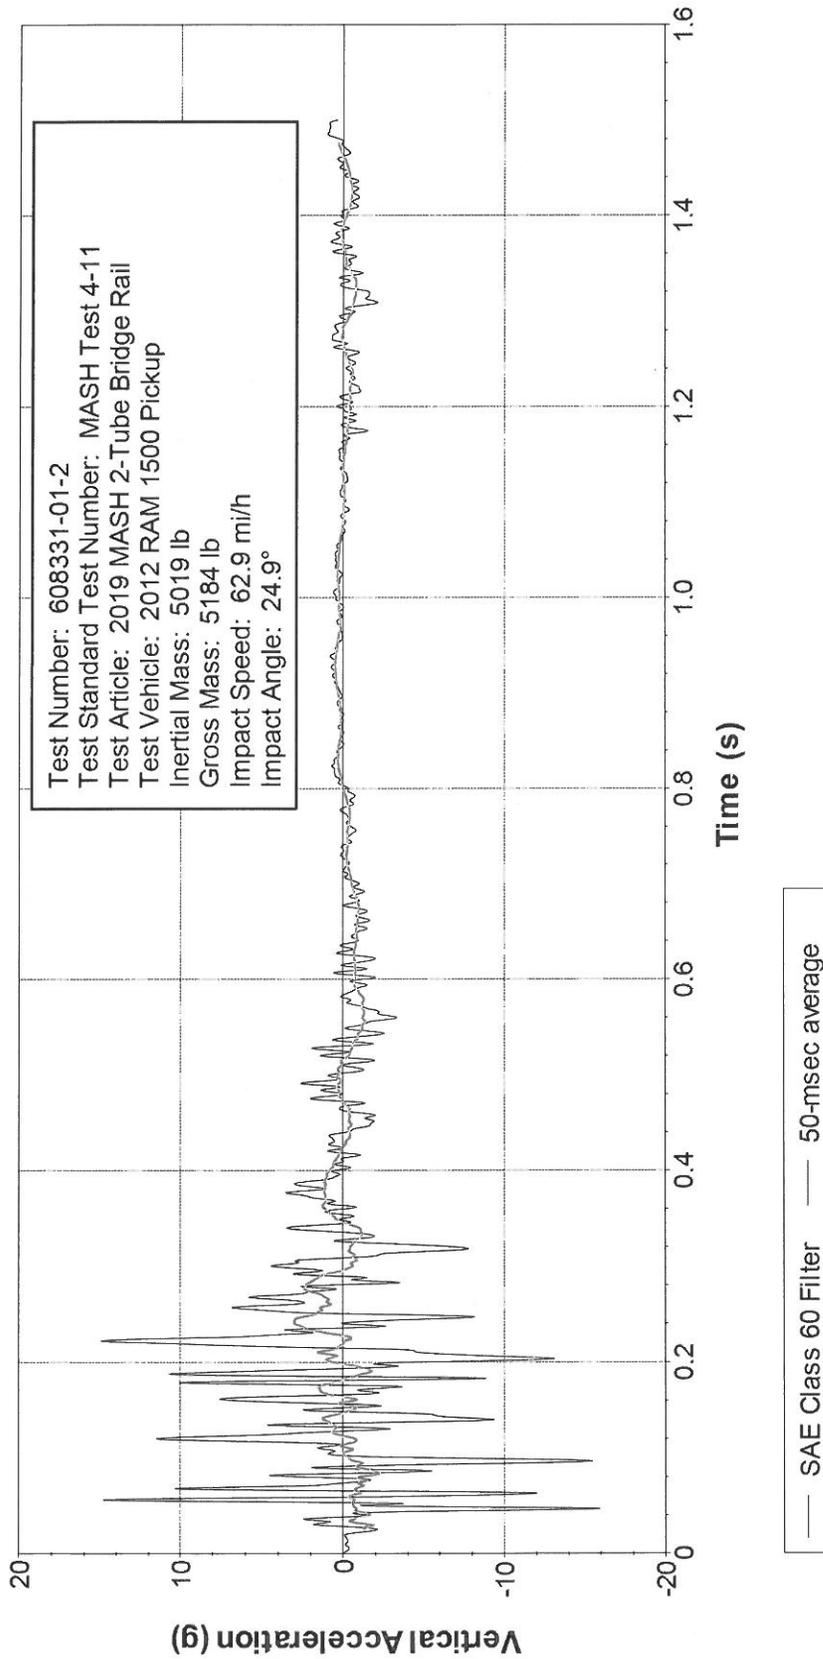
Figure D.9. Vehicle Vertical Accelerometer Trace for Test No. 608331-01-2 (Accelerometer Located Rear of Center of Gravity).

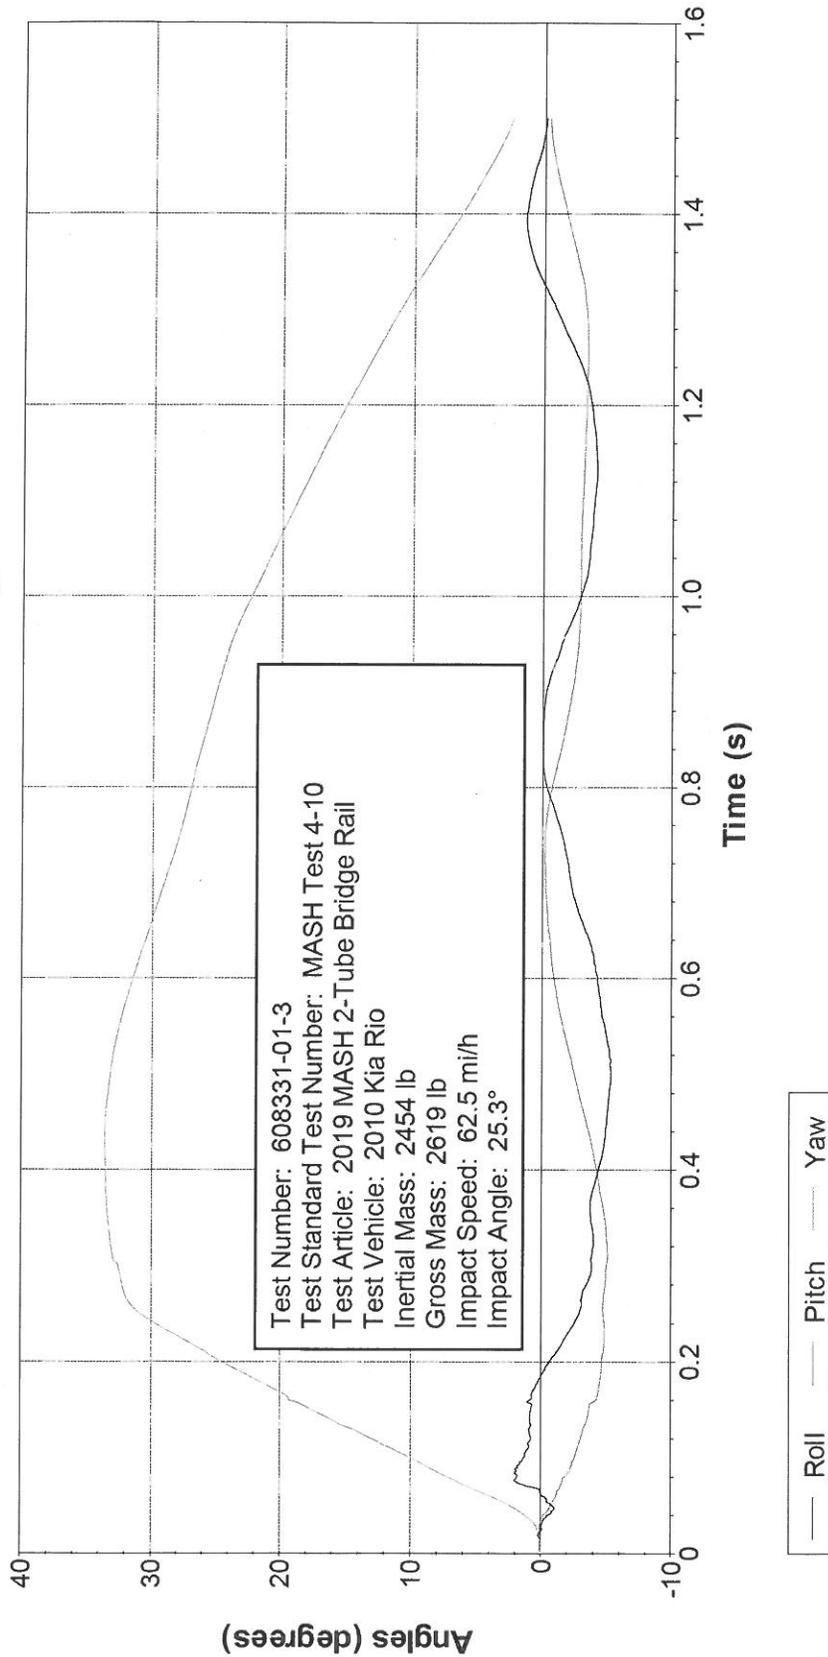
Figure E.3. Vehicle Angular Displacements for Test No. 608331-01-3.
