Test Report No. 608331-01-1A-2-3
Test Report Date: April 2019

MASH TL-4 EVALUATION OF 2019 MASH 2-TUBE BRIDGE RAIL

Sponsored by
State of Alaska Department of Transportation and Public
Facilities and North Dakota Department of Transportation

TEXAS A&M TRANSPORTATION INSTITUTE PROVING GROUND

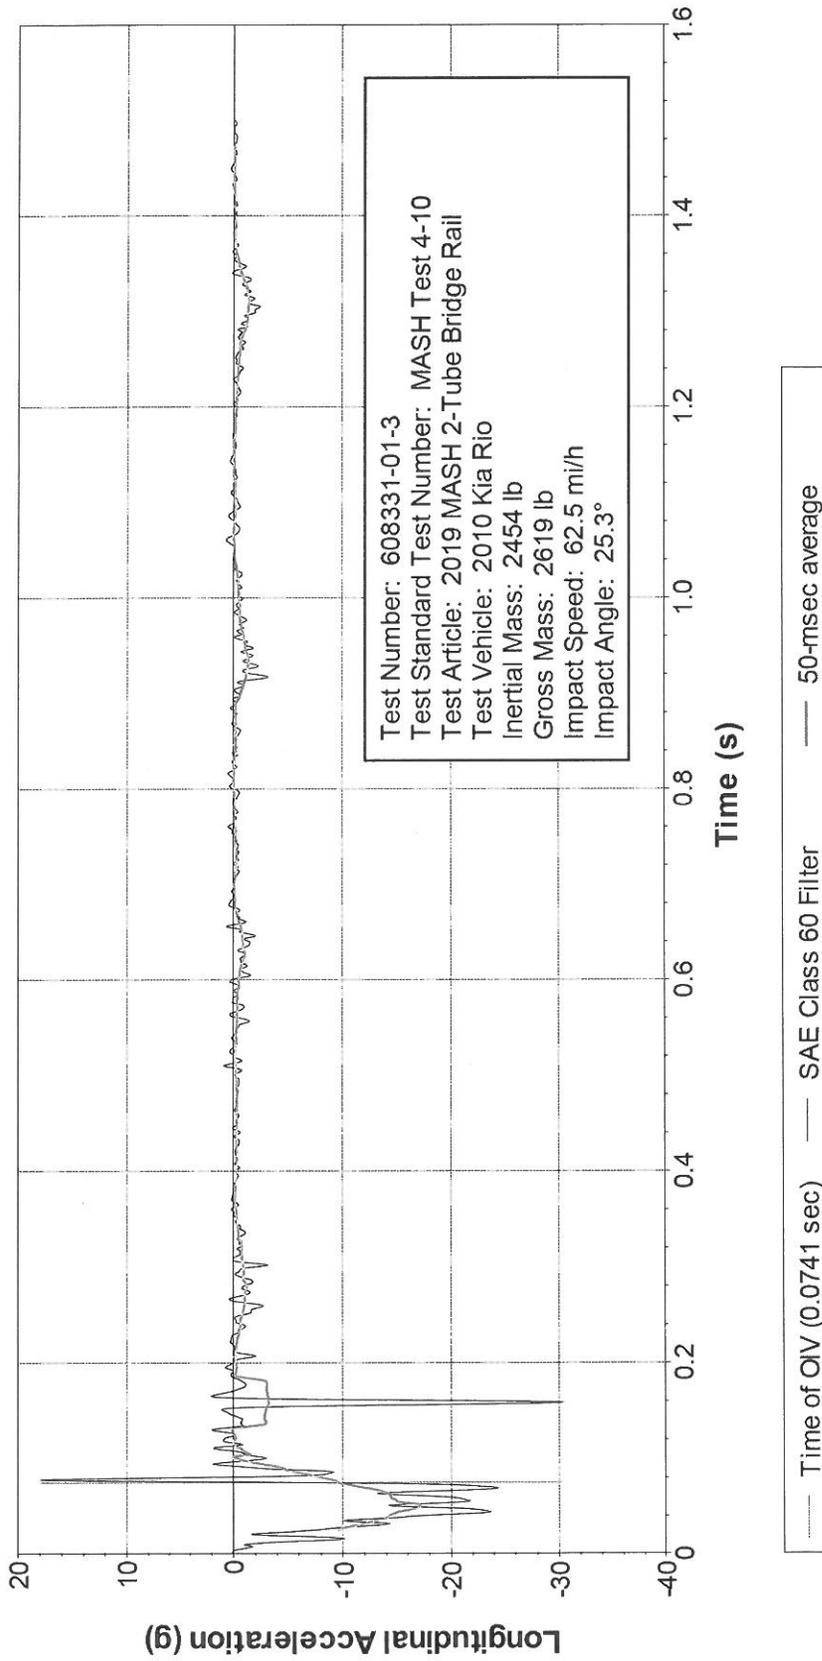
Figure E.4. Vehicle Longitudinal Accelerometer Trace for Test No. 608331-01-3 (Accelerometer Located at Center of Gravity).

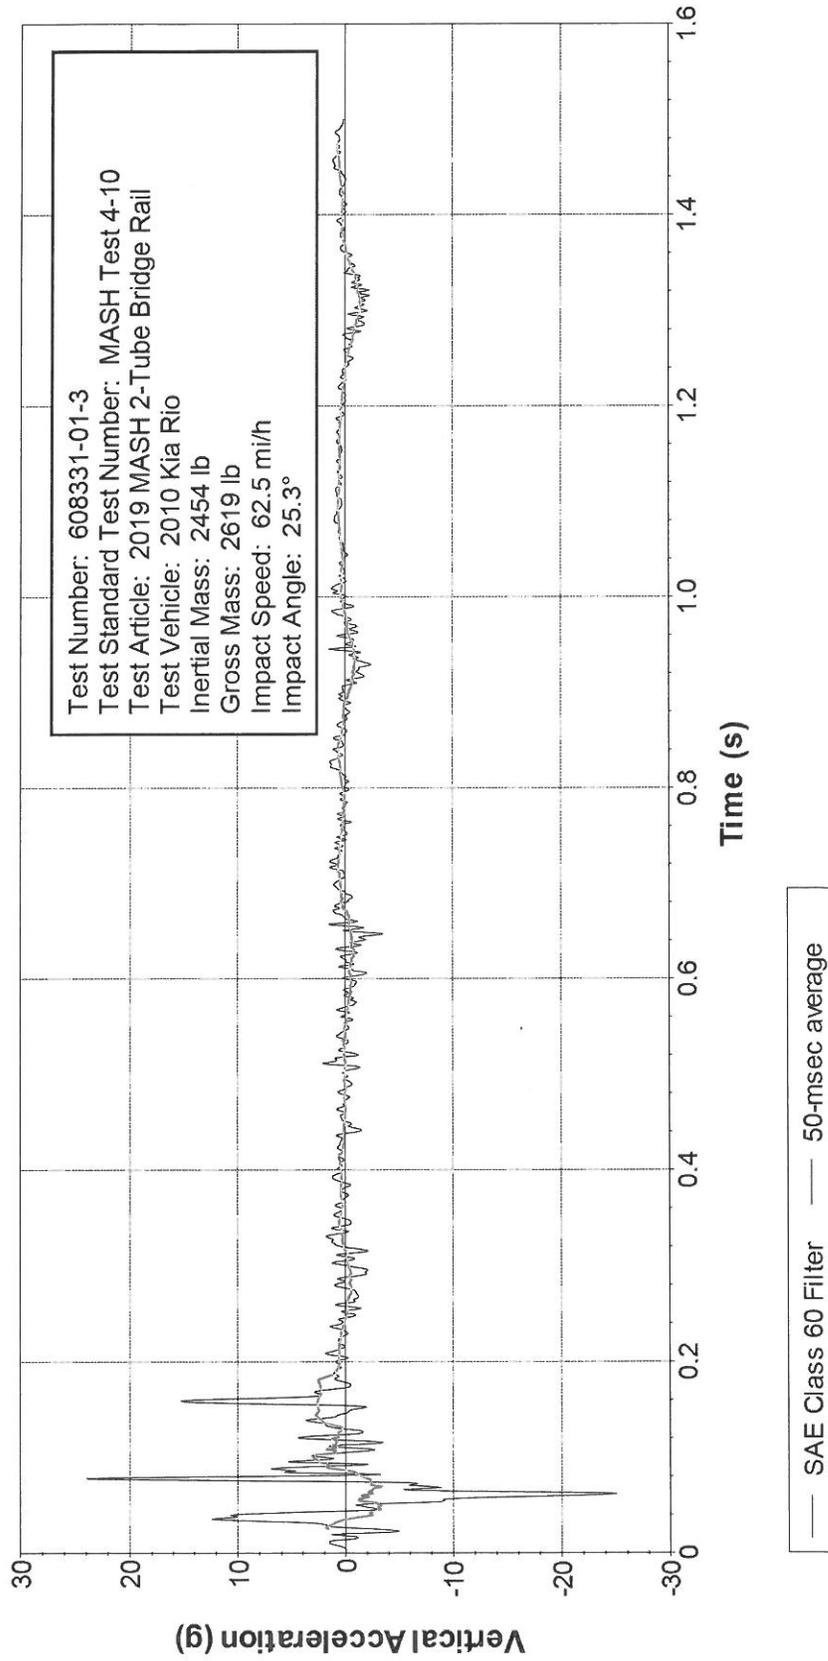
Figure E.6. Vehicle Vertical Accelerometer Trace for Test No. 608331-01-3 (Accelerometer Located at Center of Gravity).

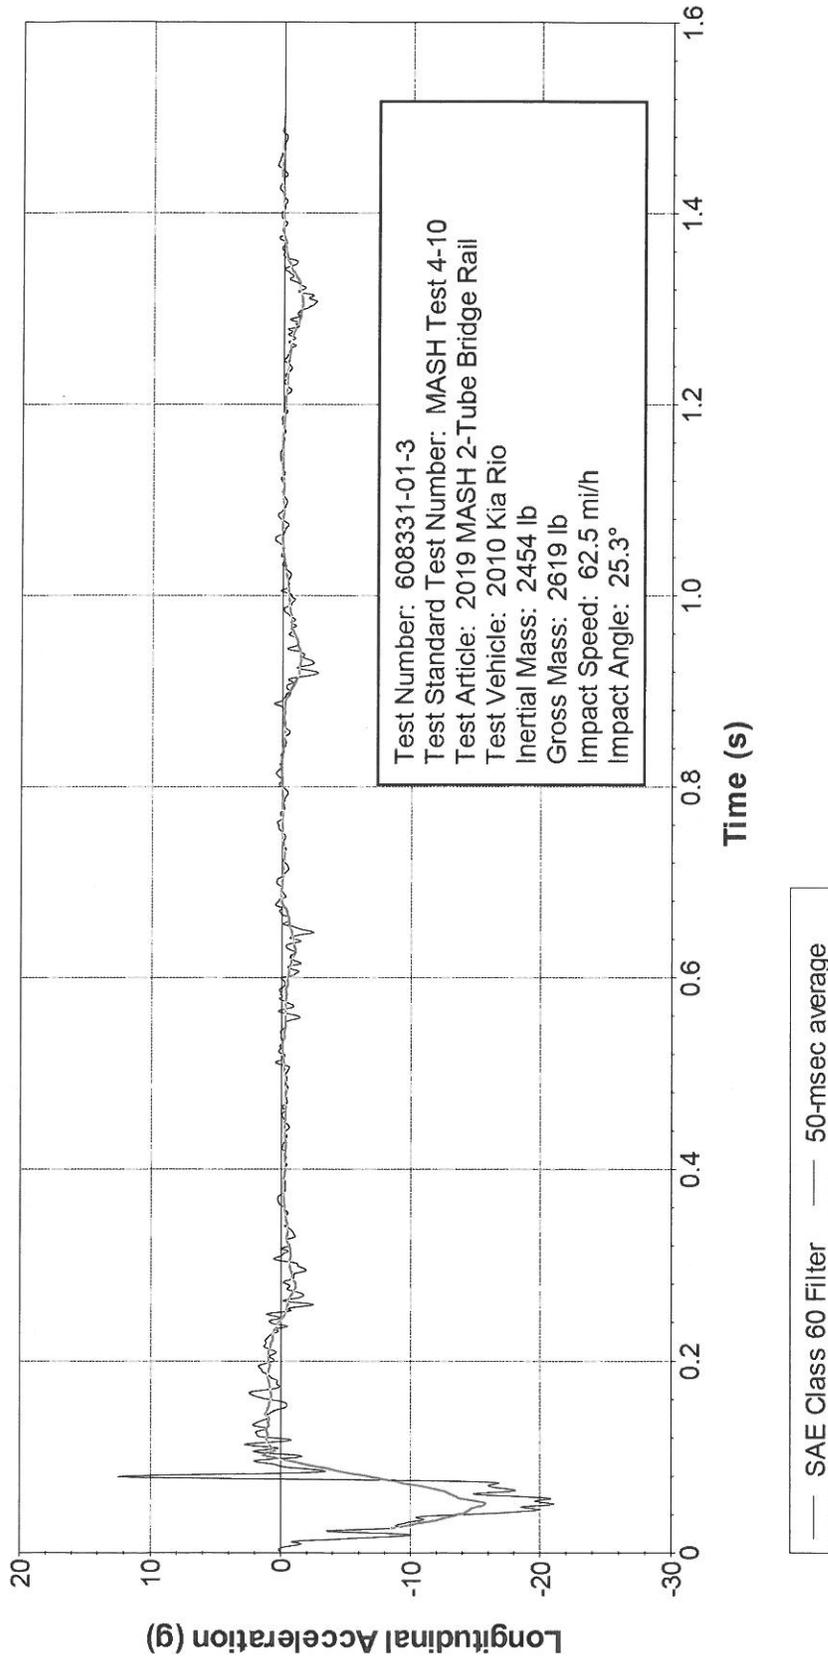
Figure E.7. Vehicle Longitudinal Accelerometer Trace for Test No. 608331-01-3 (Accelerometer Located Rear of Center of Gravity).

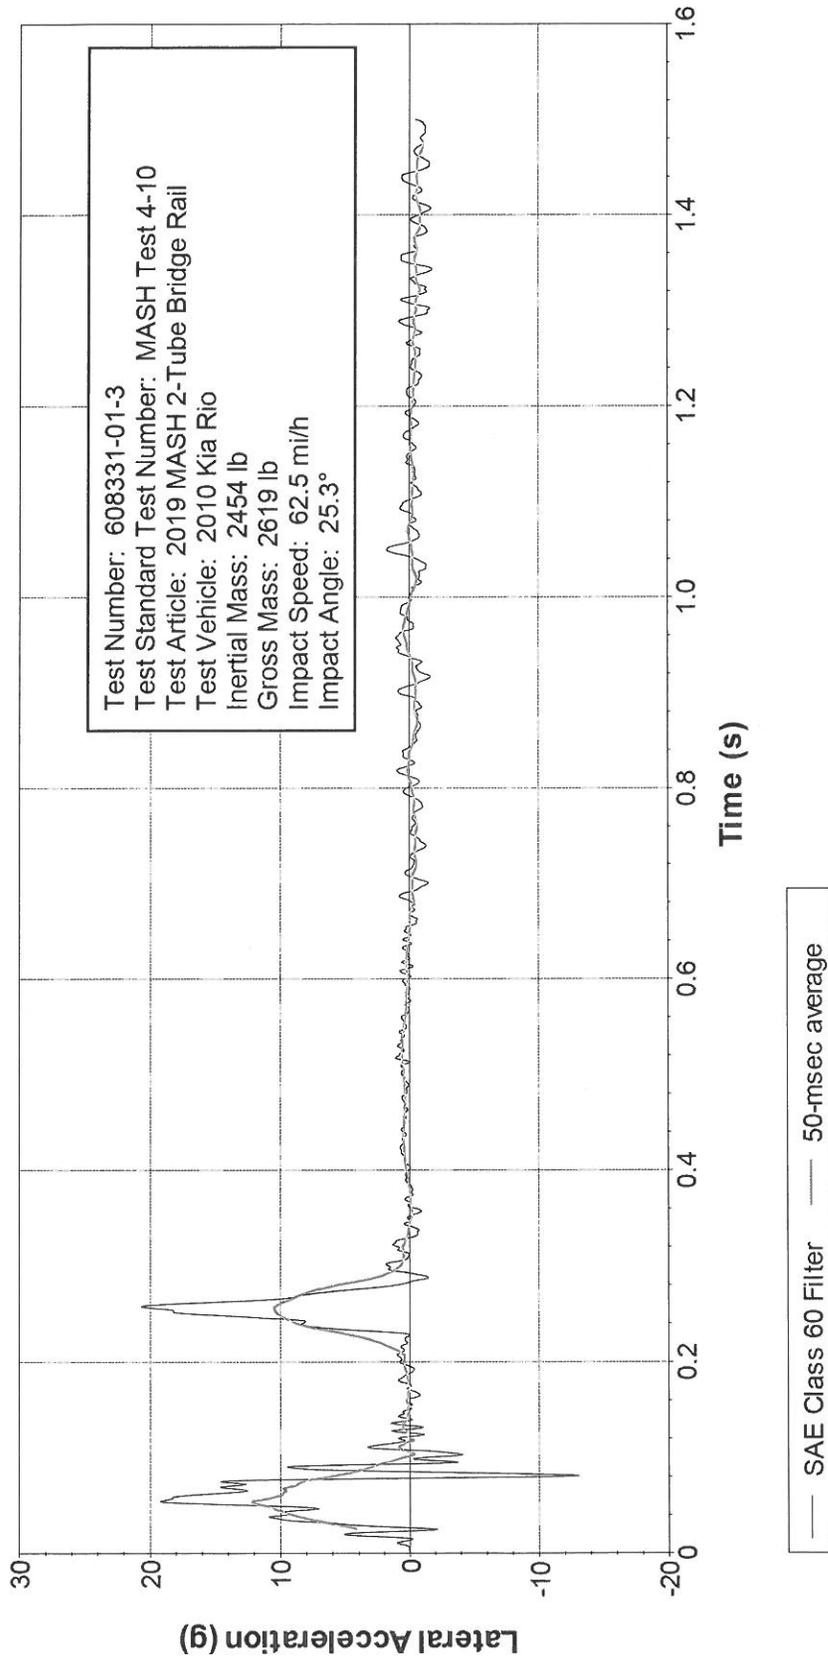
Figure E.8. Vehicle Lateral Accelerometer Trace for Test No. 608331-01-3 (Accelerometer Located Rear of Center of Gravity).

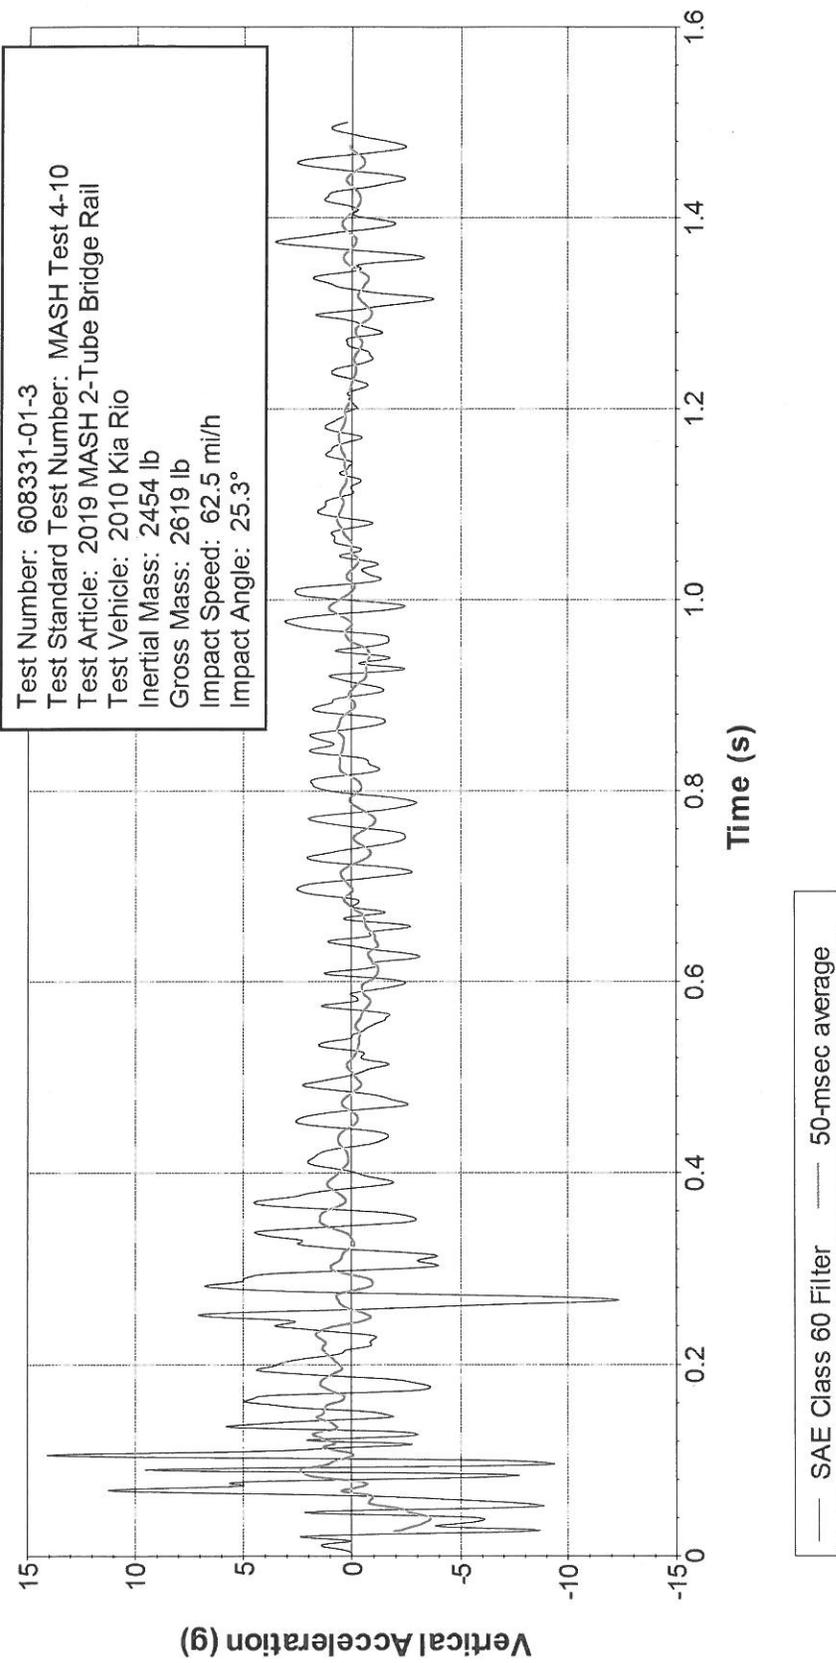
Figure E.9. Vehicle Vertical Accelerometer Trace for Test No. 608331-01-3 (Accelerometer Located Rear of Center of Gravity).
