Ductility of Welded Steel Column to Steel Cap Beam Connections

February 1, 2010

FHWA-AK-RD-10-04

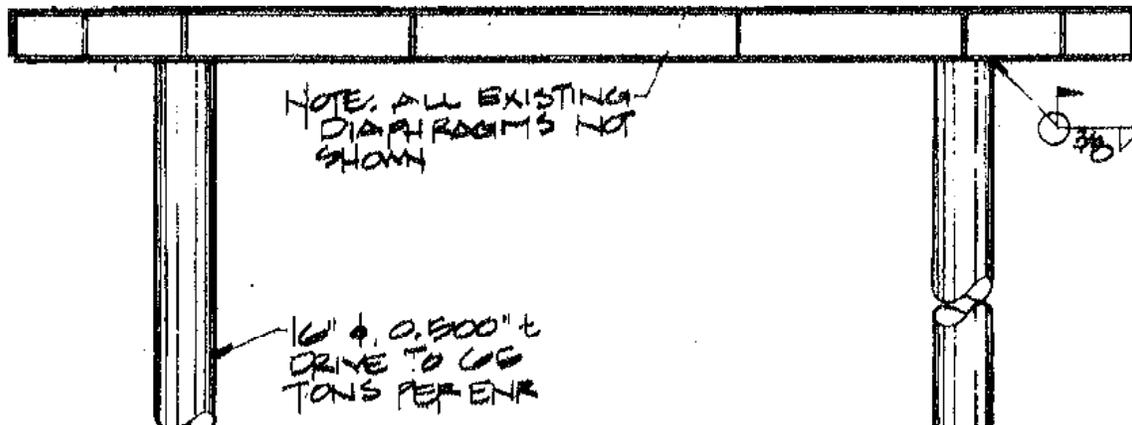
Figure 1.4 Excerpt from Lowell Creek Bridge As-Builts
Compliments of AKDOT

excitation. In particular, major concern exists regarding the capabilities of the welded column to cap beam connection. The typical connection utilized in existing bridges and the design of new bridges prior to this research project consisted of a simple field performed fillet weld. Many of the fillet welds in the existing structures are too small to develop the full flexural strength of the pile. Examples of existing connections can be seen in Figure 1.4 and Figure 1.5.

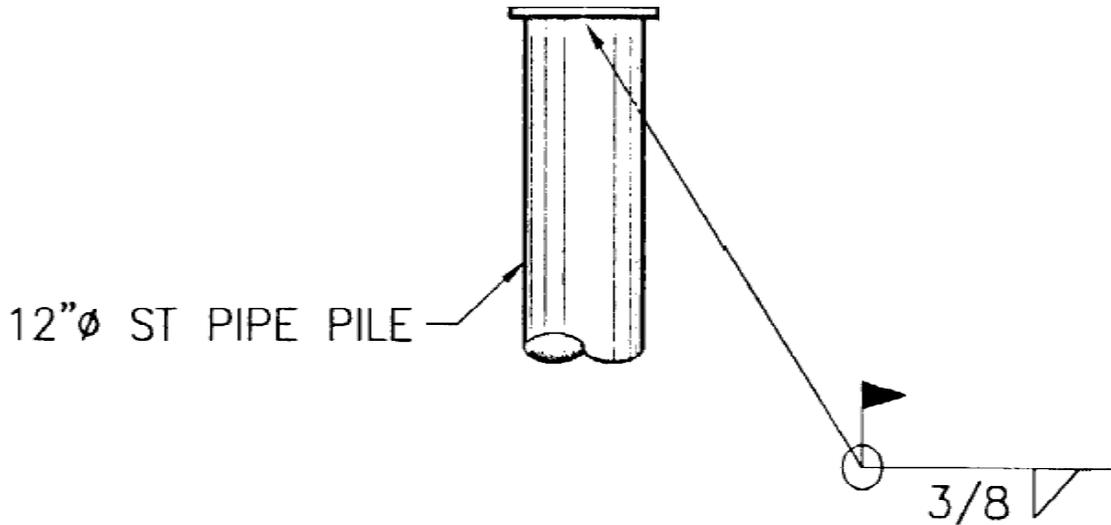
Figure 1.5 Excerpt from Bodenbug Creek Drawings (Note: Pile Thickness 0.375")
Compliments of AKDOT

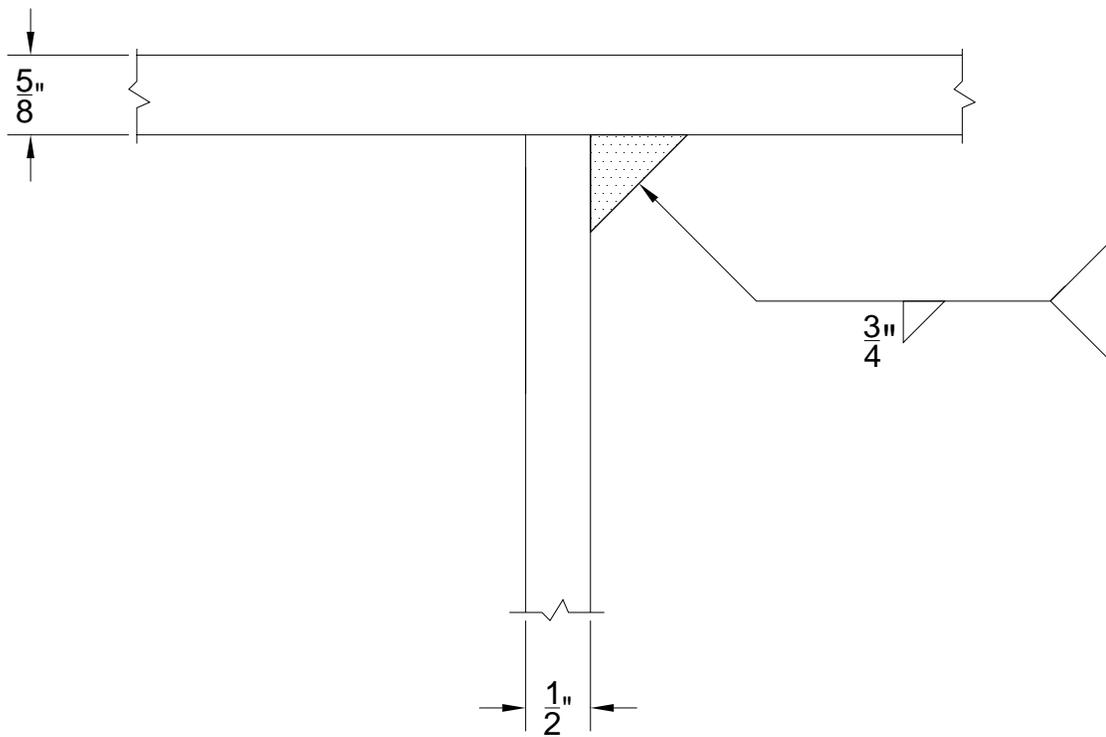
Figure 3.1 Test 1 Connection Detail Section

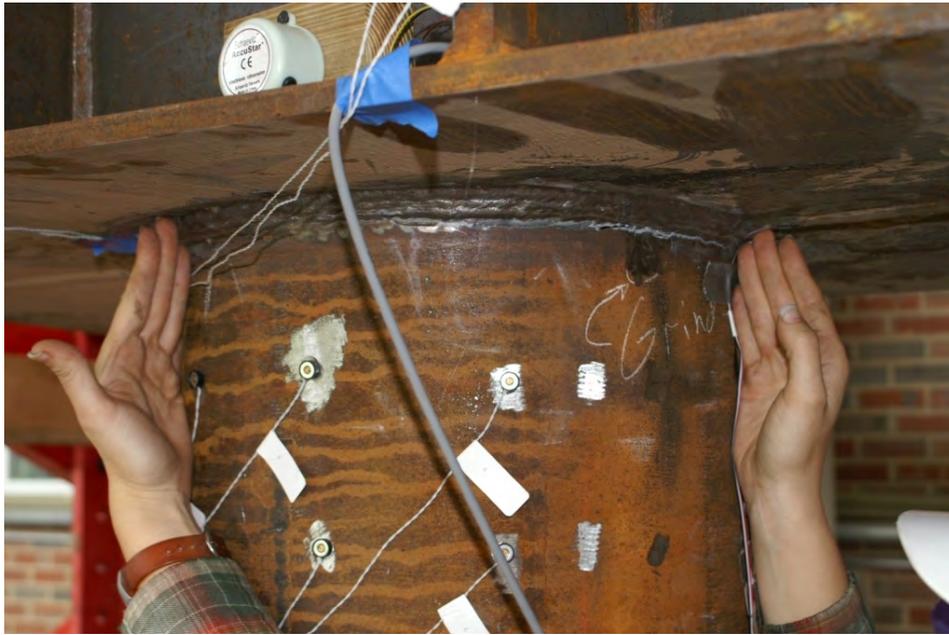
Figure 3.5 Cracking of South Column in Test 1

the toe of the fillet weld on the south column as can be seen in Figure 3.5 and described in Table 3.1. The effect of this cracking in regards to the strength of the specimen can be seen in Figure 3.6 and Figure 3.7 which provide the force displacement hysteresis and the load history respectively. It should be noted that the force displacement hysteresis appears to be shifted towards the positive direction due to the effects of base displacement which is plotted in Figure 3.8. As a result of the cracking in the first cycle of ductility 2, the specimen was assumed to be failed and the test was concluded.

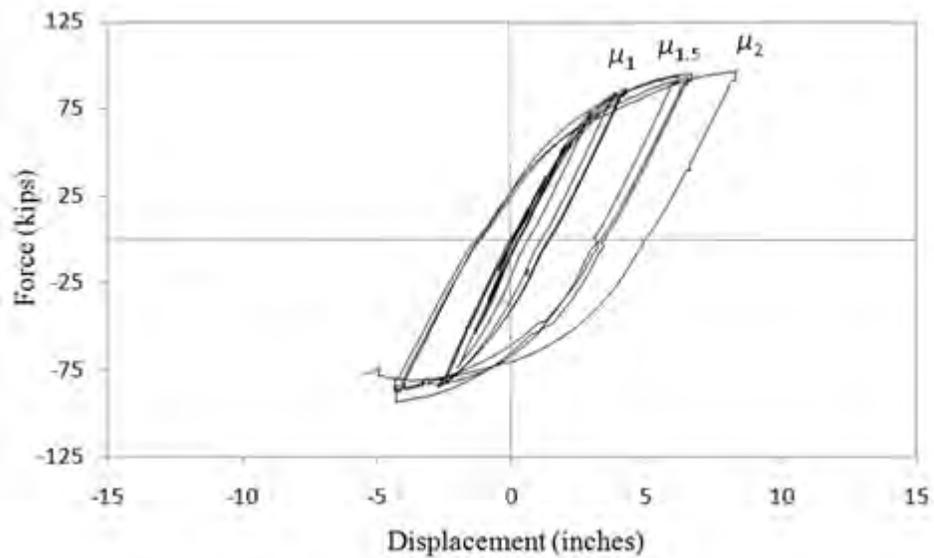
Figure 3.6 Test 1 Force Displacement Hysteresis

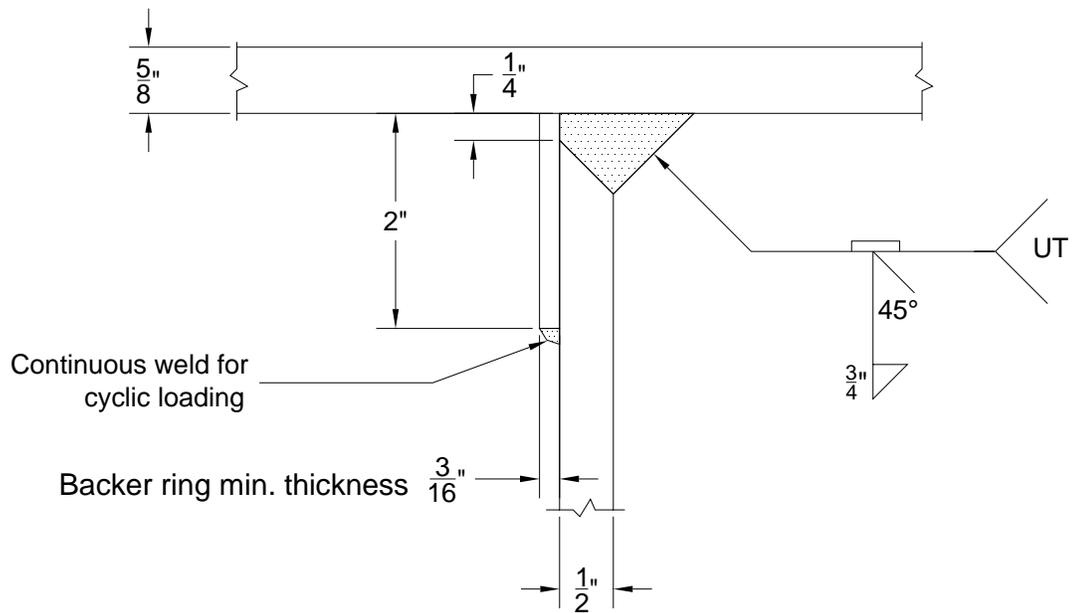
Figure 3.9 Test 2 Connection Detail Section

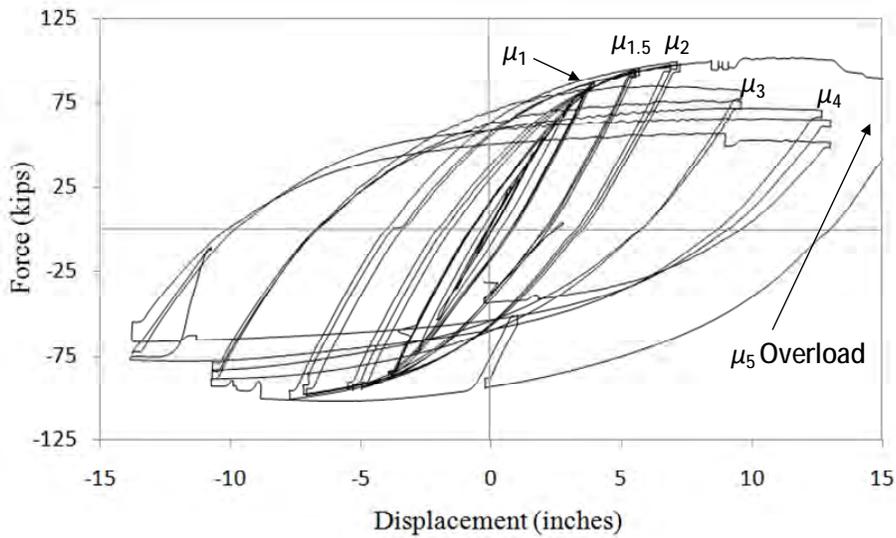
Figure 3.13 Test 2 Force Displacement Hysteresis

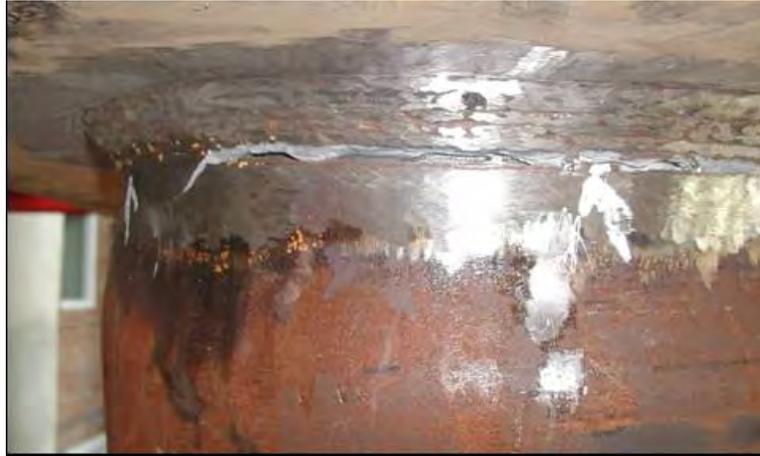
Figure 3.15 Test 2- Cracking at Weld Toe North Column South Face

column. This crack extended from the extreme fiber of the south face to approximately the neutral axis as shown in Figure 3.15. It is possible that this crack was due to damage sustained during the overload cycle. For this reason and the fact that only minor strength loss had been experienced as is shown in Figure 3.14, the test was continued.

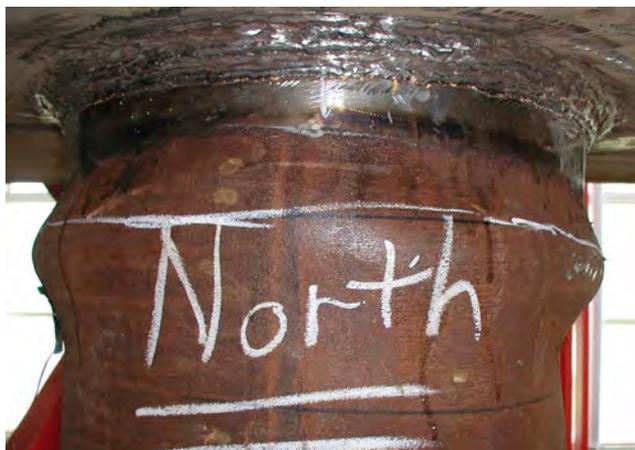
Figure 3.16 Test 2 – Local Buckling of North Column

Ultimately the specimen was able to develop local buckling as is seen in Figure 3.16 when subjected to ductility 4 displacements. This buckling led to significant strength degradation and base material fracture at a location of local buckling on the south column shown in Figure 3.17. The failure mechanism of this specimen can be summarized as a combination of local buckling, strength loss, base material fracture, and weld to fracture possibly due to the overload cycle. A summary of these failure mechanisms has been provided in Table 3.2,

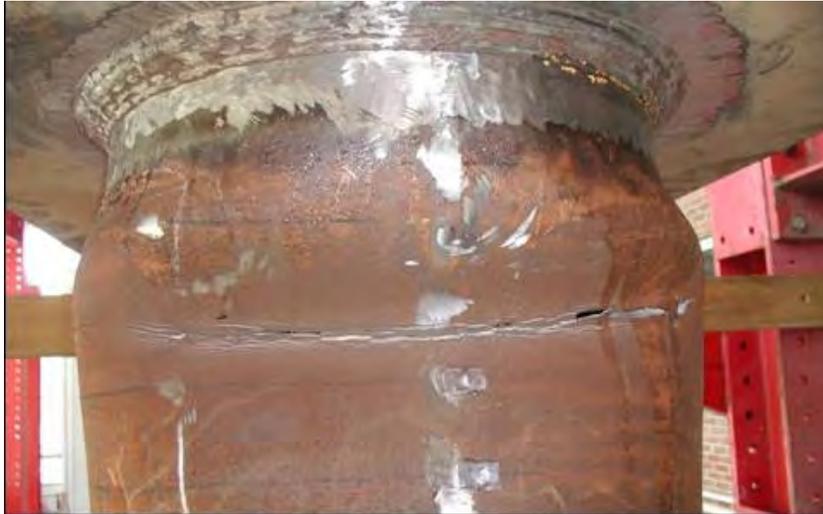
Figure 3.17 Test 2- Base Material Fracture on South Column

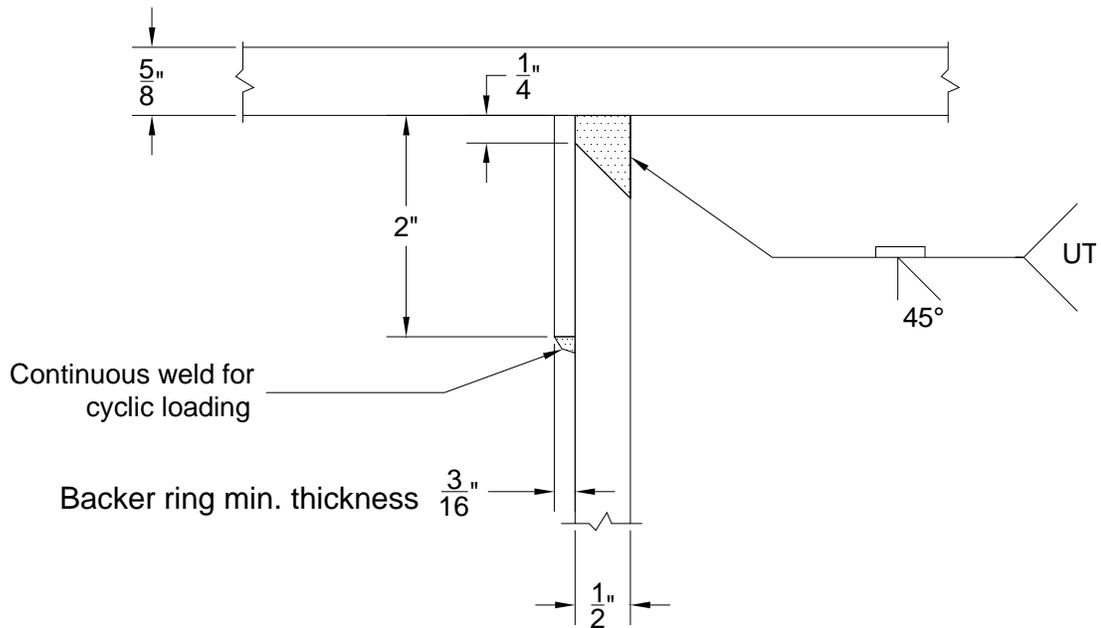
Figure 3.19 Test 3 Connection Detail Section

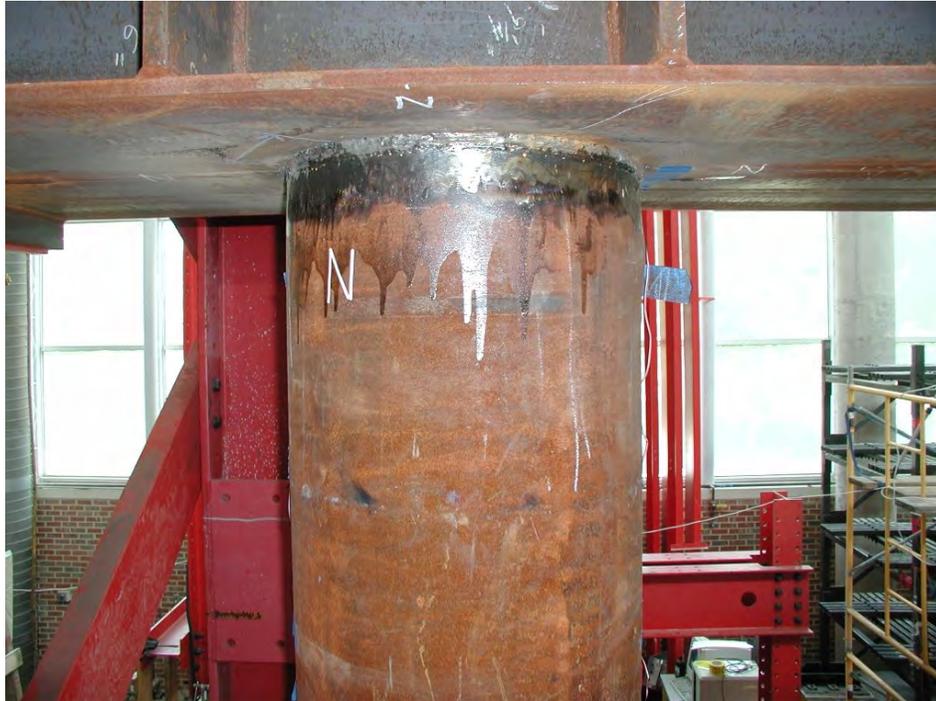
Figure 3.20 Test 3 Connection

As in test 2, significant quality control measures were implemented to ensure that the best possible weld, still constructed under realistic conditions, was achieved. Both visual and ultrasonic testing of the weld, which can be seen in Figure 3.20, was conducted and can be found in Appendix 4.

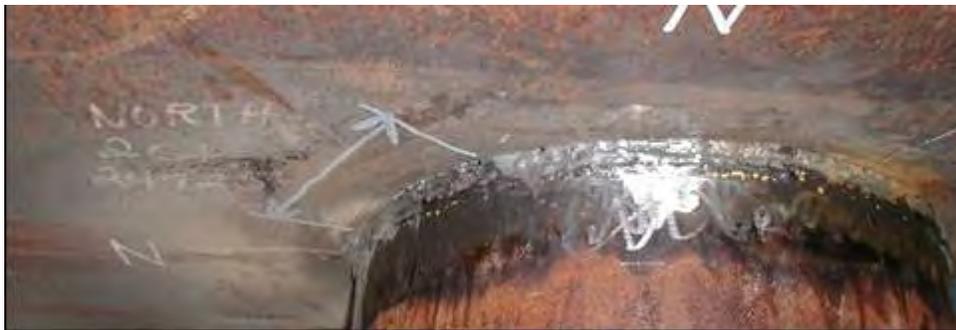
Figure 3.23 North Column Crack During Overload Cycle

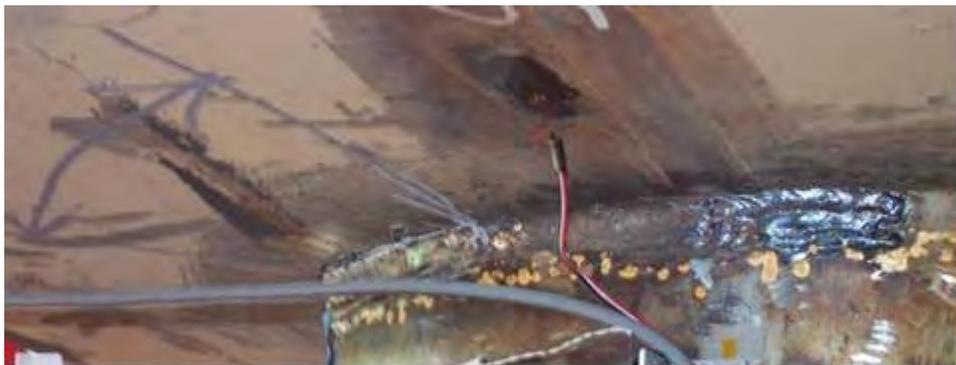
Figure 3.24 South Column Cracking – Ductility 1.5 Second Pull cycle

second pull cycle of ductility 1.5 on the south column in the northeastern quadrant at the cap beam weld toe as seen in Figure 3.24. Multiple small cracks also developed on the south side of the south column. The crack seen at the weld toe of the north column also grew in length during this cycle. The cracks already formed on both columns continued to grow both in length and width during the first cycle of the second ductility level and even propagated through the weld in the case of the cracking on the south column during the second cycle of ductility 2 as shown in Figure 3.25. The cracking observed on the north pile was also seen to propagate through the weld during the third cycle of ductility 2 as shown in Figure 3.26. The test was continued into ductility three even though the reduction in strength was clearly more than 20%. After the first cycle of ductility 3 the cap beam showed distortion near both columns, as seen in Figure 3.27, and a new crack had formed in the north column at the cap beam weld toe. At this point the test was stopped due the extent of damage and loss of strength of the test unit as has been summarized in Table 3.3.

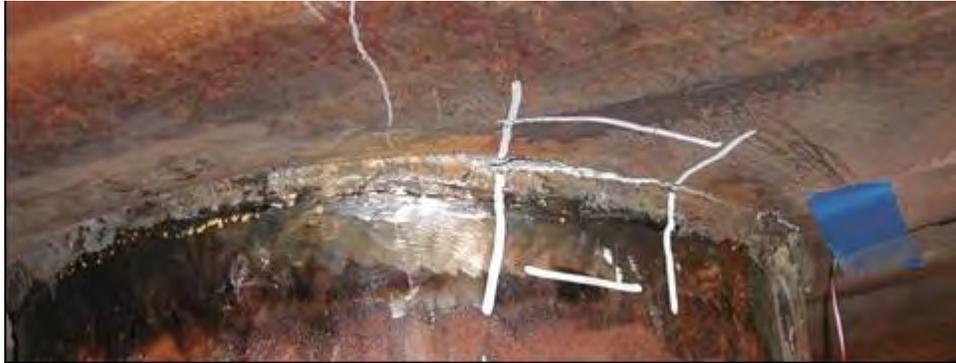
Figure 3.25 South Column Propagation of Cracking through the Weld

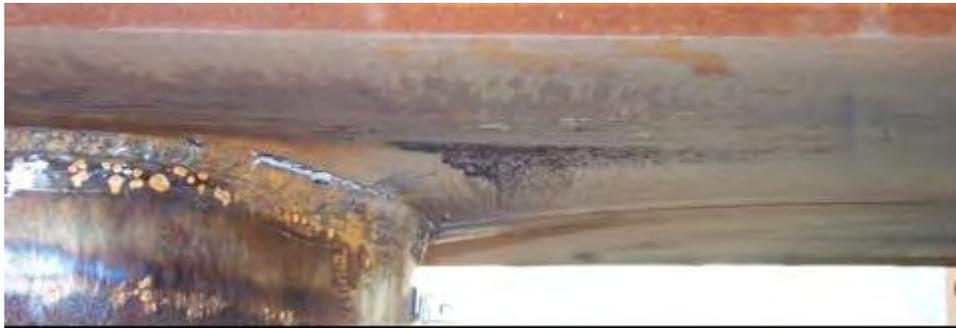
Figure 3.26 North Column Propagation of Cracking through the Weld

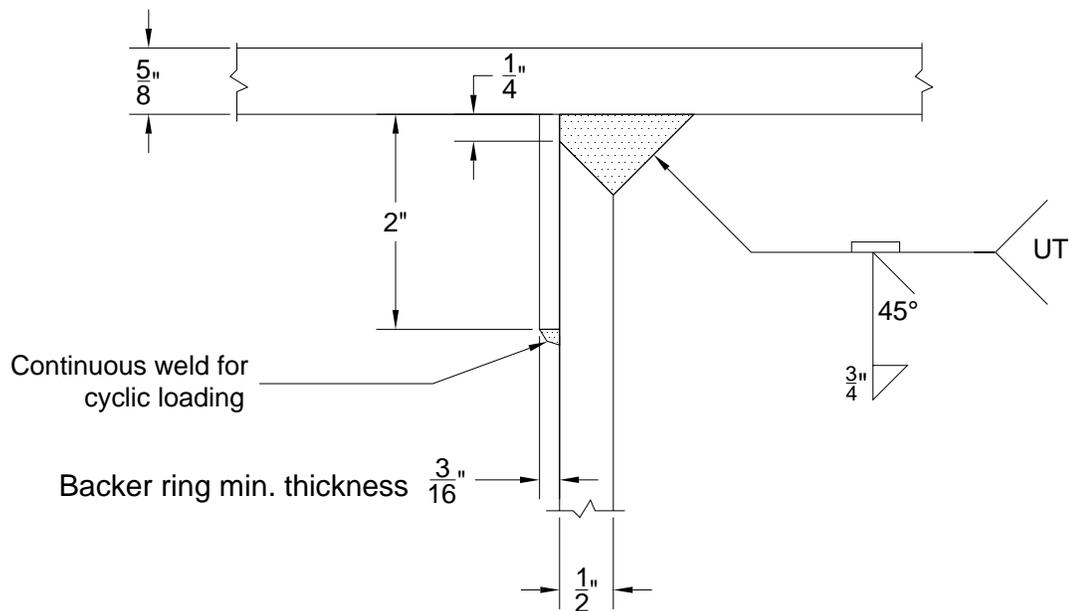
Figure 3.28 Test 4 Weld Detail Section

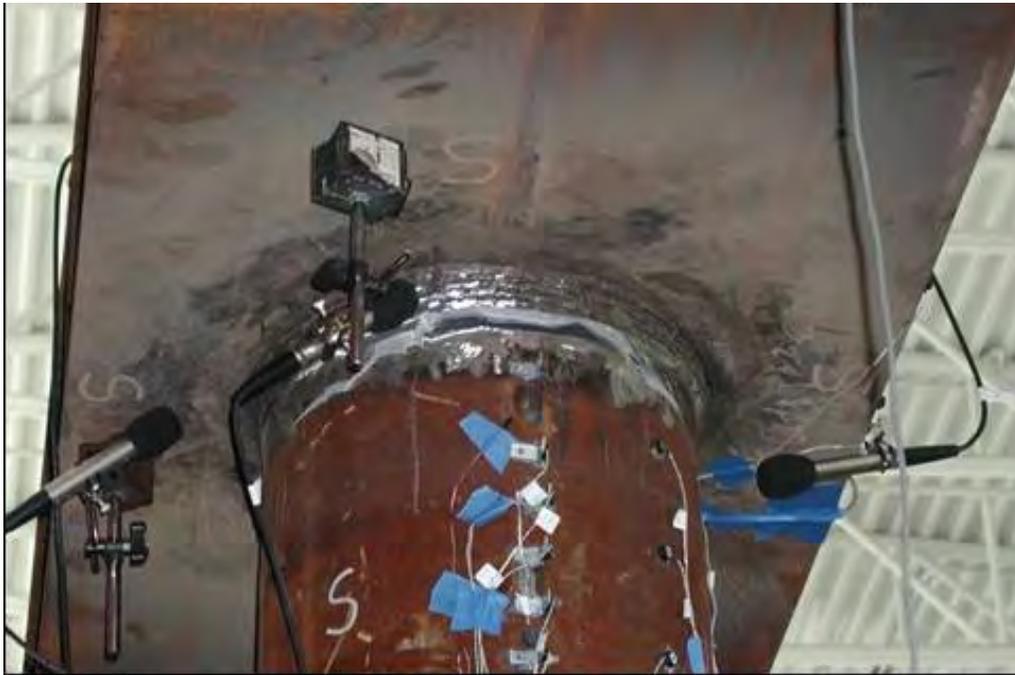
Figure 3.33 Cracking on South Column

Ultimate failure occurred rapidly during the third push cycle of ductility 3. A large crack quickly formed and propagated around a significant portion of the south face of the south column as seen in Figure 3.33 and Figure 3.34. This crack significantly affected the strength of the system as can be seen in both Figure 3.35 and Figure 3.36. The last pull cycle of ductility three was completed and the test was assumed to be completed given the significant cracking on the south column and approximately 30% strength loss.

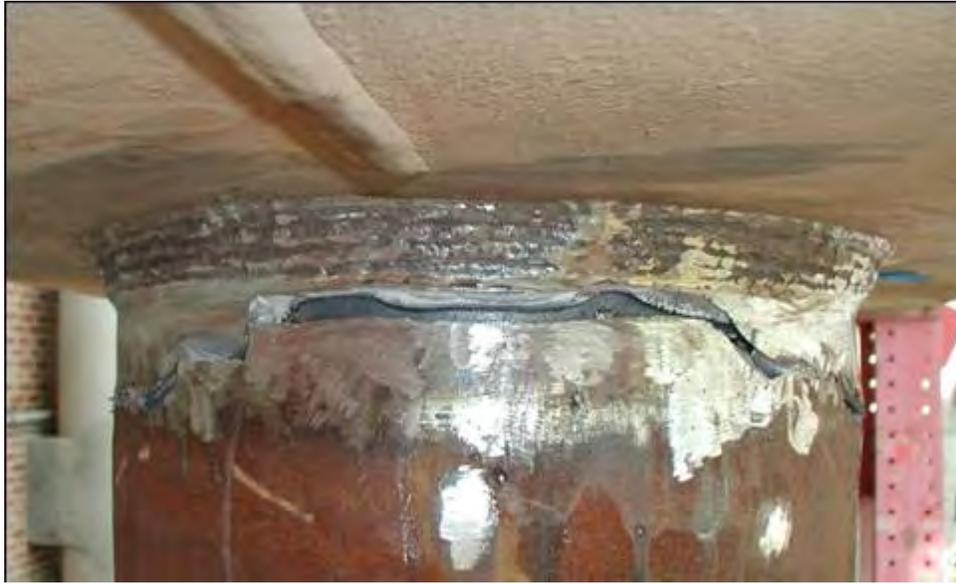
Figure 3.34 Cracking on South Column – Post Test

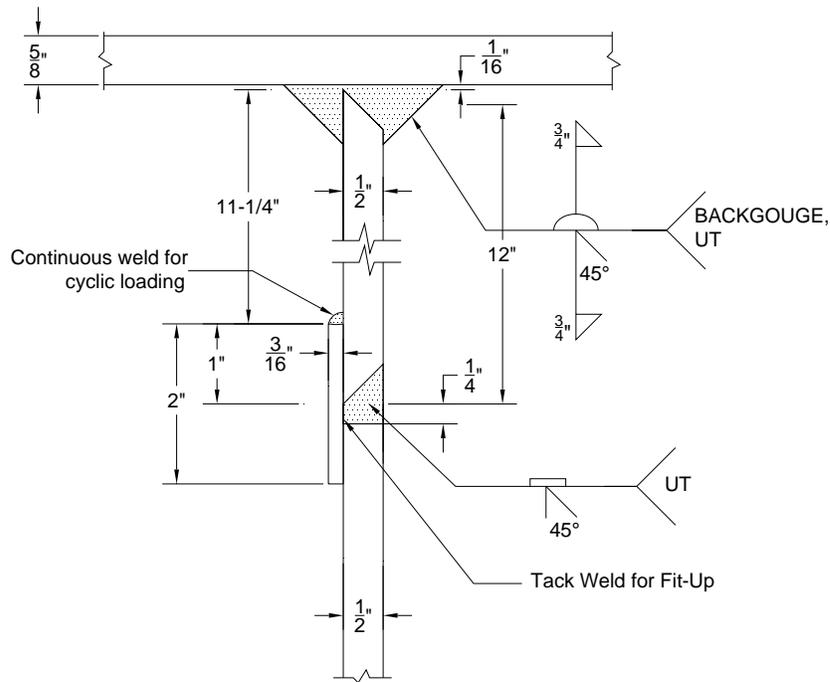
Figure 3.38 Connection Detail Section

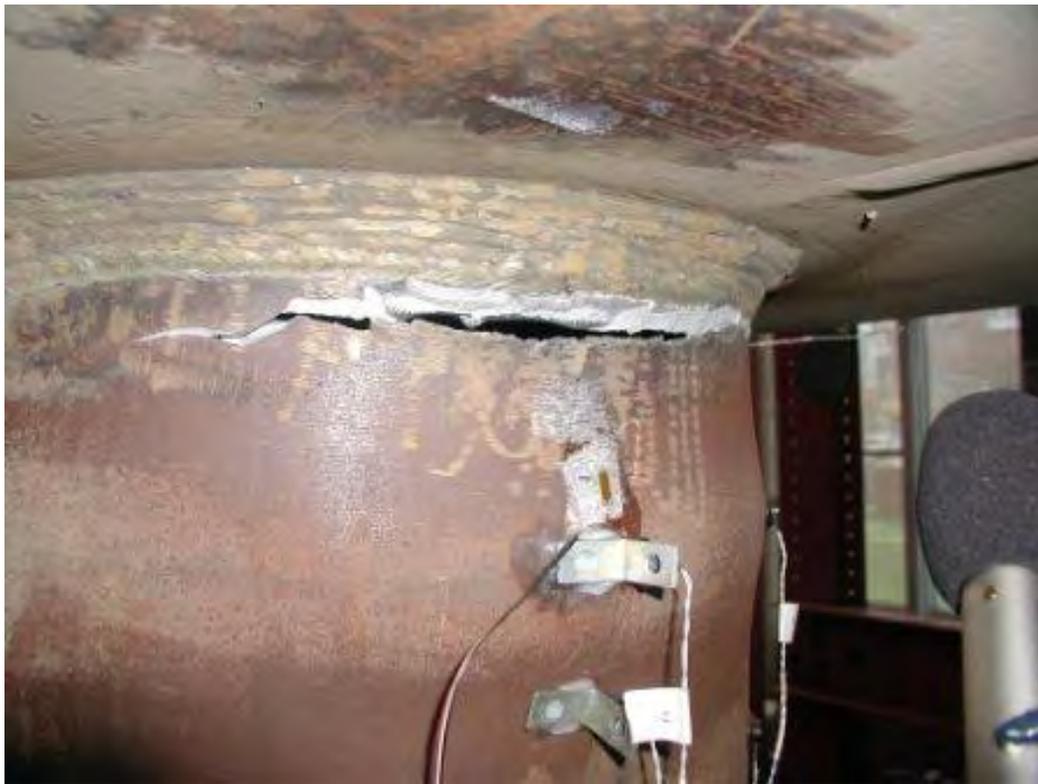
Figure 3.42 Failure Crack – Ductility 3 Cycle 3

of ductility 3 at a location just above the splice weld on the north face of the south column and near the cap beam weld on the north face of the north column. The second pull cycle of ductility 3 led to slight local buckling developing near the cap beam weld on the south face of the south column and at both the cap beam weld and splice weld on the south face of the north column as can be seen in Figure 3.45. The buckling never had a chance to propagate and develop strength loss due to large the fracture that formed shortly after buckling had begun.

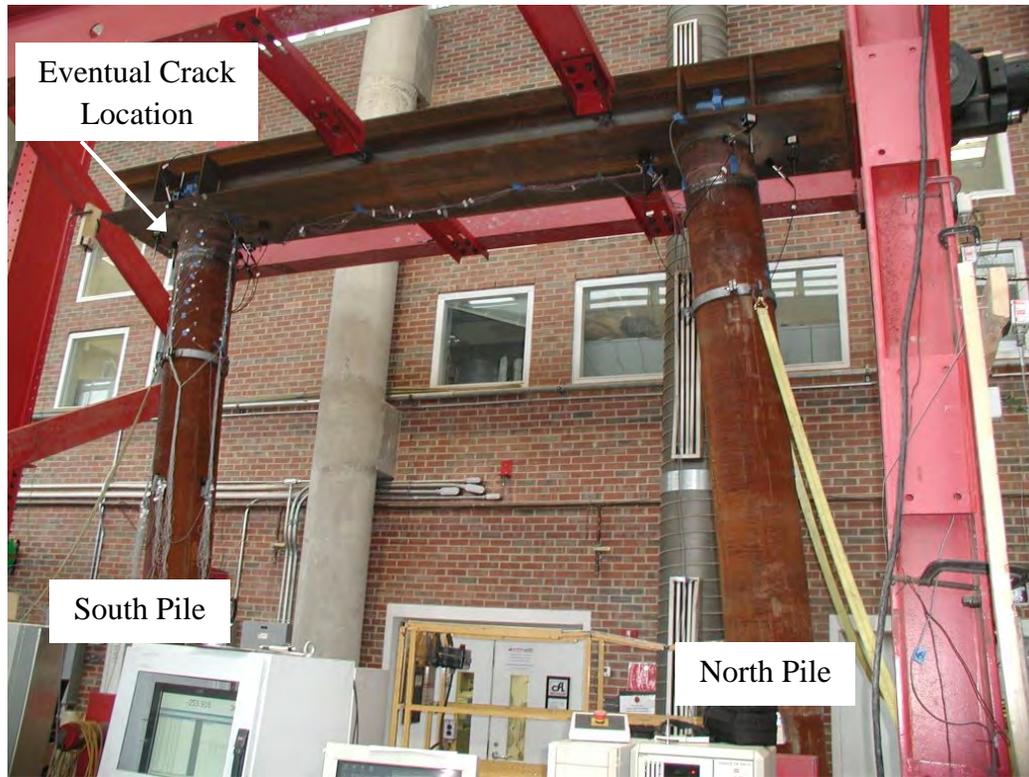
Figure 3.46 Test 5 Response – Ductility 3

Although the test 5 specimen was able to withstand most cycles of ductility 3 as is shown in Figure 3.46, the reliability of the design was no better than that of test 4. The test 5 detail did allow for minor local buckling to begin occurring, but ultimately the failure took place again at the weld toe. The detail was not capable of producing a base material failure and was therefore considered to be inadequate and unreliable. It was still felt following this test that the weld toe failures observed were likely strain related as opposed to stress related. Unfortunately the inside reinforcing fillet weld did not prolong the life of the structure leading to the conclusion that the failure may be strain controlled.

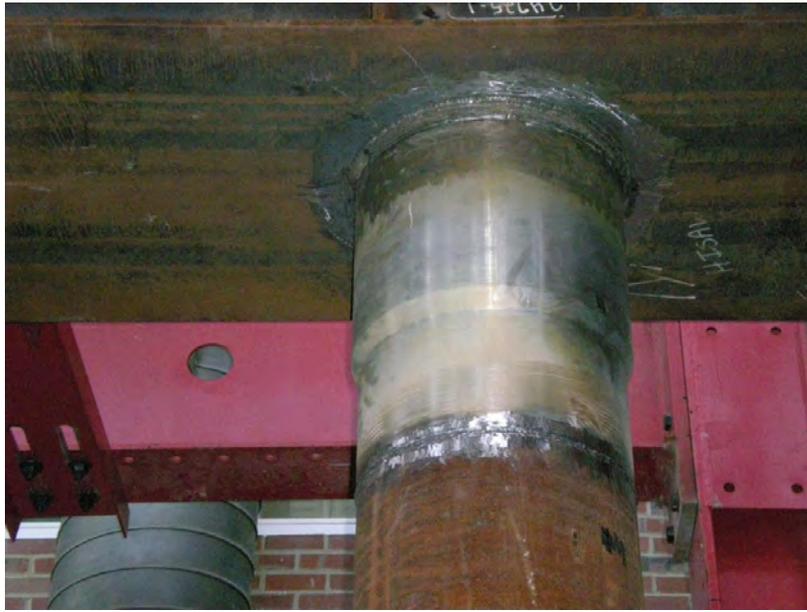
Figure 3.47 Test 6 – Flared Column Capital

Ultimately it was decided that a flared column capital as shown in Figure 3.47 would be utilized. Although the system was more complicated than originally desired by AKDOT, it was considered a necessary effort should for an adequate connection to be achieved.

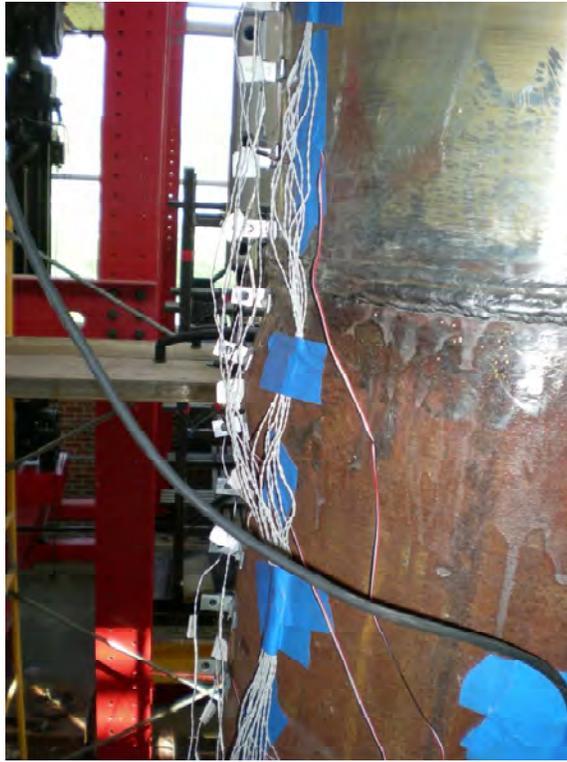
Figure 3.53 Propagation of Local Buckling – Ductility 3 Cycle 1

The test 6 specimen showed no signs of failure through ductility 1.5 and began to develop slight local buckling during ductility 2 as shown in Figure 3.53. This local buckling progressed throughout the cycles of ductility 2, 3, and 4. The slow propagation of the local buckling on both columns allowed for the degradation of the structures strength to also take place in a slow manner. Ultimately failure was dictated by base material rupture at a location of local buckling on the south column as shown in Figure 3.54. This rupture was not associated with a welded zone and occurred after approximately 30% strength loss as can be seen in Figure 3.55 and Figure 3.56.

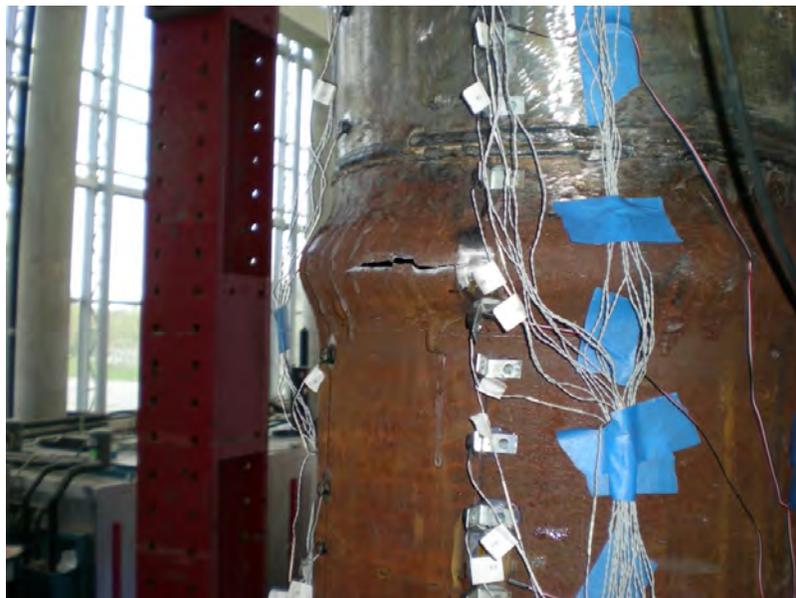
Figure 3.54 Test 6 Rupture – South Column North Face – Ductility 4 Cycle -3

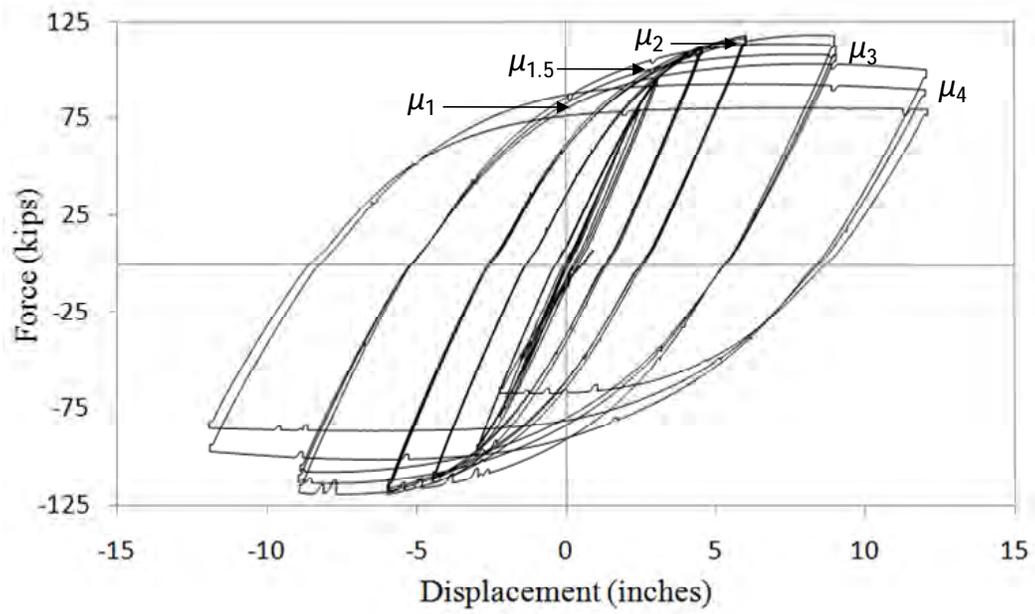
Figure 3.55 Test 6 Force Displacement Hysteresis

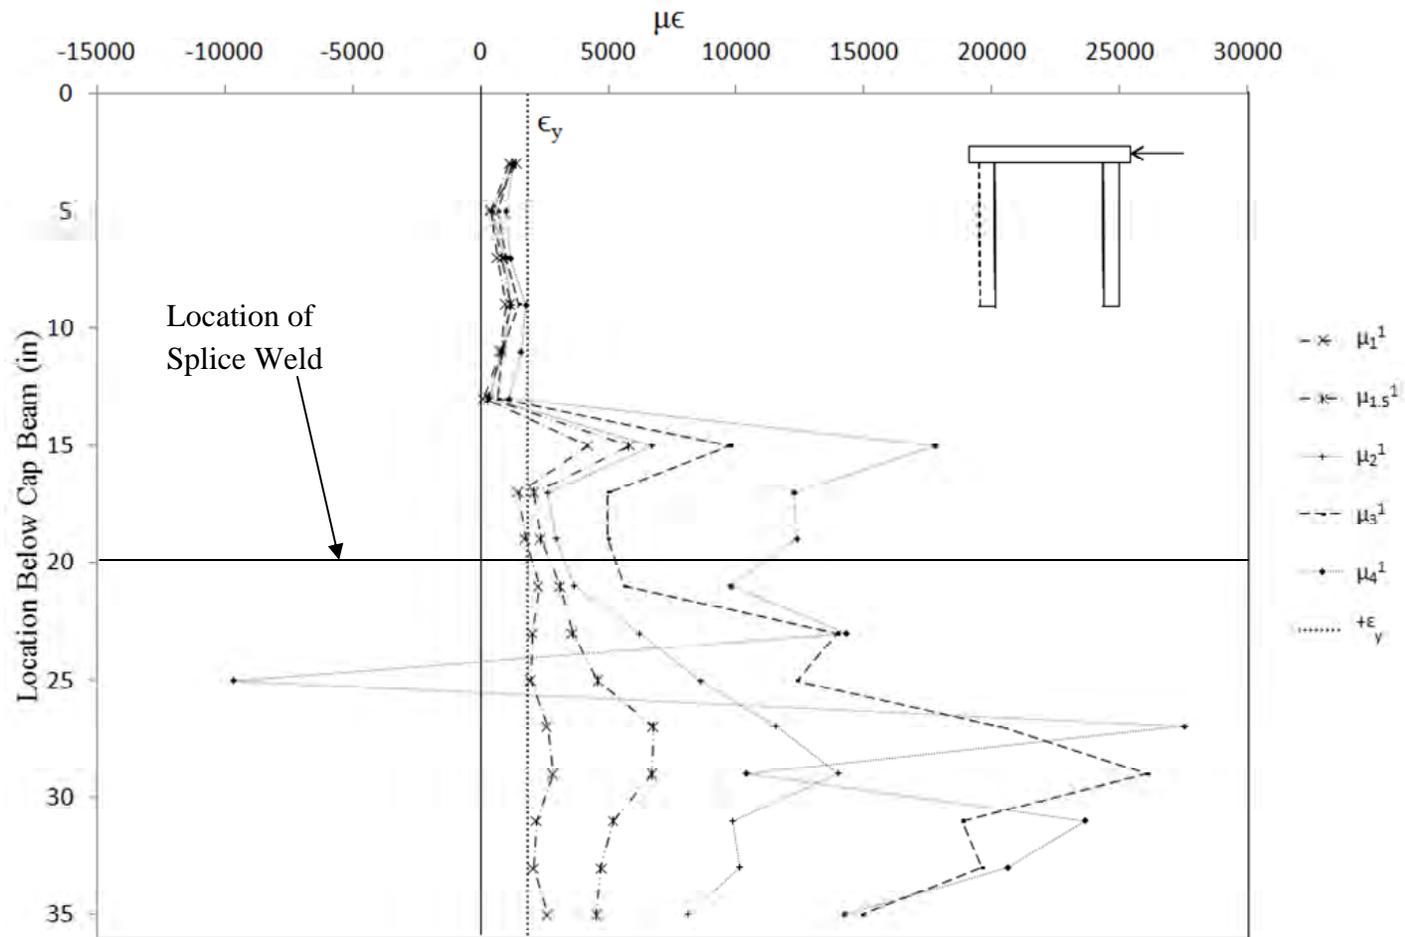
Figure 3.57 Vertical Strain Profile – South Column South Face

As can be seen in the figures provided the buckling observed occurred below the intended hinging region of the flared column capital. Initial speculation for how this occurred included the possibility that the capital was acting as a rigid end more than a flexural member for an unknown reason. As seen in Figure 3.57 Vertical Strain Profile – South Column South Face, flexural strains were present in the capital and it was not acting as a rigid end block. However, the strains were marginally higher just below the intended region. Although no theoretical reasons exist for this since the intended hinge region and plane pile section have the same properties, it is likely due to stiffening effects created by the presence of the backer ring and splice weld. In future tests it would be possible to avoid this effect by lengthening the intended hinge region or weakening the material. A combination of both would also be possible. It should be noted that in this particular tests, no adverse affects were generated by the location of buckling being outside the intended region. It is however desired to be able to control the exact location of this buckling to ensure that it will not occur near the splice weld. More in depth analysis of test 6 as well as discussion of future considerations are both provided in subsequent Chapters of this report.

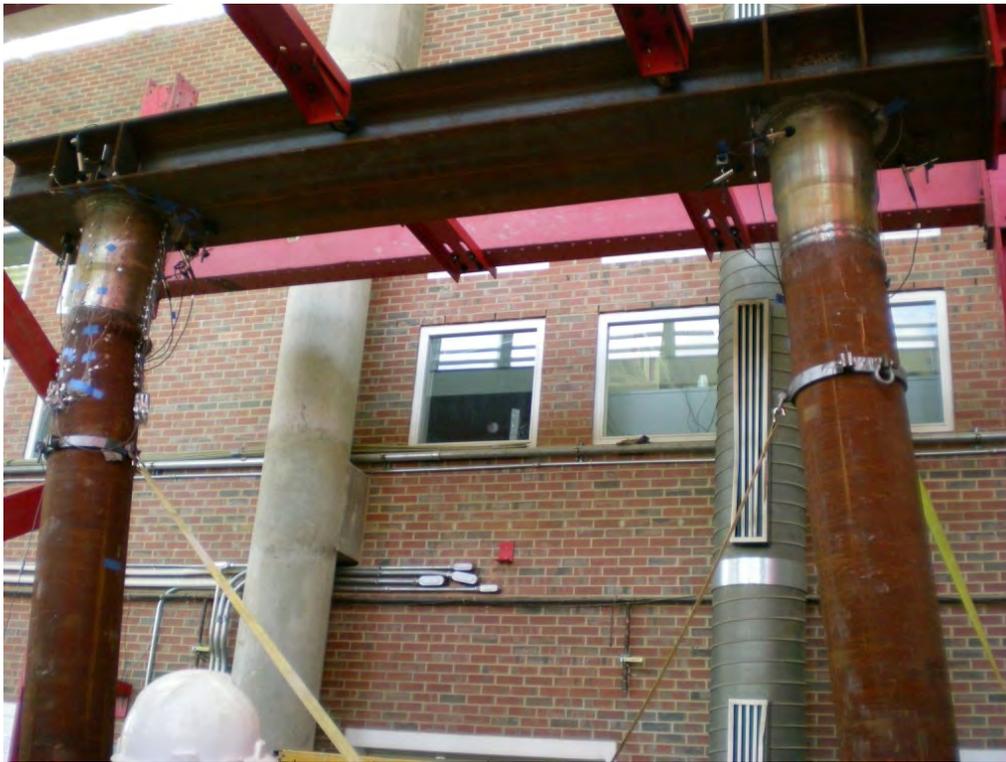
Figure 3.58 Test 6 – Ductility 4

In general, the test 6 specimen significantly outperformed that of any prior specimen as can be seen in Figure 3.58. The system would likely be assigned a reliable ductility of 3 or 4, at least one level greater than that of test 1-5. Not only was the ultimate displacement ductility capacity increased in this test, a more desirable and controllable failure mode was observed. By inducing local buckling and base material fracture prior to brittle rupture at a weld region the specimen has achieved its ultimate capability. Should greater displacement capacity be desired, it may be possible with a detail similar to that of test 6 to decrease the pile D/t ratio and achieve an even higher reliable ductility prior to base material fracture.

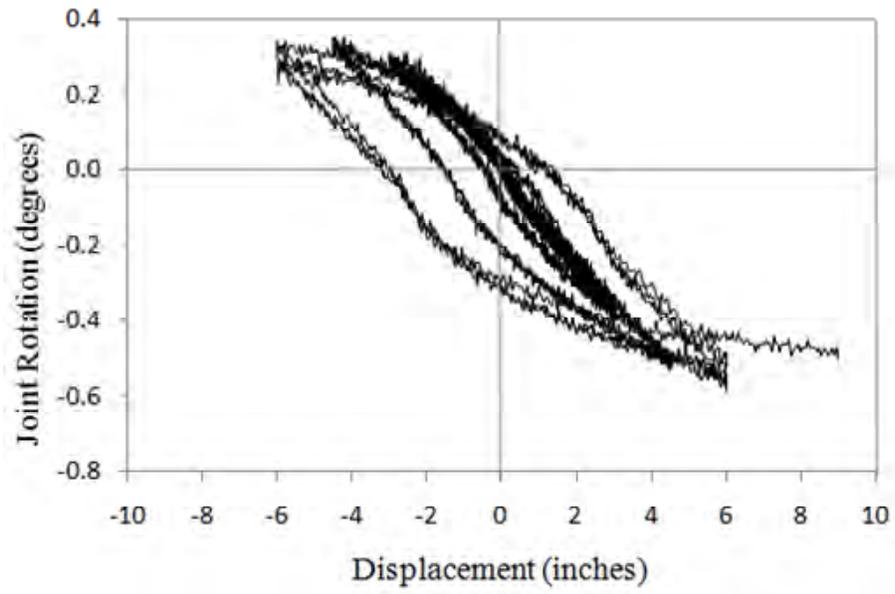
Figure 3.60 North Column Joint Rotation

During the testing of specimen 6 it was noted that both inclinometers located at the intersections of the cap beam and pile centerlines fell off at an early ductility level. This prompted the research team to investigate the data recorded by the gauges prior to them falling off. It was found that the joint rotations of this intersection were much higher than expected at first yield. It also appears that inelastic panel shear strain was experienced in the joint as is seen in Figure 3.60. This apparently weak joint could be the source of some or all of the first yield displacement discrepancy that had been experienced. These issues will also be discussed in more detail in the following Chapters.

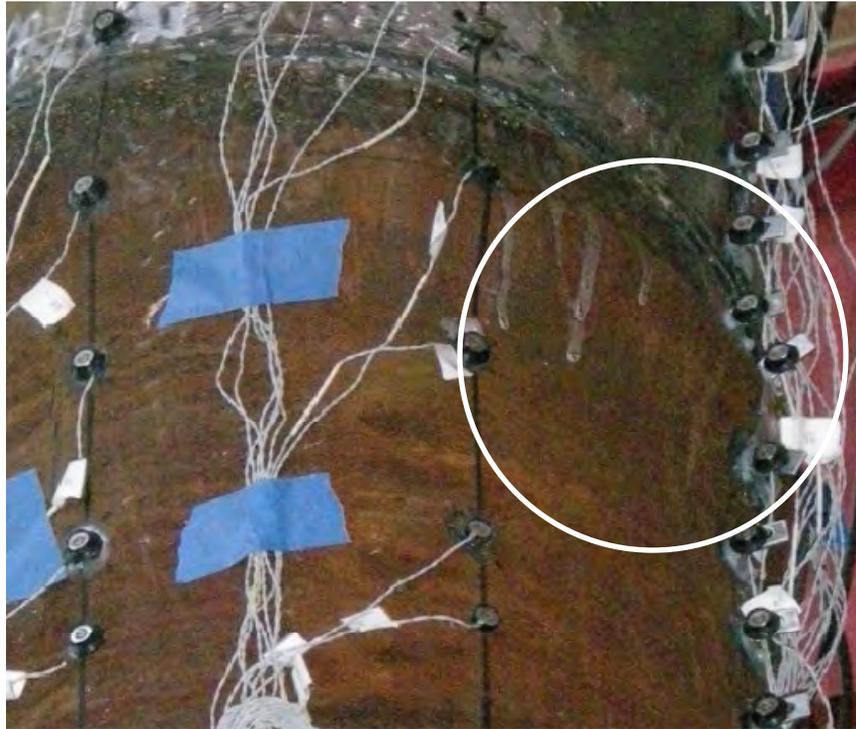
Figure 6.3 Severe Local Buckling in Test 6 – Ductility 4

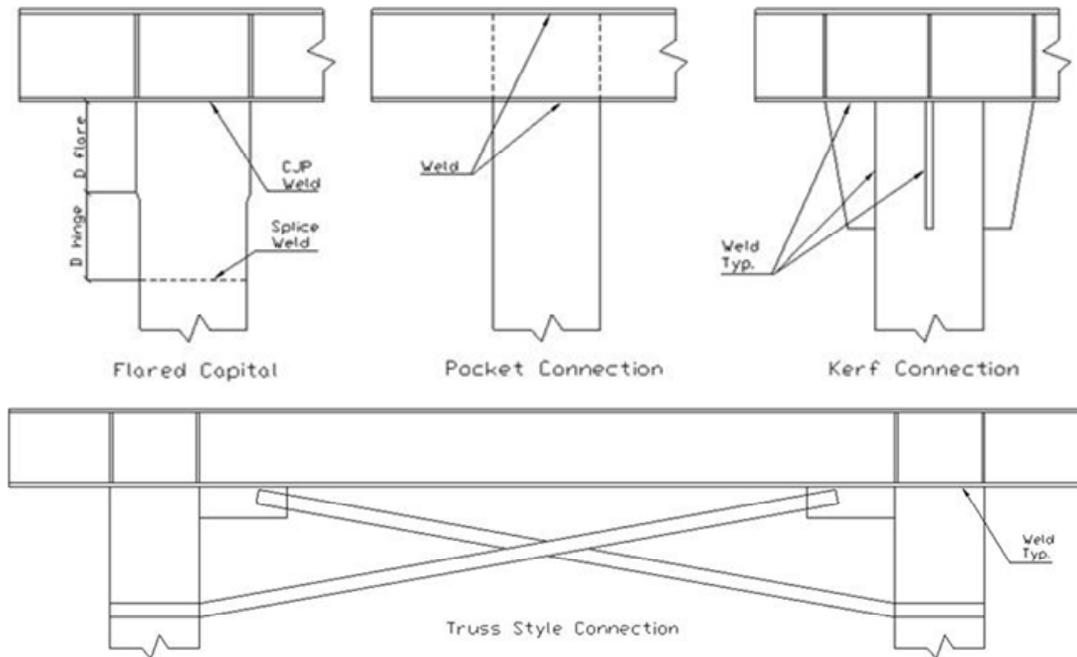
Figure 7.3 Possible New Design Conections
