The Effect of Load History on Reinforced Concrete Bridge Column Behavior

Jason Goodnight, Yuhao Feng
Dr. Mervyn Kowalsky, Dr. James Nau

August 2012

FHWA-AK-RD-12-09

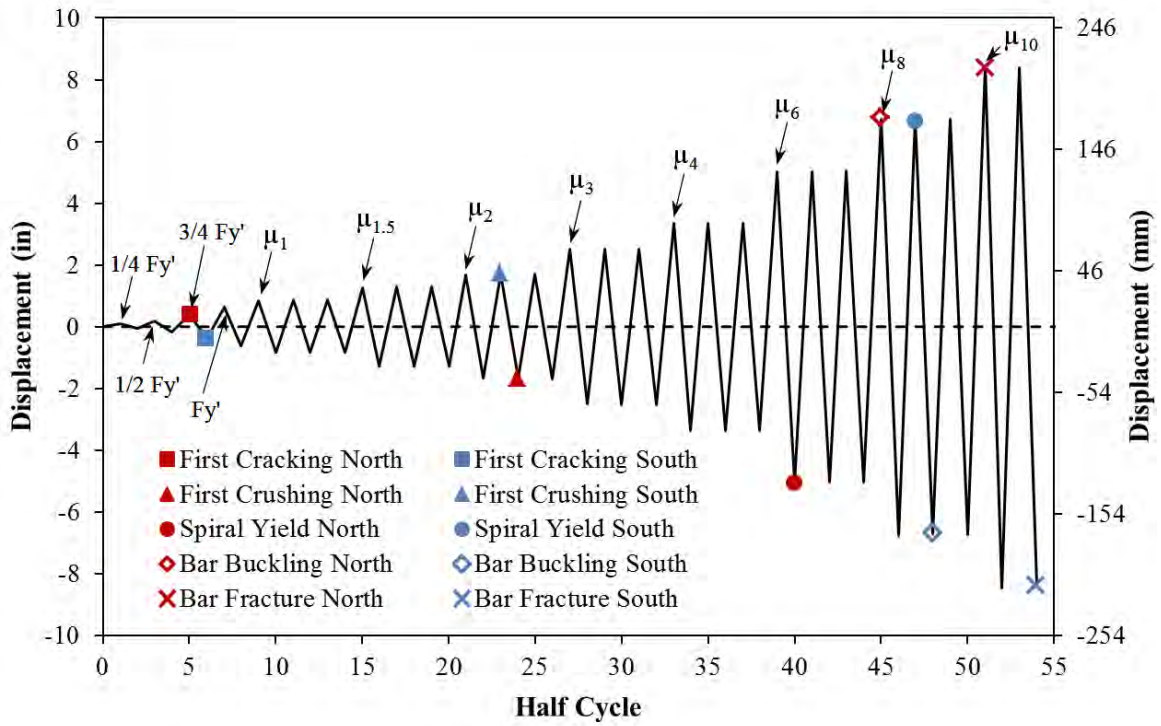
Figure 2-1. Test 9 – Symmetric Three Cycle Set Load History

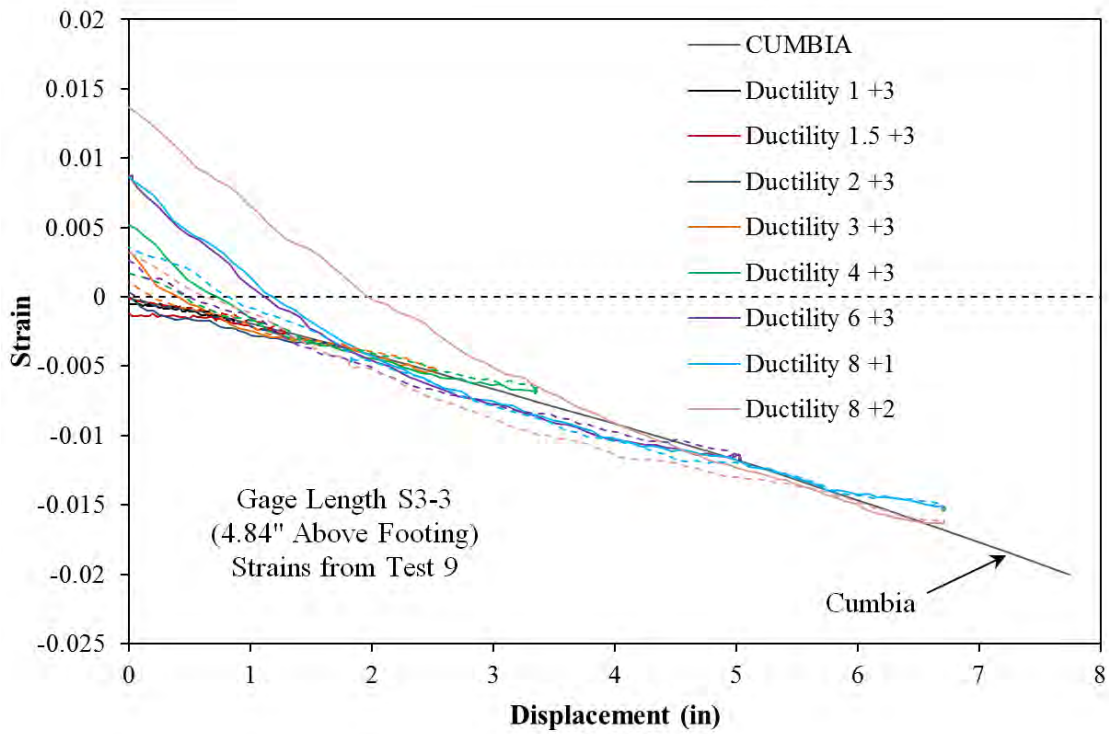
Figure 2-24. Test 9 – Strain and Displacement for Bar S3 during Push Cycles

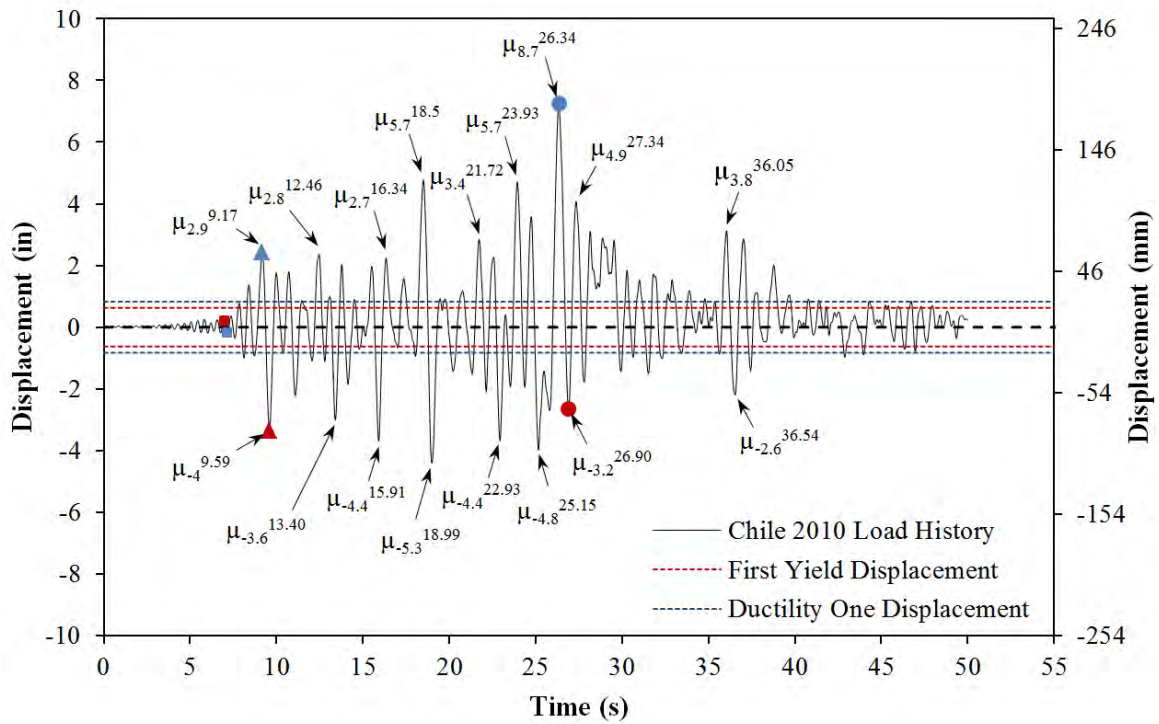
Figure 2-39. Test 8 – Chile 2010 Earthquake Load History

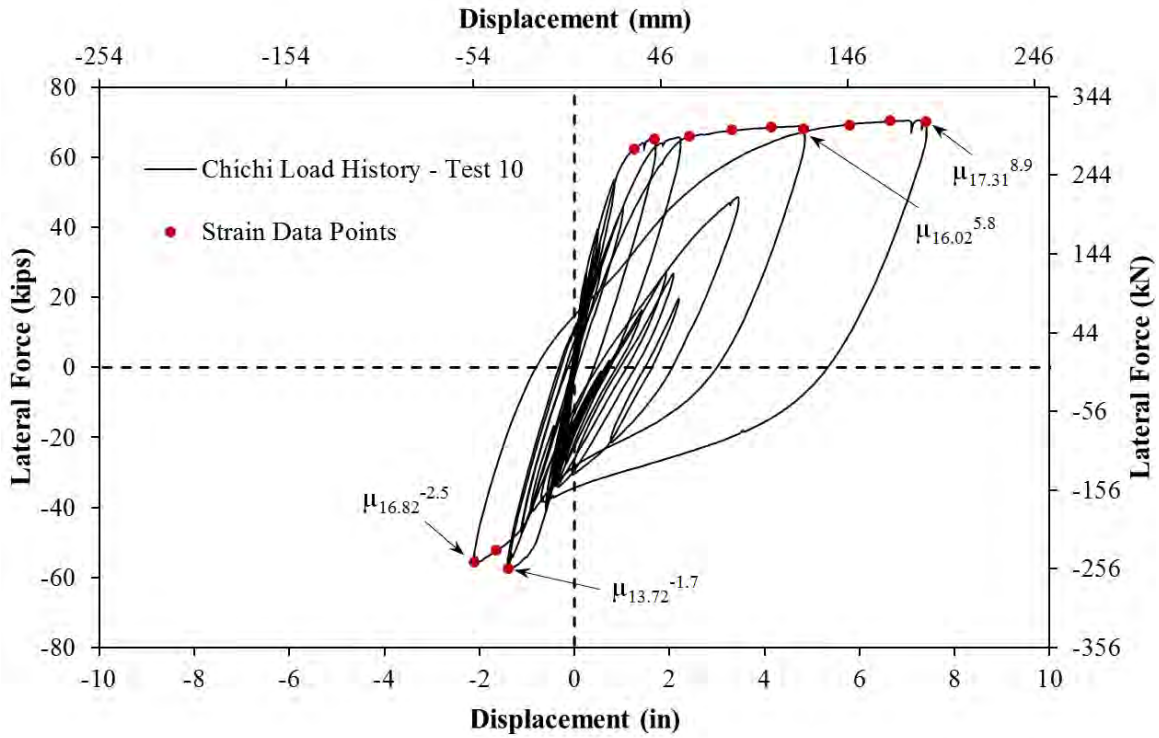
Figure 2-79. Test 10 – Strain Data Observation Points along the Backbone Curve

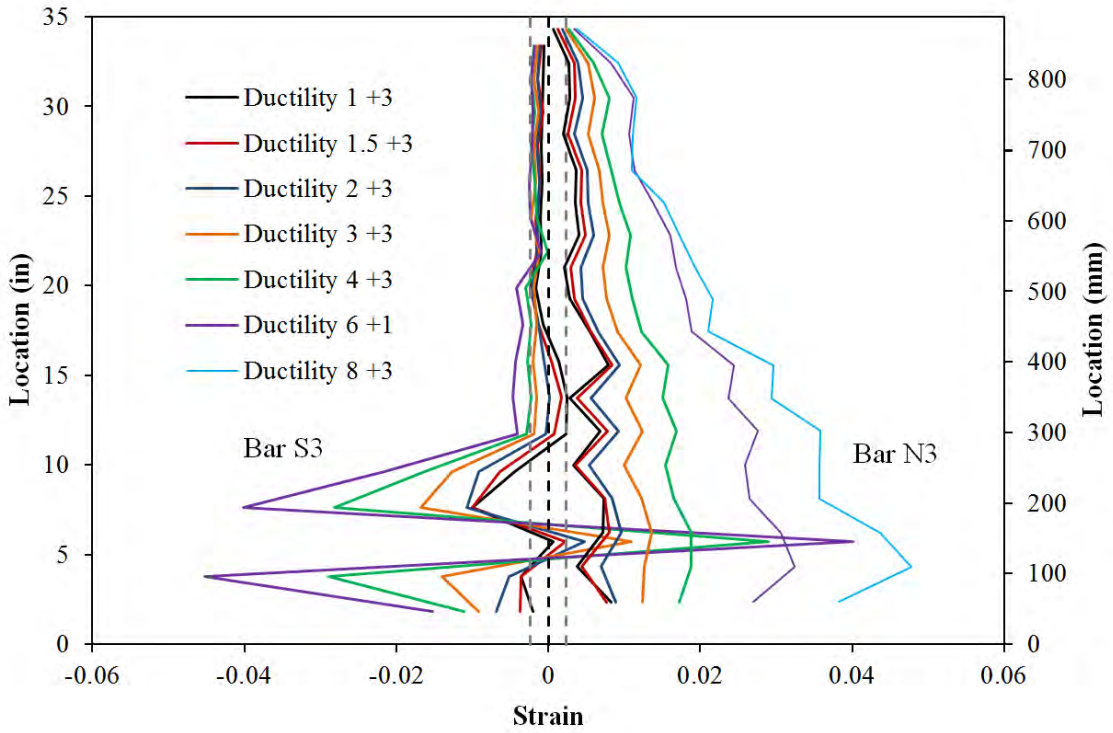
Figure 2-97. Test 10b – Extreme Fiber Vertical Strain Profiles during Push Cycles (Significant Measurable Deformation in Bar S3)

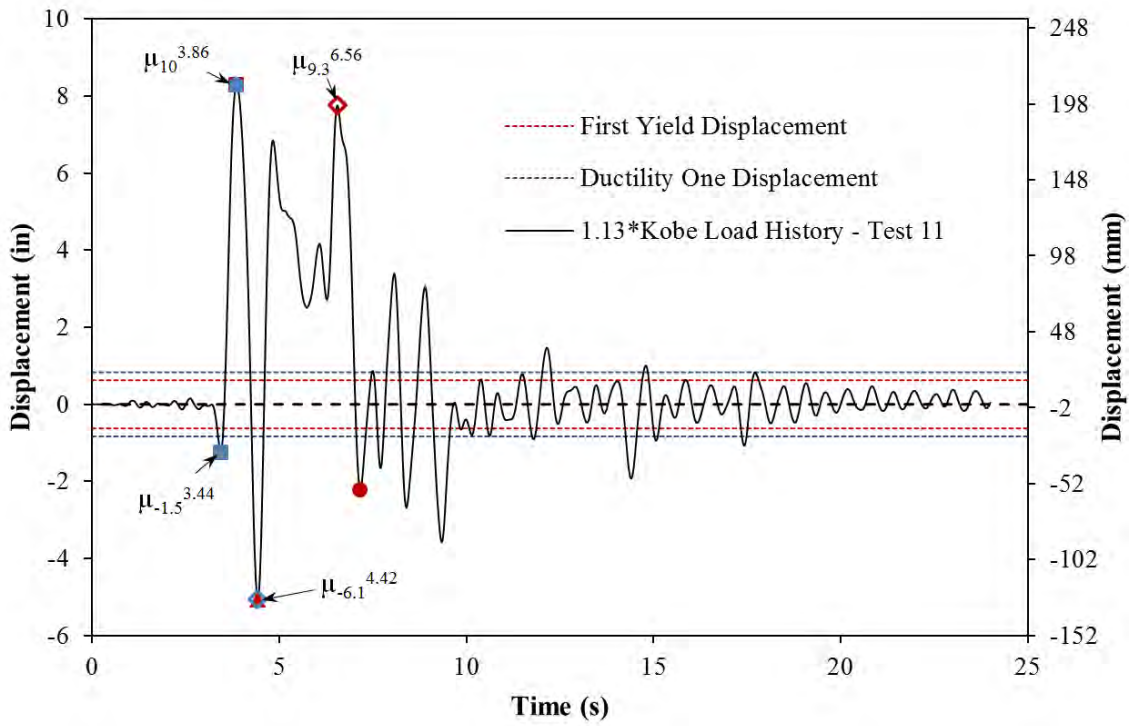
Figure 2-105. Test 11 – Kobe Earthquake Load History

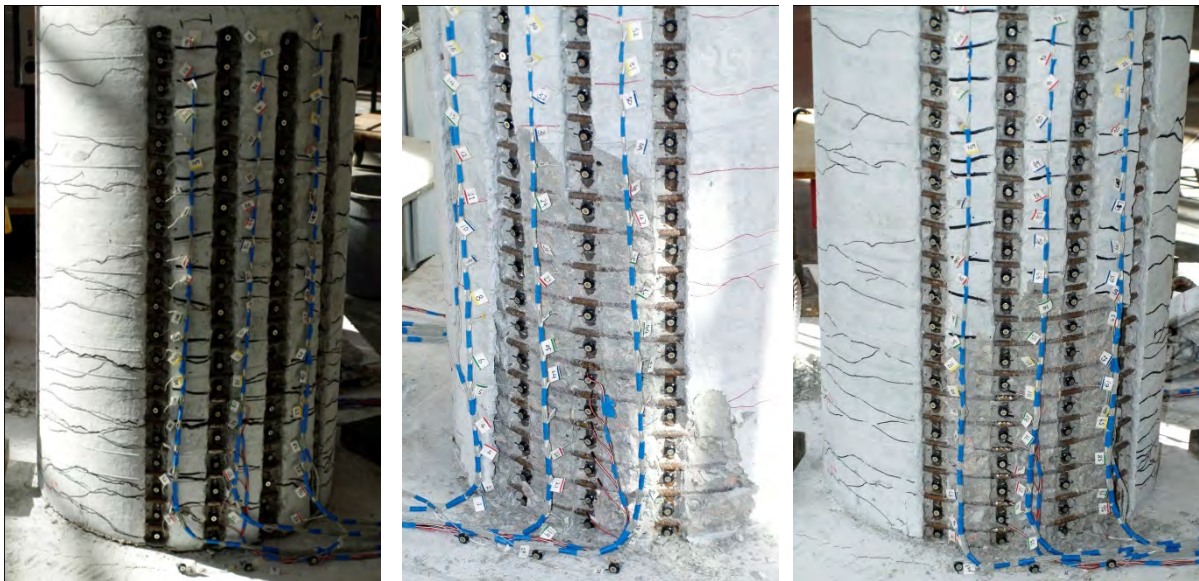
Figure 2-108. Test 11 – (Left and Middle) North and South Sides of Specimen during ($\mu_{10}^{3.86 \text{ sec}} = 8.28''$) and (Right) North Side of the Specimen during ($\mu_{-6.1}^{4.42 \text{ sec}} = -5.08''$)

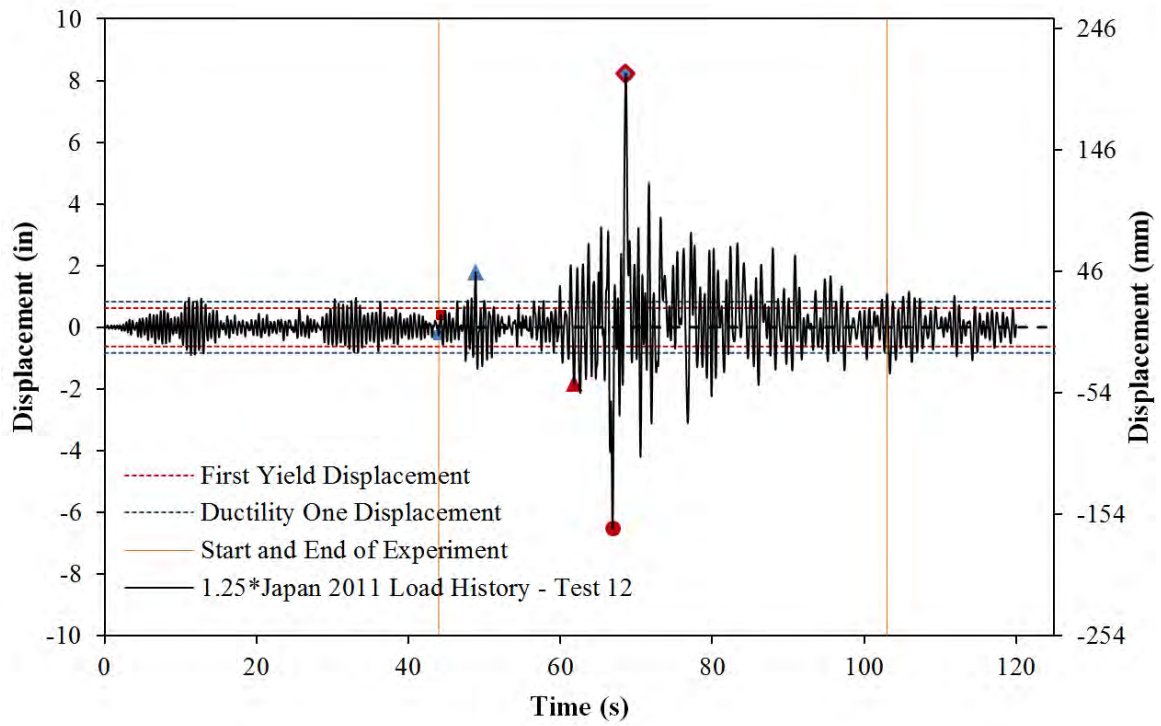
Figure 2-128. Test 12 – Complete Japan 2011 Load History Scaled to Displacement Ductility Ten (1.25*Recorded Accelerations)

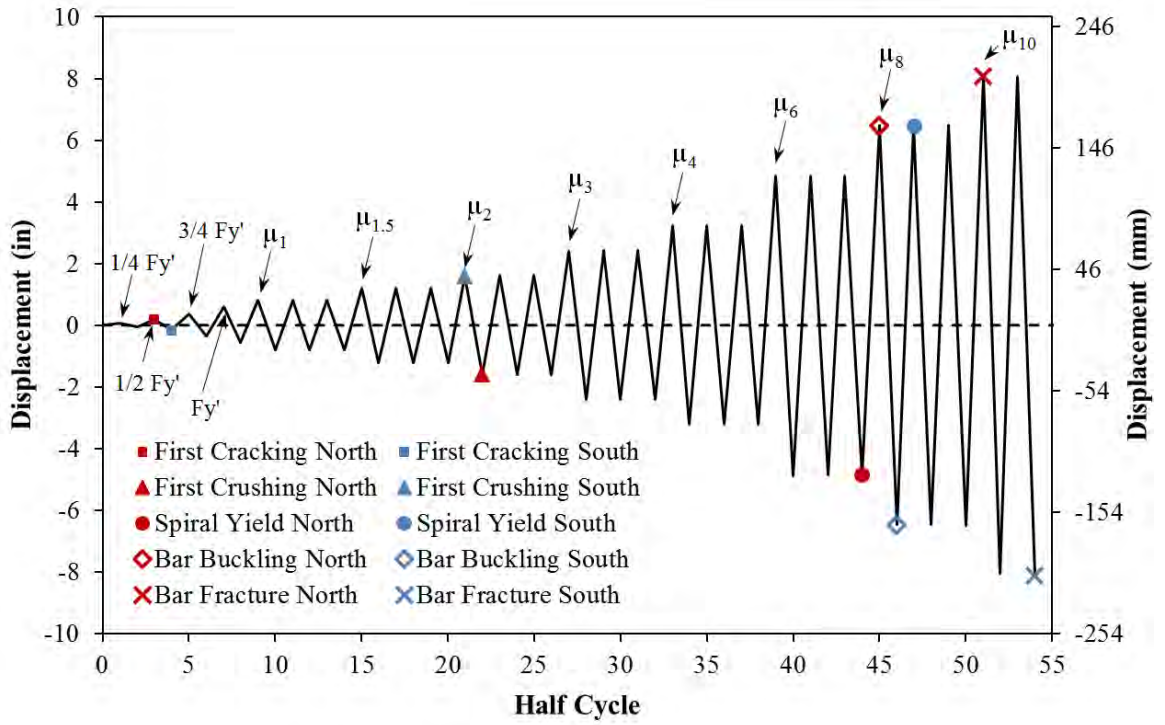
Figure 2-160. Test 13 – Symmetric Three Cycle Set Load History

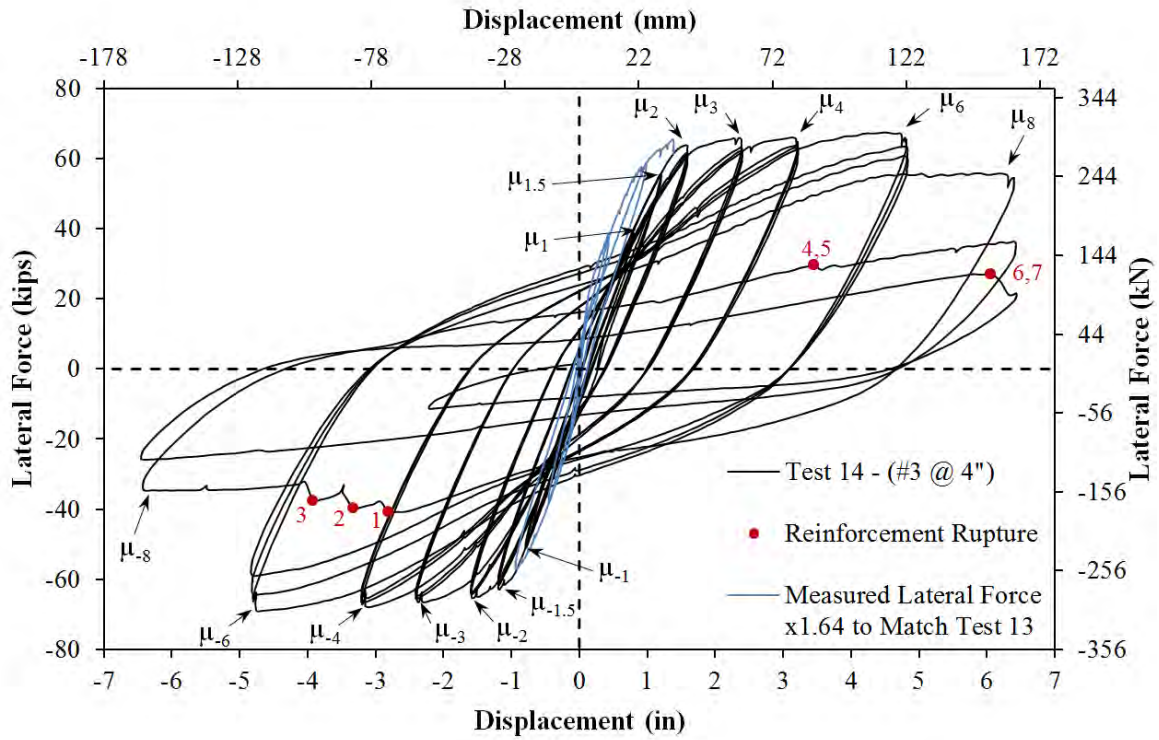
Figure 2-197. Test 14 – Rupture History of Previously Buckled Reinforcement

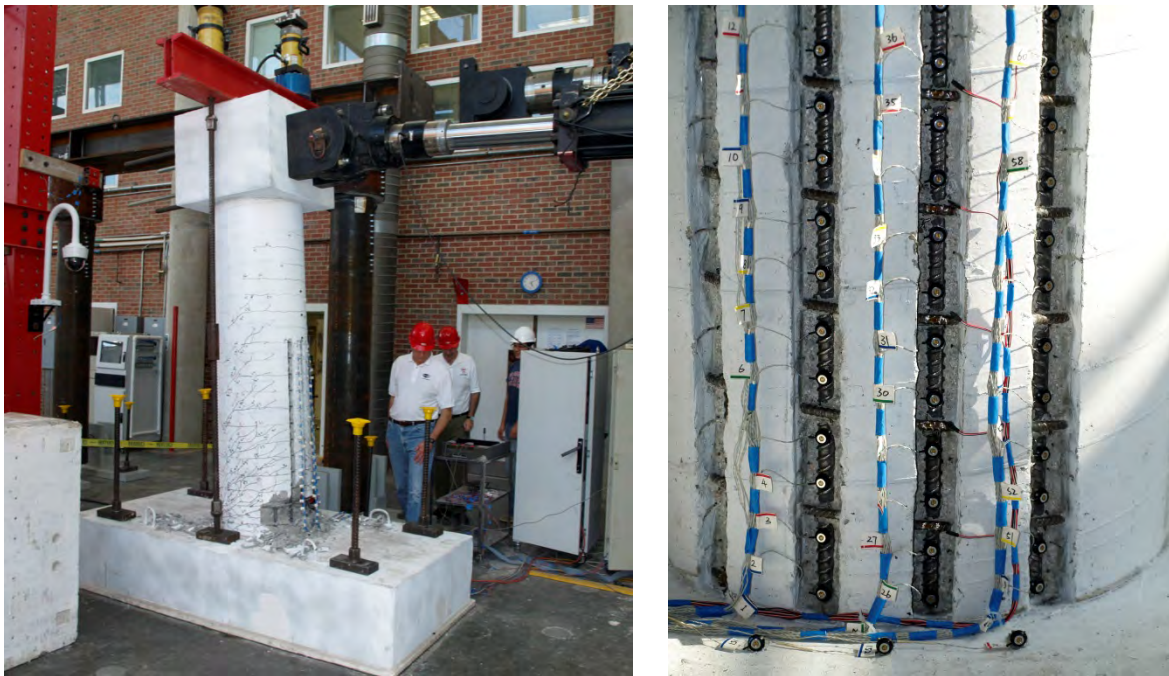
Figure 2-198. Test 14 – (Left) Test Setup and Specimen at ($\mu_8^{+2} = 6.40''$) and (Right) Two Target Markers within Each 4" Transverse Steel Spacing

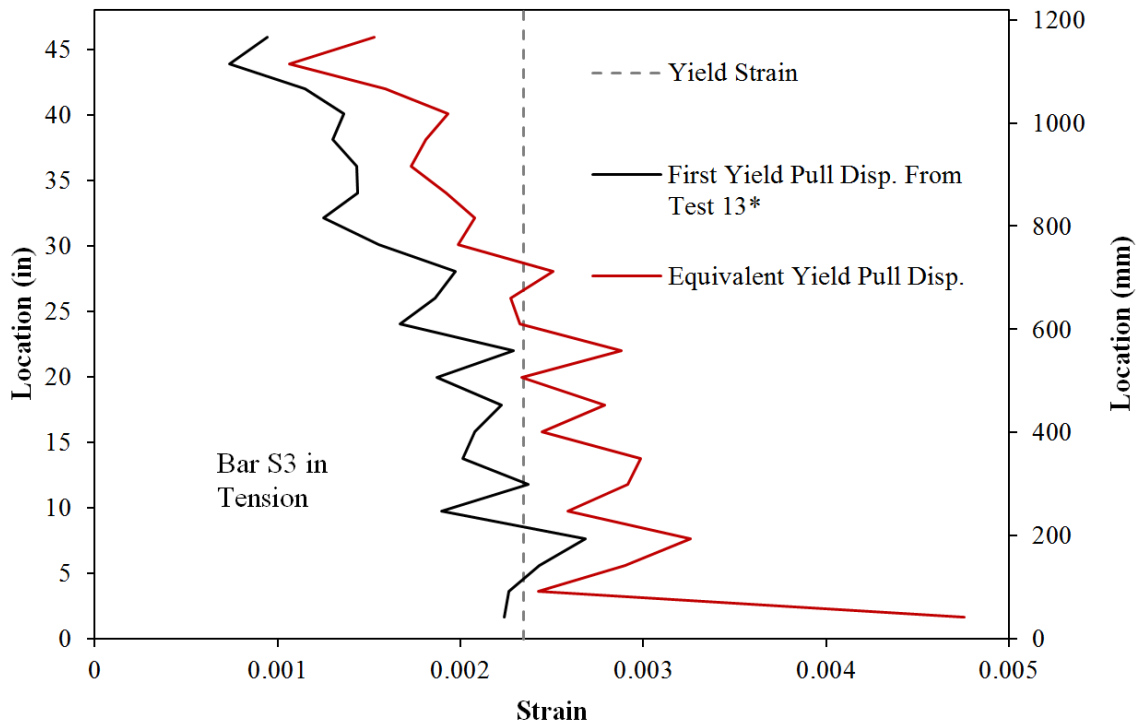
Figure 2-200. Test 14 – Bar S3 Strain Profiles during $-\Delta'_y$ (Test 13) and $-\Delta_y$

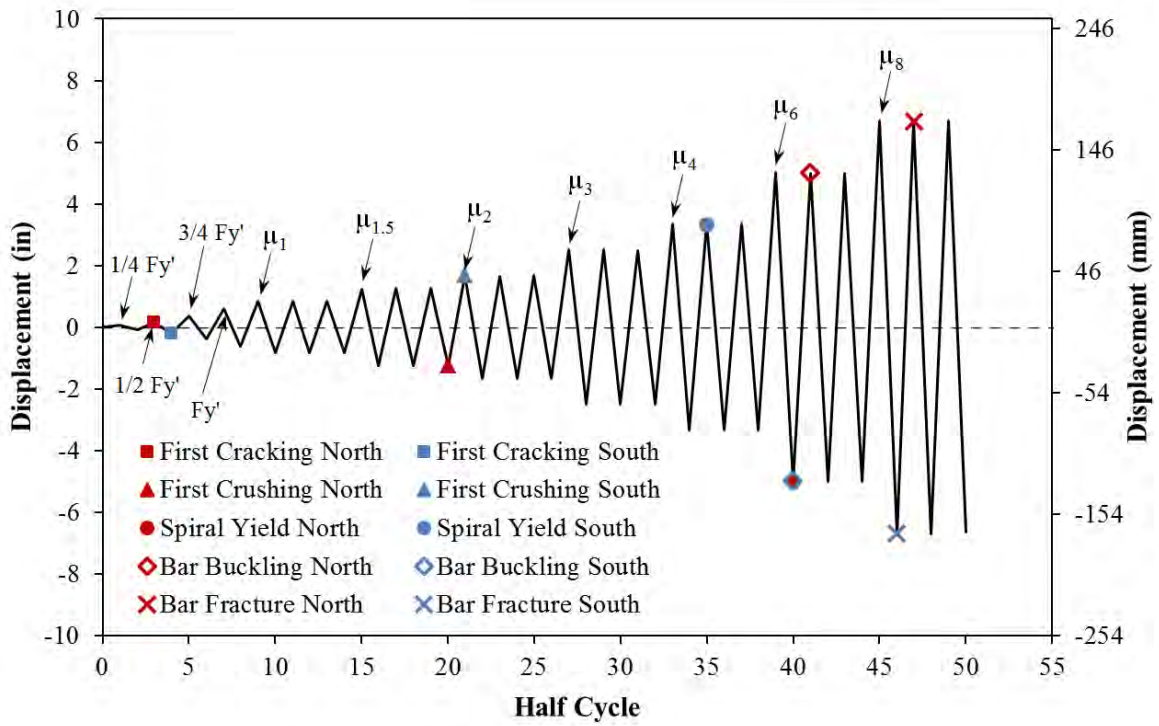
Figure 2-230. Test 15 – Symmetric Three Cycle Set Load History

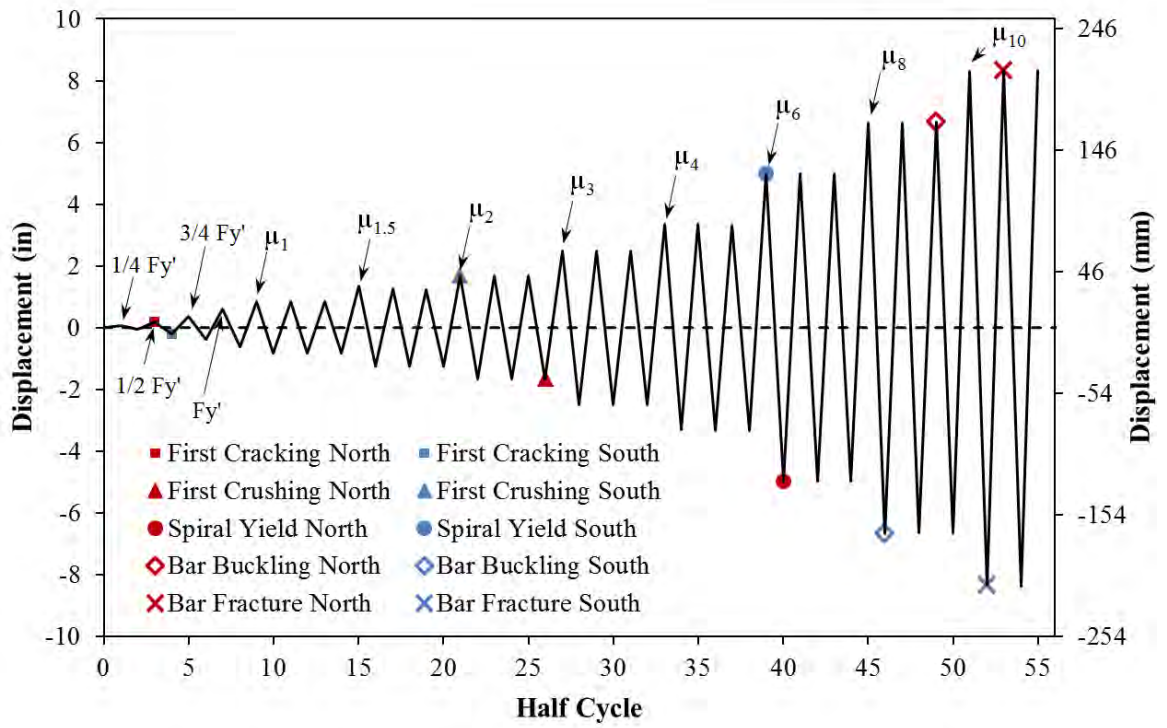
Figure 2-267. Test 16 – Symmetric Three Cycle Set Load History

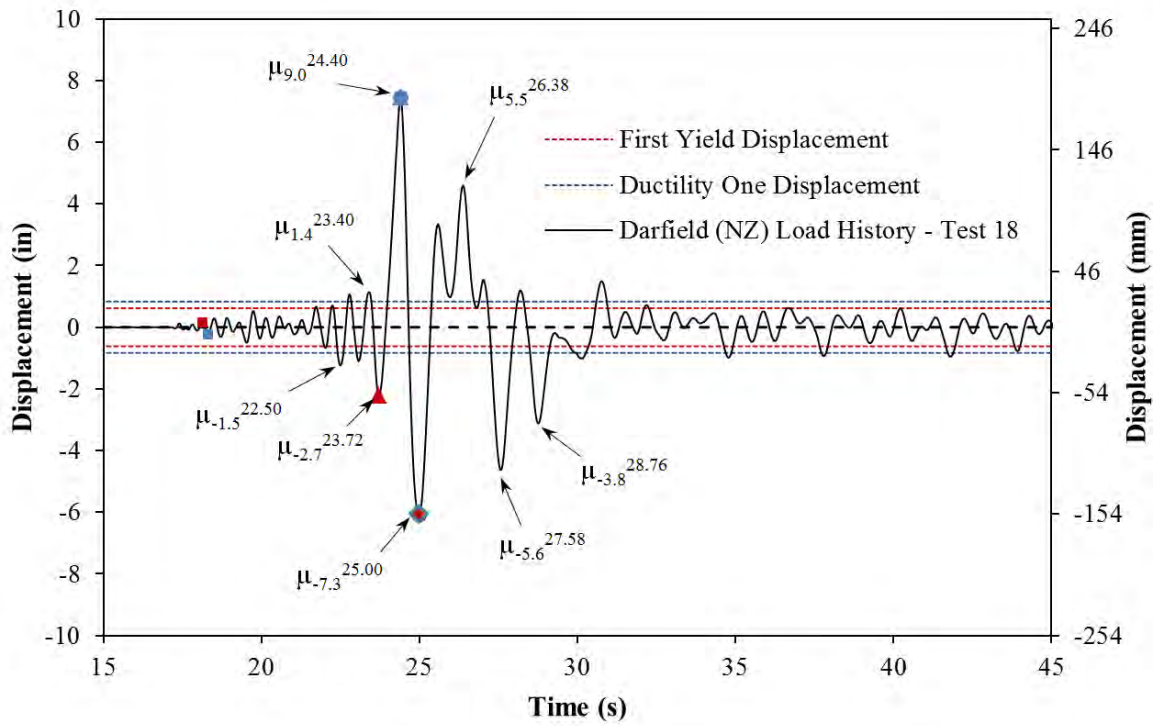
Figure 2-340. Test 18 – Darfield NZ 2010 Earthquake Load History

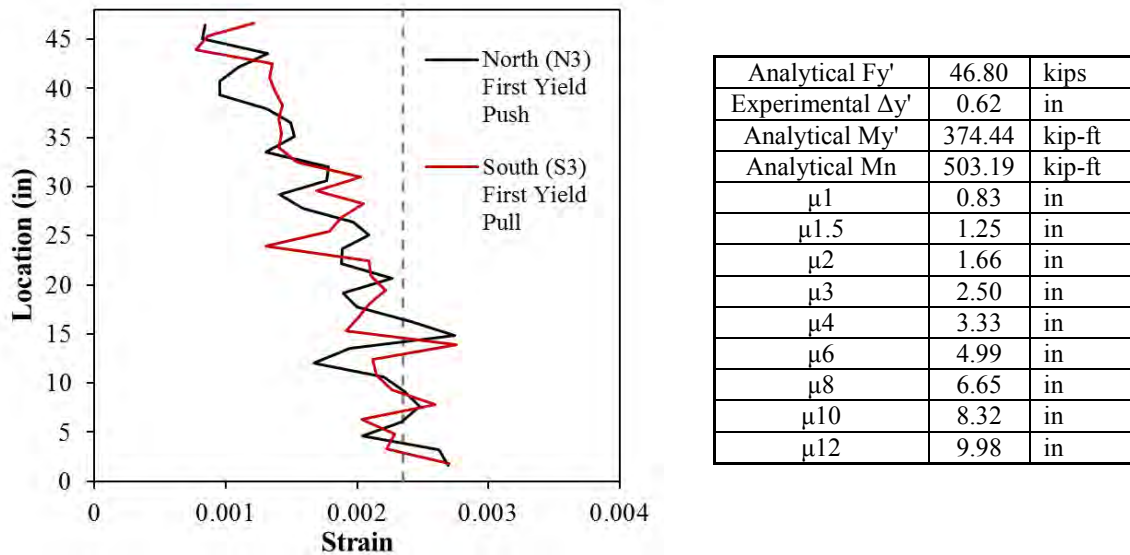
Figure 2-345. Test 18 – (Left) Tensile Vertical Strain Profiles Used to Verify Test 16 First yield Displacement and (Right) Displacement Ductility Levels from Test 16 Which Also Apply for Test 18 due to Identical Detailing, Geometry, and Material Properties

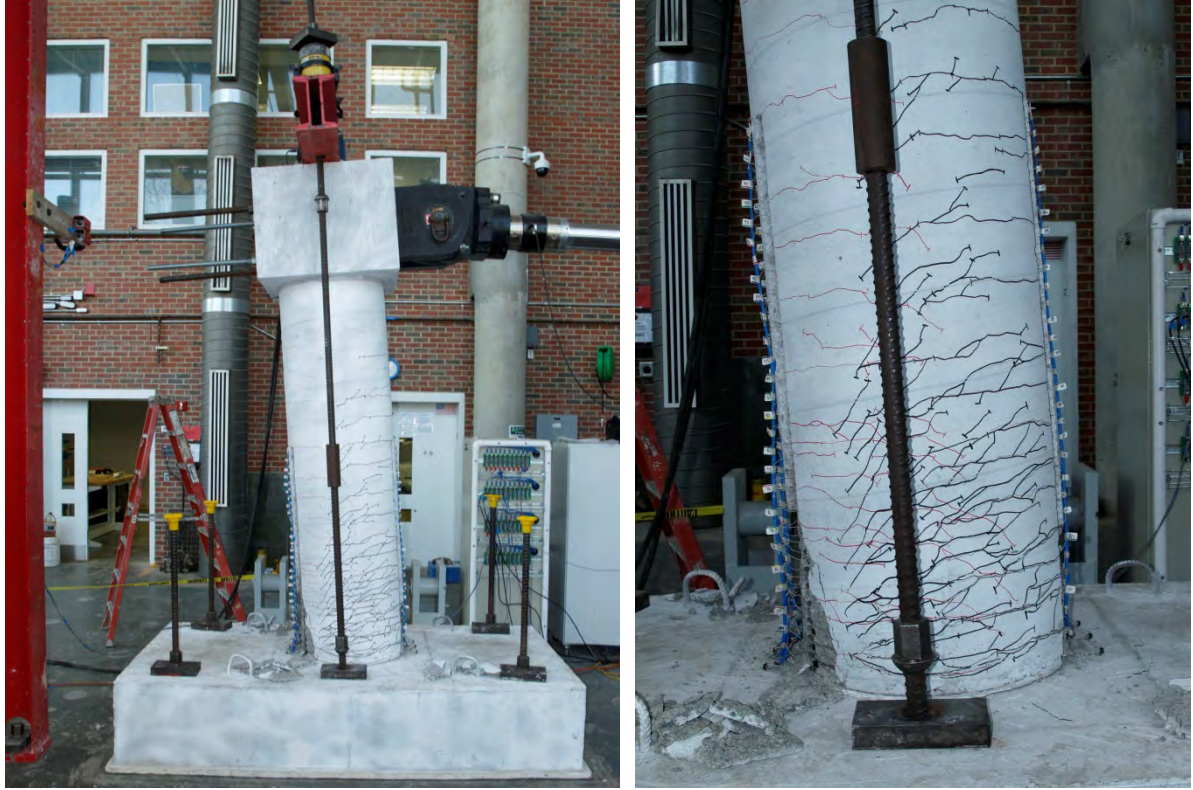
Figure 2-350. Test 18 – Crack Distribution at Peak Displacement ($\mu_{9,0}^{24.40 \text{ sec}} = 7.46''$)

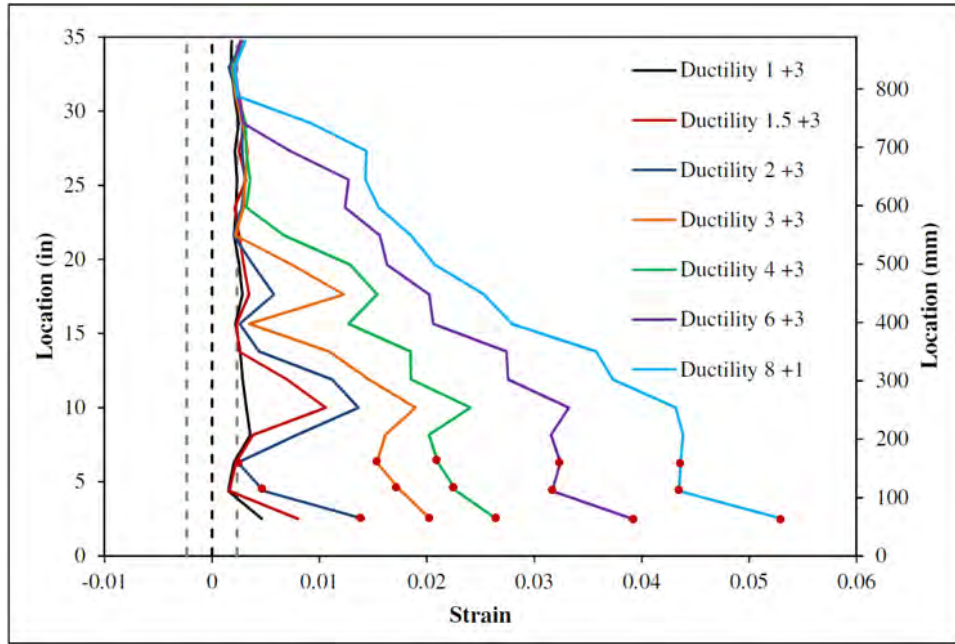
Figure 3-41. Strain Profile of Bar N3 at Tensile Cycles

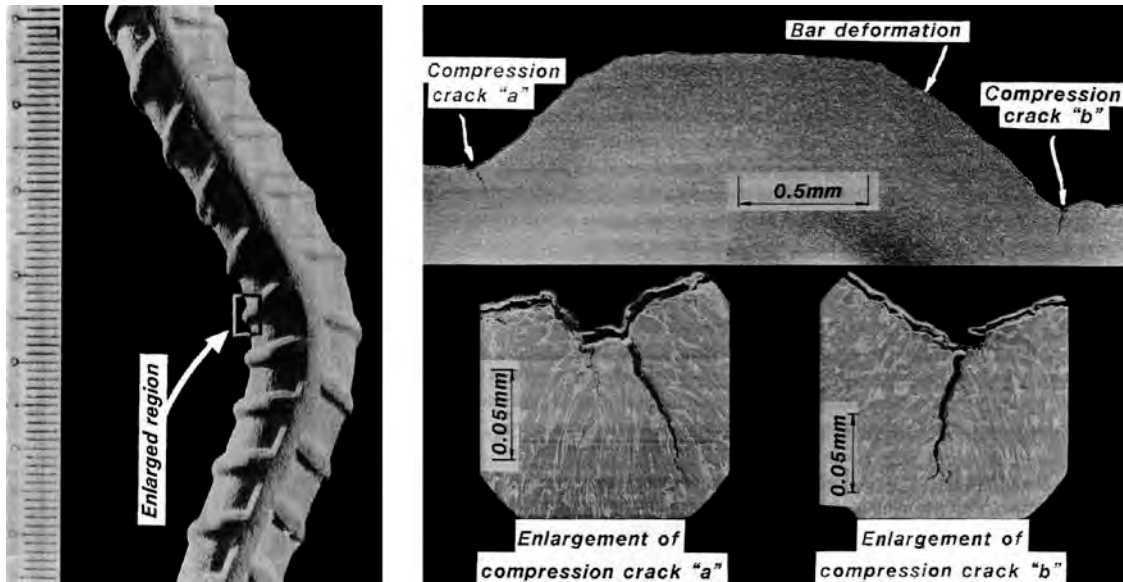
Figure 4-3. Cracks on a Buckled Bar, from (Restrepo-Posada et al. (1994))

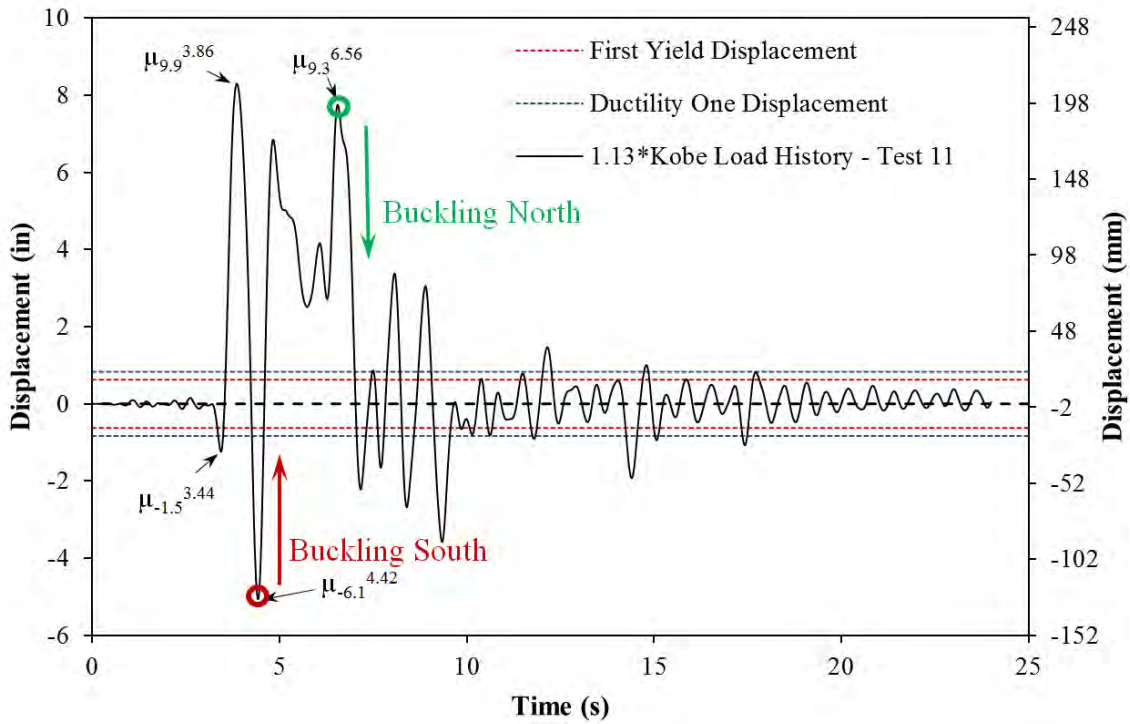
Figure 4-4. Top Column Displacement History for the Kobe 1995 Earthquake
