# Monitoring and Analysis of Frozen Debris Lobes, Phase I

December 2012

INE/ AUTC 12.25

FHWA-AK-RD-12-17

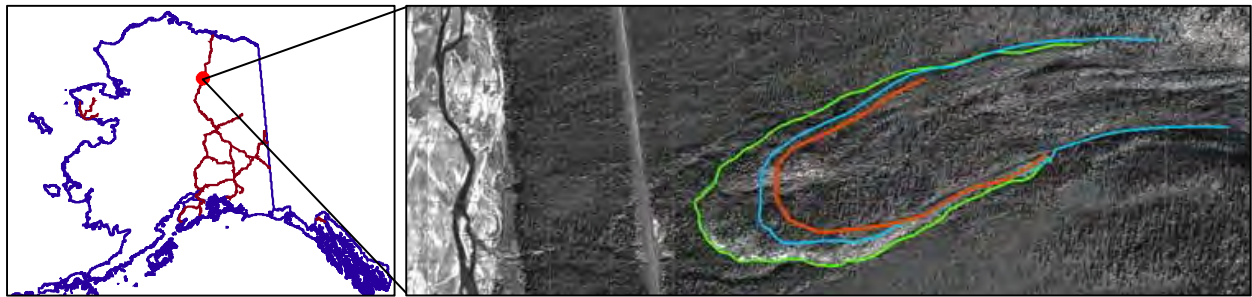
Figure 1. Location of the study area within Alaska. The inset illustrates the termini position of FDL-A from 1955 (red line), 1979 (blue line), and 2008 (green line) from high-resolution aerial and satellite-based remotely sensed imagery. Two drainage channels in front of the lobe are not part of the moving body. (Inset modified from Daanen et al. 2012).

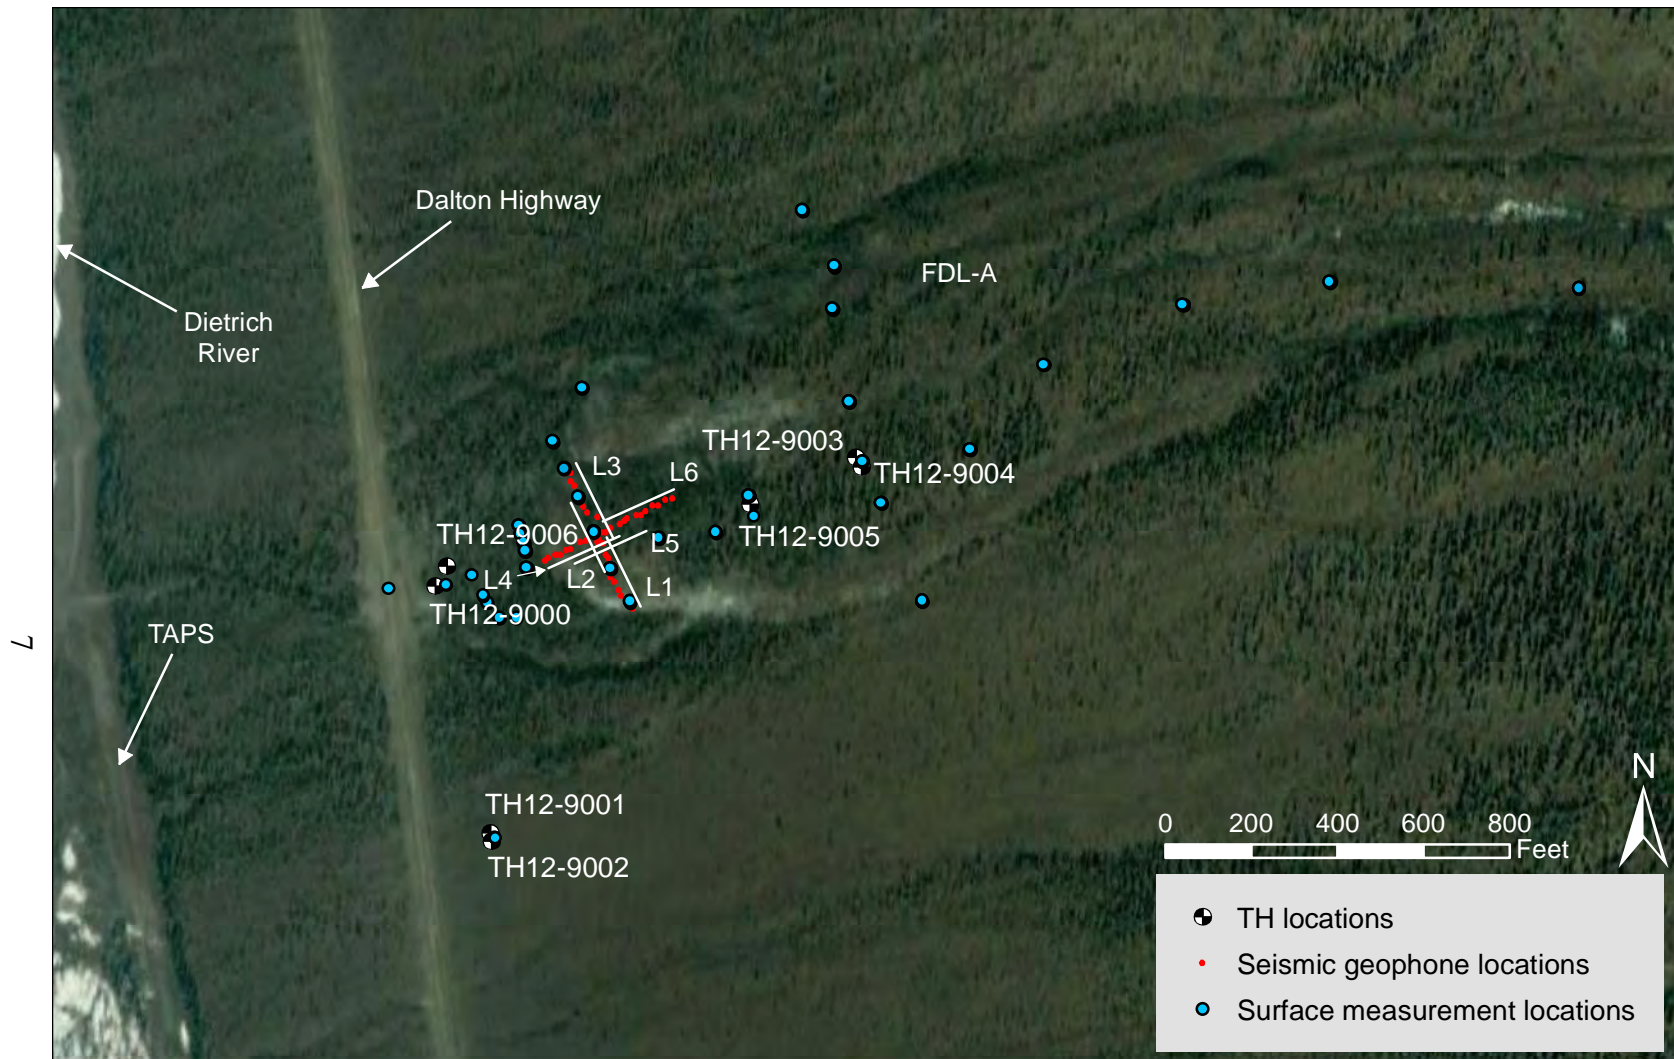
Figure 5. Locations of field measurements on and near FDL-A. The base image, which was imported from Google Earth, was acquired in 2002. It does not accurately represent the location of FDL-A, which has advanced since its acquisition. Currently the toe of the lobe is at the location of the blue surface measurement points that intersect the text of “TH12-9000”. The placement of the seismic lines is represented by white lines adjacent to the geophone locations.

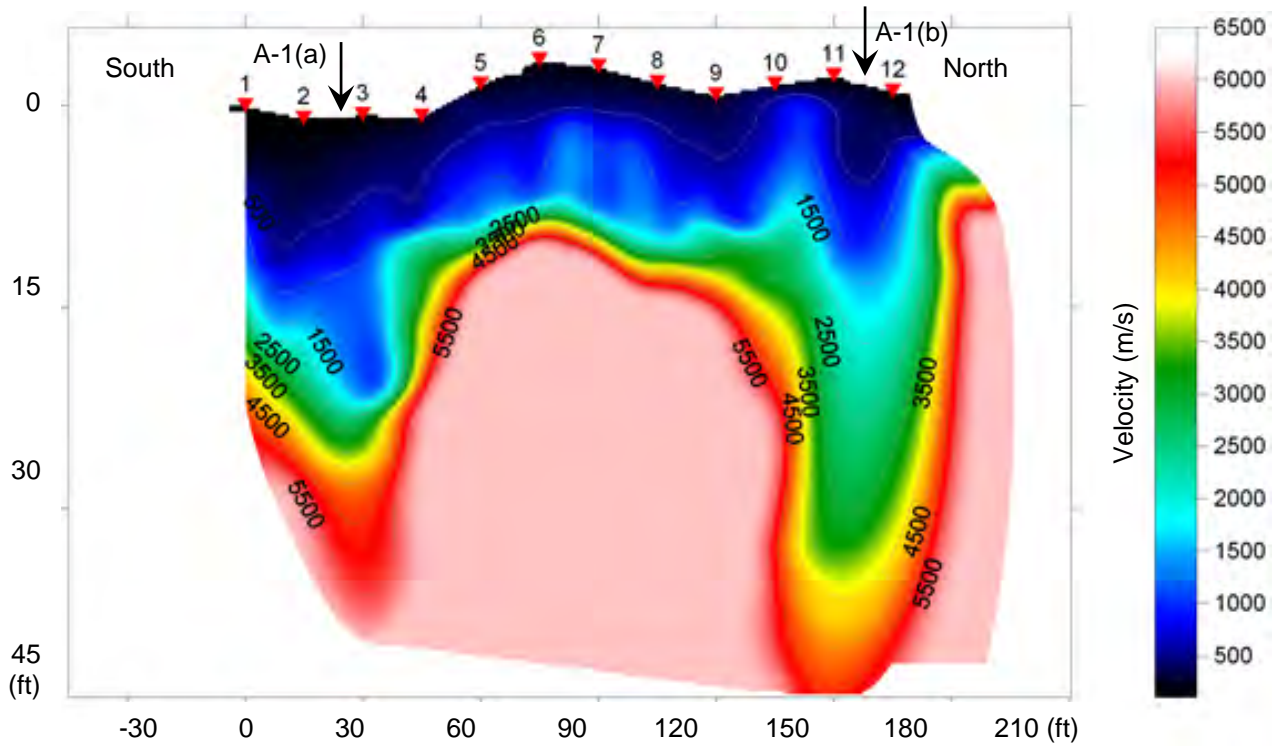
Figure 6. Seismic survey results for L1. Elevation and distance provided are relative to Shot 1 along this line. Velocity is provided in m/s from the seismic program. Arrows and identifiers correspond to those figures in Appendix A.

The resulting cross sections of seismic velocities are presented in Figure 6 through Figure 11. The velocities in the figures are presented in m/s as this is the software program output; however, in this discussion velocities are also presented in ft/s (in parentheses). The greatest depth that we achieved with our seismic lines was about 50 ft, which was insufficient to reach the bottom of FDL-A. Instead, our results indicate that the upper portion of FDL-A demonstrates high variability in seismic velocity. Hauck et al. (2007) indicated that velocities within the active layer range between 400 and 1,500 m/s (1,300 and 4,900 ft/s), with permafrost demonstrating a high contrast with velocities greater than 2,000 m/s (6,600 ft/s). Bush and Schwarz (1964), who conducted seismic refraction along the Nelson River in Manitoba, indicated that saturated sand and gravel, dense till, and compact clay all demonstrated velocities between 1,800 and 2,100 m/s (6,000 and 7,000 ft/s). Velocities increased as a function of the thickness of the frozen soil, ranging from 2,300 m/s (7,500 ft/s) for thin frozen layers to up to 4,300 m/s (14,000 ft/s) for thick frozen layers. Elsewhere on FDL-A, we intercepted the permafrost table between 6 and 8

ft bgs (below ground surface). In many parts of these profiles, this depth corresponds to the 1,500 m/s (4,900 ft/s) velocity. Additionally, the velocity for Line 1, and Lines 4 through 6 quickly increases with depth starting from 1,500 m/s (4,900 ft/s). Based on these characteristics, we interpret the 1,500 m/s (4,900 ft/s) contour to represent the permafrost table. The results for Lines 2 and 3 do not demonstrate the rapid increase in seismic velocity; additionally, the area of overlap between Lines 1 and 2 do not demonstrate the same range of velocities. We are uncertain if these results indicate that this portion of the lobe was thawed more deeply, or if the results are an artifact of how the data was collected and processed. Because of this uncertainty, we will limit the following discussion to Lines 1, and 4 through 6.

As mentioned above, the seismic velocity is far from uniform with depth. Instead, there are several areas where lower velocities are present dipping down into the subsurface. These low velocity areas seem to correlate with the location of cracks observed at the surface; photographs of examples of cracks documented along the seismic lines are included in Appendix A. As these cracks may function as conduits for liquid water, it follows that the water thaws the adjacent debris, which results in deep zones of lower seismic velocity.

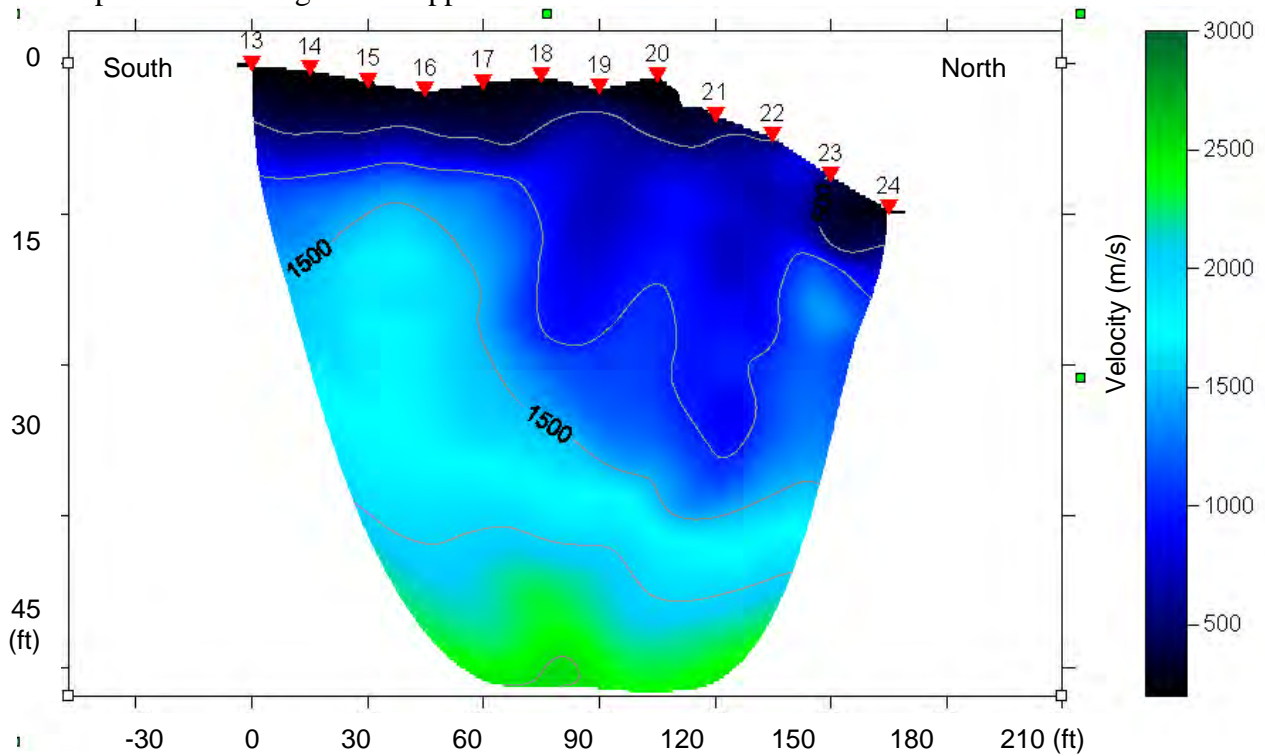
Figure 7. Seismic survey results for L2. Elevation and distance provided are relative to Shot 13 along this line. Velocity is provided in m/s from the seismic program.

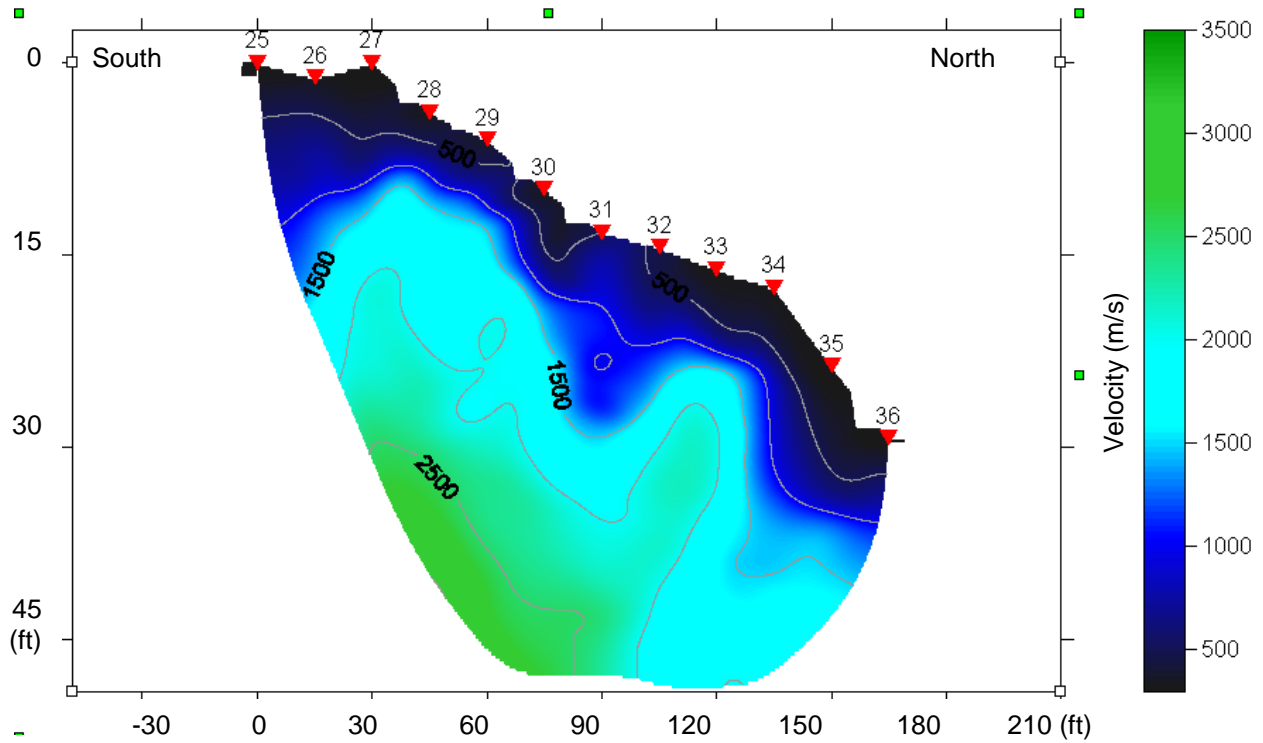
Figure 8. Seismic survey results for L3. Elevation and distance provided are relative to Shot 25 along this line. Velocity is provided in m/s from the seismic program.

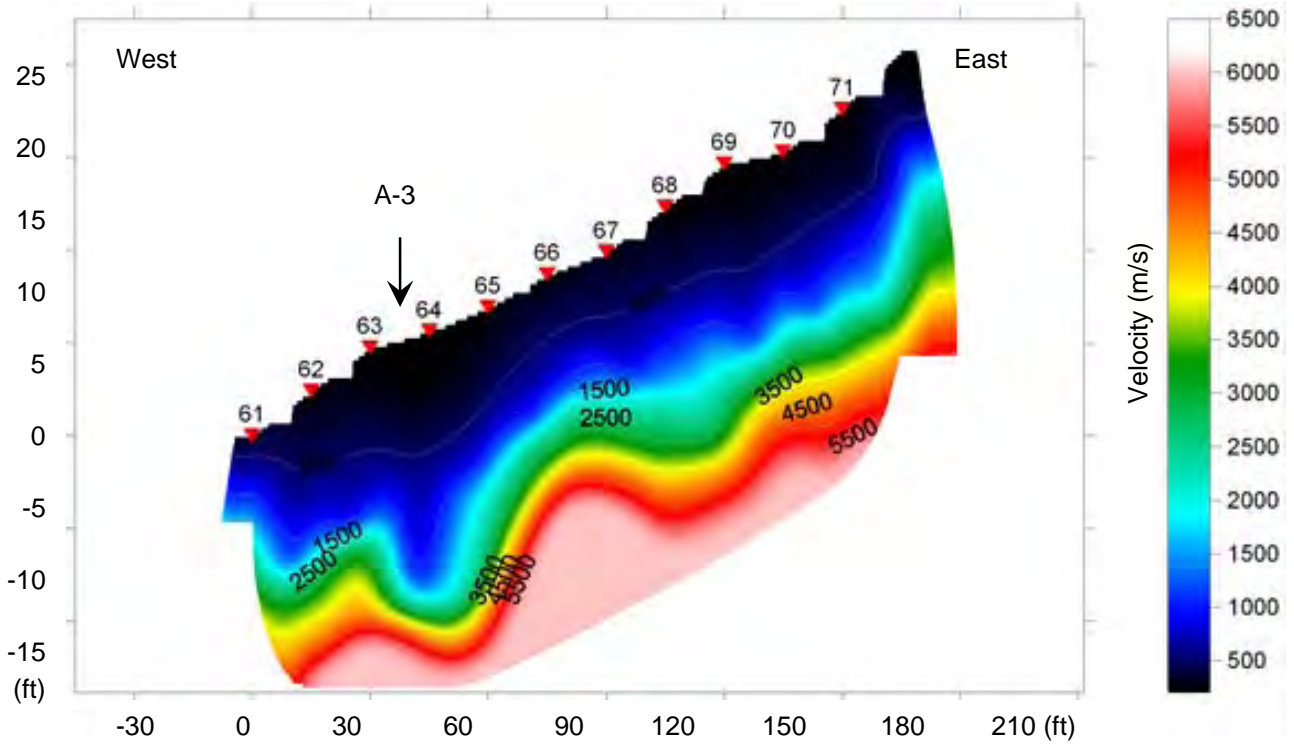
Figure 11. Seismic survey results for L6. Elevation and distance provided are relative to Shot 61 along this line. Velocity is provided in m/s from the seismic program. Arrow and identifier correspond to that figure in Appendix A.

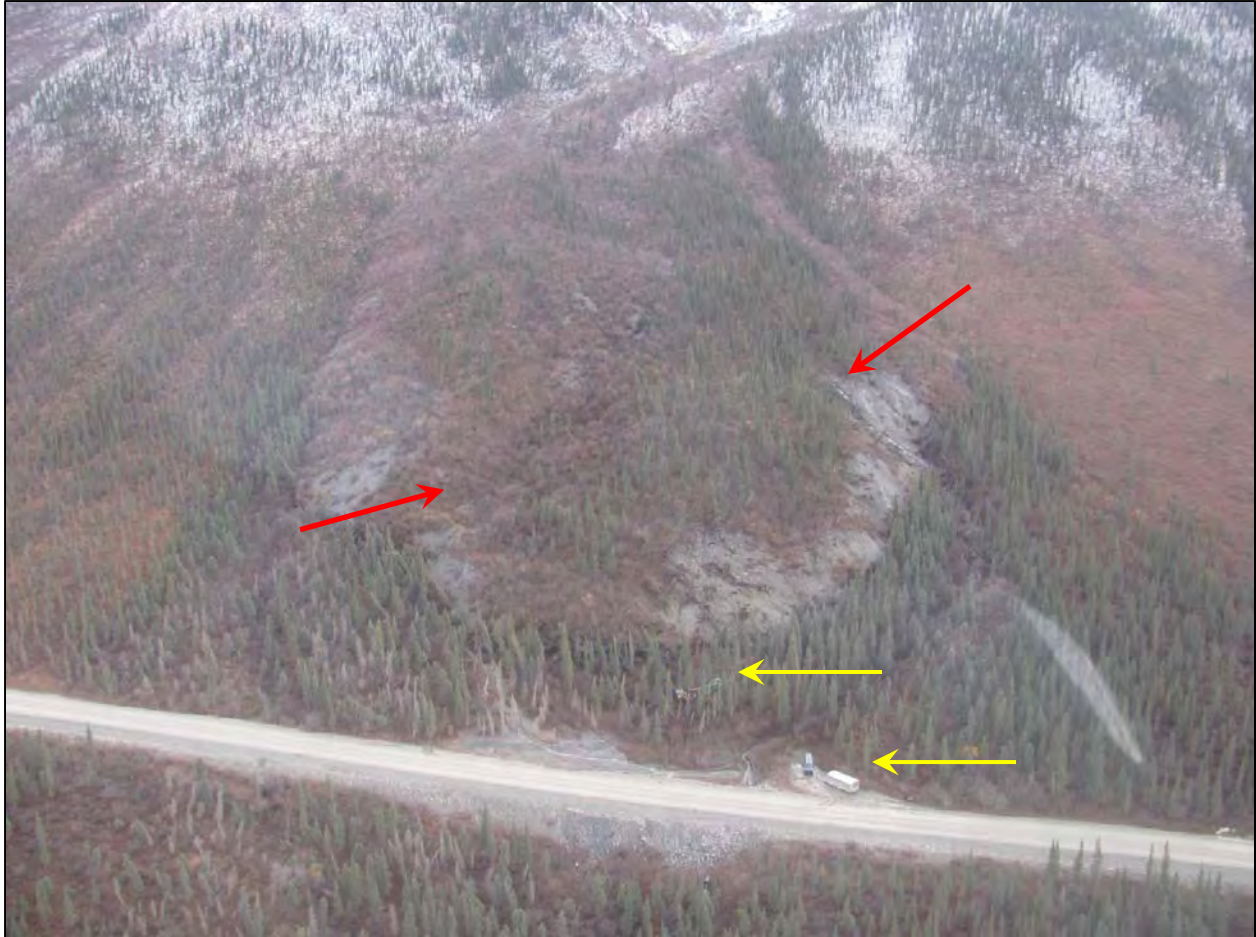
Figure 12. Oblique aerial view of FDL-A during the September 2012 drilling program. This photograph was taken to the east, with the Dalton Highway in the foreground. The drilling support vehicles were located in a pull-out off of the highway (indicated by the lower yellow arrow) and the drill rig was positioned between the toe of the lobe and the highway at TH12-9000 (indicated by the upper yellow arrow). An old surficial drainage channel is indicated by the left red arrow. The surficial drainage shifted in recent years, and now flows off of the debris lobe to the south, as indicated by the right red arrow. (Photograph courtesy of F. Wuttig)

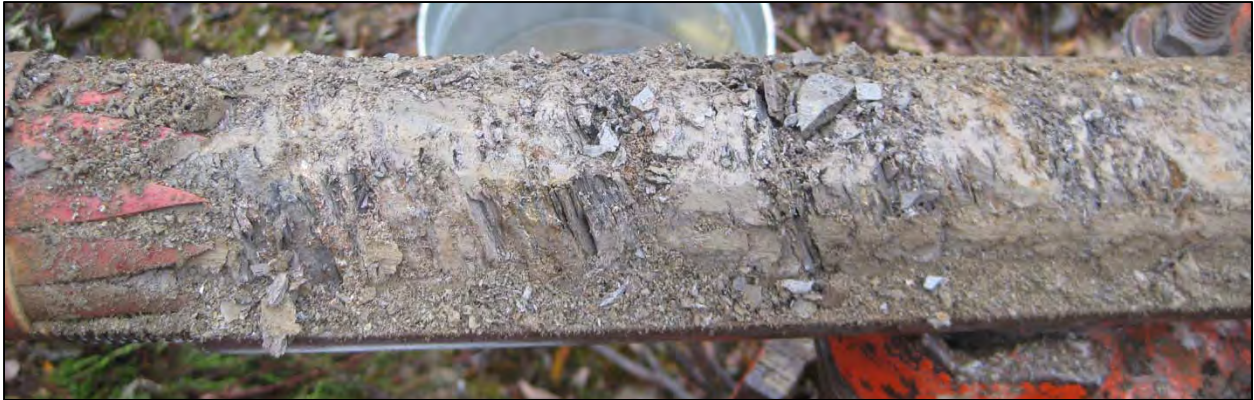
Figure 13. White mica schist bedrock as it appeared when sampled in a split spoon sampler (photograph shows about 1 ft of the sample). Notice the prominent foliation of the sample. (Photograph by M. Darrow)

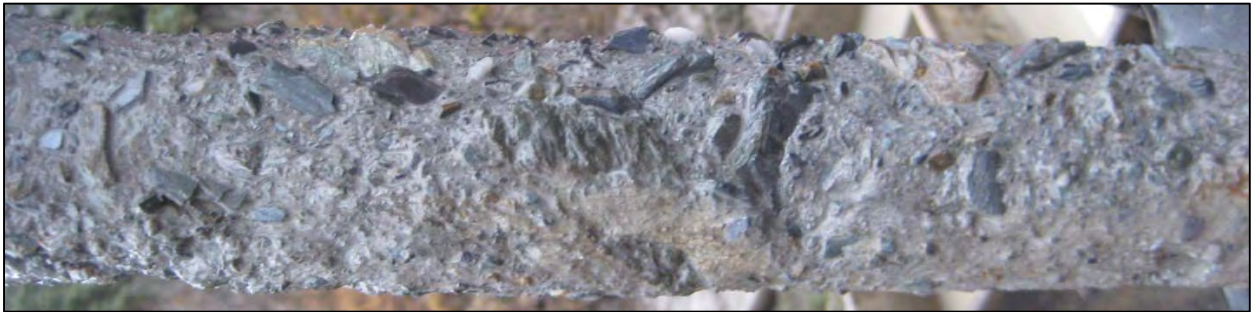
Figure 14. Example of frozen silty gravel typical of FDL-A. For scale, this photograph spans a 2-ft long split spoon sample. (Photograph by M. Darrow)

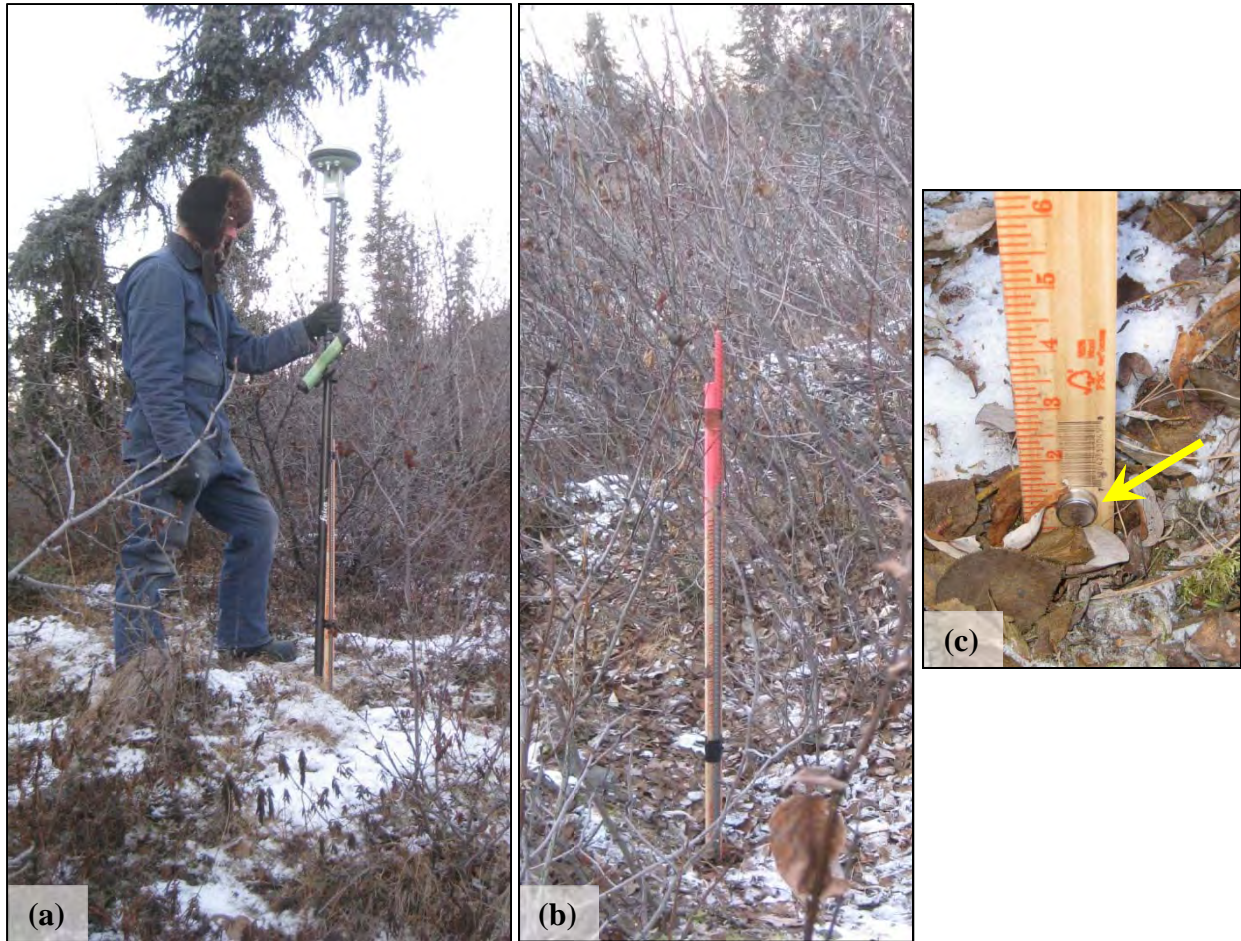
Figure 15. Measuring movement of the FDL-A surface. (a) Repeated measurements were made throughout the fall using a differential global positioning system (D-GPS) unit. (b) We installed steel rods, with yard sticks (spray-painted pink for high visibility) and (c) temperature recording devices attached (indicated with yellow arrow). (Photographs by M. Darrow)

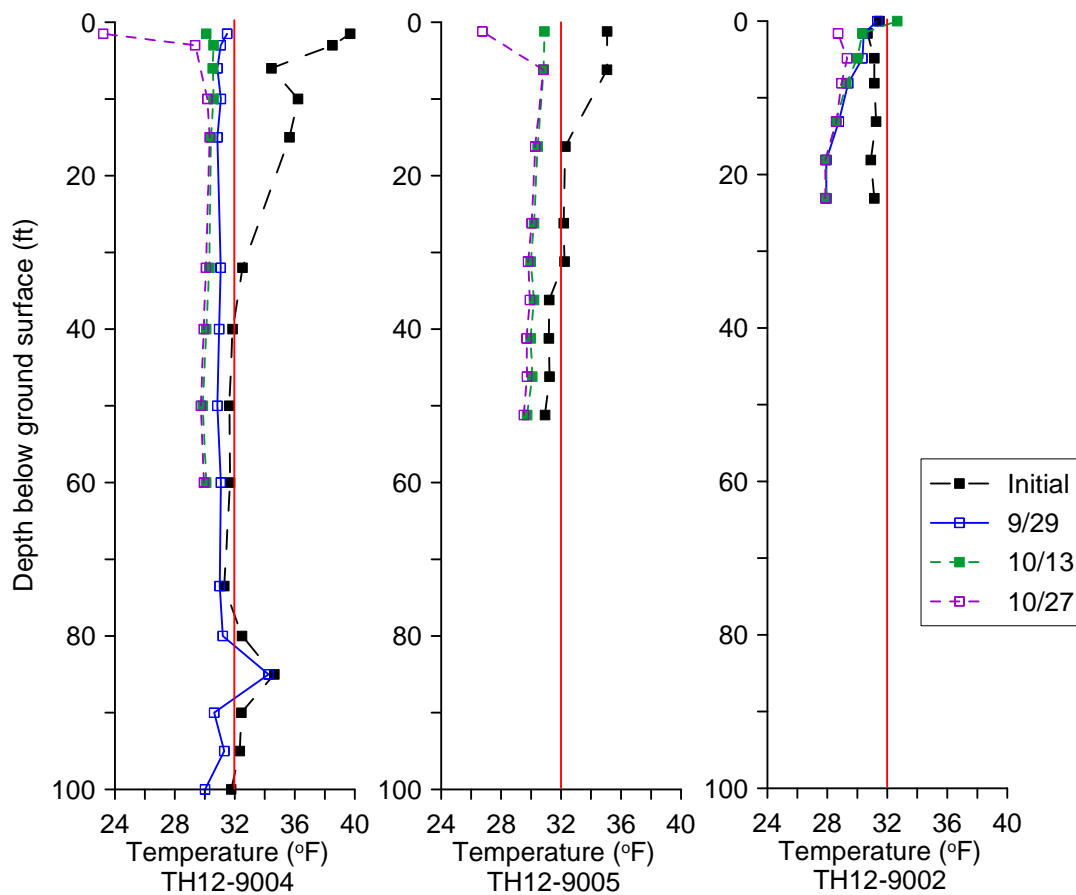
Figure 16. Temperature profiles for borings located on FDL-A (i.e., TH12-9004 and TH12-9005) and in the “undisturbed” area (i.e., TH12-9002), illustrating time for thermal equilibrium after drilling. The phase-change temperature is indicated by the vertical red line. The “initial” readings are September 19, 2012 for TH12-9002, September 22, 2012 for TH12-9004, and September 30, 2012 for TH12-9005.

During the drilling program, the permafrost table was intercepted at approximately 2 ft bgs in the “undisturbed” area and between 6.5 ft and 8 ft bgs on FDL-A. Given the time of year, these depths can be interpreted as the active layer depths typical for the general area and the FDL, respectively. Averaging the sensors at depths in pseudo-equilibrium indicates that the permafrost temperature in the “undisturbed” area is 28°F, whereas the temperatures at depth within FDL-A average 30°F.

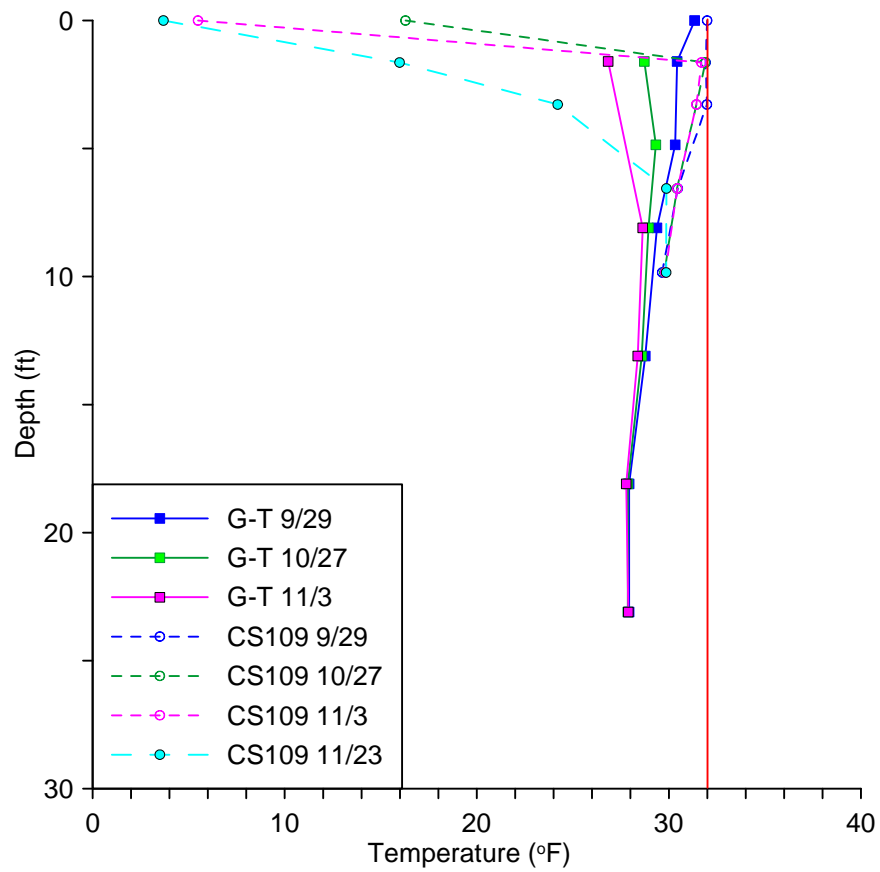
Figure 17. Combined temperature readings for the TH12-9002 area. “G-T” measurements are from the thermistor string within the boring, and “CS109” measurements are from sensors installed in TH12-9001 about 20 ft away. The phase-change temperature is indicated by the vertical red line.

Figure 17 through Figure 19 are temperature profiles for each of the cased borings from installation to November 23. Each plot combines the temperature measurements made with the variety of sensors at each location. Most of the measured temperatures fit the trend that developed with depth during the equilibrating process. One exception to this is the temperature measured at 85 ft bgs in TH12-9004 (see Figure 19). The temperature recorded by the vibrating wire piezometer at 85.5 ft bgs (i.e., “P2”) also is plotted in Figure 19. As the P2 temperature fits the expected trend, the likely explanation for the higher temperature is that it represents a malfunctioning thermistor. Unfortunately, all thermistors below 60 ft bgs failed on October 11, 2012. On October 26, the P2 unit also failed. Another exception to the stable temperature trend is illustrated with data collected on November 23 (see Figure 19). Starting on November 9, the remaining thermistors at depth began reporting a steady increase in temperature resulting in above-freezing values, as indicated by the somewhat erratic temperature profile from November 23; yet the vibrating wire piezometer located at 53.5 ft bgs (i.e., “P1”) measured 29.7°F, matching the previous temperature trend. Figure 20 is a plot of temperatures obtained using the M-IPI device installed within the casing in TH12-9004. The sensors in the M-IPI are not calibrated, but previous research indicated that they report temperatures  $\pm 0.4^\circ\text{F}$  (Darrow, 2012). To reduce some of the temperature variability to illustrate data trends better, nearest pairs of readings were averaged together; these average values are plotted in Figure 20. The device stopped reporting accurate temperatures below 65.5 ft bgs on October 24; however, the data above this depth are sufficient to indicate below freezing temperatures. Thus, the thermistors below 15 ft bgs began to malfunction on November 9, likely the result of glycol entering the cable and affecting the measured resistance. The glycol could reach the thermistors because of the earlier shearing of the cable.

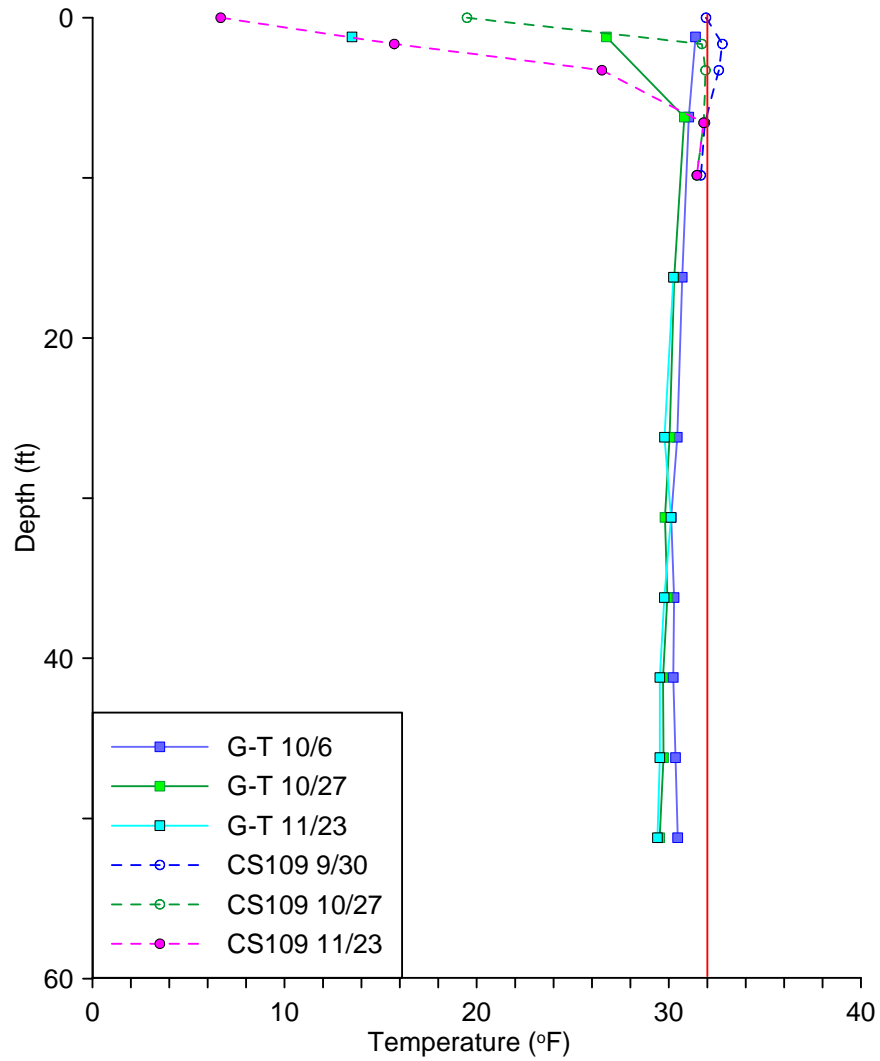
Figure 18. Combined temperature readings for the TH12-9005 area. “G-T” measurements are from the thermistor string within the boring, and “CS109” measurements are from sensors installed in a boring made about 50 ft away. The phase-change temperature is indicated by the vertical red line.

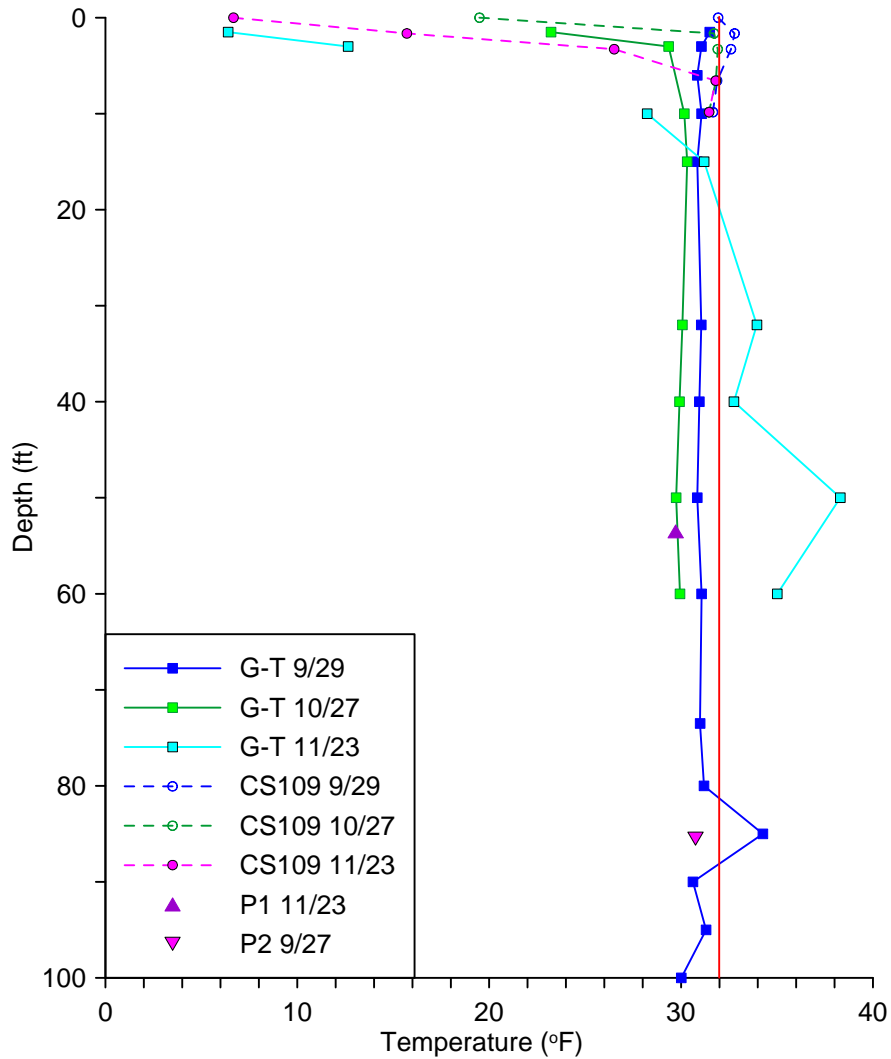
Figure 19. Combined temperature readings for the TH12-9004 area. “G-T” measurements are from the thermistor string within the boring, “P1” and “P2” are readings from the vibrating wire piezometers installed at 53.5 and 85.5 ft bgs, respectively, and “CS109” measurements are from sensors installed in a boring made about 15 ft away. The phase-change temperature is indicated by the vertical red line.

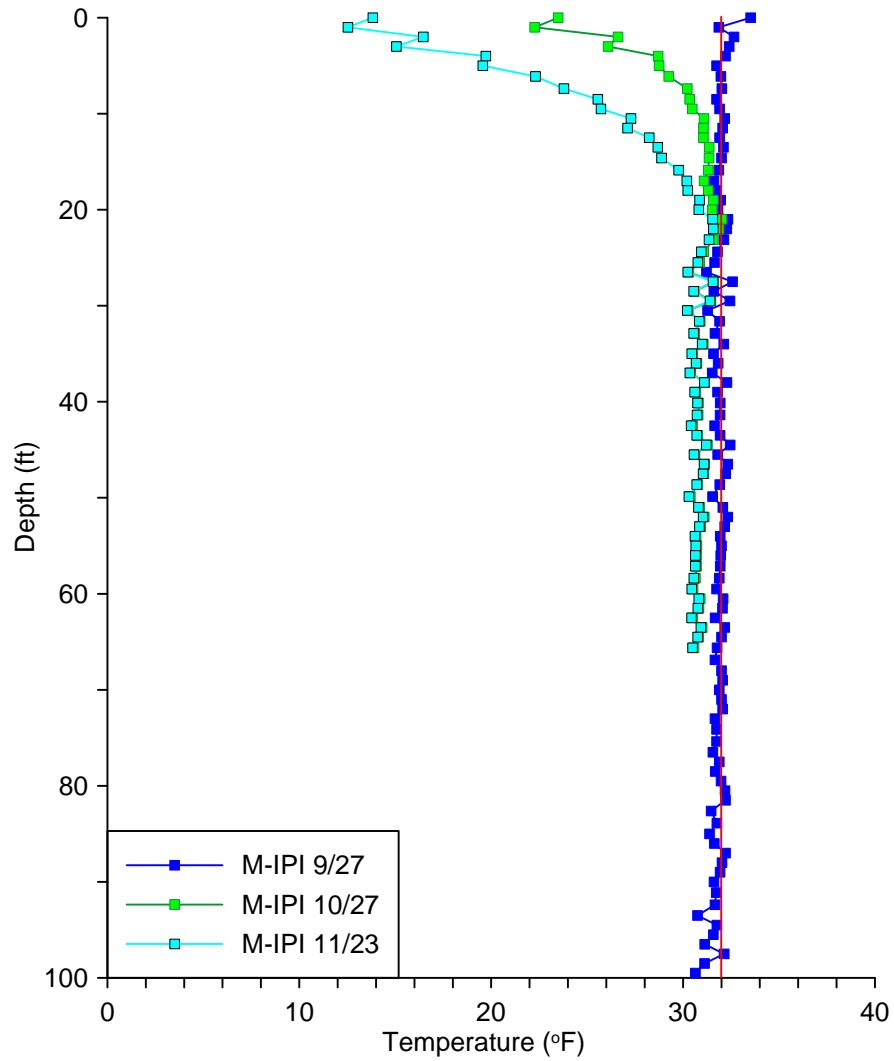
Figure 20. Temperature readings from the M-IPI device installed within TH12-9004. Nearest pairs of readings were averaged to reduce the scatter. The phase-change temperature is indicated by the vertical red line.

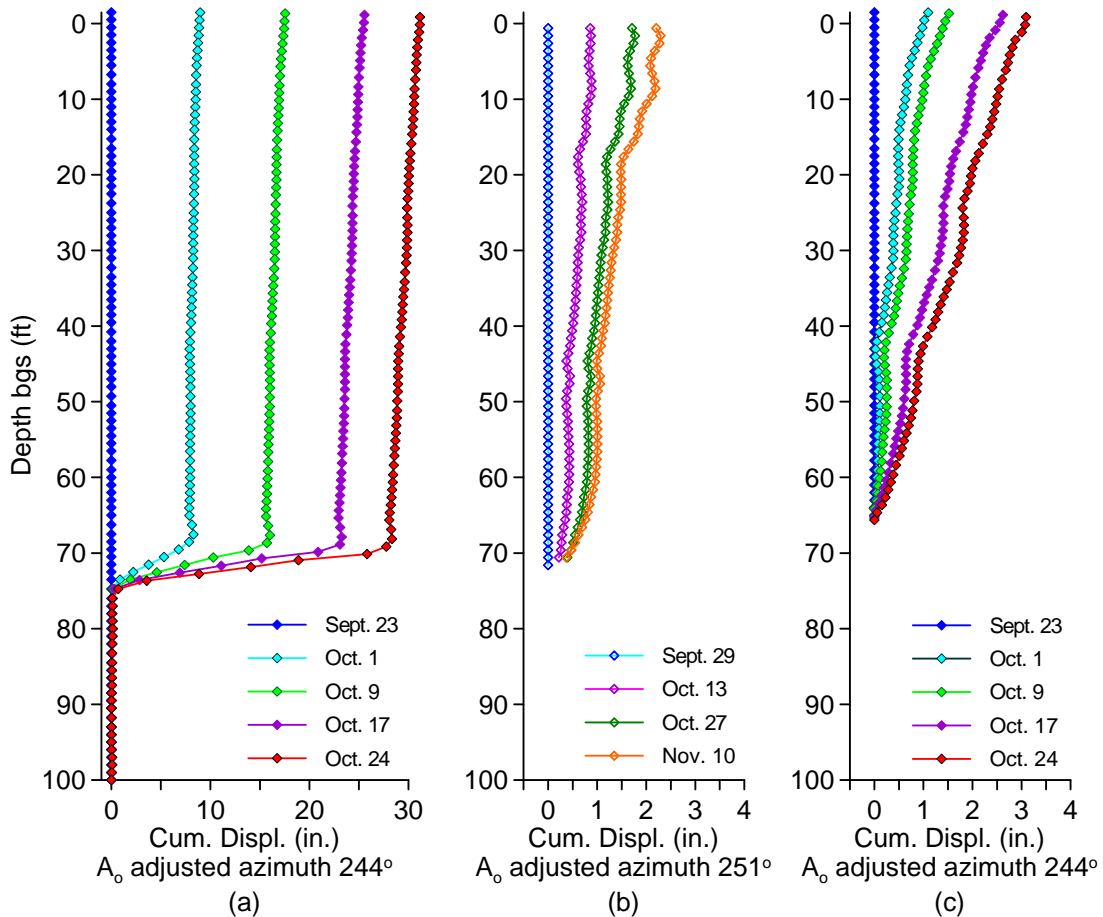
Figure 22. Cumulative displacement measurements for (a) TH12-9004 and (b) TH12-9005. The data in (a) was adjusted to show only movement from above the shear zone at 67.5 ft bgs; the adjusted data is shown in (c).

The plots of cumulative displacement in Figure 22a demonstrate fairly consistent movement over the measurement period, with a total of 31.2 in. of movement at the surface in about 31 days, or approximately 1.0 in. of movement per day. Early in the morning of October 24, the M-IPI began to record “retrogressive” movement upslope between 67 and 70 ft bgs. Considering the earlier failure of the thermistor string and the subsequent failure of the piezometer, we suspected that a few of the M-IPI sensors were damaged in the shear zone. The manufacturer of the device agreed, indicating that the sensors “probably deformed or rotated within the housing” (J. Lemke, pers. comm., Nov. 2012). Despite the damaged sensors, the entire M-IPI continued to record data, acquiring reasonable measurements of cumulative displacement below the depth of 70.5 ft. The sensor original at 69.5 ft bgs recorded the largest amount of shear (i.e., 30.4 in.) within this zone before failing. Then on October 31, the M-IPI sensors below 66 ft bgs ceased reporting data. Movement of FDL-A has continued, however, as indicated by the sensors above 66 ft bgs.

At first glance, it appears that only about 2 in. of movement occurred overall in TH12-9005 (see Figure 22b). Instead, these readings indicate that this boring is too shallow; when drilling, we did not penetrate through the shear zone and into the underlying bedrock as was suggested by drill reaction. Ideally, a slotted casing is installed 10 to 20 ft beyond the depth of movement (Cornforth 2005, Dunncliff 1993) so that systematic errors can be identified and corrected based on the zone of stable readings below the shear surface. This zone of stable readings is missing in Figure 22b; however, if the movement below 67 ft in TH12-9004 is factored out, the cumulative displacement appears to be about 3 in. (see Figure 22c), or about the same order of magnitude as seen in TH12-9005. Thus, since the casing in TH12-9005 does not penetrate the shear zone, it is only recording the deformation within the sliding mass. Although minor in comparison to the amount of movement within the shear zone, the upper portion of the lobe also is deforming, as indicated by the progressive “leaning” of the casing. This suggests that there is both internal shear and slow to moderate flow occurring within FDL-A.

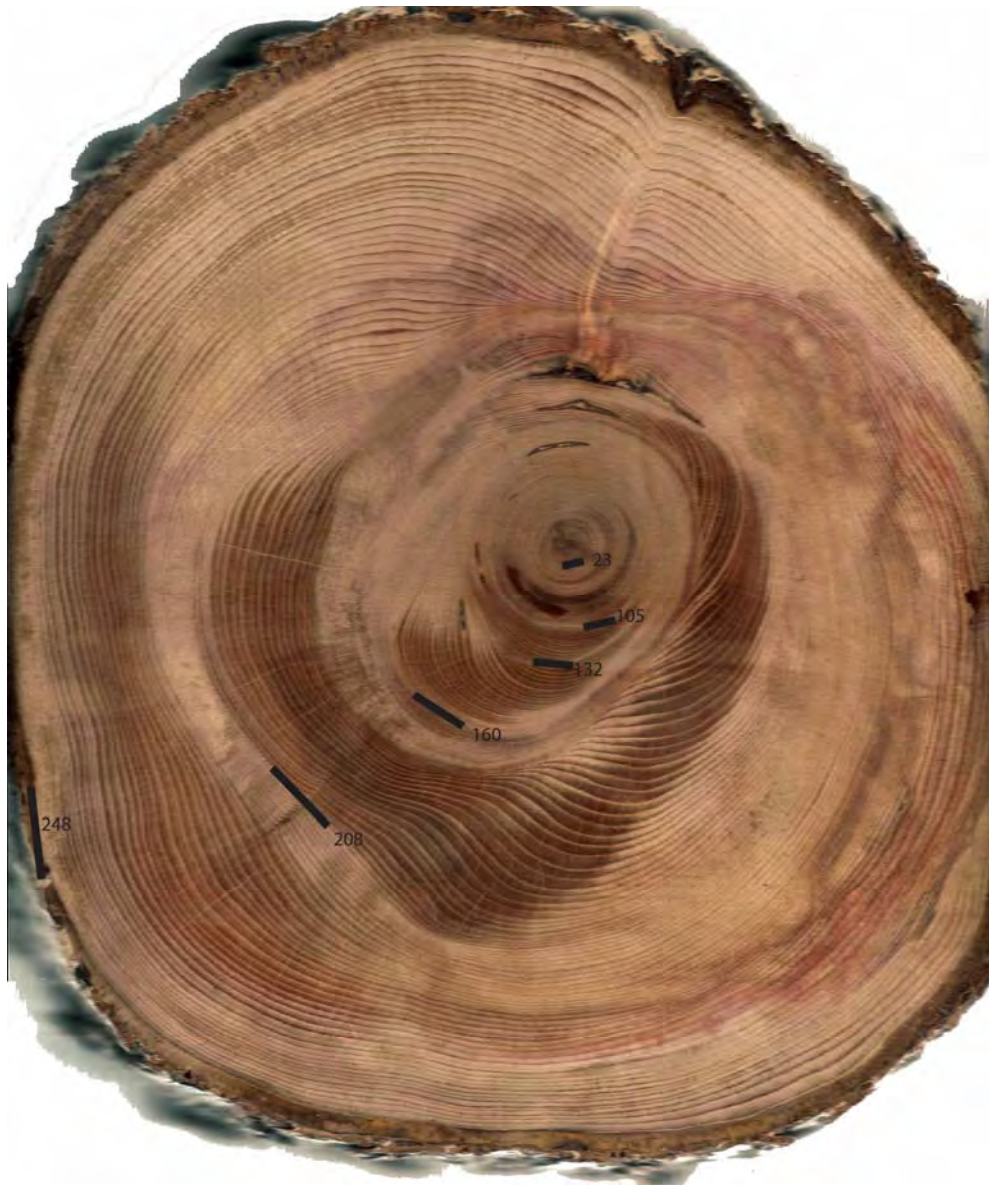
Figure 29. Tree slab from the FDL-A surface, showing tree ring deformation as a result of changing tree orientation. The photograph contains annotations indicating the age of particular rings when change in the tree's orientation occurred. (Photograph by R. Daanen)

Figure 29 illustrates a particular tree ring pattern associated with one such tree that grew on the shifting surface of FDL-A for 248 years. The pattern reveals that the tree started its life growing vertically for about 23 years, after which time the ground shifted. Eighty-two years went by with very dense growth rings, possibly due to damage in the root system, but without a shift in the tree's growth direction. The next 27 years indicate that the tree grew in a different direction. The tree shifted again after another 28 years, followed by 48 years of continuous rotation, like a corkscrew. The last 40 years of growth on the tree shows a relatively stable period. More detailed growth information can be obtained by comparing the width of the rings to healthy trees in the area; stress caused from ripping roots would reduce the tree's growth, resulting in thinner rings. As part of future studies, we will develop a dataset of tree ring width and correlate it to movement of FDL-A.

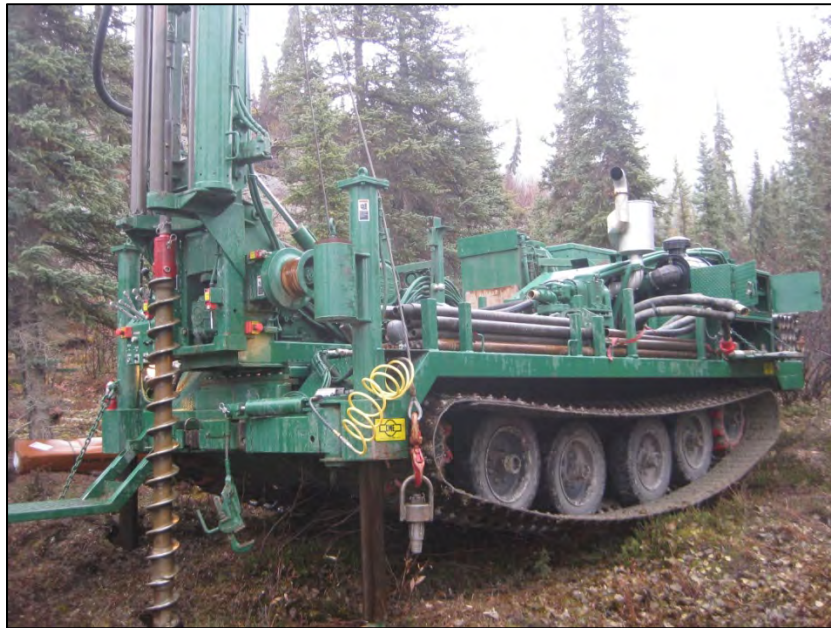
Figure B-1. Typical rig set-up for hollow-stem auger, with the CME 850X track-mounted drill. Photograph taken while drilling TH12-9000. (Photograph by M. Darrow)

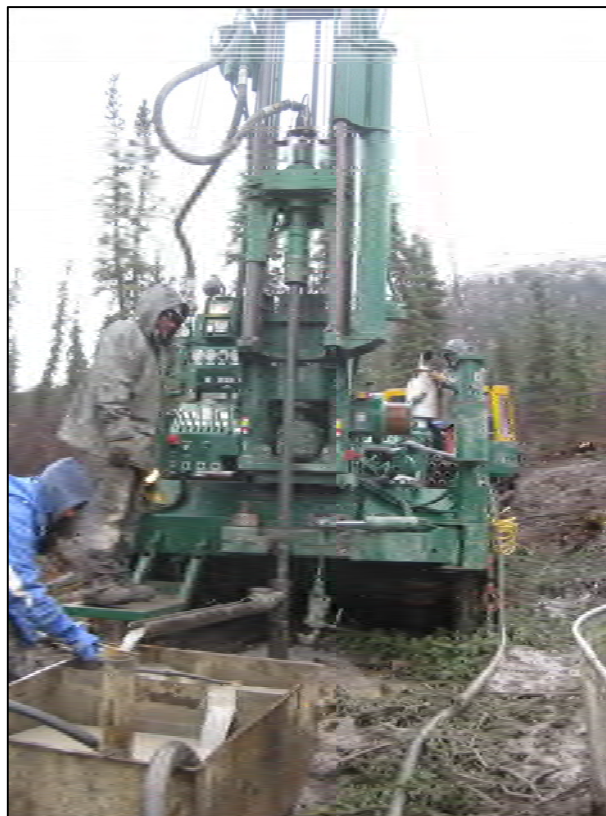
Figure B-2. Typical rig set-up for tricone and casing. Photograph taken while drilling TH12-9004. (Photograph by M. Darrow)

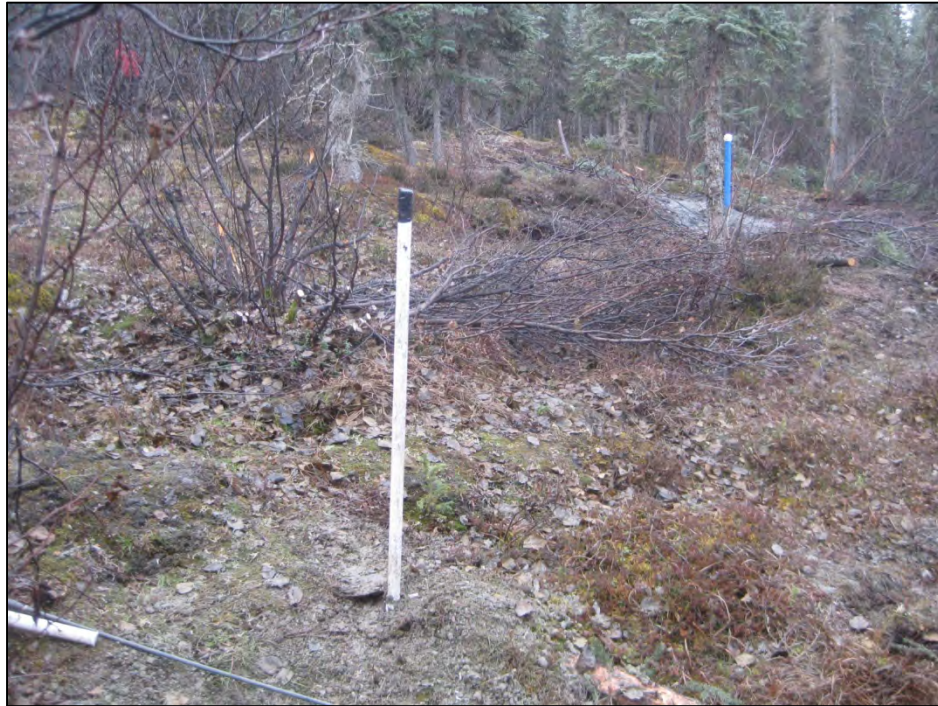
Figure B-3. Completed casing installations for TH12-9006 in the foreground and TH12-9000 in the background to the right. This photograph is taken to the south; the Dalton Highway is to the right of the photograph, and the toe of FDL-A is to the left. (Photograph by M. Darrow)

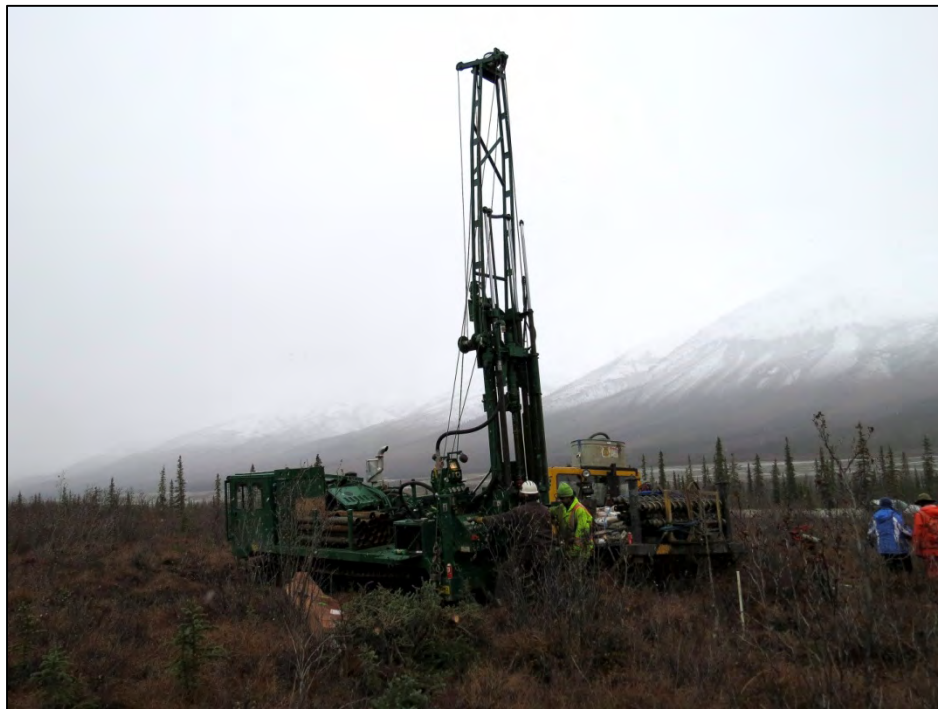
Figure B-4. Location of TH12-9002. View is to the southwest, with the Dalton Highway visible in the middle-right of the figure. (Photograph courtesy of M. Carew)
