# Monitoring and Analysis of Frozen Debris Lobes, Phase I

December 2012

INE/ AUTC 12.25

FHWA-AK-RD-12-17

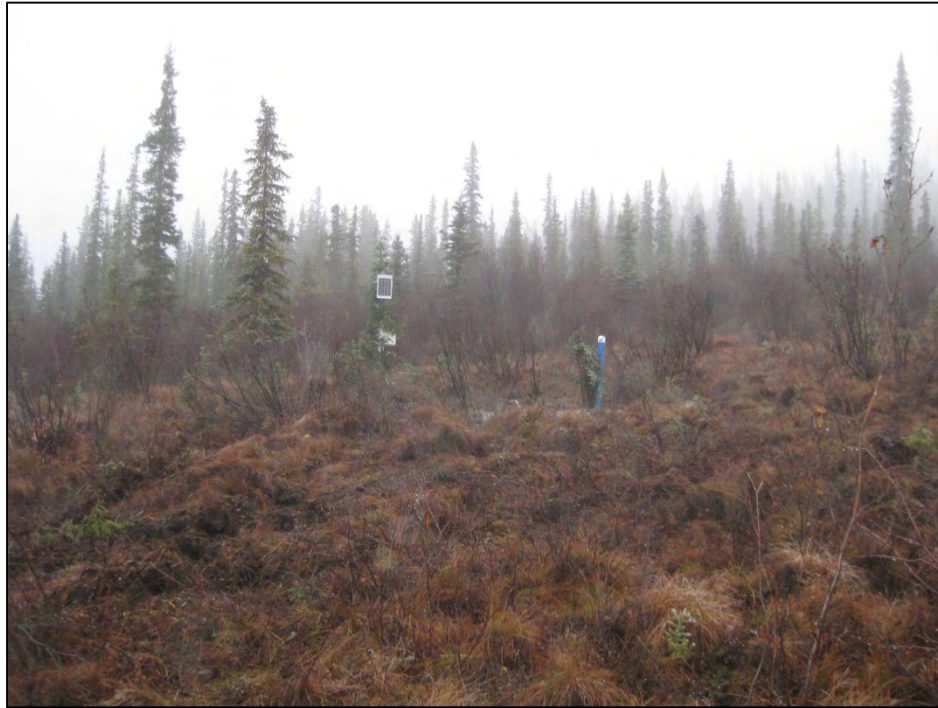
Figure B-5. Final set-up of the “undisturbed” satellite ADAS. This photograph was taken to the north; the Dalton Highway is located to the left of this photograph, and FDL-A is beyond the trees that are just visible in the fog. The ADAS and slotted casing were covered with tree branches to reduce their visibility from the highway. (Photograph by M. Darrow)

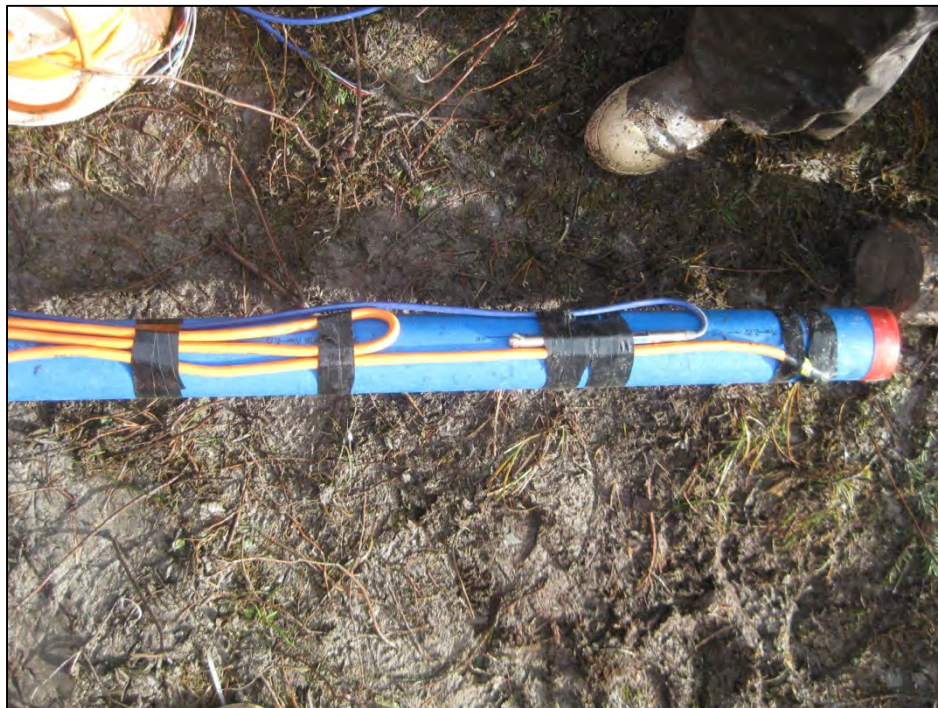
Figure B-6. Configuration of the piezometer and thermistor bead at the bottom and outside of the casing installed in TH12-9004. (Photograph by M. Darrow)

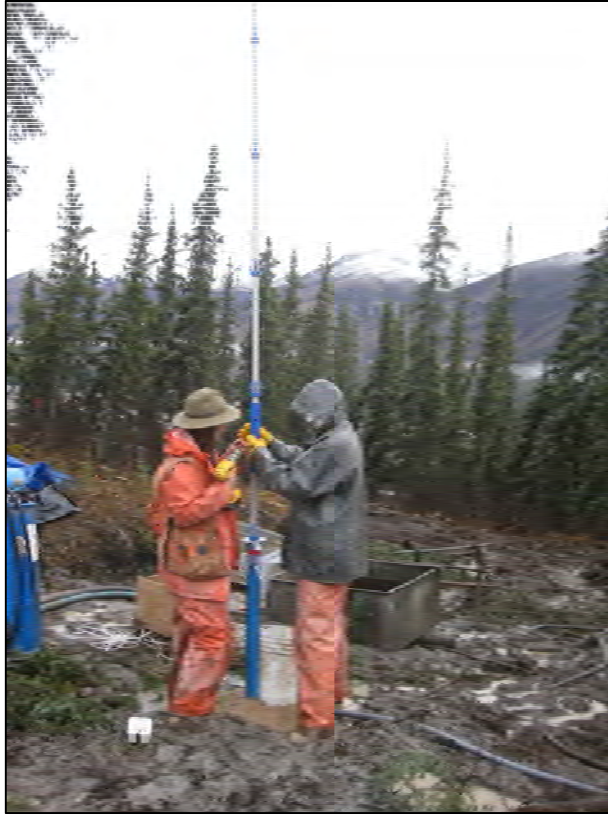
Figure B-7. Installing the MEMS-based in-place inclinometer (M-IPI) within the slotted casing in TH12-9004. (Photograph by J. Simpson)

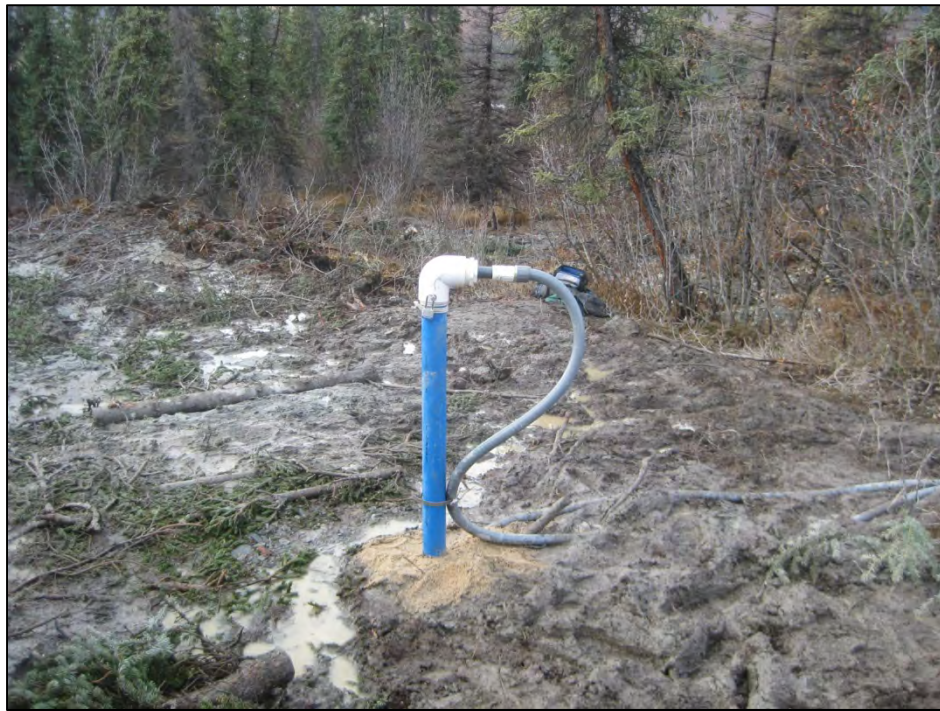
Figure B-8. Completed casing and instrument installation in TH12-9004. (Photograph by M. Darrow)

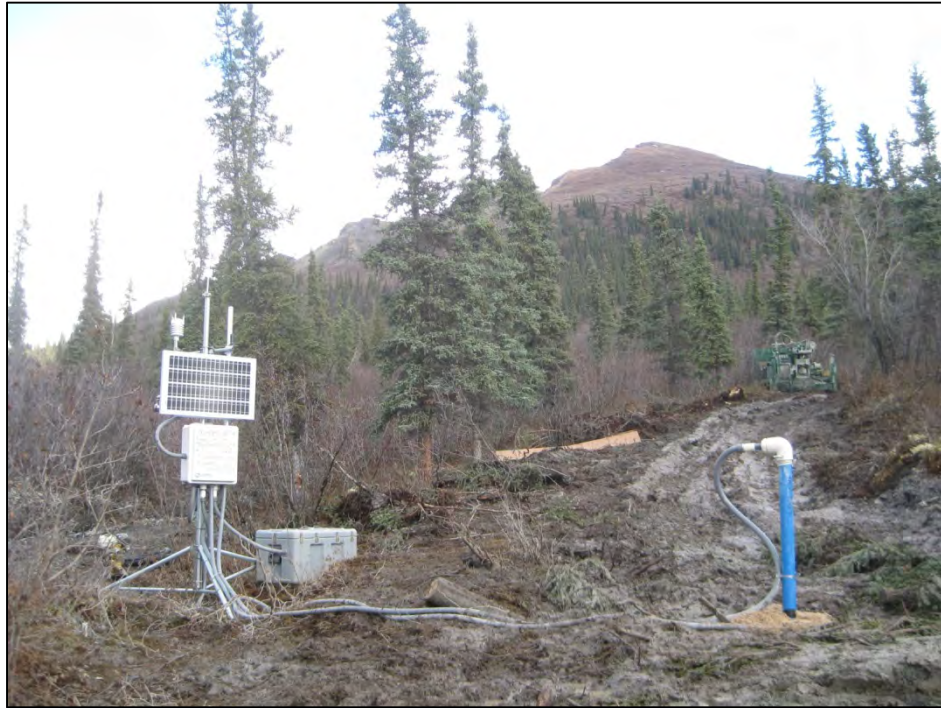
Figure B-9. Completed “main” ADAS location and casing installation of TH12-9004. (Photograph by M. Darrow)

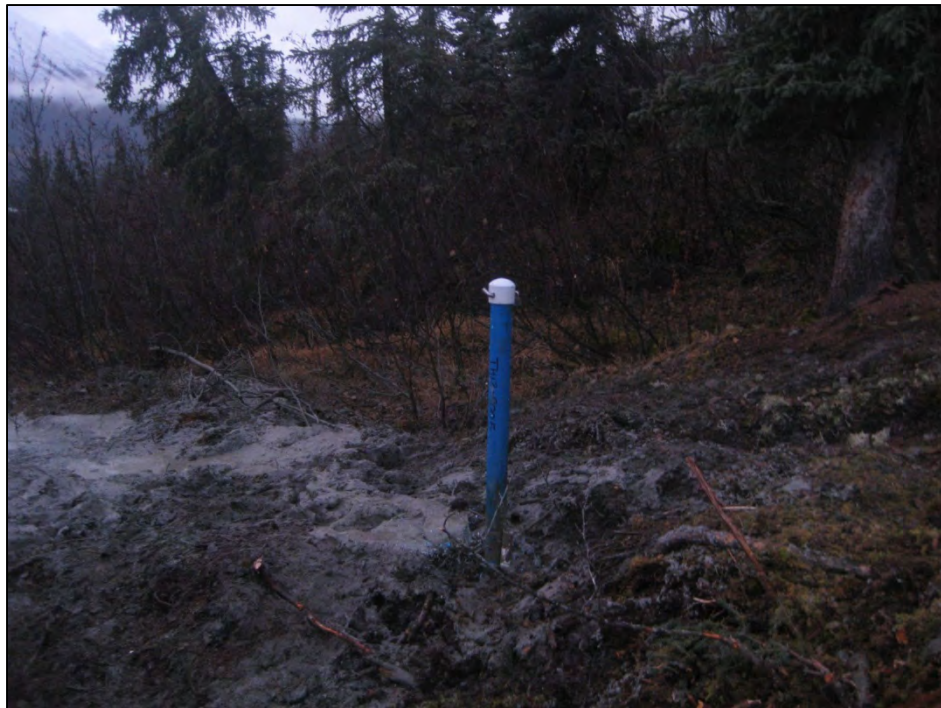
Figure B-10. Completed casing installation for TH12-9005. (Photograph by M. Darrow)

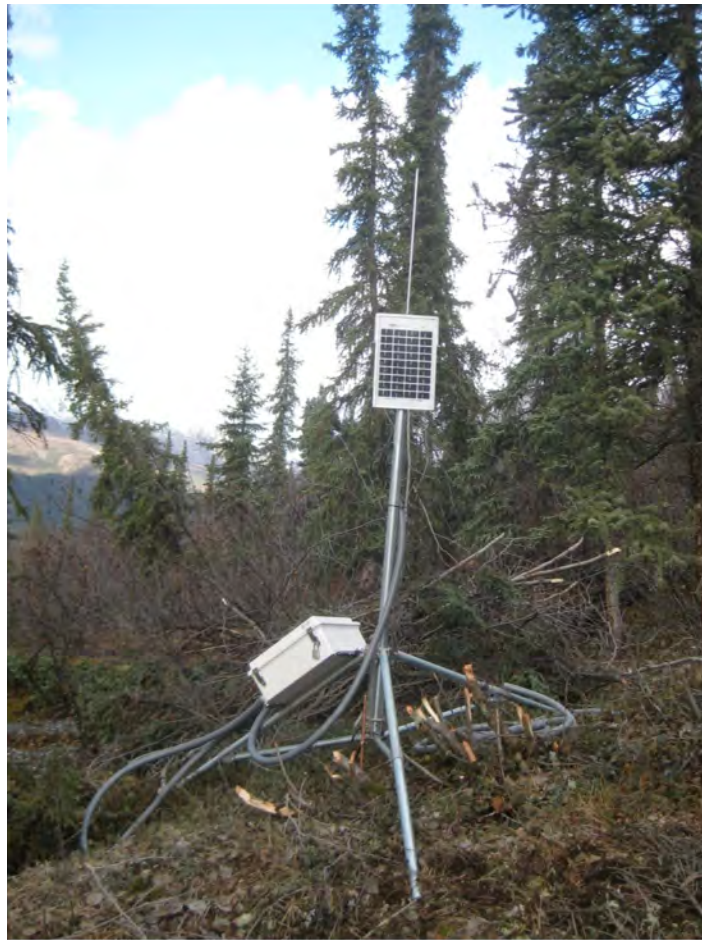
Figure B-11. Completed “lower” satellite ADAS installation. TH12-9005 is located beyond the brush behind the ADAS in the photograph. (Photograph by M. Darrow)

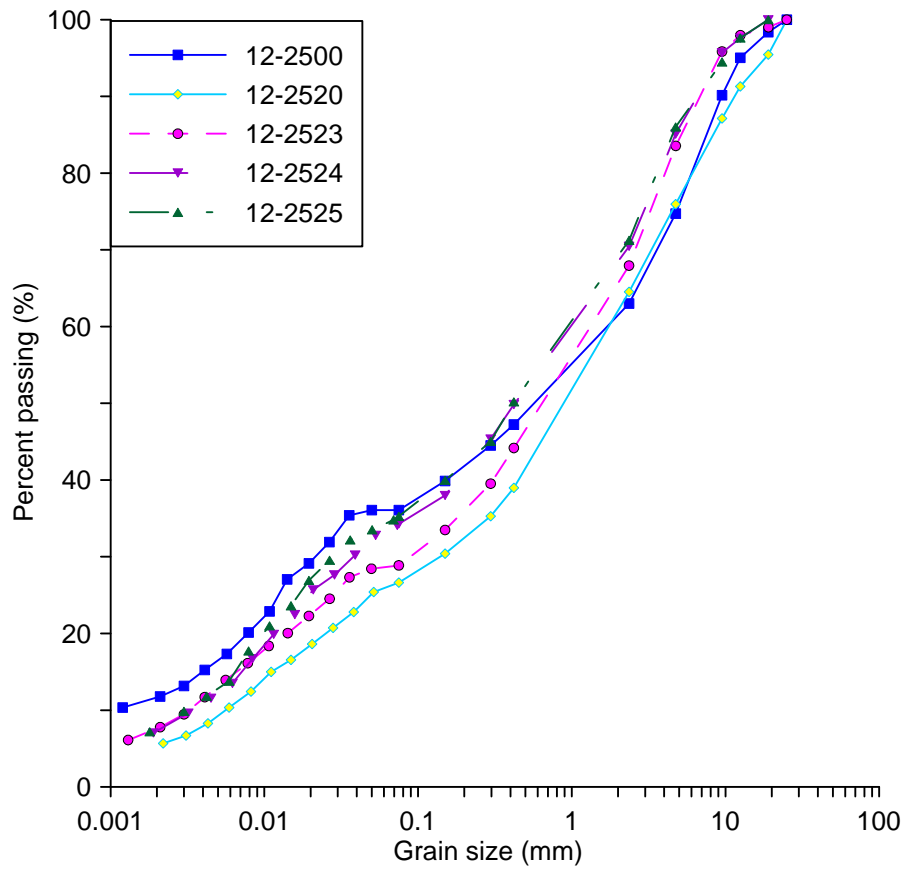
Figure D-1. Grain size distributions for the five samples tested from FDL-A.
