**Point Hope Airport Runway
Realignment:
Wetland Delineation Photo Log**

Overview Map

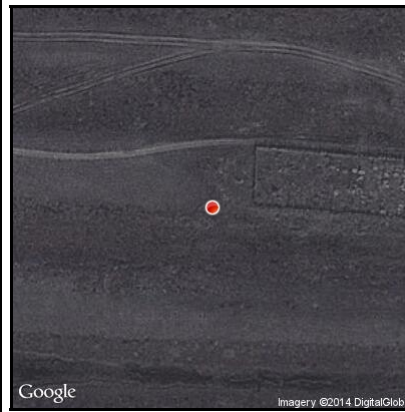
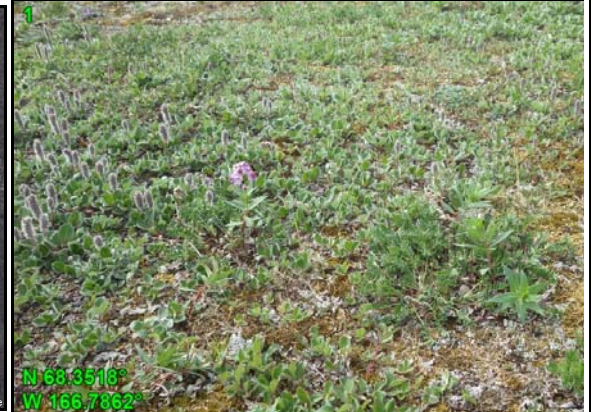
Attributes	
Title	1
Subject	Upland
Comment	Test Plot
Description	Upland coastal plain area west of cemetery on raised beach dune.
Latitude	N 68.3518°
Longitude	W 166.7862°
Photo Direction	274° W
Date Time Stamp	7/14/2014 4:04:59 PM

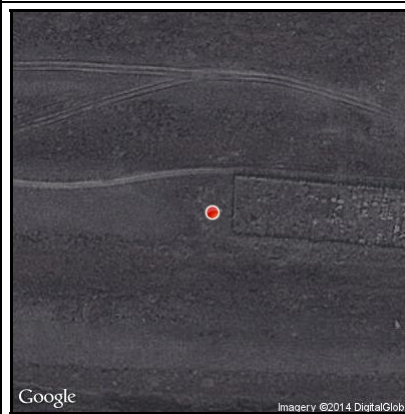
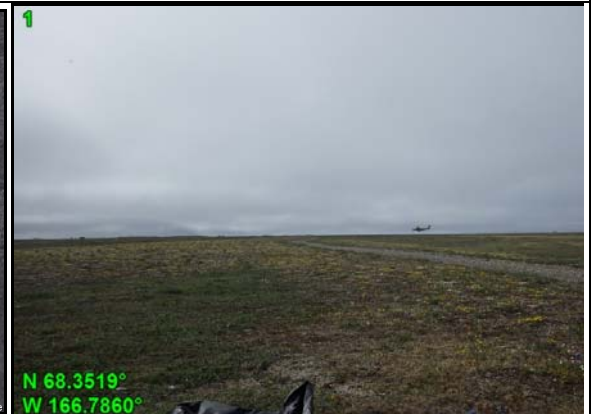
Attributes	
Title	1
Subject	Upland
Comment	Test Plot
Description	Upland coastal plain area west of cemetery on raised beach dune.
Latitude	N 68.3519°
Longitude	W 166.7860°
Photo Direction	342° N
Date Time Stamp	7/14/2014 4:34:40 PM

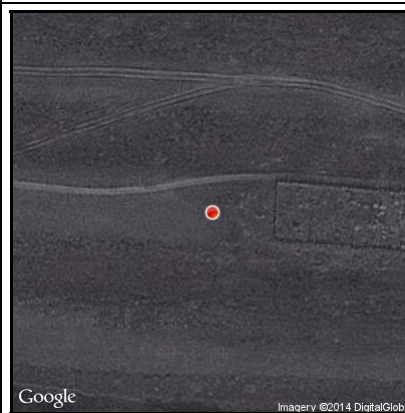
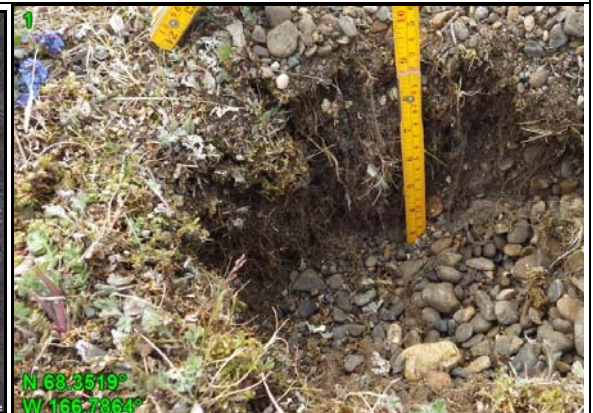
Attributes	
Title	1
Subject	Upland
Comment	Test Plot
Description	Dry sandy/gravelly soils.
Latitude	N 68.3519°
Longitude	W 166.7864°
Photo Direction	226° SW
Date Time Stamp	7/14/2014 4:44:04 PM

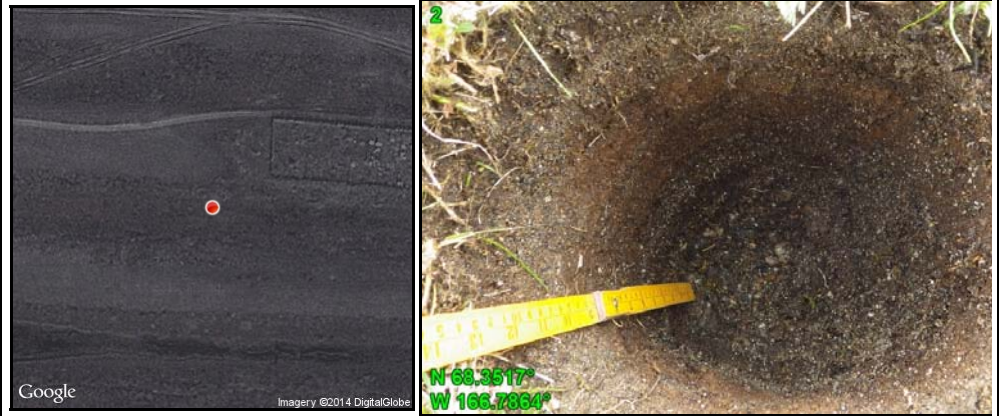
Attributes	
Title	2
Subject	Upland
Comment	Test Plot
Description	Dry sandy soils.
Latitude	N 68.3517°
Longitude	W 166.7864°
Photo Direction	114° SE
Date Time Stamp	7/14/2014 5:01:36 PM

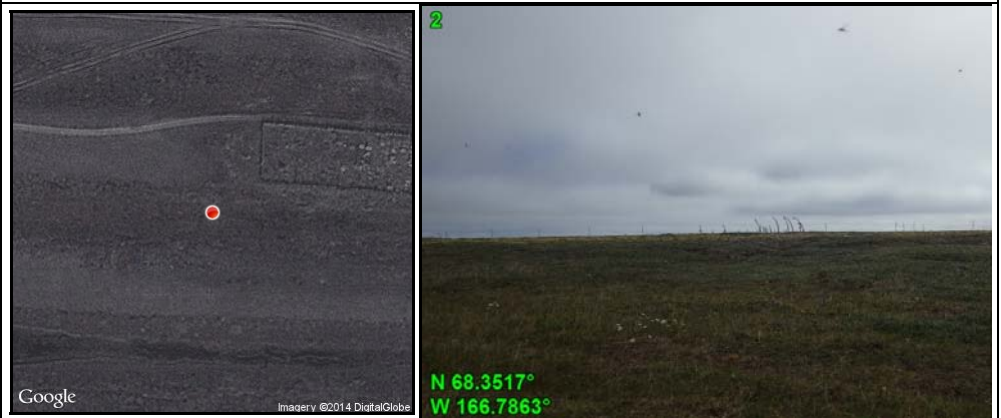
Attributes	
Title	2
Subject	Upland
Comment	Test Plot
Description	Upland coastal plain area west of cemetery on the linear depression of a beach dune.
Latitude	N 68.3517°
Longitude	W 166.7863°
Photo Direction	128° SE
Date Time Stamp	7/14/2014 5:01:49 PM

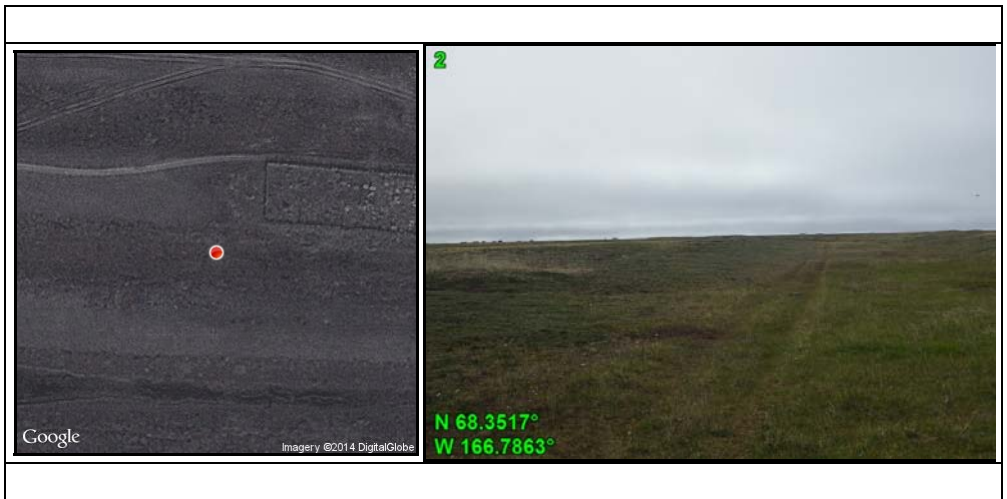
Attributes	
Title	2
Subject	Upland
Comment	Test Plot
Description	Upland coastal plain area west of cemetery on the linear depression of a beach dune.
Latitude	N 68.3517°
Longitude	W 166.7863°
Photo Direction	307° NW
Date Time Stamp	7/14/2014 5:01:58 PM

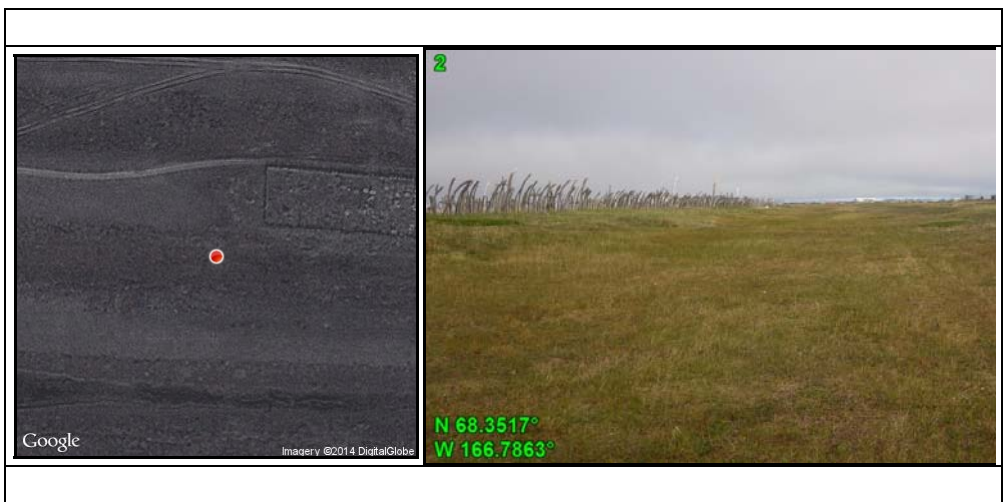
Attributes	
Title	2
Subject	Upland
Comment	Test Plot
Description	Upland coastal plain area west of cemetery on the linear depression of a beach dune.
Latitude	N 68.3517°
Longitude	W 166.7863°
Photo Direction	78° E
Date Time Stamp	7/14/2014 5:02:10 PM

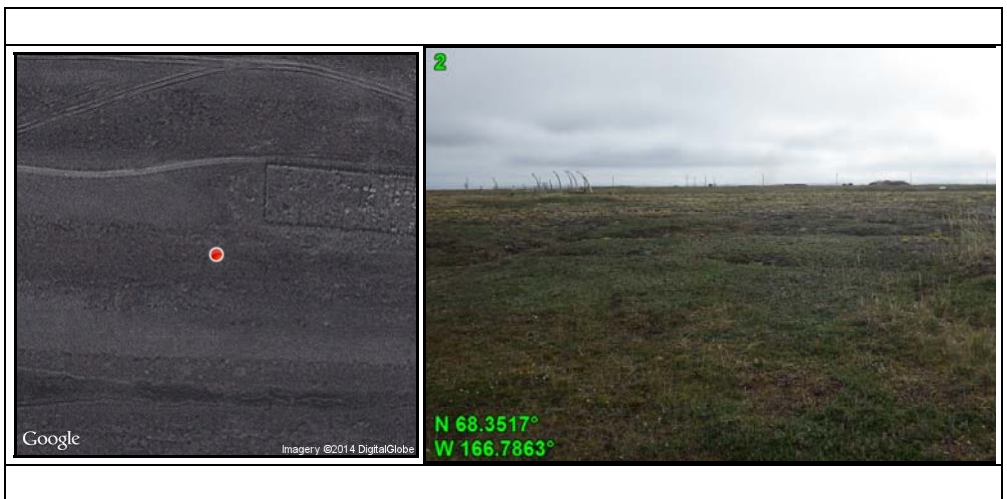
Attributes	
Title	2
Subject	Upland
Comment	Test Plot
Description	Upland coastal plain area west of cemetery on the linear depression of a beach dune.
Latitude	N 68.3517°
Longitude	W 166.7863°
Photo Direction	142° SE
Date Time Stamp	7/14/2014 5:02:15 PM

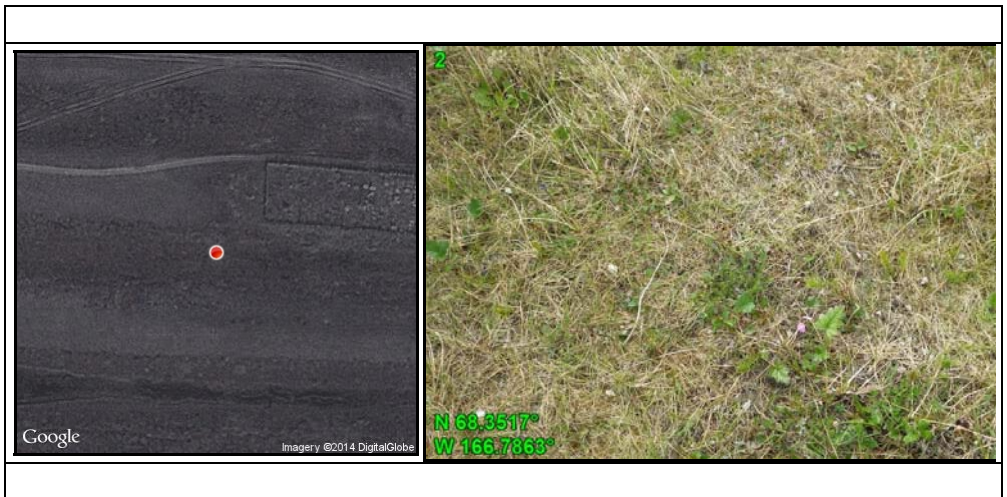
Attributes	
Title	2
Subject	Upland
Comment	Test Plot
Description	Upland coastal plain area west of cemetery on the linear depression of a beach dune.
Latitude	N 68.3517°
Longitude	W 166.7863°
Photo Direction	259° W
Date Time Stamp	7/14/2014 5:02:20 PM

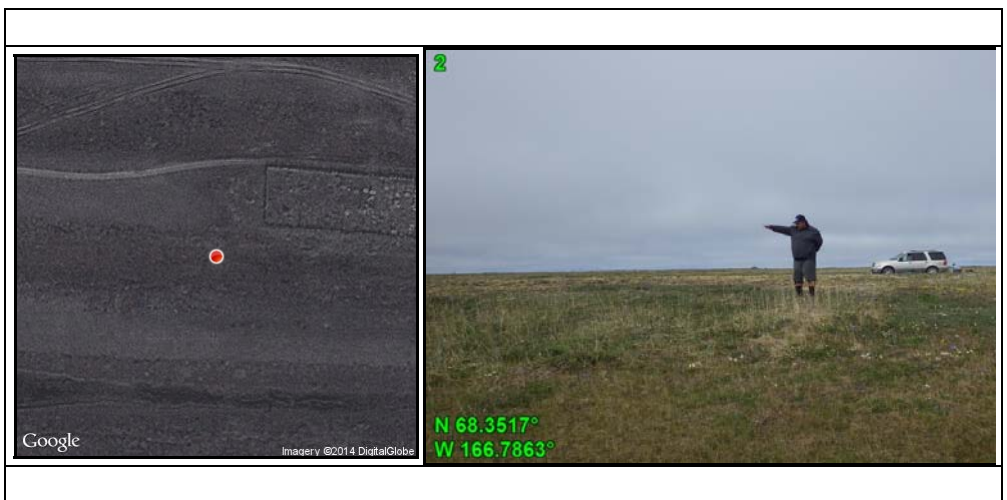
Attributes	
Title	2
Subject	Upland
Comment	Test Plot
Description	Local Cultural Resource Observer pointing out a sensitive area to avoid digging test plots.
Latitude	N 68.3517°
Longitude	W 166.7863°
Photo Direction	28° NE
Date Time Stamp	7/14/2014 5:02:39 PM

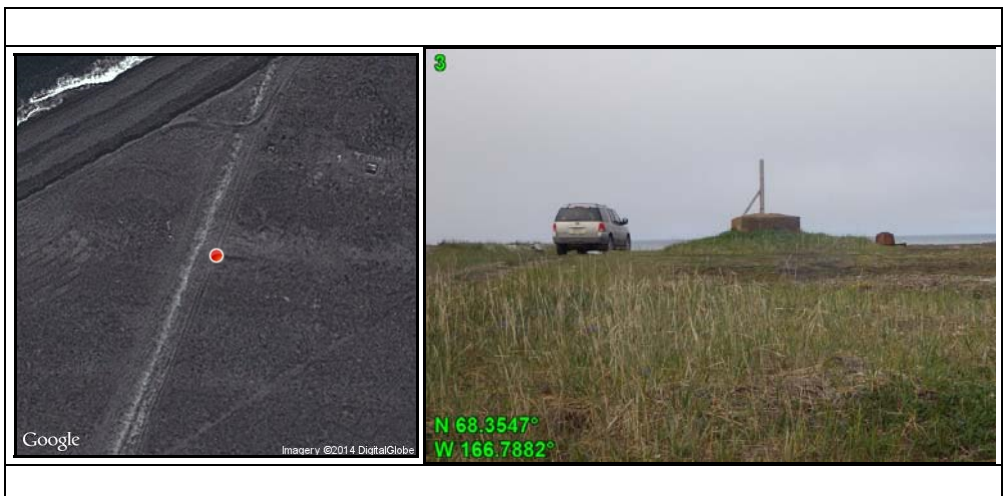
Attributes	
Title	3
Subject	Upland
Comment	Photo Point
Description	Same habitat characteristic at 1. Arctic willow dominates, dry gravelly soils with rocks visible at surface. Rolling dunes with microtopographic depressions.
Latitude	N 68.3547°
Longitude	W 166.7882°
Photo Direction	38° NE
Date Time Stamp	7/14/2014 6:25:19 PM

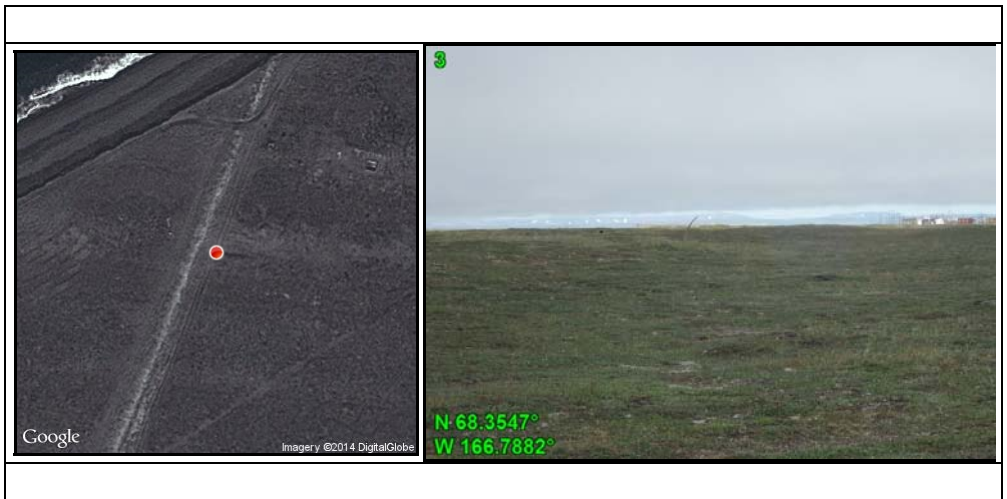
Attributes	
Title	3
Subject	Upland
Comment	Photo Point
Description	Same habitat characteristic at 1. Arctic willow dominates, dry gravely soils with rocks visible at surface. Rolling dunes with microtopographic depressions.
Latitude	N 68.3547°
Longitude	W 166.7882°
Photo Direction	82° E
Date Time Stamp	7/14/2014 6:25:26 PM

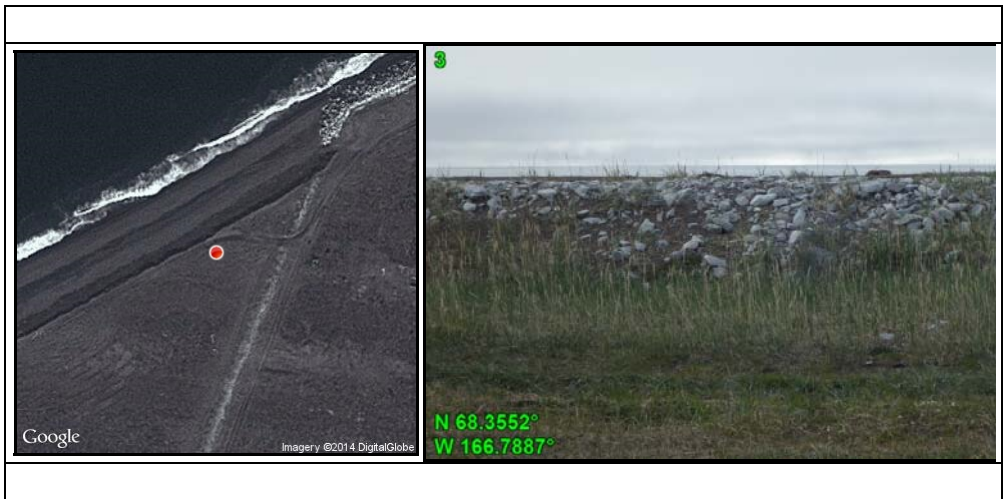
Attributes	
Title	3
Subject	Upland
Comment	Photo Point
Description	Same habitat characteristic at 1. Arctic willow dominates, dry gravelly soils with rocks visible at surface. Rolling dunes with microtopographic depressions.
Latitude	N 68.3552°
Longitude	W 166.7887°
Photo Direction	327° NW
Date Time Stamp	7/14/2014 6:25:36 PM

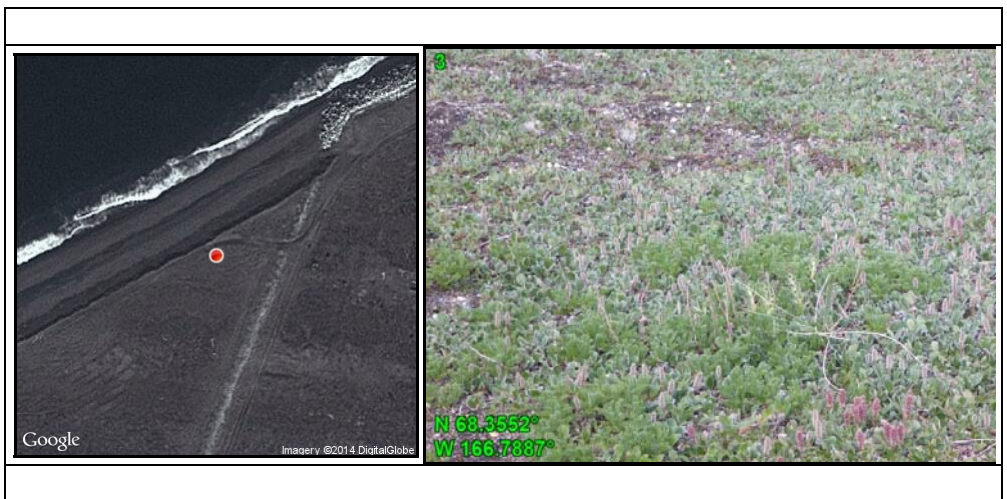
Attributes	
Title	3
Subject	Upland
Comment	Photo Point
Description	Same habitat characteristic at 1. Arctic willow dominates, dry gravelly soils with rocks visible at surface. Rolling dunes with microtopographic depressions.
Latitude	N 68.3552°
Longitude	W 166.7887°
Photo Direction	43° NE
Date Time Stamp	7/14/2014 6:25:57 PM

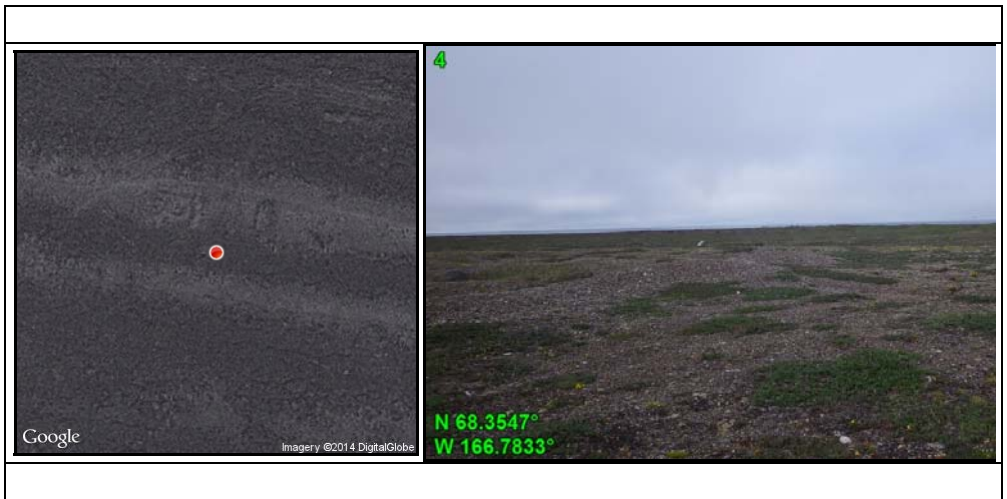
Attributes	
Title	4
Subject	Upland
Comment	Photo Point
Description	Same habitat characteristic at 1 and 3 except more surface gravels observed. Local Cultural Resources Observer requested us not to dig test plots in this area (shown on Figure 2).
Latitude	N 68.3547°
Longitude	W 166.7833°
Photo Direction	31° NE
Date Time Stamp	7/14/2014 6:38:03 PM

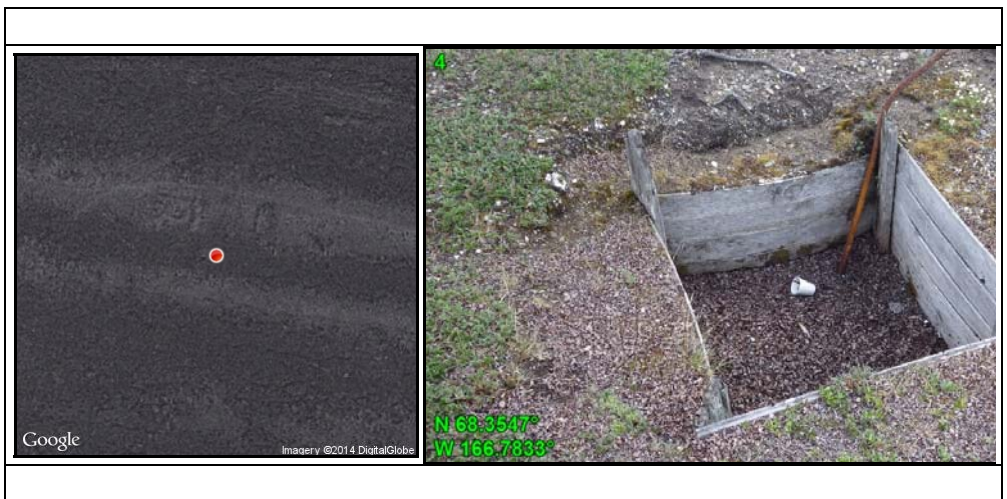
Attributes	
Title	4
Subject	Upland
Comment	Photo Point
Description	Remanent cultural resources.
Latitude	N 68.3547°
Longitude	W 166.7833°
Photo Direction	132° SE
Date Time Stamp	7/14/2014 6:38:27 PM

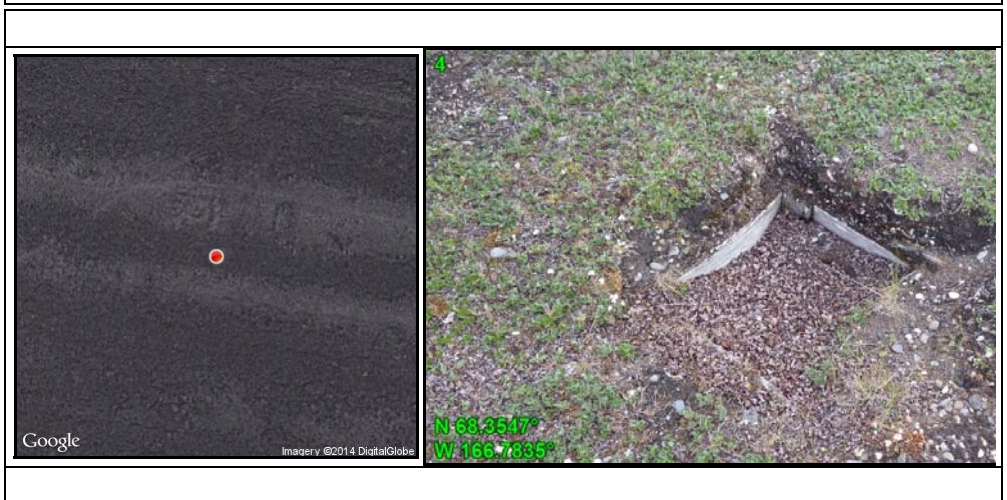
Attributes	
Title	4
Subject	Upland
Comment	Photo Point
Description	Remanent cultural resources.
Latitude	N 68.3547°
Longitude	W 166.7835°
Photo Direction	116° SE
Date Time Stamp	7/14/2014 6:38:34 PM

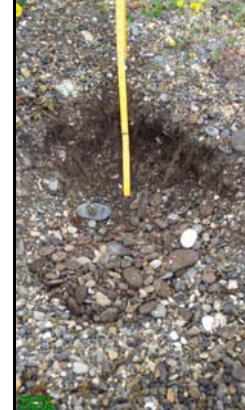
Attributes	
Title	5
Subject	Upland
Comment	Test Plot
Description	Dry sandy/gravelly soils.
Latitude	N 68.3513°
Longitude	W 166.7929°
Photo Direction	205° SW
Date Time Stamp	7/15/2014 9:24:27 AM

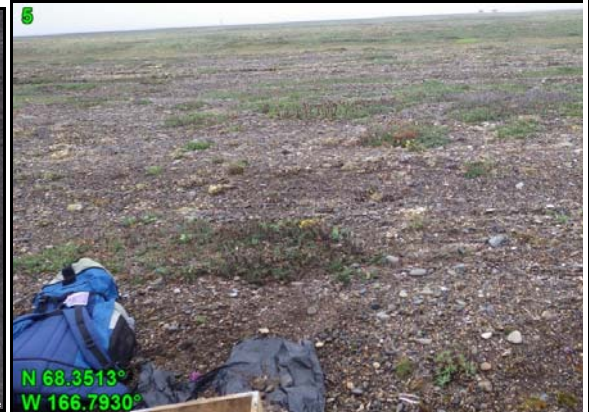
Attributes	
Title	5
Subject	Upland
Comment	Test Plot
Description	Upland coastal plain area with an abundance of exposed gravel.
Latitude	N 68.3513°
Longitude	W 166.7930°
Photo Direction	12° N
Date Time Stamp	7/15/2014 9:26:47 AM

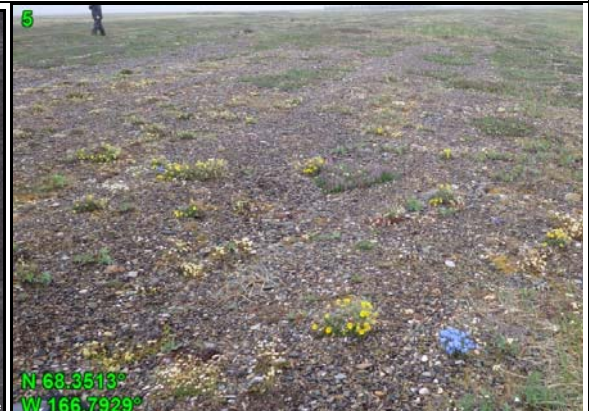
Attributes	
Title	5
Subject	Upland
Comment	Test Plot
Description	Upland coastal plain area with an abundance of exposed gravel.
Latitude	N 68.3513°
Longitude	W 166.7929°
Photo Direction	70° E
Date Time Stamp	7/15/2014 9:26:58 AM

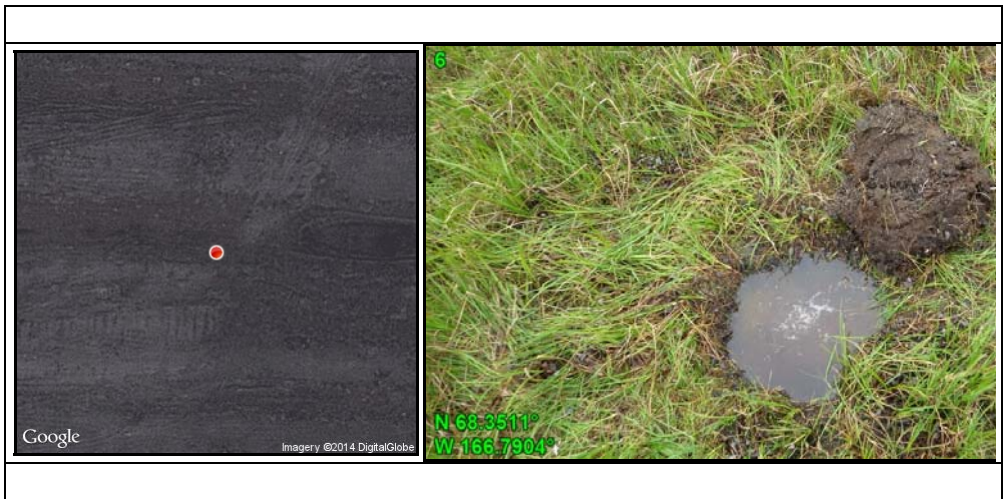
Attributes	
Title	6
Subject	Wetland (PEM1B)
Comment	Test Plot
Description	Organic/sandy soils with apparent hydrogen sulfide odor surrounding test plot.
Latitude	N 68.3511°
Longitude	W 166.7904°
Photo Direction	69° E
Date Time Stamp	7/15/2014 10:01:14 AM

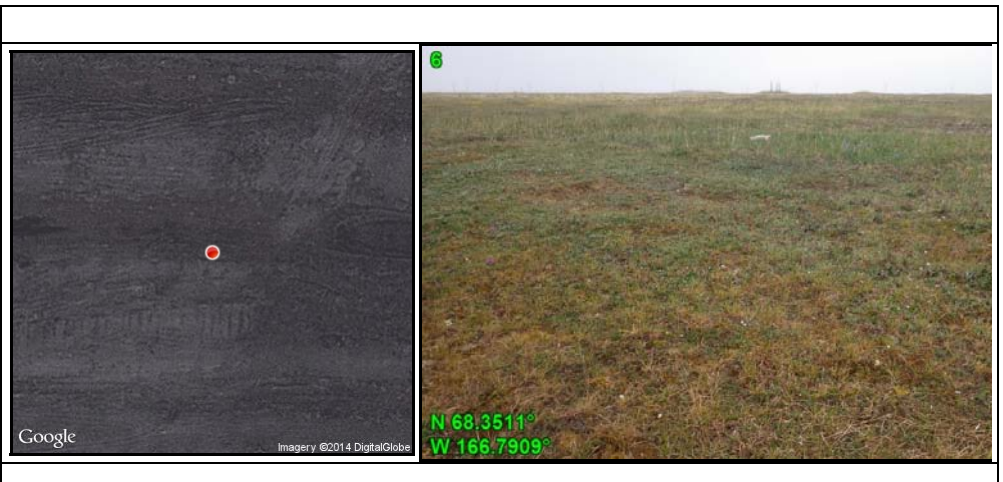
Attributes	
Title	6
Subject	Wetland (PEM1B)
Comment	Test Plot
Description	Linear depressional area carries water within the beach dune area.
Latitude	N 68.3511°
Longitude	W 166.7909°
Photo Direction	136° SE
Date Time Stamp	7/15/2014 10:01:58 AM

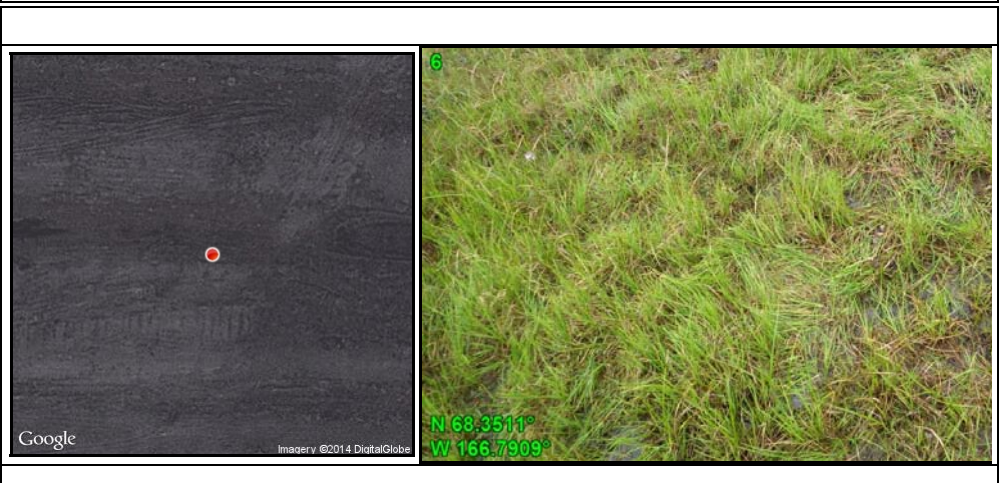
Attributes	
Title	6
Subject	Wetland (PEM1B)
Comment	Test Plot
Description	Linear depressional area carries water within the beach dune area.
Latitude	N 68.3511°
Longitude	W 166.7909°
Photo Direction	20° N
Date Time Stamp	7/15/2014 10:02:14 AM

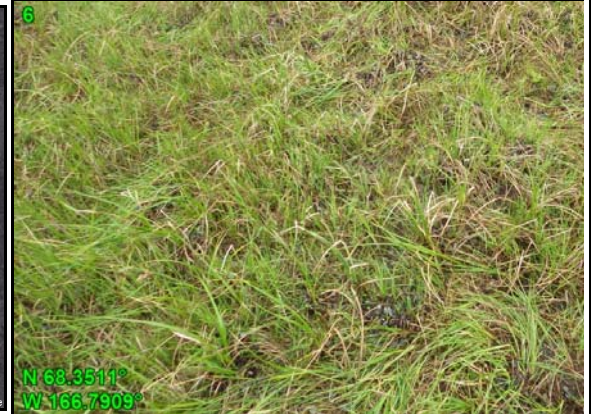
Attributes	
Title	6
Subject	Wetland (PEM1B)
Comment	Test Plot
Description	Linear depressional area carries water within the beach dune area.
Latitude	N 68.3511°
Longitude	W 166.7909°
Photo Direction	74° E
Date Time Stamp	7/15/2014 10:02:27 AM

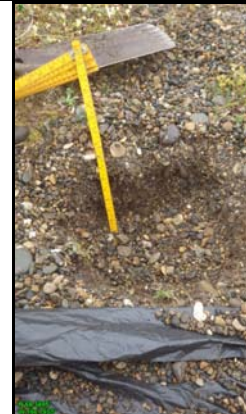
Attributes	
Title	7
Subject	Upland
Comment	Test Plot
Description	Sandy/gravelly soils. Gravel falling in on itself while attempting to excavate test hole deeper.
Latitude	N 68.3495°
Longitude	W 166.7933°
Photo Direction	42° NE
Date Time Stamp	7/15/2014 10:16:51 AM

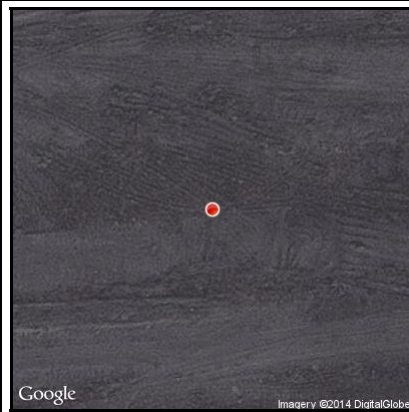
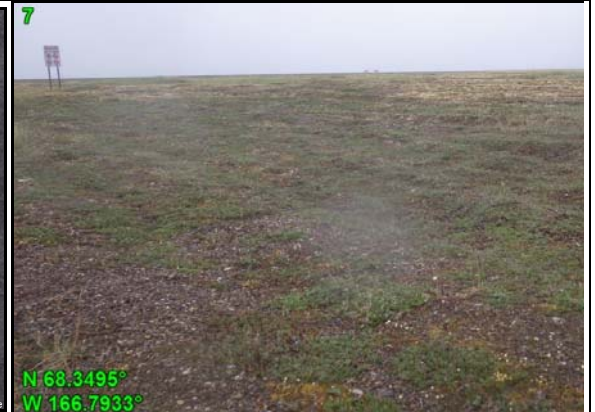
Attributes	
Title	7
Subject	Upland
Comment	Test Plot
Description	Rolling beach dunes of coastal plain area. Gravel ground cover abundant.
Latitude	N 68.3495°
Longitude	W 166.7933°
Photo Direction	30° NE
Date Time Stamp	7/15/2014 10:18:14 AM

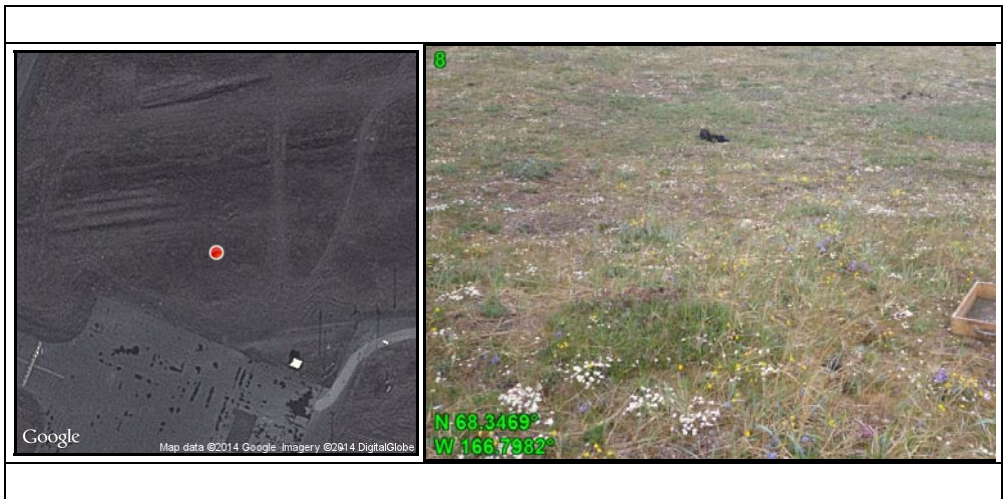
Attributes	
Title	8
Subject	Upland
Comment	Photo Point
Description	Same habitat characteristic at 1. Gravel covers 30% of ground cover. Rolling dune landscape.
Latitude	N 68.3469°
Longitude	W 166.7982°
Photo Direction	163° S
Date Time Stamp	7/15/2014 10:48:48 AM

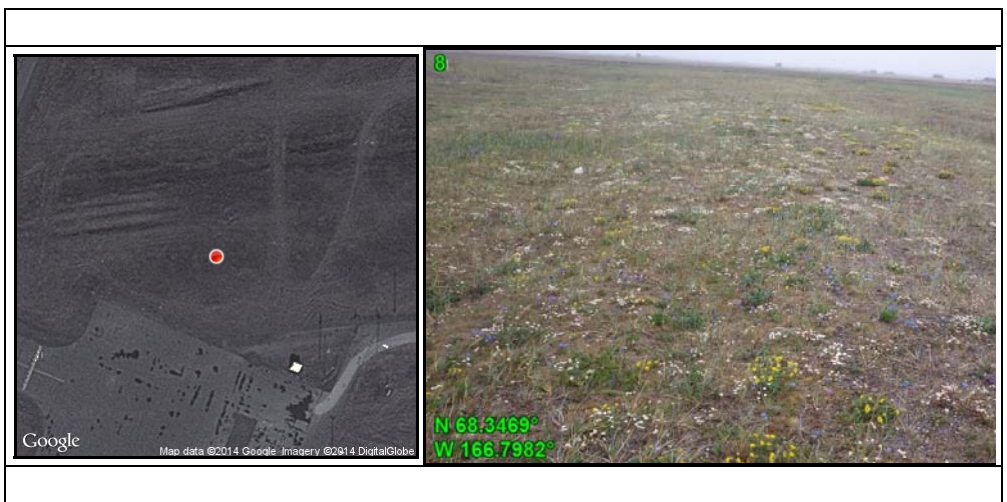
Attributes	
Title	8
Subject	Upland
Comment	Photo Point
Description	Same habitat characteristic at 1. Gravel covers 30% of ground cover. Rolling dune landscape.
Latitude	N 68.3469°
Longitude	W 166.7982°
Photo Direction	305° NW
Date Time Stamp	7/15/2014 10:48:54 AM

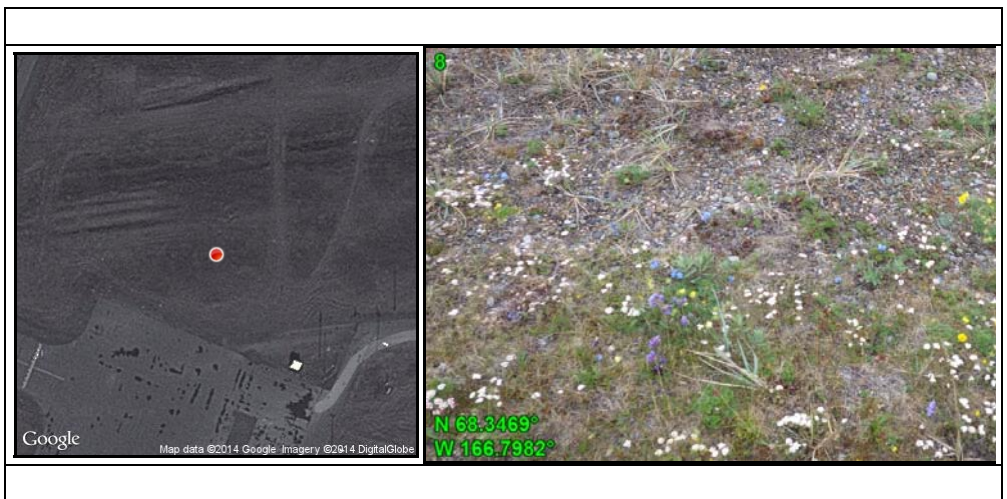
Attributes	
Title	8
Subject	Upland
Comment	Photo Point
Description	Same habitat characteristic at 1. Gravel covers 30% of ground cover. Rolling dune landscape.
Latitude	N 68.3469°
Longitude	W 166.7982°
Photo Direction	9° N
Date Time Stamp	7/15/2014 10:48:59 AM

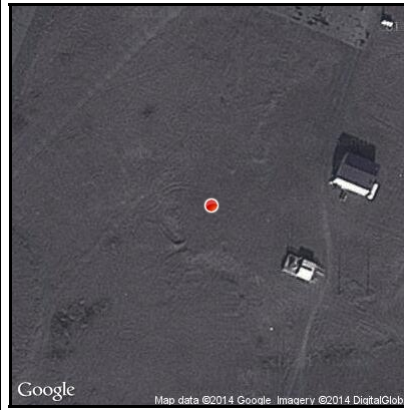
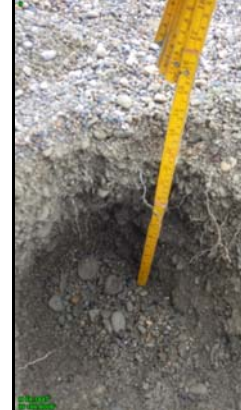
Attributes	
Title	9
Subject	Upland
Comment	Test Plot
Description	Gravelly/sandy soils. Gravel falling in on itself while attempting to excavate test hole deeper.
Latitude	N 68.3447°
Longitude	W 166.8008°
Photo Direction	253° W
Date Time Stamp	7/15/2014 11:01:41 AM

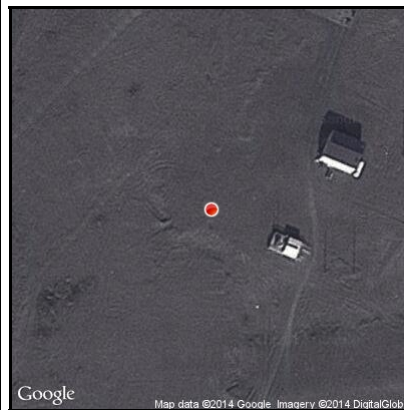
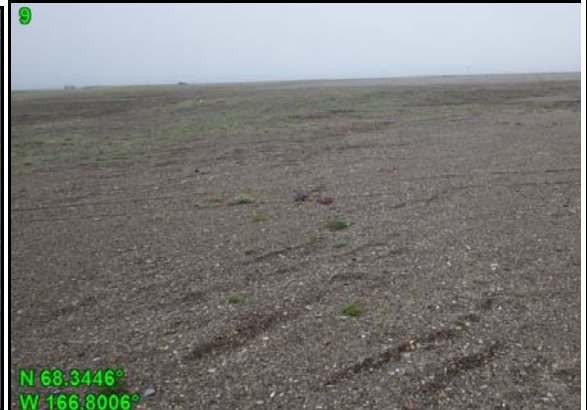
Attributes	
Title	9
Subject	Upland
Comment	Test Plot
Description	Old material site south of apron. Mostly exposed gravel with minimal vegetation.
Latitude	N 68.3446°
Longitude	W 166.8006°
Photo Direction	17° N
Date Time Stamp	7/15/2014 11:02:53 AM

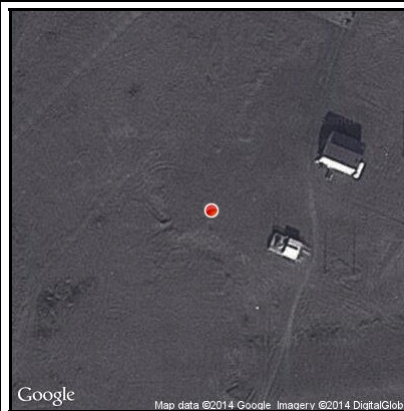
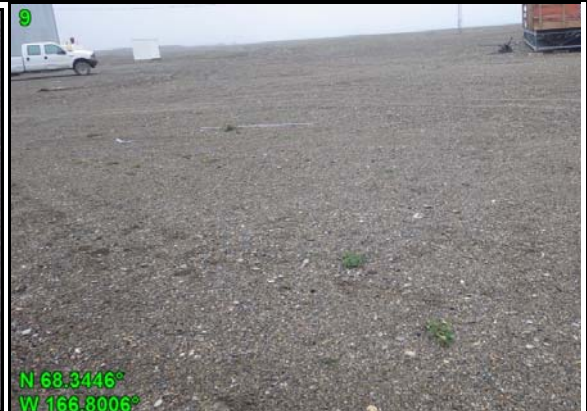
Attributes	
Title	9
Subject	Upland
Comment	Test Plot
Description	Old material site south of apron. Mostly exposed gravel with minimal vegetation.
Latitude	N 68.3446°
Longitude	W 166.8006°
Photo Direction	72° E
Date Time Stamp	7/15/2014 11:02:57 AM

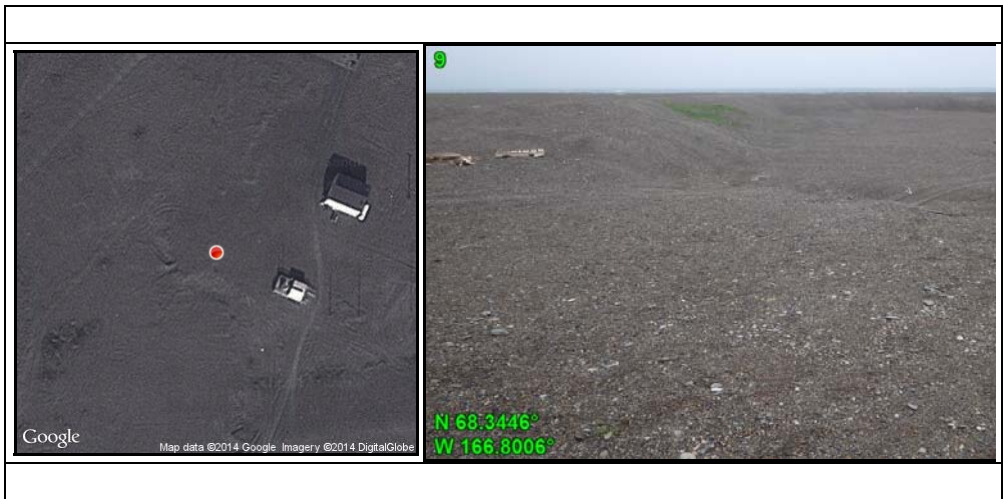
Attributes	
Title	9
Subject	Upland
Comment	Test Plot
Description	Old material site south of apron. Mostly exposed gravel with minimal vegetation.
Latitude	N 68.3446°
Longitude	W 166.8006°
Photo Direction	125° SE
Date Time Stamp	7/15/2014 11:03:02 AM

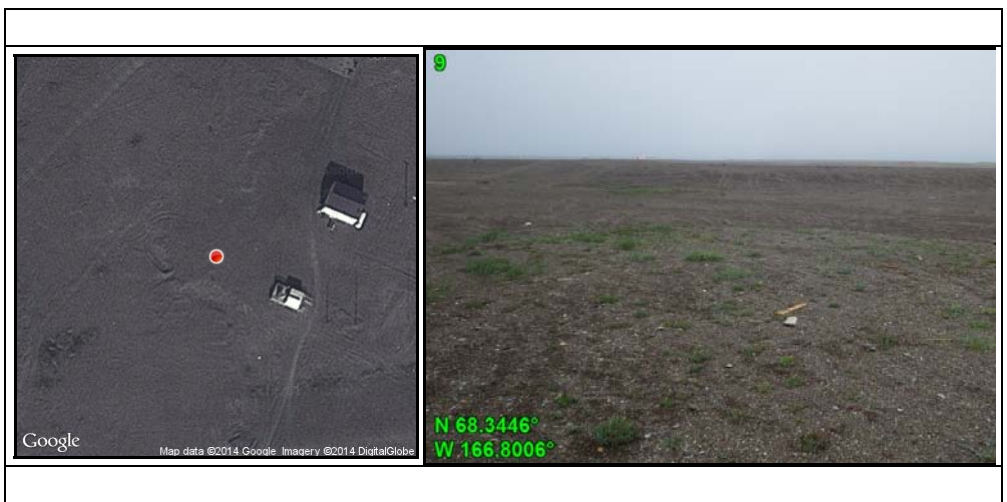
Attributes	
Title	9
Subject	Upland
Comment	Test Plot
Description	Old material site south of apron. Mostly exposed gravel with minimal vegetation.
Latitude	N 68.3446°
Longitude	W 166.8006°
Photo Direction	277° W
Date Time Stamp	7/15/2014 11:03:06 AM

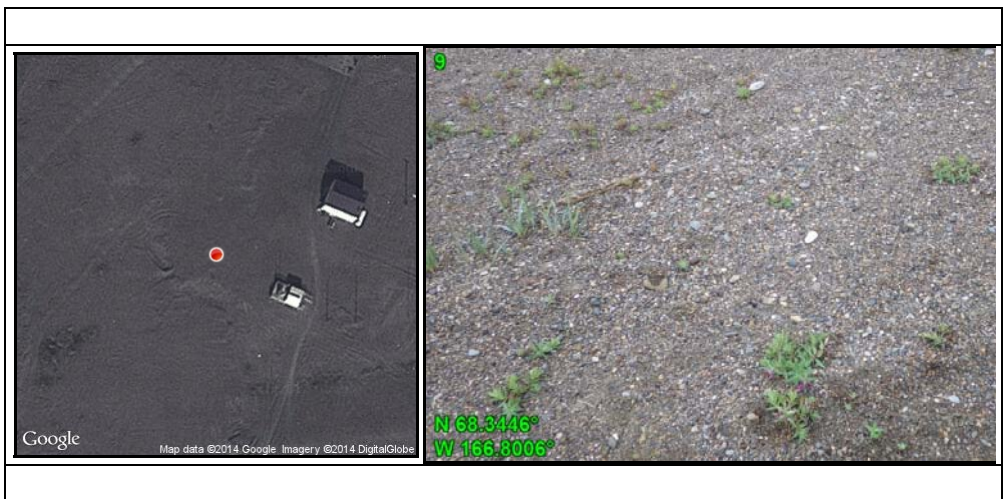
Attributes	
Title	9
Subject	Upland
Comment	Test Plot
Description	Old material site south of apron. Mostly exposed gravel with minimal vegetation.
Latitude	N 68.3446°
Longitude	W 166.8006°
Photo Direction	350° N
Date Time Stamp	7/15/2014 11:03:11 AM

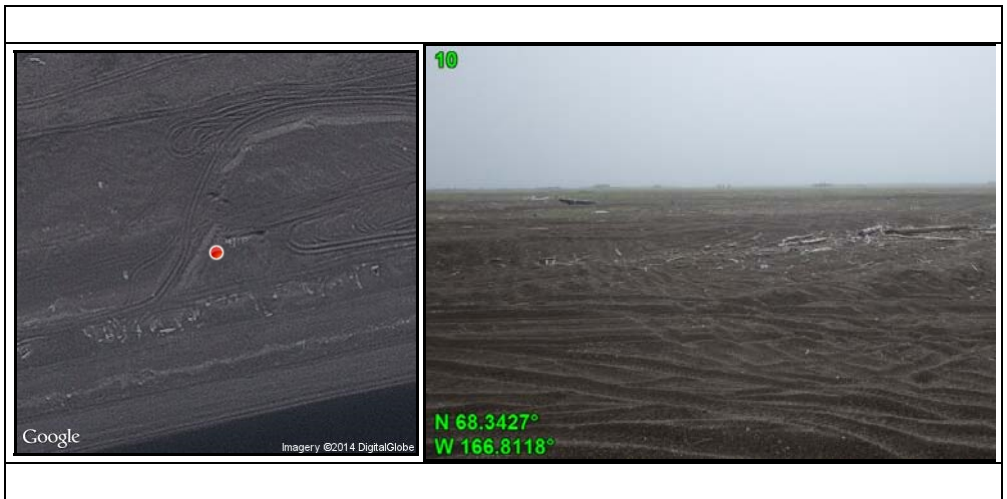
Attributes	
Title	10
Subject	Tidal
Comment	Photo Point
Description	High tide line void of vegetation with abundant gravel/sand. Scattered drift wood throughout.
Latitude	N 68.3427°
Longitude	W 166.8118°
Photo Direction	355° N
Date Time Stamp	7/15/2014 1:46:10 PM

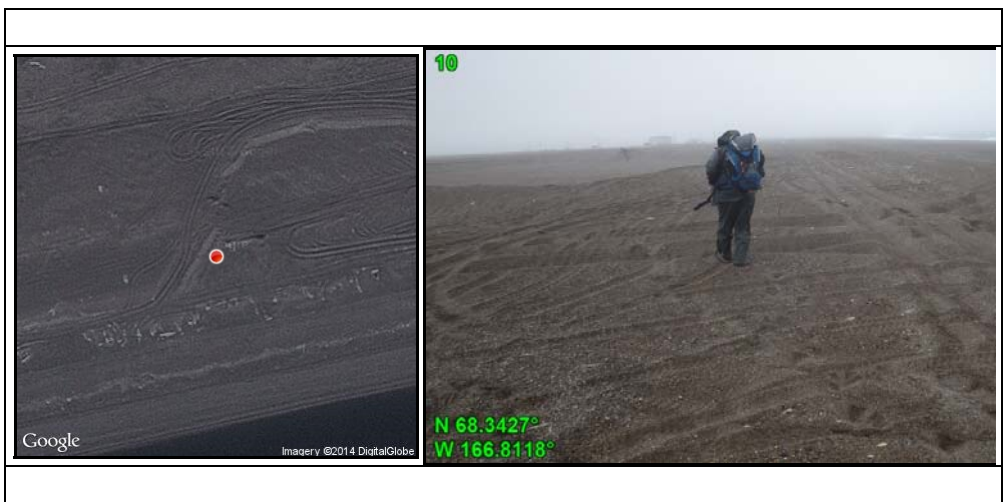
Attributes	
Title	10
Subject	Tidal
Comment	Photo Point
Description	High tide line void of vegetation with abundant gravel/sand. Scattered drift wood throughout.
Latitude	N 68.3427°
Longitude	W 166.8118°
Photo Direction	55° NE
Date Time Stamp	7/15/2014 1:46:21 PM

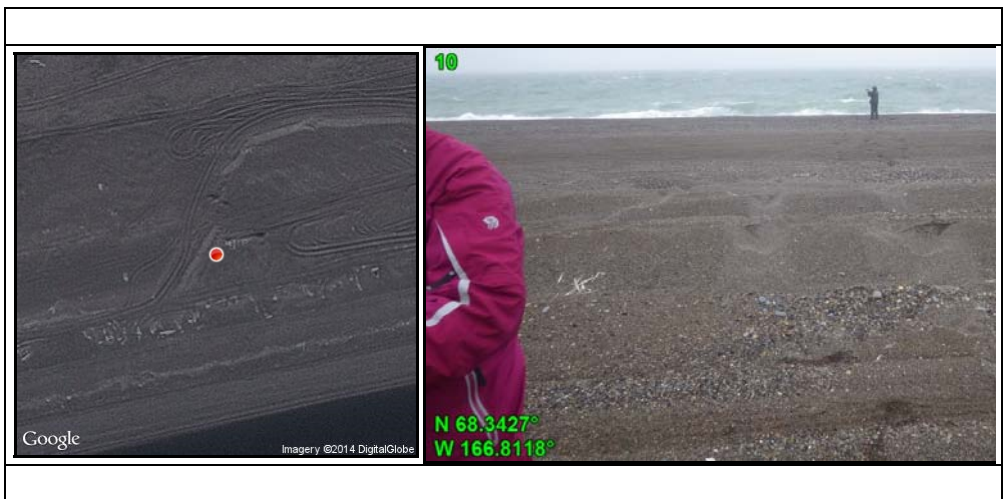
Attributes	
Title	10
Subject	Tidal
Comment	Photo Point
Description	High tide line void of vegetation with abundant gravel/sand. Scattered drift wood throughout.
Latitude	N 68.3427°
Longitude	W 166.8118°
Photo Direction	151° SE
Date Time Stamp	7/15/2014 1:46:26 PM

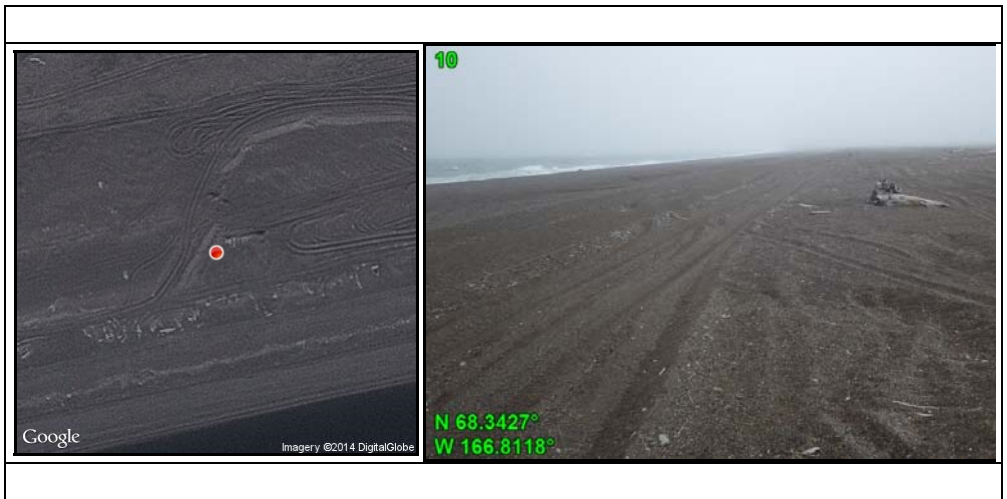
Attributes	
Title	10
Subject	Tidal
Comment	Photo Point
Description	High tide line void of vegetation with abundant gravel/sand. Scattered drift wood throughout.
Latitude	N 68.3427°
Longitude	W 166.8118°
Photo Direction	270° W
Date Time Stamp	7/15/2014 1:46:31 PM

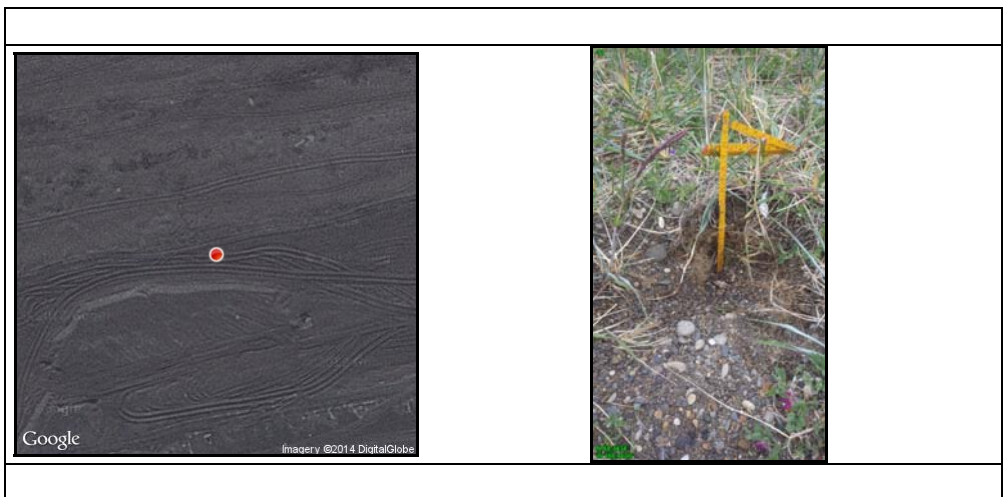
Attributes	
Title	11
Subject	Upland
Comment	Test Plot
Description	Dry gravelly/rocky soils. Gravel falling in on itself while attempting to excavate test hole deeper.
Latitude	N 68.3434°
Longitude	W 166.8100°
Photo Direction	201° S
Date Time Stamp	7/15/2014 2:03:48 PM

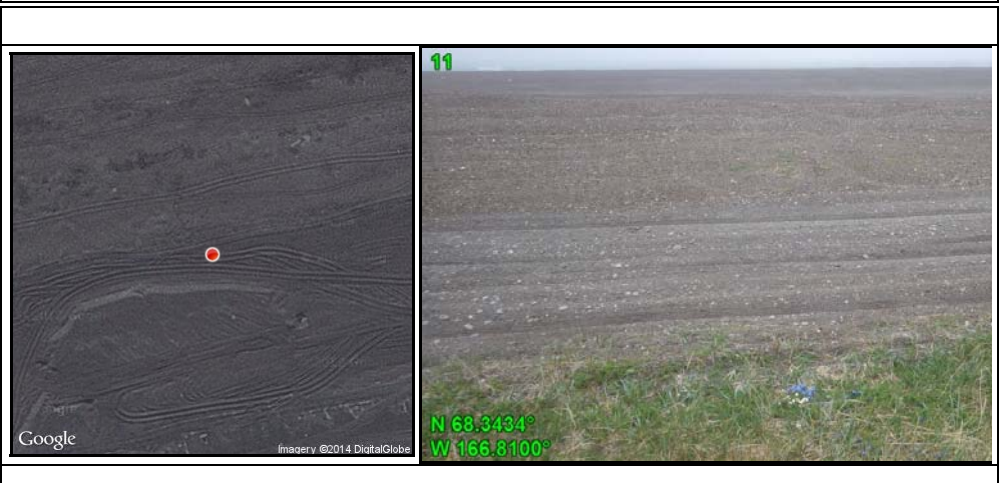
Attributes	
Title	11
Subject	Upland
Comment	Test Plot
Description	Southwest edge of where vegetation begins growing from tidal area.
Latitude	N 68.3434°
Longitude	W 166.8100°
Photo Direction	149° SE
Date Time Stamp	7/15/2014 2:06:20 PM

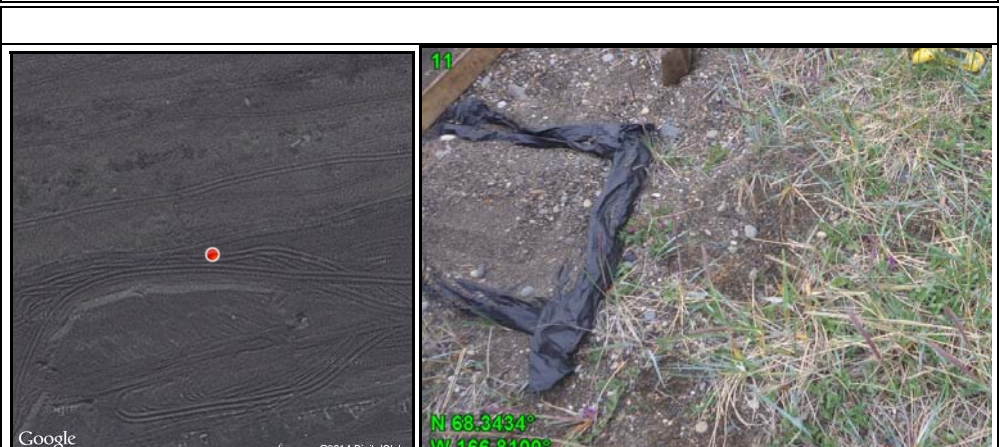
Attributes	
Title	11
Subject	Upland
Comment	Test Plot
Description	Excavated test plot material analyzed by archaeologist.
Latitude	N 68.3434°
Longitude	W 166.8100°
Photo Direction	29° NE
Date Time Stamp	7/15/2014 2:06:34 PM

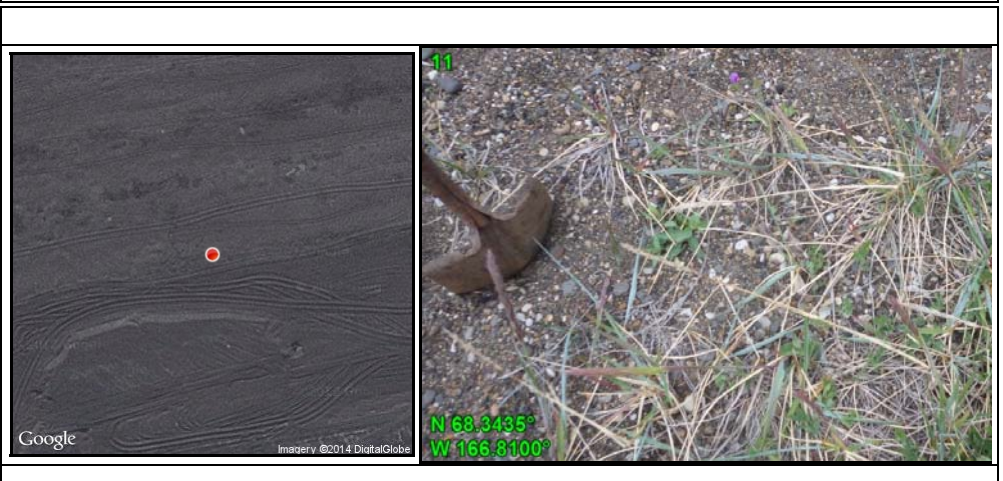
Attributes	
Title	11
Subject	Upland
Comment	Test Plot
Description	Southwest edge of where vegetation begins growing from tidal area.
Latitude	N 68.3435°
Longitude	W 166.8100°
Photo Direction	39° NE
Date Time Stamp	7/15/2014 2:07:51 PM

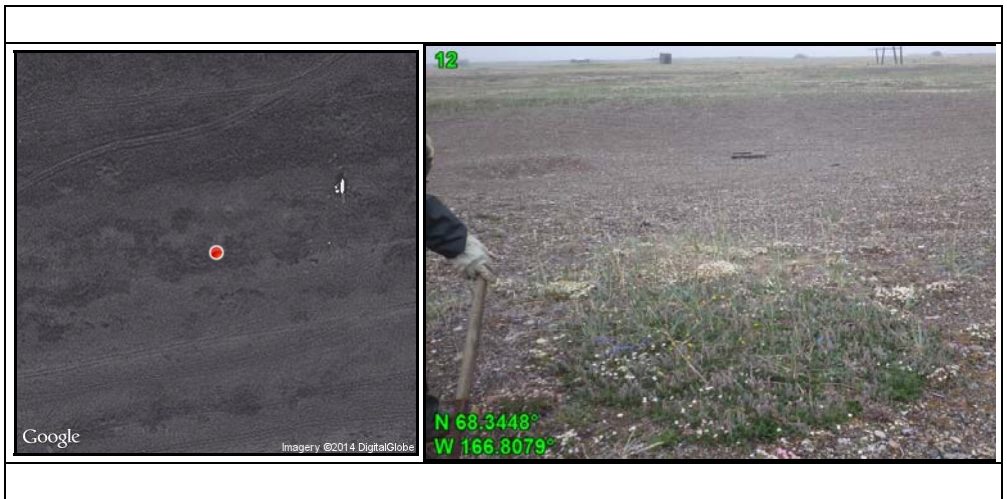
Attributes	
Title	12
Subject	Upland
Comment	Photo Point
Description	Habitat with same characteristics as 1. Arctic willow dominates vegetation and gravel dominates ground cover.
Latitude	N 68.3448°
Longitude	W 166.8079°
Photo Direction	9° N
Date Time Stamp	7/15/2014 2:24:02 PM
