**Point Hope Airport Runway
Realignment:
Wetland Delineation Photo Log**

Overview Map

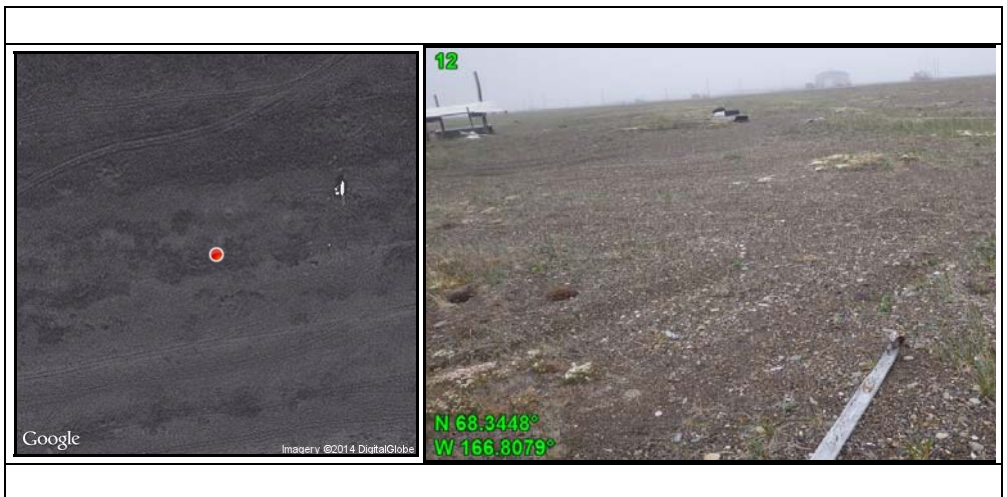
Attributes	
Title	12
Subject	Upland
Comment	Photo Point
Description	Habitat with same characteristics as 1. Arctic willow dominates vegetation and gravel dominates ground cover.
Latitude	N 68.3448°
Longitude	W 166.8079°
Photo Direction	69° E
Date Time Stamp	7/15/2014 2:24:10 PM

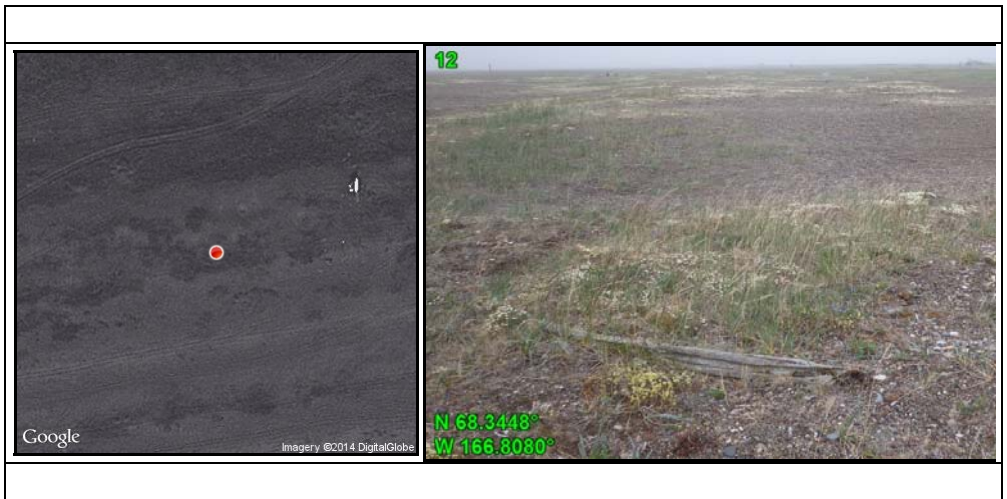
Attributes	
Title	12
Subject	Upland
Comment	Photo Point
Description	Habitat with same characteristics as 1. Arctic willow dominates vegetation and gravel dominates ground cover.
Latitude	N 68.3448°
Longitude	W 166.8080°
Photo Direction	286° W
Date Time Stamp	7/15/2014 2:24:41 PM

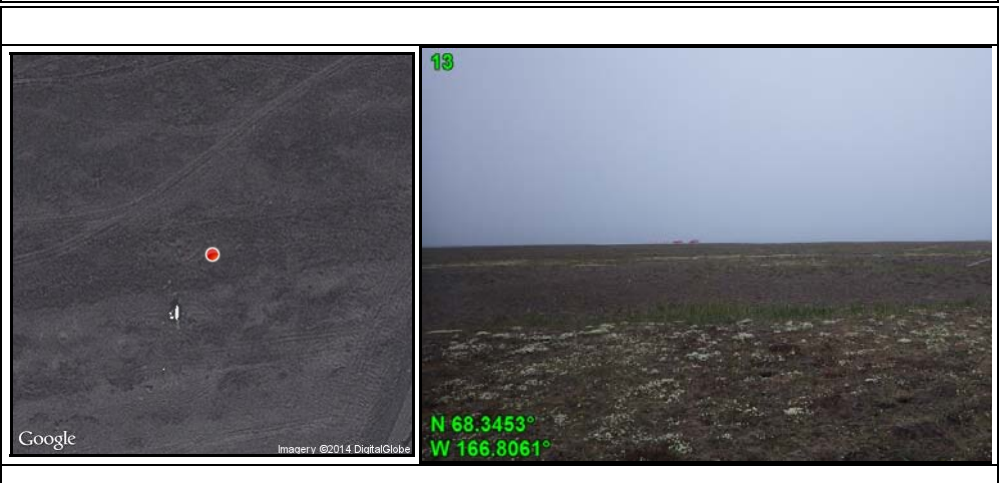
Attributes	
Title	13
Subject	Upland
Comment	Test Plot
Description	Linear beach dune depression between raised beach dune areas.
Latitude	N 68.3453°
Longitude	W 166.8061°
Photo Direction	160° S
Date Time Stamp	7/15/2014 2:37:21 PM

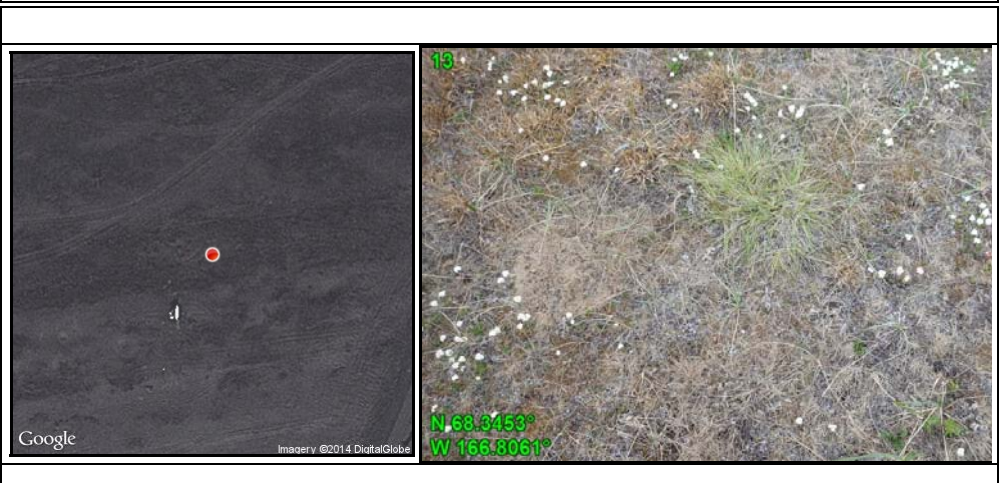
Attributes	
Title	13
Subject	Upland
Comment	Test Plot
Description	Linear beach dune depression between raised beach dune areas.
Latitude	N 68.3453°
Longitude	W 166.8061°
Photo Direction	72° E
Date Time Stamp	7/15/2014 2:37:31 PM

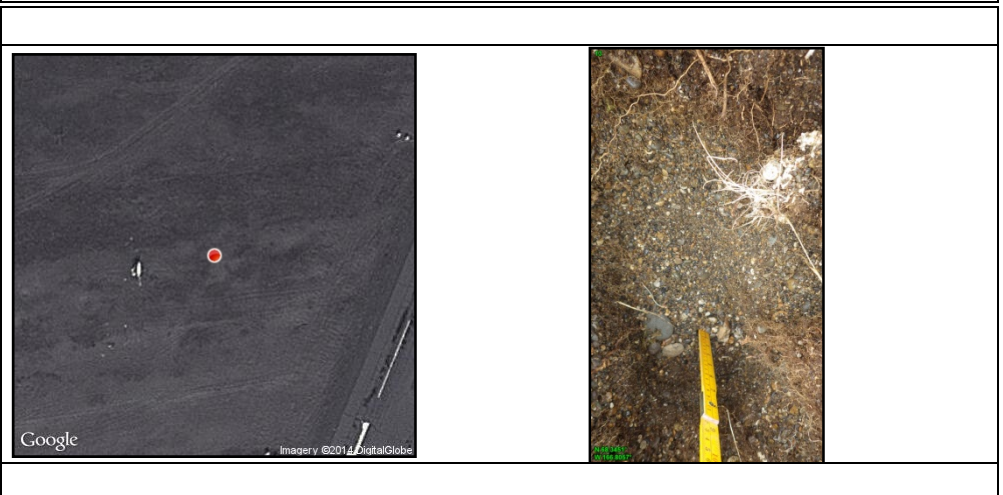
Attributes	
Title	13
Subject	Upland
Comment	Test Plot
Description	Dry gravely/sandy soils.
Latitude	N 68.3451°
Longitude	W 166.8057°
Photo Direction	38° NE
Date Time Stamp	7/15/2014 2:40:03 PM

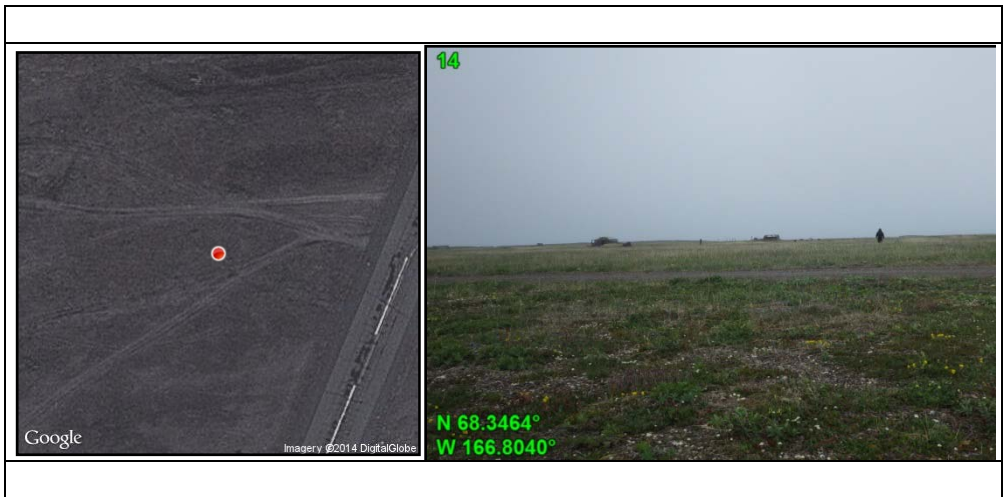
Attributes	
Title	14
Subject	Upland
Comment	Photo Point
Description	Same habitat characteristic at 13. Surface soil cracks visible but hydric soil and hydrophytic vegetation not present.
Latitude	N 68.3464°
Longitude	W 166.8040°
Photo Direction	346° N
Date Time Stamp	7/15/2014 2:54:51 PM

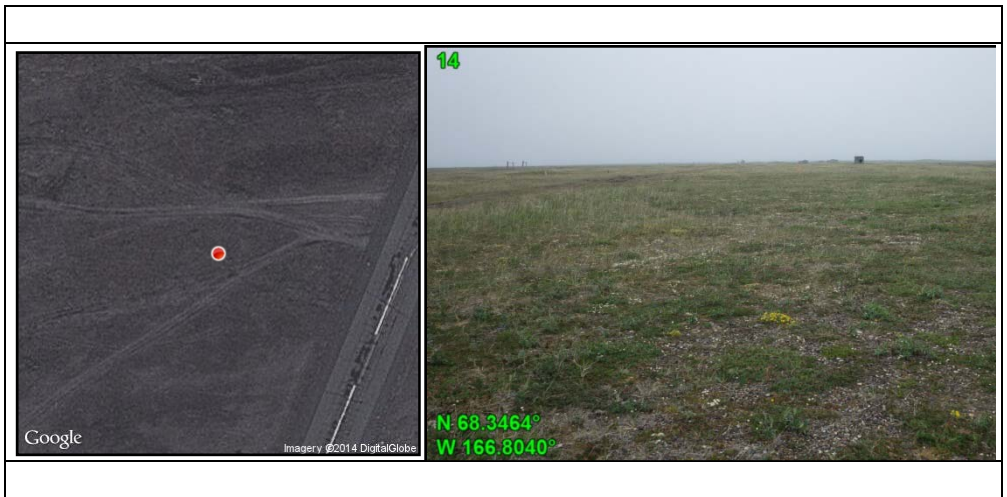
Attributes	
Title	14
Subject	Upland
Comment	Photo Point
Description	Same habitat characteristic at 13. Surface soil cracks visible but hydric soil and hydrophytic vegetation not present.
Latitude	N 68.3464°
Longitude	W 166.8040°
Photo Direction	290° W
Date Time Stamp	7/15/2014 2:55:02 PM

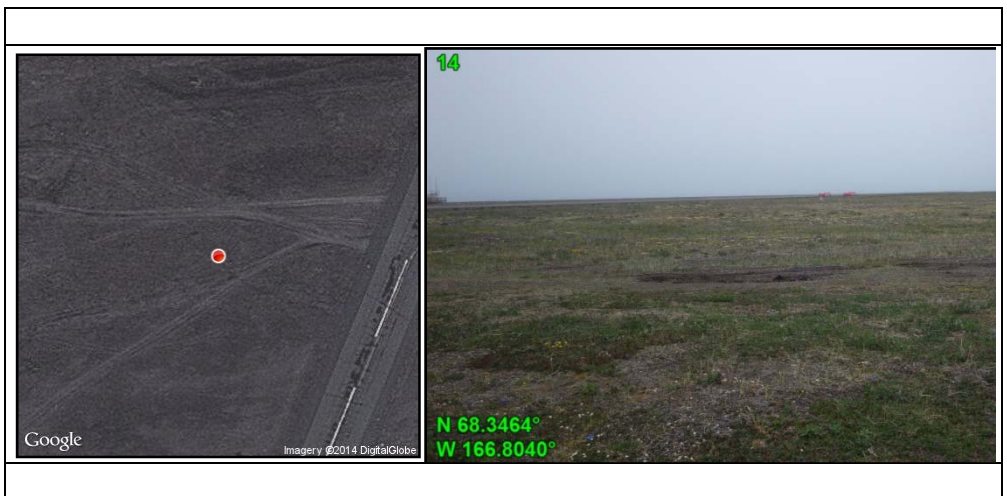
Attributes	
Title	14
Subject	Upland
Comment	Photo Point
Description	Same habitat characteristic at 13. Surface soil cracks visible but hydric soil and hydrophytic vegetation not present.
Latitude	N 68.3464°
Longitude	W 166.8040°
Photo Direction	94° E
Date Time Stamp	7/15/2014 2:55:07 PM

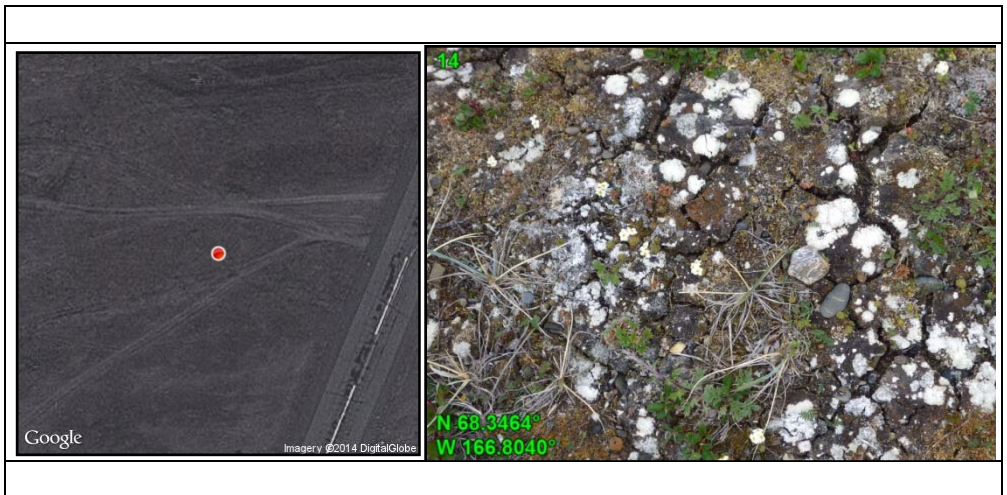
Attributes	
Title	14
Subject	Upland
Comment	Photo Point
Description	Same habitat characteristic at 13. Surface soil cracks visible but hydric soil and hydrophytic vegetation not present.
Latitude	N 68.3464°
Longitude	W 166.8040°
Photo Direction	30° NE
Date Time Stamp	7/15/2014 2:55:19 PM

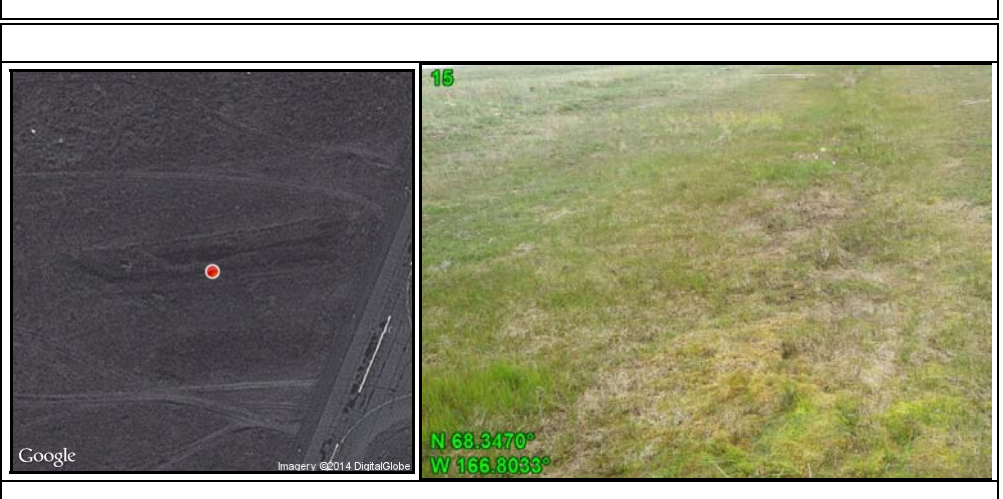
Attributes	
Title	15
Subject	Wetland (PEM1B)
Comment	Test Plot
Description	Linear beach dune depression between raised beach dune areas.
Latitude	N 68.3470°
Longitude	W 166.8033°
Photo Direction	55° NE
Date Time Stamp	7/15/2014 3:08:01 PM

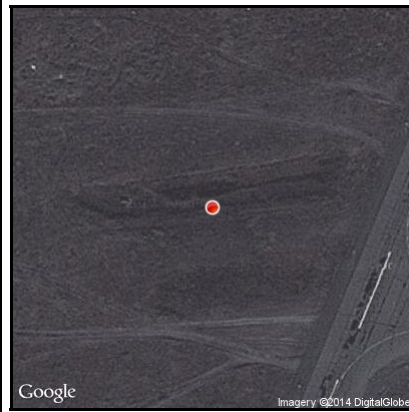
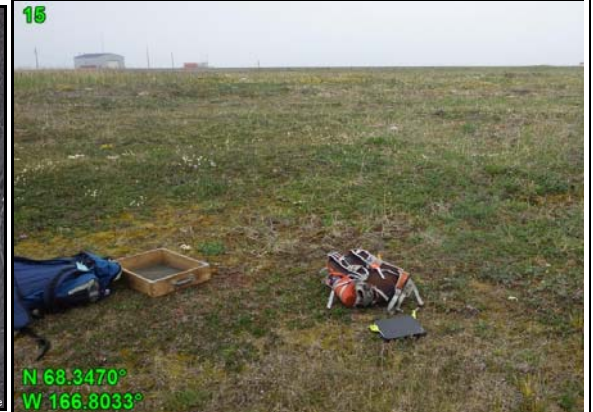
Attributes	
Title	15
Subject	Wetland (PEM1B)
Comment	Test Plot
Description	Linear beach dune depression between raised beach dune areas.
Latitude	N 68.3470°
Longitude	W 166.8033°
Photo Direction	110° E
Date Time Stamp	7/15/2014 3:08:08 PM

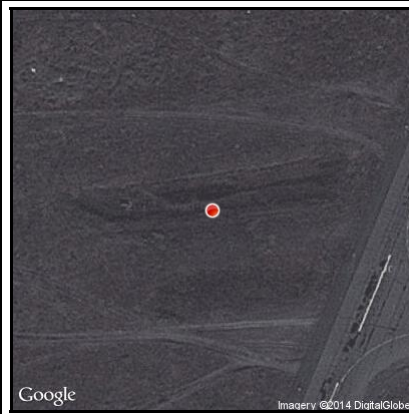
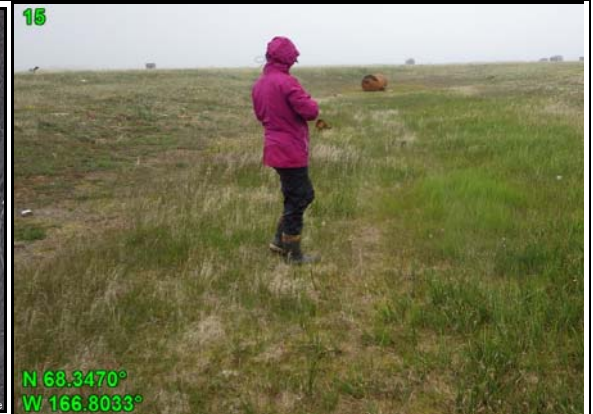
Attributes	
Title	15
Subject	Wetland (PEM1B)
Comment	Test Plot
Description	Linear beach dune depression between raised beach dune areas.
Latitude	N 68.3470°
Longitude	W 166.8033°
Photo Direction	310° NW
Date Time Stamp	7/15/2014 3:08:12 PM

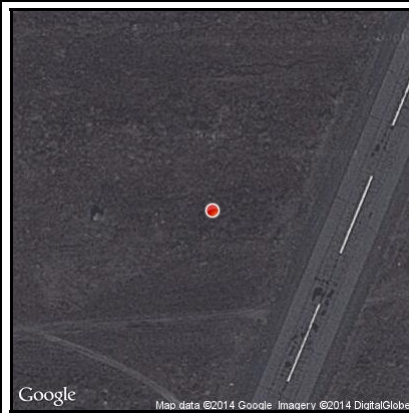
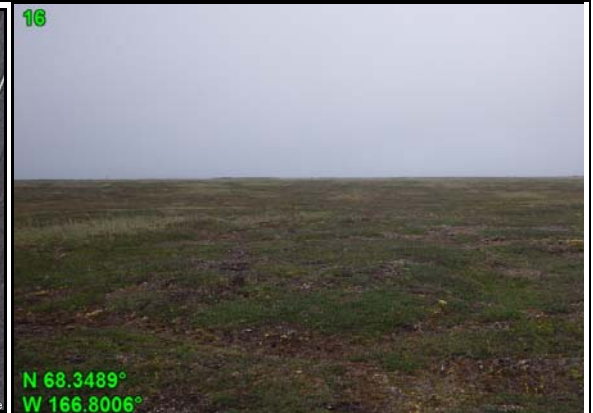
Attributes	
Title	16
Subject	Upland
Comment	Photo Point
Description	Habitat same characteristic as 13. Abundant gravel ground cover, some surface soil cracks. Arctic willow and poppy dominate vegetation.
Latitude	N 68.3489°
Longitude	W 166.8006°
Photo Direction	24° NE
Date Time Stamp	7/15/2014 3:31:11 PM

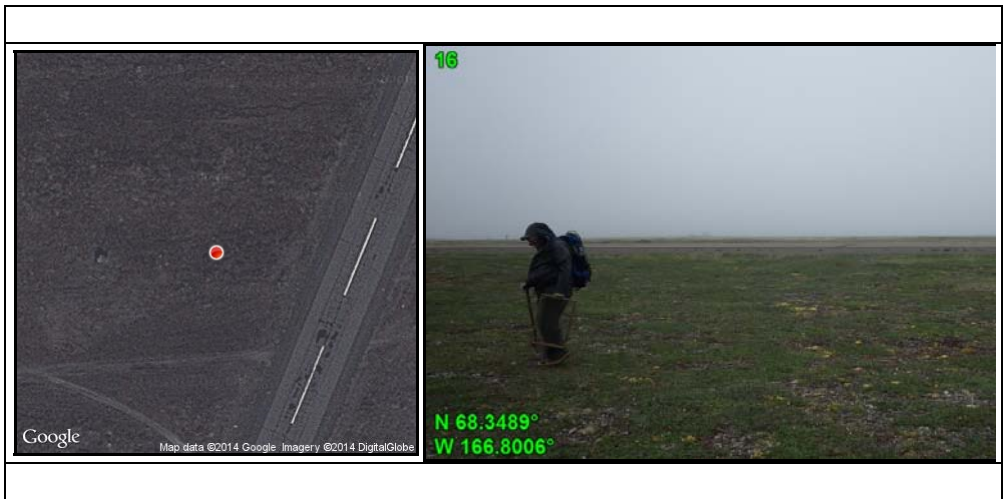
Attributes	
Title	16
Subject	Upland
Comment	Photo Point
Description	Habitat same characteristic as 13. Abundant gravel ground cover, some surface soil cracks. Arctic willow and poppy dominate vegetation.
Latitude	N 68.3489°
Longitude	W 166.8006°
Photo Direction	61° NE
Date Time Stamp	7/15/2014 3:31:15 PM

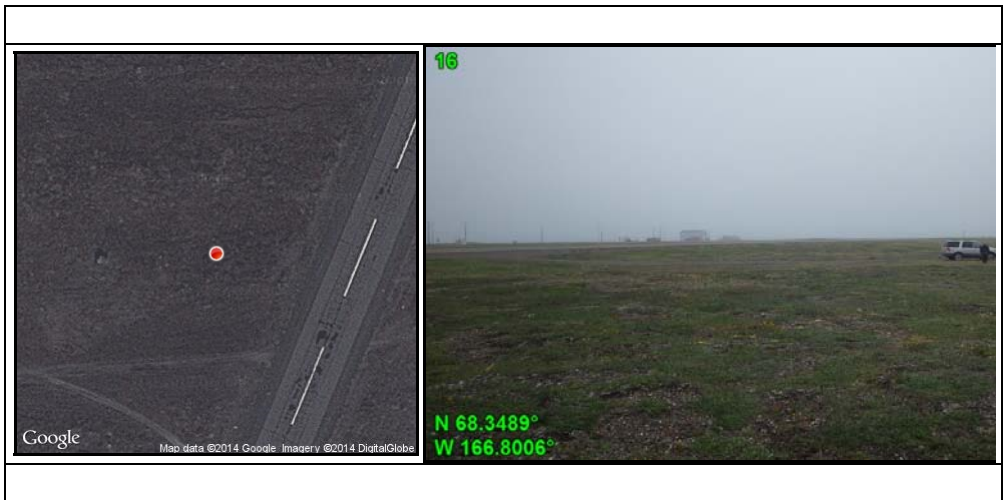
Attributes	
Title	16
Subject	Upland
Comment	Photo Point
Description	Habitat same characteristic as 13. Abundant gravel ground cover, some surface soil cracks. Arctic willow and poppy dominate vegetation.
Latitude	N 68.3489°
Longitude	W 166.8006°
Photo Direction	146° SE
Date Time Stamp	7/15/2014 3:31:22 PM

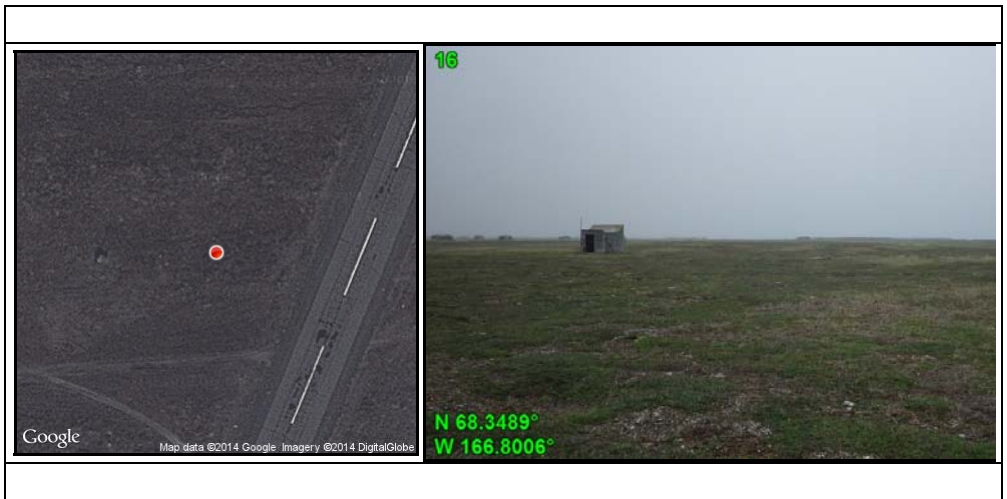
Attributes	
Title	16
Subject	Upland
Comment	Photo Point
Description	Habitat same characteristic as 13. Abundant gravel ground cover, some surface soil cracks. Arctic willow and poppy dominate vegetation.
Latitude	N 68.3489°
Longitude	W 166.8006°
Photo Direction	324° NW
Date Time Stamp	7/15/2014 3:31:26 PM

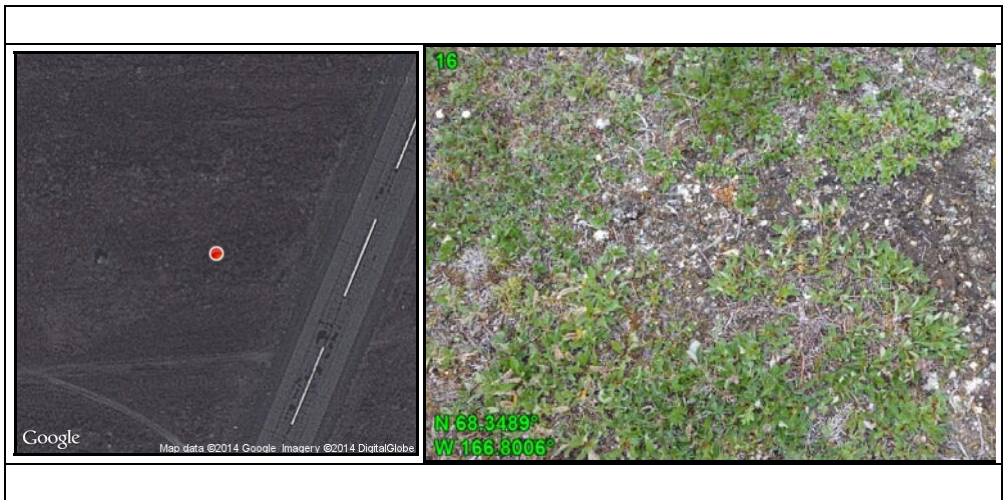
Attributes	
Title	16
Subject	Upland
Comment	Photo Point
Description	Habitat same characteristic as 13. Abundant gravel ground cover, some surface soil cracks. Arctic willow and poppy dominate vegetation.
Latitude	N 68.3489°
Longitude	W 166.8006°
Photo Direction	85° E
Date Time Stamp	7/15/2014 3:31:38 PM

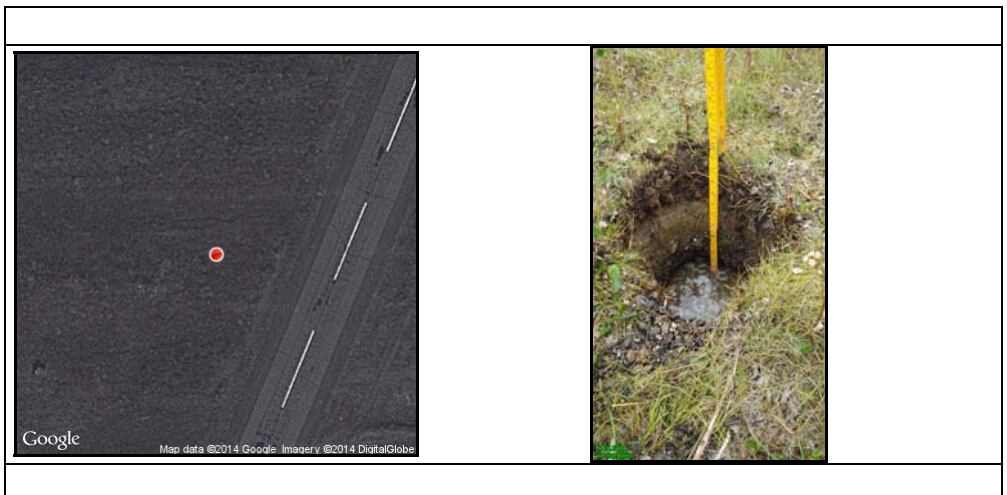
Attributes	
Title	17
Subject	Upland
Comment	Test Plot
Description	Dry sandy/gravelly soils.
Latitude	N 68.3494°
Longitude	W 166.8000°
Photo Direction	15° N
Date Time Stamp	7/15/2014 3:46:07 PM

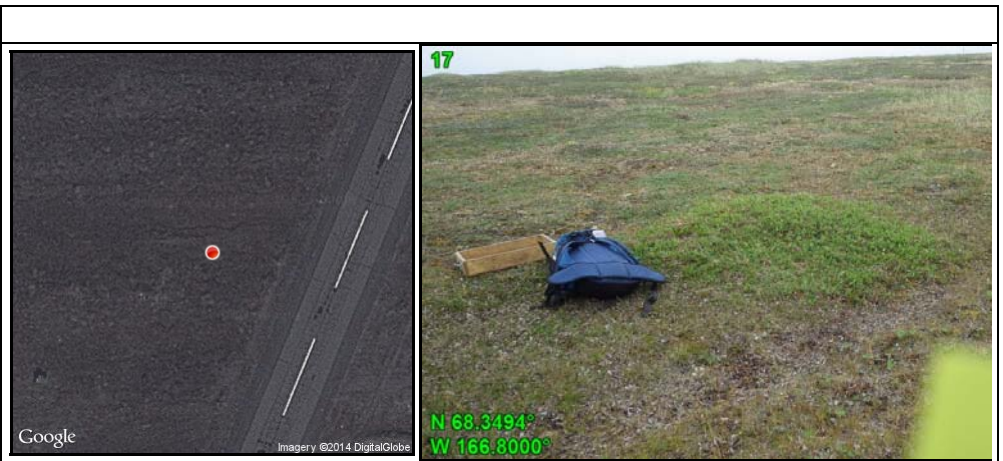
Attributes	
Title	17
Subject	Upland
Comment	Test Plot
Description	Upland coastal plain area on the raised area of a beach dune.
Latitude	N 68.3494°
Longitude	W 166.8000°
Photo Direction	23° NE
Date Time Stamp	7/15/2014 3:47:03 PM

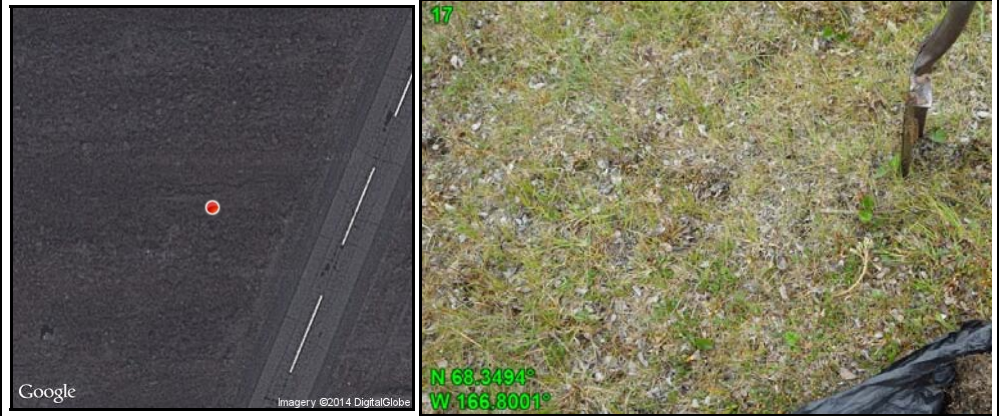
Attributes	
Title	17
Subject	Upland
Comment	Test Plot
Description	Upland coastal plain area on the raised area of a beach dune.
Latitude	N 68.3494°
Longitude	W 166.8001°
Photo Direction	21° N
Date Time Stamp	7/15/2014 3:47:42 PM

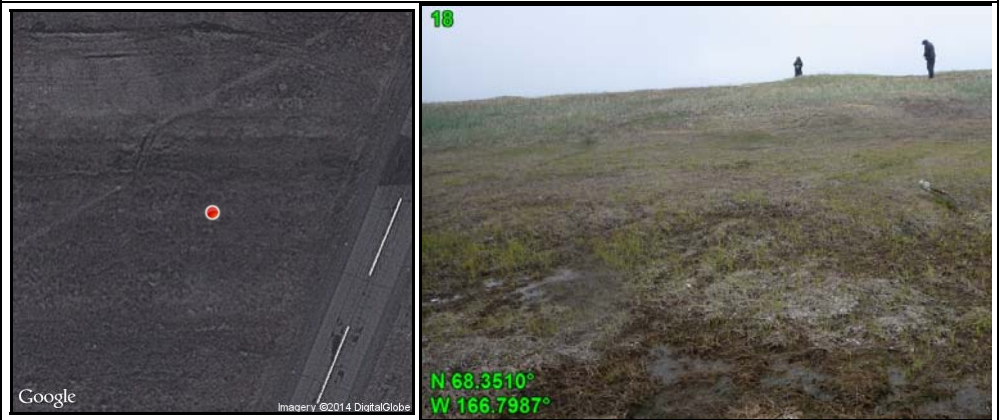
Attributes	
Title	18
Subject	Wetland (PEM1B)
Comment	Photo Point
Description	Wetland connected to 6 under runway. Linear depression with visible standing algal mat/crust. Sedges and grasses dominate vegetation.
Latitude	N 68.3510°
Longitude	W 166.7987°
Photo Direction	350° N
Date Time Stamp	7/15/2014 4:03:46 PM

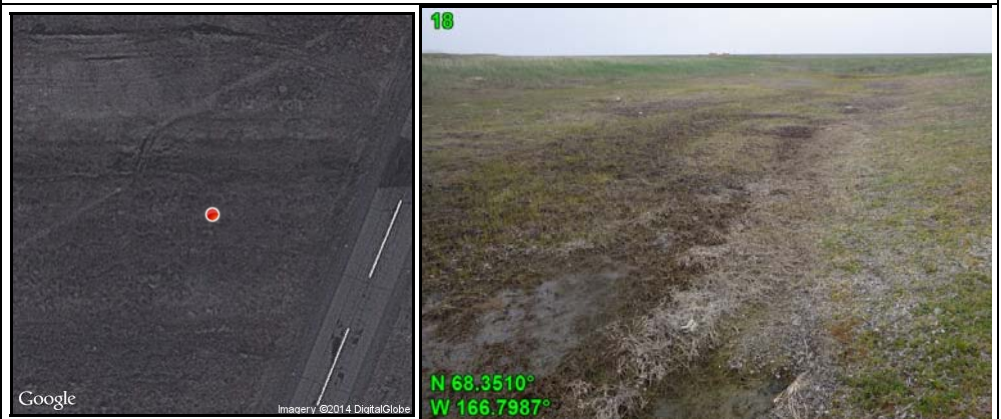
Attributes	
Title	18
Subject	Wetland (PEM1B)
Comment	Photo Point
Description	Wetland connected to 6 under runway. Linear depression with visible standing algal mat/crust. Sedges and grasses dominate vegetation.
Latitude	N 68.3510°
Longitude	W 166.7987°
Photo Direction	35° NE
Date Time Stamp	7/15/2014 4:03:54 PM

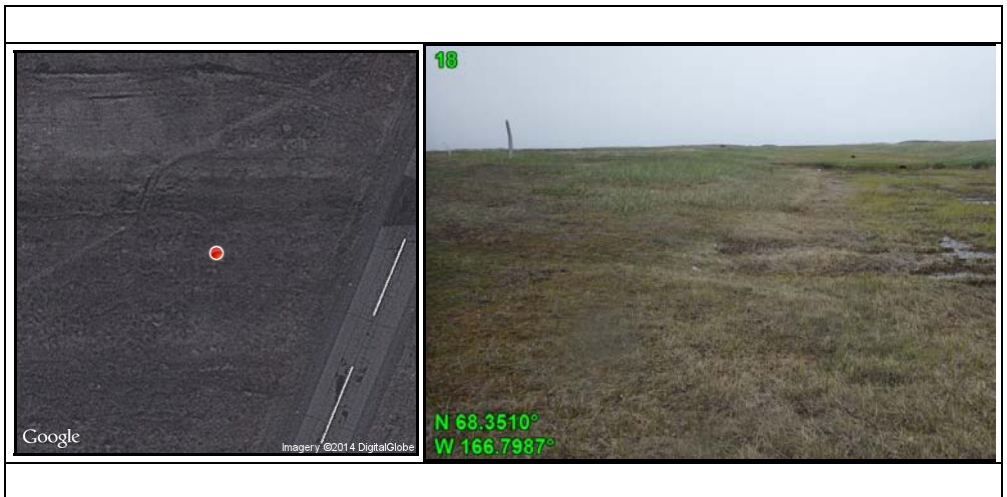
Attributes	
Title	18
Subject	Wetland (PEM1B)
Comment	Photo Point
Description	Wetland connected to 6 under runway. Linear depression with visible standing algal mat/crust. Sedges and grasses dominate vegetation.
Latitude	N 68.3510°
Longitude	W 166.7987°
Photo Direction	290° W
Date Time Stamp	7/15/2014 4:04:05 PM

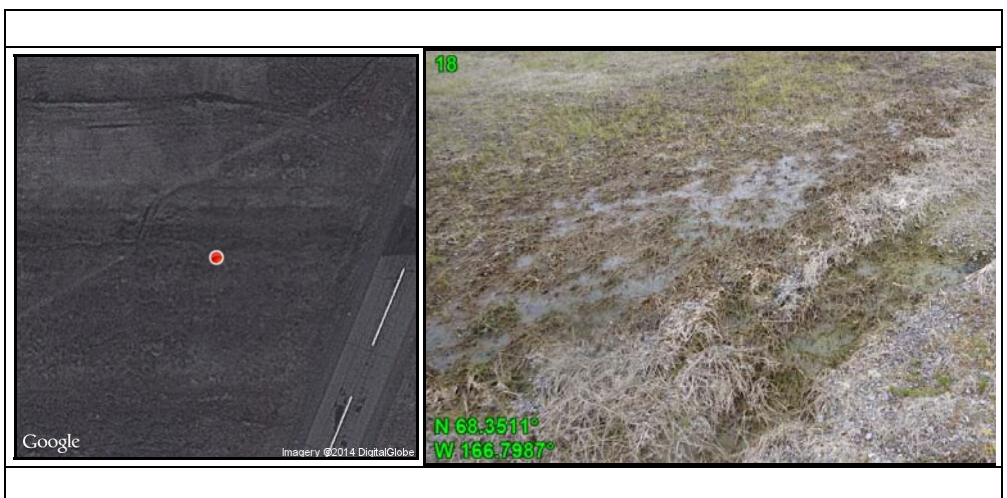
Attributes	
Title	18
Subject	Wetland (PEM1B)
Comment	Photo Point
Description	Wetland connected to 6 under runway. Linear depression with visible standing algal mat/crust. Sedges and grasses dominate vegetation.
Latitude	N 68.3511°
Longitude	W 166.7987°
Photo Direction	39° NE
Date Time Stamp	7/15/2014 4:04:12 PM

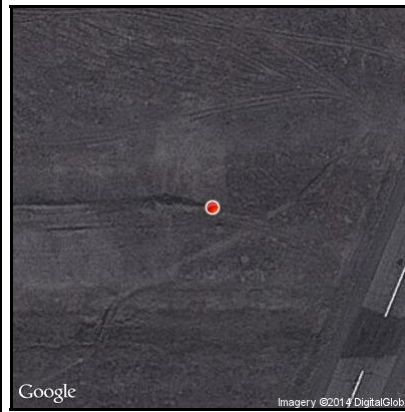
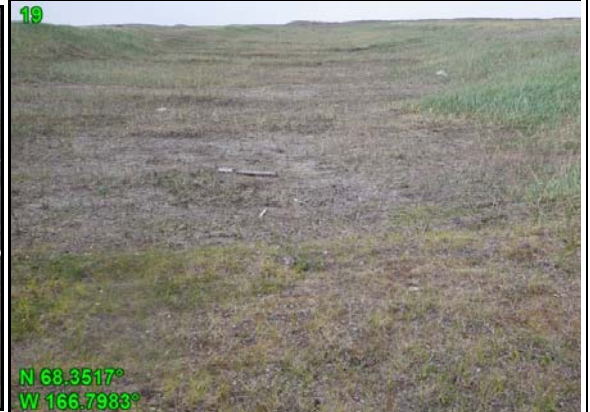
Attributes	
Title	19
Subject	Upland
Comment	Photo Point
Description	Same upland habitat as 11. No wetland indicators present.
Latitude	N 68.3517°
Longitude	W 166.7983°
Photo Direction	313° NW
Date Time Stamp	7/15/2014 4:10:50 PM

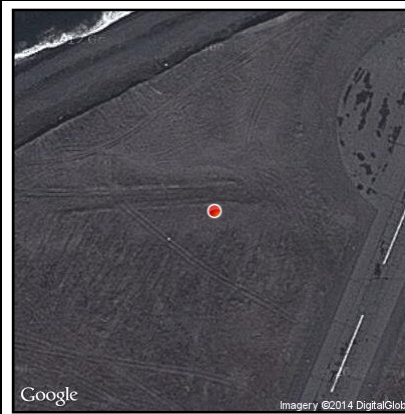
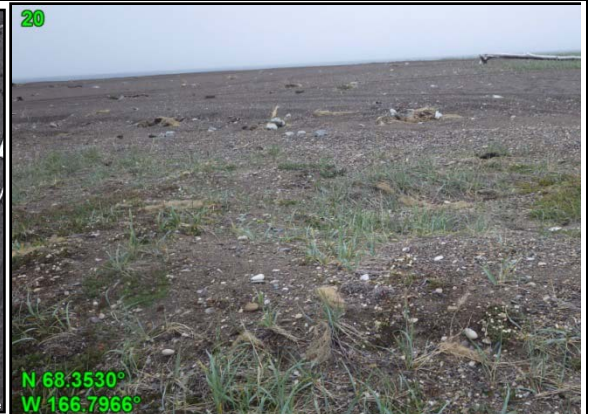
Attributes	
Title	20
Subject	Upland
Comment	Photo Point
Description	Same habitat characteristic as 11. Arctic willow and arctic bluegrass dominate vegetation. Gravel visible surface cover.
Latitude	N 68.3530°
Longitude	W 166.7966°
Photo Direction	337° NW
Date Time Stamp	7/15/2014 4:20:08 PM

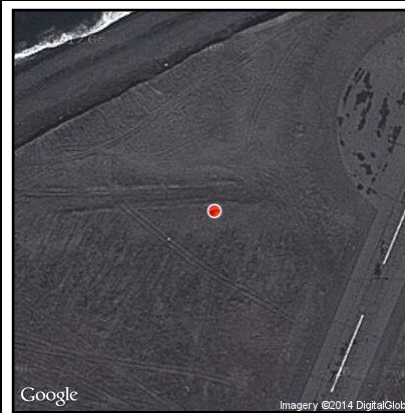
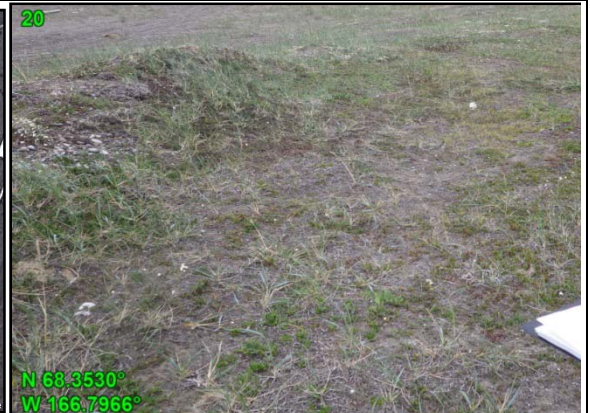
Attributes	
Title	20
Subject	Upland
Comment	Photo Point
Description	Same habitat characteristic as 11. Arctic willow and arctic bluegrass dominate vegetation. Gravel visible surface cover.
Latitude	N 68.3530°
Longitude	W 166.7966°
Photo Direction	42° NE
Date Time Stamp	7/15/2014 4:20:14 PM

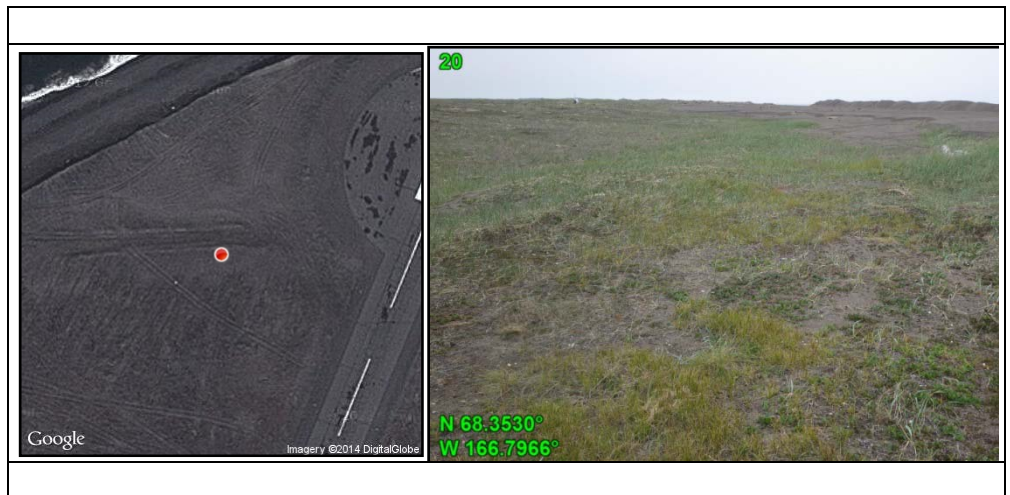
Attributes	
Title	20
Subject	Upland
Comment	Photo Point
Description	Same habitat characteristic as 11. Arctic willow and arctic bluegrass dominate vegetation. Gravel visible surface cover.
Latitude	N 68.3530°
Longitude	W 166.7966°
Photo Direction	281° W
Date Time Stamp	7/15/2014 4:20:23 PM

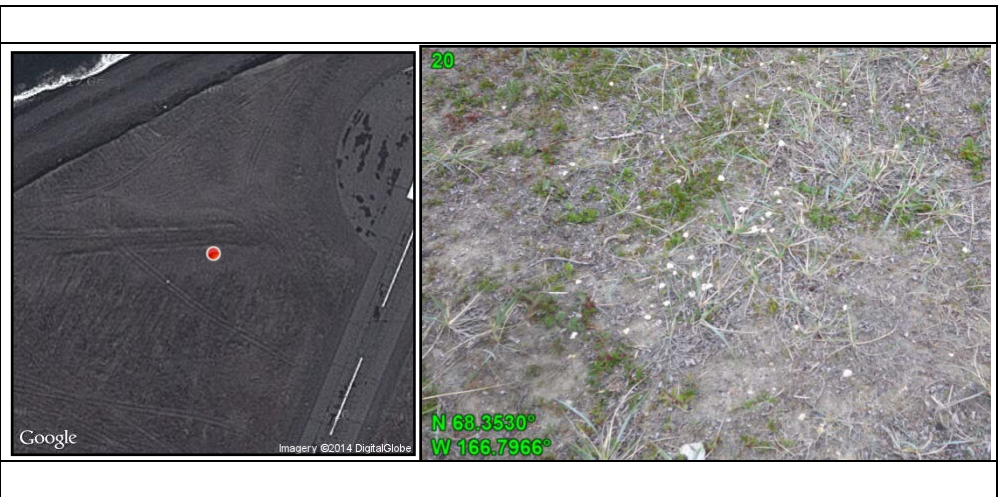
Attributes	
Title	20
Subject	Upland
Comment	Photo Point
Description	Same habitat characteristic as 11. Arctic willow and arctic bluegrass dominate vegetation. Gravel visible surface cover.
Latitude	N 68.3530°
Longitude	W 166.7966°
Photo Direction	54° NE
Date Time Stamp	7/15/2014 4:20:34 PM
