**Project Name:** *Ekwok Airport Rehabilitation*

# EKWOK AIRPORT REHABILITATION

ADOT&PF Project No. 55377

## *Wetlands Delineation Report*

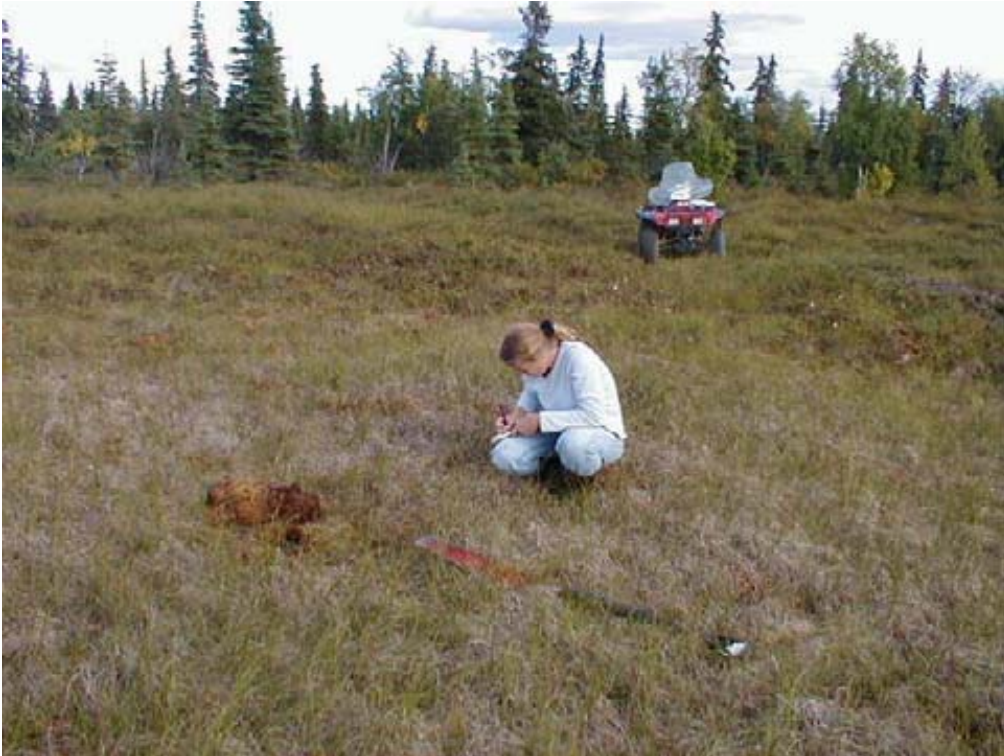
Sample Point W-1

Two of the sample points were determined to be situated in wetlands (W-1 and W-2). W-1 is a large wetland (greater than 30 acres) on the northern edge of the airport property. W-2 is a small wetland (approximately 1.4 acres) adjacent to the airstrip that was not clearly evident on the aerial photography because of a line created by airport tree-clearing activities, but was identified during the ground-truthing survey. Based on the Cowardin et al. (1979) wetland classification system, W-1 is a palustrine, semipermanently flooded, moss-dominated, persistent emergent marsh transitioning into a broad-leaved deciduous shrub marsh. W-2 is a palustrine, saturated, broad-leaved deciduous shrub bog. The dominant vegetation at sample point W-1 included Scheuchzer's cottongrass (*Eriophorum Scheuchzeri*), dwarf arctic birch, and bog cranberry (*Oxycoccus microcarpus*). The dominant vegetation at sample point W-2 included black spruce, dwarf arctic birch, diamondleaf willow (*Salix planifolia*), bog blueberry, Labrador-tea (*Ledum palustre*), and crowberry (Tables 1 and 2). Wetland delineation data sheets completed during the survey are included in Appendix 1. Appendix 2 contains survey photographs.

Hydrology at W-1 ranged from inundated (term flooded used in Cowardin et al., 1979) to saturated (Table 1). No hydrology was observed at W-2 during this site visit, but it is likely that the wetland was saturated earlier in the growing season. Soil profiles of W-1 and W-2 were composed of varying degrees of decomposing organic matter in the upper 15 to 16 inches (Table 1).

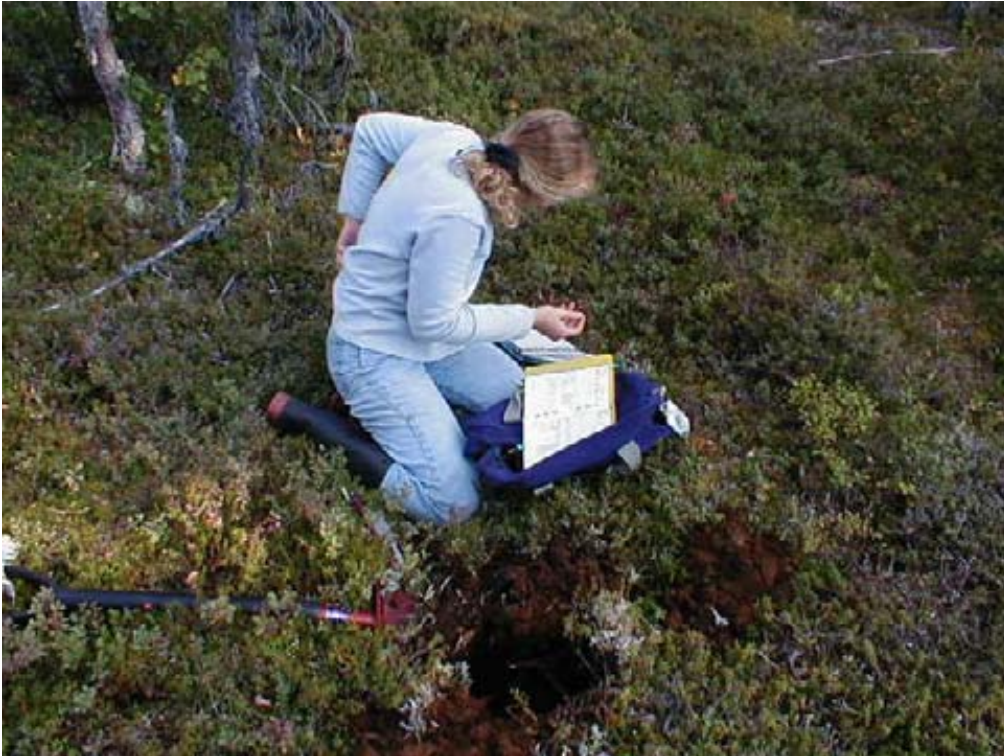
Sample Point U-1

Sample point U-1 was located near the upland boundary of wetland W-1 and was examined as a comparison and to aid in identifying the wetland boundary. Sample point U-2 was located in one of the possible wetland sites identified during the aerial photograph delineation (see Section 4.1).

No hydrologic indicators were observed at U-1 and U-2. Soil profiles of U-1 and U-2 were very similar, with a thin organic layer above friable silt loam soil (Table 1).

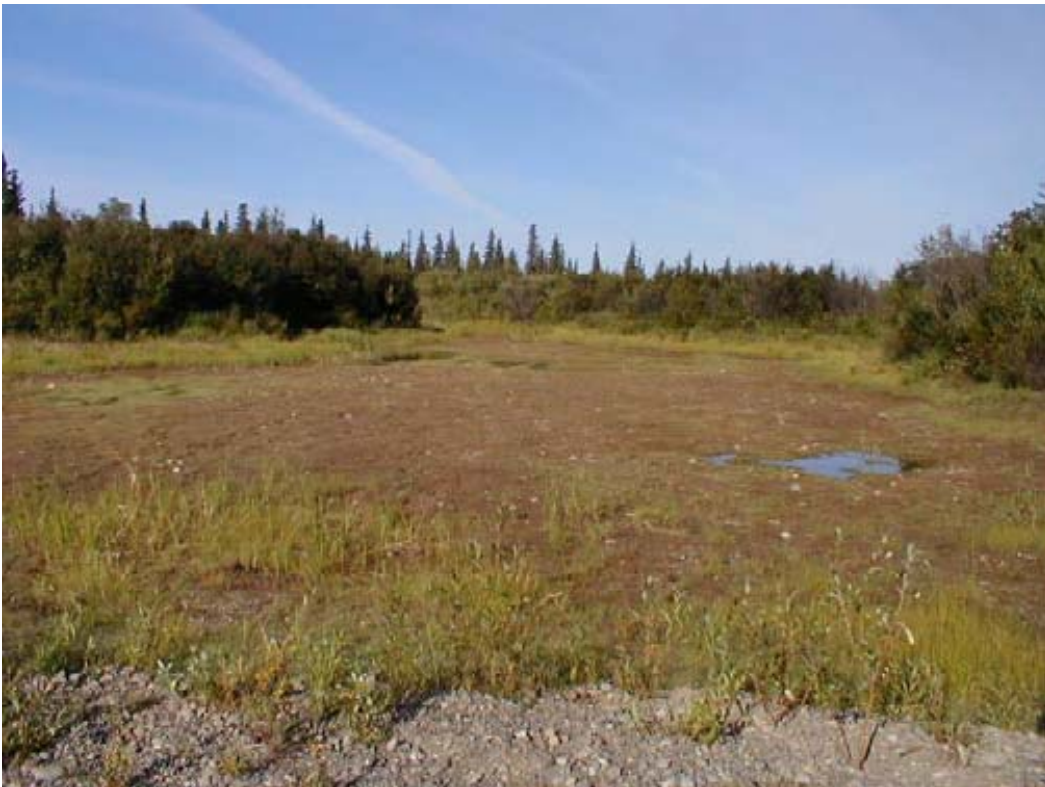
Sample Point G-1, in Gravel Pit

During the survey, wetland vegetation was observed growing in portions of a man-made gravel pit. A representative area was chosen to further examine the vegetation, hydrology, and soils (G-1). Sample point G-1 had hydrophytic plants and wetland hydrology but lacked hydric soils (Table 1). The wet conditions at this site likely developed after the materials were excavated and the ground water table was exposed. This site is an atypical (disturbed) site and would not be considered a jurisdictional wetland by the USACE because it does not have positive wetland indicators for each of the three parameters (vegetation, hydrology, and soil).
