WILDLIFE HAZARD ASSESSMENT

EKWOK AIRPORT REHABILITATION

ADOT&PF Project No. 55377

WILDLIFE SURVEY REPORT

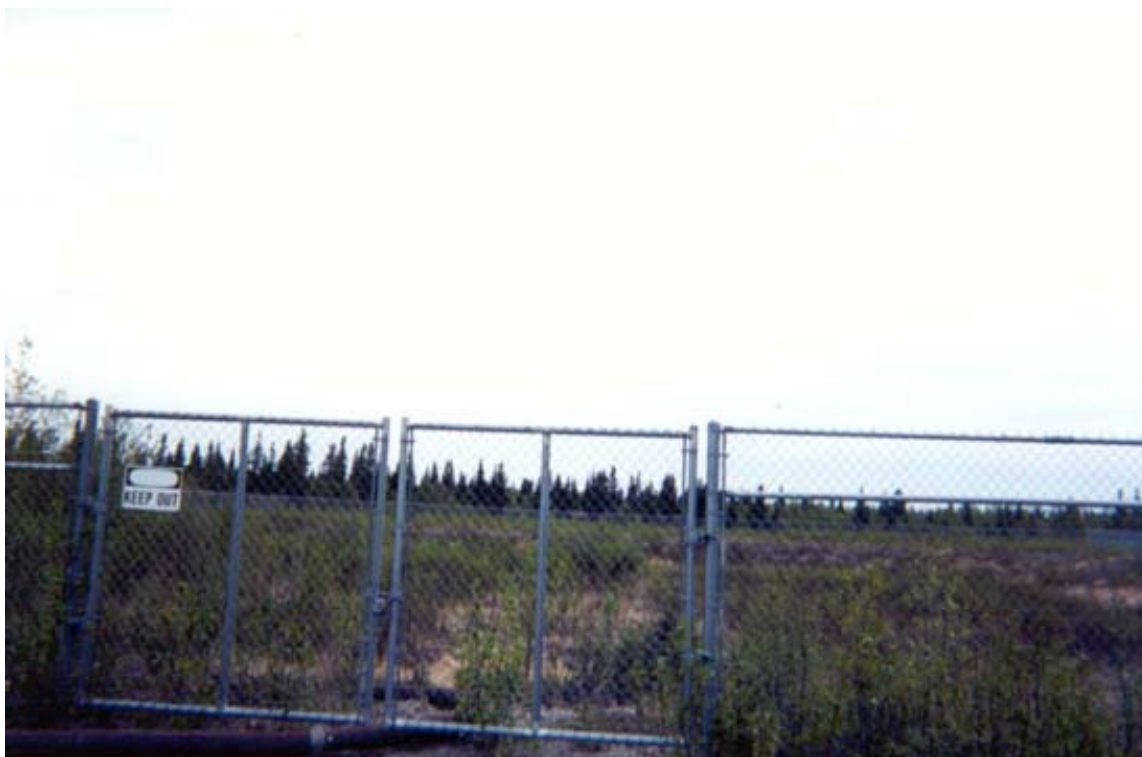
The Ekwok sewage lagoons are located just to the southwest of 5th Street, west of the town (Appendix A). The lagoon area was surrounded by a chain-link fence and little open water was present (approximately a 25-foot by 25-foot pond). Most of the vegetation in the lagoon area consisted of shrub-sized birch (*Betula papyrifera*), alder (*Alnus* sp.), and willow (*Salix* sp.), with bluejoint grass (*Calamagrostis canadensis*) and other herbs scattered throughout. Ravens and gulls did not appear to be using the sewage lagoons for foraging. One common raven (*Corvus corax*) was observed at the area on May 27, 2003 (Table 1), but no other ravens, gulls, or waterfowl were observed in the area during the field survey. Several sparrows and tree swallows (*Tachycineta bicolor*) were observed in the forested areas adjacent to the lagoons.

Sewage Lagoon

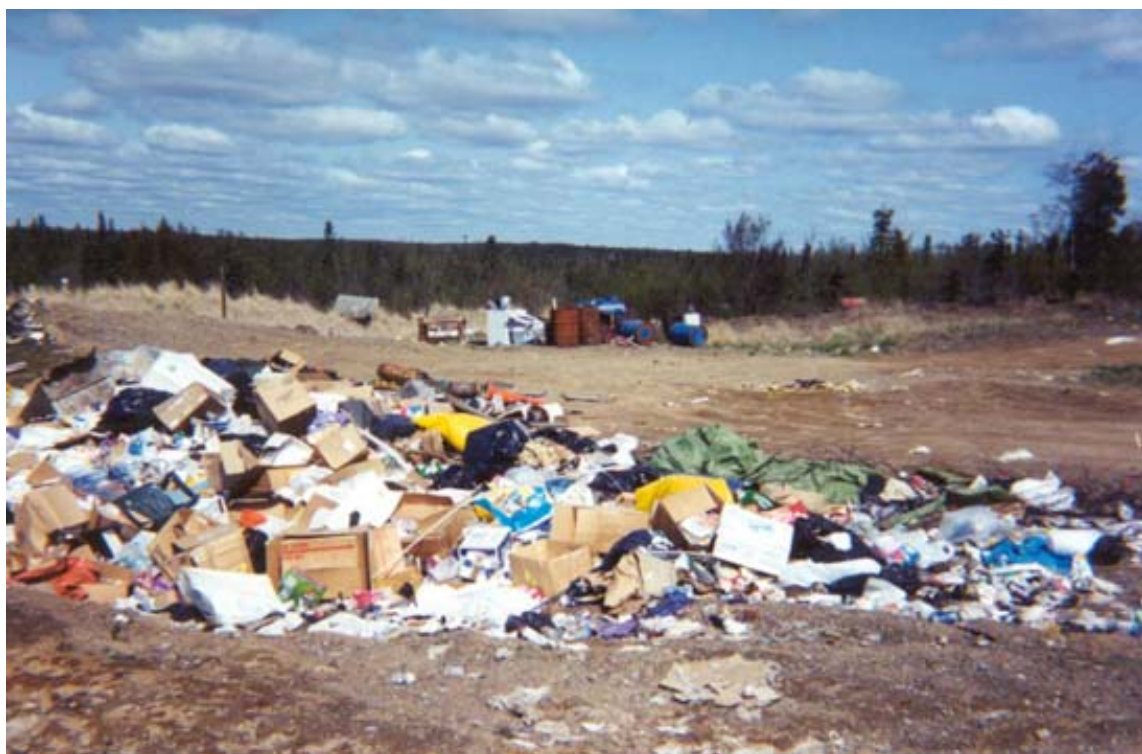
fall when carcasses are present in the landfill. No caribou or moose carcasses were observed in the landfill during the field survey. The landfill consists of a trench that is used for depositing waste materials that are then apparently burned at irregular intervals. Waste in the landfill included cardboard boxes, metal and plastic containers, aluminum cans, plastic bags, asphalt shingles, tar paper, a space heater, wood products, and various other household waste (Appendix A). Several empty 55-gallon drums and old appliances were present at the northeast end. The landfill was very full and trash was spilling out onto the roadway during the site visit. Luki Akelkok said that the landfill was very full because the residents had not been allowed to burn it because of an enforced burn ban. The landfill did not appear to be closely attended or controlled.

Landfill

- *Burn all animal carcasses and food waste frequently*– All animal carcasses and food waste should be burned in either an incinerator or some other safely contained device. This may require the assignment of a local person to supervise the burning, and/or a device constructed in a manner that residents could safely operate themselves. The device should not be accessible to either birds or bears at any time. A safely constructed device or facility may allow waste to be burned even when an open burning ban is in effect, as the fire danger could be adequately neutralized. If waste is to be deposited in an open trench, as is currently being done, it should be covered or buried on a daily basis when burning is not allowed.

- *Consider the installation of a complete perimeter fence around the landfill* – The construction of a complete perimeter fence around the landfill to exclude mammals should be considered. An 8-foot tall chain-link fence with 3-strand barbed wire at the top and a skirt buried at least 3 feet deep to prevent digging, is the recommended structure to prevent mammal access to landfills. It would also be necessary to have a gate through which the public could access the landfill. It would be extremely important to keep this gate securely fastened when the landfill is not in use.

- *Consider the construction of a wire grid or exclusionary netting connected to a perimeter fence* – A wire grid or large netting to exclude birds from accessing the landfill could be attached to the top of a perimeter fence. Grid wires should be spaced only several feet apart, as the target species, ravens and magpies, can easily navigate between even small openings. Such a structure would need to be constructed with possible equipment operation in mind.

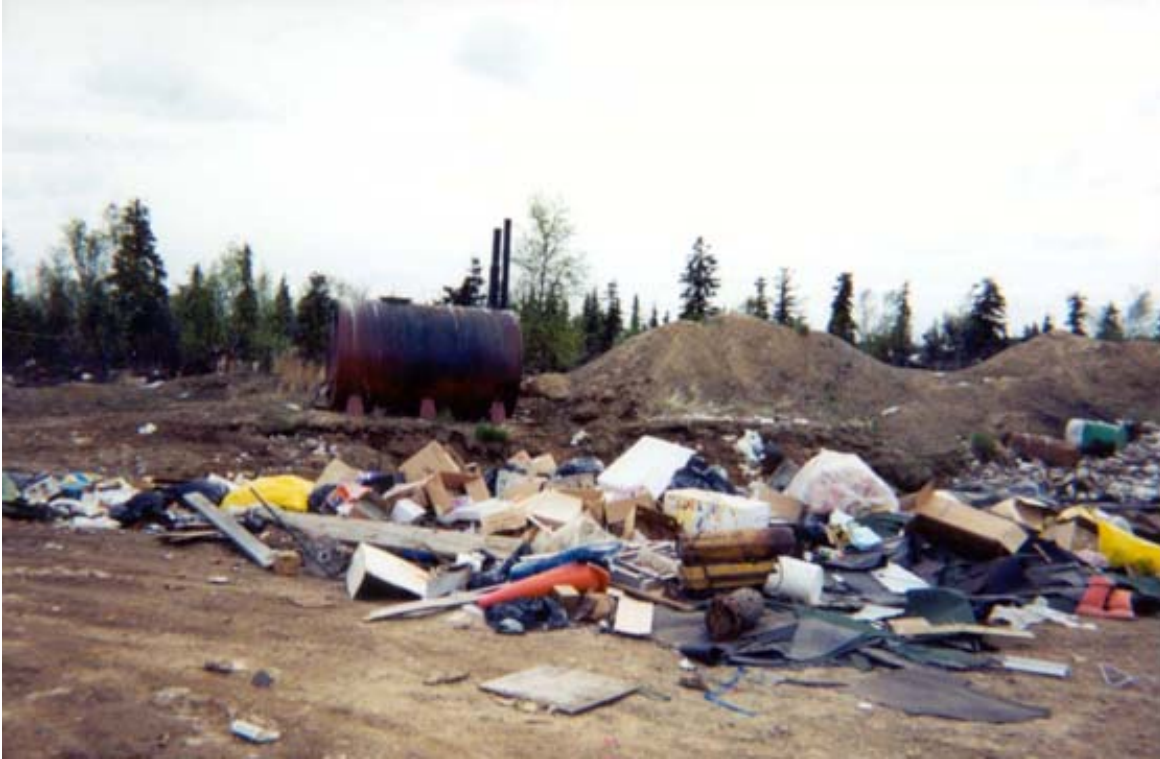
Landfill

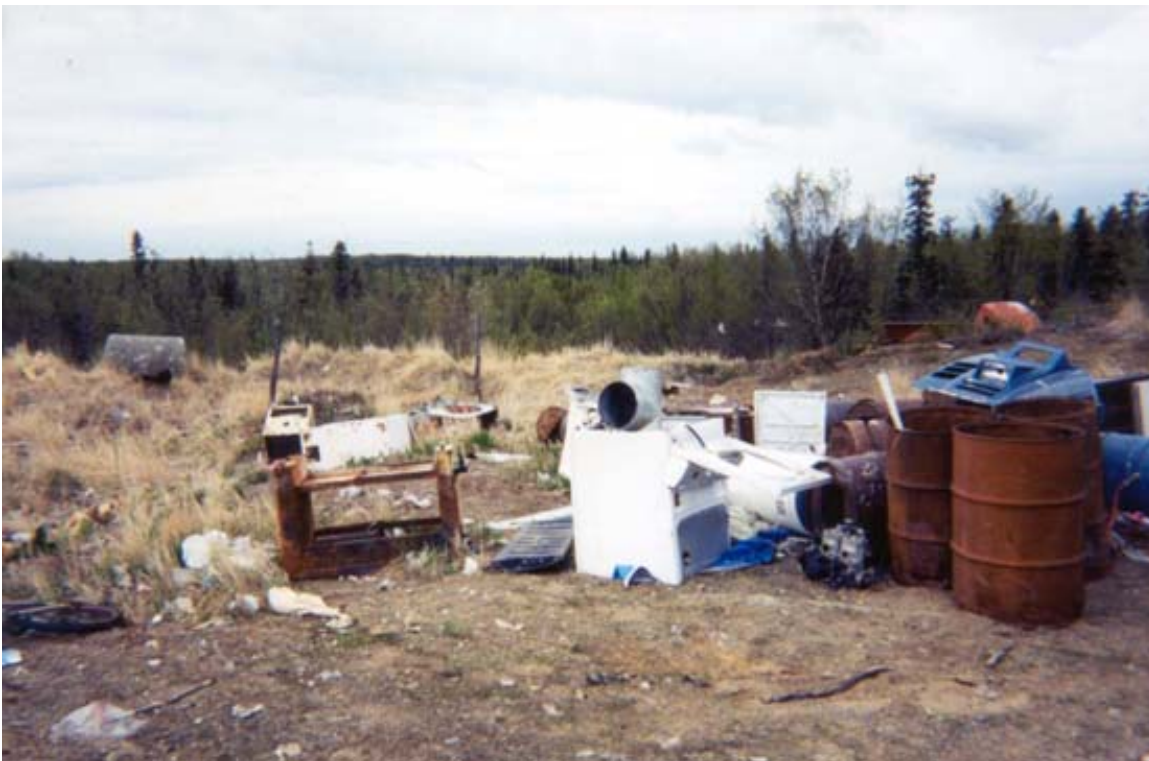
The area around the landfill was examined on May 27, 2003. No bear scat or obvious trails were observed. The area was obviously disturbed by trash blown into the vegetation and all-terrain vehicle (ATV) use. Tree cover consisted of shrubby (less than 20-foot-tall) black spruce (*Picea mariana*) and birch, with scattered willows. Ground cover was dominated by crowberry (*Empetrum nigrum*) and Labrador tea (*Ledum palustre*), with scattered low-bush cranberry (*Vaccinium vitis-idaea*). Interviews with local residents indicated that some bears are seen at the landfill in the fall when caribou carcasses are present, but they are rarely seen otherwise (Appendix B). Many of the birch trees in the area were broken off, indicating browsing by moose in the winter or possible damage from snowmobiles.

Landfill - northeast end

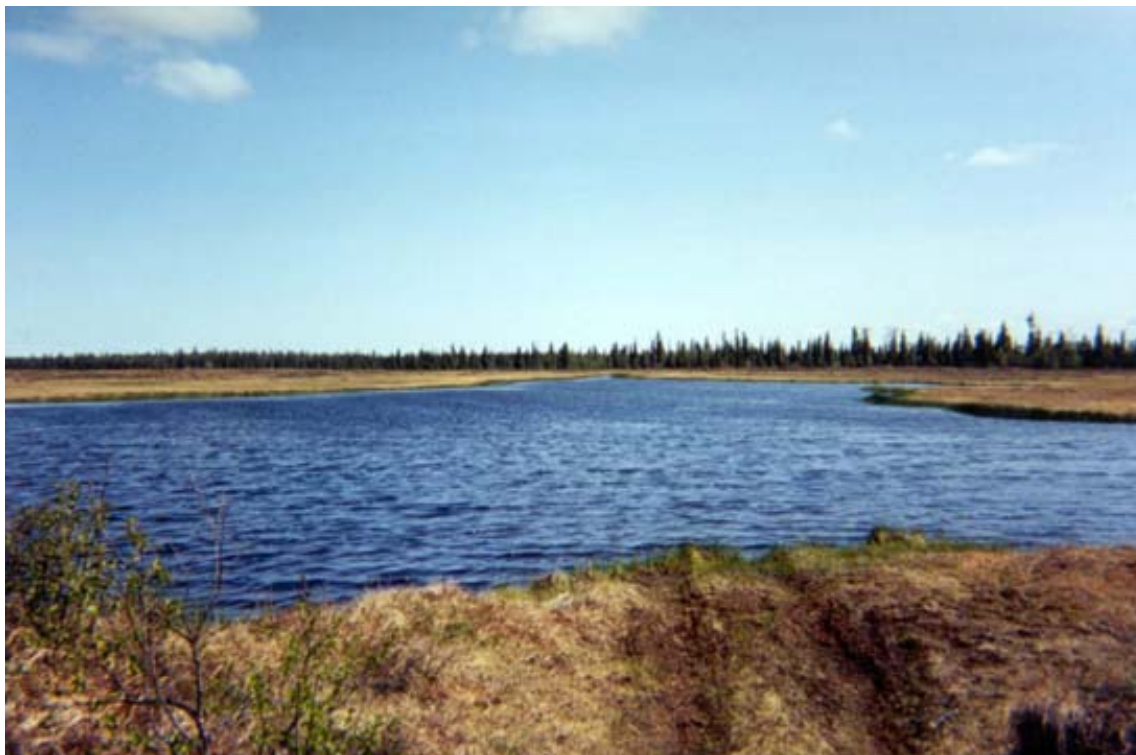
No birds were observed at the pond northeast of the existing runway (Figure 2; Table 3; Appendix A). It appeared that the pond could potentially provide waterfowl habitat, but no waterfowl, ravens, or gulls were observed in the area.

Pond northeast of runway

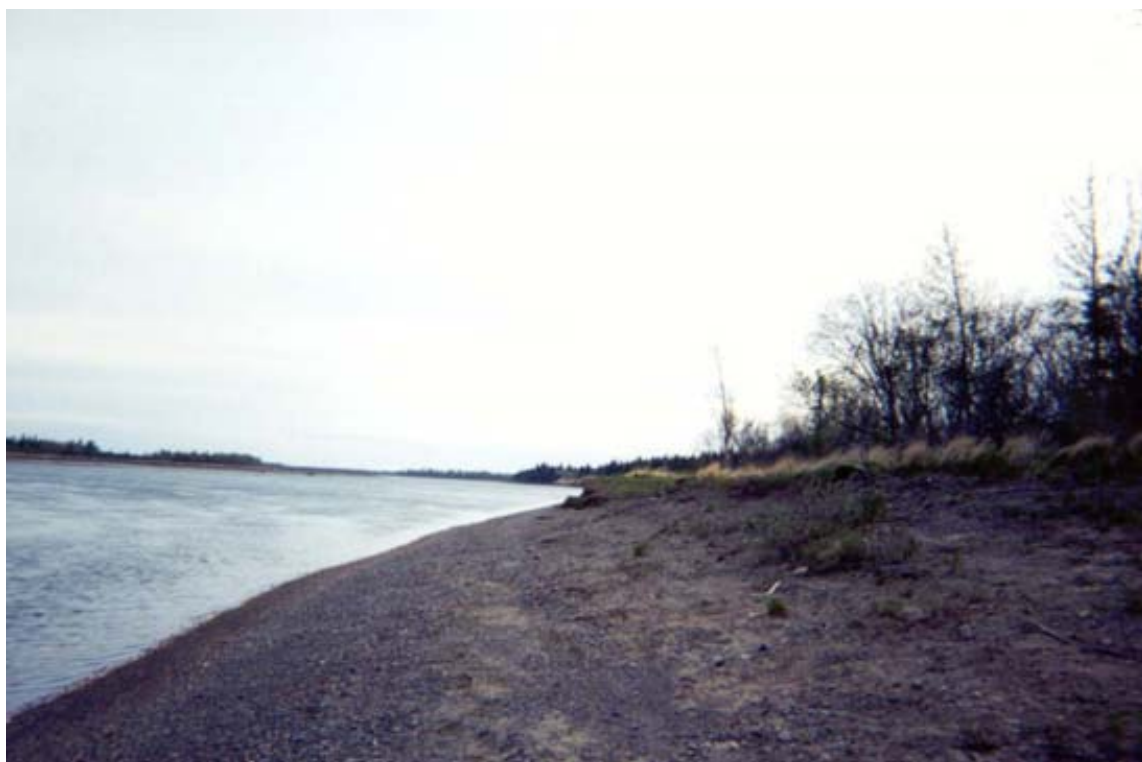
Water levels were low enough that the observer was able to reach the large island in the Nushagak River southeast of the existing airport runway by foot (Figure 2; Appendix A). On May 27, 2003, the observer walked around the perimeter of the island to observe any nesting birds. No nesting gulls or waterfowl were seen. Bald eagles (*Haliaeetus leucocephalus*) and gulls were seen flying up and down the river corridor, and various shorebirds were observed in the shallow water areas. The island was again visited on May 30, 2003, and the same observations were noted as on May 27.

Nushagak River
