# **GEOTECHNICAL DATA REPORT**

## **STERLING HIGHWAY MP 45-60 SUNRISE TO SKILAK LAKE RD - PHASE 1B (MP 45-46.5)**

FEDERAL NO. 0212015/STATE NO. Z530140000

**30 APRIL 2020**

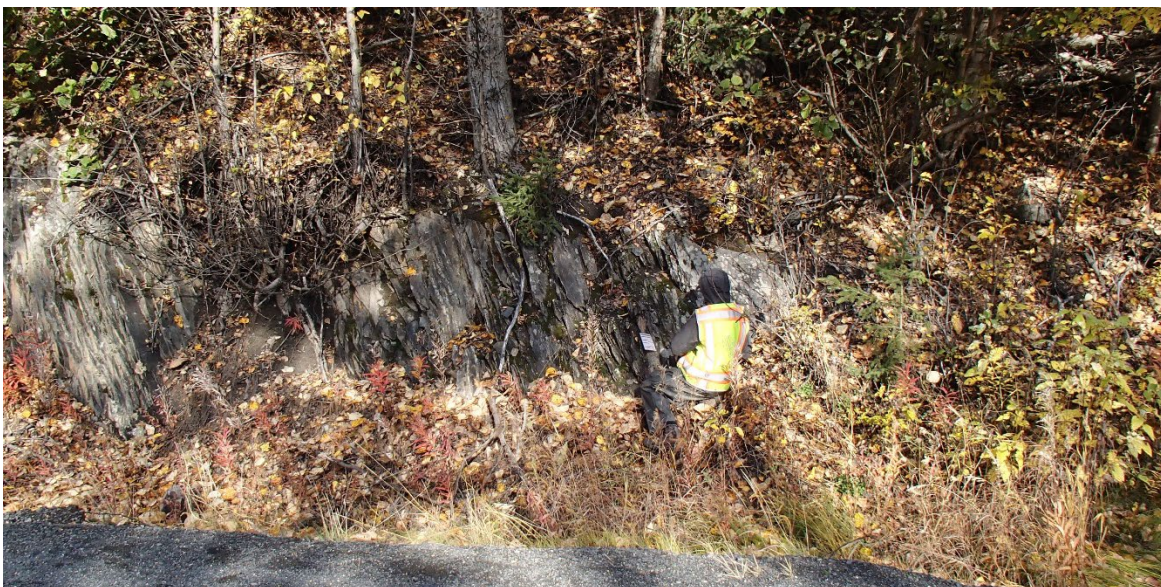
**FIGURE 3-1: ROCK OUTCROP NEAR STATION 2043+00**

Bedrock was observed exposed in existing cut sections adjacent to the highway around Station 2037+50 and Station 2043+00, and bedrock was encountered in test borings at depths ranging from around 2 feet to greater than 21.5 feet below ground surface. Generally, the deeper soil deposits were primarily composed of roadway embankment fill materials. Bedrock exposed in cuts was interpreted to consist of fine-grained graywacke and shale, consistent with the rock of the Valdez Group (Figure 3-1).

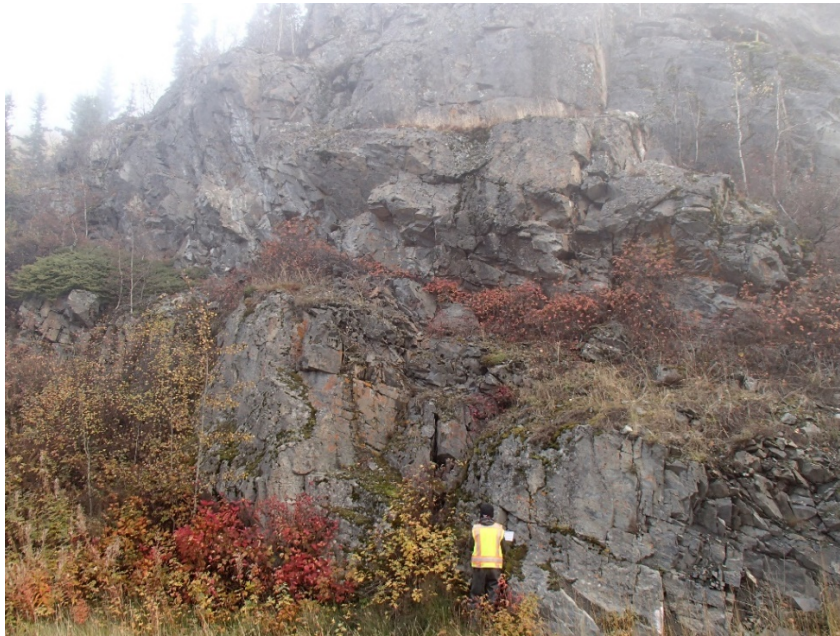
**FIGURE 3-2: ROCK OUTCROP NEAR STATION 2068+00**

Bedrock was observed exposed in existing cut sections around Stations 2055+50 to 2058+00, Stations 2059+50 to 2061+50, Stations 2067+50 to 2071+50, and Stations 2072+50 to 2074+00. Additionally, a natural bedrock outcrop was observed adjacent to the alignment left of Stations 2063+00 to 2063+50. Bedrock was encountered in test borings at depths ranging from around 3 feet to greater than 22 feet below ground surface. Bedrock exposed in cuts was interpreted to consist of siltstone, fine-grained graywacke, and shale, consistent with the rock of the Valdez Group (**Figure 3-2**).

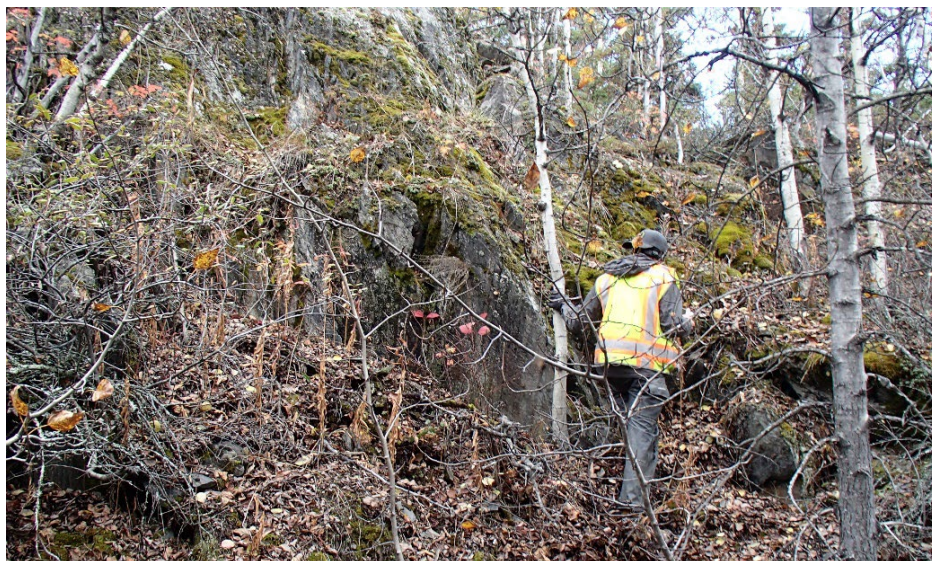
**FIGURE 3-3: ROCK OUTCROP NEAR STATION 2083+50**

Coarse-grained colluvial soils with frequent cobbles and boulders were encountered at test borings drilled in this interval, and bedrock was encountered at depths ranging between 2 and 5 feet below the ground surface. Bedrock exposed in cuts was interpreted to consist of lightly metamorphosed siltstone and sandstone, and shale, consistent with the rock of the Valdez Group (Figure 3-3).

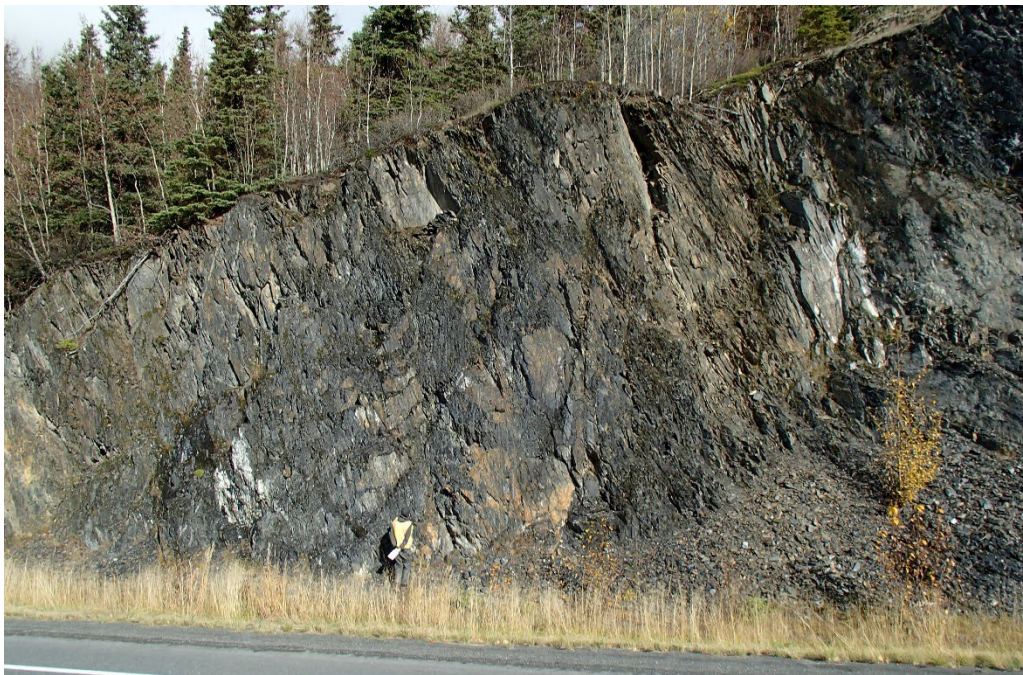
**FIGURE 3-4: ROCK OUTCROP RIGHT OF STATION 2086+00**

Coarse-grained colluvial deposits with frequent cobbles and boulders were encountered at test borings drilled in this interval, and bedrock was encountered at depths of zero to eight feet below the ground surface. Bedrock exposed in cuts near this alignment was interpreted to consist of primarily slate consistent with the rock of the Valdez Group (Figure 3-4).
