WHITTIER TUNNEL ROCK MITIGATION RESPONSE & USE OF GLOBAL MAPPER TO VIEW LIDAR

CRAIG BOECKMAN
REGIONAL GEOLOGIST
CENTRAL REGION MATERIALS

Whittier Tunnel Rock Wall Stabilization October/November 2016

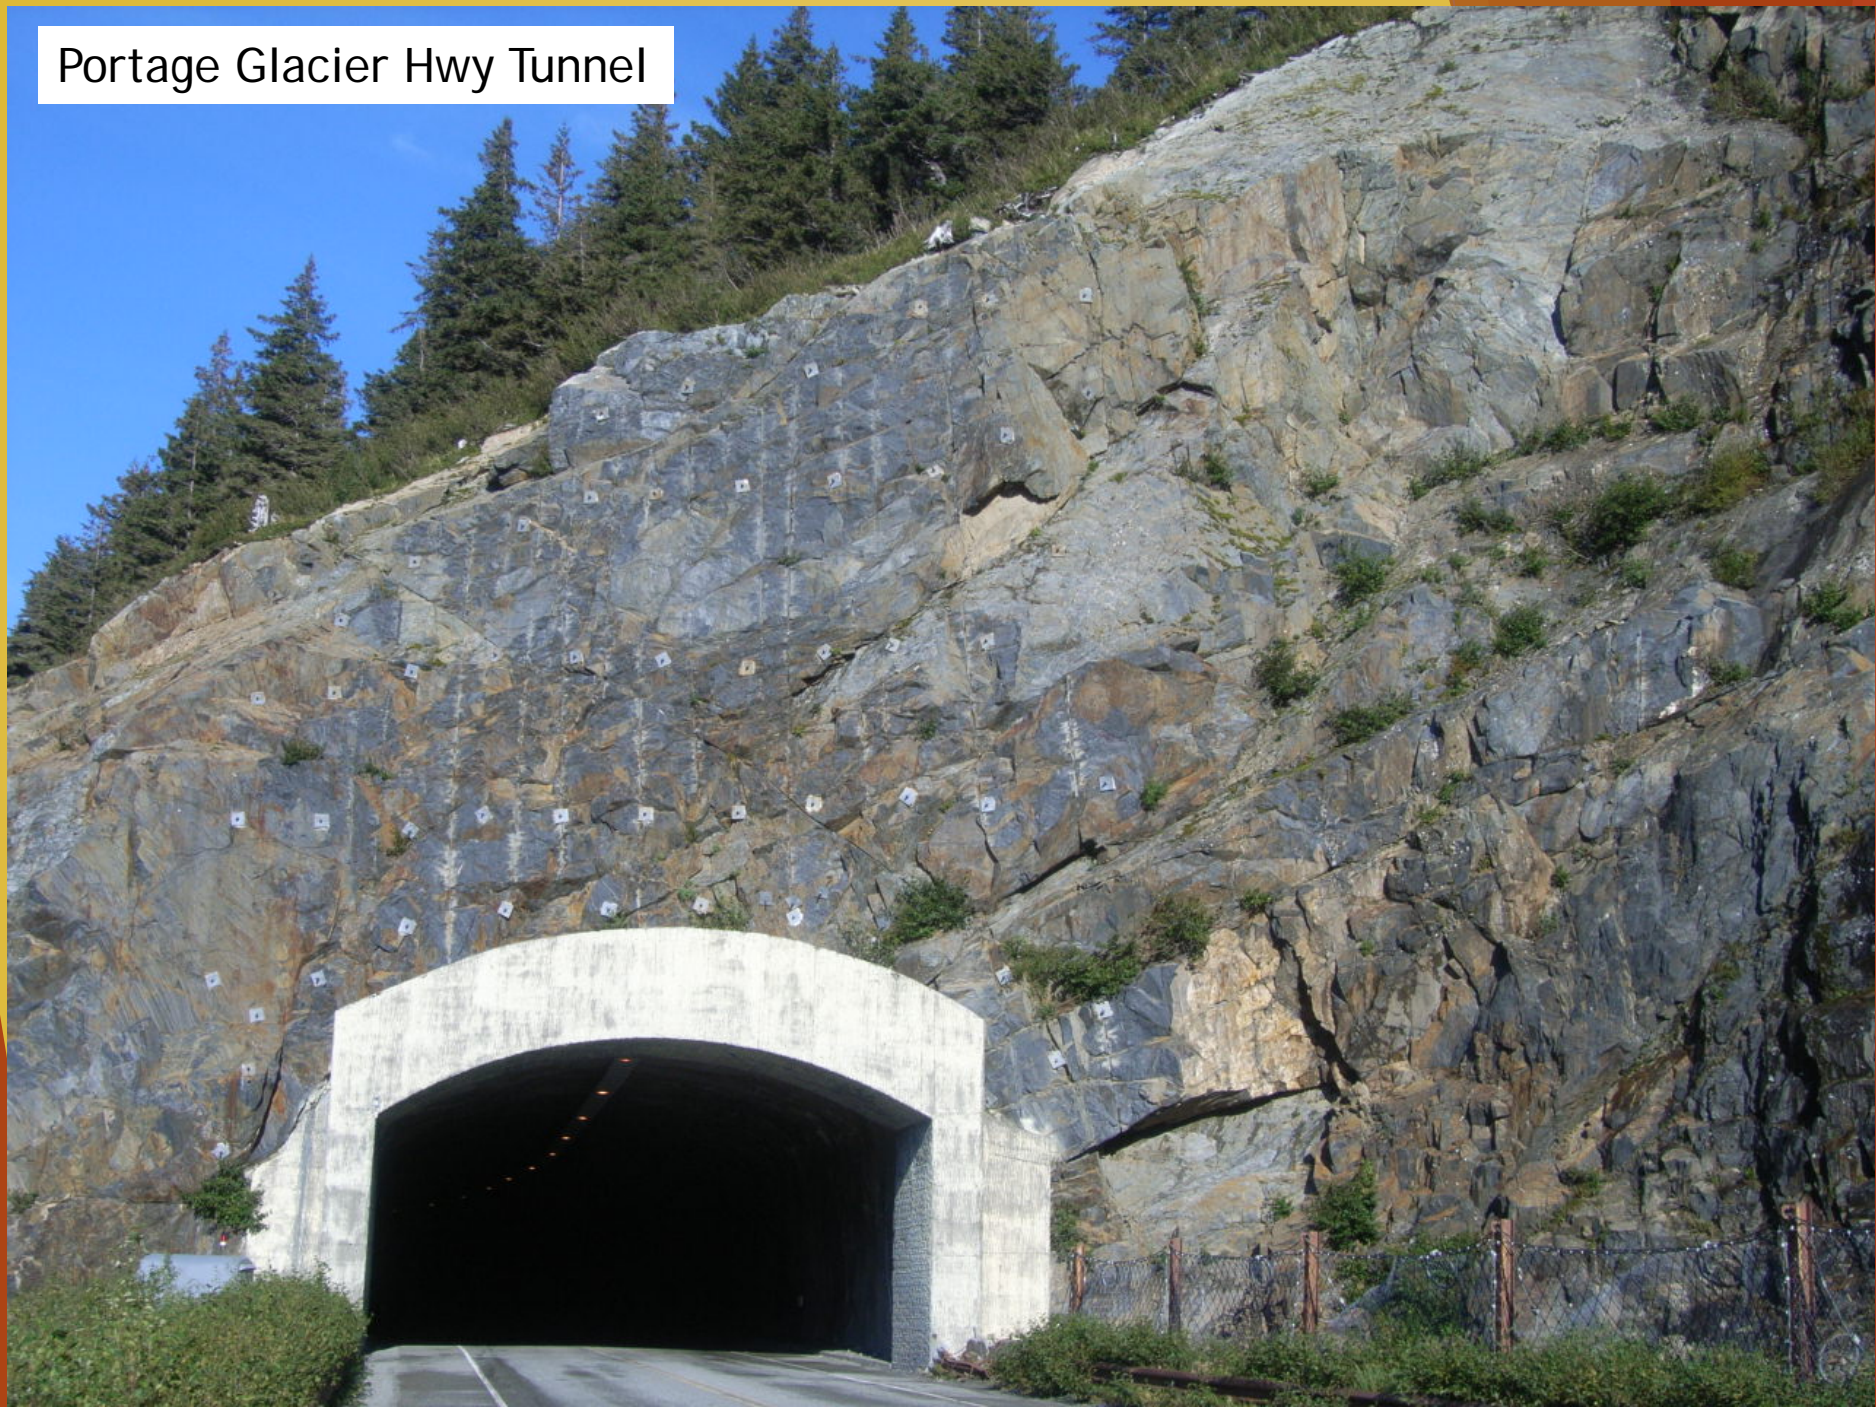
East Portal of Access Road Tunnel - north of Portage Lake.

Undated Photo.

Shows blocks (yellow highlighted area) that have fallen since this image was taken. Based on comparison to an August 2014 Photo of the same area.

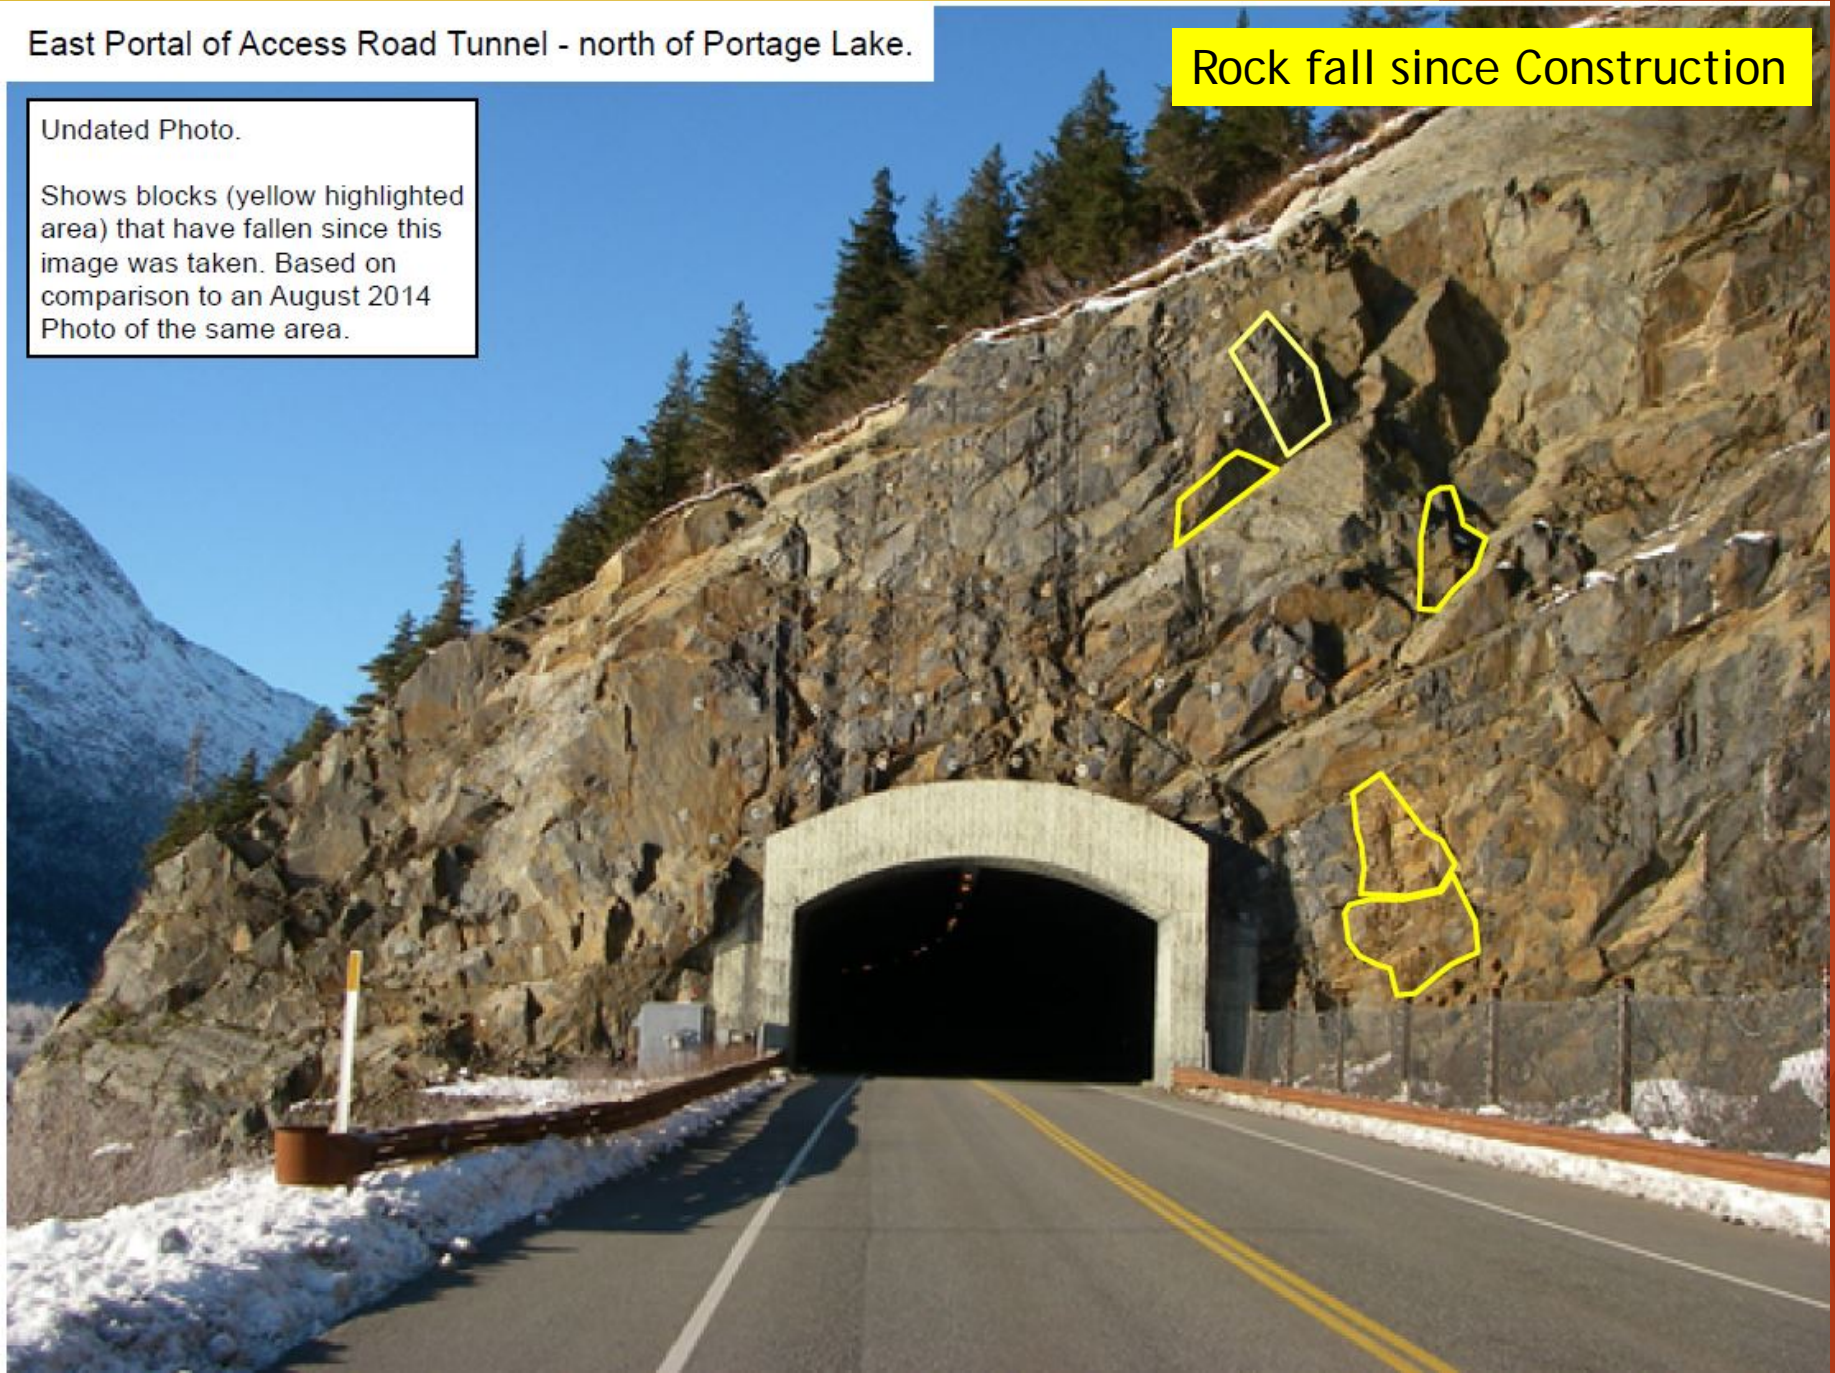
Rock fall since Construction

Rock fall from behind a rock bolt

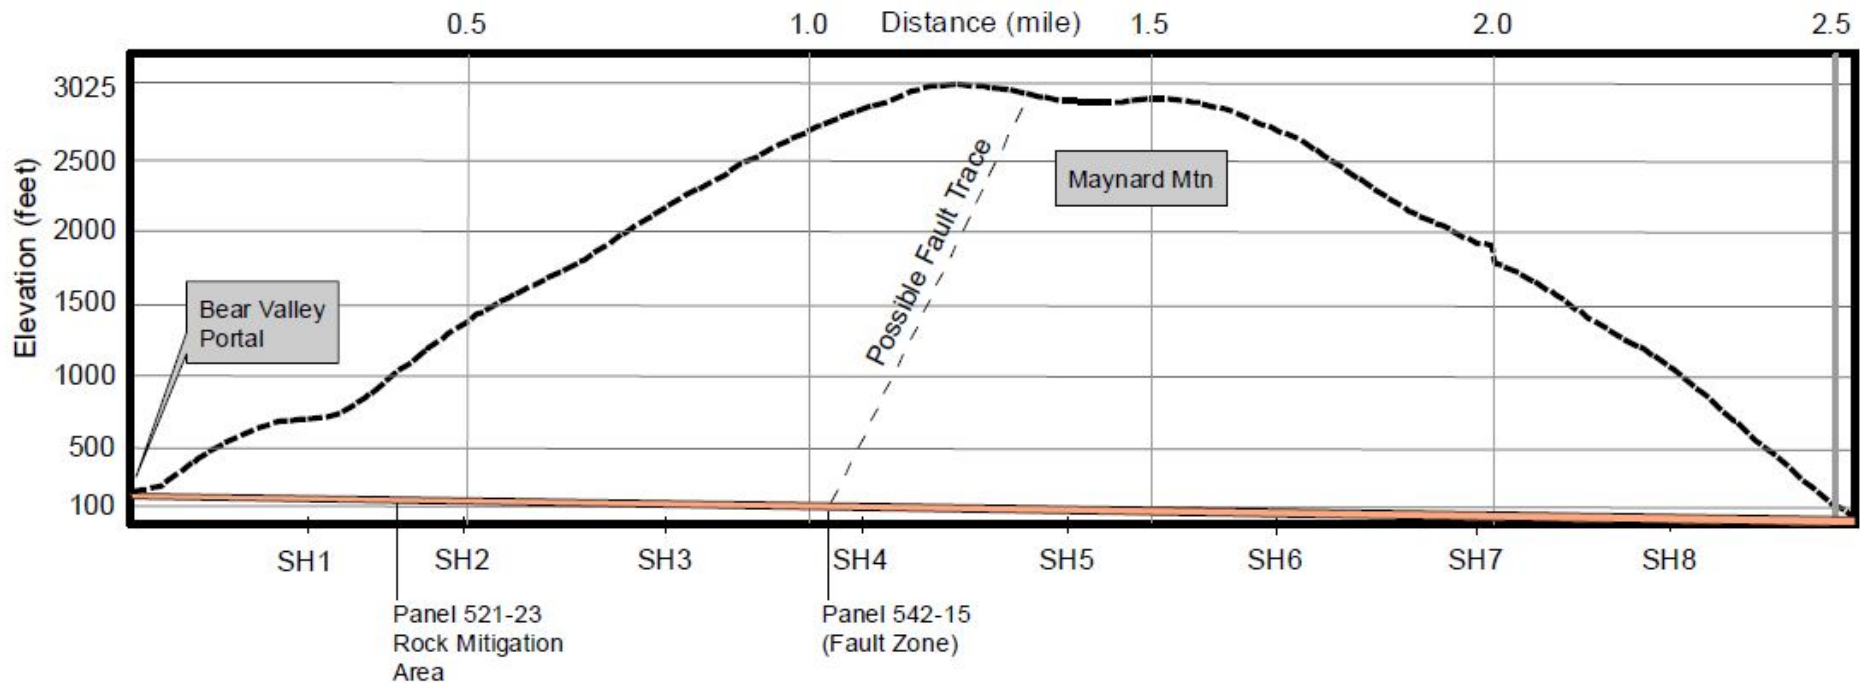
Generalized Whittier Tunnel Profile

Start Location	End Location	Start Station	End Station	Distance (ft)
Face of Bear Valley Portal	SH #1	132+50	146+29	1379
Middle of SH#1	Middle of SH#2	146+29	158+78	1249
Middle of SH#2	Middle of SH#3	158+78	174+24	1546
Middle of SH#3	Middle of SH#4	174+24	189+94	1570
Middle of SH#4	Middle of SH#5	189+94	205+53	1559
Middle of SH#5	Middle of SH#6	205+53	221+45	1592
Middle of SH#6	Middle of SH#7	221+45	237+36	1591
Middle of SH#7	Middle of SH#8	237+36	252+11	1475
Middle of SH#8	Face of Whittier Portal	252+11	265+55	1344

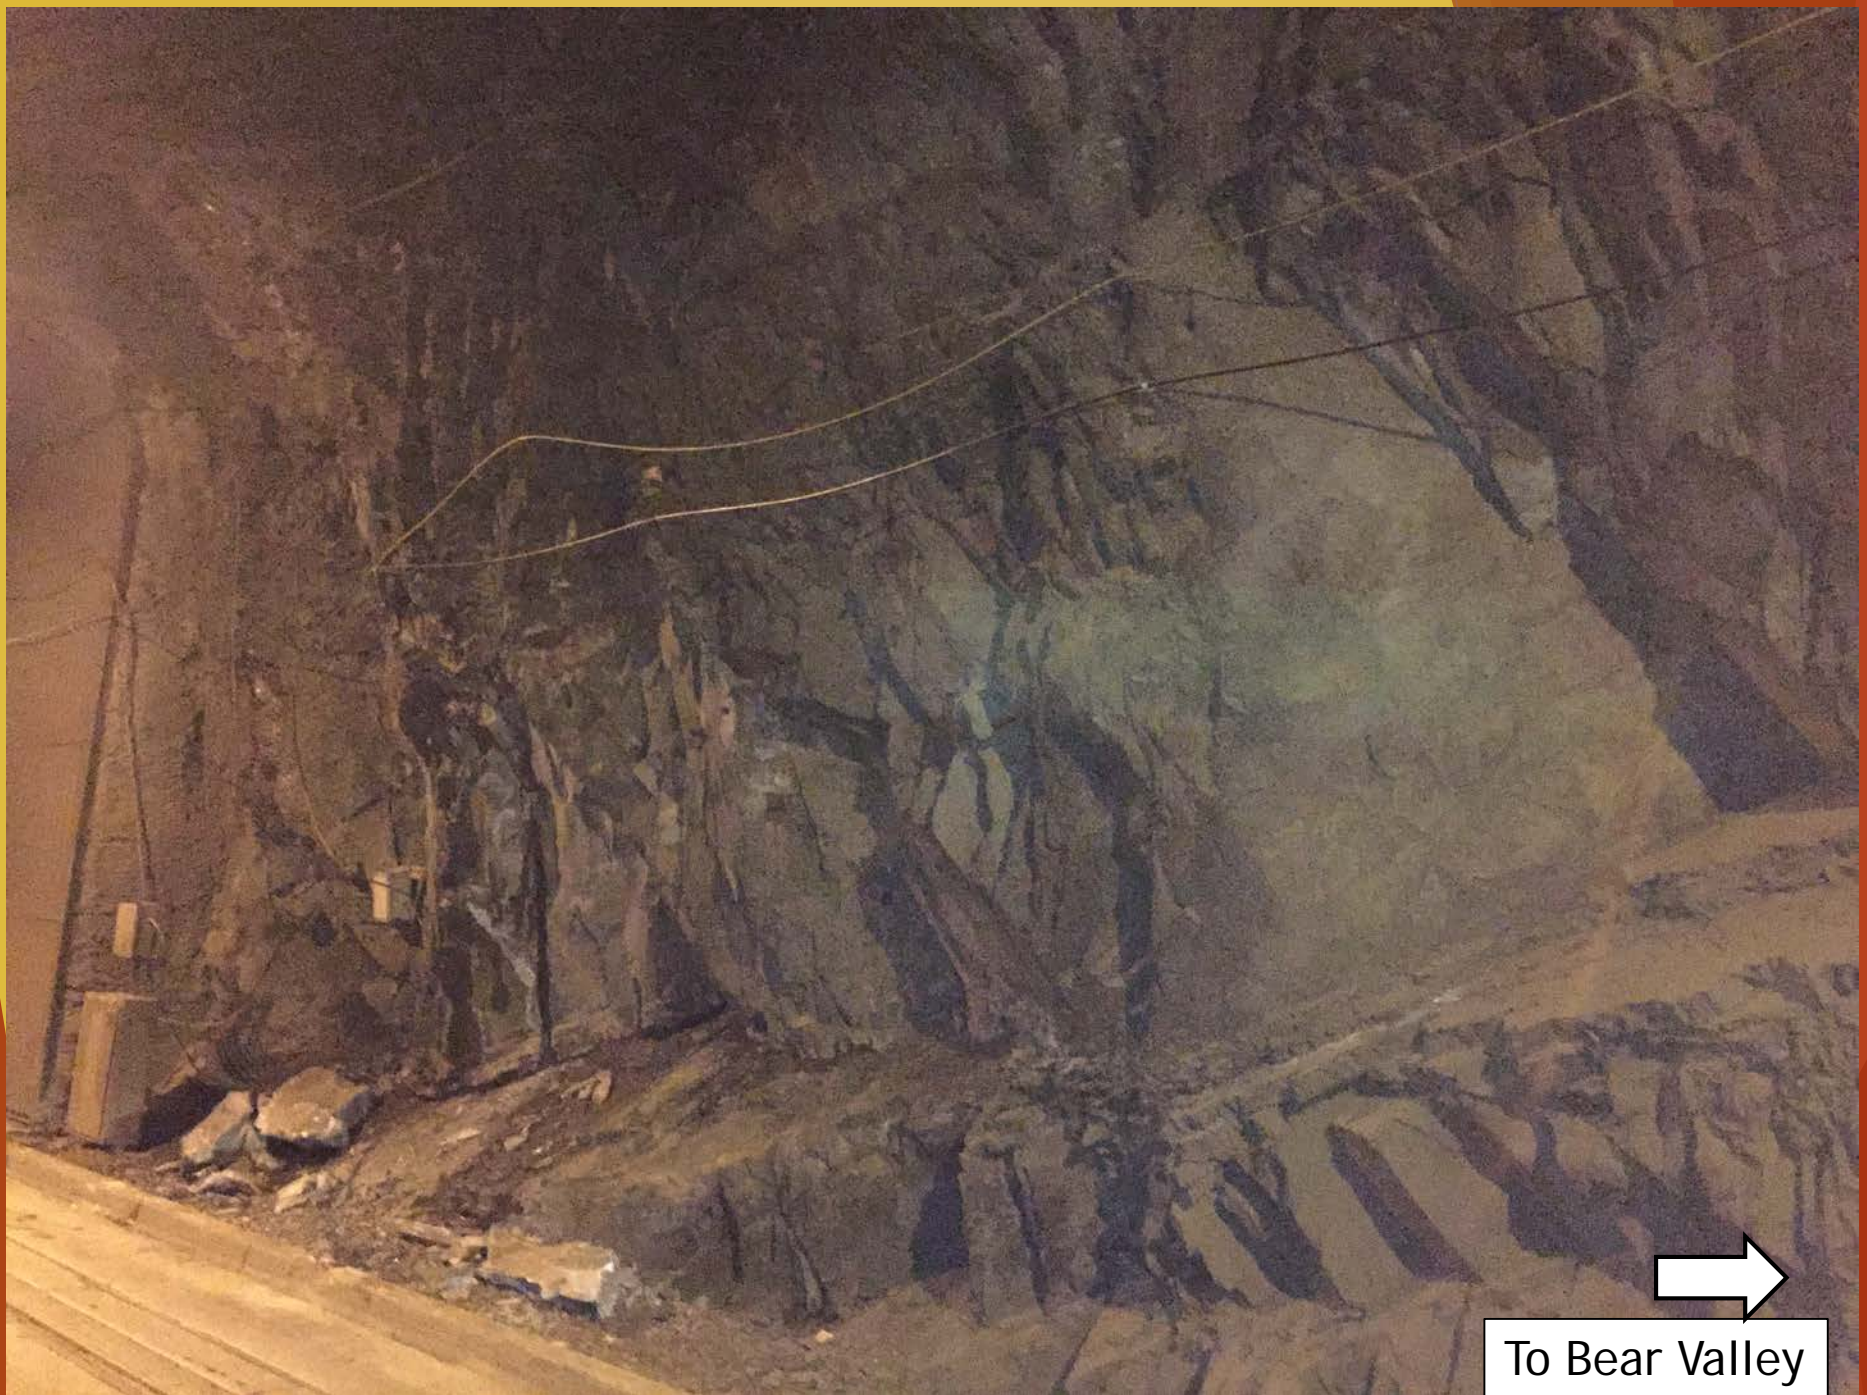
Photo 2: This photo shows the rock that fell or was removed. The tunnel staff was removing the initial rock fall (Block1) when they noticed the large partially detached block (Block2) that separated due to the open fracture. That block was removed once the area above was stabilized. It was about 3.4 tons of material. To the left of that was an area (Block3) that slid out during the rock mitigation work. That area amounted to about 3 tons of material. A total of 6.5 tons of material removed from the area.

- ❑ Installation of mechanical rock bolts (#8 hollow bar, torqued to 25 kips, and grouted), split-set bolts, and wire mesh (Geo-brugg mesh @ 3,100 lbs/ft²).

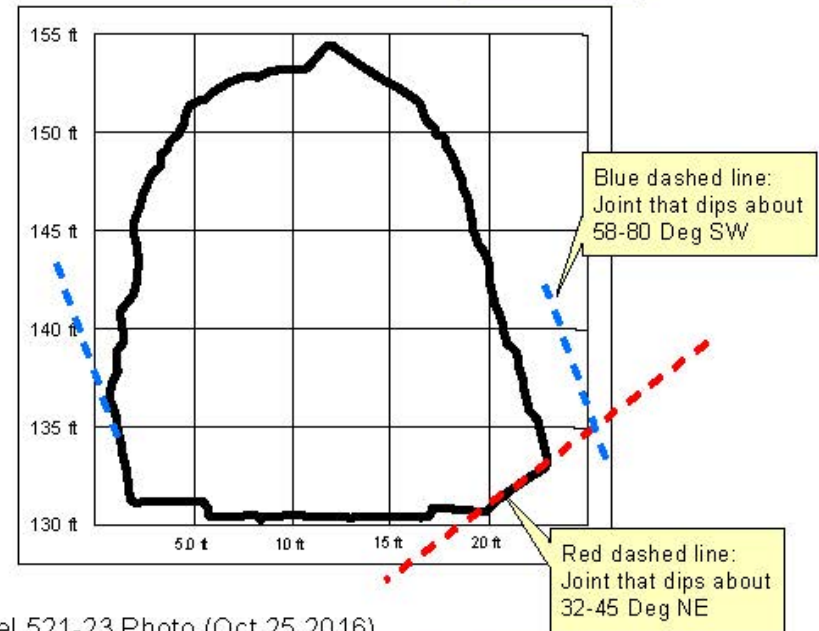
Panel 521-23 Cross Section

Rock fall site
