A Geotechnical and Geological Perspective on MATERIAL SITES

Craig Boeckman, C.P.G. – Regional Geologist

Presentation TOC

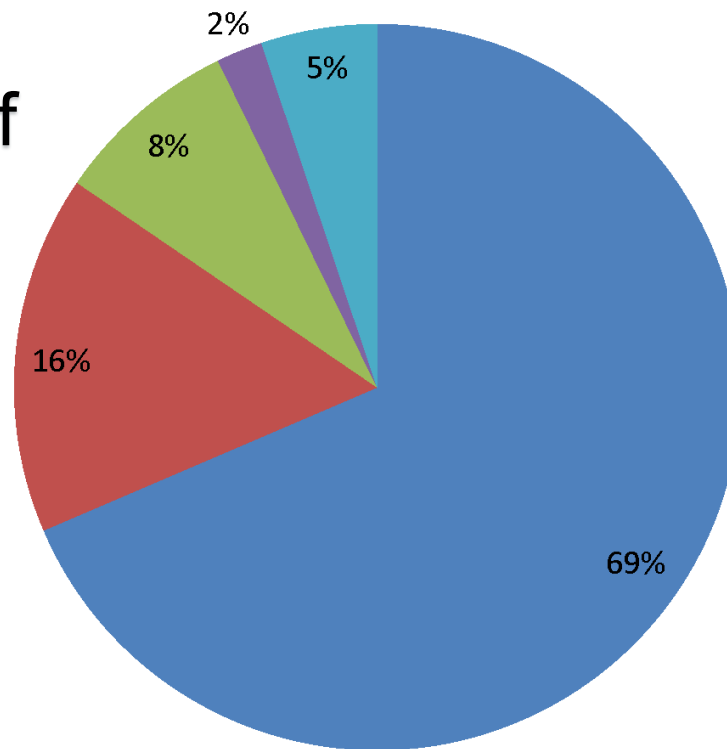
Sites north of
Anchorage

Date of Soils Information for CREG Material Sites (Parks, Glenn, Mat/Su Area, Talkeetna Area)

■ 1960's Data ■ 1970's Data ■ 1980's Data ■ 1990's Data ■ 2000-2007 Data

If there was
data - it was
mostly pre
1980s data

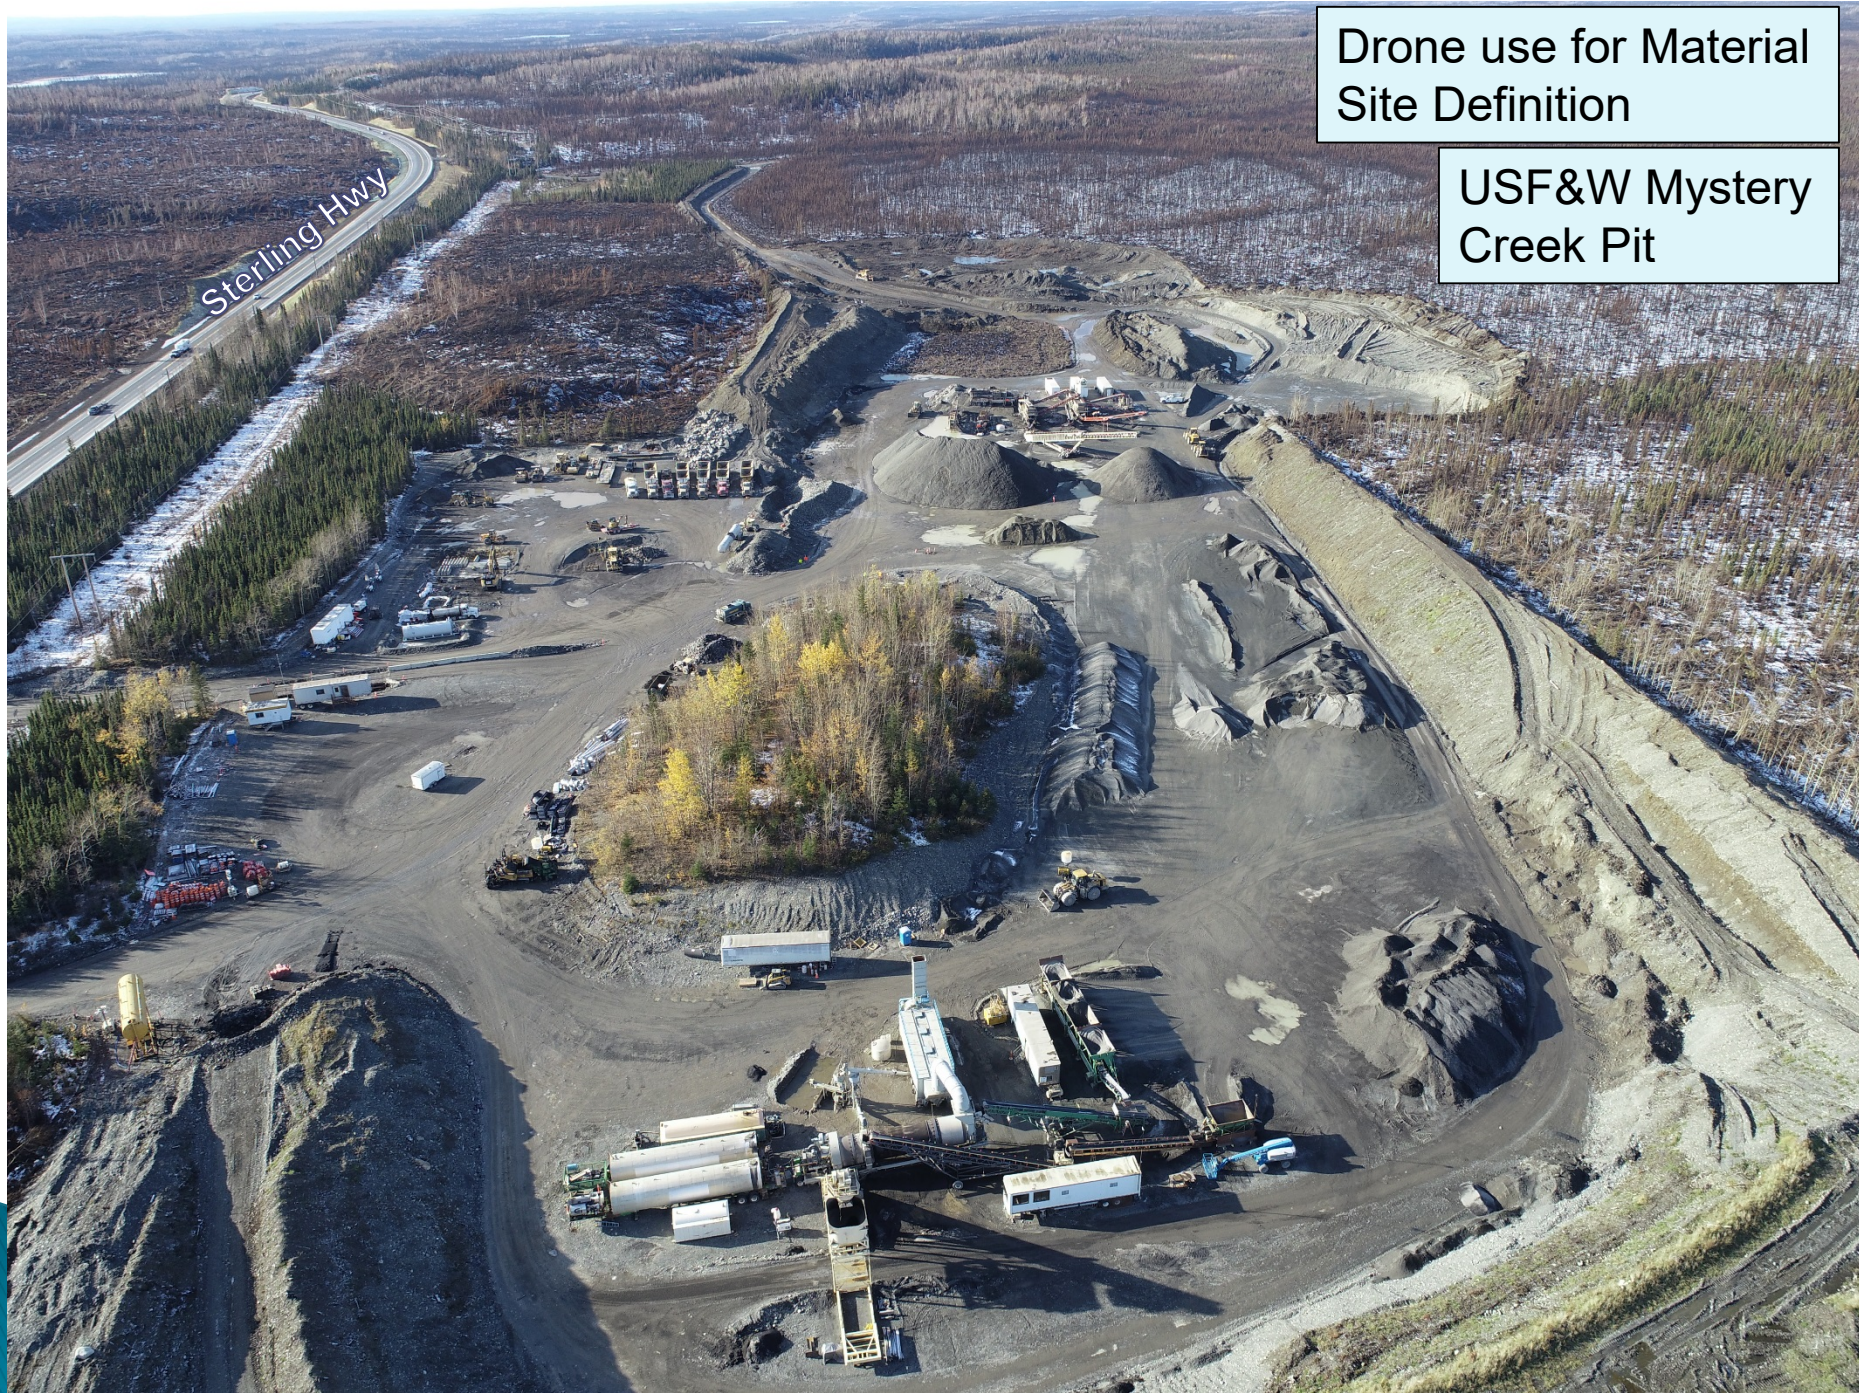
USF&W Mystery
Creek Pit

Drone use for Material
Site Definition

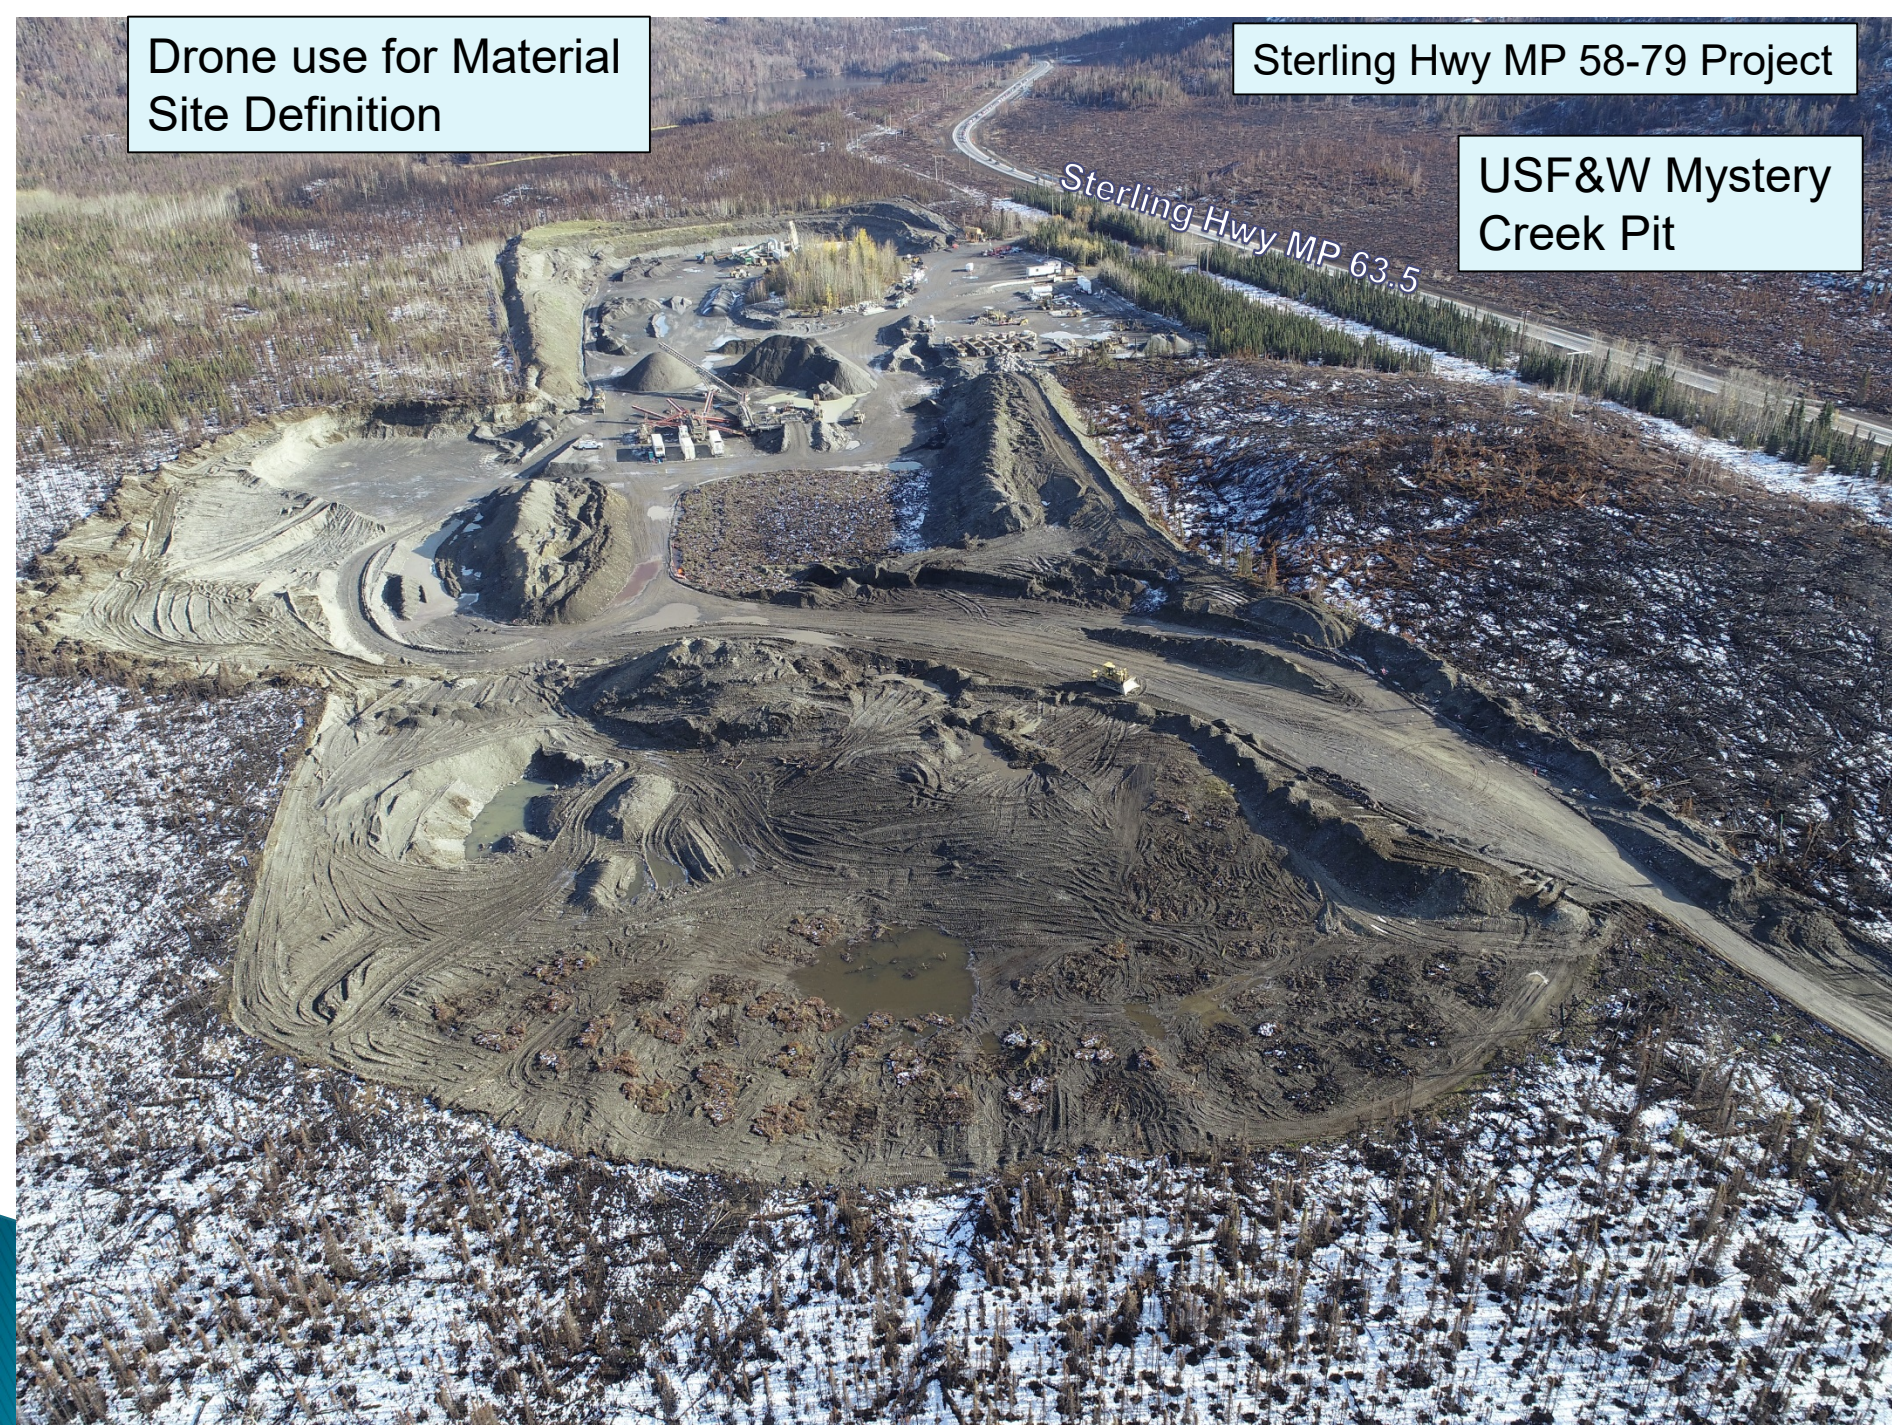
Sterling Hwy MP 63.5

Drone use for Material
Site Definition

USF&W Mystery
Creek Pit

2018 Sample Data:

LA = 14

Sodium Sulfate = 0/1

Deg = 71.5

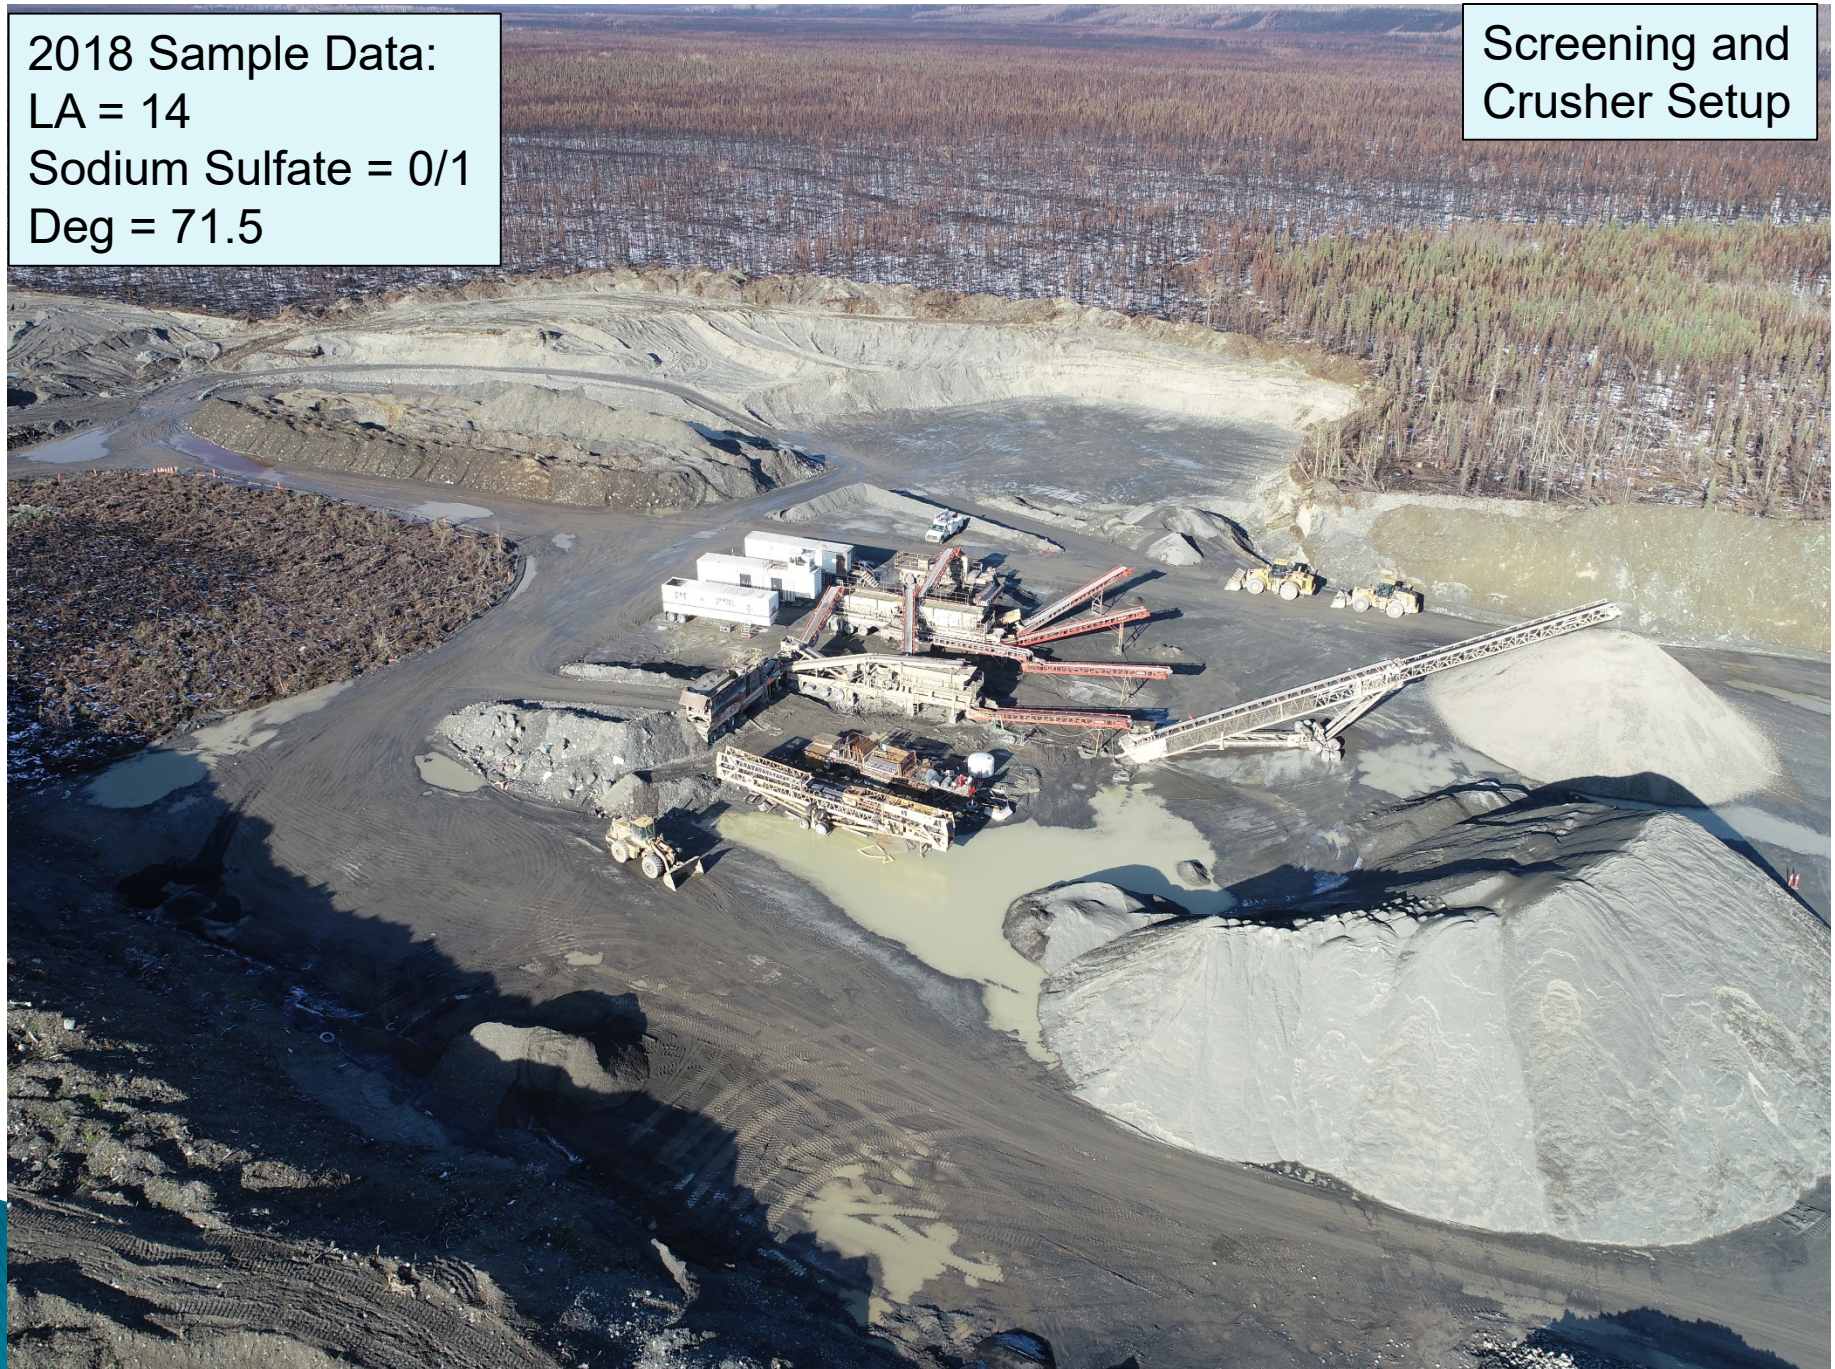
Screening and
Crusher Setup

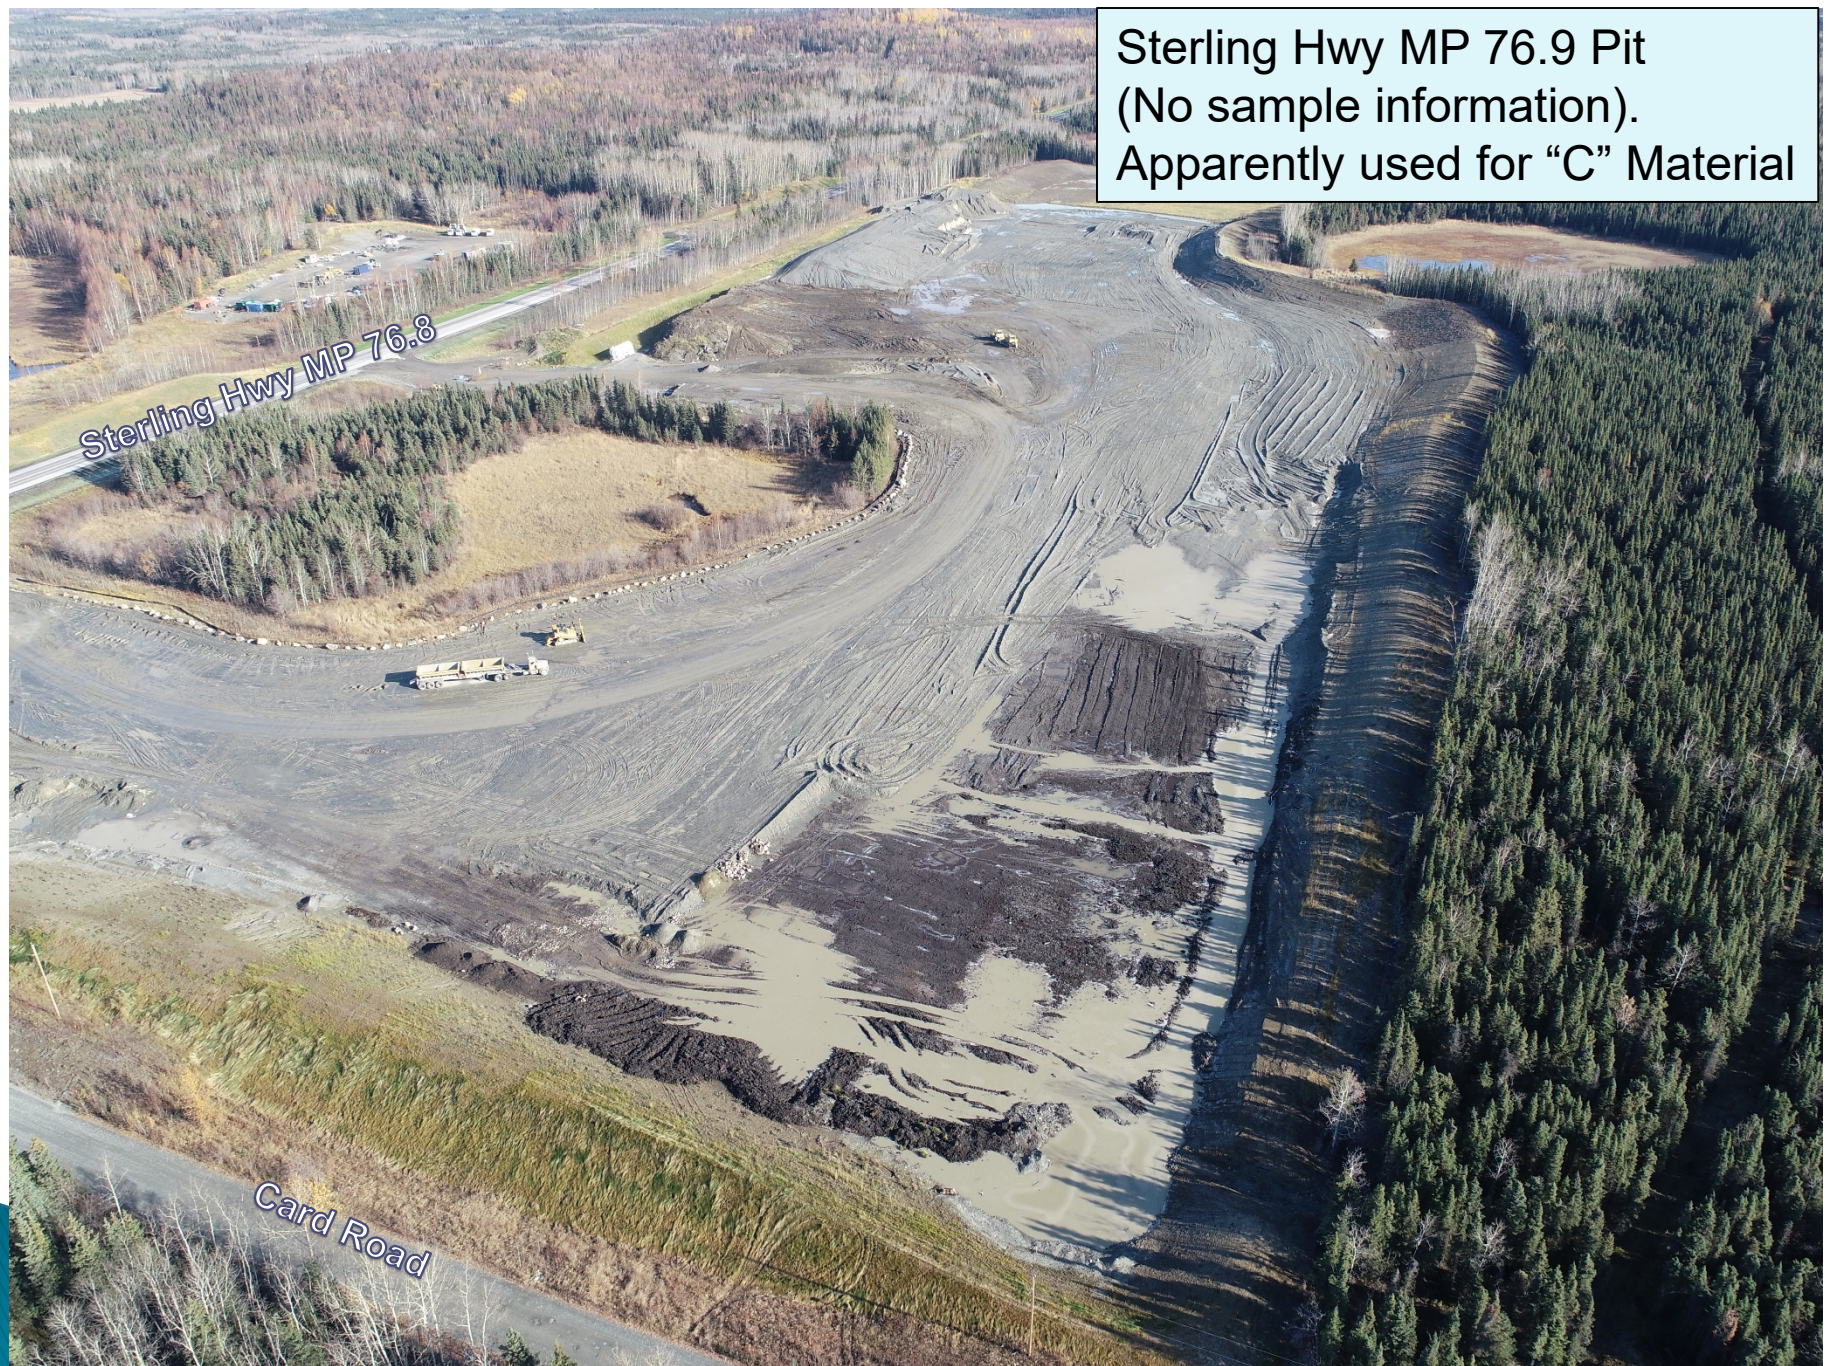
Sterling Hwy MP 76.9 Pit
(No sample information).
Apparently used for "C" Material

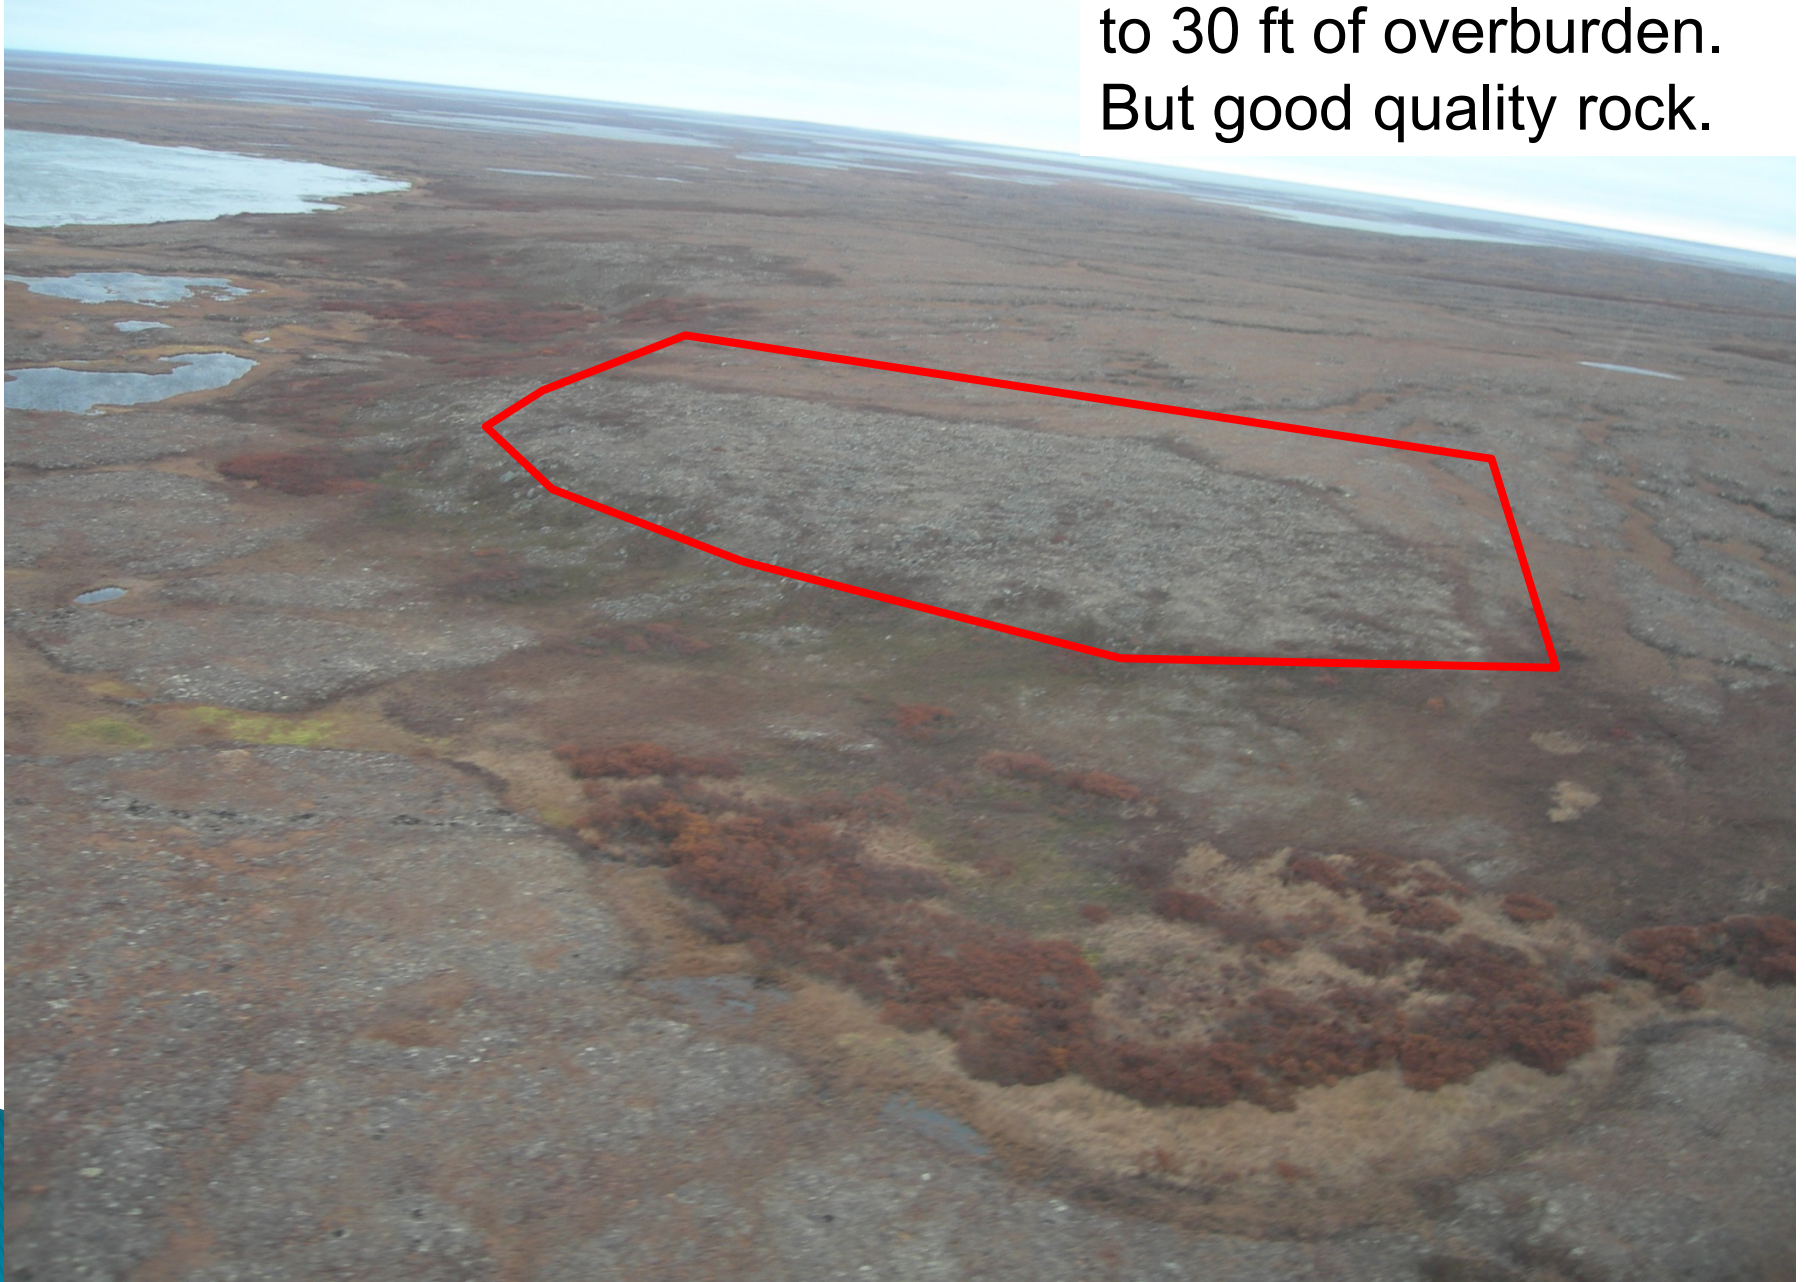
Cheeching Mtn Material Source

Test holes indicated 20 to 30 ft of overburden. But good quality rock.

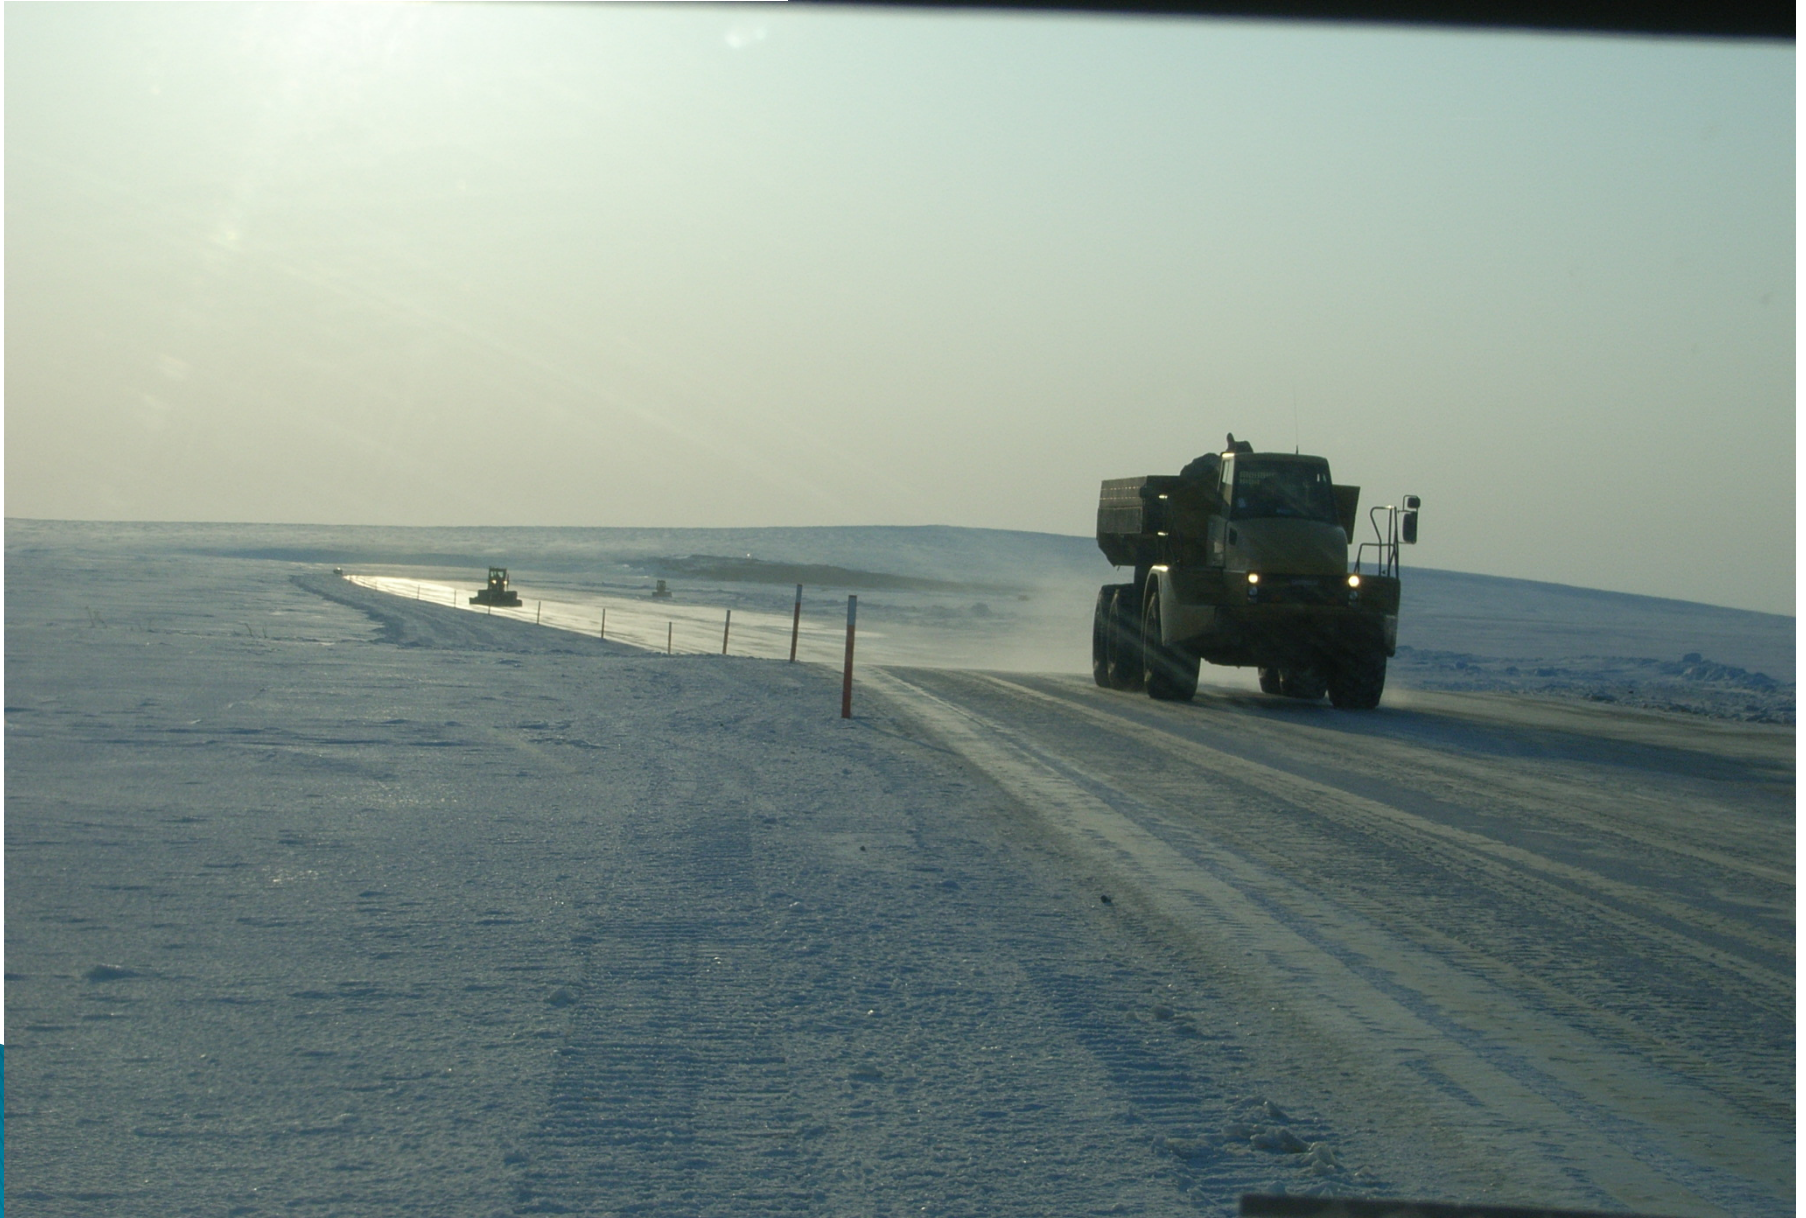
Ice road from Cheeching Mtn to Chefornak Runway:

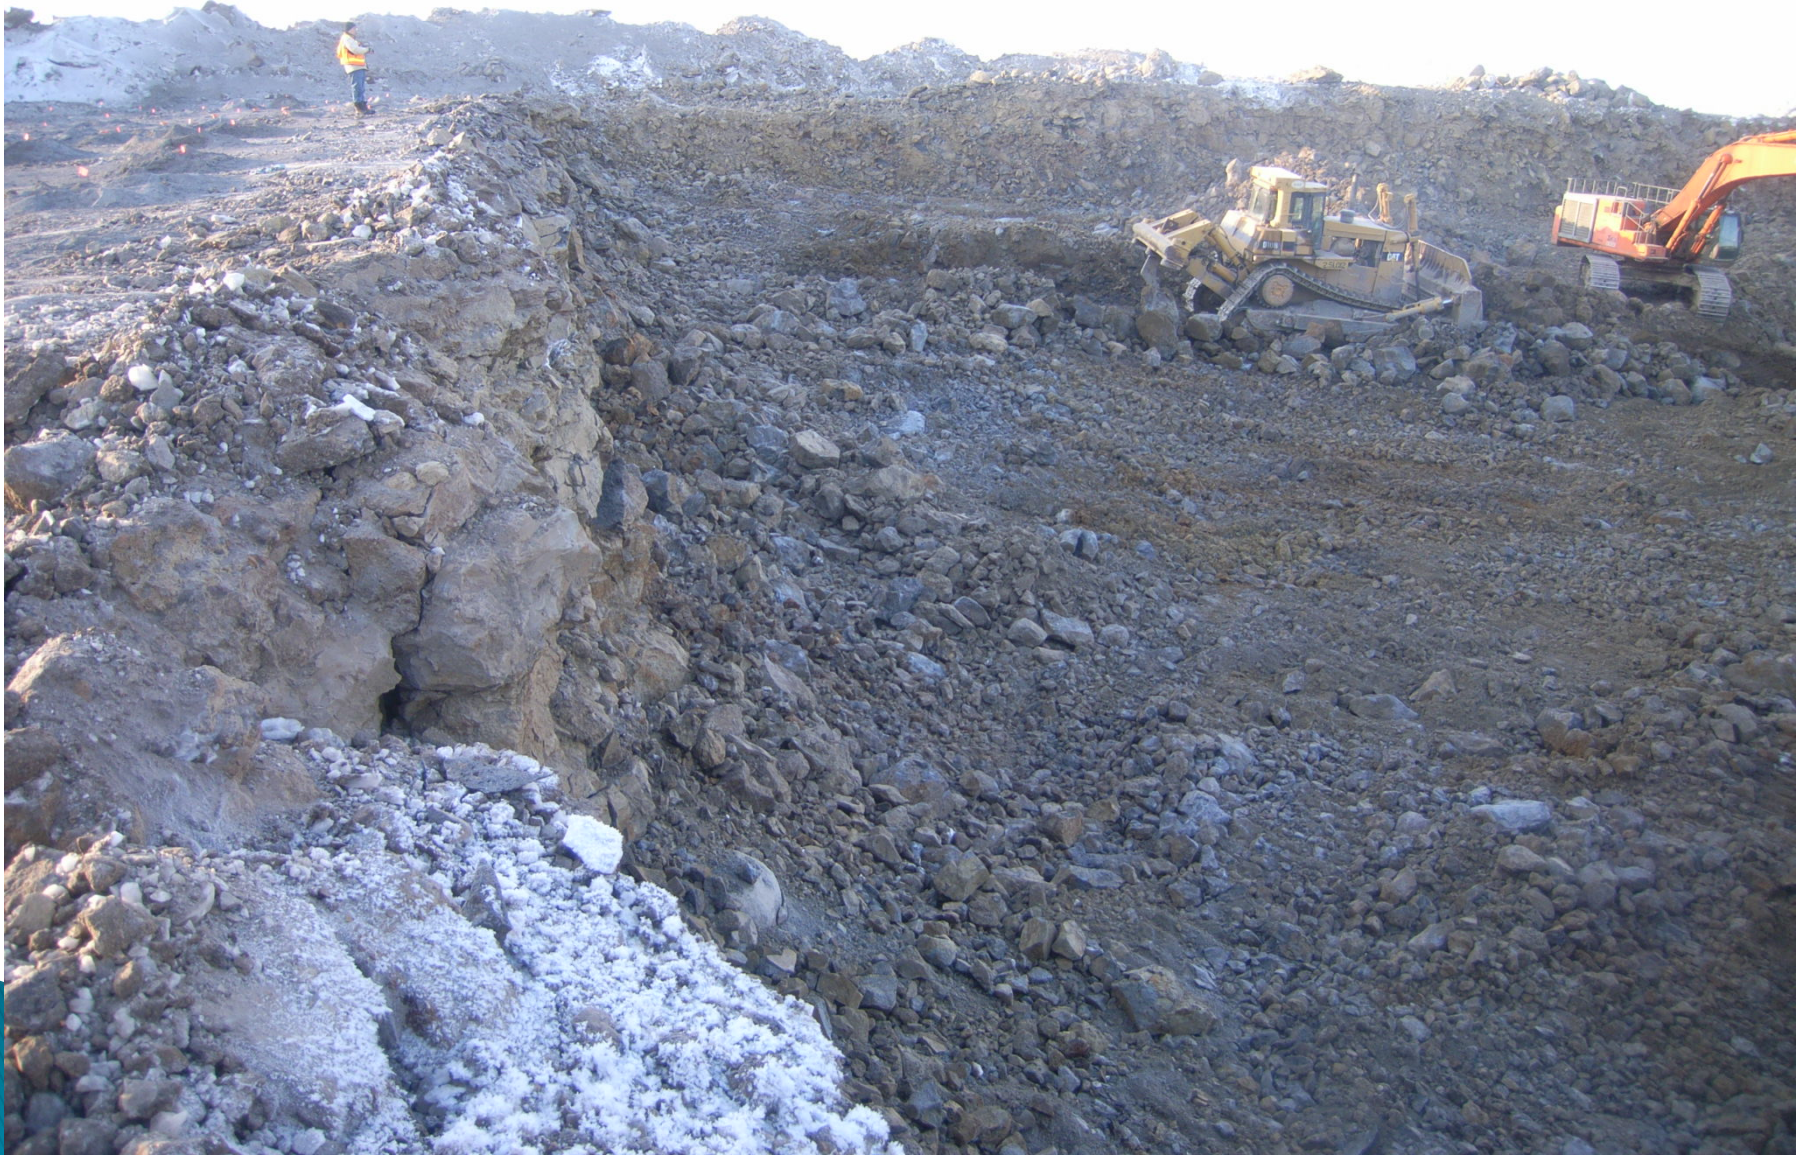
Cheeching Mtn Quarry. A blocky material was generated from the shots. About 13 to 15% fines generated with the shot.

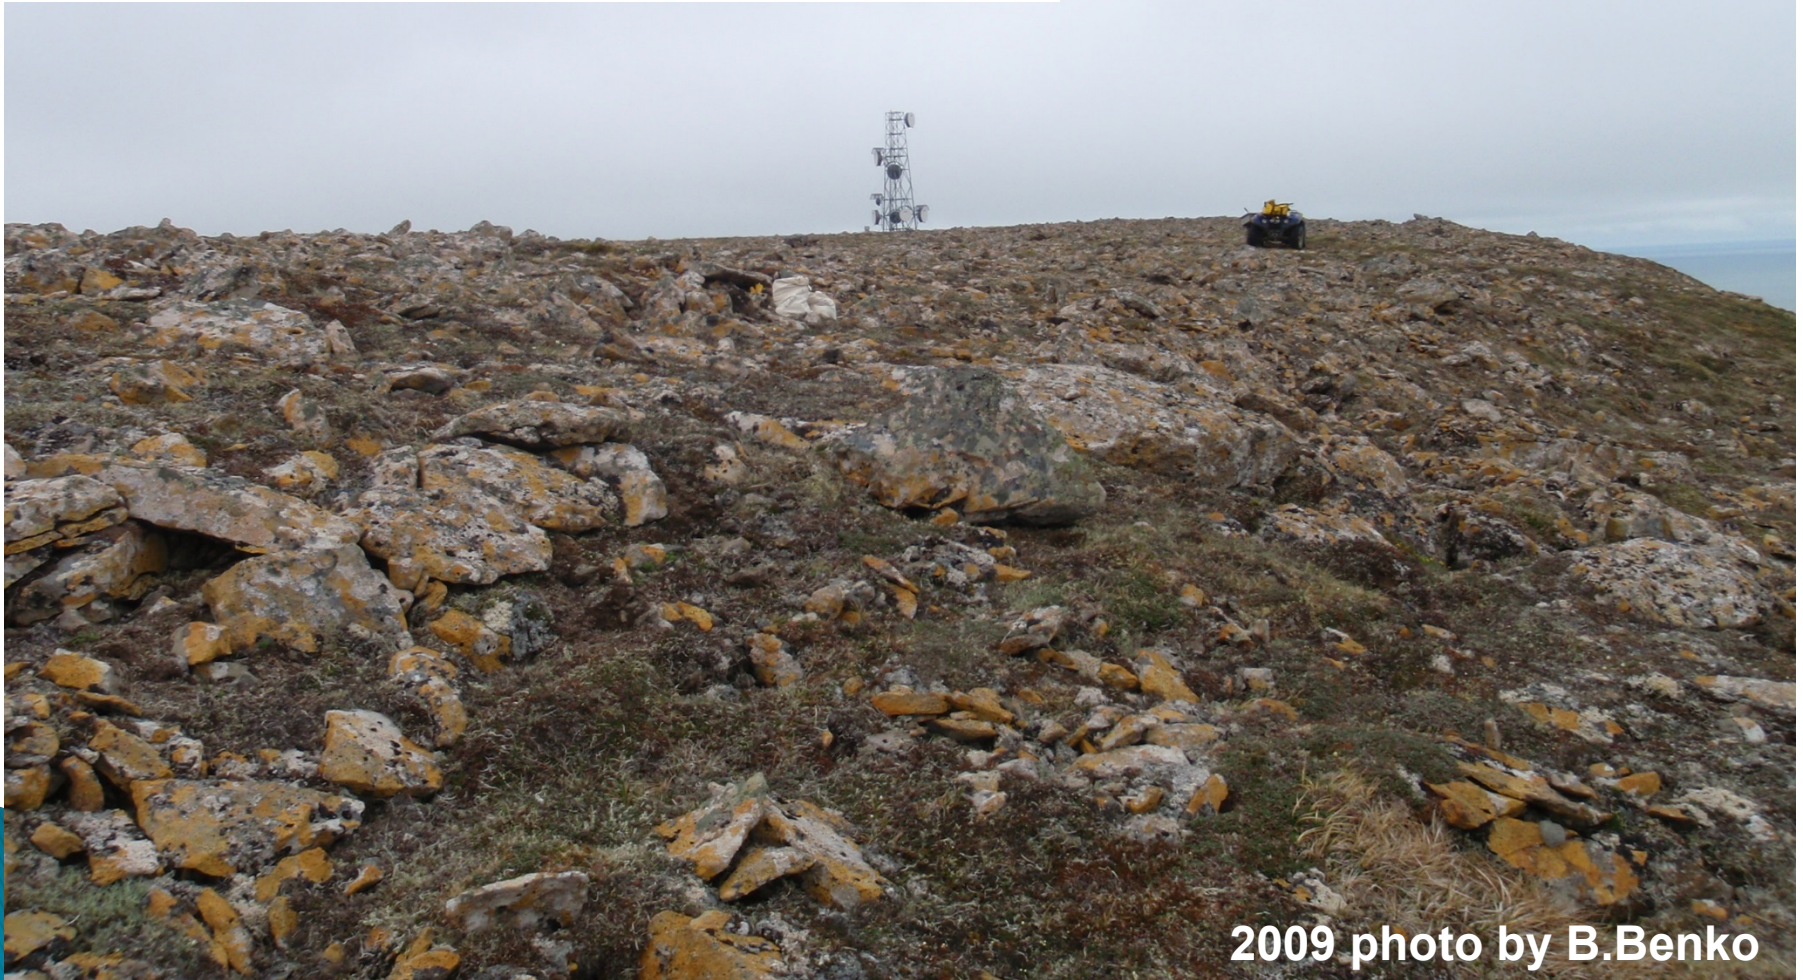
Top of Mt Ugchirnak:

Cell phone tower.

Rocks covering surface.

Some bedrock outcrops observed.

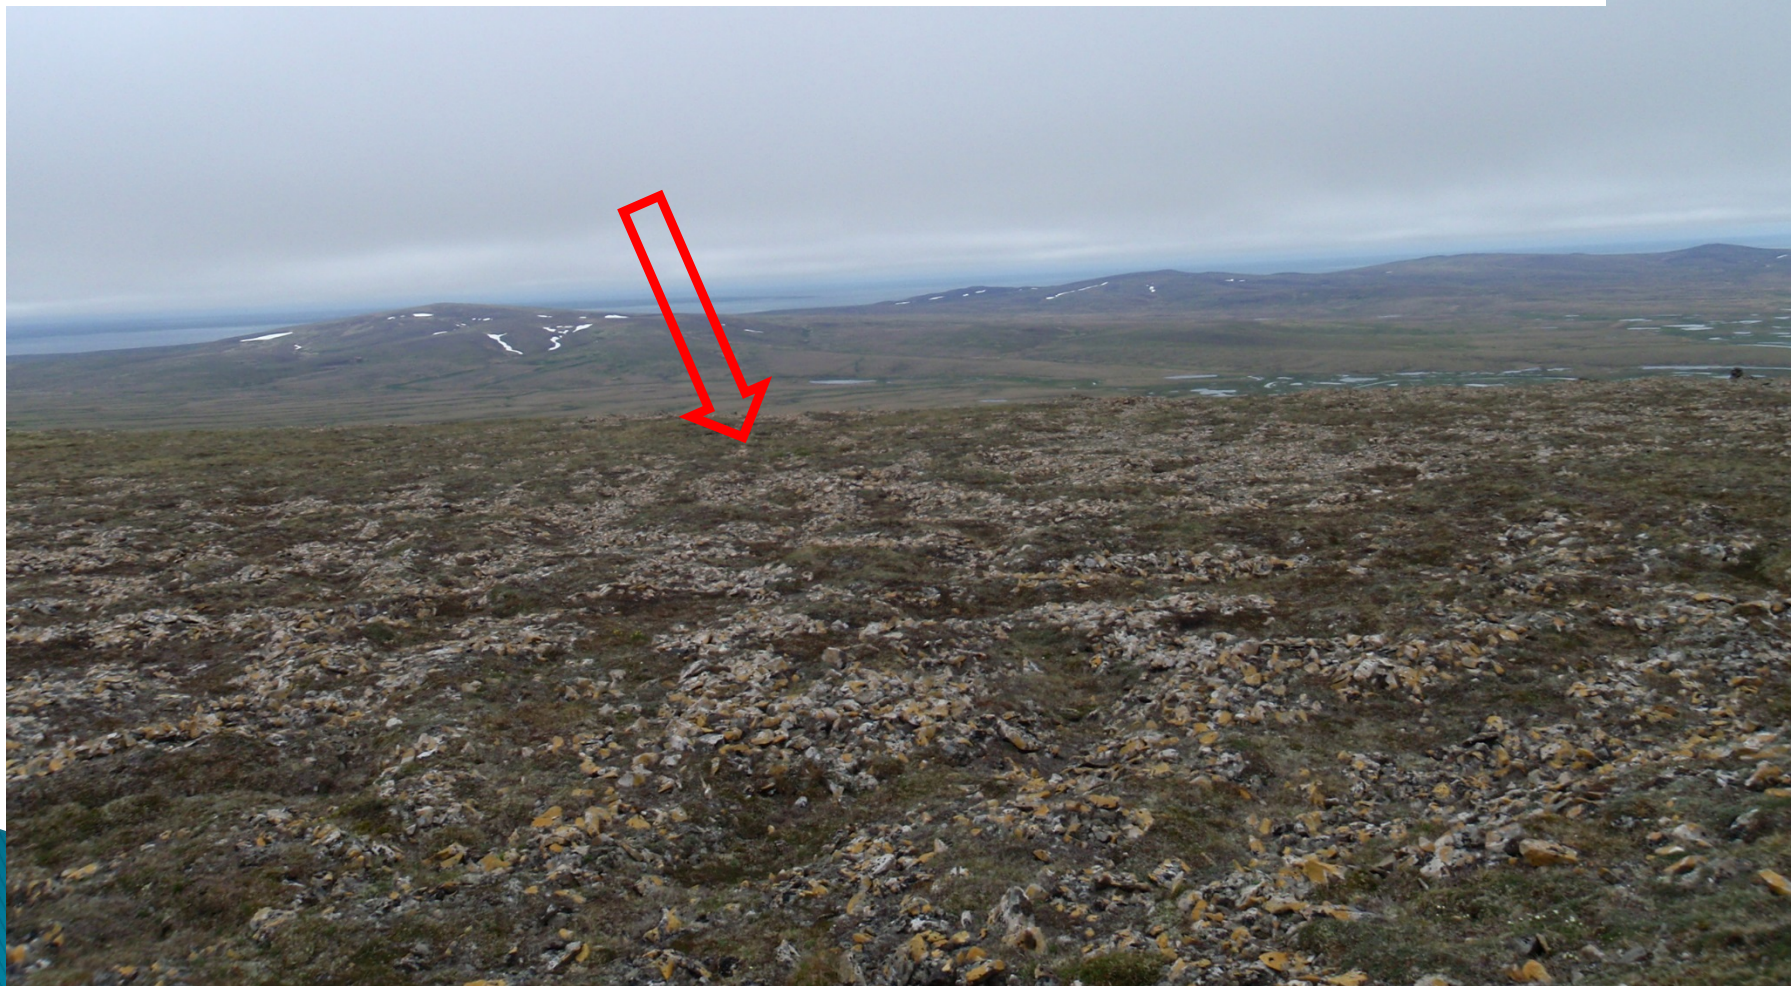
Top of Mt Ugchirnak:

This kind of patterned ground indicates permafrost activity. Rock rings. Indicate presence of an “active layer” (i.e., presence of soil overburden).
