A Geotechnical and Geological Perspective on MATERIAL SITES

Craig Boeckman, C.P.G. – Regional Geologist

Presentation TOC

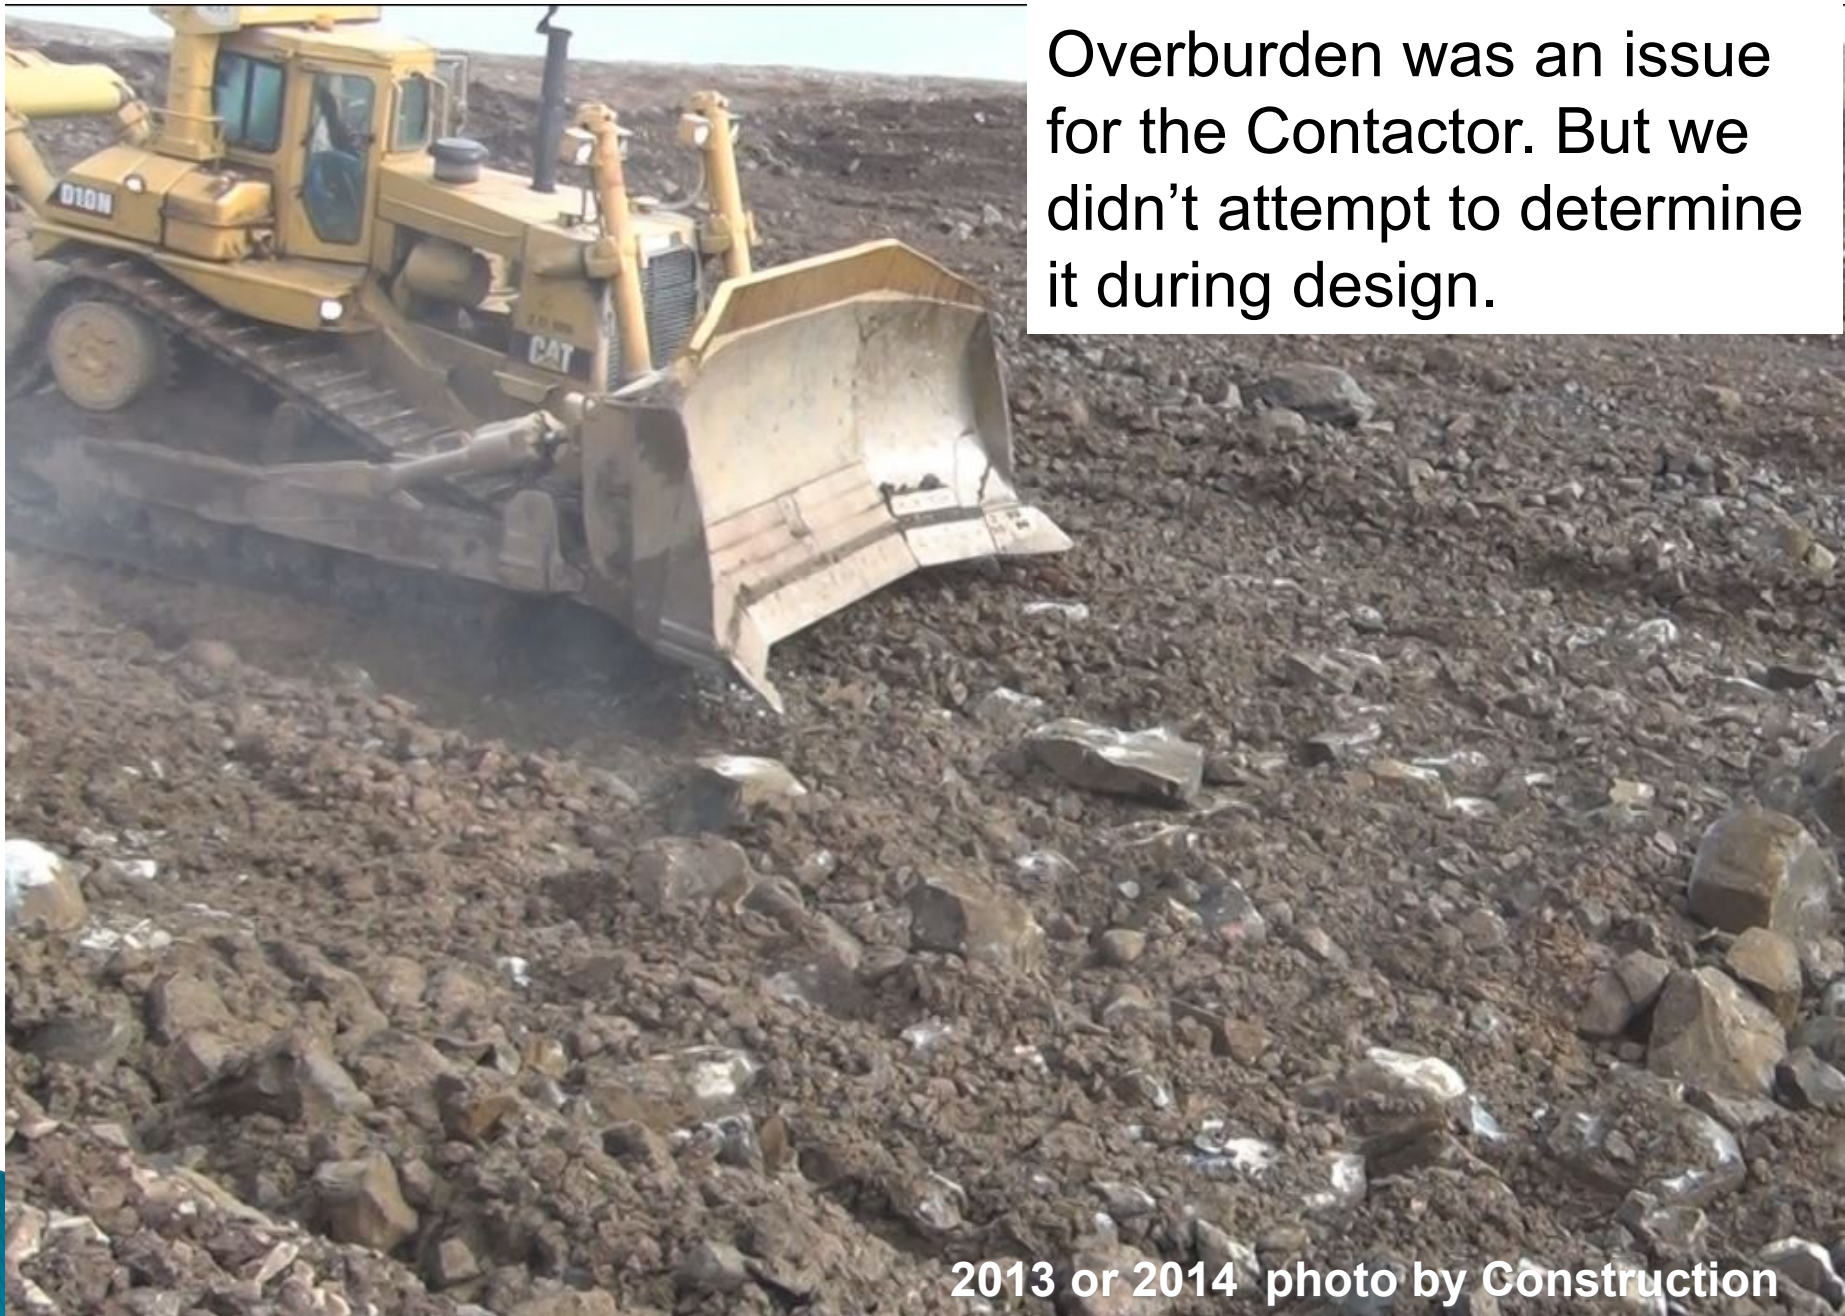
Overburden was an issue for the Contactor. But we didn't attempt to determine it during design.

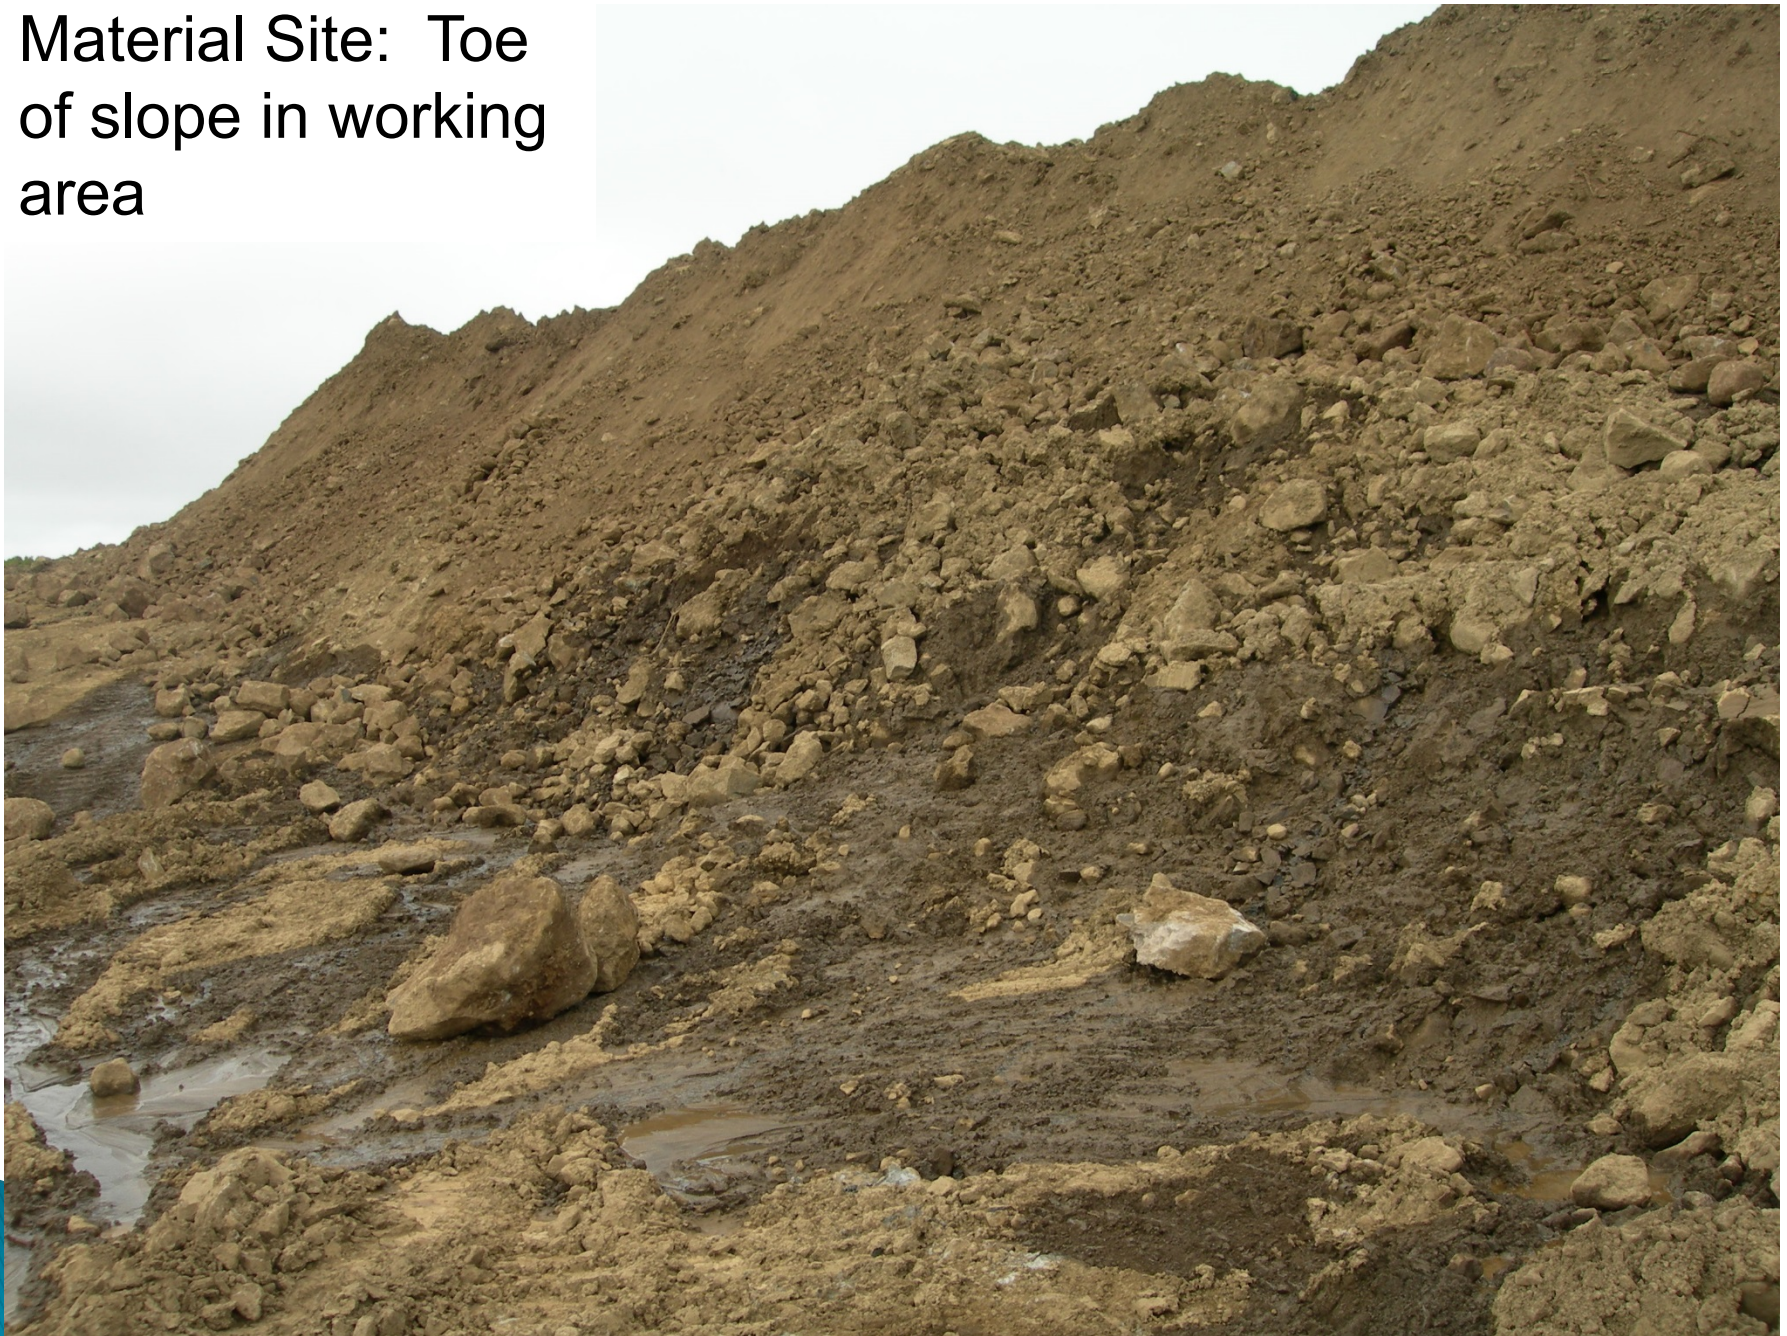
Material Site: Toe
of slope in working
area

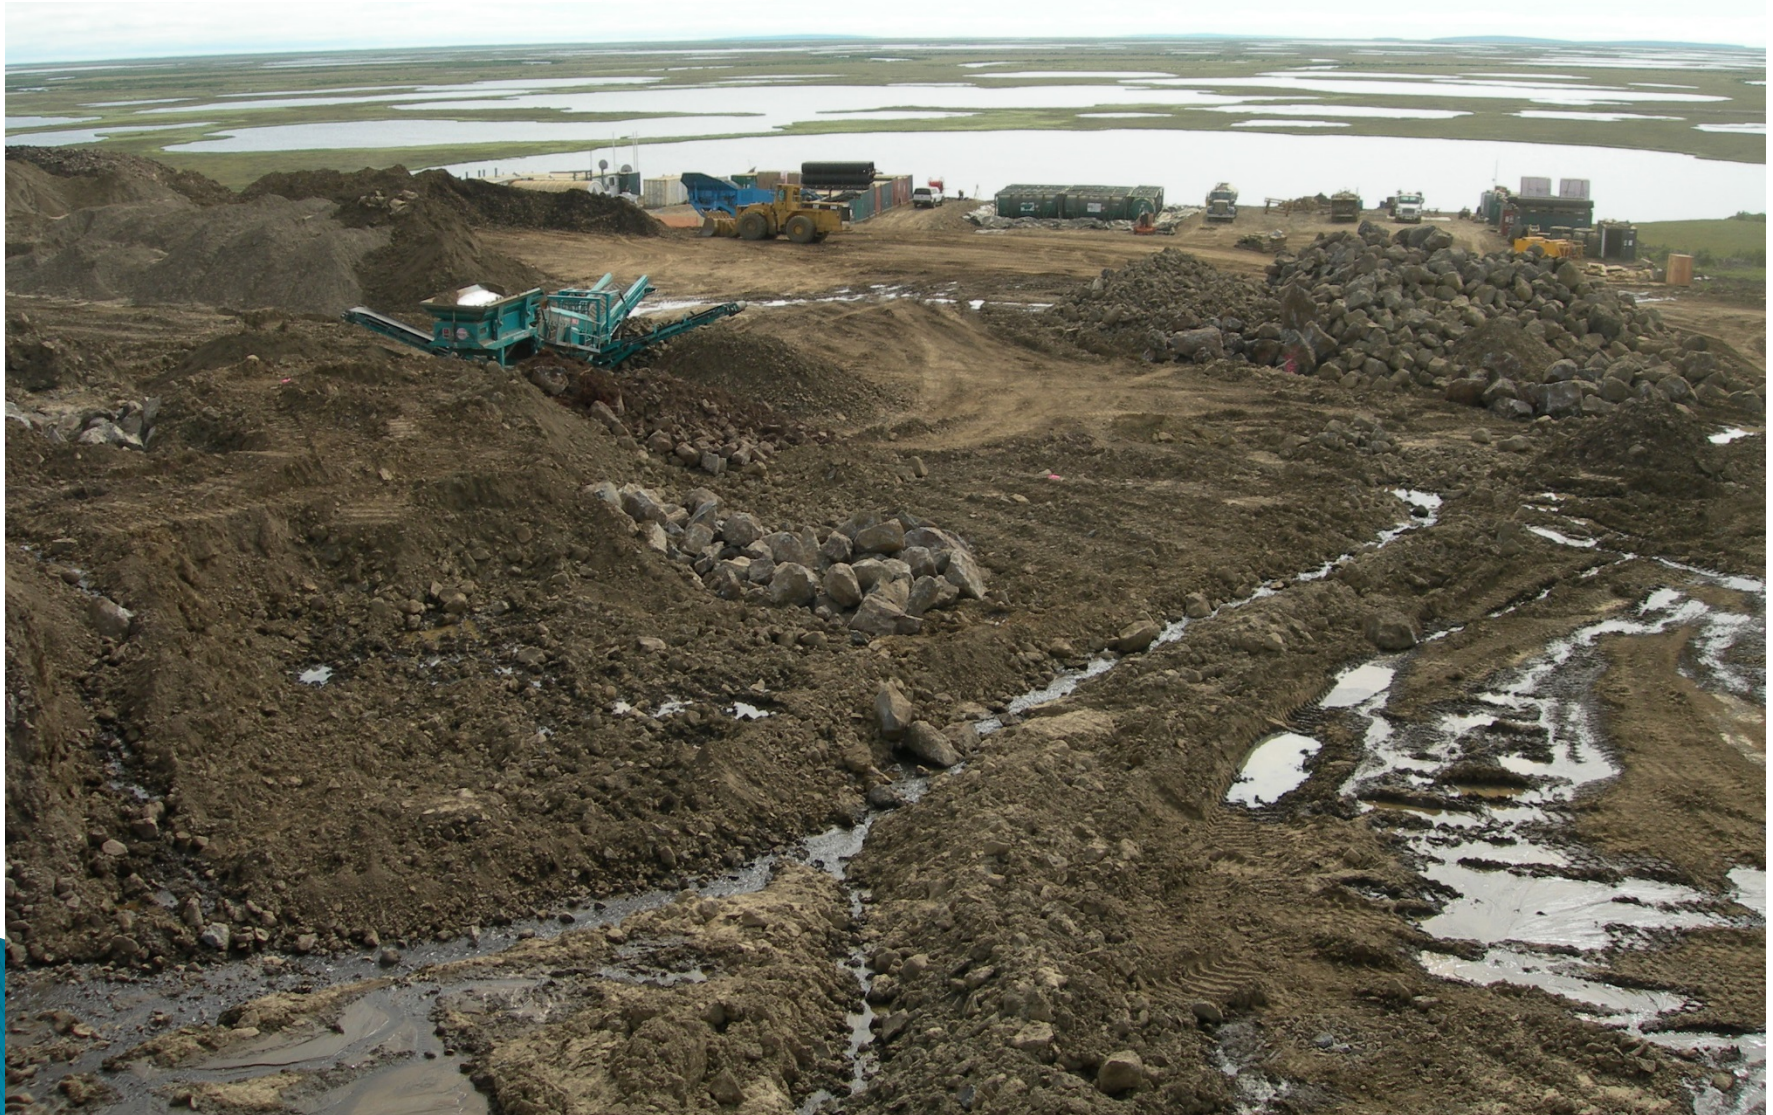
Material Site: Drainage from slope/working area

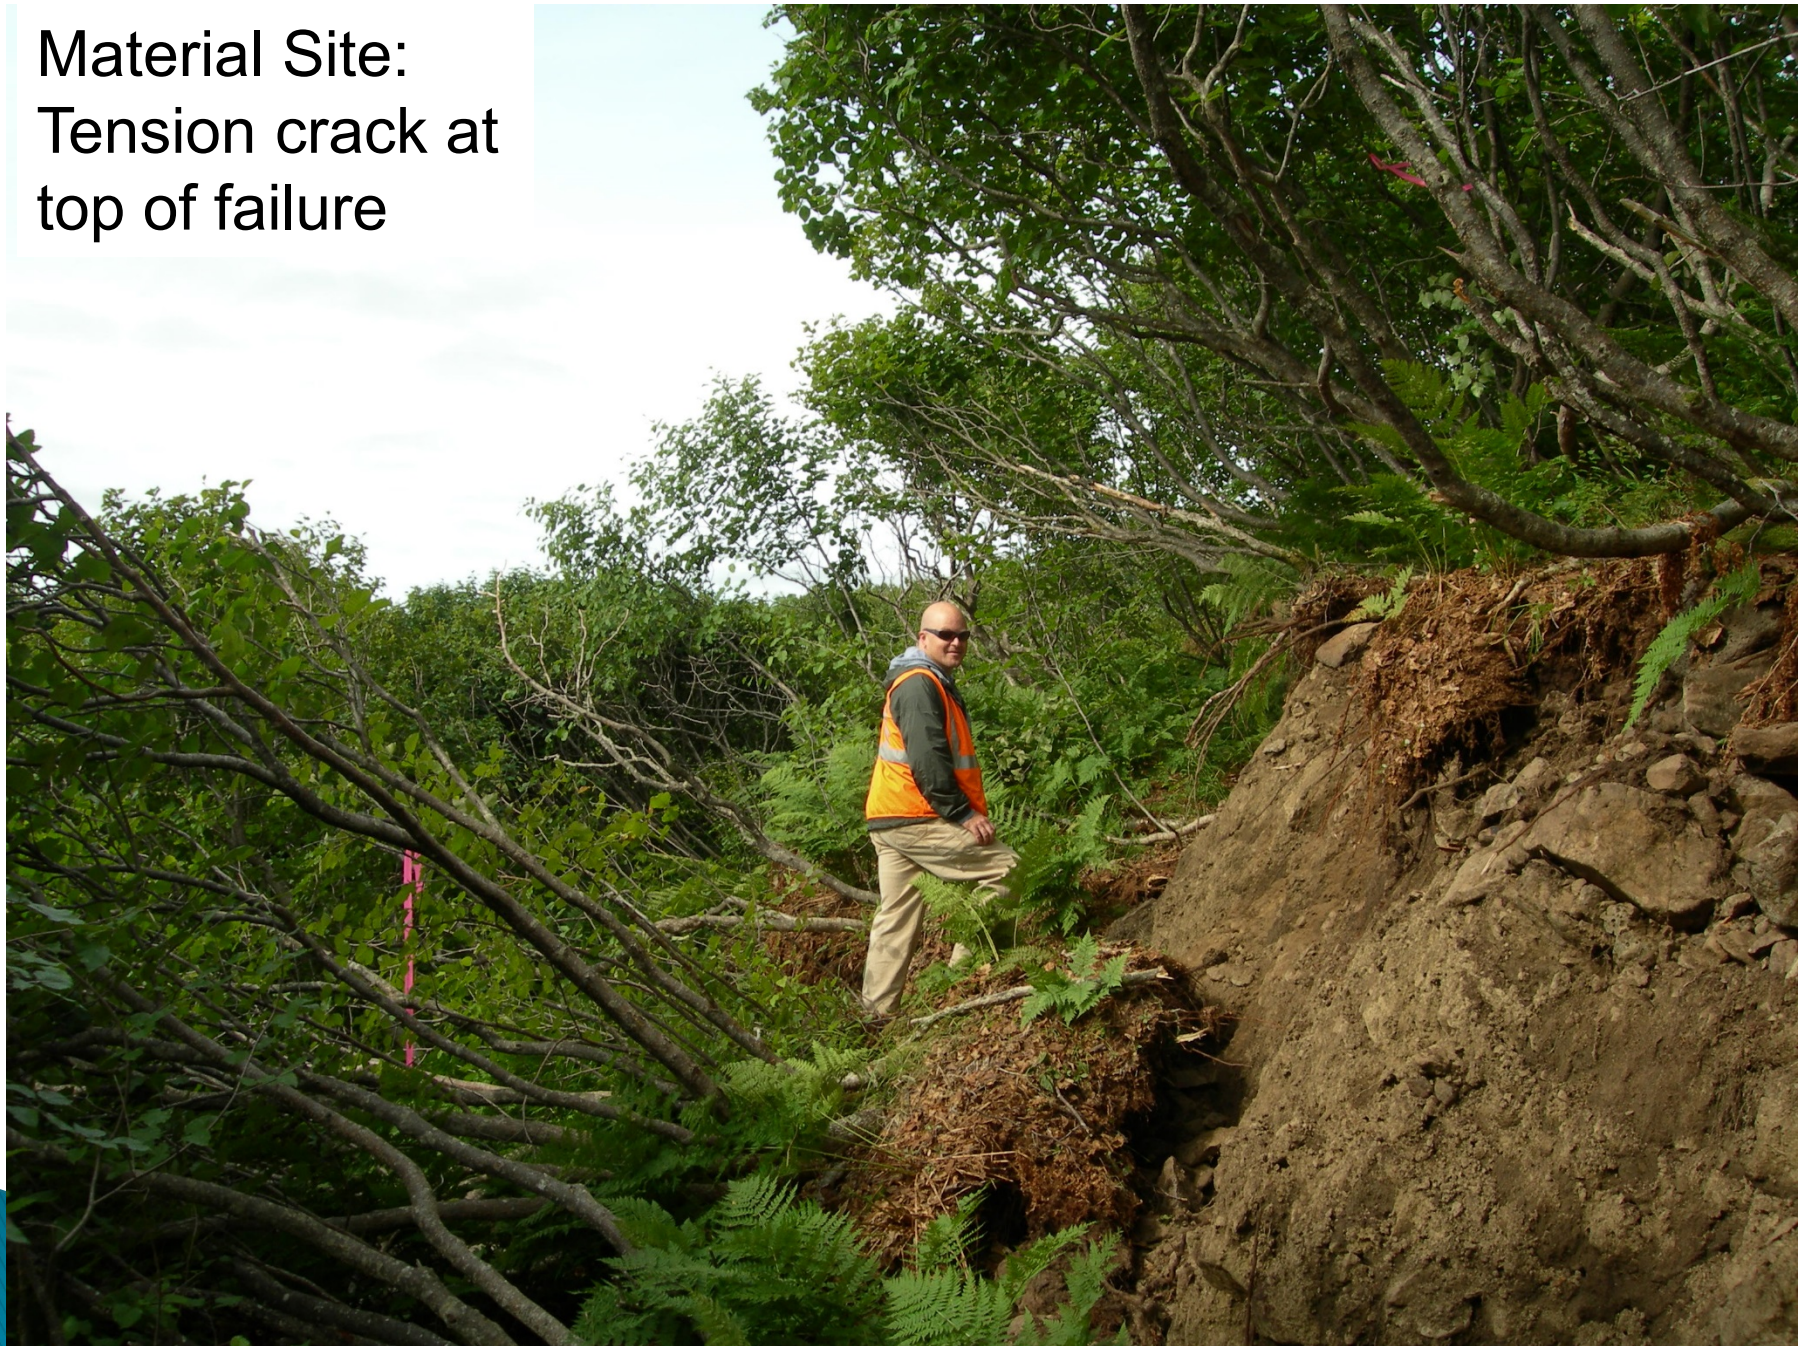
Material Site:
Tension crack at
top of failure

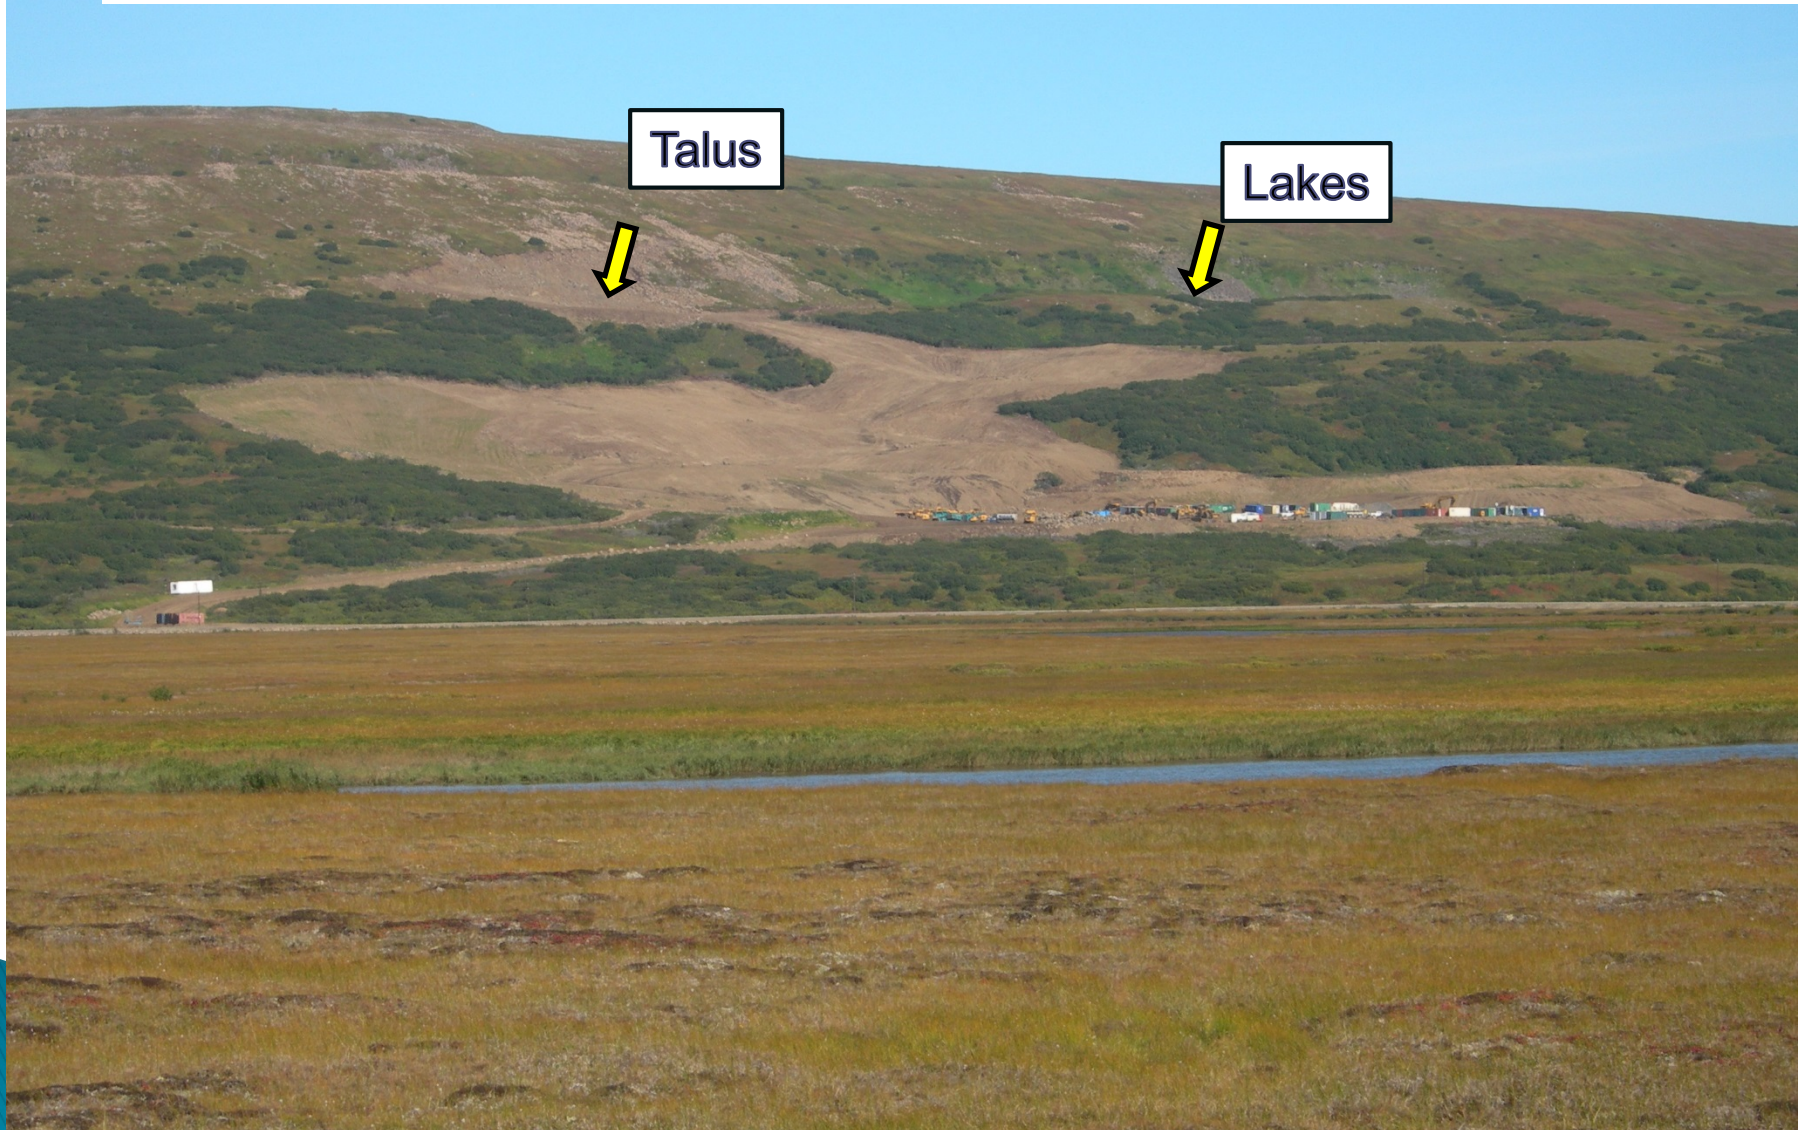
Material Site: The contractor went up to the Talus Area and excavated boulders for processing. Either because of the slope failure (they unloaded the slope), less drainage issues, or to get better quality rock.

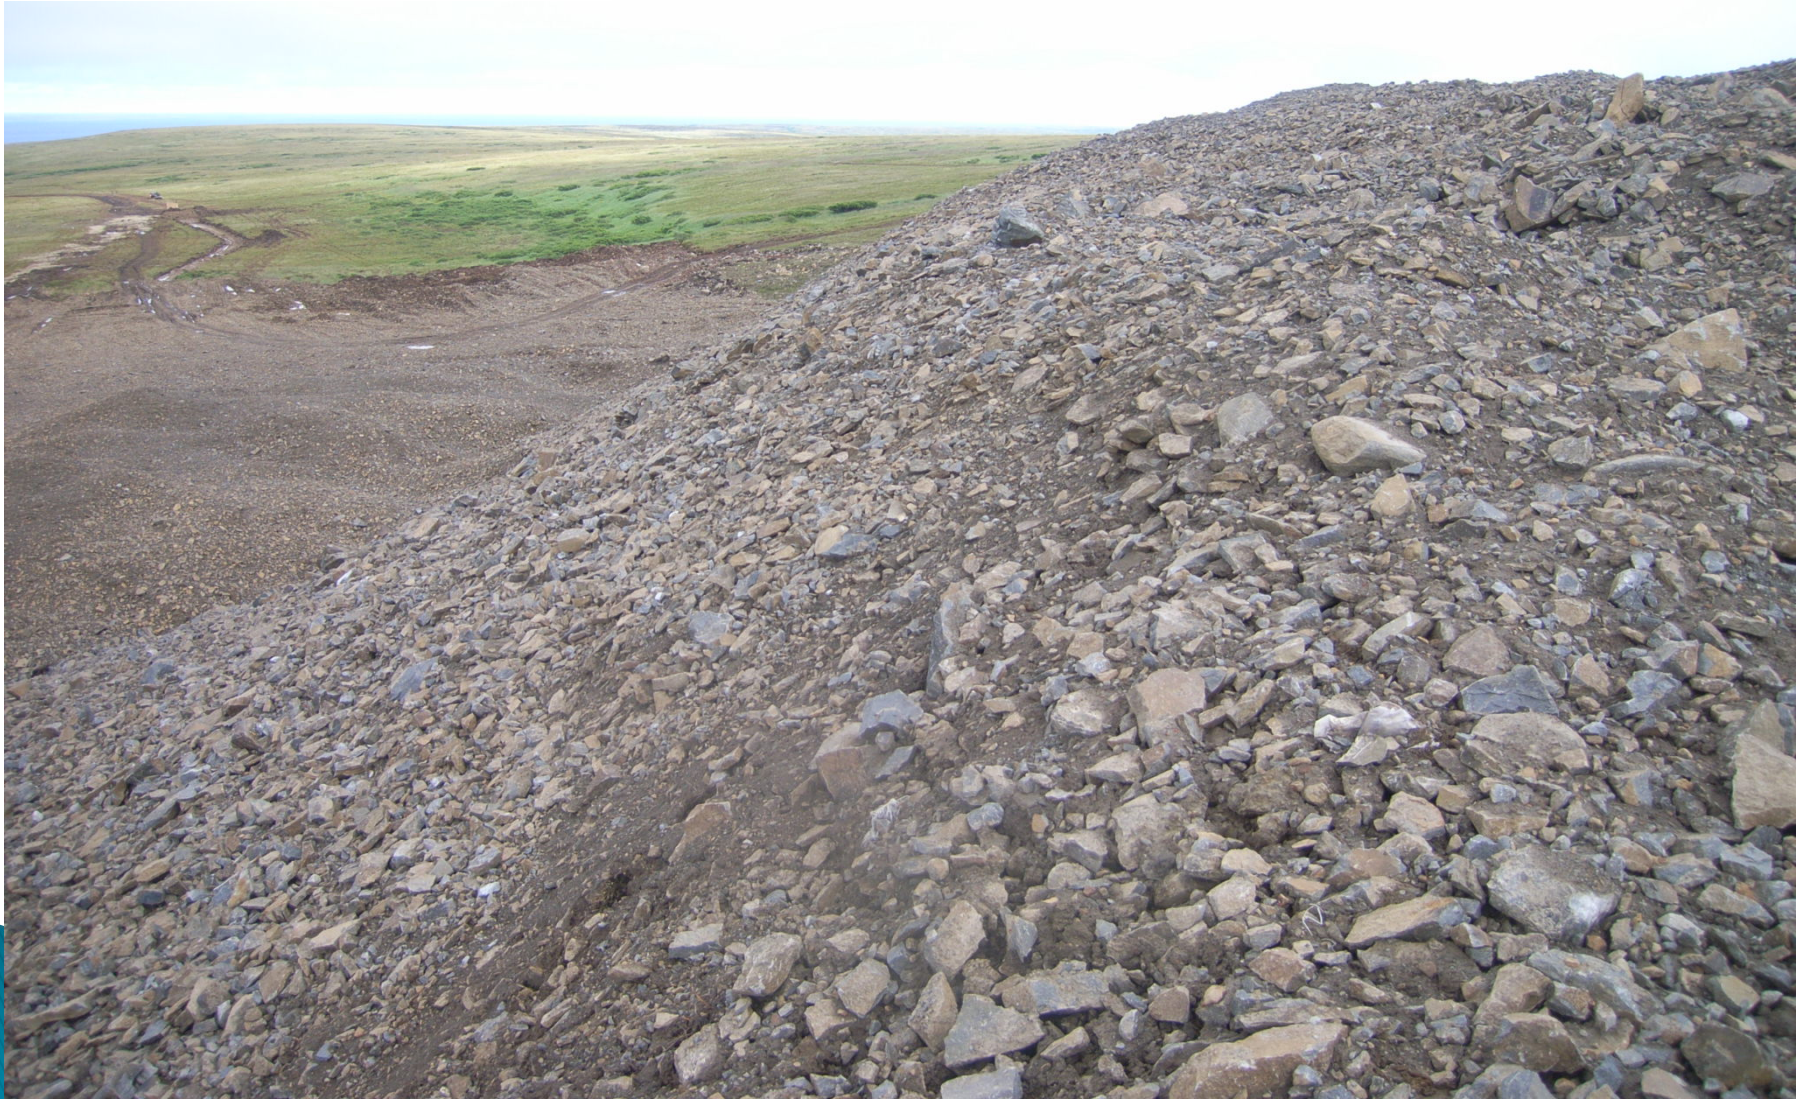
2011: Initial shot
material at “Hill 460”
Quarry. Drilled and shot
by the IRT Contractor

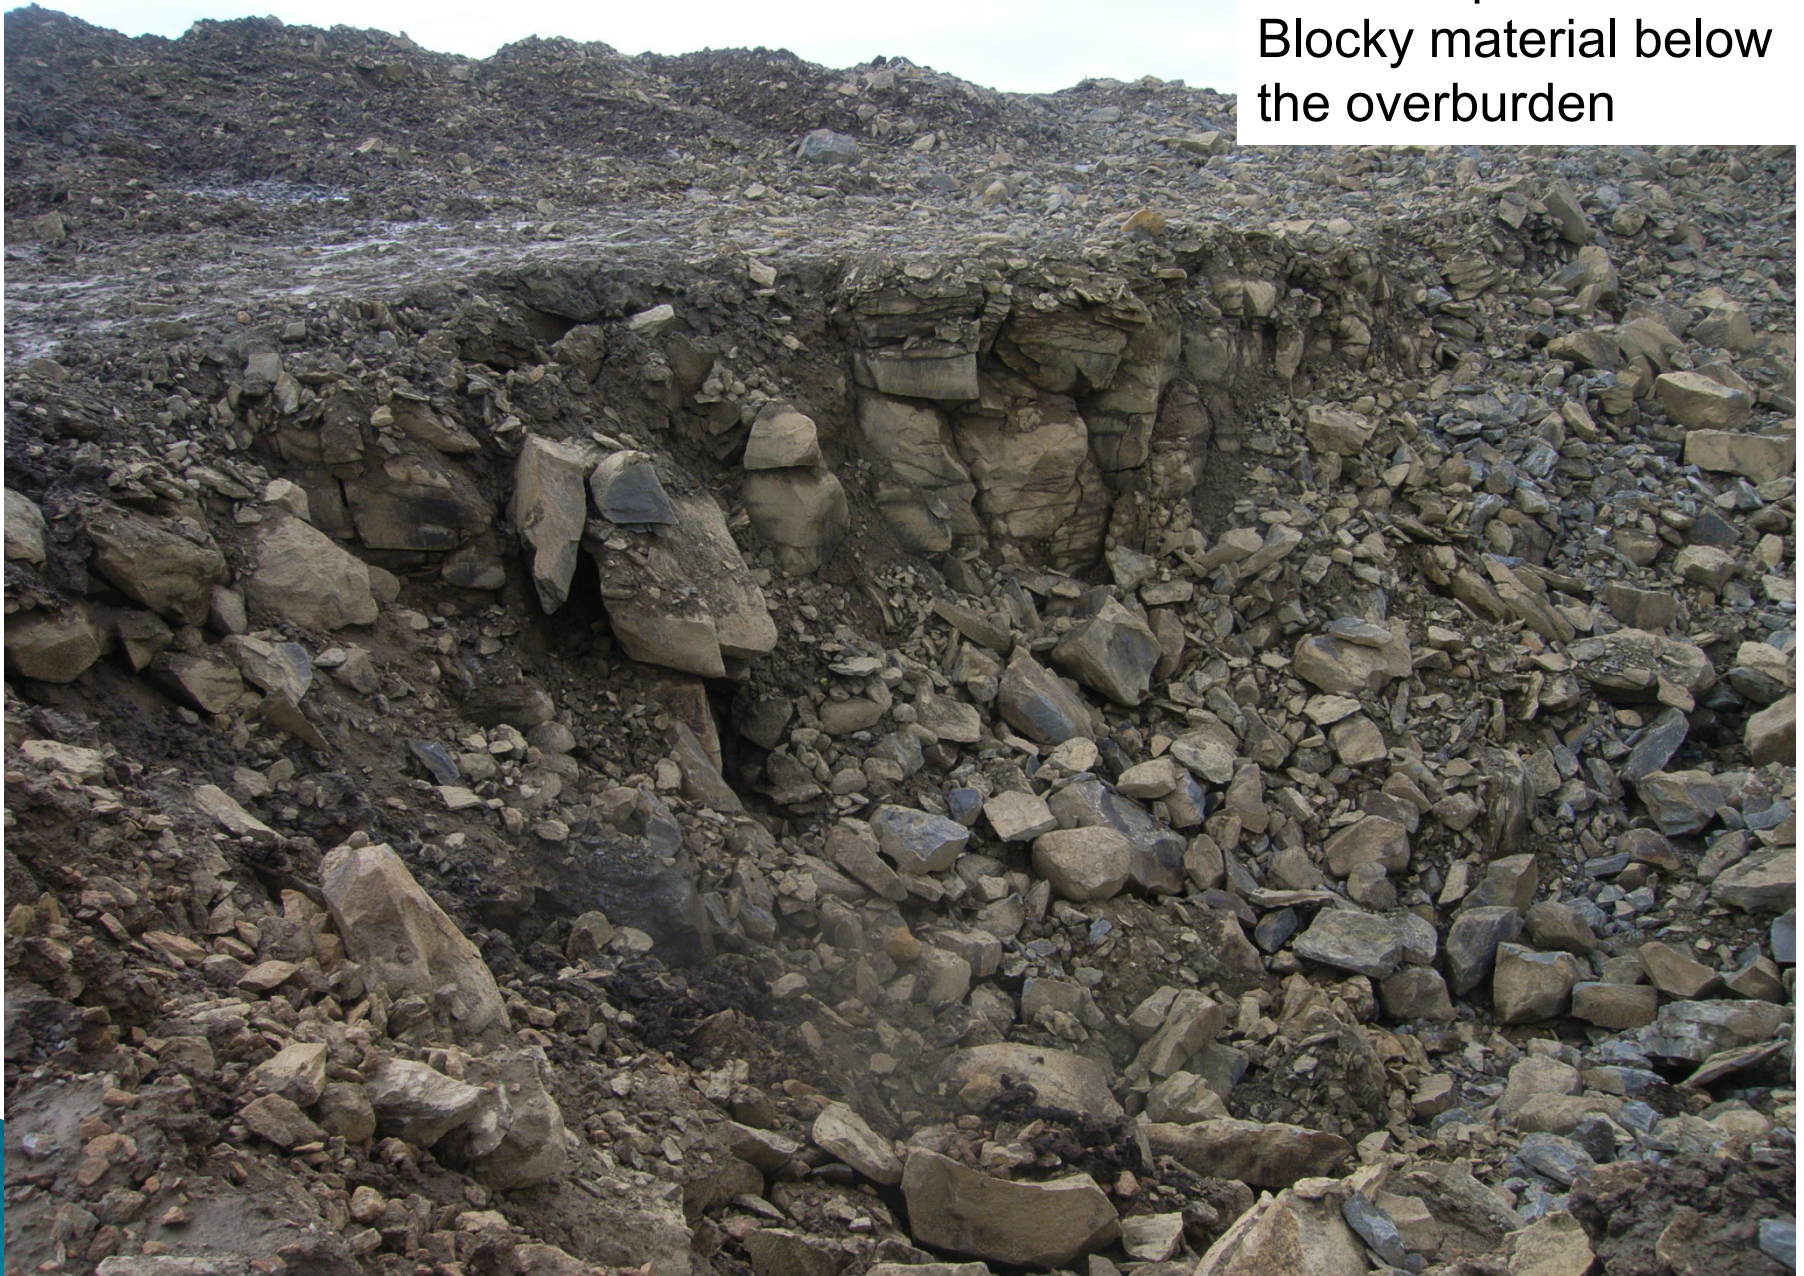
2011: Top of shot.
Blocky material below
the overburden

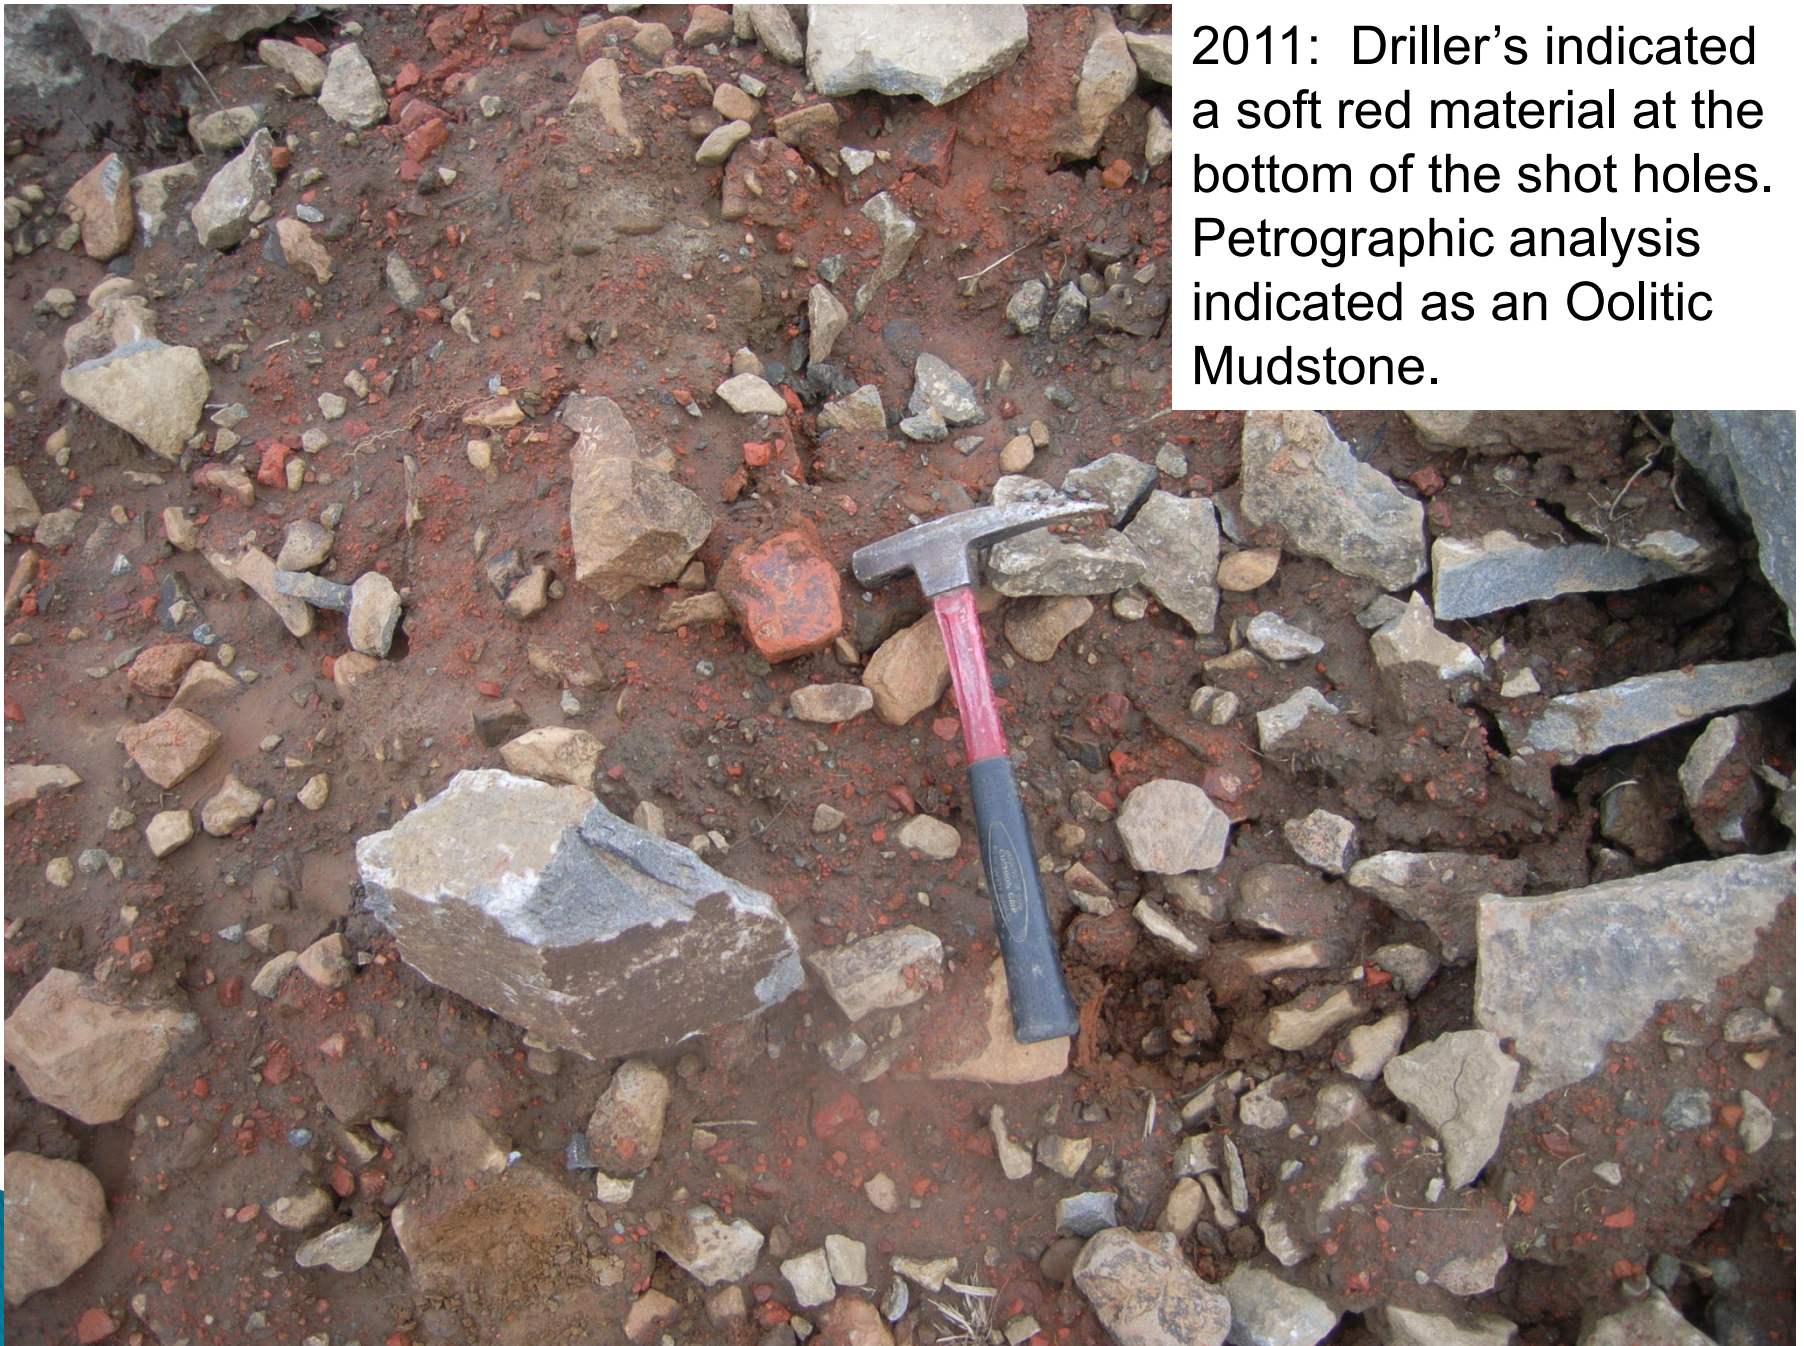
2011: Driller's indicated a soft red material at the bottom of the shot holes. Petrographic analysis indicated as an Oolitic Mudstone.

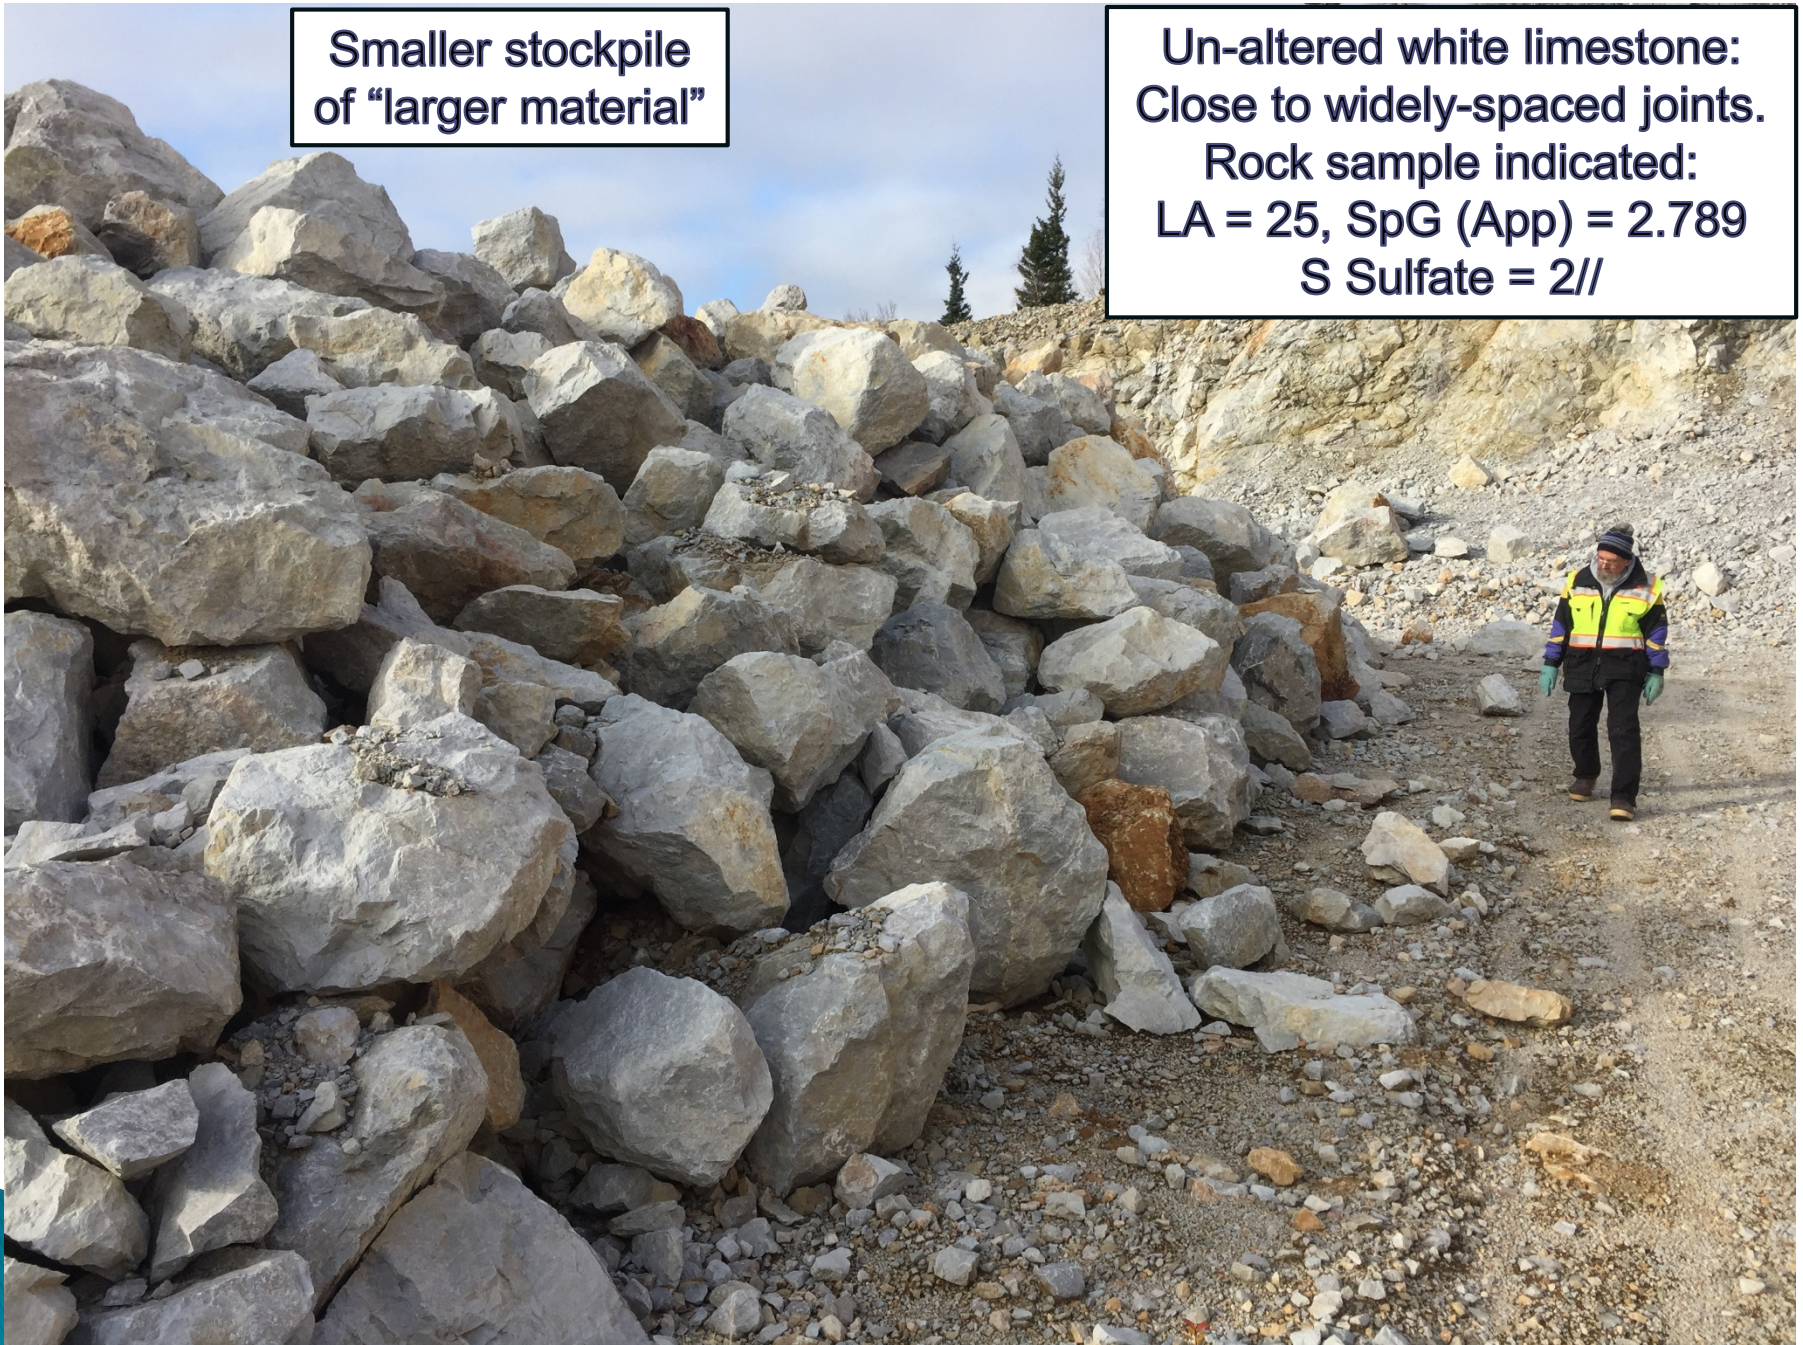
Smaller stockpile
of “larger material”

Un-altered white limestone:
Close to widely-spaced joints.
Rock sample indicated:
LA = 25, SpG (App) = 2.789
S Sulfate = 2//

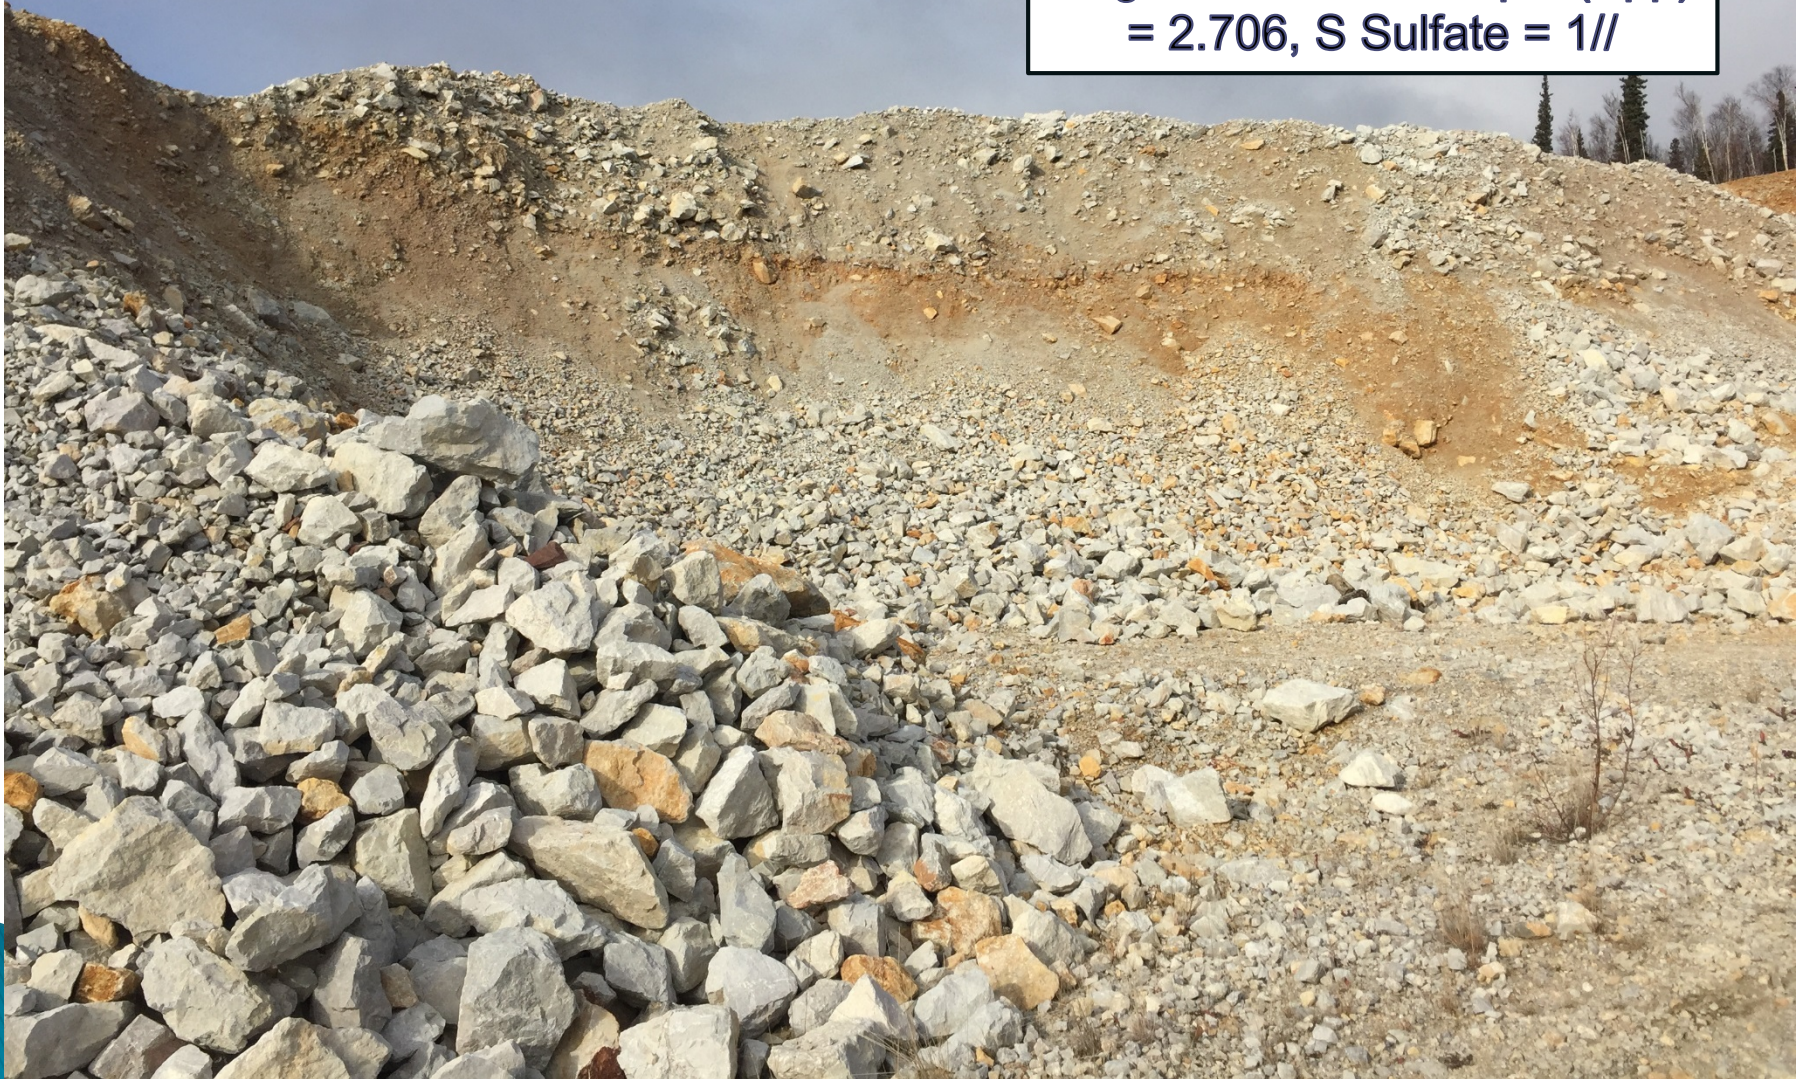
**Larger stockpile
of “smaller material”**

**Variable material. Altered and
not altered.**

**Rock sample indicated:
Deg = 34, LA = 25, SpG (App)
= 2.706, S Sulfate = 1//**
