A Geotechnical and Geological Perspective on MATERIAL SITES

Craig Boeckman, C.P.G. – Regional Geologist

Presentation TOC

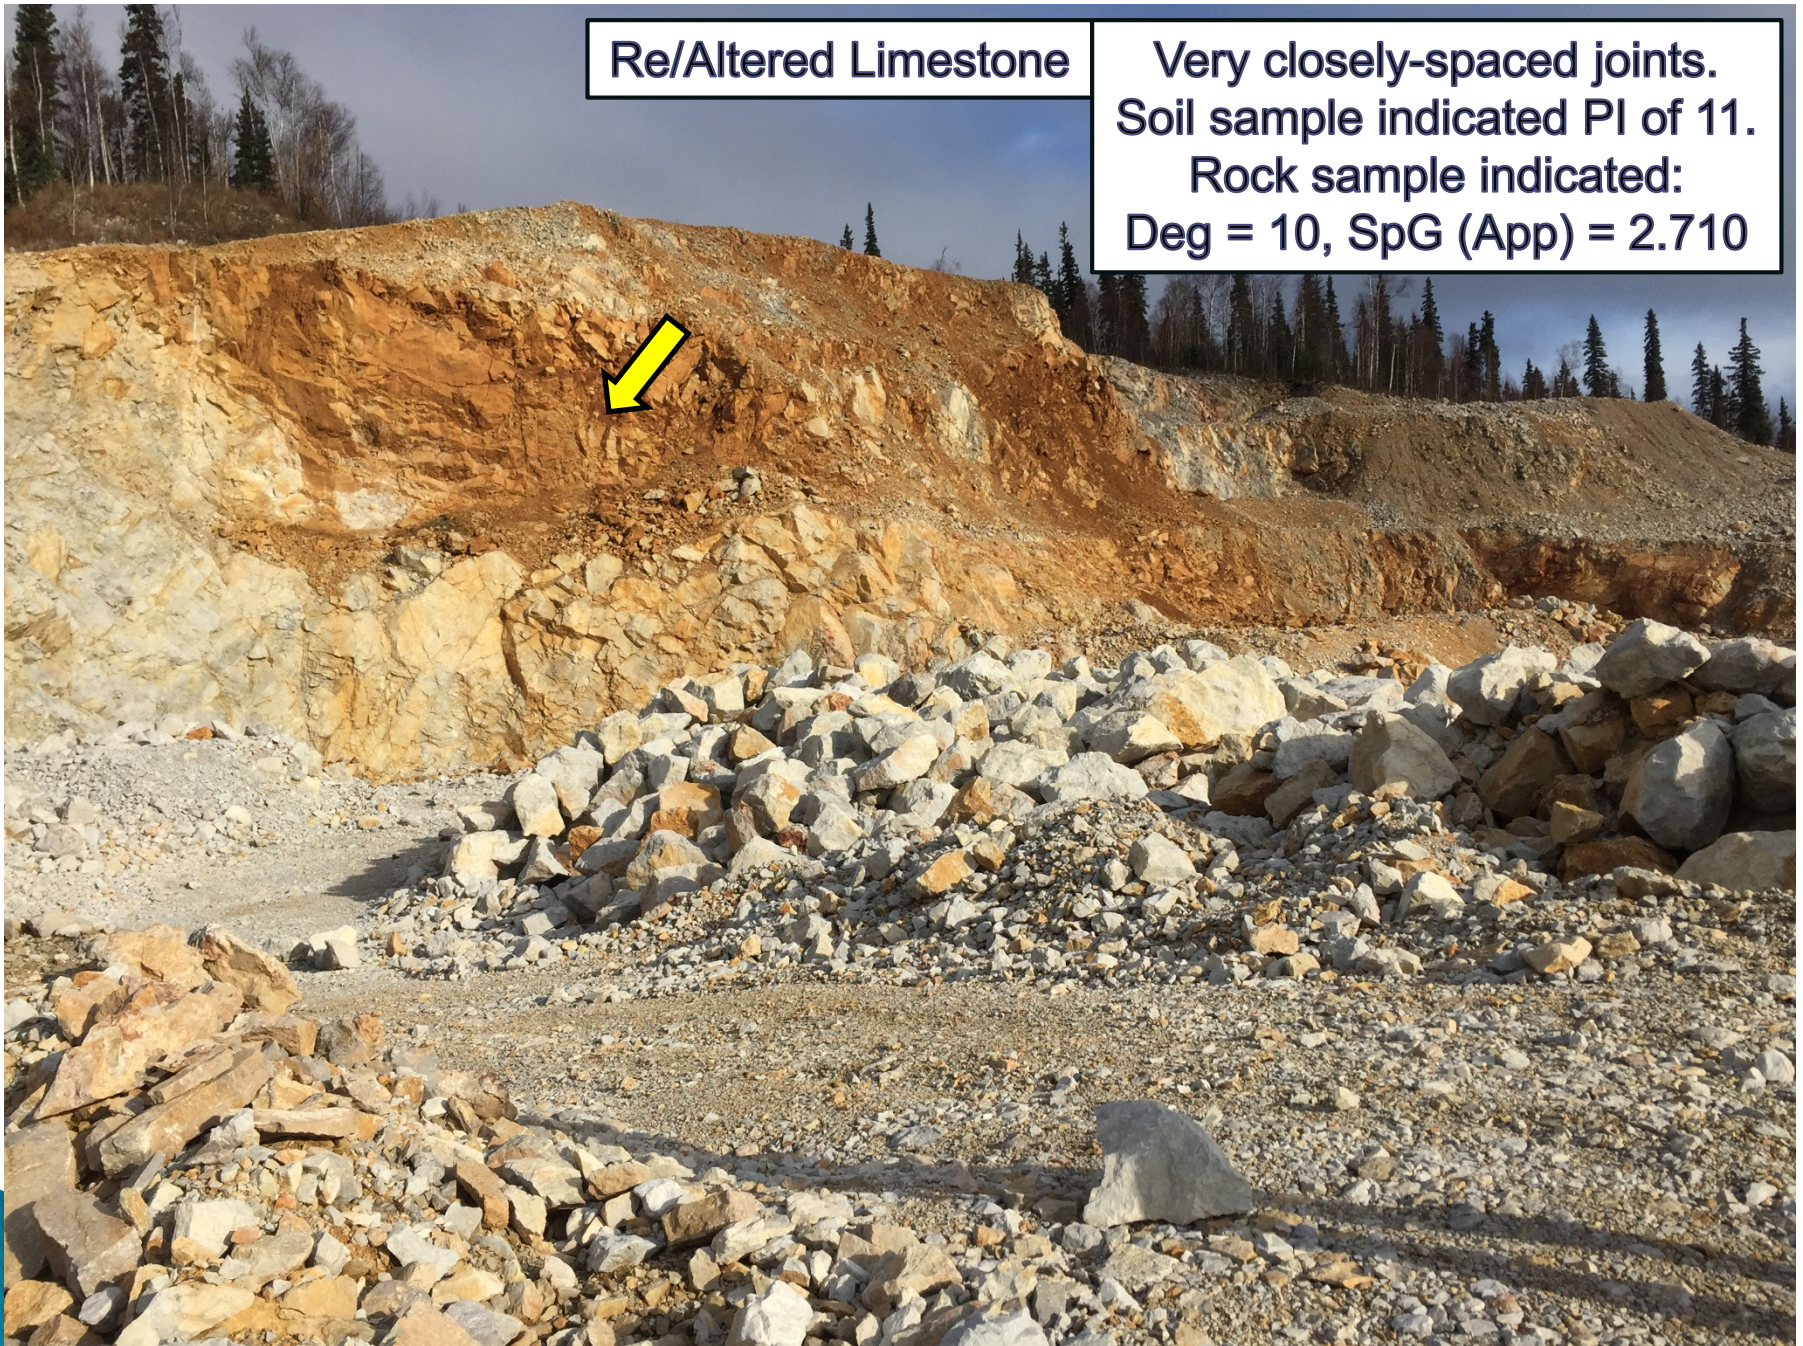
Re/Altered Limestone

Very closely-spaced joints.
Soil sample indicated PI of 11.
Rock sample indicated:
Deg = 10, SpG (App) = 2.710
