STATE OF ALASKA  
DEPARTMENT OF TRANSPORTATION  
&  
PUBLIC FACILITIES  
Survey Control Diagram  
AKSAS 58575

Brayton Drive Pavement Preservation

Located within: Sections 20, 29, 32, & 33, T12N, R3W, S.M.

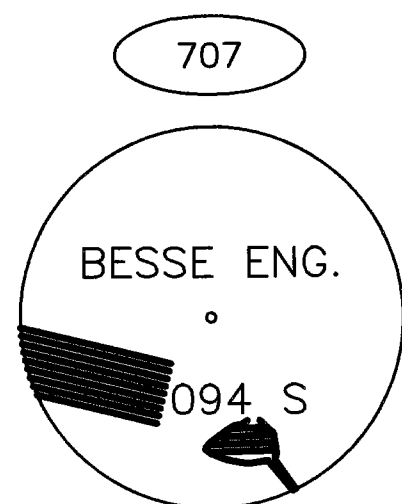
—FOUND—  
1 1/4" PLASTIC CAP  
FLUSH WITH GRADE

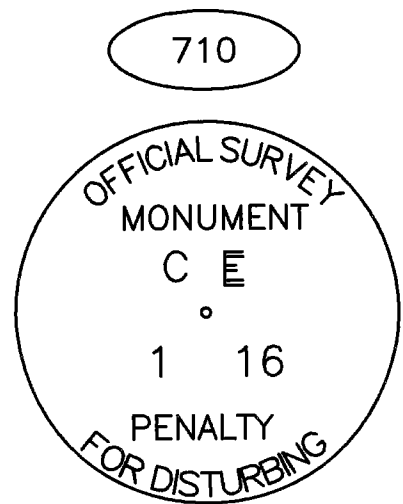
—FOUND—  
2 1/2" BRASS MONUMENT  
0.2' BELOW GRADE  
CAP DETACHED FROM PIPE

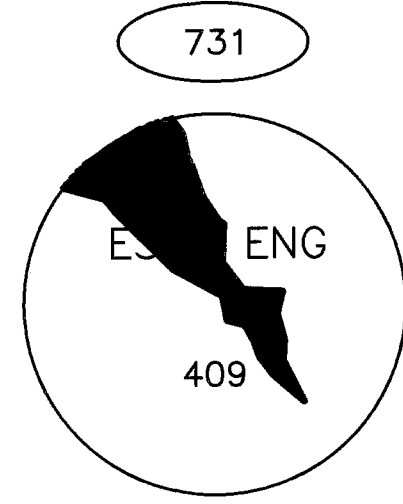
—FOUND—  
1 1/4" CRACKED PLASTIC CAP  
1.0' BELOW GRADE

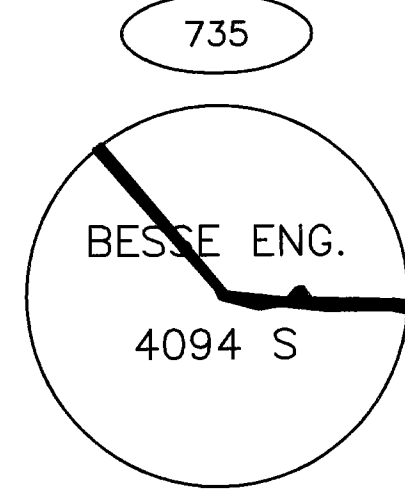
—FOUND—  
1 1/4" PLASTIC CAP  
0.3' ABOVE GRADE  
CAP CRACKED AND FADED

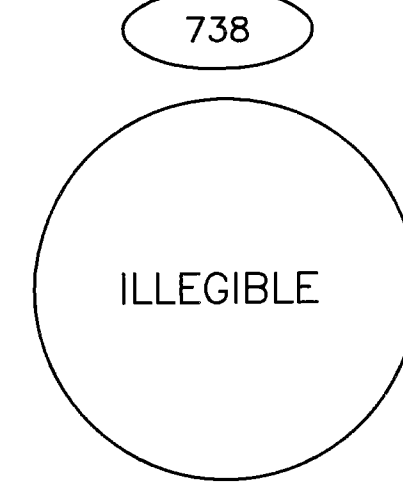
—FOUND—  
2" PLASTIC CAP  
0.4' BELOW GRADE  
BENT NORTHERLY

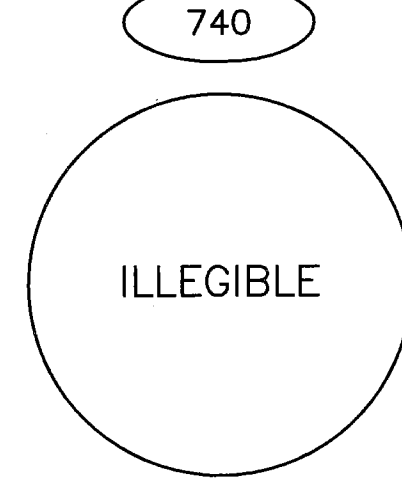
—FOUND—  
2" ALUMINUM CAP  
0.8' BELOW GRADE

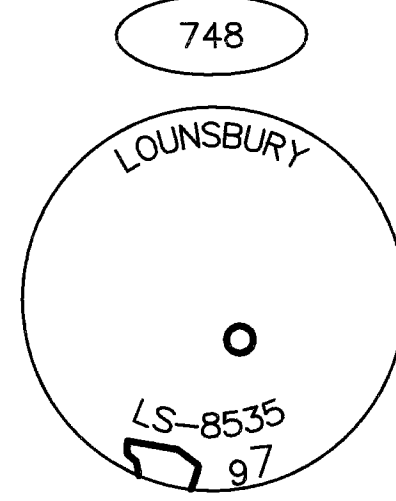
—FOUND—  
2" ALUMINUM CAP  
0.6' ABOVE GRADE

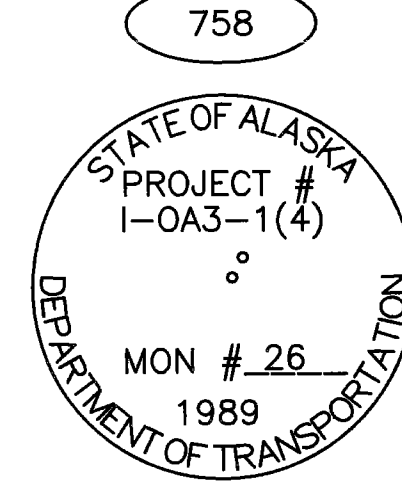
—FOUND—  
3 1/4" BRASS MONUMENT  
IN A MONUMENT CASE  
0.4' BELOW GRADE

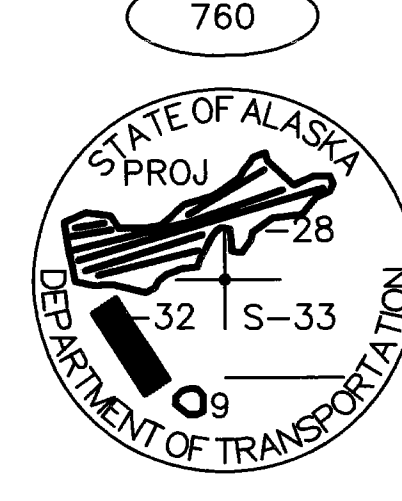
—FOUND—  
3 1/4" BRASS MONUMENT  
IN A MONUMENT CASE  
0.4' BELOW GRADE  
BENT WESTERLY
