# Runway Safety Area Practicability Study

Kwigillingok Airport Improvements

**KWIGILLINGOK AIRPORT**  
 KWIGILLINGOK, ALASKA  
 RSA PRACTICABILITY STUDY  
 ALTERNATIVE 1 EXHIBIT

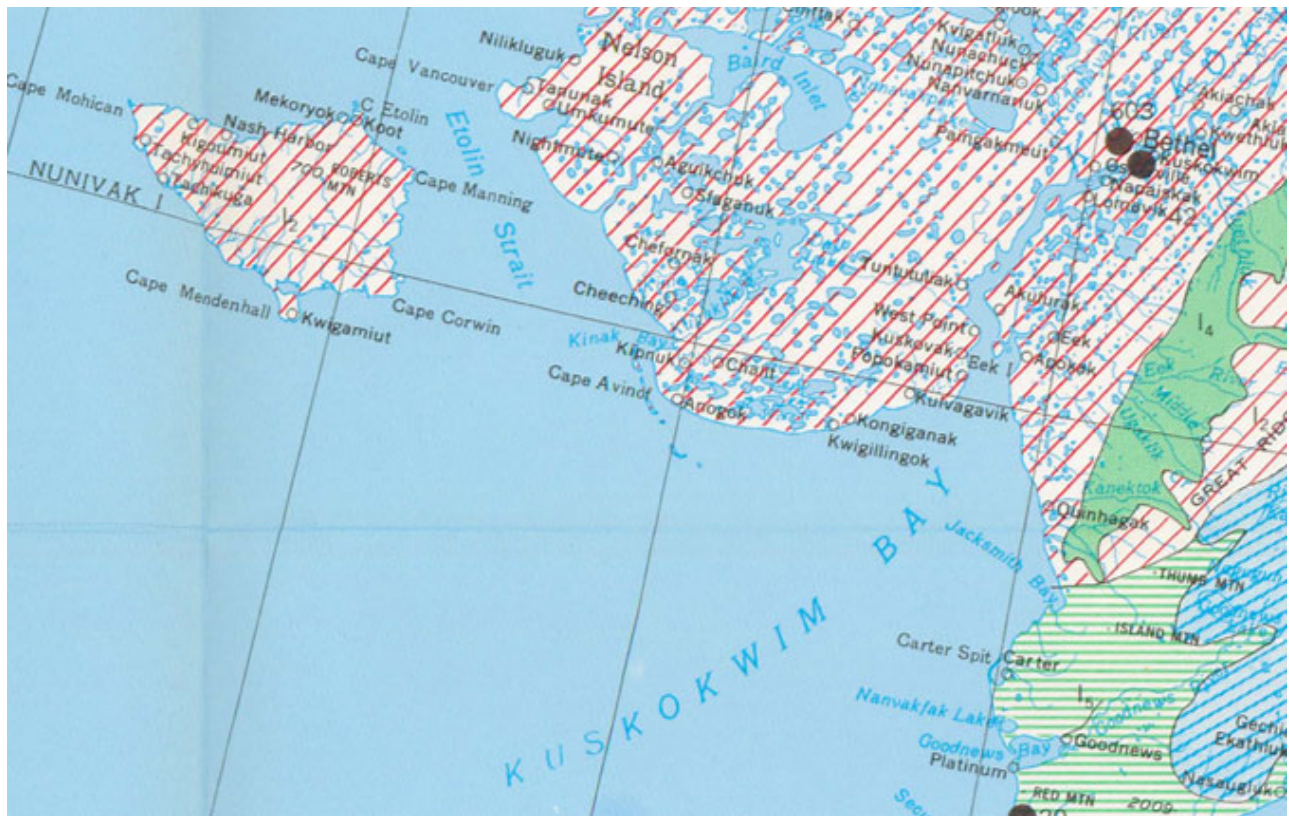
Figure 2 – Permafrost Map of Alaska

According to the Permafrost Map of Alaska (Oscar J. Ferrians, Jr., 1965), see Figure 2, Kwigillingok is generally underlain by moderately thick to thin permafrost. Any significant excavation in the project area can cause warming, and settlement.

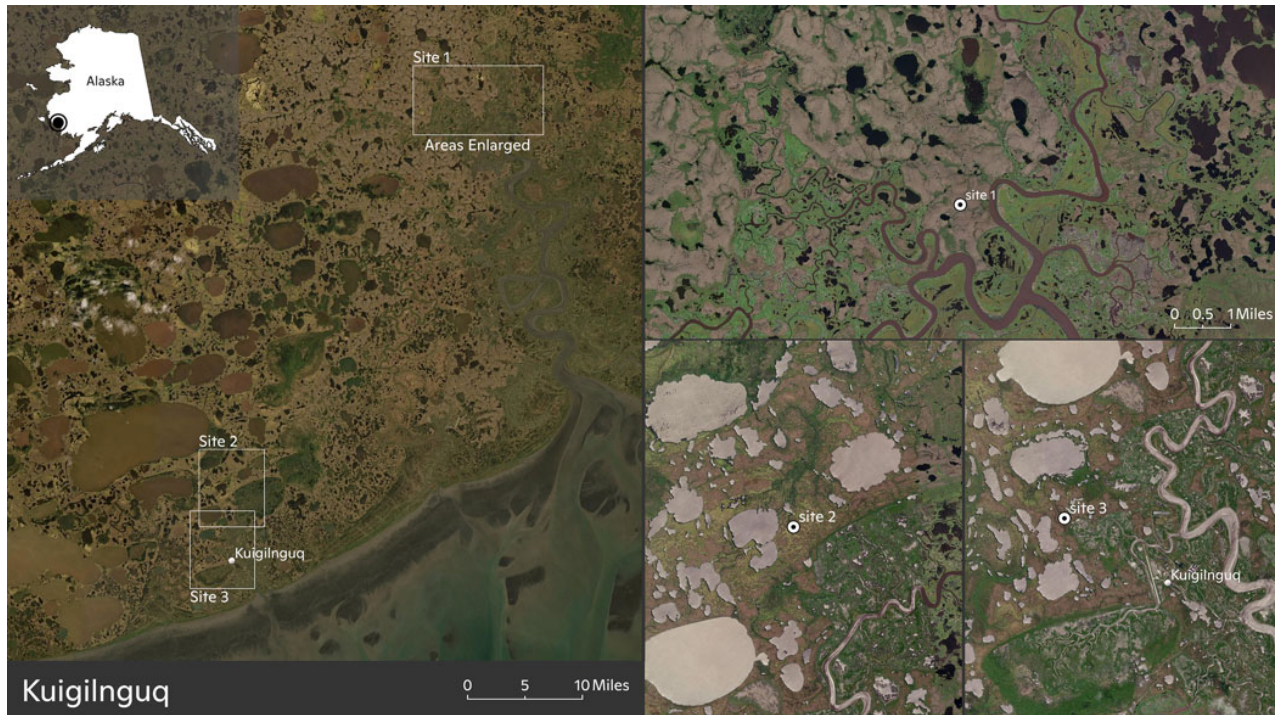
**Figure 4: Relocation Sites**

Alternative 3.A proposes to construct a 75' x 3,300' runway with a 150' x 3,900' RSA by relocating the airport to a new site. The Native Village of Kwigillingok is experiencing settlement and melting permafrost, which is exposing the village to more flooding and storm surge impacts. In response, the village is considering relocation and is evaluating three sites for community relocation (See Figure 4). These three sites are further discussed below.

*Site 1*

Site 1 is located approximately 23 miles from the current location. Relocation to Site 1 was deemed not practicable or feasible at this time because it would remove airport access from the village while they are likely still 20 to 30 years away from moving.

*Site 2 and 3*

Sites 2 and 3 are approximately 3.5 and 1 mile away from the current location, respectively. Both options would have significant wetland impacts and require a new Environmental Assessment and ALP. This would greatly increase the time required for project development and there are safety concerns about the current runway deteriorating to an unusable level before construction can begin.
