# FAIRVIEW LOOP ROAD REHABILITATION AND PATHWAY – STAGES 1 & 2

Project No.: NFHWY00748 / 0002523

# FINAL DESIGN STUDY REPORT

# ALASKA DEPARTMENT OF TRANSPORTATION AND PUBLIC FACILITIES

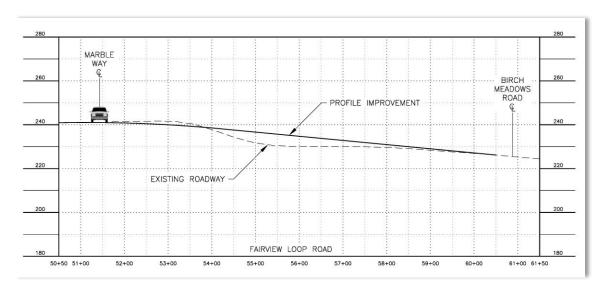
Figure 3 Marble Way

Site	Description
A	Marble Way – Figure 3
	Existing Conditions: Just south of the intersection with Marle Way, Fairview Loop has sharp vertical curves with design speeds as low as 25 mph. This results in poor sight lines for vehicles on Fairview Loop and turning traffic from Marble Way. The recorded accident history between the years 1998 and 2007 indicated Marble Way as one of the locations with a vehicle collision resulting in major injuries.  Safety Improvements: Flatten the grades and lengthening the vertical curves along Fairview Loop near Marble Way and minor realignment of the intersection to improve sight lines. The existing profile grade is near 7%, and will be flattened to just under 2%, improving visibility and driver experience.
В	<u>Carl Drive – Figure 4</u>
	Existing Conditions: Approximately 2,000 feet of Fairview Loop from Carl Drive to Chestnut Lane has a rolling profile with several vertical curves. Tangent sections in the existing profile are steep, approximately 12% max in multiple locations making winter driving treacherous. The rolling profile limits the sight distance of oncoming traffic  Safety Improvements: The Fairview Loop profile between Carl Drive and Chestnut Lane will be improved by flattening the grades and replacing the existing vertical curves with fewer lengthened ones. The new roadway profile drastically reduces the grade to approximately 6%, improves intersection sight distance at Carl Drive, and improves sight distance of oncoming traffic.

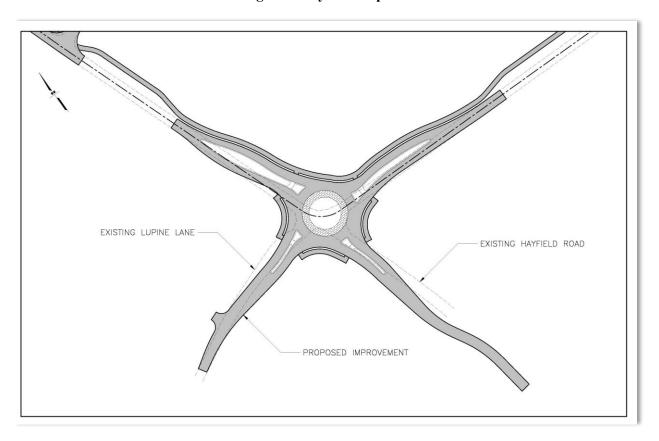
Figure 5 Hayfield-Lupine

C	<u>Lupine Lane/Hayfield Road – Figure 5</u>
	<b>Existing Conditions</b> : The existing configuration of the Hayfield-Lupine-Fairview intersection is stop-controlled via signage, while Fairview has a through motion. In its current configuration, vehicle movements have many points of conflict. It is not immediately clear to drivers which turning movements have the right-of-way and which movements are stop controlled. The intersection has a higher rate of crashes than the statewide average. <b>Safety Improvements</b> : The Hayfield-Lupine-Fairview intersection will be reconstructed, utilizing a 4 leg,
	single lane roundabout. The profile of the road will be raised to promote sight distance, drainage, and help calm traffic entering the intersection. The roundabout will also include pedestrian crossings and a pathway along the northside, connecting to the overall stage 2 pathway plan.
D	<u>Cottonwood Creek</u>

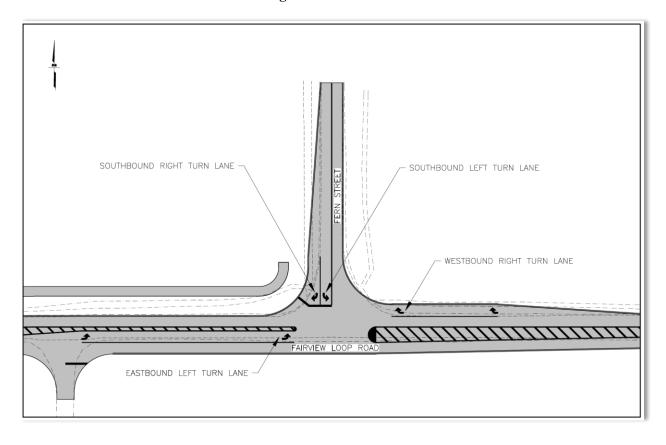
Figure 7 Fern Street

**Existing Conditions**: In 2014, Fern Street was extended north to shorten the distance and reduce the travel time for motorists traveling between KGB and Fairview Loop. With the extension, the ADT at the Fern Street/Fairview Loop intersection has increased. At Fairview Loop, Fern Street is a two-lane, stop-controlled, T-intersection that lacks turn lanes.

Safety Improvements: Existing roadway geometry, reported crash data, anecdotal evidence, and future traffic volume forecasts do not indicate the need for auxiliary turn lanes based on the PCM, AASHTO, and NCHRP guidance. However, to enhance safety and improve operations, an eastbound left turn lane will be constructed to separate vehicles that are slowing or stopping to turn left onto Fern Street from vehicles in the through lane. On Fern Street, separate southbound right and left turn lanes will be constructed to replace the single southbound lane. Refer to the Technical Memorandum found in Appendix C for additional information concerning the Fern Street/Fairview Loop intersection.

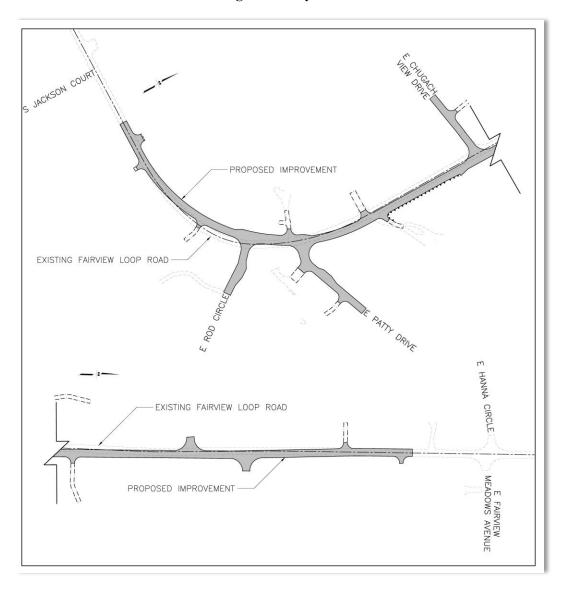
Figure 8 Patty-Rod

**Existing Conditions**: Fairview Loop from Patty to East Chugach View is comprised of multiple compound curves with a design speed of 30 mph. The existing vertical profile has an approximate maximum grade of 12% with a crest curve that prevents adequate intersection and stopping sight distance from being met. This location has a crash history making it a candidate for safety spot improvements.

**Safety Improvements**: Fairview Loop will be realigned to accommodate a single, large curve that meets the horizontal geometry for a design speed of 40 MPH. The profile will also be adjusted, moving to a max grade of 8%. This design speed and profile grade are less than what is recommended for new construction but were selected to maximize safety improvements while remaining cost effective and minimizing impacts. The change in profile will lower the peak of the crest curve approximately eight (8) feet. With the combination of horizontal and vertical alignment changes, both intersection and stopping sight distance are improved for this location. In addition, the shoulder will be widened near Rod and Patty to eight (8) feet. This will provide space to allow vehicles to make an evasive maneuver if required.

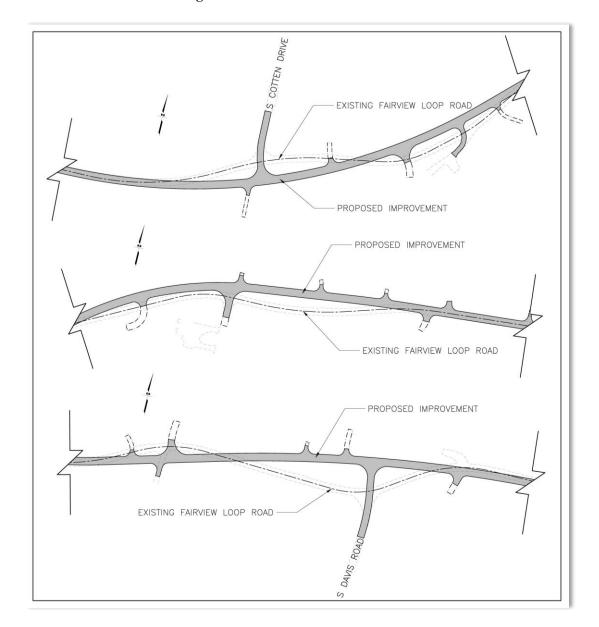
Figure 10 Cotten Drive & Davis Road

**Existing Conditions**: Horizontally, Fairview Loop between Cotten Drive and Davis Road consists of a series of S-curves. The design speed of the S-curves varies between 30 mph and 40 mph. Vertically, Fairview Loop is relatively flat. The K-values for the crest and sag vertical curves correspond to design speeds greater than 50 mph. Between 1998-2007, six recorded accidents occurred in the vicinity of Cotten Drive and six recorded accidents occurred in the vicinity of Davis Road.

**Safety Improvements**: Adjustments to the horizontal alignment are needed to replace the existing series of Scurves. Long tangent sections and five flat sweeping curves with radii exceeding the 50 mph design speed will replace the existing 1.12 miles of Fairview Loop beginning just west of Cotten Drive to just east of Davis Road.

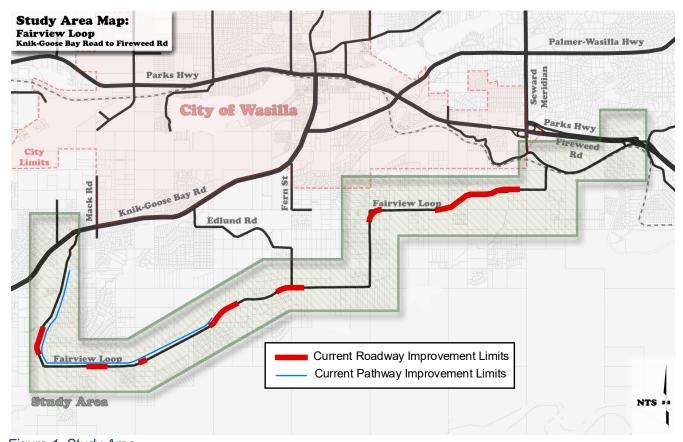
Figure 1. Study Area

Figure 1 shows the original 2010 3R analysis study area which we used for this updated analysis.

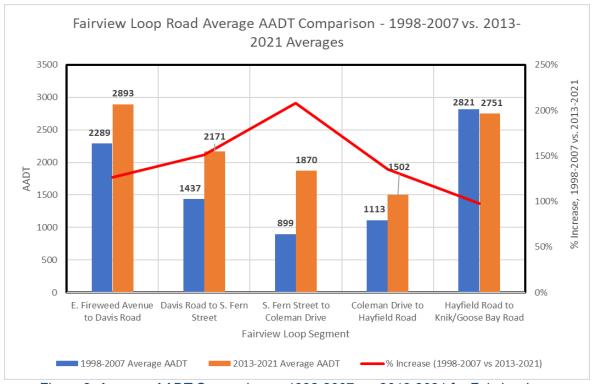
The following Figure 2 and Figure 3 provide a graphic comparison of AADT increases from the 2010 3R report to the most recent available volume data for Fairview Loop Road and major side streets.

Figure 2. Average AADT Comparison – 1998-2007 vs. 2013-2021 for Fairview Loop

As shown in the preceding table and figures, traffic volumes have increased by 125-210% on most segments of Fairview Loop Road and by 120-285% at major side streets from the 1998-2007 time period used in the 2010 3R analysis and currently available traffic volume information.

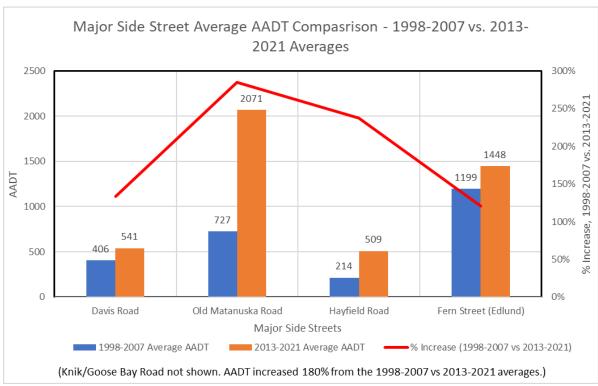
Figure 3. Average AADT Comparison – 1998-2007 vs. 2013-2021 for Major Side Streets

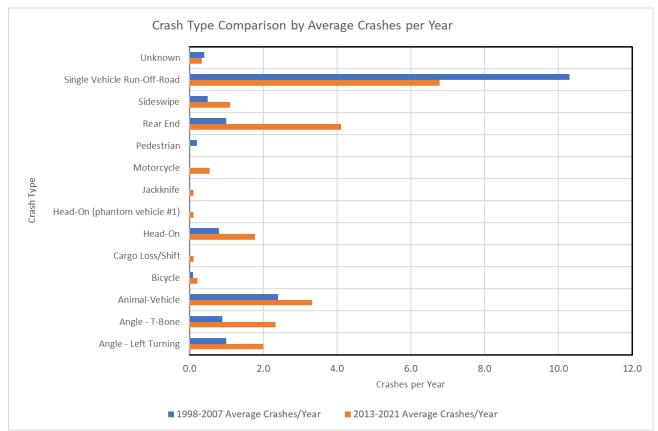
Figure 4 compares crash types per year and Figure 5 compares percentage of intersection vs. segment crashes for the 1998-2007 vs. 2013-2021 time periods

Figure 4. Crash Type Comparison by Average Crashes per Year for 1998-2007 vs. 2013-2021 Time Periods

The major crash type, single vehicle run-off-the-road crashes, have decreased significantly during the two study periods while rear end, head-on and sideswipe crashes have all increased. This is reflected in the decrease in single vehicle and increase in multi-vehicle crashes discussed later in the report. The other large crash type, animal-vehicle, remained similar by percentage of total crashes.

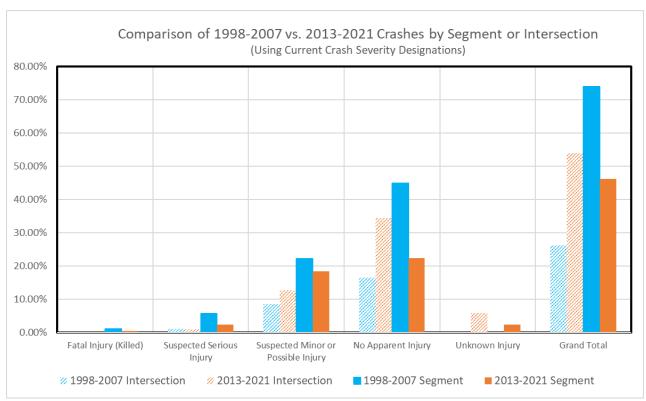
Figure 5. Crash Type Comparison by Intersection vs. Segment for 1998-2007 vs. 2013-2021 Time Periods

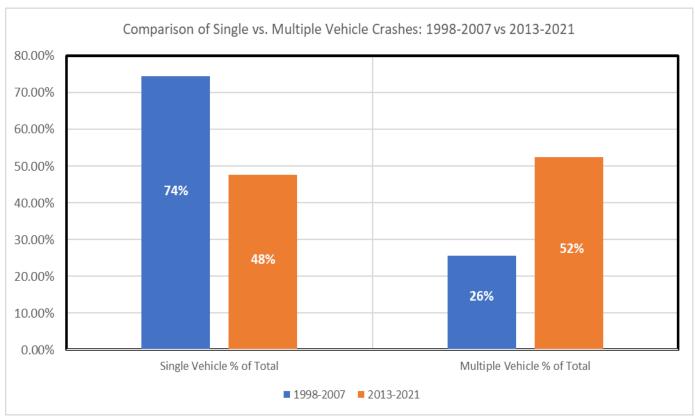
Figure 6 compares crashes by single vs. multiple vehicles for the 1998-2007 and 2031-2021 time periods.

Figure 6. Comparison of Single vs. Multiple Vehicle Crashes for the 1998-2007 and 2013-2021 Time Periods

These data set comparisons also show that single vehicle crashes are down from 74% to 48% of total crashes for the two time periods. However, multi-vehicle crashes increased from 26% to 52% of total crashes during that same period.

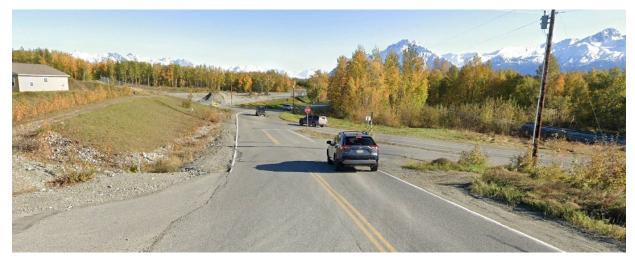
A review of individual crash narratives for crashes at this location (either officer or driver) refer to not being able to stop at stop/yield sign due to the downhill approach on Old Matanuska Road. Figure 7 and Figure 8 show the downgrade approach to Fairview Loop on Old Matanuska Road.

Figure 7. Looking East on Old Matanuska Road showing the downhill approach to Fairview Loop Road

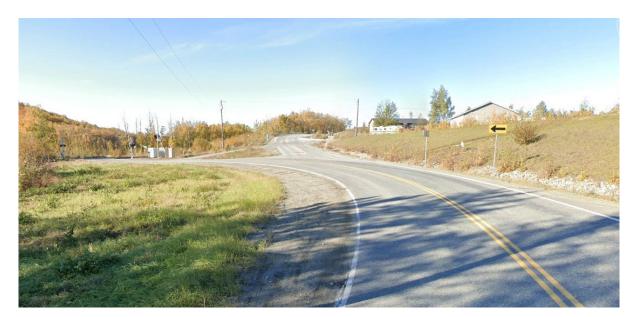
Other narratives also site the lack of a visual queue as to the alignment of westbound Fairview Loop at Old Matanuska Road, making it difficult for drivers waiting at the stop sign on Old Matanuska Road determine if westbound Fairview Loop traffic is turning onto Old Matanuska Road or continuing west on Fairview Loop. Figure 8 shows the alignment issue.

Figure 8. Intersection geometry on westbound Fairview Loop appears to become Old Matanuska Road

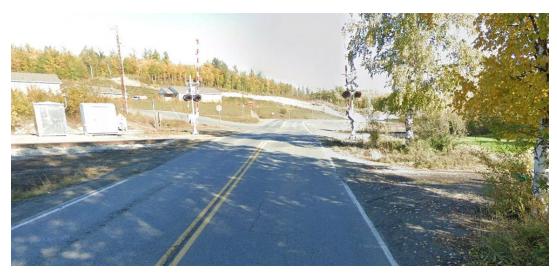
Another issue affecting the intersection geometry is the nearby railroad/highway grade crossing which limits the ability to improve both approach grades and intersection alignment. Figure 9 shows the proximity of the railroad/highway grade crossing to the intersection.

Figure 9. Proximity of Old Matanuska Road Intersection to Railroad/Highway Grade Crossing

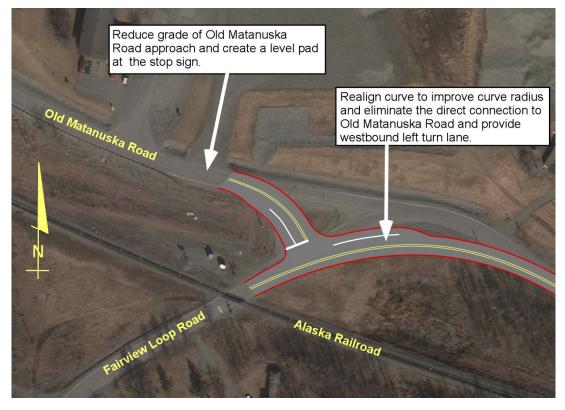
Some of these crashes could be mitigated by realignment of the curve, reducing the downgrade approach on Old Matanuska Road, adding shoulders, and improving the intersection channelization. Figure 10 shows possible geometric improvements which could help mitigate crashes at this intersection.

Figure 10. Potential Geometric Improvements at Old Matanuska Road

Although some of these changes could improve the crash situation here, it is important to note that there are several issues relating to potential realignment of this intersection and flattening of the horizontal curve which may require a separate project to address. They include:

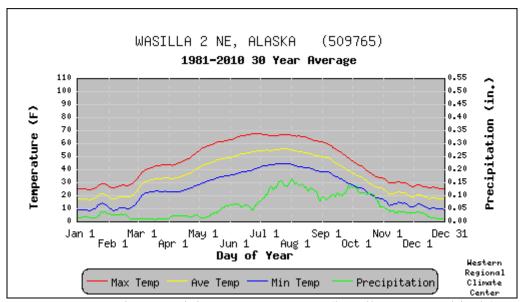
The average maximum temperature in January is 23 degrees Fahrenheit with an average minimum temperature of 8 degrees. In July, average maximum and minimum temperatures are 67 and 45 degrees Fahrenheit, respectively.

**Graph 1-** Maximum, Minimum Temperatures (http://www.wrcc.dri.edu)

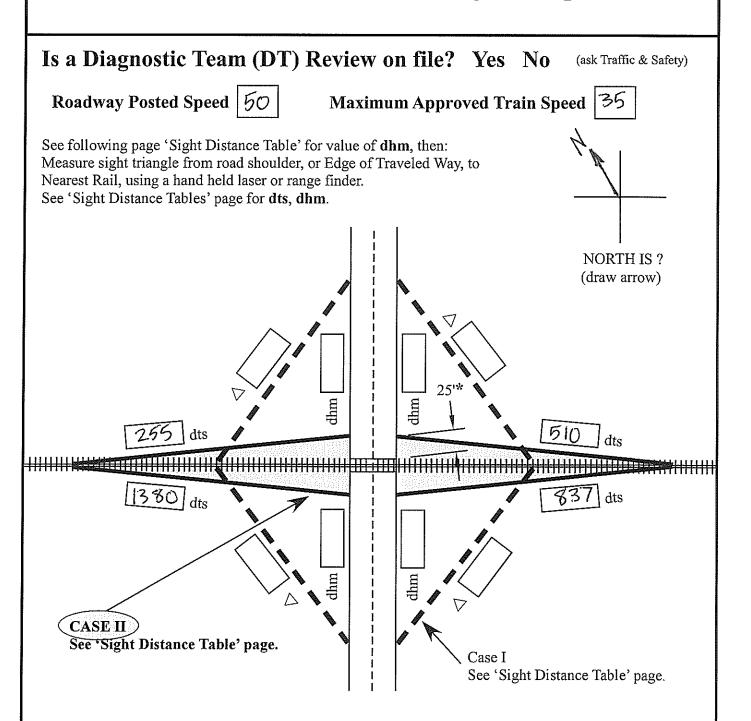
## SIGHT TRIANGLES

\*25 ft. = Stopped Condition for motorist, measured from the nearest rail. This will normally be 10 ft. back from the STOP bar or the Crossbuck Sign.

All distances in feet.
