WETLANDS DETERMINATION, FUNCTIONAL ASSESSMENT AND HABITAT ASSESSMENT FOR PROPOSED KIANA AIRSTRIP IMPROVEMENTS, ALASKA

Alaska Department of Transportation & Public Facilities 2301 Peger Road Fairbanks, AK 99709-5316

ABR, Inc.—Environmental Research & Services P.O. Box 240268 Anchorage, AK 99518

January 2013

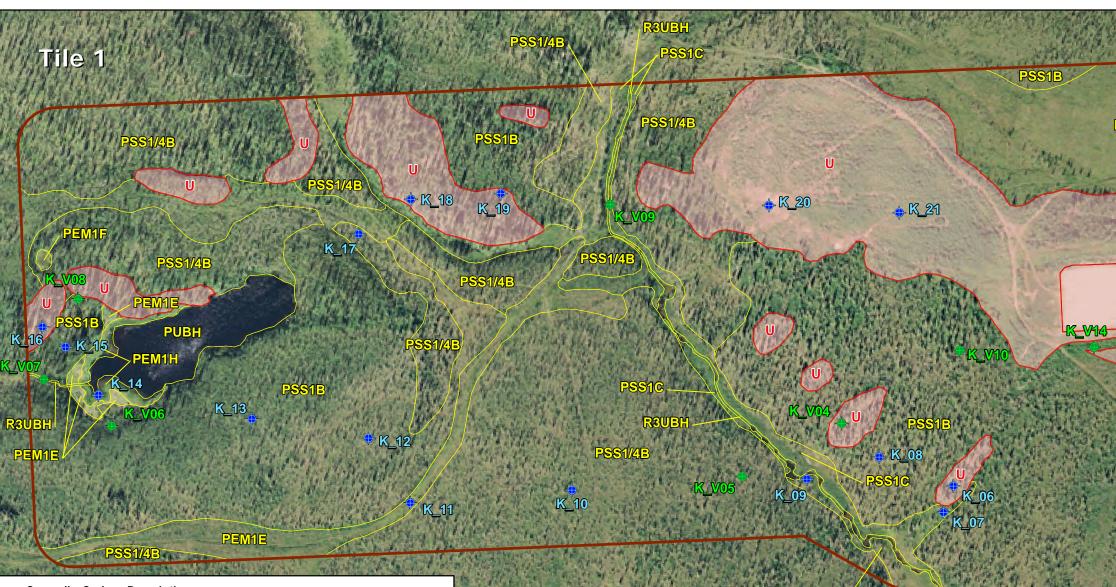
Material Site Tile 3 Airport Site

Cowardin Code Descri		Description				
	Non-Navigable Waters of the U.S.					
	R3UBH	R3UBH Upper Perennial River				
	PUBH	H Permanently Flooded Pond				
	Wetlands					
	PEM1H	Permanently Flooded Emergent Marsh				
	PEM1F	Semi-permanently Flooded Emergent Meadow				
	PEM1E	Seasonally Flooded Saturated Emergent Meadow				
	PEM1C	Seasonally Flooded Emergent Meadow				
	PEM1B	Saturated Emergent Meadow				
	PSS1C	Seasonally Flooded Deciduous Shrub Scrub				
	PSS1B	Saturated Deciduous Shrub Scrub				
	PSS3/1B	Saturated Broadleaf Evergreen/Deciduous Shrub Scrub				
	PSS1/3B	Saturated Deciduous Shrub/Broadleaf Evergreen Scrub				
	PSS1/4B	Saturated Deciduous Shrub/Needleleaf Evergreen Scrub				
	PFO4B	Saturated Needleleaf Evergreen Forest				
	Non-Wetlands					
	U	Upland				
	Us	Upland Fill

Emergent and shrub-dominated wetlands are the most common types found in the Airport and Material site study areas, although the emergent classes are confined to the Airport study area. Emergent wetlands range in hydrologic regime from saturated to permanently flooded (PEM1H, PEM1F, PEM1E, and PEM1B), with Saturated Emergent Meadow (PEM1B) being the most prevalent (3.19 acres, 1.51%). This wetland type was primarily associated with disturbed surfaces alongside the existing airport runway and consisted primarily of *Calamagrostis canadensis* (bluejoint grass) (Table 1, Figure 2.1 and 2.2). The permanently flooded, semipermanently flooded and seasonally flooded saturated emergent types reflect a lacustrine fringe gradient associated with the larger pond west of the airport. Combined, they account for 4.34 acres (2.05%) (Table 1). Common species include *Eriophorum angustifolium* (tall cottongrass), *Carex utriculata* (Northwest Territory sedge), *Arctophila fulva* (pendantgrass), *Equisetum fluviatile* (water horsetail), and *Comarum palustre* (purple marshlocks). Surface water (A1 hydrology indicator) is present throughout. Additional PEM1H and PEM1F wetlands occur as small depressions north of the runway and within a drainage feature connected to the stream running west of the airport (Figure 2.1 and 2.2).

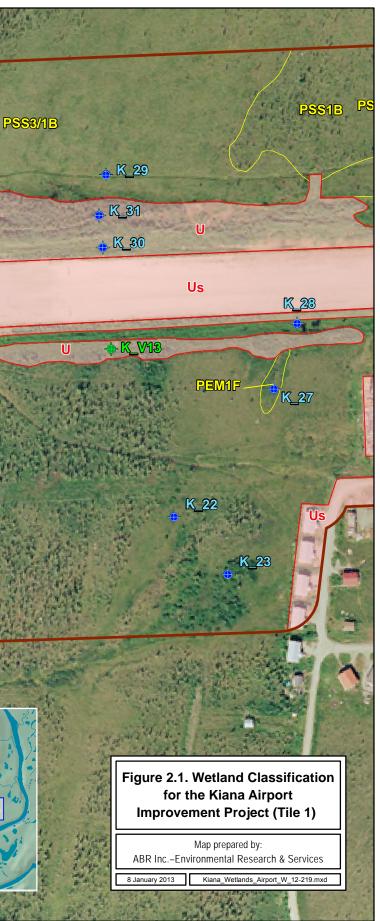
Notes: Mapping by ABR, Inc. Color aerial orthorectified photography by Kodiak Mapping, Inc. at a nominal scale of 1:18,000: pixel resolution 4 feet. Map projection: Alaska Albers, NAD 1983, meters. Map scale when printed at 11"x17" is 1:3,000 or 1"=250'.

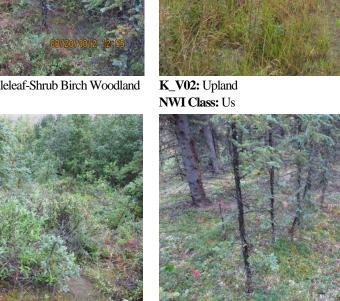
K_V01: Palustrine Saturated Needleleaf-Shrub Birch Woodland NWI Class: PFO4B

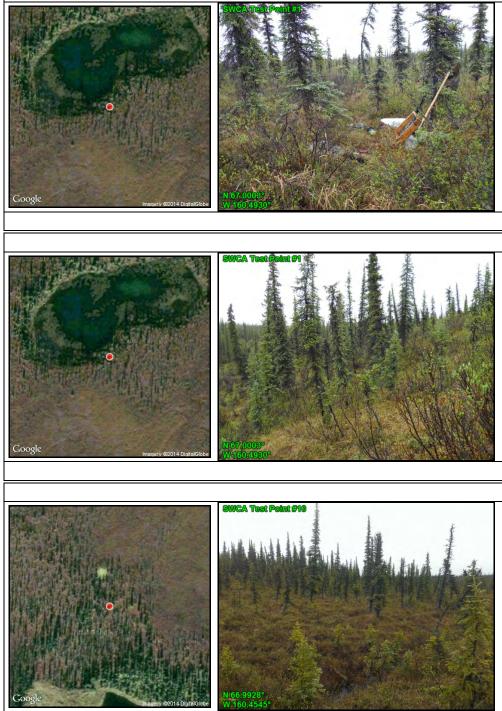
Attributes	
1	
SWCA Test Point #1	
PSS. Characteristic	
overview of PSS	
habitat.	
N 67.0003°	
W 160.4930°

Attributes	
Title	1
Subject	SWCA Test Point #1
	PSS. Characteristic
Description	overview of PSS
	habitat.
Latitude	N 67.0003°
Longitude	W 160.4930°

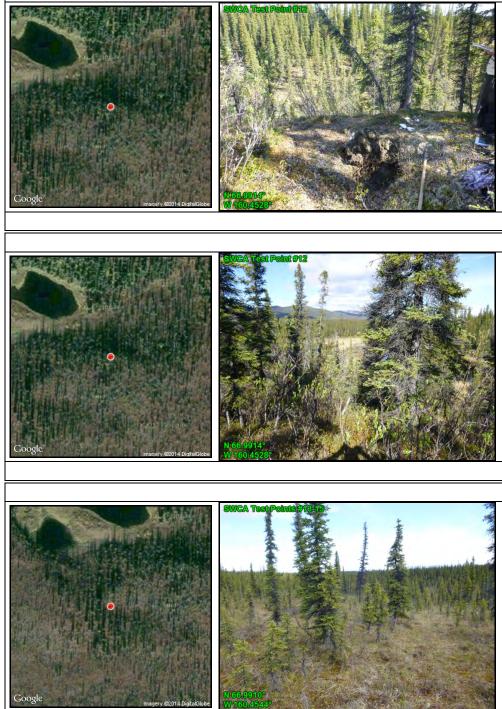
Attributes	
12	
SWCA Test Point #12	
Upland. View of	
hillside bluff upland	
habitat.	
N 66.9914°	
W 160.4528°	
	12 SWCA Test Point #12 Upland. View of hillside bluff upland habitat. N 66.9914°

Attributes	
Title	12
Subject	SWCA Test Point #12
Description	Upland. View of
Description	hillside bluff upland
	habitat.
Latitude	N 66.9914°
Longitude	W 160.4528°
